**Investigation of Two Bridge Alternatives for
Low Volume Roads - Phase II
Volume 2 of 2**

**Concept 2:
Beam In Slab Bridge**

July 2000

Iowa DOT Project TR-410

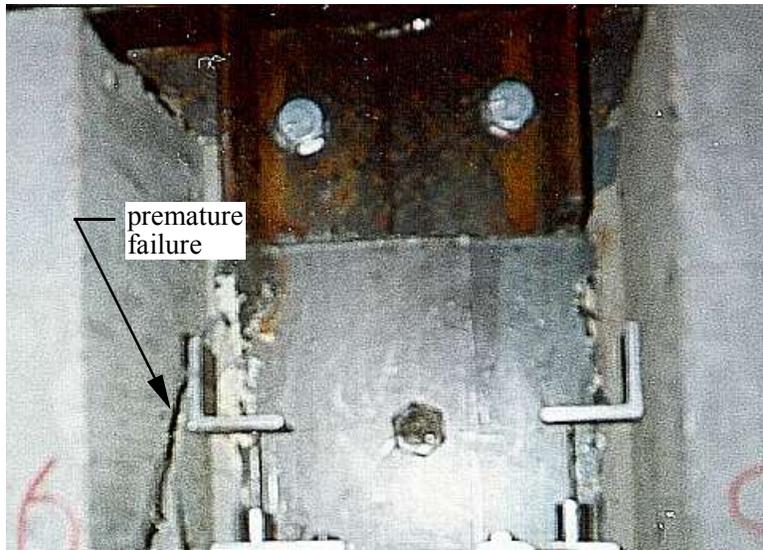
Figure 5.20. Photograph of specimen SH3-6 during testing.

For specimen SH3-6, results have been neglected because the 2 in. x 2 in. angle on the left concrete block was not in place due to a premature crack in the concrete while the test was still in progress (Fig. 5.20).

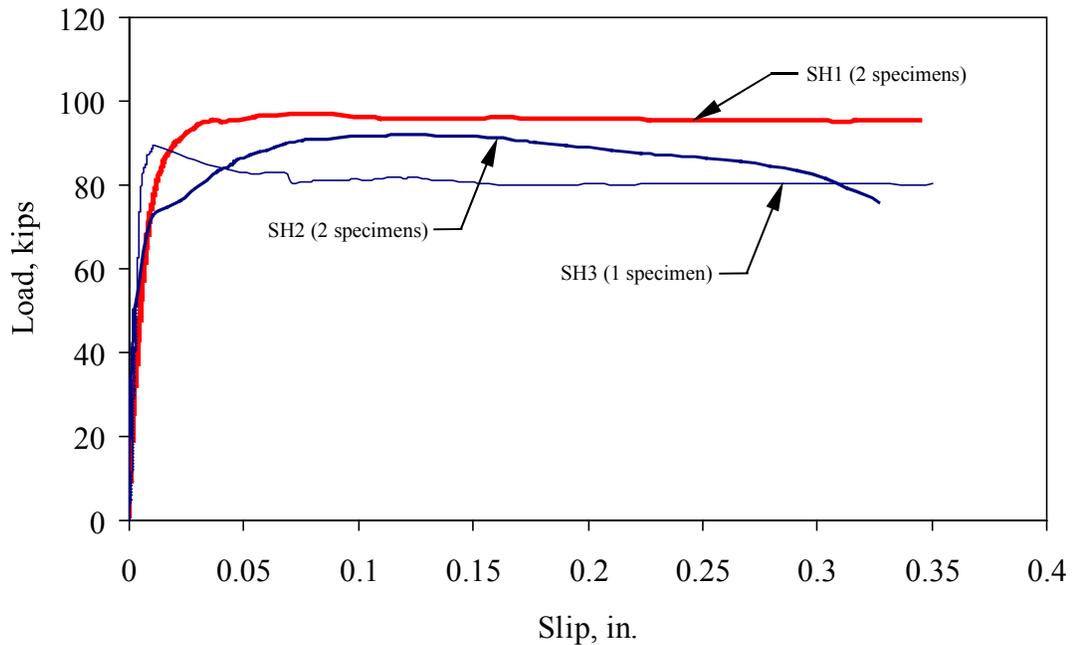
Figure 5.21. Static load-slip curves.

In Fig. 5.21, the load-slip curves for all three series of the static tests are presented. For series SH1 and SH2, the load-slip curves are the average of the load-slip curves for the individual specimens, which are presented in Reference 21. While the load-slip curve of series SH3 is the load-slip curves for the specimen SH3-4. For all specimens, the difference between the two individual slip readings was less than ± 20 percent.

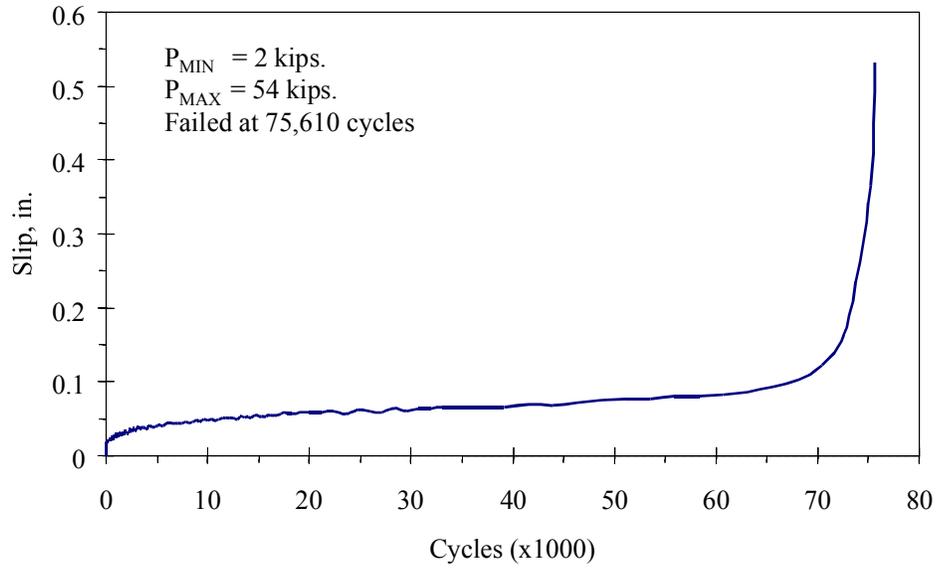
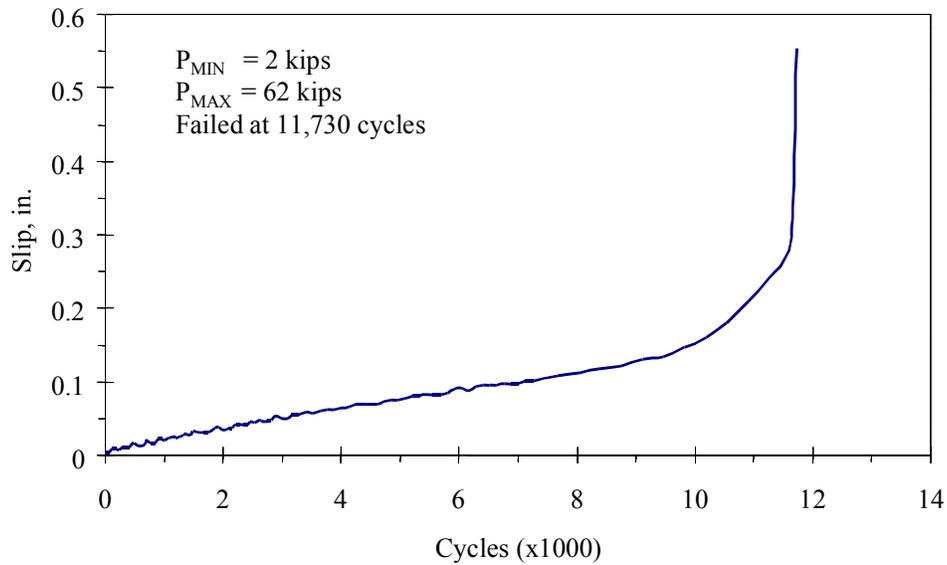
a. Typical fatigue slip-cycle curve for low load level (SH1-5 at 69 percent).

b. Typical fatigue slip-cycle curve for high load level (SH1-11 at 80 percent).

Typical slip-cycle curves for specimens tested in fatigue are presented in Fig. 5.22. In general, for specimens tested at the low maximum load level (69 percent of the ultimate static strength), the fatigue slip-cycle curves exhibited three separate phases of slip characteristics. The first phase was a gradual increase of slip at the beginning of the fatigue test. The second phase was a nearly level slip curve with little increase in slip until near failure, and the last phase was a sharp increase in the rate of slip as specimens reached failure (Fig. 5.22a). Unlike the specimens tested at low maximum load level, the second phase was not clearly defined for specimens tested at high maximum load level (80 percent of ultimate static strength) (Fig. 5.22b). Having observed these types of slip characteristics on the first few specimens, it was possible to predict impending failure of the other specimens. The fatigue slip-cycle curves for all of the individual specimens are presented in Reference 22.

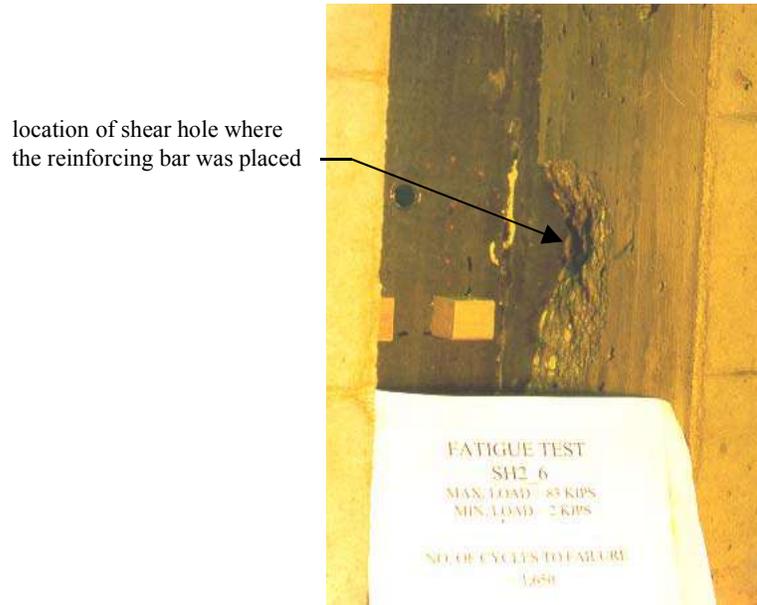
Figure 5.23. Failure of concrete in high stress area.

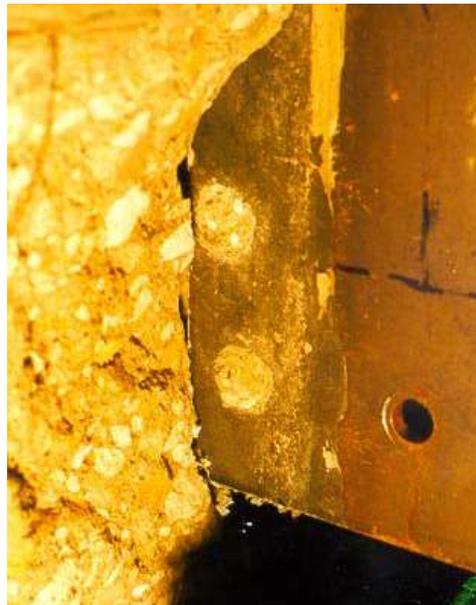
Figure 5.24. Photograph of concrete dowel failed in double shear (specimen SH2-7).

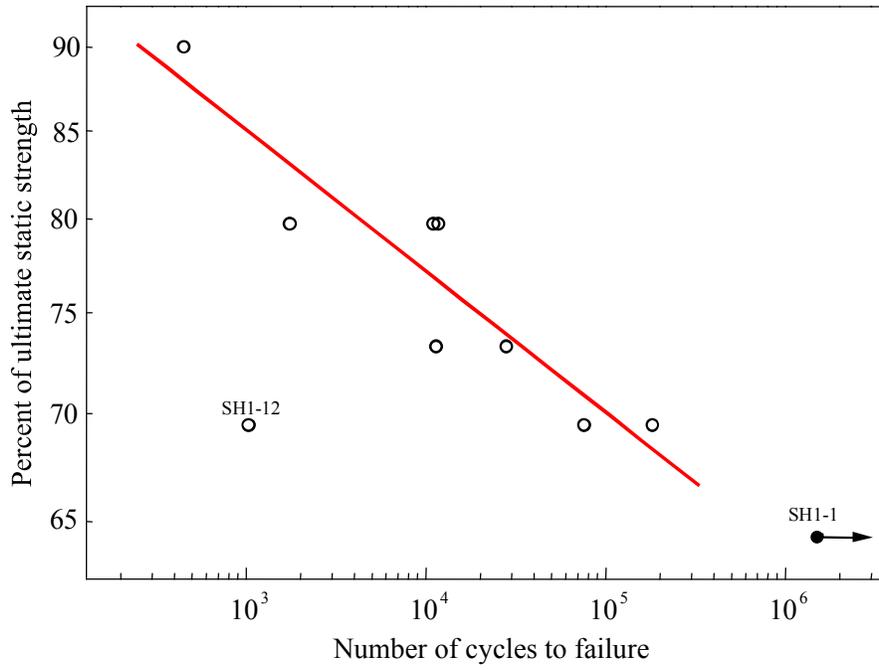
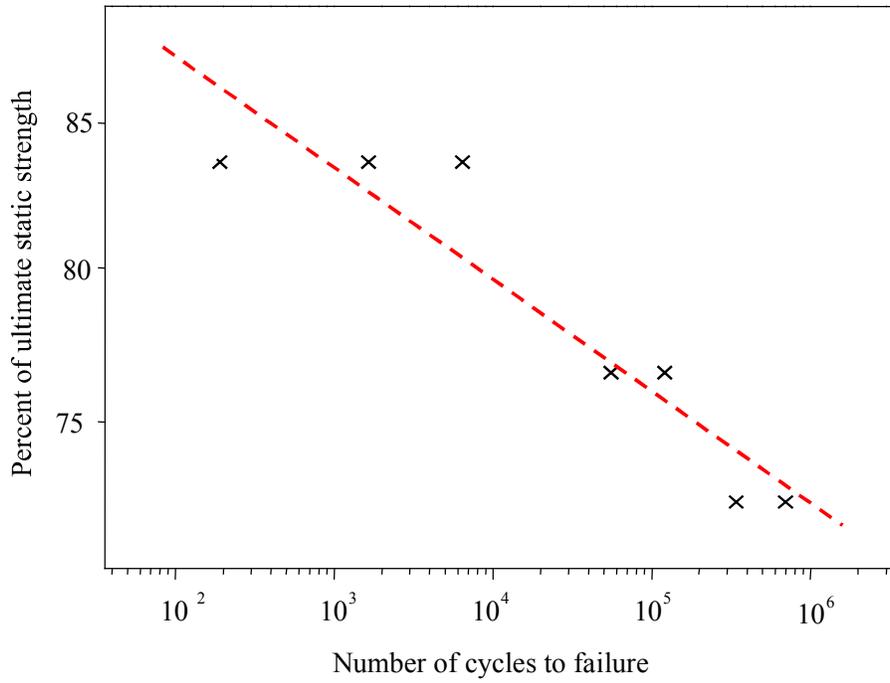
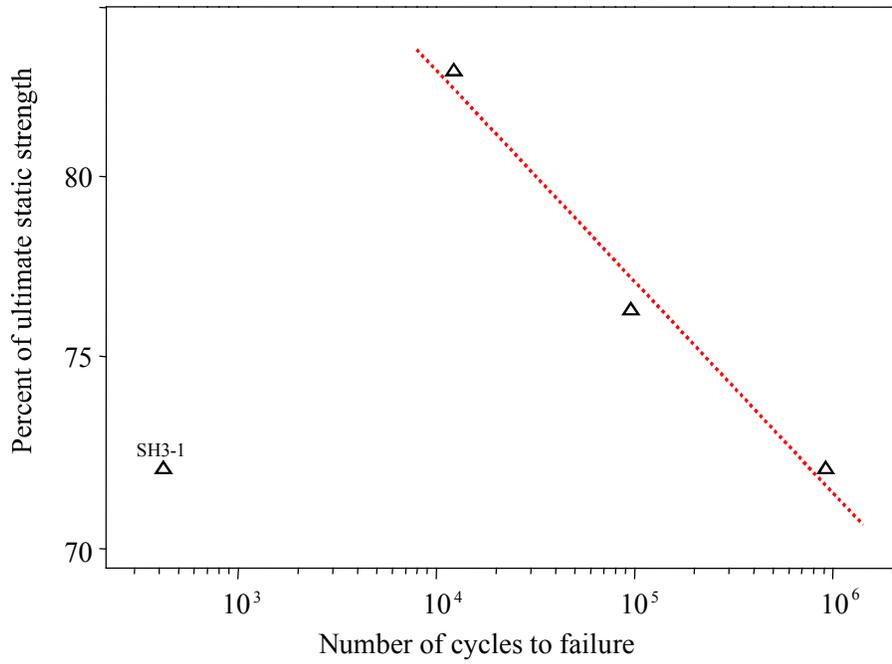
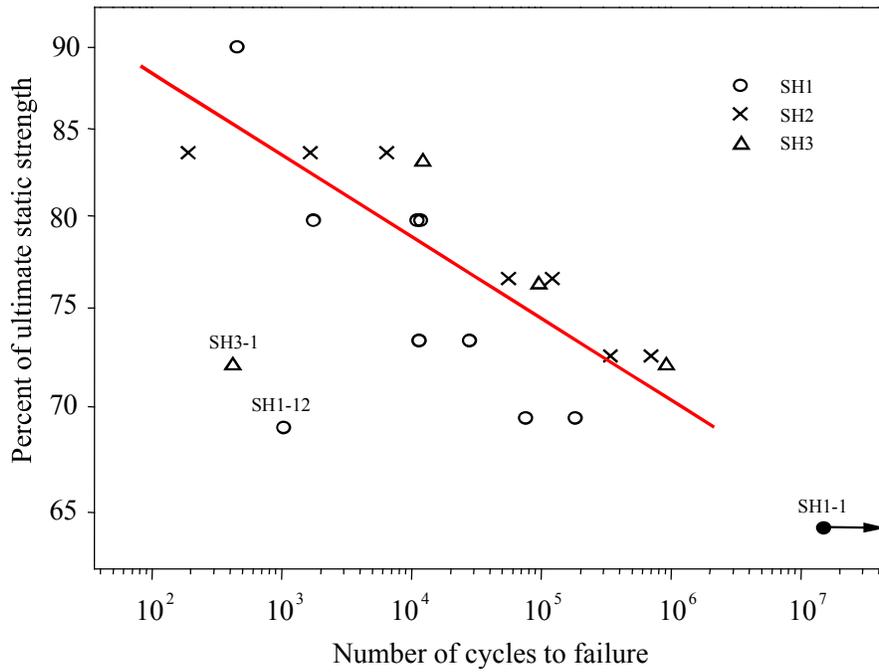
Figure 5.25. S-N curves.

a. S-N curve for series SH1.

b. S-N curve for series SH2.

c. S-N curve for series SH3.

d. S-N curve for all three series.

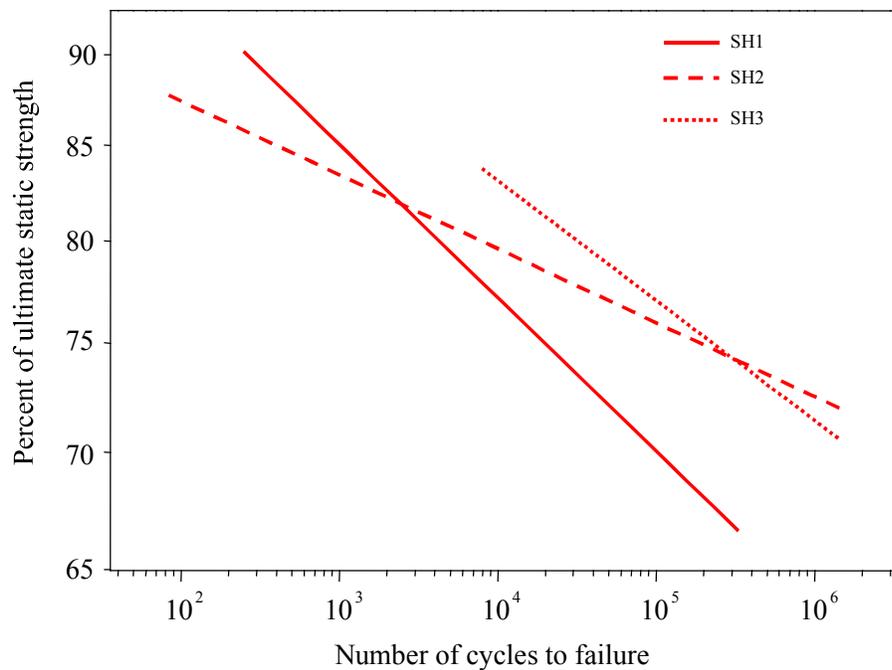
Figure 5.26. Composite S-N curves.

The plots show that at the lower maximum load levels series SH2 has higher fatigue strength than series SH1. This infers that minimal strength was gained when the shear hole alignment was staggered. It also suggests that the best way to place the reinforcing bars
