Pavement Instrumentation

FHWA-EP-88-621-001

Iowa Department of Transportation
Iowa Highway Research Board
Project HR 293

| 4. Title and Subtitle Experimental Project No. 621, Pavement Instrumentation | | 5. Report Date March 1988 | |

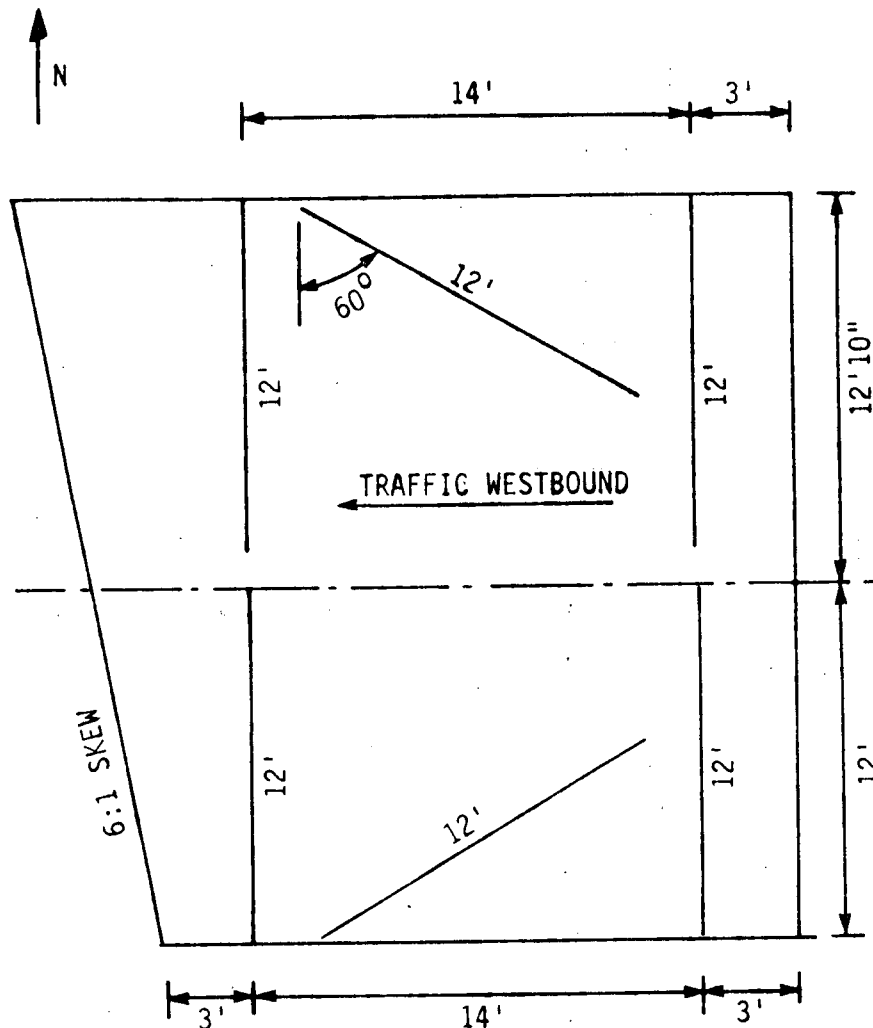
Figure 2 Vehicle Lateral Location Piezo Cable Configuration

cable. The diagonal cable is placed equally distant from the transverse cables with one end in placed near the edge of the pavement. The dimensions are controlled by the fact that this slab contains a perpendicular joint at one end and the skewed joint at the other end near the instrumented slab. This layout will be utilized to measure the location of the vehicle tires relative to the edge of the pavement as the vehicle enters in instrumented area. This installation can also be used to gather the weight, speed, and axle spacing data gathered at the first sites and evaluate the effect of the bridge on the loadings being measured.

The use of separate piezo installations in each lane and at locations on each end of the bridge allows for both the intended function of triggering the data collection and the accurate lateral measurement of vehicle location on the slab. A secondary study is possible to measure the effect of the bridge on increasing the dynamic weight of the axles and vehicle due to the bridge surface vertical alignment.

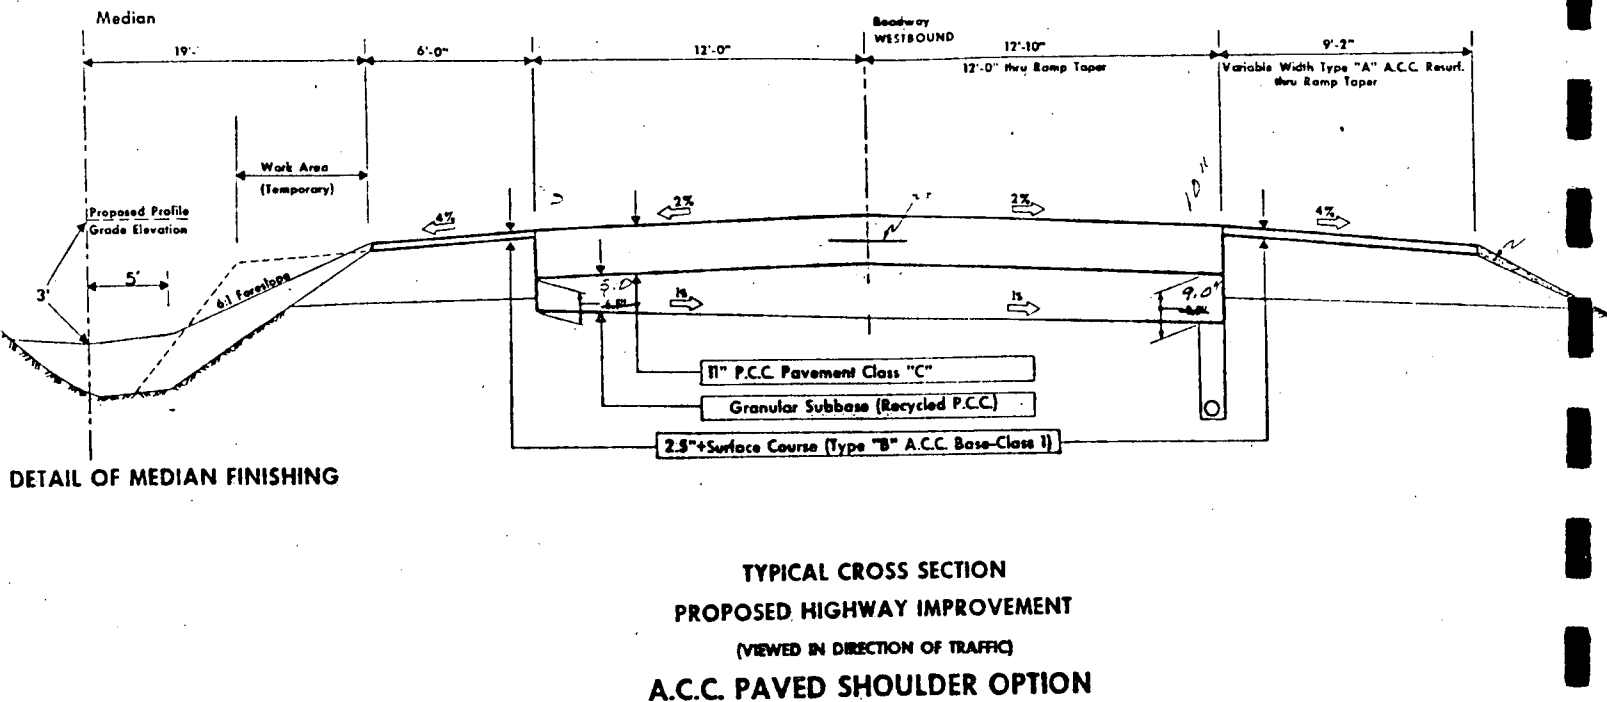
Figure 7 Typical Cross Section of Proposed Highway Improvement

placement of a 24 foot, 10 inch wide portland cement concrete pavement and allow the equipment to pass by the retained shoulder materials. The existing pavement was crushed and returned to the site to be used as a drainable base. The base varied in thickness from a 6.5 inches at the median side of the driving surface to 9.5 inches at the outside shoulder edge. An 11 inch thick joint reinforced concrete pavement was placed on top the base. The shoulders were resurfaced with 2.5 inches of Type B asphaltic concrete base (class 1) material. The new cross section is illustrated in Figure 7.

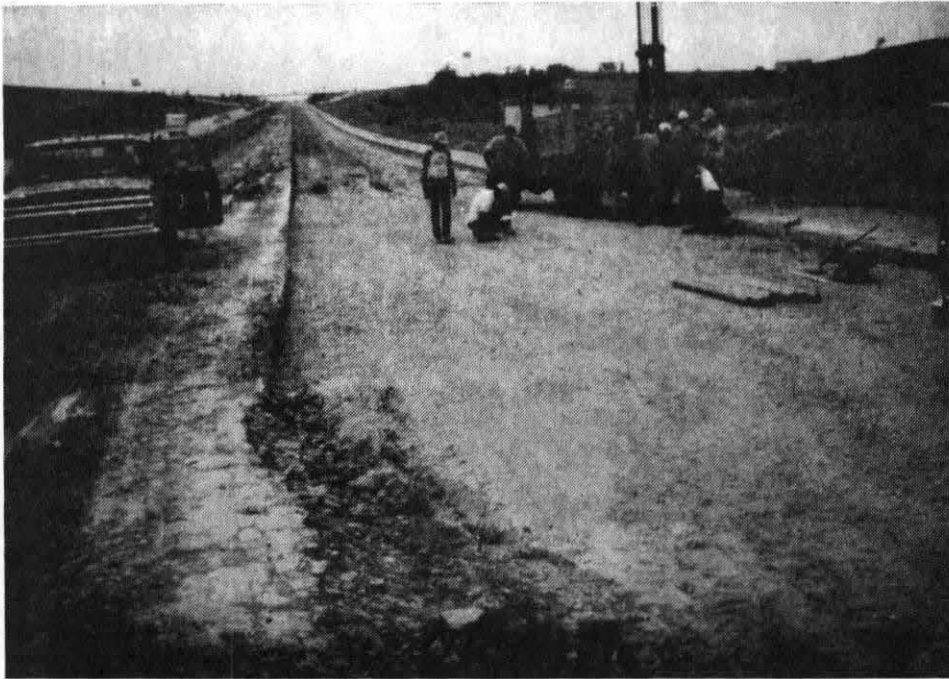
Figure 8 Test Site With Base Material in Place

A view of the completed base construction looking west from the Keg Creek bridge is shown in Figure 8. The work of placing the deflection reference conduits is underway in the photo.

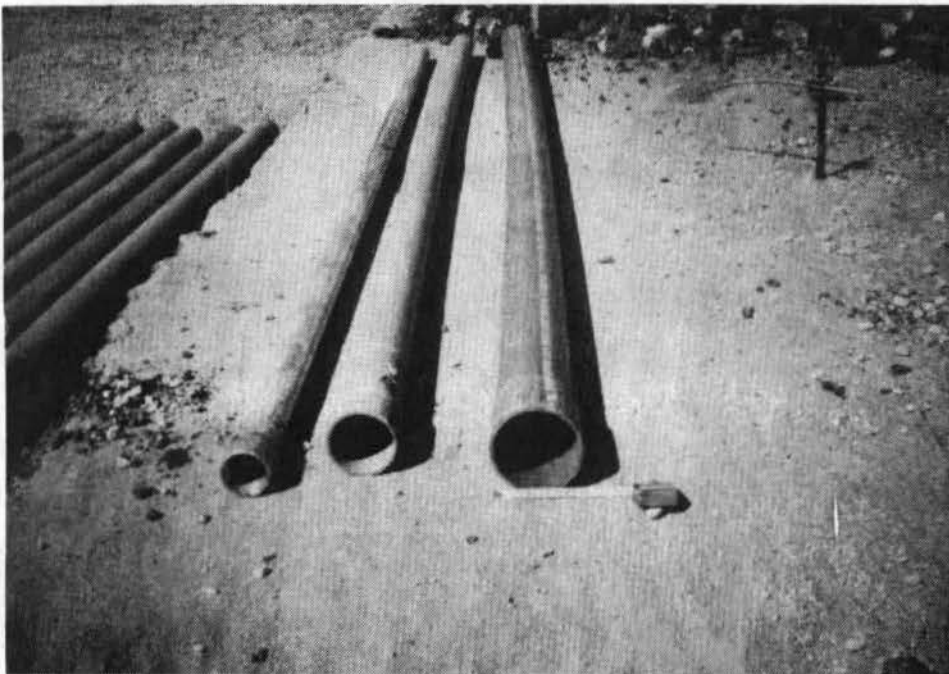
Figure 11 Typical 2 inch Aluminum and 3 and 4 inch Diameter PVC Pipe

Department of Transportation staff were used to cut trenches at five locations across the base material and through openings created by the contractor in each shoulder. Two inch inside diameter aluminum irrigation pipe for nuclear moisture density testing, such as the single pipe at the left of the three types of pipe used in project and shown in Figure 11, was placed through the pavement area and the outside shoulder in 10 ft. lengths on a 1% slope from the median edge of the pavement to the outside edge of the pavement. Pipes were sealed at the joints with joint materials and capped to inhibit water from entering. The last 10 ft of each pipe was placed in the median shoulder after the paving train of equipment had passed on that side to the pavement to protect the pipe structure and the grade of the pipes.

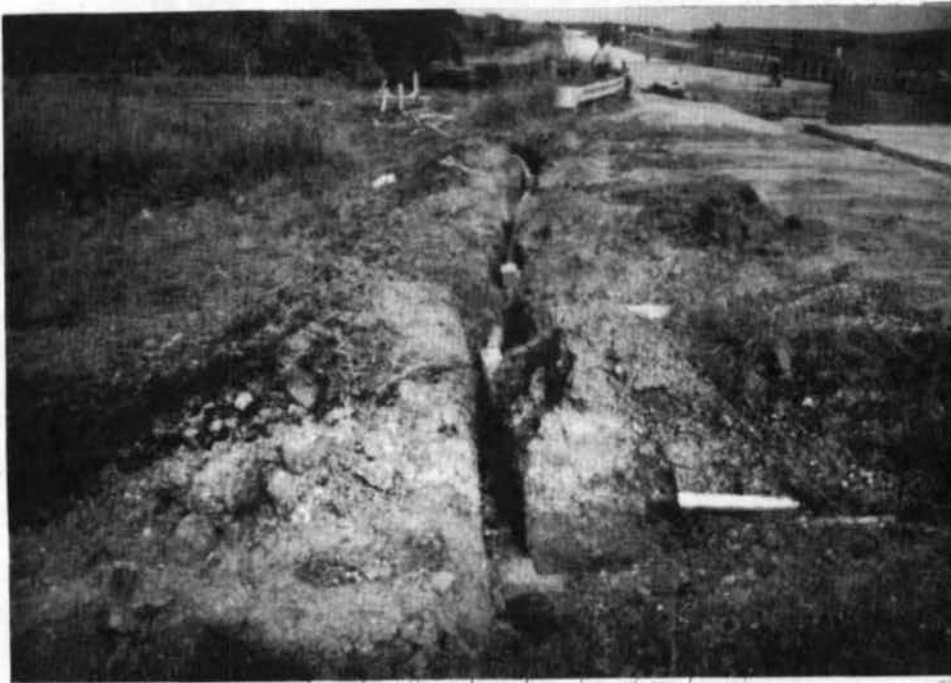
Figure 12 Longitudinal Trench Connection

A common trench approximately 6 inches wide was cut longitudinally from the the westerly most pavement joint of the test site, easterly on the outside shoulder to the control box site on the wing dike of the Keg Creek Bridge as shown in Figure 12. The concrete for the control cabinet was supplied by the paving

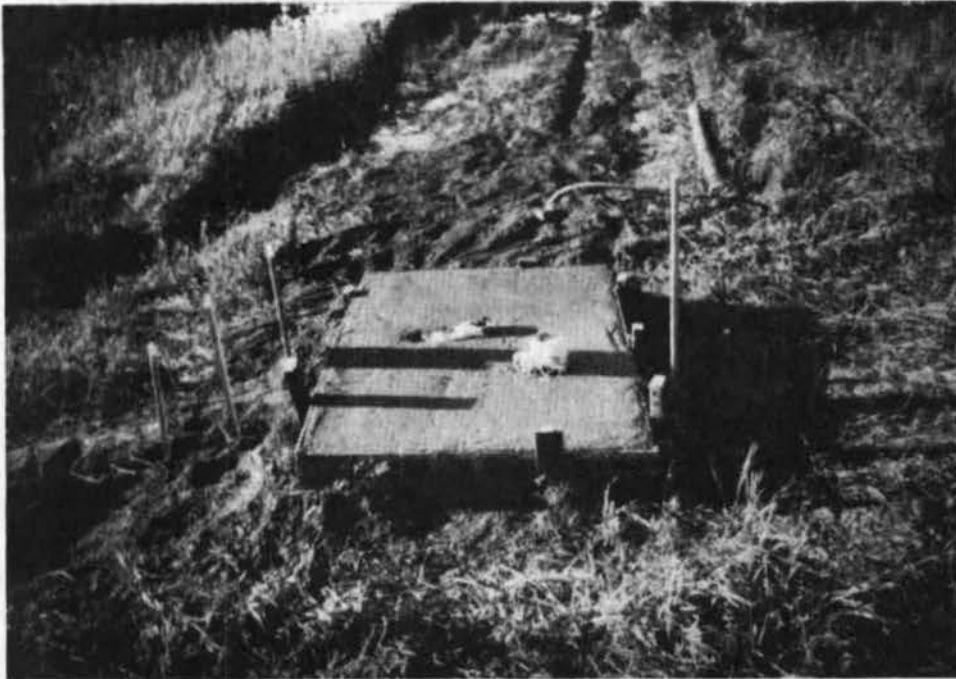
Figure 13 Control Cabinet Completed Base

contractor and placed by Department staff. A control cabinet and base shown in Figure 13 were installed after the concrete placement by Department staff and insulated as shown in Figures 14 and 15. This serves as the command center for the data collection and analysis at the field installation.

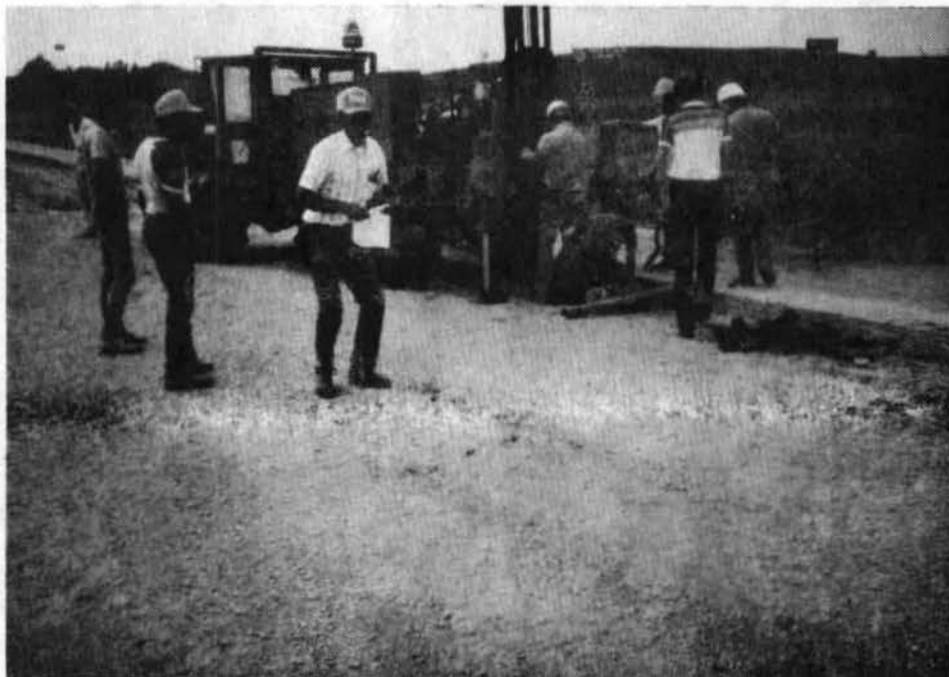
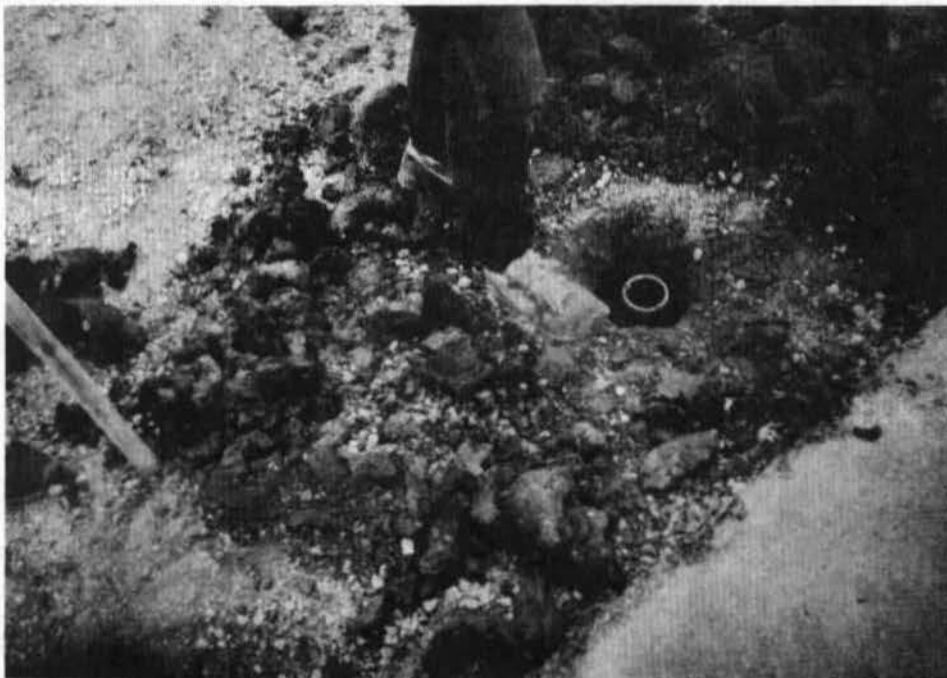
A Department of Transportation soils investigation drill unit was used to drill 5 inch diameter holes, 5 foot deep at each of the deflection gage locations. This was accomplished in the completed base and subgrade prior to the paving operation. A five foot section of 3 inch diameter PVC pipe was

inserted in each of the holes as shown in Figures 16 and 17. This casing provided protection for the reference rod driven later. A one foot square section of plywood (Figure 18) was used to cover each of the holes during concrete placement. The center of each hole was precisely located by the Department of Transportation survey crew for future retrieval purposes. The target plywood section shown in Figure 18 was painted four colors (red, yellow, green and blue) and placed in the same color arrangement over each hole. This was done to insure a way to identify any location changes required in the drilling of the completed concrete to place the housing over the test hole. An example of the target covers in place over the reference holes is shown in Figure 19.

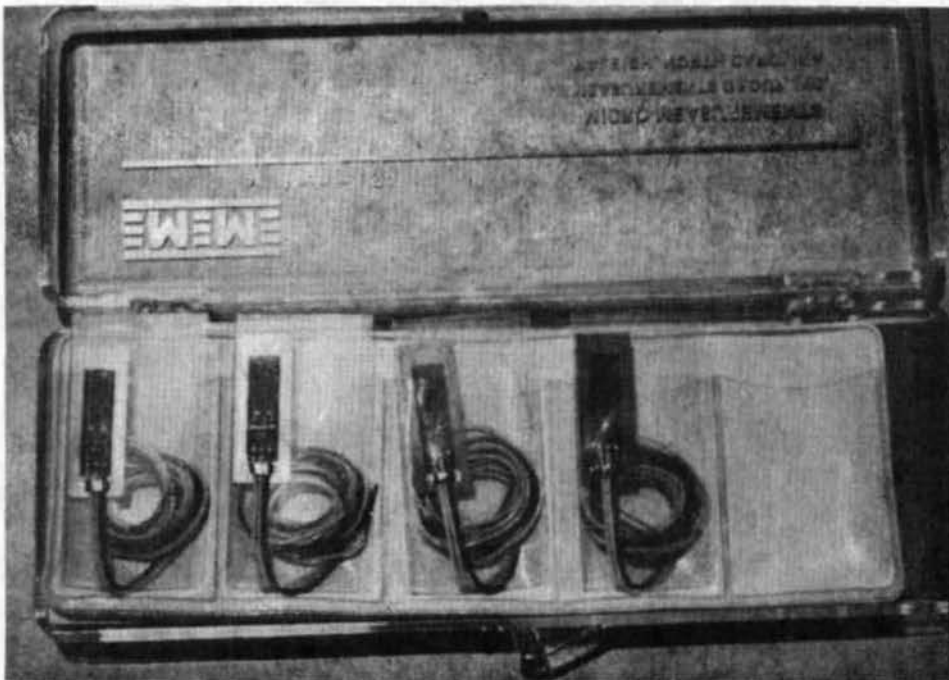
Figure 21 Weldable Strain Gage

Reinforcing Dowel Strain Measurement: A weldable strain gage, model LWK-06-W250B-350 made by Micro Measurements Division of Measurements Group, Raleigh, North Carolina, was used on the selected rebars at each of the three pavement joints. Weldable gages were selected due to the speed of installation versus bonded gages. Surface preparation requirements are significantly lower for weldables than bonded gages. The other primary advantage of these particular gages was the pre-attached lead wires (10 inches long). Soldering to gage pads is a time consuming and technically difficult project, where as in soldering of the lead wires to the shielded cable was simple and required relatively little techniques. The gage shown in Figure 21 is a precision foil sensor bonded to a metal carrier for spot welding to structures and components. It measures 6.35 mm long by 3.18 mm wide and has a

nominal resistance of $350 \pm$ ohms. It has a strain range of $\pm 5,000$ micro strain meters per meter and a temperature range of -195 to $+260$ degrees centigrade. The gage is also packaged in groups of five for delivery.

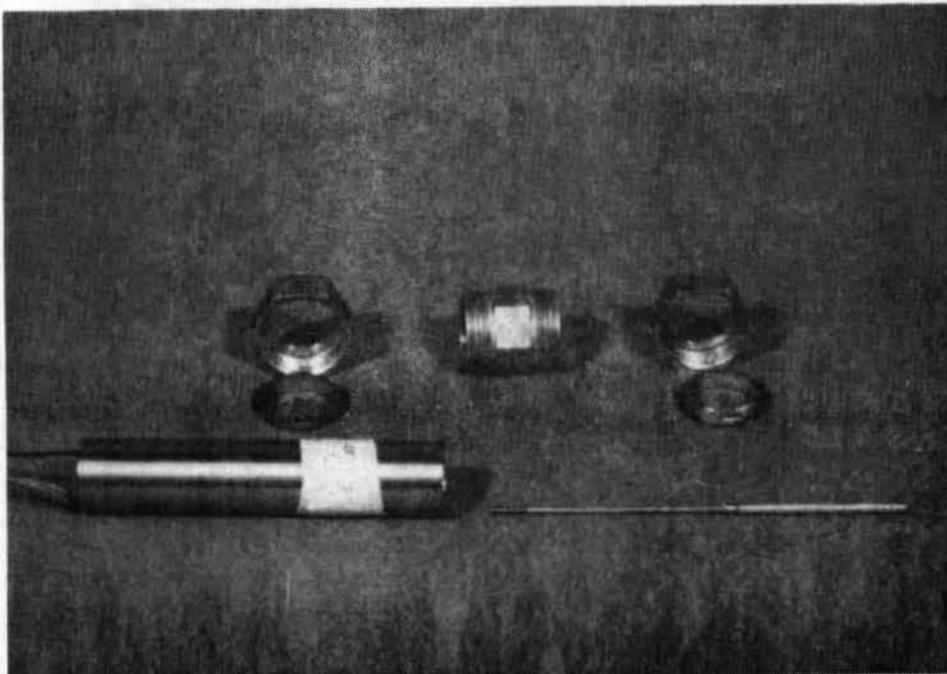
Figure 22 Deflection Gage

Deflection Measurement: A Trans-Tek Inc. Displacement Transducer DC-DT series 240-000 was used in specially built housings in the wheel paths to measure pavement deflection. The gage, shown in Figure 22, has a working range of ± 0.500 volts.

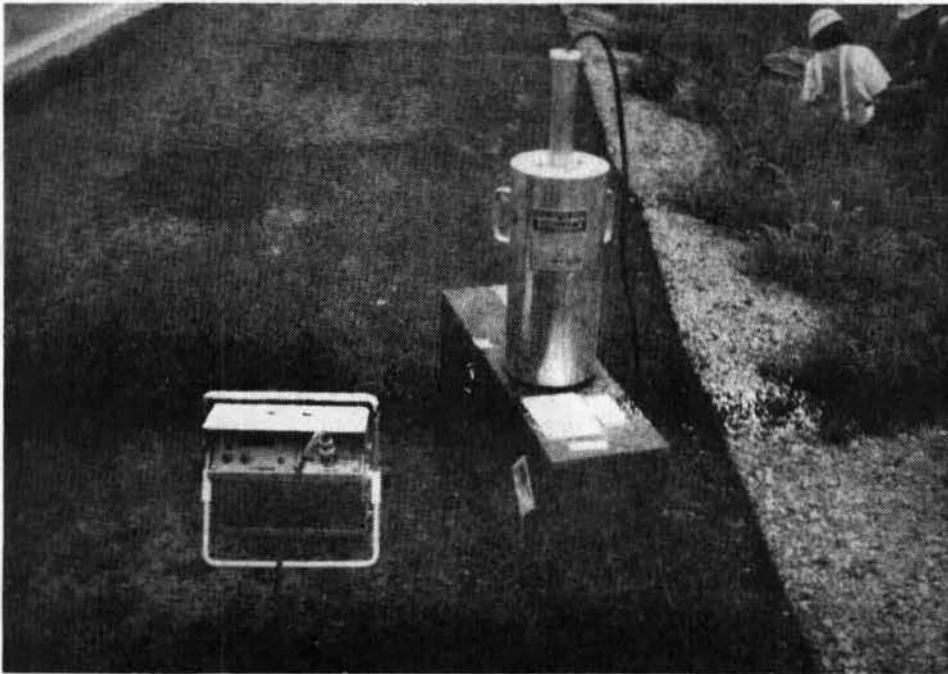
Figure 23 Troxler Density Gage With Scaler Unit

Moisture and Density Measurement: Troxler equipment was selected to perform measurements on the relative moisture and density in the base and subgrade material. A density gage model 1352 (Figure 23) with scaler unit and moisture gage model 3321 (Figure 24) were used for the testing. Special 90 and 100 foot hoses were obtained for the units to allow passage completely across the road under the pavement. Such units have not been tested under these type of conditions before and are experimental when used in this in operational mode. The test probe shown in Figure 25, that is pulled through the conduits to assure no obstruction, was specially fitted with a chain on each end for retrieval in the case of an obstruction.

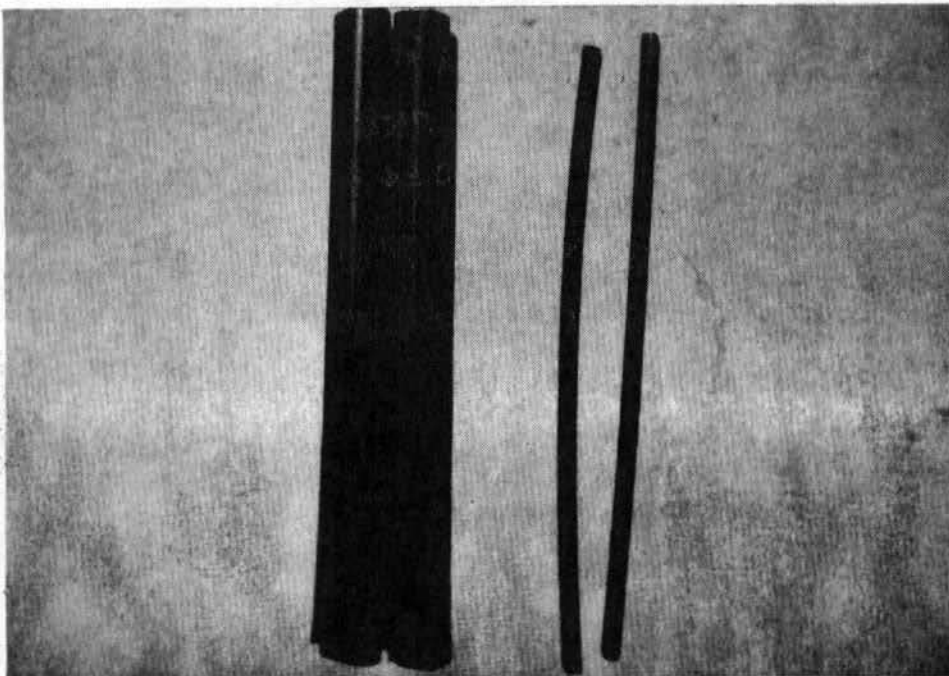
Figure 31 Surface Irradiated Polyolefin Material

Each of the concrete gages was tested in the laboratory to insure that there were properly connected. The concrete gage lead wires were cut to a short length and soldered to the Belden wire according to a predetermined standard three wire color code configuration. This operation should be accomplished in the laboratory to reduce the chance of gage damage. Each of the wire welded connections was first coated with M-coat B and encased with a special heat shrinking tubing (Surface Irradiated Polyolefin #Fit-300-wire diameter in inches) with a meltable interior wall to seal the connection. This material is used to seal, strengthen and waterproof the joint. Shown in Figure 31, the material is placed on the wire prior to the welding, moved over

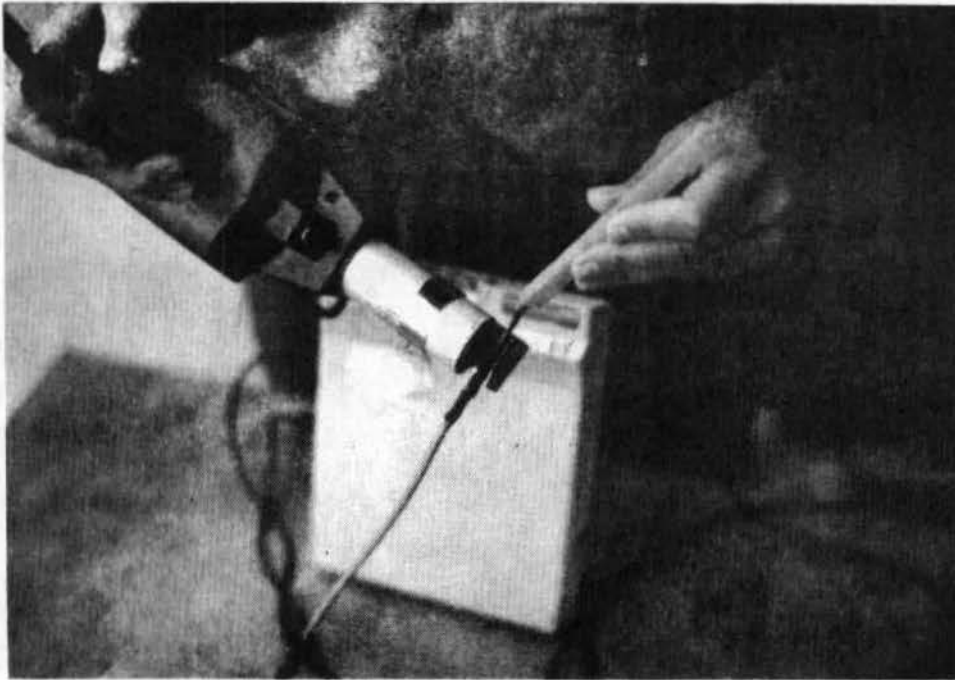
Figure 32 Heat Gun Used in Sealing Wire Connections

the completed joint and heated to shrink around the joint as shown in Figure 32. This material was used to seal all sensor to control wire connections. The insulation of the solder connections is the foremost factor in the longevity of the gage installation, therefore it should be treated with the upmost care. Different insulations adhere differently to various sealants, so the combinations should be carefully considered.

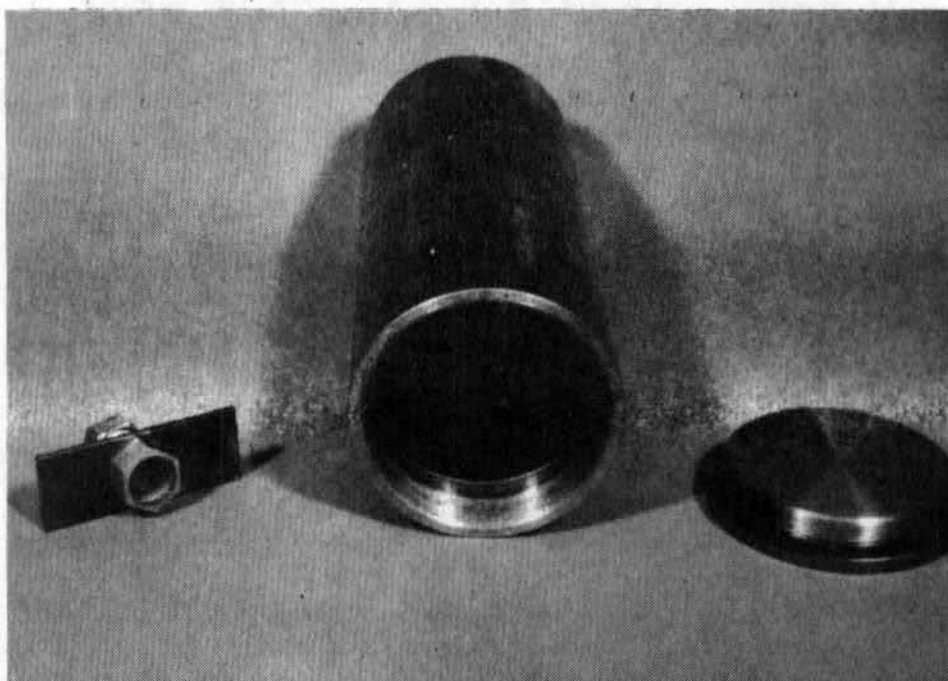
Figure 38 Deflection Housing and Cap

Special housings for the deflection gages were constructed in the Department of Transportation Machine Shop from stock materials. The housing shown in Figures 38-42 is constructed from 4-1/2 inch O.D. drill casing conduit and cut to eleven inch lengths. Each was threaded at one end and a special cap of bar stock was machined to fit the opening as shown in Figure 38.

A rubber O-ring was used to allow for opening and resealing of the lid. The assembly is held in place in the concrete by three set screws mounted near the top of the assembly for access by the appropriate wrenches. Two holes were drilled partially through the lid to form a place for a specially designed wrench to be used in opening the assembly.

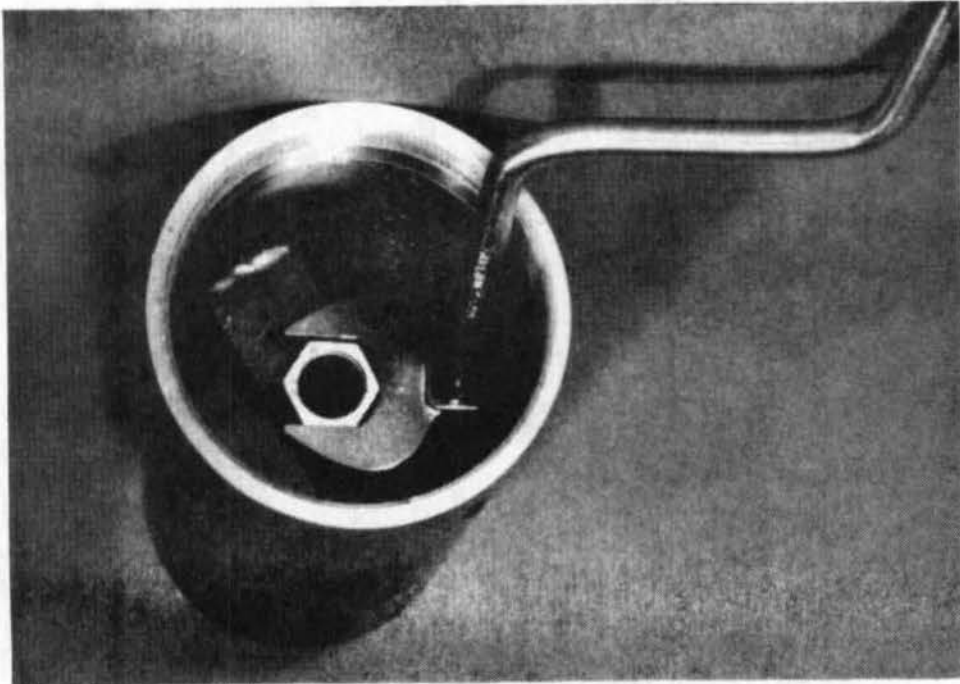
Figure 39 Deflection Housing Adjustment Assembly

Inside the deflection housing, a horizontal brace was used to support a self locking nut device which will support the actual deflection sensor. The device allows the sensor to be inserted, position changed vertically, and removed from the site without removal of the housing. A one inch crows foot head for a 3/8 inch drive set is used to tighten and loosen the locking device while it is in place as shown in Figure 39. The wiring for the deflection devices was connected in the field to wires placed under the concrete slab and into the three inch PVC housing the deflection reference rods.
