USE OF LONGITUDINAL SUBDRAINS IN THE 3R PROGRAM

Progress Report
Project HR-509

IOWA DEPARTMENT OF TRANSPORTATION

PROGRESS REPORT
FOR
PROJECT HR-509

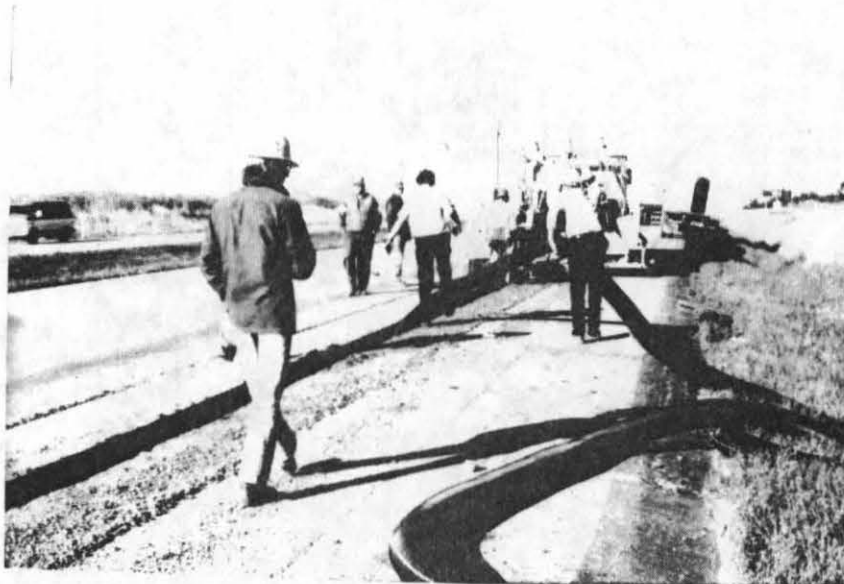
Figure 4: Hand Placement of the Tubing

Polyethylene tubing deteriorates if exposed to sunlight and therefore, a note on the plans required protected storage even though the producer claimed that an additive would protect the tubing for up to six months. The tubing was placed in the trench manually (Figure 4).

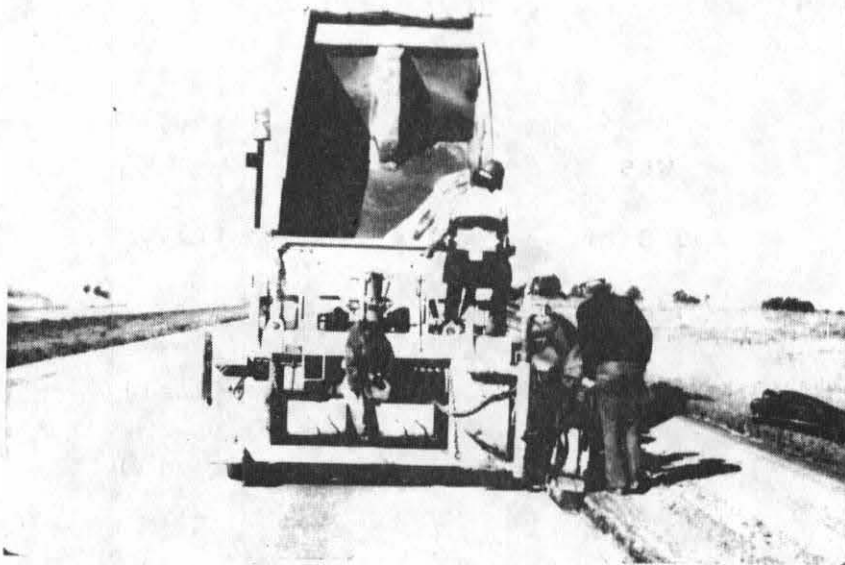
Figure 5: Blawknox RW-38 Placing Porous Backfill

The next operation in the train was the proper placement of the porous backfill material using a Blawknex RW-38 road widener (Figure 5) with a special box attachment. This operation caused the most problems and required special attention. With proper modifications, the tubing was threaded through a guide in the special attachment and the 3" bedding beneath the pipe was achieved. A vibrating pan unit (Figure 6) was attached to the special box for compaction of the porous backfill.

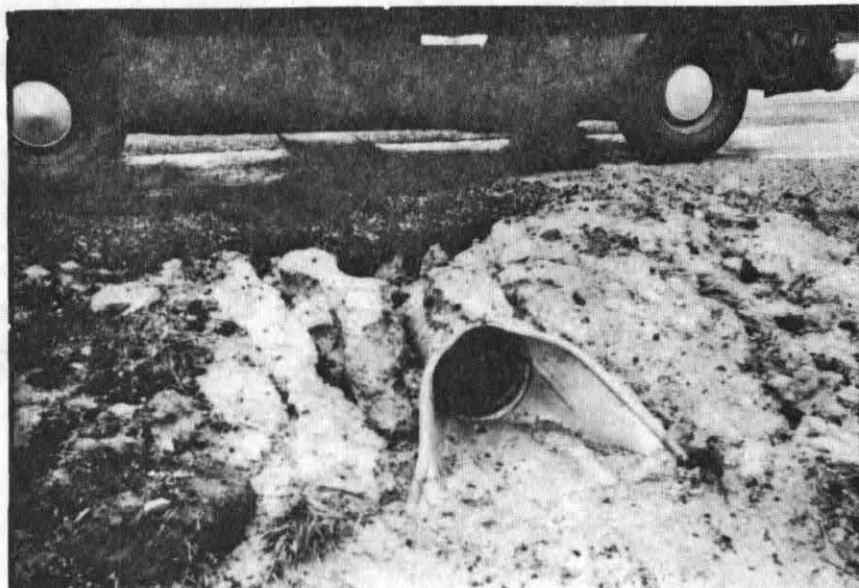
Figure 11: Erosion Around the RF-22 Outlet

Construction was not completed during 1978. Another problem was recognized in the early spring of 1979. The RF-22 outlets froze shut during the winter period. Early spring flow from the subdrains eroded the earth fill around the RF-22 outlet (Figure 11). This problem was solved by carrying the porous backfill the total length of the RF-22 outlet.
