Final Report on Phase I

ALTERNATE METHODS OF STABILIZING DEGRADING STREAM CHANNELS IN WESTERN IOWA

**Submitted to
the Highway Division of
the Iowa Department of Transportation
and
the Iowa Highway Research Board**

**ISU-ERI-Ames-81047
Project 1421**

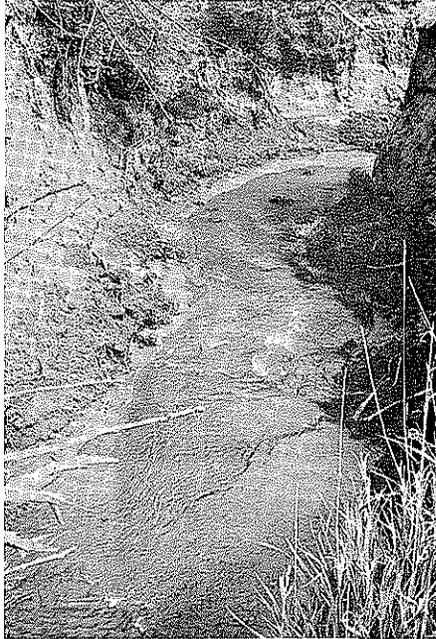
Plate 1. An example of a degrading stream in Monona County. Note the blocks of soil sliding down the channel sides.

Since the beginning of channel straightening at the turn of the century, the streams of western Iowa have degraded 1.5 to 5 times their original depth. This vertical degradation (Plate 1) is often accompanied by increases in channel widths of 2 to 4 times the original widths. The deepening and widening of these streams has jeopardized the structural safety of many bridges by undercutting footings or pile caps (Plate 2), exposing considerable length of piling (Plate 3), and removing soil beneath and adjacent to abutments (Plate 4).

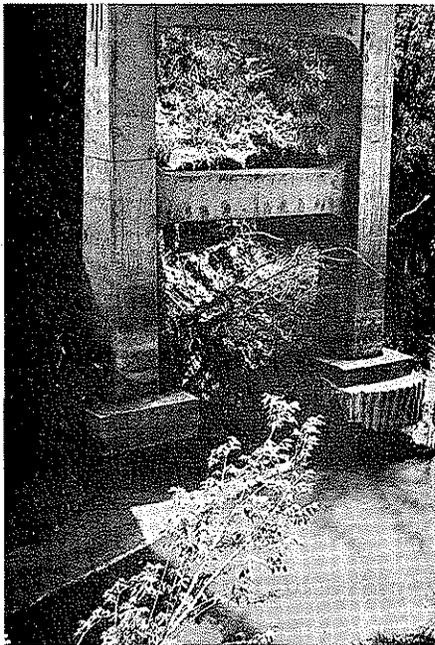
Plate 2. Degradation exposed pile cap of pier at left. Pier at right has had remedial work.

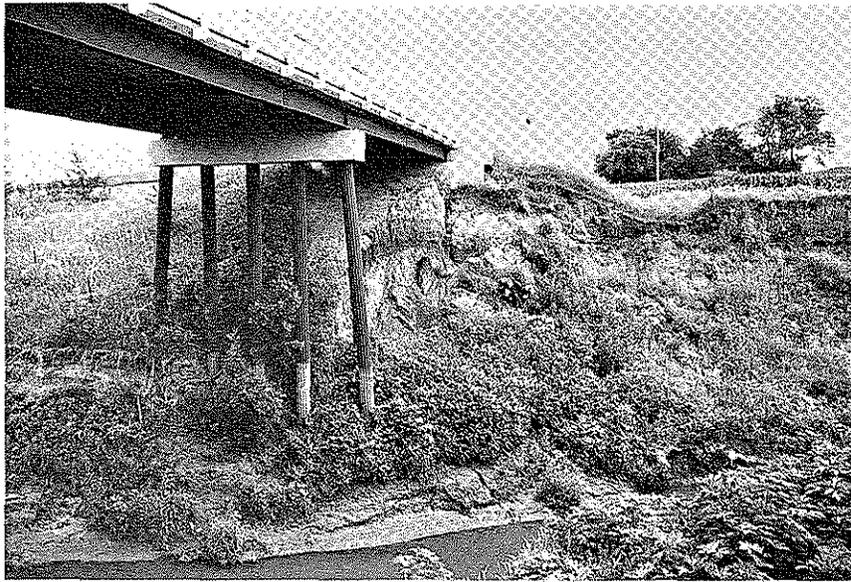
Plate 3. Channel degradation has exposed portions of these piles. Former ground level is indicated by the top of the light-colored portion at bottom of piles. Note also the soil pulling away from the abutment.

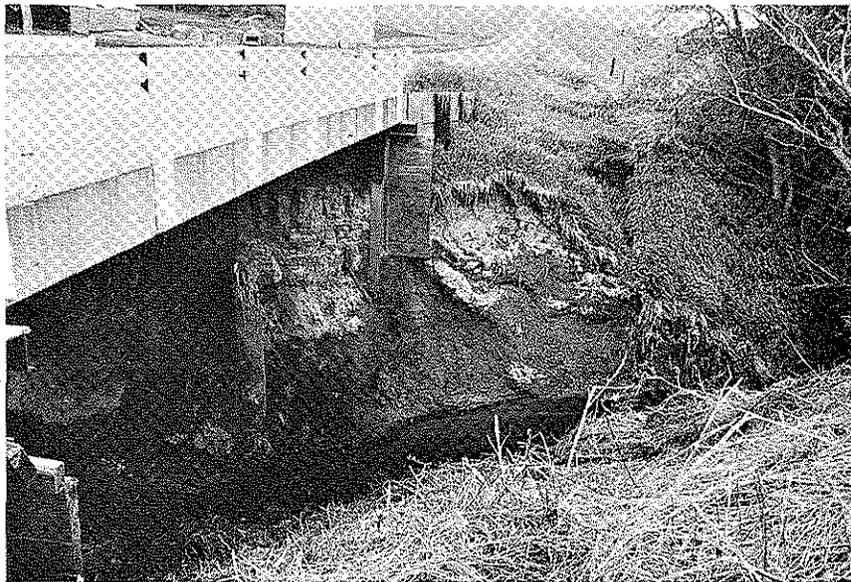
Plate 4. Degradation and the associated landslide has removed soil adjacent to the abutment on this Shelby County bridge.

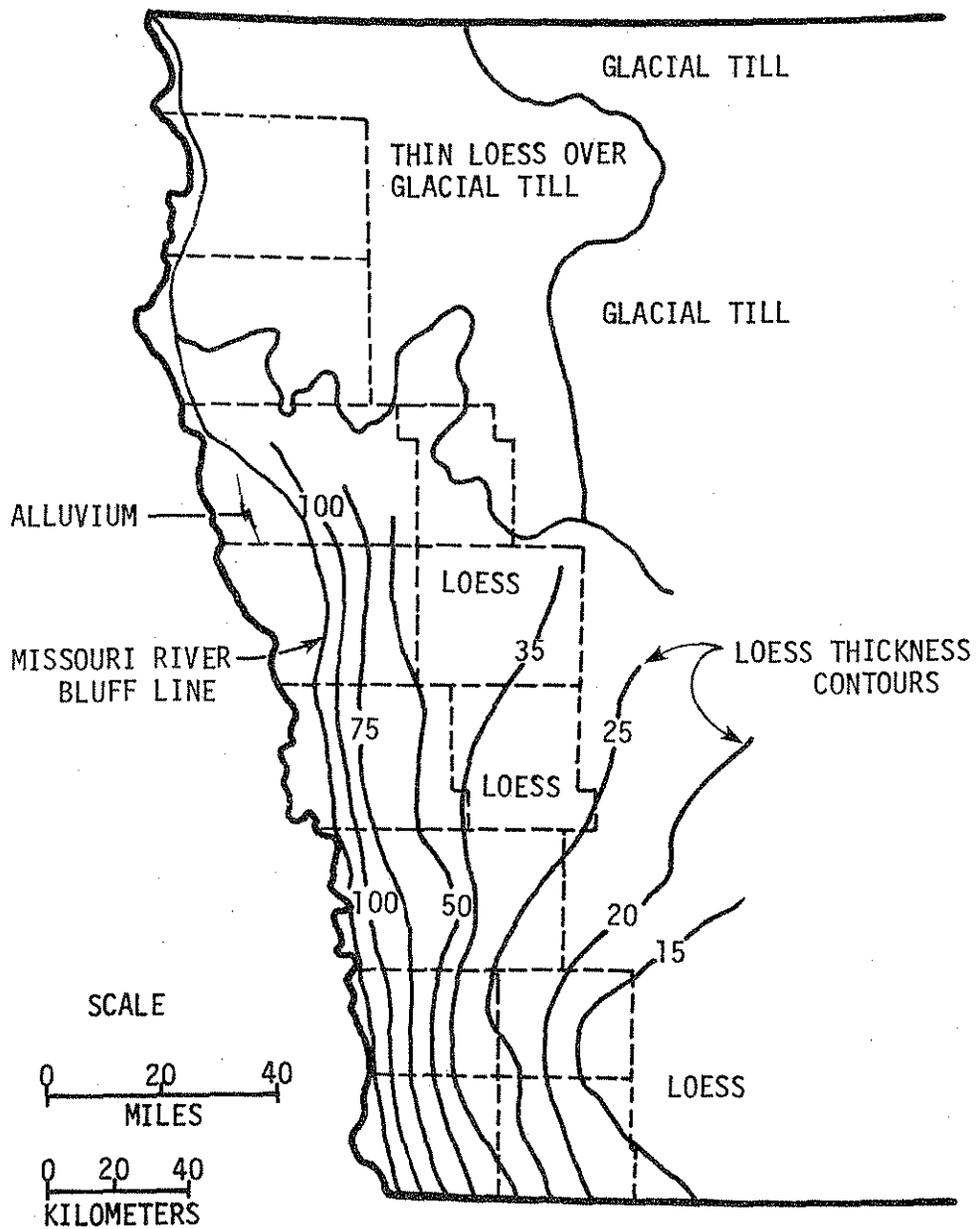
Fig. 3. Surficial geology of western Iowa showing thickness of loess. After Dahl et al. (1958).

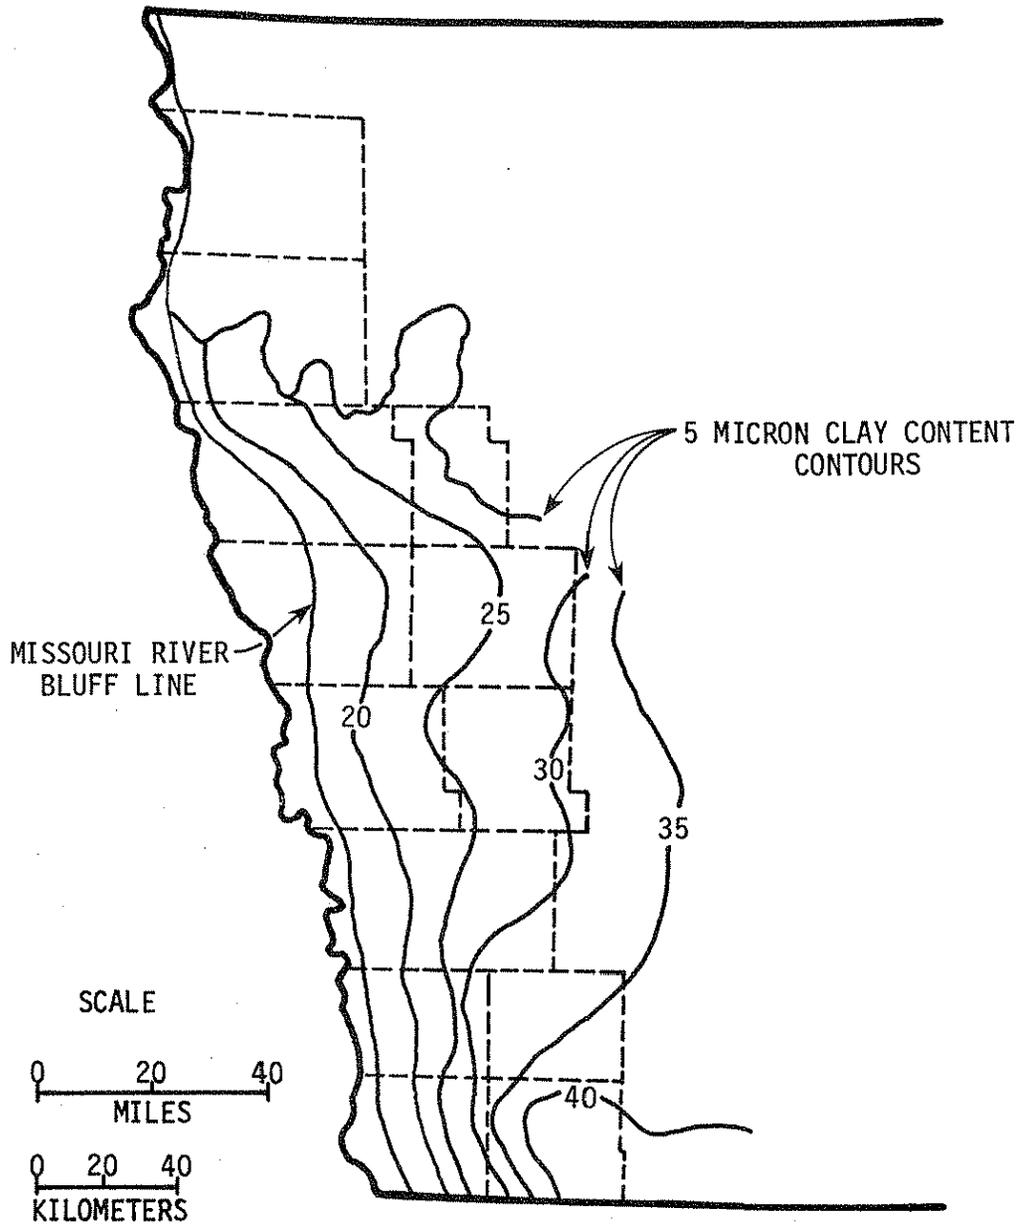
Fig. 4. Geographic distribution of 5 micron clay (in percent) contours in loess of western Iowa. After Dahl et al. (1958).

Associated with the eastward thinning of the loess deposits are systematic trends in the properties of the upland loess. Figure 4 from Dahl et al. (1958) shows that clay content increases with increasing distance from the Missouri River. Davidson and Handy (1952) show that in-place dry density varies linearly from 69 pcf at the bluff line to about 84 pcf at a distance 78 miles from the bluff, whereas the plasticity index increases and the shrinkage limit decreases with increasing distance from the river. Both median particle diameter and percent

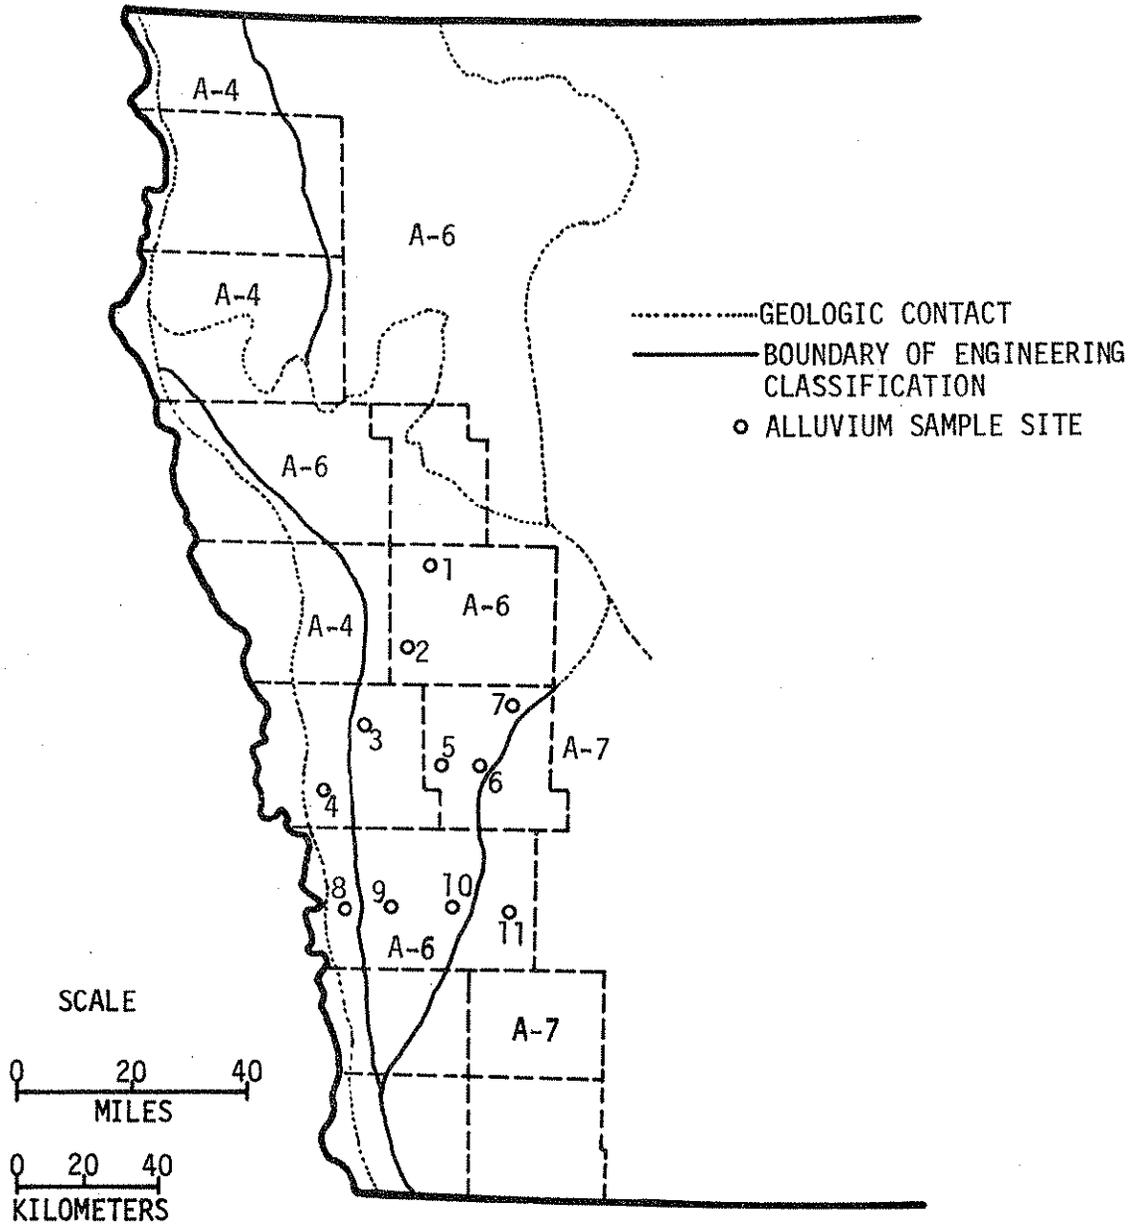
Fig. 5. Engineering classification of loess in western Iowa. After Hansen et al. (1959) and location of alluvium sample sites.

Although the upland soils have been described extensively, only two studies have characterized the regional variations of the alluvium or secondary loess in the valleys. Engineering data for the pedologically classified soils in western Iowa provide a basis for comparing and contrasting the alluvium with the upland soils. The principal pedological soil associations of western Iowa are shown in Fig. 6 (from Simonson et al., 1952). In the southern, deep loess portion of the study area the Monona-Ida-Hamburg (MIH) soil association occupies the western portion, with the Marshall association eastward. The alluvial soils of the MIH association are the McPaul and Napier, whereas the upland soils of the MIH are the Monona, Ida, and Hamburg. The Hamburg soils occur on the steeply sloping hills of the extreme western bluffs. In the Marshall association the alluvial soils are the Wabash-Judson complex with the Marshall as the principal upland soil. Some of the engineering data for these soil series is reported by Miller et al. (1978). These data indicate that, although the alluvium tends to be somewhat higher in clay content and more plastic than the upland soils, the engineering classification of these two groups of soils is similar with both alluvium and upland soils classifying as A-4 in the extreme west, A-6 in the mid region, and A-7 in the eastern portion of the study area.

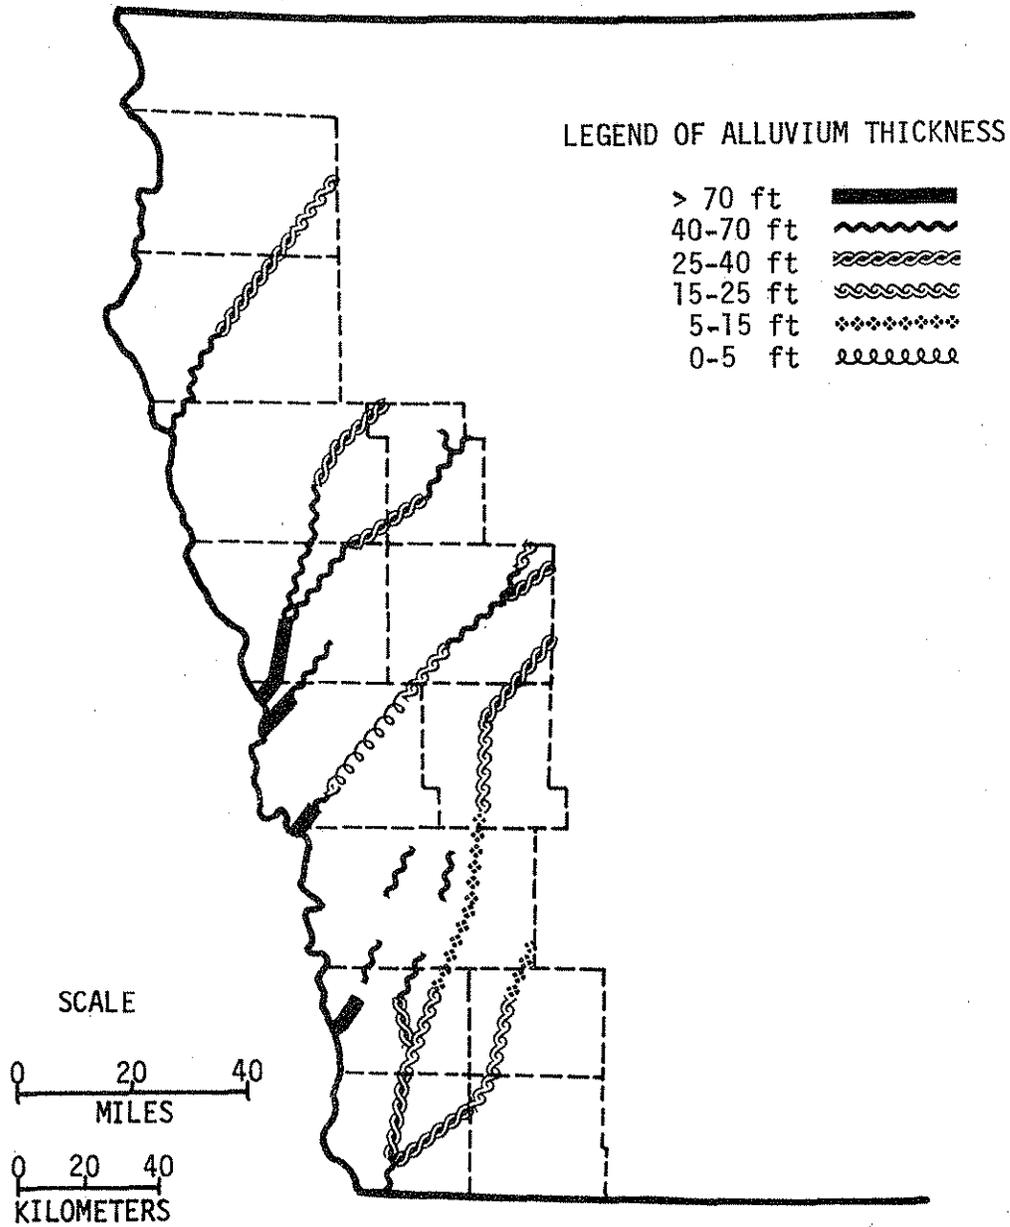
Fig. 7. Thickness of alluvium beneath channel bottom. Modified from Antosch and Joens (1979).

and Joens, 1979) or due to degradation. In any event it can be seen that the alluvium is greater than 15 ft, thus in most cases, the chance of the streams degrading to a more resistant base level is not likely to occur for many years.

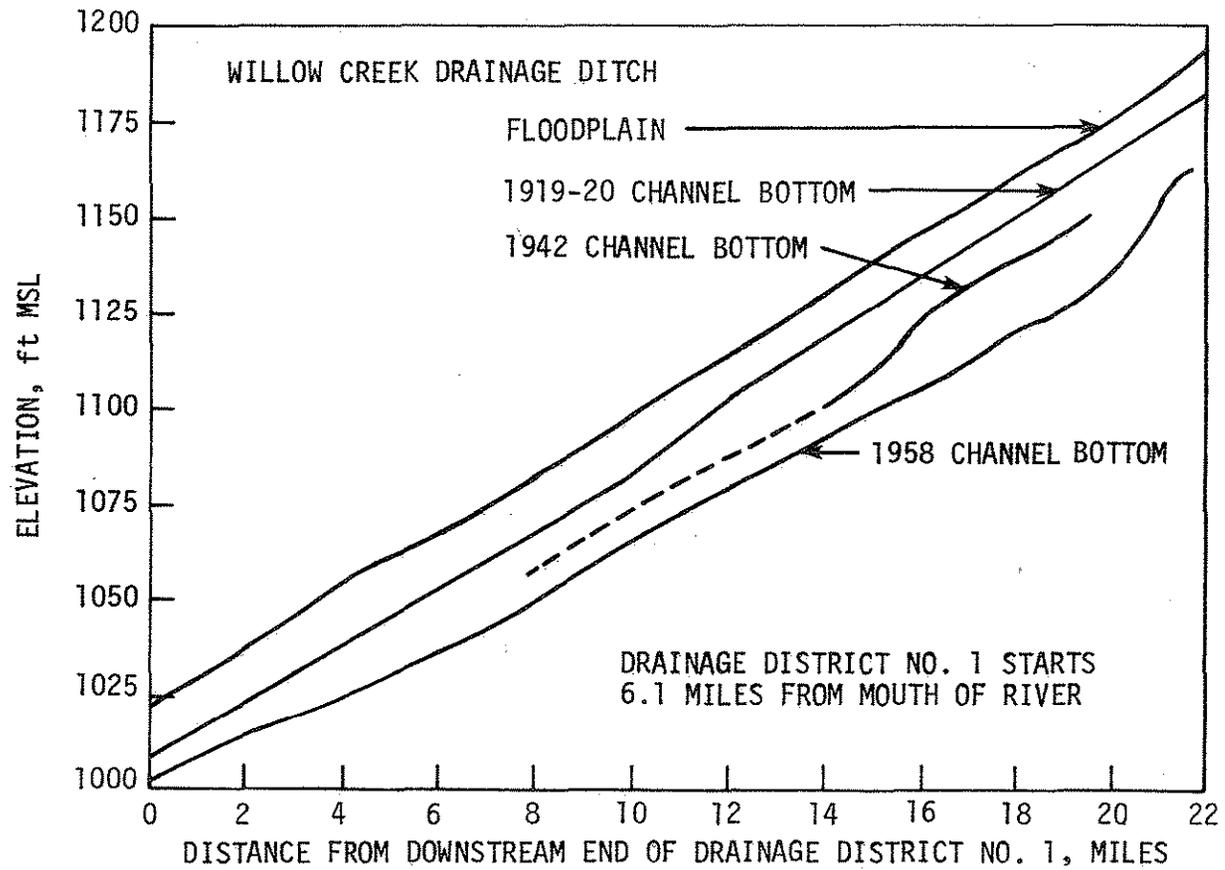
Fig. 10. Longitudinal profile of Willow drainage ditch in Drainage Districts 1 and 2. After Daniels (1960).

the period 1919 to 1958 are shown in Fig. 10. Longitudinal profiles from 1966 to 1980 as well as Daniels 1958 profile are shown in Fig. 11. The data between 1919 and 1958 clearly indicate that the channel was degrading at rates varying from 0.8 ft/yr to 0.18 ft/yr with the maximum amount of degradation at 24 ft and a maximum depth of channel below the floodplain of nearly 40 ft!

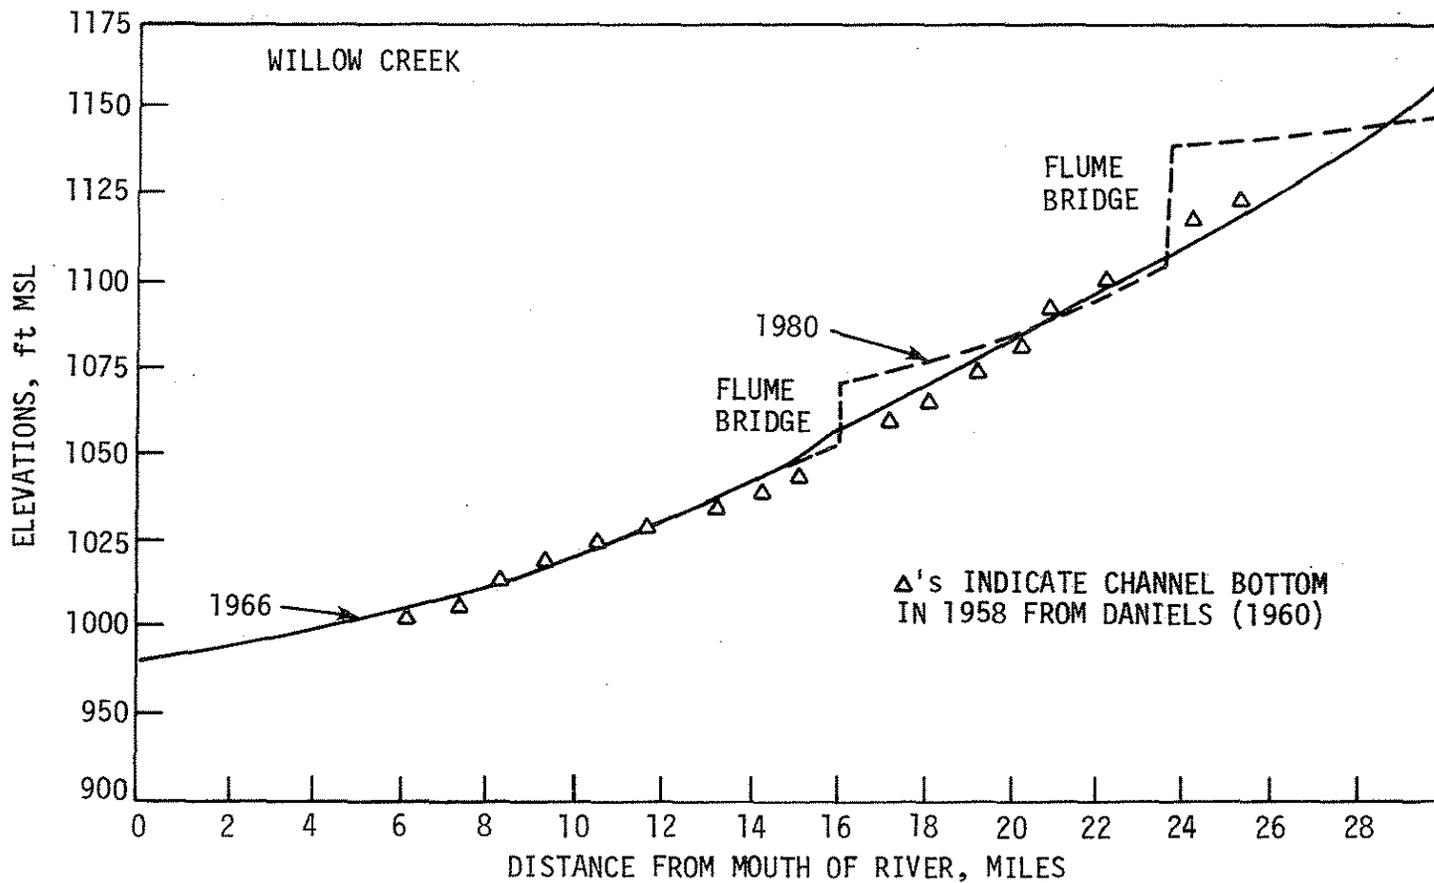
Fig. 11. Longitudinal profiles of Willow Creek 1958, 1966, and 1980.

A comparison of the 1958 and 1966 profiles raises some questions. At 11 sections there is evidence of degradation with a maximum depth of 3.2 ft, whereas at 7 sections the measurements indicate aggradation with accumulations of up to 3.6 ft. Thus, about half of the straightened portion of Willow Creek appears to have been aggrading while the other half appears to be degrading with a sequence of aggradation, degradation, aggradation, degradation, progressing upstream. These data suggest that the channel bottom has been essentially stable between 1958 and 1966 and confirms the Daniels and Jordan (1966) speculation that this reach of the channel was stable by 1958. In the early 1970s two flume bridges were constructed as grade stabilization structures. A comparison of the 1966 and 1980 profiles shows the effectiveness of the flume bridges in sedimenting the degraded channels. The flume bridge with a 17-ft drop has backed up sediment for approximately 2.5 miles

upstream, whereas the flume with a 34-ft drop has caused sedimentation over 6 miles upstream. It appears that the aggradation is effective only to the elevation of the crest of the structure in the case of the lower structure, but aggradation has extended further upstream in the other flume. Although there are no data to indicate the dates at which the sedimentation was complete, the fact that both structures are full 8 or 9 years after construction indicates that the sedimentation rate is rapid.

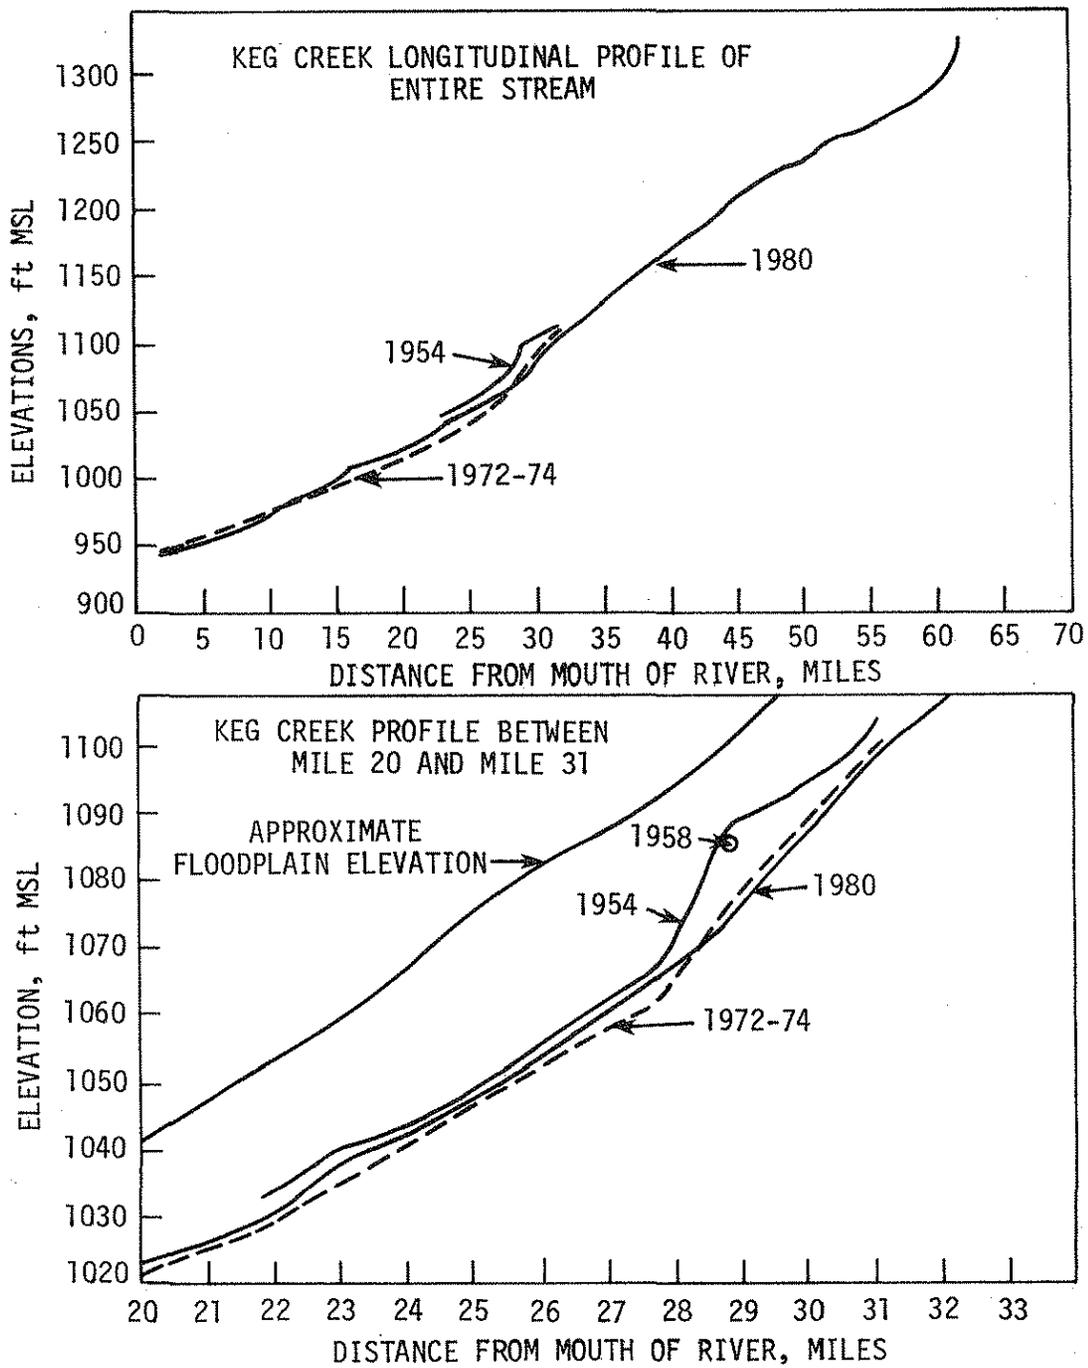
Fig. 12. Longitudinal profile of Keg Creek.

Keg Creek provides additional documentation of stream degradation in western Iowa; however, the data are more recent than those of the streams previously discussed. Keg Creek was straightened throughout half its length, but the original maps or plans are not available. The only source of data has been bridge plans and subsequent inspection reports. Figure 12 shows the 1980 longitudinal profile of Keg Creek with some data going back to 1954. The 1972 profile of the stream is 2 to 3 ft above the 1980 profile to mile 14.5. Upstream from mile 14.5 to mile 28.5 the 1973-74 profile is 1 to 3 ft below the 1980 profile. Comparing the 1954 profile with the two more recent profiles between

mile 22 and mile 27.8, the 1954 profile is 1 to 2.5 ft above the 1980 profile. The interpretation is that this lower reach of the stream has been relatively stable with regard to degradation in the last 25 years. However, between mile 28.5 and mile 31 there is evidence of degradation of as much as 10 ft within this same time span. This suggests that a knickpoint (Plate 5) has moved through this reach of river. According to reports, a knickpoint about 5 ft high was downstream of mile 28.5 in the early 1970s. The knickpoint which existed in 1979 was observed by the authors in the reach approximately at mile 29 and consisted of 3 riffles 1 to 3 ft in height. During the summer of 1980, four riffles from 1 to 1.5 ft high were observed between mile 29.5 and 31.5. It is concluded that this reach of the stream is actively degrading. Little difference exists between the profiles of 1976 and 1980 in the upper reaches where the 1976 channel bottom is only 2.5 ft above the 1980 channel bottom. Thus, there is little evidence for degradation in the upper reaches of Keg Creek. This is verified by the county engineer who stated that this reach of the stream is not creating any bridge problems at present.

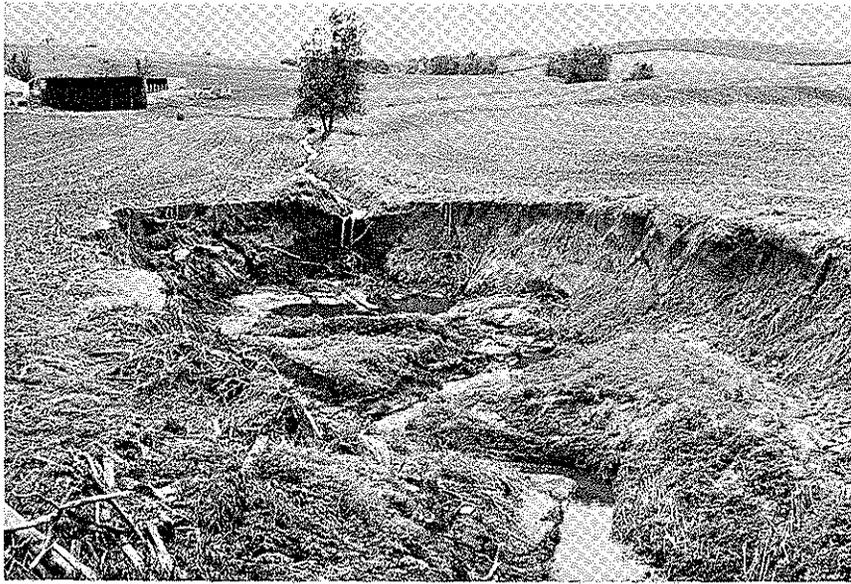
Plate 5. An example of a knickpoint eroding headward in a small tributary stream.

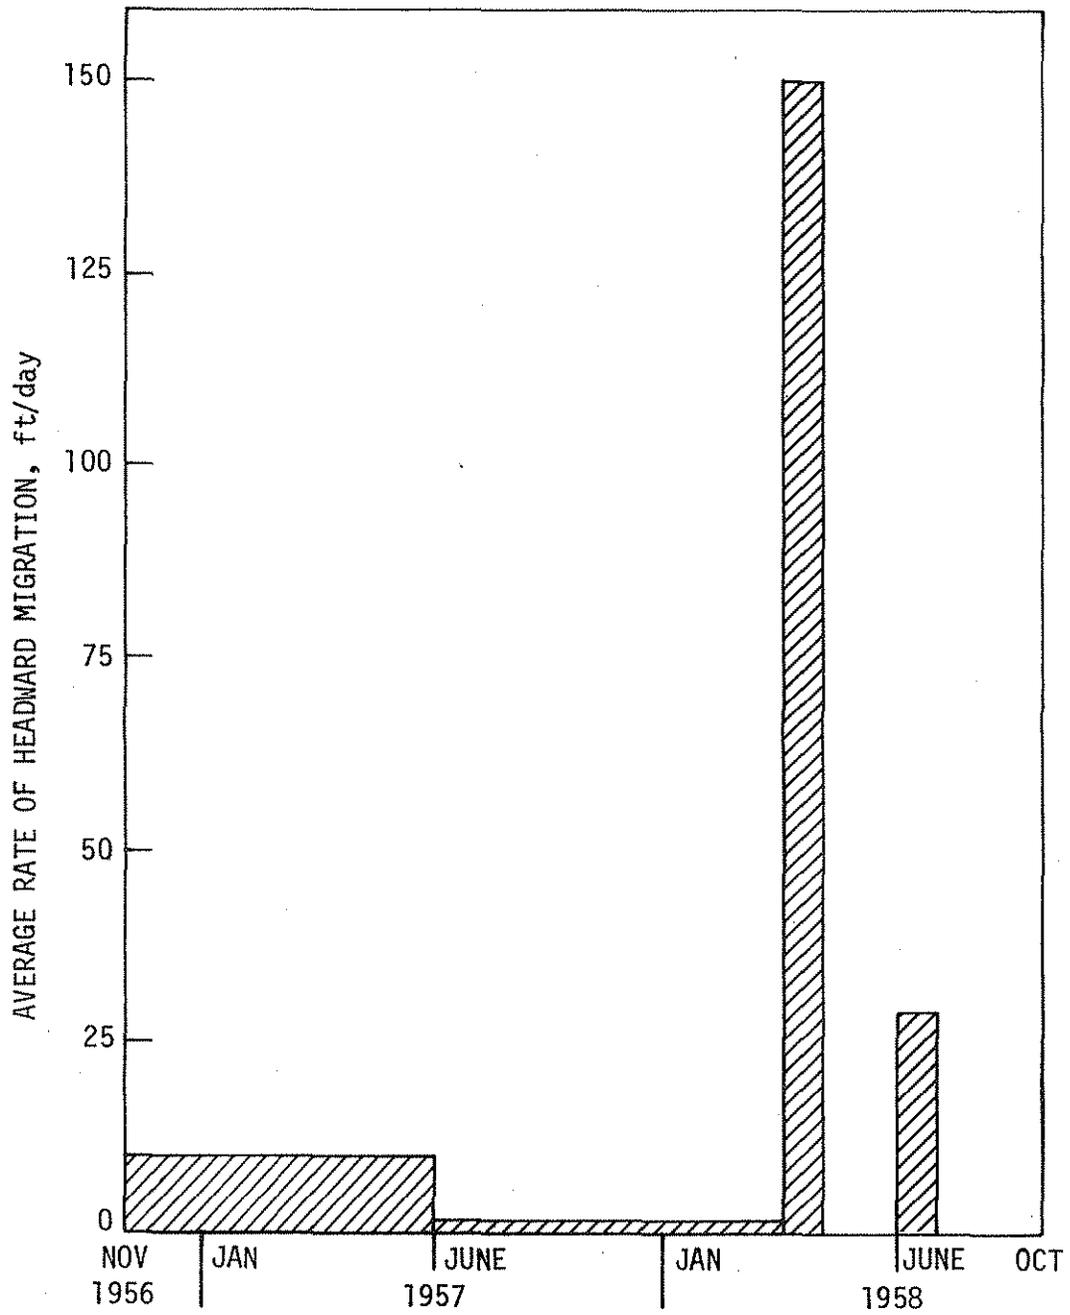
Fig. 13. Average Rate of knickpoint migration on Willow Creek. Plotted from data reported by Daniels (1960).

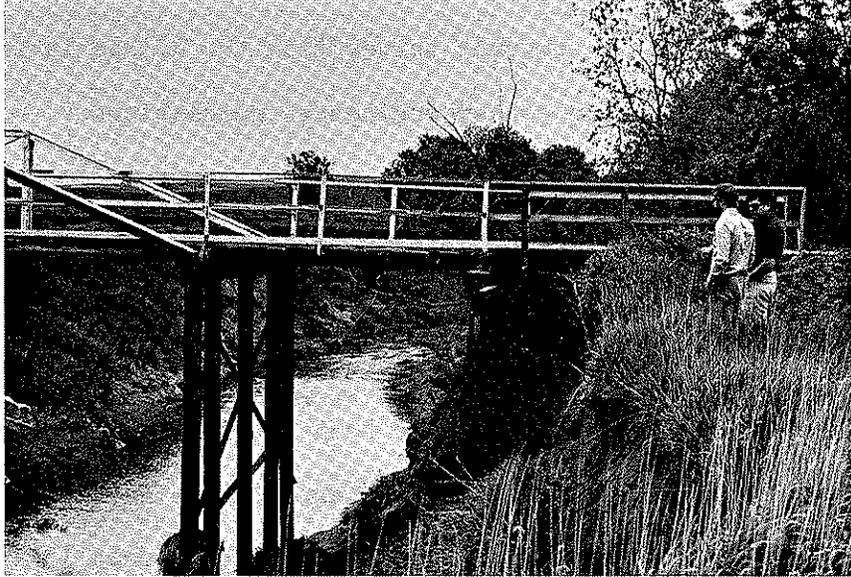
Plate 6. Stream degradation has exposed the bottom of the piles in this Crawford County bridge and caused a landslide which pulled soil from behind the abutment. Note that an approach span has been added to accommodate the increased valley width.

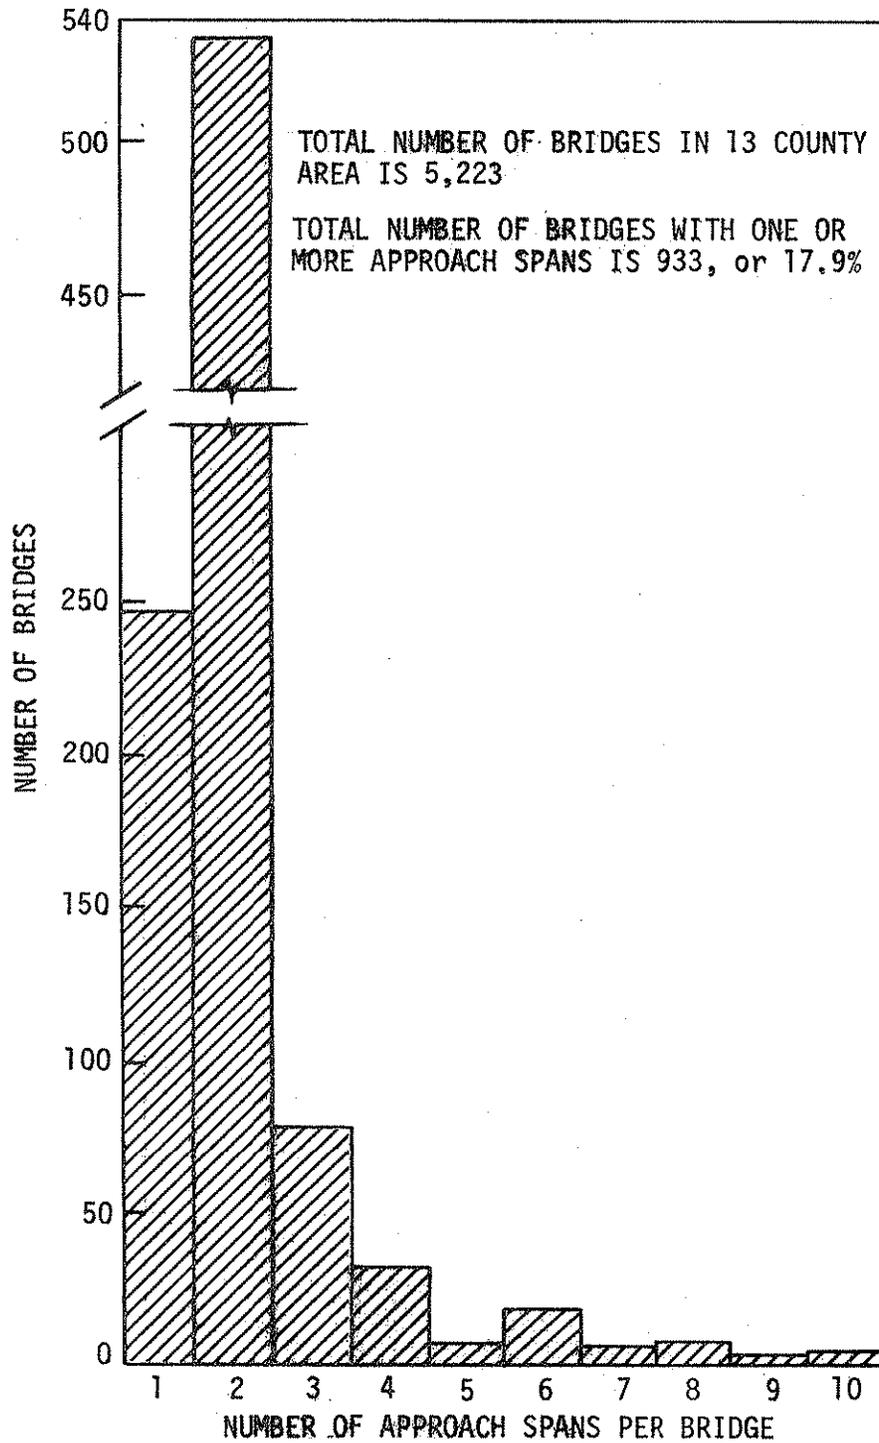
Fig. 17. Number of bridges having various numbers of approach spans.

As pointed out earlier, channel degradation leads to landslides which cause an increase in channel width. An attempt was made to quantitatively define the problem by determining the number of bridges in the area with approach spans. In western Iowa, presence of approach spans usually indicates that spans have been added since construction (Plate 6). The Iowa DOT bridge inventory data on the number of bridges with approach spans are summarized in Table 6. These data indicate that problem structures are more abundant in counties with deep loess deposits. The bar graph in Fig. 17 shows (for the entire 13-county area) the distribution of the number of approach spans among the bridges having such spans. Although the majority of the bridges have fewer than 3 approach spans, there are 14 bridges with 8 or more approach spans. Of the 5,223 bridges in the 13-county area, nearly 18% have one or more approach spans.

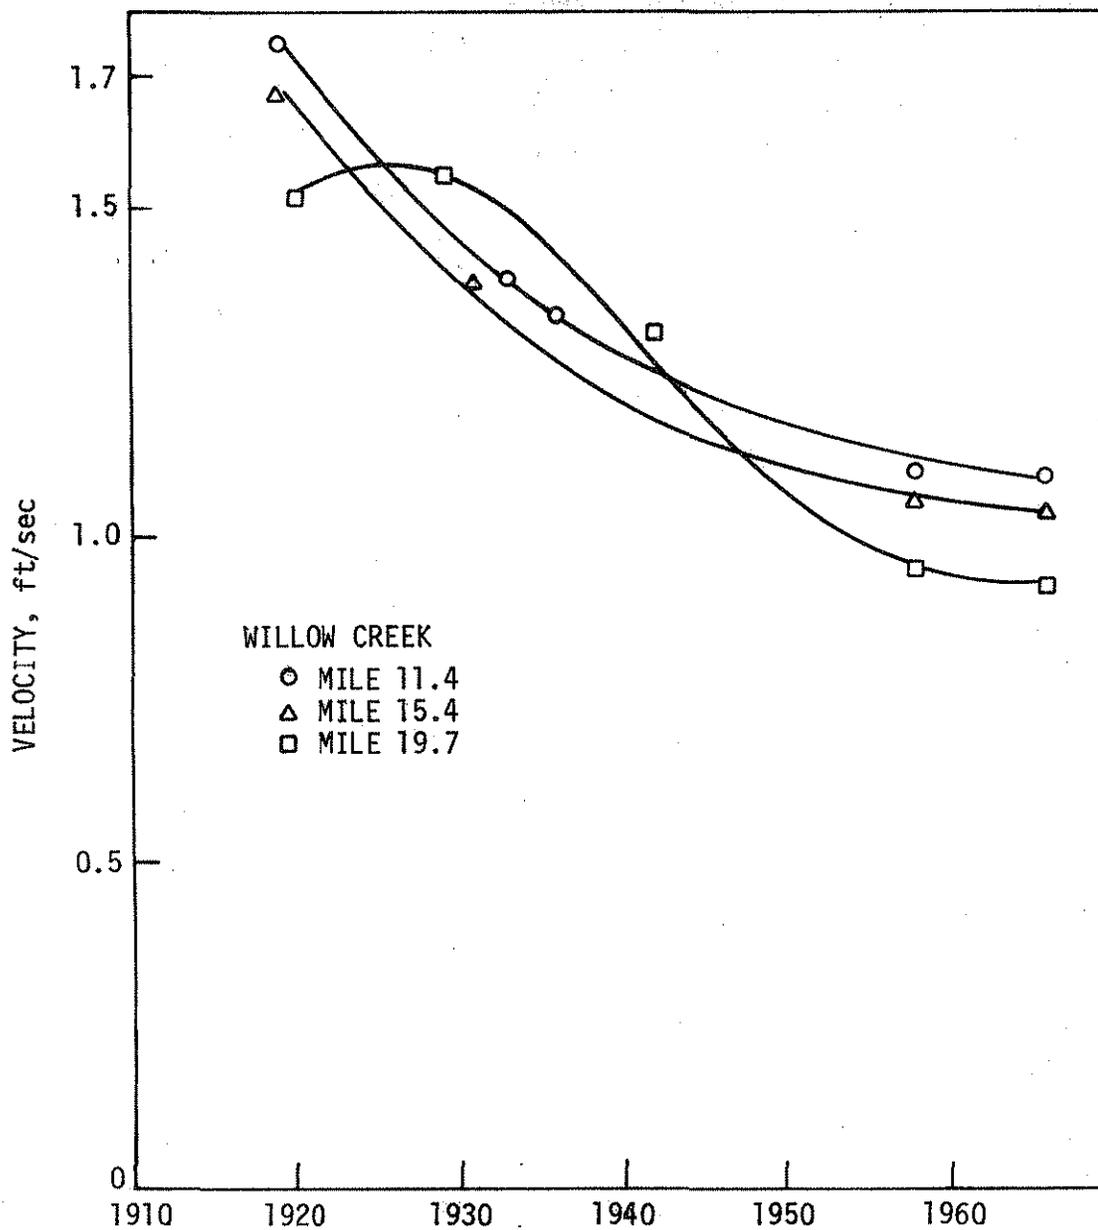
Fig. 18. Velocity variation with time for 3 sections of the Willow Creek.

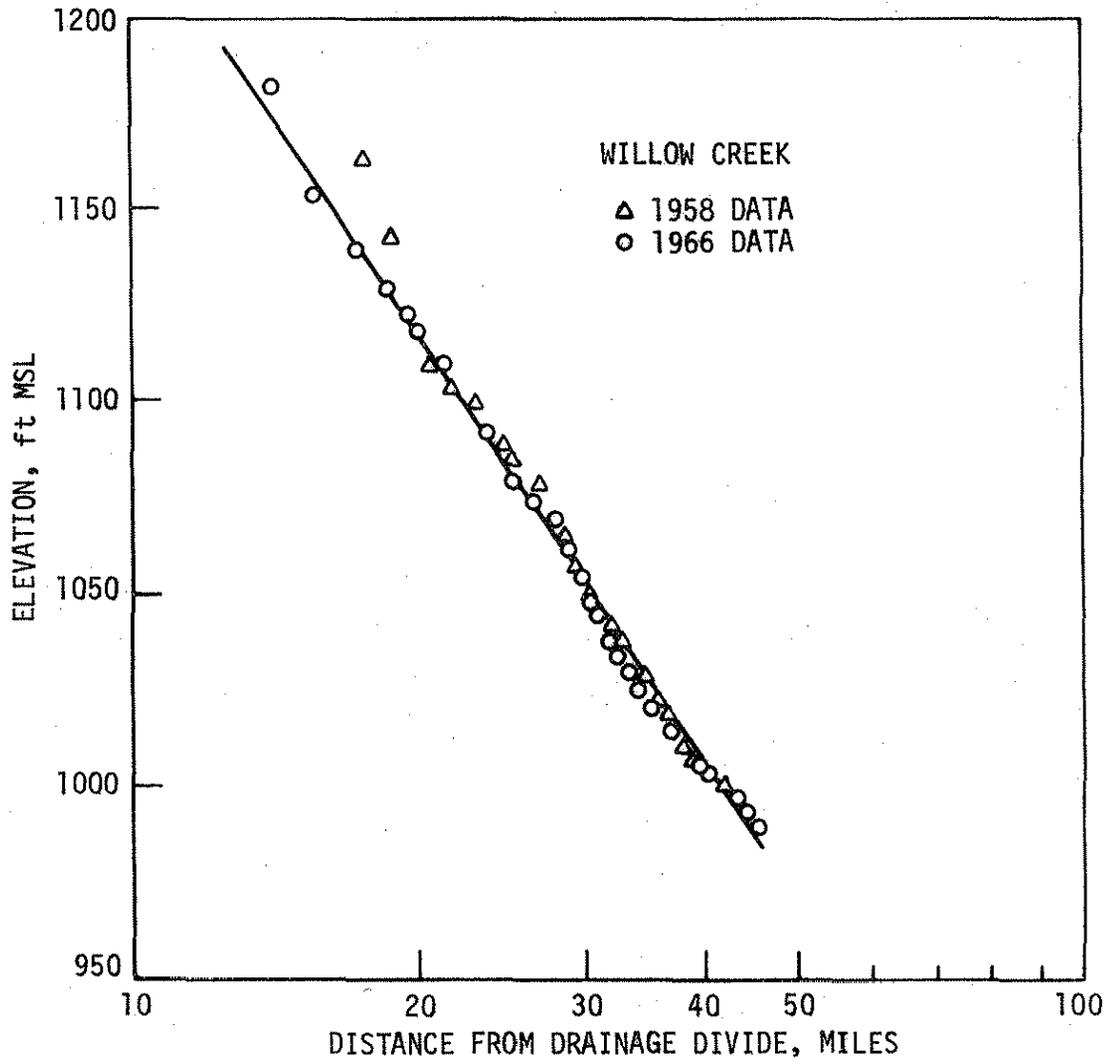
Fig. 19. Longitudinal profile of Willow Creek on semilog plot.

as introduced earlier in this report. This relationship plots as a straight line on semilog paper. Daniels plotted the 1958 profile of the Willow and noted that in the lower reaches, one slope was apparent whereas in the upper reaches a different slope value of k existed. He then assumed that the lower reaches of the stream were in equilibrium

and that the difference in the slopes of the two lines on the semilog plot indicated the amount of entrenchment the upper reaches of the stream would undergo before reaching equilibrium. By projecting the line of the downstream reach upstream on the graph and comparing the present elevation at that point with the elevation on the linear extrapolation, he predicted the amount of downcutting that would occur before the stream reached equilibrium. Figure 19 shows the semilog plot of elevation versus distance from the head of the stream for the 1958 and 1966 data. Note that the 1966 and 1958 profiles coincide below mile 19.5, but diverge upstream. The data points at mile 17.4 and 18.4 fit nicely on the same line established by the lower reaches of the stream. It can also be seen that the reaches of a stream below Willow Drainage District No. 1 (miles 39 to 45) also fit the semilog relationship very well. Figure 19 is simply a graphical presentation of the conclusion stated in a previous section of this report, i.e., Hack's equation for the longitudinal profile of a stream can be used to predict the amount of degradation by extrapolating the straight line on a semilog plot upstream from the equilibrium reaches to those reaches actively downcutting and noting the elevation difference between the degrading channel and the extrapolated line. The difference is the amount of entrenchment that will occur before equilibrium is reached. Having estimated the amount of downcutting, the next problem is to determine a method for estimating the rate of degradation.

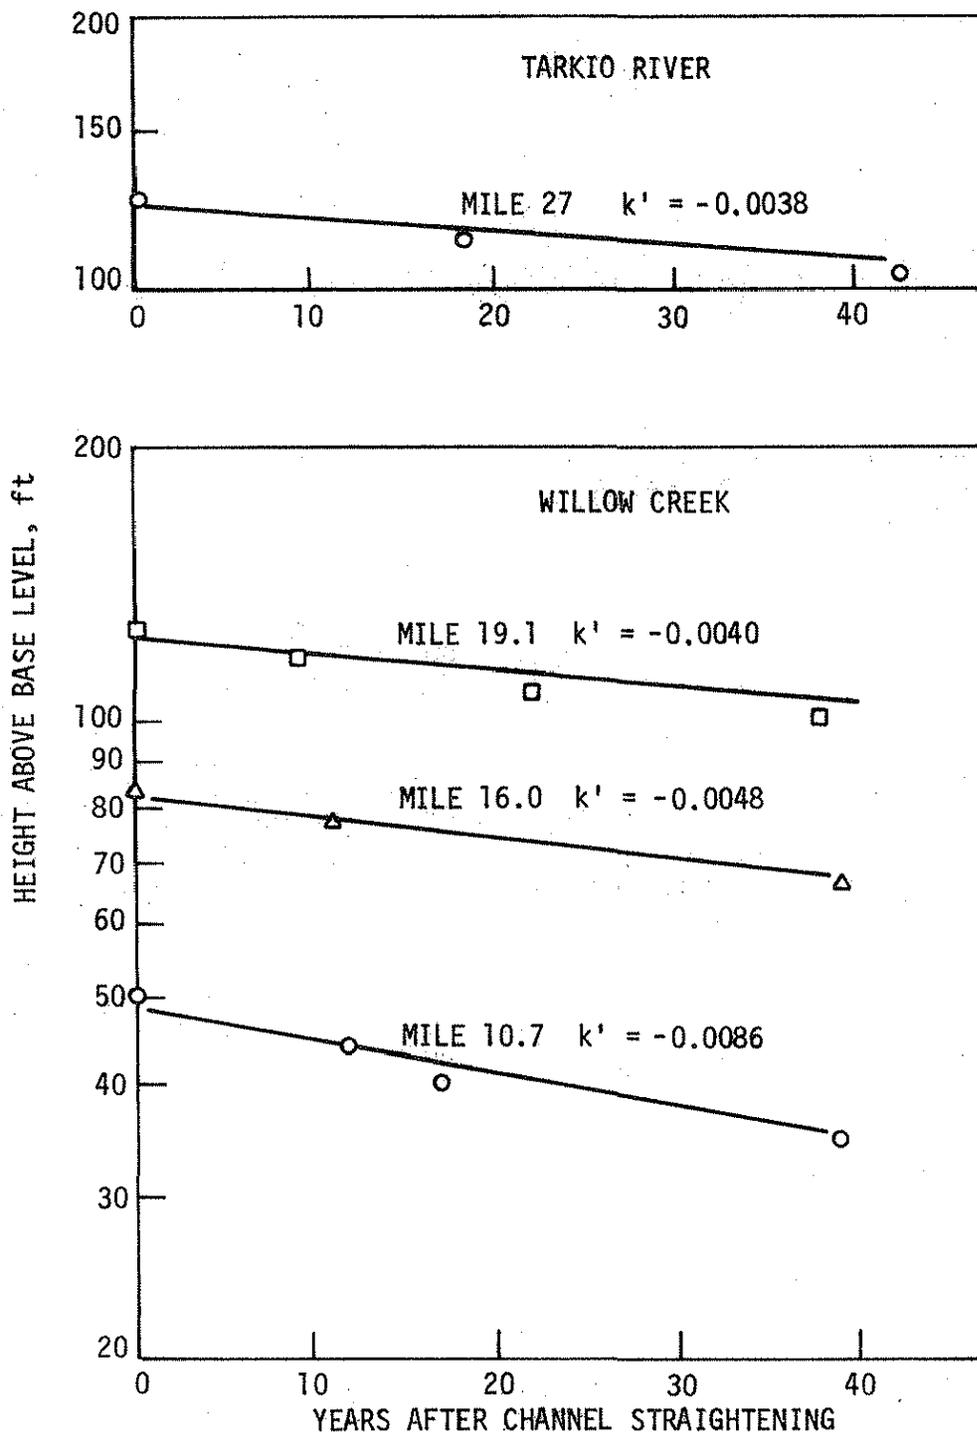
Fig. 20. Time versus log height above base level for reaches of Willow and Tarkio Rivers.

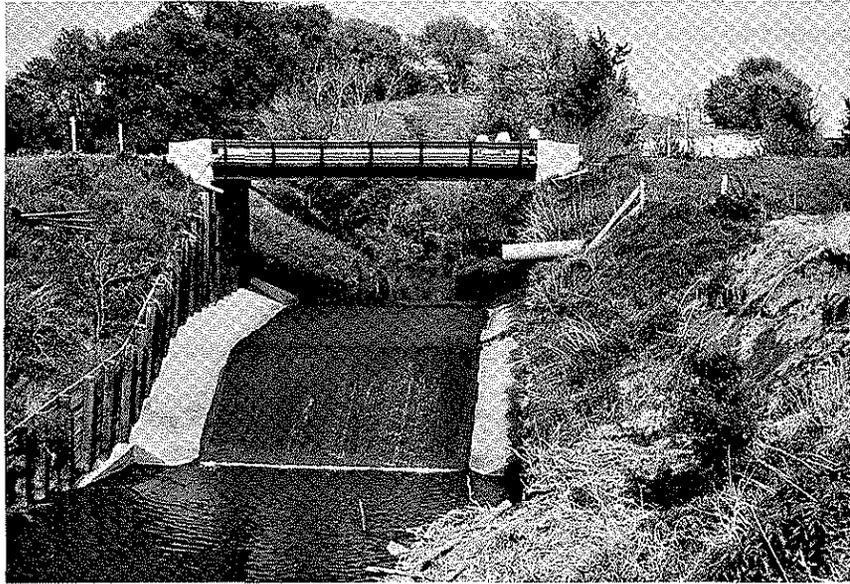
Plate 7. Flume bridge in Fremont County. Note wood piles inside the flume.

The full flow structures currently used in western Iowa include flume bridges (Plate 7), flexible drop structures of riprap or derrick stone with a sheetpile control crest (Plate 8), a double row of sheetpile as a control crest using less riprap (Plate 9), earth embankments with drop inlets or broken back culverts, reinforced concrete vertical drop structures of Soil Conservation Service (SCS) design (Plate 10), or reinforced concrete chute spillway structures with a Saint Anthony Falls (SAF) stilling basin at the end of the chute. In most cases all of these structures have performed well. In cases where grade stabilization structures have not performed well, it appears that the seepage through the earth embankment portions of the structure has not been controlled, either in design or construction. In other situations erosion at the downstream

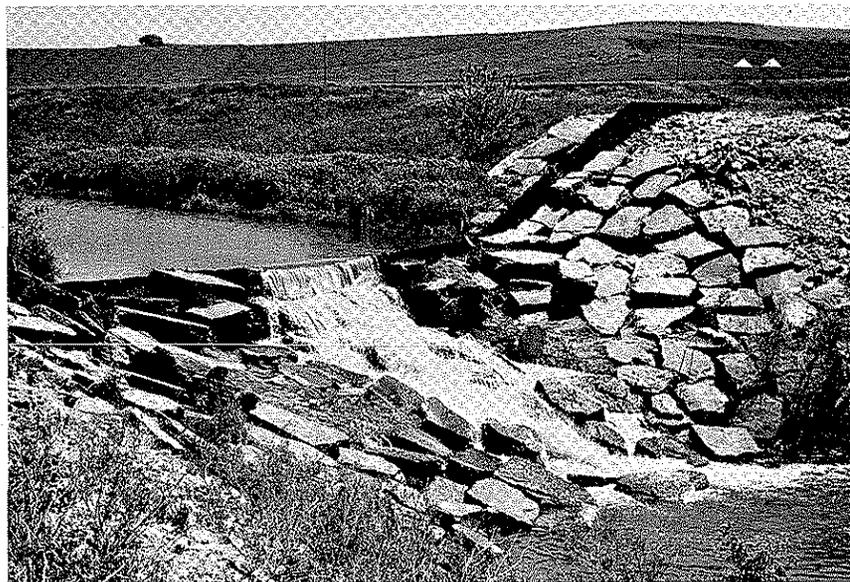
Plate 8. Grade stabilization structure consisting of a single row of sheetpile reinforced with derrick stone.
