Final Report on Phase I

ALTERNATE METHODS OF STABILIZING DEGRADING STREAM CHANNELS IN WESTERN IOWA

**Submitted to
the Highway Division of
the Iowa Department of Transportation
and
the Iowa Highway Research Board**

**ISU-ERI-Ames-81047
Project 1421**

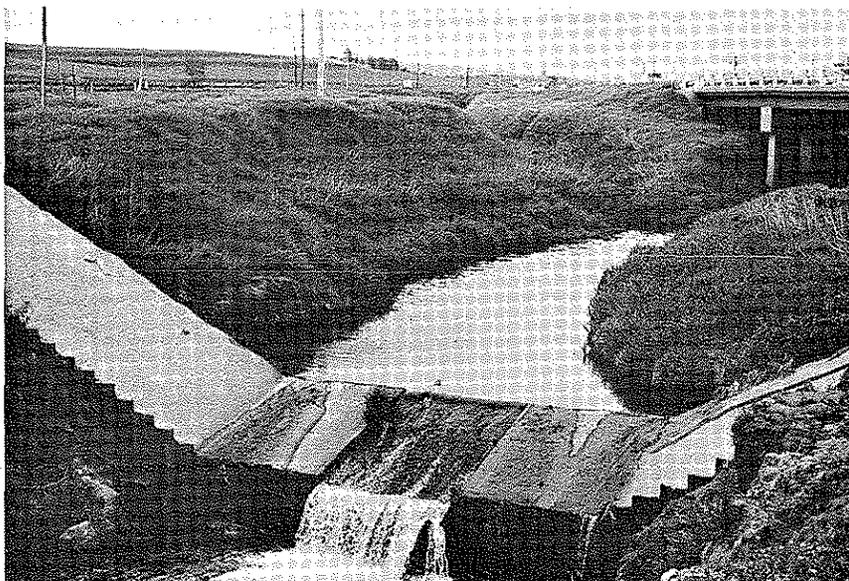
Plate 9. Grade stabilization structure consisting of double row of steel sheetpile with a concrete core and cap. Note large crack in right side resulting from adjacent landslide caused by downstream scour in plunge pool.

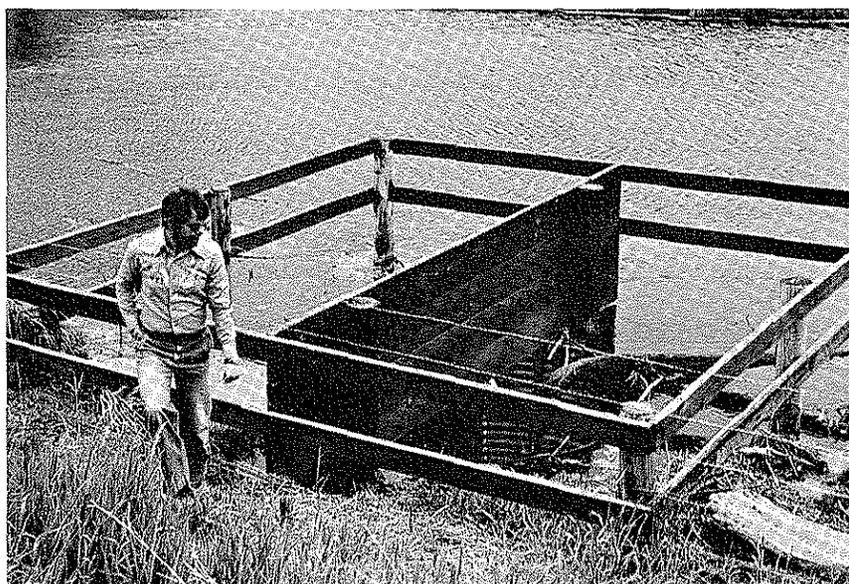
Plate 10. An SCS-type drop inlet for a grade stabilization structure. Note baffle plate to disrupt vortices and trash rack.

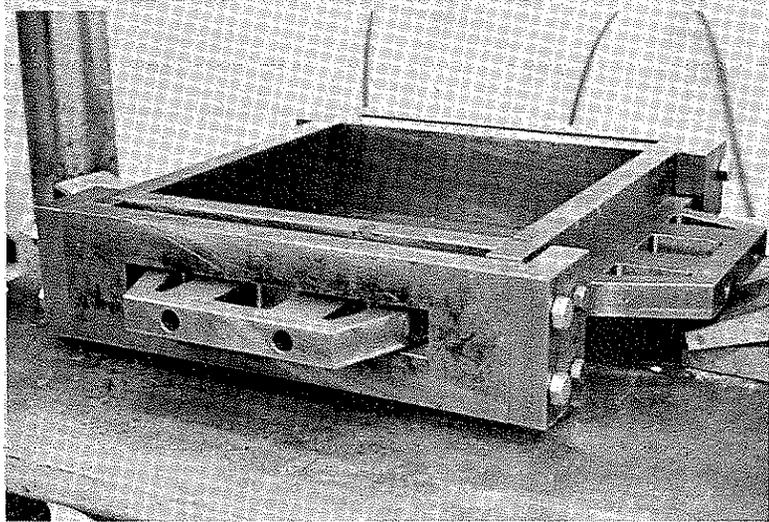
Plate 11. Mold used for preparing soil-cement specimens for erosion tests.

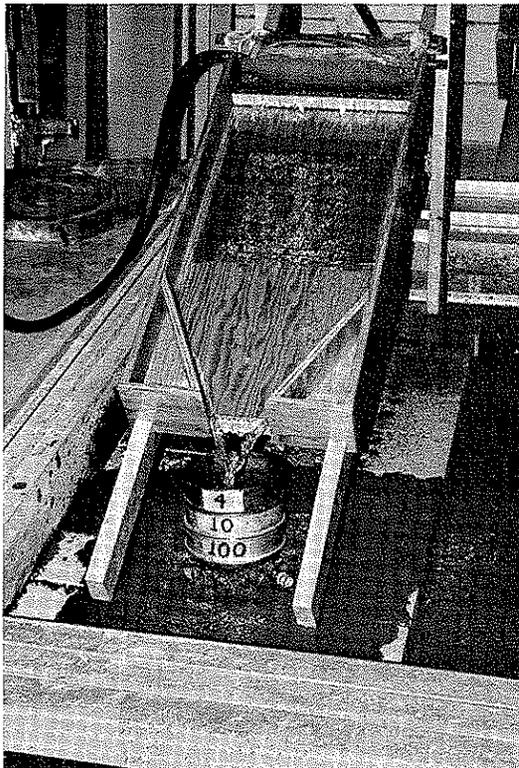
Plate 12. Erosion flume used in cement stabilization study.

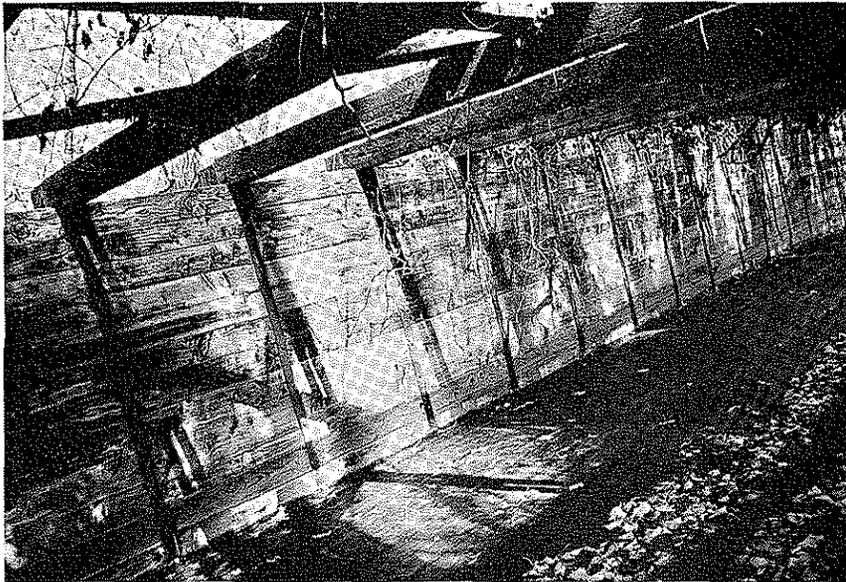
Plate 13. Flume of the original flume bridge in Fremont County. Note wood sidewalls and floor, cross braces on top, and absence of piles in the interior of the flume.

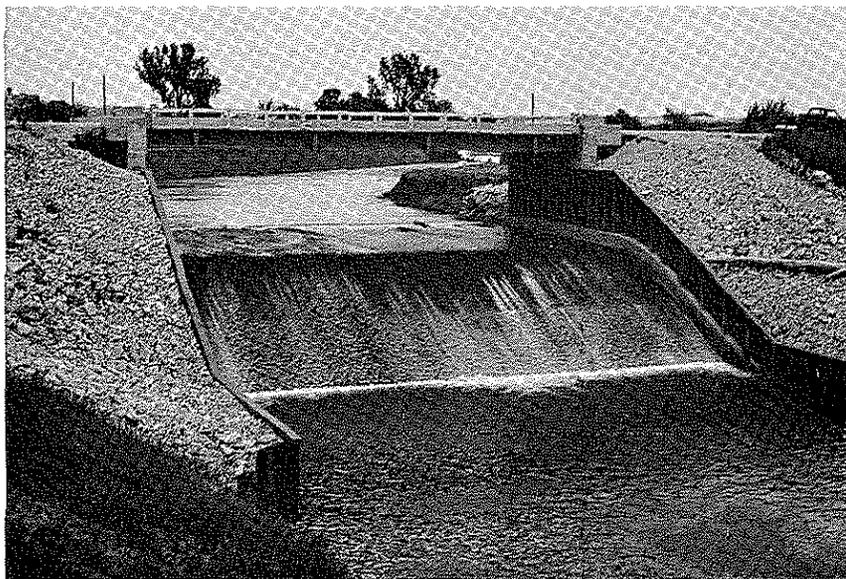
Plate 14. Recently built flume bridge in Harrison County. Note the use of steel piles in the sidewalls and bridge alignment relative to stream channel.

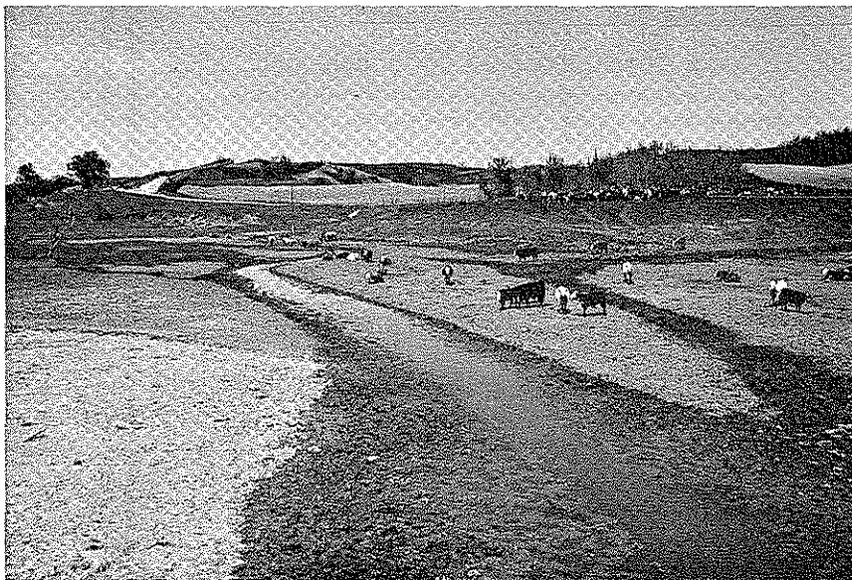
Plate 15a. The aggraded prism of sediment deposited upstream of a flume bridge in Monona County. Compare this photo with the downstream view in 15b.

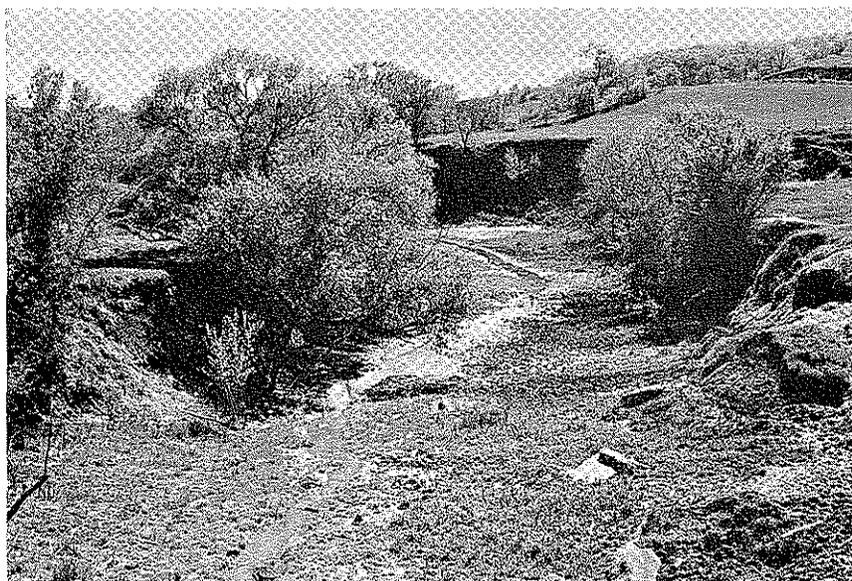
Plate 15b. A degraded channel downstream from a flume bridge. Compare this photo with the upstream view in 15a.

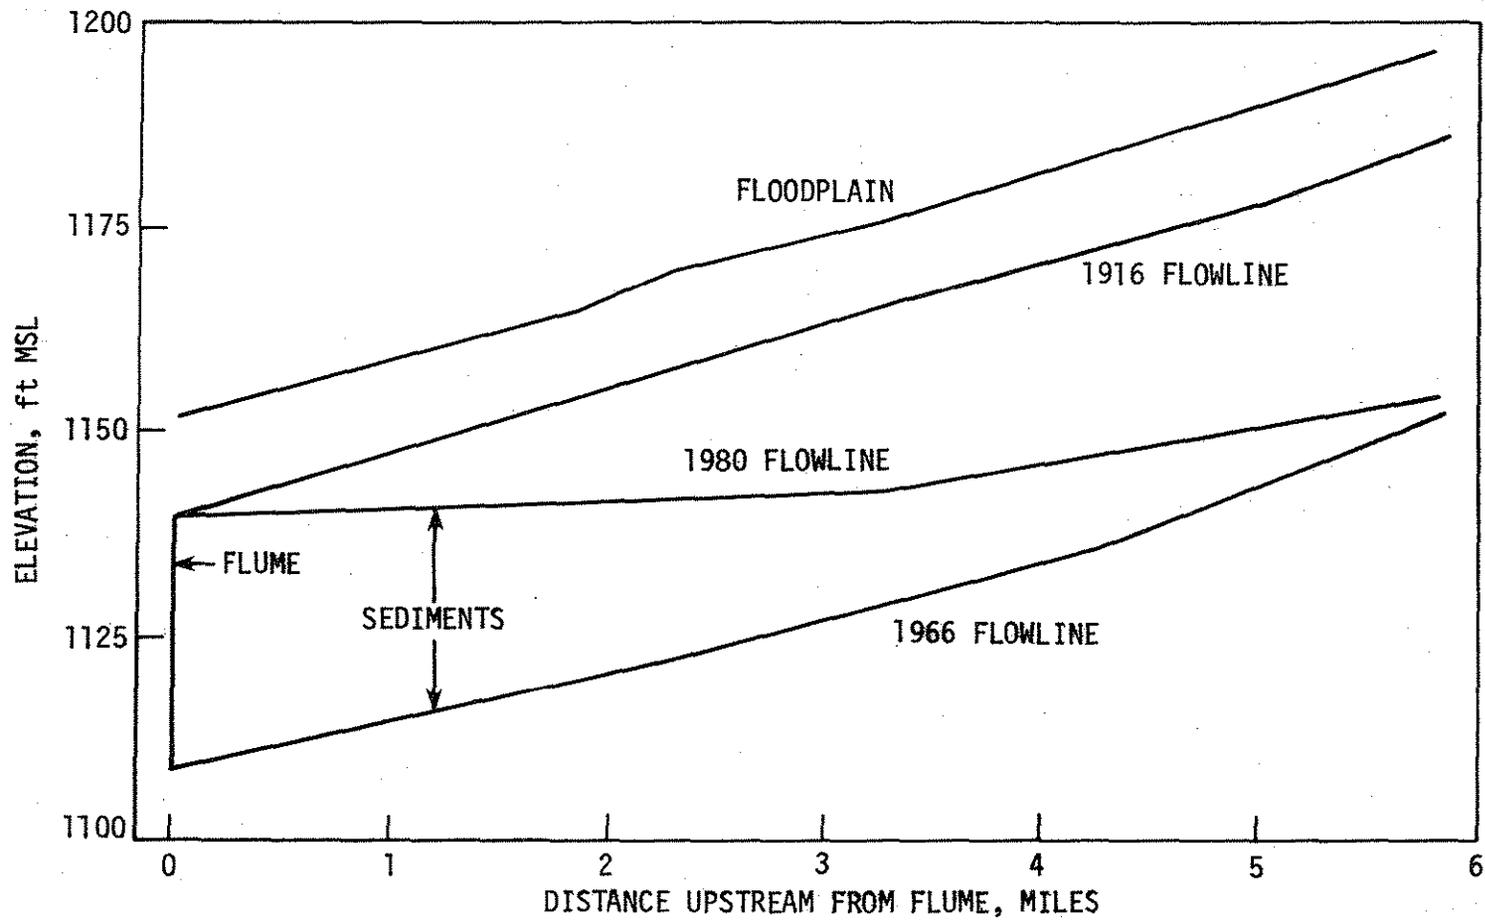
Fig. 21. Flume bridge at mile 23.5 on Willow Creek showing sediment deposition.

Figure 21 shows a larger scale drawing of the effect of alluviation of the 34-ft high flume bridge at about mile 23.5 on Willow Creek. For reference, the profile of the floodplain and the 1916 channel is shown.

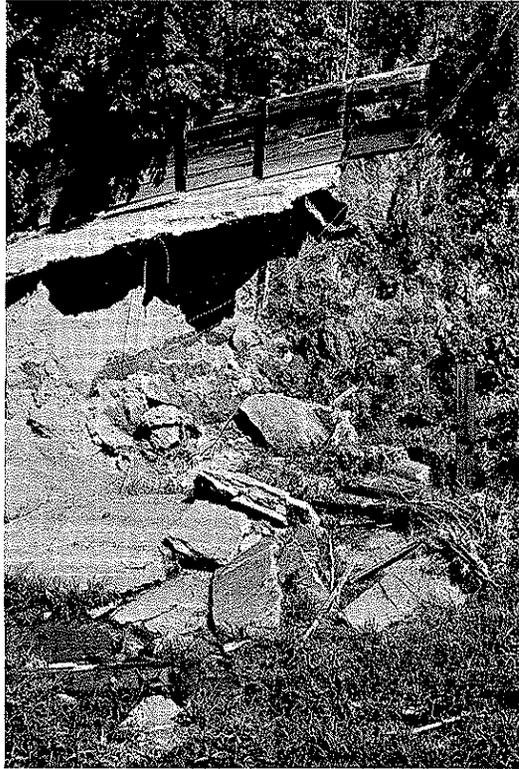
Plate 16. The remainder of the concrete floor and timber sidewalls of a flume which has failed, probably through piping.

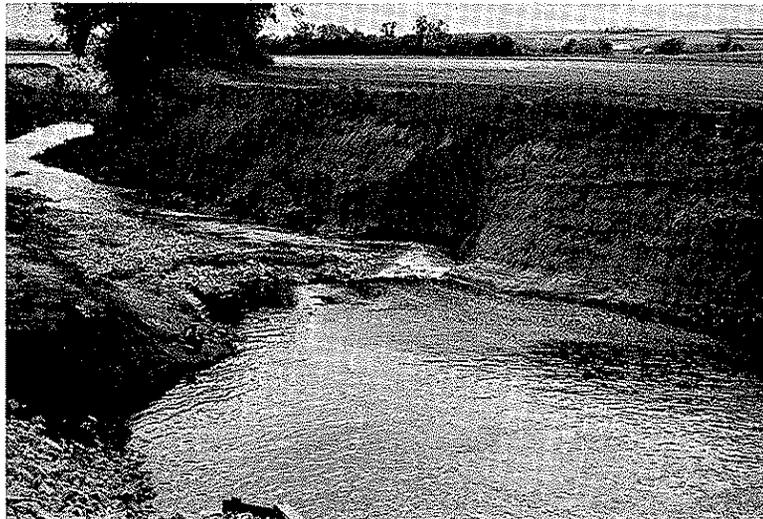
Plate 17. Scour hole at stilling basin downstream from flume bridge. Note how deflection of channel is causing lateral erosion.

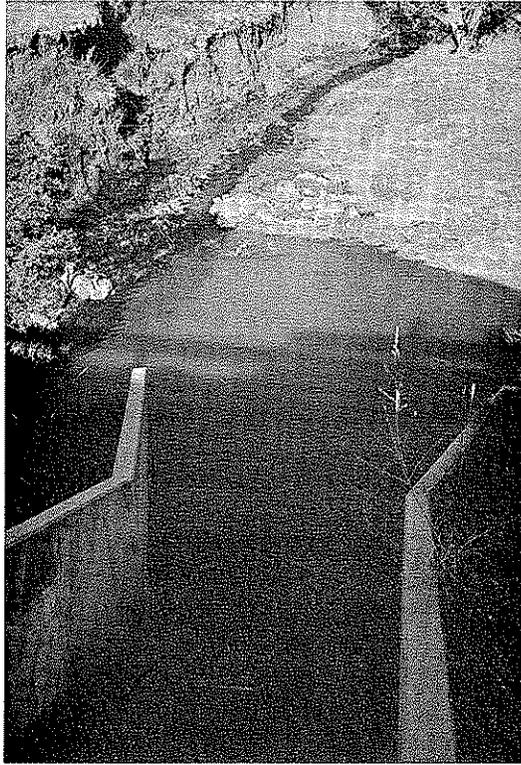
Plate 18. Undissipated energy on the downstream side of this box culvert having an IDOT flume outlet resulted in erosion of a scour hole and bank instability.

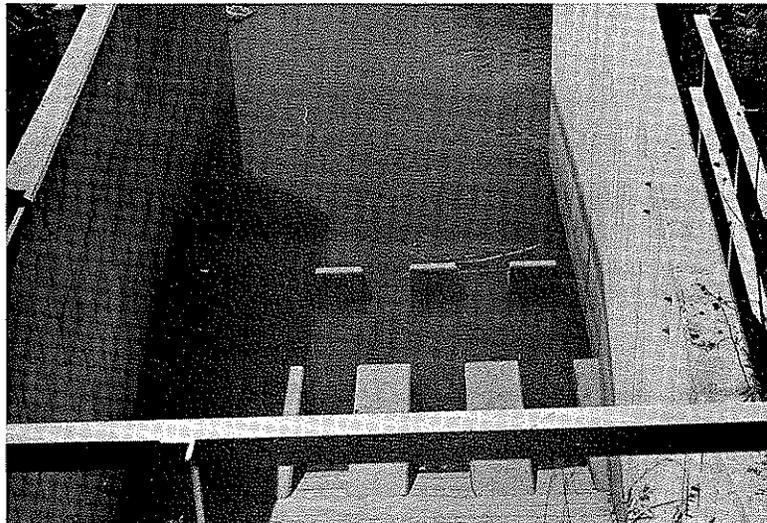
Plate 19. Chutes and baffle blocks for energy dissipation on downstream side of box-culvert type of grade stabilization structure.

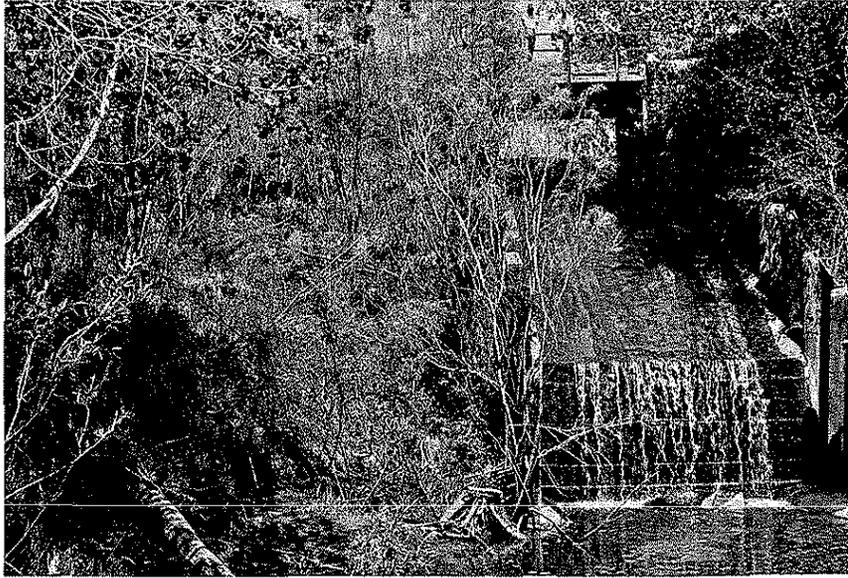
Plate 20. A foreshortened flume outlet; the irregular topography in the soil to the left of the flume is the result of landslides caused by seepage forces in the embankment.

Field observation of embankment instability induced by seepage through the embankment (Plate 20) suggests that some flume bridge embankments have been designed as highway embankments when in fact they should have been considered earth dams. It is also the opinion of many of the engineers in the area that failures in some cases have been caused by piping through the embankments or in other situations by uplift pressures and/or piping beneath the concrete. It is recognized that piping problems may result from poor construction rather than from poor design. The aforementioned application of plastic soil-cement may provide remedial measures when piping is observed but before a major

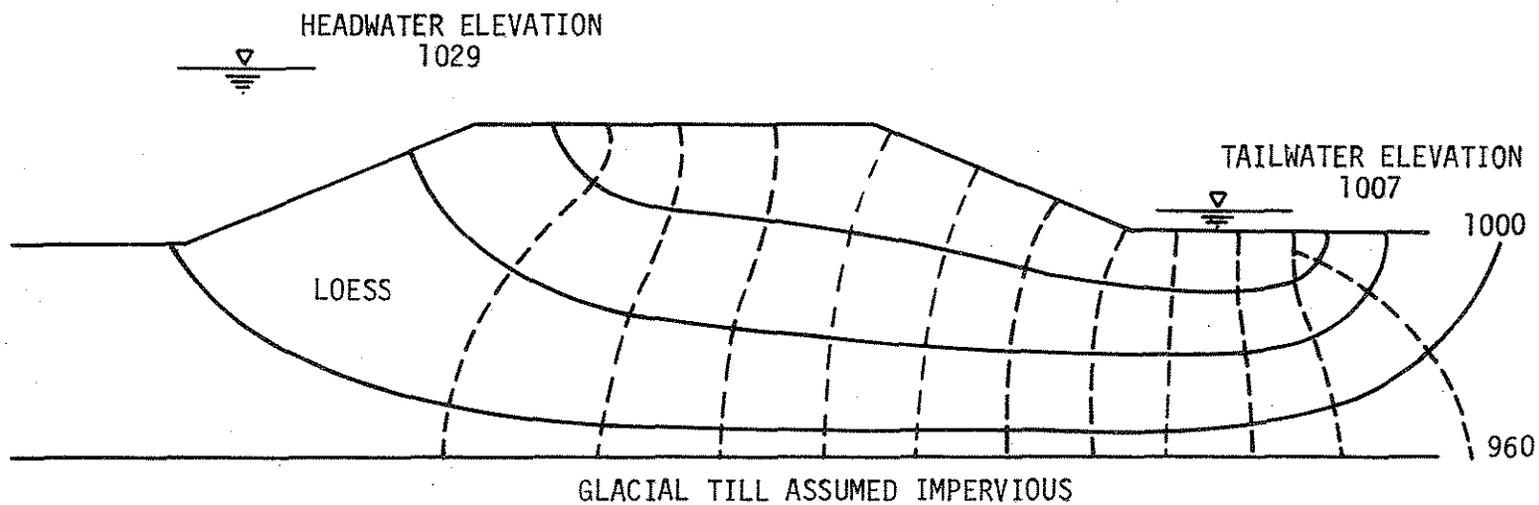
Fig. 22. Flow net beneath structure for Flume No. 2.

Two flume bridges were selected for analysis of seepage. One of these, Flume No. 2, was used in the stilling basin analysis. A third flume is used here to compare and contrast the effect of an impermeable zone at different depths beneath the structures. Flume No. 3, designed for a 5527-cfs discharge is 30.9 ft high, 67.5 ft wide with a stilling basin 24 ft long. Boring logs from Flume No. 3 indicate glacial till 15 ft below the alluvium, whereas beneath Flume No. 2 the glacial till is estimated from the alluvial thickness map to be about 40 ft. The flow nets for Flume No. 2 and Flume No. 3 are shown in Figs. 22 and 23, respectively. These nets do not show the structures as built, but represent cases without seepage control. It can be seen that the exit gradients are higher beneath Flume No. 3 than beneath Flume No. 2. There are cutoff walls on the upstream side of both structures. Although

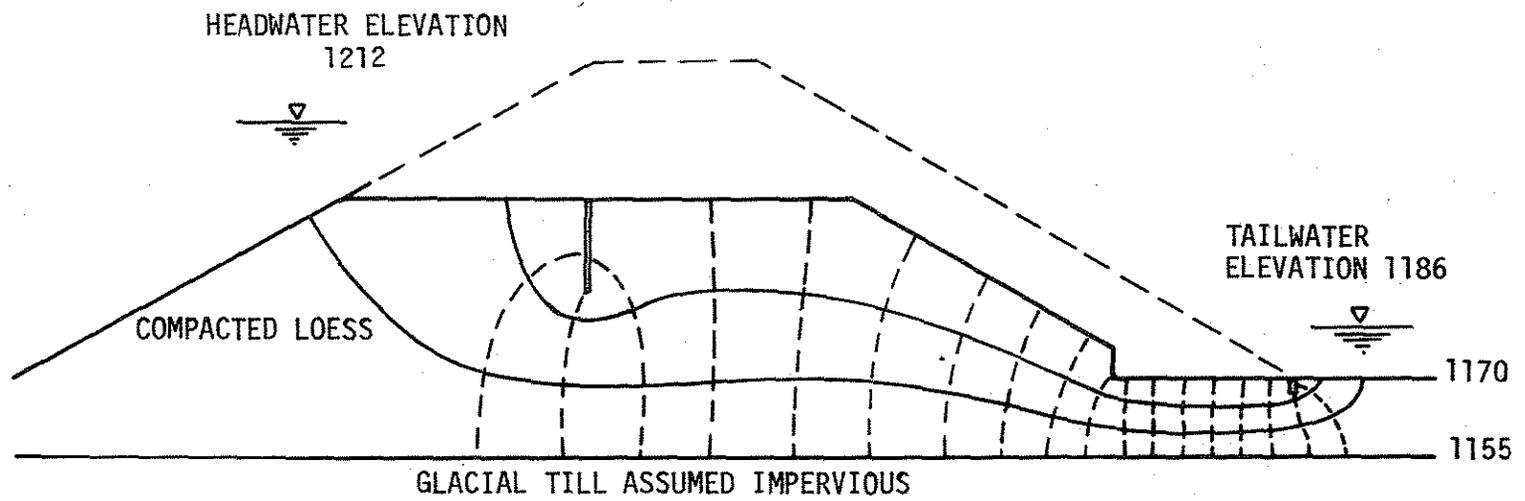
Fig. 23. Flow net beneath structure for Flume No. 3.

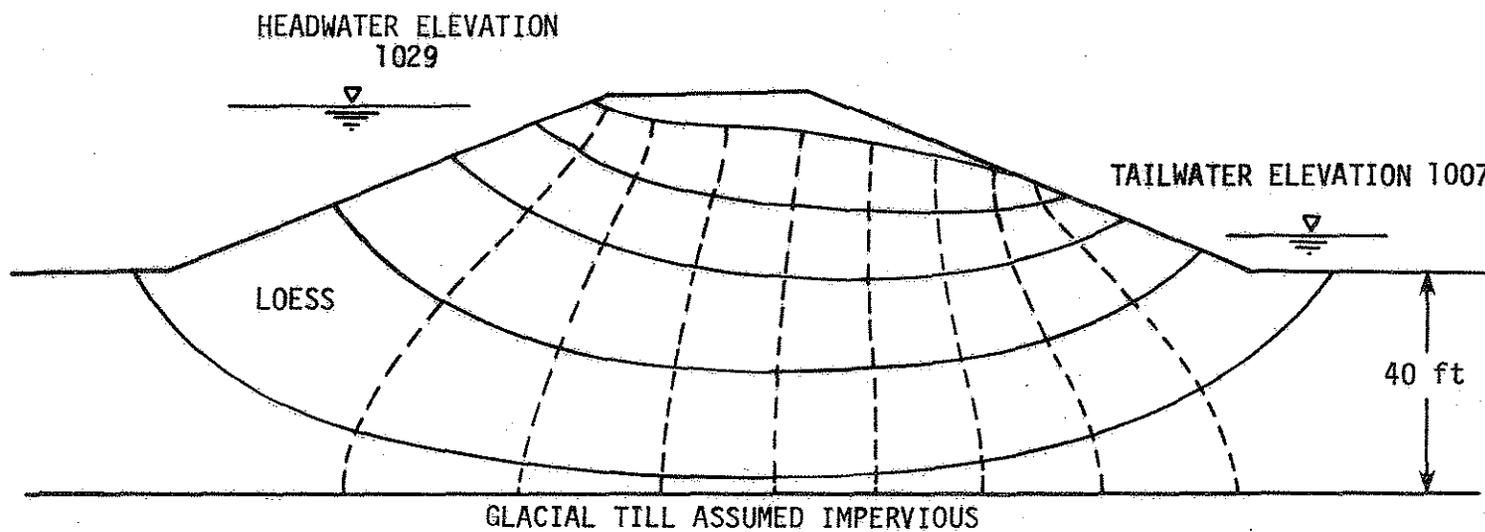
Fig. 24. Flow net through embankment adjacent to structure for Flume No. 2.

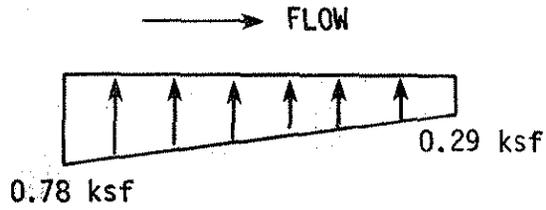
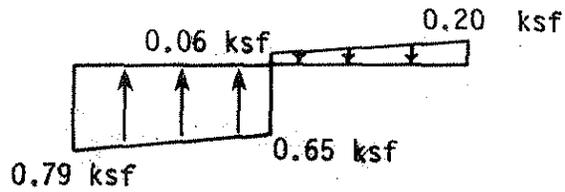
CASE I
NATURAL JUMP
WITH UPLIFT

CASE II
BAFFLED JUMP
WITH UPLIFT

Fig. 25. Loading cases considered--Flume No. 2.

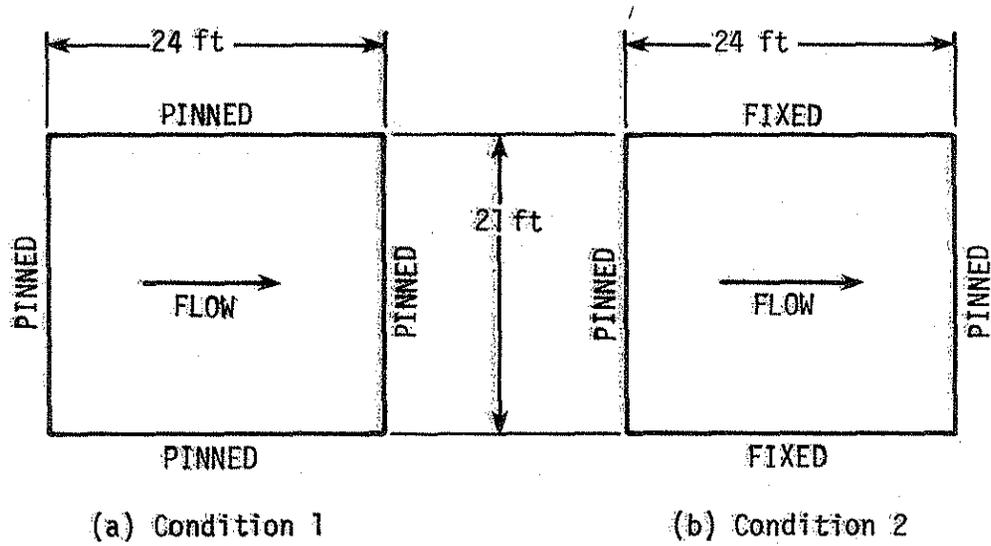
Fig. 26. Plan view of stilling basin with assumed edge conditions--
Flume No. 2.

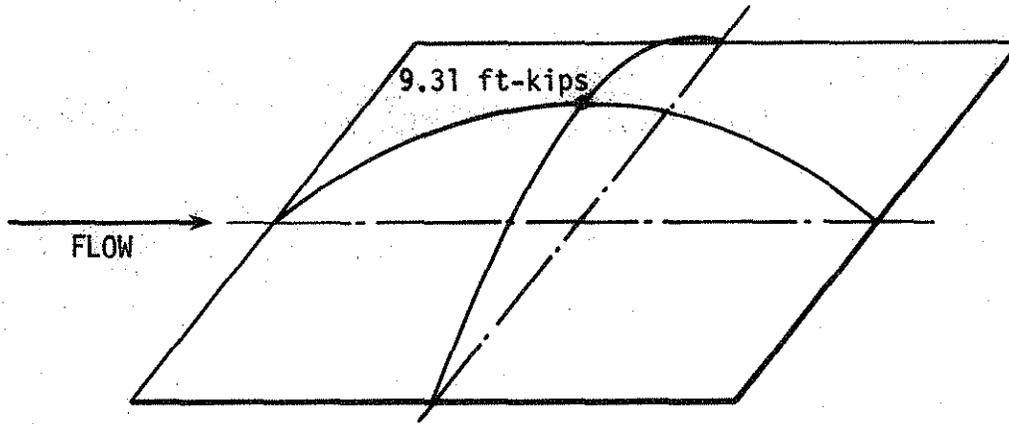
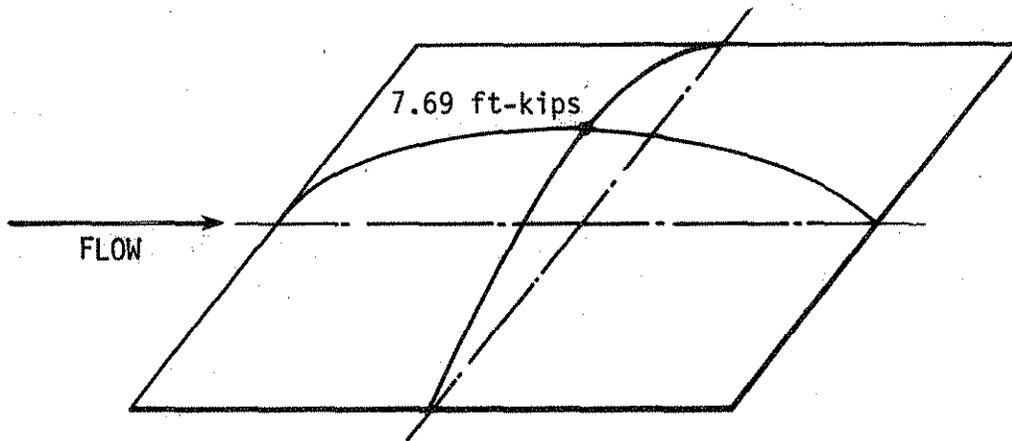
(a) Longitudinal Moments, M_L

(b) Transverse Moments, M_T

Case	Condition 1				Condition 2			
	M_L (ft-kip/ft)	A_{SL} (in. ² /ft)	M_T (ft-kip/ft)	A_{ST} (in. ² /ft)	M_L (ft-kip/ft)	A_{SL} (in. ² /ft)	M_T (ft-kip/ft)	A_{ST} (in. ² /ft)
I Natural Jump with Uplift	12.67	0.67	10.69	0.56	8.24	0.42	4.59	0.23
II Baffled Jump with Uplift	7.95	0.42	10.19	0.55	6.00	0.30	6.37	0.33
III Uplift Only	9.31	0.45	7.69	0.37	6.03	0.29	3.73	0.19
