**PROGRESS REPORT**

**SURFACE IMPROVEMENT AND  
DUST PALLIATION OF UNPAVED  
SECONDARY ROADS AND STREETS**

James M. Hoover

*ISU-ERI-AMES 9991  
Project 856-S*

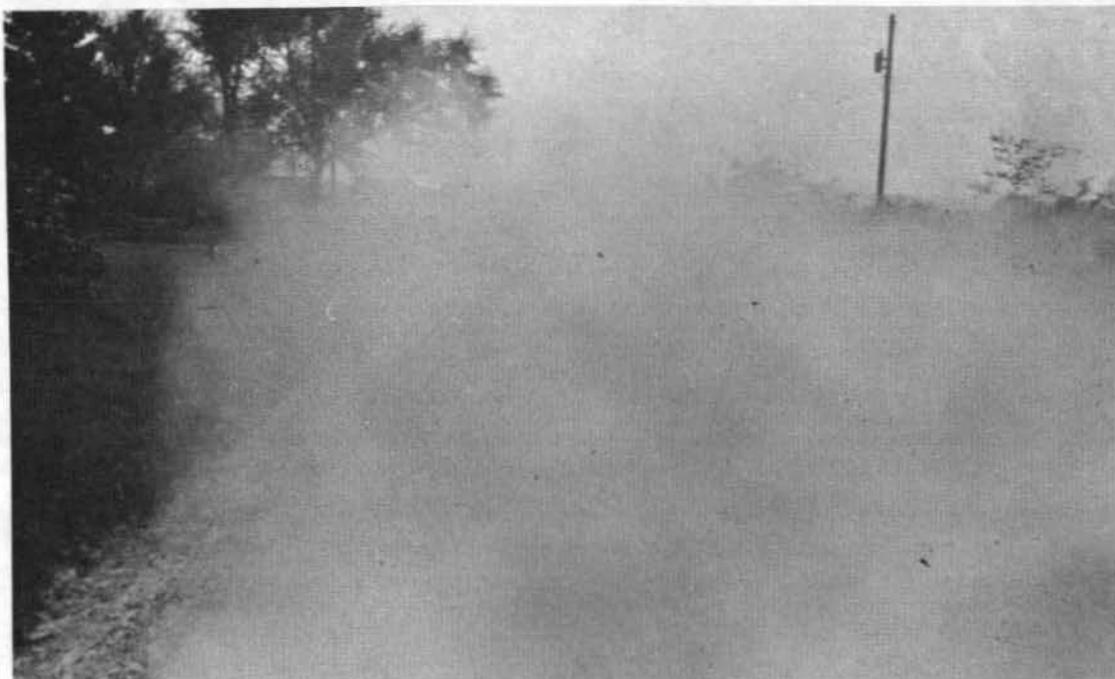
Fig. 1. Road dust at 40 mph behind a moving vehicle. A pickup truck is following, but hidden in the dust cloud.

unpaved surfaces include reduction of sight distance, with a consequent reduction of safe speeds (See Fig. 1). Loose surface aggregate produces skidding and swaying of vehicles, less positive steering response, longer stopping distance, and broken windshields from flying rock (See Fig. 2). Dust from unpaved surfaces infiltrates homes and destroys the esthetics of both rural and urban living (See Fig. 3). Dust and loose aggregate contribute to severe maintenance and aggregate replacement costs - such costs are illustrated by blade grading of 20 or more times per year and one known Iowa county whose aggregate replacement costs exceed \$500,000.00 annually.

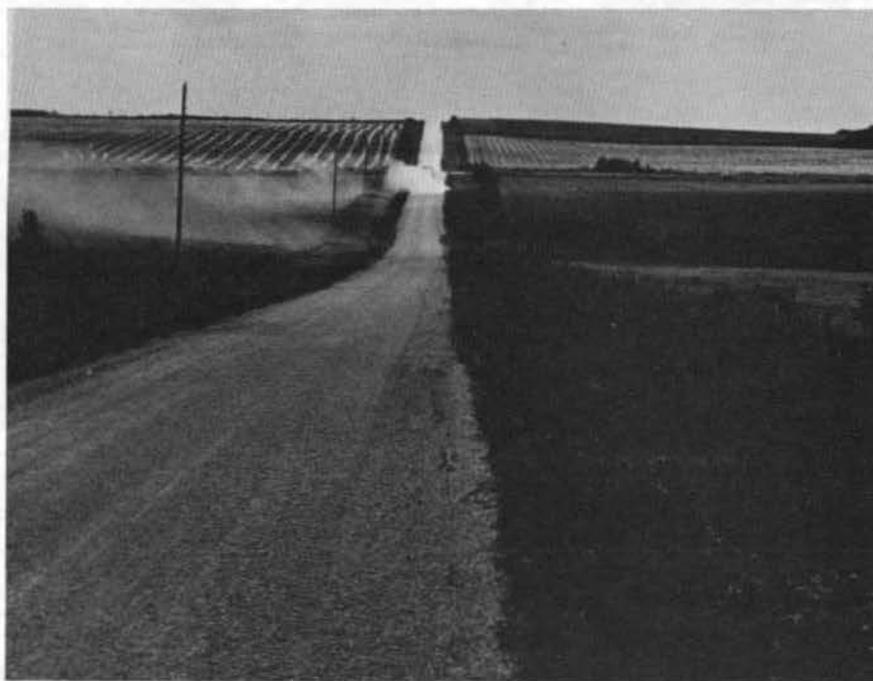
Fig. 2. Loose surface aggregate and blowing dust.

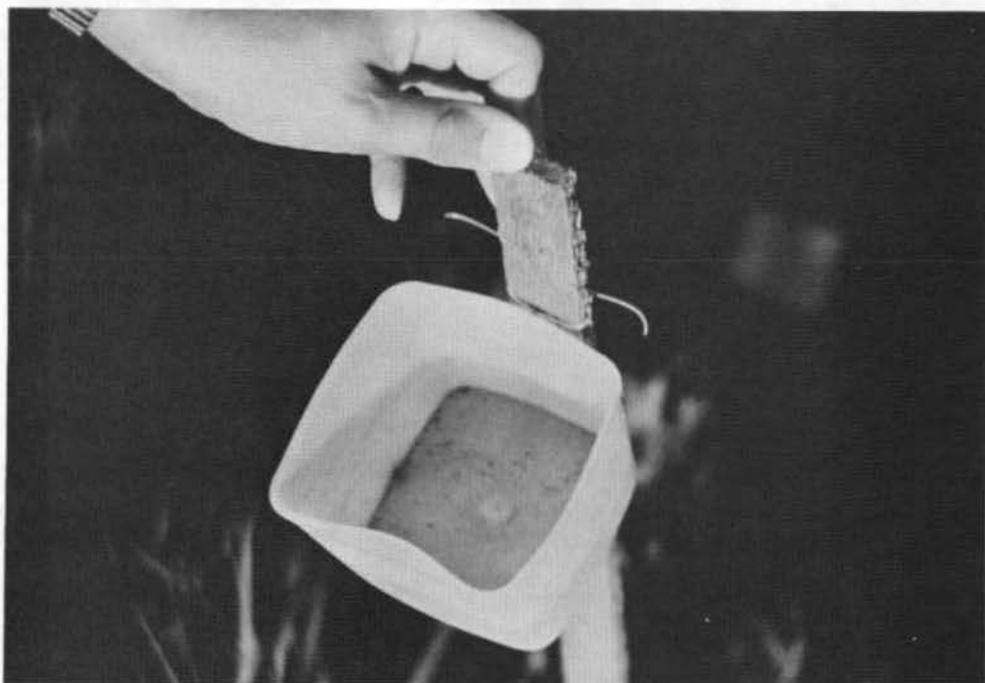
Fig. 5. Road dust collector after 24 hr on site.

frozen food containers attached to wood lath and placed 3 ft above ground surface was used as shown in Figs. 4, 5, and 6. Each container was half-filled with distilled water and remained in place exactly 7 days. A traffic counter was installed for the same period of time with average traffic recorded slightly over 110 vpd. The containers were checked daily for water level\* and after the 7 day period were sealed and returned to the laboratory. Following removal of all organic matter, including bugs, chaff, and seeds, the contents of each box were oven-dried, weighed, and examined under a microscope. The average daily accumulation of dust over the bottom area of each box was calculated in pounds per acre per day of dust, and are shown in Fig. 7. Microscopic examination indicated that the dust was composed predominantly of limestone particles.

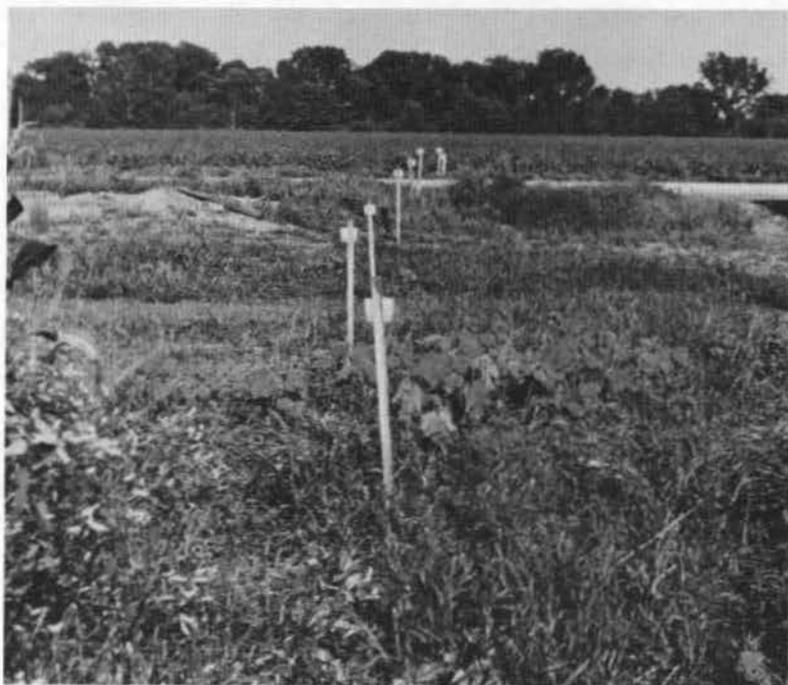
Fig. 6. Road dust collectors installed at 20 ft intervals up to 140 ft each side of center-line.

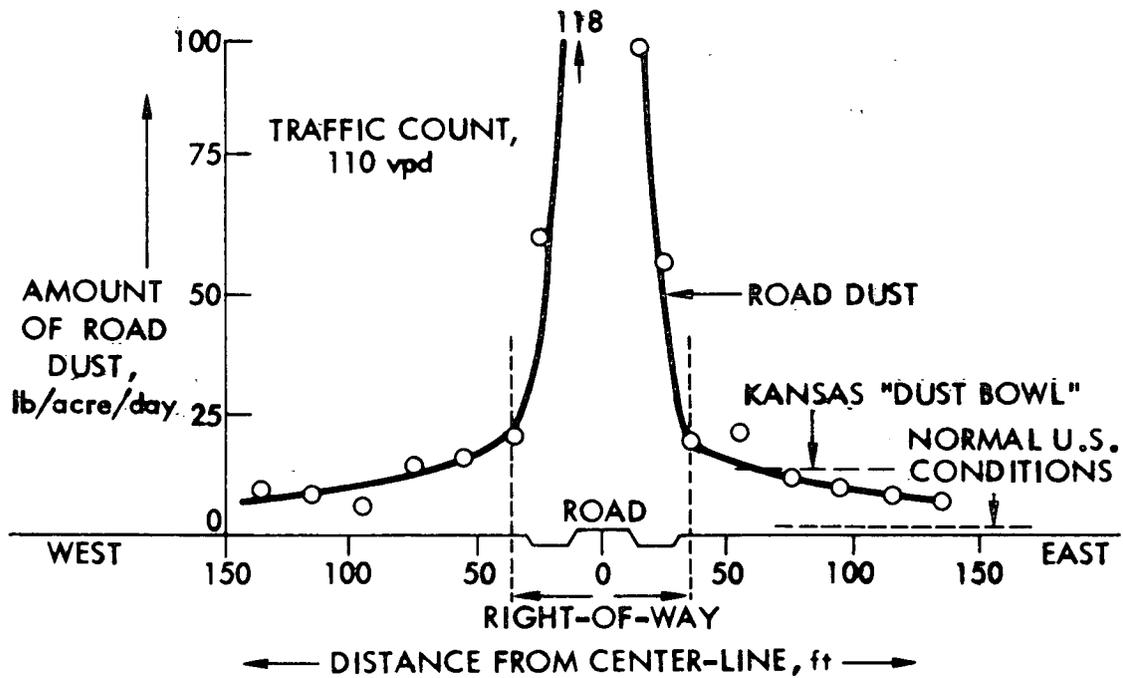
Fig. 7. Amount of daily road dust accumulation vs distance from centerline.

Figure 7 also compares the preliminary sampling data with both normal U.S. conditions and 1954 Kansas "dust bowl" conditions. Figure 8 compares the preliminary sampling data with agricultural field dust data from across the U.S.

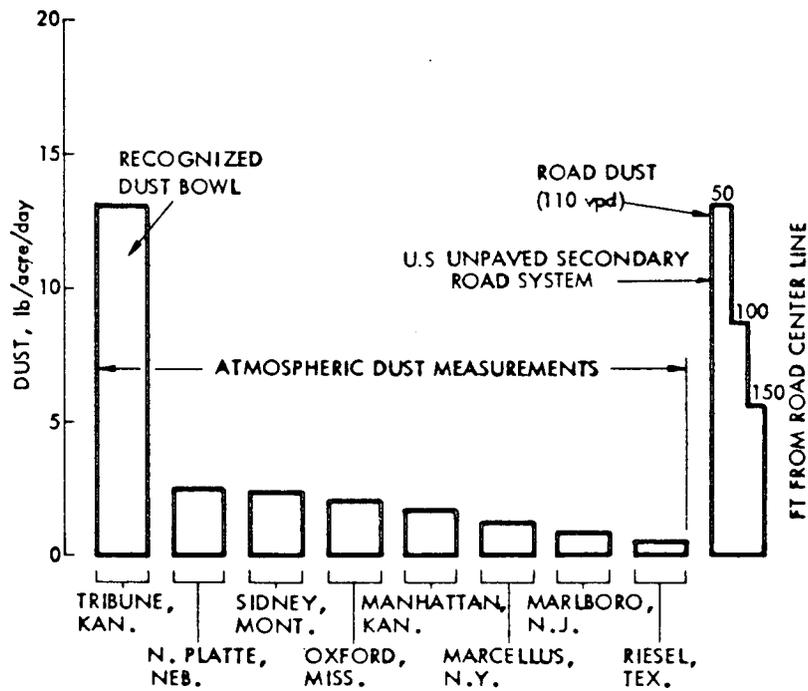
Fig. 8. Amount of daily road dust accumulation at 50, 100 and 150 ft from centerline compared with agricultural field dust data at various U.S. locations.

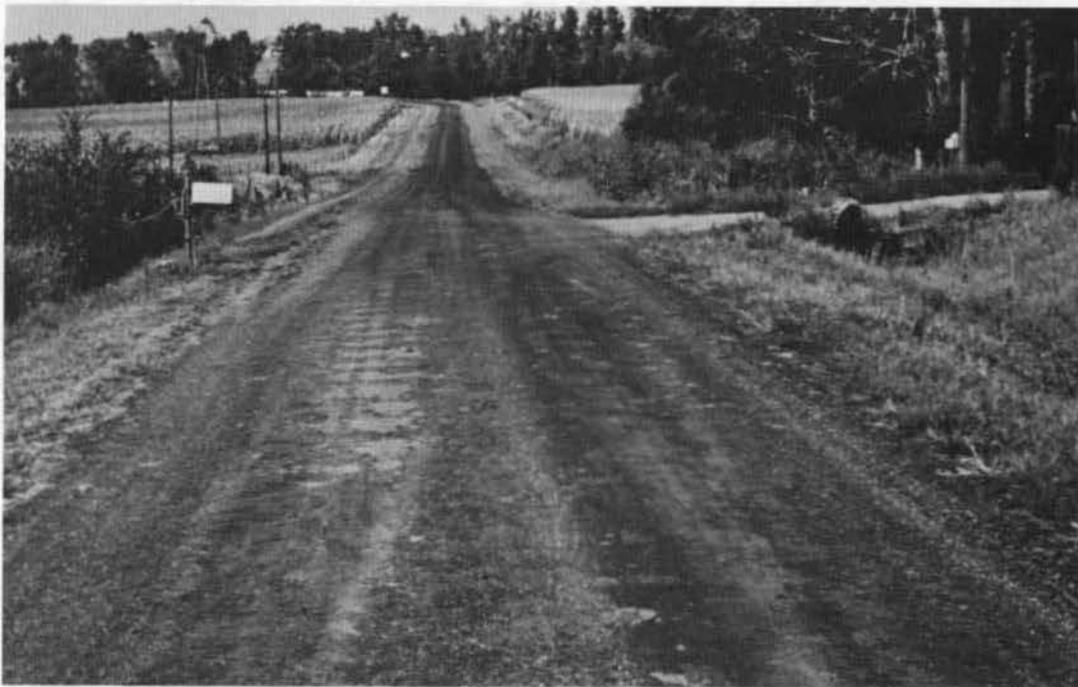
Fig. 10. Oiled road surface showing effects of ravelling and pot holing.

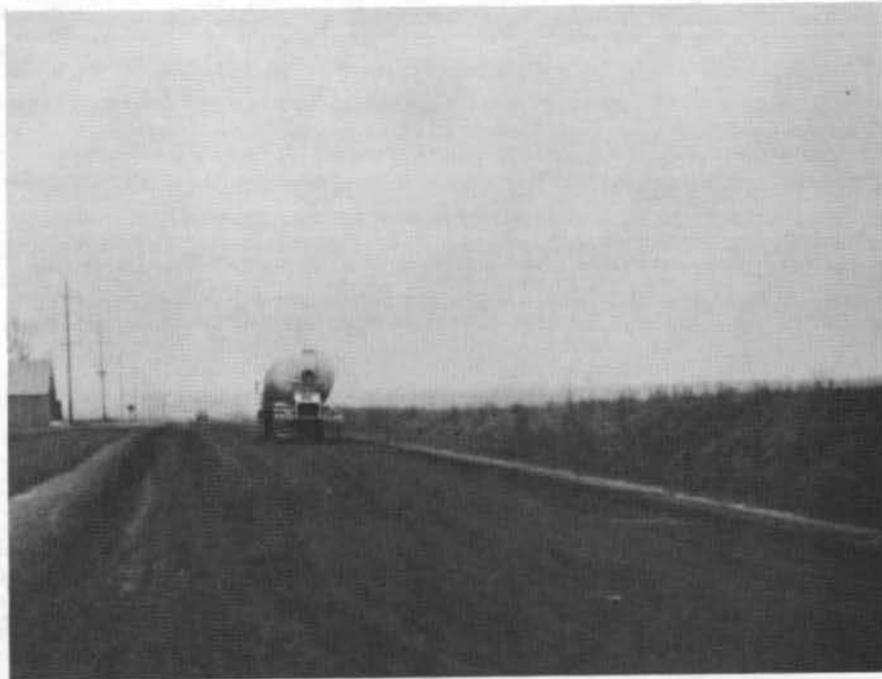
Fig. 11. Lignin-surface treated road. Treatment approximately two weeks old. Tank truck in background travelling at estimated 30 mph speed.

Lee County now has over 140 miles of road surface treated with lignin, some of which have been treated annually for better than 10 years with quite reasonable success (See Figs. 11 and 12). Lee County also has the advantage of having a local pulp mill as a source of lignin at about 11% solids concentration.

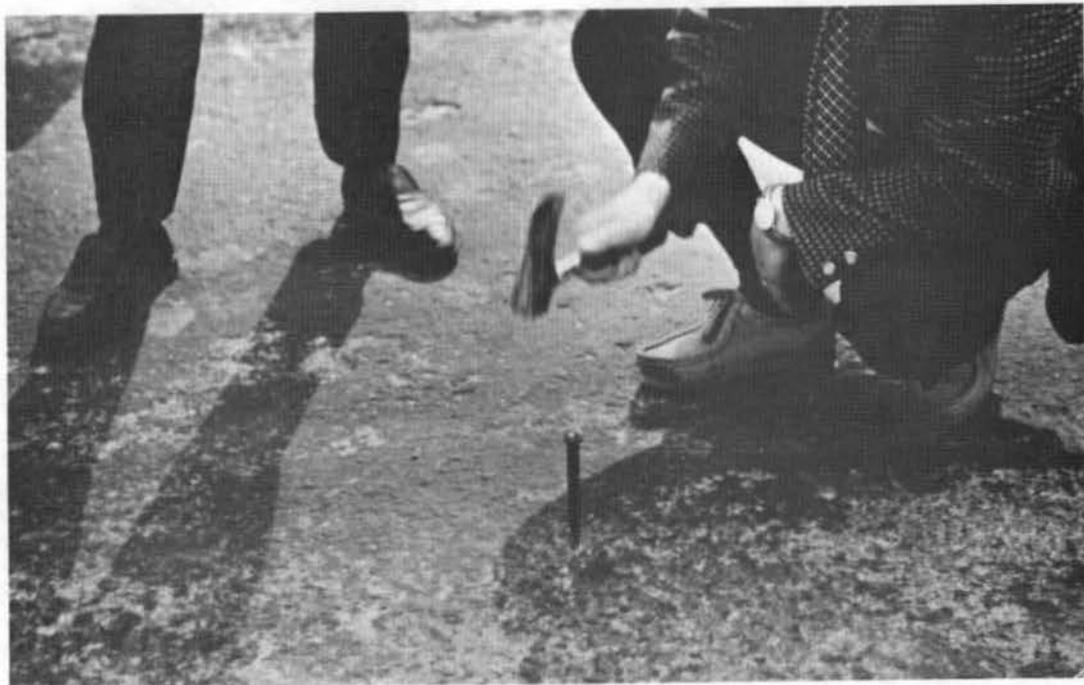
Fig. 12. Lignin-surface treated road. Treatment approximately 2 weeks old.

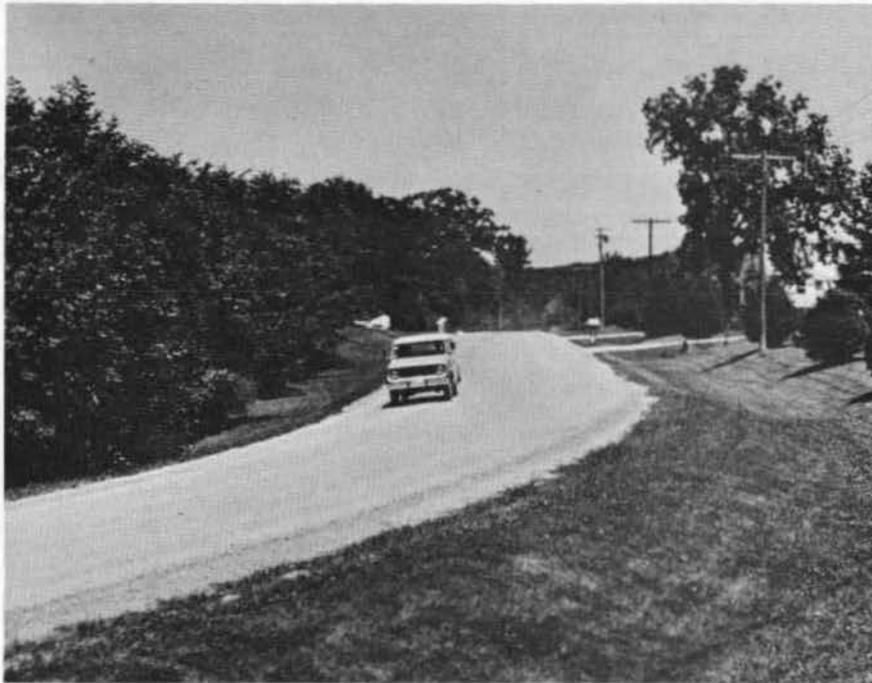
Fig. 13. Lignin plus aluminum sulfate in-depth treated roadway in urban residential area using in-place soil-aggregate. Vehicle speed 40 mph.

Since lignins are water soluble, periodic replenishment is needed. Studies by Demirel and Davidson<sup>1</sup> indicated either lime, or salts of aluminum, iron, chromium and manganese appeared applicable as secondary additives to potentially eliminate the need for lignin replenishment. Figure 13 shows a lignin plus aluminum sulfate (alum) treated roadway in an urban residential area. Constructed in Linn County in 1969, the roadway was scarified, windrowed, treated with combined lignin and alum, bladed to crown and cross section, and compacted. Following compaction, a light topshot of lignin/alum was surface sprayed. Since construction, dusting has been about 10% of original and only slight amounts of aggregate pullout have occurred, primarily on the curves. Lignin leaching appears to have been at least retarded over the two year period since construction.

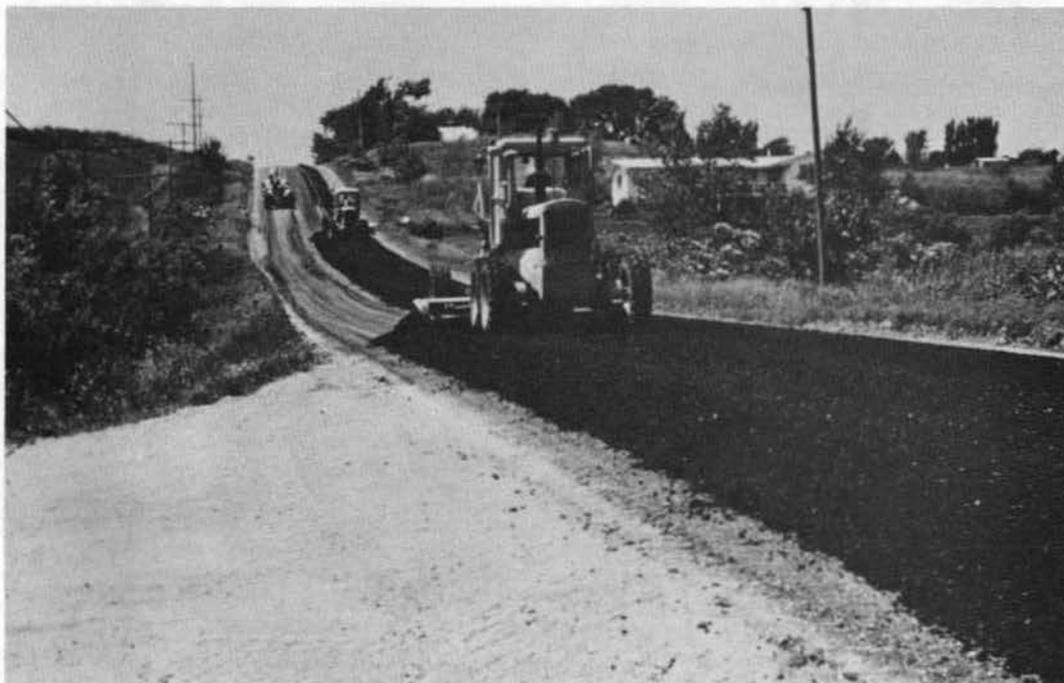
Fig. 14. MC-800 cutback asphalt in-depth treated surface improvement construction using in-place soil-aggregate. Treatment depths about 2-2½ in.

Similar in-depth treatments have been used by several counties for a number of years, incorporating cut-back asphalts to a depth of two or more inches with the in-place soil and aggregate (See Figs. 14-17). In the figures noted, dusting has been nearly eliminated (volumetric dust measurements on the roads noted in Figs. 15 and 16 were so small as to be undetectable

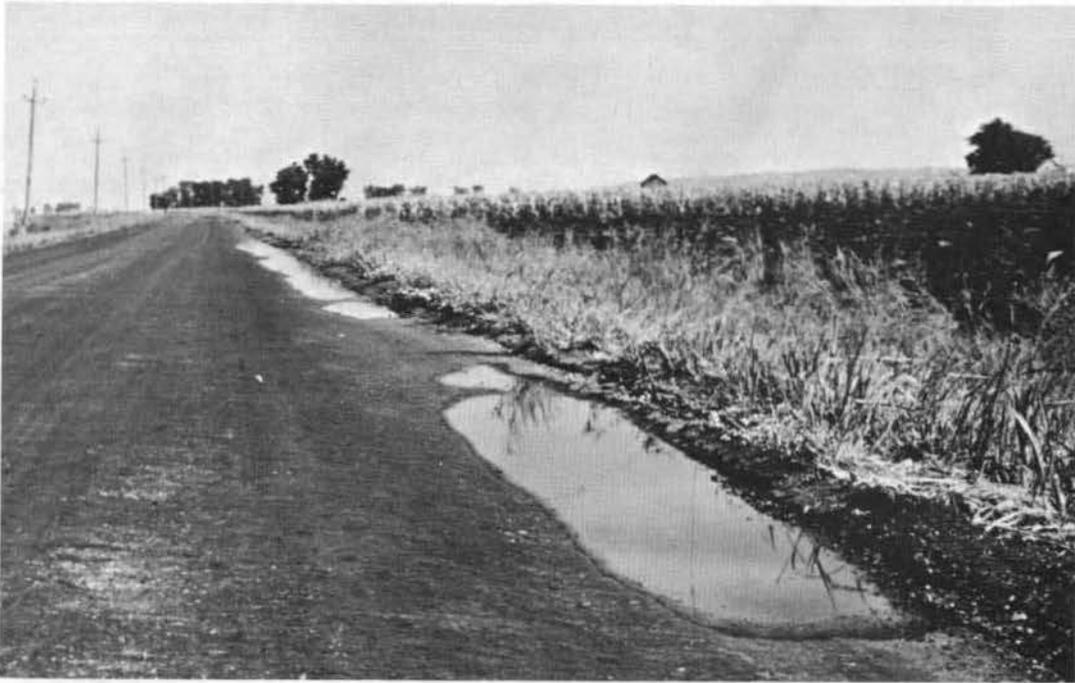
Fig. 15. Cut-back asphalt, in-depth treated surface improvement near De Soto Bend National Park using in-place soil-aggregate. Summer traffic, approximately 4000 vpd. Thickness about 2-2½ in. Age about 1 year.

on an analytical balance) though very small amounts of aggregate pull-out may be observed. Practicable quantities of the cut-back asphalt appear to be 4% or less, however, as may be noted by comparing the shoving in Figs. 15 and 16.

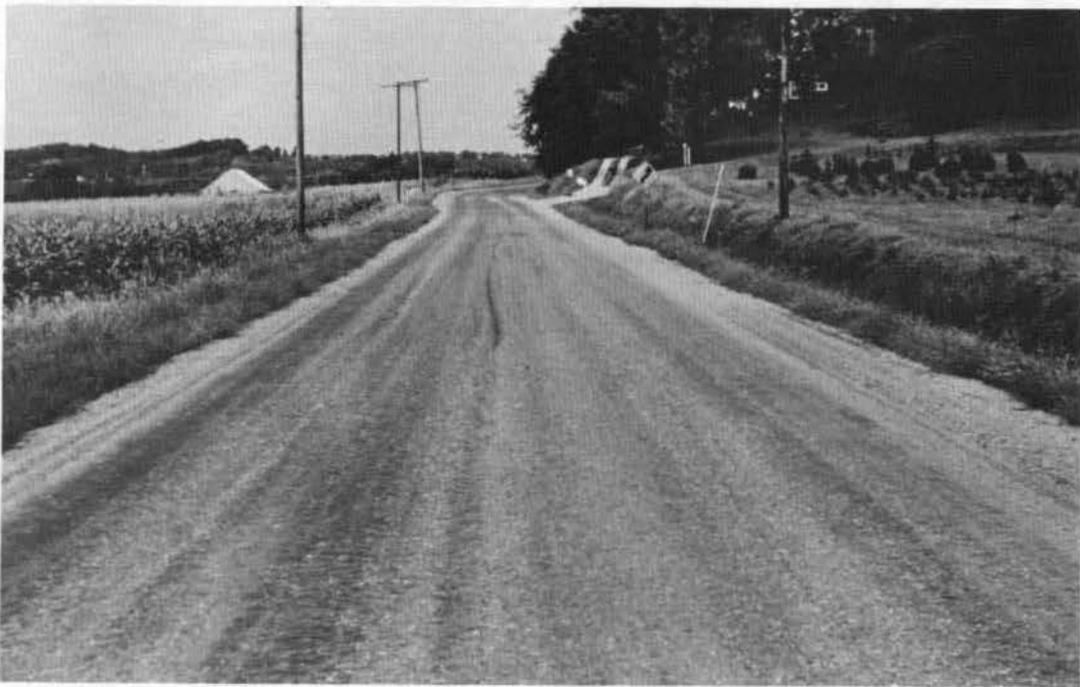
Fig. 16. Cut-back asphalt, in-depth treated surface improvement using in-place soil-aggregate. Traffic, 700 vpd. Thickness about 2-2½ in. Age about 1 year.

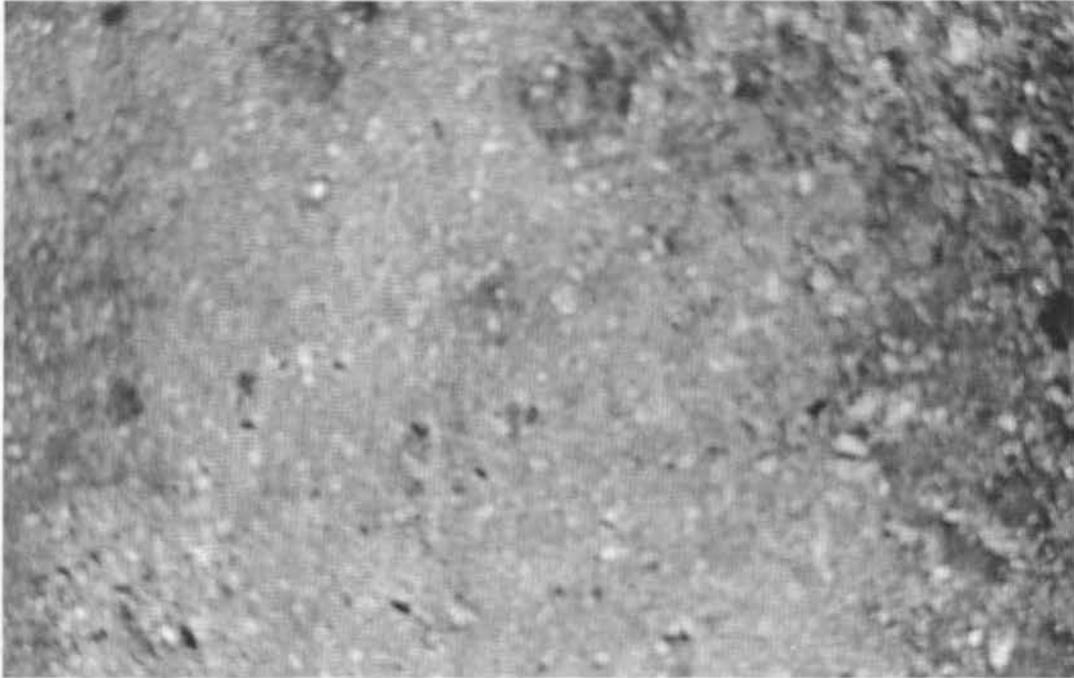
Fig. 17. Surface characteristics of cut-back asphalt section noted in Fig. 16.

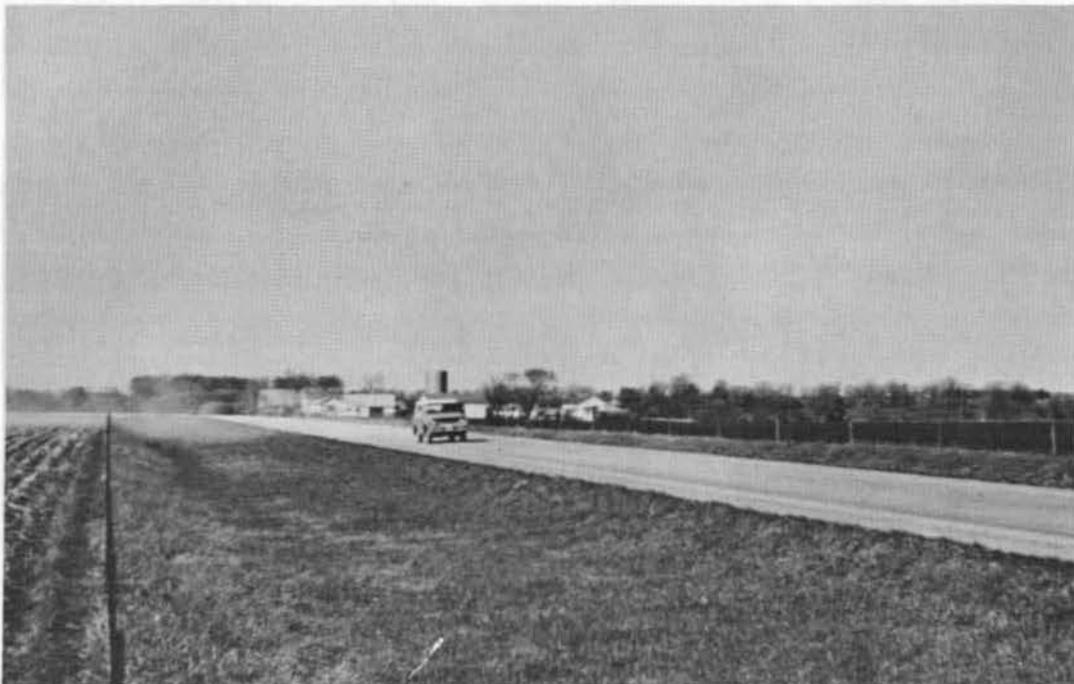
Fig. 18. Floyd County, 4 in. lignin treatment, about 1 year old. Vehicle had just left untreated area at 40 mph.

1. From Rockford, northwest, about 1 mile in length, 4 in. depth treatment with 50% solids concentration of lignin providing about 1% solids by dry soil weight in place (See Figs. 18 and 19). As of mid-May, 1971, the section was slightly less than one year old, little dusting is occurring except on the curves where some aggregate pullout is observable, some of the matrix surface aggregate is actually showing polishing due to traffic, and as far as is known by the researchers, the road has received no maintenance since construction.
2. From Rockford, southeast, about  $1\frac{1}{2}$  miles in length, same treatment level and similar observed results.
3. Southeast of Charles City, near the YMCA camp, about  $\frac{1}{4}$  mile in length, same treatment level. The surface as of mid-May 1971 had definitely been bladed as observed from

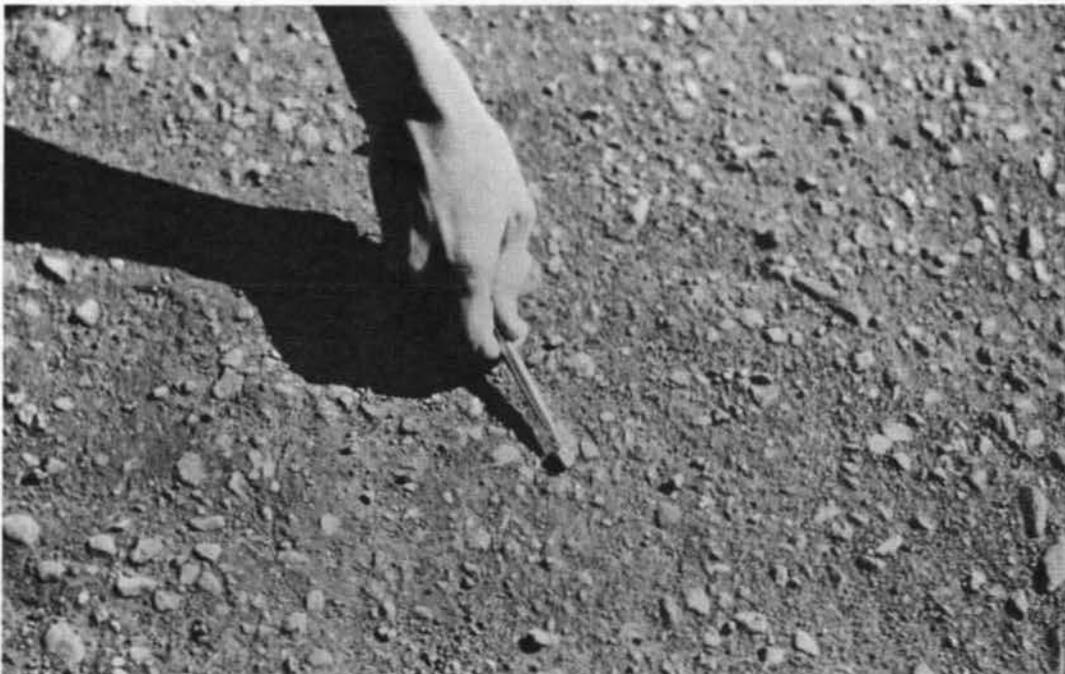
Fig. 19. Surface characteristics of road noted in Fig. 18.

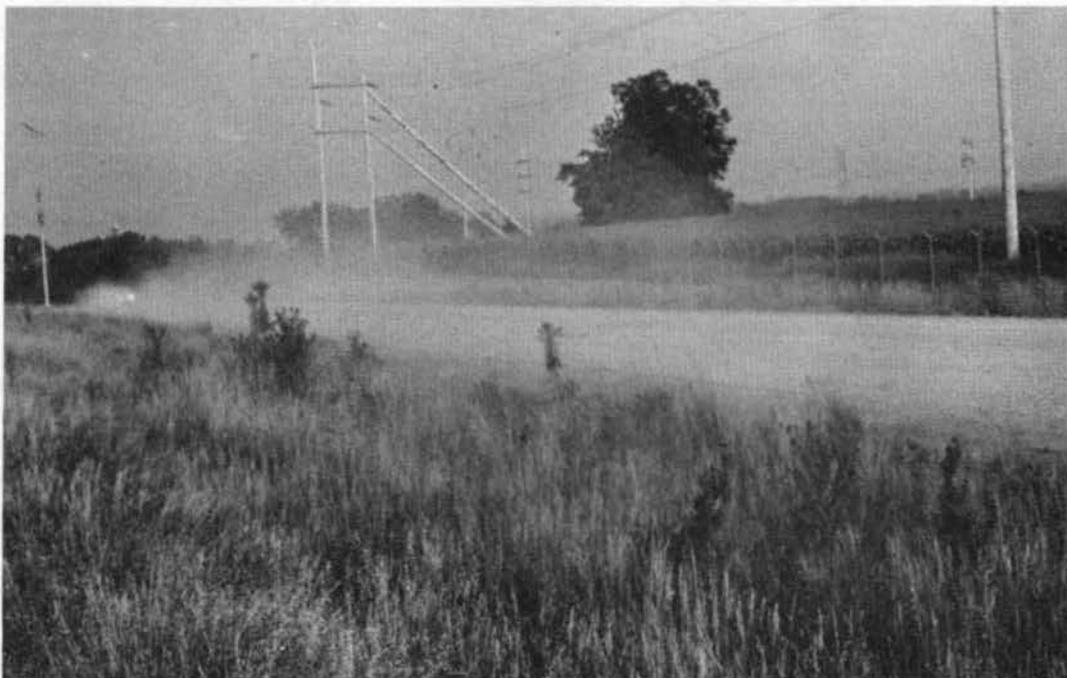
Fig. 20. Clinton county, residual test section dust prior to treatment. Vehicle speed, 40 mph.

Figure 20 illustrates dusting on the residual section prior to construction. Figure 21 illustrates the residual section surface characteristics this spring, indicating some fines plus aggregate pull-out which appear to be the result of construction problems. Construction processes followed by the county crews were worked out between the County Engineer and the researchers. This included scarification to provide 6 in. compacted depth, windrowing scarified material to each side of road, tamping foot rolling of subgrade trench, pulling one-half the material back into the trench, mixing of the required quantity of additive, tamping foot rolling, repeating mixing and rolling with final half of windrowed material, blading to crown, and rubber rolling. The lignin-lime, and the lignin-only sections were completed, but only the first lift of the residual section was completed prior to a deluge of rain. Water ponded in the remaining trench of the residual section,

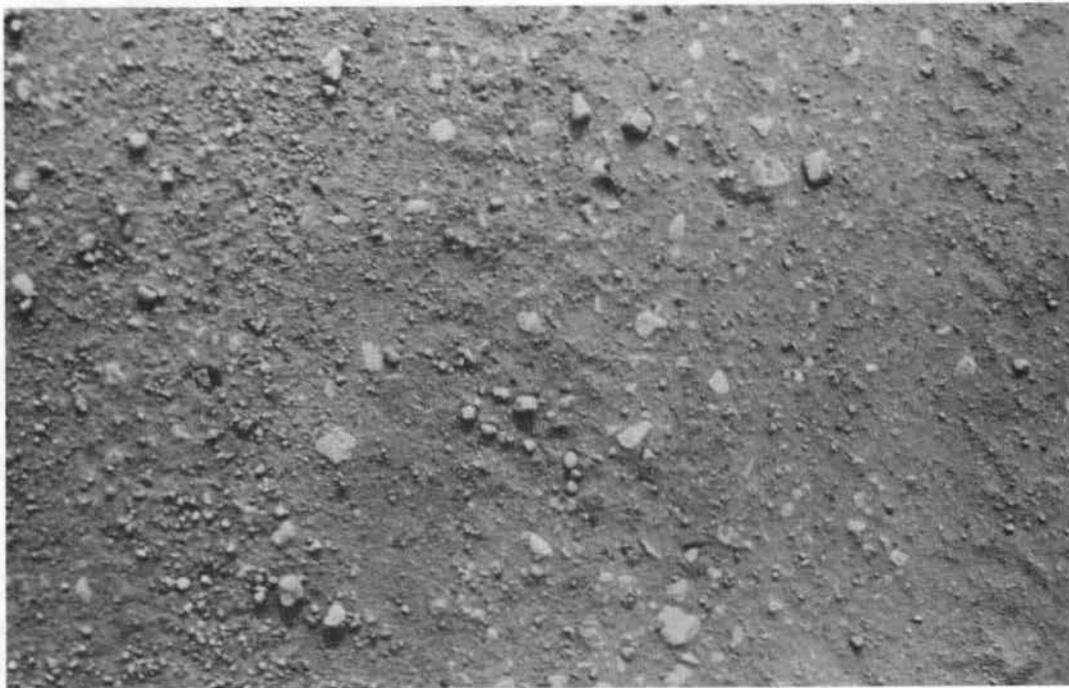
Fig. 21. Surface characteristics, Clinton County residual test sections, spring 1971.

thus allowing thorough saturation of the subgrade and remaining windrowed material. Drying was never accomplished prior to completion of construction several days later. A number of soft spots thus appeared and some frost heaving was noted during the winter. This spring, however, the section has returned to fairly good shape, though slightly potholed, but with an overabundance of fines on the surface and some aggregate pullout as noted in Fig. 21. The other two sections have thus far encouragingly survived with little dusting and aggregate pullout.

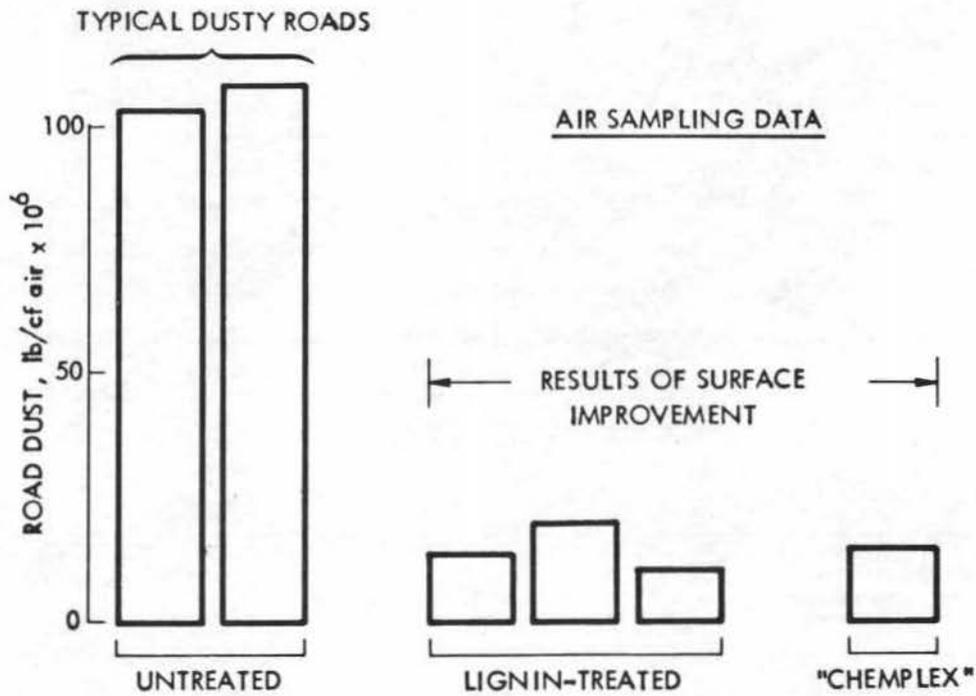
Fig. 22. Dust data by volumetric method. Average lignin treated data from left to right are Floyd, Lee and Clinton counties, respectively.

Figure 22 illustrates the average variations in volumetric dust data obtained from the Floyd and Clinton County tests as well as dust sampling data from the spray on surface treatments used in Lee County. Data shown in this figure was taken from about two weeks to up to six months after construction. It will be noted that the various additives reduced the amount of dust to about 10-20% that of typical untreated dusty roads.

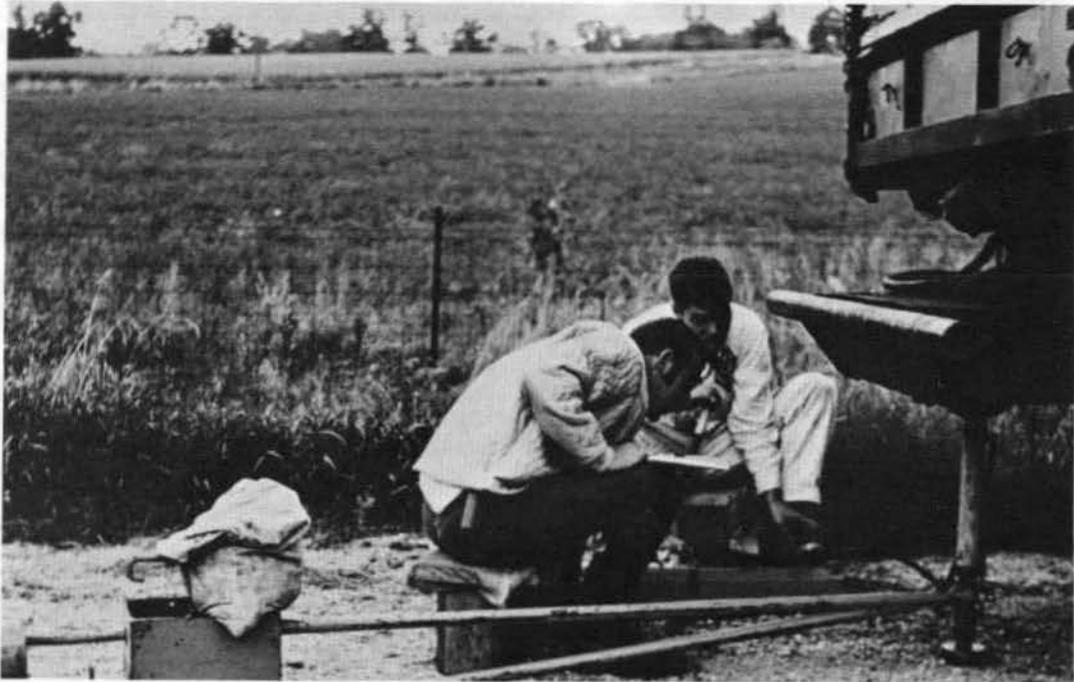
Fig. 23. Spherical Bearing Value (SBV) test in process.

1. Spherical Bearing Value Test. Figures 23 and 27 illustrate this test, using a 6 in. diameter sphere. The SBV test is a reasonably quick field test for analyzing the relative bearing capacity of the various sections. Though requiring about the same time to conduct as an in-place CBR test, it has been shown to have far better reproducibility than either CBR or plate bearing tests and has been correlated with the CBR test for use in design of pavements.<sup>2</sup>
2. Benkelman Beam Deflection Test. Figure 24 shows the test being conducted within the outside wheel path of an untreated section in Linn County. Deflections are determined under a 17,280 lb

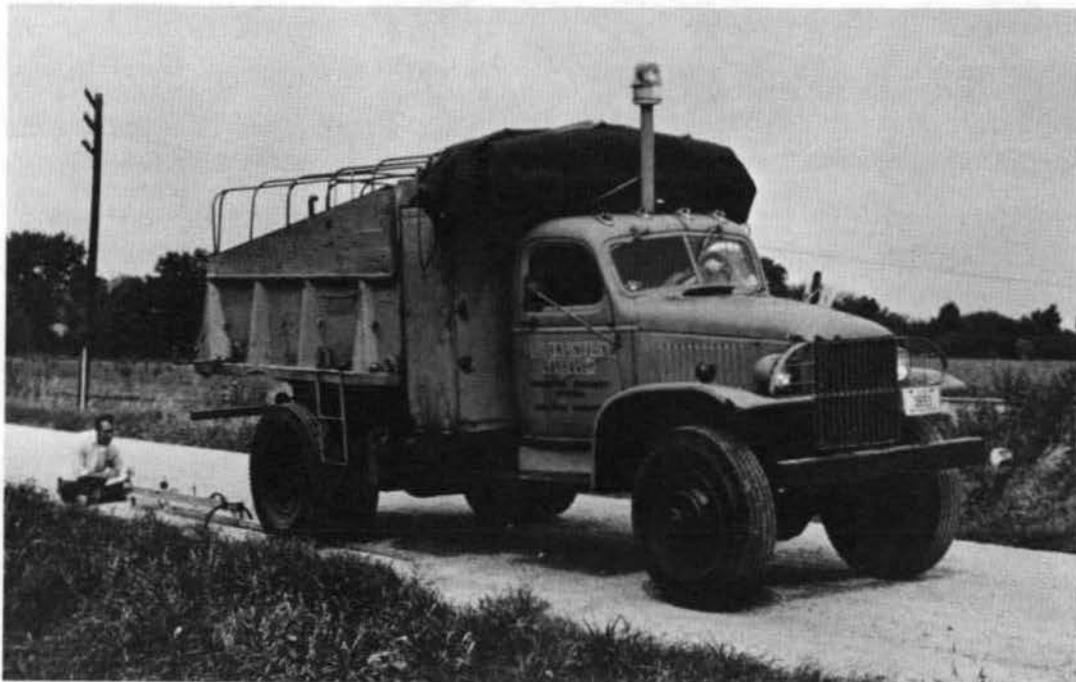
Fig. 24. Benkelman beam deflection test in process.

rear axle load with the truck moving. Deflections may be converted to what has been termed a "stiffness" factor,<sup>3</sup> which is the wheel load in thousands of pounds (kips) divided by the maximum deflection. Deflection and stiffness values from other roads within the state will provide comparisons with more common pavement materials.

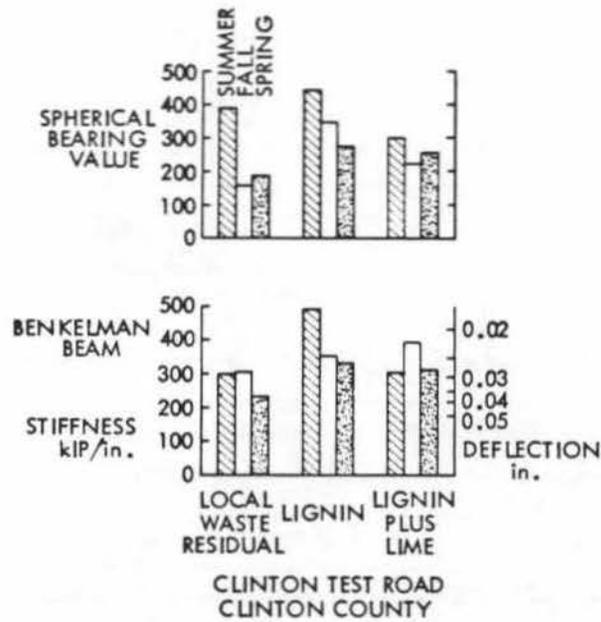
Fig. 25. Clinton county in-place test results. "summer" is prior to construction, "Fall" is about two weeks after construction, "spring" is shortly after thaw.

Figure 25 presents a portion of the SBV and B beam field test results from the Clinton test sections. The effect of softening due to construction (and the extremely wet conditions during construction of the residual section) are particularly evident with the SBV values. Maximum Benkelman beam deflections in all cases is less than 0.04 in. Stiffness is in general about a quarter to a third that of a test roadway consisting of 6 in. lime treated subbase, 7 in. soil-cement base, and 3 inch asphaltic concrete surface.<sup>3</sup> The effect of softening immediately following the spring thaw is also evident. Results of beam and SBV tests taken June 3, 1971 were not computed prior to preparation of this report but appear to show increases in SBV and stiffness, with subsequent decreases in deflection from those taken early this spring. A minimum of one more series of tests will be taken prior to late fall 1971.

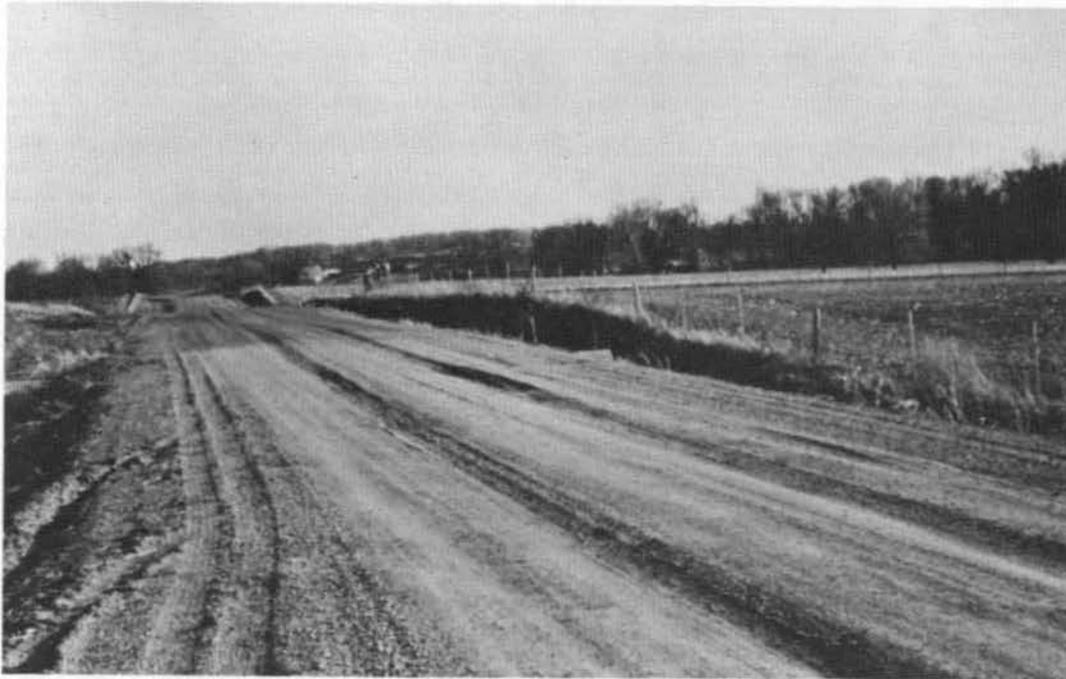
Fig. 26. Linn County, test section 2 in foreground, test section 1 in background, shortly after spring thaw.

Figure 26 shows section 2 in the foreground and section 1 in the background, shortly after the spring thaw this year. Rutting is quite evident in the untreated section, while the treated 400 Ton/mile sections showed little or no rutting.

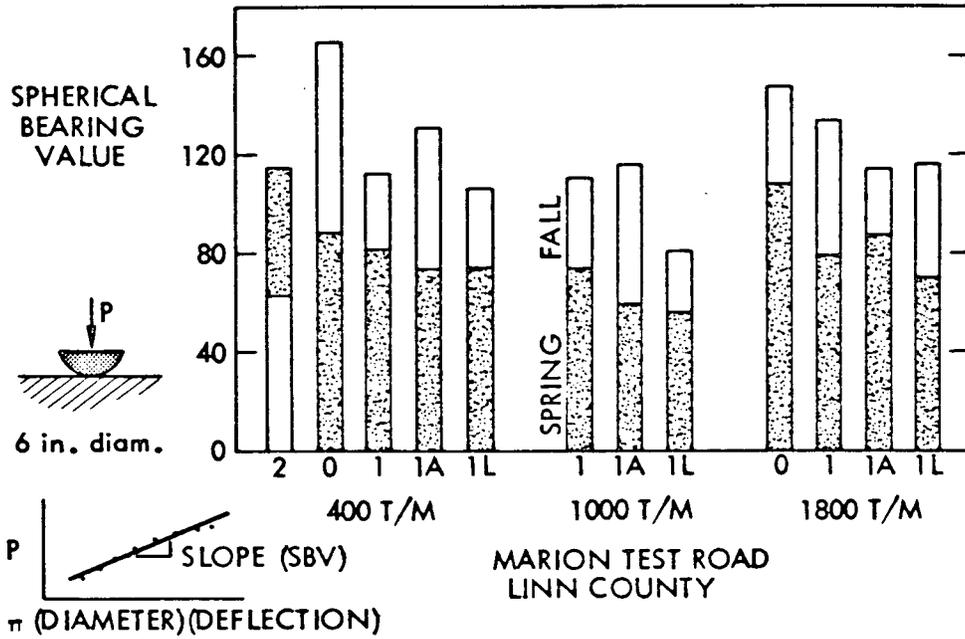
Fig. 27. Linn County in-place SBV test results. Also illustrated is the manner in which SBV values are obtained.

Figure 27 presents the average results of SBV tests approximately seven days after surface improvement construction and again early this spring. Additional tests were taken June 4, 1971, but are not included in this report. It is evident that SBV values decreased following construction and again early this spring due to moist subgrade conditions. An unexplained anomaly is apparent with the 2% lignin, 400 Ton/mile section, having a higher SBV value this spring than following construction. Laboratory screening tests indicated 1% lignin to be about optimum for all sections. Consequently, section 1 is being watched very closely.

Figure 27 also presently indicates a general trend of maximum reduction of SBV within the 1000 ton/mile crushed stone sections this spring, as well as a general trend of decreased SBV from 0-1% lignin, to 1% lignin plus the secondary additives.

This spring a definitive decrease in average stiffness and increase in average deflection developed, opposed to increasing aggregate content within the sections (See Fig. 28). Comparison of results from Figs. 27 and 28 indicate that the materials are generally capable of withstanding the traffic volume and the imposed loads, but deform to a greater extent with larger amounts of aggregate, i.e., are more flexible under moist subgrade conditions. This may be indicative of less bonding capabilities due to lower fines content and thus a lessening of the overall capabilities of the matrix surrounding the coarse particles.

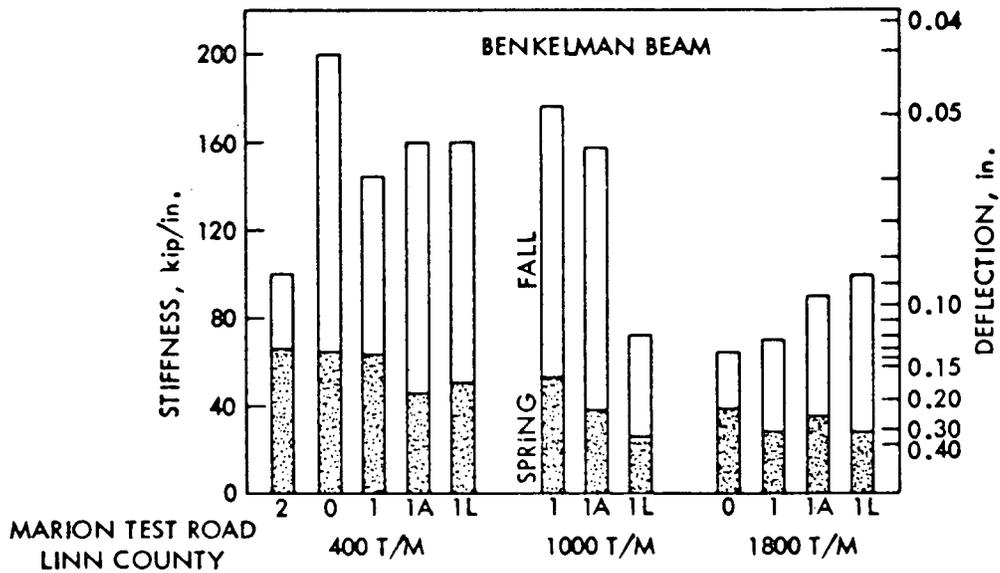
Fig. 28. Linn County in-place Benkelman Beam deflection test results.

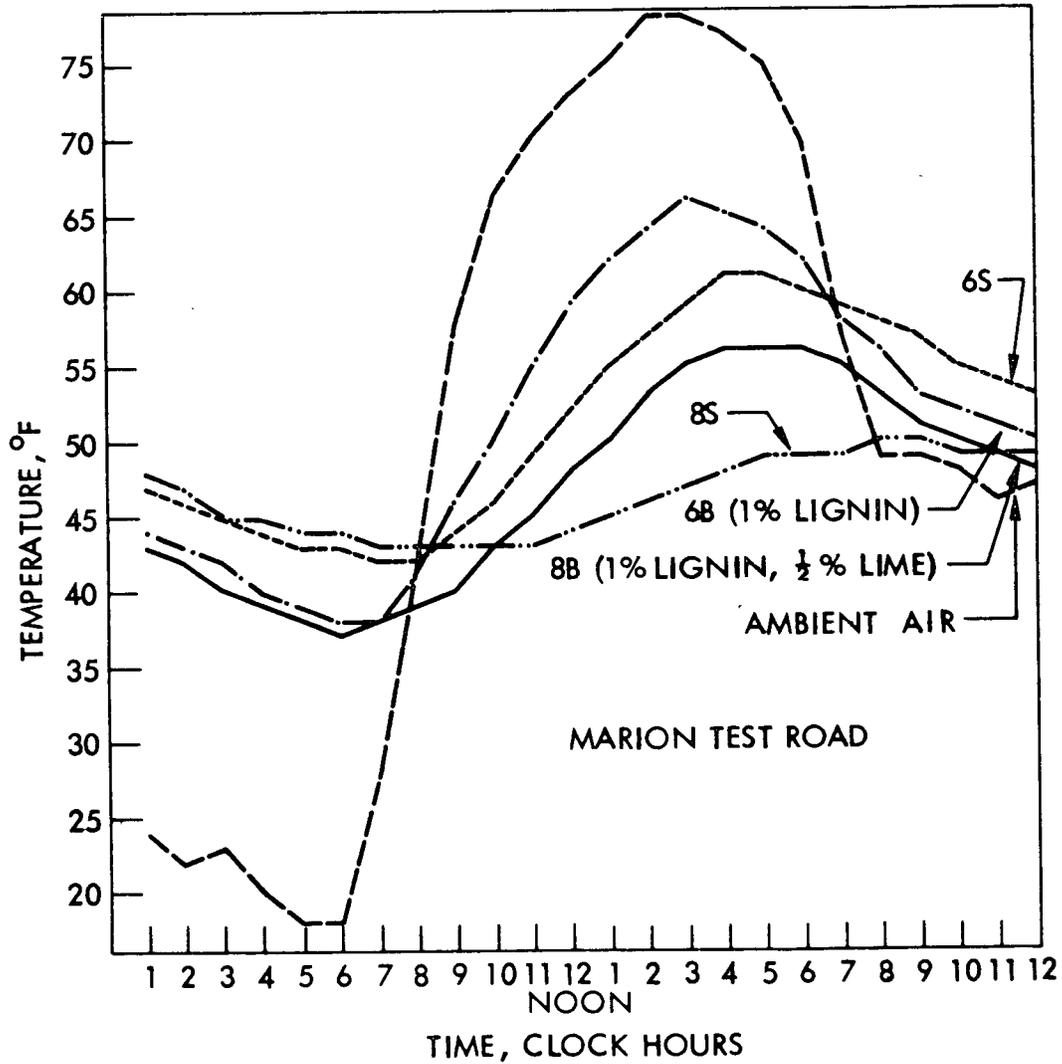
Fig. 29. Illustration of observed temperatures, sections 6, 8 and ambient air, Linn County.

Shown in Fig. 29 are a portion of the observed temperatures from sections 6 and 8, plus ambient air, for one 24 hr period in early April. In general, the 1% lignin plus lime surface improvement section (8B) appears to maintain a more uniform subgrade (8S) temperature and indicates a slightly lower thermal conductivity than does the 1% lignin treatment (6B) only. A lower thermal conductivity may be advantageous in lessening the number of freeze-thaw cycles of the surface material but does not necessarily indicate a lowering of the freezing point. Temperatures within sections 7 and 9 were intermediate between those values shown in Fig. 29, for sections 6 and 8.

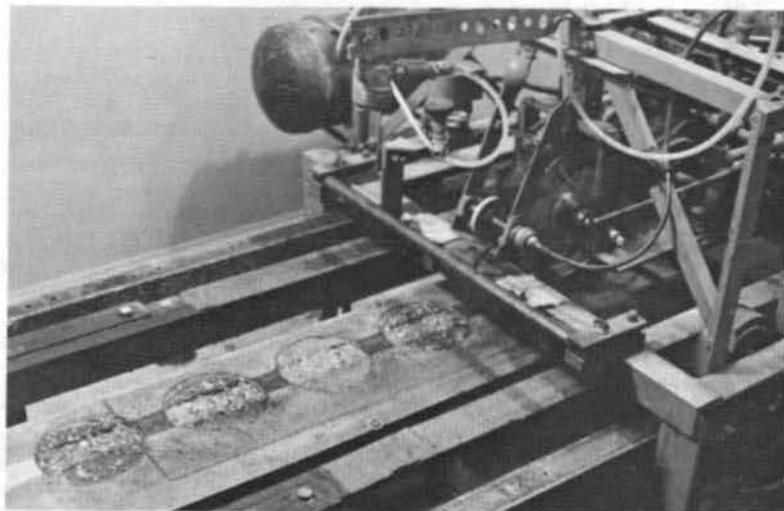
Fig. 30. Trafficability simulator with specimens in process of testing.

A number of cutback asphalts, latex asphalt emulsions (including a high solids content emulsion), cationic emulsions and Penepime have been screened using the 2 x 2 in. specimen process noted above. Most of these products appeared promising and have subsequently been tested in a trafficability simulator (See Figs. 30 and 31). This equipment magnifies many times the ravelling and rutting effects of traffic under a single wheel load within several thousand passes (approximately 1000/hour). After a number of trials, the test process environmental conditions shown in the upper portion of Fig. 32 was adopted, using a wheel contact pressure of 85 psi. Observations of this process show comparable stages of ravelling, rutting and final failure similar to those associated with in-situ pavements and previously observed surface improvement projects. No direct comparisons can be made with in-situ dust palliations, though the asphaltic additives noted previously in this report have shown no measurable dusting. In addition, it may be assumed that if the additive does not retard ravelling and rutting during periods of simulated rainfall, fine particles will accumulate at the surface following drying and dusting will occur.
