**PROGRESS REPORT**

**SURFACE IMPROVEMENT AND  
DUST PALLIATION OF UNPAVED  
SECONDARY ROADS AND STREETS**

James M. Hoover

*ISU-ERI-AMES 9991  
Project 856-S*

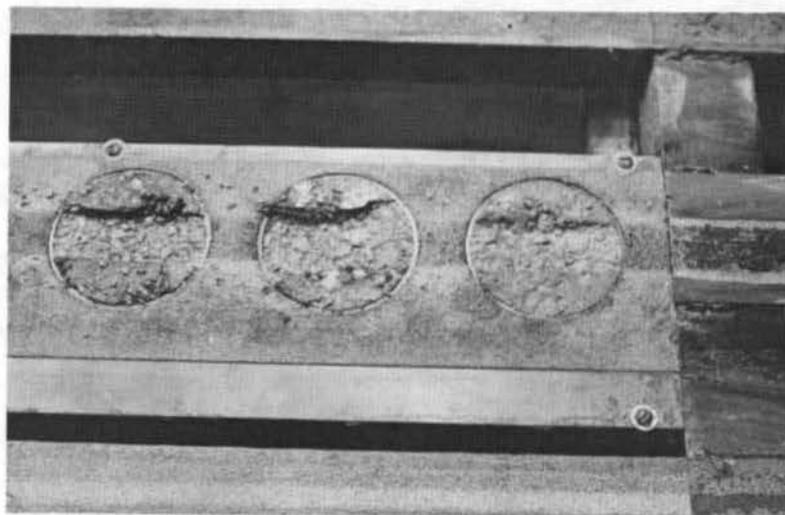
Fig. 31. Closeup of three trafficability simulator test specimens following failure.

A number of cutback asphalts, latex asphalt emulsions (including a high solids content emulsion), cationic emulsions and Penepime have been screened using the 2 x 2 in. specimen process noted above. Most of these products appeared promising and have subsequently been tested in a trafficability simulator (See Figs. 30 and 31). This equipment magnifies many times the ravelling and rutting effects of traffic under a single wheel load within several thousand passes (approximately 1000/hour). After a number of trials, the test process environmental conditions shown in the upper portion of Fig. 32 was adopted, using a wheel contact pressure of 85 psi. Observations of this process show comparable stages of ravelling, rutting and final failure similar to those associated with in-situ pavements and previously observed surface improvement projects. No direct comparisons can be made with in-situ dust palliations, though the asphaltic additives noted previously in this report have shown no measurable dusting. In addition, it may be assumed that if the additive does not retard ravelling and rutting during periods of simulated rainfall, fine particles will accumulate at the surface following drying and dusting will occur.

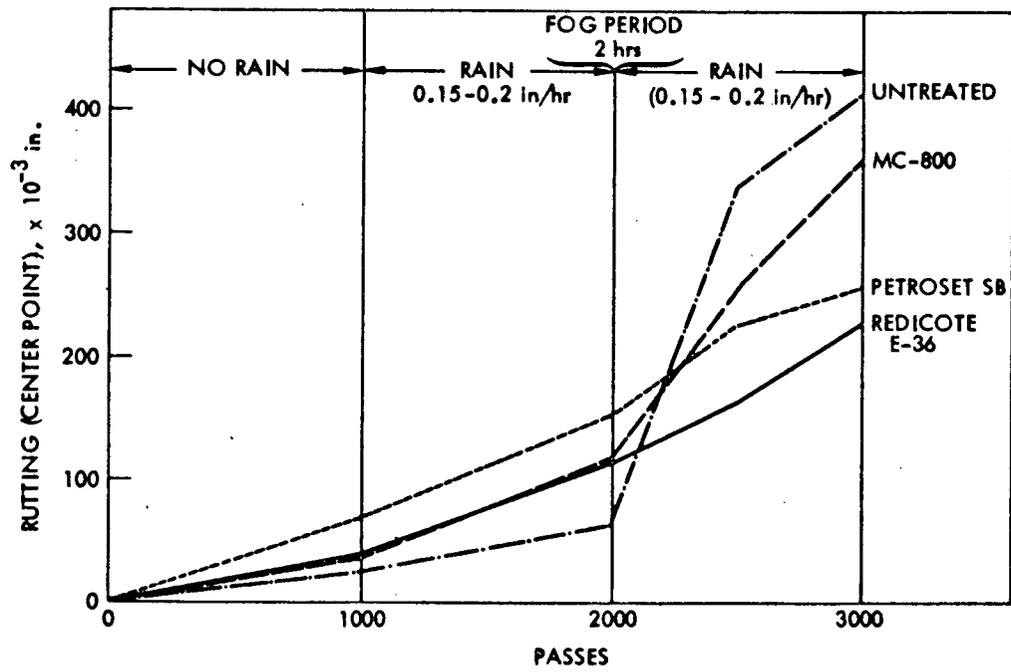
Fig. 32. Trafficability simulator test results. Generalized test environmental conditions noted at top of figure.

Figure 32 presents only a limited portion of the trafficability results, with each of the additives noted, at 3% by dry weight concentrations. The soil material used in the study illustrated was a very poor quality crushed stone containing 20% passing the no. 200 U.S. standard sieve. The Petroset SB is a latex asphalt emulsion, while the Redicot E-36 is a cationic asphalt

emulsion. Both of the emulsions can be applied cold, while the MC-800 required heating. However, it was found that if the cationic emulsion was heated to slightly more than 100°F, rutting was somewhat reduced from that noted following 3000 passes. The MC-800 has been satisfactorily used in Pottawattamie County as previously noted. The Petroset SB appears somewhat more satisfactory after 3000 passes than does the MC-800 but is outlandishly expensive. To be economically competitive with the two other products shown, the Petroset must be used at about 0.4% by dry soil weight with test results more comparable to MC-800. The Redicote E-36 cationic emulsion appears to be the most satisfactory asphaltic product thus far analyzed and is recommended for a field trial this summer. Preliminary discussions have been held with the Powshiek County engineer and road samples are presently being analyzed in the laboratory.
