Rapid Replacement of Bridge Deck Expansion Joints Study – Phase I

**Interim Report
December 2014**

Sponsored by
Iowa Department of Transportation
Federal Highway Administration
(InTrans Project 13-451)

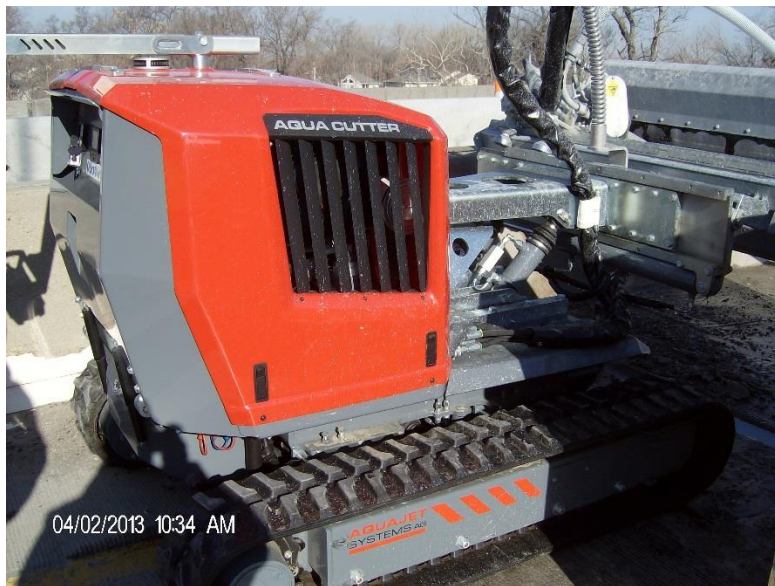
Figure 3.4 Aqua Cutter hydrodemolition machine

Equipment mobilization began shortly after traffic was completely rerouted, which was about an hour into the project. This job was unique in that the contractor utilized hydrodemolition for the majority of the concrete removal on Joint A. The contractor utilized an Aqua Cutter from Aquajet Systems AB, similar to the one shown in Figure 3.4.
