**PERFORMANCE  
OF  
VARIOUS THICKNESSES  
OF  
PORTLAND CEMENT  
CONCRETE PAVEMENT**

**30-Year Report**

**Iowa Highway Research Board  
Project HR-9**

Performance  
of  
Various Thicknesses  
of  
Portland Cement Concrete Pavement

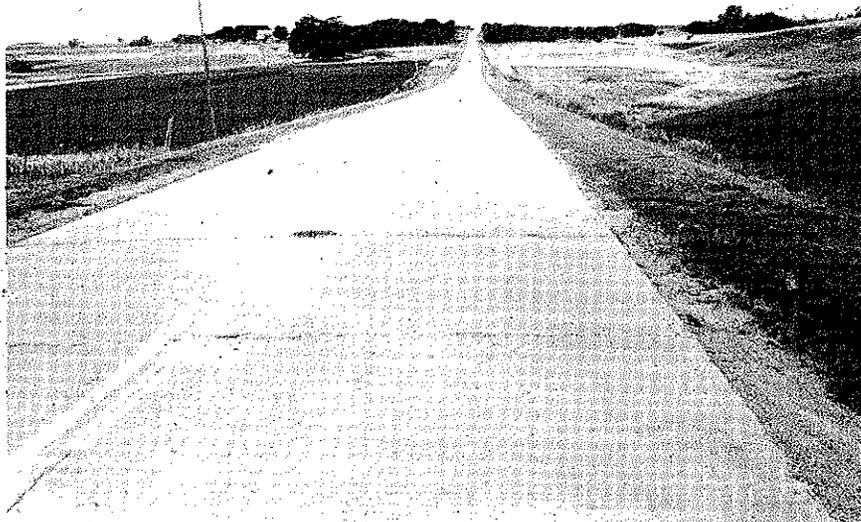
Typical surface appearance of the pavement is shown in Figure 4 (4-1/2" or 11.4 cm non-reinforced) and Figure 5 (6" or 15.2 cm non-reinforced). Even though transverse joints were not sawed, the random cracking in the 6" (15.2 cm) pavement produced a relatively uniform spacing with an orientation nearly perpendicular to the centerline. Most of the transverse cracking occurred early in the life of the pavement. In the thinner sections, little additional cracking developed after the first two years. Transverse cracks continued to develop in the 6" (15.2 cm) pavement through 28 years, but at a declining rate.

FIGURE 5 - TYPICAL PAVEMENT CONDITION OF THE 6"  
NON-REINFORCED SLAB IN SECTION 9
