**Evaluation of Maturity and Pulse Velocity
Measurements for PCC Traffic
Opening Decisions**

March, 1998

Iowa DOT Project HR-380

Department of Civil and Construction Engineering

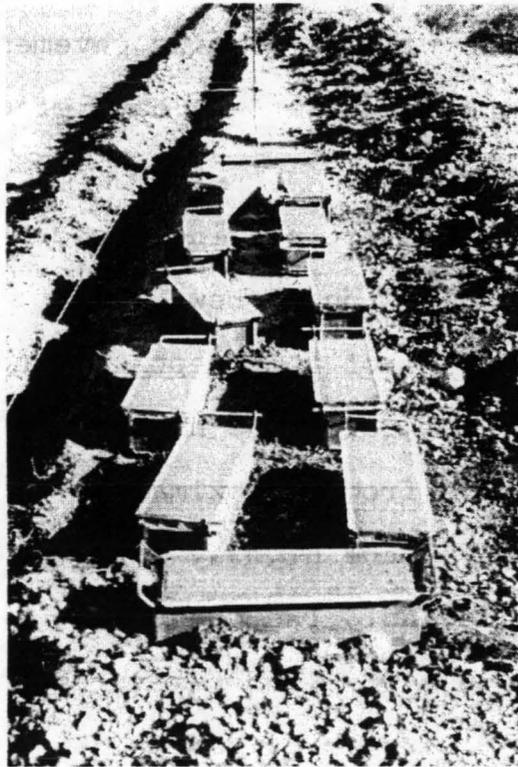
Figure 1, Flexural Strength Test Beams

this type would require the preparation of multiple flexural test beams or cylinders as shown in Figures 1 and 2. In this case the

test specimens are not part of the slab and the results of the testing can be affected greatly by the curing location and care, handling and transportation and the differences in testing personnel and procedures. The goals for the Lee County research were as follows:

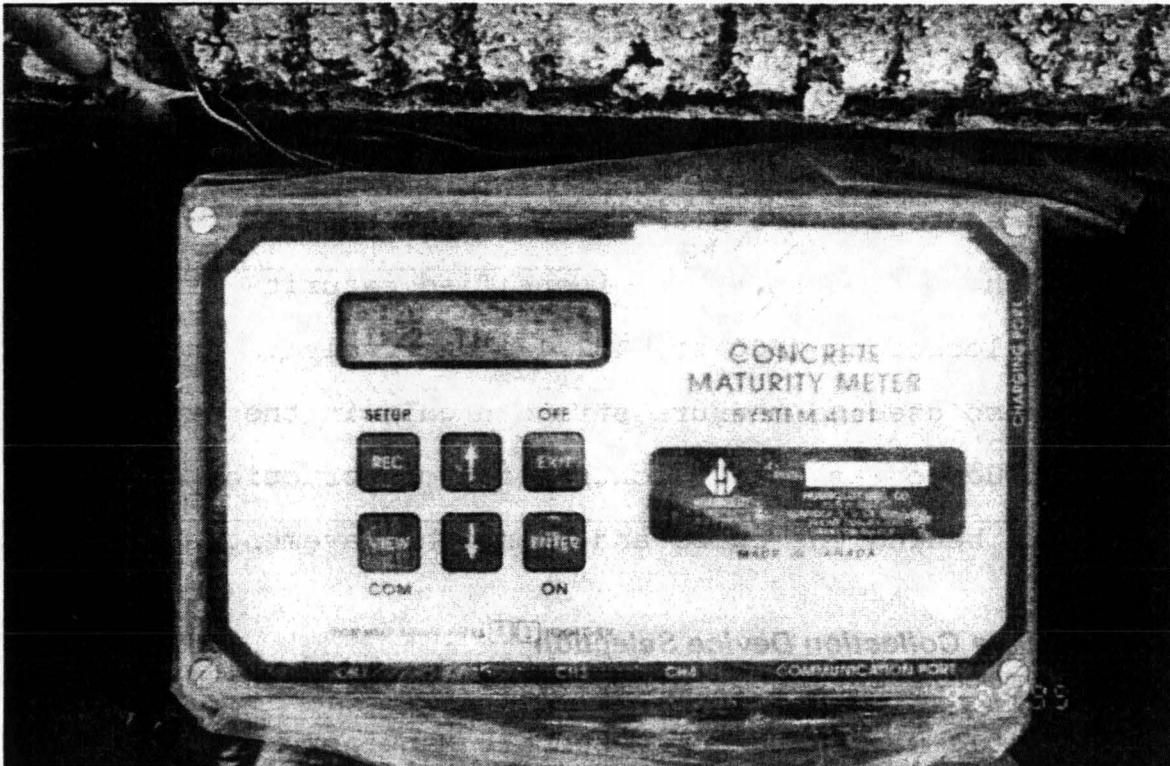
Maturity meters selected for this project were the Model H-2680, System 4101, manufactured by Humbolt Manufacturing Co. This device provides the potential for monitoring four channels or thermocouples simultaneously. Each meter can be programmed to begin recording at a user specified time, sample at a specified time interval, record time and temperature, and calculate maturity relationships in terms of time/temperature or equivalent age. It also provided the storage capacity for data of 365 days of recording and could be downloaded to most popular computer spreadsheets. It was chosen for its programming and recording abilities, number of channels and download capabilities. Figure 3 shows an example of the devices used in this project. Four such

Figure 3, Humbolt Model H-2680, System 4101 Maturity Recorder devices were utilized for this project. Each device came with a handy carrying case, thermocouple connectors, and cabling for downloading. The device is connected to the pavement by a simple two-pole connector and "T" type thermocouple wire. One end of the wire is attached to the connector and the other is stripped approximately 1 in. (25 mm) to allow for twisting of the metal wire ends. The twisted end of the wire was positioned on a wood dowel for the desired depth of measurement. The dowel is then inserted into the concrete to measure temperatures at a 1-in. (25 mm) and 3.5 in. (87-mm) depth. The dowel is illustrated in Figure 4.

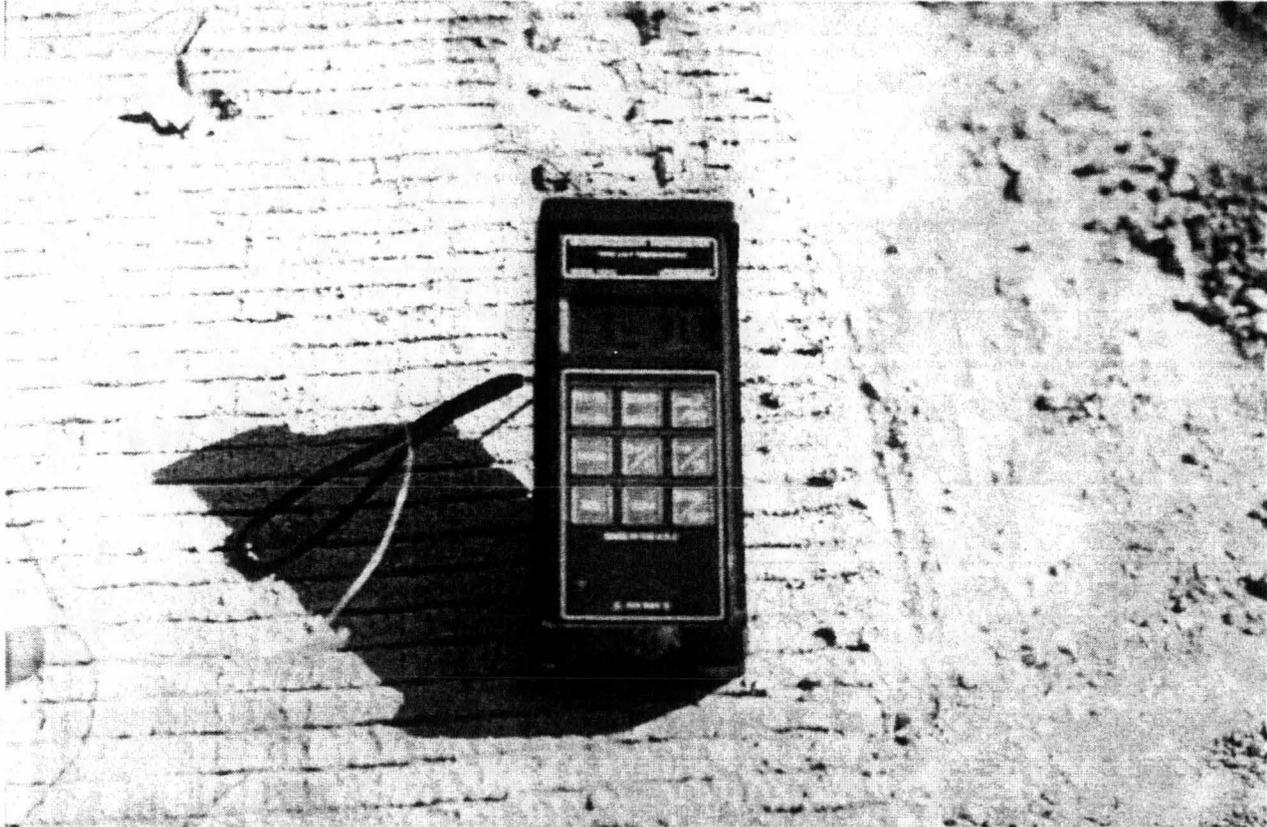
Figure 5, Omega Industries Digital Thermometer

Maturity temperatures were also measured with the use of digital thermometers manufactured by Omega Industries. These devices came in two models, the HH-23 and HH-25. An example of these devices is shown in Figure 5. They utilized the same type "T" thermocouple wire and connectors as used with the recording maturity meters. In the case of the Model HH-25 one thermocouple may be connected and evaluated. The Model HH-23 utilizes two connectors and can evaluate each thermocouple output or the differences between outputs. This unit also is equipped with an adapter that allows for the connection of six

thermocouples at the same time.

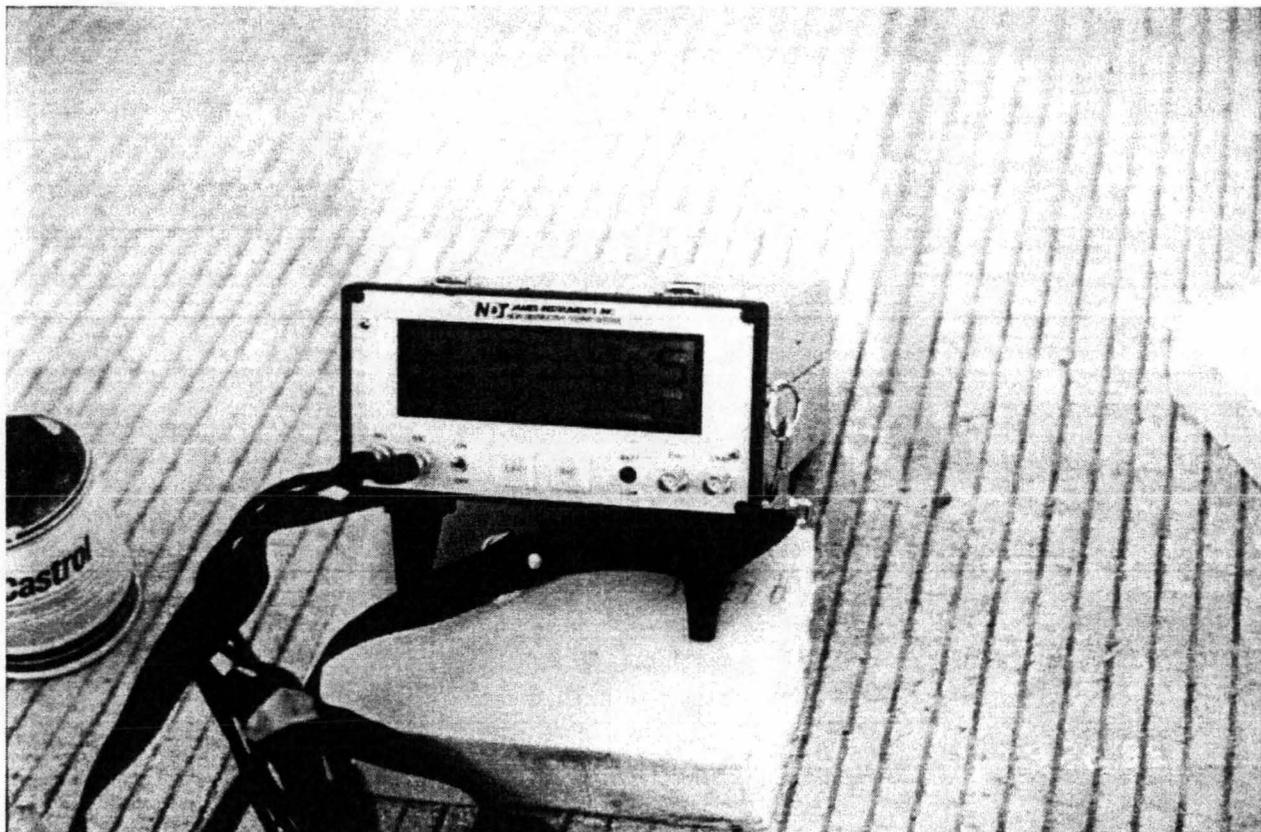
Figure 6, James Industries Inc. Pulse Velocity Meter, Mark II

Pulse velocity was measured with the V-Meter; Mark II distributed by James Instruments Inc. The unit is housed in a carrying case and requires a container of grease for assisting in the development of a solid contact, between the sensor heads and the concrete face. This device has two transducers that must be placed in full contact with the concrete surface and pointed directly at each other. The concrete surfaces are greased to provide full contact with the transducers. The device is illustrated in Figure 6.

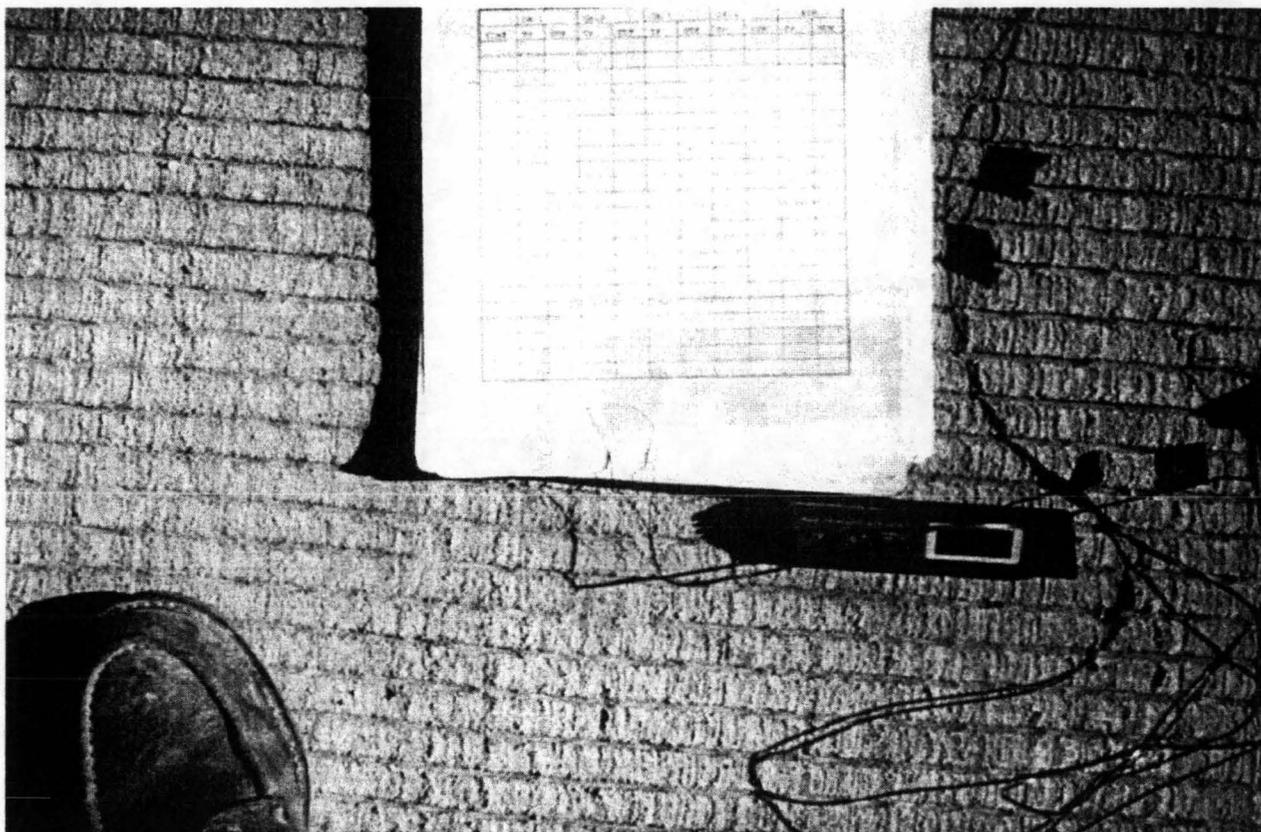
Figure 7, Omega Industries Temperature/Relative Humidity Device

A final device selected for this project consisted of a simple hand held temperature and relative humidity measuring instrument. The Pen Humidity/Temperature distributed by Omega was selected for this project. This device measures temperature in degrees Fahrenheit or Celsius and the relative humidity of the air at the site. It can be carried in a pocket or carrying case. It was used to provide a comparison between the air temperature and relative humidity to the temperature and maturity of the concrete at each manual temperature measurement location. An example of this device is shown below the clipboard, in Figure 7, which provides an insight into the relative size.

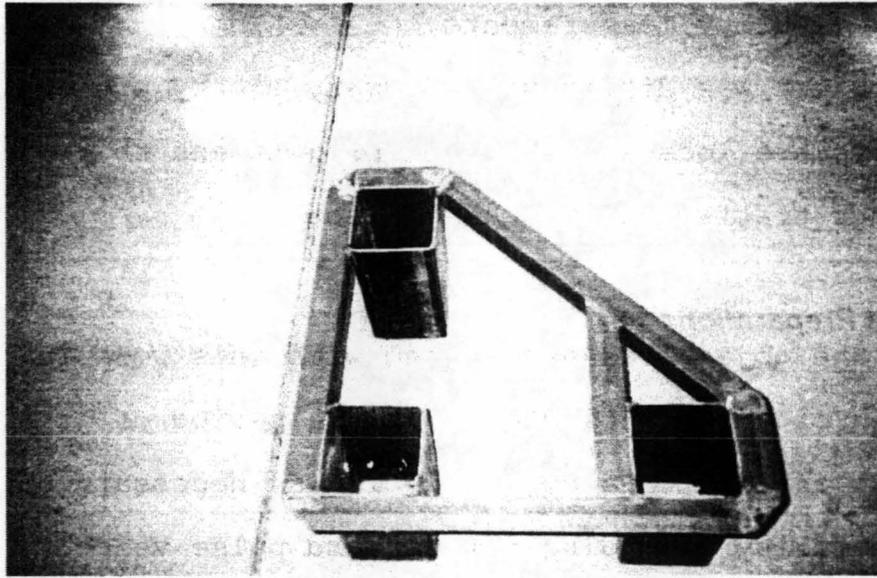
Figure 9, Pulse Velocity Metal Access Template

After many unsuccessful attempts to develop a metal template that could provide three 6 in. by 6 in. (150 mm by 150 mm) square holes simultaneously, a template and individual hole devices were developed. The prototype metal template is shown in Figure 9. The weight of this device made it impractical for

rapid use in the field by a single person. Figure 10 shows the wood template in place on the concrete slab. Placement was made immediately after the curing compound was placed on the slab.

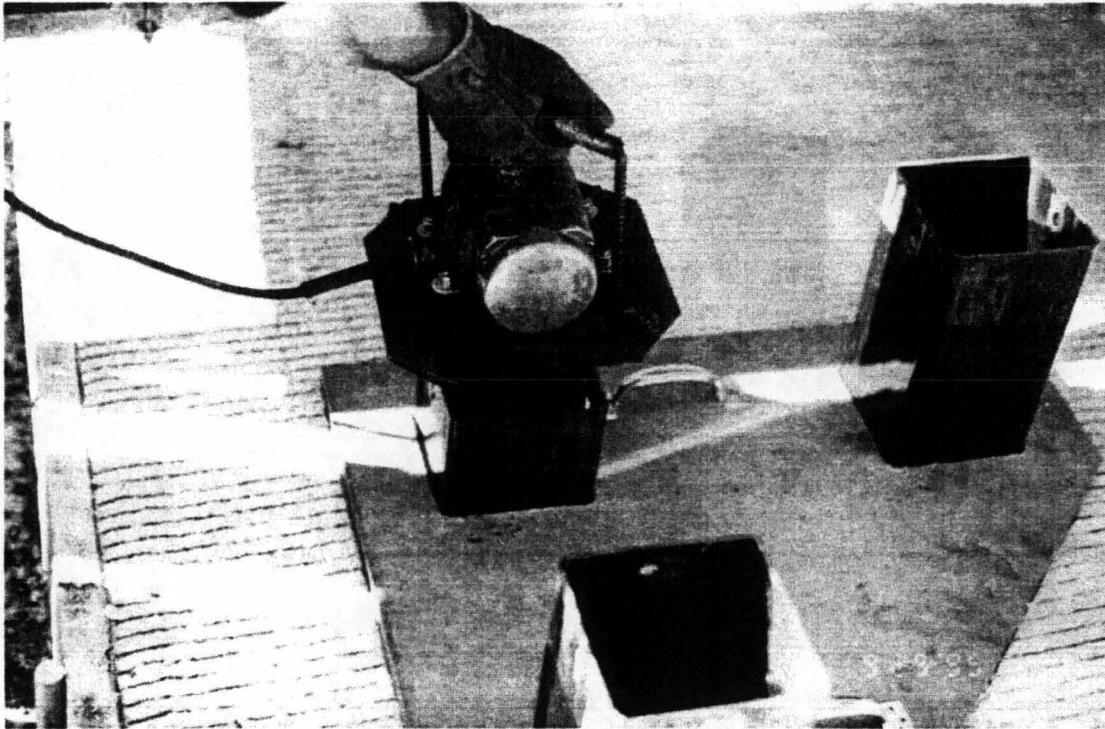
Figure 11, Pulse Velocity Access Insertion Layout

Metal rectangular tubing was used to develop the test hole shaping devices. One-foot (305-mm) lengths of tubing were cut for each of the holes to be developed in the concrete to provide ample height for insertion and removal from the plastic concrete. An example of the tubing is shown in Figure 10. This figure also illustrates the positioning of the tubing over the template holes. In this figure, the driving head and vibrator are also shown. A simple truck bed vibrator and custom made driving head, powered by a portable generator were used to vibrate each tube

section into the plastic concrete. Concrete form oil was placed on each side of the insert to release it from the fresh concrete. The wood template was first positioned on the slab and then the three tubes were positioned on the template. Figure 11 illustrates the template and tubes ready for insertion in the

concrete. Next the driving head was positioned over each tube and the vibrator operated until the tube reached the bottom of the slab. Depth was measured on the side of the tube and by feel of the vibrator. In this case the use of the contractor's portable paving bridge aided access to a location directly over the access holes for driving the tubing and removing it. It also served as a way to insert the maturity thermocouple wires near the center of the pavement cross section. The metal inserts allowed for the

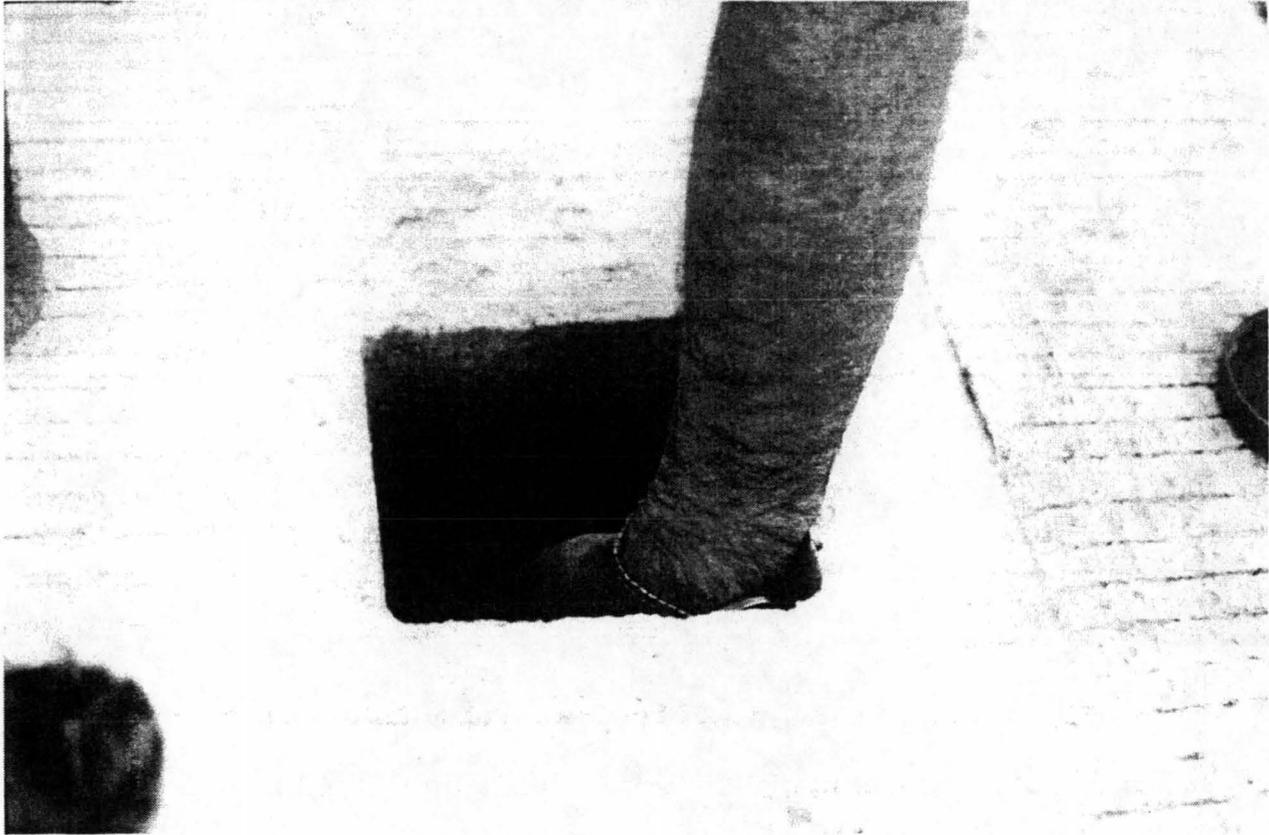
Figure 12 Pulse Velocity Test Concrete Removal Methods

removal of concrete from the interior of the test hole by use of a trowel or hands as shown in Figure 12. Tubing was removed upon removal of the concrete from the pavement in each test hole.

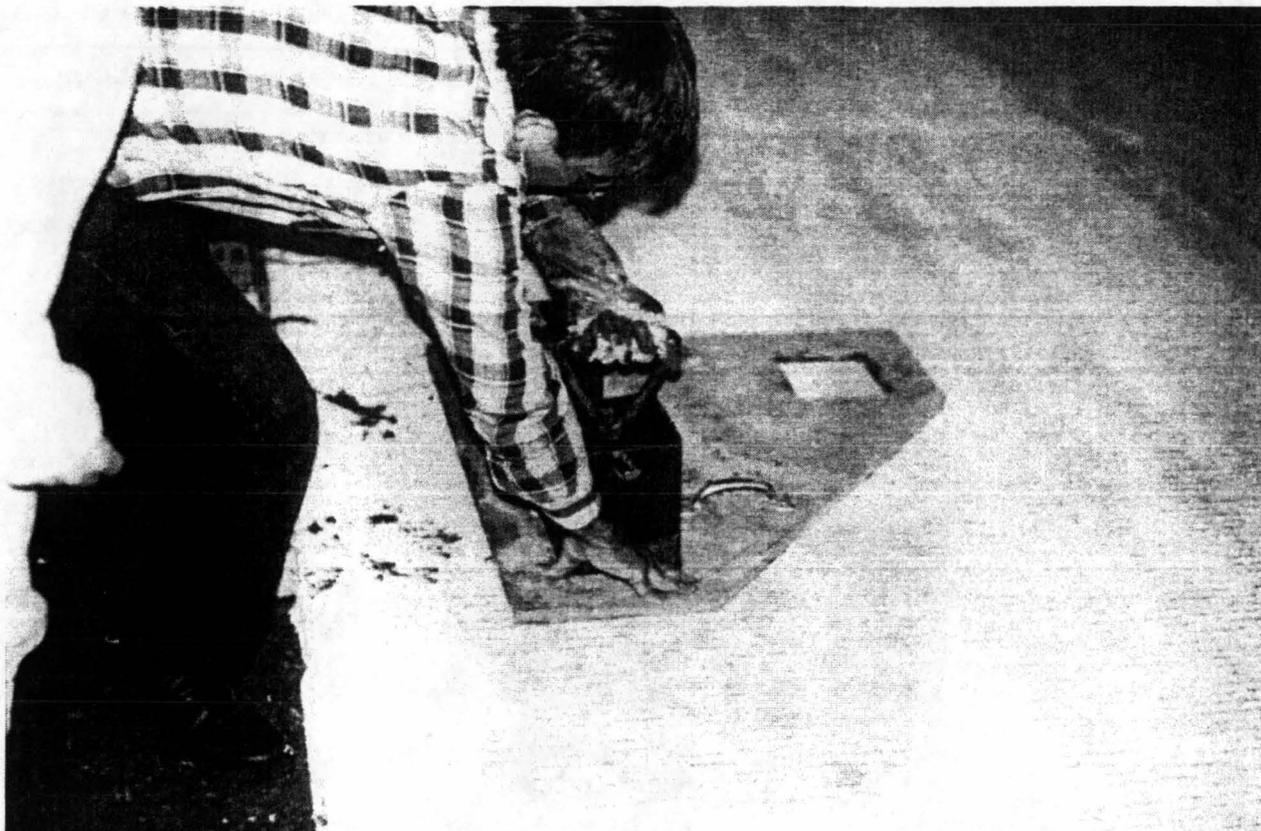
Figure 13 Pulse Velocity Test Tube Extraction

The form tubing was removed by extracting it vertically as shown in Figure 13. A custom built handle was inserted into holes near the top of the tubing on opposite sides. This method worked very well when the tubing was well oiled prior to insertion and pulled vertically after the concrete was removed. The result was a four sided, smooth walled hole that provided good contact for the transducers.

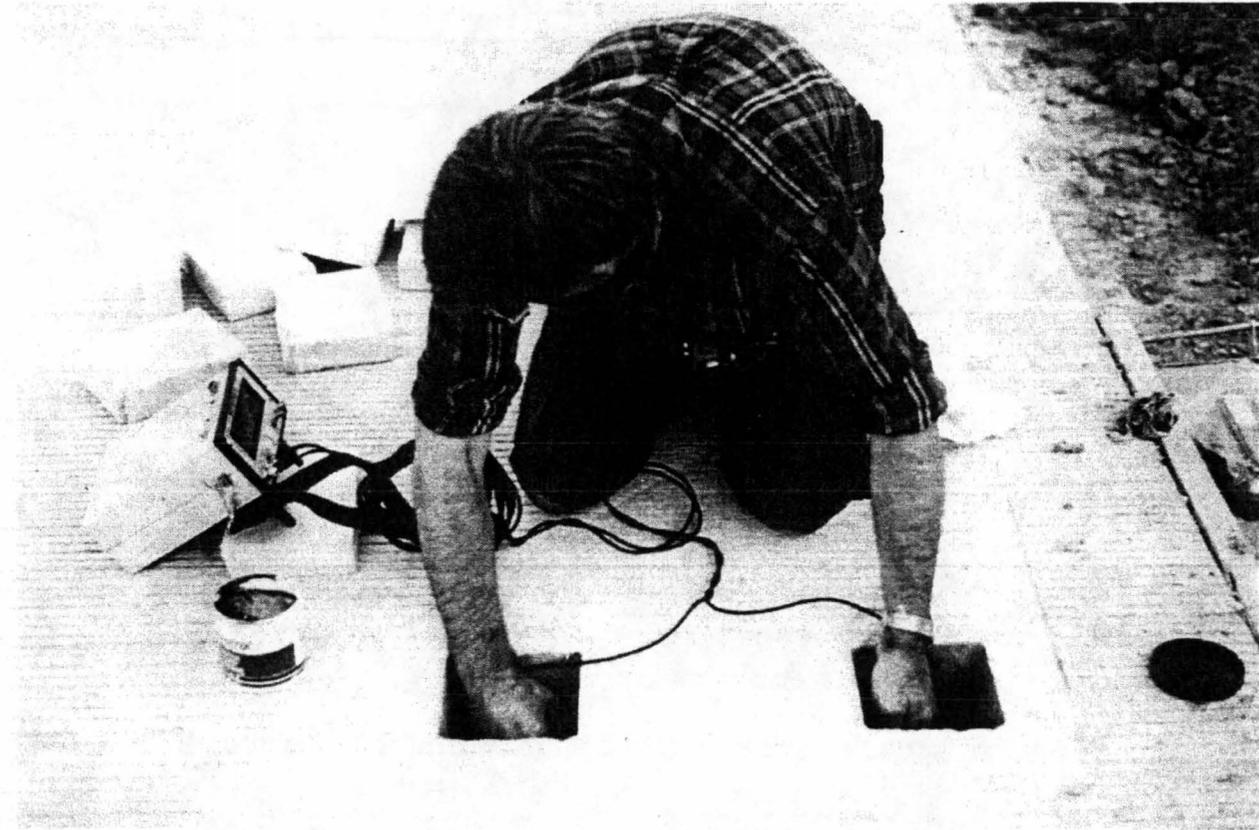
Figure 14, Pulse Velocity Measurement Activity

Pulse velocity measurements were taken by attaching the two geophones to the readout device, greasing the geophone heads and positioning them in two adjacent holes with the heads pointing at each other. The grease served to make an airtight contact with sidewall of the hole and prevent adhesion of the concrete with the device. This test is illustrated in Figure 14. Note the presence of insulation blocks on the pavement. These were inserted in the access holes during the time between pulse readings to assure the retention of temperature and moisture in the walls of the access holes. Upon completion of the pulse

velocity measurements, the access holes were filled with concrete from the paving operation by members of the research team. One of the major problems with the pulse velocity measurement process was the access to the pavement area. Figure 15 illustrates the amount of equipment required to develop the access holes for the test. In addition to this equipment the pulse velocity meter had to be moved between test locations. There was insufficient room on the road shoulders to move the equipment by vehicle and the actual movement resulted from human packing or attaching the generator to the contractor work bridge. This option required work by two or more persons to transport

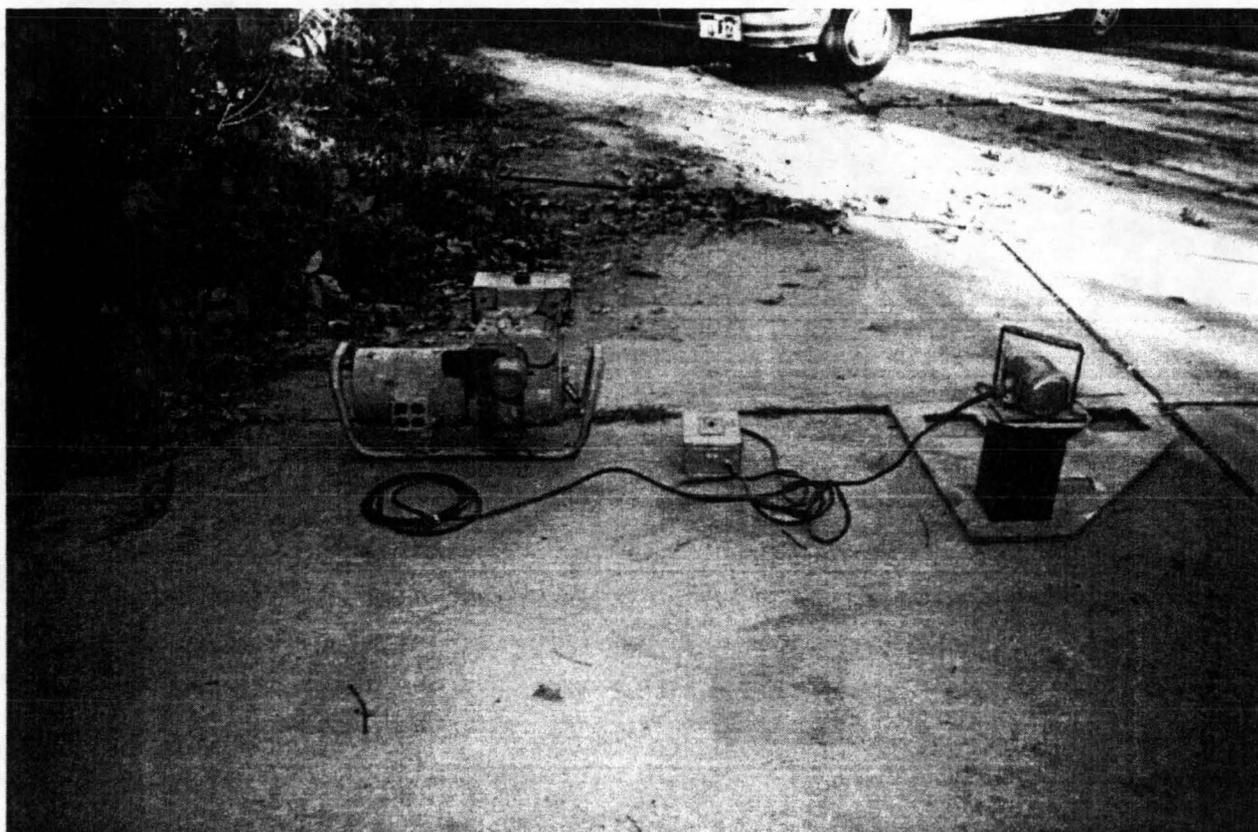
Figure 15, Pulse Velocity Access Preparation Equipment

the equipment along the roadway. As a result of these constraints and the inconsistent results, the method was terminated early in the construction.

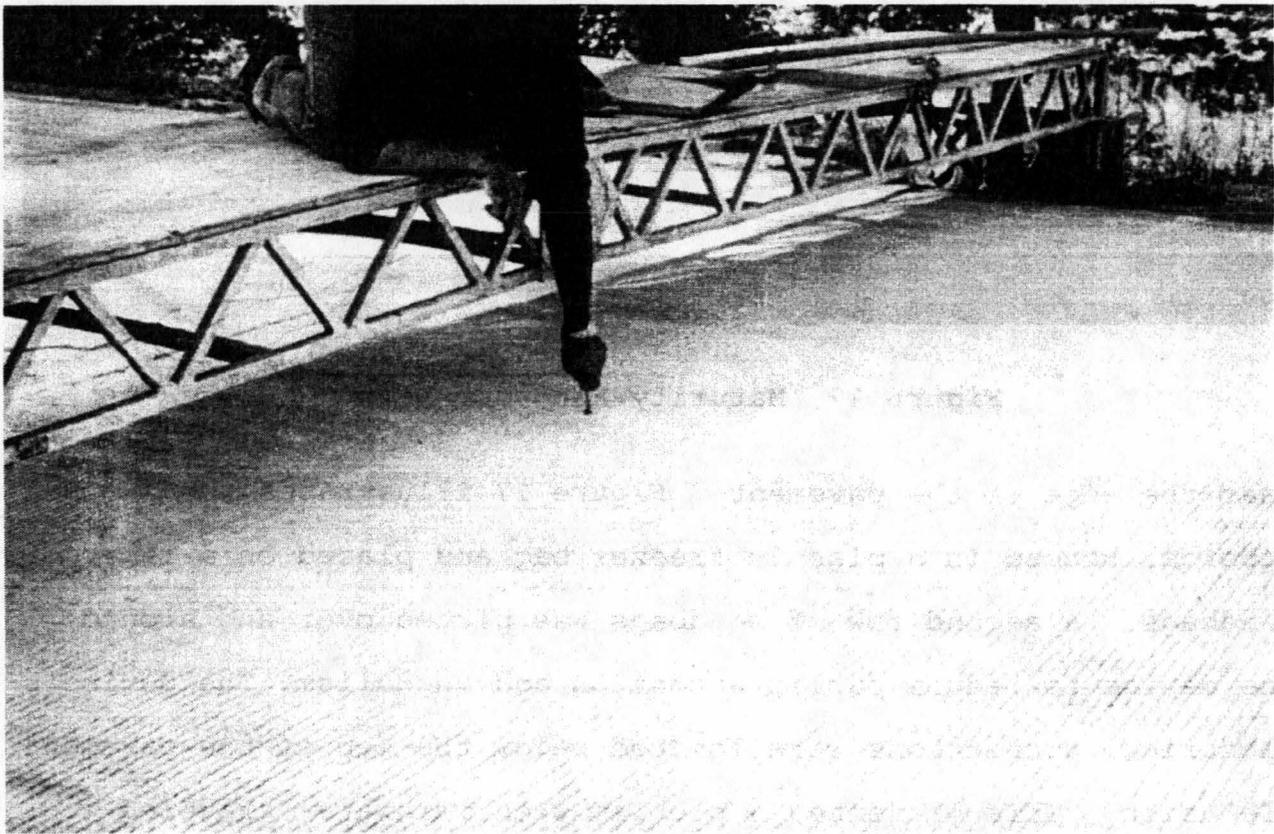
Figure 16, Maturity Thermocouple Installation

Maturity thermocouples were placed near the centerline of the pavement with the aid of the construction work bridge as shown in Figure 16. Lead wire lengths were cut to allow for readings to be taken from the pavement edge for these sites.

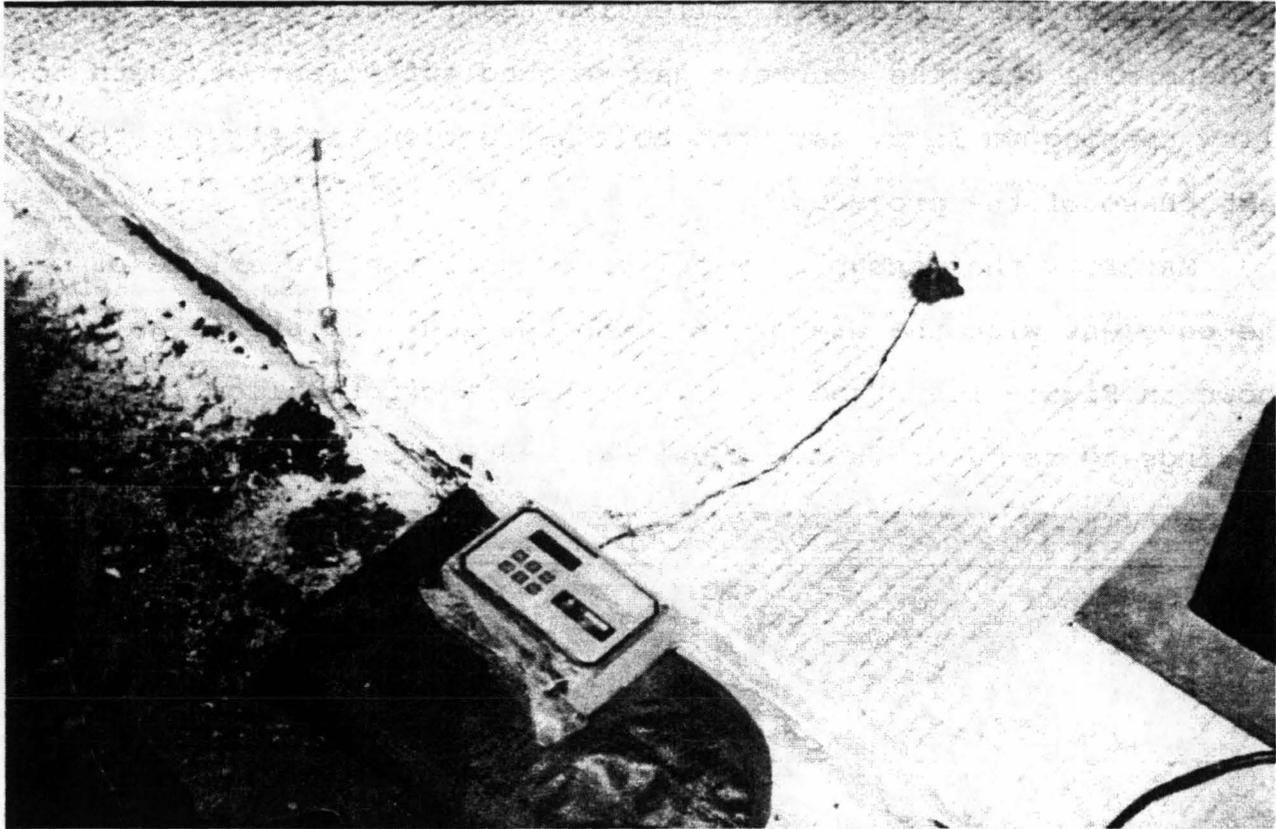
Figure 17, Maturity Recorder Layout

The sites established for the use of the recording maturity devices were developed in the manner shown in Figure 17.

Thermocouple wires were attached to the recording device located

near the edge of the pavement. Figure 17 illustrates the recorder housed in a plastic freezer bag and placed on a layer of sandbags. A second row of sandbags was placed over and around the device to reduce public attention and vandalism. The device's electrical connections were located below the top of the pavement elevation. This presented a problem when rainwater traveled along the wires and shorted the electrical system.

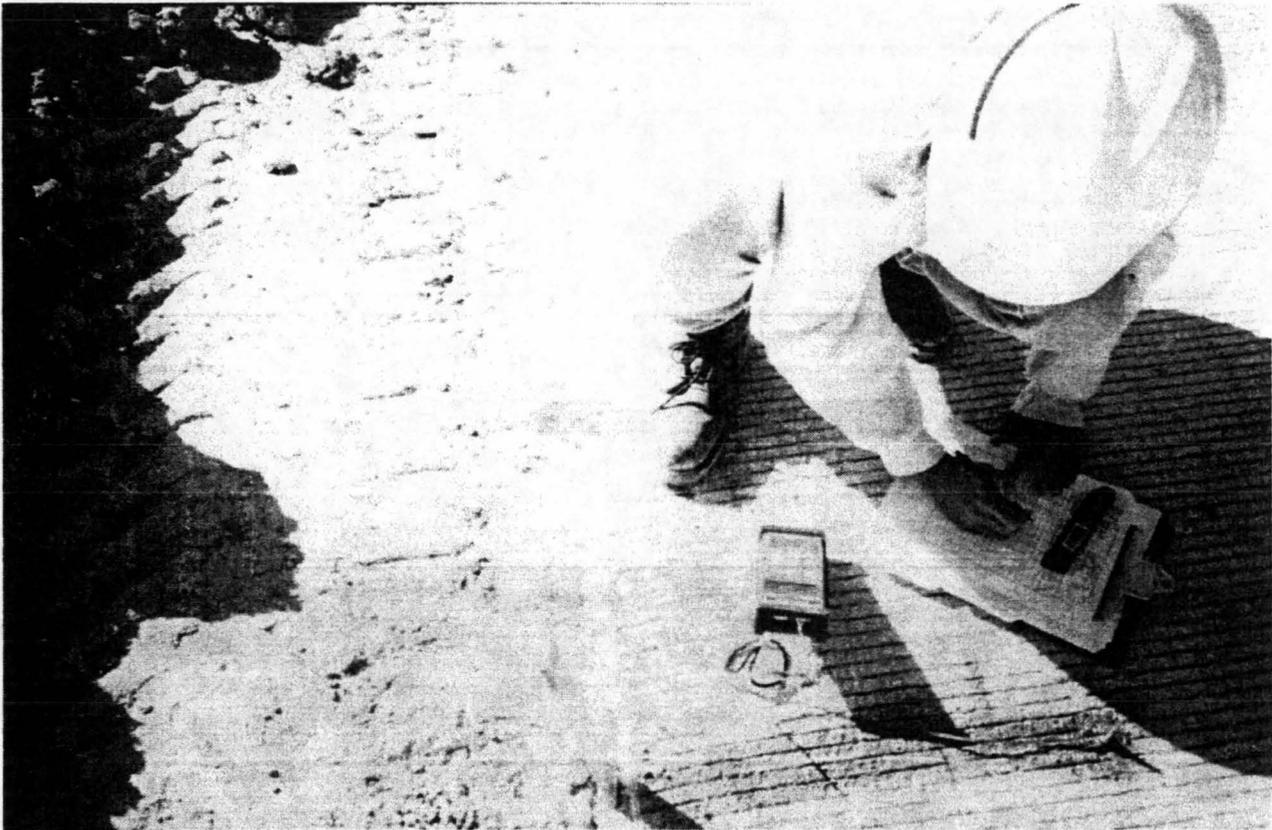
Figure 18 Manual Maturity Measurement

Use of the handheld digital thermometers allowed the research staff to collect large amounts of maturity data quickly. Sites were marked with a paint stripe or circle on the pavement for rapid identification. Figure 18 illustrates the use of the

thermometer to collect data at one of these sites.

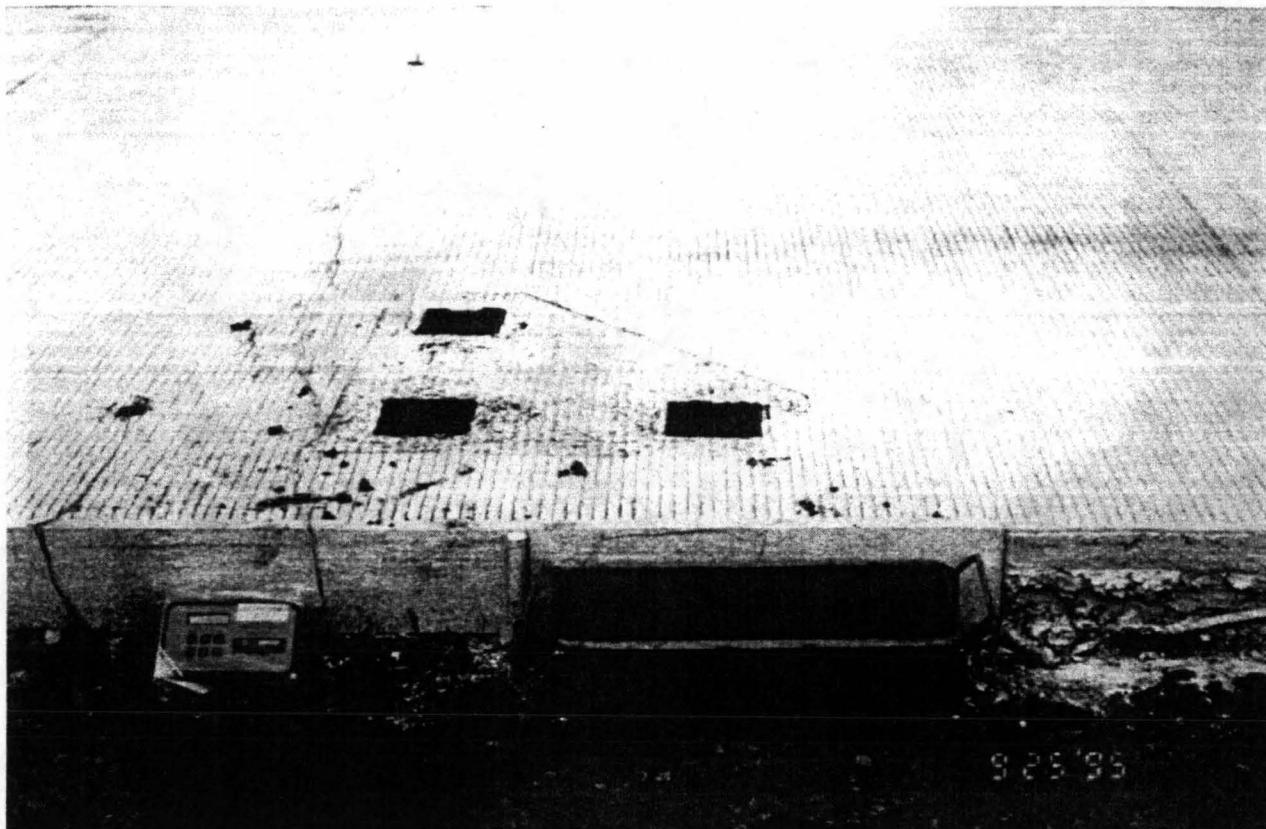
Figure 19, NDT Site Layout

A full test site setup including the pulse velocity access points, and the maturity probes with one in a test beam at the site are shown in Figure 19. This provides a view of the amount of work that was required by the research staff to accomplish this effort.

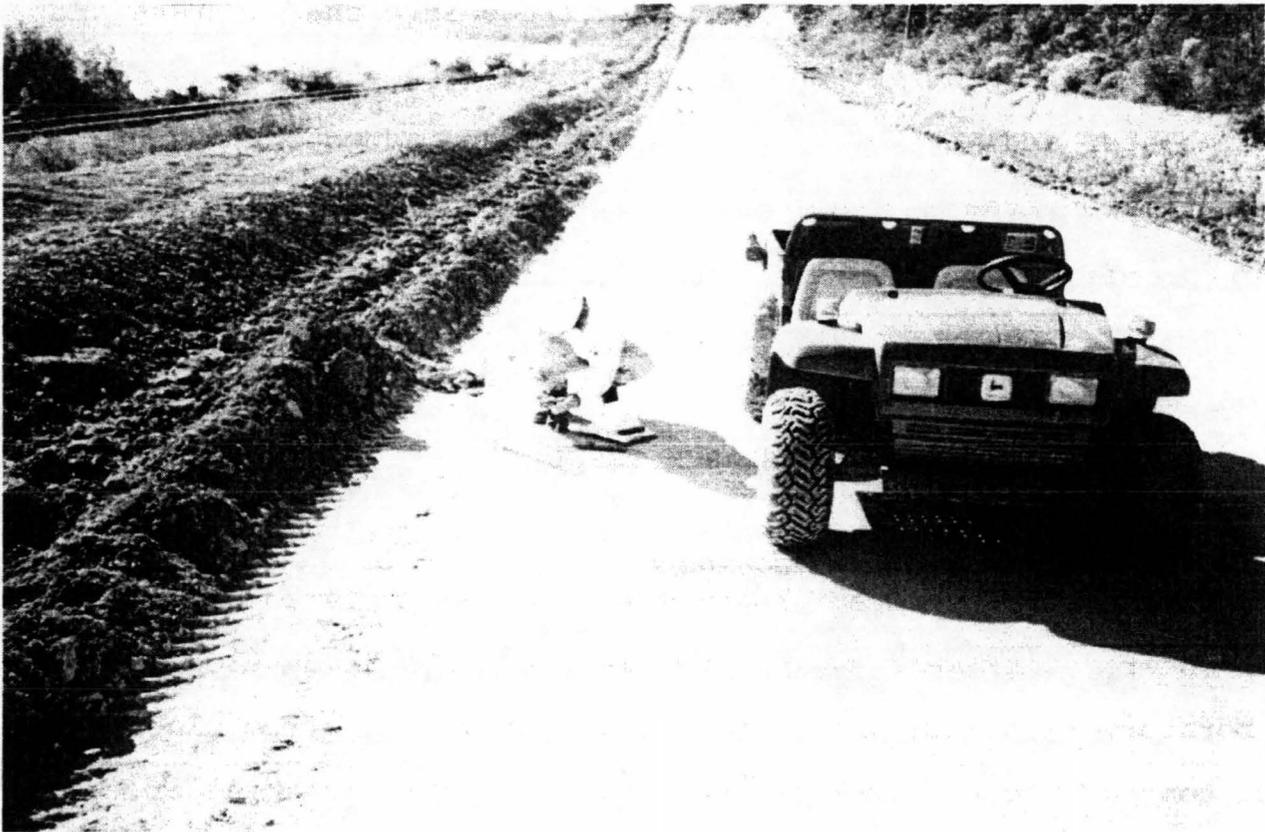
Figure 20, Data Collection Vehicle

The speed of paving and the accessibility to various parts of the project did make data collection more difficult. The lack of access roads at the end of each mile and the narrow shoulders did not allow for full size vehicles to traverse the project during concrete curing. The research team was able to minimize the problem with the rental of a small four wheel drive vehicle to navigate the shoulders and new pavement area prior to full vehicle access. A John Deere "Gator", shown in Figure 20 was found to be very helpful to the research team and county

personnel for movement of testing equipment and supplies along the length of the project. It allowed for collection of large amounts of maturity data in small amounts of time.

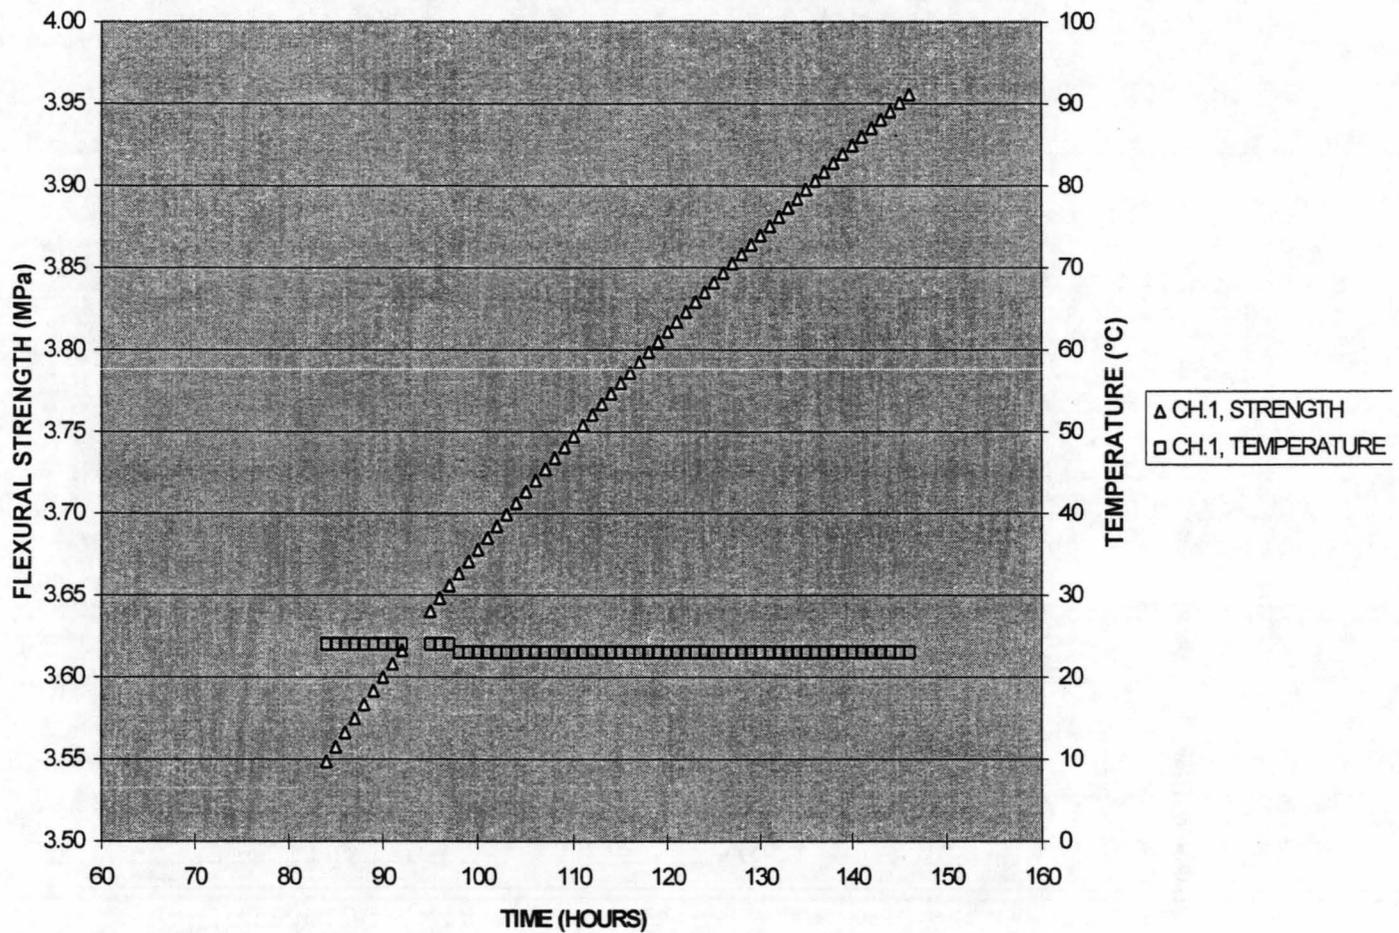
Figure 21 Laboratory Flexural Strength vs Maturity Relationship

As previously noted, samples of the materials to be used in the concrete mix were brought to Ames and used to develop a laboratory relationships between the elapsed time from placement vs. concrete temperature and concrete strength (flexural or compressive) and pulse velocity. Time, temperature and the strength relationship comprise what is referred to as maturity of the concrete in terms of time-temperature factor or equivalent concrete age. Ten flexural test beams were constructed and nine were broken as part of the test. Previously noted compressive strength cylinders were not cast as part of the laboratory work. The resulting relationship between modulus of rupture and curing time under center point loading is shown in Figure 21. This graph indicates the design strength of 350 psi (2.41 MPa) could be reached at approximately 80 hours under laboratory conditions. The area under the time-temperature curve for 80 hours of curing under cool laboratory temperatures represented approximately 1000 degree-hours of maturity. The maturity data collected in this

STRENGTH/TEMPERATURE VS MATURITY

Lab Data Ending AUG 28/95 9:32 AM

test also indicated for example, if the temperature in the concrete could be maintained at 60 degrees Fahrenheit (15.5 degrees Celsius) for approximately 17 hours, the concrete pavement could be opened to car only traffic. Due to the fall paving dates, temperatures were reduced at night and the total amount of time necessary to meet the requirement for maturity was extended to 20-24 hours.

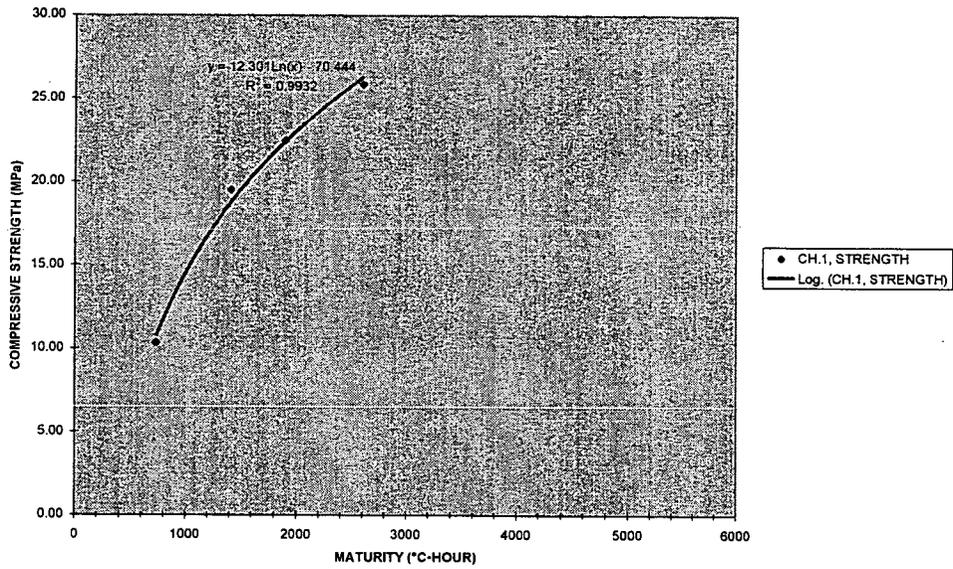
Figure 22, Laboratory Compressive Strength vs Time Relationship

COMPRESSIVE STRENGTH VS MATURITY

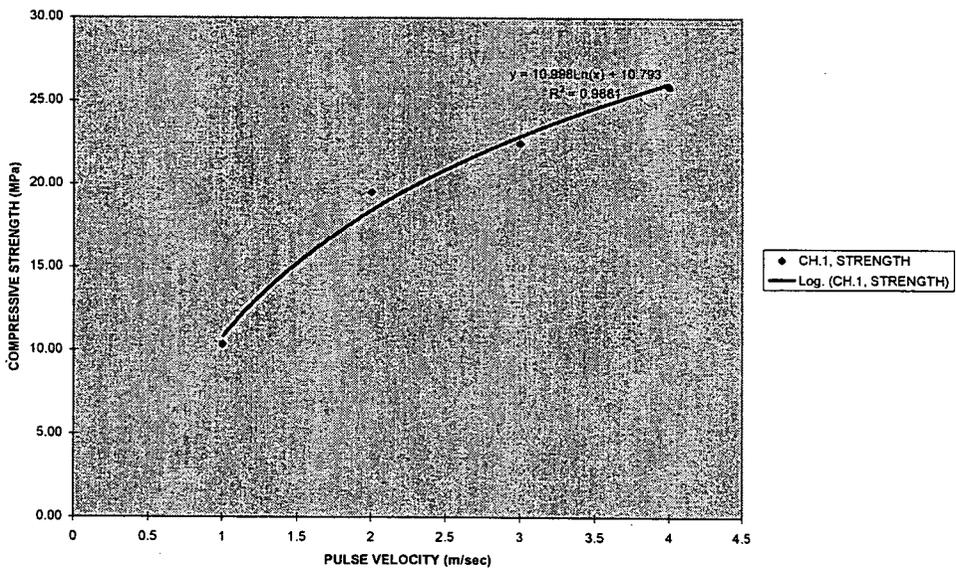
Figure 23, Laboratory Compressive Strength vs Pulse Velocity Relationship

COMPRESSIVE STRENGTH VS PULSE VELOCITY

Use of this measuring device requires a large amount of training in the settings to be used in conducting measurements.

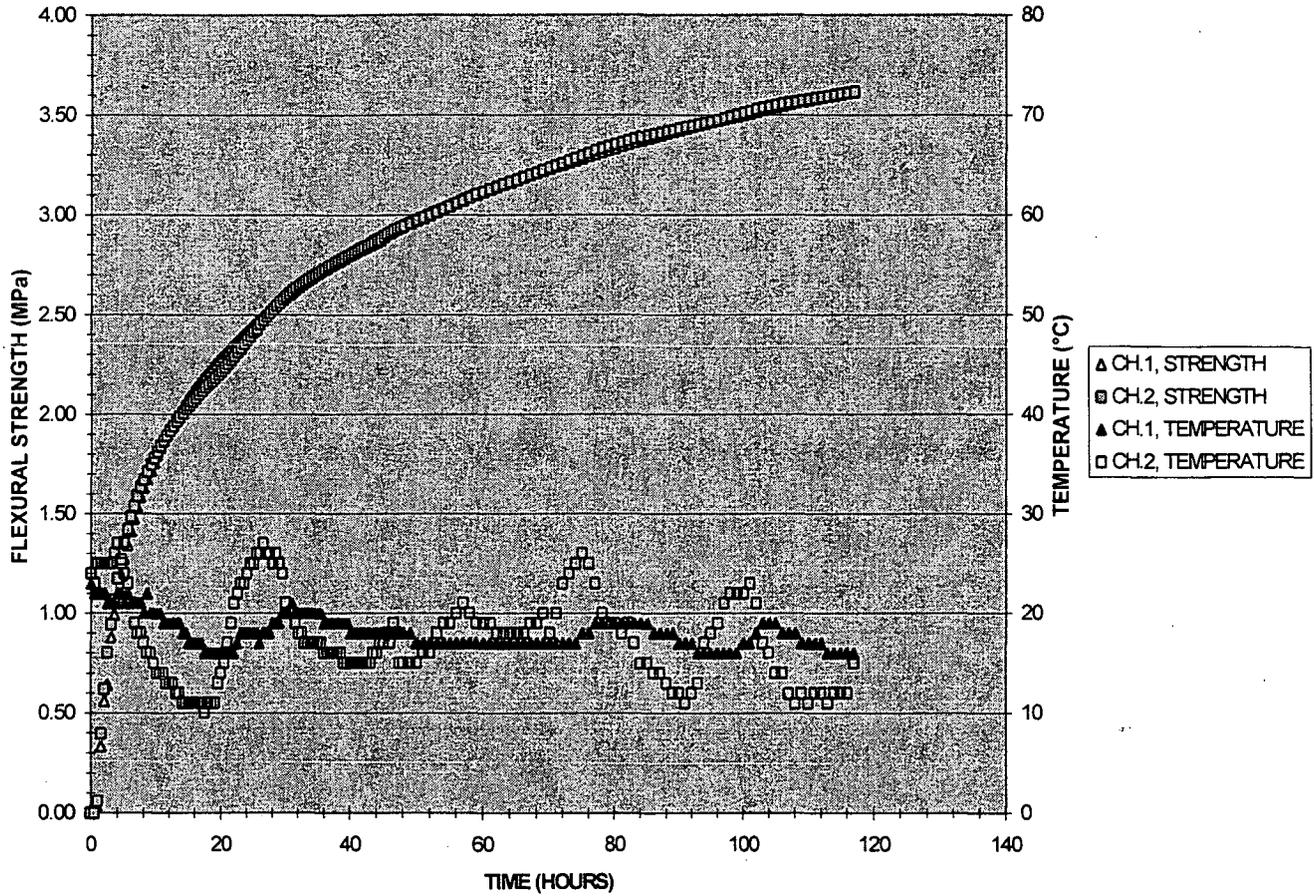
Figure 24, Field Maturity Curve

The results of the project control test are shown in Figure 24. The graph indicates that the desired minimum strength of 350 psi flexural (2.41 MPa) strength was reached in approximately 24-26 hours under the field conditions. The project staff was able to use this relationship throughout the project for mainline and shoulder opening decisions because no changes in materials were introduced

STRENGTH VS TIME VS TEMPERATURE
September 27/95 12:37 PM to October 2/95 10:02 AM
