**Evaluation of Maturity and Pulse Velocity
Measurements for PCC Traffic
Opening Decisions**

March, 1998

Iowa DOT Project HR-380

Department of Civil and Construction Engineering

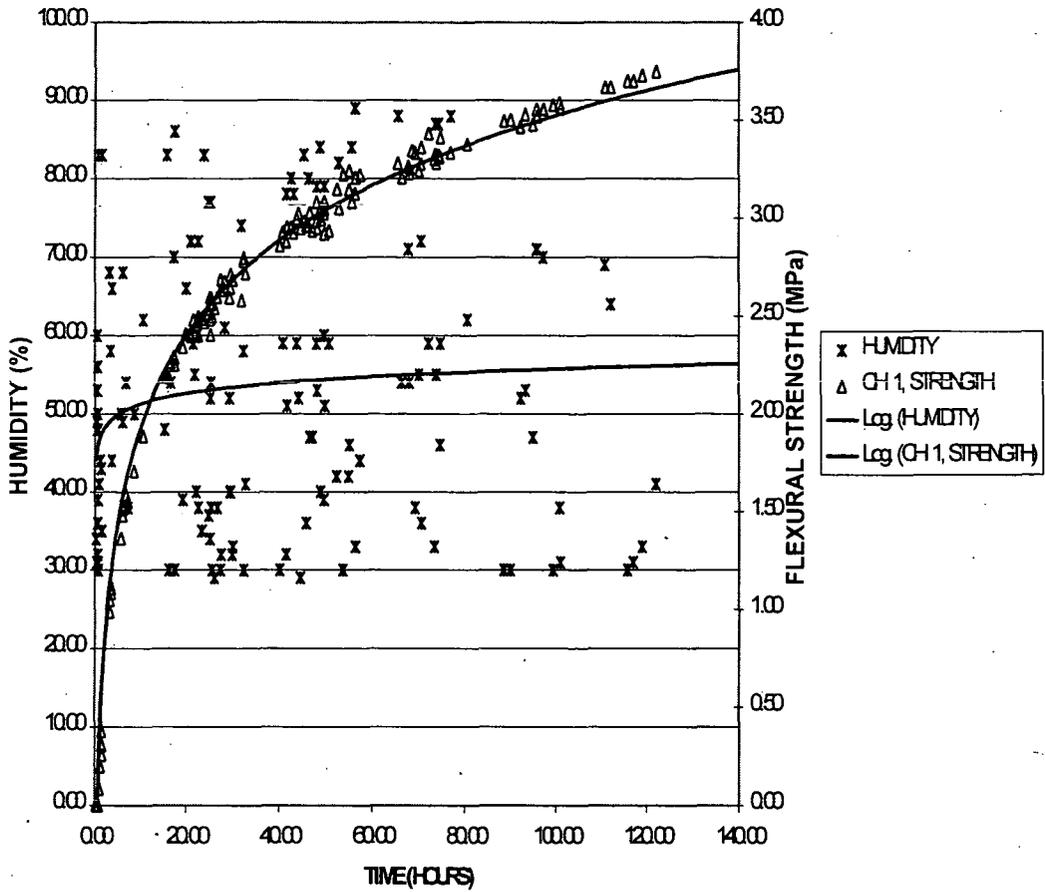
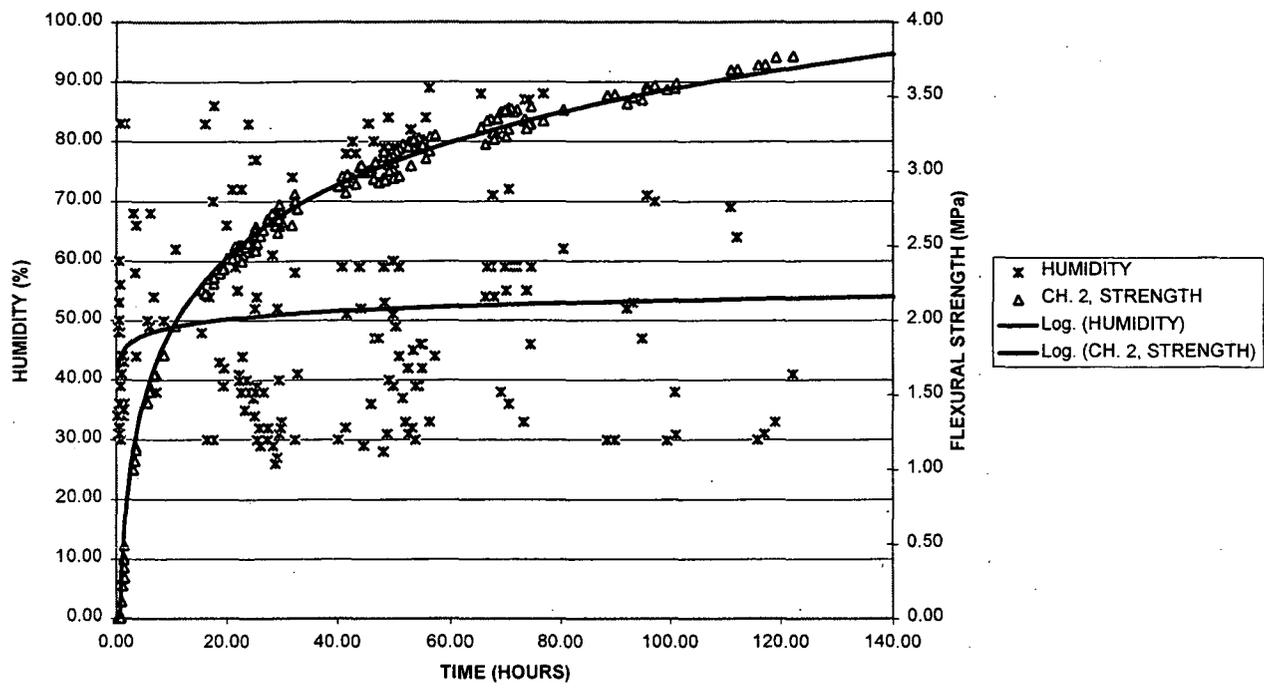
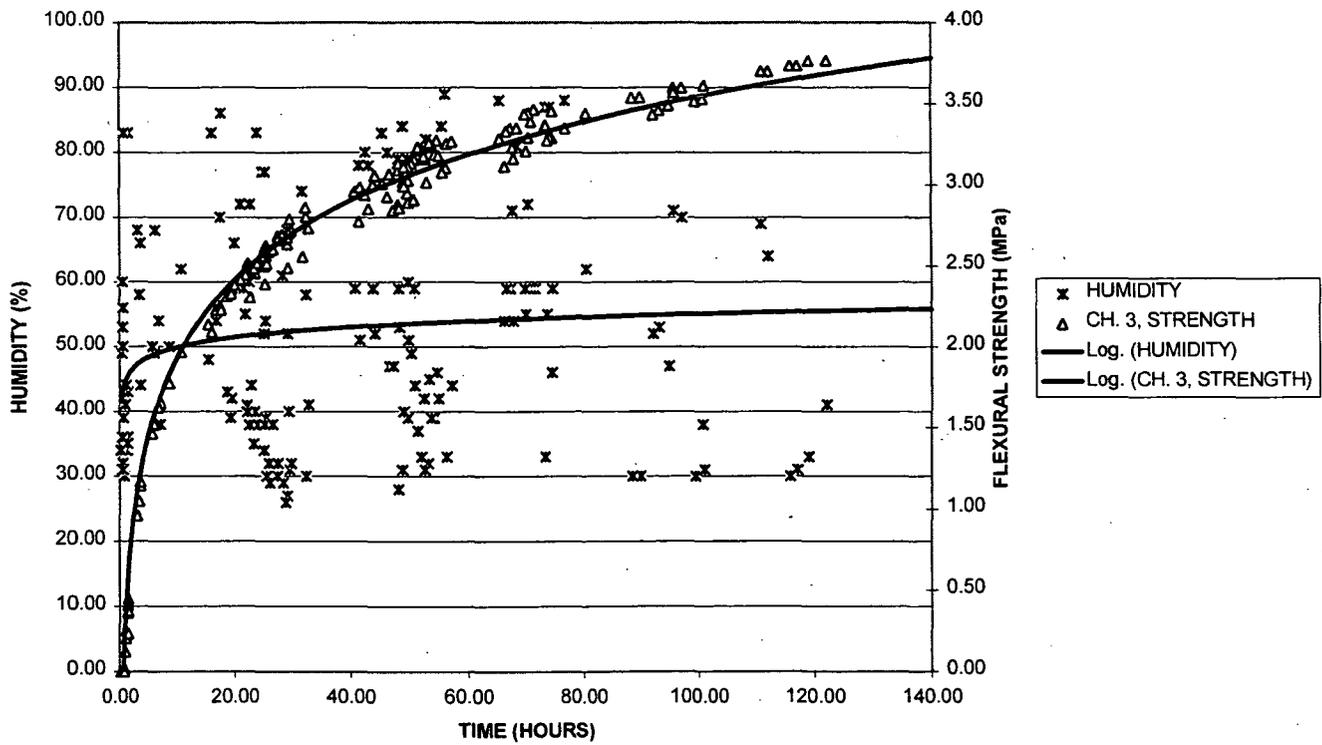
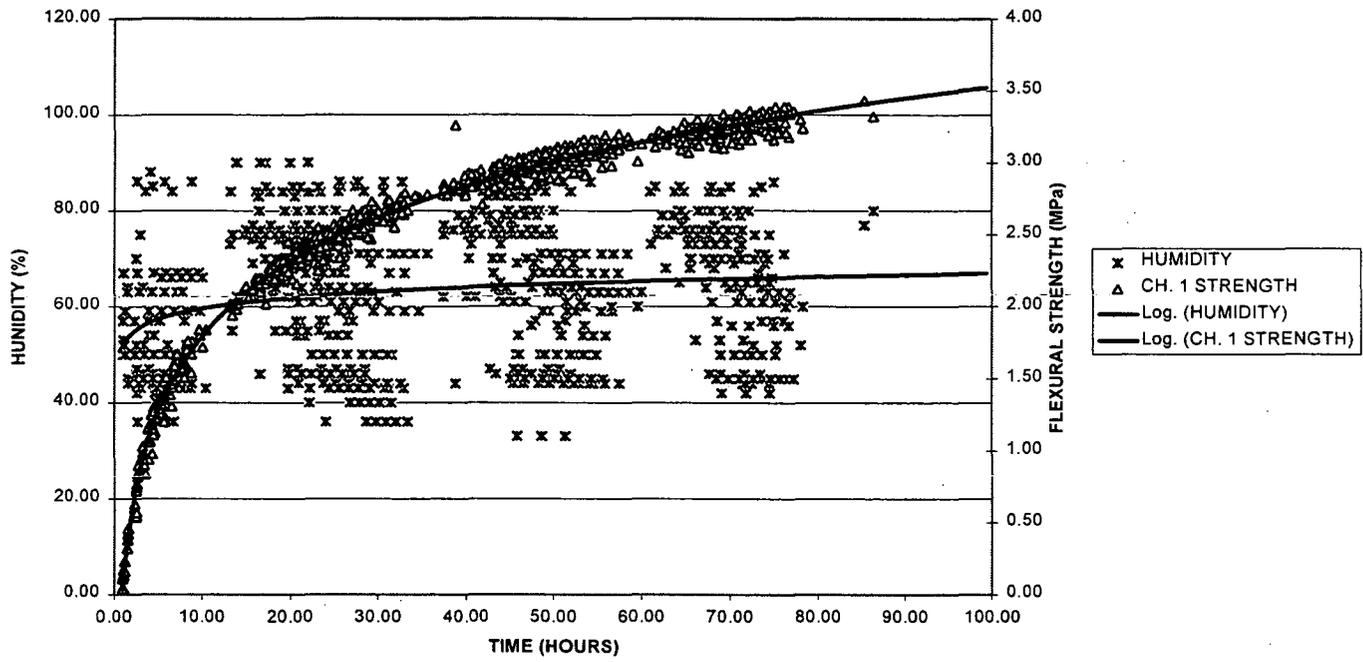
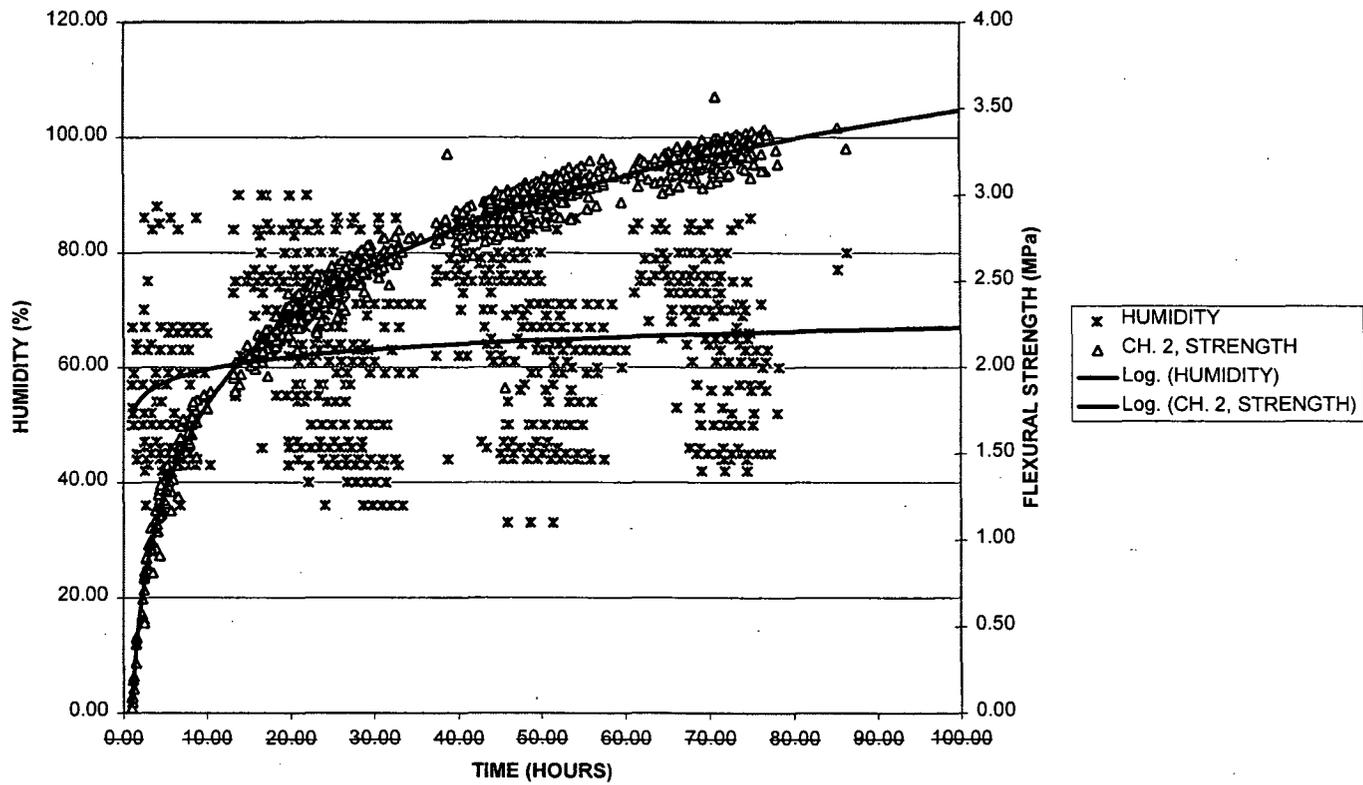
Hand held temperature measuring devices were used at regular intervals of 500 ft. (152.4 m) locations at the edge of the pavement and at the 1 in. (25 mm) and 3.5 in. (90 mm) depths in the slab. Research team staff monitored these multiple times daily as time permitted to establish the rate of strength gain of various sections of the pavement. The results of that data were used to develop a project wide relationship of maturity and estimated flexural strength. The paving of the mainline was completed in less than two weeks and the shoulder paving was completed in two weeks. The maturity data is available in tabular or graphical form for each of the self recording and handheld recording stations utilized on the project. The data from each of the maturity test sites was combined to develop a mathematical relationship between the flexural strength, time of curing and the relative humidity. The results of those measurements are illustrated in Figures 25 through 27 for the mainline paving and 28 through 29 for the shoulder paving.

Figure 25, Maturity Strength vs Cure Time vs Humidity (Top of Slab)

Figure 26, Maturity Strength vs Time vs Humidity (Midslab)

Figure 27, Maturity Strength vs Time vs Humidity (Bottom of Slab)

Figure 28, Maturity Strength vs Time vs Humidity (Top of Shoulder)

Figure 29, Maturity Strength vs Time vs Humidity (Middepth)

The relationship (curve shape) between the time of curing and the concrete strengths for both the mainline and shoulders is as would be expected for most concrete mixes tested thus far for the Iowa DOT. The points shown on the graphs for each represent the data from all the sites measured by the handheld recording devices. Differences in the curve shape would be expected if changes in the mix materials were made during the project to produce an earlier or later setting mix. If the graphs representing the top, middepth and bottom of the mainline slab, or top and middepth of the shoulders, are superimposed, the impact of the temperature gradient from top to bottom of slab can be identified. In this project the temperature differences between top and bottom did not have a large impact on the final curve. They could have impacted the time of sawing vs time of opening if the contractor has chosen to use the early softcut method of joint development.

The statistical equation for each of these lines is available, but only applicable to these project mix and site conditions. The R-squared values for each of the mainline and shoulder equations exceeded 0.98 when the data was fit with a natural log function equation. Data points that exhibited zeros or incomplete data in terms of temperature and humidity were not included in the analysis.

Relative humidity was also correlated to the strength and cure time relationship in the same manner for both the mainline and shoulder data. A natural log function equation was developed

for the top, middepth and bottom of the mainline and top and middepth of the shoulder pavement. The R-squared values of 0.03 for the mainline and 0.04 for the shoulders indicated that the relationship was almost nonexistent. The graphs indicated the large amount of scatter and the difficulty encountered in attempting to find a relationship. This type of data may be very helpful in understanding the reasons for premature or shrinkage cracking in some pavements, but does not apply well to maturity measurements.
