DEMONSTRATION PROJECT NO. 72
AUTOMATED PAVEMENT DATA
COLLECTION EQUIPMENT
Roughness and Profile Measurement

Iowa DOT Evaluation of the
PASCO Road Survey System

K. Jeyapalan
J. K. Cable, P.E.
R. Welper
Civil Engineering Department
Iowa State University
Ames, Iowa

March 1987

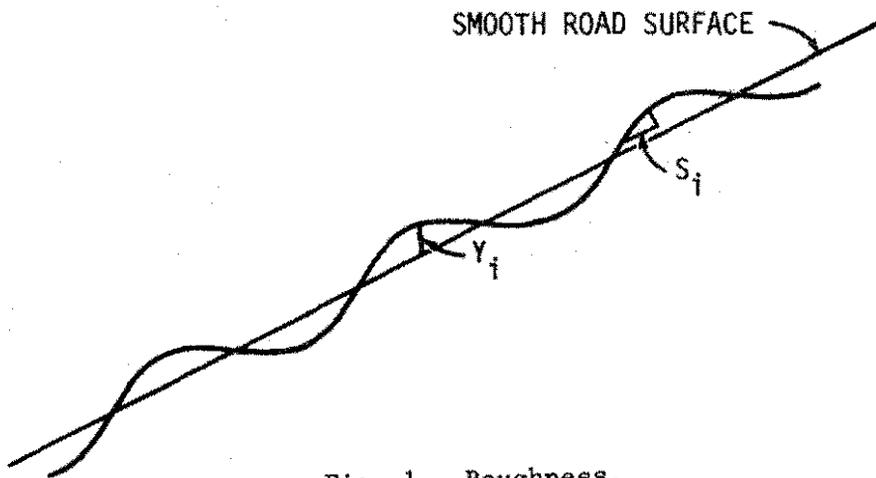
Fig. 1. Roughness.

S_i = slope at a point i (see Fig. 1).

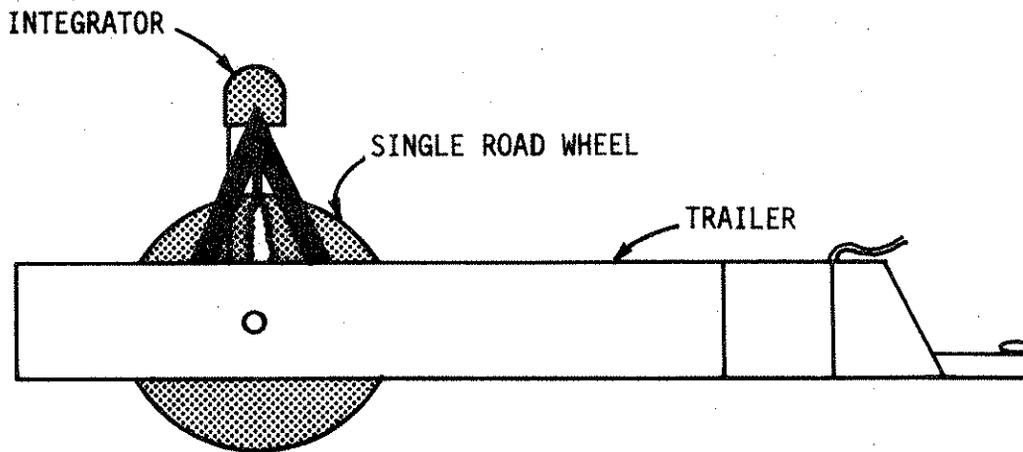
Fig. 2. BPR method.

The Iowa DOT uses the Bureau of Public Roads (BPR) roughometer to obtain the roughness in terms of inches of roughness per mile. The BPR consists of a single road wheel attached to an accumulating counter by a one-way clutch (see Fig. 2). As the wheel moves up and down while being towed, all movements in one direction are summed. Another counter records the number of revolutions of the tire so that distance traveled can be calculated (see the Appendix A).

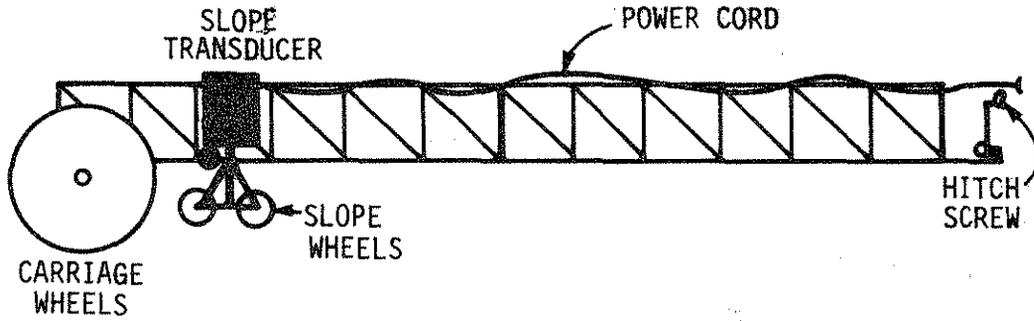
Fig. 3. CHLOE profilometer.

The BPR readings are calibrated against a standard roughometer, CHLOE, to give the LPVs. The CHLOE consists of two units: a trailer unit, which carries the transducing mechanism, and the electronic computer, which gets the information from the transducer, does the necessary computation, and displays the results. Figure 3 shows the CHLOE, Fig. 4 shows the transducer, and Fig. 5 shows the computer. The slope transducer is equipped with two eight-inch road wheels attached to the pivot arm. The transducer provides a continual measure of the angle between the bar connecting the slope wheels and the arbitrary reference of the trailer unit. The values obtained by the CHLOE are not affected by possible change in the towing vehicle's suspension. Because the CHLOE is very sensitive, slopes are obtained at five mph, which is time consuming. With the slope value, S , the slope variance SV (which is the variance of the slope) is computed from

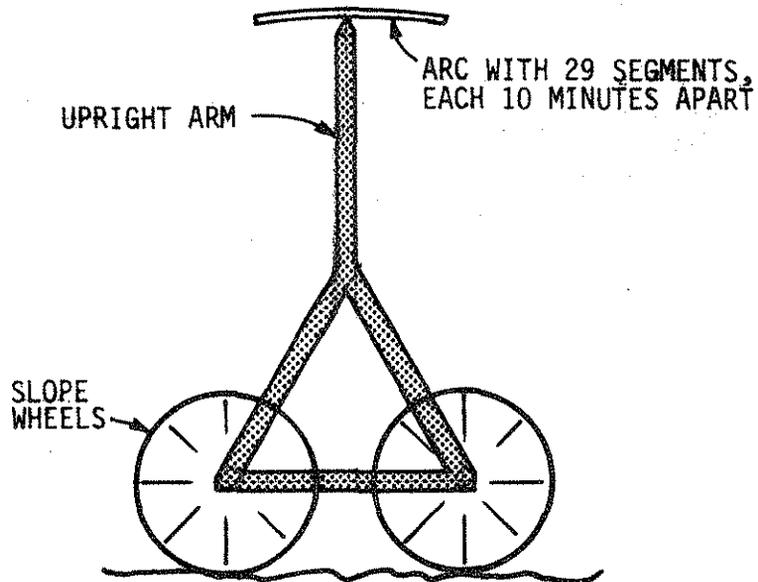
Fig. 4. Transducer,

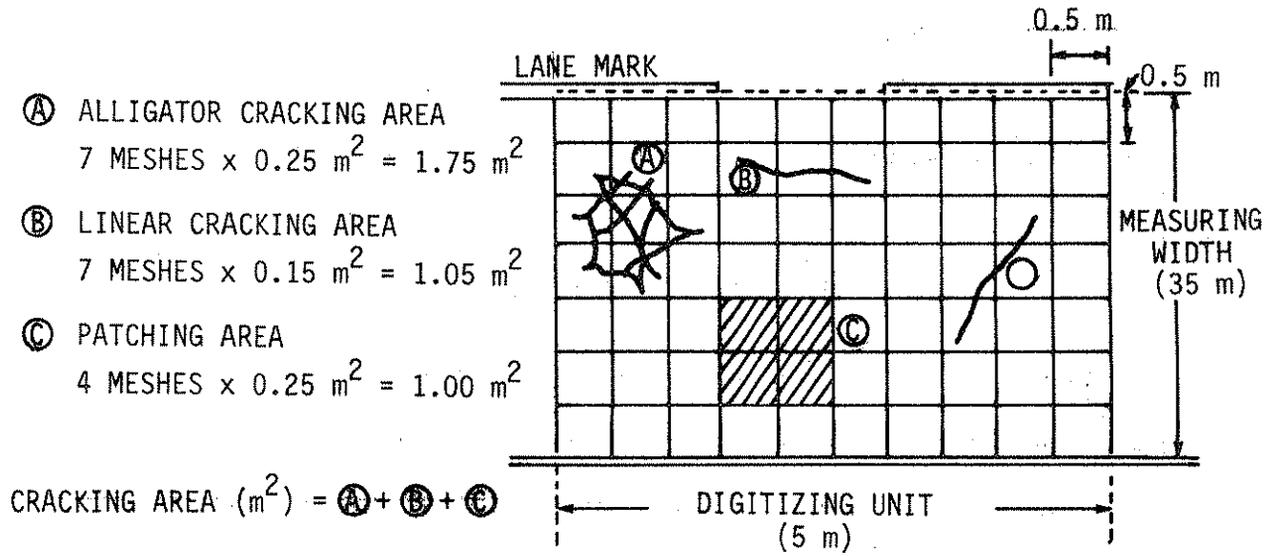
Fig. 6. Crack-digitizing method.

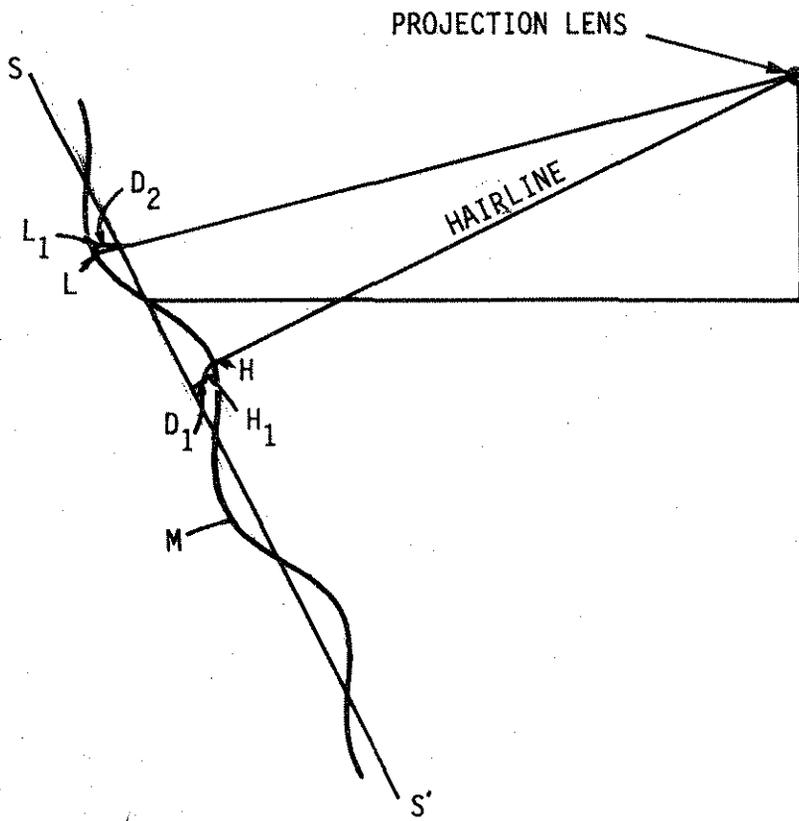
Fig. 7. Cross section of rutting wave pattern.

Figure 7 shows the projection of a hairline on the cross section of a road. If there is no rutting wave pattern, the hairline will be projected as a straight line SS'. However, if there is a rutting pattern LHM present, then the hairline at the high point H will be projected as H₁ and at the low point L will be projected as L₁. The distance D₁ of H₁ from SS' is proportional to the height of rutting HH₁ and distance D₂ of L₁ from SS' is proportional to the depth of the rutting. Now if the projected line is photographed by a vertical camera (see Fig. 8) directly above the line SS', then the hairline at H will be imaged at h and the hairline at L will be imaged at l. If p is the principal point of the camera, then ph = d₁ and pl = d₂ can be measured accurately using a comparator (photogrametric instrument used to measure x-y coordinates on a photograph to an accuracy of one micron). Then, the distance

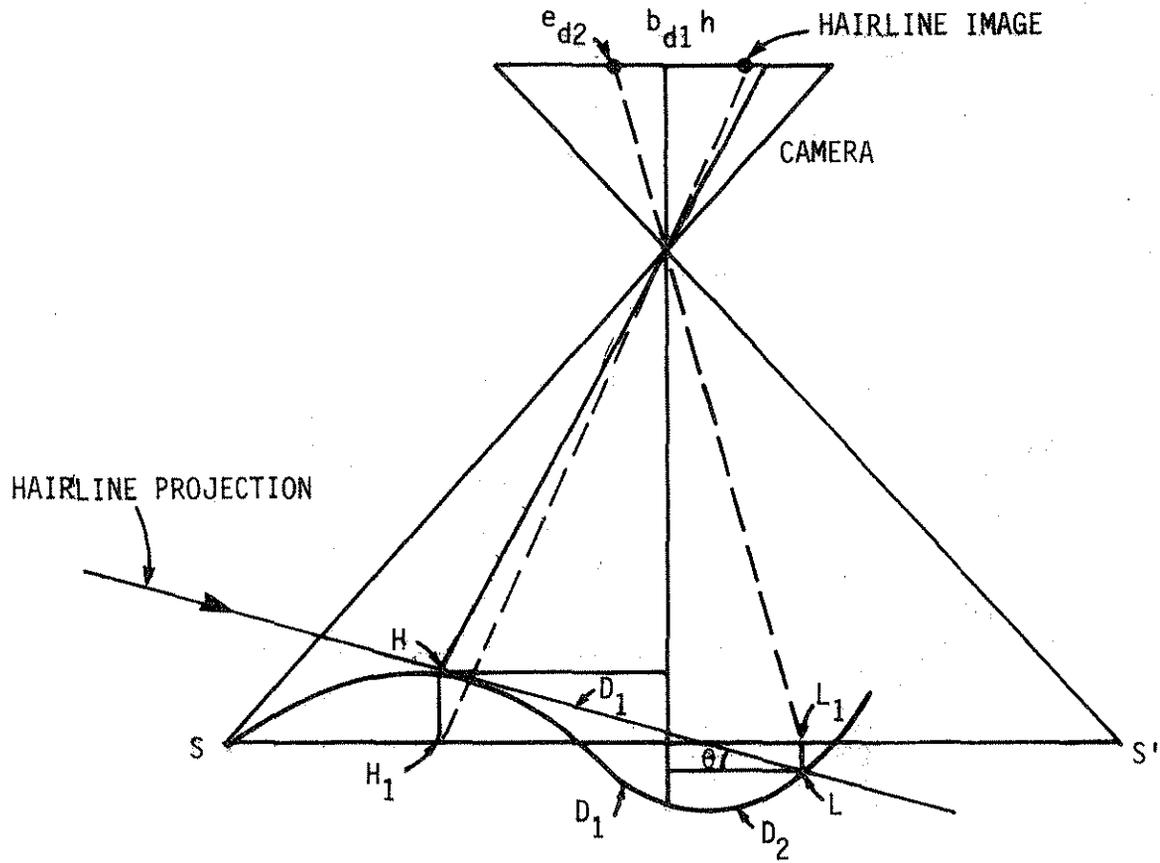
Fig. 8. ROADRECON-75.

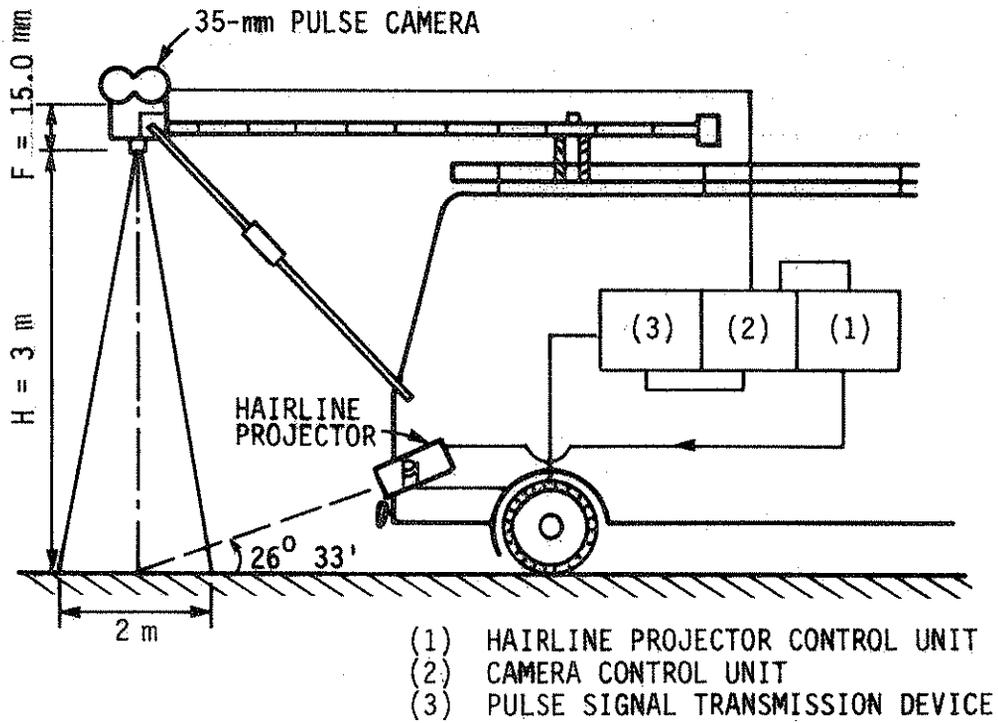
Fig. 9. ROADRECON-75 for rutting survey.

In the ROADRECON-75 system the strobe light is mounted on the bumper of the survey vehicle and projects the hairline at an angle $\theta = 26^\circ 33 \text{ min.}$, such that $\tan \theta = 1/2$. The camera, mounted on a boom on top of the vehicle, photographs the lane in which the vehicle is driving (see Fig. 9). The camera is aimed straight down so any rutting is represented by a wave pattern in the hairline. The focal length of the camera, $f = 0.6 \text{ in. (15 mm)}$, and the height of the camera above the ground, $H = 120 \text{ in. (3000 mm)}$, result in a scale for the photograph of $S = 200$. Thus, the total rut depth = $200(d_1 + d_2)/2$, and if d_1 and d_2 are measured to an accuracy of $\pm 0.0002 \text{ in. } (\pm 0.005 \text{ mm})$ by a comparator (or to an accuracy $\pm 0.008 \text{ in. } (\pm 0.02 \text{ mm})$ on a digitizing tablet and

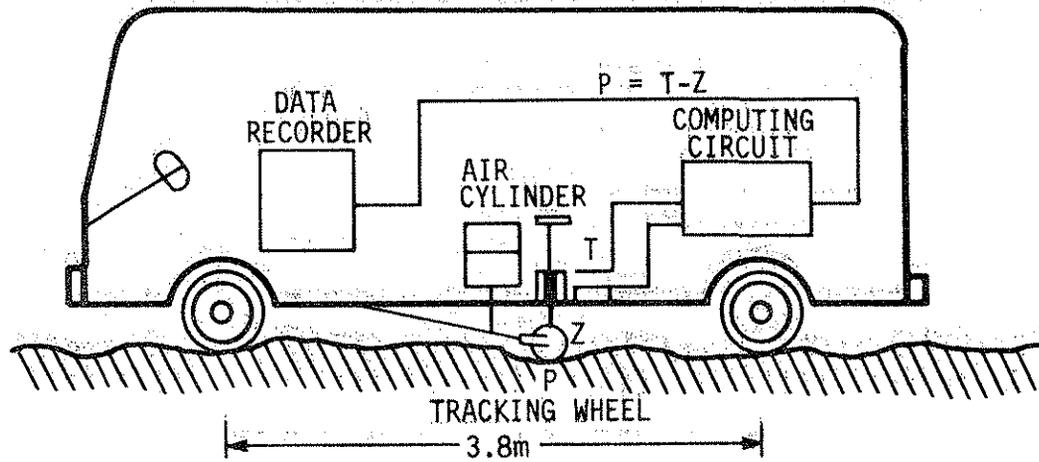
Fig. 10. ROADRECON-77 for evenness survey.

The ROADRECON-77 uses a tracking wheel to measure longitudinal roughness of a road surface. The roughness is measured by a differential transformer and a Servo accelerometer attached to the tracking wheel. The tracking wheel is arranged so that it measures the roughness in the right wheel track of the lane in which the survey vehicle is driving (see Fig. 10). The accelerometer, attached to the tracking wheel or profile detector, measures the vertical acceleration and feeds the information to an on-board computer. The computer performs the necessary integration to determine the vertical displacement

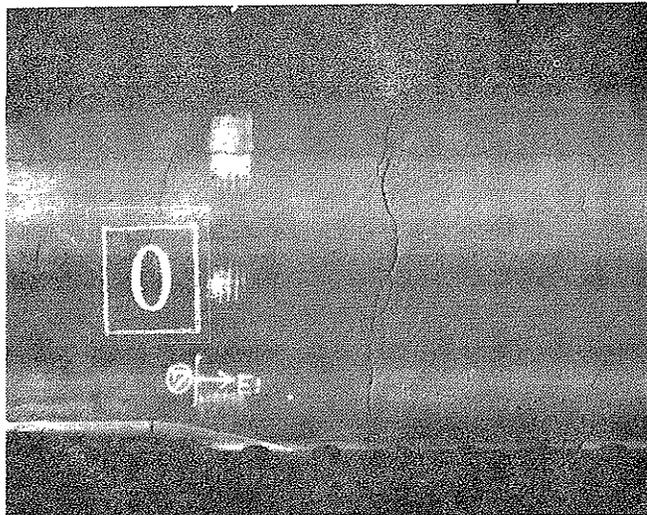
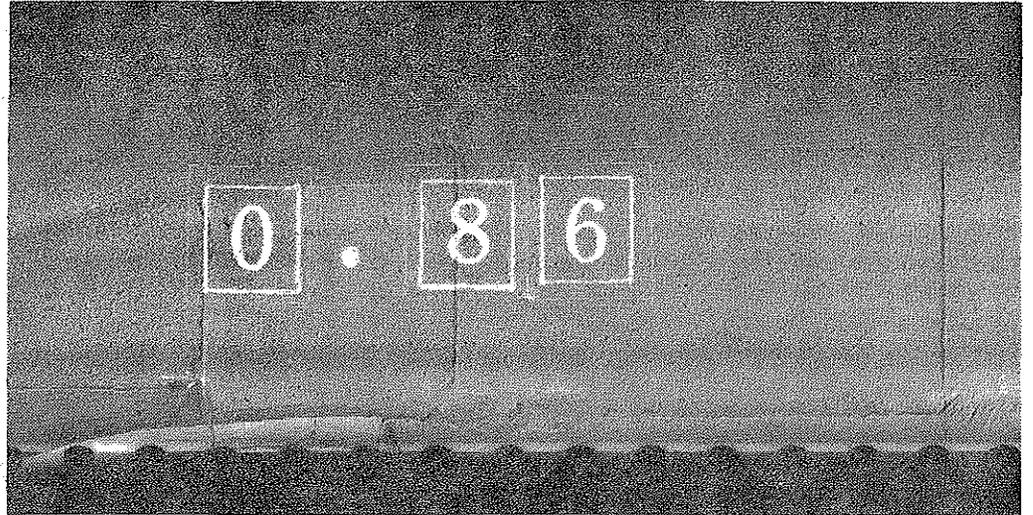
Fig. 12. Continuous strip photograph.

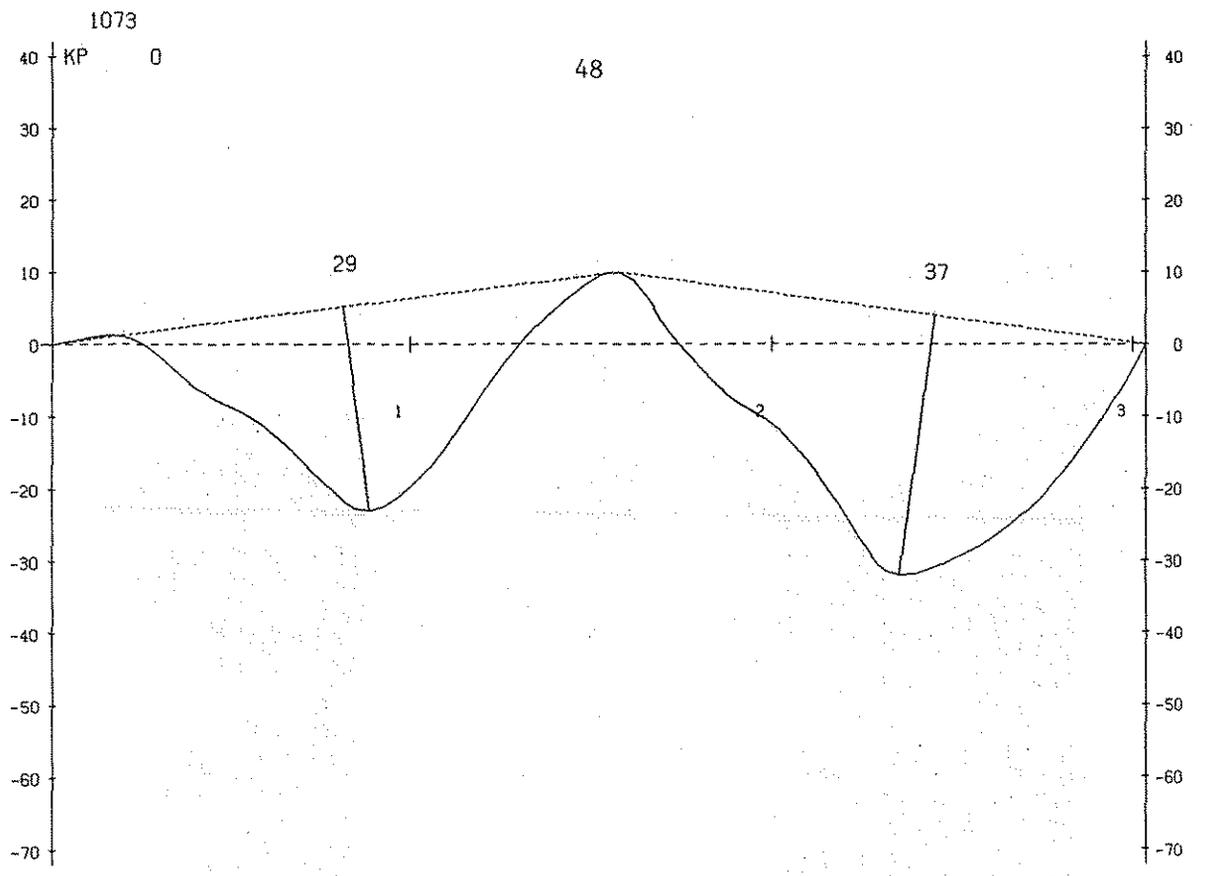
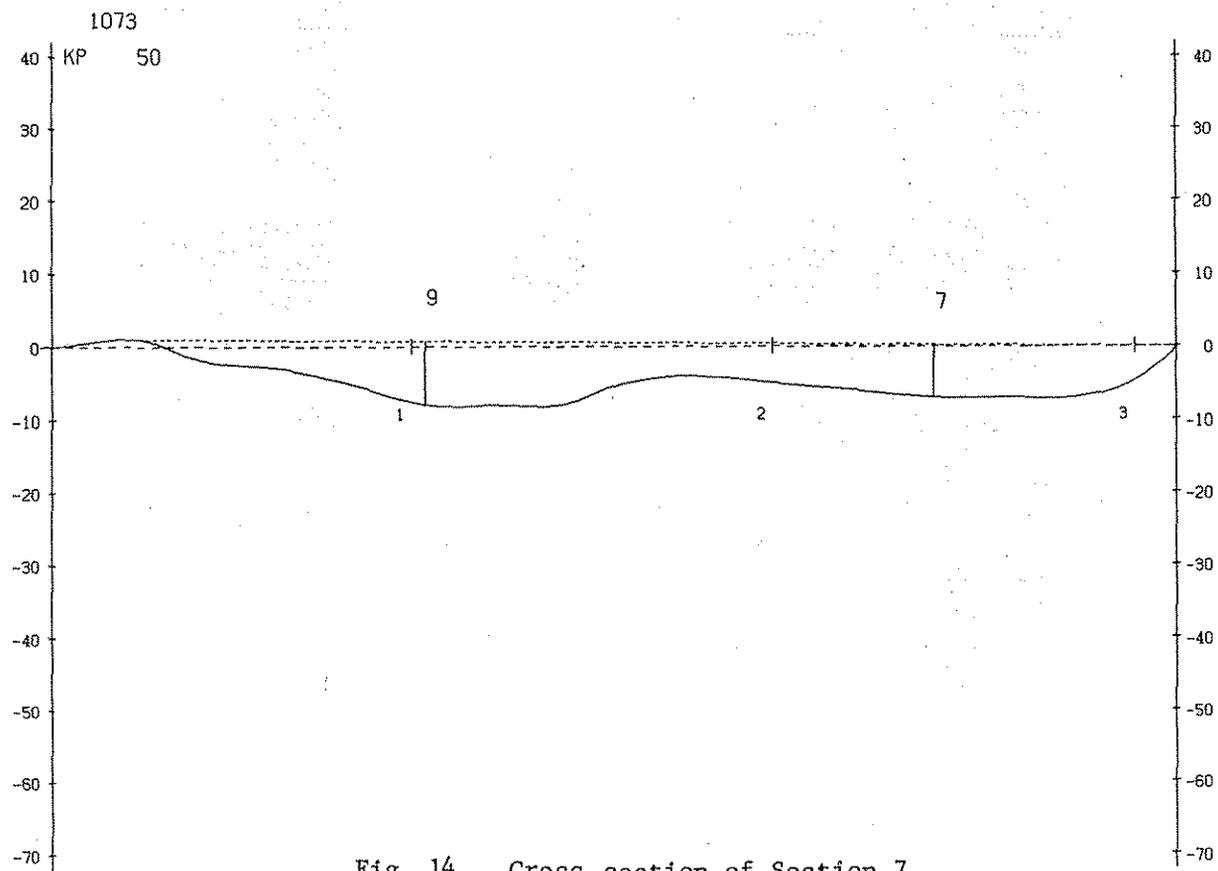
Fig. 14. Cross section of Section 7.

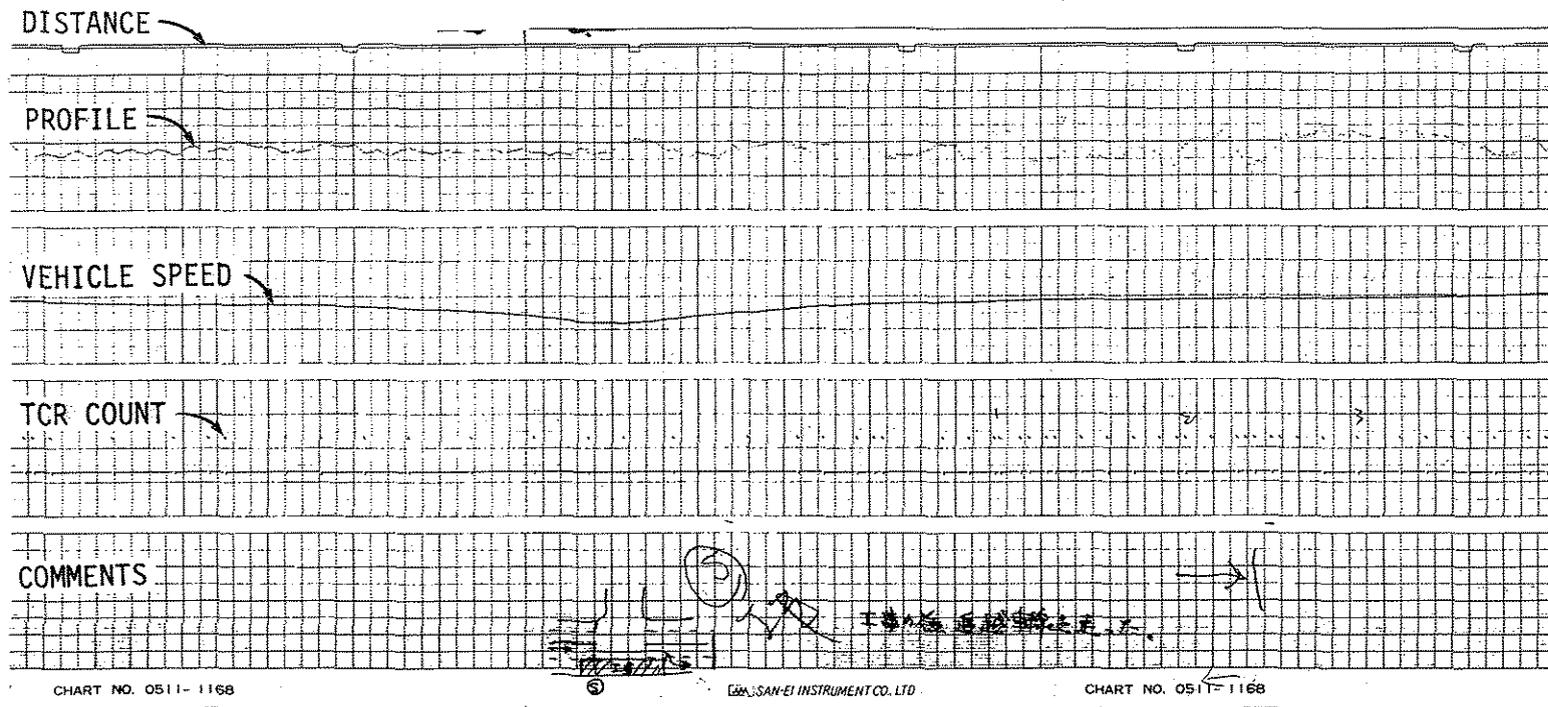
Fig. 15. Paper chart (longitudinal profile) by tracking wheel.

the paper chart is made manually at the beginning and end of the section. The cassette and the paper chart are sent for computations of the roughness. Figure 15 shows the paper chart of a typical run. The strip chart is broken into four separate tracing areas longitudinally. The upper trace is used to identify the distance traveled along the top of the trace area with 0.08 in. (2 cm) along the paper being equal to 8.9 ft (2 m) of travel. The second line of data within the same trace is the longitudinal profile of the section surveyed. The vertical scale on the graph is 2.0 in. of roughness per 0.4 in. (10 mm). The second trace area contains a plot of the speed of the survey vehicle. Its scale is 6.25 mph (10 km/h) for each 0.4 in. (10 mm) on the vertical scale. The third trace contains vertical tick marks near the center that represent the TCR count with each one equal to 0.4 in. (1 cm) of additional roughness. The additional information shown in this section was not used in this test and pertains only to the manufacturer's needs. The final trace area is used to make notes relative to particular problems noted in the survey such as the location of intersections or other special features along the route.

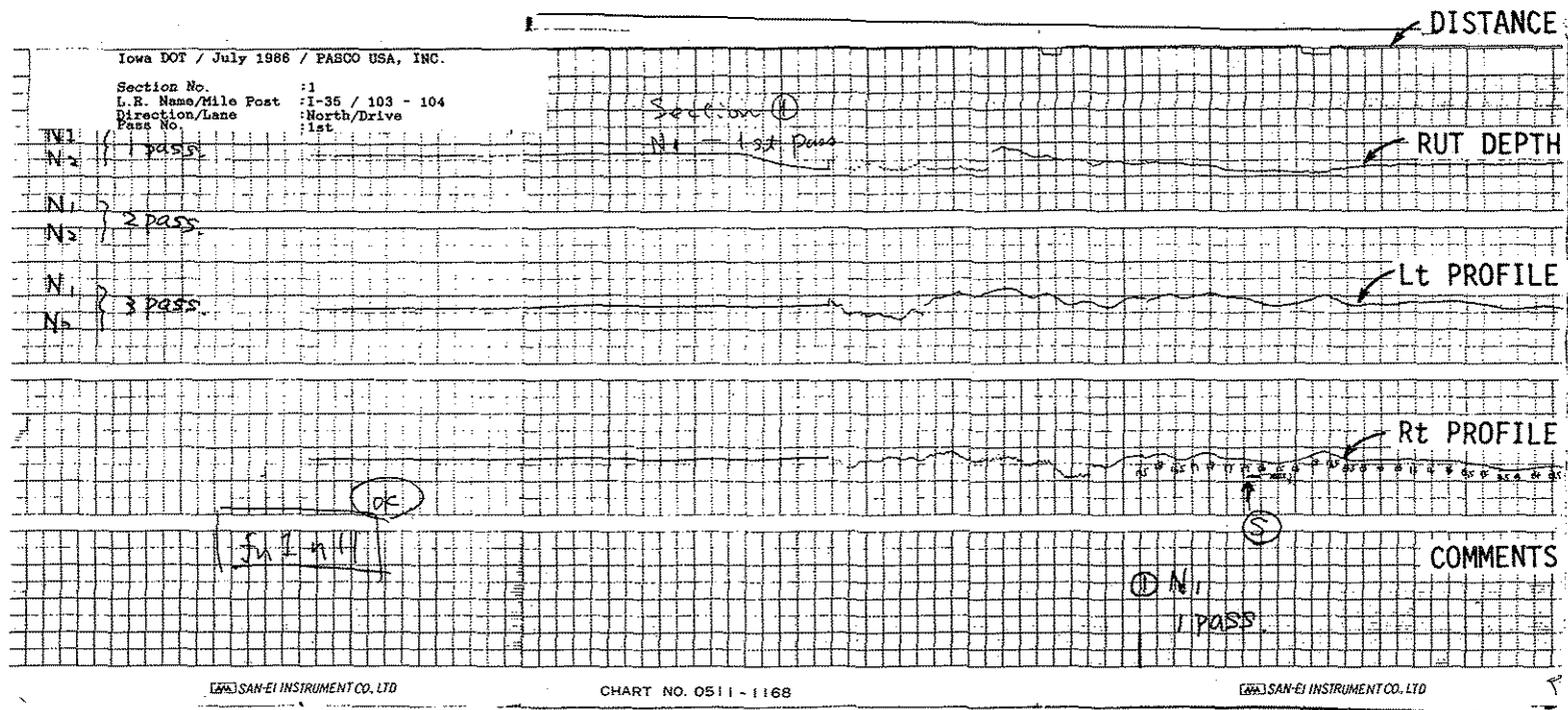
Fig. 16. Longitudinal profile by laser.

For ROADRECON-85B the mounting of the lasers takes about 10 to 15 min. Checking of proper connections and paper feeds takes another 5 min. Model 85 utilizes premounted laser units that require no setup time, but this model was unavailable for the test evaluation. The system is started well before the operation, and marks are made on the paper chart manually at the beginning and end of each section. The charts and the cassette tape are sent for computations of the roughness. Figure 16 shows the paper chart of a portion of a section. This chart is laid

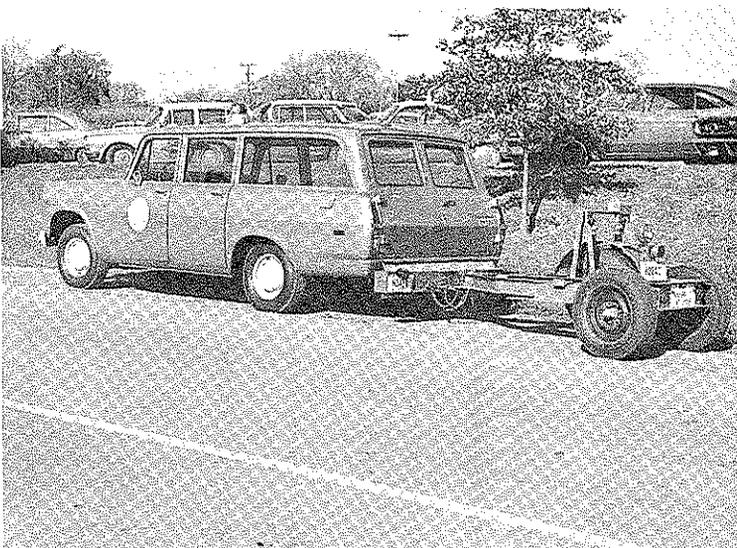
Fig. 1
Roughometer in Towing Position

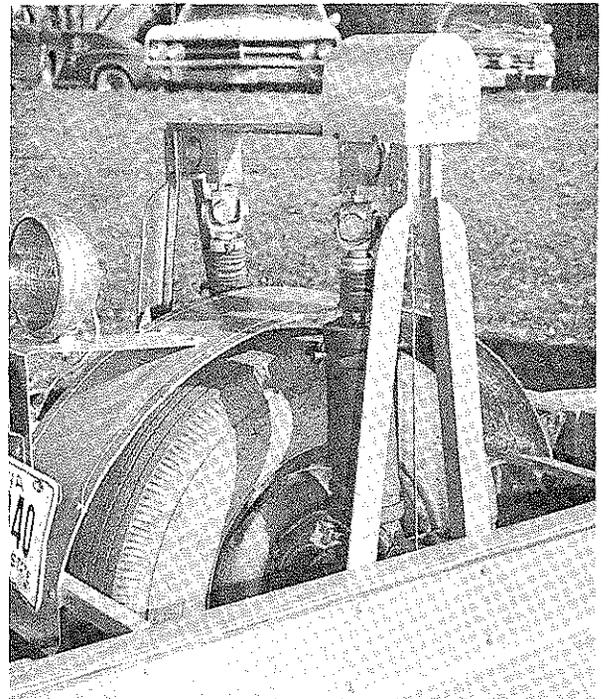
Fig. 2
Close-up of Roughometer

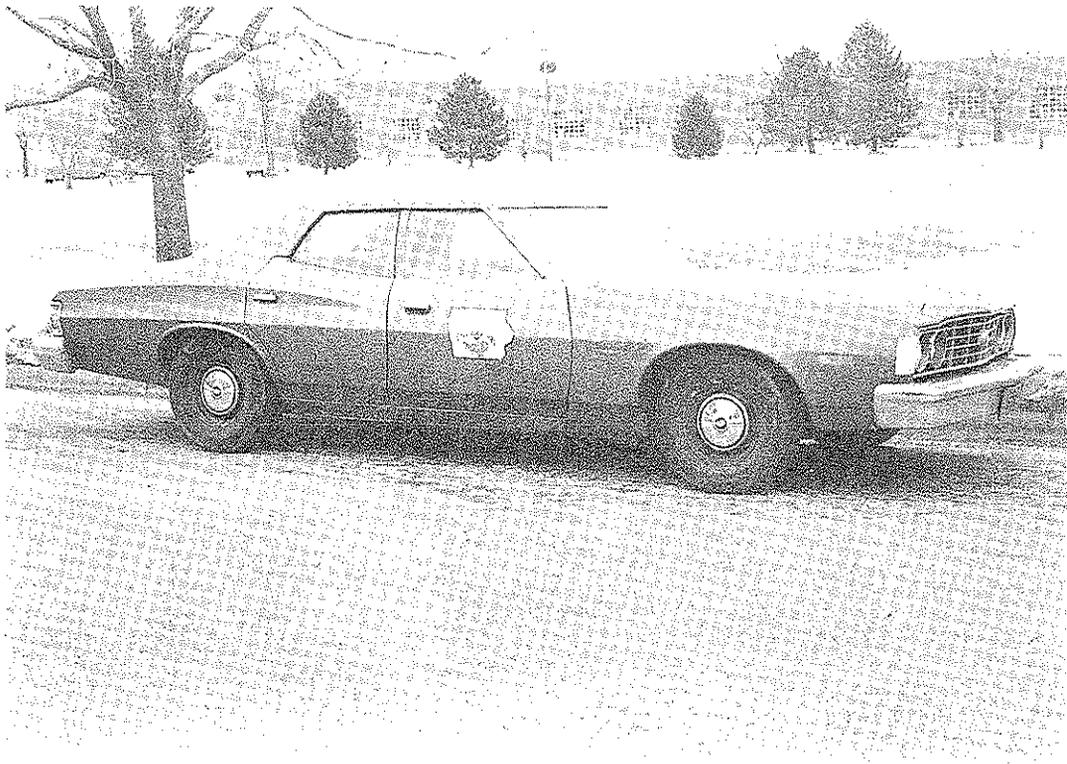
Fig. 1

The IJK Ride Indicator Vehicle

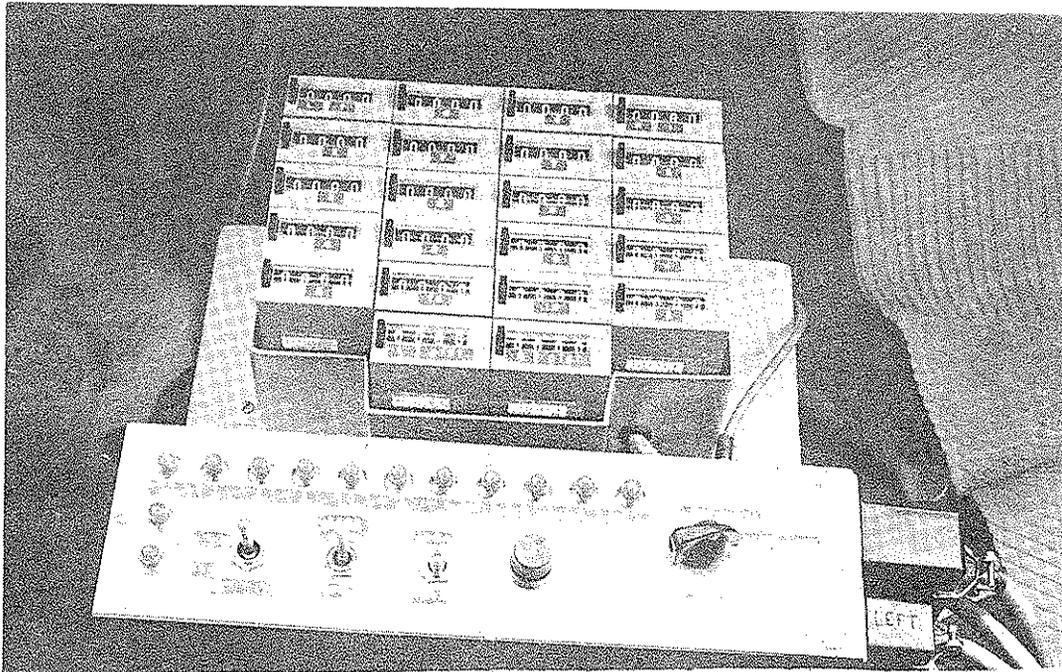
Fig. 2

The IJK Ride Indicator Control Console, showing Visual Indicators, Switches and Electrical Counters on the floor of the automobile.

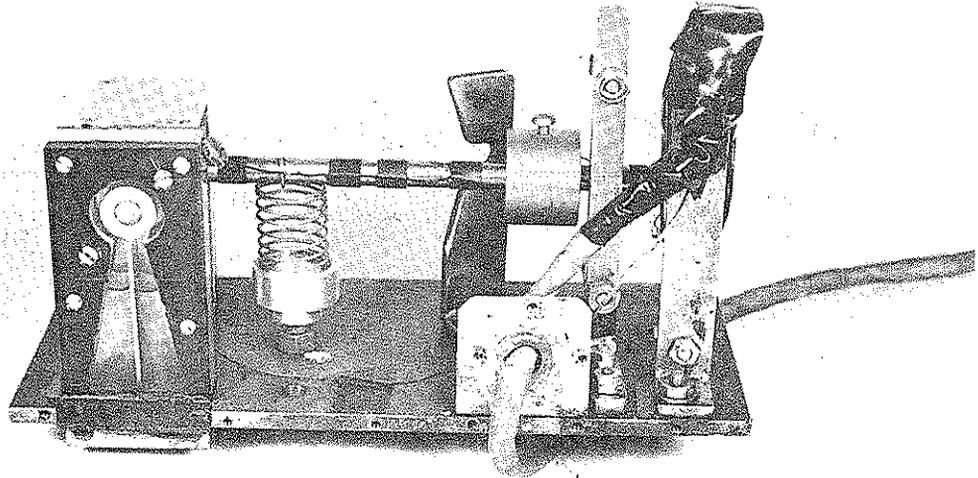
Fig. 3

The IJK Ride Indicator Sensing Unit

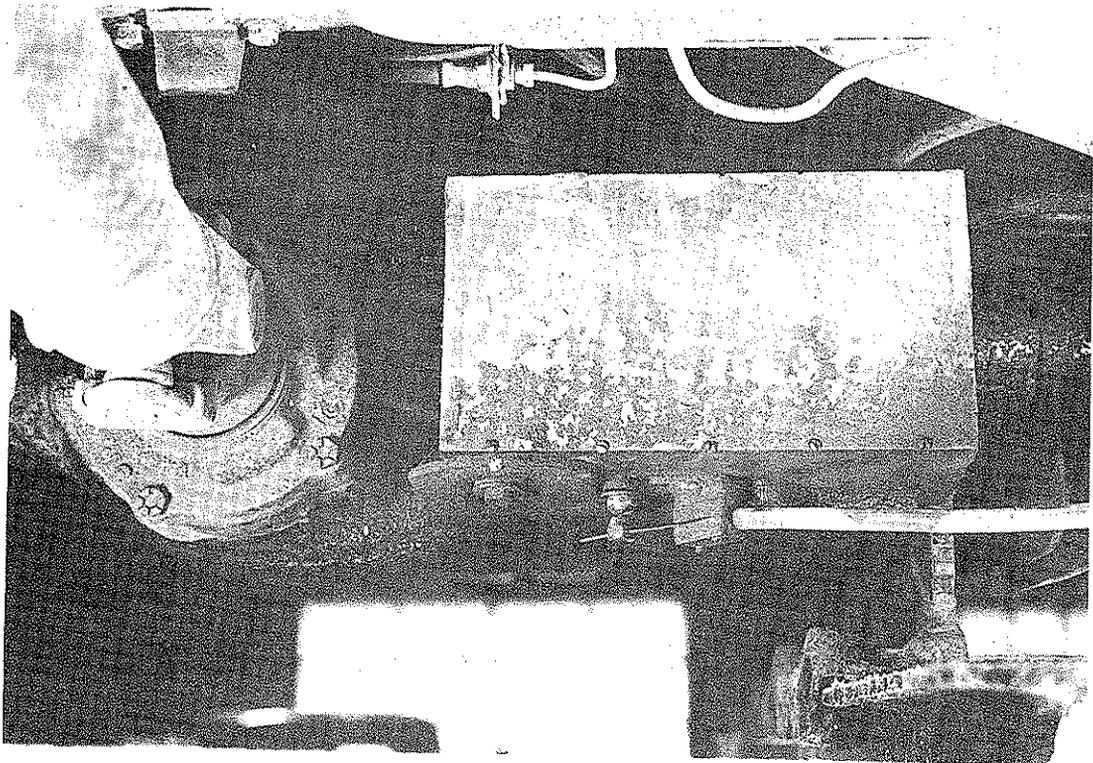
Fig. 4

The IJK Ride Indicator Sensing Unit with Cover as Mounted on the Rear Differential Housing of the Vehicle

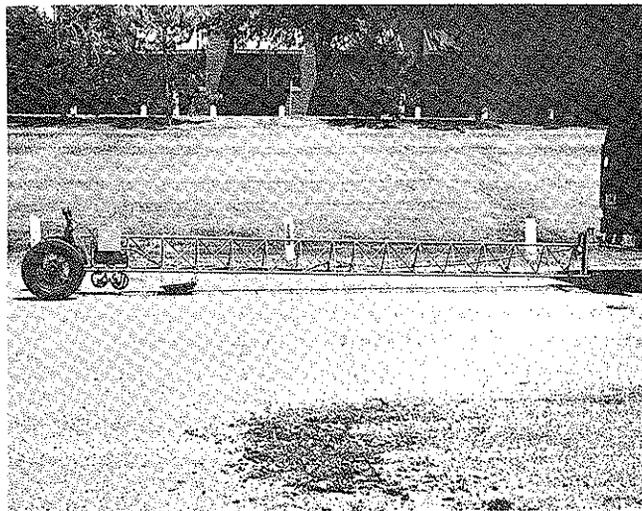
Fig. 2
CHLOE Trailer Section

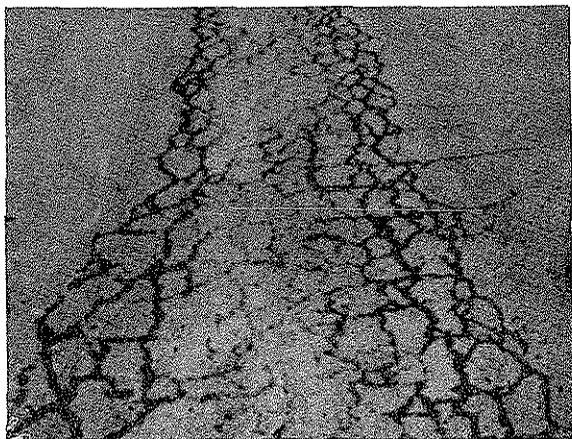
Figure 1.

Alligator cracking

Cracking, C, is defined as the square feet per 1000 square feet of pavement surface exhibiting alligator or fatigue cracking. This type of cracking is defined as load related cracking which has progressed to the state where cracks have connected together to form a grid like pattern resembling chicken wire or the skin of an alligator. This type of distress can

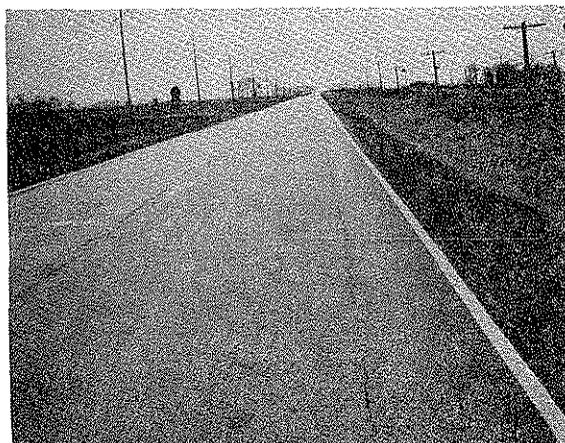
Figure 2.

Longitudinal Cracks

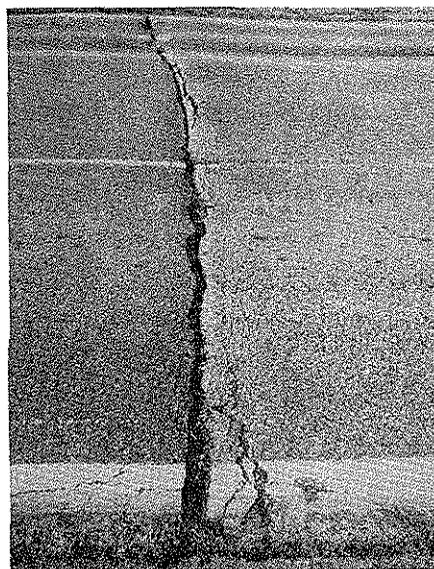
Figure 3.

Transverse Cracks and Faulting

Cracking, T, is defined as the number of transverse (right angles to traffic direction) cracks that are open to a width of 1/4" over half their length or have been sealed. Random or diagonal cracks are ignored.

Faulting, F, is defined as the mean vertical displacement, in inches, measured with a 4-ft. straightedge.

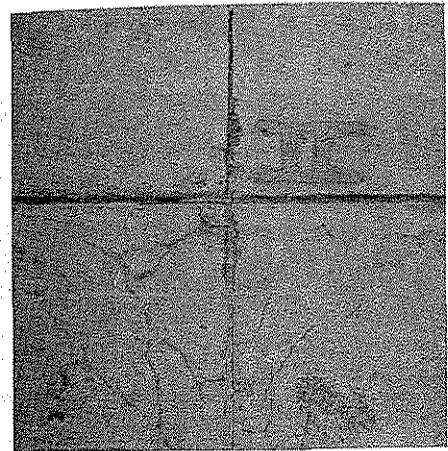
Figure 4.

D-cracking - Initial stages

D-cracking, D, refers to a characteristic pattern that can develop in portland cement concrete. Initially, the occurrence of D-cracking may be preceded and accompanied by staining of the pavement surface near joints and cracks. However, not all stained joints and cracks develop D-cracking. D-cracked concrete will first exhibit fine parallel cracks adjacent to the transverse and longitudinal joints at the interior corners. The D-cracks will bend around the corner in a concave or hourglass pattern. As the D-cracking progresses, the entire length of the transverse, longitudinal and random cracks will be affected. The cracked pieces may become loose and dislodged under the action of traffic. The occurrence of D-cracking in the check sections will be rated on a point scale as described in the Test Procedure section.

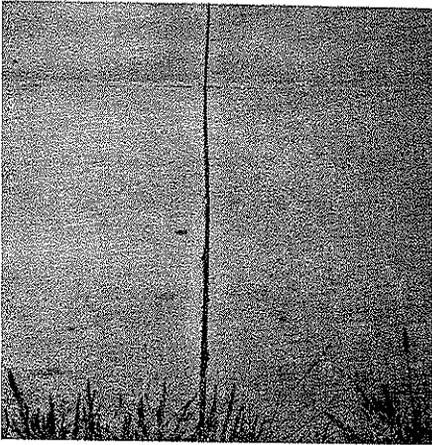
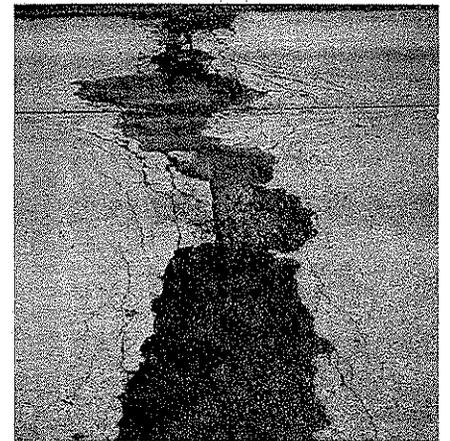
Figure 6. Examples of D-crack Occurrence Factors

- 4 = D-cracking very evident as in 3 above. Spalling and removal by traffic has progressed to point that regular maintenance patching is required. Effect on riding quality of pavement is now noticeable.

- 5 = D-cracking has continued to progress at sites identified in 3 above and requires regular maintenance patching. Full depth patches may be necessary. Ride quality has deteriorated to point where reduced driving speed is necessary for comfort and safety.

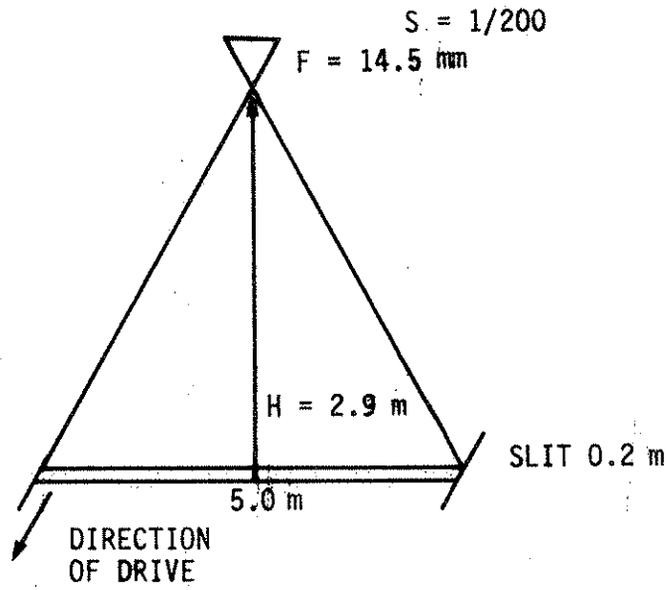
Fig. B.1. The ROADRECON-70.

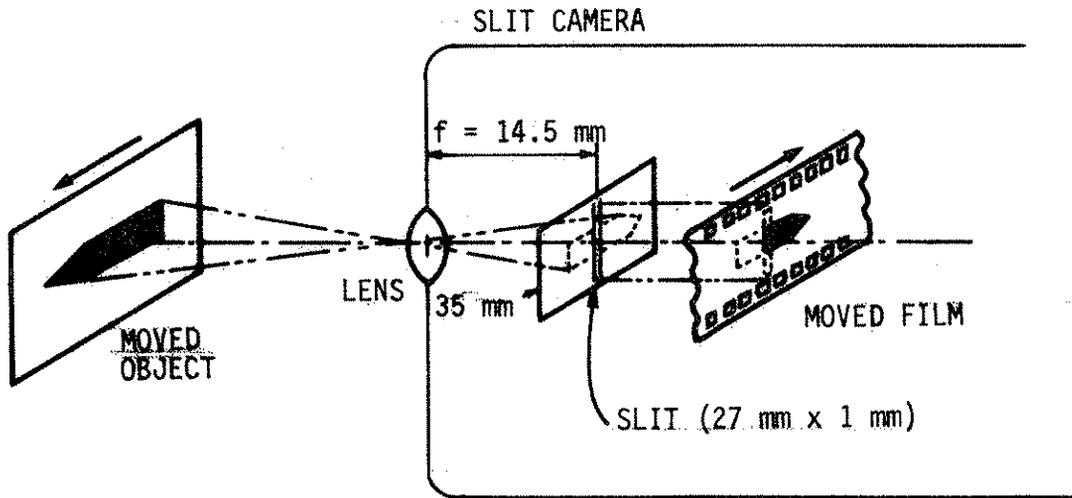
Fig. B.2. Slit camera.

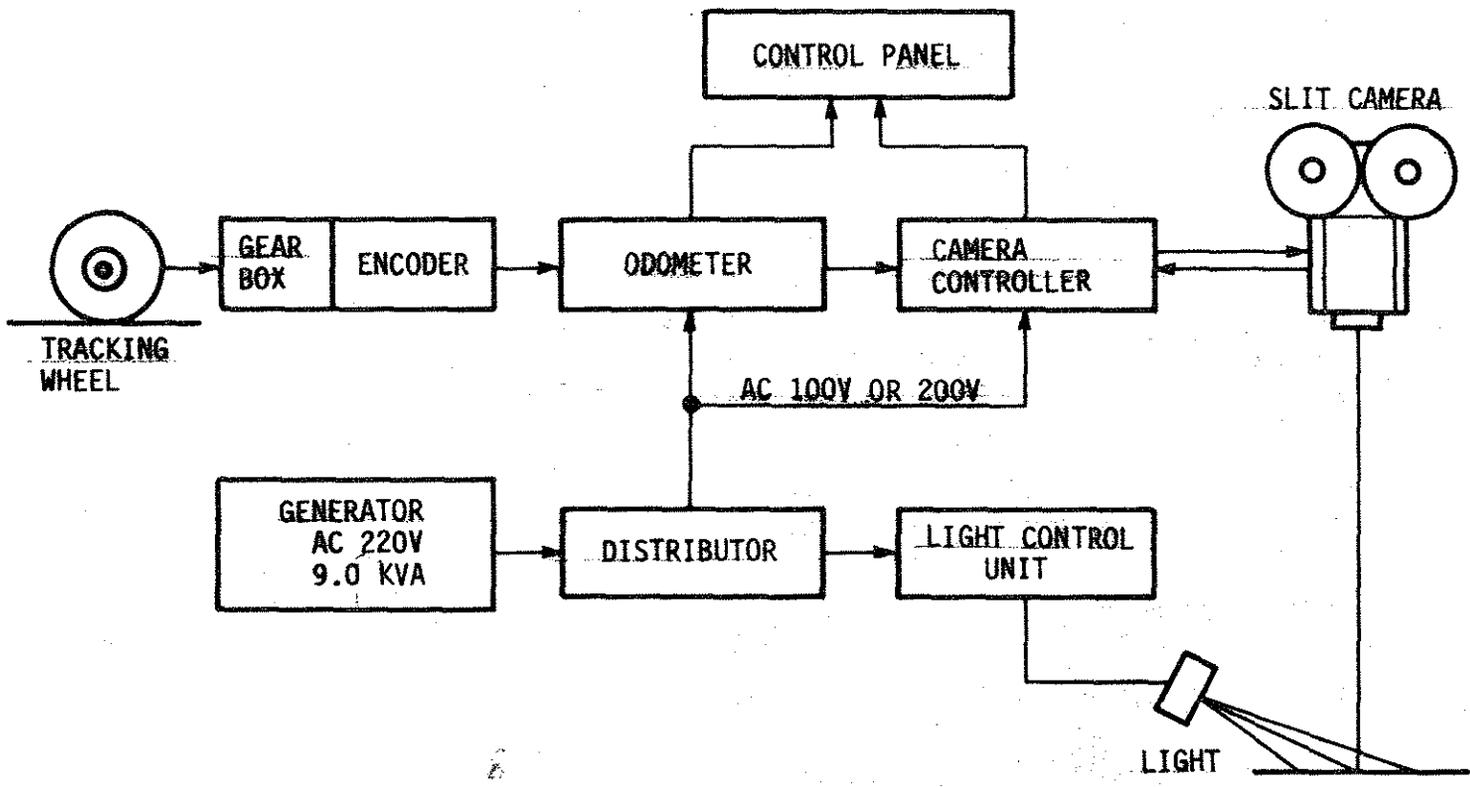
Fig. B.3. ROADRECON-70 system.

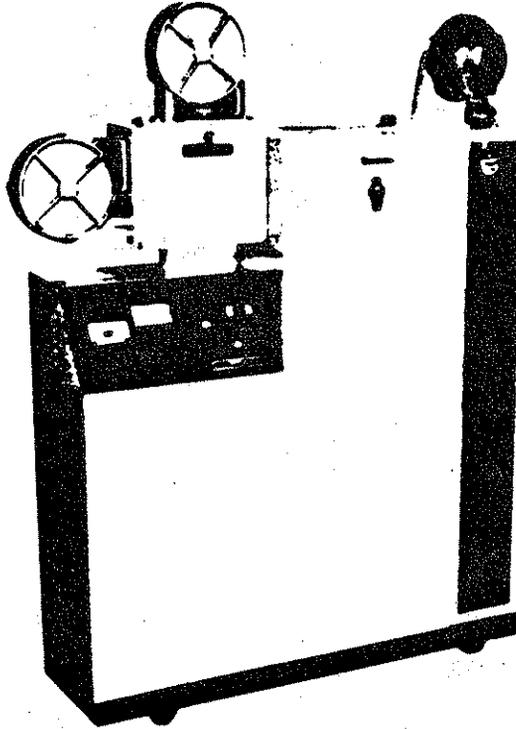
Processing speed:	0 - 30 feet/min.
Developing temperature:	15° - 40°C
Fixing temperature:	fixed at 28°C
Drying temperature:	40° - 70°C
Water consumption:	4 liters/min. (at 4° - 30°C)
Film magazine:	1,000 feet

Fig. B.4. Automatic film processor.

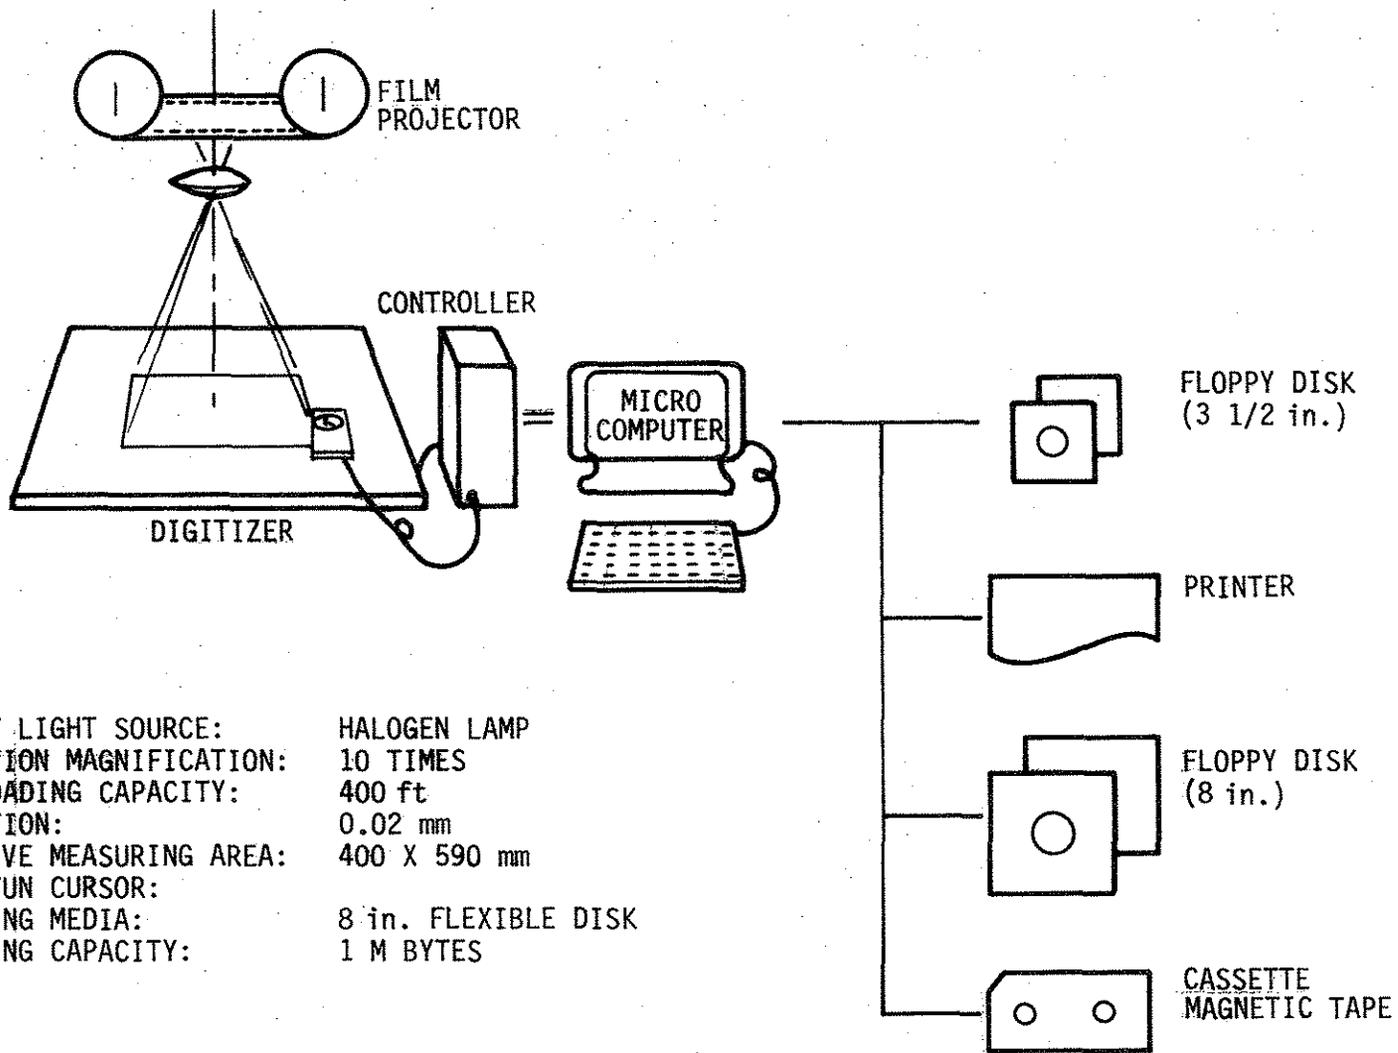
Fig. B.5. ROADRECON film digitizer.
