DEMONSTRATION PROJECT NO. 72
AUTOMATED PAVEMENT DATA
COLLECTION EQUIPMENT
Roughness and Profile Measurement

Iowa DOT Evaluation of the
PASCO Road Survey System

K. Jeyapalan
J. K. Cable, P.E.
R. Welper
Civil Engineering Department
Iowa State University
Ames, Iowa

March 1987

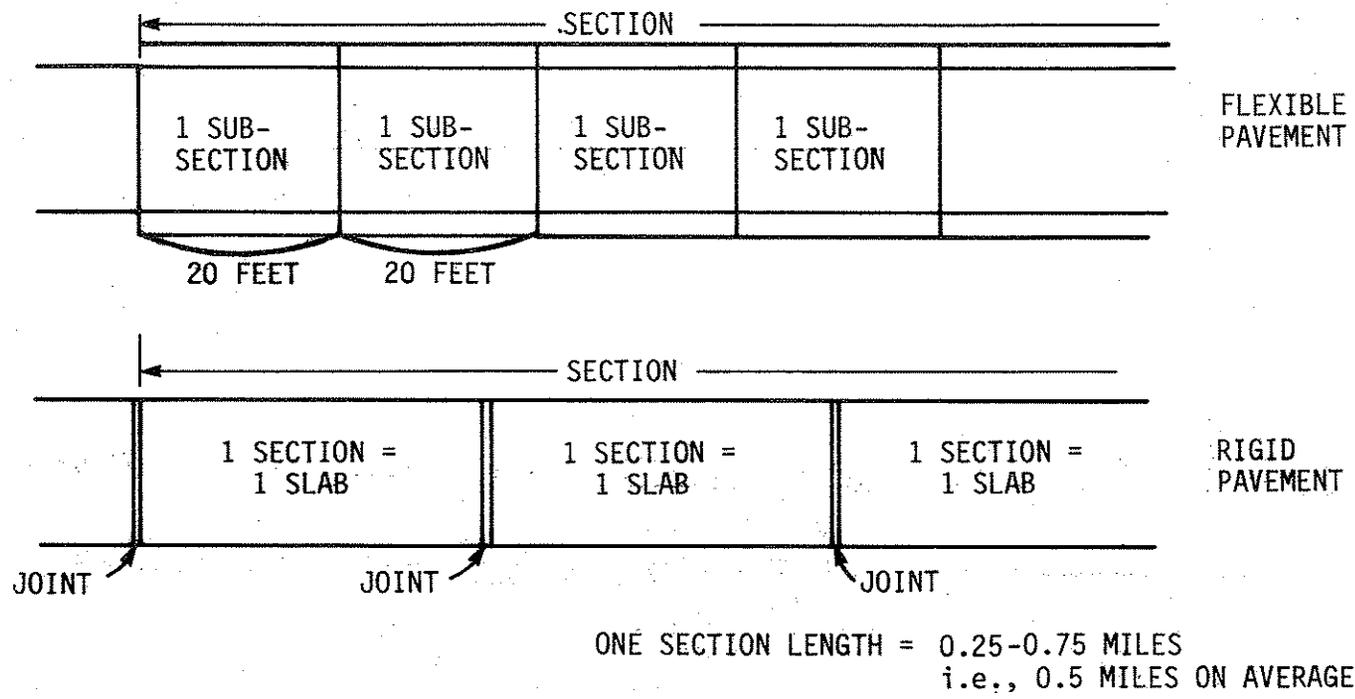
Fig. B.6. Definition of subsection.

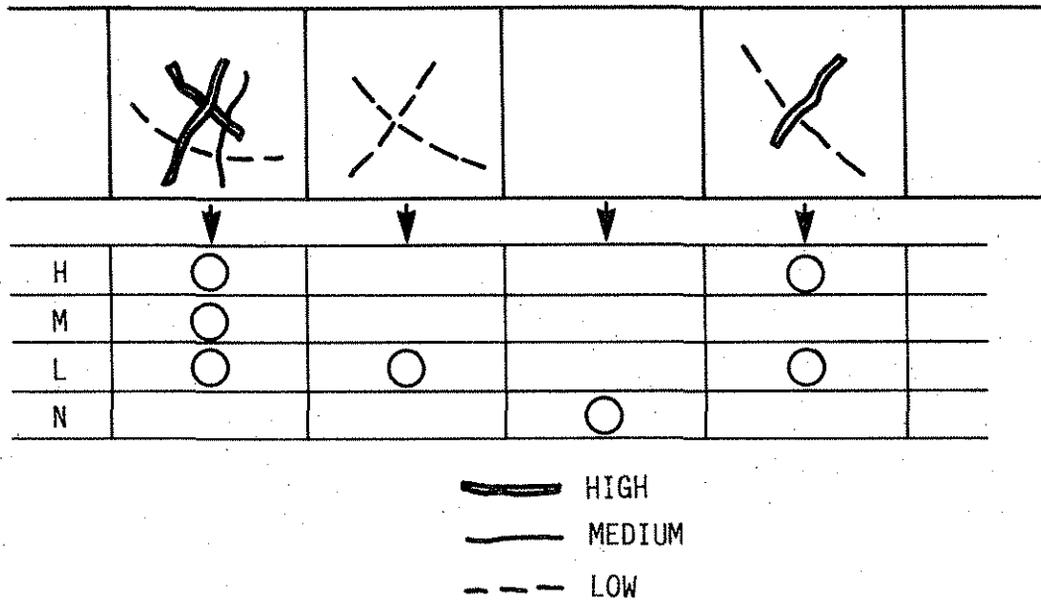
Fig. B.7. Interpretation of cracking on ROADRECON-70 film positives.

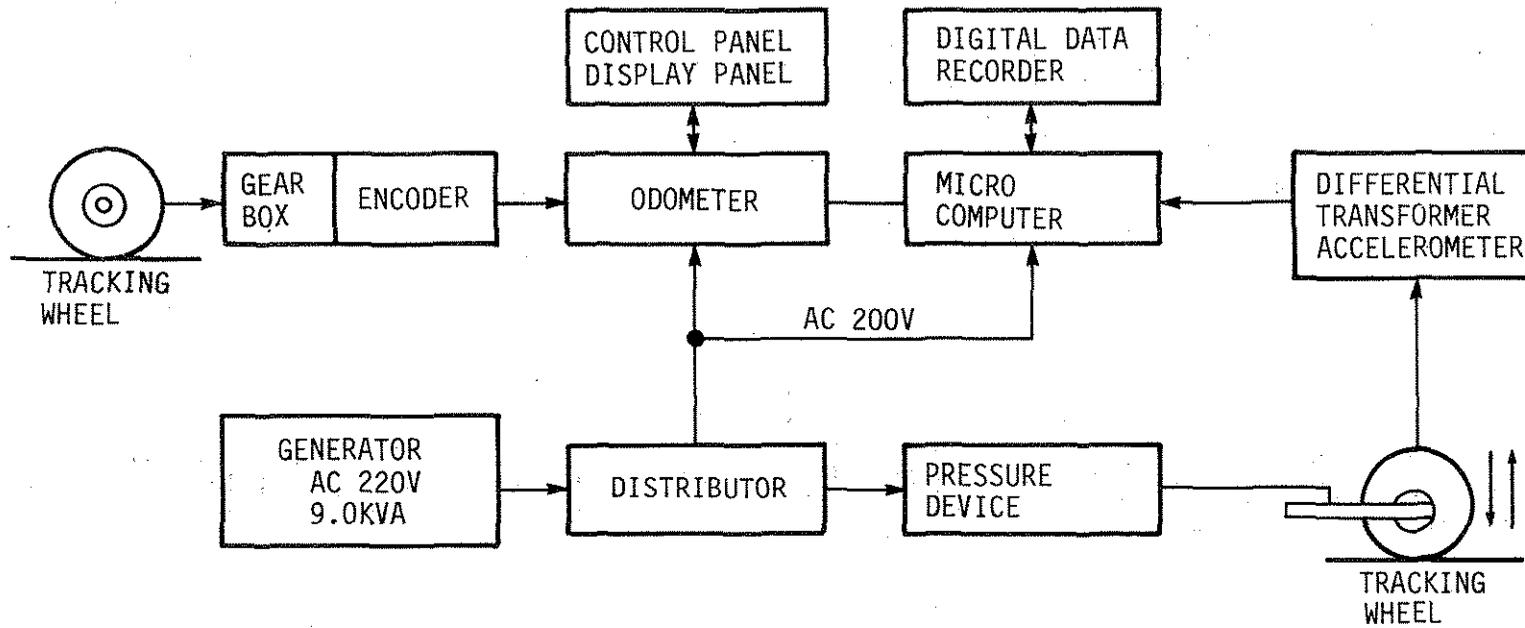
Fig. B.8. ROADRECON 77 system.

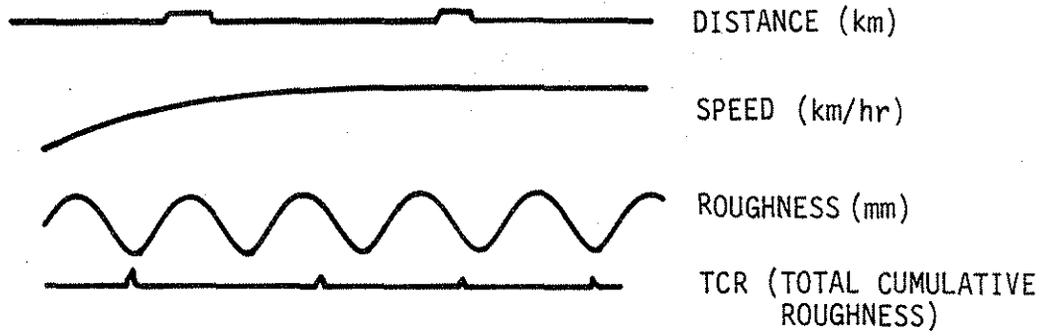
Fig. B.9. Paper chart.

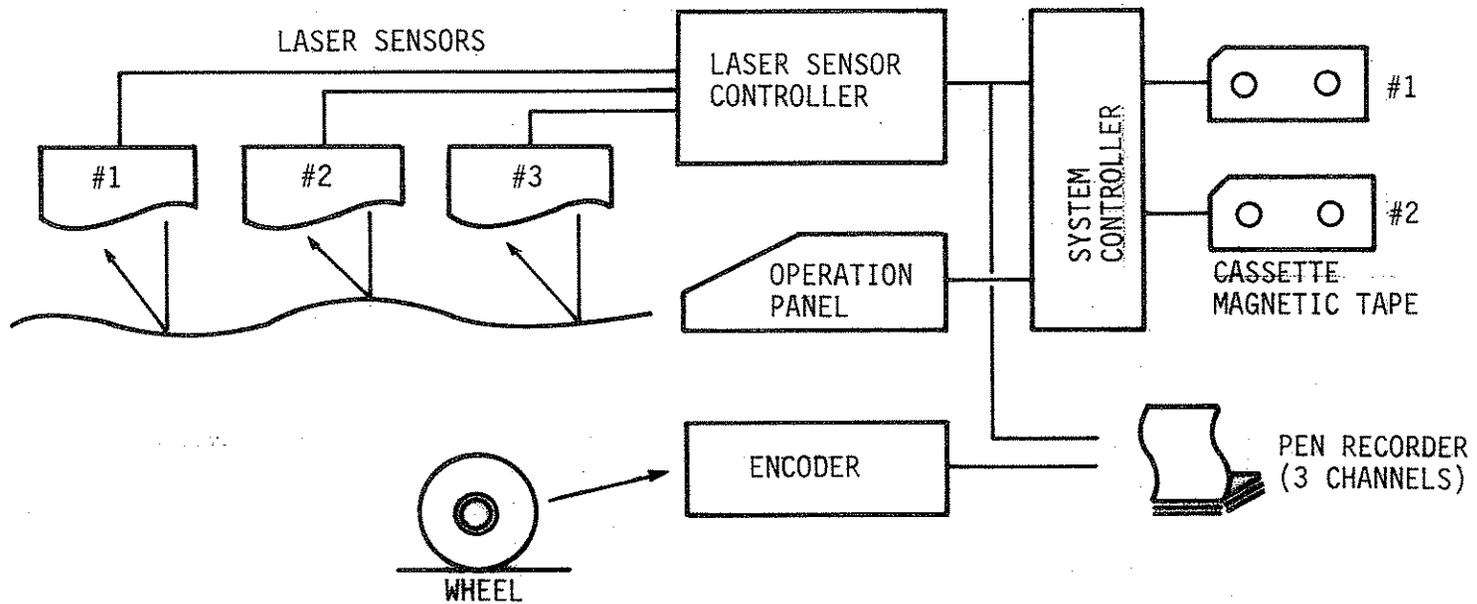
Fig. B. 11. Diagram of laser system composition. (ROADRECON-85B).

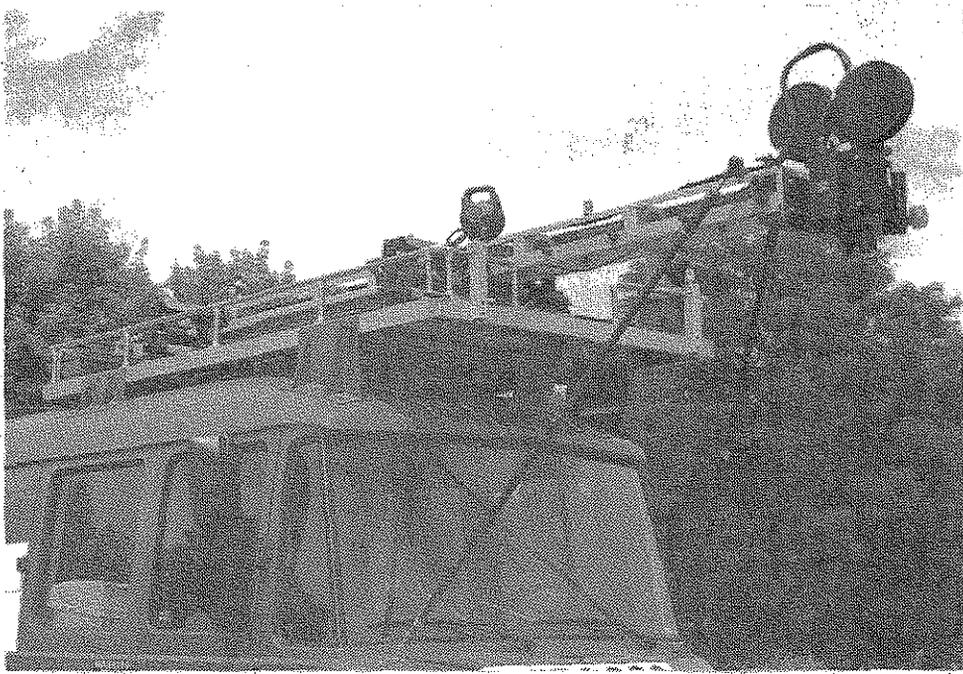
Fig. B.12. Camera mounting on PASCO vehicle.

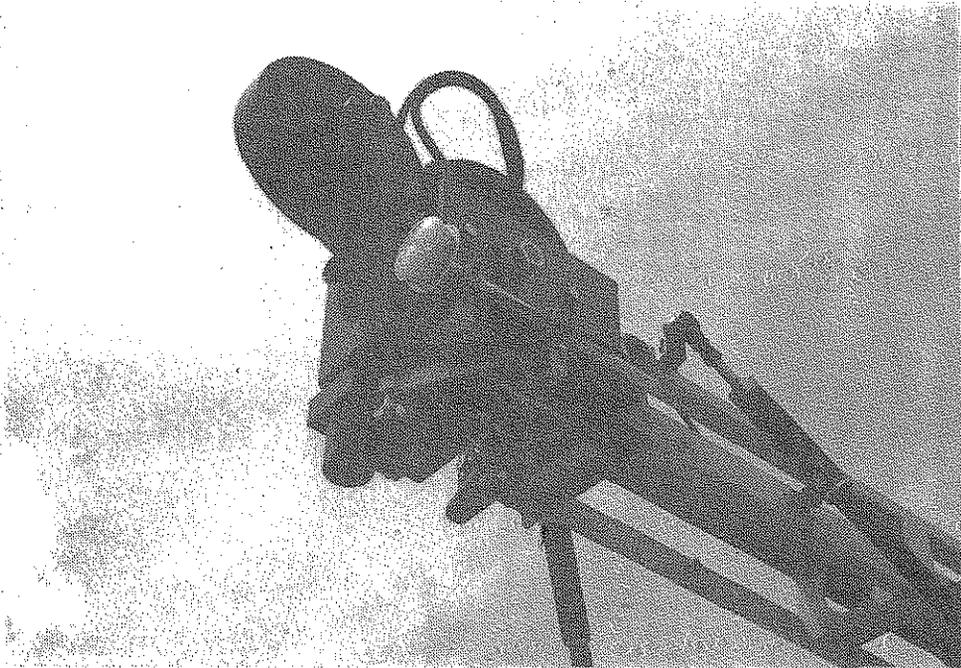
Fig. B.13. Slit camera.

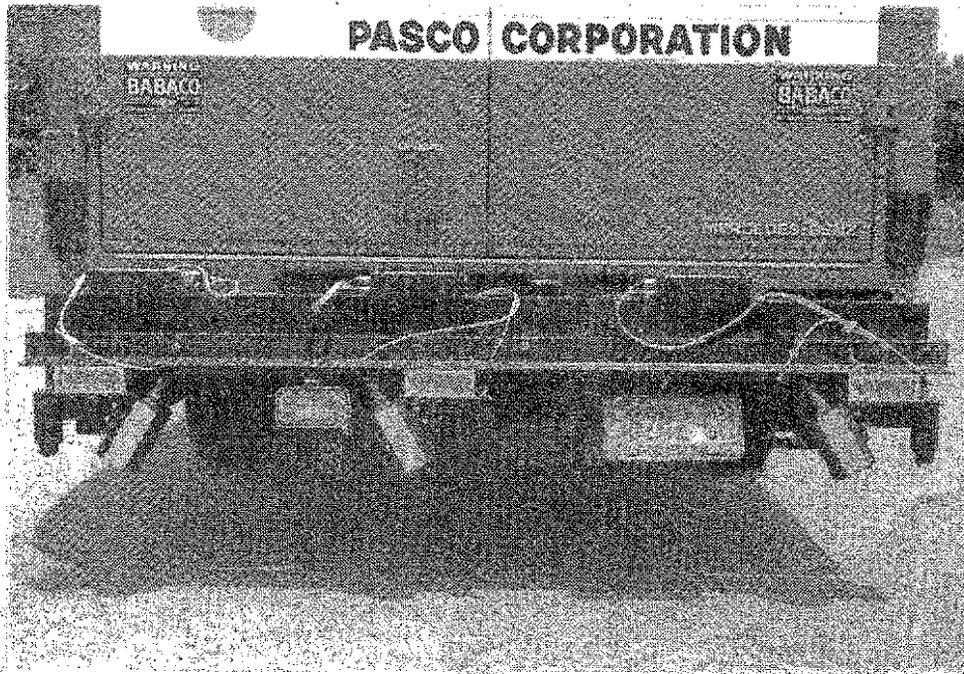
Fig. B.14. Laser mounting on PASCO vehicle.

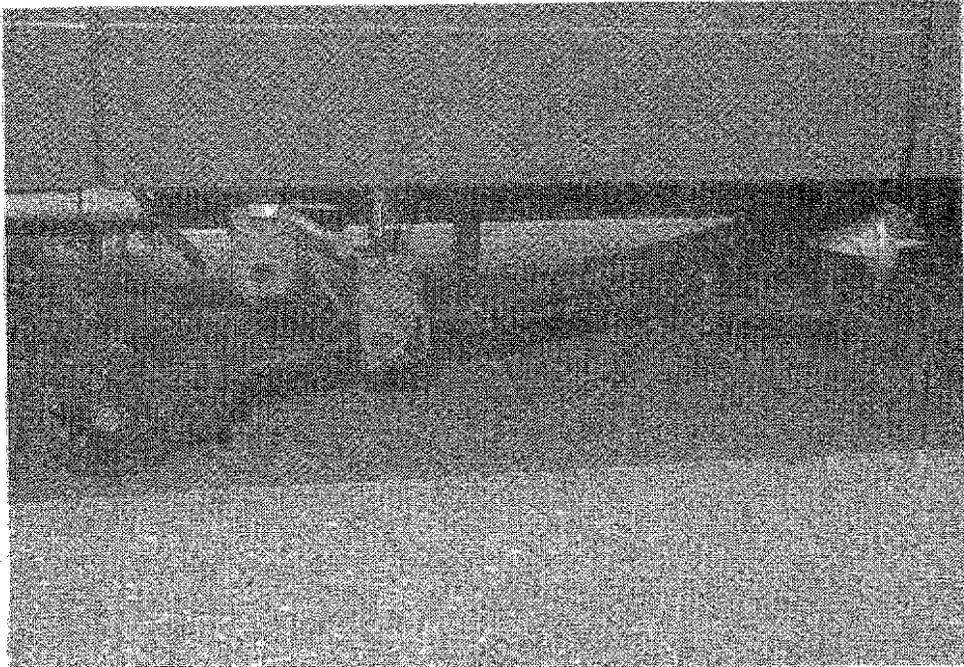
Fig. B.15. Tracking wheel mounting on PASCO vehicle.

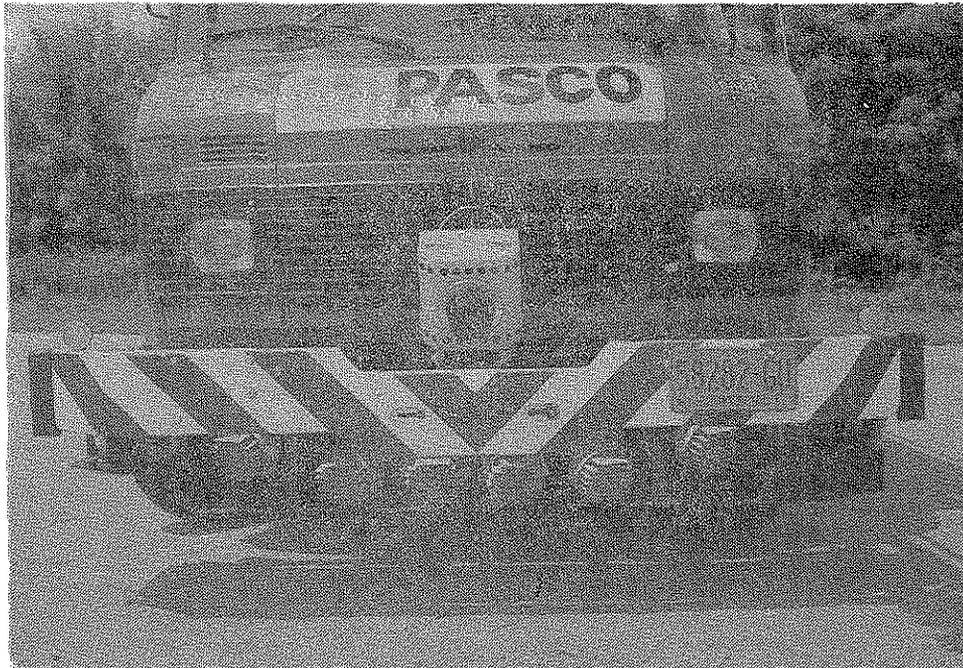
Fig. B.17. Hairline projection mounting on PASCO vehicle.

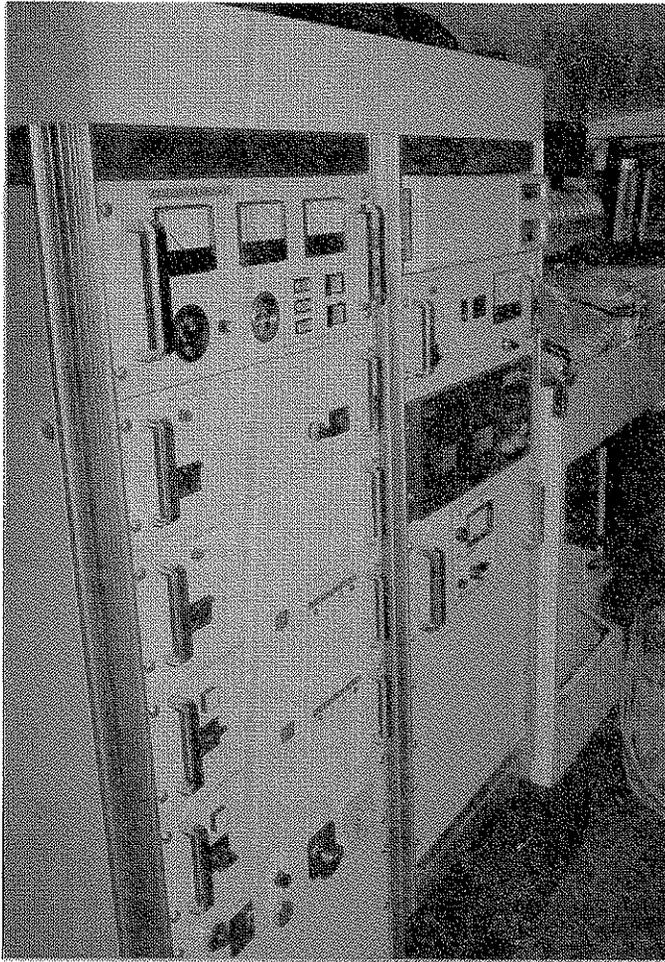
Fig. B.18. Computer on board the PASCO vehicle.

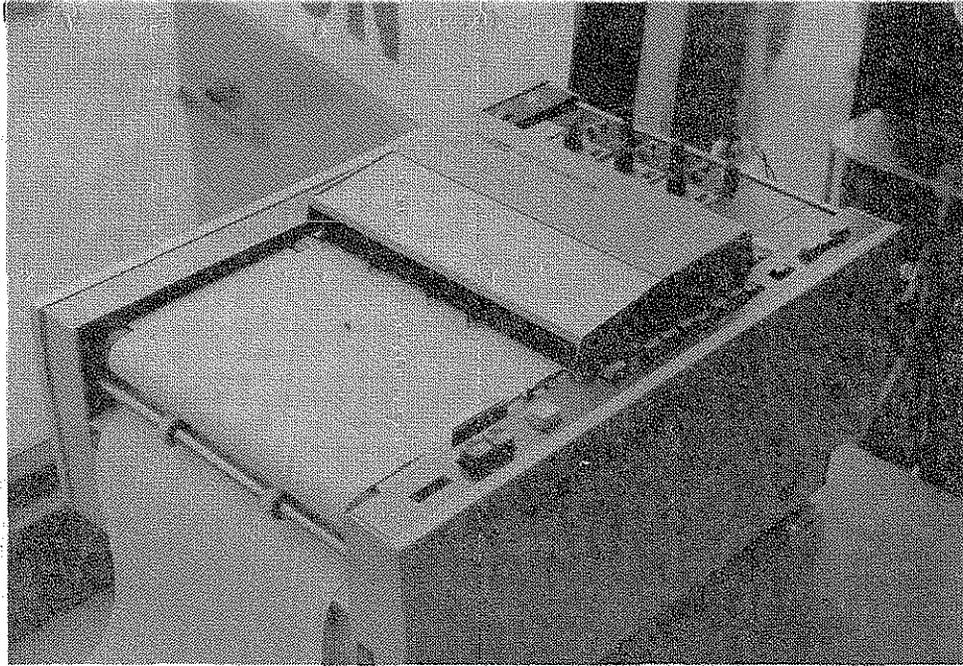
Fig. B.20. Paper chart plotter mounting on PASCO vehicle.

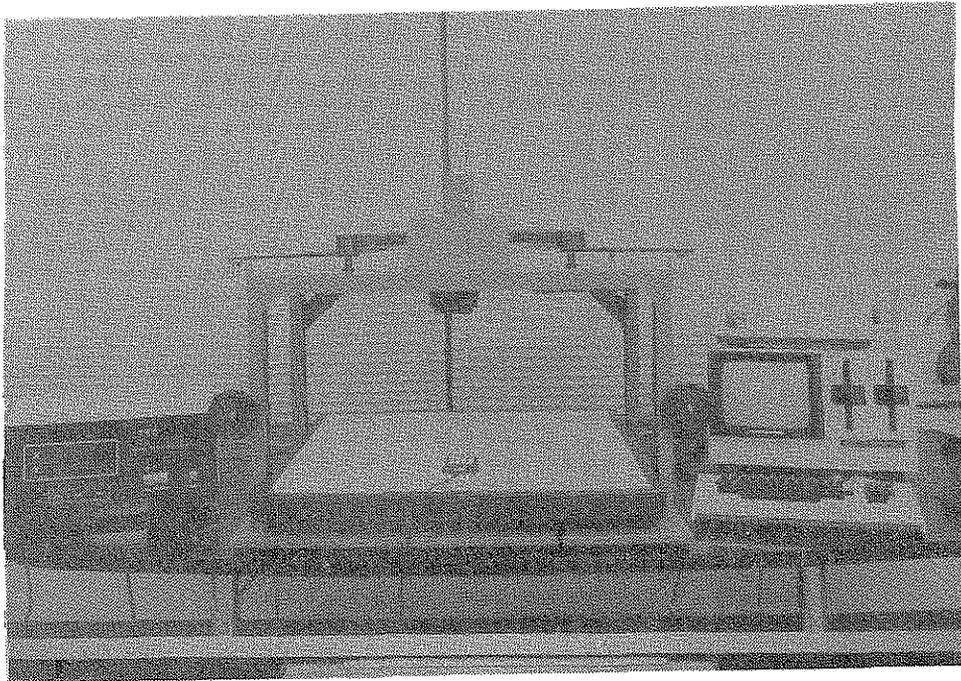
Fig. B.21. Photo analyzer.

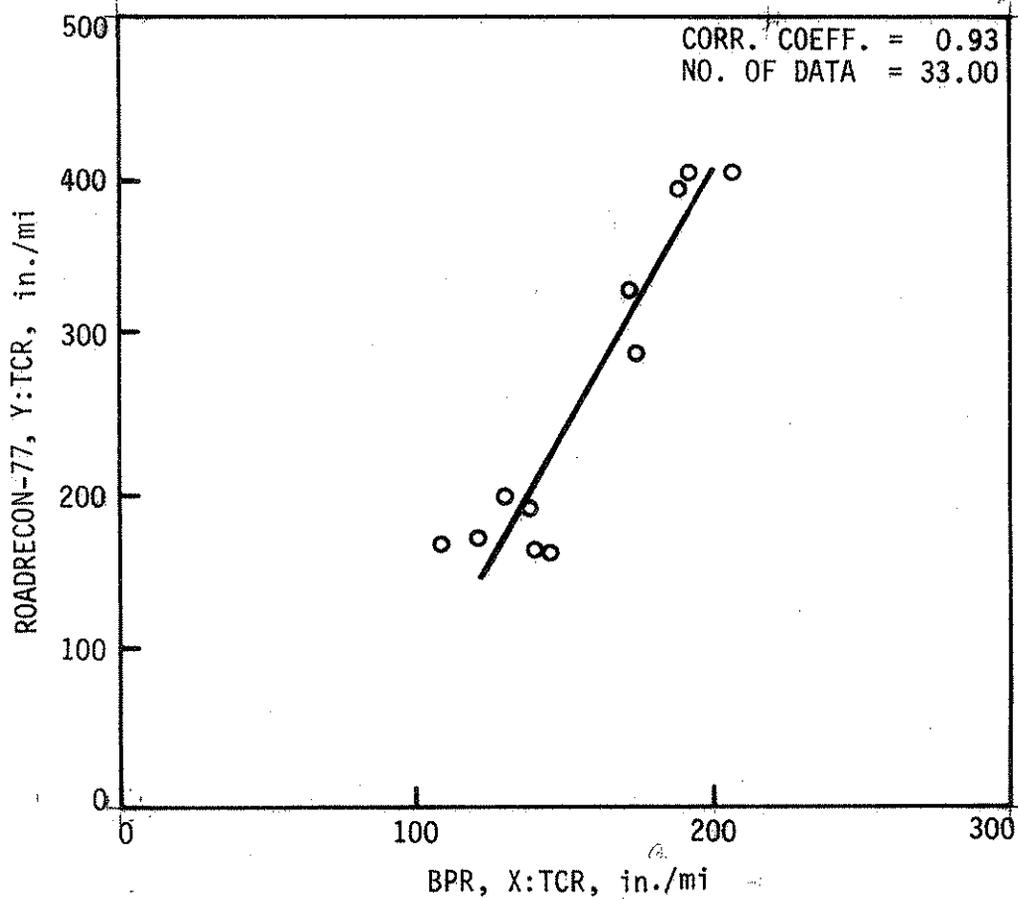
Fig. C.1. BPR vs ROADRECON-77 (TCR).

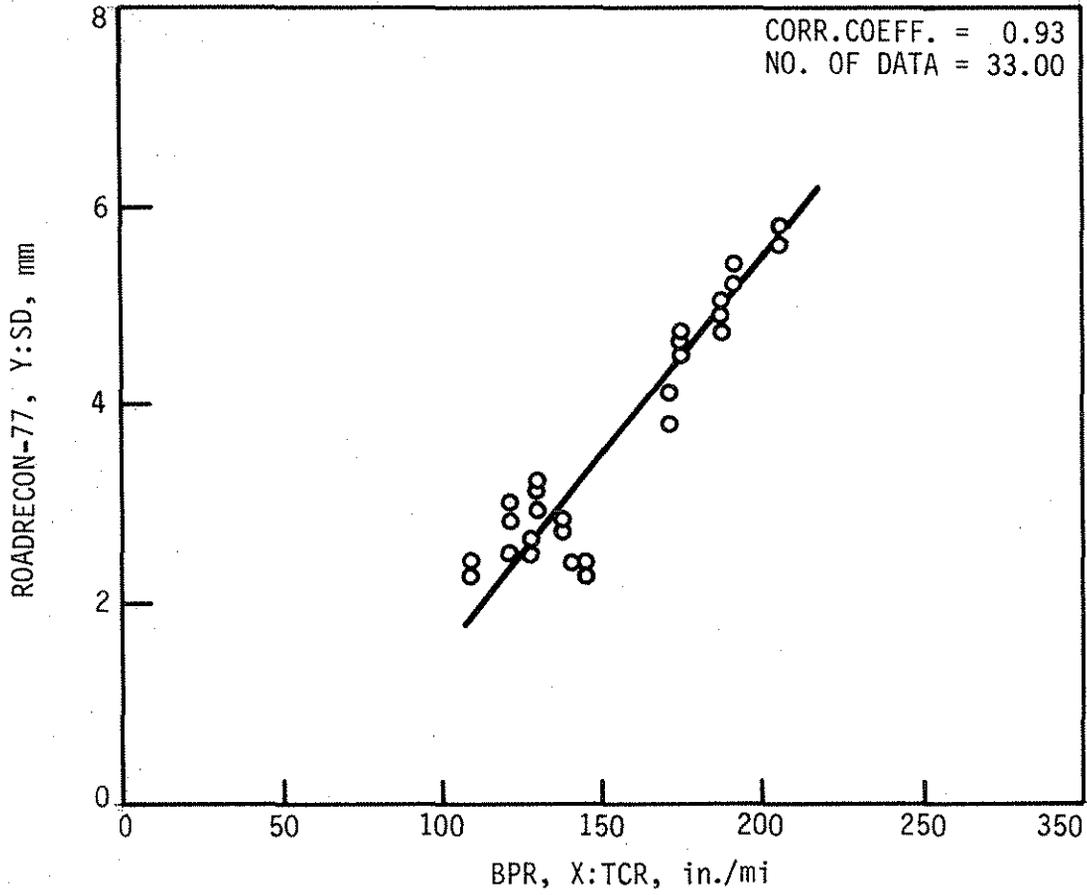
Fig. C.2. BPR vs ROADRECON-77 (SD).

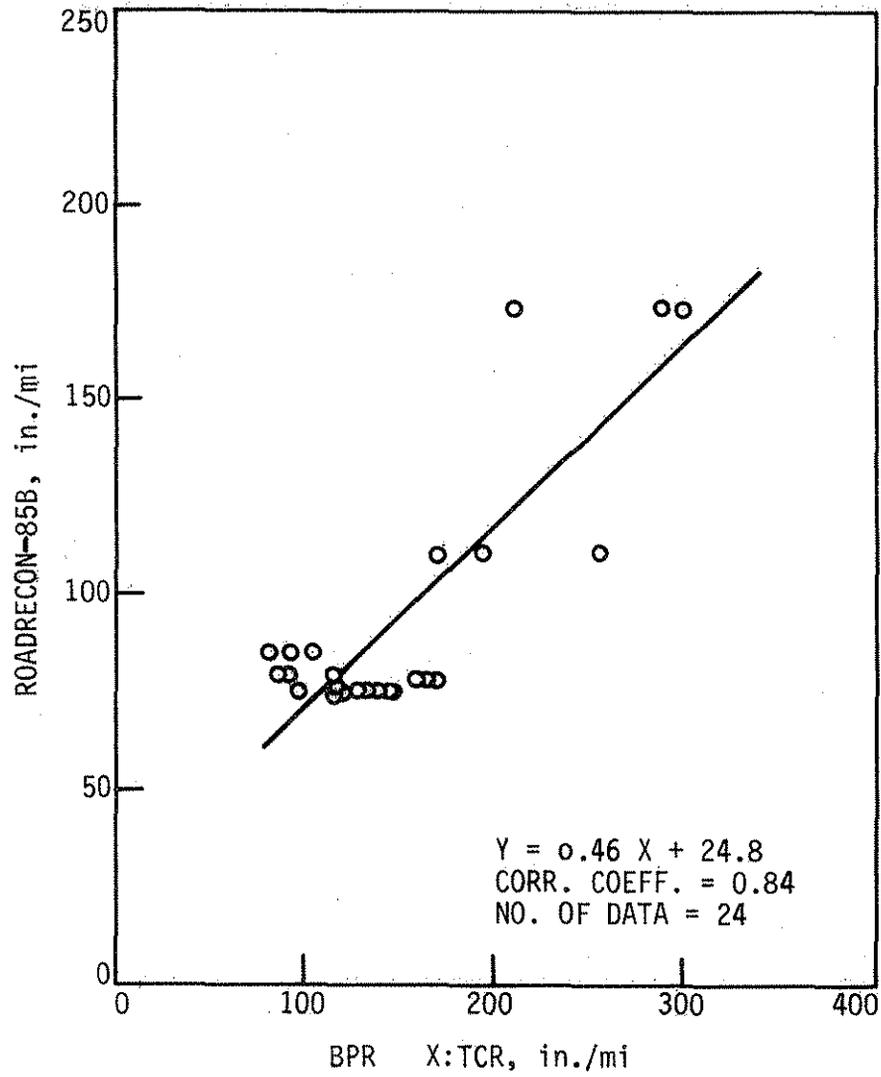
Fig. C.3. BPR vs ROADRECON-85 (TCR).

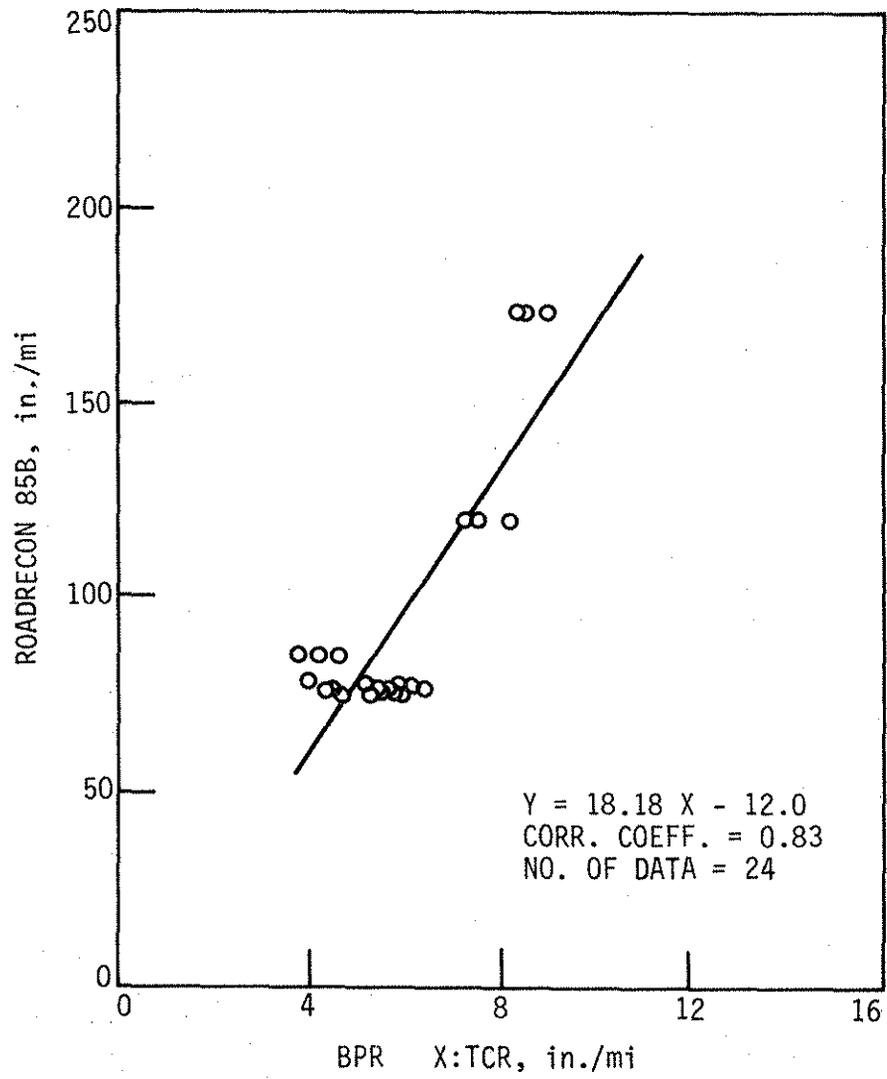
Fig. C.4. BPR vs ROADRECON-85 (SD).

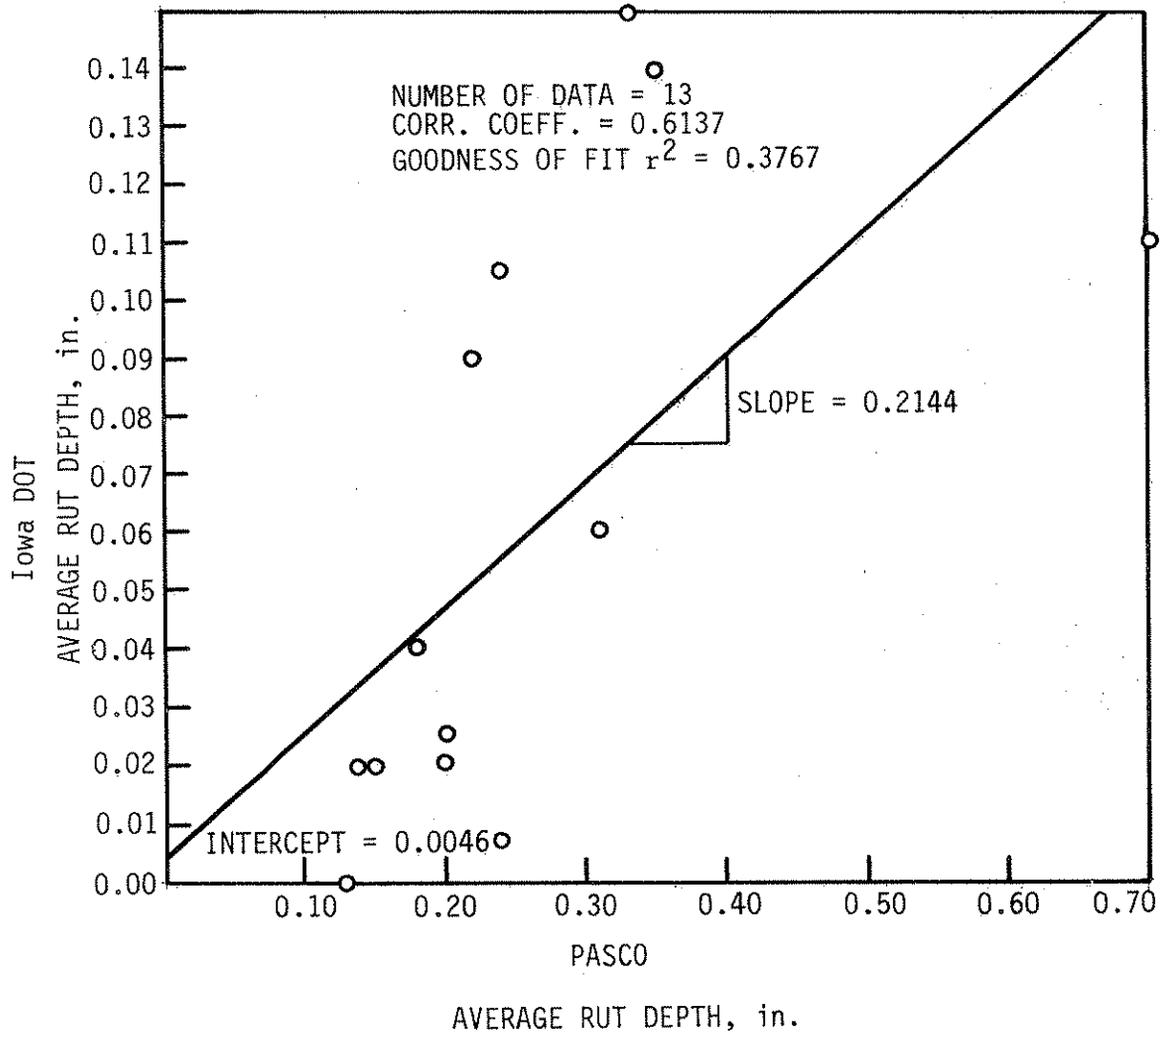
Fig. C.5. Rut depth (PASCO vs Iowa DOT).

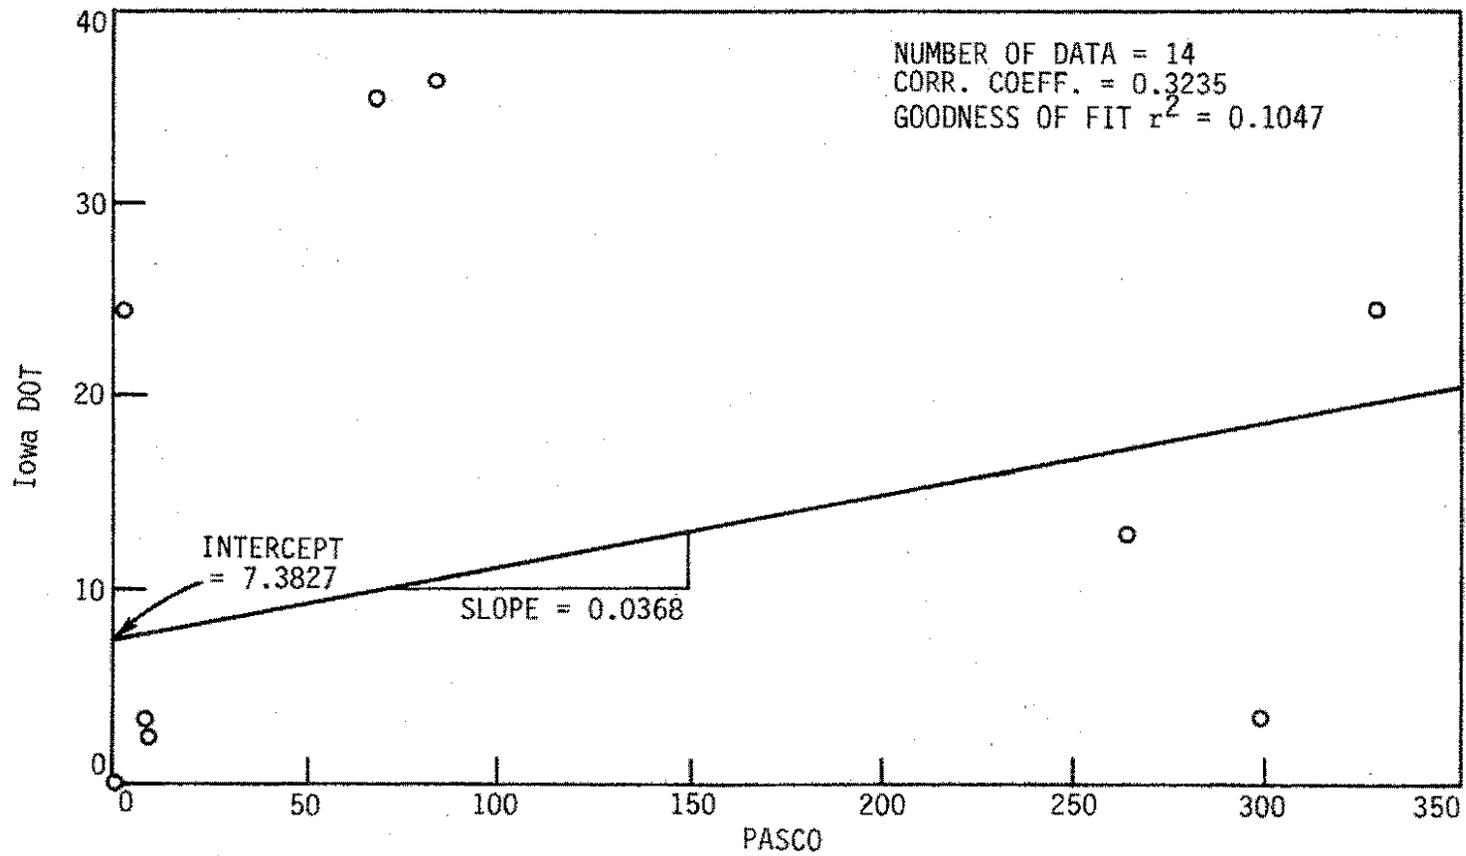
Fig. C.6. Cracks (PASCO vs Iowa DOT).

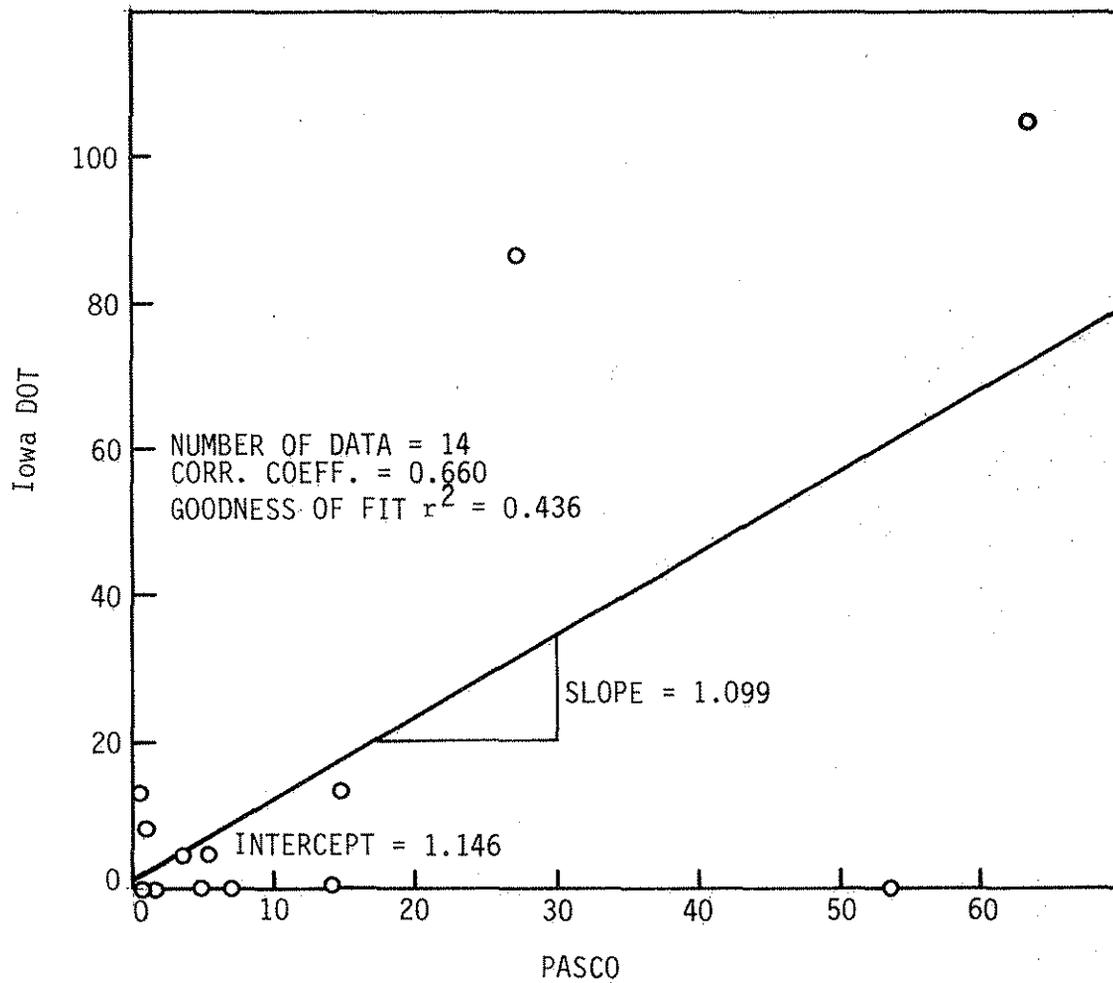
Fig. C.7. Patches (Iowa DOT vs PASCO).

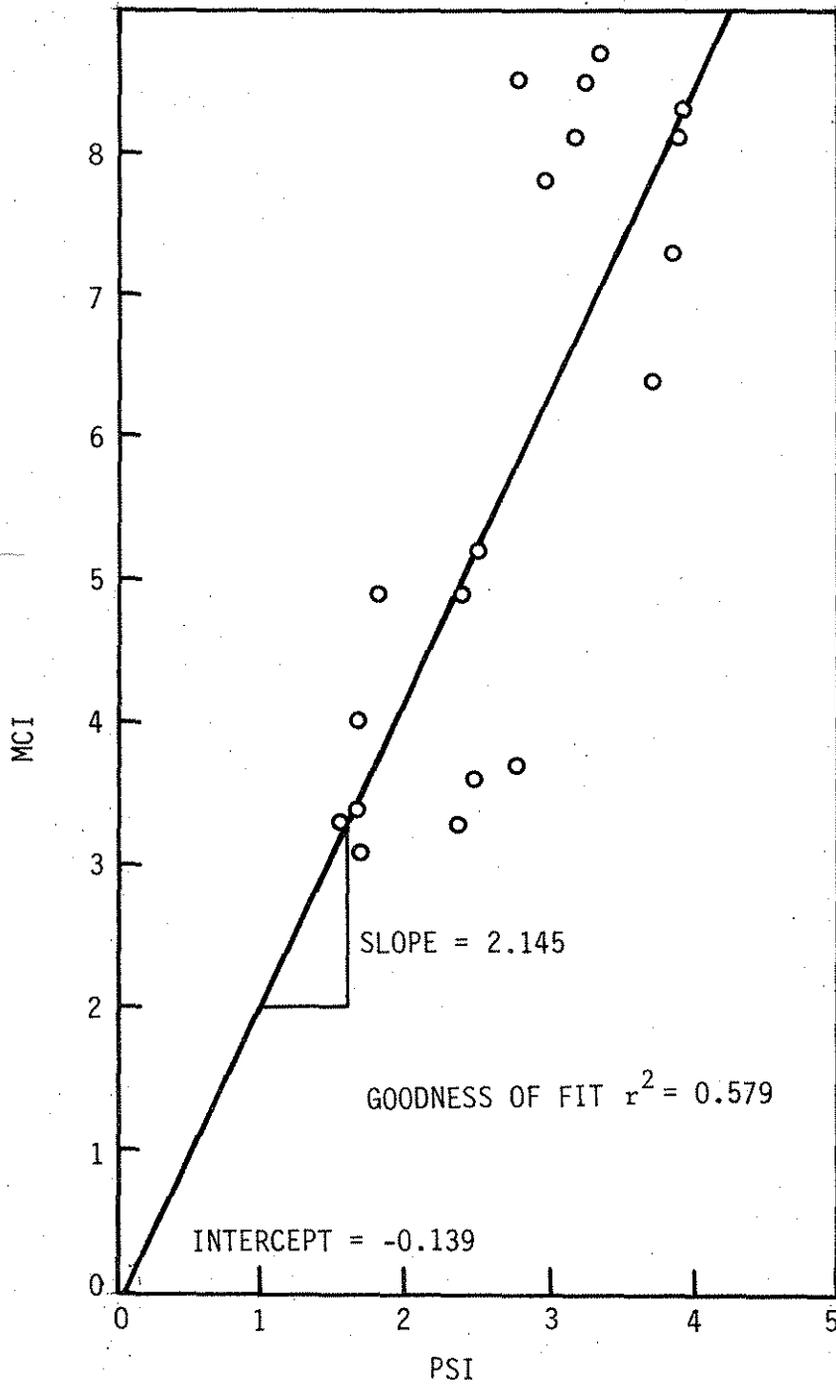
Fig. C.8. MCI vs PSI.

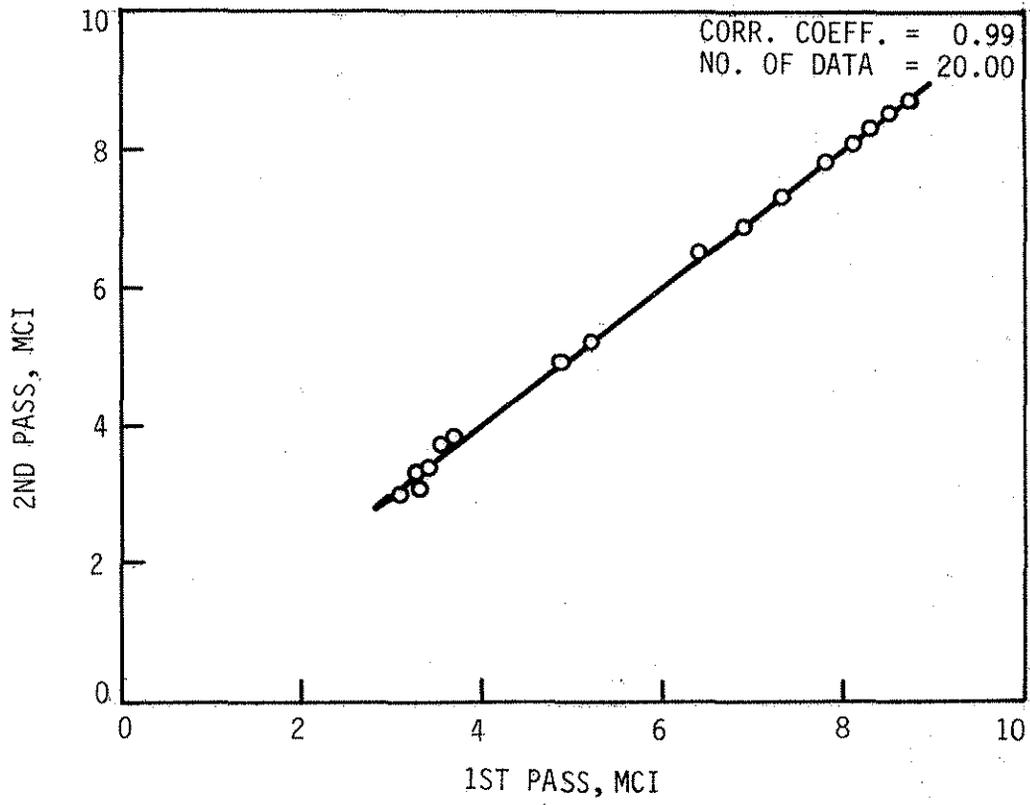
Fig. C.9. MCI (1st pass vs 2nd pass).

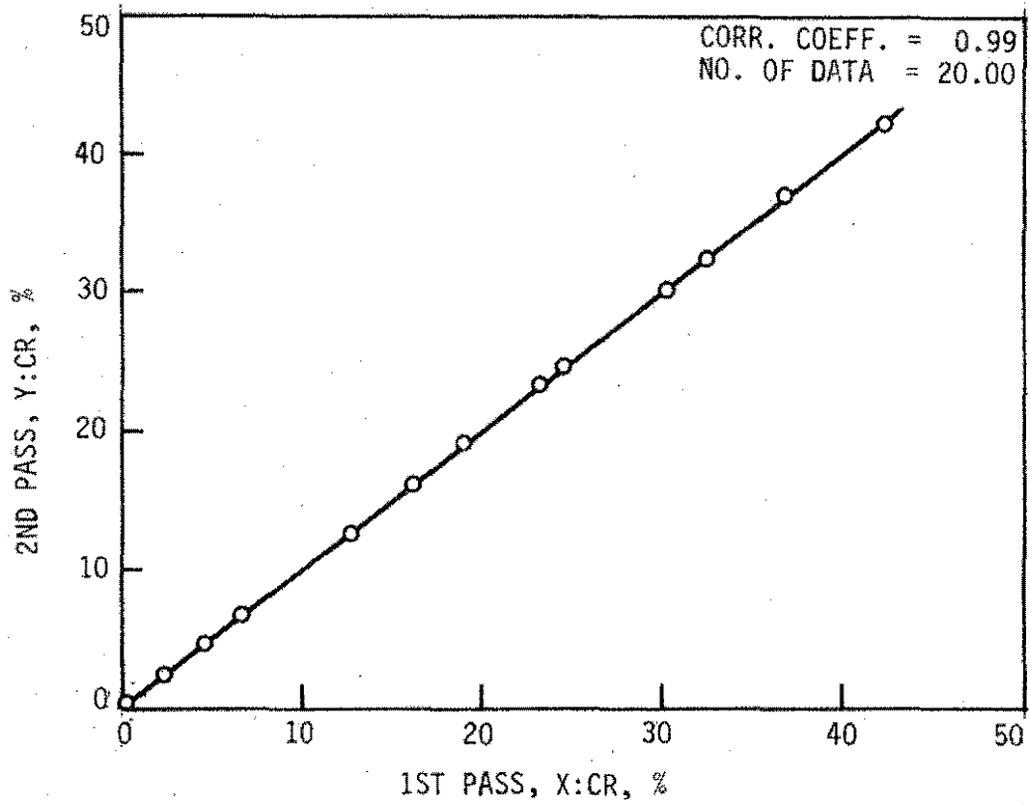
Fig. C.10. ROADRECON-70 (1st pass vs 2nd pass).

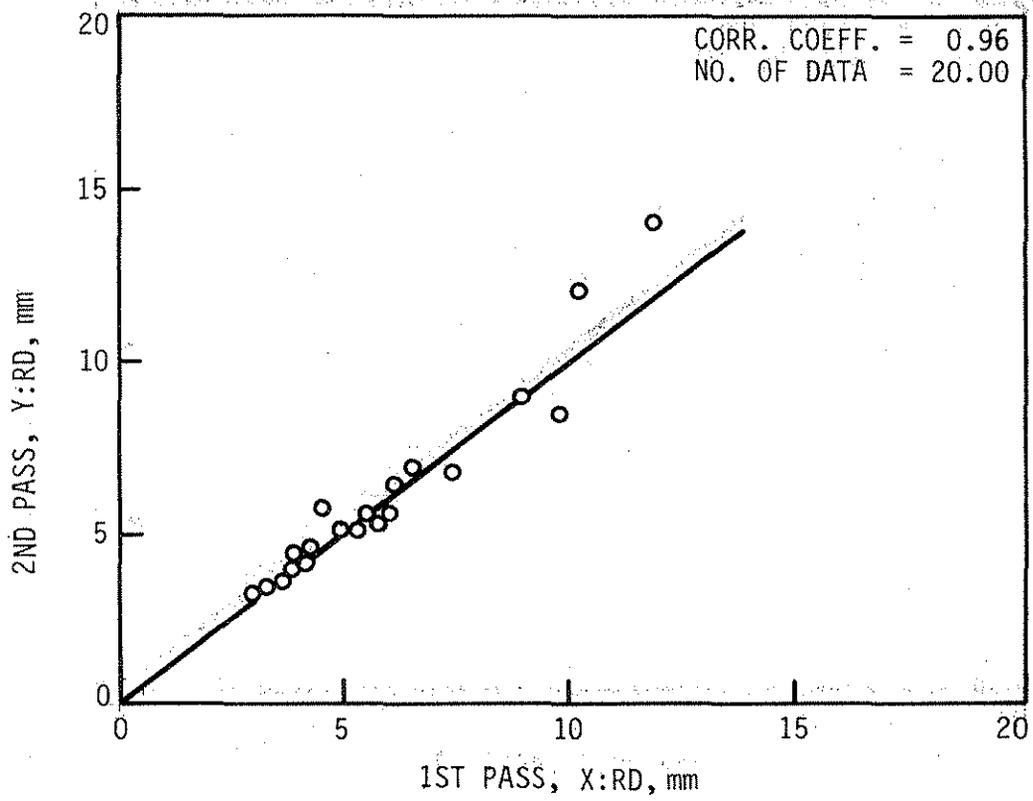
Fig. C.11. ROADRECON-75 (1st pass vs 2nd pass).

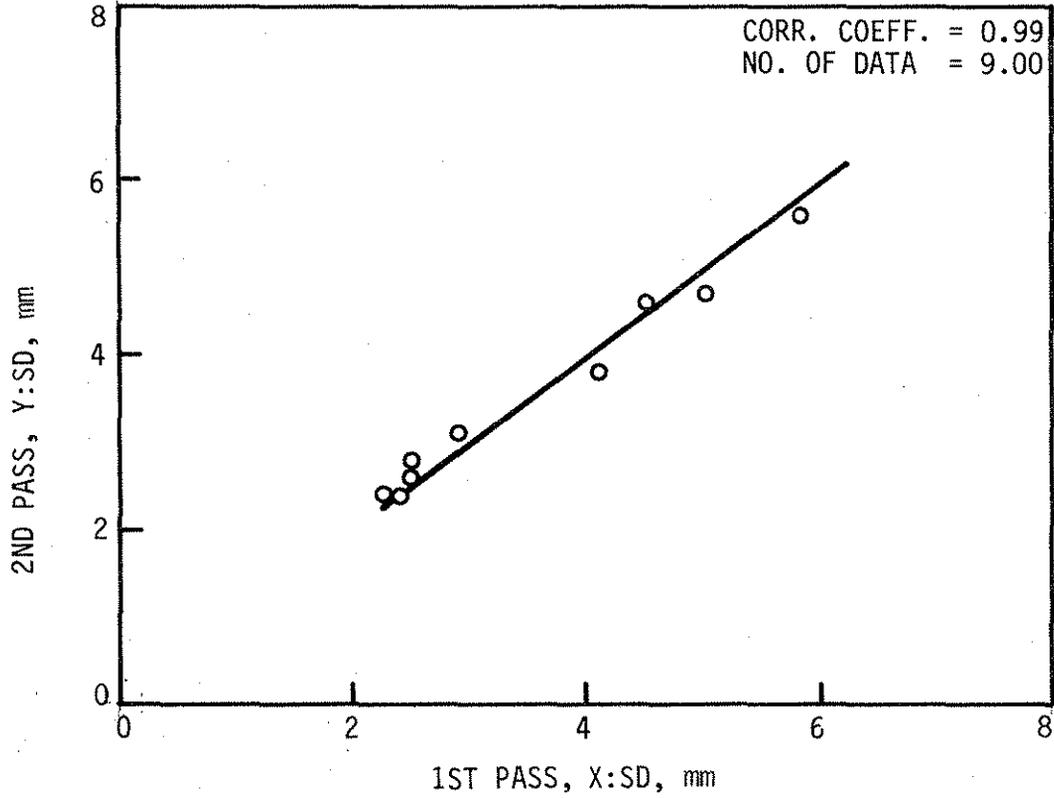
Fig. C.12. ROADRECON-77 (1st pass vs 2nd pass).

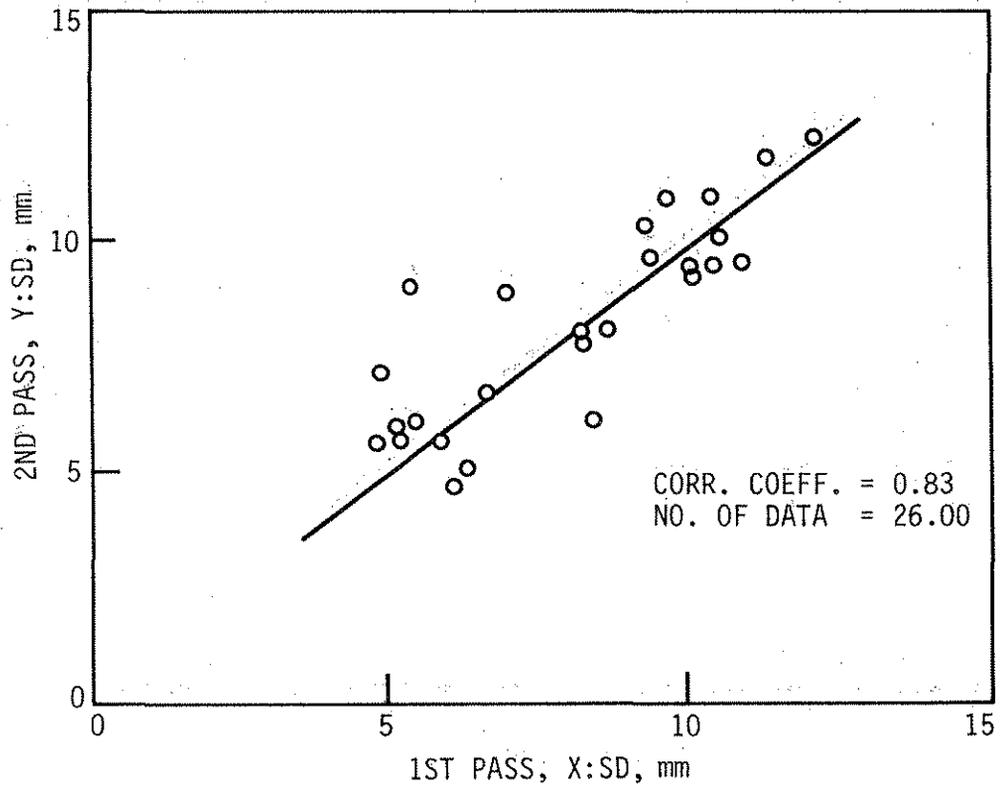
Fig. C.13. ROADRECON-85B (1st pass vs 2nd pass).
