Evaluation of Dowel Bar Retrofits for Local Road Pavements

February 2008

IHRB Project TR-520

FINAL REPORT

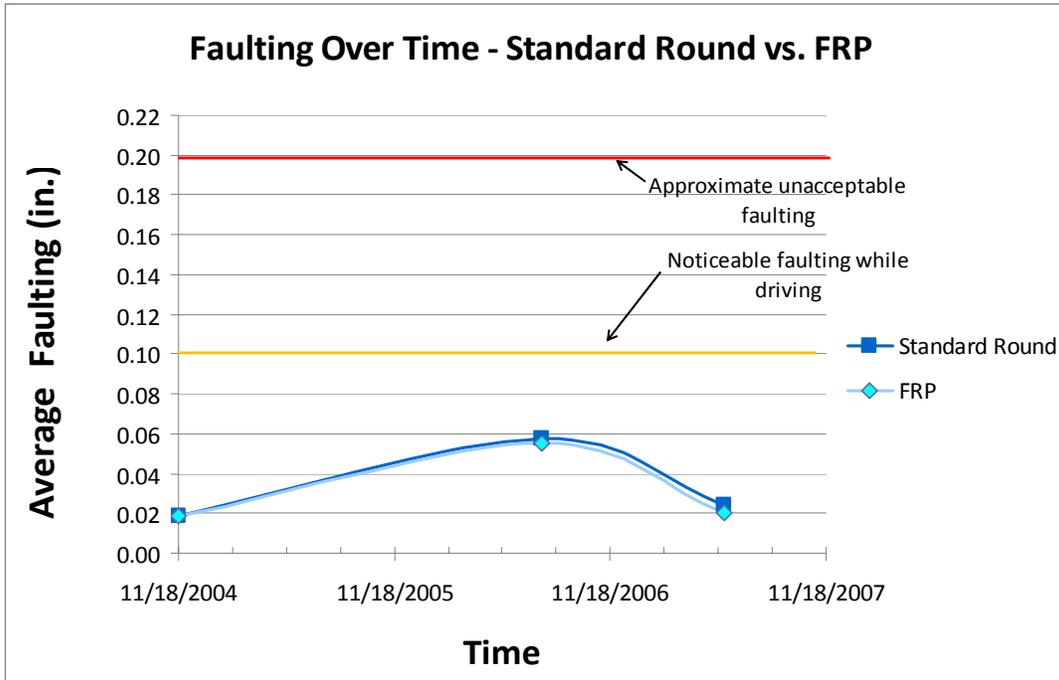
Figure 4. Faulting over time – standard round vs. FRP

To analyze dowel bar performance, the least change in faulting over the testing period was determined to indicate the most successful joints. The average faulting over the project life is found in Figures 4 and 5. Figure 4 compares standard round dowel bars with FRP dowel bars. Figure 5 compares standard round dowels with elliptical dowel bars. In the figures all dowel sections were assumed to have the same initial faulting of

0.019 inches, which was the average faulting achieved through diamond grinding. This is to show the performance of each type over time. The faulting decrease from 2006 to 2007 can be attributed to effects of weather, season, and pavement temperature differences. Regardless of the decrease in faulting from 2006 to 2007, the graphs still show there is no significant difference in faulting based on dowel material or shape. Hence the conclusion is that all four dowel bar types have equal performance in faulting. Also important to note is that the average faulting values over the study period were lower than the noticeable faulting tolerance of drivers.

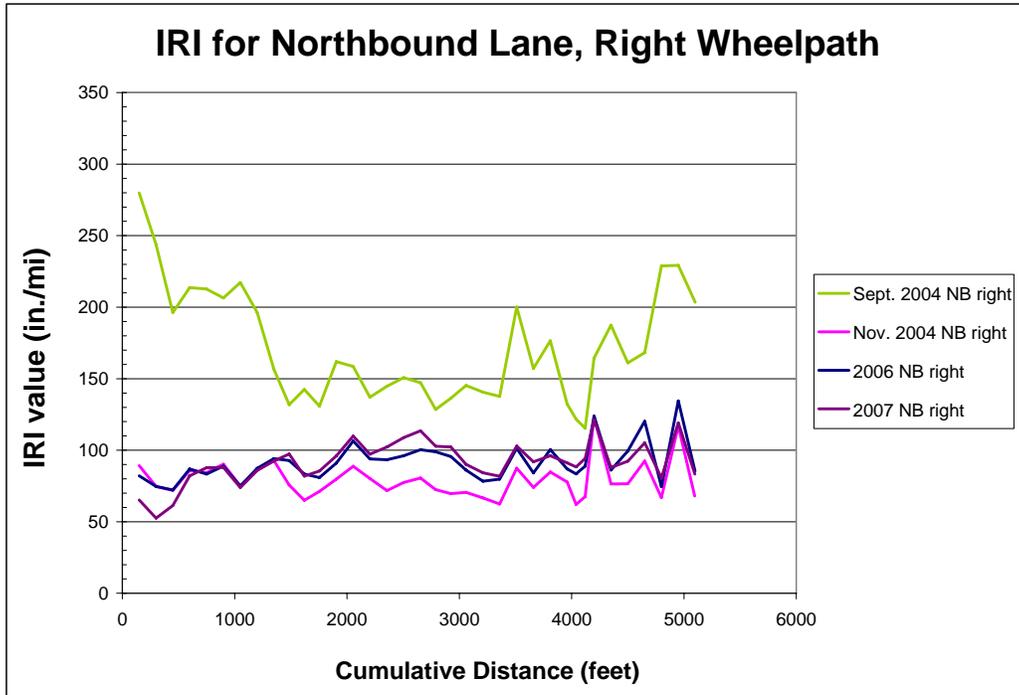
Figure 10. IRI for northbound right wheel path

Figures 10 and 11 show the IRI over time for the northbound and southbound lanes, respectively. In the figures the IRI is much higher in September 2004. This marks the IRI of the pavement before the diamond grinding had taken place. The November 2004 IRI data drops significantly, which indicates the IRI after diamond grinding. The IRI then gradually goes up, showing general wear of the pavement over time.

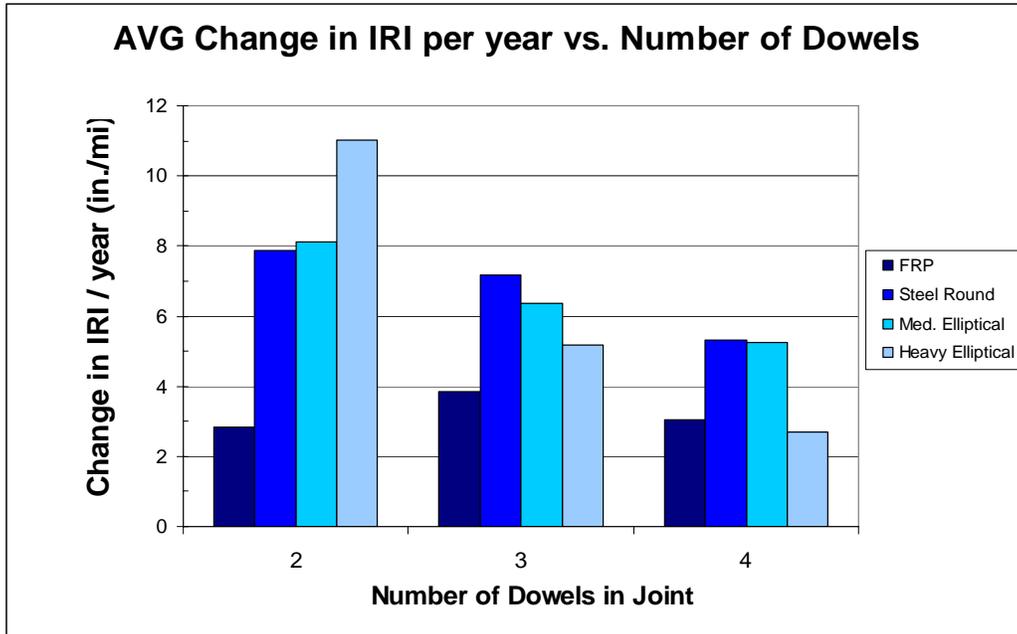
Figure 13. Change in IRI per year vs. number of dowels used

Figure 13 shows the average change in IRI per year by the number of dowels used in the joint. Excluding FRP bars, Figure 13 shows that using two bars will give a higher IRI value and thus a rougher pavement over time than using three and four bars. FRP bars performed in an unexpected manner. The use of two bars yielded better results than using three or four bars according to this research data.

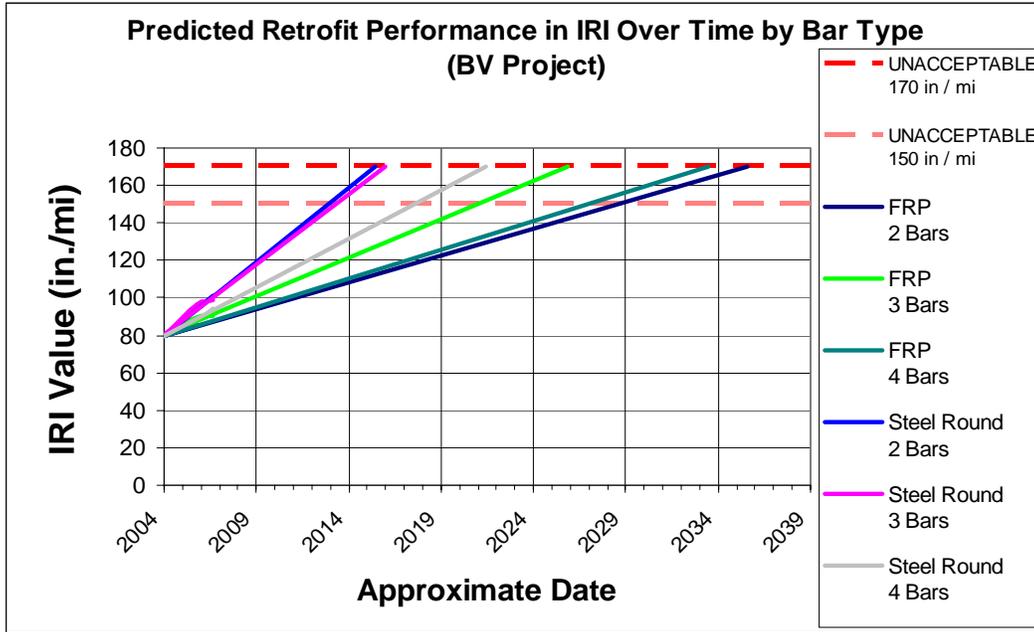
Figure 14. Predicted IRI over time (FRP & steel round)

The quantitative value used to compare the number of bars used in each joint is expressed as an average change in IRI per year. The change in IRI per year was used to determine the average pavement life extension caused by the dowel retrofit in terms of road smoothness. The change in IRI data collected during this study was graphed versus time starting at a value of 80 (approximate value attained after grinding). A linear trendline was assigned to each data set. These trendlines were then extended until they passed the maximum acceptable IRI values of 150 and 170 in./mi. These numbers were mentioned earlier as the acceptable road user tolerances for roughness. These points signify the useful life of the retrofit based on IRI. The graphical representation of the data can be found in Figures 14 and 15. These graphs are based on a linear interpolation of the data collected in this report. The linear relationship between time and change in IRI is unknown, but the IRI values from the collected data were used to predict long term IRI maintainability. Also important to note is that all interpolations were based on a linear regression of three data points except for the FRP dowels and heavy elliptical sections with four bars. Earlier, Table 9 showed that there appeared to be irregularities in the FRP data. For this reason, data from November 2004 and September 2006 were used to do a straight line regression for two and four FRP bars. The data for three FRP bars appeared to be regular, so all three data points were used for its linear regression. The heavy elliptical data with four bars per section also seemed to have a small inconsistency with the September 2006 data. For this reason, data from November 2004 and July 2007 were used to do a straight line regression for four heavy elliptical bars.

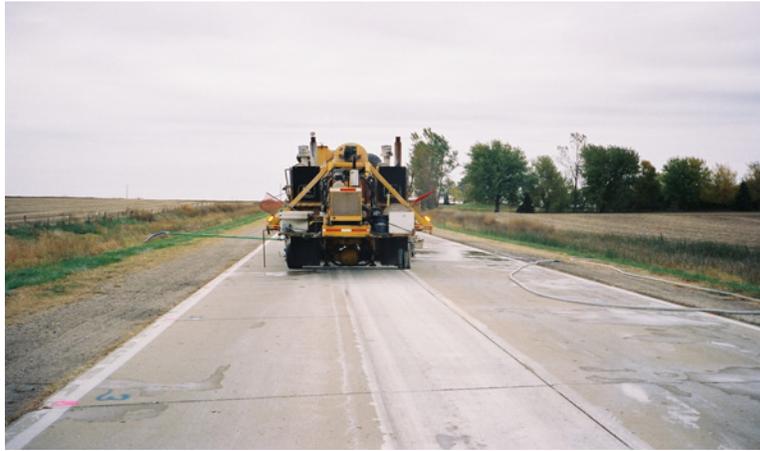
Figure A.1. Surface grinder

Typically diamond grinding of the finished dowel retrofit project is used to remove excess grout over the dowels, remove joint faulting, and maximize surface ride quality. It is usually the final step in the retrofit project and done under traffic. In this case, the closed roadway and dowel placement in only one wheel path allowed the contractor to do grinding and retrofitting simultaneously and to reduce road closure construction time.

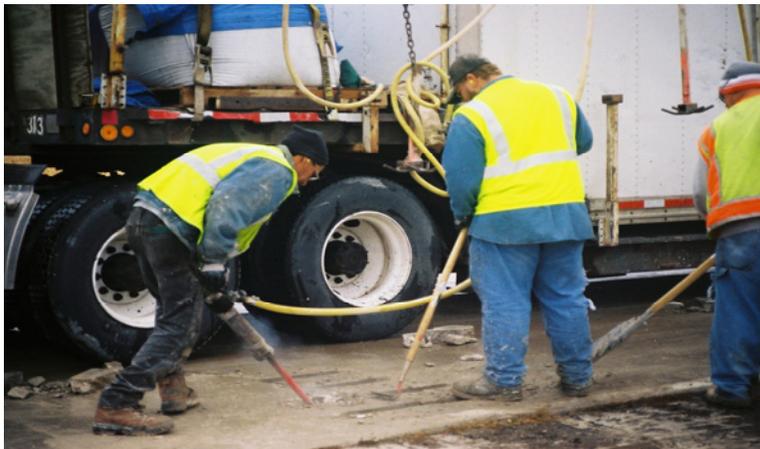
Figure A.3. Slot material removal

After the slots were cut, there was excess material left by the upward motion of the slot-cutting saw. This material was removed by a jackhammer with a flat hammer on the end, called bushing (Figure A.3).

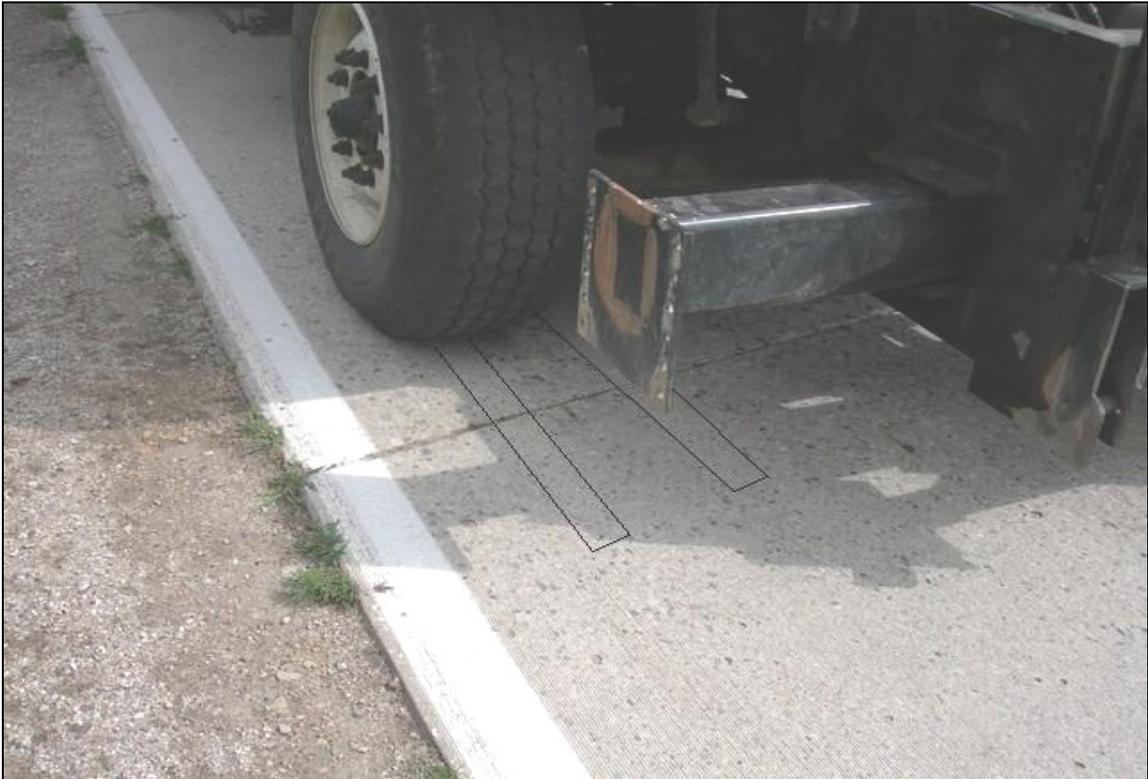
Figure A.13. Truck driving over doweled joint (retrofit trenches outlined)
