Crack Development in Ternary Mix Concrete Utilizing Various Saw Depths

National Concrete Pavement
Technology Center

Final Report
February 2009

Sponsored by
the Iowa Highway Research Board
(IHRB Project TR-587)
and
the Iowa Department of Transportation
(CTRE Project 08-317)

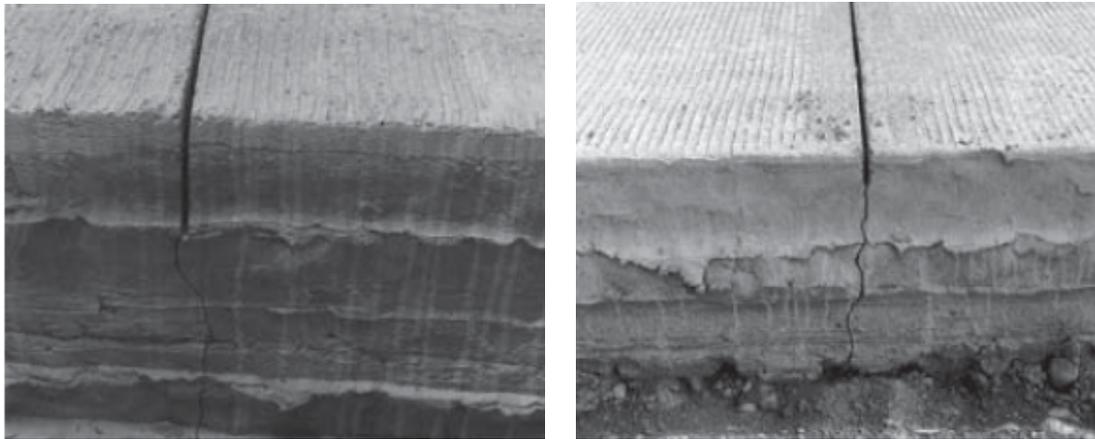
(a) Conventional

(b) Early entry sawing

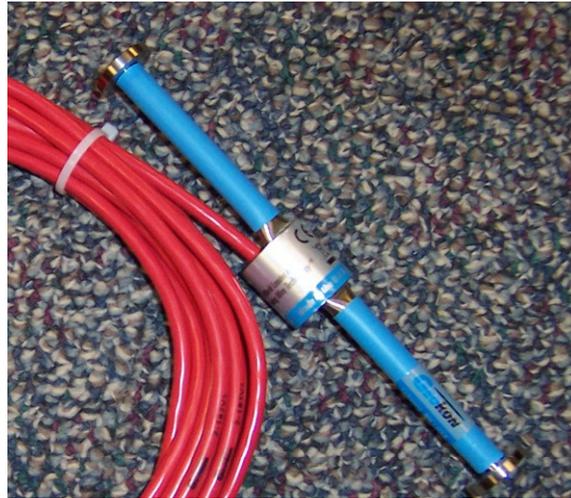
Figure 2. Geokon 4200 vibrating wire strain gage

The 4200 VW strain gage has a 152 mm gage length and a 1 micro-strain ($\mu\epsilon$) sensitivity and is commonly used for strain measurements in foundations, piles, bridges, dams, tunnel linings, etc. Detailed specifications, according to the product manual from the manufacturer (Geokon 2008a), can be found in Table 1.

The deformation of the 20 ft concrete slab was calculated accordingly based on the effective strain gage length of 152 mm (see Figure 3). Since the deformation of the strain gage is caused by the expansion or shrinkage of the concrete pavement, the deformation of the concrete pavement and the strain level inside the pavement can be calculated accordingly. Figure 20 presents an example (Joint 7, logger number B1) of the deformation calculation for the strain gage (pavement) and the strain inside the pavement.

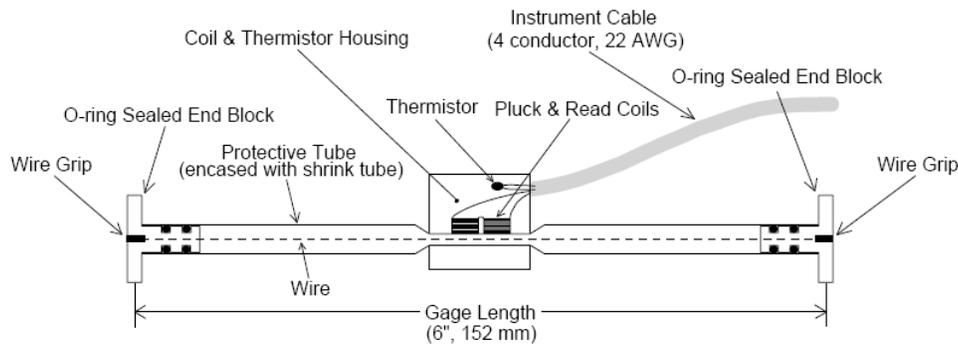
Figure 3. Internal view of 4200 vibrating wire strain gage

The primary means of gage placement is direct embedment in concrete by pre-attaching the gage to rebar or tensioning cables, pre-casting the gage into a concrete briquette that is subsequently cast into the structure, or grouting the gage into boreholes in the concrete. Strains are measured using the vibrating wire principle: a length of steel wire is tensioned between two end blocks that are firmly in contact with the mass concrete. Deformations in the concrete cause the two end blocks to move relative to one another, altering the tension in the steel wire. This change in tension is measured as a change in the resonant frequency of vibration of the wire.

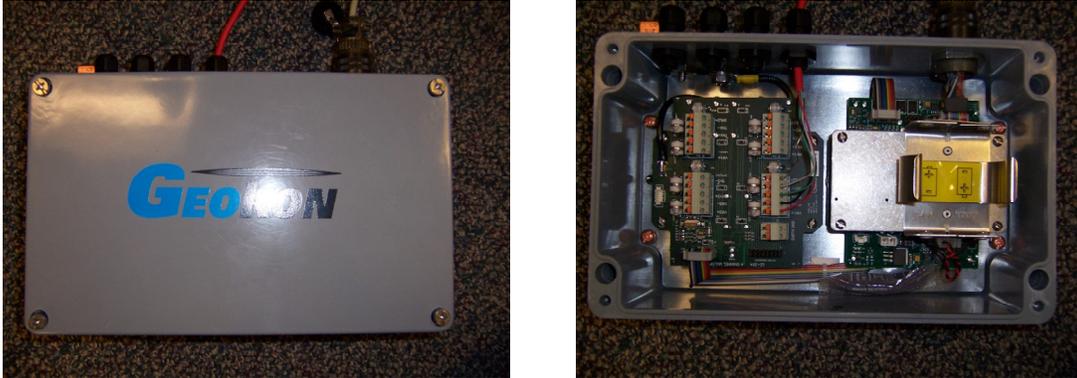
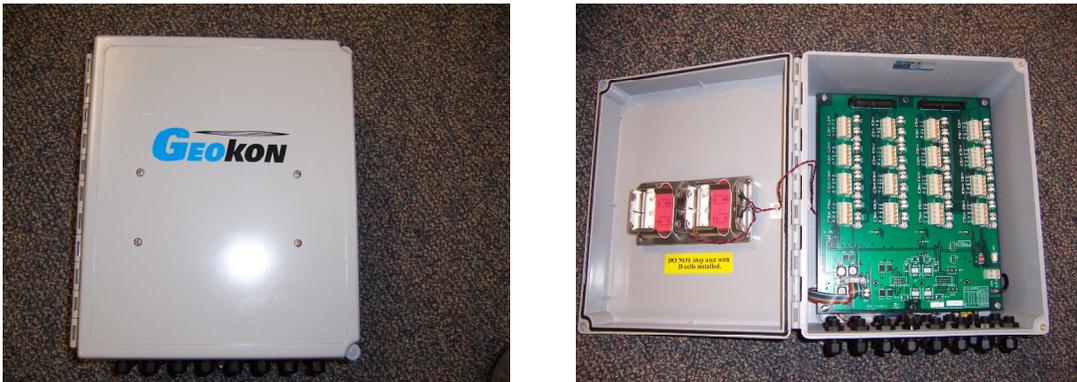
Figure 4. LC-2 4-channel and 16-channel data logger

Upon deciding the type and number of strain gages, a data logger was chosen accordingly in order to store the strain reading from strain gages. A Geokon model LC-2X16 16-channel data logger and a model LC-2X4 4-channel data logger were chosen based on the strain gages' layout, number of channels, price, and size of memory. The data loggers are shown in Figure 4.

(a) LC-2X4

(b) LC-2X16

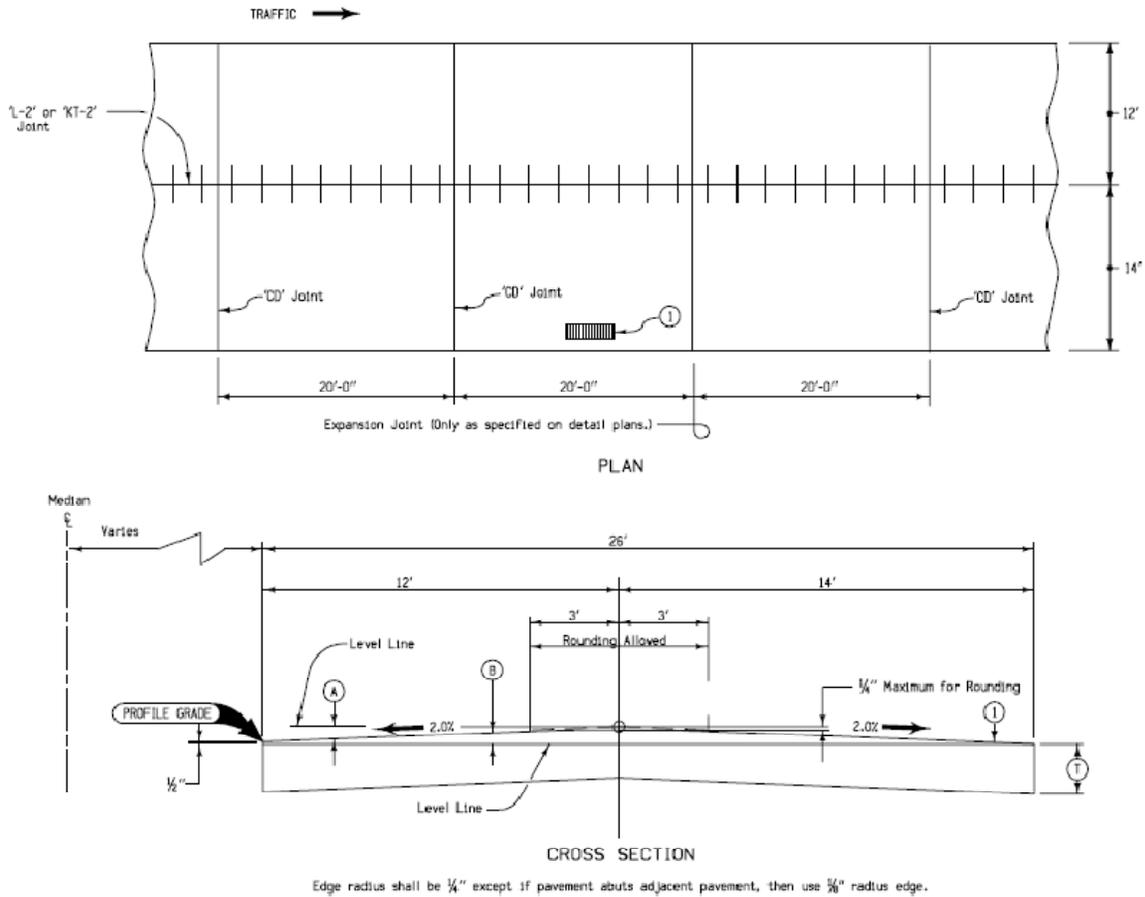
Figure 6. Plan and cross-section of pavement

The pavement design is based on plans from the Iowa DOT’s Office of Design Standards, “Road Plans RH-53: Four-Lane Divided Roadway 26 ft. P.C. Concrete Pavement,” as shown in Figure 6. The pavement thickness at the testing section is 10 in. (260 mm), and the width of the pavement is 12 ft + 14 ft (3.6 m + 4.2 m), with a typical joint space of 20 ft (~6 m).

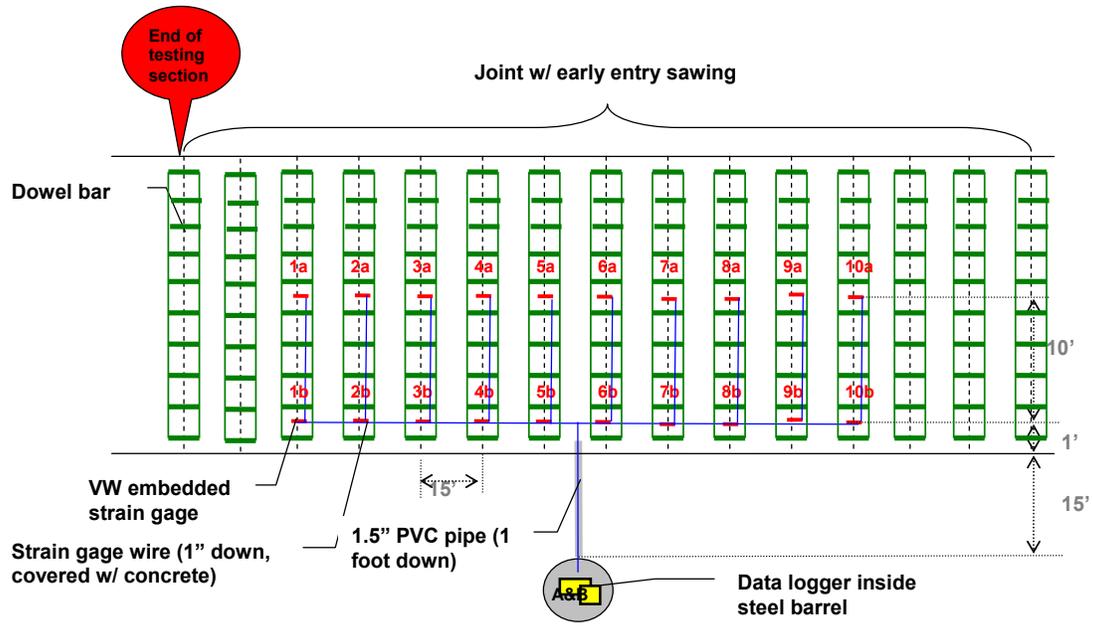
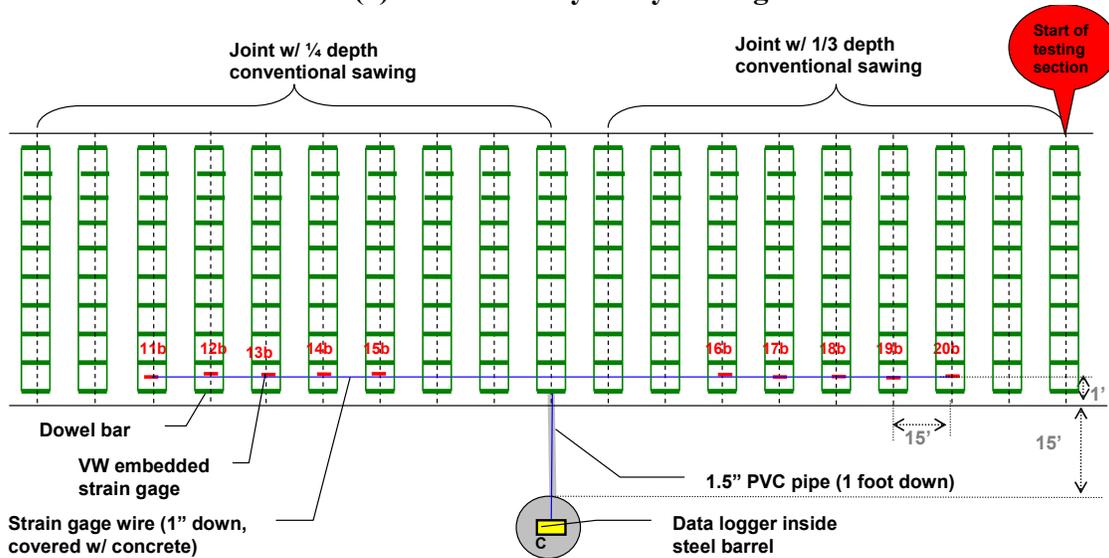
Figure 7. Floor plan of strain gage setup

In order to avoid disturbance/damage from possible external forces during concrete paving and to ensure the correct orientation, the concrete embedment strain gages were installed prior to the concrete placement. As shown in Figure 8, two short pieces of steel rebar were tied to the existing dowel bars using nylon tie-wraps. The strain gages were then tied to the short pieces of rebar, again using nylon tie-wraps. The gages were located approximately at the middle height of pavement thickness ($4 \frac{3}{8}$ in.). Special care was paid to ensure that the strain gages are located across the joints and lined up perpendicular to the joints.

(a) Part I – Early entry sawing

(b) Part II - Conventional sawing

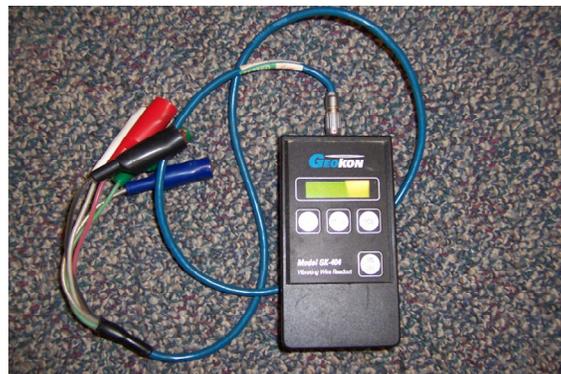
Figure 9. CK-404 vibrating wire readout

Prior to connecting the strain gages to the data loggers, an initial strain reading, a “zero reading,” was taken using the CK-404 vibrating wire readout on each of the gages in order to ensure the proper functioning of the gages (Figure 9). The readings provide necessary voltage pulses to pluck the wire and convert the measured frequencies so as to display the reading directly in micro-strain units ($\mu\epsilon$). The results indicated that all gages but one were working properly after installation.

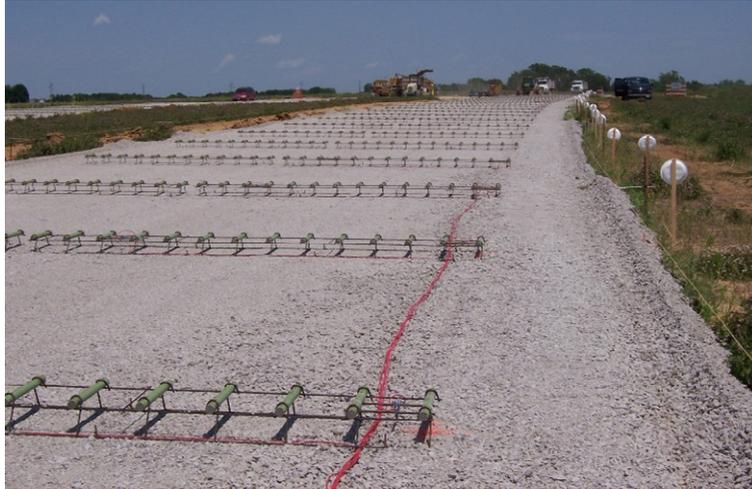
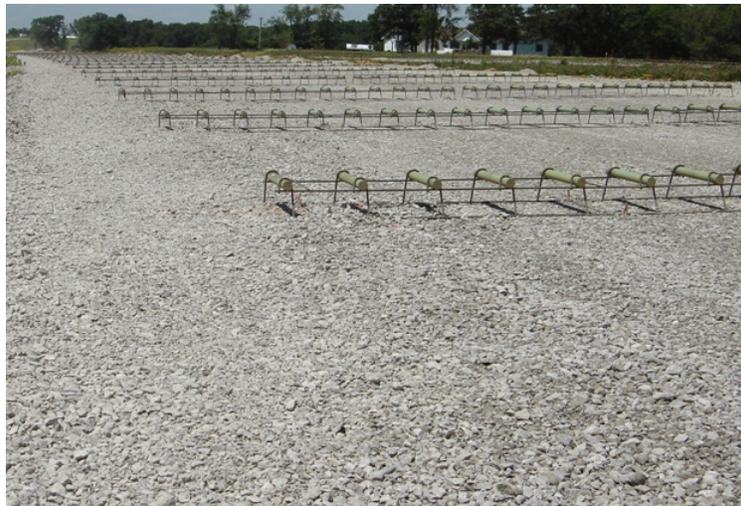
Figure 10. Setup of cables for strain gage

Depending on the location of the strain gages, the length of the cable for wiring the gages to the logger ranges from 35 to 175 ft. The information about lengths of cable for individual strain gages can be found in Table A.3 in Appendix A. In order to protect the cable from damage during concrete paving, all cables running underneath the pavement, as shown in Figure 7, were buried inside small trenches approximately one inch deep. The cable from the strain gages located 11 ft away from the pavement edge were run inside the dowel baskets and met with the cable over the edge of the pavement. The trenches were then backfilled so that the cables were completely buried. Pictures of the cable setup can be found in Figure 10. It appeared that there was no obvious disturbance on the base surface caused by the installation of the strain gages and cables.

(a) Arrangement of strain gages and cables

(b) Cables after installation

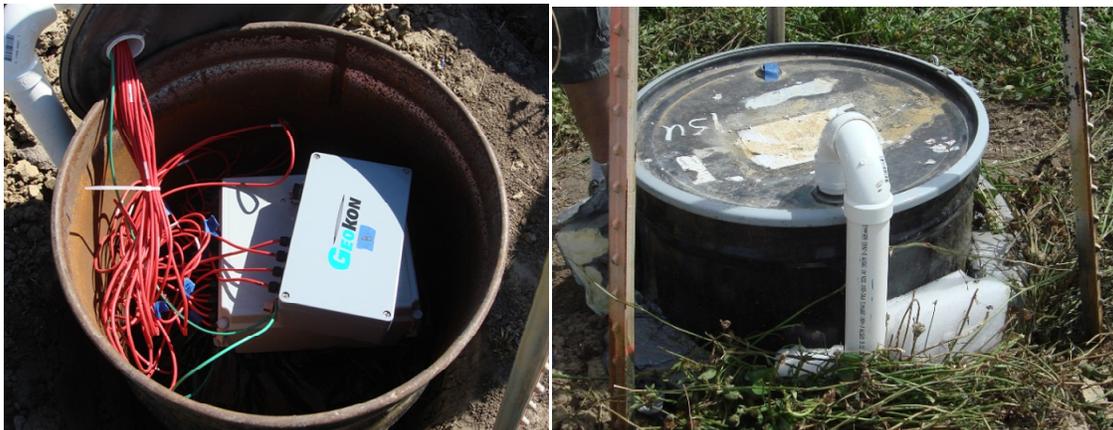
Figure 11. Setup of data loggers

“U shape” tube to protect them from damage and prevent water getting inside the barrels. Both steel barrels were half-buried and locked for security reasons (Figure 11).

All strain gages were lightning protected through a ground connection made possible by the earth grounding of the data loggers (as shown in the green cables in Figure 11). Grounding cable was used to divert the energy from a lightning strike safely to ground. The grounding rod was driven as close to the data logger as possible and to a depth of approximately three feet. A copper grounding lug was supplied on the exterior of the LC-2X16 and LC-2X4 enclosure to provide connection to this wire from the grounding cable.

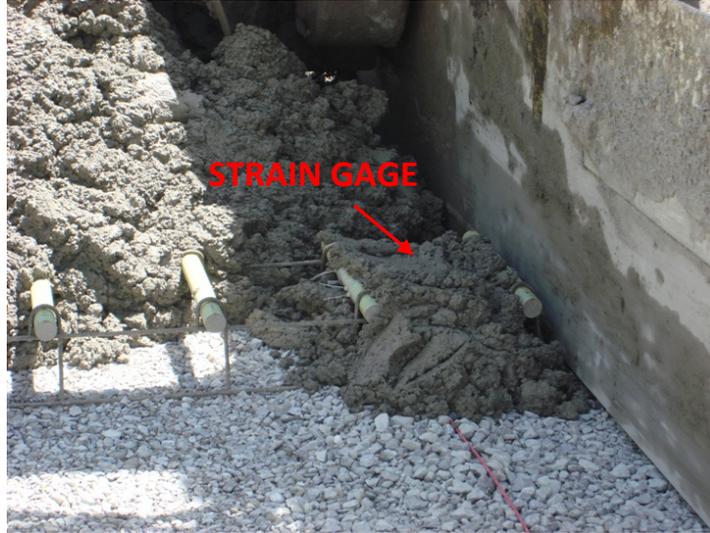
Figure 12. Strain gages during paving

The test section was paved on June 23, 2008 in the afternoon. The paving time through each joint was recorded and is shown in Table A.4 in Appendix A. The strain gages and cables during paving are shown in Figure 12. It appeared that both strain gages and cables were well protected against the paving process. The air content was also measured on site during paving: air contents of 9.6% and 6.9% were recorded before and after paving, respectively.

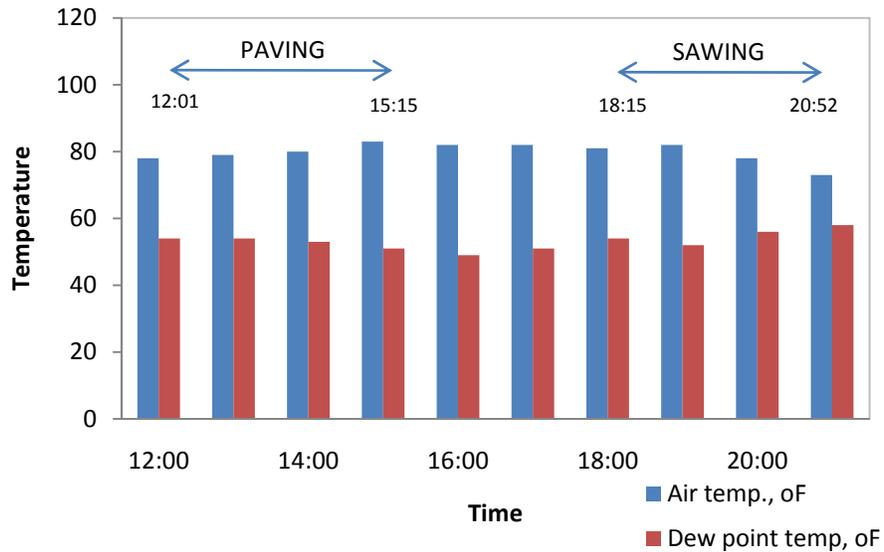
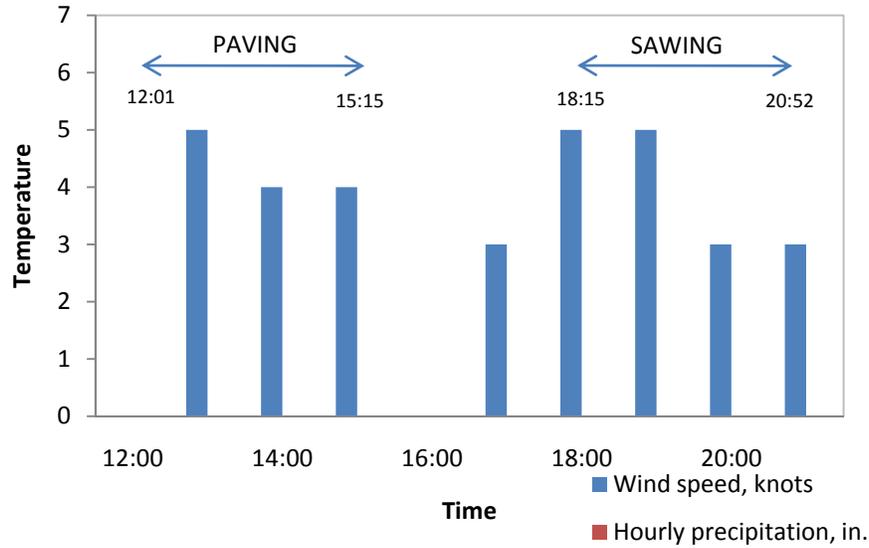
Figure 13. Weather condition during paving and sawing

The weather profile of the paving site was obtained from Iowa Environmental Mesonet (IEM) of the Iowa State University Department of Agronomy. The data was accessed by Automated Weather Observing System (AWOS) sensors managed by the Iowa DOT. Weather data from a weather station at latitude 41.05 and longitude -91.98 located in Fairfield, Iowa, was used in the present study. The weather information during paving and sawing is shown in Figure 13. It appeared that, due to the summer construction, the air temperature remained relatively high, while wind speed was negligible and no precipitation was observed during the paving and sawing period.

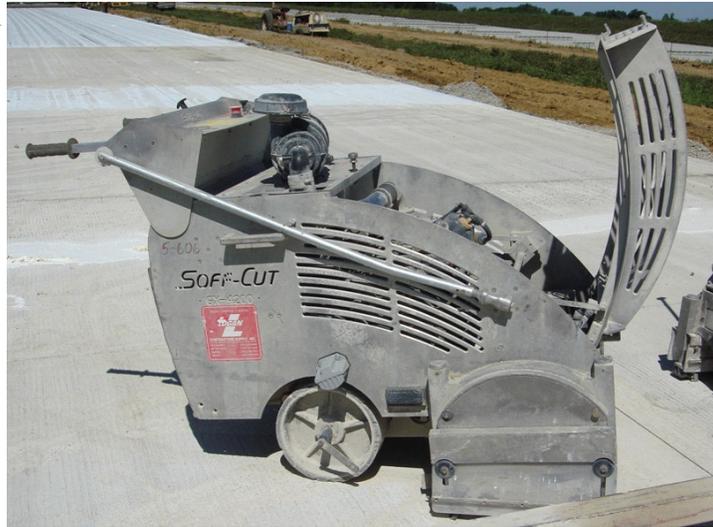
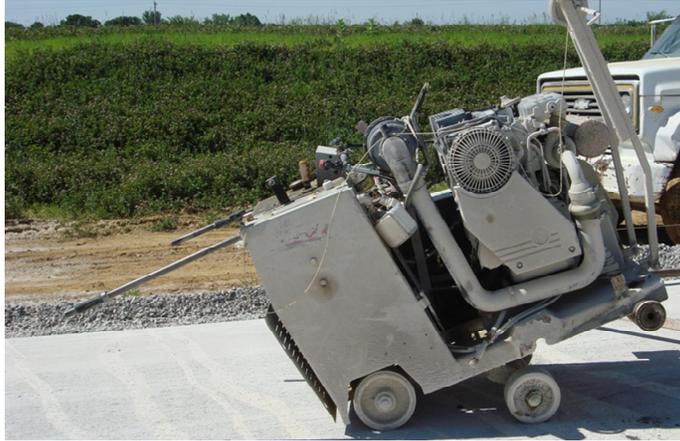
Figure 14. Sawing equipment

In order to compare the effect of different sawing types and depths, two different types of sawing equipment were used in this study. A GX-4200 Soff-Cut was used for early entry sawing (see Figure 14[a]) and conventional sawing with the depth of one-quarter of pavement thickness (T/4). A Diesel conventional sawing machine (Figure 14[b]) was used for conventional sawing with the depth of one-third of the pavement thickness (T/3). The sawing information regarding blade types and joint depths were provided by the contractor and are summarized in Table 3. The pavement joints with

(a) Early entry sawing

(b) Conventional sawing

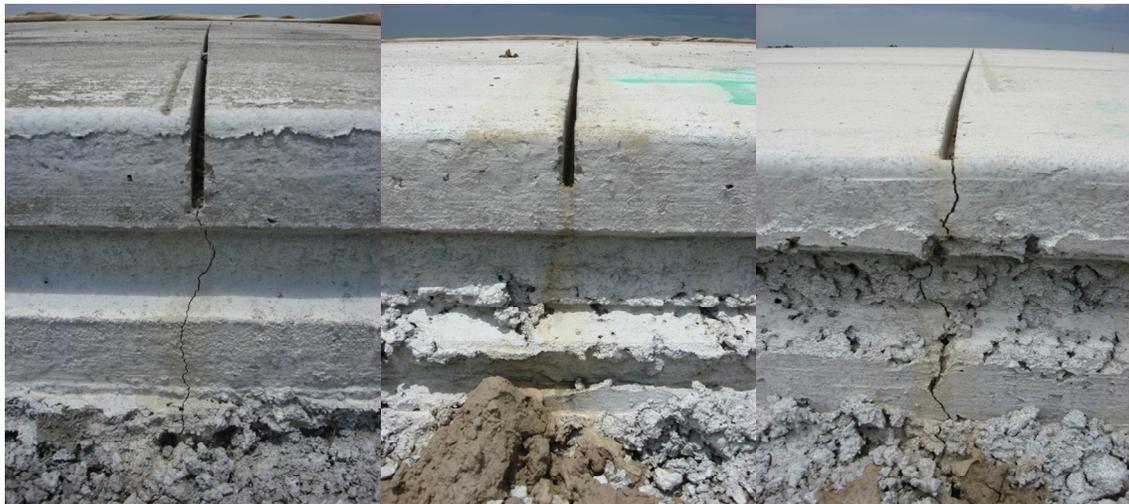
Due to the differences in joints and sawing machines, joints were sawed at different periods after paving. The early entry sawing was performed at approximately 5.1 hours after paving, and the conventional sawing was performed a little later, at approximately 6.6 hours after paving. More detailed sawing information can be found in Table A.4 in Appendix A.

(a) T/3

(b) T/4

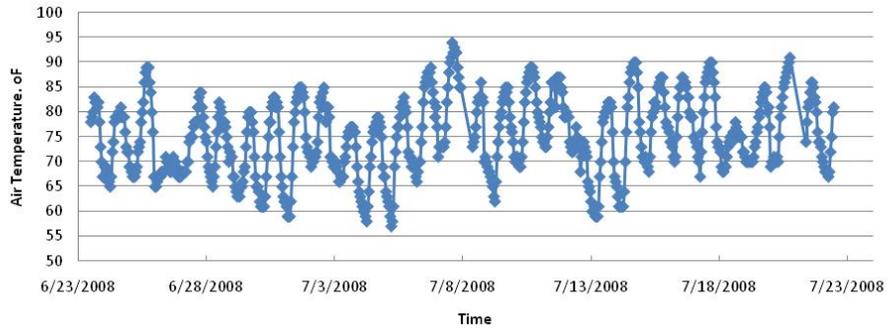
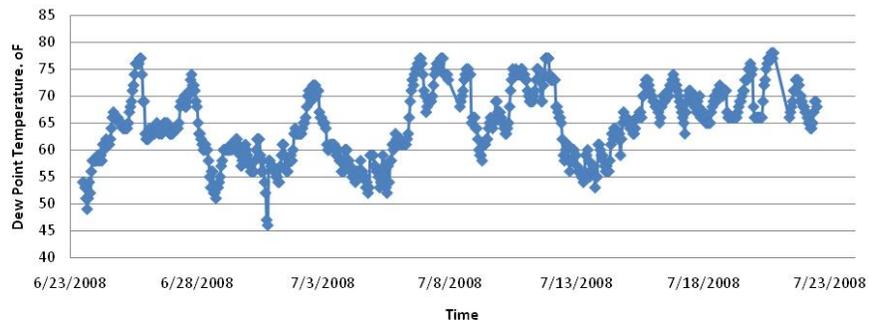
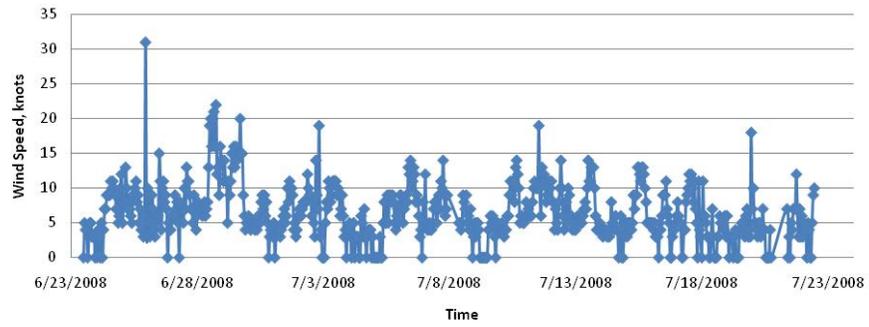
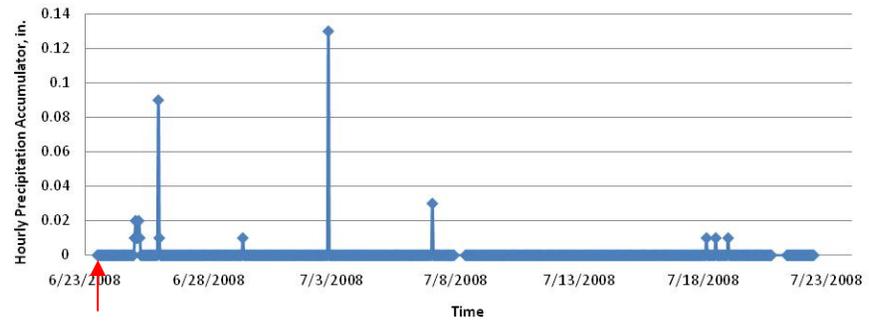
Figure 17. Weather profile of paving site

As mentioned above, the weather profile of the paving site was obtained from IEM of the Iowa State University Department of Agronomy. The weather profiles of the first 30 days after paving are shown in Figure 17. The daily high and low temperature profiles for the first 30 days after paving show that the temperatures were in a band of 55 °F to 95 °F and were cycling between daytime and nighttime relatively constantly. The difference between the low and high peaks of a cycle can be up to 30°F, which might have significantly affected the joint cracking development and pavement deformation, while a relatively low wind speed and precipitation accumulation should not have had a major effect.

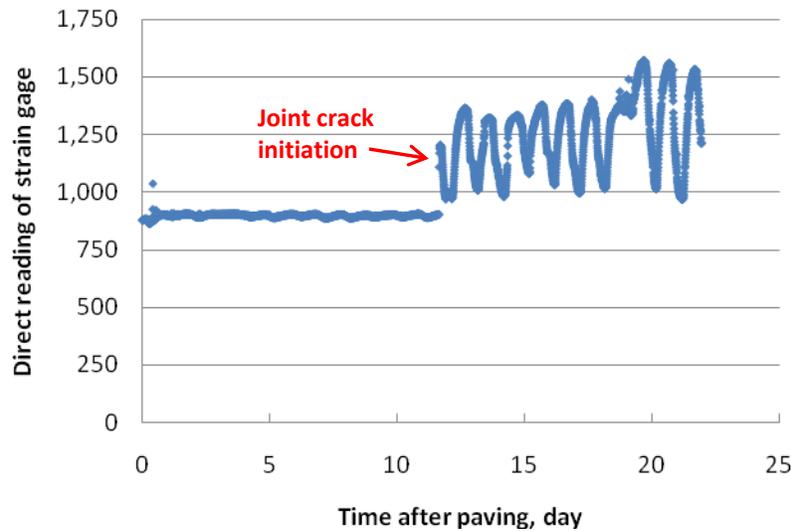
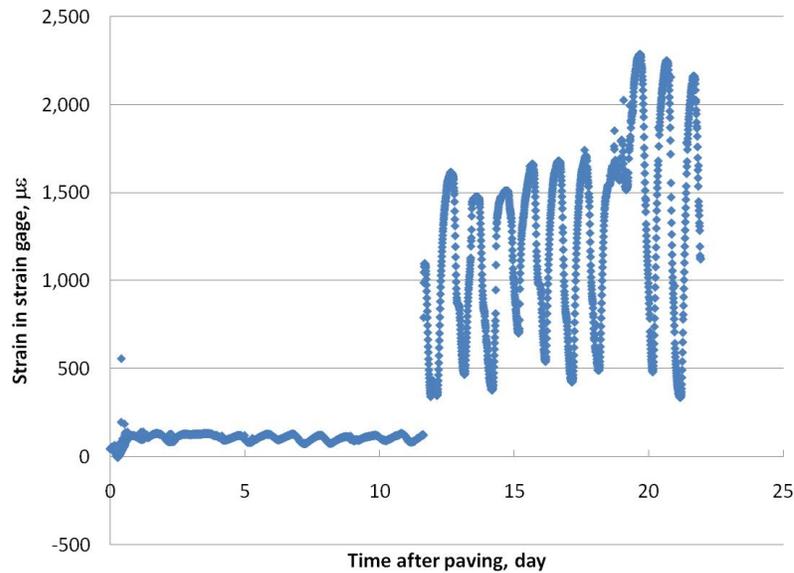
Figure 18. Example of strain calculation (Joint 7)

By using Equation 6, the true strain of the strain gages can be calculated. An example of the difference between the direct strain gage reading and the calculated strain in the gage (Joint 7, logger number B1) for 30 days after paving is shown in Figure 19(a) and (b). A zero reading of 862.0 and a temperature of 17.2°C at zero reading was used in Equation 6 for the calculation of true strain in this strain gage.

(a) Direct reading from strain gage

(b) Calculated strain in strain gage

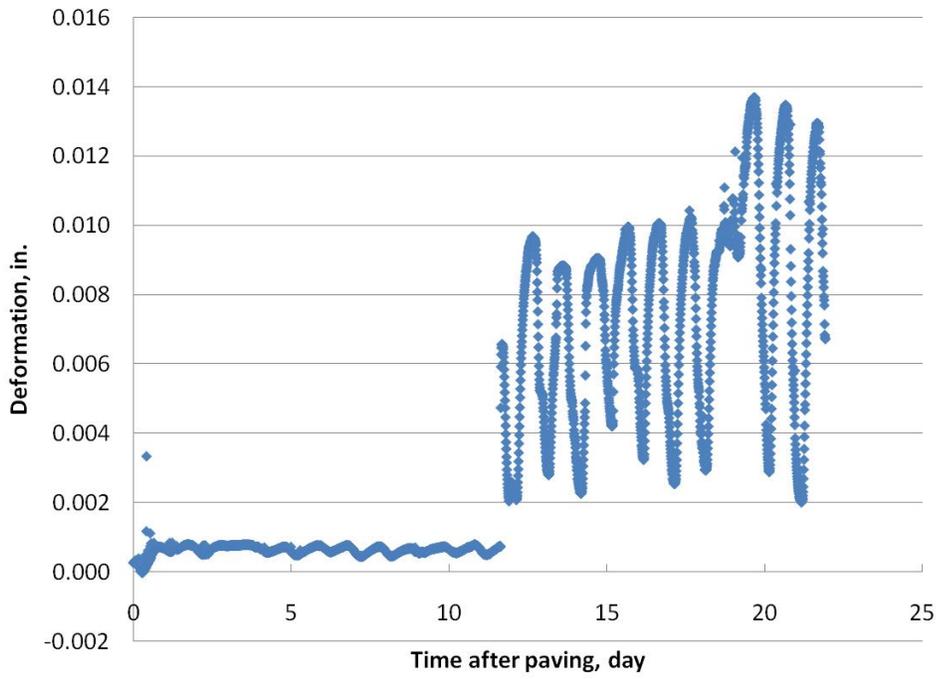
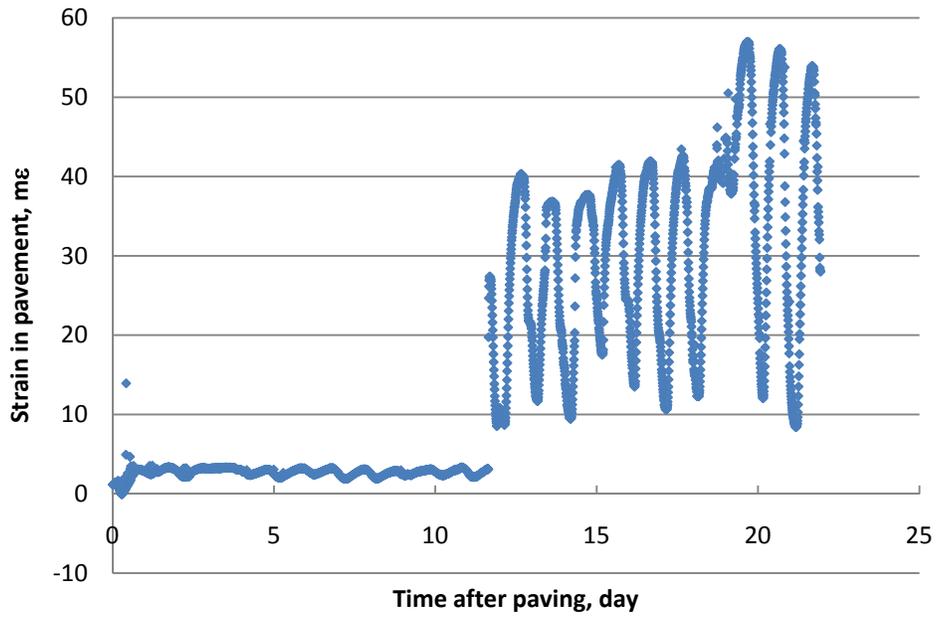
Figure 20. Example of pavement strain and deformation calculation

The dramatic increase of the strain and deformation indicated that the strain level increases significantly during a very short period of time after paving, usually within hours. This first dramatic increase of strain and deformation inside the pavement was considered to be the initiation of joint cracking. The periodic decrease and increase of the deformation after cracking, however, is considered to be caused by the thermal deformation of the concrete slab due to daily temperature variation, which includes approximately one cycle per day. The maximum daily length change of a 20 ft long concrete slab due to thermal effect is calculated based on the temperature data, as shown in Figure 21. Based on the available temperature data, the theoretical free expansion due to the daily temperature differences can range between 0.011 and 0.033 in. The values calculated from the strain gage measurements fall in this range, as shown in Figure 20.

(a) Calculated deformation

(b) Calculated strain in pavement

Based on the same procedure presented in Figure 20, the strain and deformation levels for all 30 strain gages and the corresponding pavement deformation and strain level were calculated. Examples of the deformation of a 20 ft PCC pavement slab with early entry sawing (Joint 7, logger number B1, and Joint 6, logger number A6) and conventional sawing (T/4 – Joint 13, logger number C3, and T/3 – Joint 20, logger number C10) under different periods are presented in Figure 22 and Figure 23. Results show that the strain (deformation) development generally showed two different styles: a few of the strain gages stopped taking readings after a drastic increase in strain, and most of the gages showed a cycling strain development with periodic increases and decreases. The former situation probably indicates that the crack width falls out of the strain gage measurement range, and the latter shows that the crack width fluctuation due to temperature cycling occurs in the measurement range.

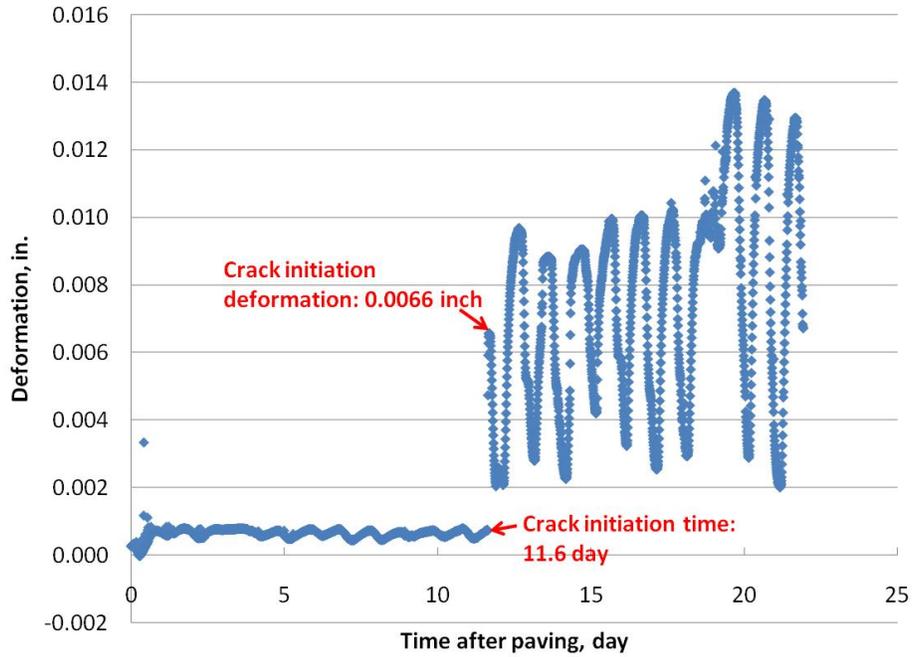
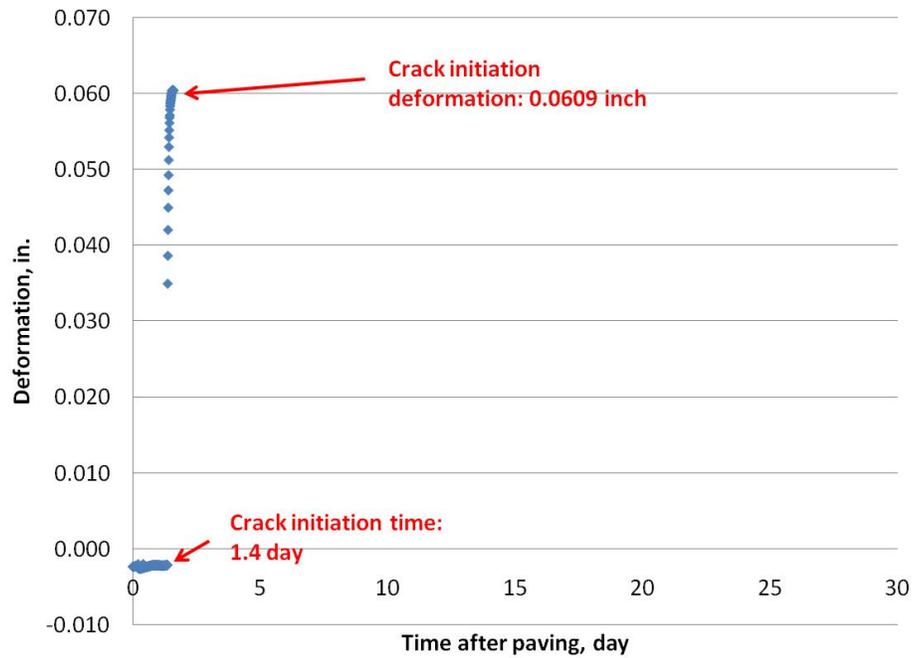
Figure 22. Examples of stress development of early entry sawing

(a) Joint 7, logger number B1

(b) Joint 6, logger number A6

In the present study, the time at which the first significant peak observed from the strain gage readings (with a deformation larger than 0.005 in.) was considered to be the joint cracking time (or crack initiation time). Table 6 shows the joint crack times for all the joints studied with early entry sawing. The table illustrates that the crack times measured from the two strain gages installed at a given early entry sawing joint are the same or very close, indicating a good reliability for the strain gages. The average time is 12.3 days, and the range is 1.4 to 24.1 days.

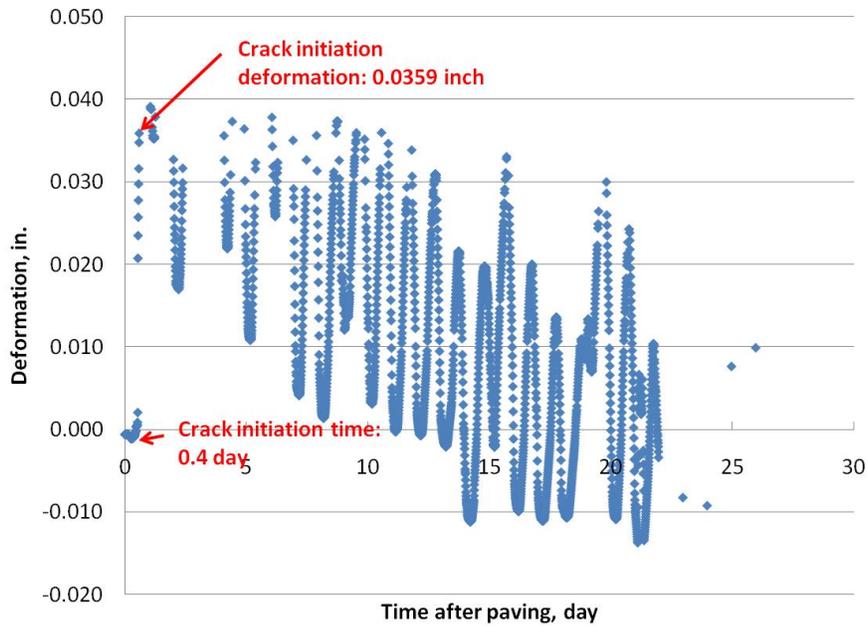
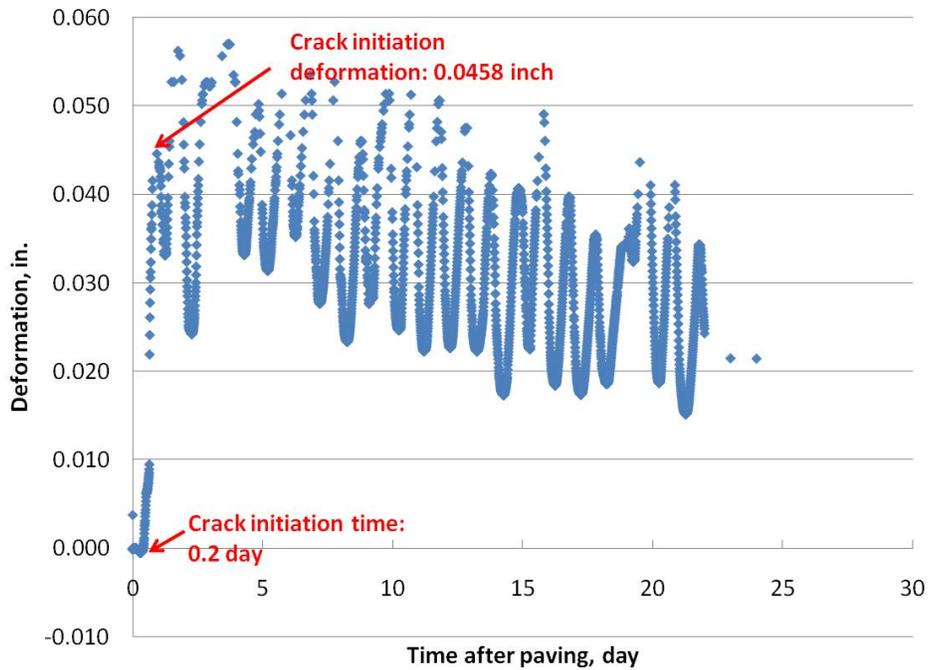
Figure 23. Example of stress development of early entry sawing

(a) Joint 13, logger number C3

(b) Joint 20, logger number C10

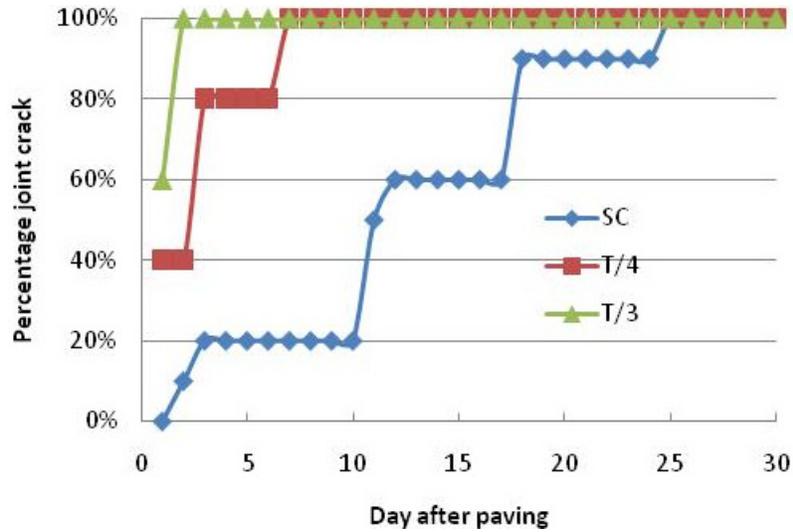
Figure 24. Percentage of joint cracking at different ages

Based on the estimation of cracking data, as shown in Table 6 and Table 7, the percentage of cracked joints at different ages was calculated by dividing the number of cracked joints by the total number of joints with certain types of sawing (5 joints with conventional sawing or 10 joints with early entry sawing). For example, two out of five joints (40%) with T/4 conventional sawing cracked within one day and two more joints cracked between one to two days, which means four out of five joints (80%) cracked within two days, and all five (100%) cracked with seven days. The results are summarized in Figure 24, which shows that most of the joints formed with conventional sawing cracked within 5 days and that the percentage reaches to 100% at less than 10 days. The figure also shows that only approximately 20% of the joints formed with early entry sawing cracked at the age of 10 days and that the percentage reaches 100% by approximately 25 days.

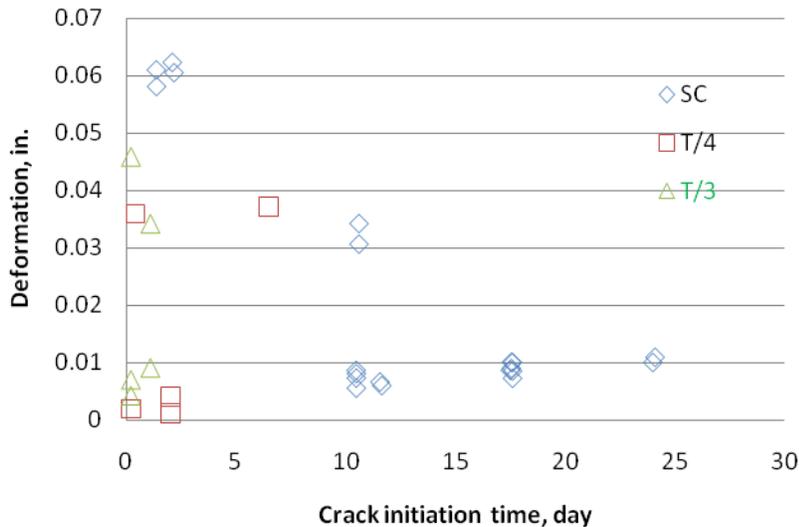
Figure 25. Relation between crack time, initiation time, and deformation at the joints

The relationship between the time of crack initiation and the deformation at that point was also studied. The results, as shown in Figure 25, indicate that, in early entry sawing, early cracking is usually associated with a higher deformation level, which is reasonable because a higher concentration of stress should likely result in an earlier crack initiation. However, no obvious relation between deformation and time of crack initiation was found in the joints formed with conventional sawing.
