Field and Laboratory Evaluation of Precast Concrete Bridges

Iowa DOT Project TR-440

FINAL REPORT

Department of Civil and Construction Engineering

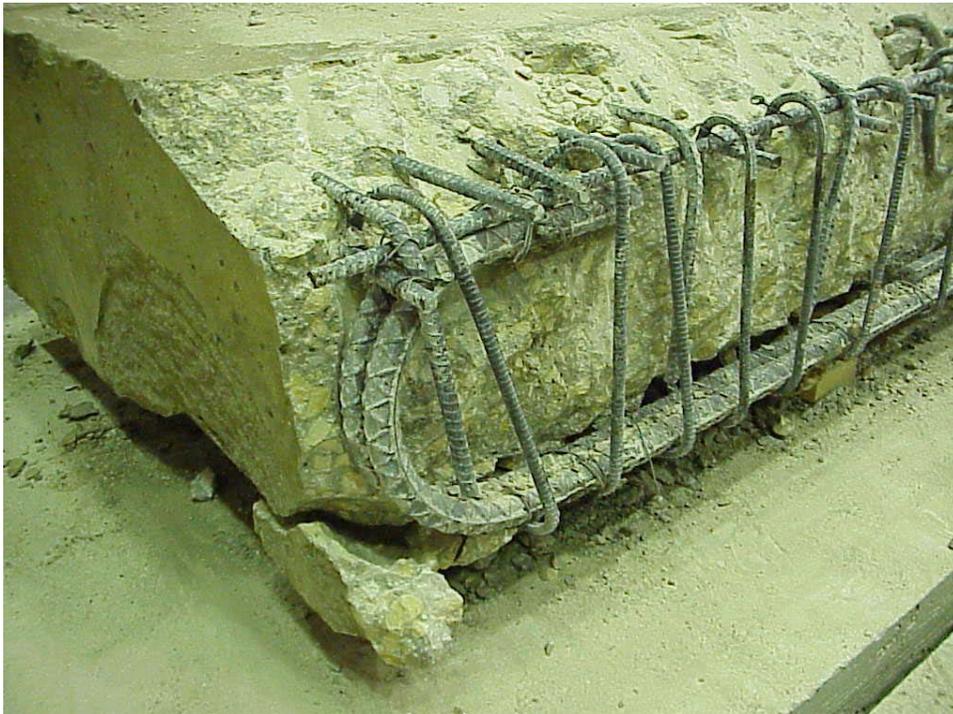
Each end of a Type I PCDB panel was anchored to either an abutment or pier. A 1 in. diameter dowel bar extended up from the abutment into a 6 in. diameter vertical hole at the end of each panel. Following erection of the bridge panels, each hole was filled with concrete.

Figure 2.2. Hooked ends of lower reinforcing bars.

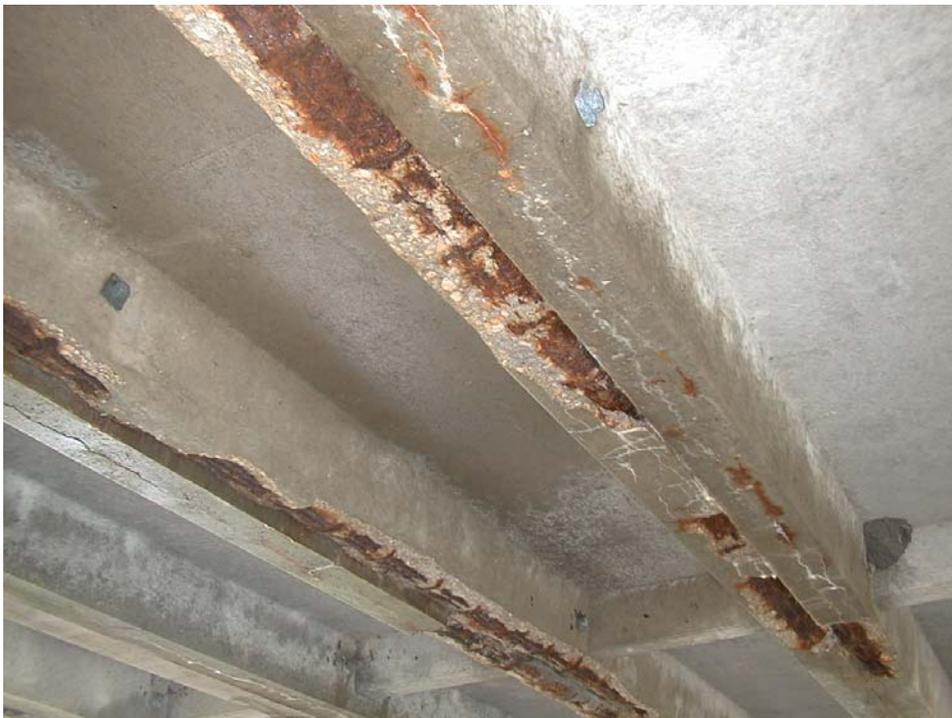
Many PCDBs throughout Iowa were found to be in a deteriorated state. Common damage included corrosion of the primary reinforcing steel and spalled concrete cover. In areas of intact concrete cover, a longitudinal crack running parallel to the primary reinforcement was often observed. The extent of the deterioration varied from bridge to bridge. Some PCDBs were found in excellent condition while others were severely deteriorated. Bridges with over half of the primary reinforcement exposed or with longitudinal cracks in most of the stems were considered severely damaged. An example of such deterioration is shown in Figure 2.4.

Figure 2.4. Deterioration damage common to PCDBs.

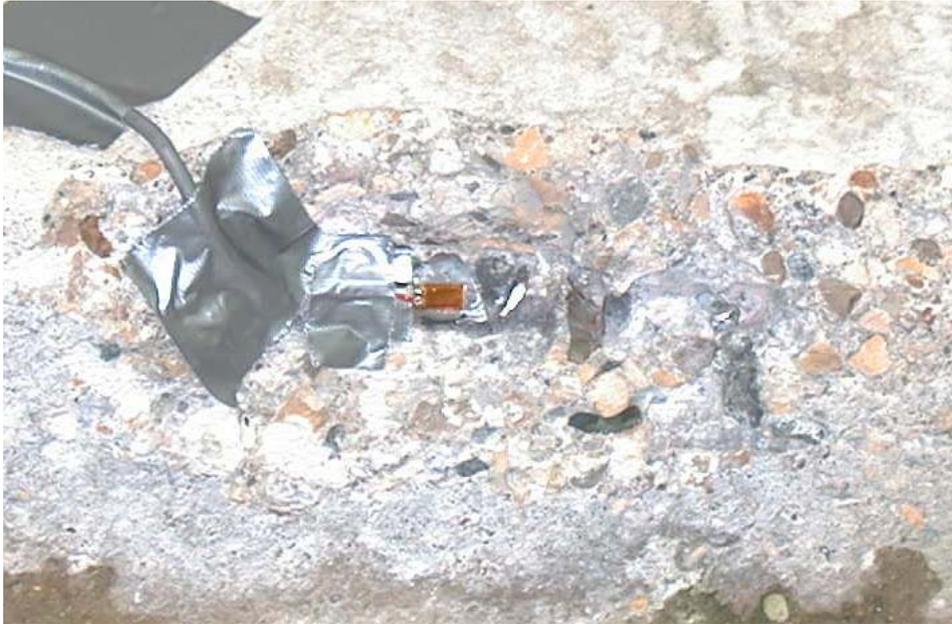
resulted in a flat, polished surface ideal for strain gage installation. Both the concrete and steel strain gages were bonded using the recommended adhesives. An example of a bonded steel strain gage is shown in Figure 3.1.

Figure 3.1. Bonded steel strain gage.

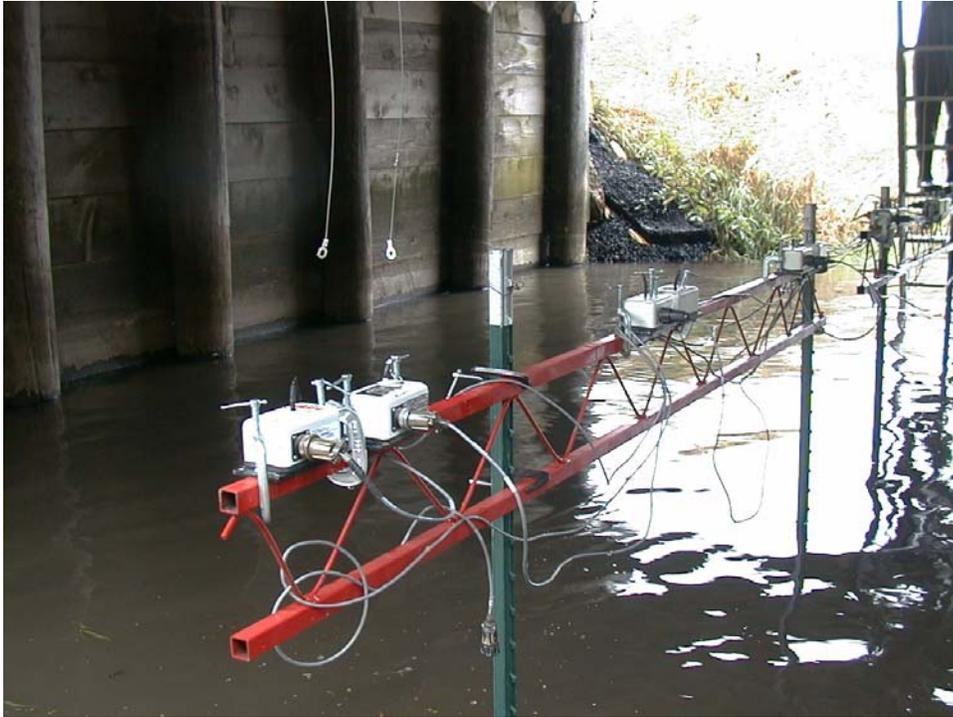
was reduced by the use of metal truss sections and 'T' posts. Each truss was 8 ft long, approximately 8 in. deep, and was fabricated from two 1 in. square tubes and 1/4 in. diameter bar stock. A 'T' post was used to support each end of the truss. Less time was needed to setup the displacement transducers since many displacement transducers could be mounted on a single truss as shown in Figure 3.2.

Figure 3.2. Fabricated metal truss supporting multiple displacement transducers.

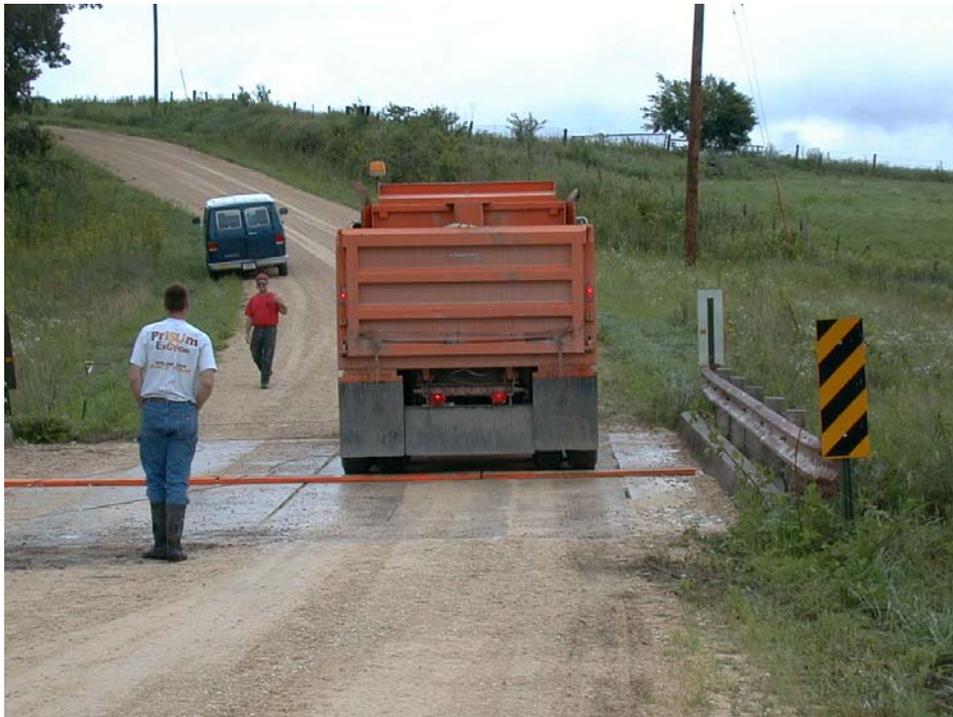
For all four test vehicles, the distance between the center of each wheel line was approximately the same as the width of two PCDB panels. Also, the width of each wheel line was less than the width of a single PCDB panel. Due to this geometry, two unique methods of transversely positioning the truck were possible. First, the test vehicle could be positioned so that each wheel line of the test vehicle would track entirely on a single panel, as shown in Figure 3.3. For this transverse position, care was taken to ensure that the centerline of each wheel line was as close to the centerline of each panel as possible. Secondly, the test vehicle could be positioned so that each wheel line tracked directly over the joints between adjacent panels.

Figure 3.3. Test vehicle tracking entirely on two panels.

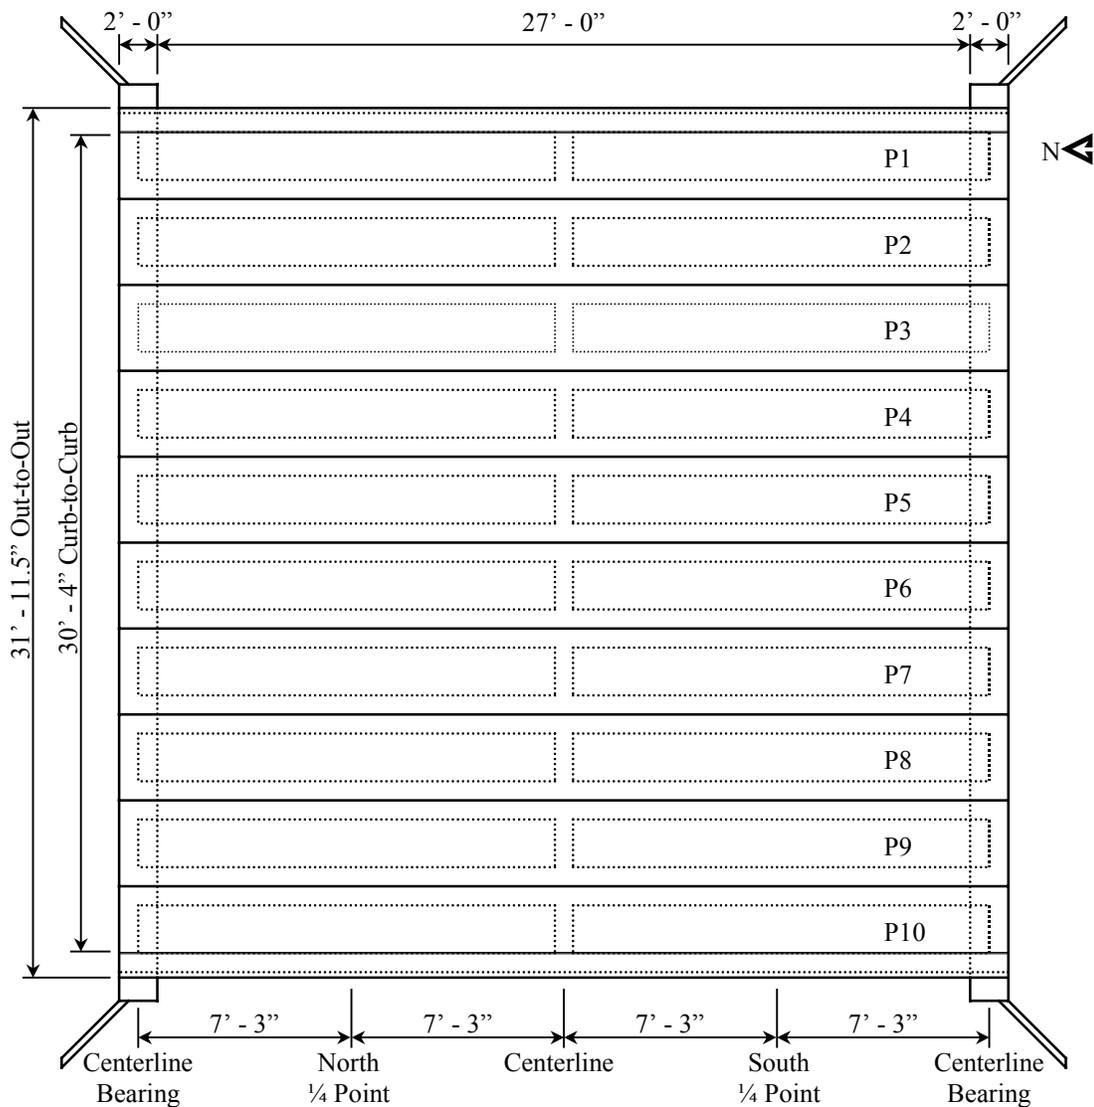
At the time of the service load test, Bridge 1 consisted of ten Type II (H20) PCDB panels. The overall length of each panel was 31 ft - 0 in. and the total width of the bridge from inside of the curb to the inside of curb was 30 ft - 4 in., as shown in Figure 3.5. Galvanized bolts secured the panels longitudinally and galvanized concrete-filled pipe was properly installed in each longitudinal joint. The panels rested on the reinforced cast-in-place concrete abutments supported by timber piling. Each abutment was 2 ft wide and crowned to provide proper roadway drainage.

Figure 3.5. Plan view of Bridge 1.

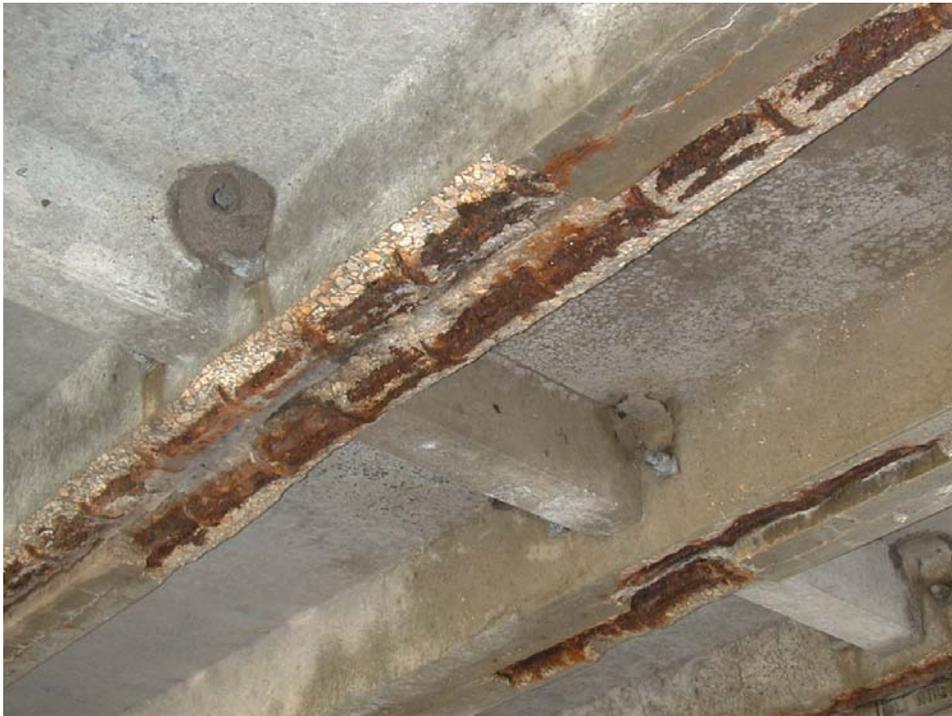
The PCDB panels in Bridge 1 had significant deterioration. All panels had longitudinal cracks along the bottom face of the stems and the bundled longitudinal reinforcement was exposed on significant portions of eight of the ten PCDB panels, as shown in Figure 3.6. Bridge 1 also exhibited another form of deterioration less common to PCDBs. The deck surface of two panels had delaminated and spalled; efflorescence was visible on the underside of these panels. The delamination was likely caused by corrosion of the deck reinforcement. An asphalt cement concrete (ACC) patch had been used to replace the missing concrete.

Figure 3.6. Close-up of Bridge 1 corrosion damage.

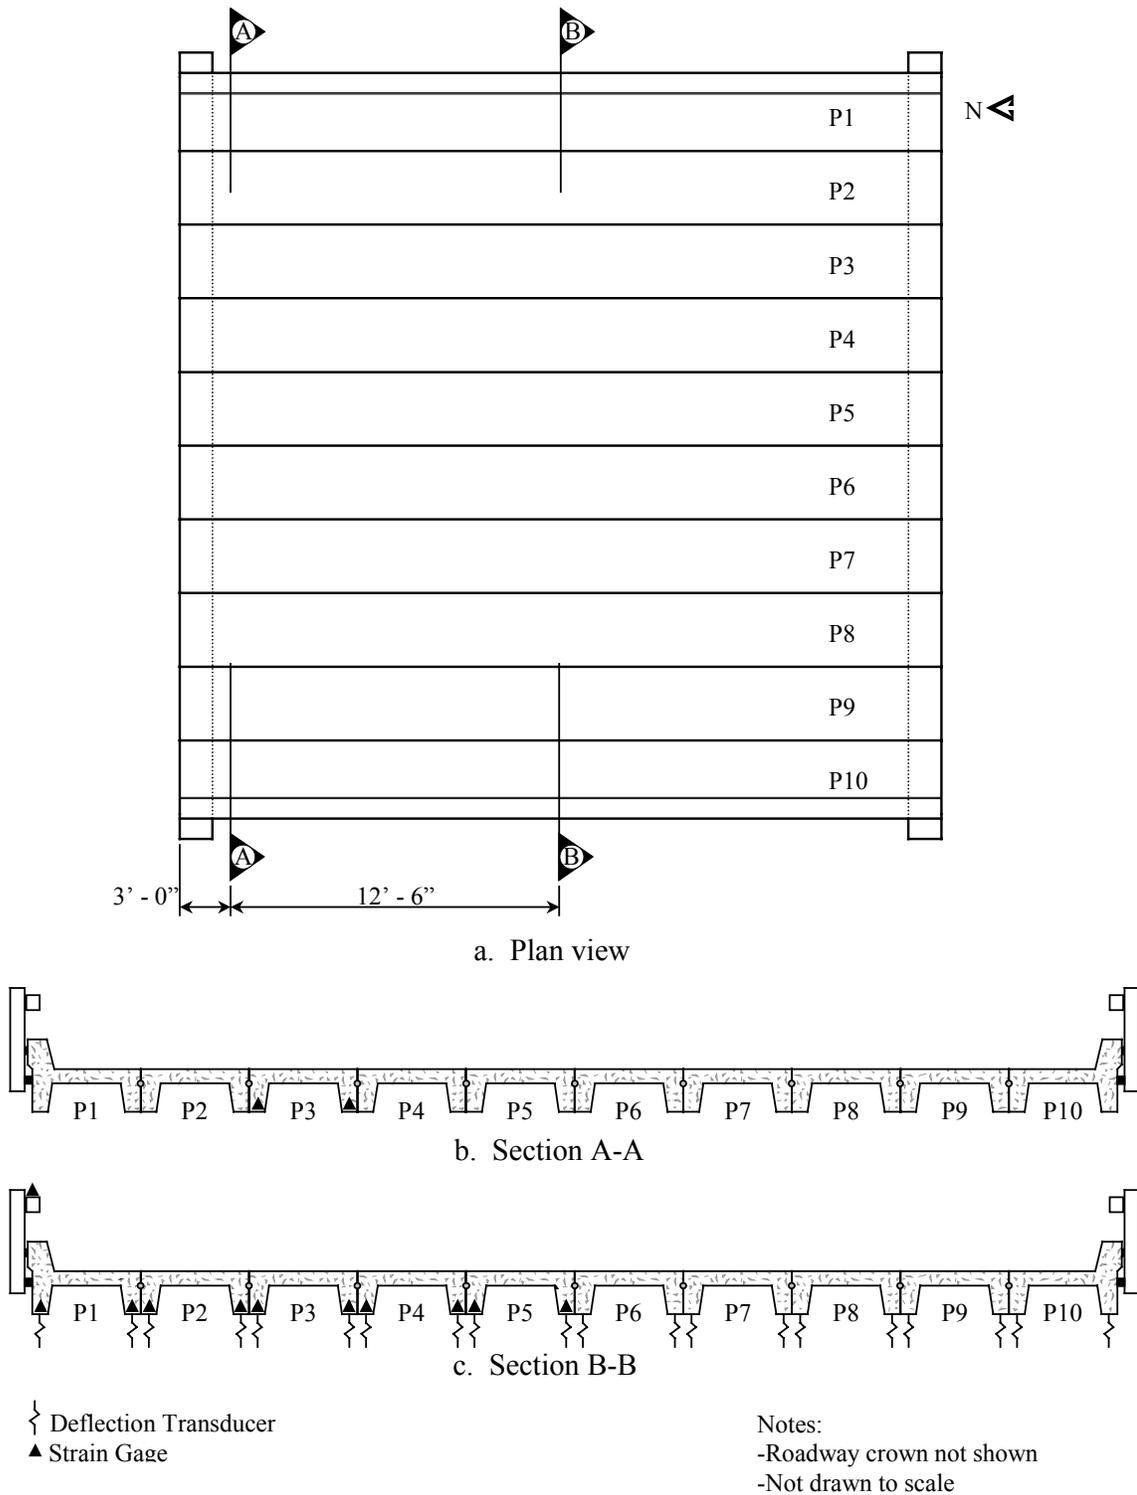
A truck tractor-semitrailer combination was used as the test vehicle. The test vehicle as well as the vehicle's dimensions and weight distribution (Gross Vehicle Weight (GVW) = 80.18 kip) are shown in Figure 3.8. The test vehicle moved north across Bridge 1 in three different transverse positions, shown in Figure 3.9. Load positions 1-LP24.x and 1-LP79.x corresponded approximately to the northbound and southbound travel lanes, respectively. In these two positions, the test vehicle was tracking entirely on two panels. For load position 1-LP56.x, the test vehicle was transversely centered on Bridge 1 and was tracking over panel joints between P4 and P5 and P6 and P7.

Figure 3.7. Location of strain gages and displacement transducers for Bridge 1.

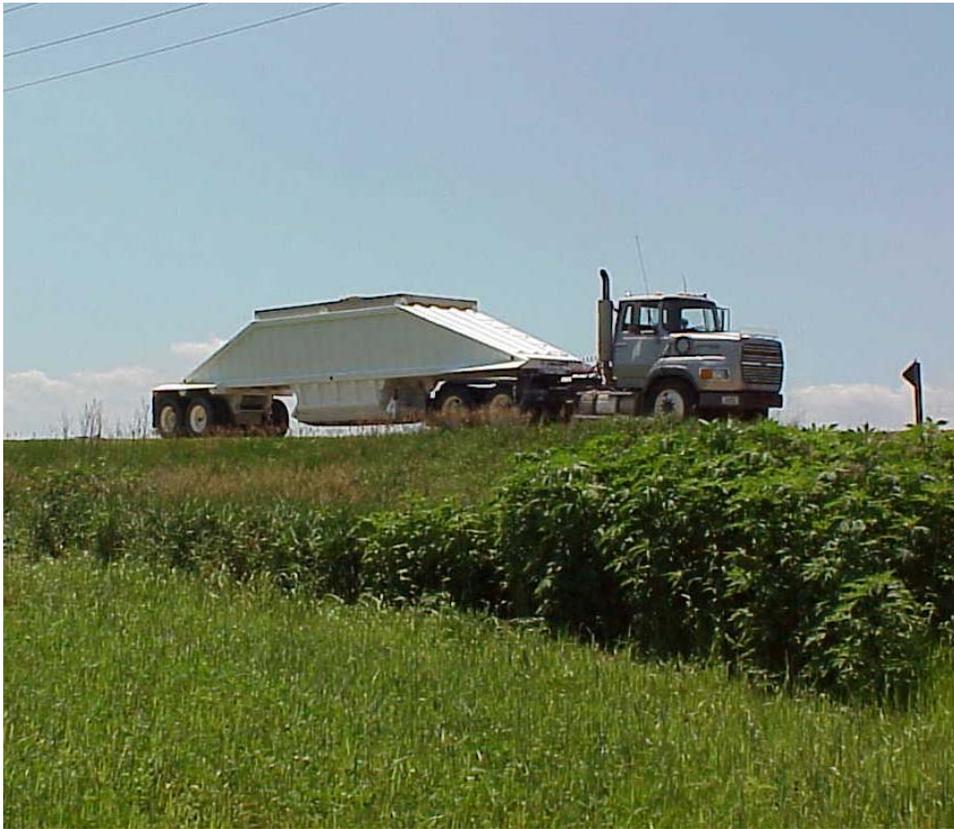
a. Photograph of test vehicle

Figure 3.8. Bridge 1 test vehicle.

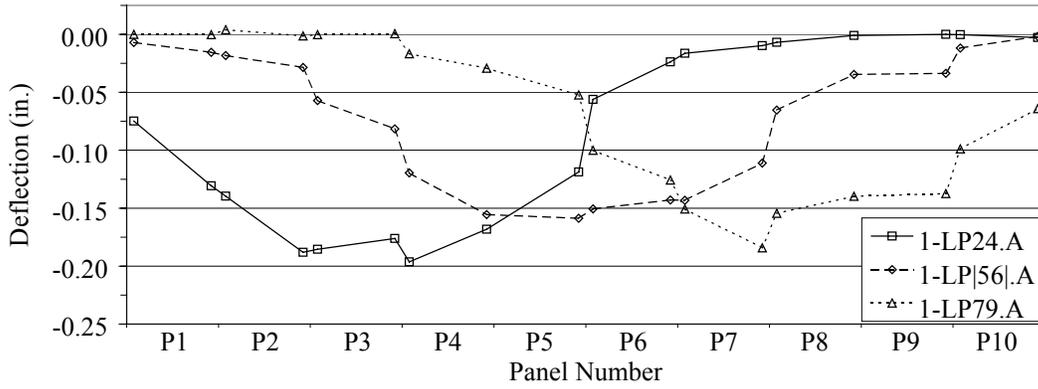
The displacement measurements from which the experimental load fractions were calculated are plotted in Figure 3.10. These plots are also useful in determining whether Bridge 1 responded symmetrically to corresponding symmetrically placed loads. Structural inadequacies, such as a panel weakened by corrosion or a failing shear connection, would be indicated by an unsymmetrical response. As shown in Figure 3.10, some minor variation exists between 1-LP24.x and 1-LP79.x but overall the data are reasonably symmetric and no

a. Deflection data for 1-LPxx.A

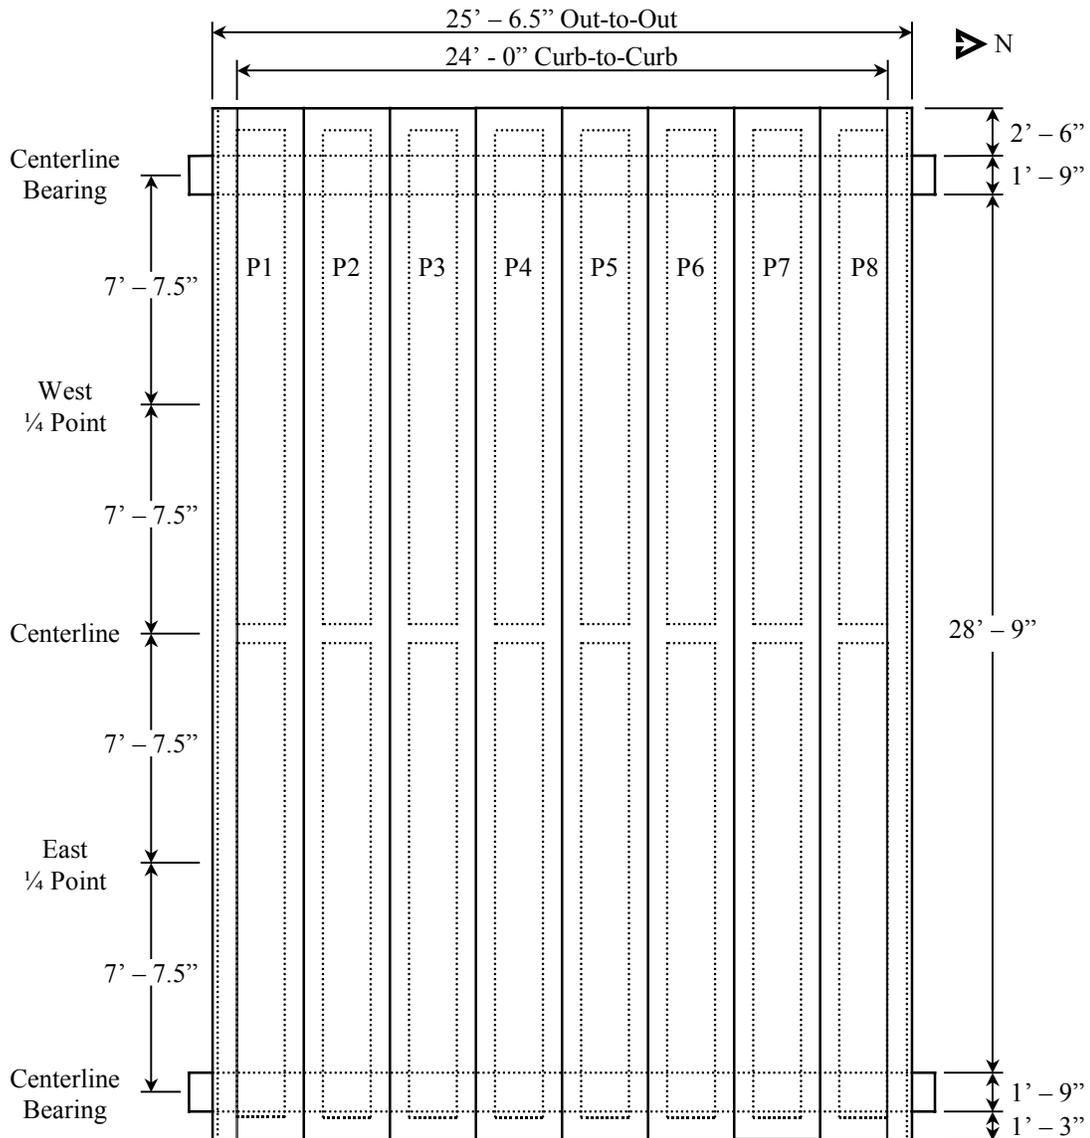
Bridge 2 consisted of eight Type II (H15) PCDB panels, and the overall length of each panel was 36 ft – 0 in. As shown in Figure 3.13, the outer face of each abutment was several feet in from the panel ends. This geometry was unique to Bridge 2 and cause for some concern since loads placed on the cantilevered panel ends cause negative bending in the panels. The J-10 Standards are only for simple span bridge configurations and the panels were likely not designed to withstand negative bending.

Figure 3.13. Plan view of Bridge 2.

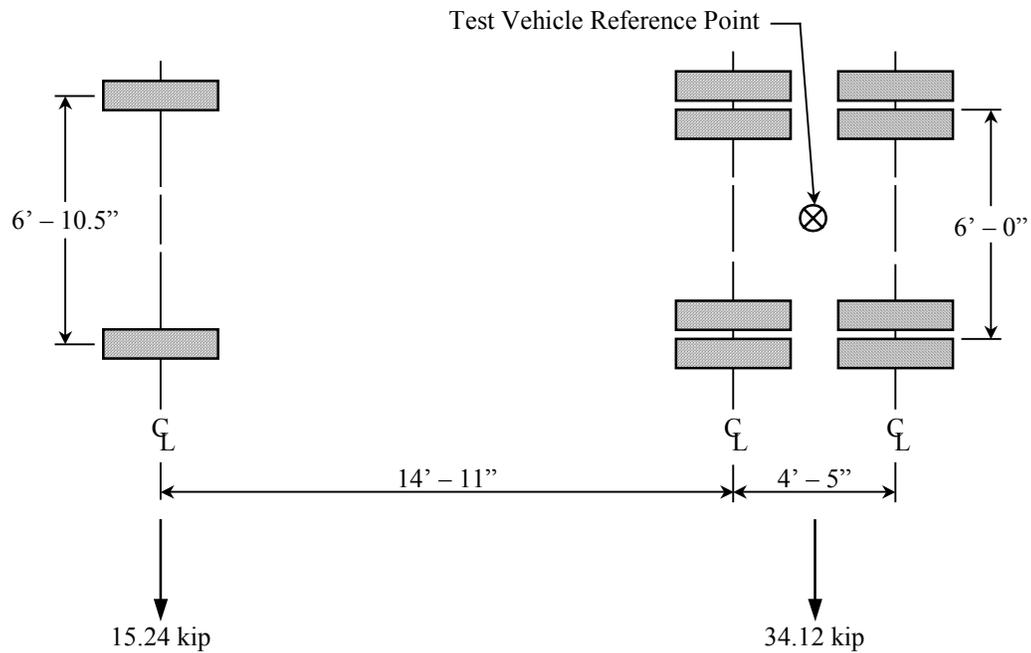
b. Wheel configuration and weight distribution of test vehicle

Figure 3.15. Bridge 2 test vehicle.

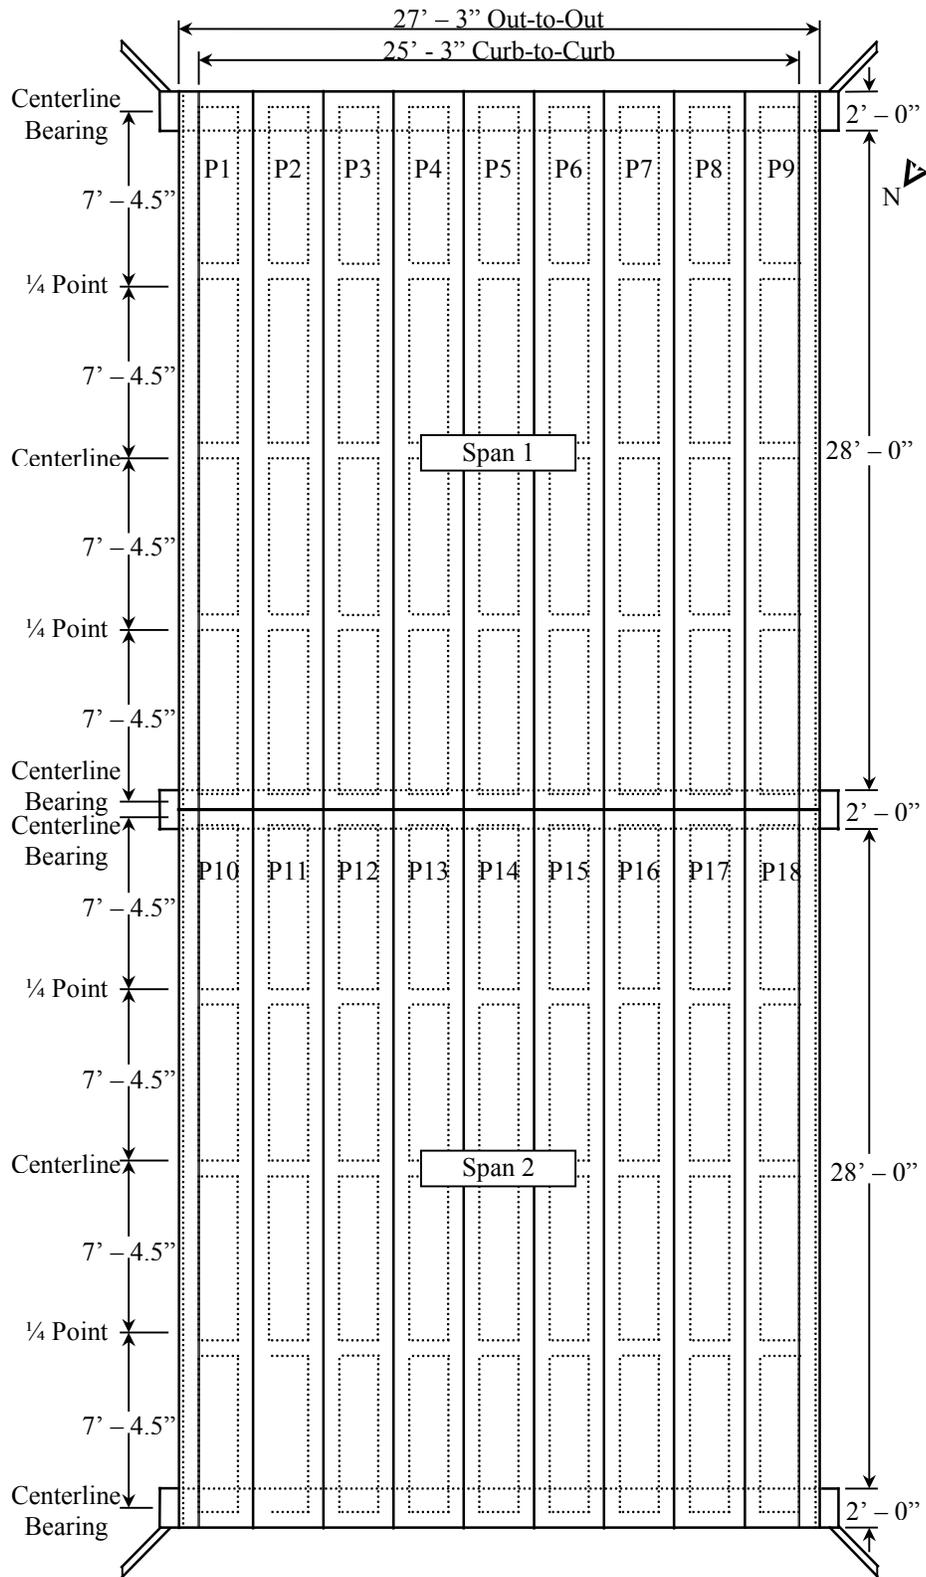
Figure 3.19. Plan view of Bridge 3.

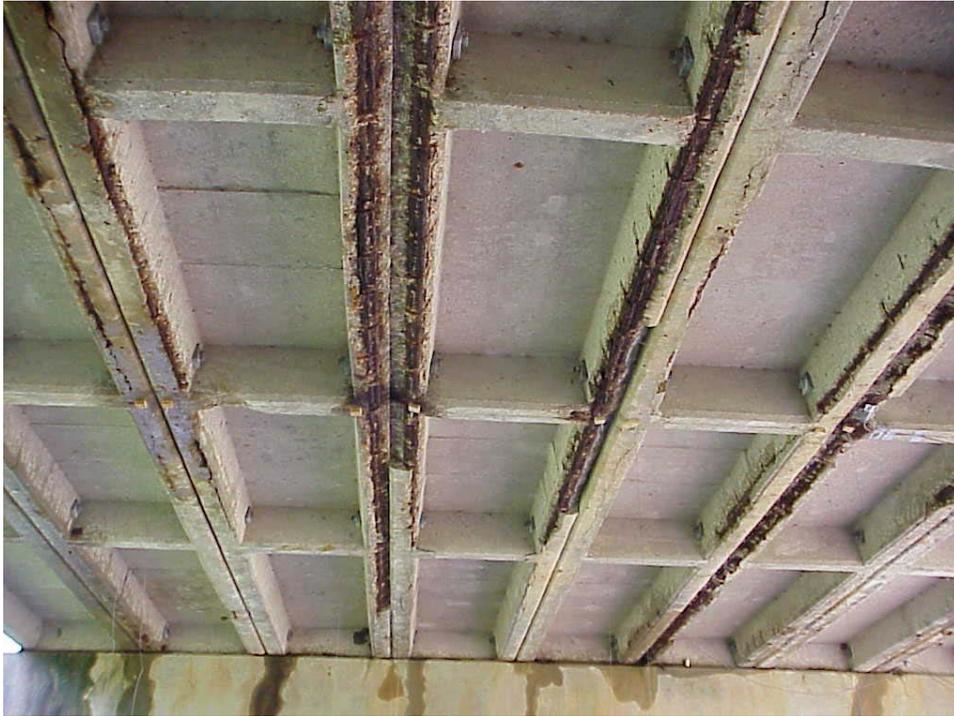
A bridge inspection performed in 1999 noted “much spalling with exposed rebar”. The condition of the deck and superstructure received low ratings and based on a rating

Figure 3.20. Bridge 3 corrosion damage.

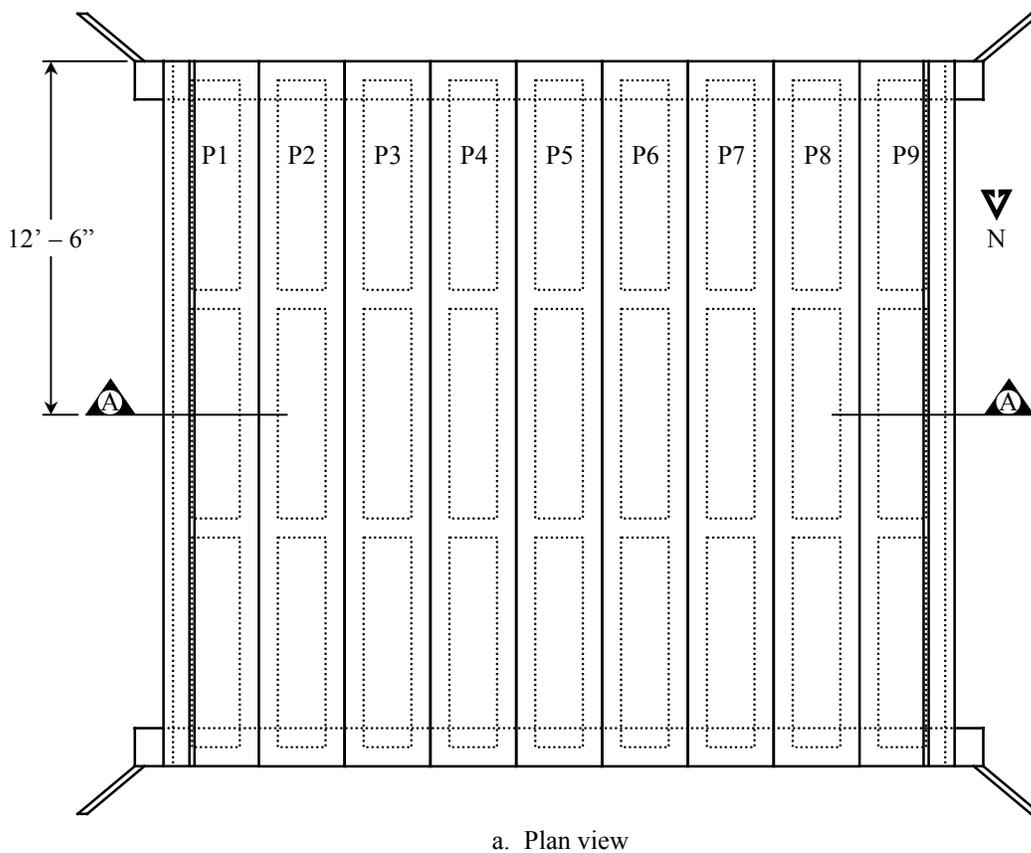
Three BDI gages were installed on each PCDB panel; one on each stem and one on the underside of the panel. All gages were located at midspan as shown in Figure 3.28.

Figure 3.28. Location of strain gages and displacement transducers on Bridge 4.

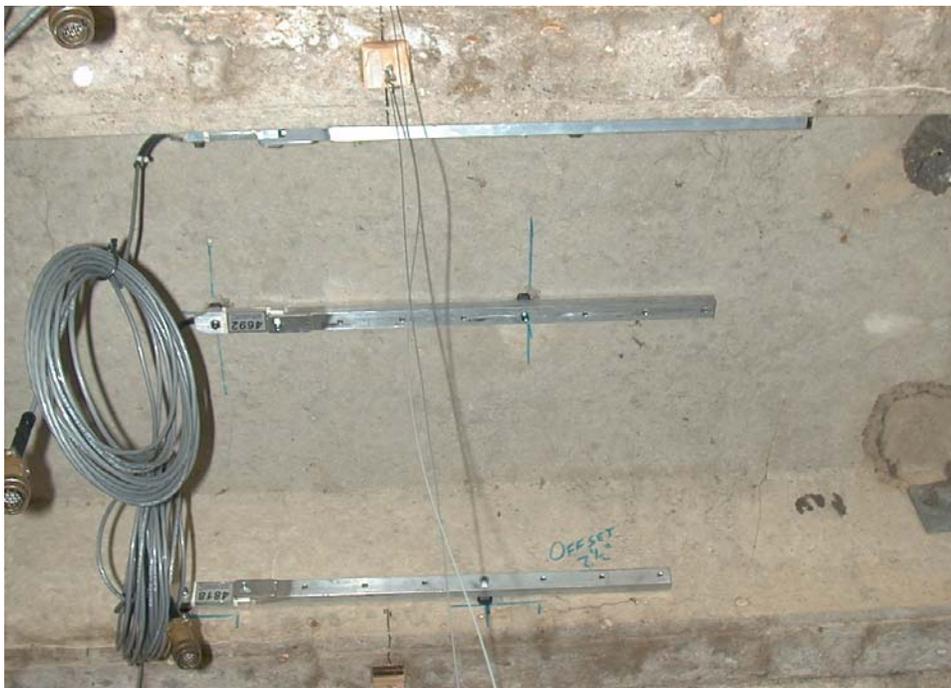
The BDI gages on the panel stems were approximately at the same elevation as the primary steel reinforcing. Therefore, assuming ‘perfect bond’ between the concrete and reinforcing steel, the strains measured by the BDI gages were assumed to equal the actual steel reinforcing strain. Laboratory testing validated this assumption.

Figure 3.29. Typical BDI gage installation.

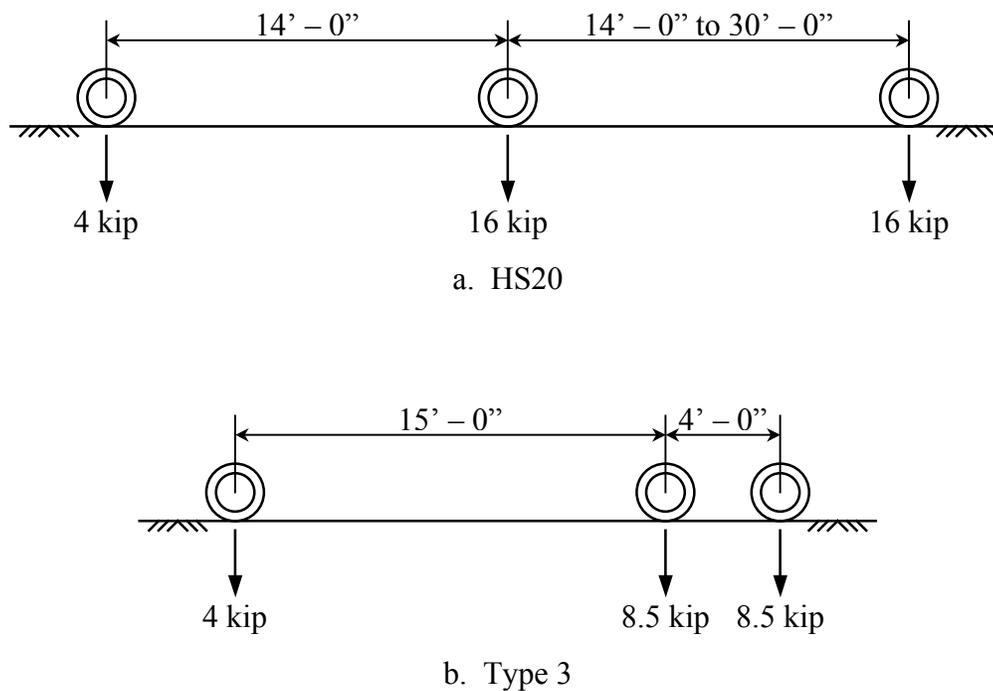
Rating vehicles were selected to represent traffic served by the PCDBs. The HS20 truck is a hypothetical truck used for bridge design and should induce stresses in a bridge that represent those produced by actual vehicles on the bridge. The Type 3 rating vehicle is similar to the tandem axle dump trucks used as the test vehicle for the field service load testing. Axle spacing and wheel line loads are presented for both rating vehicles in Figure 3.33. Also, for comparison, each bridge was rated for one and two lanes loaded. All four PCDBs tested were two lane bridges but the two bridges on gravel roads, Bridge 2 and Bridge 4, would practically function as one lane bridges.

Figure 3.33. Rating vehicles: axle spacing and wheel line loads.

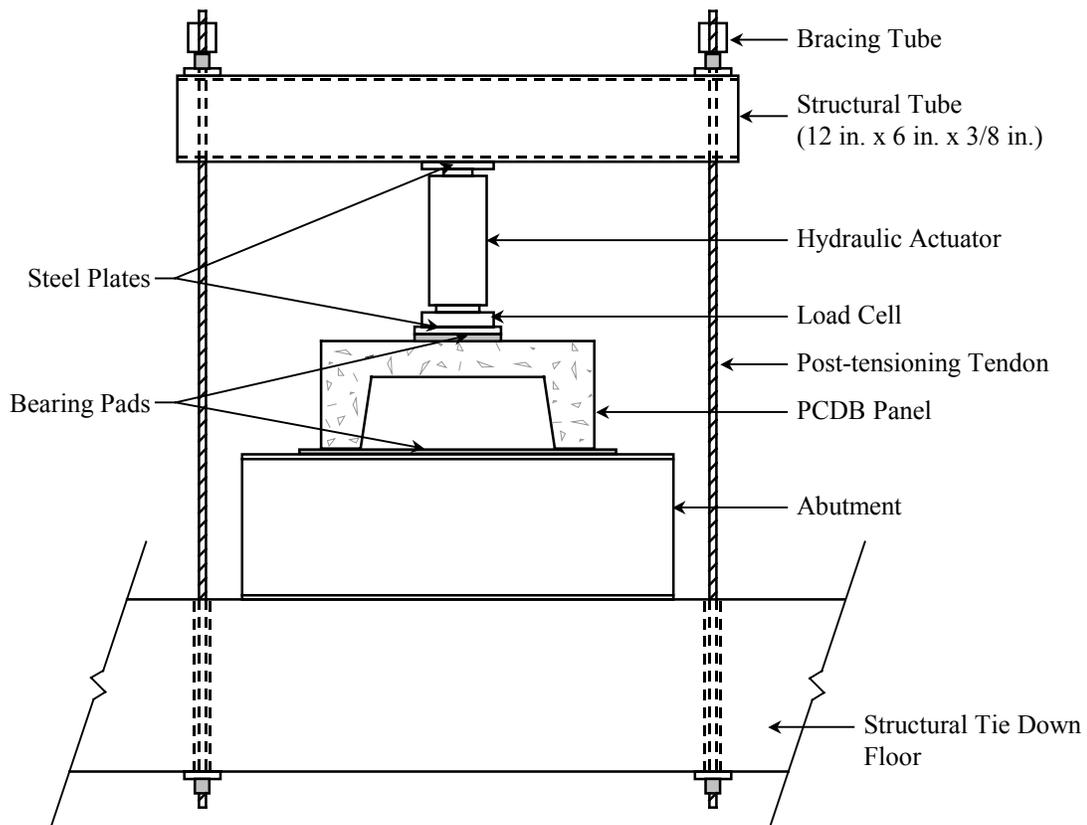
Figure 4.3. Cross-section view of loading setup for individual panel load tests.

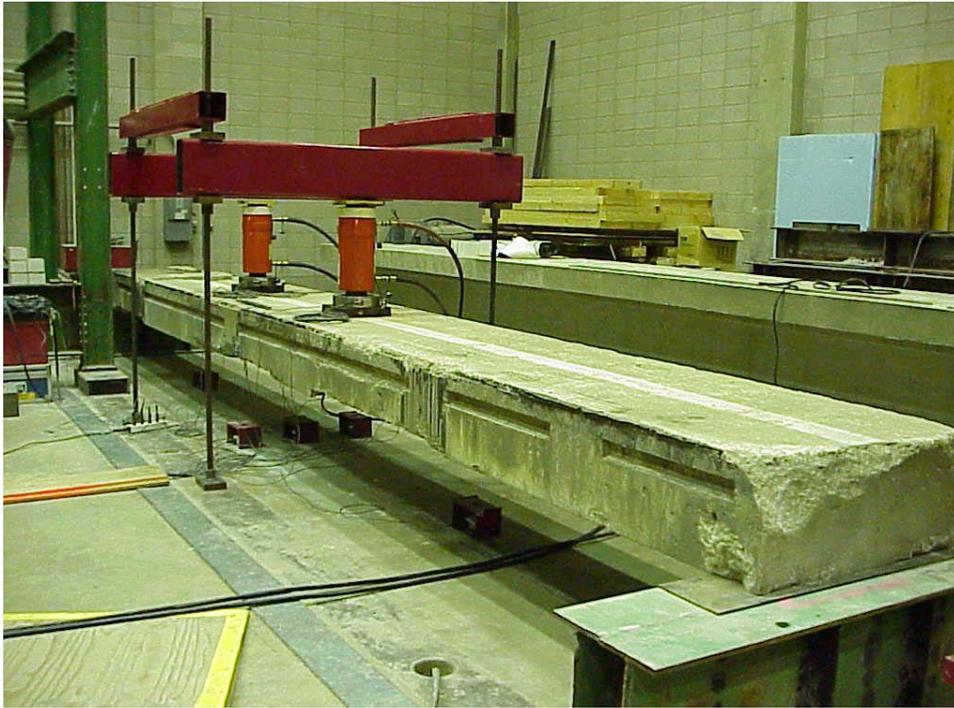
Figure 4.4. Photograph of loading setup for individual panel load tests.

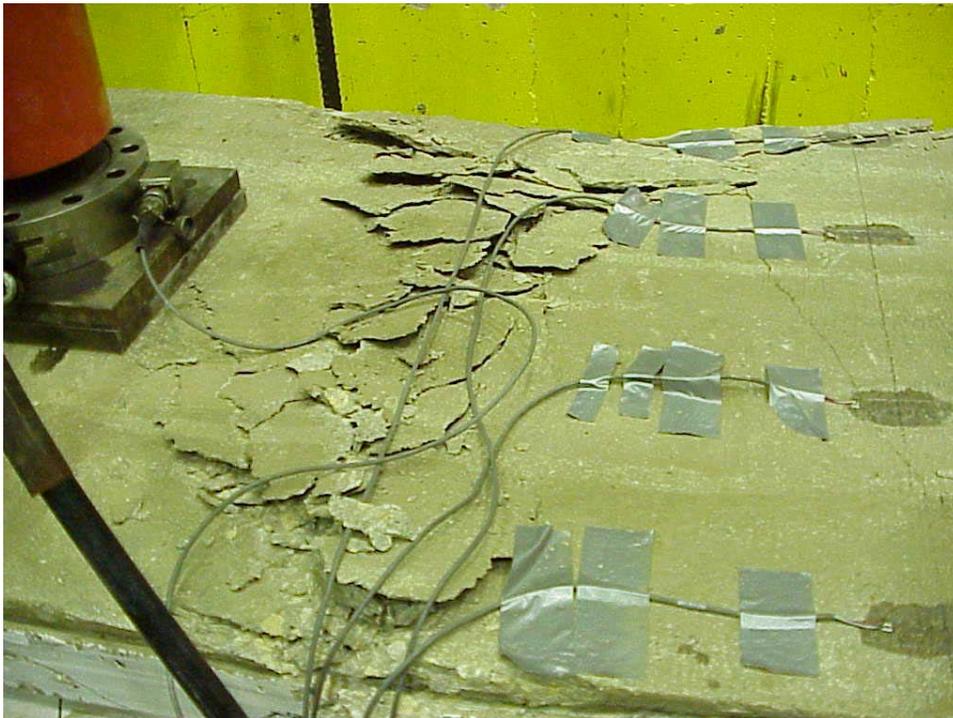
A photograph of the failure is presented in Figure 4.5. Imminent failure was indicated by popping noises from the deck surface. Failure began when one edge of the deck ruptured between the load points. A series of small ruptures then quickly progressed across the deck to the opposite edge. A few seconds later, a large sheet of concrete approximately 30 in. by 24 in. by 1.5 in. thick sheared loose from the panel deck. After the load was removed, it was determined that the ruptured concrete extended down to the level of the upper layer of the longitudinal deck reinforcement.

Figure 4.5. Line of ruptured concrete across the deck of Cedar 1.

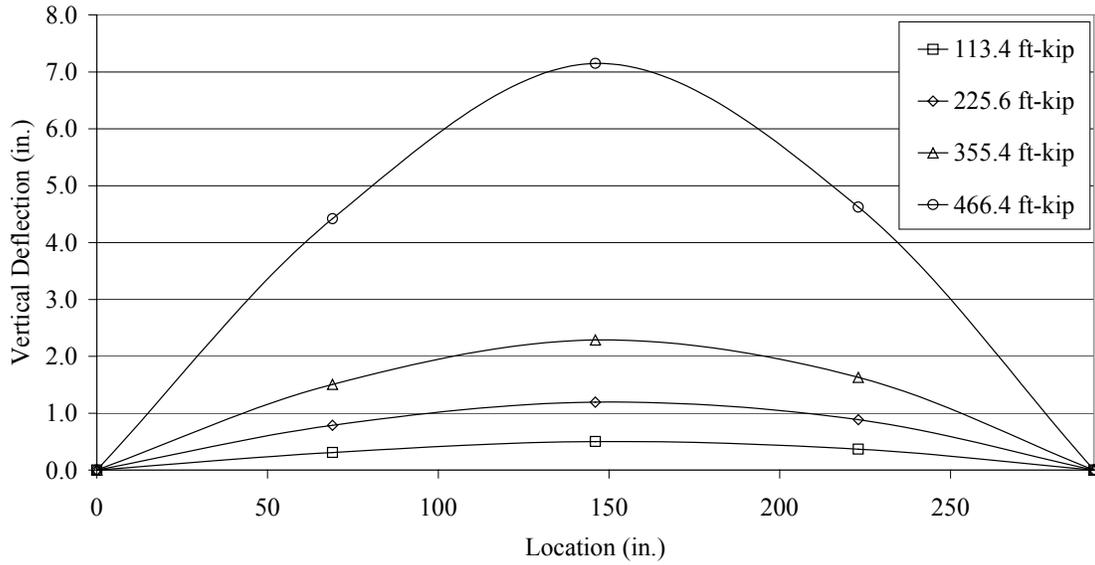
Figure 4.6. Vertical deflection along the length of Cedar 1.

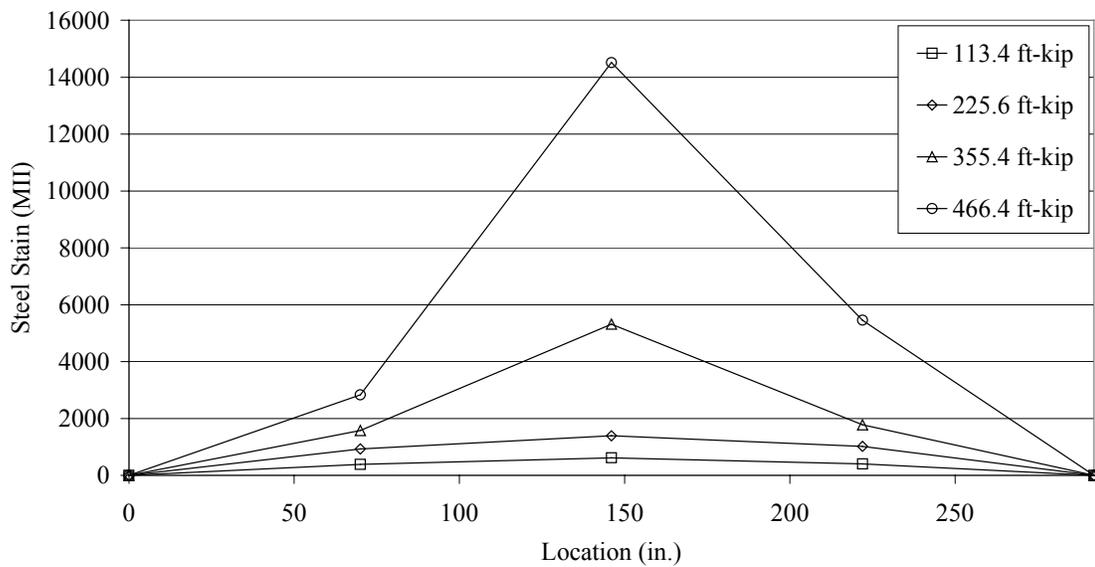
Similarly, average steel strain at each quarterpoint and midspan location for the same four midspan moments are presented in Figure 4.7. When panel behavior was elastic, theoretical steel strains compared favorably with the measured steel strains. For example, at

Figure 4.7. Steel strains along the length of Cedar 1.

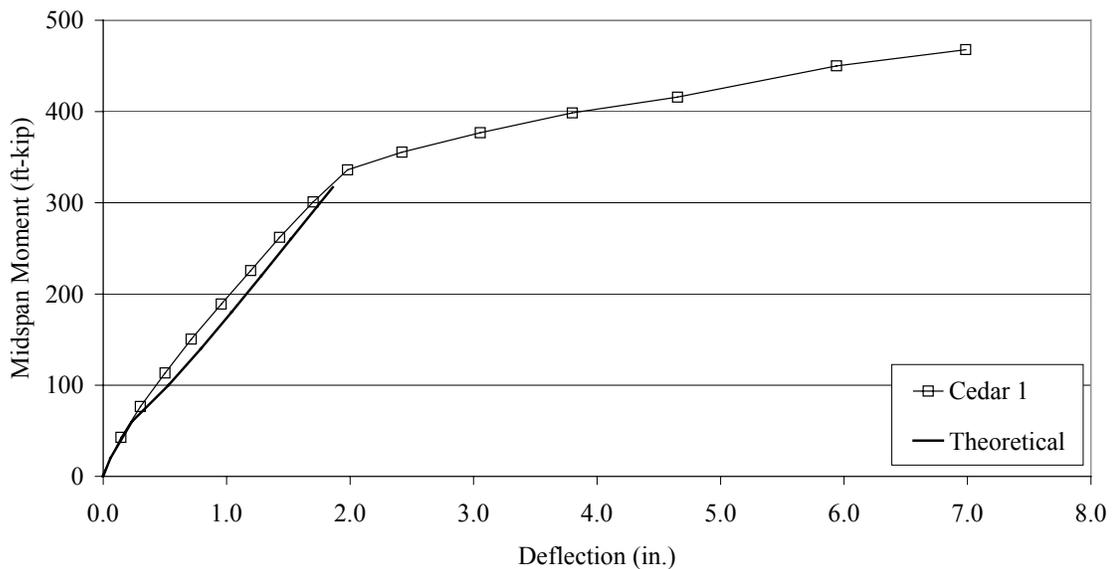
A moment/deflection curve and theoretical midspan deflections for Cedar 1 are presented in Figure 4.8. Similarly, a moment/steel strain curve and moment/concrete strain curve for Cedar 1 are presented in Figure 4.9 and 4.10, respectively. All theoretical values correlated well the corresponding experimental values. Due to the similarity between these three curves, only moment/deflection curves are presented for the other panels discussed in subsequent sections.

Figure 4.8. Midspan moment vs. midspan deflection for Cedar 1 ultimate strength test.

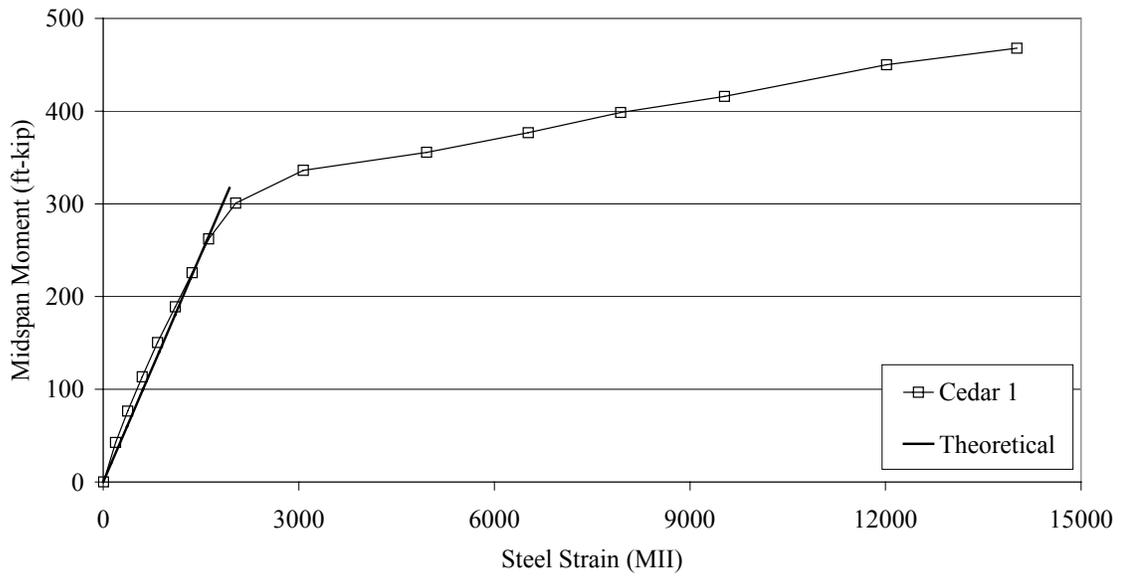
Figure 4.9. Midspan moment vs. midspan steel strain for Cedar 1 ultimate strength test.

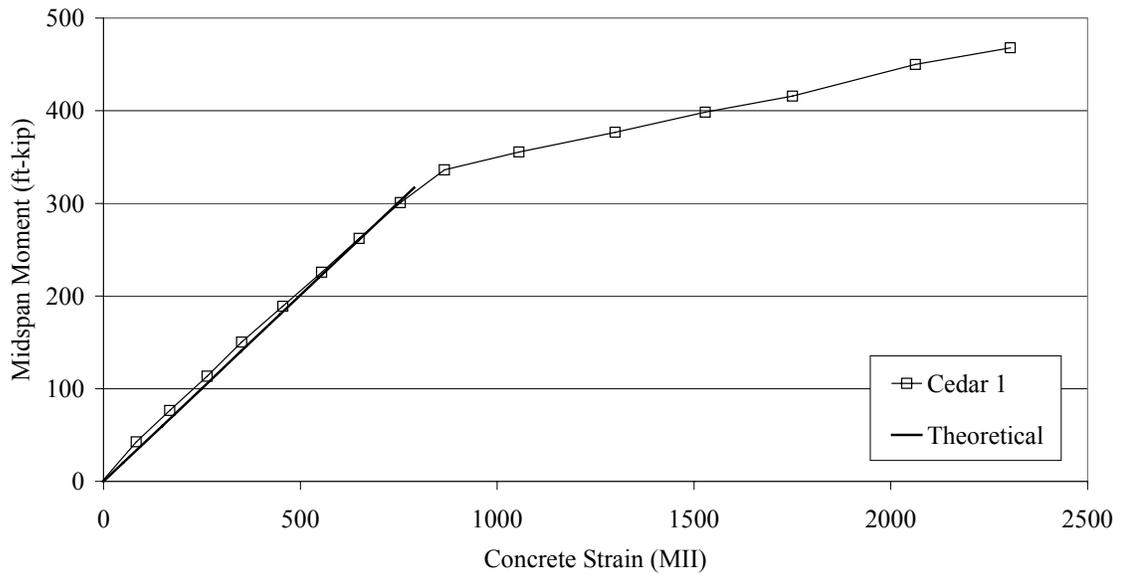
Figure 4.10. Midspan moment vs. midspan concrete strain for Cedar 1 ultimate strength test.
