Field and Laboratory Evaluation of Precast Concrete Bridges

Iowa DOT Project TR-440

FINAL REPORT

Department of Civil and Construction Engineering

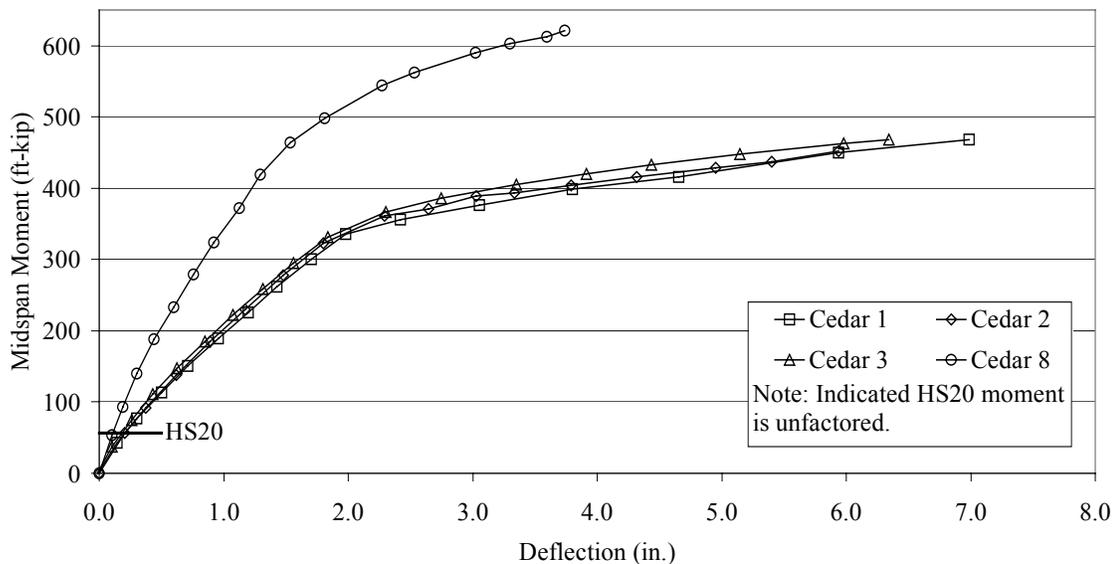
Moment/deflection curves for Cedar 1-3 and Cedar 8 are presented in Figure 4.11. Cedar 1-3, the three interior panels, displayed nearly identical behavior throughout the entire elastic range. In the inelastic range, behavior of these three panels deviated only slightly. Although the amount of deterioration varied between these three panels, the close correlation of the test data indicates that the deterioration had essentially no effect on the strength of the panels.

Figure 4.11. Midspan moment vs. midspan deflection for Cedar 1, 2, 3 and 8 ultimate strength tests.

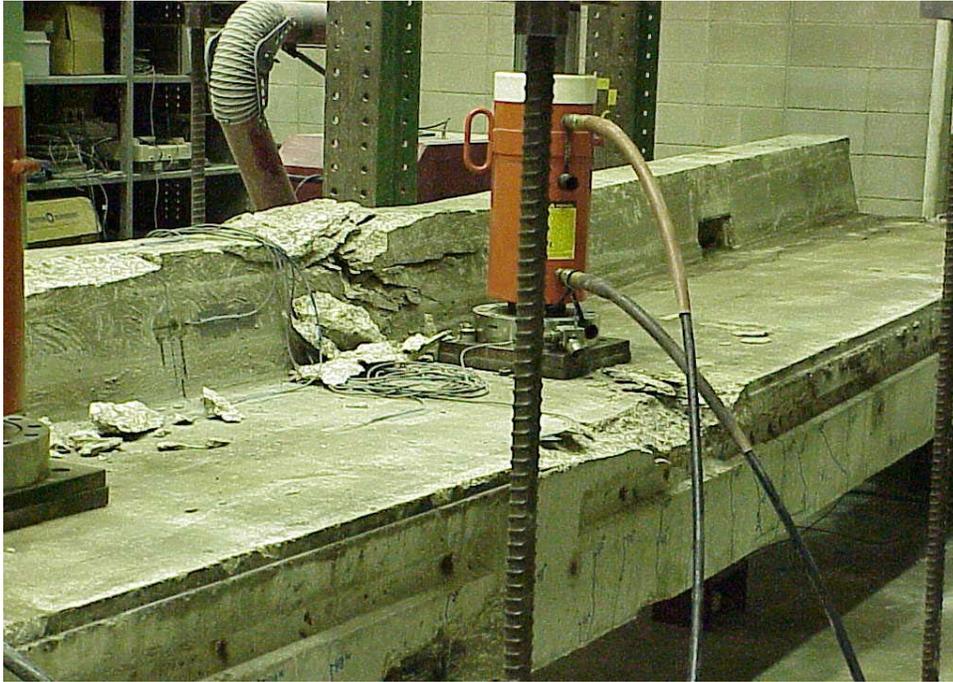
Figure 4.12. Failed curb on Cedar 8.

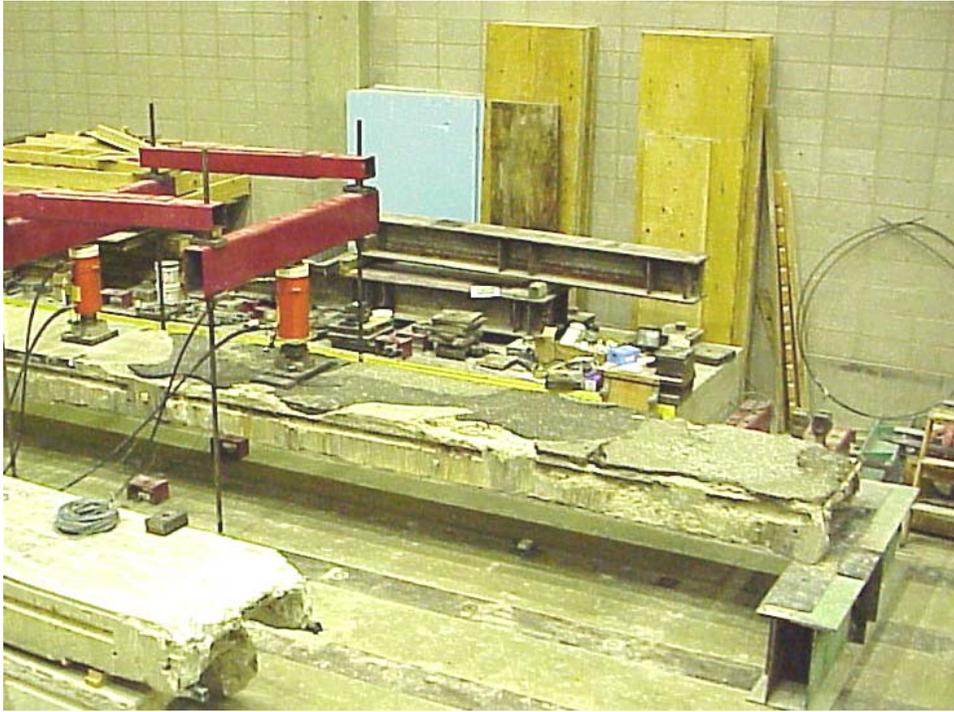
Figure 4.13. Deck deterioration in Butler 3.

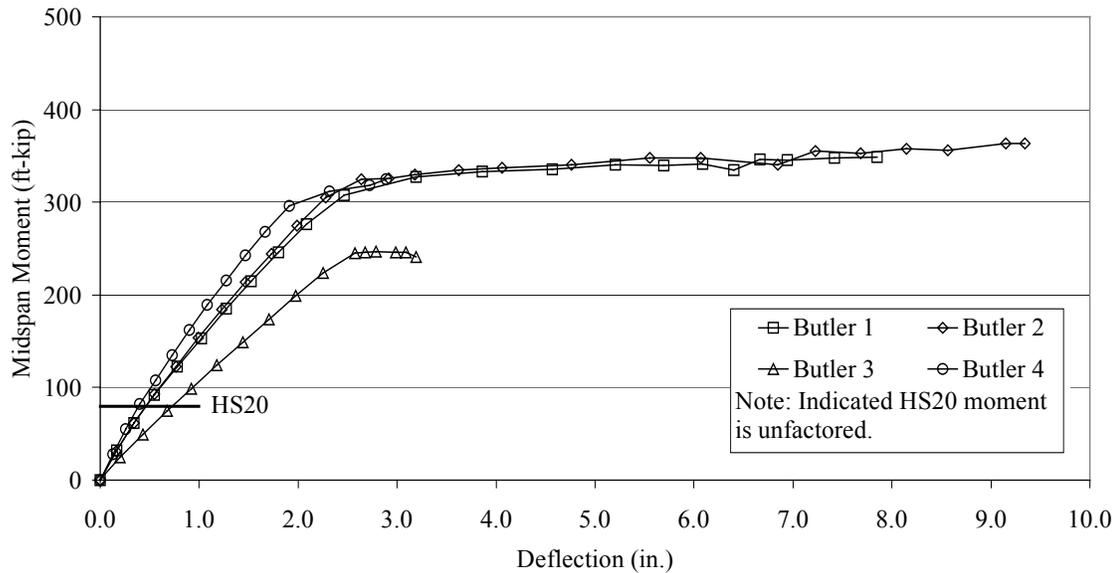
Figure 4.14. Ultimate strength tests of Butler 1-4: midspan moment vs. midspan deflection.

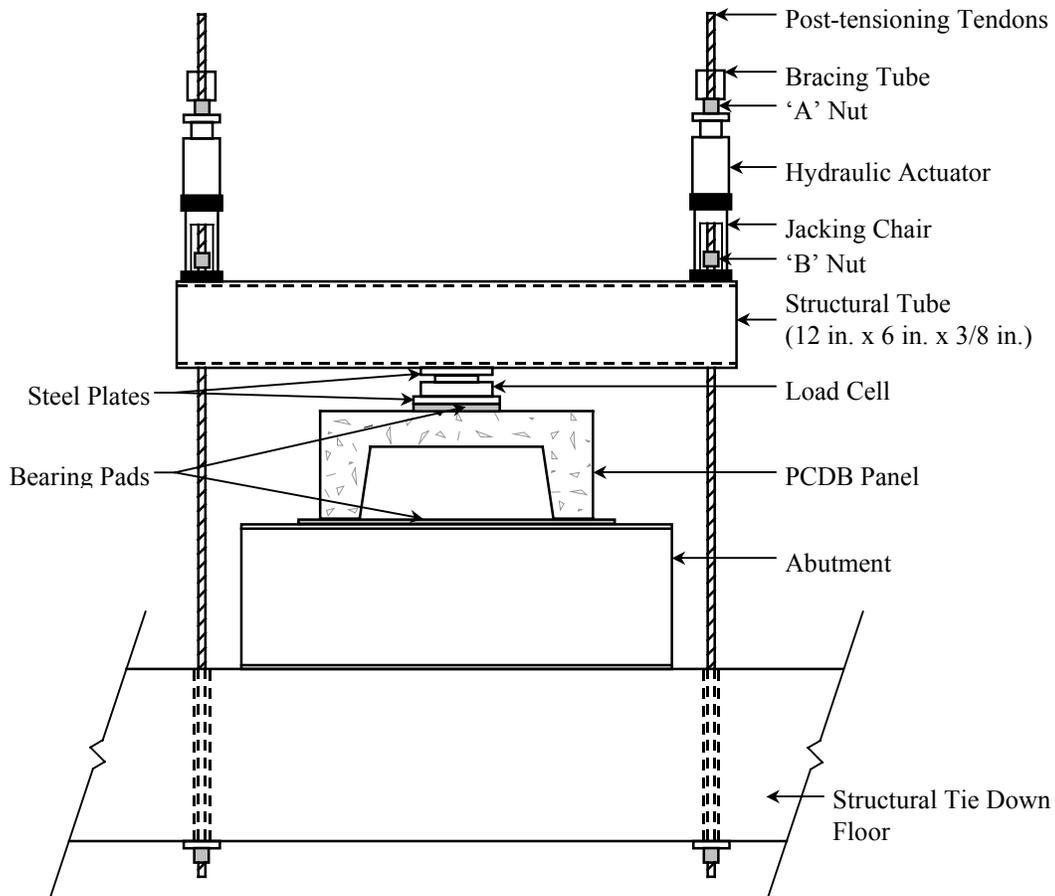
Figure 4.15. Modified loading setup.

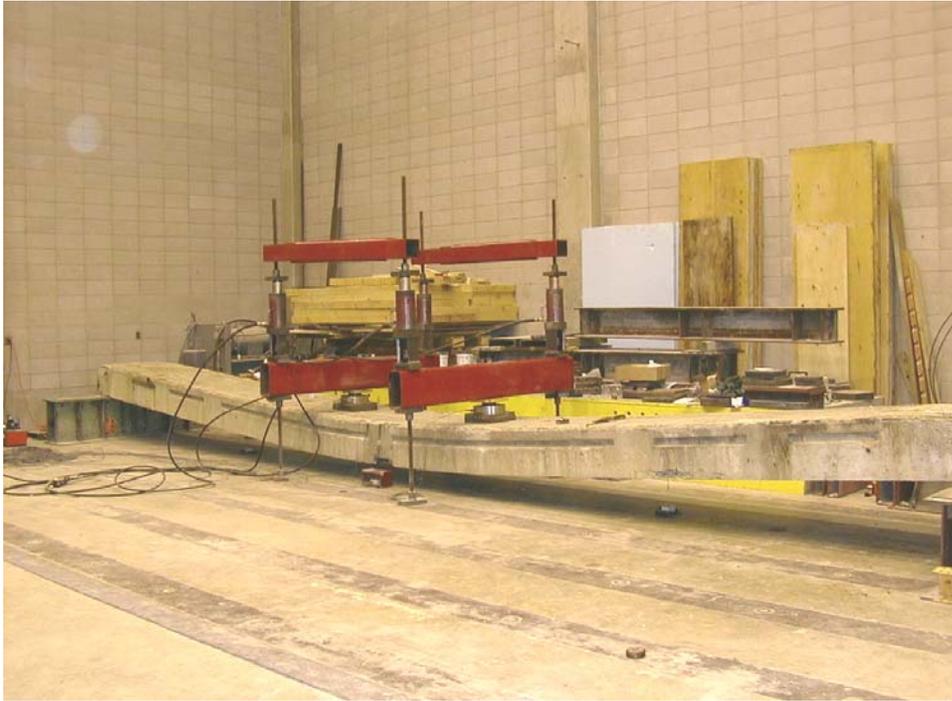
jacking chairs were tightened down. With these nuts holding the structural tube in position, hydraulic pressure to the actuators was released allowing the actuators to retract. The 'A' nuts were then tightened down and hydraulic pressure was restored to the actuators. This cycle continued until panel failure occurred. The modified load setup, as well as the large ductility of the Black Hawk panels, is shown in Figure 4.16.

Figure 4.16. Black Hawk 3 at imminent failure.

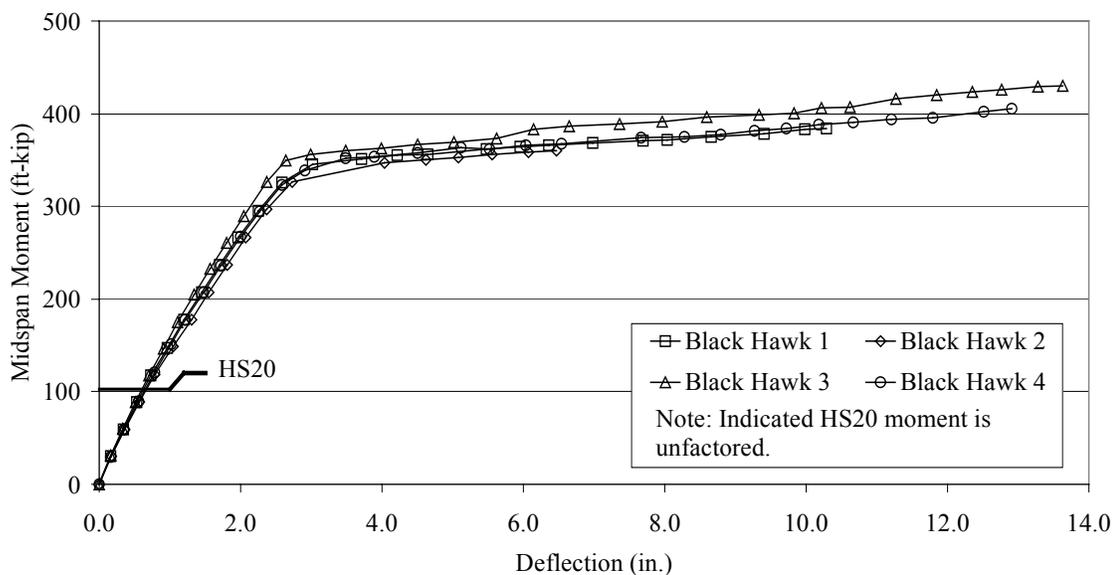
experimentally. Cedar 1-3 were the shortest panels tested and theoretically the weakest, but experimental ultimate strengths for these panels exceeded all others. This anomaly was due to the fact that the Cedar County panels had the highest material strengths. Reinforcing steel in the Cedar County panels had the highest yield strength and exhibited a significant amount of strain hardening. Strain hardening was far less prevalent in the other two groups of panels. This is apparent through a comparison of the moment/deflection curves of all three groups of panels.

Figure 4.17. Midspan moment vs. midspan deflection for Black Hawk 1-4 ultimate strength tests.

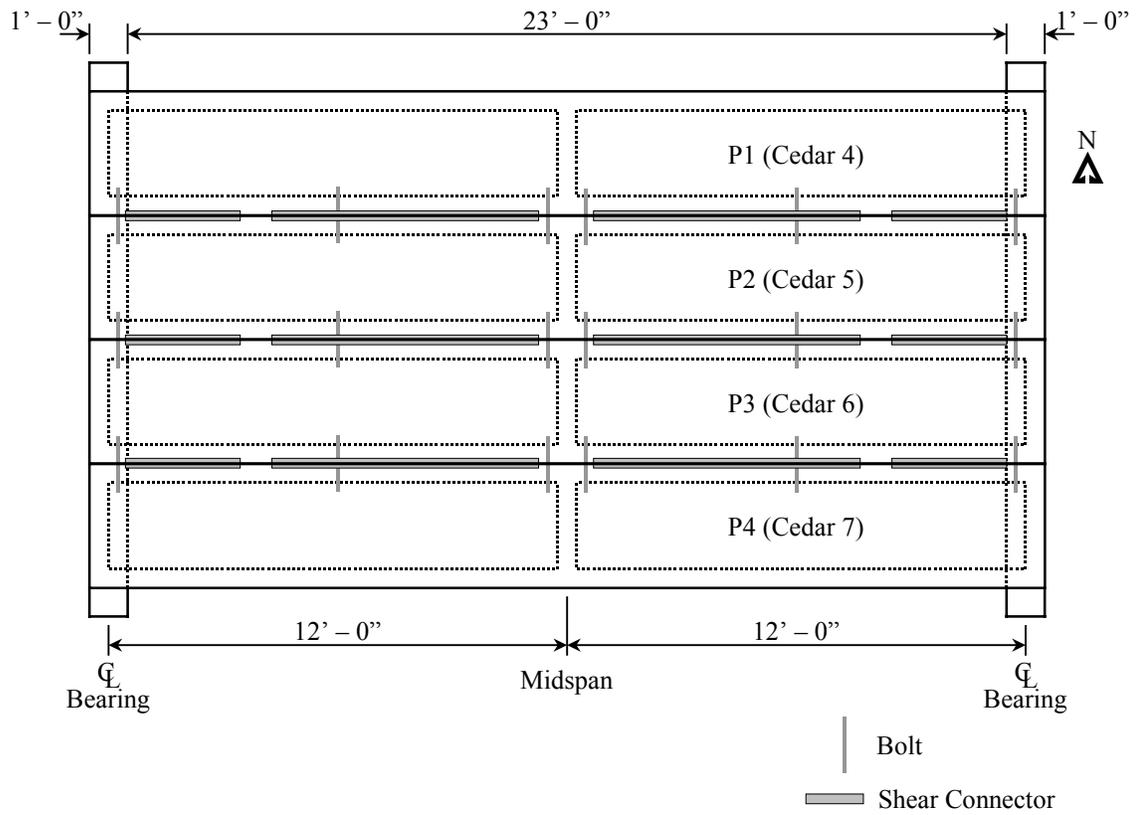
A plan view and photograph of the laboratory PCDB are presented in Figure 5.1 and Figure 5.2, respectively. The individual panels were joined together by three different joint configurations. For the first joint configuration, hereafter referred to as ‘loose bolts only’, the long, galvanized bolts (hereafter simply referred to as bolts) were installed in the six locations (see Figure 5.1). The bolts connecting P1 and P2 were loosely installed while all other bolts were tightened with a torque wrench to 40 ft-lbs. This torque value was assumed to represent typical field conditions for bolt tightness. For the second joint configuration, hereafter referred to as ‘tight bolts only’, all panels were again connected only with bolts, all which were tightened to 40 ft-lbs. In the third joint configuration, hereafter referred to as ‘tight bolts plus shear connectors’, the shear connectors (concrete-filled galvanized pipes) were installed in all panel joints and all of the bolts were installed and tightened to 40 ft-lbs.

Figure 5.1. Plan view of laboratory PCDB.

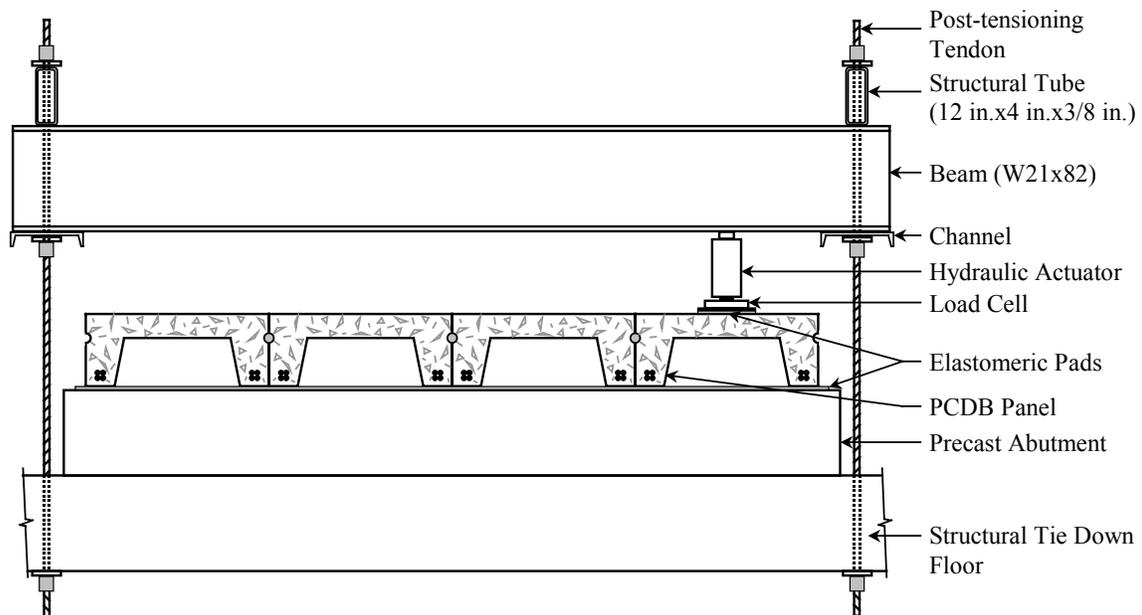
Figure 5.4. Load setup for joint configuration tests.

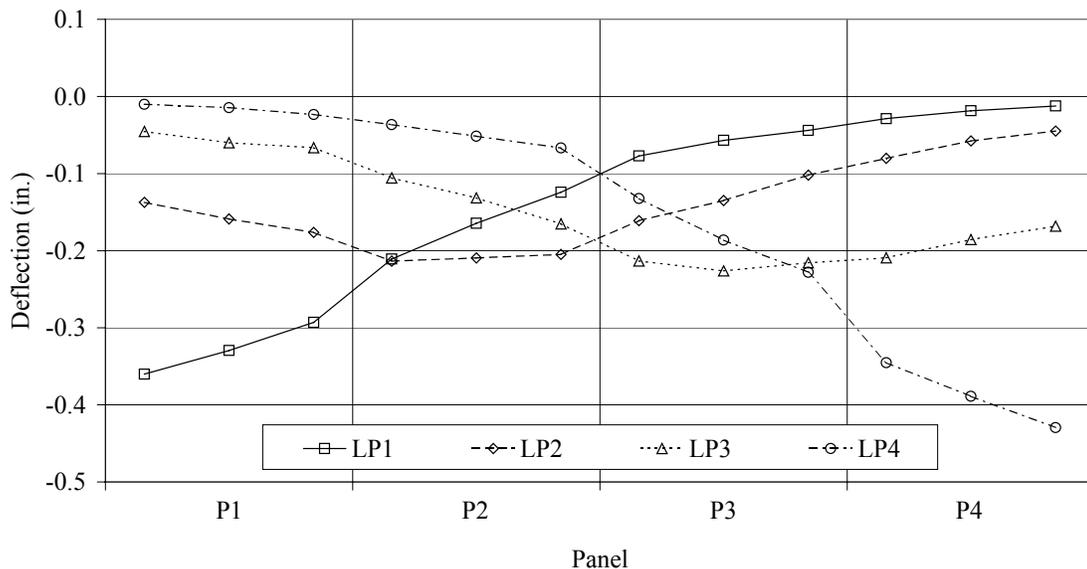
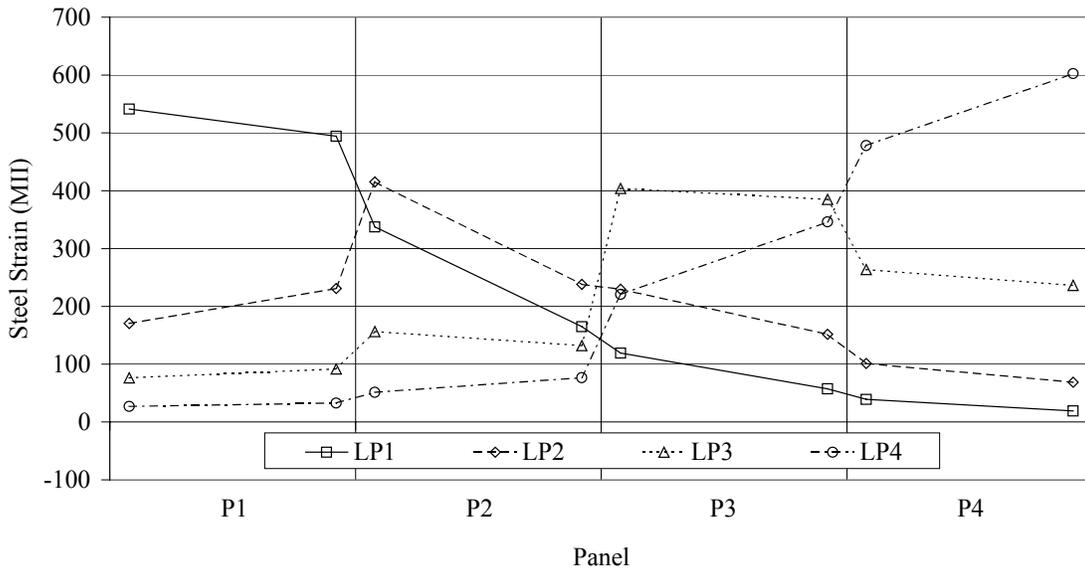
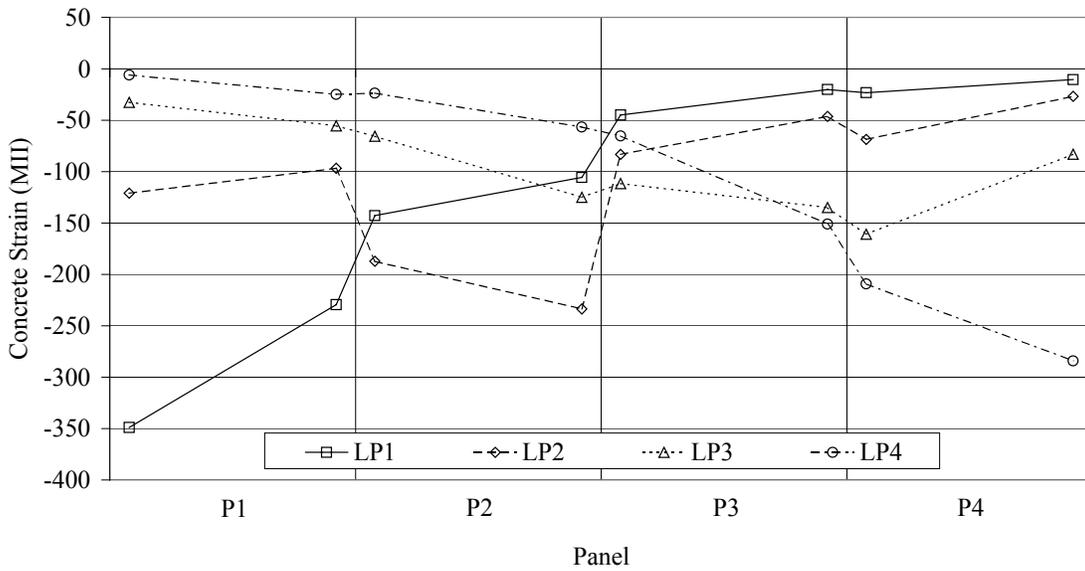
a. Midspan vertical deflection

Figure 5.6. Laboratory PCDB response curves at 28 kip for ‘tight bolts plus shear connectors’ joint configuration.

b. Midspan steel strain

c. Midspan concrete strain

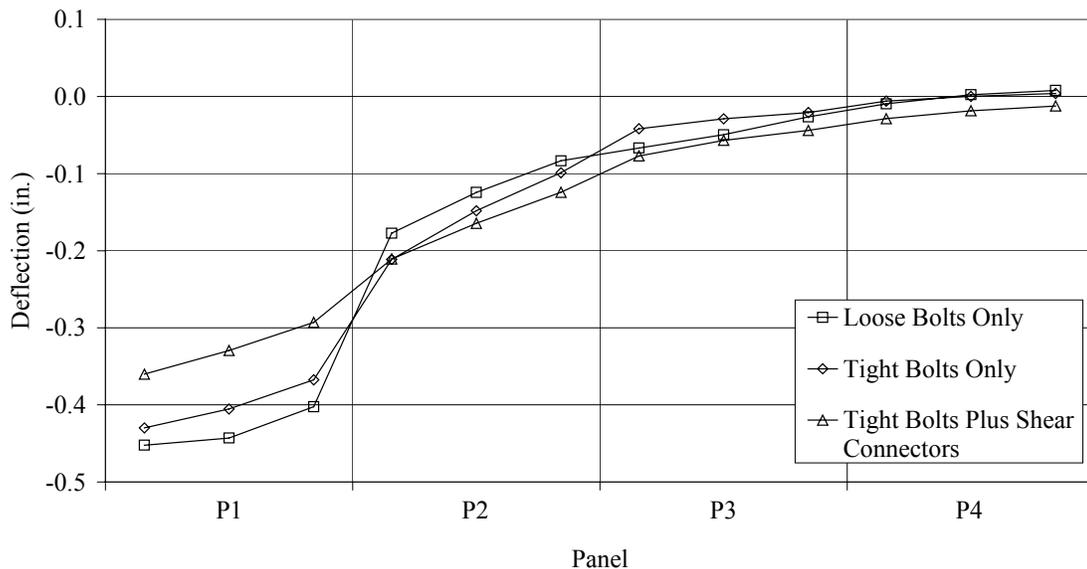
Figure 5.8. LP1 midspan deflection at 28 kip for all three joint configurations.

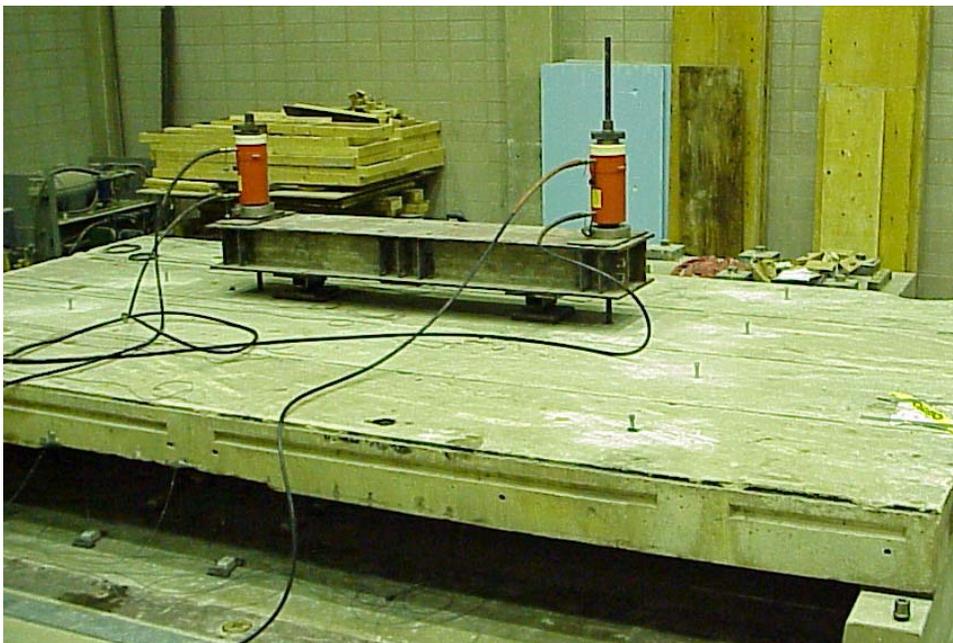
Figure 5.9. Photograph of load setup used in the ultimate strength test of the laboratory PCDB.

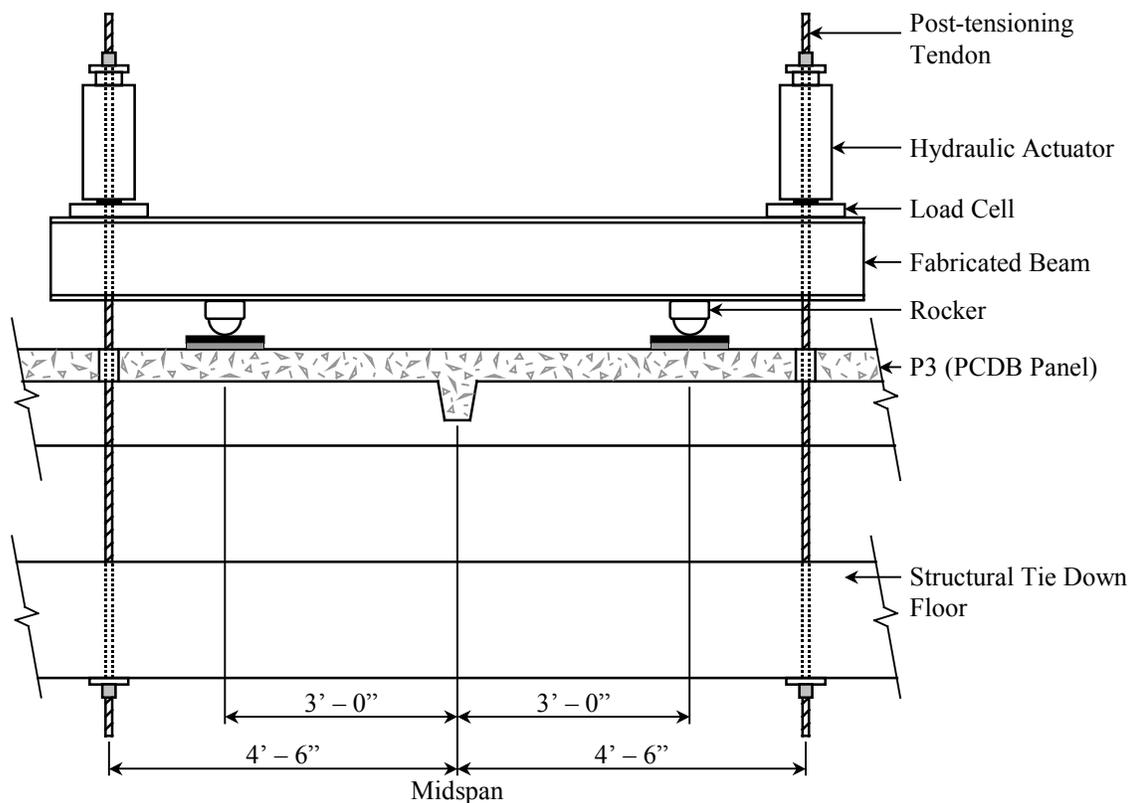
Figure 5.10. Details of load setup for ultimate strength test of the laboratory PCDB.

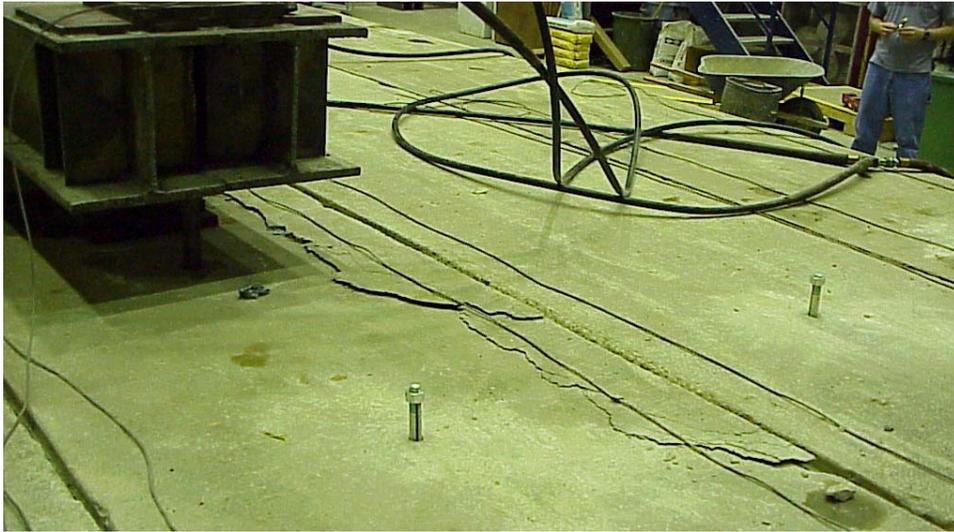
Figure 5.11. Crack in deck of P3 at failure.

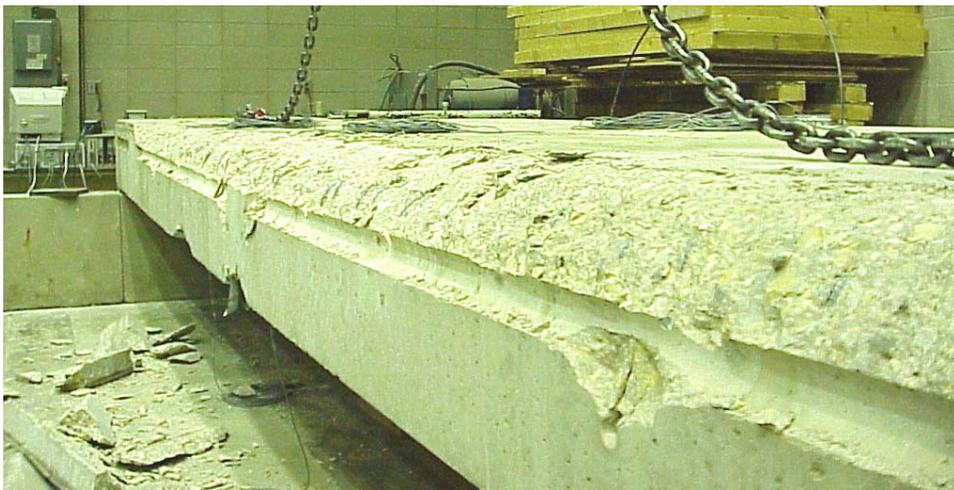
Figure 5.13. Failed concrete above shear connector in P3 (looking east).

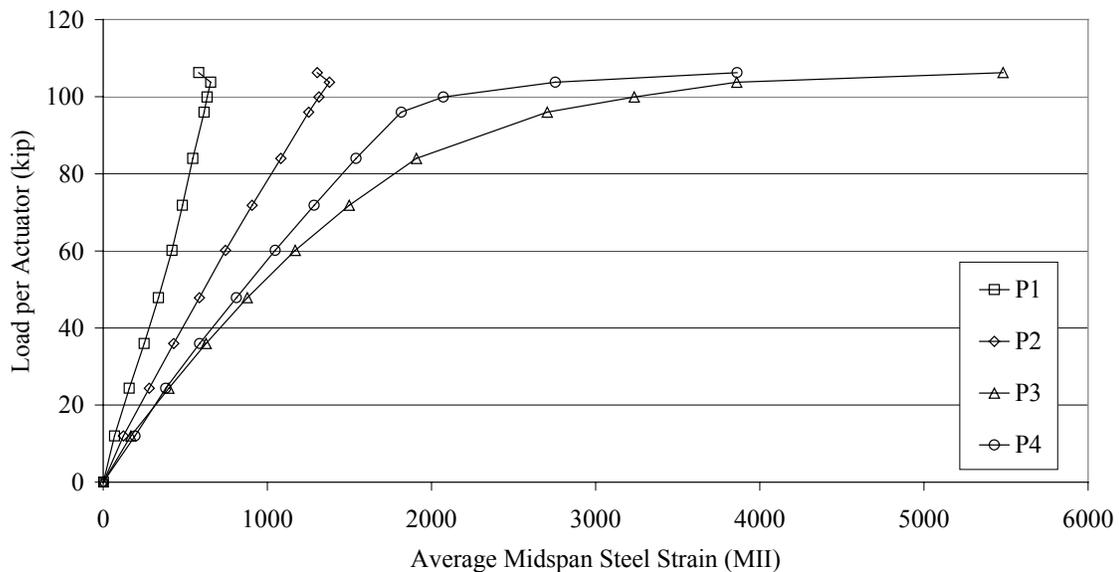
Figure 5.14. Load/steel strain plot for laboratory PCDB ultimate strength test.

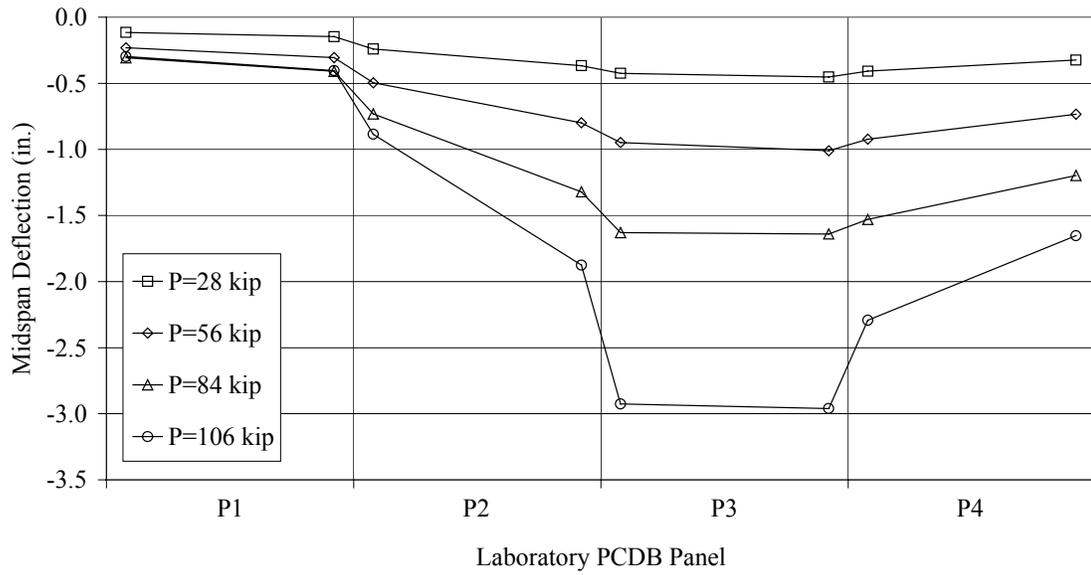
Figure 5.15. Midspan deflections at various loads for laboratory PCDB ultimate strength test.

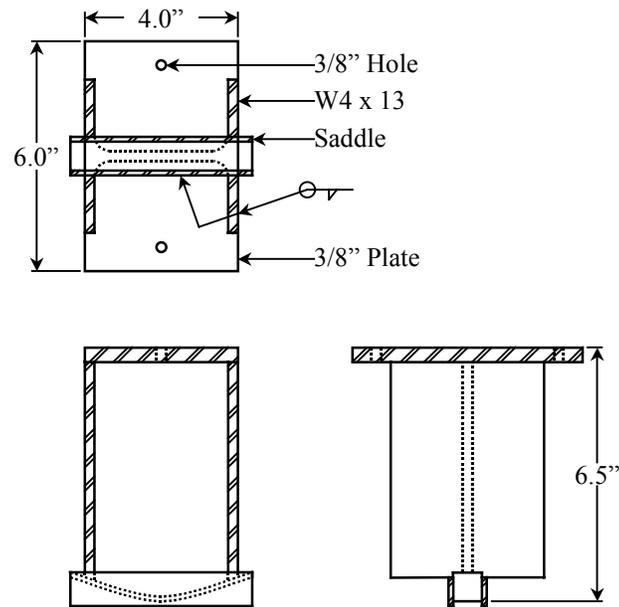
Figure 6.1. Strut developed for strengthening retrofit.

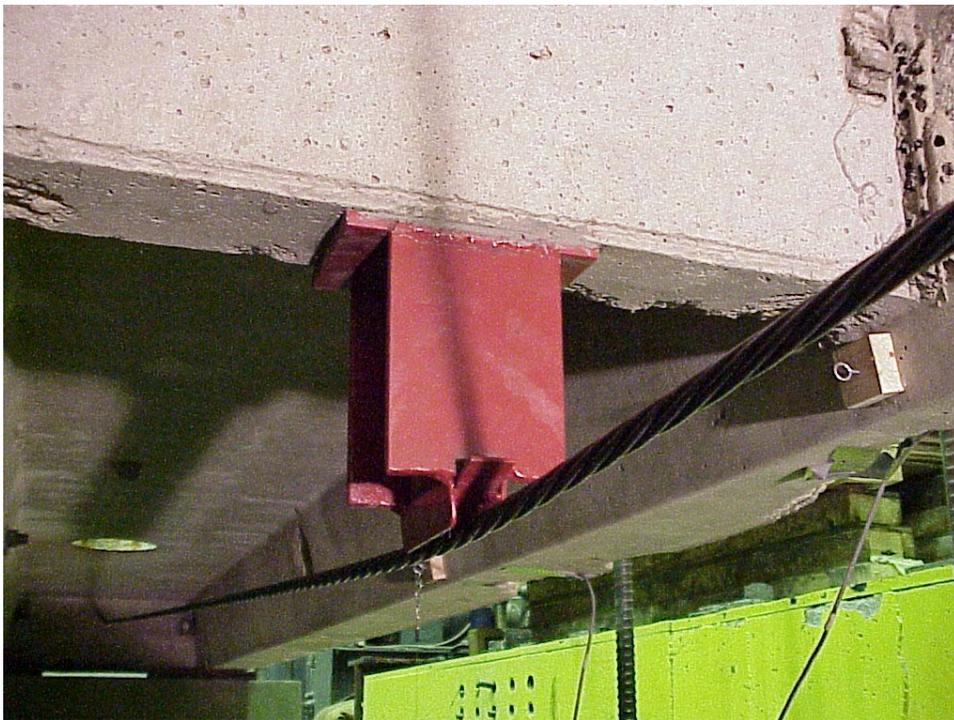
Figure 6.2. Photograph of strut installed on midspan diaphragm.

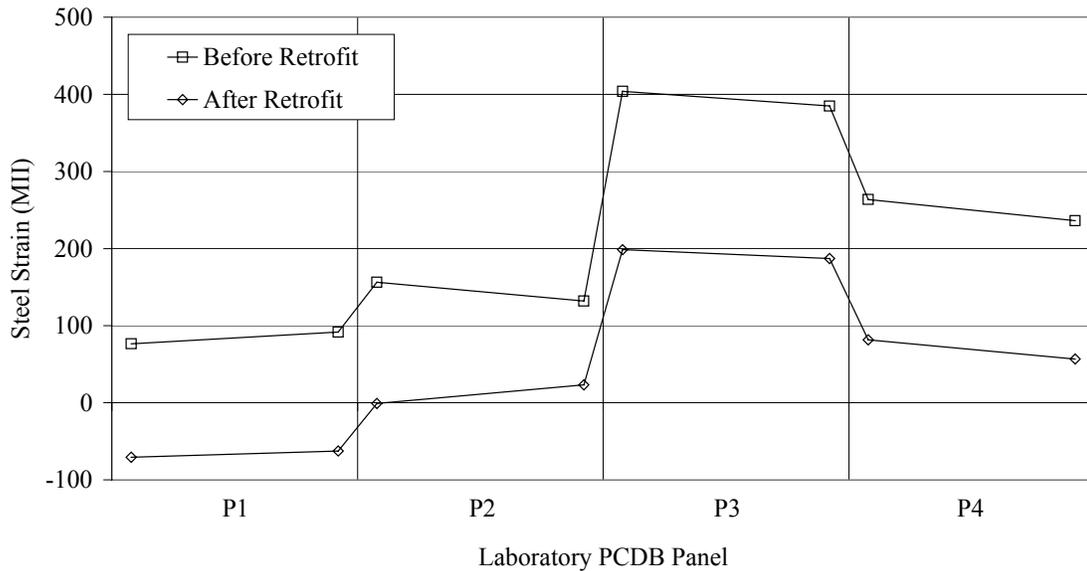
Figure 6.6. Midspan steel strains for LP3 at 28 kip.

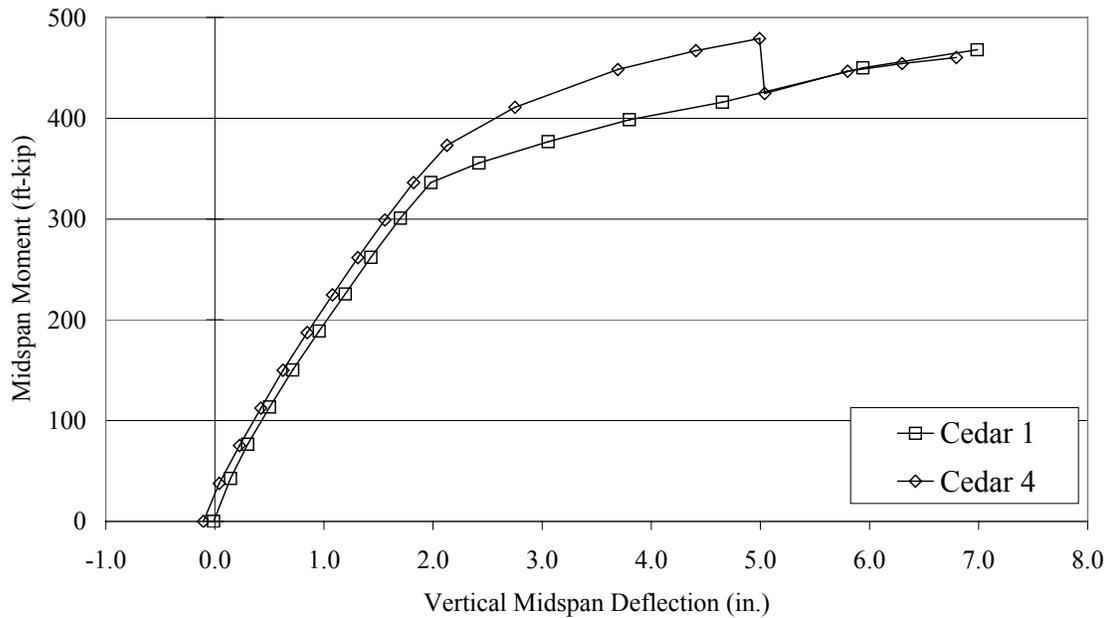
Figure 6.7. Midspan moment vs. midspan deflection for Cedar 1 and 4 during the ultimate strength tests.

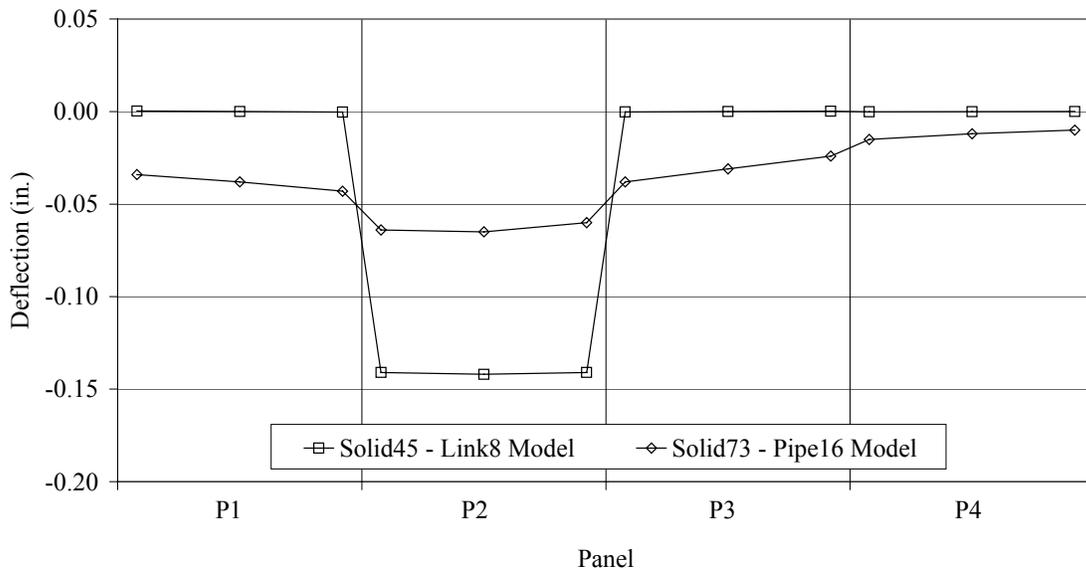
Figure 7.10. Comparison of the Solid45 – Link8 and Solid73 – Pipe16 models for LP2.

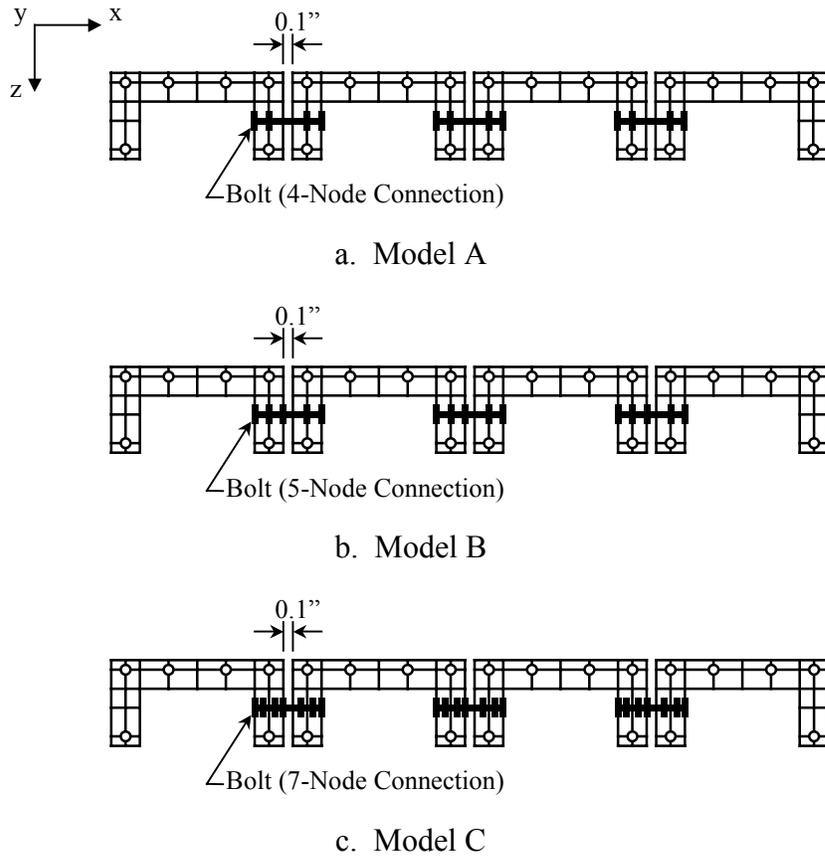
Figure 7.11. Models of bolt connections.

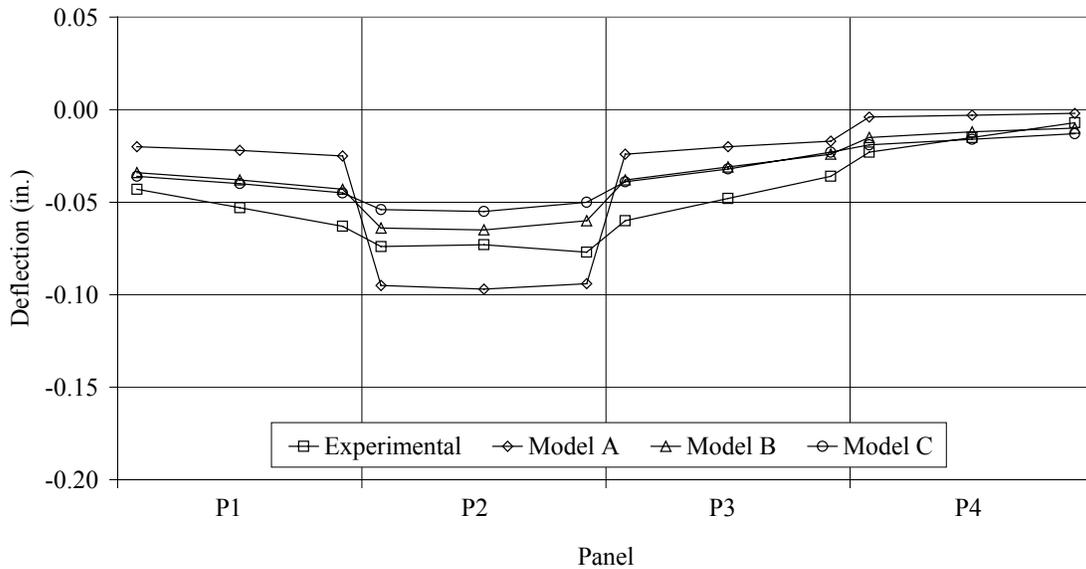
Figure 7.12. Comparison of node connections scenarios of bolt model for LP2.

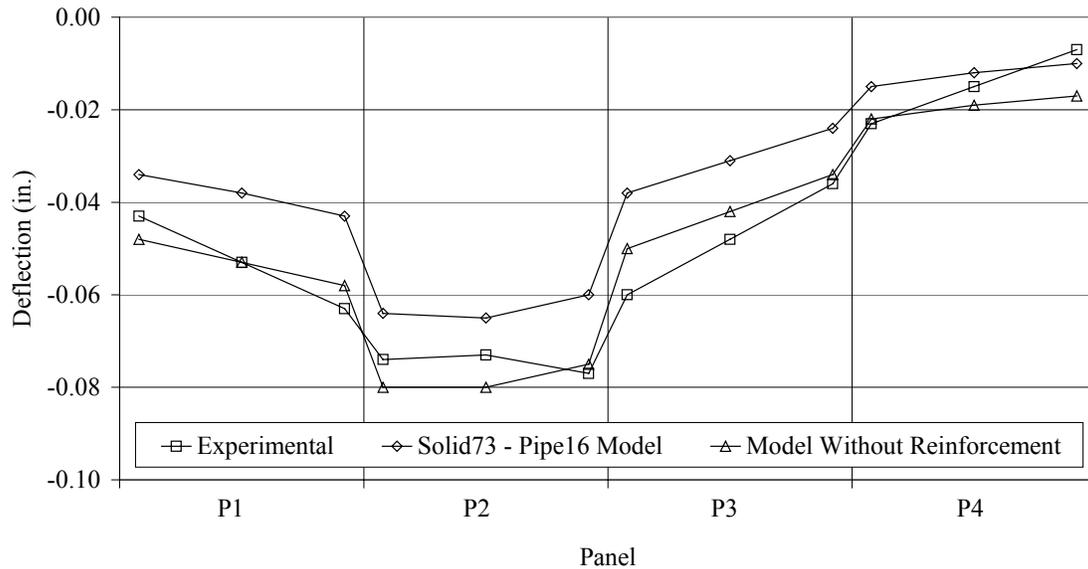
Figure 7.13. Effect of reinforcement and model on deflection.

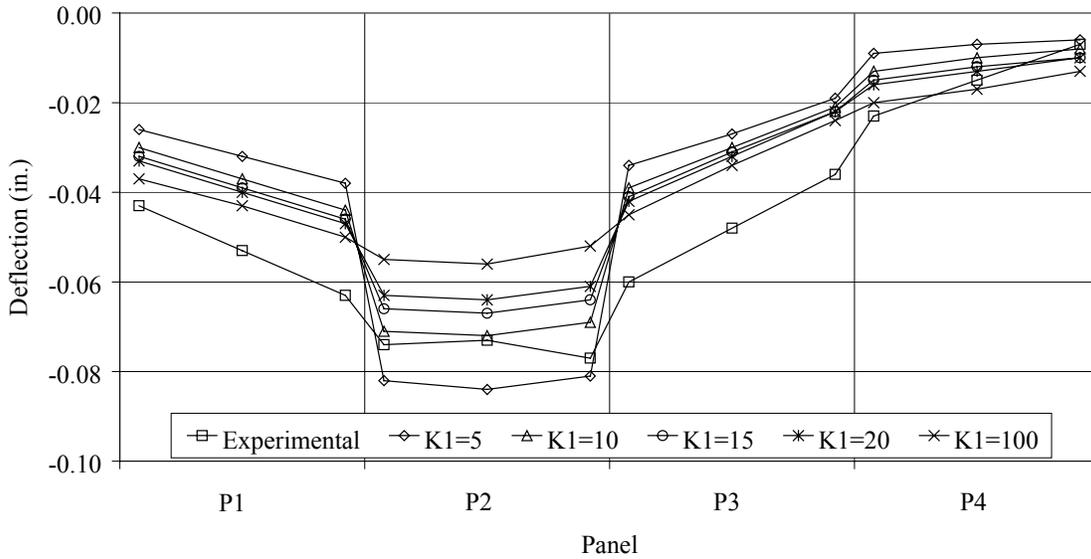
Figure 7.15. Effect of translational stiffness of Combin7 element on deflection for LP2.
