**EFFECTIVENESS OF
ELECTROCHEMICAL CHLORIDE
EXTRACTION
FOR THE IOWA AVENUE
PEDESTRIAN BRIDGE**

Final Report

**Sponsored by
Iowa Department Transportation
Iowa Highway Research Board
Project # TR-499**

**PUBLIC POLICY CENTER
CIVIL AND ENVIRONMENTAL ENGINEERING
UNIVERSITY OF IOWA
March 2005**

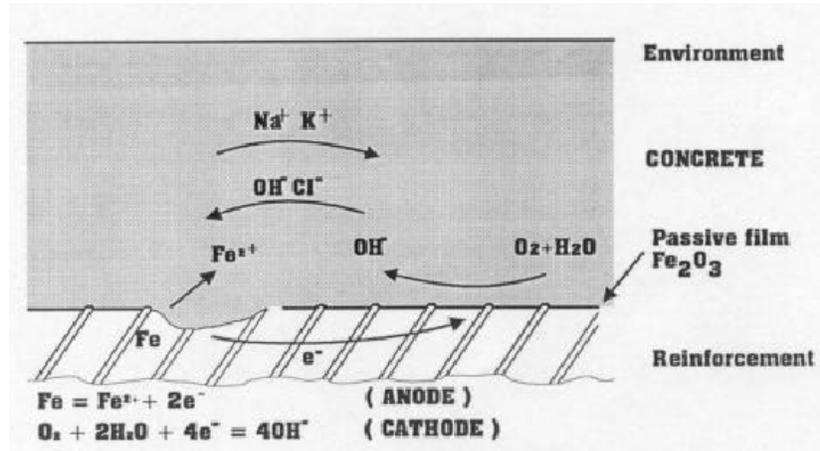
Figure 1 Mechanism of Reinforcement Corrosion (Klinghoffer, 1995)

separates from the reinforced concrete structure. The concrete must be repaired to recover its strength for safety (Daily, 2003). The electrochemical corrosion mechanism in concrete induced by chloride can be seen in Figure 1.

The area where the metal ion goes into solution becomes the anodic region. If the metal is iron (Fe), it goes into the solutions to form ferrous ions (Fe^{2+}) and two electrons ($2e^-$) (Cho, 1997).

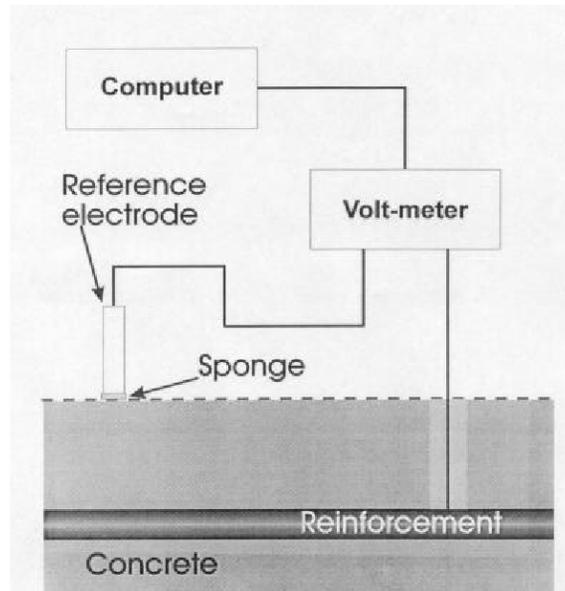
Figure 2 Basic Setup of Half-cell Method (Oskar, 1995)

This method was first developed in the late 1950's and has since been used extensively for the assessment of concrete bridges. It was adopted in 1977 as ASTM method C876. The method measures the electrochemical potential of reinforcement against a reference electrode placed on the concrete surface. The basic setup of this method is shown in Figure 2. Prior to testing, electrical continuity of reinforcement is checked by applying a potential difference across rebar at different sections of the structure. Normally a measured resistance of less than 1 ohm is used to indicate continuous electrical connection of reinforcement.

In order to ensure a good contact with the reference electrode the concrete surface must be moist. A number of reference electrodes may be used, including copper/copper sulfate (CSE), silver/silver chloride or calomel (SCE). Potentials are measured with a high impedance voltmeter (>10 Mega ohm) to ensure low current conditions during testing. ASTM C876-87 provides a classification for assessing the results of the half-cell potential mapping as shown in Table 1.

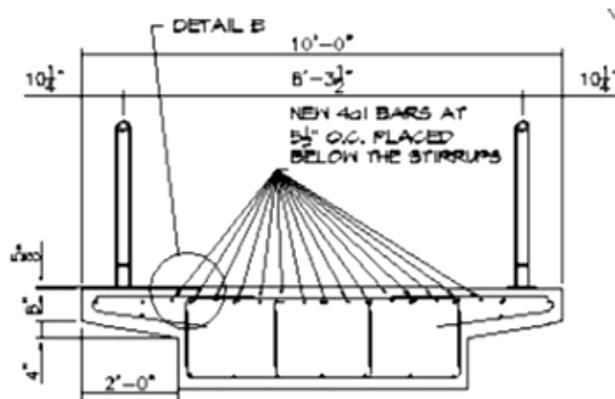
Figure 3 Cross Section of the Test Bridge Deck Near the Pier

In order to investigate the effectiveness of ECE technique, the properties of the bridge deck related to corrosion were examined. First, the half-cell potential technique was used for the determination of corrosion probability in the bridge deck. A beam at the Iowa Avenue Bridge in Iowa City, as shown in Figure 3, was selected to measure the corrosion. Values from 30 spots in the beam, as shown in Figure 4 and 5, were collected to improve the accuracy.

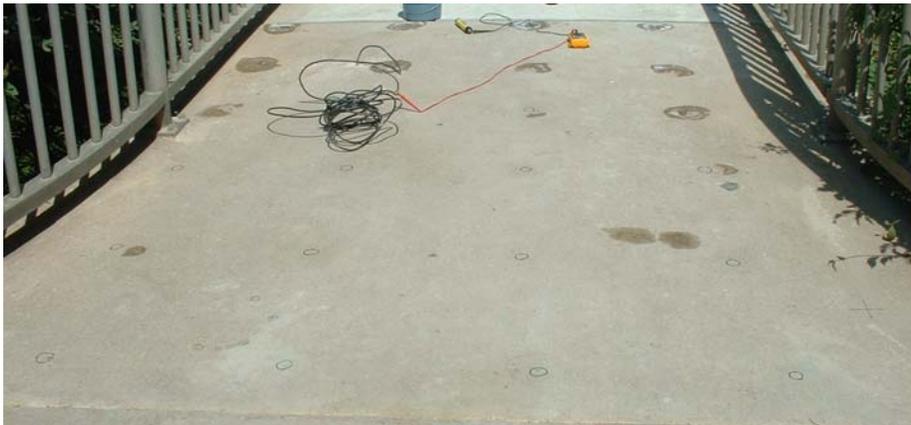
Figure 4 Half Cell Test Measurement Locations

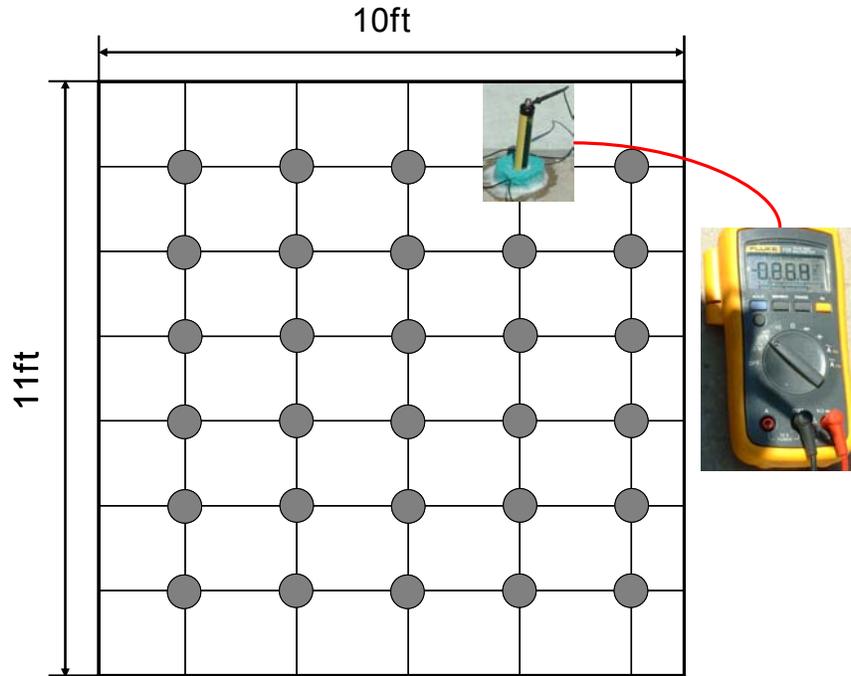
Figure 5 Half Cell Test Locations

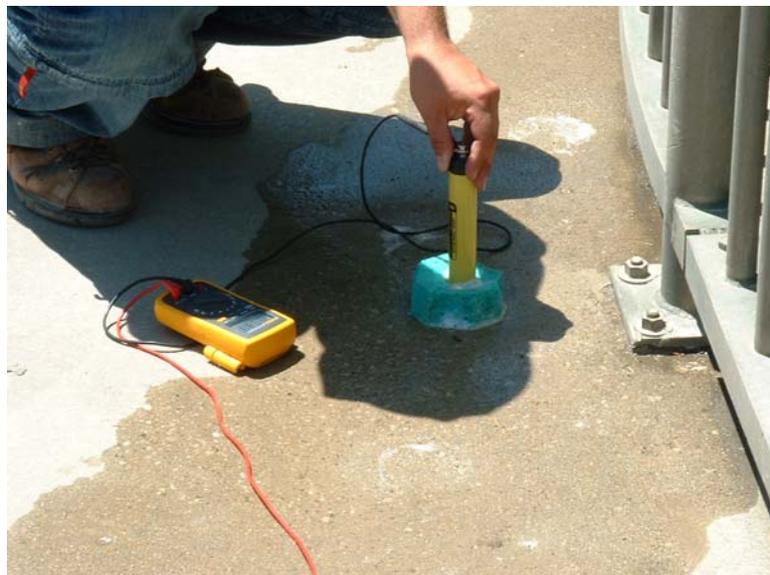
Figure 6 Measuring Potential with Half-cell Reference

Values of the potential were measured per the requirements of ASTM C-876. The testing pattern layout is shown in Figure 6. Detergent solution was used to improve conductivity between the concrete surface and the half cell, which was used vertically. When potential values were read, the temperature was also recorded for calibration. Each value of potential was collected four times in three days.

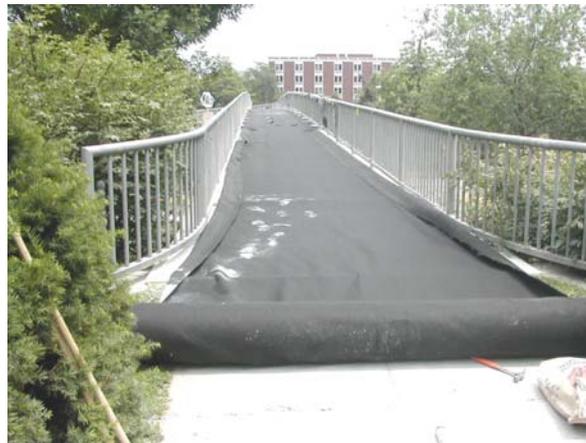
Figure 7 Felt Mat Placed on the Deck

The process of chloride extraction in the field for this study involved a number of steps. (1) A layer of lime was placed on the deck. (2) Then a layer of felt (landscaping mat) was placed on the lime. See Figure 7 below.

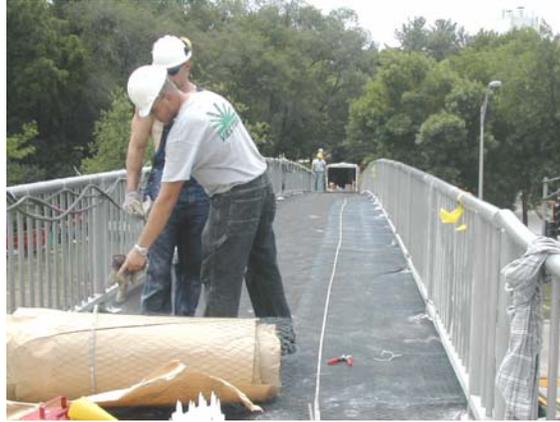
Figure 8 Titanium Mesh Placed on the Deck

(3) Next, the titanium mesh was placed. Steel mats were used on the spiral ramps to the deck, in lieu of the titanium, so the expensive rolls of titanium would not need to be cut. See Figures 8 & 9 next page.

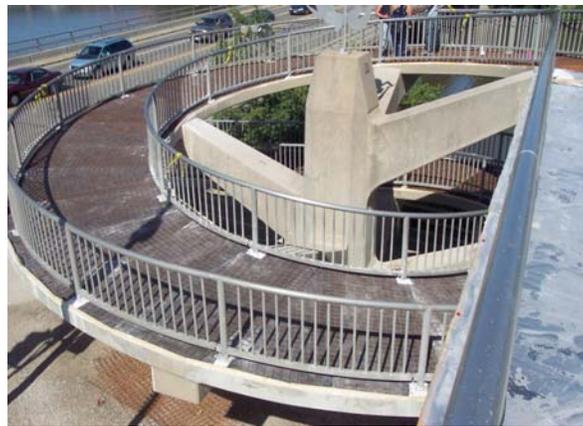
Figure 9 Steel Mats Placed on the Spiral Ramps to the Deck

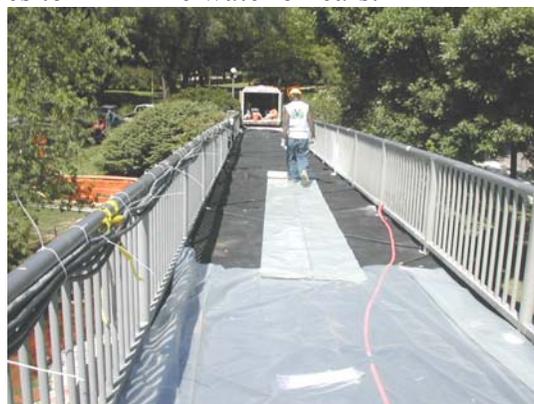
Figure 10 Soaker Hoses & Plastic Sheets Placed on the Felt

(4) Another layer of felt was placed on top of the steel and titanium mesh (anode). (5) Then a soaker hose was snaked across the deck, and a final layer of 6 mil plastic sheets put in place. The concrete surface was kept wet during the extraction. Hoses were connected over a long distance to bring water to the pedestrian bridge. A 2 x 2 silicone strip was placed at the edges of the deck over the traffic lanes to minimize water on cars.

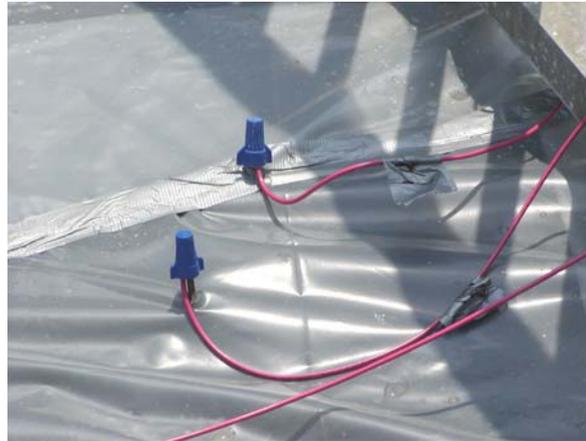
Figure 11 Electrical Connections to the Deck Rebar

The electric lines and rectifiers were put in place. To ensure a consistent voltage, there were four zones (4 rectifiers) which were 40 Volt maximum. Each rectifier serves 900 to 1000 square feet of deck. Connections to the rebar were made at 2 to 4 locations per zone. For power, a 480 Volt electric line was run from the University of Iowa campus. A direct current of around 1 A/m² of surface area was maintained. The ECE system was left in place for a period of 8 weeks.

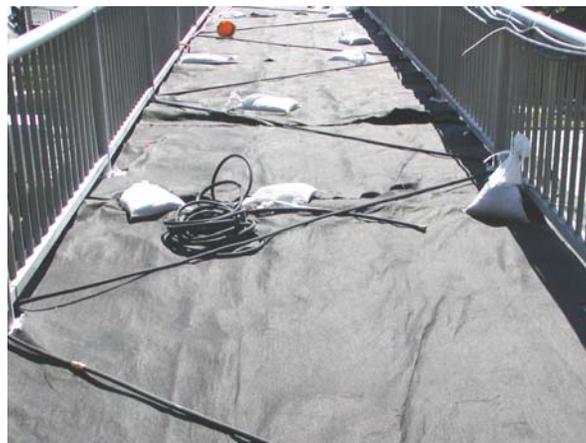
Figure 12 ECE System in Place

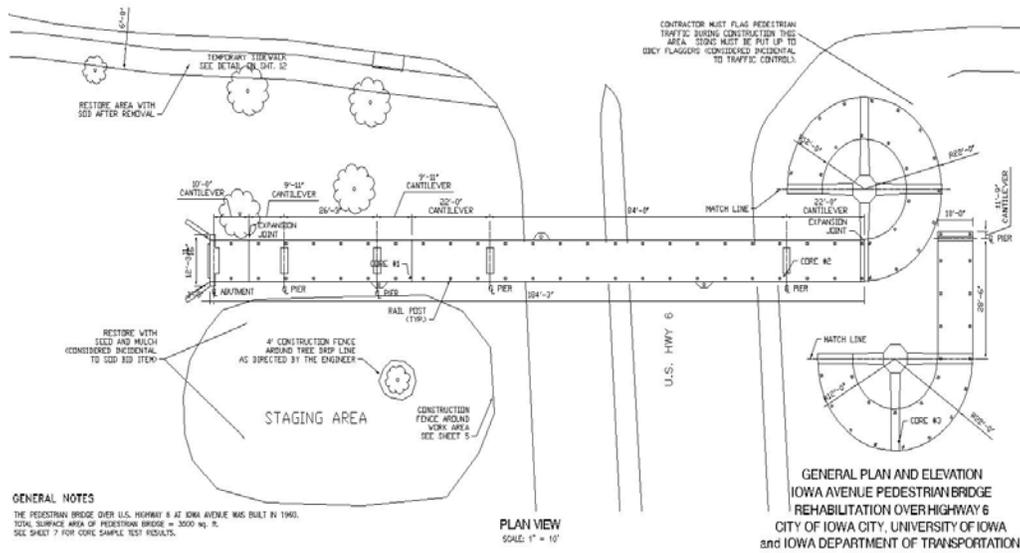
Figure 13 Plan View of Bridge

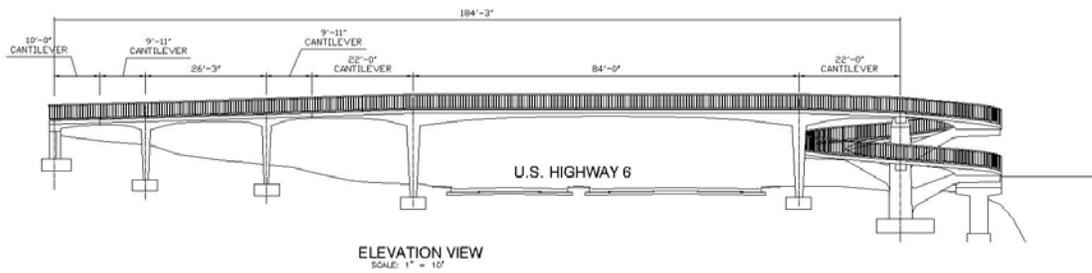
Figure 14 Elevation View of Bridge

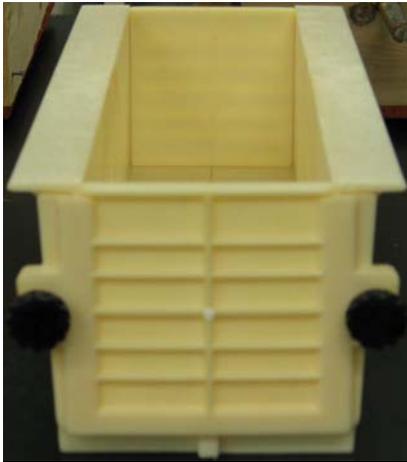
Figure 15 Beam Specimen

The size of beam specimens was 21.5" x 6" x 6" (= 0.5ft³). See Figure 15. Slab specimens were 21" x 21" x 7" (= 2ft³). Steel reinforcing bars (35/30 in. long) were placed in the center of the slab thickness as shown in Figures 16 and 18. Rebars were sandblasted and each concrete specimen had a 21.5" long crack in the center, which was artificially created by using a 1/32" thick aluminum sheet as shown in Figures 17 and 18.

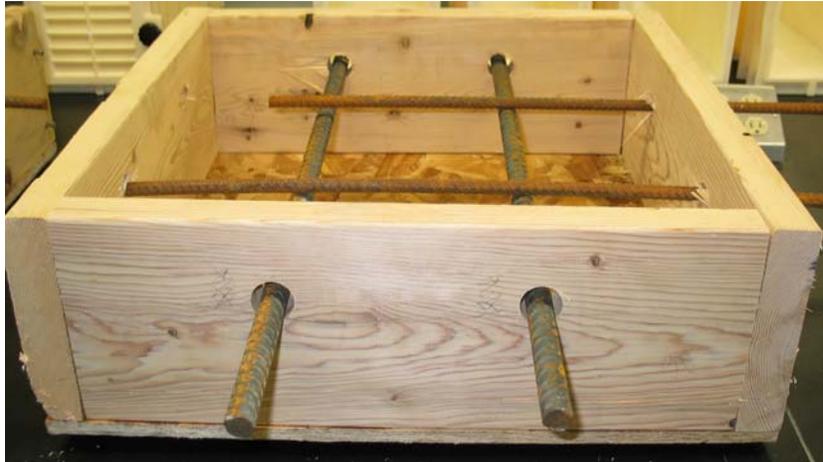
Figure 16 Slab Specimen

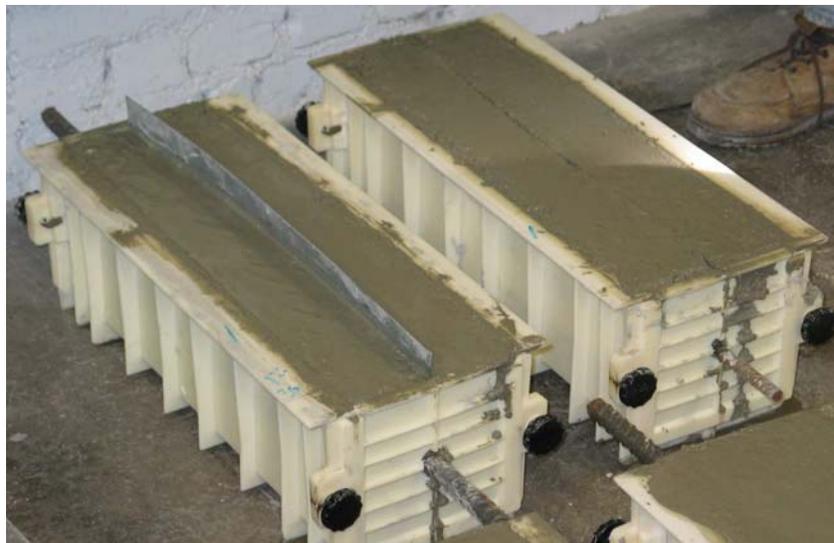
Figure 17 Beam Specimen Cracked

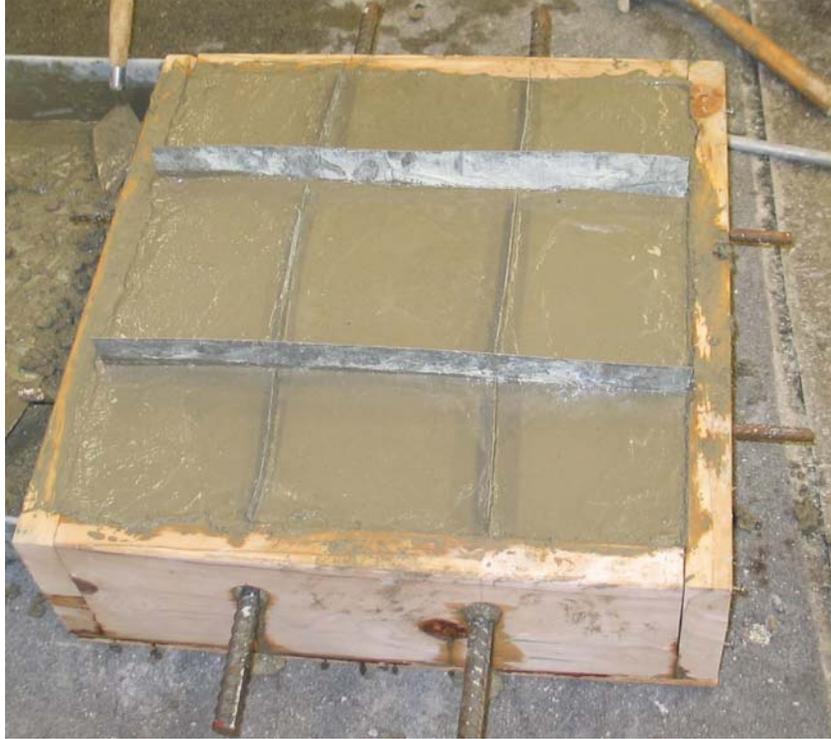
Figure 18 Slab Specimen Cracked

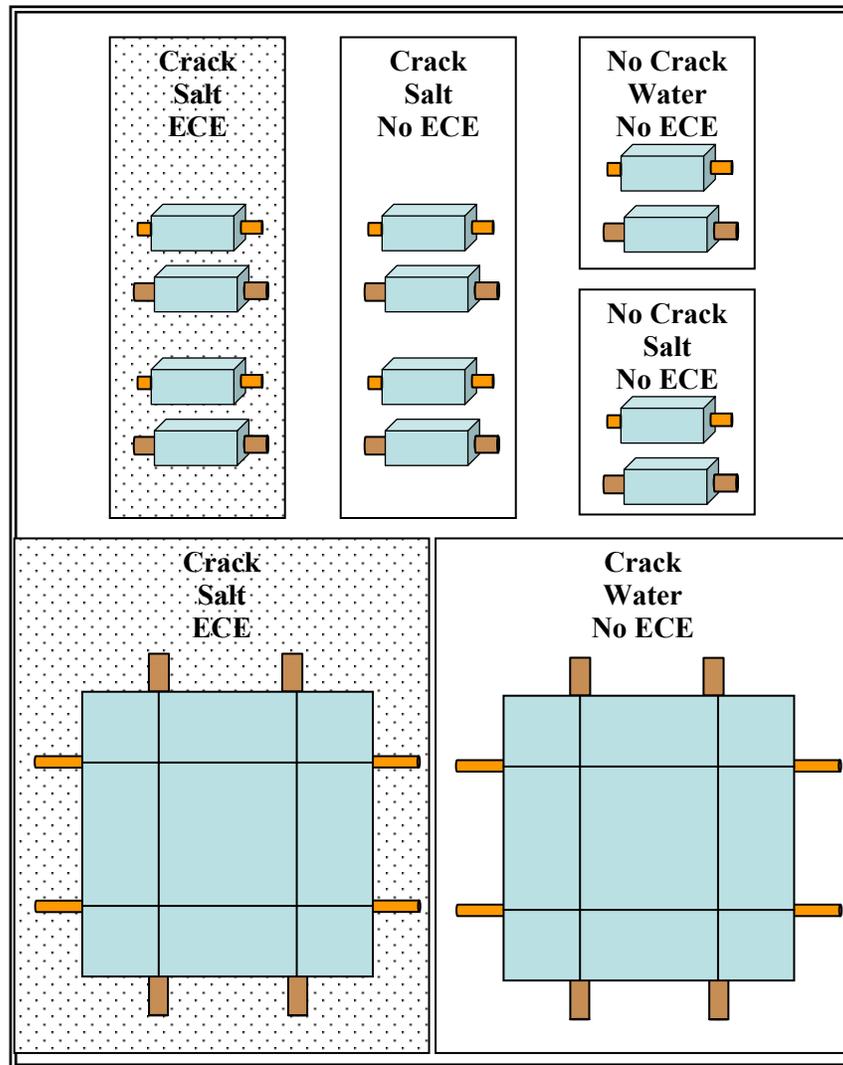
Figure 19 Combination of Specimens

As shown in Table 3 and Figure 19, a total of 12 beams and 2 slab specimens were prepared. Beam specimens were separated into four testing groups: 1) Crack, salt supply, ECE supply, 2) Crack, salt supply, no ECE supply, 3) No crack, salt supply, no ECE supply, and 4) No crack, water supply, no ECE supply. Two slab specimens were used to test the following conditions: 1) Crack, salt supply, ECE supply and 2) Crack, water supply, no ECE supply.

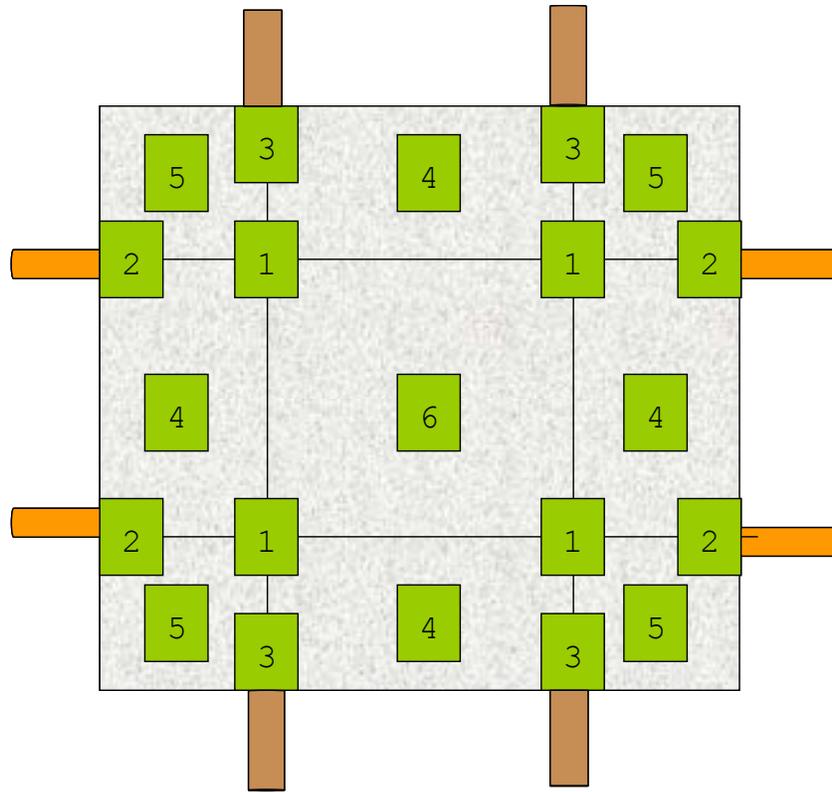
Figure 20 Group for Measurement in Slab Specimens

After one week of curing, corrosion was monitored using half cell and voltmeter. Potential data were collected from 21 spots on the surface of the slab specimens as described in Figure 20. One potential measurement was made from the center of the beam specimen. When the potential data became stabilized, 20 ml of deicer solution was added to the specimens. Following ASTM G109, deicer solution was used with a 3% concentration, which would provide the most aggressive concentration. The corrosiveness of salt solutions to steel reaches a maximum at 3% and then begins to fall off due to decreasing oxygen solubility (Uhlig, 1963). The corrosion data was recorded in 12 hours after salt solution is added everyday until the potential values show that the specimens are corroded with 95% probability. After the test specimens reached 95% corrosion probability, the salt solution was discontinued and the ECE was provided.

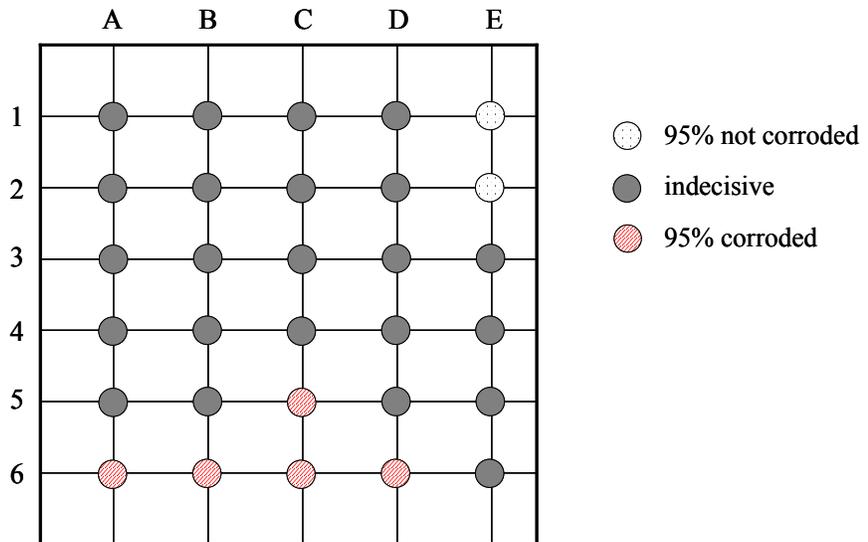
Figure 21 Status of Corrosion in Bridge Deck

Table 4 summarizes the potentials measured from 30 spots in the bridge deck. As shown in Figure 21, 2 spots appeared to have a probability of corrosion of less than 5%, 5 spots with a probability of corrosion of 95%. Since the rest of the spots are located in the indecisive range of corrosion, this bridge deck would have tended to continue to corrode.

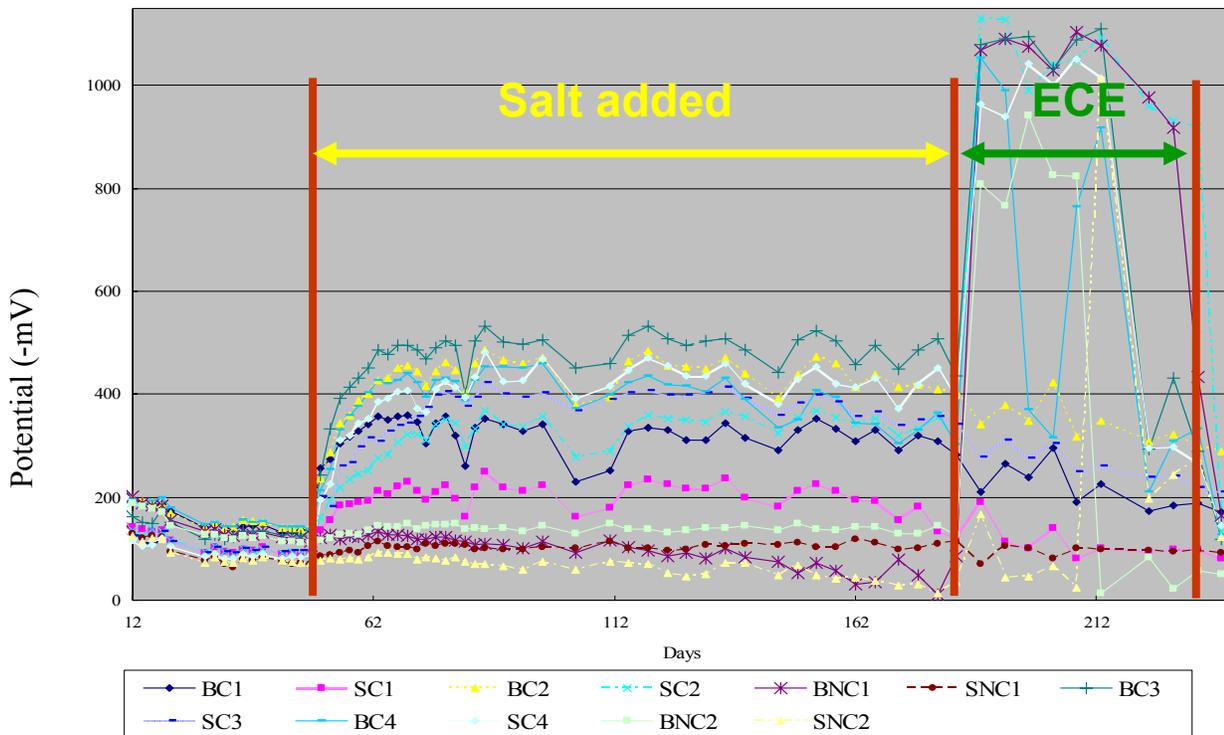
Note B: Big Rebar, S: Small Rebar, C: Cracked Beam, NC: Non-Cracked Beam

Figure 22 Potential Measurement Values from Beam Specimens for 6 Months

Figure 22 illustrates the potential values of beam specimens for six months. Until the salt is added on the 48th day, half-cell potential has decreased from -200 mV to -100 mV. Upon introduction of 3% salt solution, the potential reached up to -500 mV. In general, the larger the rebar diameter we observed the higher potential. As shown in Figure 22, when the salt solution was added into the cracked specimens, the potential values jumped up to -300mV in one week. This was not the case for Non-Cracked specimens (BNC, SNC) and Small Cracked specimen (SC1). As expected, the cracked specimens produced the higher potential values than non-cracked ones.

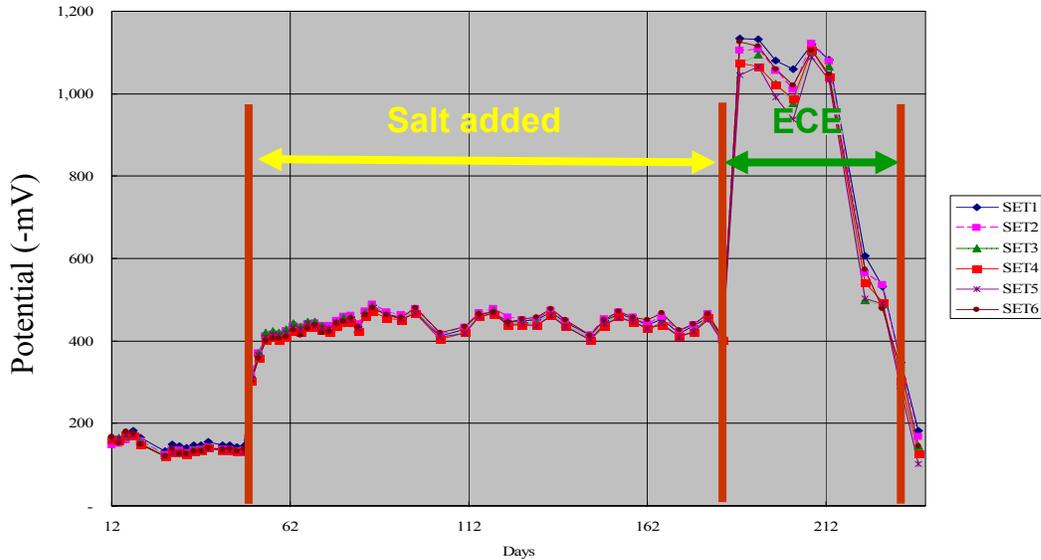
Figure 23 Potential Values of Slab with Salt

Figures 23 and 24 present potential values for a slab with salt added and the other without salt, respectively. Measurements were made every other day for six months. The slab with a smaller initial potential value was chosen for the application of salt solution. It should be noted that Measurement Set 1, measured at the intersection of rebar, consistently produced the highest potential value among 6 groups. As expected, after salt was added, the potential values of the slab jumped up to -400mV , whereas the slab without salt stayed lower than -250mV .

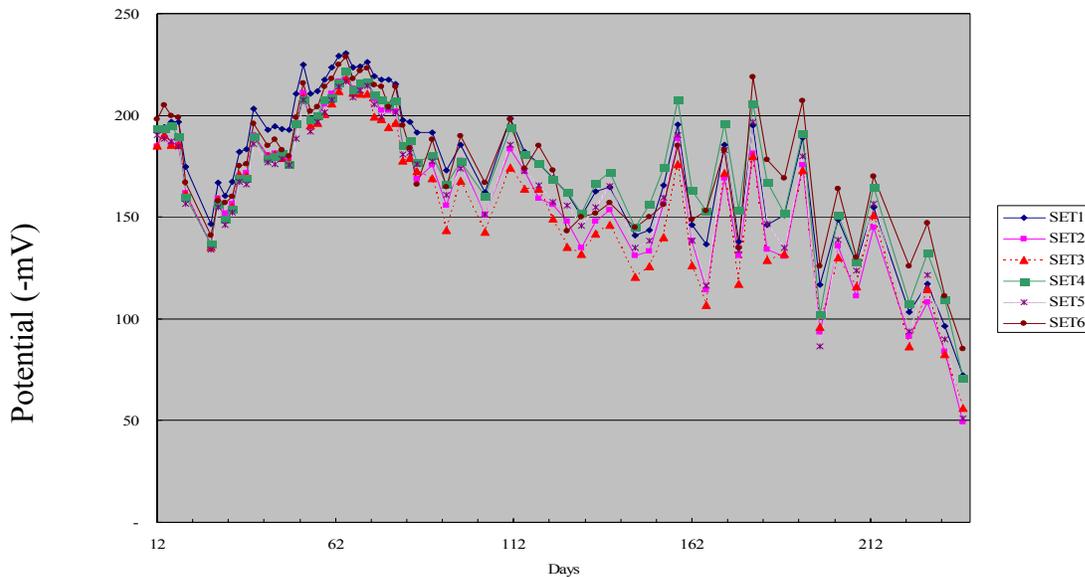
Figure 24 Potential Values of Slab Without Salt
