FIELD INSTRUMENTATION, TESTING,  
AND LONG-TERM MONITORING OF  
HIGH-MAST LIGHTING TOWER NO. 1  
AT THE I-35/US18 INTERCHANGE  
NEAR CLEAR LAKE  
IN THE STATE OF IOWA  
PHASE 3

**Final Report**

**September 2009**

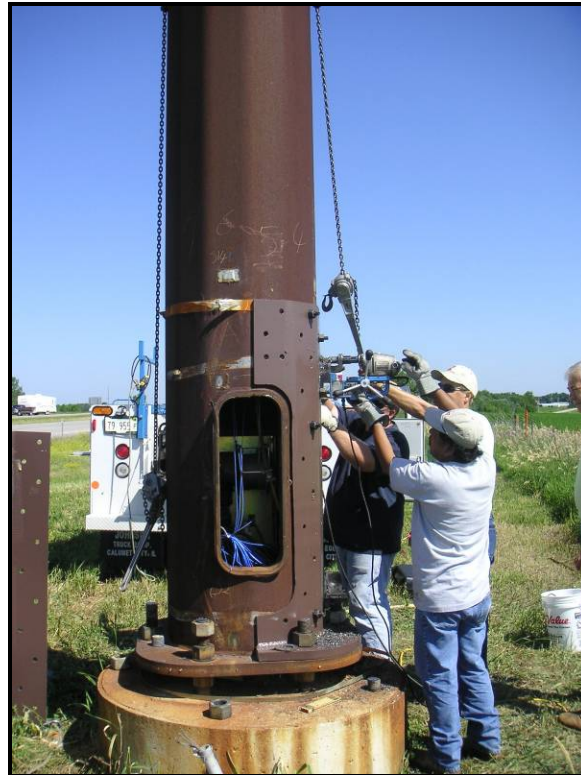
Figure 1.1 – Installation of the reinforcing jacket

A photograph of the installation of the reinforcing jacket is presented in Figure 1.1. Static and dynamic load tests were performed and long-term monitoring of the tower was recently completed. This report presents the findings of this third phase of work at this location.

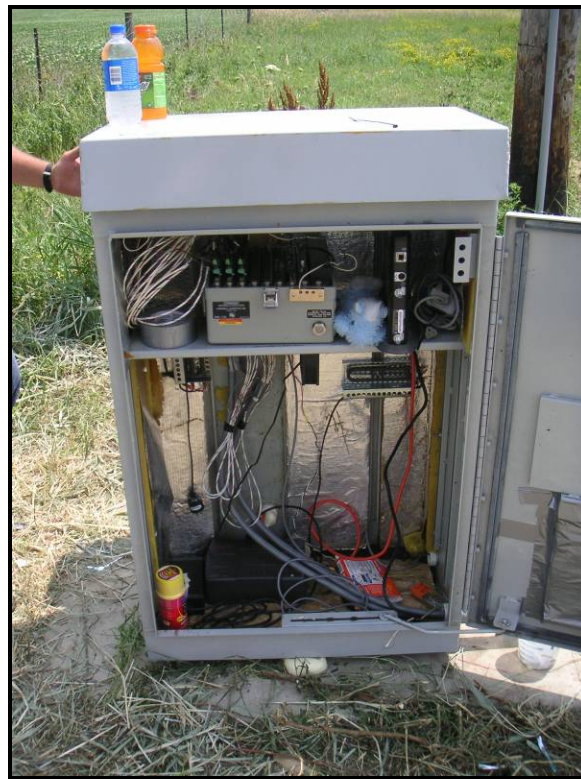
Figure 2.1 – Weather-tight enclosure adjacent to the high-mast tower used to house the data acquisition and communications equipment

The data logger was enclosed in a weather-tight box adjacent to the tower (see Figure 2.1). Remote communications with the data logger were maintained through a satellite internet connection. Data collection was performed automatically. The satellite link was also used to upload new programs as needed. Data were collected and reviewed periodically to assure the integrity of the data.

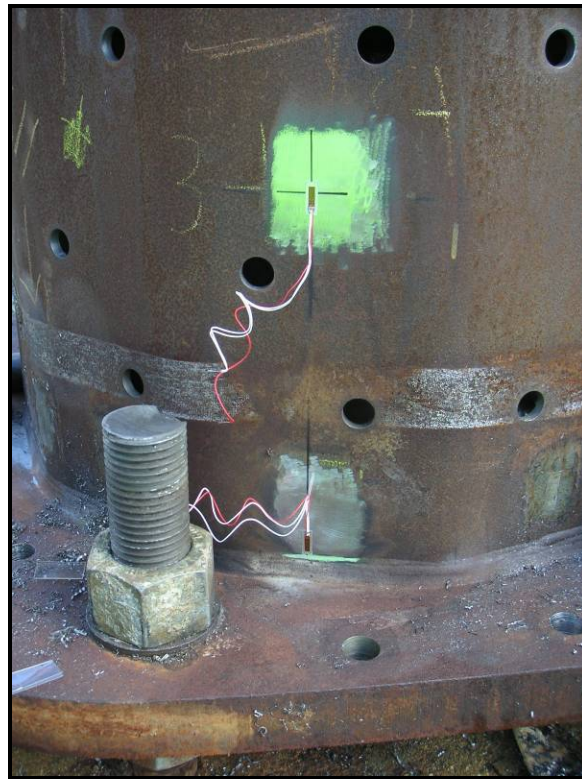
Figure 2.4 – Strain gages installed on the existing high-mast tower at the toe of the base weld and 12 in. above the base plate

On the existing tower, a set of four strain gages were installed 90 degrees apart at a section 6 feet above the base plate. Two strain gages were placed on the tower 180 degrees apart approximately 53 inches above the baseplate (just below the top of the reinforcing jacket). Two strain gages were placed on the tower 180 degrees apart 12 inches above the baseplate. Finally, a set of four strain gages were installed 90 degrees apart adjacent to the base weld. All of these strain gages were oriented vertically. The inside of the reinforcing jacket was ground out at strain gaged locations so pressure would not be applied to the strain gage after the bolted jacket connection was fully tightened. Shown in Figure 2.4 is a photograph of weldable strain gages installed on the existing high mast tower at the toe of the base weld and 12 inches above the base plate. This photograph was taken prior to the installation of weatherproofing material and reinforcing jacket.

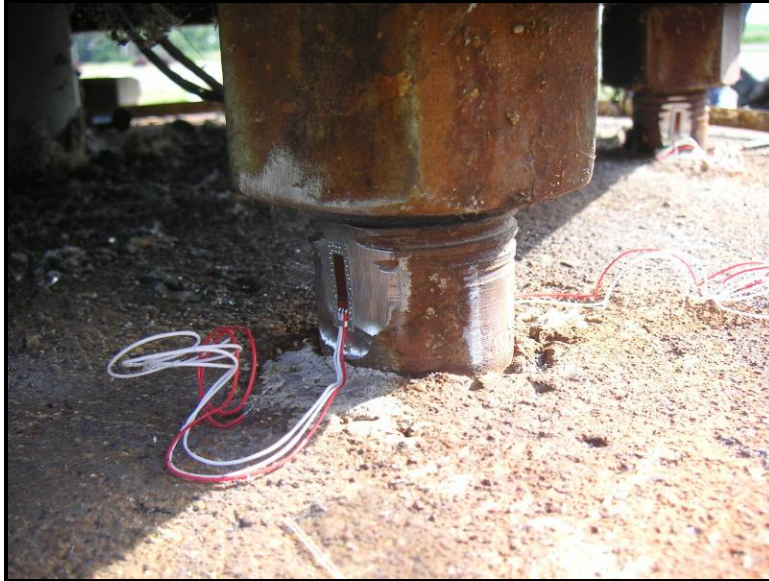
Figure 2.5 – Strain gage installed on the anchor rod between the concrete foundation and lower leveling nut

Two anchor rods on the north side of the tower were instrumented. These are shown in Figure 2.5. On each anchor rod, two strain gages were installed 180 degrees apart on the free length of the anchor rod between the concrete foundation and the

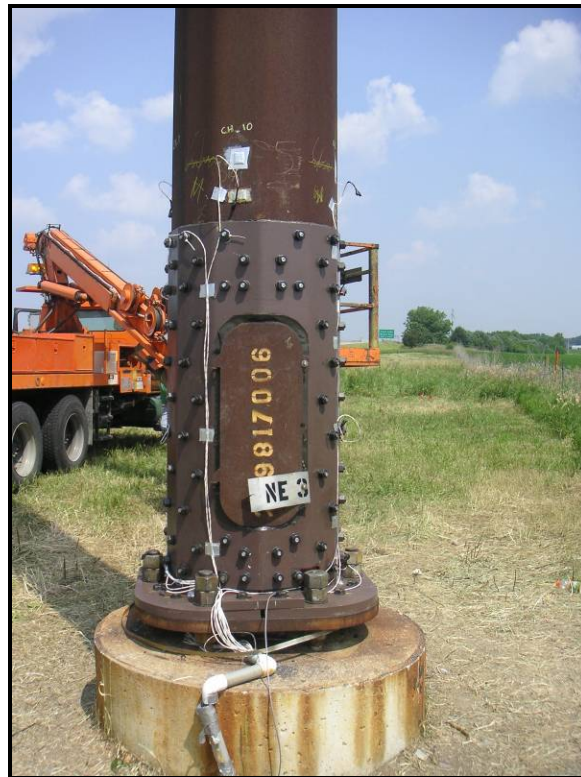
Figure 2.6 – Base of high-mast tower after installation of reinforcing jacket and all instrumentation

underside of the base plate. A view of the completed reinforcing jacket can be seen in Figure 2.6.

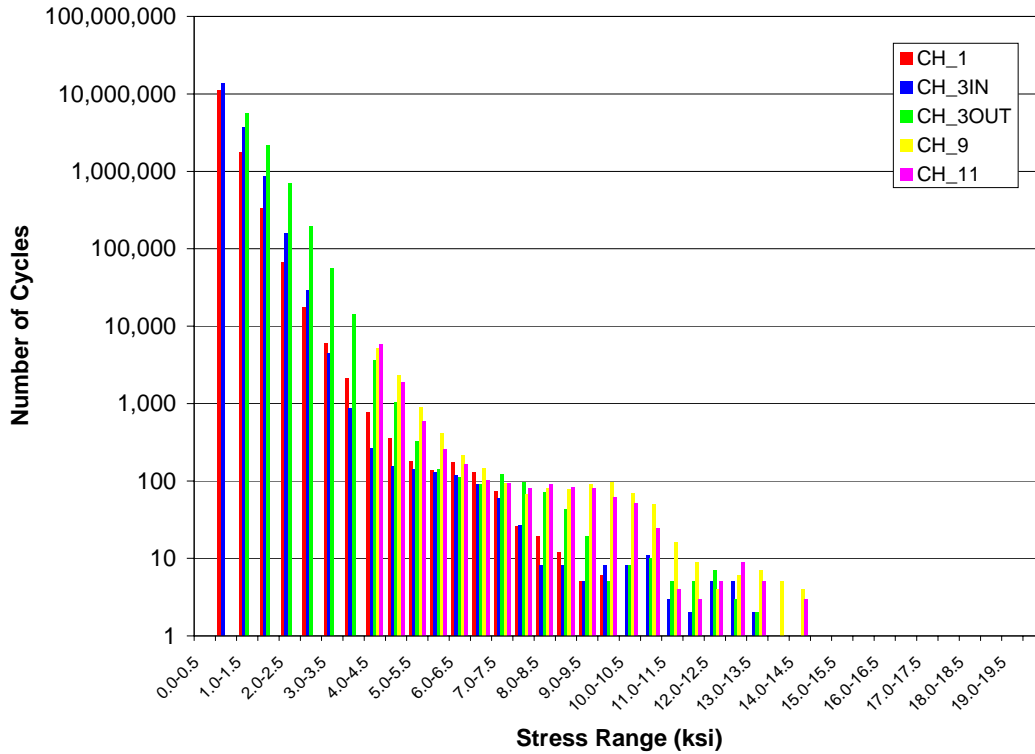
Figure 4.1 – Stress-range histograms 1 - November 8, 2006 through July 31, 2008  
total of 380 days of monitoring

A total of ten strain gages were monitored as identified in Table 4.1. Figure 4.1, Figure 4.2, and Table 4.2 contain the measured stress-range histograms for these ten strain gages for the period between November 8, 2006 through July 31, 2008. Data were not recorded continuously due to various outages. During this period, a total of 380 days of data were collected. Strain gage CH\_16 failed during the monitoring period and therefore only 290 days of data were obtained. Strain gage CH\_19 also failed prematurely and only 53 days of data were obtained. The histograms for CH\_16 and CH\_19 presented graphically in Figure 4.2 have been scaled up to represent 380 days so direct comparison between all the strain gages can be made. The histograms presented in Table 4.2 are the raw histograms (i.e., not scaled).

Note that in Figure 4.1, Figure 4.2, and Table 4.2, very high stress cycles were recorded in a number of the strain gages, in particular gages CH\_14 and CH\_16 on the anchor rods and CH\_17 at the bend line on the west face of the reinforcing jacket. The effect of these higher stress cycles are reflected in the relatively low fatigue life estimates presented in Table 4.3. However it should be noted that the strain gages at the base were installed adjacent to the weld to at the baseplate weld (*in the previous field testing program, the gages were installed 3 inches above*). As a result, the strain gages in their current position are located in an area of high stress gradient and the measured stresses cannot be directly compared to the earlier phases of testing [2]. **Since the AASHTO S-N curves are calibrated to be used with nominal stresses, the life estimates presented in Table 4.3 are misleading and inaccurate as they underestimate the actual fatigue life.**

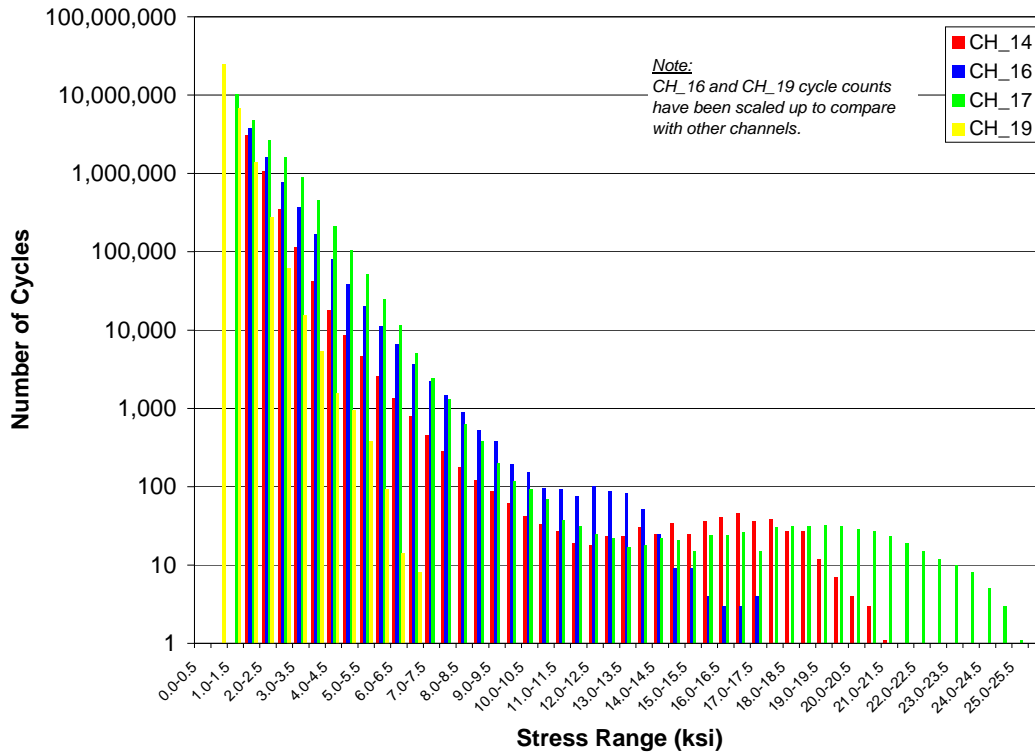
Figure 4.2 – Stress-range histograms 2 - November 8, 2006 through July 31, 2008  
total of 380 days of monitoring (except CH\_16 and CH\_19)

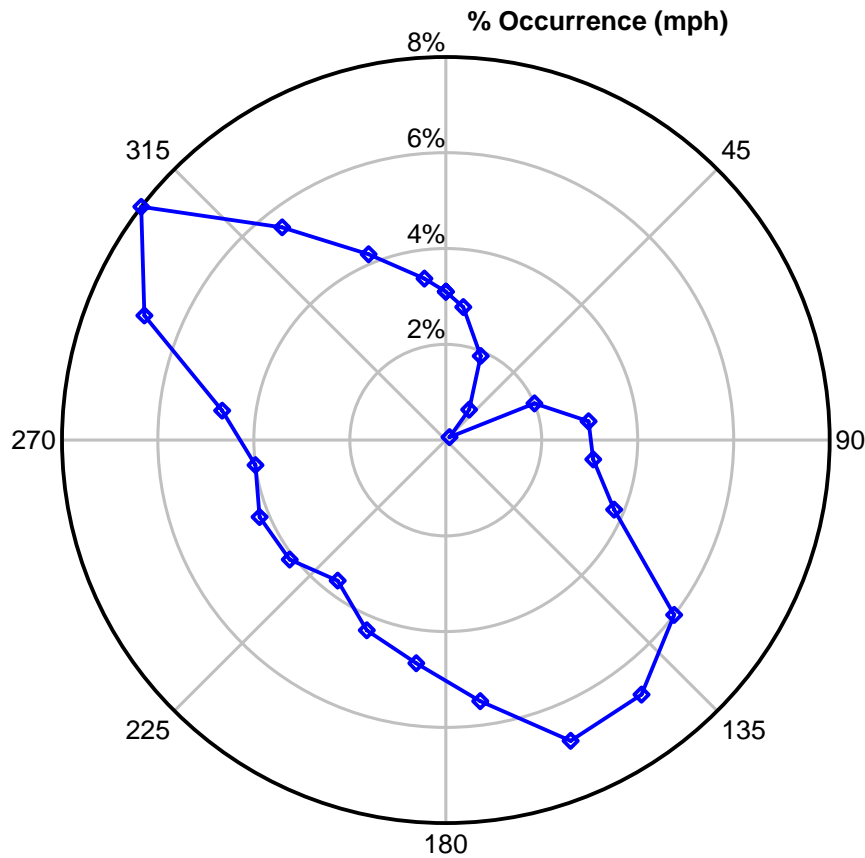
Figure 4.3 – Wind rose for percent occurrence

Figure 4.3 shows a polar histogram plot for all data collected during the long term monitoring. This plot shows the percent occurrence of winds from all directions in polar form, with zero degrees representing north. It can be seen that the plot has two lobes, indicating that most of the time the wind blows from either the northwest or southeast. The shape of this plot is similar to that developed during the earlier phases of field testing conducted in 2005 [2].

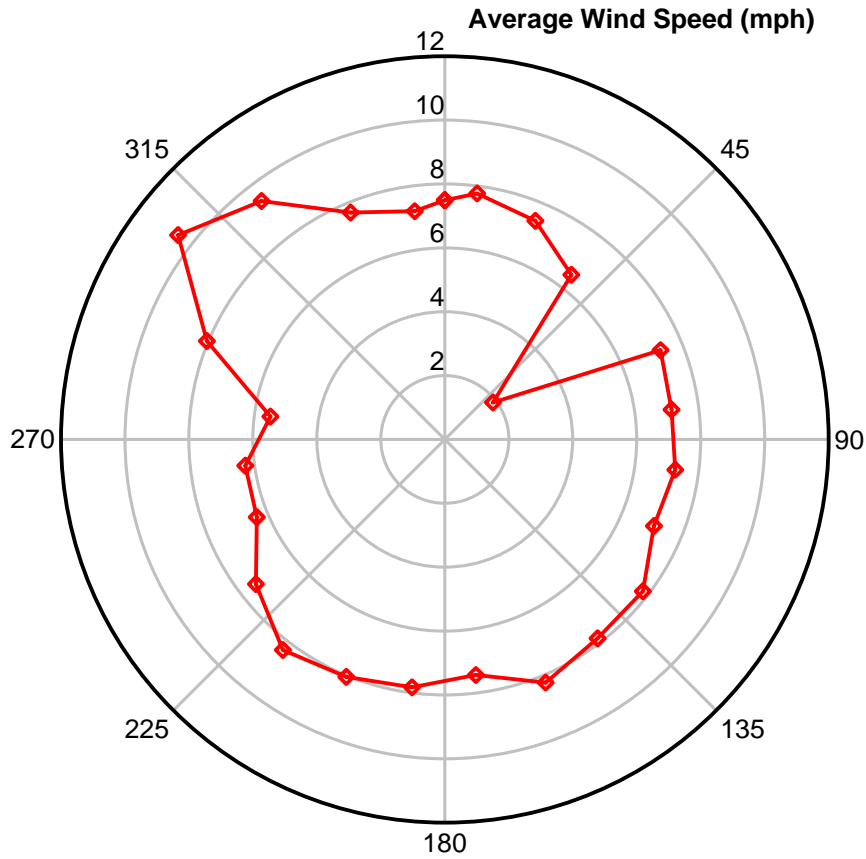
Figure 4.4 – Wind rose of average wind speed

Figure 4.4 presents a polar histogram plot of average wind speeds, which shows the average wind speed at each direction for the duration of the monitoring period. It can be seen that the highest average wind speeds are approximately 11 mph and generally occur from the same direction (NW) as the most frequent winds, as shown in Figure 4.3.

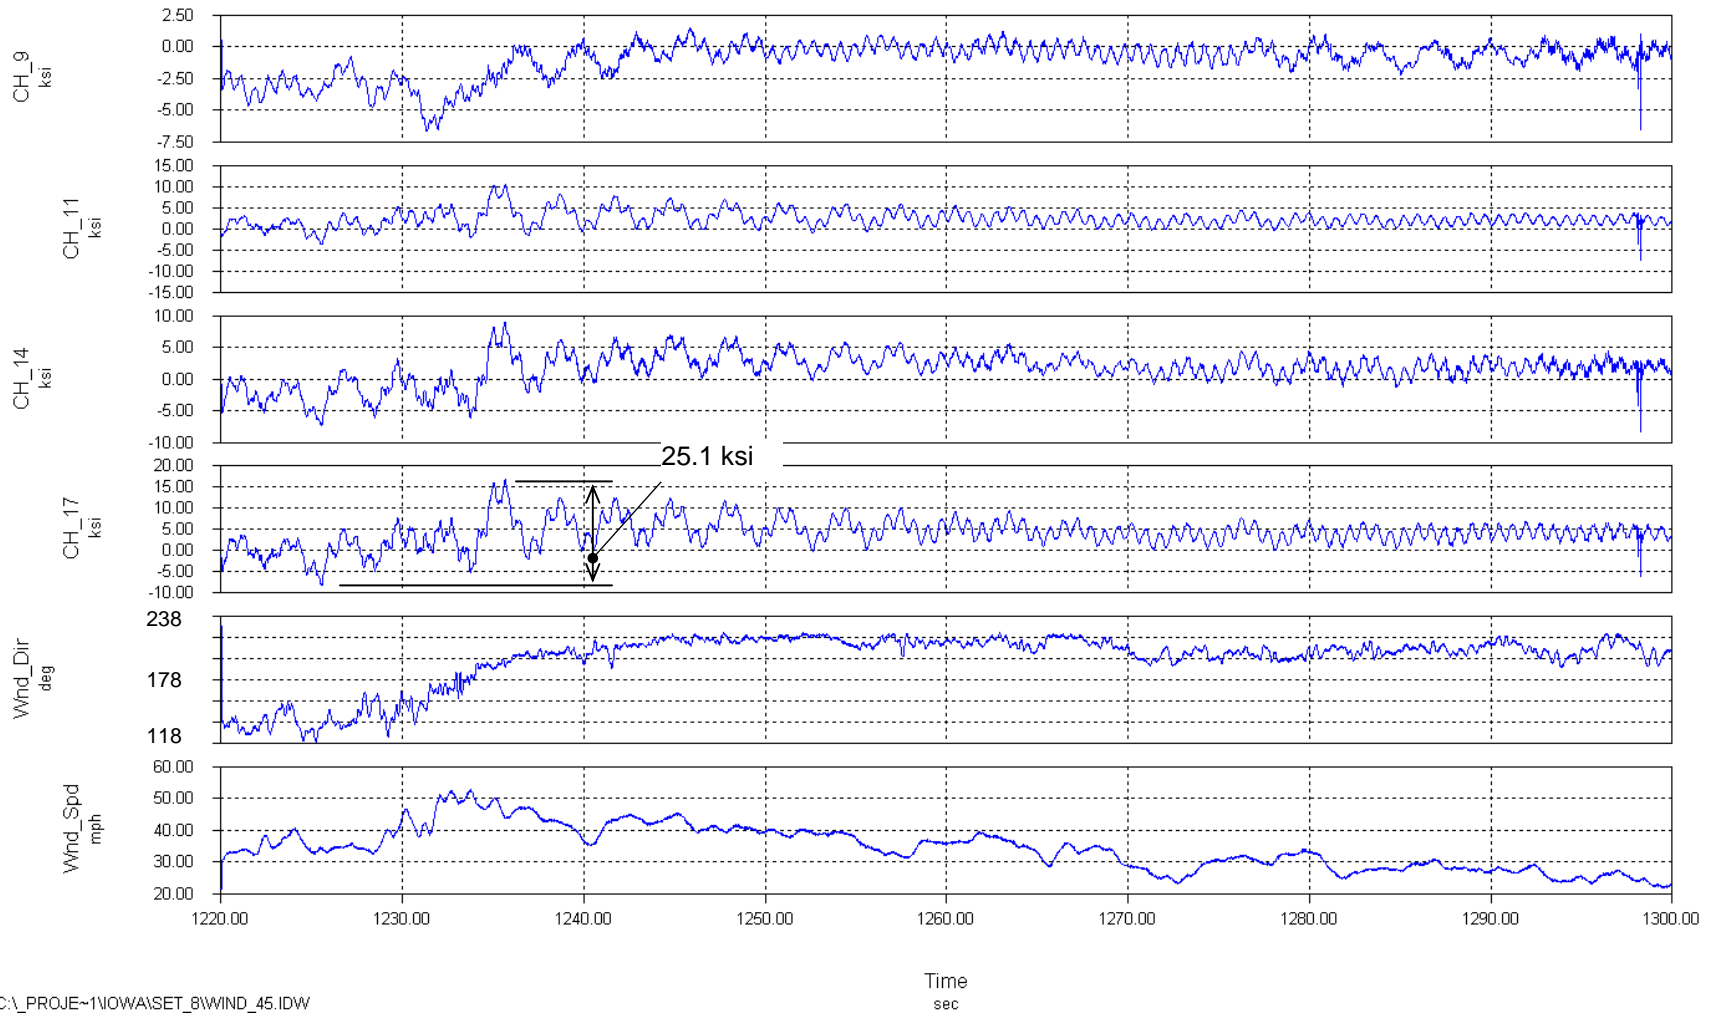
Figure 4.12 – High stress event – May 2, 2008 2:05 PM

was higher, the stresses measured during this event were lower than those measured on May 2, 2008 (see Figure 4.12).

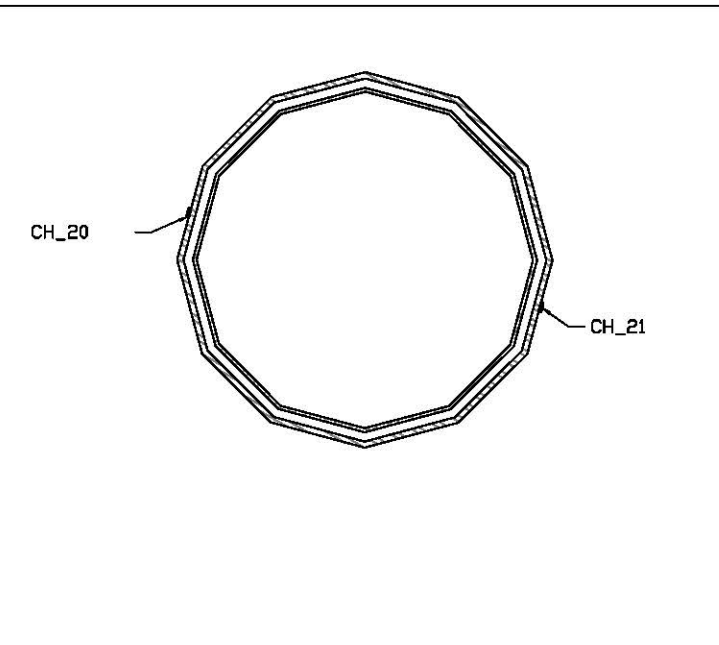
**SECTION D-D**  
H = 1'-9 1/4"  
SCALE: 3/4" = 1'-0"

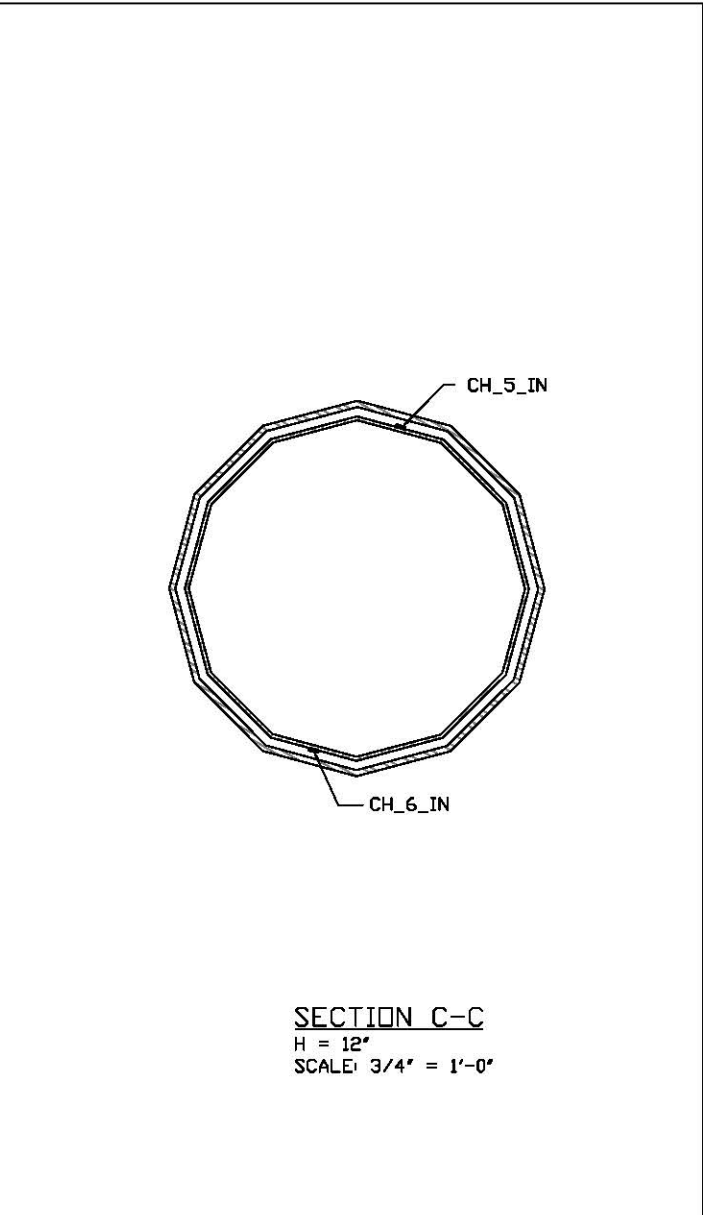
**SECTION C-C**  
H = 12"  
SCALE: 3/4" = 1'-0"
