Wind loads on dynamic message cabinets and behavior of supporting trusses

Iowa Highway Research Board (TR-612) and The Federal Highway Administration

WIND LOADS ON DYNAMIC MESSAGE CABINETS AND BEHAVIOR OF SUPPORTING TRUSSES

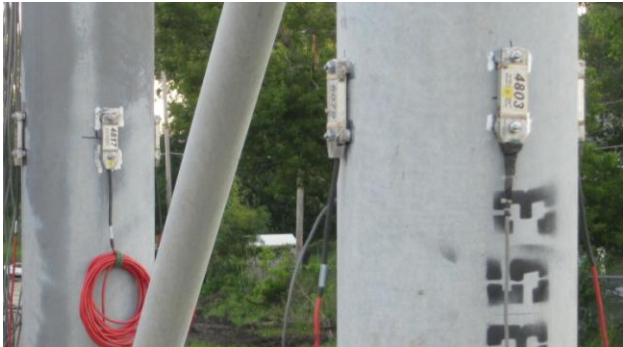
View of a strain gage attached on a truss member

The field observation portion consisted of short-term monitoring of several trusses and long-term monitoring of one truss supporting DMS Cabinets. The trusses were instrumented with strain gauges, accelerometers, and pressure gauges. The short-term monitoring involved taking measurements over one or two days. The long-term monitoring field study extended over several months. Long-term field monitoring of one of the overhead truss structures in Iowa was used as the research baseline to estimate the relationship between diurnal temperature changes and fatigue damage. Finite element modeling was developed to estimate the strain and stress magnitudes, which were compared with the field monitoring data. As part of the analysis, the stress occurring under extreme thermal conditions were estimated. Fatigue life of the truss structures was also estimated based on AASHTO specifications and the numerical modeling. Analysis of the data focused on trying to identify important behaviors under both ambient and truck induced winds and the effect of daily temperature changes.

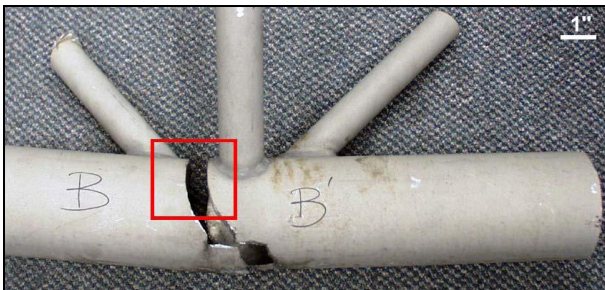
Picture showing a crack developing at the welding heat zone

The main conclusion of the study is that thermal induced fatigue damage of the truss structures supporting DMS cabinets is likely a significant contributing cause for the cracks observed in such structures.
