Low-Cost Rural Surface Alternatives:
Demonstration Project

Low-Cost Rural Surface Alternatives: Demonstration Project

tech transfer summary

A field demonstration project was conducted in Hamilton County, Iowa to compare the relative performance, durability, and costs of several stabilization methods for preventing or mitigating freeze-thaw damage to granular surfaced roads.

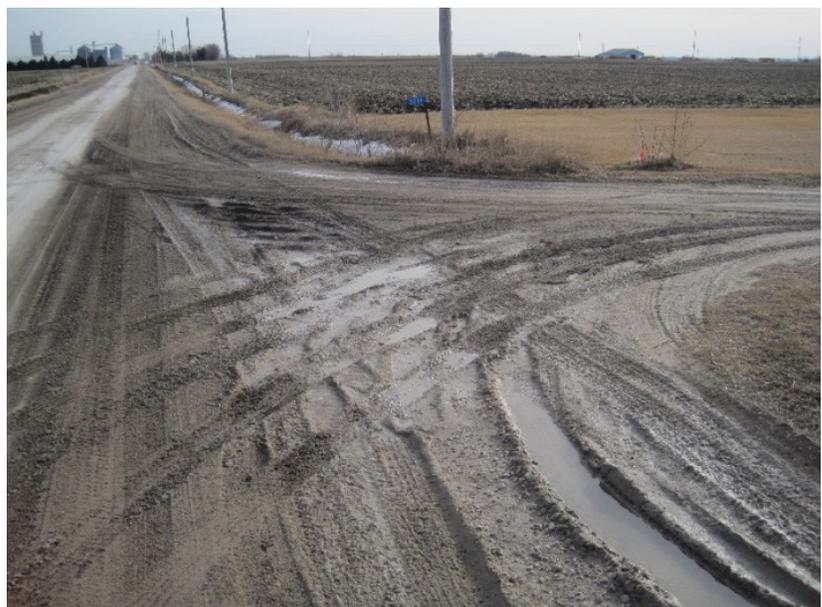
Post-thawing conditions of selected road before stabilization

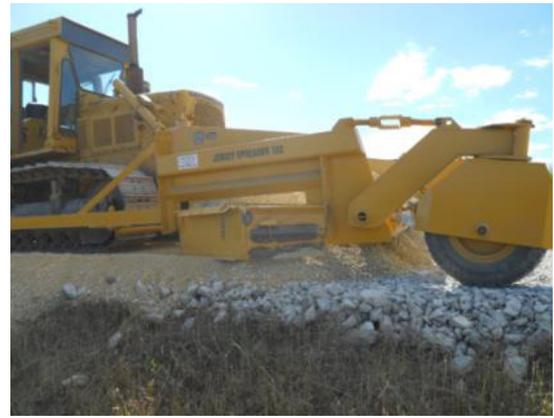
An aggregate spreader was used to place the macadam base and surface course materials

Most of the mechanical stabilization methods can be easily implemented by county secondary roads departments with existing crews and equipment. An aggregate spreader is needed for placing macadam stone.

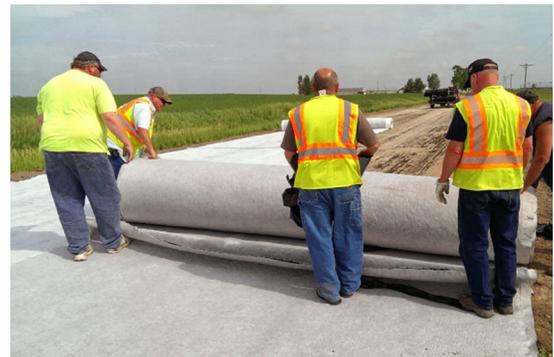
A geocomposite drainage layer was placed at the aggregate-subgrade interface in Section 18

- The geocomposite drainage layer increased the permeability of the surface material by two orders of magnitude, but some spots suffered significant rutting during thawing periods, which may require further study

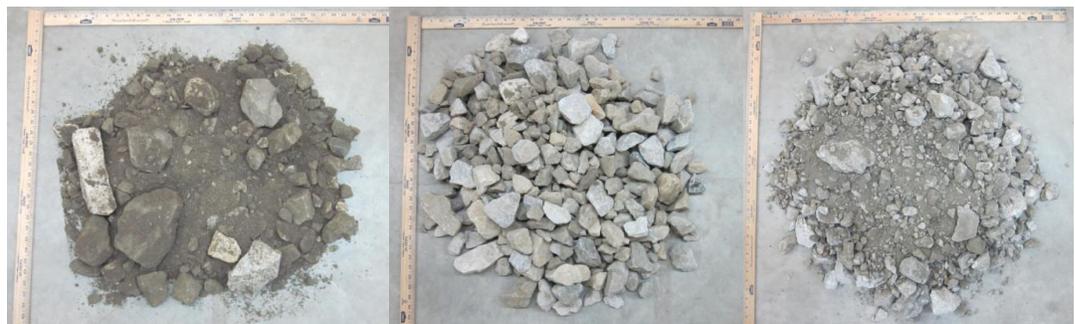
*Left to right:
Dirty, clean, and
recycled Portland
cement concrete
macadam materials*

- Three types of macadam (dirty, clean, and recycled Portland cement concrete/RPCC) were used as base materials in Sections 1 through 8 to improve stability and drainage. Nonwoven (NW) geotextile was embedded in some sections to provide separation and drainage. Chloride and bentonite surface treatment were also applied for dust control and stabilization.
- Aggregate columns were used as drainage basins in Sections 12 and 13 to prevent frost boils within the subgrade.
- Three chemical stabilizers (bentonite, class C fly ash, and cement) were used in Sections 15 through 17 to improve strength and stiffness of the surface course.
- Different geosynthetics were used in Sections 18 through 19B to improve subsurface drainage or strength of surface course.

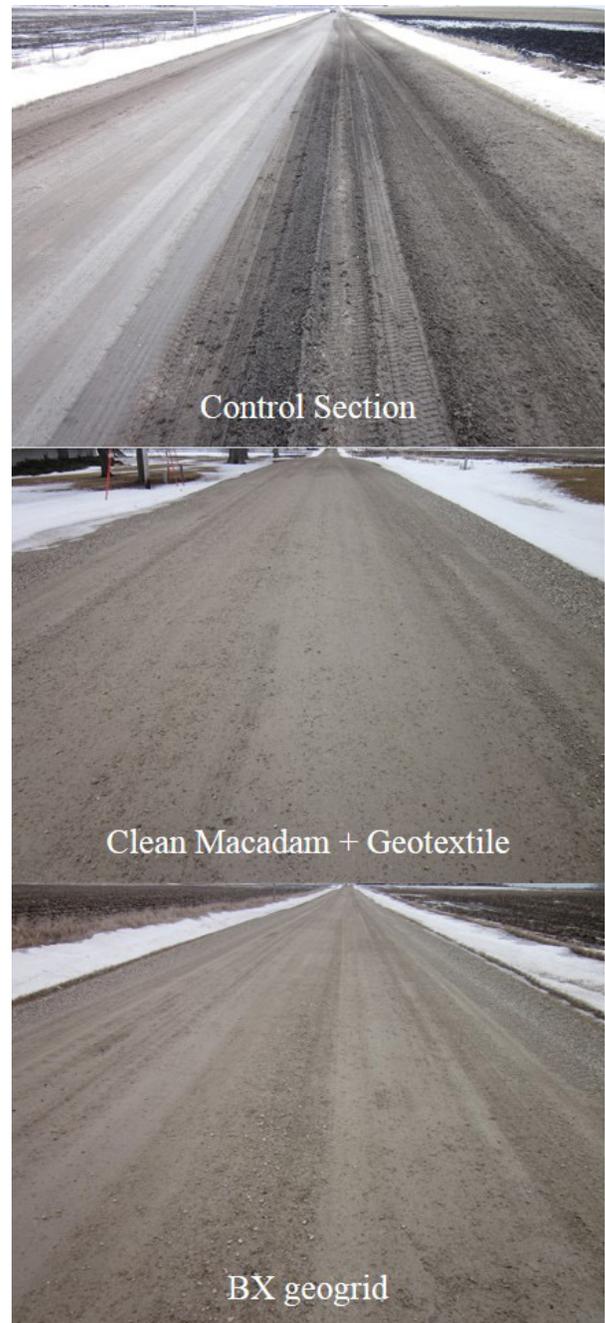
Post-thawing surface conditions of three demonstration sections (March 11, 2014)
