# Reflective Crack Mitigation Guide for Flexible Pavements

**Final Report**  
**September 2015**

**Sponsored by**  
Iowa Highway Research Board  
(IHRB Project TR-641)  
Iowa Department of Transportation  
(InTrans Project 11-424)

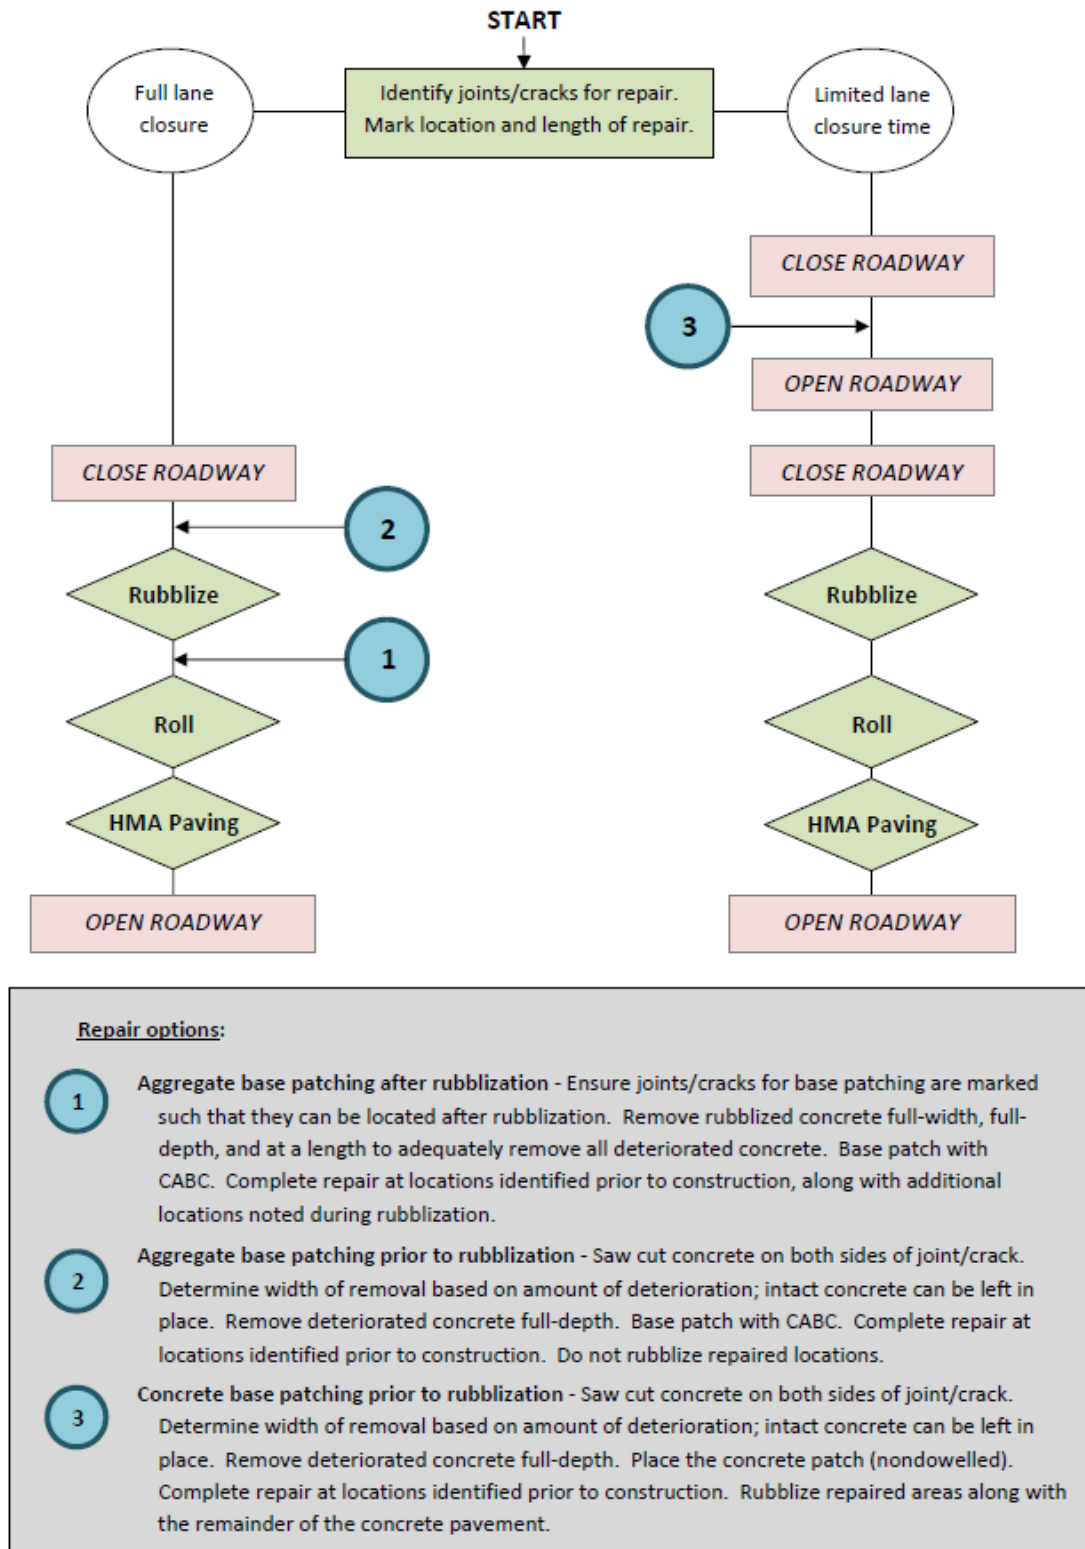
Recently, Battaglia and Paye (2011) investigated premature distress formation in Wisconsin rubblized pavements by analyzing design parameters, soil properties, historic distress levels, and several additional factors for 19 good- and poor-performing pavements. It was recommended that major cracks and distressed joints in the existing PCC pavement be repaired before rubblizing/HMA overlay to prevent reflection cracking. According to Battaglia and Paye (2011), joints with heavy deterioration, spalling, and/or evidence of pumping following the pavement condition index (PCI) rating system guidelines are candidates for repair. Recommended PCC joint repair and test rolling guidelines were also proposed by Battaglia and Paye (2011), as shown in Figure 6.

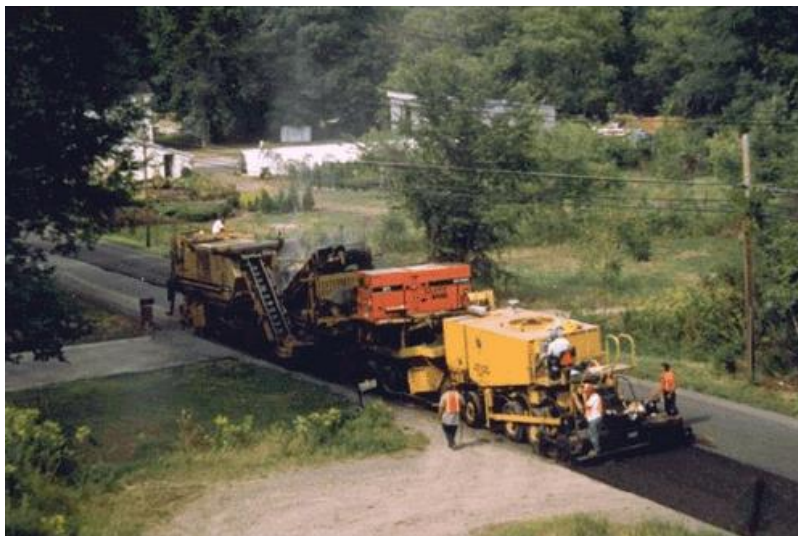
FDR and CIR are viable strategies to remove cracks in HMA pavements. CIR involves cold milling the existing HMA surface; mixing the cold milled materials with emulsified asphalt or other modifiers to improve the properties of original HMA mix; and screeding, spreading, and compacting the recycled mixture in one continuous operation (see Figure 9).

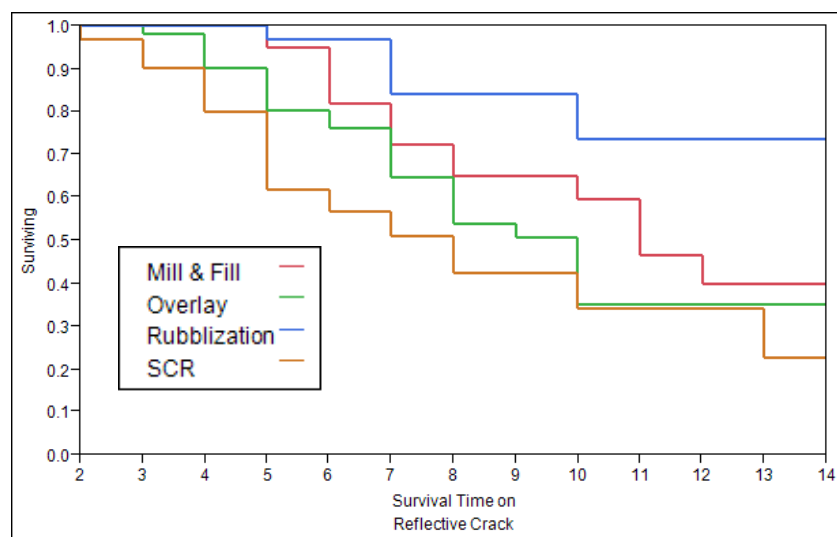
In statistical analyses, it is prudent to perform a univariate analysis before proceeding to more complicated models. In survival analysis, it is highly recommended to look at the Kaplan-Meier curves for all the categorical predictors. This will provide insight into the shape of the survival function for each group and provide an idea of whether or not the groups are proportional. The Kaplan-Meier estimator is a nonparametric maximum likelihood estimator of the survival function. It incorporates information from all of the observations available, both uncensored and censored, by considering the survival function at any point in time as a series of steps defined by the observed and censored times (Hosmer and Lemeshow 1998). Figure 14 compares the Kaplan-Meier estimate for the four different rehabilitation methods on reflective cracking.

**Figure 14. Kaplan-Meier estimator curves for reflective cracking treatments**

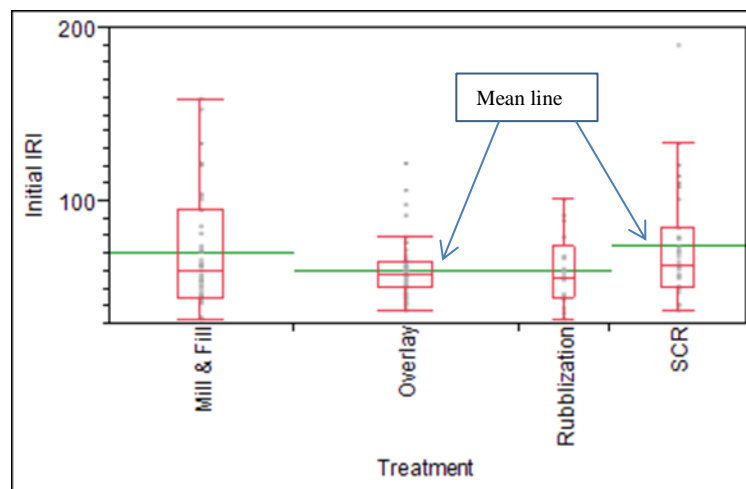
could be attributed to the initial IRI condition. To test this hypothesis, the initial IRI values for all of the 155 pavement projects were sorted and displayed in the boxplot of Figure 17.

**Figure 17. Initial IRI values for the four treatments**

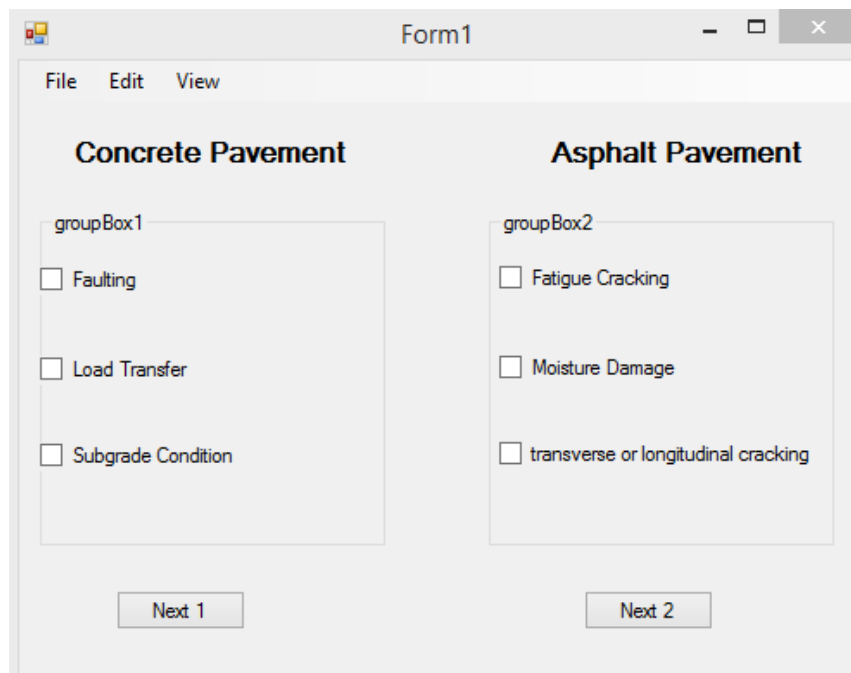
The main screen is in Figure 22.

**Figure 22. Main screen of interactive program**

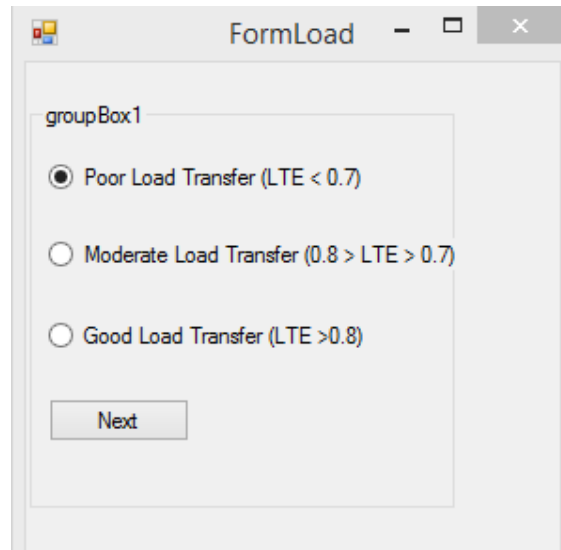
Once clicked the **Next** button, a second-level window would be opened as shown in Figure 23.

**Figure 23. Second-level window in interactive program**

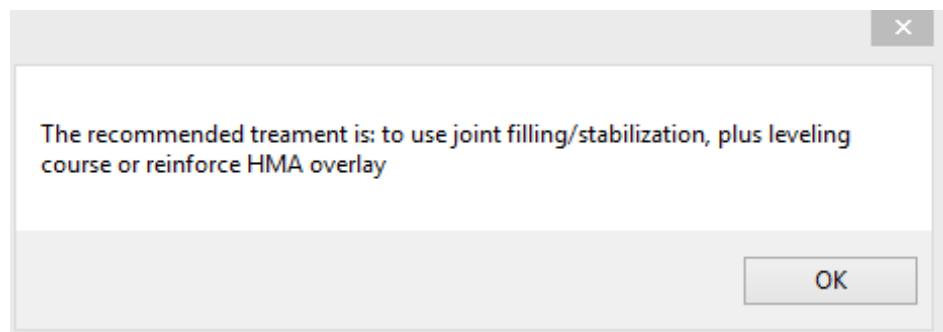
Finally, a message box would pop out showing which treatment would be recommended as shown in Figure 24.

**Figure 24. Message box for treatment selection**

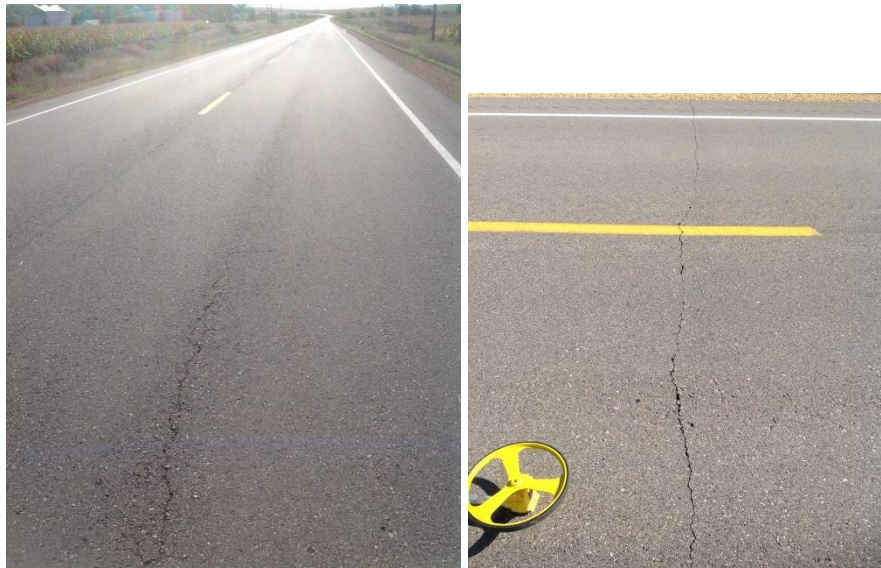
**Figure 53. Performance condition on Y4E project**

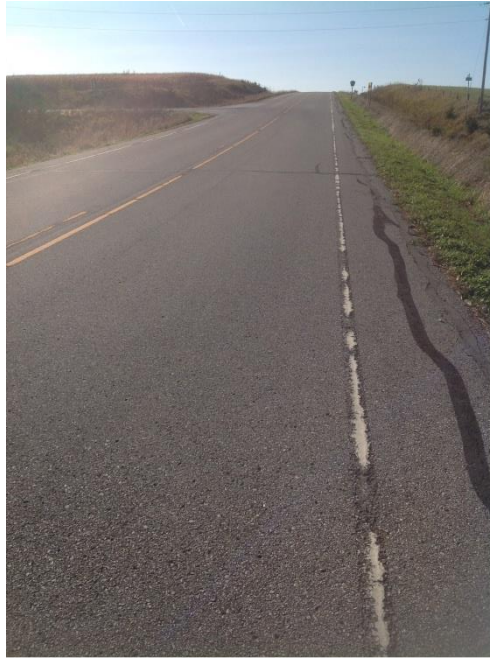
Reflective/transverse cracking pops out in a few locations meters in medium size and cracks were sealed. Longitudinal cracking is whole along the shoulder.

**Figure 54. Performance condition on H14 project**

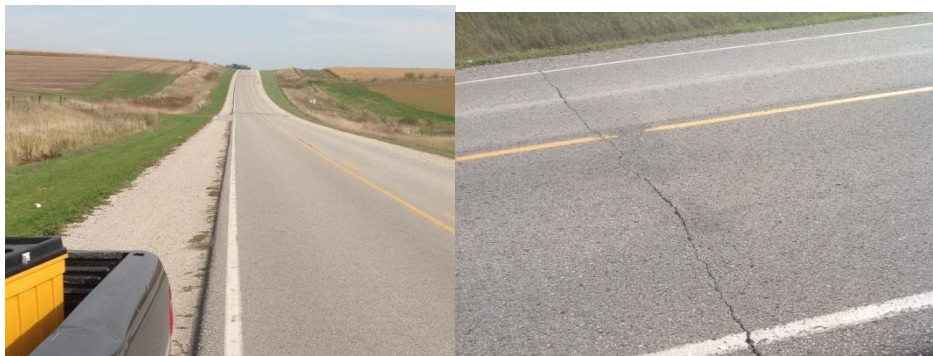
**Figure 55. Performance condition on H24 project**

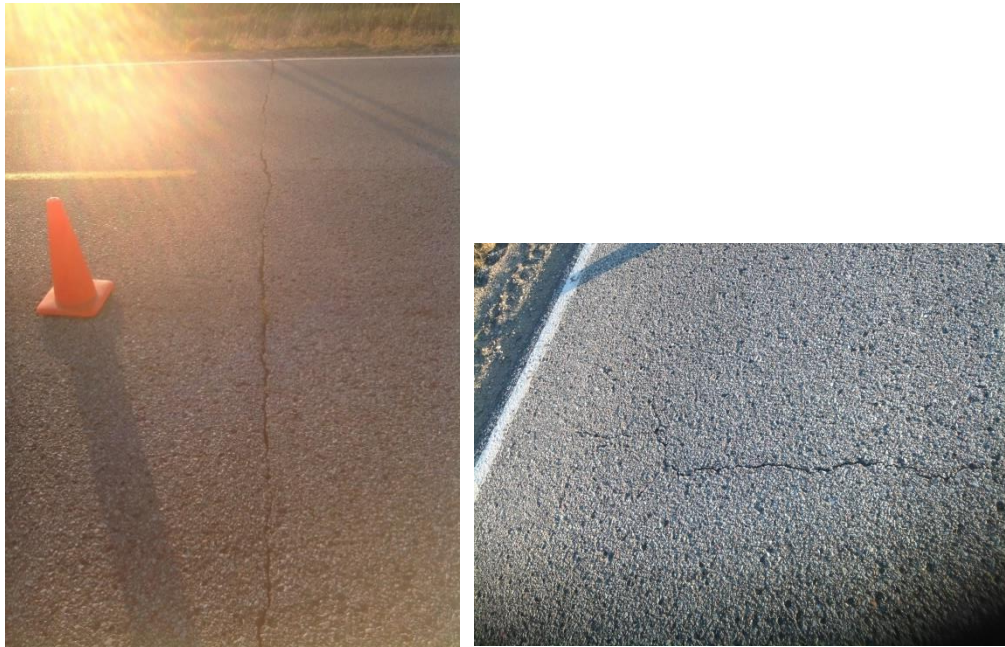
**Figure 56. Performance condition on L55 project**

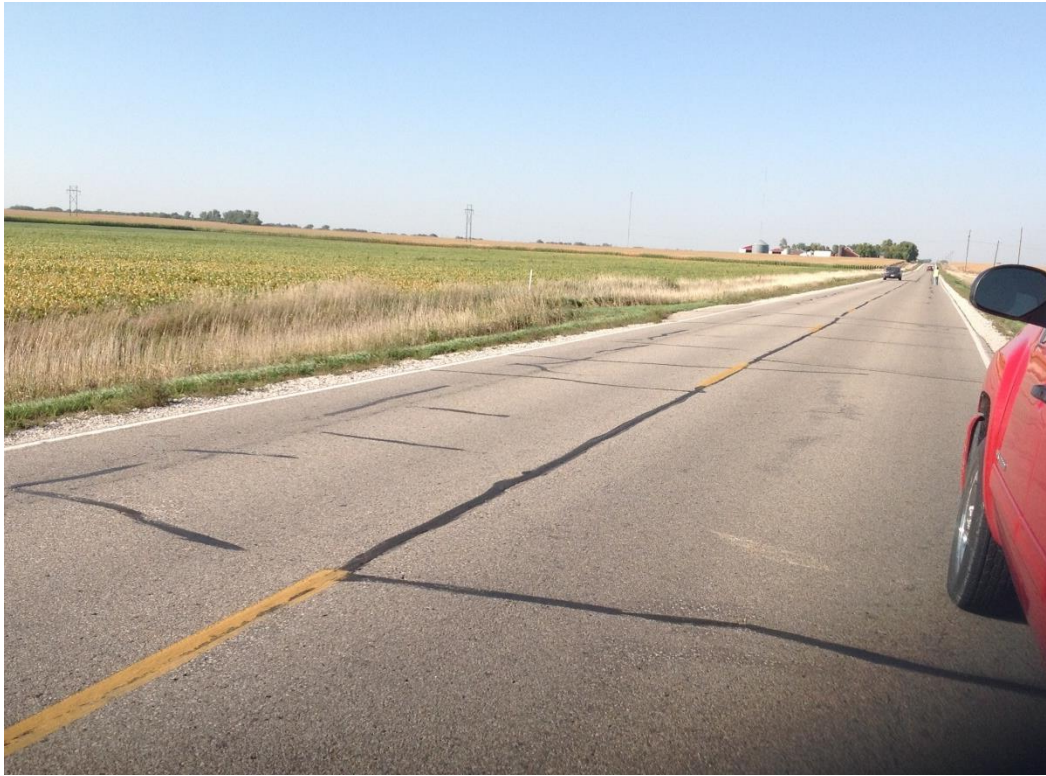
**Figure 57. Performance condition on G61 (East) project**
