## MAINTENANCE AND DESIGN OF STEEL ABUTMENT PILES IN IOWA BRIDGES

**Final Report**  
**Iowa Highway Research Board Project TR-622**  
September 2, 2014  
WJE No. 2010.0738

*Prepared for:*  
**Iowa Department of Transportation**  
Office of Bridges and Structures  
800 Lincoln Way  
Ames, IA 50010

*Prepared by:*  
**Wiss, Janney, Elstner Associates, Inc.**  
330 Pfingsten Road  
Northbrook, Illinois 60062  
847.272.7400 tel | 847.291.4813 fax

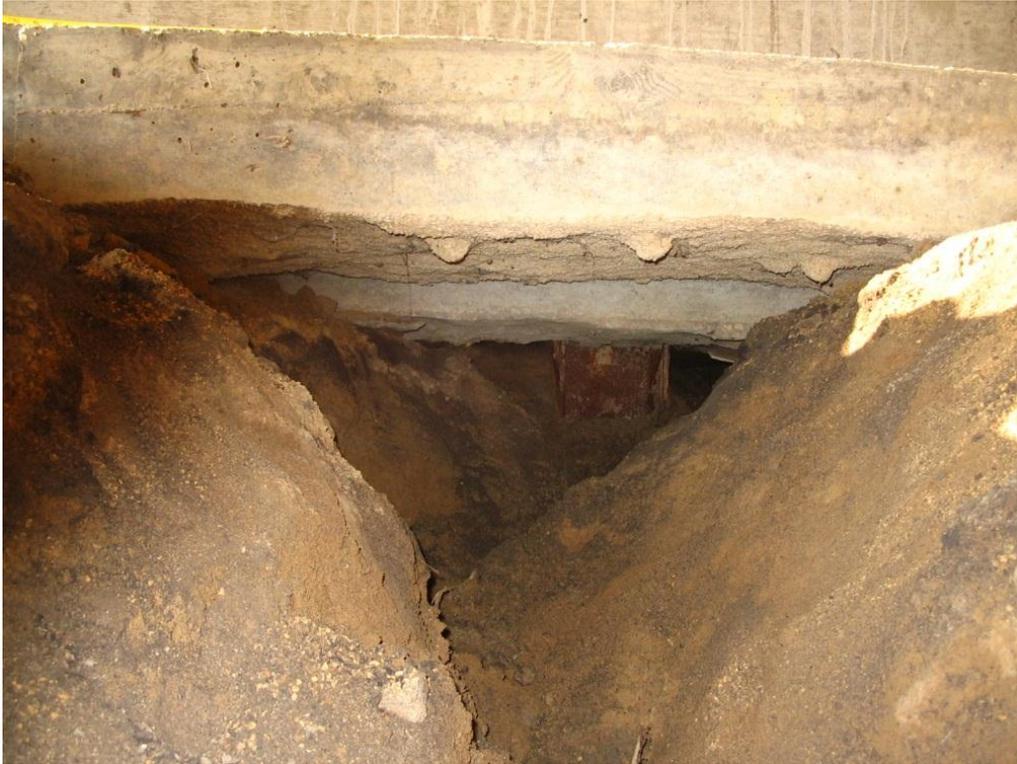
*Figure 1. Erosion and exposed pile at bridge abutment*

The study found that several of the bridge abutments exhibited severe erosion, caused by roadway runoff passing through transverse joints in the roadway or around the abutment wing walls. An example is shown in Figure 1. In many cases, after excavation of the more obvious exposed piles, it was evident that several inches of the upper portions of adjacent piles were also exposed. At several bridges, previous attempts to control and/or repair erosion were apparent. These included staked sheets of plywood installed to divert runoff (Figure 2), the use of soil to fill ditches caused by erosion and to cover exposed piles, and the use of pumped grout to fill the void under the abutment (Figure 3). Where soil fill was used, voids were observed under the abutments around the piles when the fill was removed from the face of the abutment concrete. The pumped grout was effective in filling voids and covering the previously exposed piles.

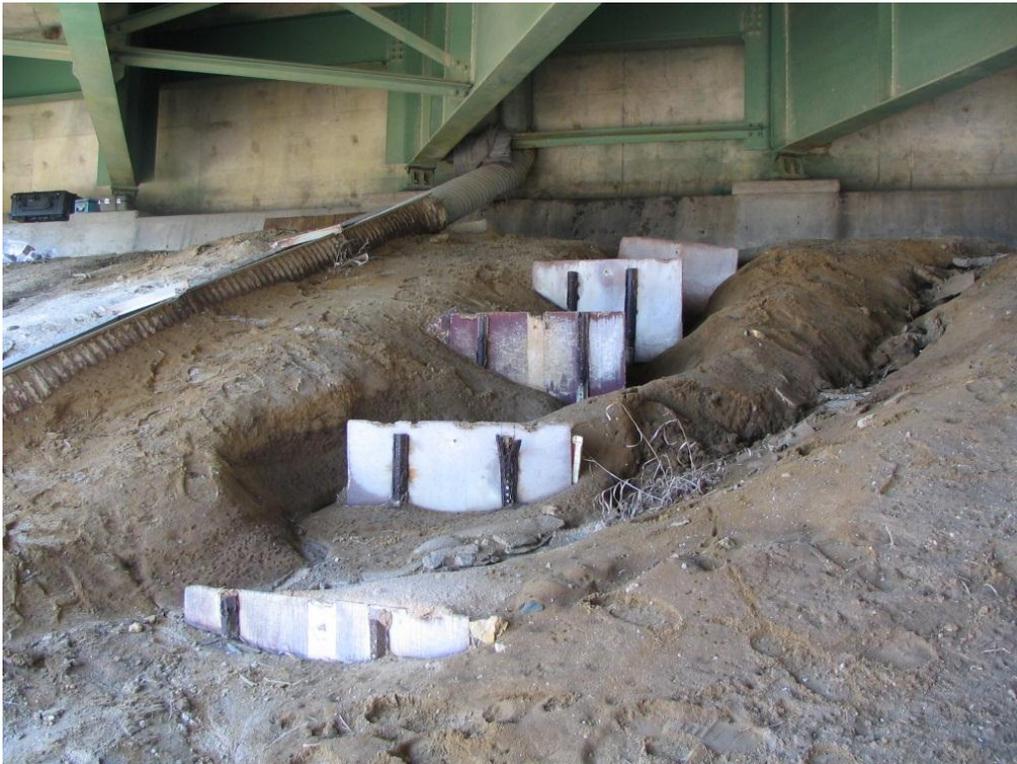
*Figure 2. Staked plywood sheets for erosion control*

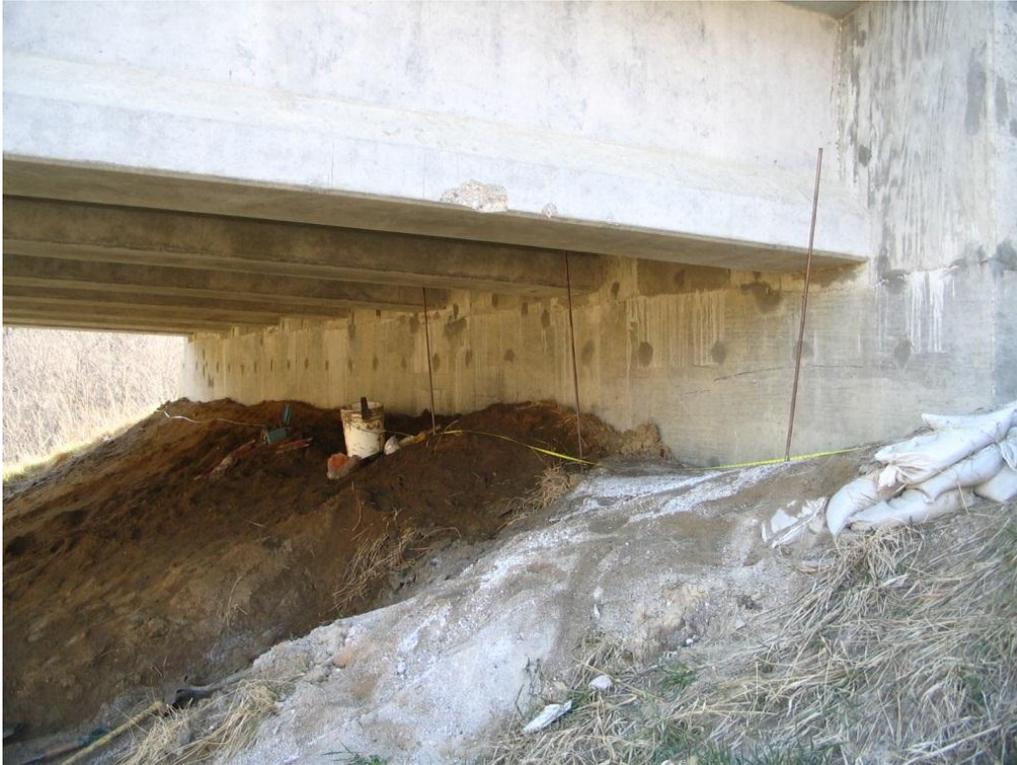
*Figure 3. Erosion repair using grout material*

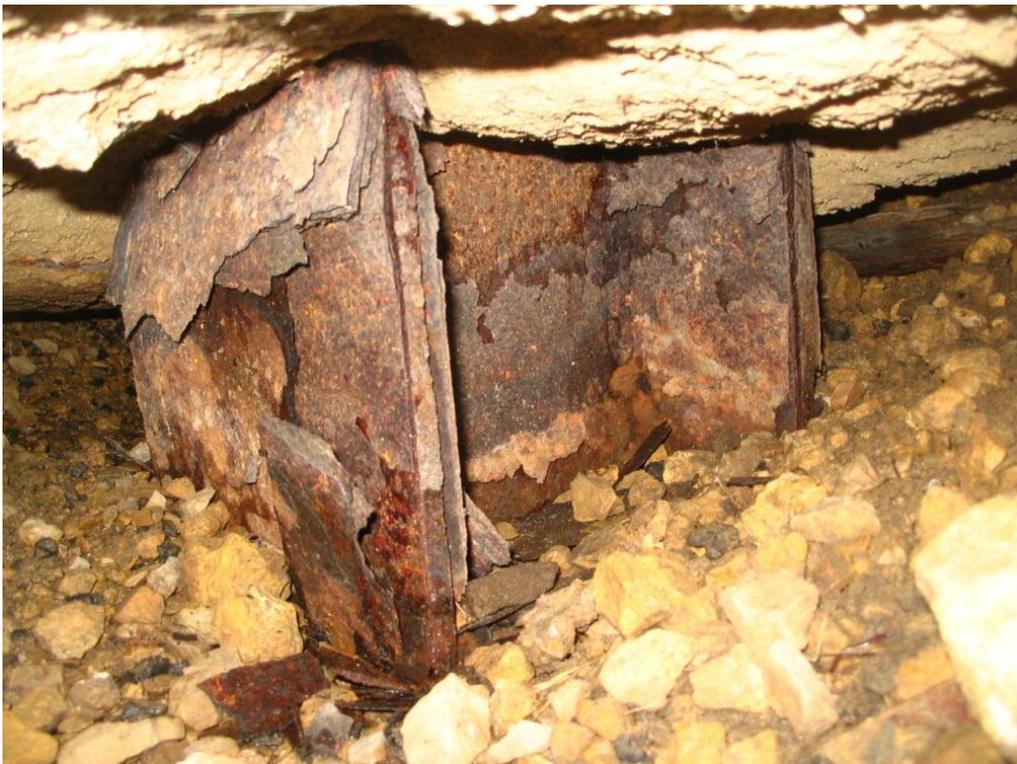
*Figure 4. Laminar corrosion at bridge pile*

Corrosion of varying severity was observed at all of the piles that had been exposed by erosion or soil consolidation. Laminar corrosion, such as that shown in Figure 4, was commonly observed at exposed portions of piles. Pitting, shown in Figure 5, was evident to some degree at both exposed and covered piles. Typically, however, very little corrosion was observed at piles that were fully covered. An example of a covered pile after excavation is shown in Figure 6. Perforations caused by corrosion were observed in one exposed pile, as shown in Figure 7.

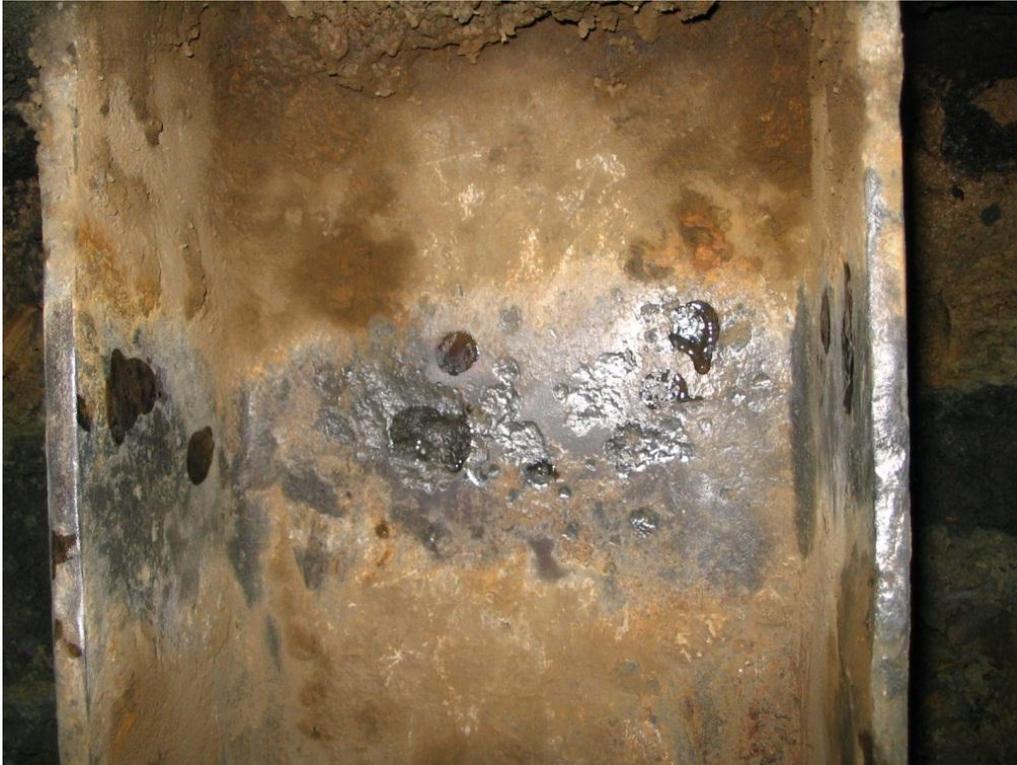
*Figure 5. Pitting in bridge pile*

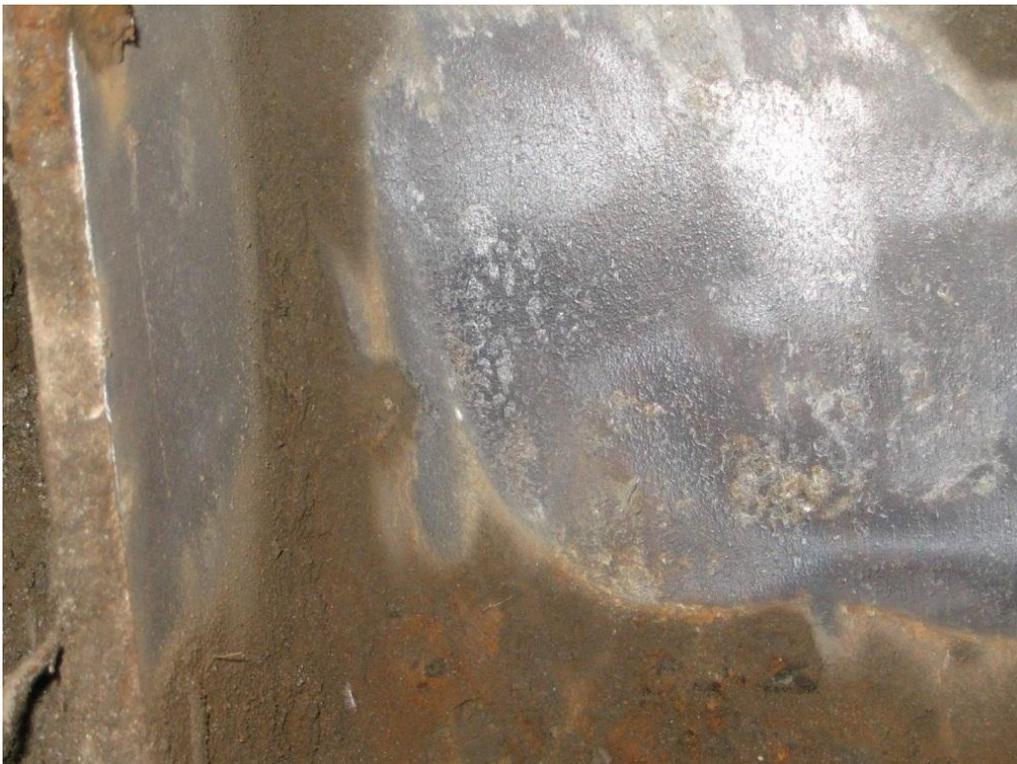
*Figure 6. Covered pile after excavation with little corrosion*

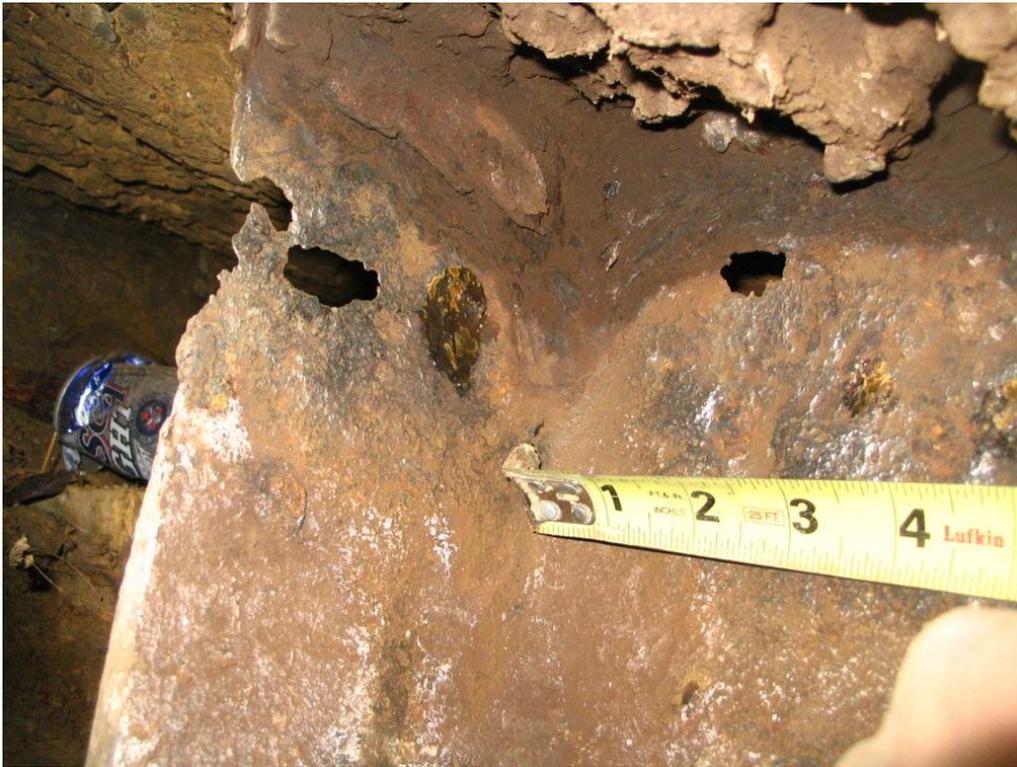
*Figure 7. Perforations in flange and web of exposed pile*

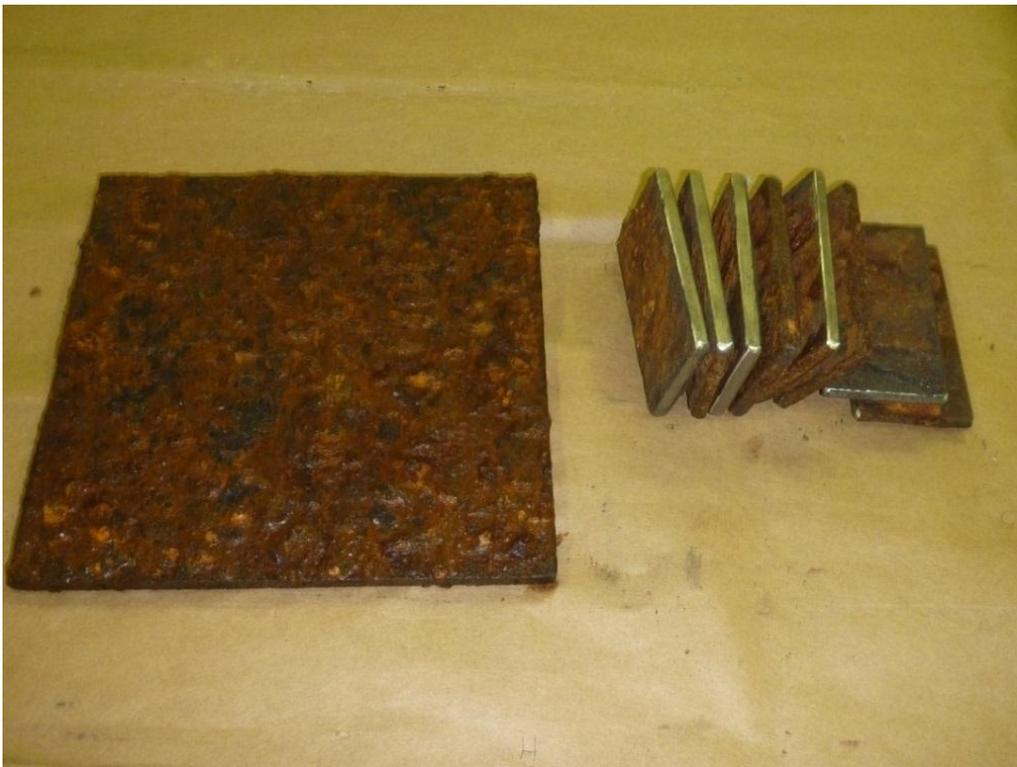
*Figure 8. Test panels cut from ASTM Rust Grade D corroded 1/4 in. ASTM A36 steel plate, prior to surface preparation*

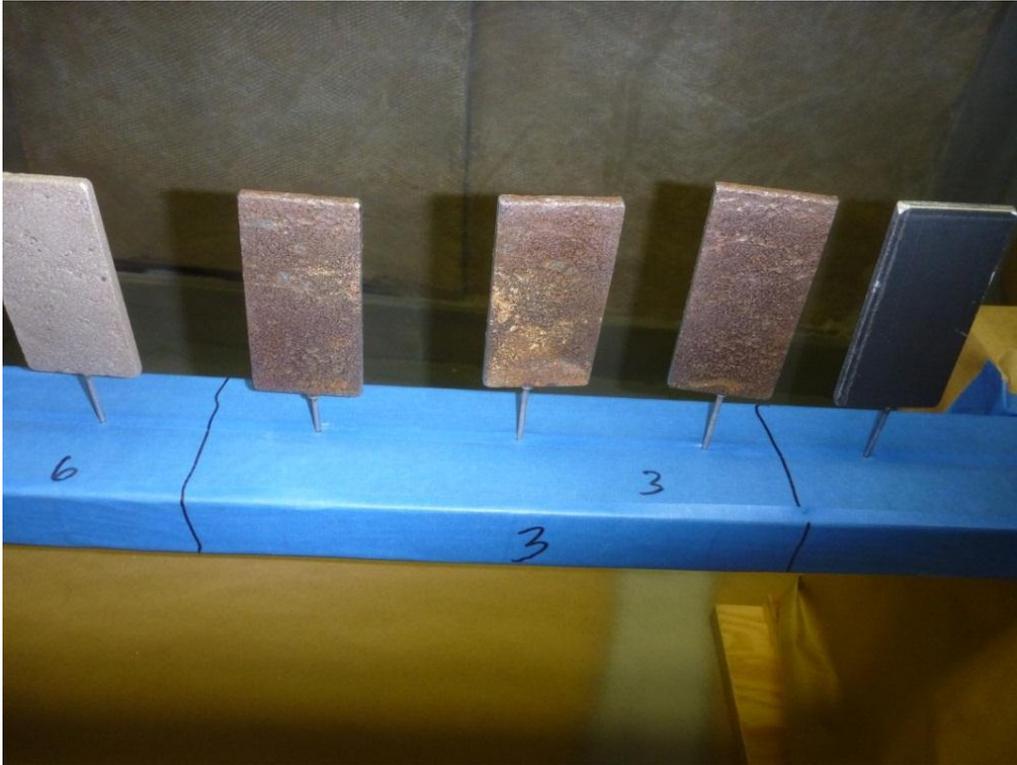
*Figure 9. Test panels prepared to SSPC SP-3 standard*

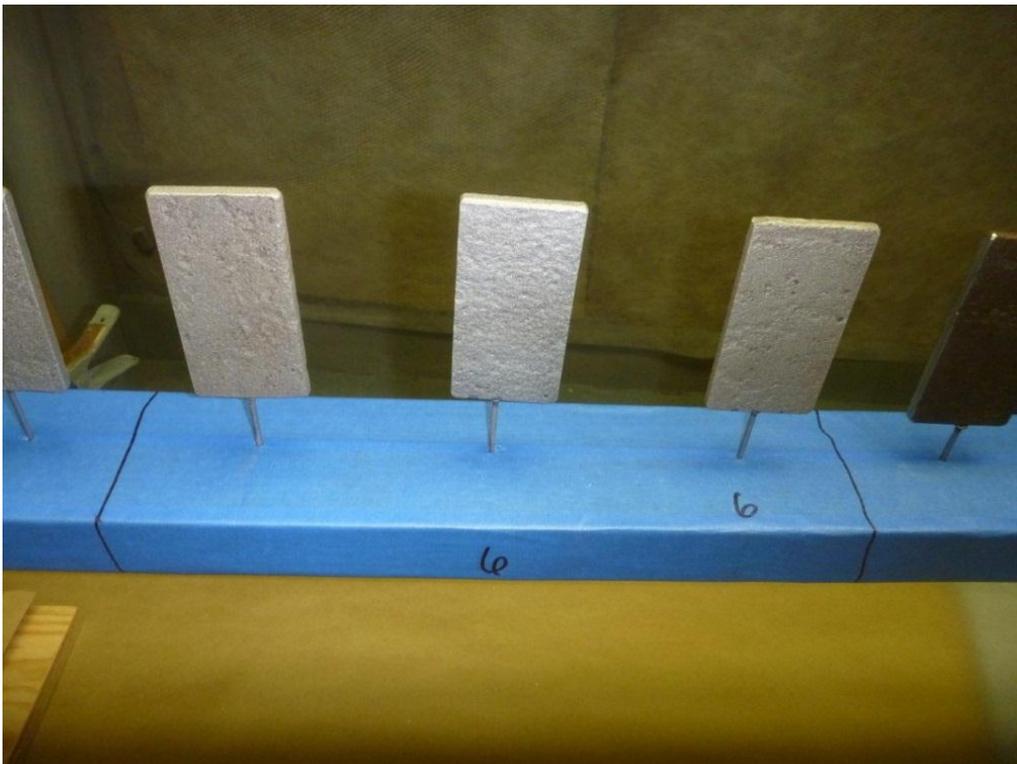
*Figure 10. Test panels prepared to SSPC SP-6 standard*

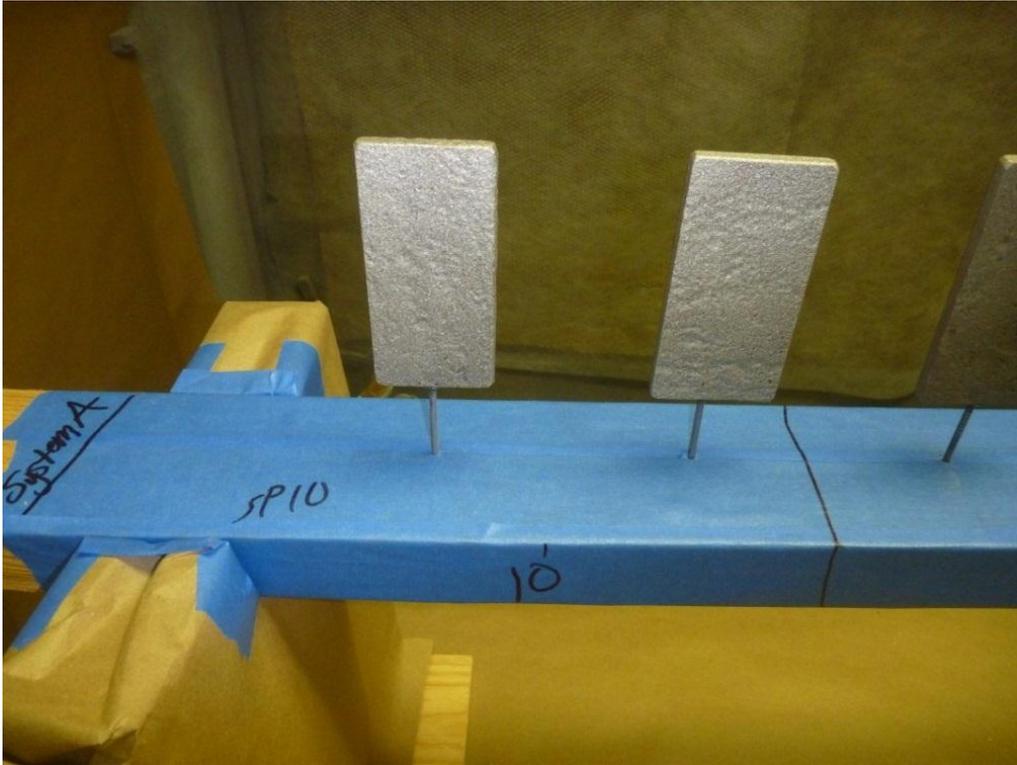
*Figure 11. Test panels prepared to SSPC SP-10 standard*

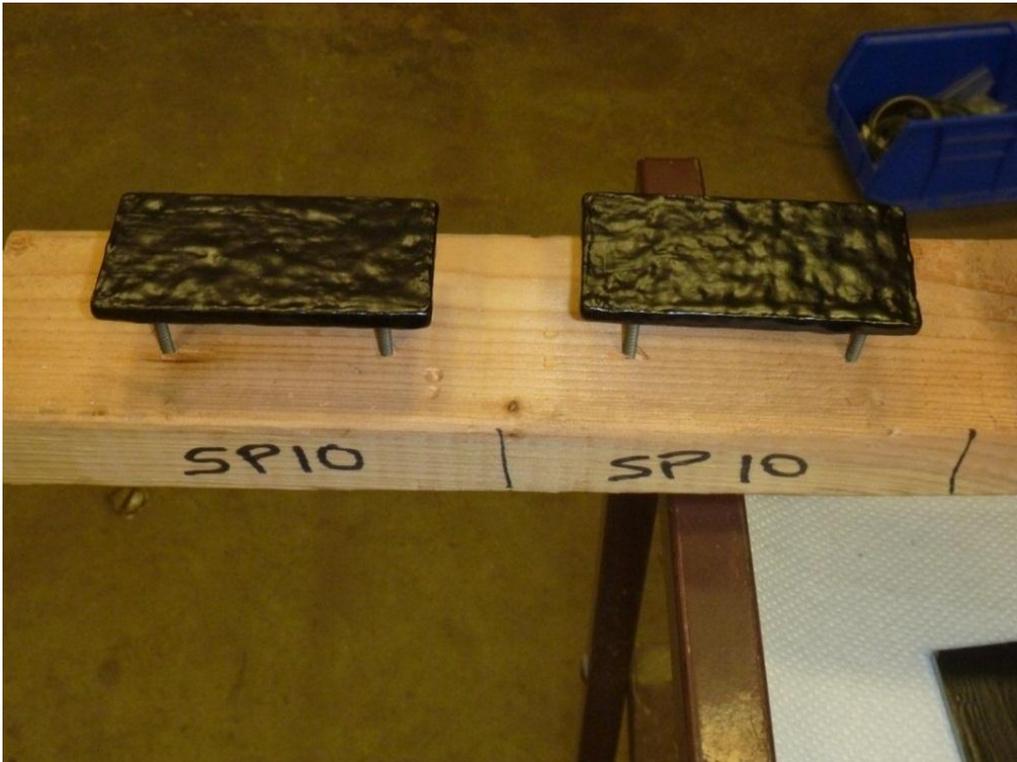
*Figure 12. Test panels coated with bituminous mastic*

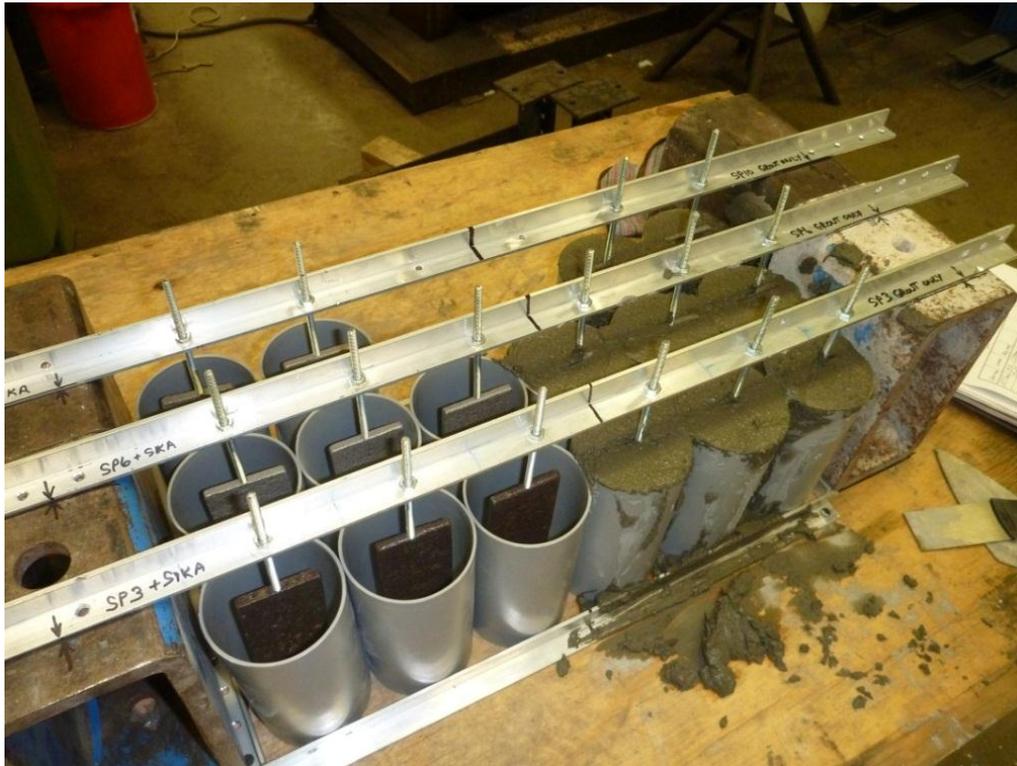
Figure 13. Formed grout encapsulation of test panels

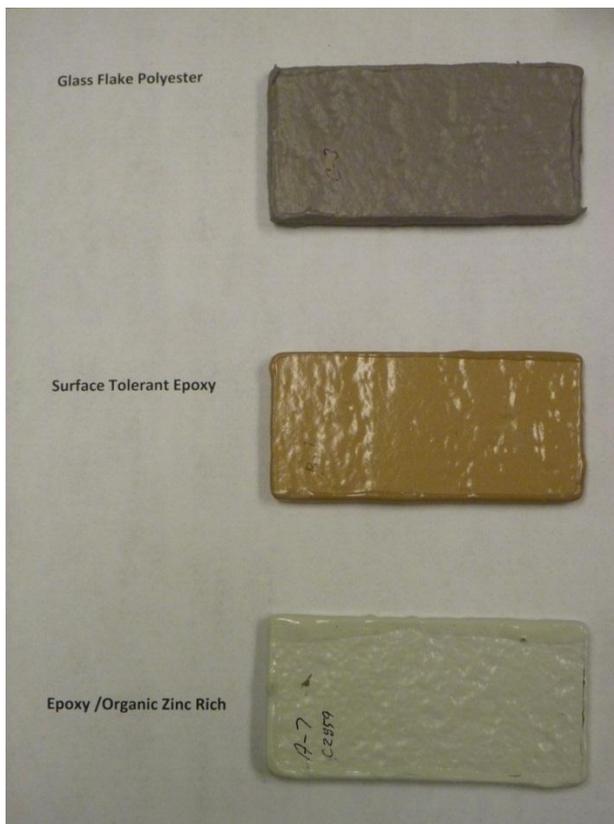
Figure 14. Test panels coated with glass flake polyester, surface tolerant epoxy, and epoxy over organic zinc rich primer

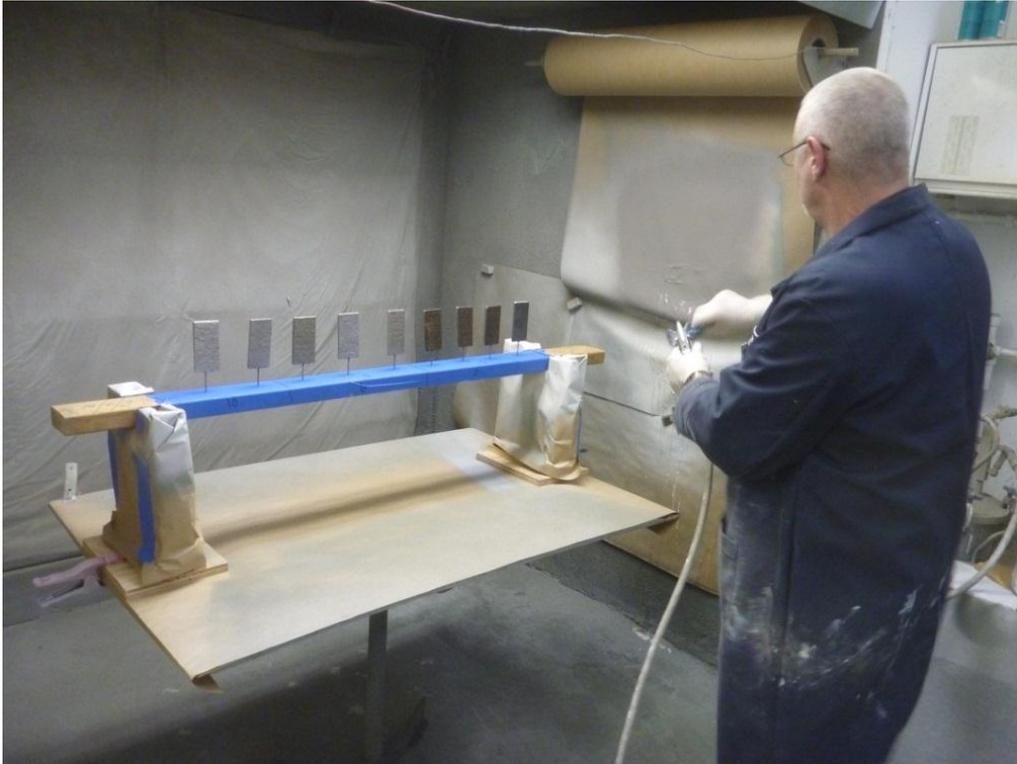
*Figure 15. Spray application of glass flake polyester coating*

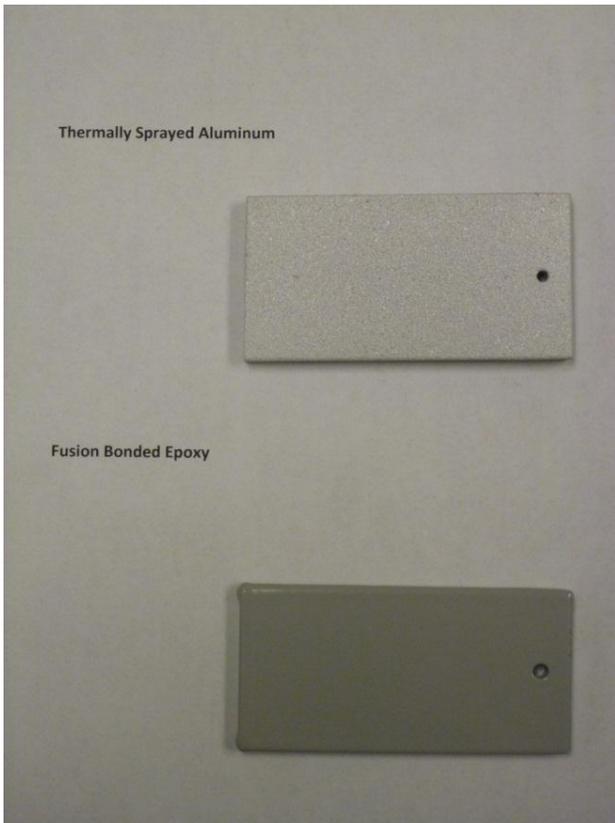
*Figure 16. Test panels coated with thermally sprayed aluminum and fusion bonded epoxy*

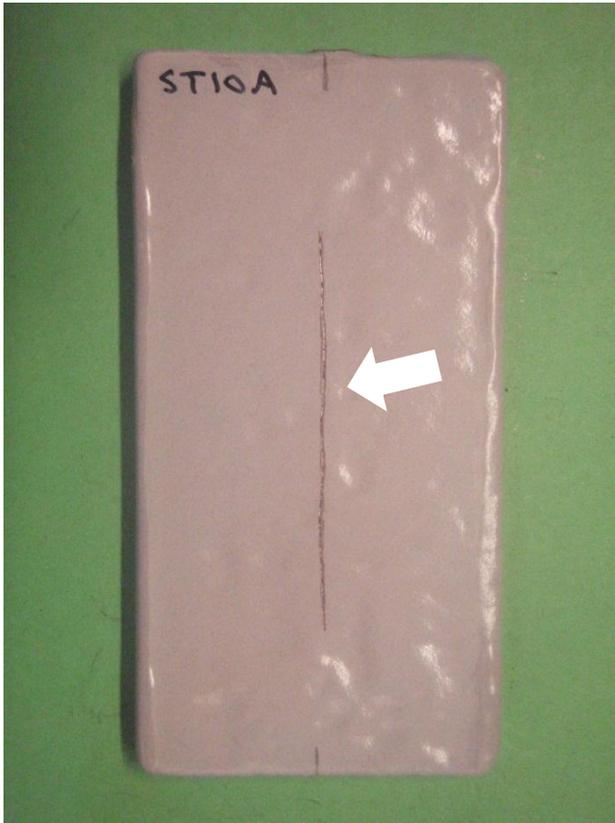
*Figure 17. Typical scribe mark on coated test panel*

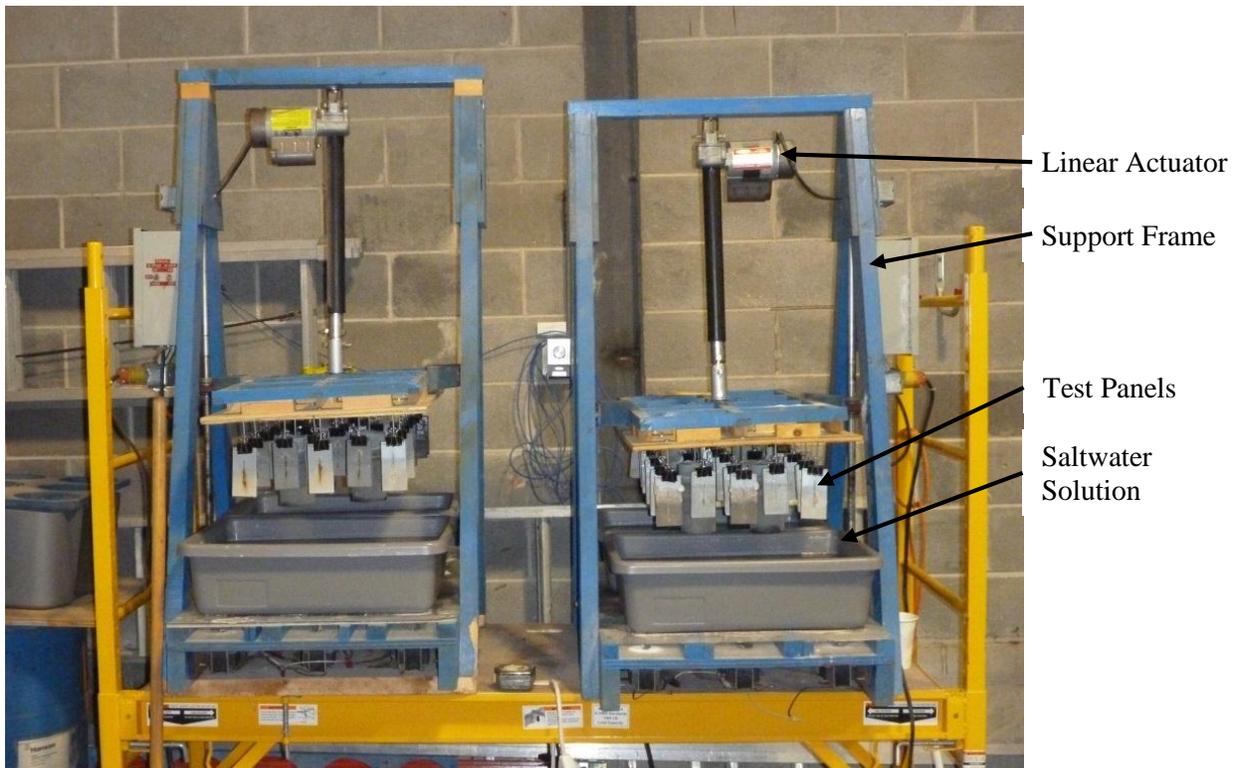
*Figure 18. Cyclic immersion test setup*

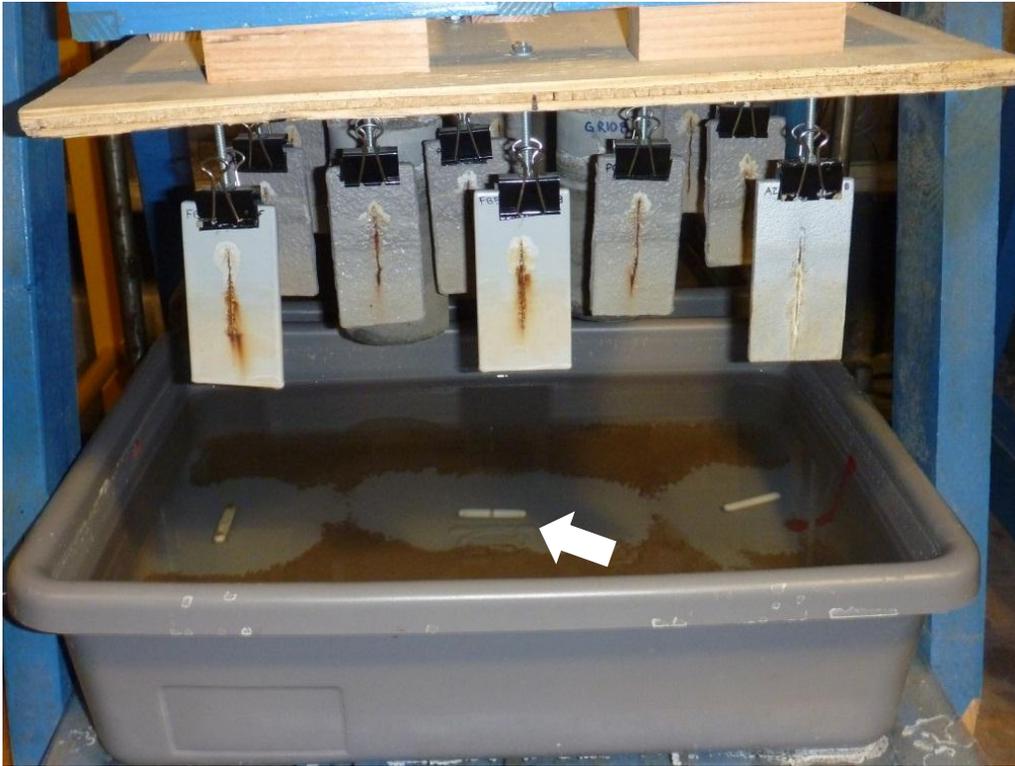
Figure 19. Close-up view of test panels. Arrow points to automatic stirrer.

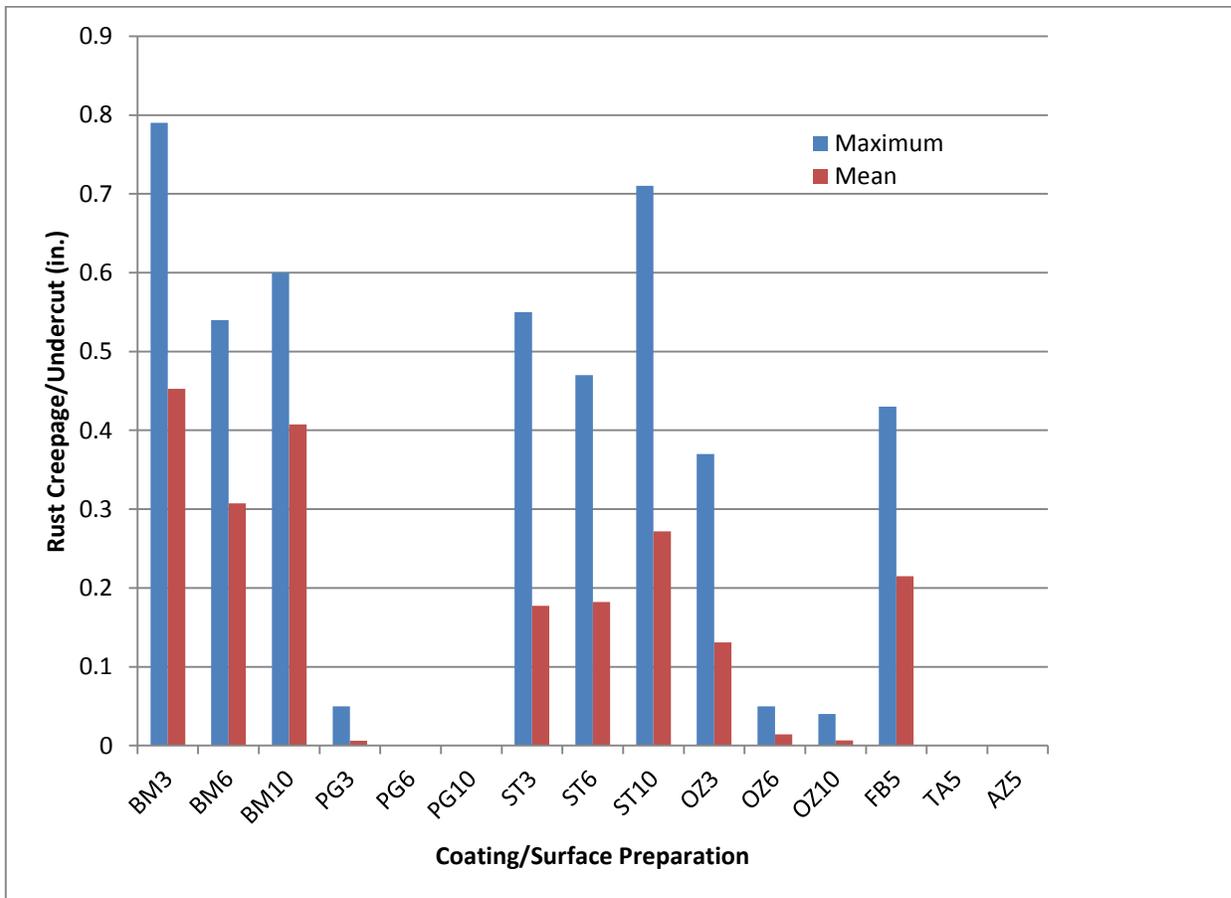
Figure 20. Maximum and mean undercut for each coating and surface preparation combination after 12 months of cyclic dip testing

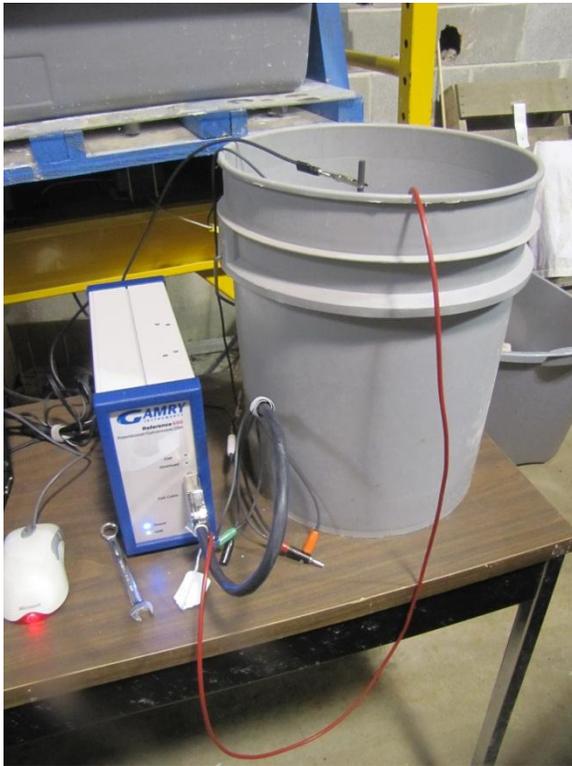
*Figure 21. Test setup used for LPR and Potentiostatic EIS testing. Hidden from view in the grey bucket is a salt solution deep enough to submerge 50% of the coated specimen (working electrode), a Ag/AgCl reference electrode, and a graphite counter electrode. The Gamry unit to the left is a potentiostat used to control the tests.*

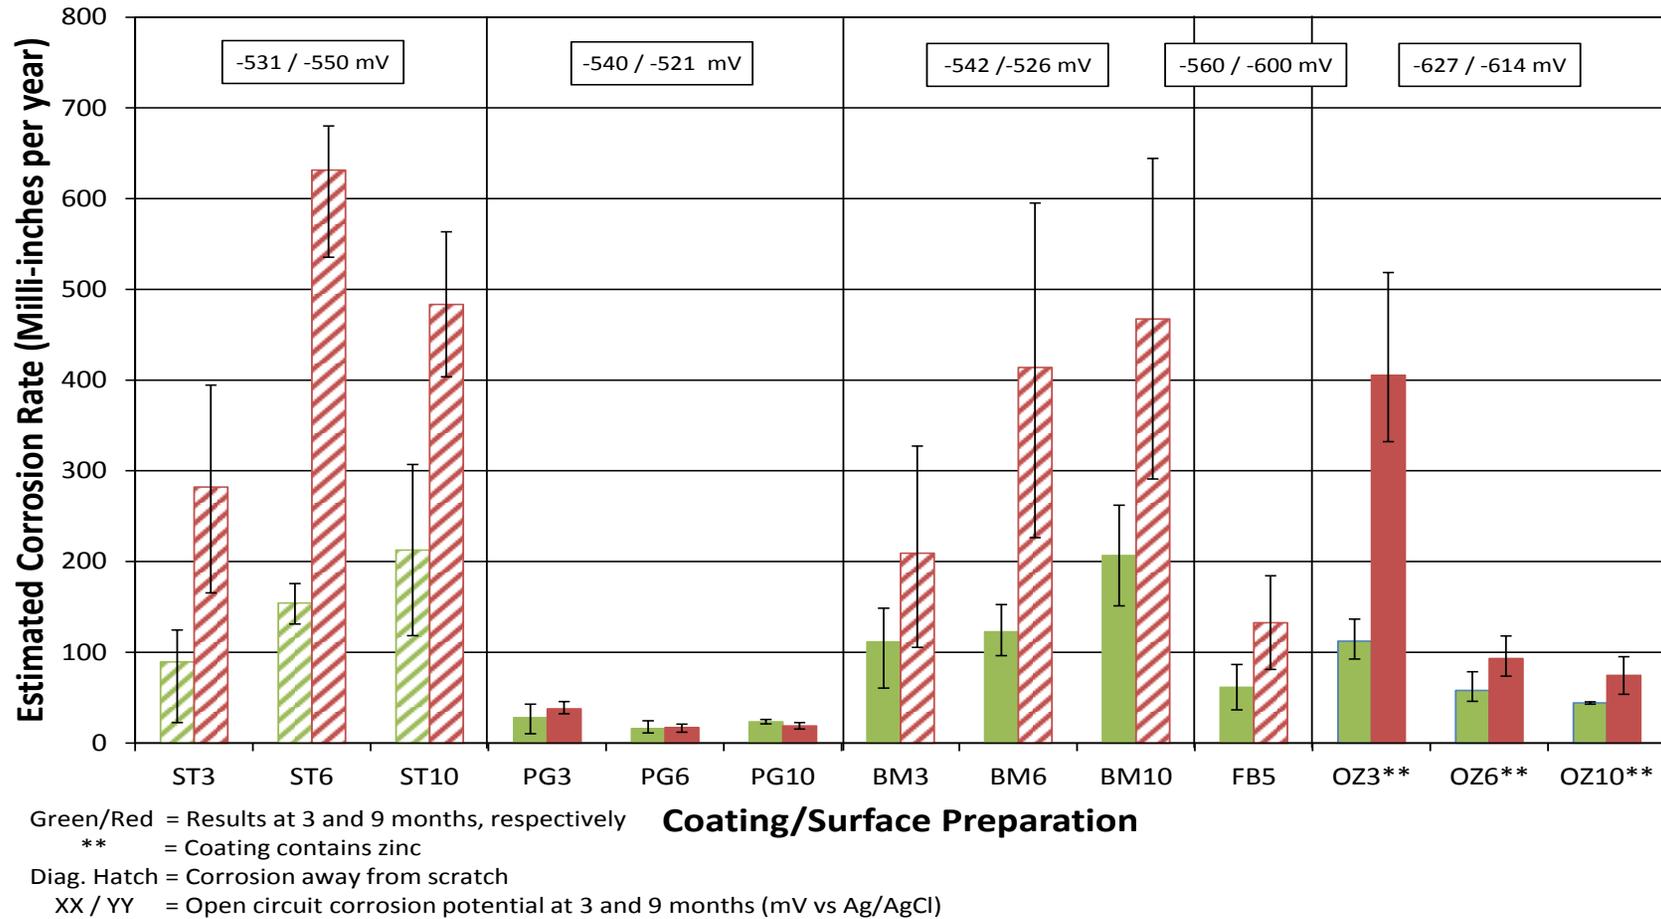
Figure 22. Estimated corrosion rate of specimens with inert coating types after 3 and 9 months of cyclic dipping. Specimen groups are named along the x-axis indicating type of coating and surface preparation.

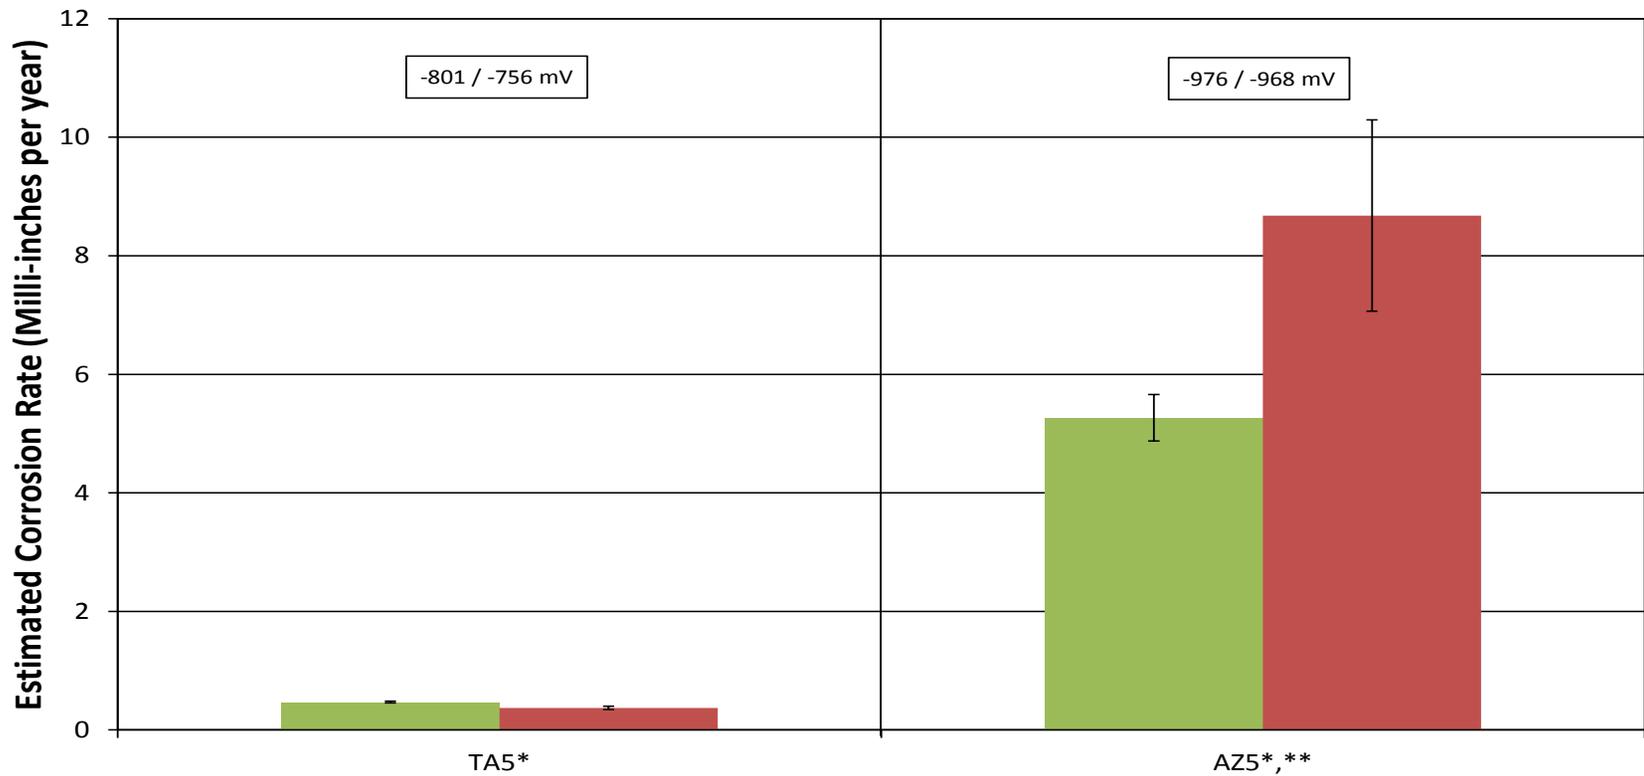
Green/Red = Results at 3 and 9 months, respectively

Diag. Hatch = Corrosion away from scratch

Figure 23. Estimated corrosion rate of specimens with active coating types after 3 and 9 months of cyclic dipping. Specimen groups are named along the x-axis indicating type of coating and surface preparation.

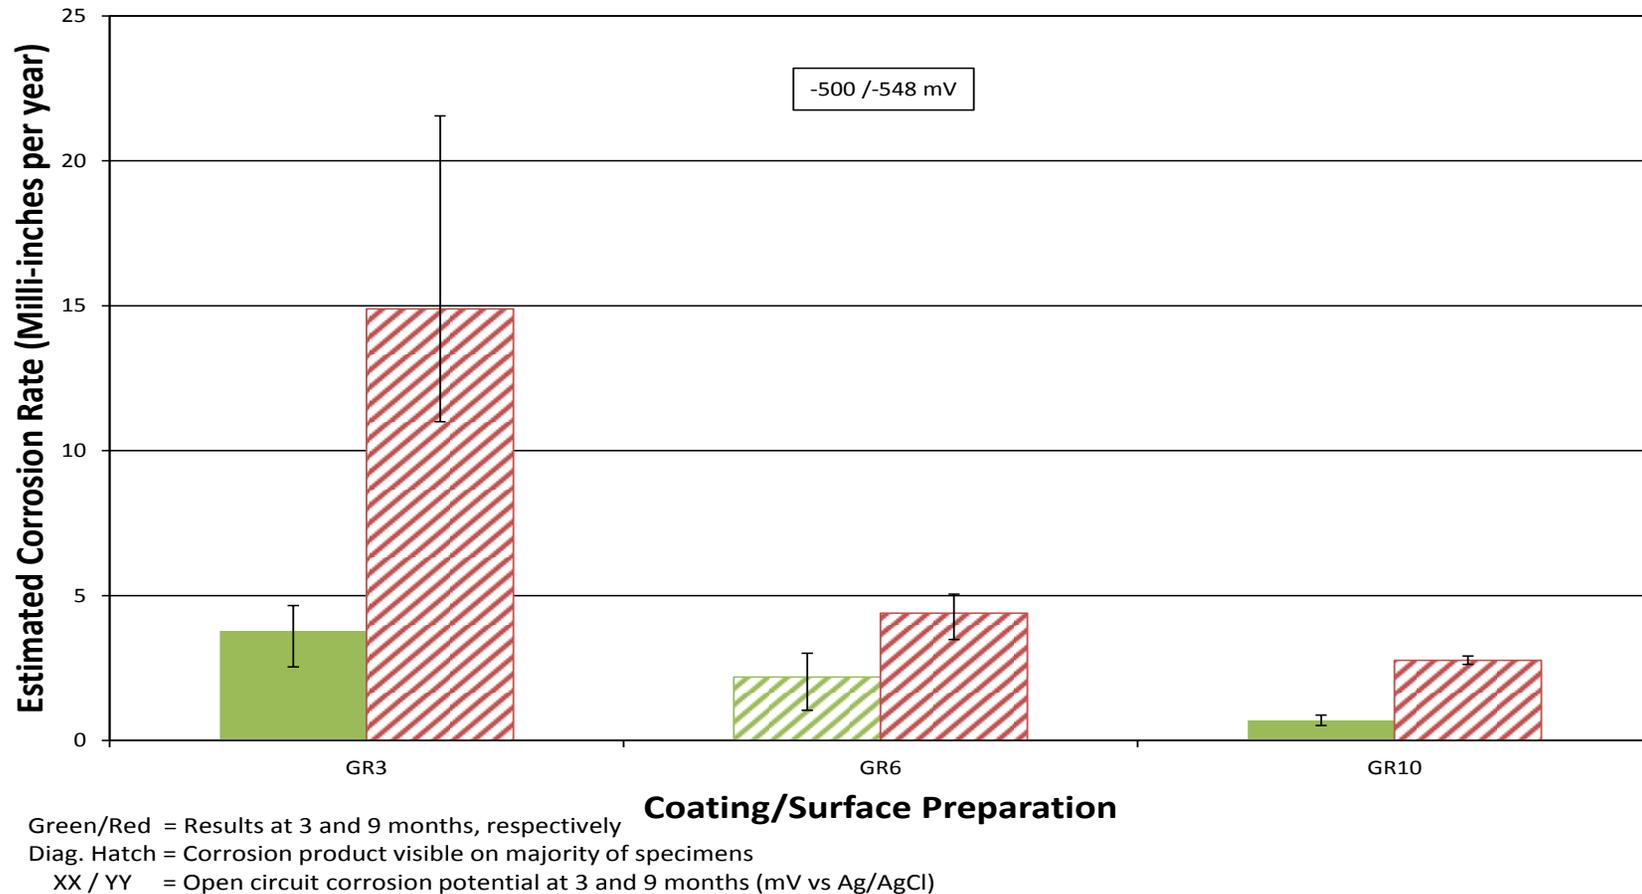
Figure 24. Estimated corrosion rate of specimens encased in grout after 3 and 9 months of cyclic dipping. Specimen groups are named along the x-axis indicating grout encasement and type of surface preparation.

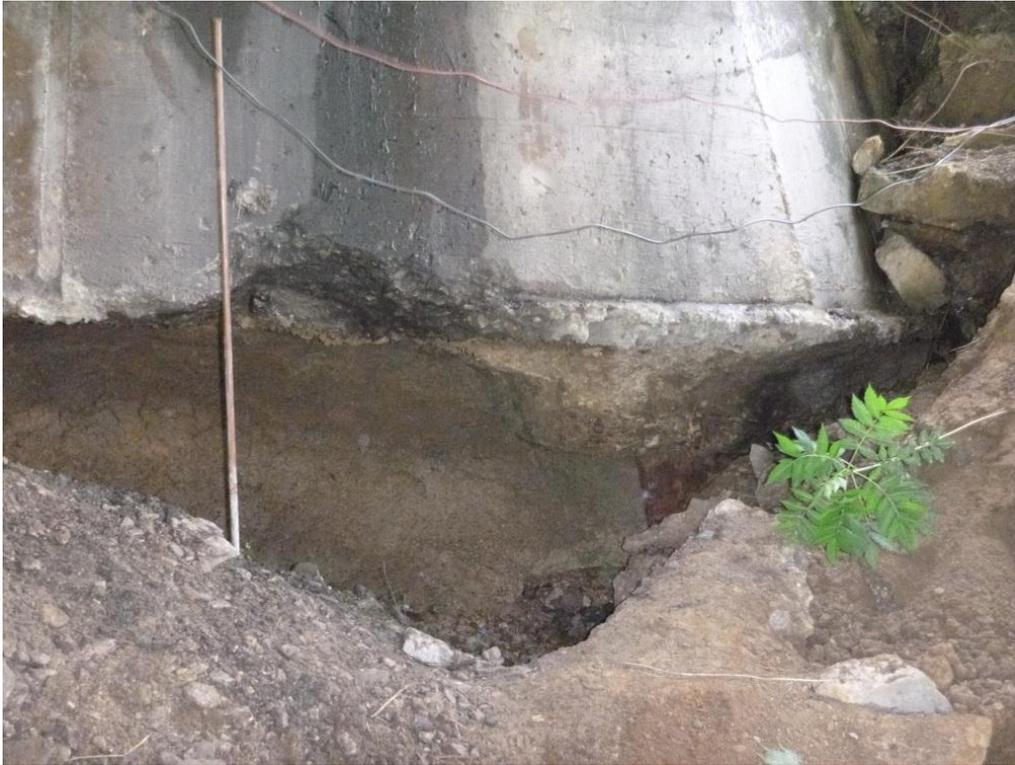
*Figure 25. Erosion at north end of west abutment of Bridge No. 9081.5S034*

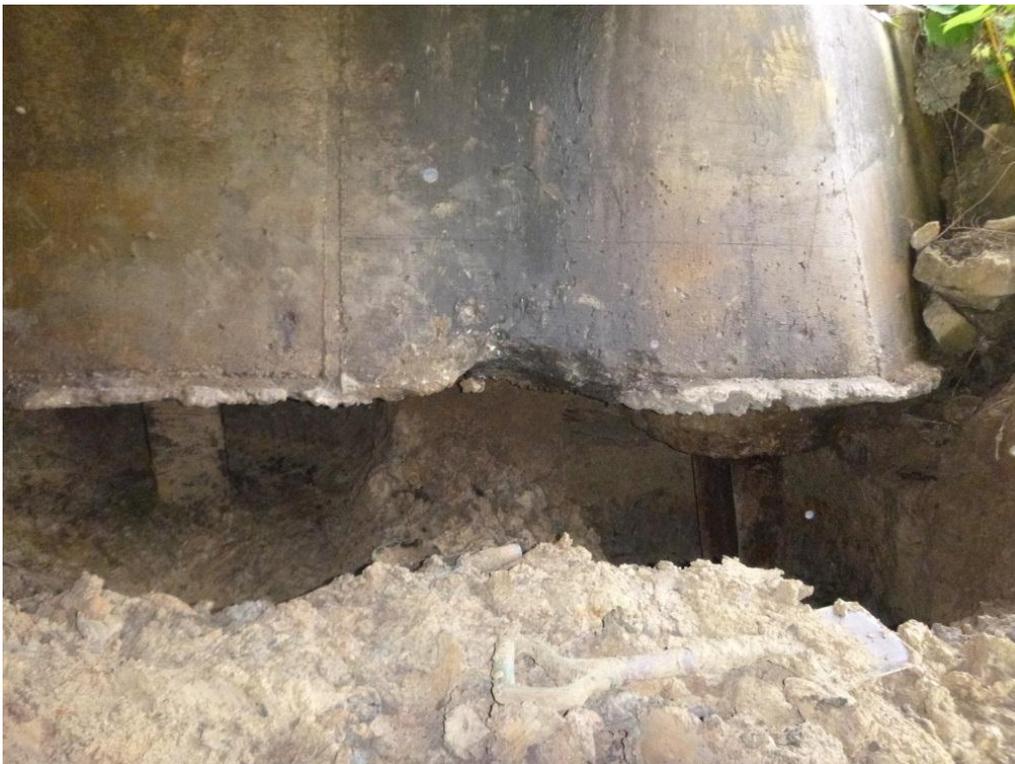
*Figure 26. Excavations at Piles 1 and 2*
