## MAINTENANCE AND DESIGN OF STEEL ABUTMENT PILES IN IOWA BRIDGES

**Final Report**  
**Iowa Highway Research Board Project TR-622**  
September 2, 2014  
WJE No. 2010.0738

*Prepared for:*  
**Iowa Department of Transportation**  
Office of Bridges and Structures  
800 Lincoln Way  
Ames, IA 50010

*Prepared by:*  
**Wiss, Janney, Elstner Associates, Inc.**  
330 Pfingsten Road  
Northbrook, Illinois 60062  
847.272.7400 tel | 847.291.4813 fax

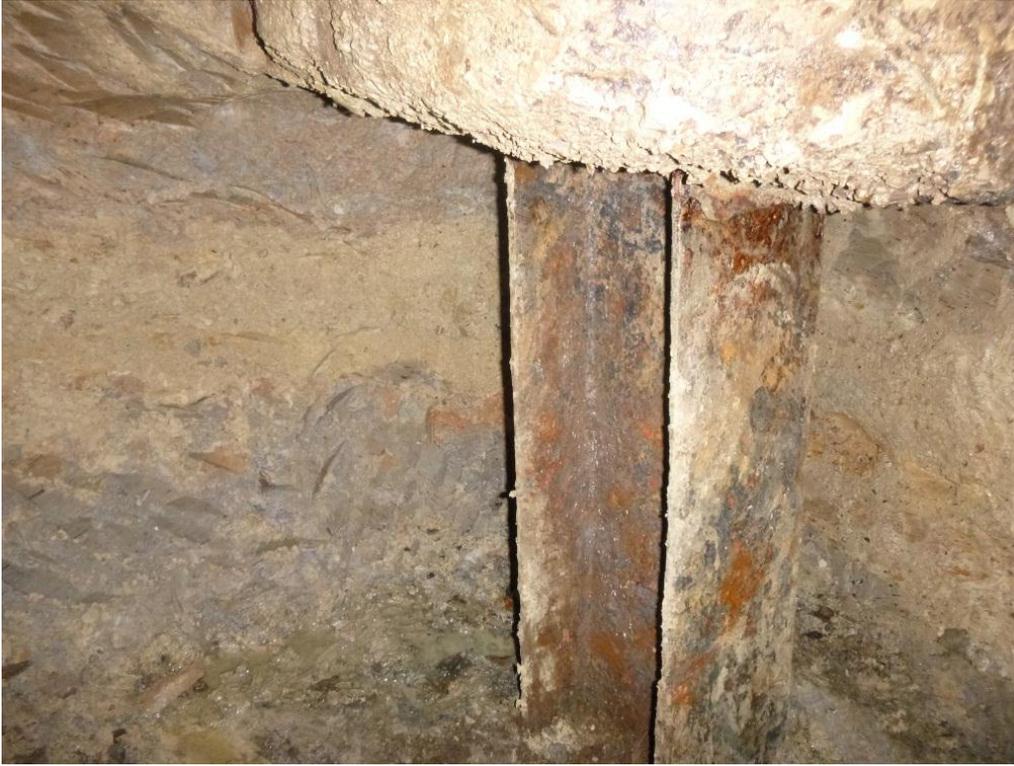
*Figure 27. Pile 1 after mechanical removal of soil from pile surfaces*

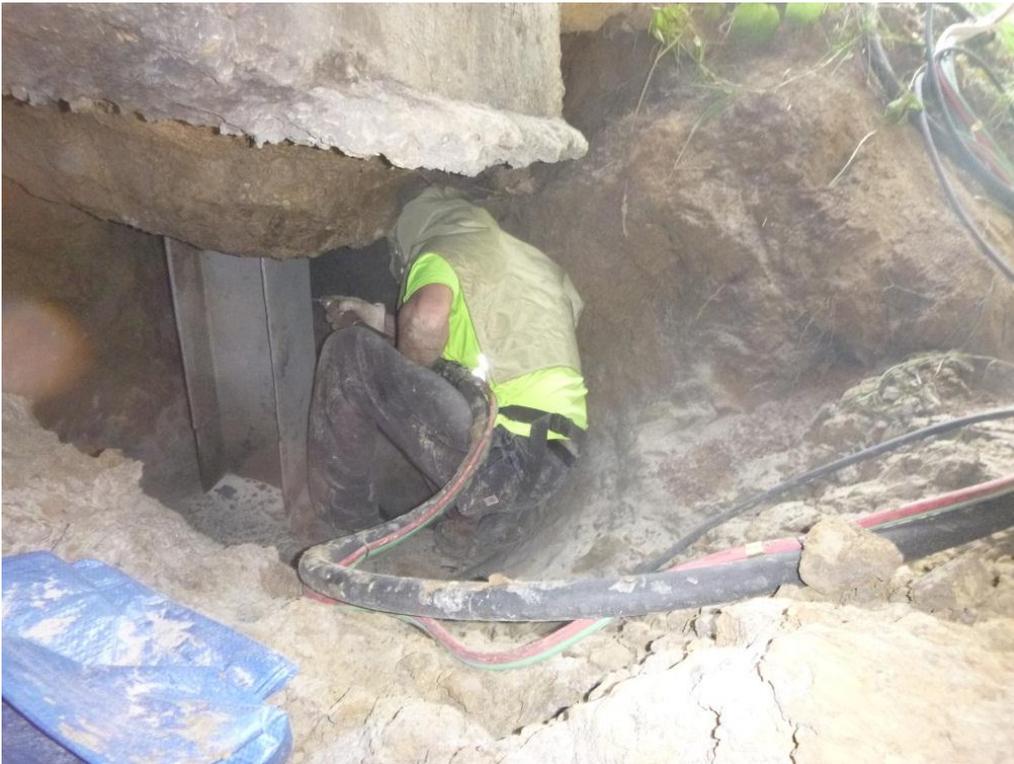
*Figure 28. Abrasive blast cleaning of Pile 1*

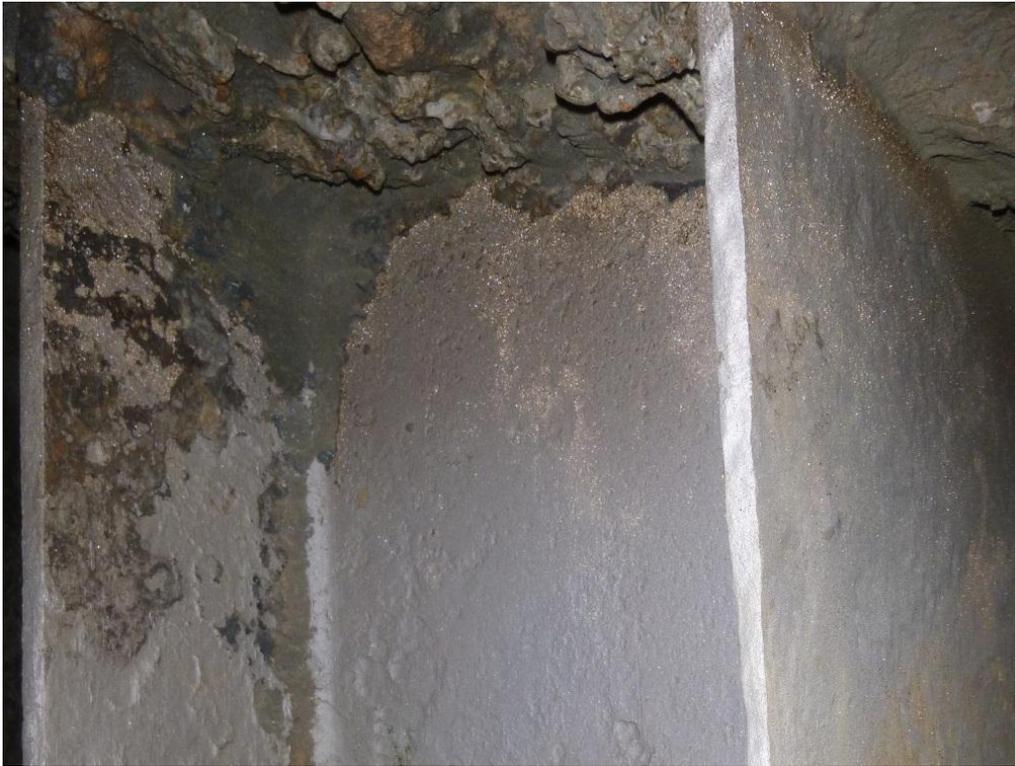
*Figure 29. Example of difficult-to-reach location on pile requiring additional cleaning effort. Note remnants of clay soil in corner of web, flange, and footing.*

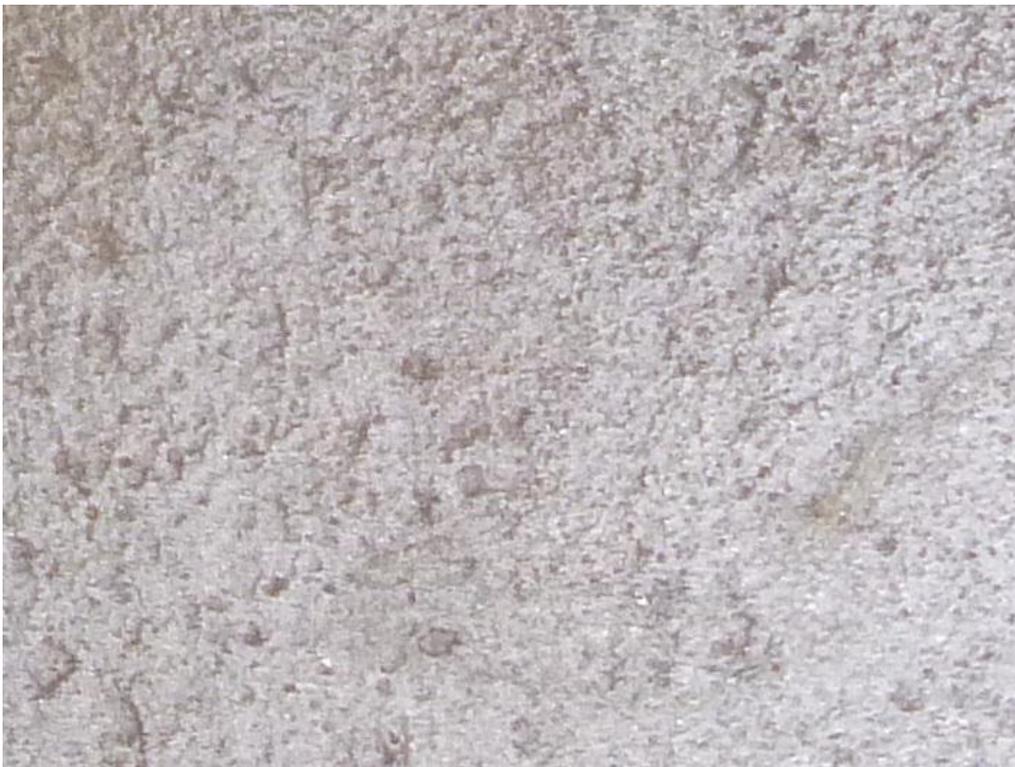
*Figure 30. Typical abrasive blast cleaned surface at relatively difficult to reach area of pile*

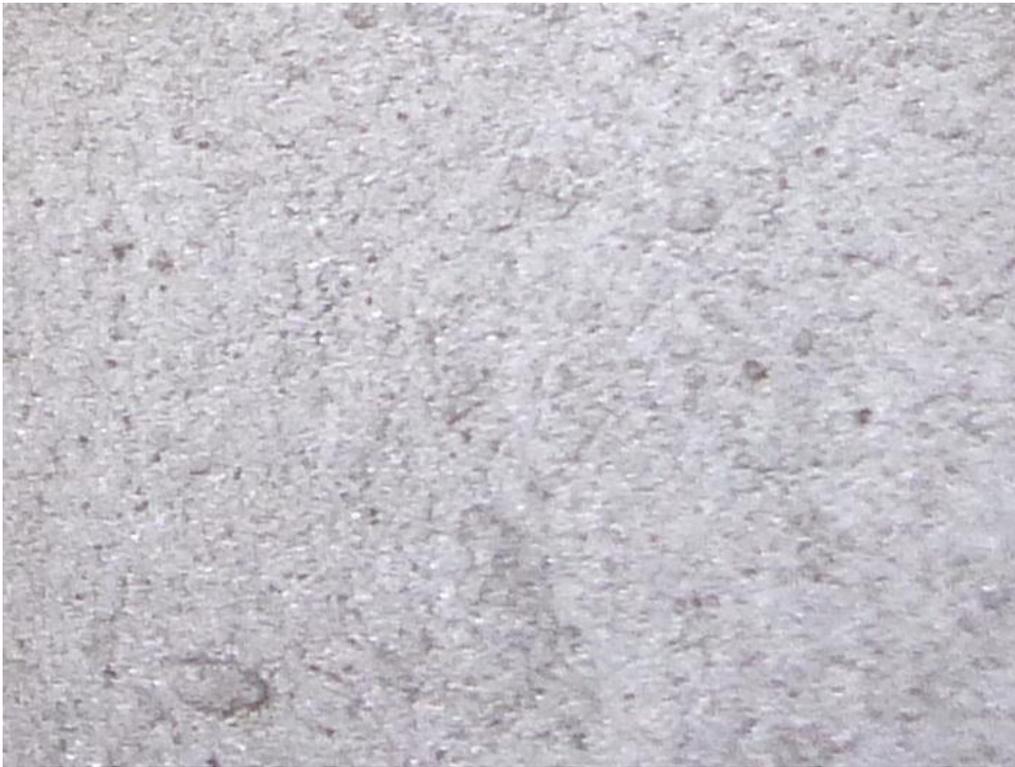
*Figure 31. Typical abrasive blast cleaned surface at relatively easy to reach area of pile*

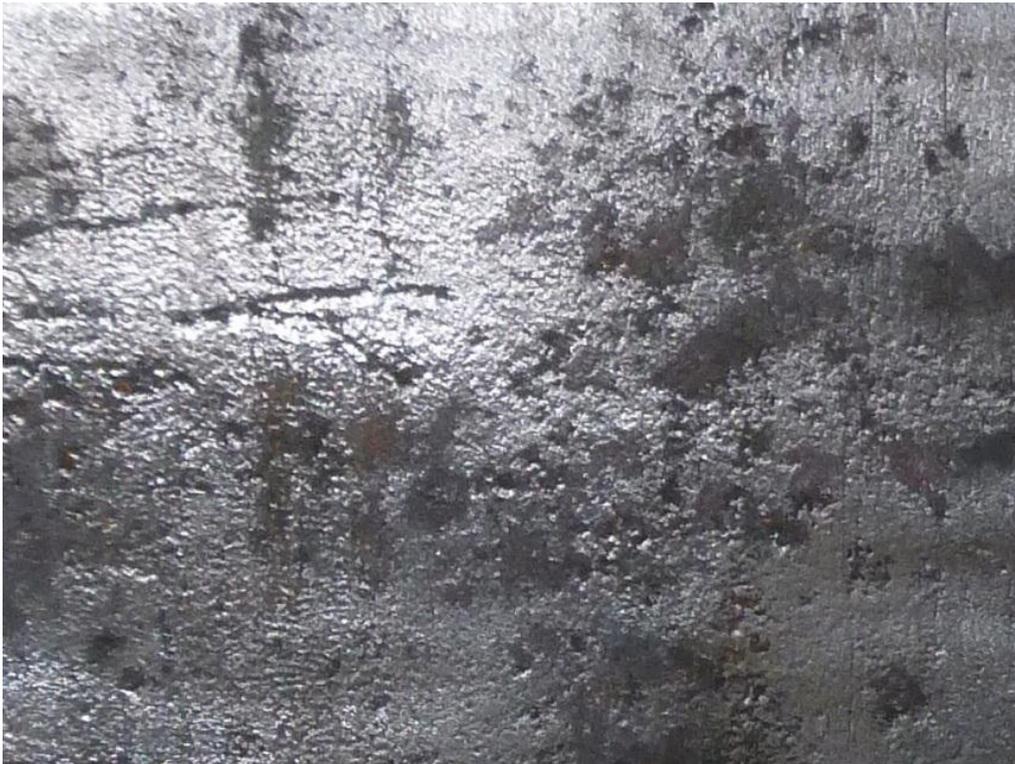
*Figure 32. Typical prepared surface using the MBX Bristle Blaster*

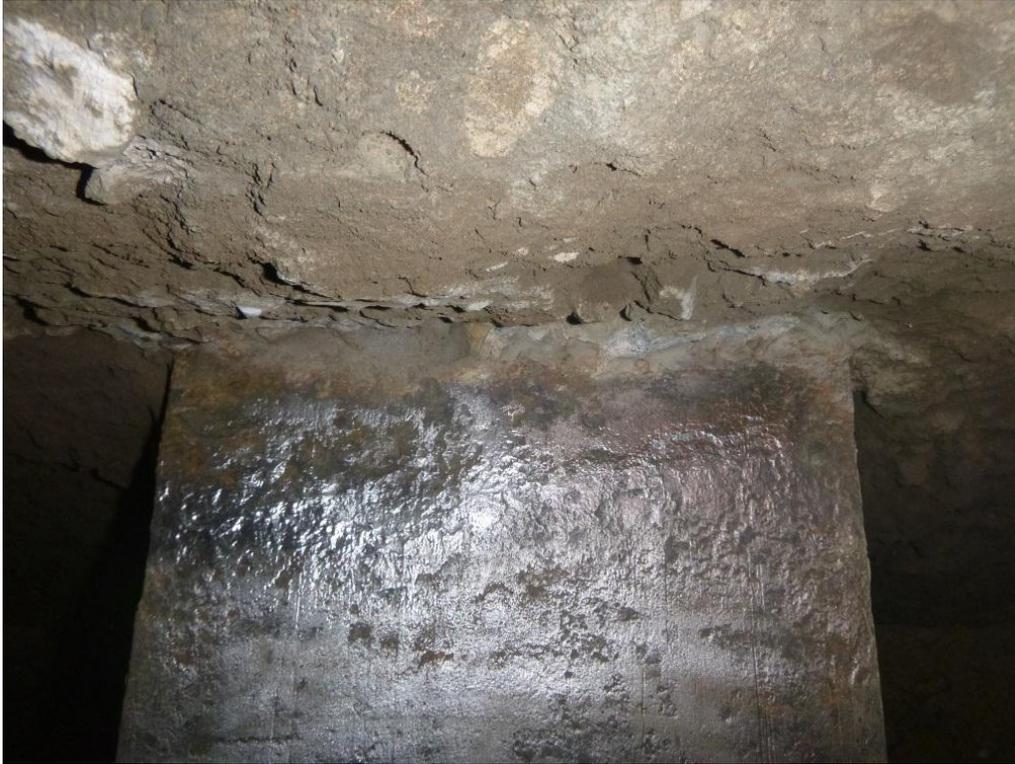
*Figure 33. Pile/abutment interface inaccessible for surface preparation with MBX Bristle Blaster*

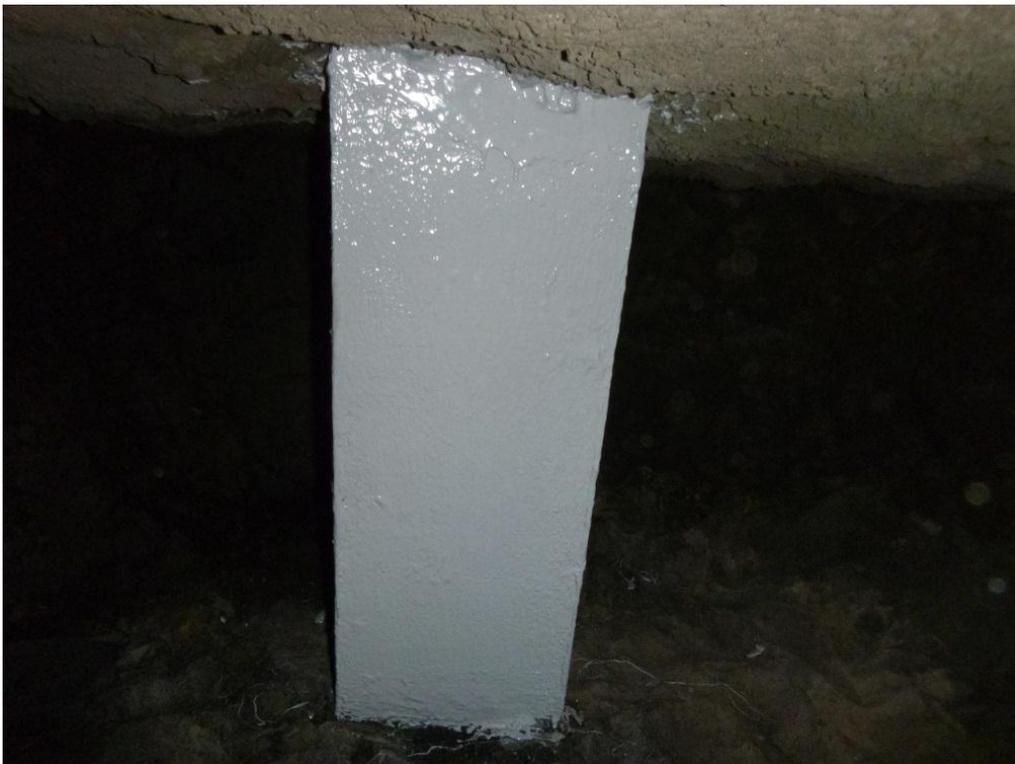
*Figure 36. Field application of epoxy top coat*

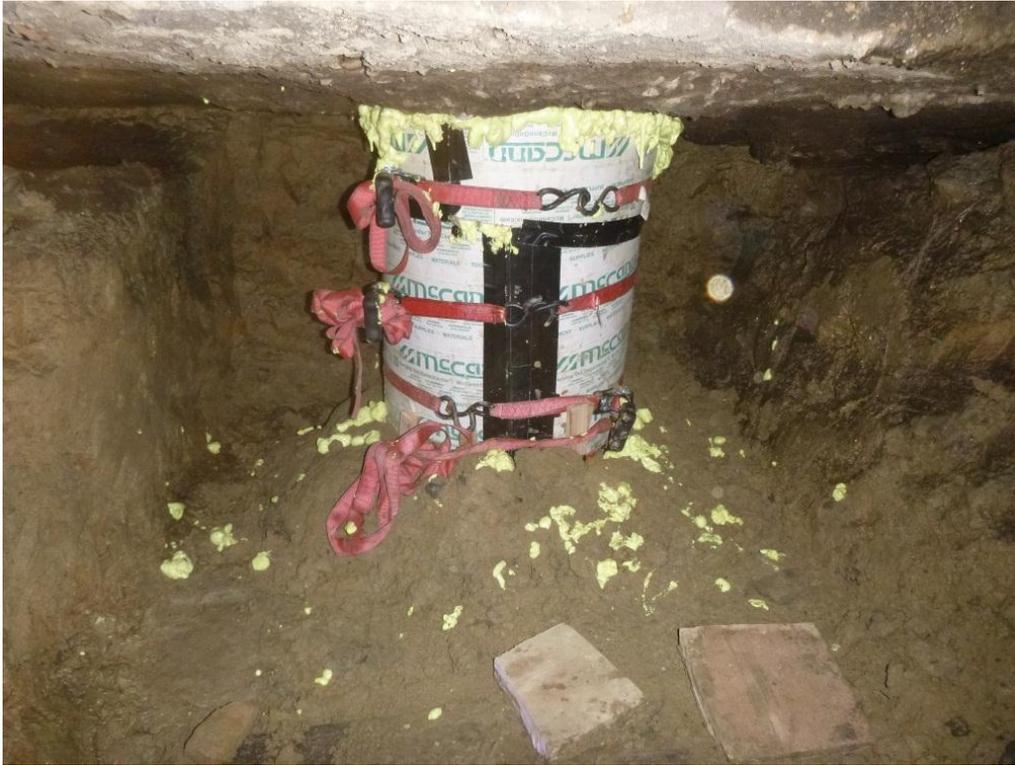
*Figure 37. Completed form for formed grout encapsulation*

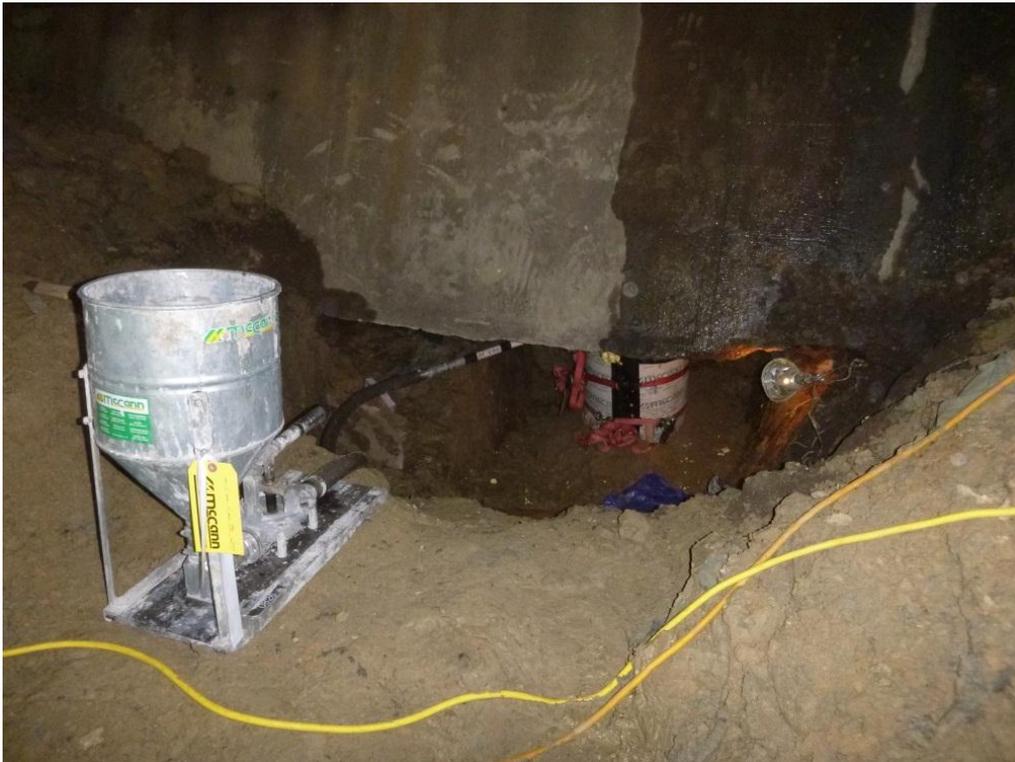
*Figure 38. Filling of grout form using manual grout pump*

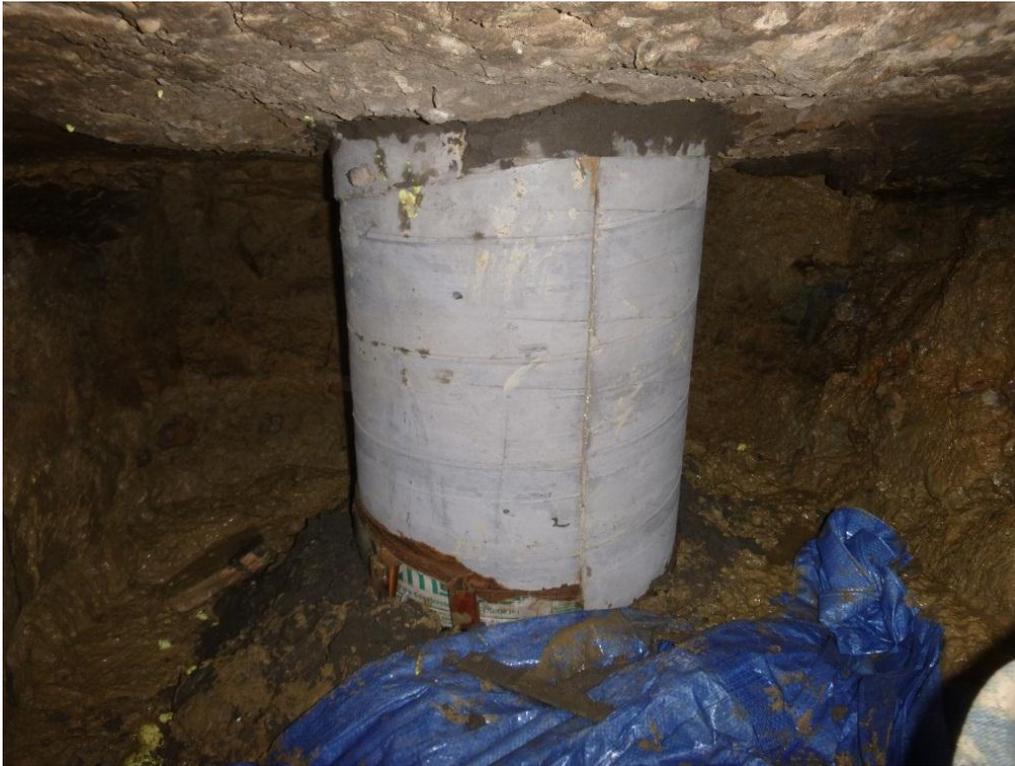
*Figure 39. Completed formed grout encapsulation*

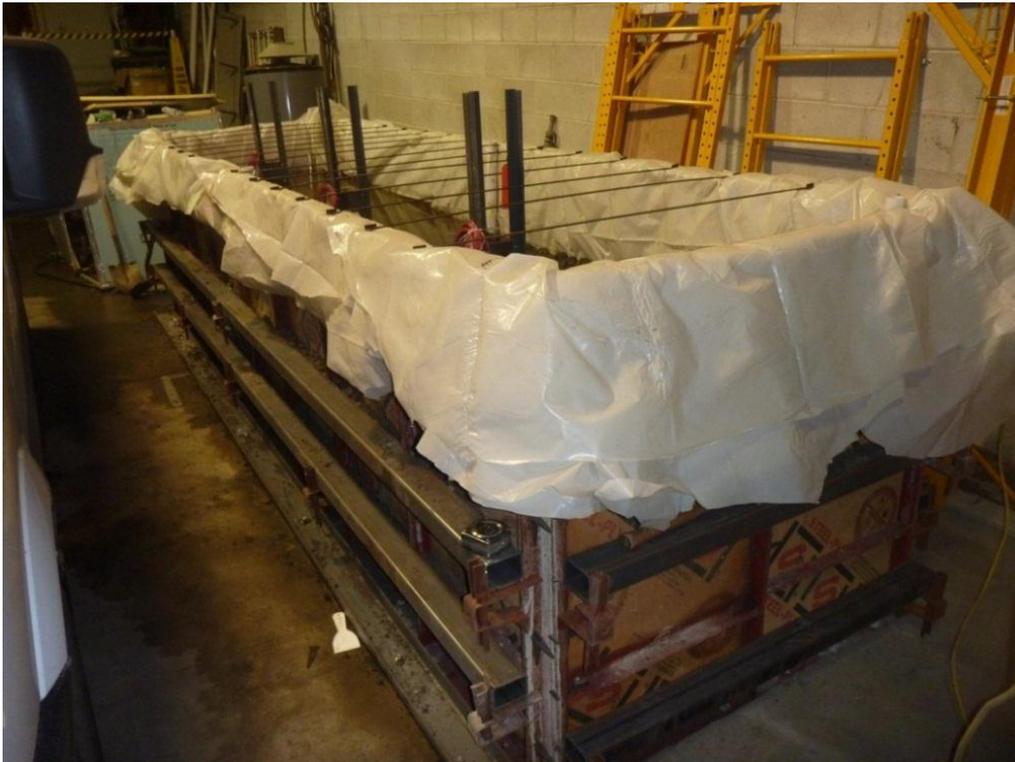
*Figure 40. Soil tank for cathodic protection test*

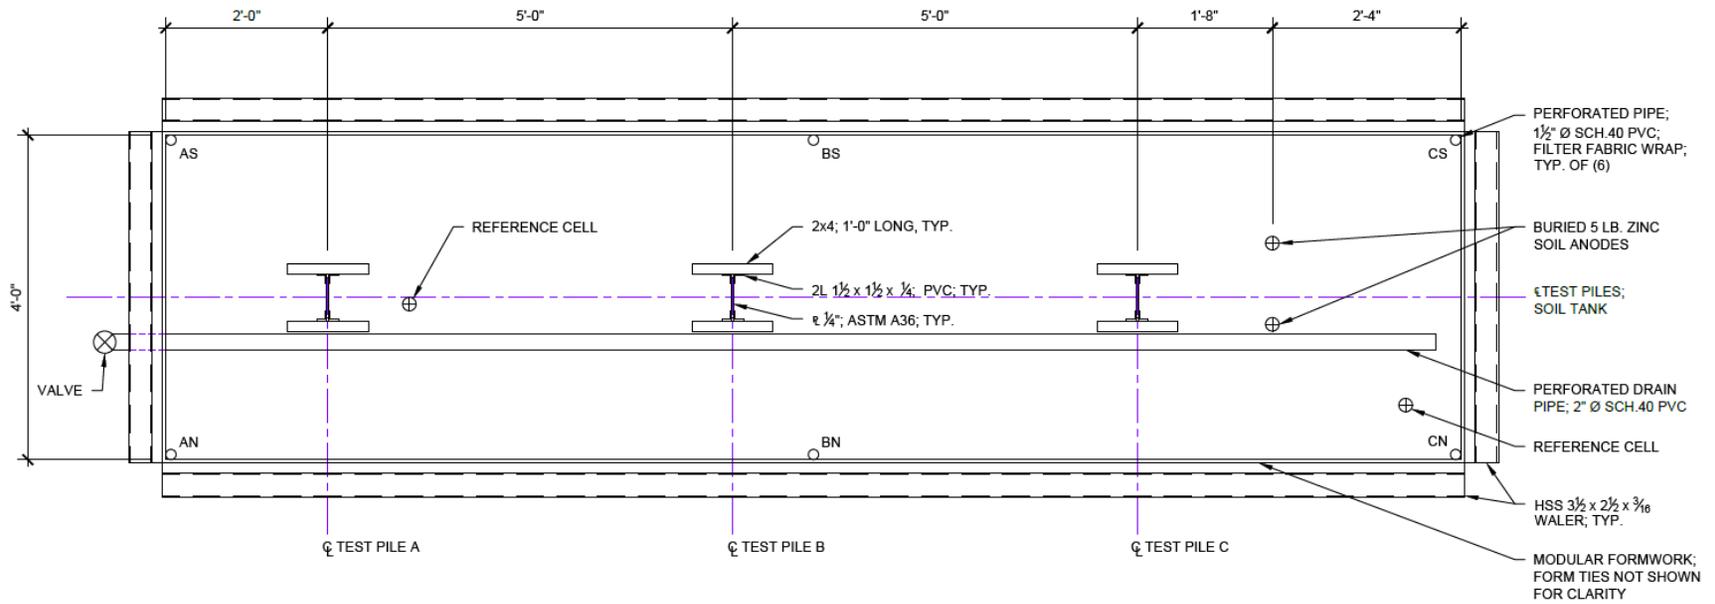
Figure 41. Plan of soil box layout

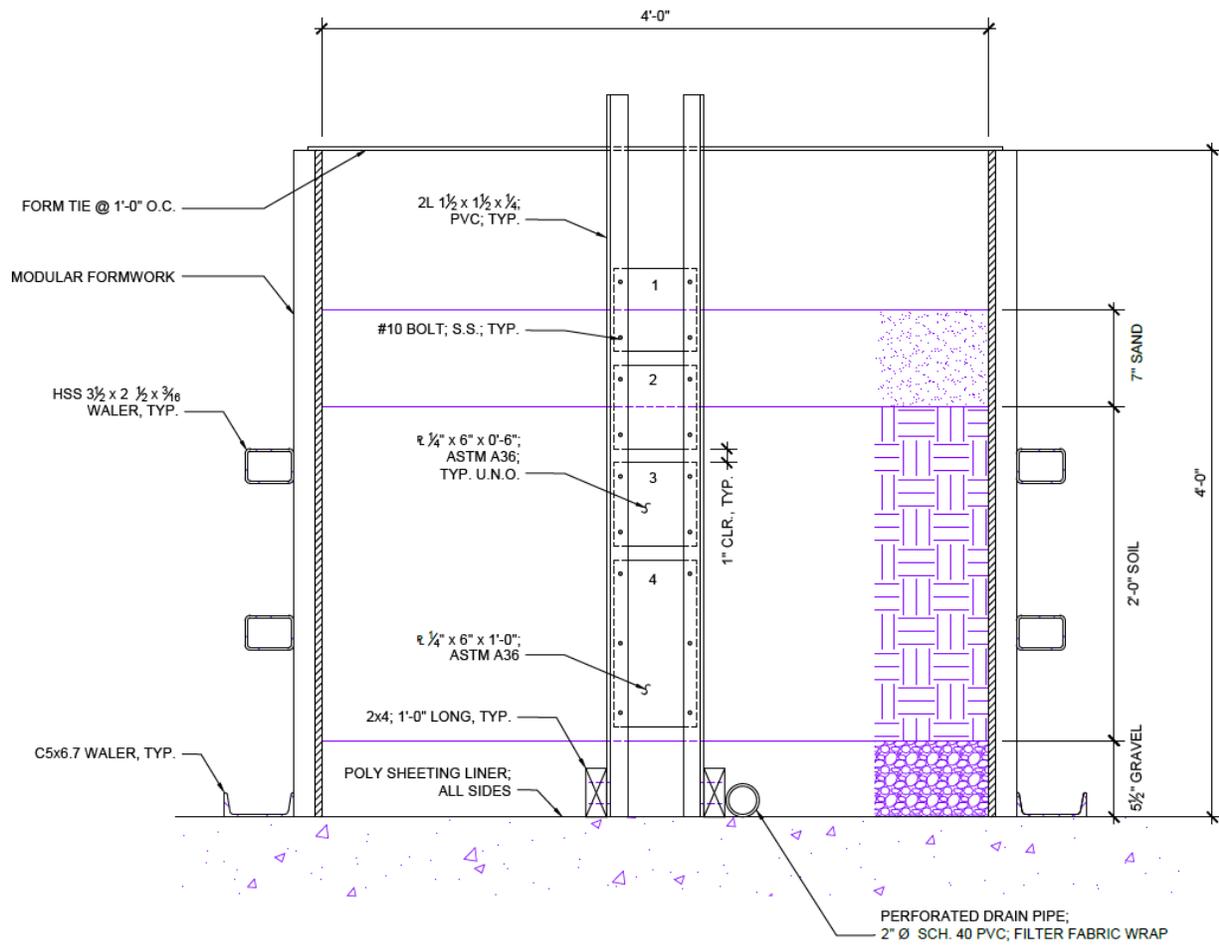
Figure 42. Section through soil box

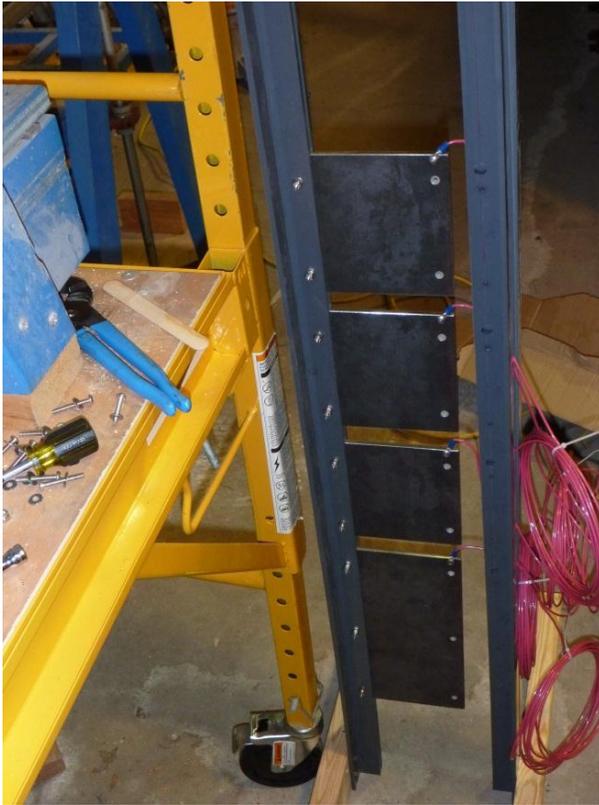
*Figure 43. Partially assembled test pile.*

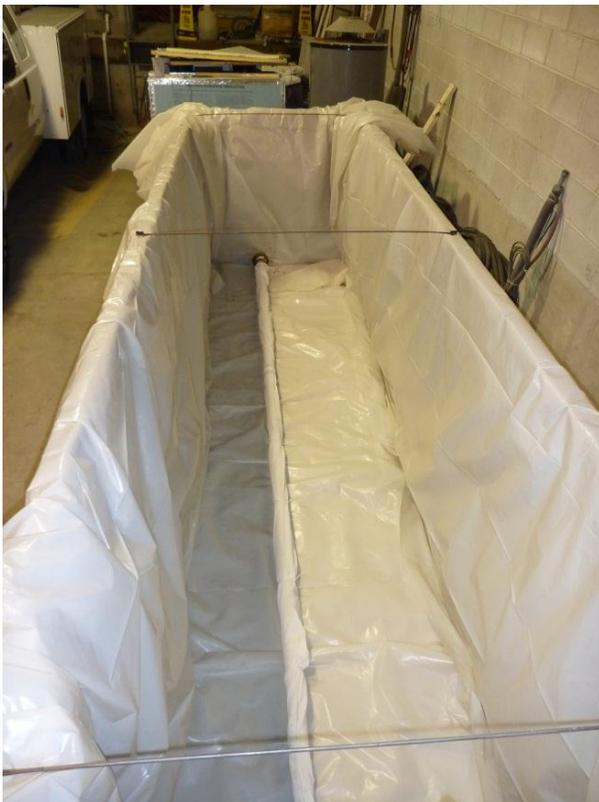
*Figure 44. Perforated drain and poly sheet barrier.*

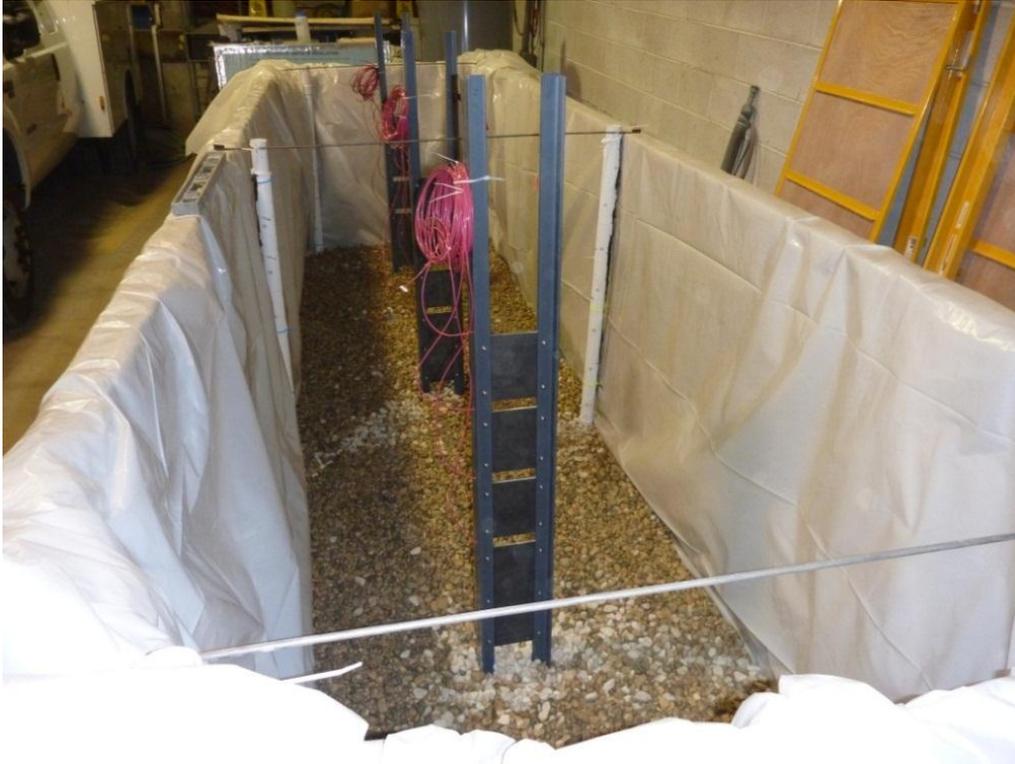
Figure 45. Test piles and gravel installed in soil tank. Note vertically oriented perforated PVC pipes for monitoring of water level during test.

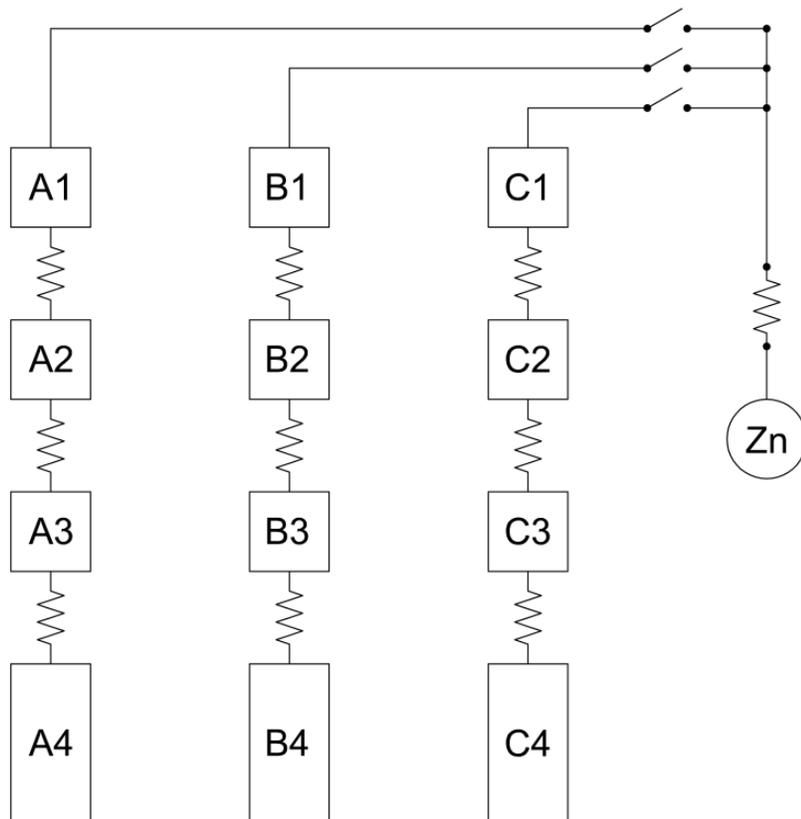
Figure 46. Wiring diagram for Setup No. 1. All resistors shown were 1 ohm.

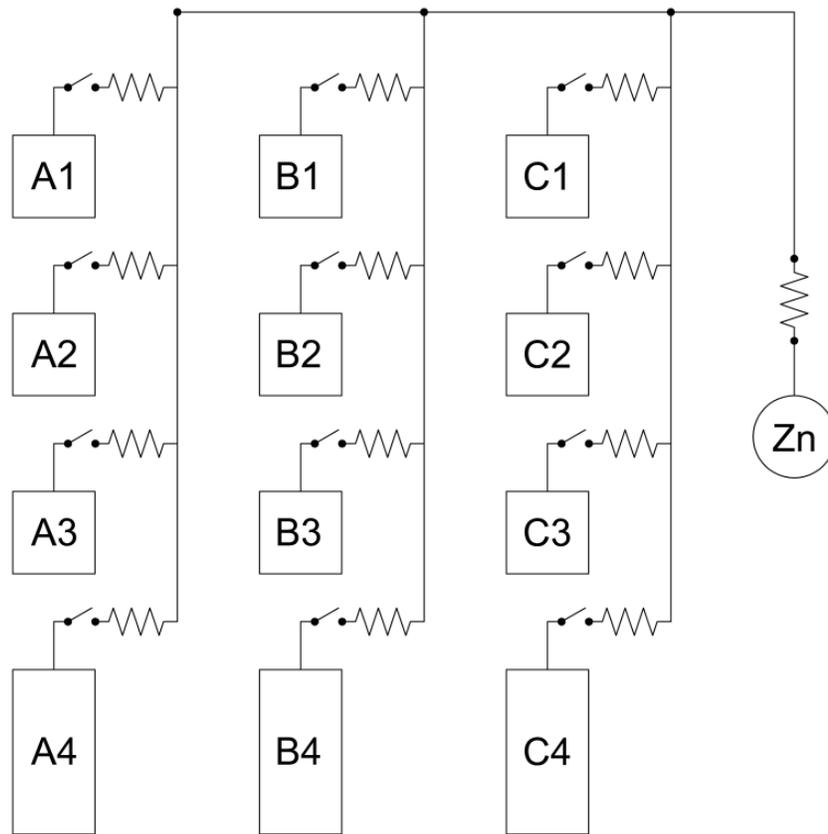
Figure 47. Wiring diagram for Setup No. 2 All resistors shown were 1 ohm.

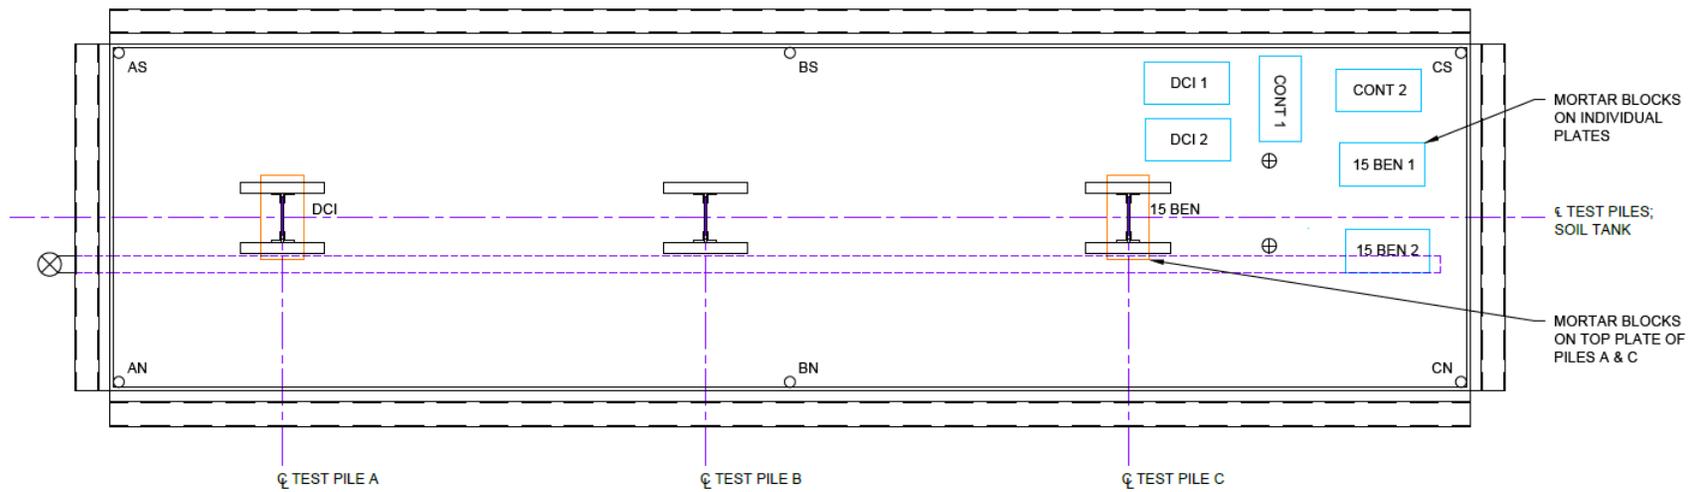
Figure 48. Layout of mortar blocks around individual plates (blue) and top pile plates (orange)

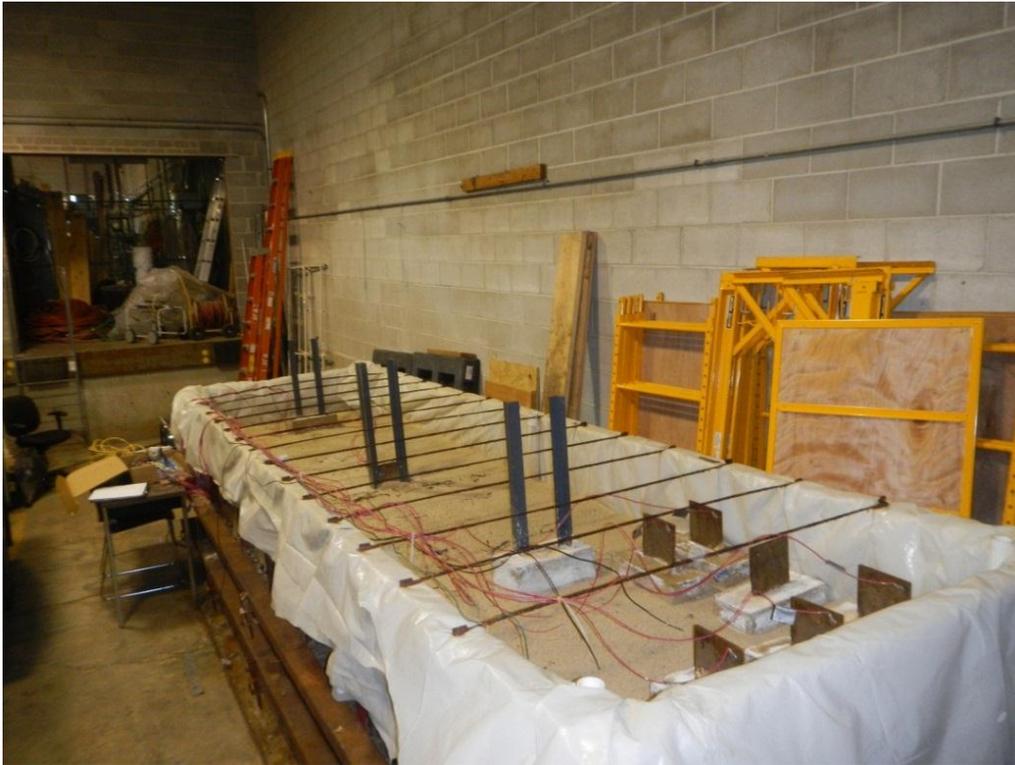
Figure 49. Overall view of soil box

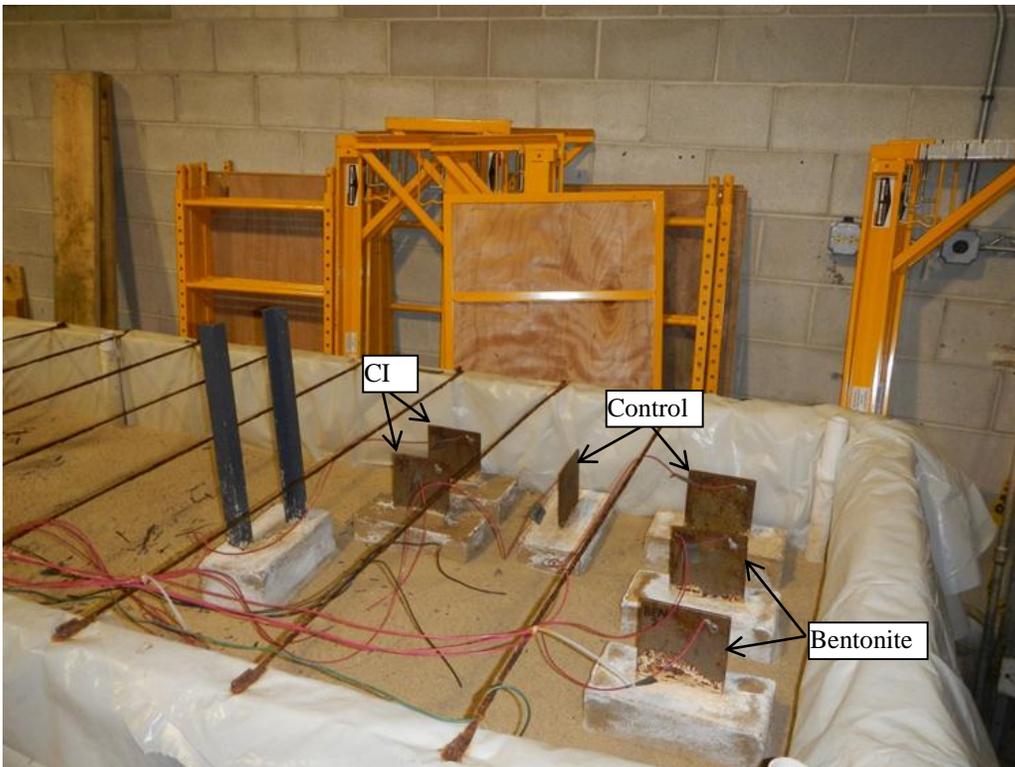
Figure 50. Layout of mortar blocks

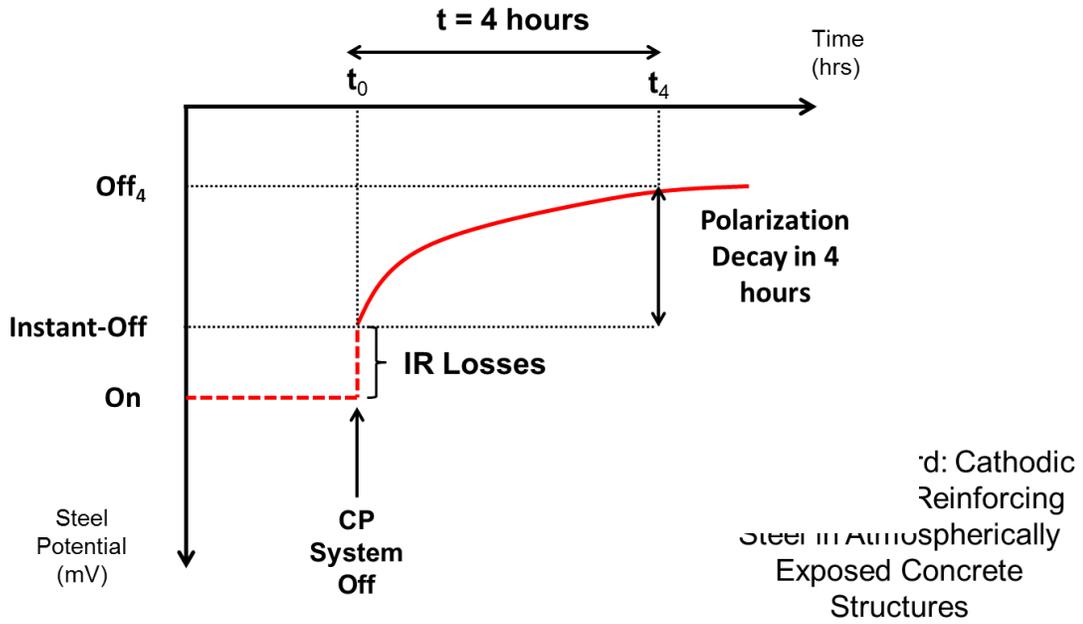
Figure 51. Typical potentials measured in depolarization test.

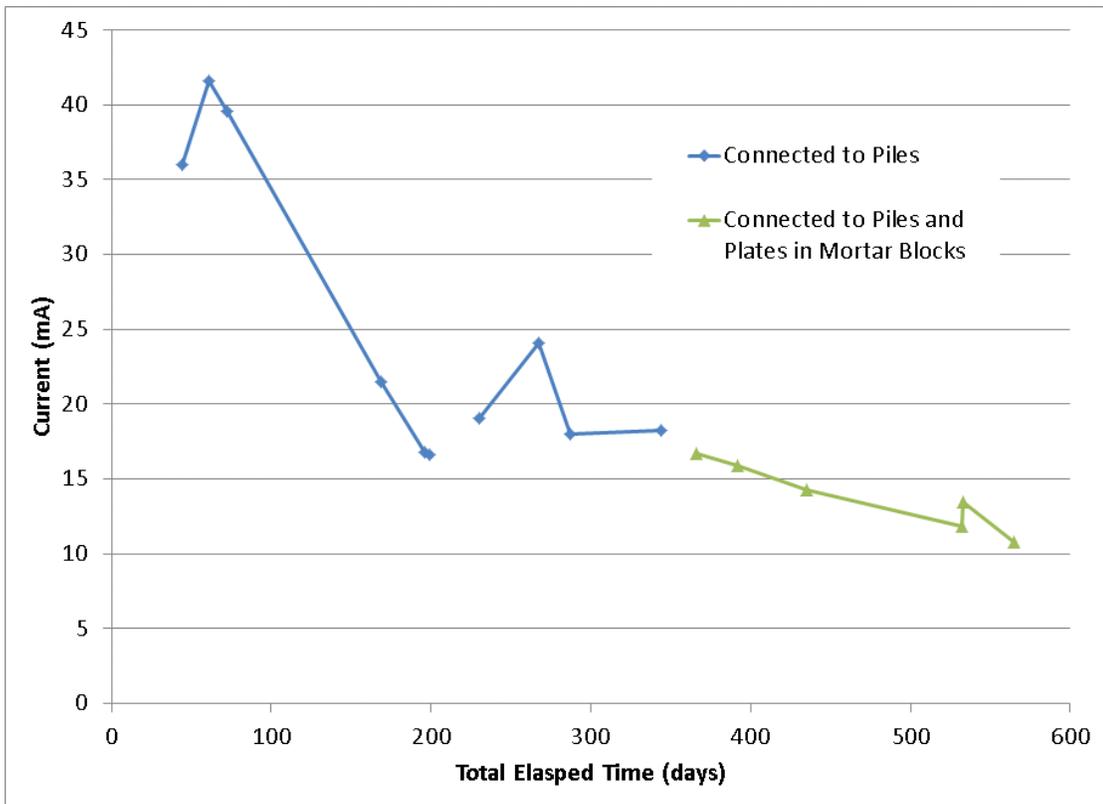
Figure 52. Total current from Anode No. 1 to 1) piles and 2) piles and plates in mortar blocks

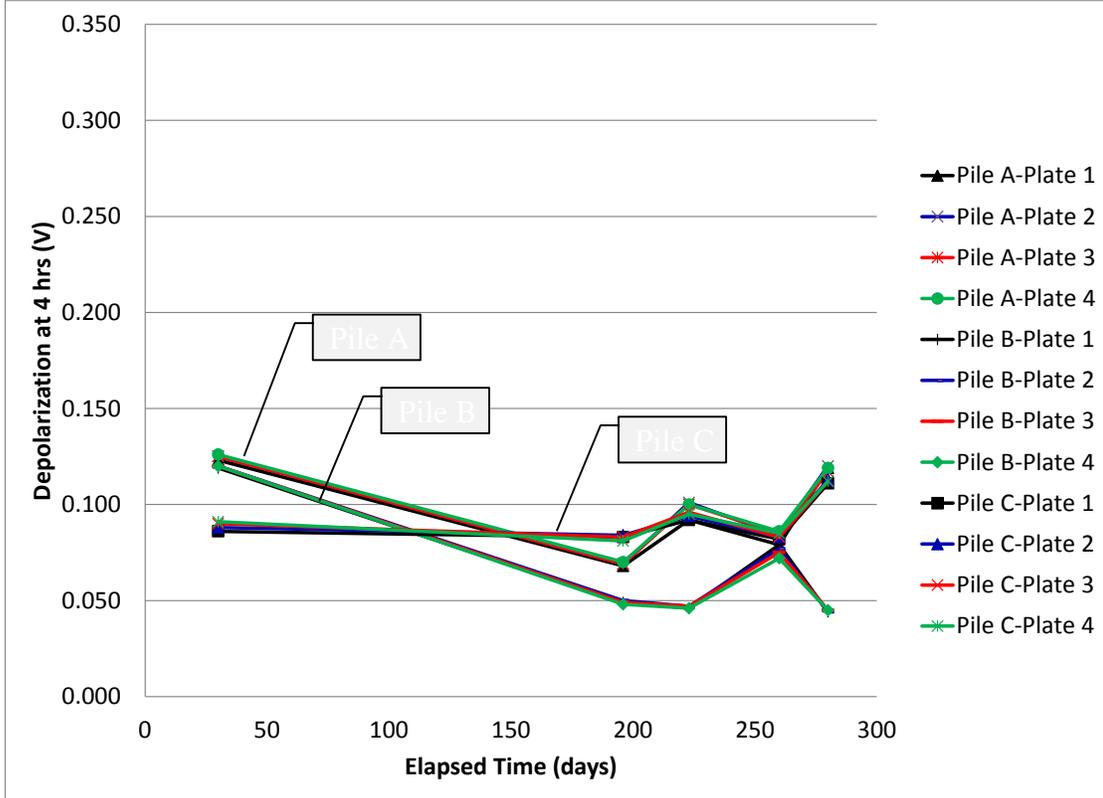
Figure 53. Depolarization after 4 hours at each pile plate versus elapsed time connected to Anode No. 1 using Setup No. 1.

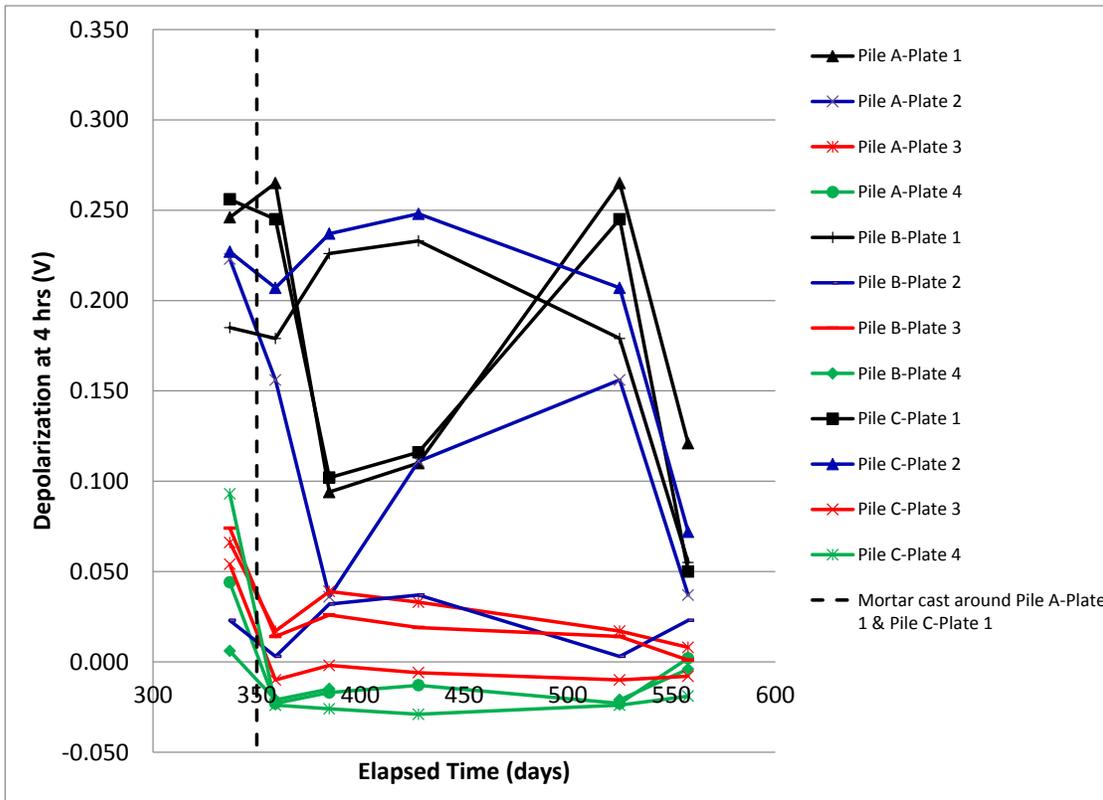
Figure 54. Depolarization after 4 hours at each pile plate versus elapsed time connected to Anode No. 1 using Setup No. 2

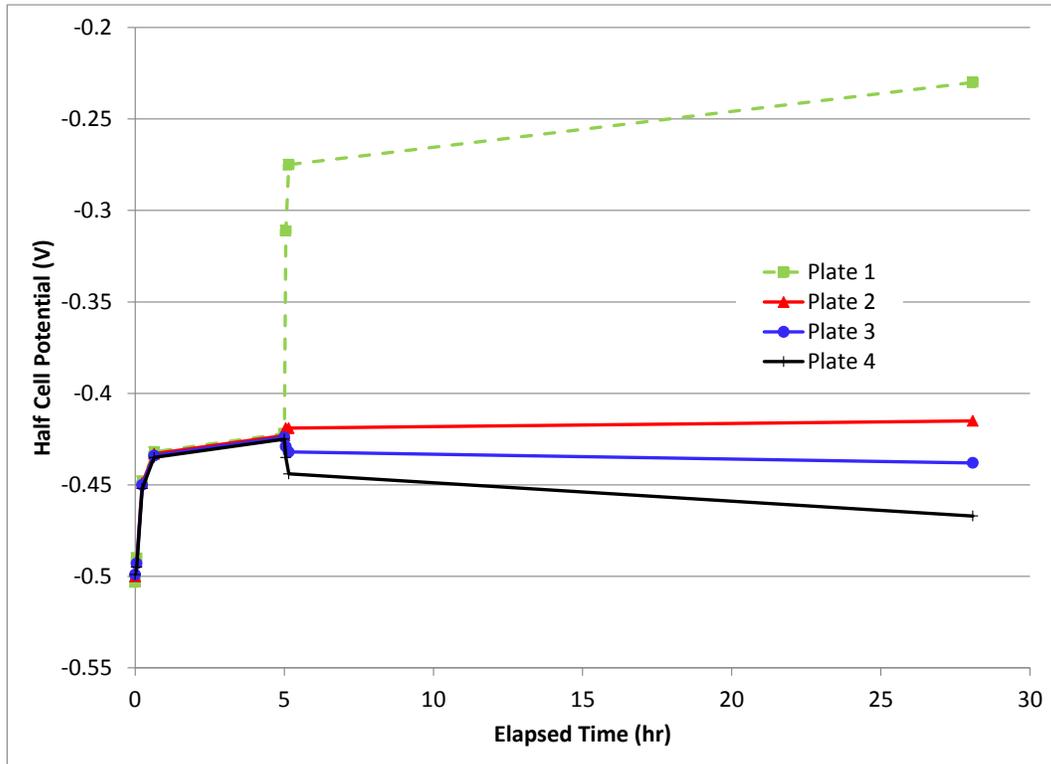
Figure 55. Typical depolarization curve, showing change in potential of Plates 1 to 4 after individual plates were disconnected from each other after 4-hour depolarization test. (This data collected relative to Reference Cell No. 1 on Feb. 22, 2012).

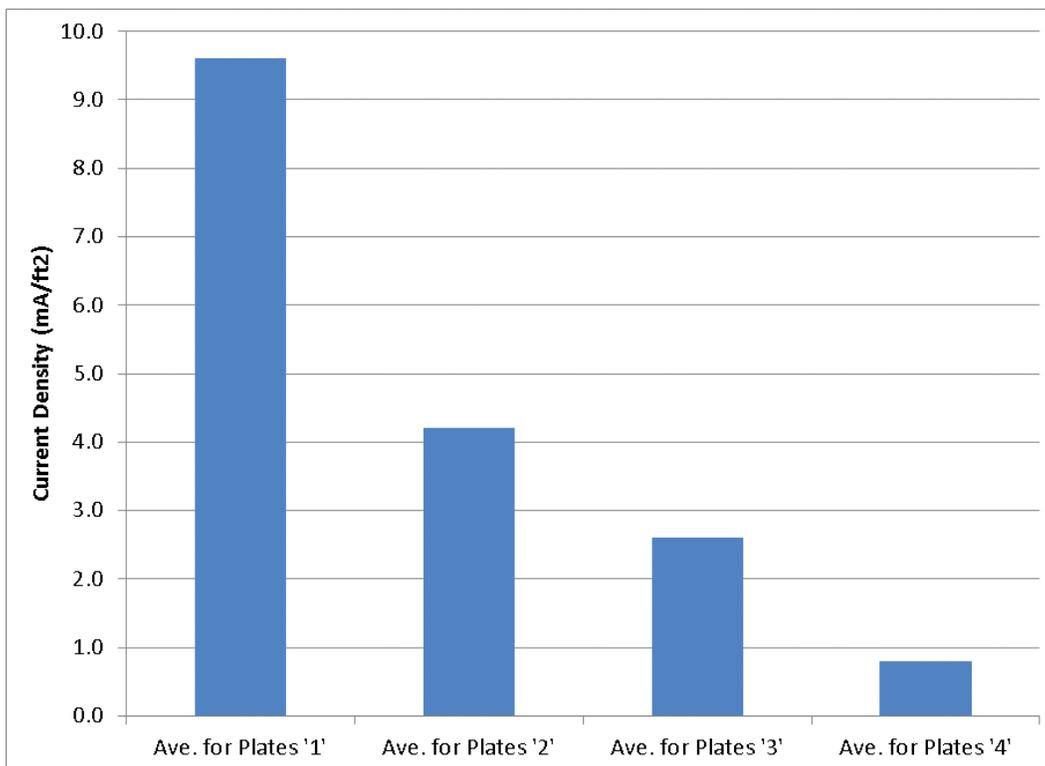
Figure 56. Average protection current density to plates between 230 and 287 days after connection was made to Anode No. 1.
