## MAINTENANCE AND DESIGN OF STEEL ABUTMENT PILES IN IOWA BRIDGES

**Final Report**  
**Iowa Highway Research Board Project TR-622**  
September 2, 2014  
WJE No. 2010.0738

*Prepared for:*  
**Iowa Department of Transportation**  
Office of Bridges and Structures  
800 Lincoln Way  
Ames, IA 50010

*Prepared by:*  
**Wiss, Janney, Elstner Associates, Inc.**  
330 Pfingsten Road  
Northbrook, Illinois 60062  
847.272.7400 tel | 847.291.4813 fax

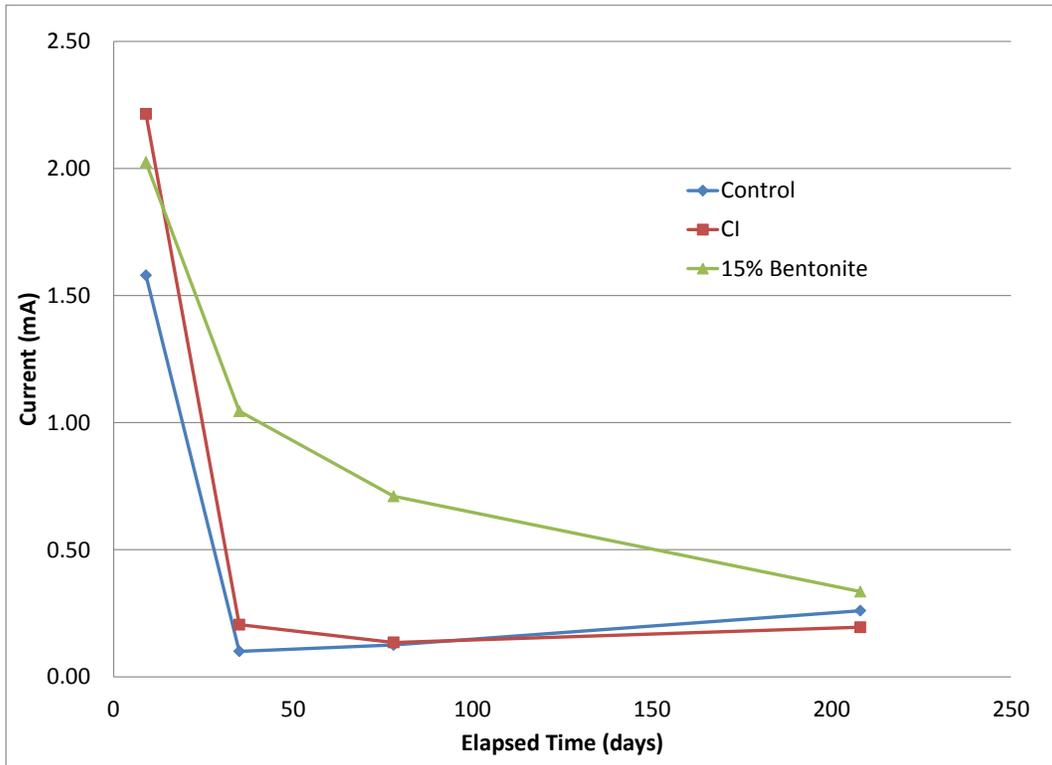
Figure 57. Average current to plates in mortar blocks versus elapsed time connected to Anode No. 1

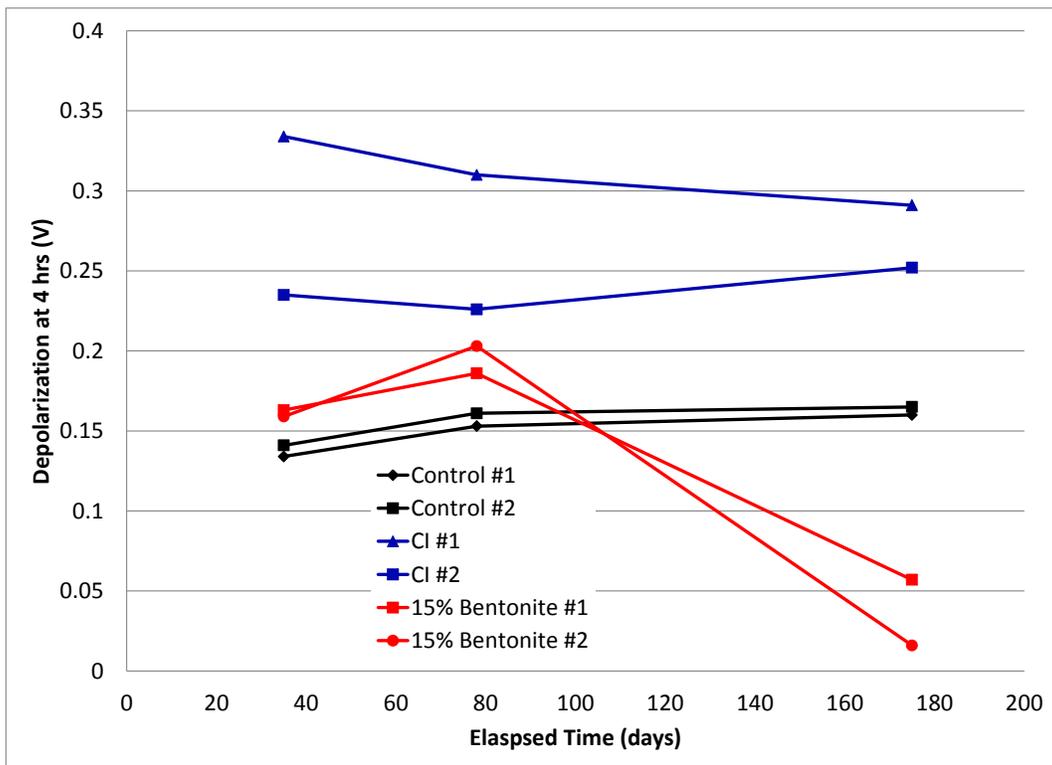
Figure 58. Depolarization after 4 hours at each plate versus elapsed time connected to Anode No. 1 using Setup No. 1.

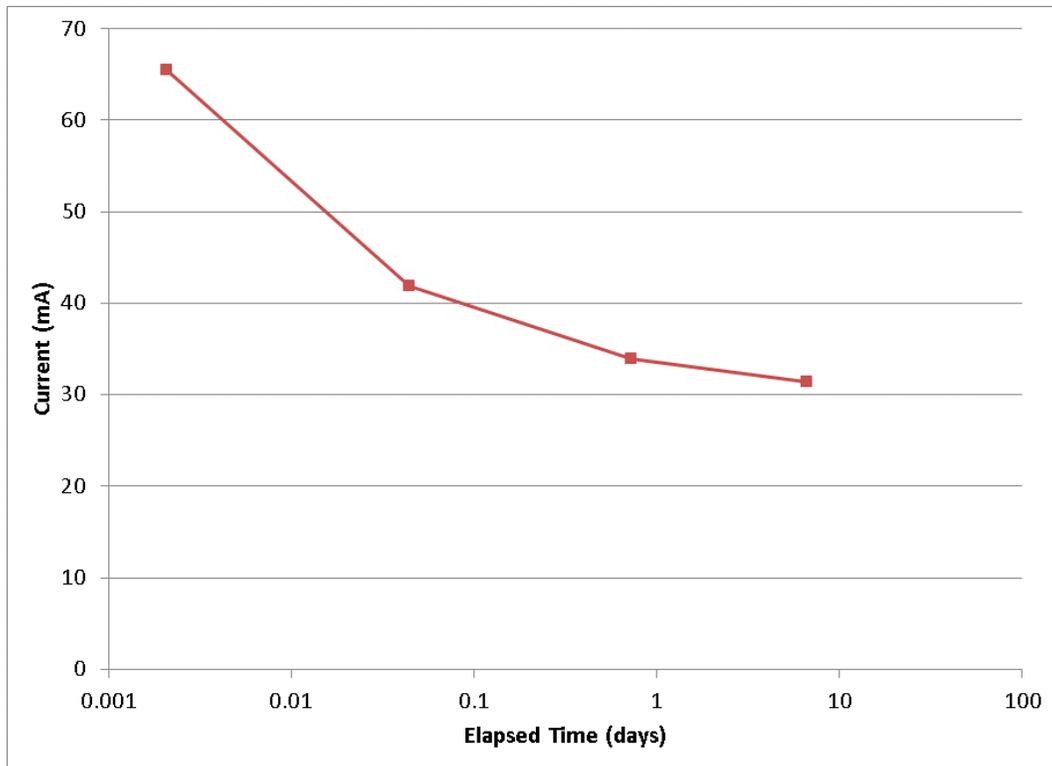
Figure 59. Total current from Anode No. 2 to piles.

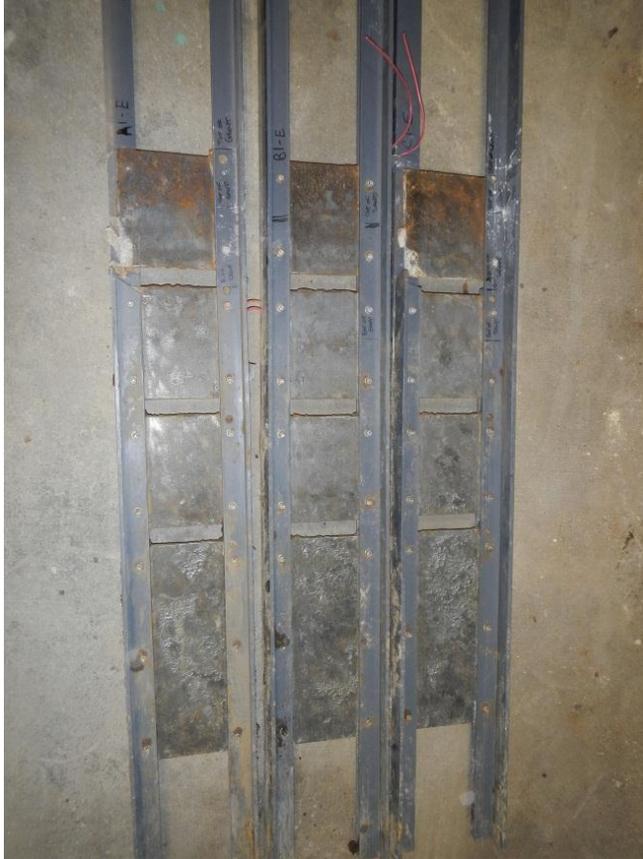
*Figure 60. Piles after cleaning with wire brush*

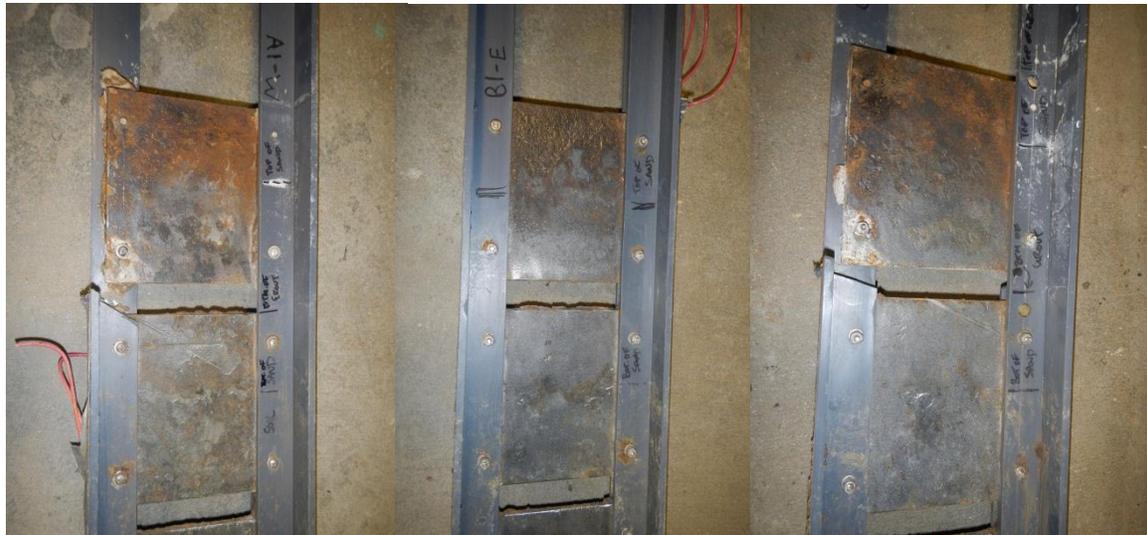
*Figure 61. Close-up view of top plates of each pile after cleaning with wire brush*

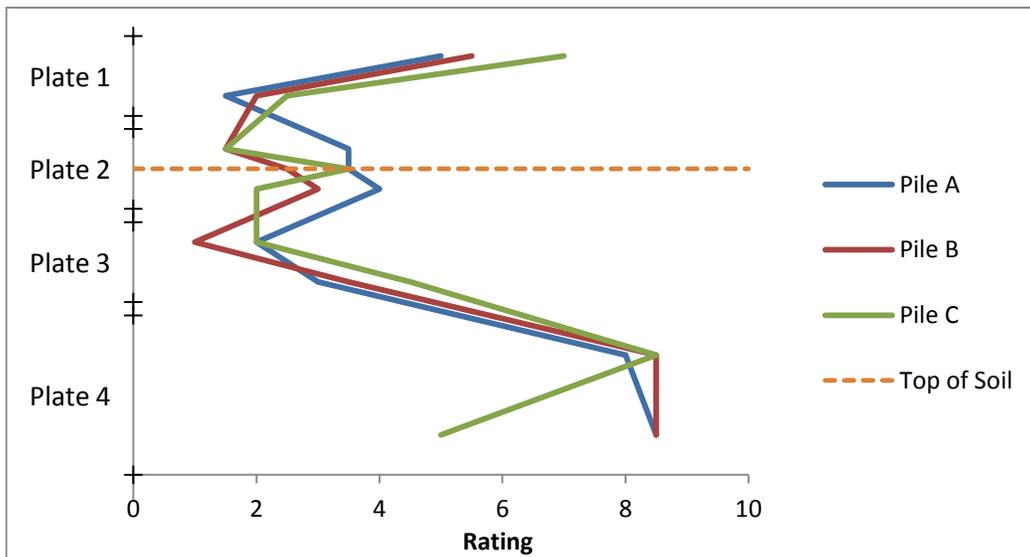
Figure 62. Visual rating of corrosion on pile top plates at end of testing, from 1 (best) to 10 (most severe).

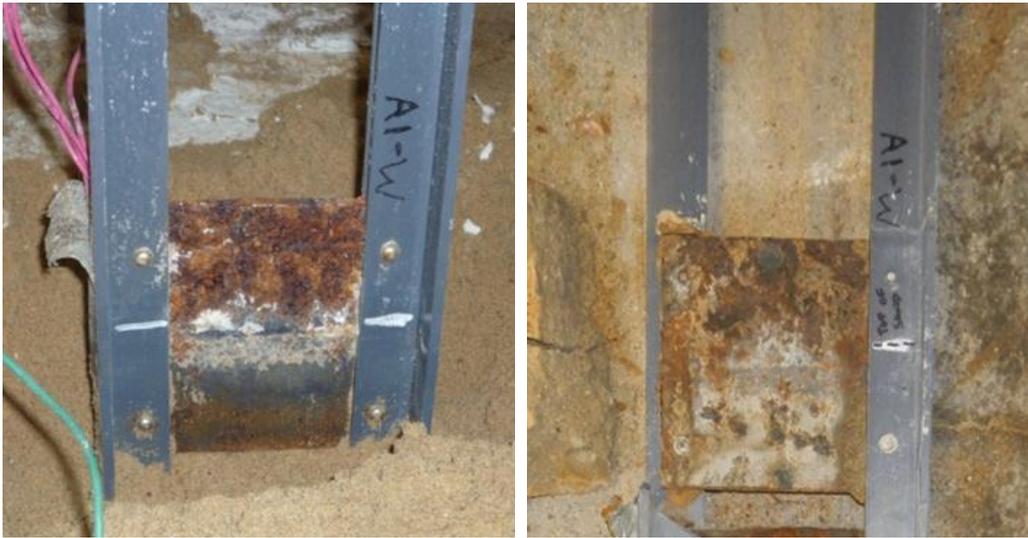
Figure 63. Plate 1 of Pile A before and after mortar block (top of sand is white line).

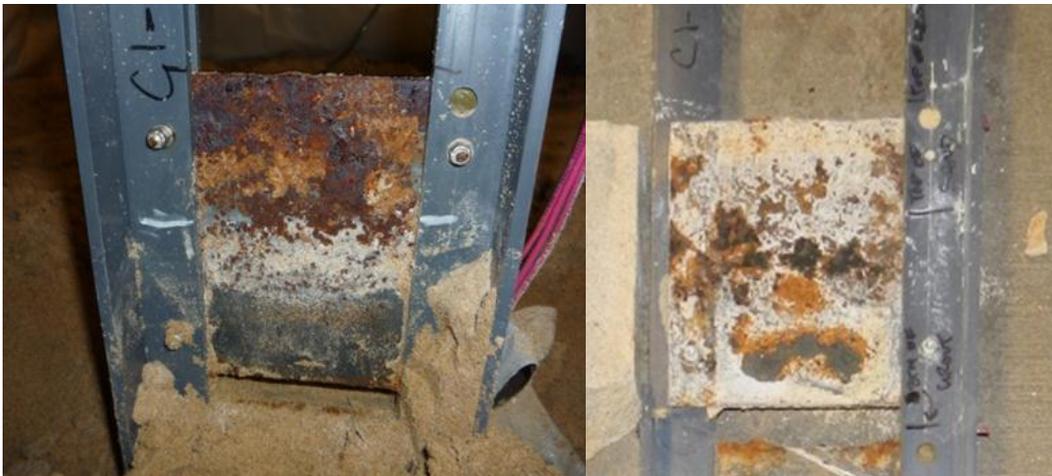
Figure 65. Plate 1 of Pile C before and after mortar block (top of sand is white line).

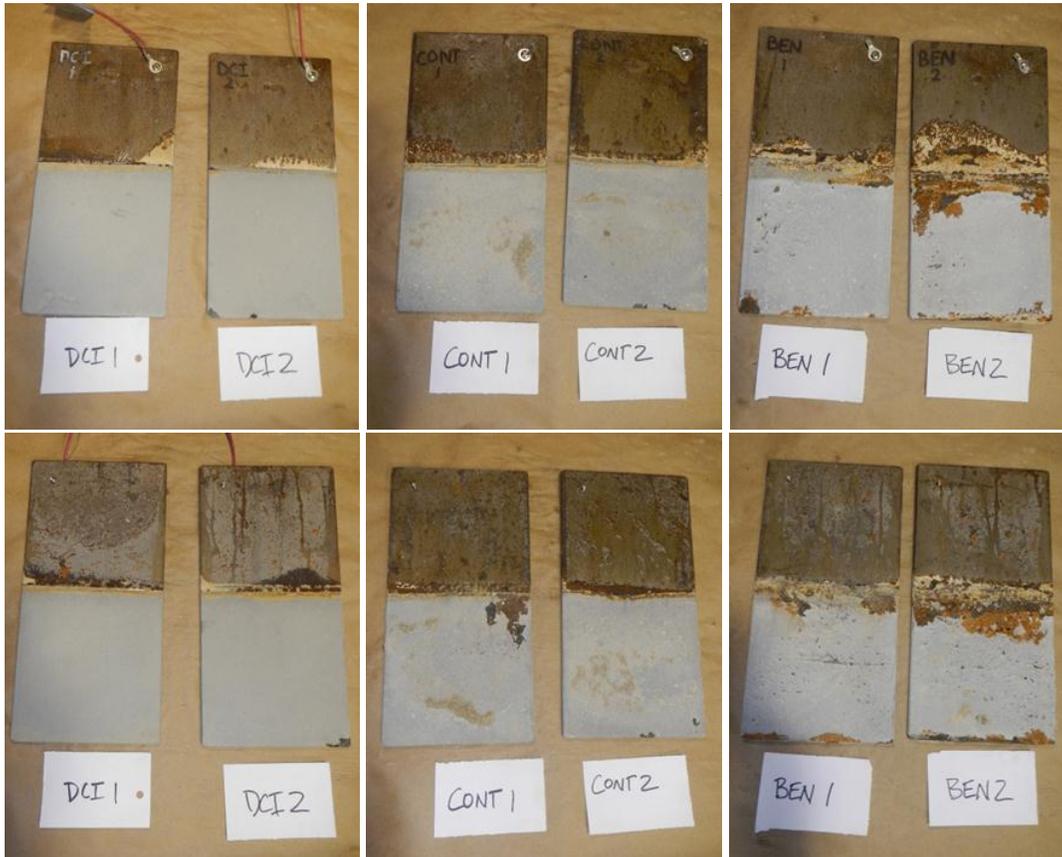
Figure 66. Both faces of embedded plates after they were broken out of the mortar blocks. The bottom half of the plates were in contact with the mortar. “DCI” is corrosion inhibitor, “CONT” is the control mortar, and “BEN” is the 15% bentonite samples.

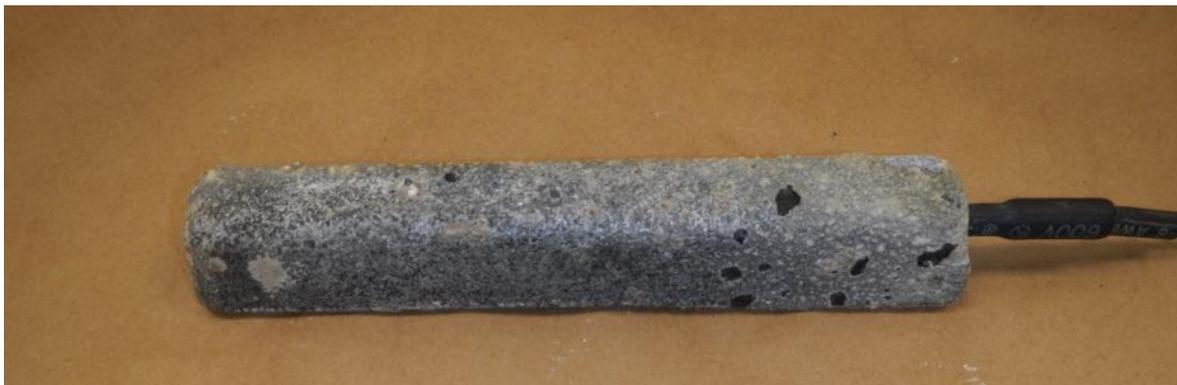
Figure 67. Anode 1 at end of testing

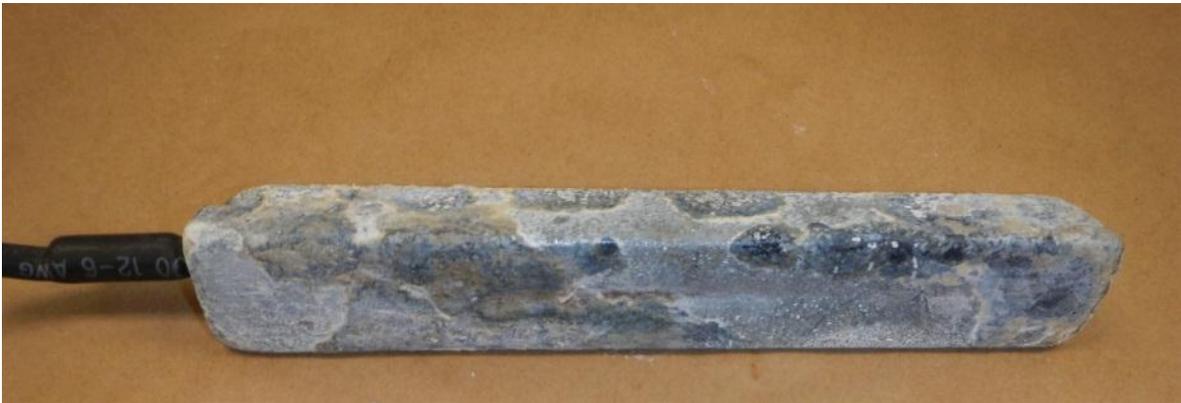
*Figure 68. Anode 2 at end of testing*
