Remote Sensing (LIDAR) for Management of Highway Assets for Safety

APPLICATION OF ADVANCED REMOTE SENSING TECHNOLOGY
TO ASSET MANAGEMENT

Final Report—October 2003

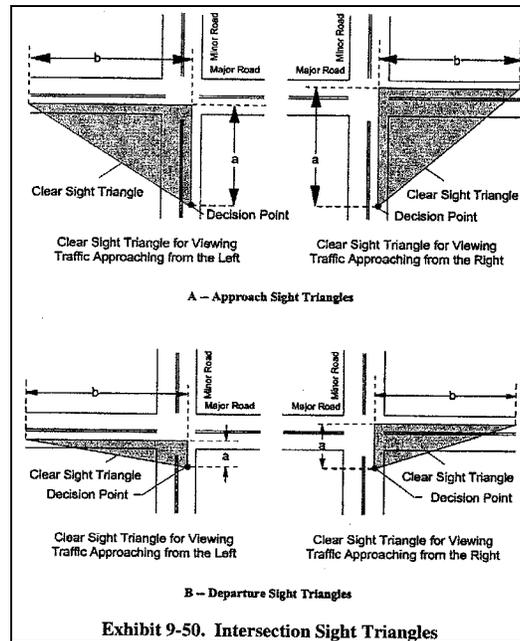
Figure 2.1. Illustration of the clear sight triangles

referred to as the Green Book), the possibility of conflicts occurring at intersections can be greatly reduced through provision of proper sight distances. To avoid collisions, the driver of a vehicle approaching an intersection should have clear view of the entire intersection to allow safe stopping. The Green Book specifies that areas along intersecting roads must be clear of obstructions; these are known as intersection sight triangles. The dimensions of these triangles depend on traffic control (stop sign, yield sign, etc.), grades, and design speeds of the intersecting roads. Exhibit 9-50 from the Green Book illustrating clear sight triangles is reproduced below as Figure 2.1.

Depending on the type of intersection control, several cases are discussed in the Green Book. These include Case A, intersections with no control; Case B, intersections with stop control on the minor road; Case C, intersections with yield control on the minor road; Case D, intersections with traffic signal control; Case E, intersections with all-way stop control; and Case F, left turns from the major road. Cases B and C have subcases depending on left-turn, right-turn, or through maneuvers from the minor road. The Green Book provides guidance on the dimensions of sight triangles depending on the type of case.

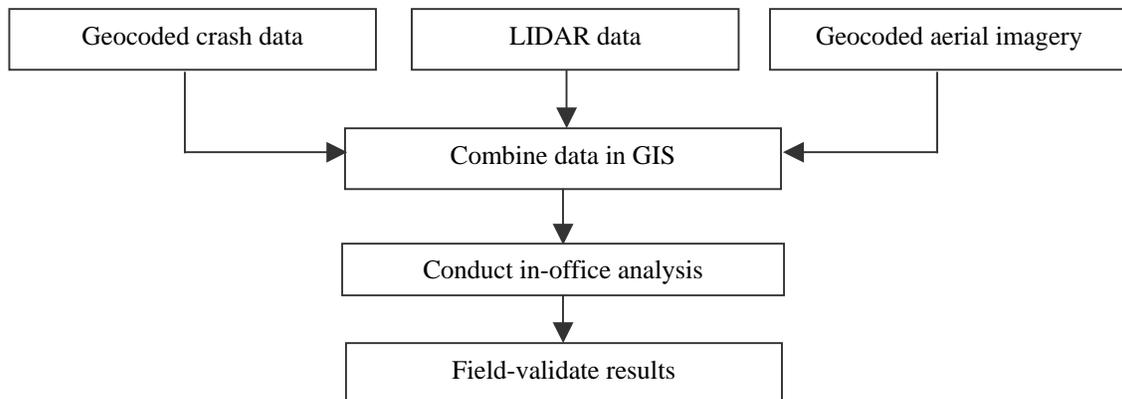
Figure 3.1. Adopted research methodology

Figure 3.1 presents the adopted methodology for this research. It consists of acquiring data from several sources and then combining those data in a GIS. The acquired data consisted of geocoded crashes, geocoded aerial images, and LIDAR output. After acquisition, these data were combined in ArcView (ESRI) GIS software for in-office analysis. The analysis was focused on utilizing the data to obtain information on obstructions in the intersection sight triangles at selected intersections. Results of the in-office analysis were then field validated.

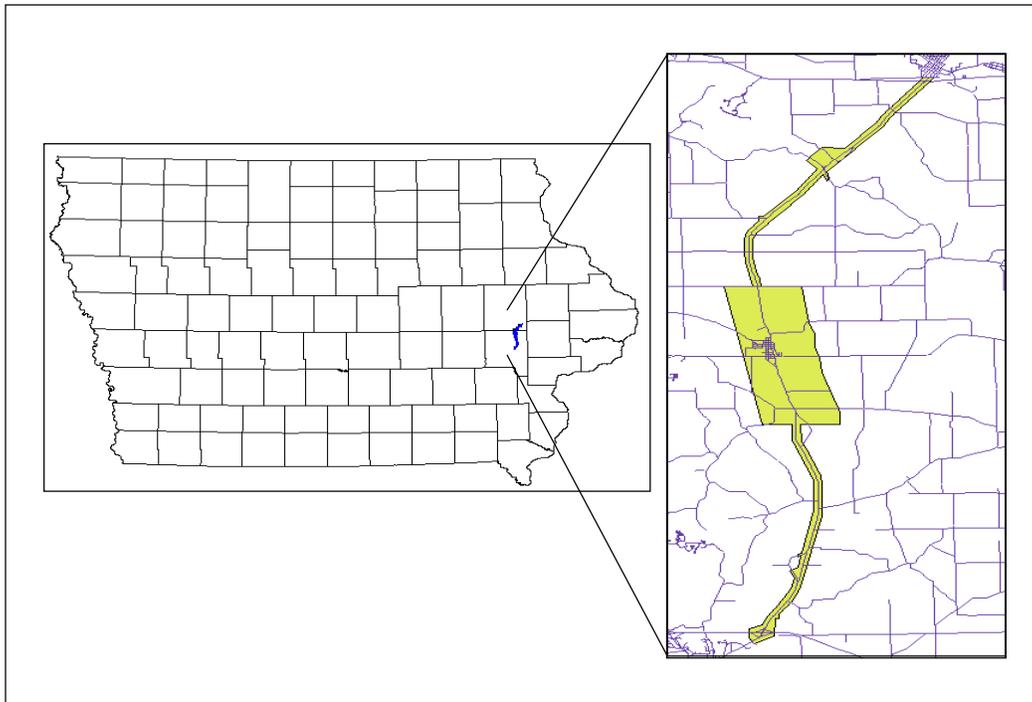
Figure 3.2. Study corridor

The study corridor, passing through Linn and Johnson Counties, Iowa, consisted of the northern section of the Iowa Highway 1 Solon bypass (see Figure 3.2). Part of the study corridor is rural in nature while the part passing through the city of Solon is urbanized. The corridor receives significant traffic during morning and evening because of its proximity to the University of Iowa. As mentioned before, crash data, aerial images, and LIDAR data were acquired for the study area. Each data set, its reduction, and processes to merge the data sets are described below.

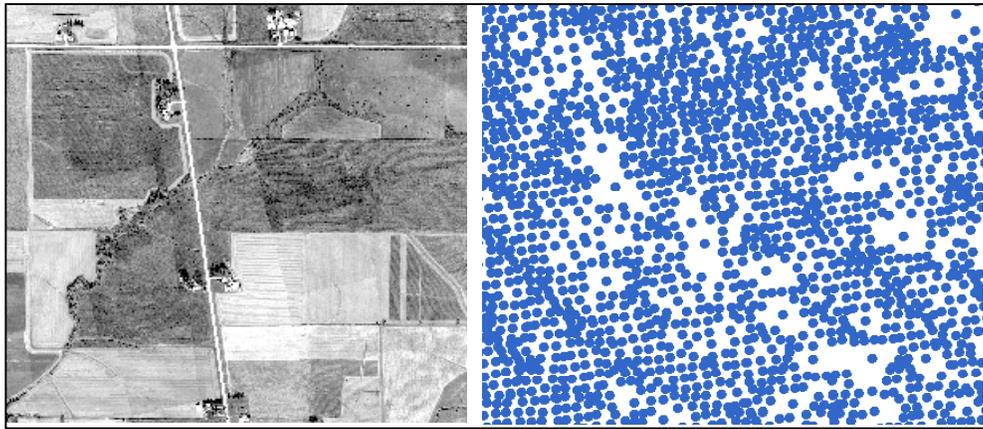
Figure 3.3. Sample orthophoto and converted LIDAR data

the analysis utilizing both the first return and last return data. Figure 3.3 shows a sample orthophoto and LIDAR data converted to ArcView point shapefile format.

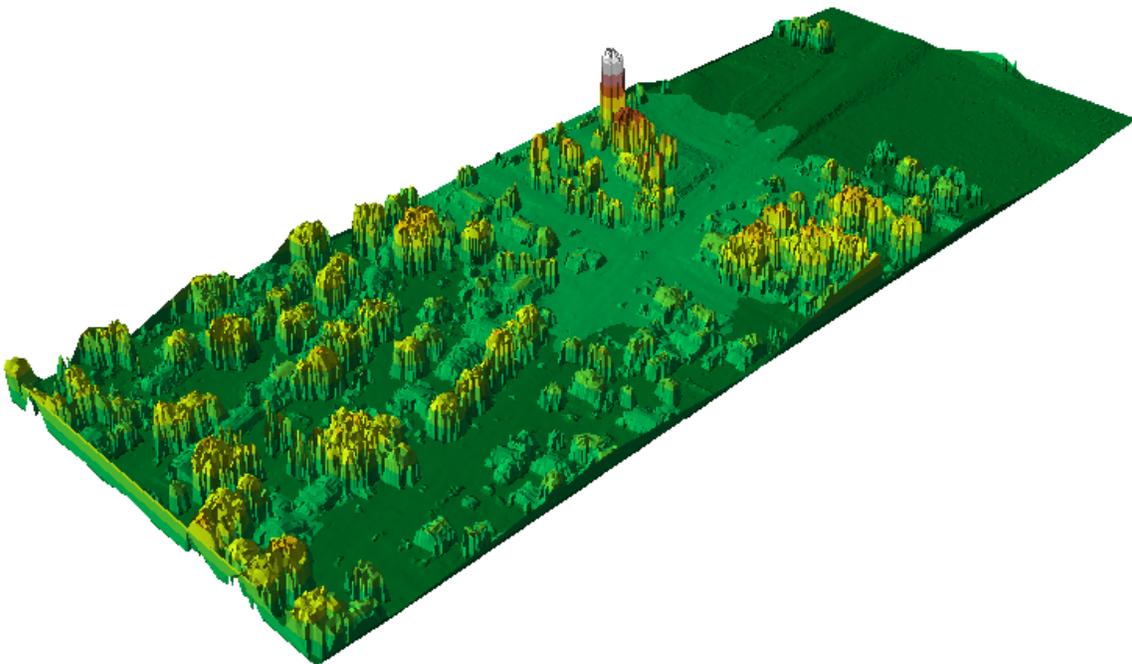
Figure 3.4. Sample 3D TIN of the study corridor passing through Solon, Iowa

The LIDAR point shapefiles were converted to three-dimensional (3D) shapefiles by incorporating height information in ArcView and finally to triangular irregular networks (TINs). Figure 3.4 shows a sample 3D TIN of a small portion of the study corridor passing through the city of Solon, Iowa. Considerable time was needed for these conversions on a computer with a 1.0 gigahertz processor and 256 kilobytes of random-access memory.

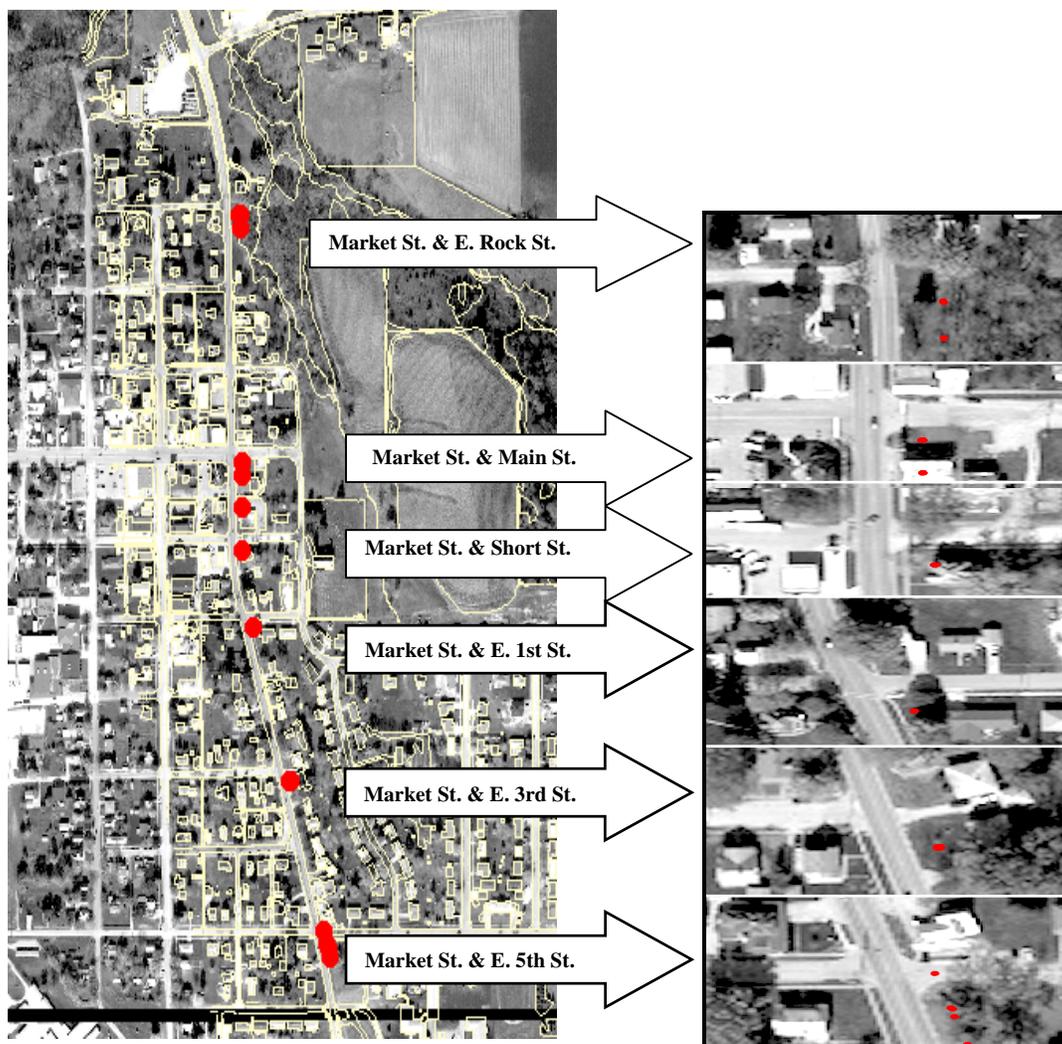
Figure 4.1. Six selected intersections and crash locations

Figure 4.1 shows the six selected intersections for which complete LIDAR data coverage was available. The zoomed view of each intersection in Figure 4.1 shows the intersecting roads in greater detail. The crashes appear to be off the road but this is due to minor discrepancies in overlaying the crash layer on the aerial imagery. All six intersections, located within the city of Solon, had stop control on the minor intersecting road. Iowa Highway 1 running north-south through Solon is named Market Street and is the major road through the six intersections. Its intersections with East Third Street and East Rock Street are three-legged while the other four intersections are four-legged.

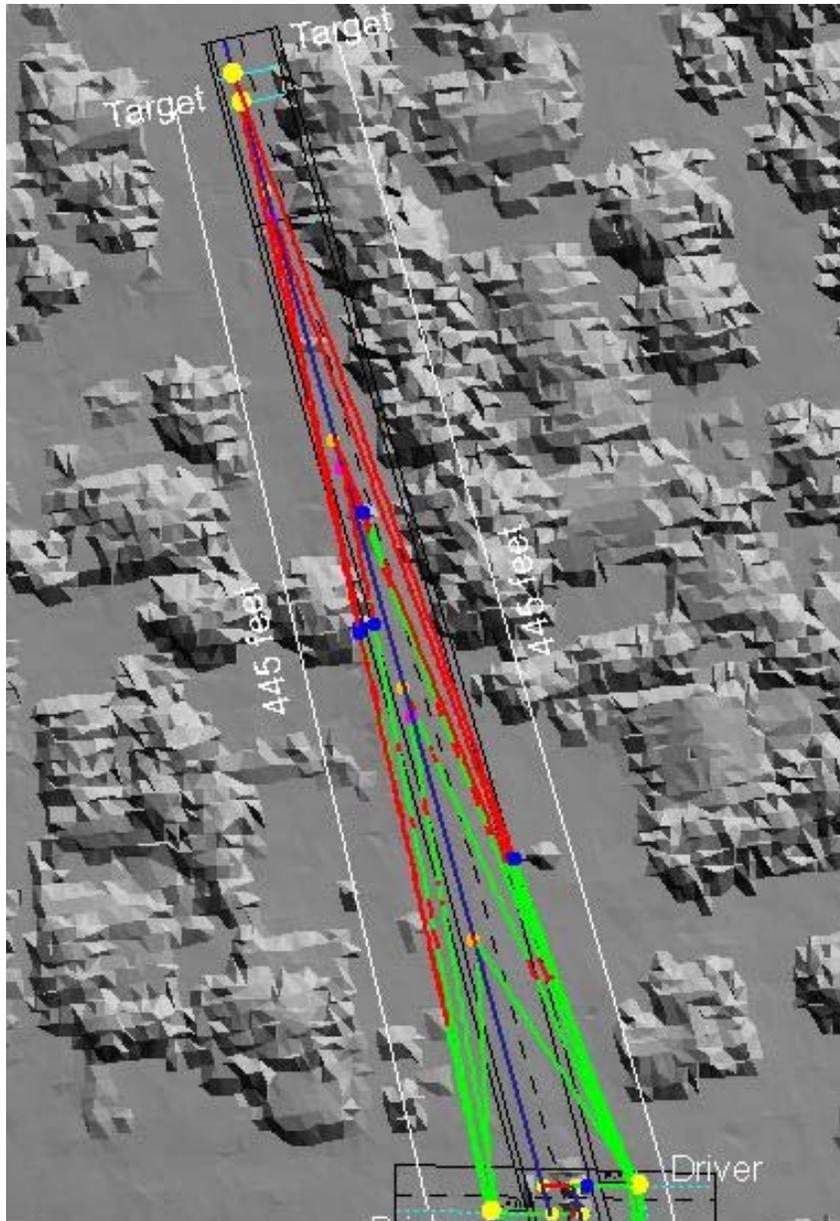
Figure 4.2. Multiple lines of sight at 100-ft interval along the major road (Market St. and E. Fifth St.)

The results of in-office line-of-sight analysis of the five intersections indicated 66 potential obstructions on the various minor approaches while no potential obstructions were detected on three of the minor approaches. To validate the existence of these obstructions, the city of Solon was visited and intersection sight triangles verified using video equipment. The next section presents details of the validation process.

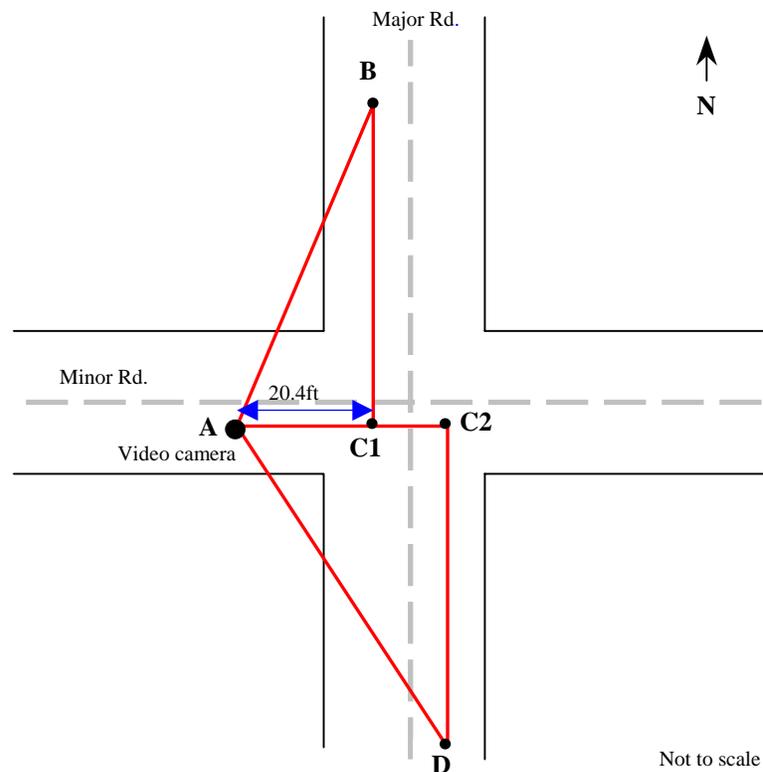
Figure 4.3. Field validation setup

To validate the results of in-office line-of-sight analysis, a three-person crew utilized a digital video camera and a passenger car to identify obstructions in the sight triangles. The field validation setup is illustrated in Figure 4.3. A digital video camera was placed on a tripod at Point A at a height of 3.5 feet and 20.4 feet from the center of the main road's closest lane. A passenger car with 3.5 feet marked on each side was driven by one of the crew members at a constant speed of 25 mph in both directions on the main road. Points B and D were locations when the passenger car was first visible to the camera operator. While the vehicle was driven, another crew member recorded its motion between points B and C1 (vehicle southbound) and points D and C2 (vehicle northbound). The last crew member, responsible for the safety of the camera operator, directed traffic on the minor road.

Driving the vehicle at a constant 25 mph speed ensured that distances could be calculated during video editing by noting the travel time of the vehicle. All six intersections were videotaped in this manner. After video capture, it was transferred to a desktop computer for editing and a frame-by-frame analysis. The MGI Video Wave 3 (Roxio, Inc.) video editing software was utilized. Using MGI Video Wave 3, time was recorded when the 3.5-foot-high marked side of the vehicle was first visible. The vehicle was followed in each video frame and time noted when it finally passed Point C1/C2. If the vehicle marking was not obstructed after first becoming visible then the clear distance is given by

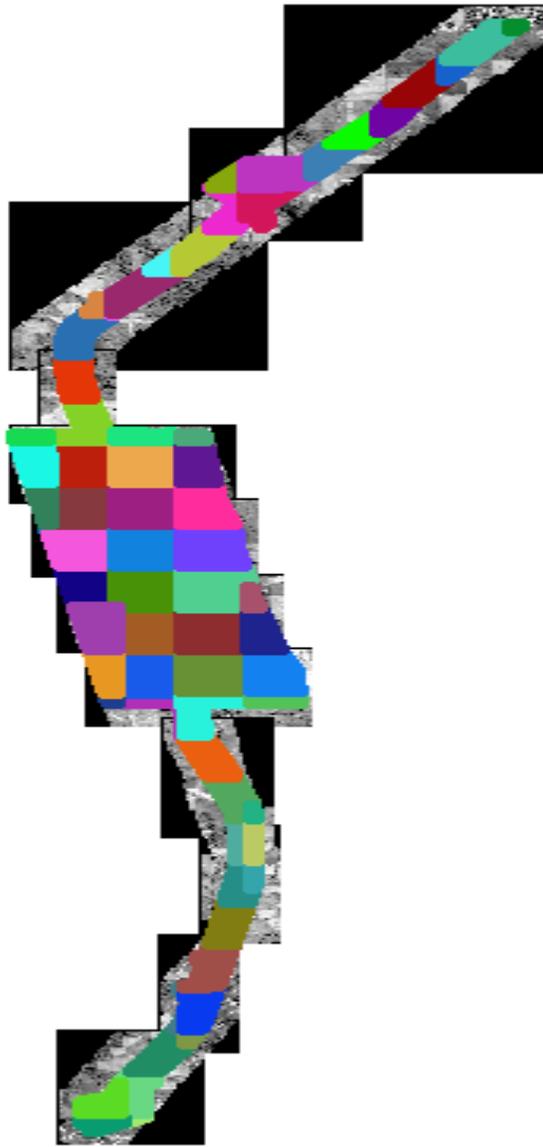
Figure A.1. Sixty-nine LIDAR bounds superimposed on 12 orthophoto bounds

To line up 12 bounds of orthophotos to 69 bounds of and LIDAR data correctly in ArcView, a trial and error process was used. An orthophoto bound was opened in ArcView and all 69 LIDAR files superimposed on it to see which files corresponded to the opened orthophoto. The LIDAR files that corresponded to a particular orthophoto were renamed so that subsequent identification of orthophotos and LIDAR data was simple. The trial and error process was time-consuming because of the large number and large size of the files. Figure A.1 in Appendix A shows the various LIDAR bounds correctly matched to the orthophotos. After conversion of all data sets to the state plane projection and correct matching of orthophotos and LIDAR data, the various data were added to an ArcView project for analysis.

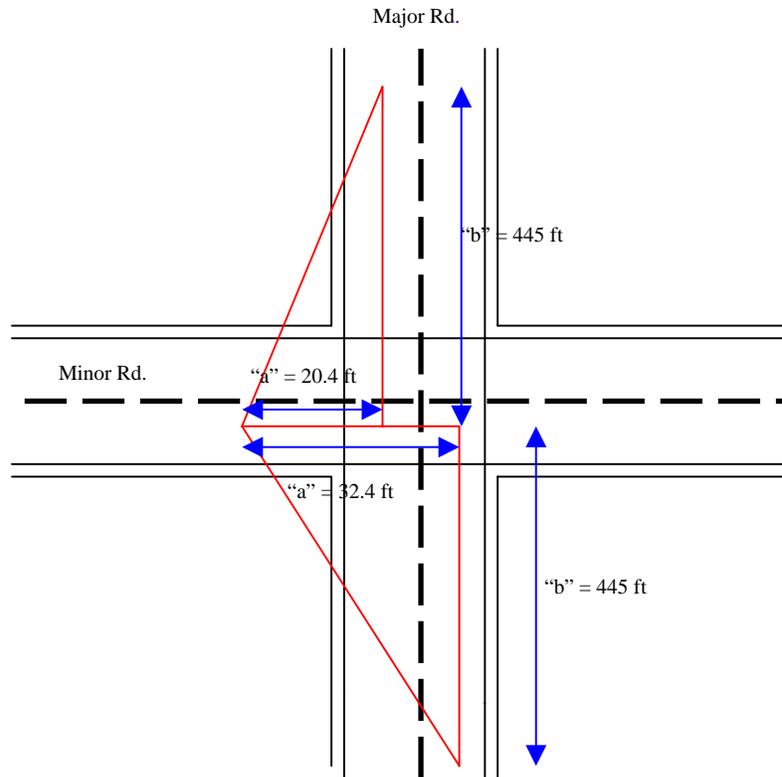
Figure B.1. Sight triangles for Case B1, left turn from the minor road

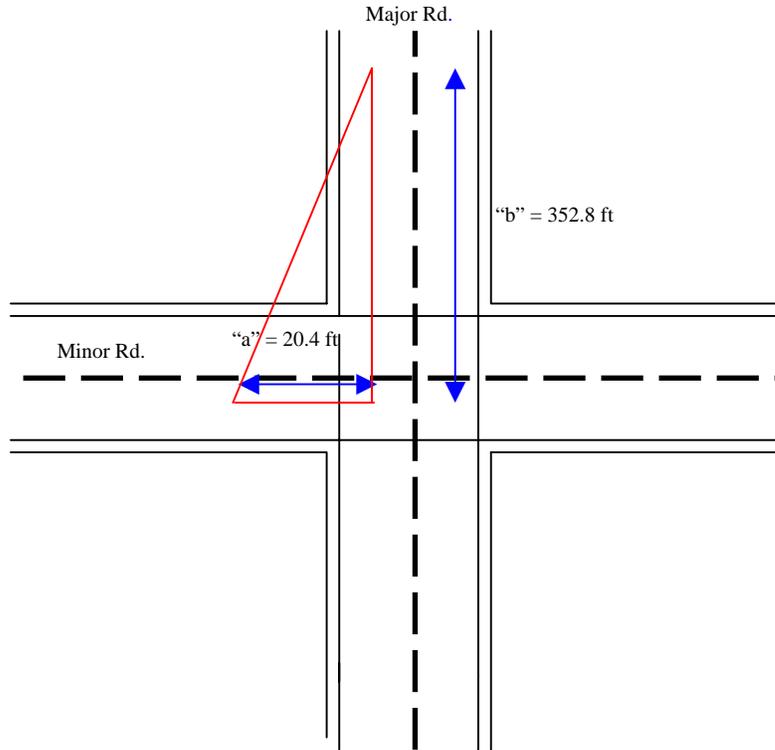
Figure B.2. Sight triangle for Case B2, right turn from the minor road

The intersection sight distance for right turns was determined similar to Case B1 except that the time gap (t_g) was adjusted. The time gap was decreased by 1.0 second for right-turn maneuvers in accordance with the Green Book's recommendation. The Green Book indicates slightly shorter time gaps for right turns than those accepted by drivers making left turns. An intersection sight distance of 352.8 feet is needed along the major road in the left direction while making right turns on to the major road (see Figure B.2).

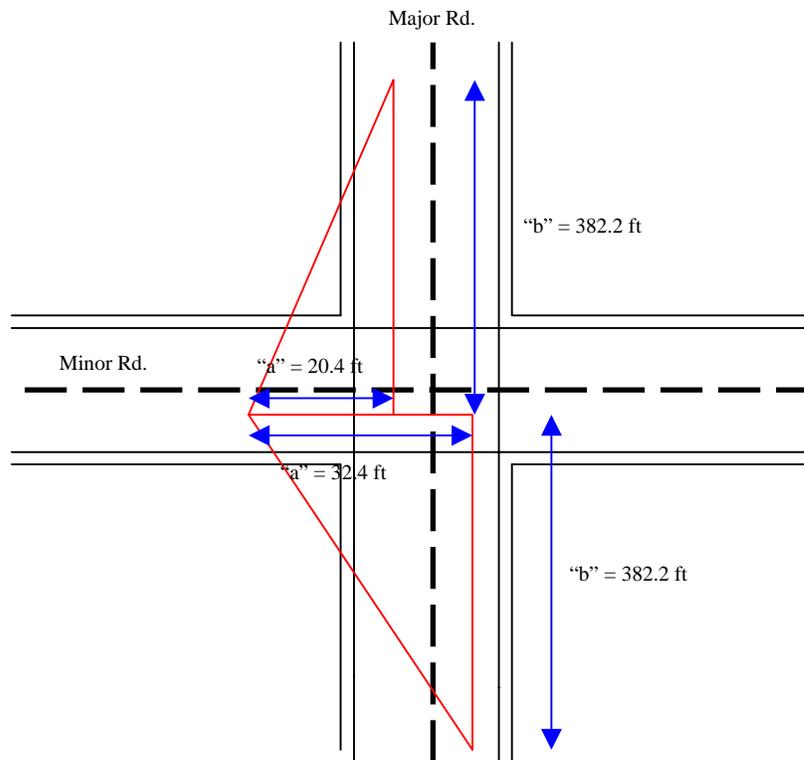
Figure B.3. Sight distance triangles for Case B3, crossing the major road

The Green Book recommends a time gap of 6.5 seconds for a passenger car to safely complete a crossing maneuver from the minor road. Substituting the required time gap, 382.2 feet of clear sight distance is required in both left and right directions, as shown in Figure B.3.

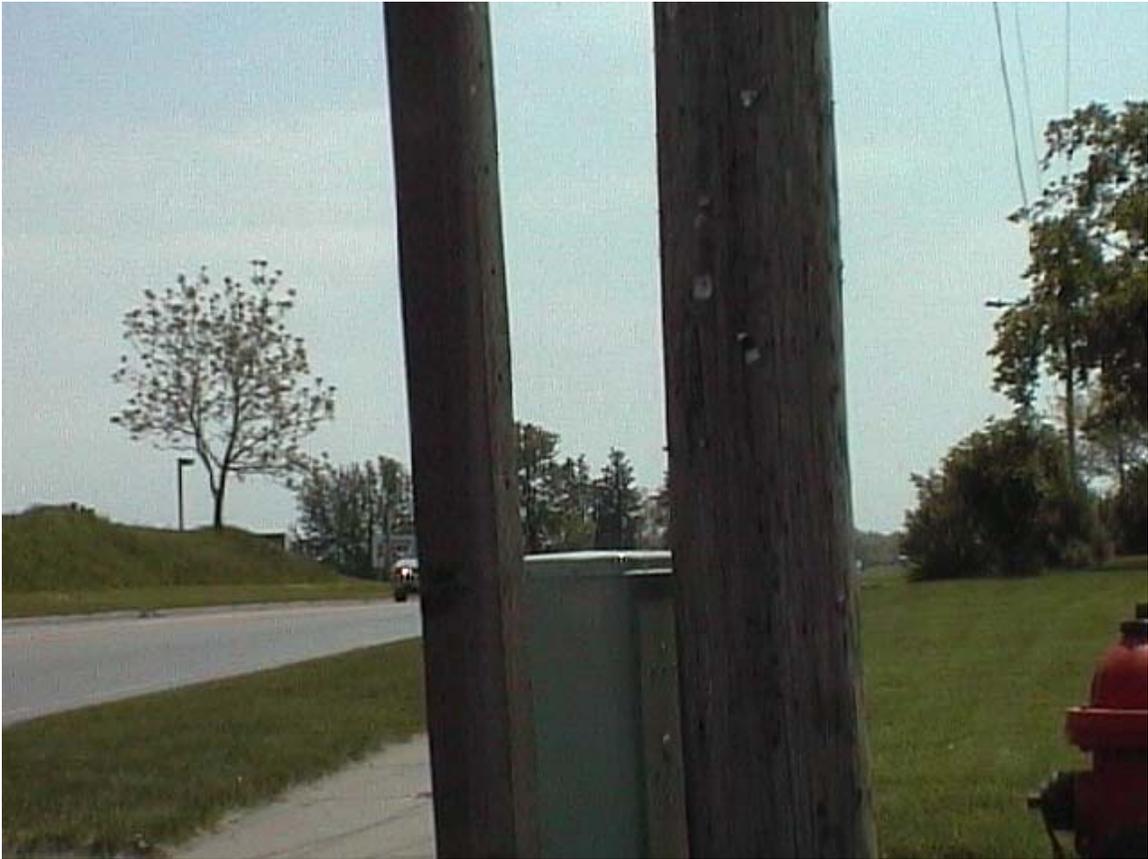
The camera that took the image in Figure C.1 was located at a point where the driver on the minor road is expected to stop. The camera was mounted at a height of 3.5 feet from the pavement, which is the supposed height of the driver's eye. The location is the intersection of Market Street and East Fifth Street, which has the highest crash frequency involving older drivers. The camera is positioned to the west of Market Street, and the sight triangle under investigation is south of the East Fifth Street. The two utility poles with a utility box in between effectively block the driver's view of the main road traffic.

Figure C.1. Stopped driver's view at the intersection of Market and East Fifth streets

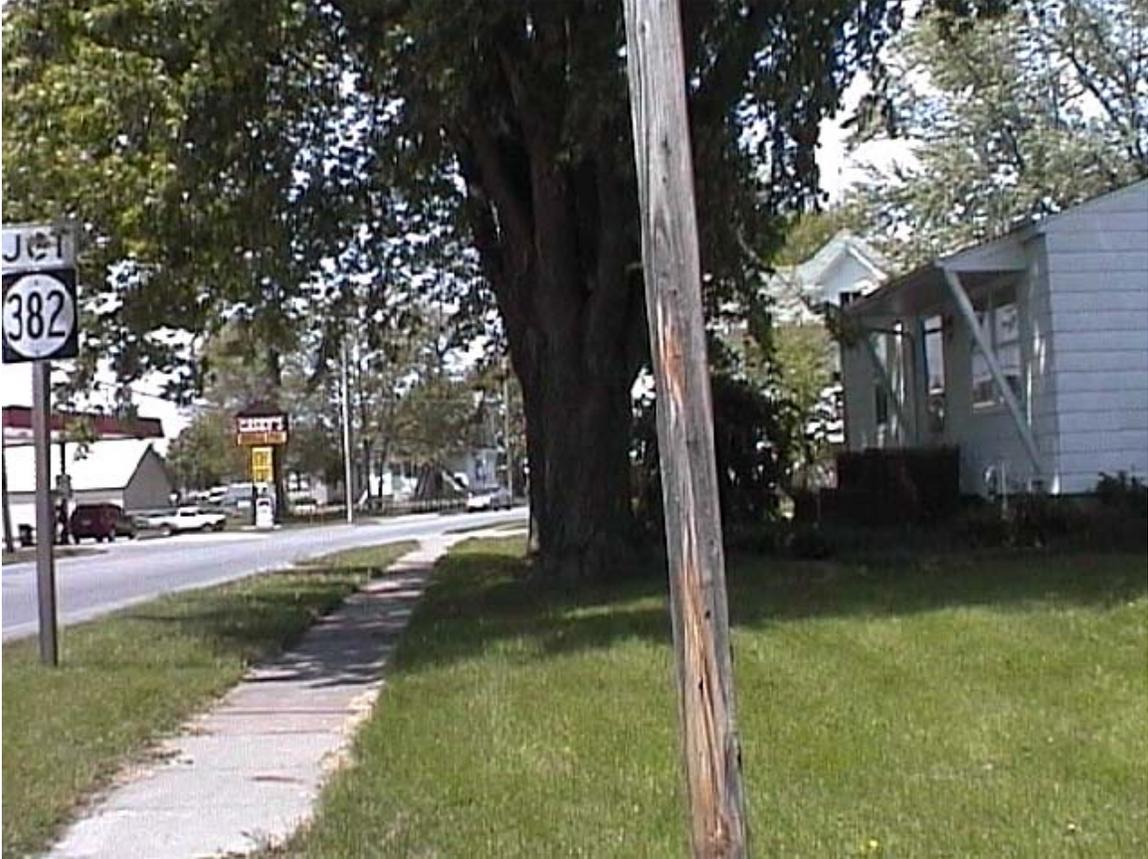
The camera in Figure C.2 was positioned at 3.5 feet height from the pavement, east of Market Street, and the sight triangle under investigation was north of East First Street. Note that the tree trunk effectively hides oncoming vehicles from the driver's view while the overhanging branches present a potential obstruction.

Figure C.2. Stopped driver's view at the intersection of Market St. and E. First St.

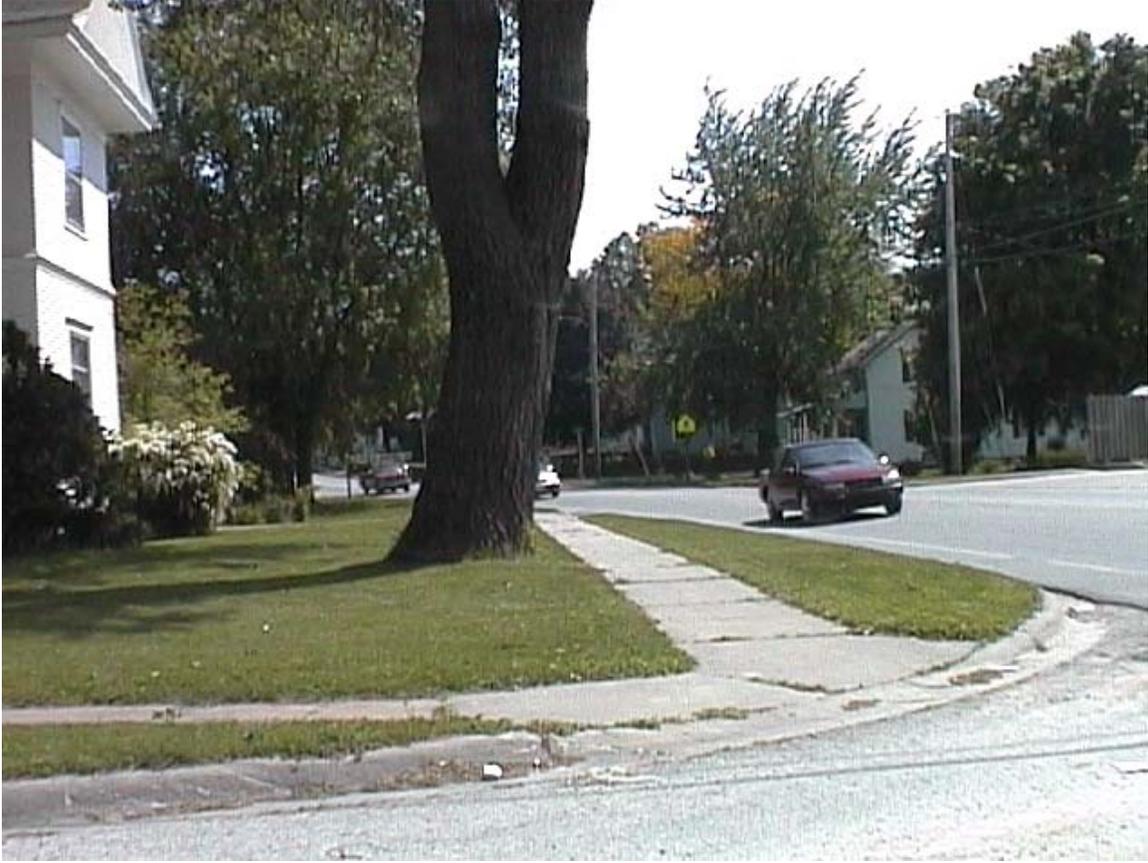
Figure C.3 shows the driver's view at the intersection of Market Street and Short Street. The camera is located west of Market Street, and the sight triangle under investigation is south of Short Street. Note that the tree is wide enough to hide oncoming vehicles on the major road. The time a vehicle is hidden behind the tree would depend on the size of vehicle on the main road, tree trunk diameter at 3.5 feet height from the surface, and proximity of the tree to the stopped vehicle.

Figure C.3. Stopped driver's view at the intersection of Market St. and Short St.

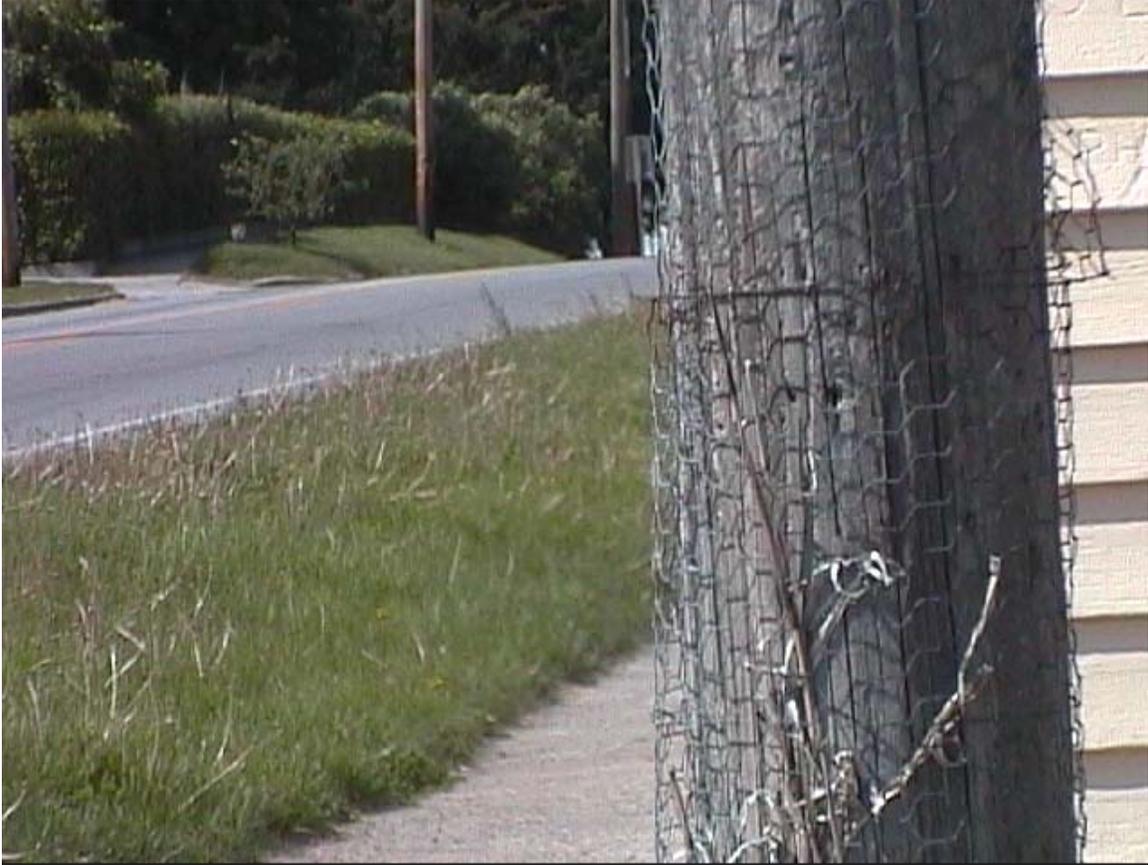
The image in Figure C.4 shows a driver's view when stopped on the Main Street at the intersection of Market Street and Main Street. The camera is positioned east of Market Street, and the intersection sight triangle under investigation is north of Main Street. Notice that the driver's sight is blocked by a utility pole and a building wall.

Figure C.4. Stopped driver's view at the intersection of Market St. and Main St.
