Material and Construction Optimization for Prevention of Premature Pavement Distress in PCC Pavements: Final Report

National Concrete Pavement
Technology Center

Final Report
March 2008

Federal Highway Administration Pooled Fund Study TPF-5(066)

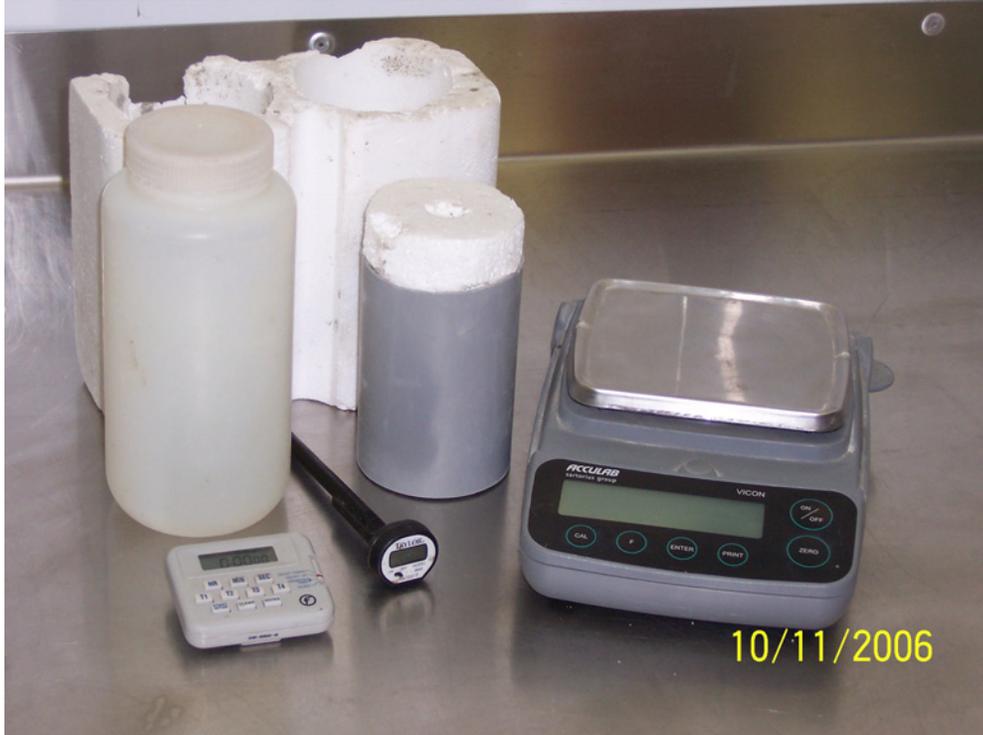
Figure 2. Coffee Cup Test Equipment

Initial criteria for the coffee cup test were provided by Grace Admixtures staff. If temperature change exceeds 3°F in any 5 minute period, then there may be early stiffening issues in the field. However, the research team noted that most tests that have exceeded this criterion are still workable in the field.

The cementitious materials are usually sampled from a truck, and the research team feels that the test results may indicate a difference between loads. However, under normal circumstances the material will be unloaded from the truck before the test results are known. The research team therefore views this test as an aid to troubleshooting field problems, as the test may flag a detrimental change in cement or cementitious materials chemistry. Figure 2 shows the coffee cup test equipment.

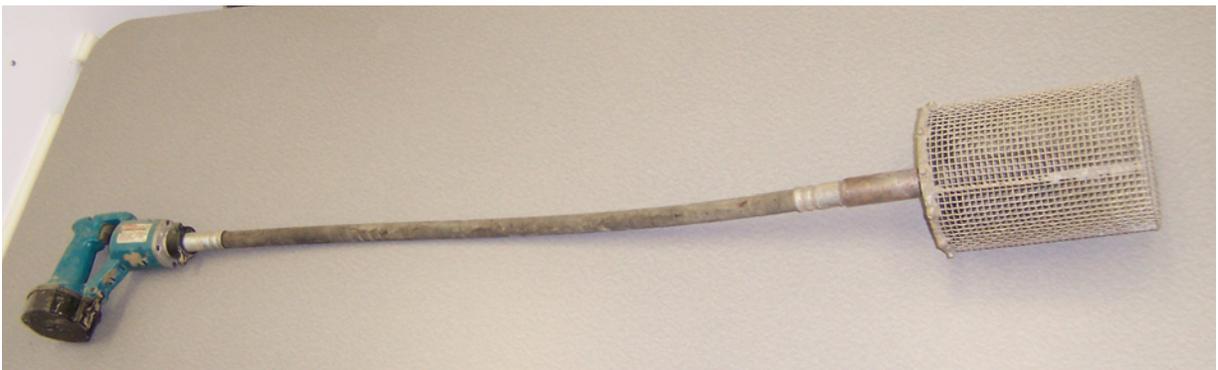
Figure 3. Handheld Vibrator and #4 Sieve Used for Set Time Test

The penetration set time test was conducted according to ASTM C 403 with a minor variation. The mortar for the test was sieved from the fresh concrete using a handheld vibrator with a custom made #4 sieve, shown in Figure 3. The fresh mortar was then placed into a coffee can and tested in accordance with ASTM C 403.

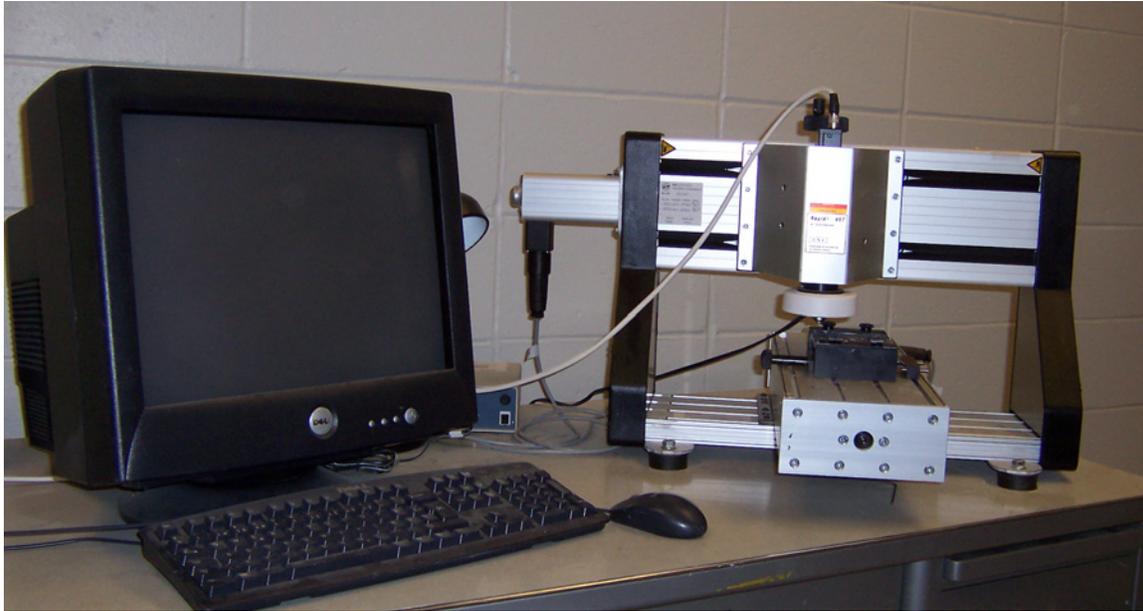
Figure 4. Rapid Air Analyzer

The rapid air analyzer uses the contrast between the blackened paste and aggregate and the white air voids to determine the air void diameter when conducting a linear traverse. The computer analysis conducts the linear traverse and analysis in about three minutes. The resulting output is the air content percentage, the specific surface of the air voids, and a spacing factor.

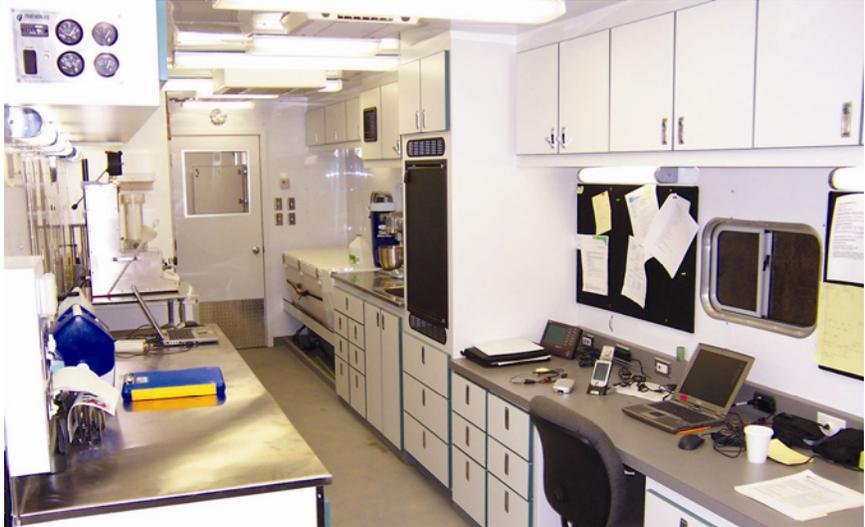
Figure 5. Inside the Mobile Lab

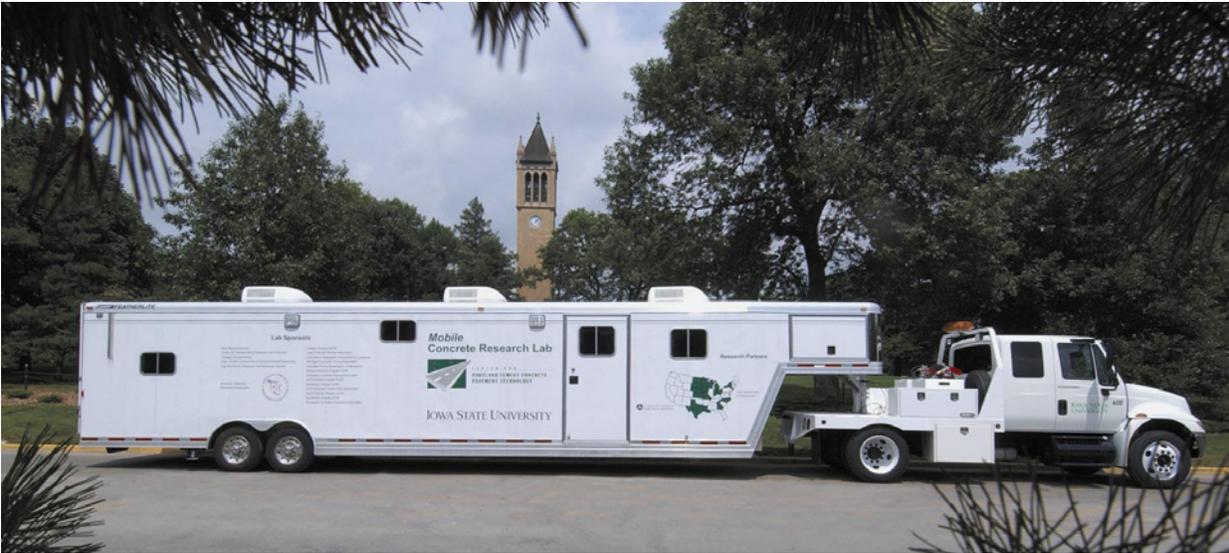
Figure 6. The Mobile Lab Parked Curbside

All stakeholder input and revisions culminated in the final custom design. The 44-foot Featherlite trailer is suitable for towing by a medium-duty truck with a flat bed. The trailer’s gooseneck style makes it more maneuverable than a semi and less costly to own and operate, with the additional advantage of having the pull vehicle available to transport material around the construction site. See Figure 6 for an external view of the mobile lab.

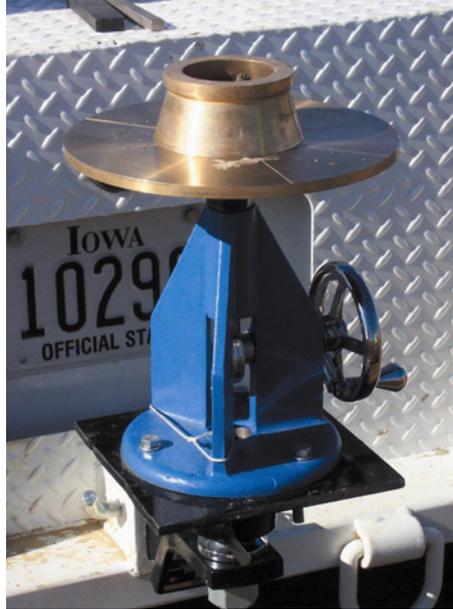
Figure 7. Flow Table Test Apparatus

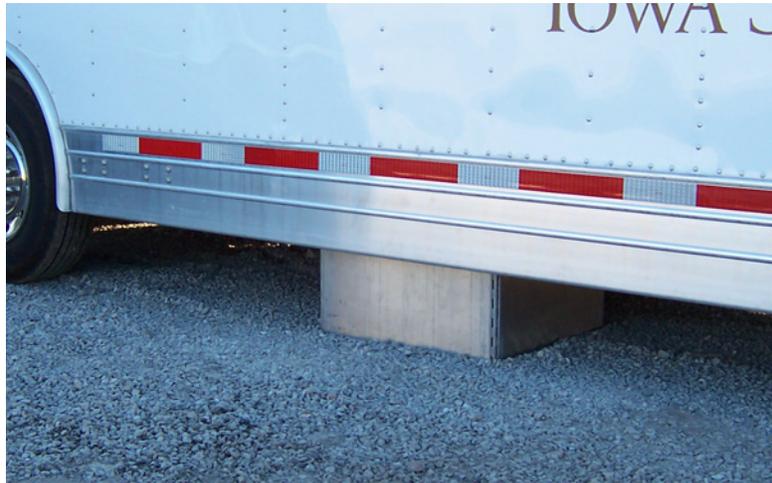
Figure 12. Outside View of the Weather Shield for the AVA

trailer. This set-up provides an accurate method of using the AVA in the field for more timely, convenient, and cost-effective quality control.

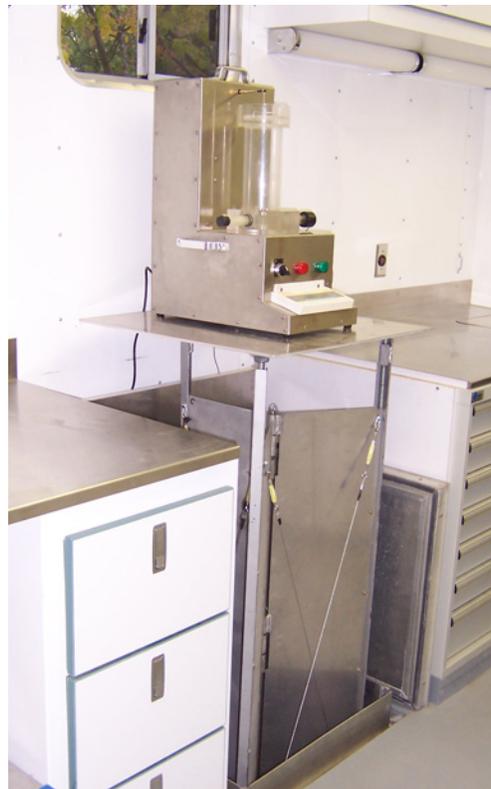
Figure 13. AVA on its Three-Legged Stand in the Mobile Lab

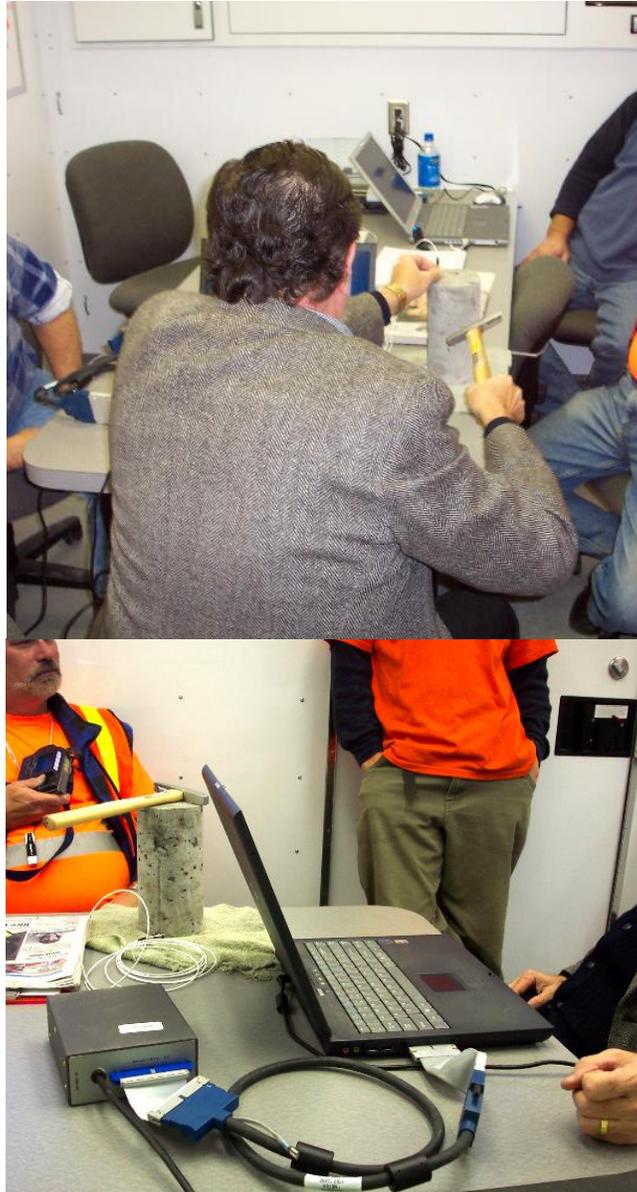
Figure 14. Free-Free Sonic Strength Test

Nondestructive tests are the goal of concrete testing whenever possible. As this test develops, it should be investigated as an addition to the conventional strength tests and, possibly in the future, a replacement for destructive tests.

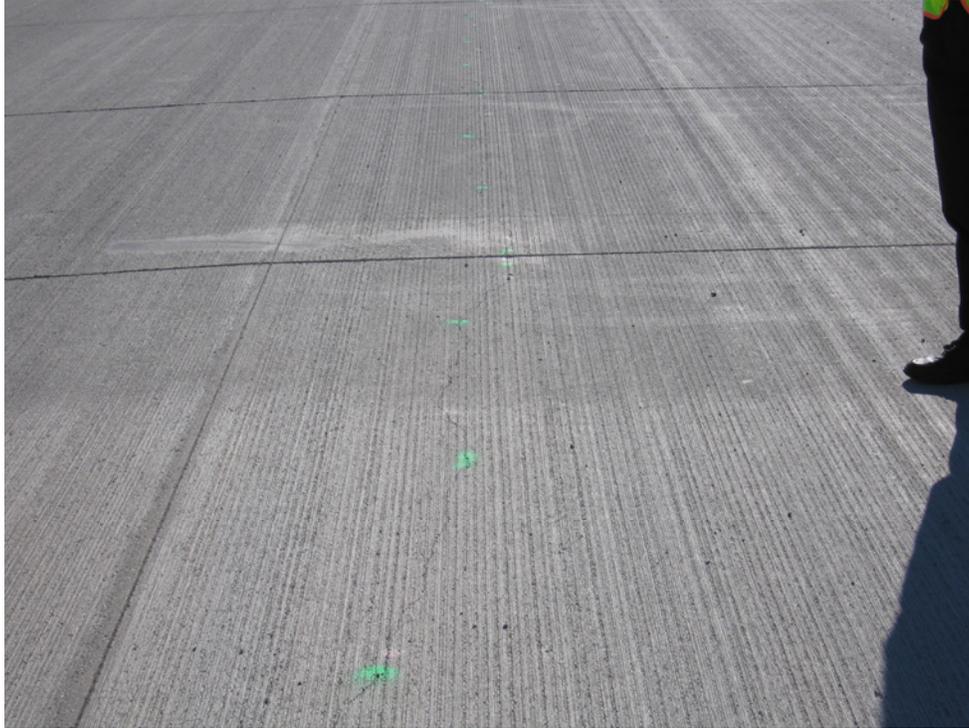
Figure 15. Random Longitudinal Crack in North Dakota Pavement

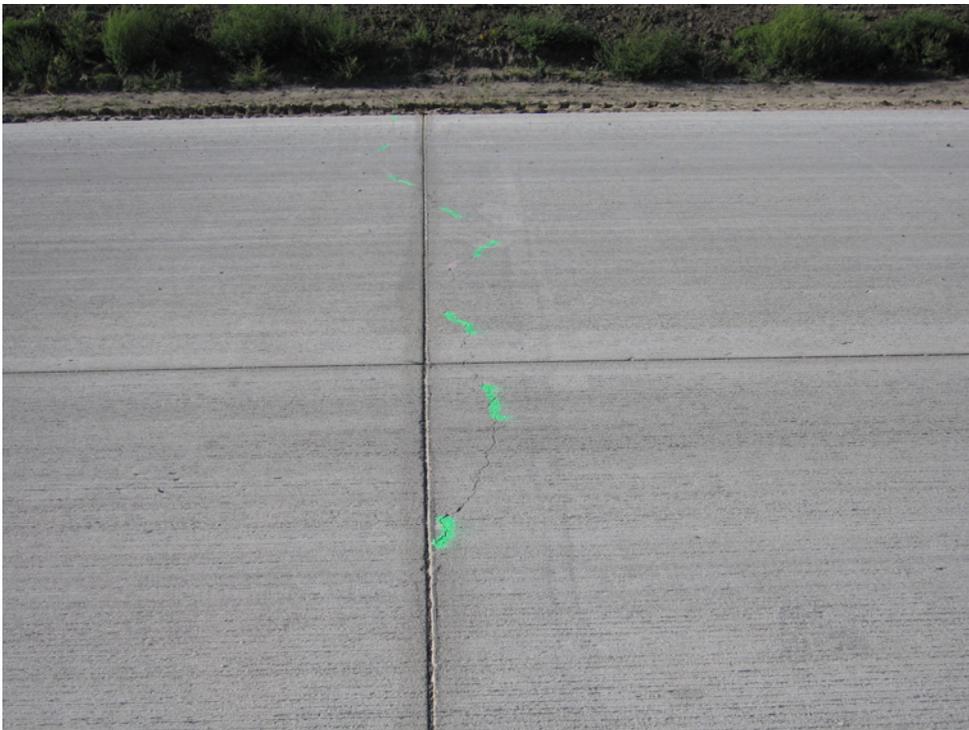
Figure 16. Random Transverse Crack in North Dakota Pavement

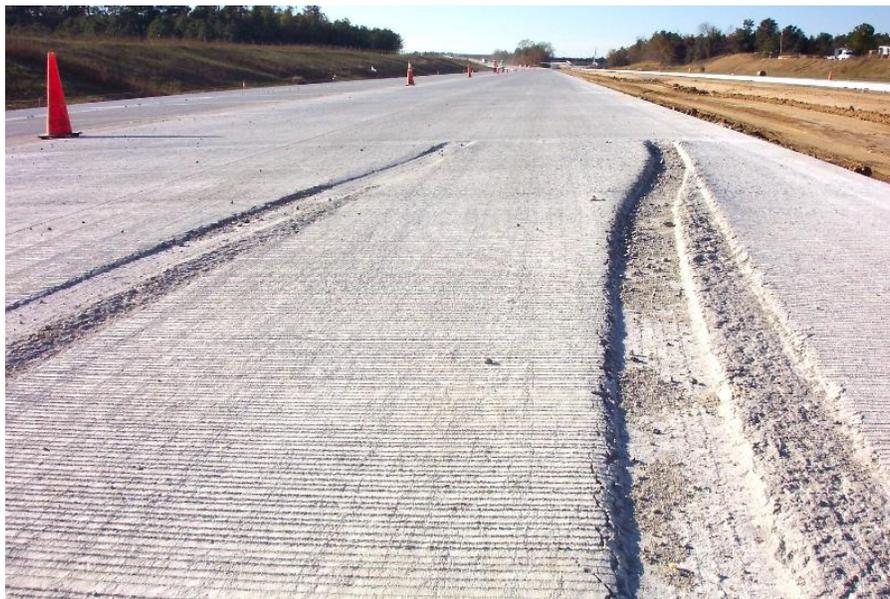
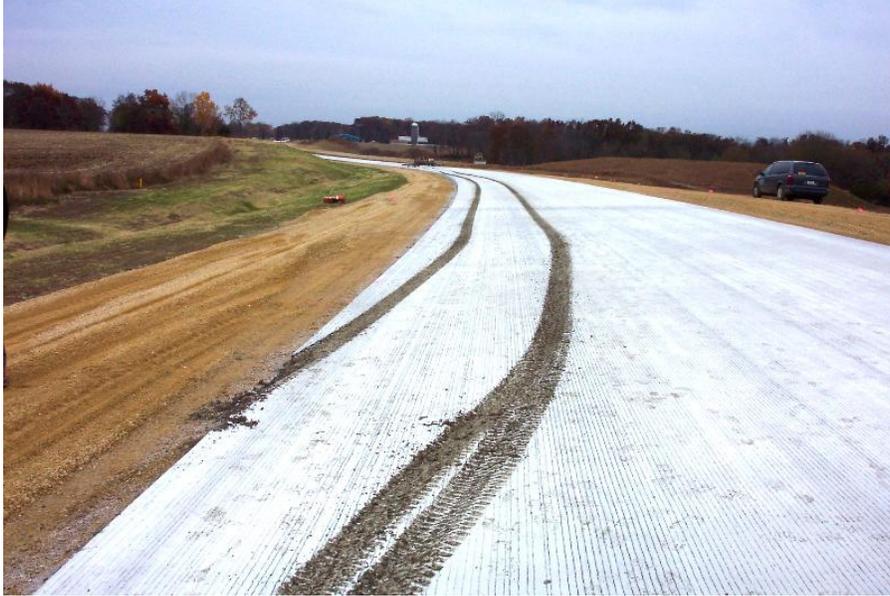
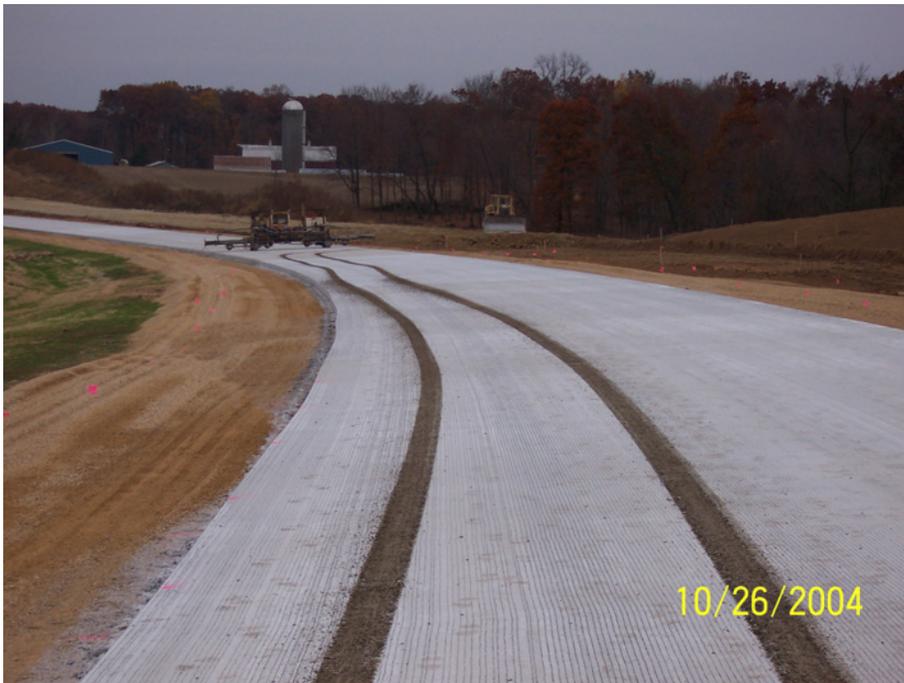
Figure 17a

The other incident occurred on the North Carolina shadow project. The westbound roadway was being constructed during the research team's visit, but in the eastbound lanes, opposite the current construction, tire tracks from a car were evident. The car had driven west on the eastbound roadway, stopped, turned around, and had driven back east in the other lane. Again, the North Carolina DOT and the contractor evaluated various methods for repairing the damage. The research team was able to assist by taking core samples for evaluation from the affected areas.

Incidents involving vandals driving on a fresh concrete pavement and leaving indentations in the concrete are rare. However, this situation arose on two consecutive shadow projects in 2004, one in Wisconsin and one in North Carolina (Figure 17).

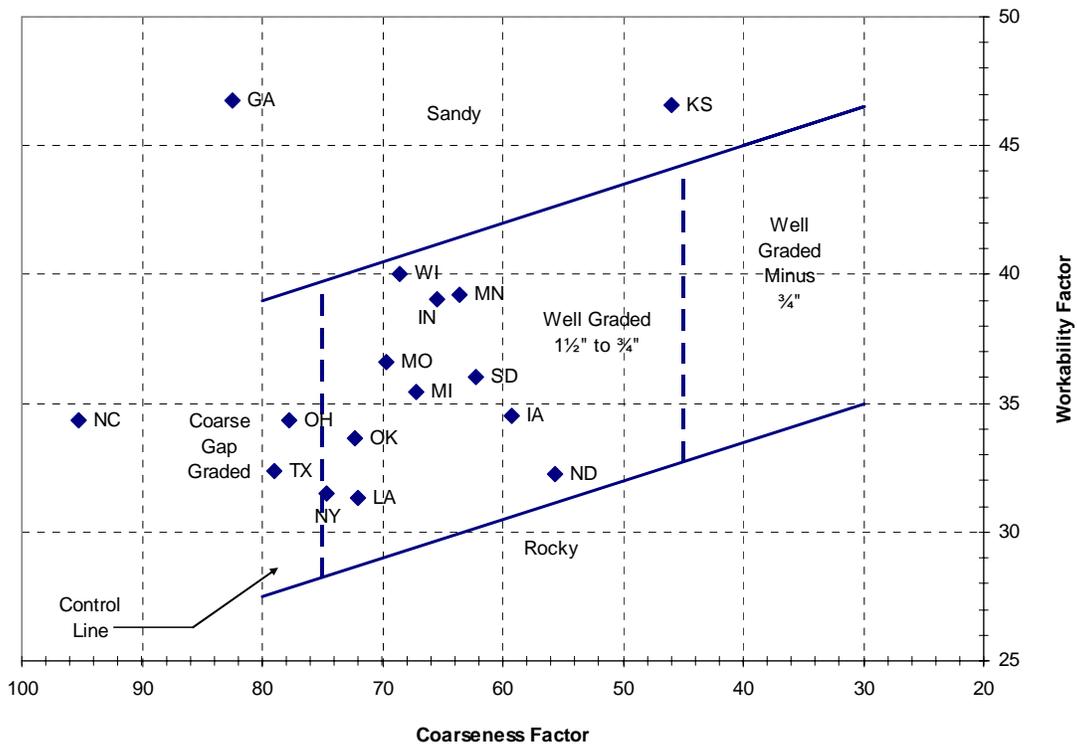
Figure 18. Workability Factor vs. Coarseness Factor for all States, Combined Gradation

Combined grading plays an important role in fresh concrete workability and hardened concrete durability. A well-graded concrete mix generally has a relatively low cementitious material content, which leads to a lower probability of shrinkage cracking. The combined gradation results for each state are shown in Figure 18. Note the five states within the well-graded 1 1/2 to 3/4 inch area, including Iowa, North Dakota, Michigan, Missouri, Indiana, and Minnesota. Although Oklahoma, Louisiana, Texas, and Ohio are not within the well-graded area that is shaded, they fall within the control lines, indicating that they are desirable but may be gap graded. Kansas, Wisconsin, and Georgia fall above the control line, indicating that mixtures from those states are sandy, and early cracking may be an issue associated with those mixtures.

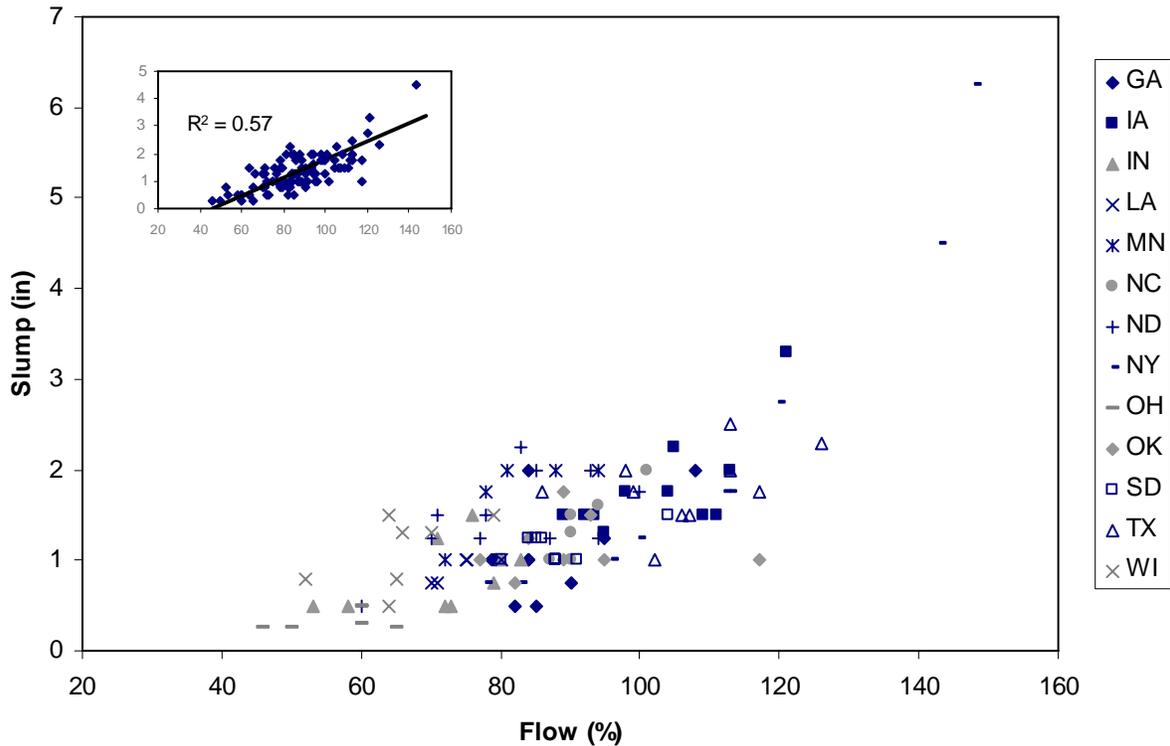
Figure 19. Slump versus Flow for All States

The correlation between slump and mortar flow is fair, due to the inherent difference between the two tests. The slump test is a static test and therefore measures the yield stress of fresh concrete. The flow test is conducted on mortar only and mostly measures viscosity. Due to the differences in what the two tests measure (i.e. viscosity or yield stress), the results show a rather low correlation.

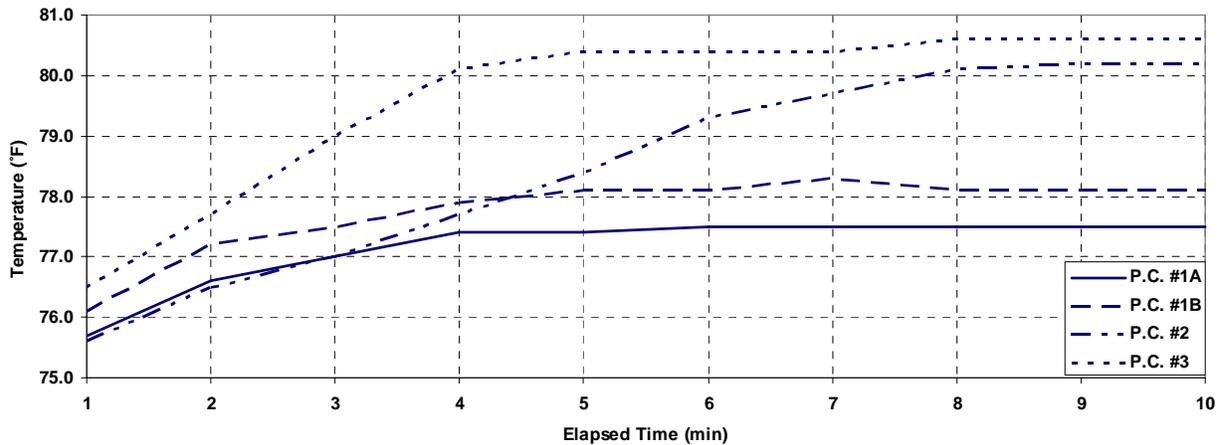
Figure 20. Coffee Cup Test Results for the Louisiana State Visit

The coffee cup test indicates whether the cementitious materials have changed significantly from a previous batch, which can have a detrimental impact on the paving operation. The coffee cup test results for the Louisiana state visit are shown in Figure 20. Note the results from PC #1A and PC #1B are repeated using the same portland cement sample to determine whether the coffee cup test is repeatable. The results show essentially the same heat generation curve, indicating that the test results are repeatable. Also note the different shapes of the curves for PC #2 and PC #3. The differing shapes of the curves may indicate variability in cement chemistry or a change in cement sources.

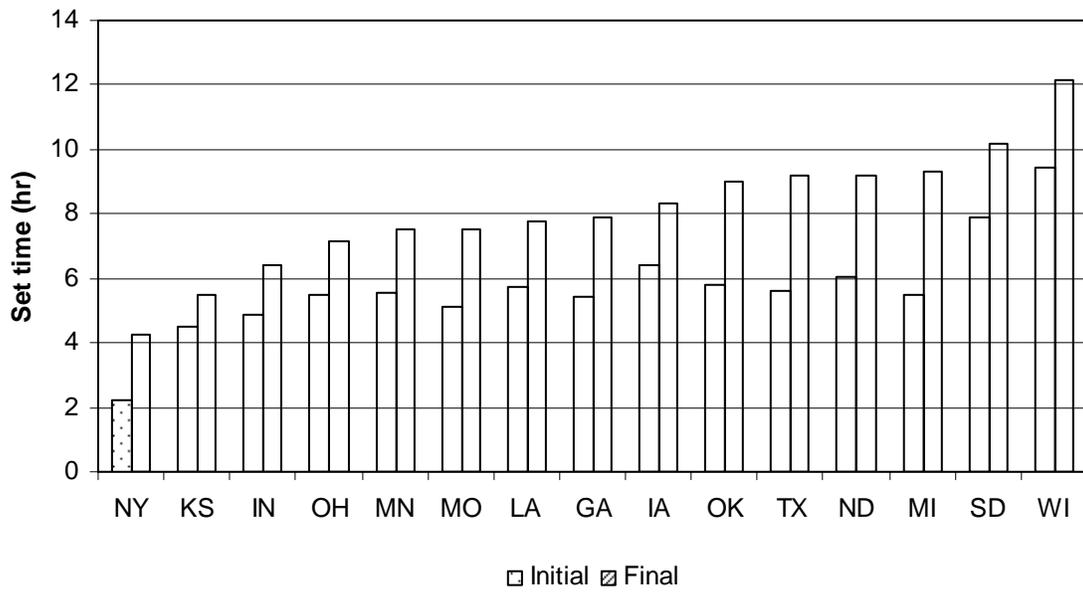
Figure 21. Initial Set and Final Set for Each State Visit

Figure 21 shows the initial and final set times for each state visit determined in accordance with ASM C 403. An initial set of 500 psi (penetrometer) ranged from about 4 to 9.5 hours, and a final set of 4,000 psi (penetrometer) ranged from about 5.5 to 12 hours. Figures 22 and 23 show the correlation between portland cement content and the initial set and final set, respectively. Set time decreases as cement content increases. Note that the correlations exclude the Wisconsin data point as an outlier. Also note that the data fit is poor, with an R^2 value of 0.51 for the initial set versus cement content, while the final set versus cement content produced a good fit, with an R^2 value of 0.70.

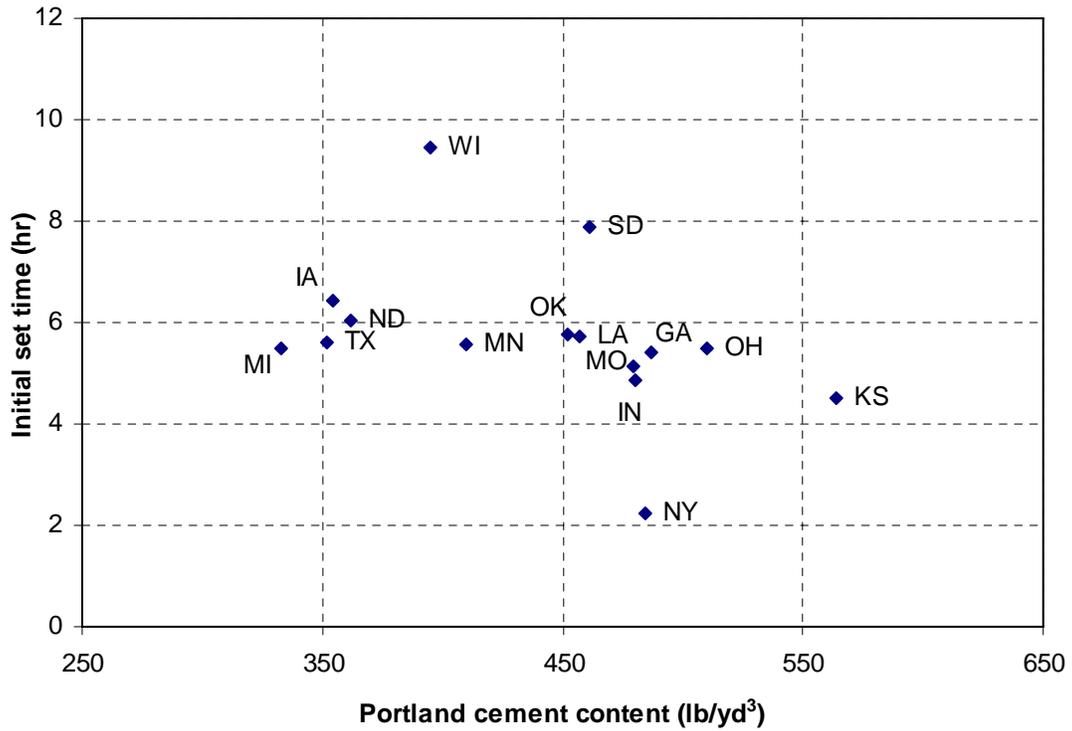
Figure 22. Initial Set versus Portland Cement Content

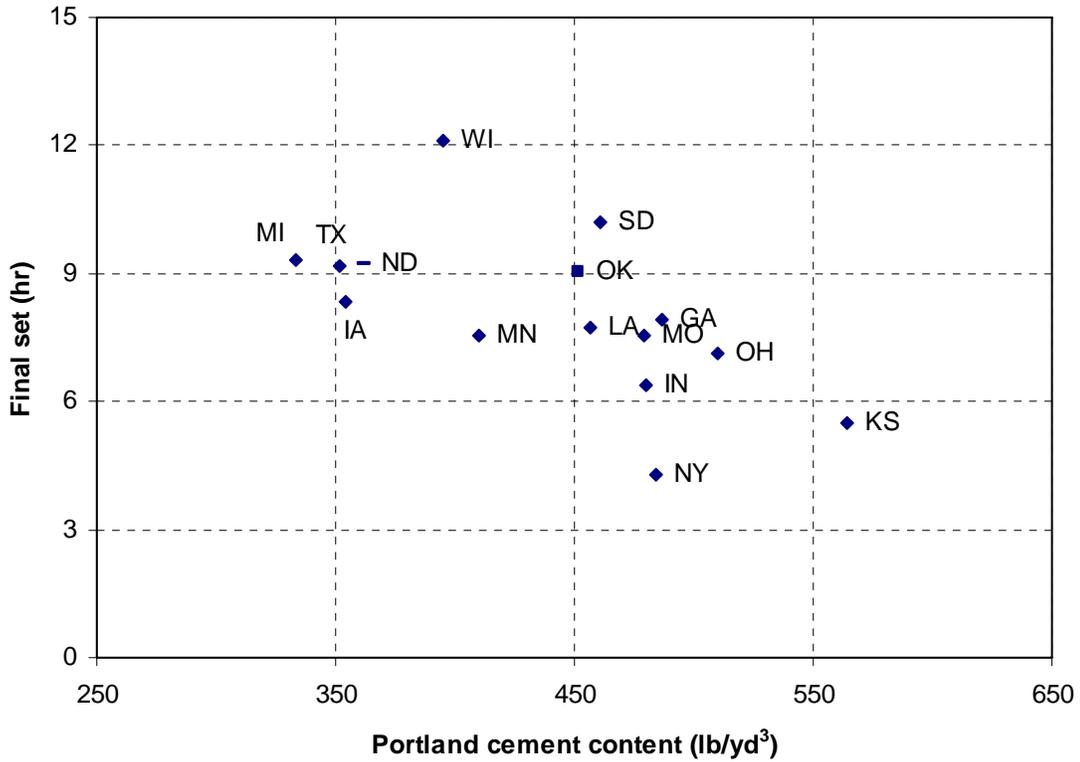
Figure 23. Final Set versus Portland Cement Content

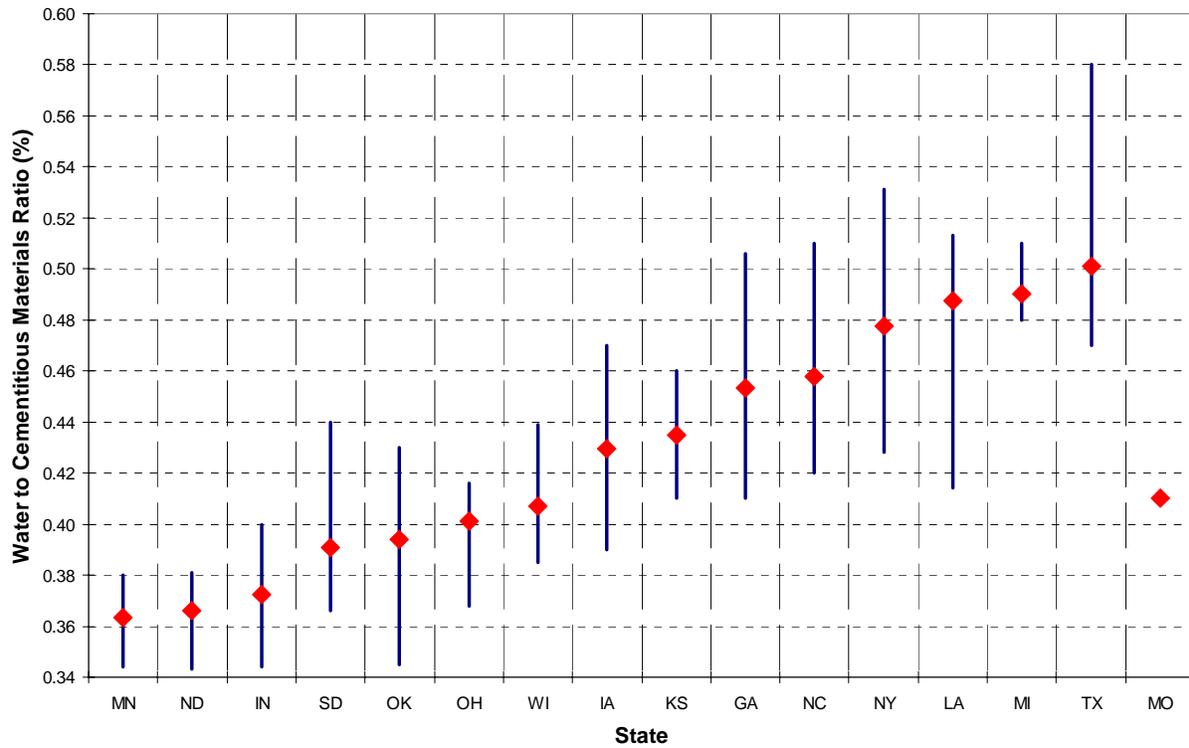
Figure 24. Microwave w/cm for All States

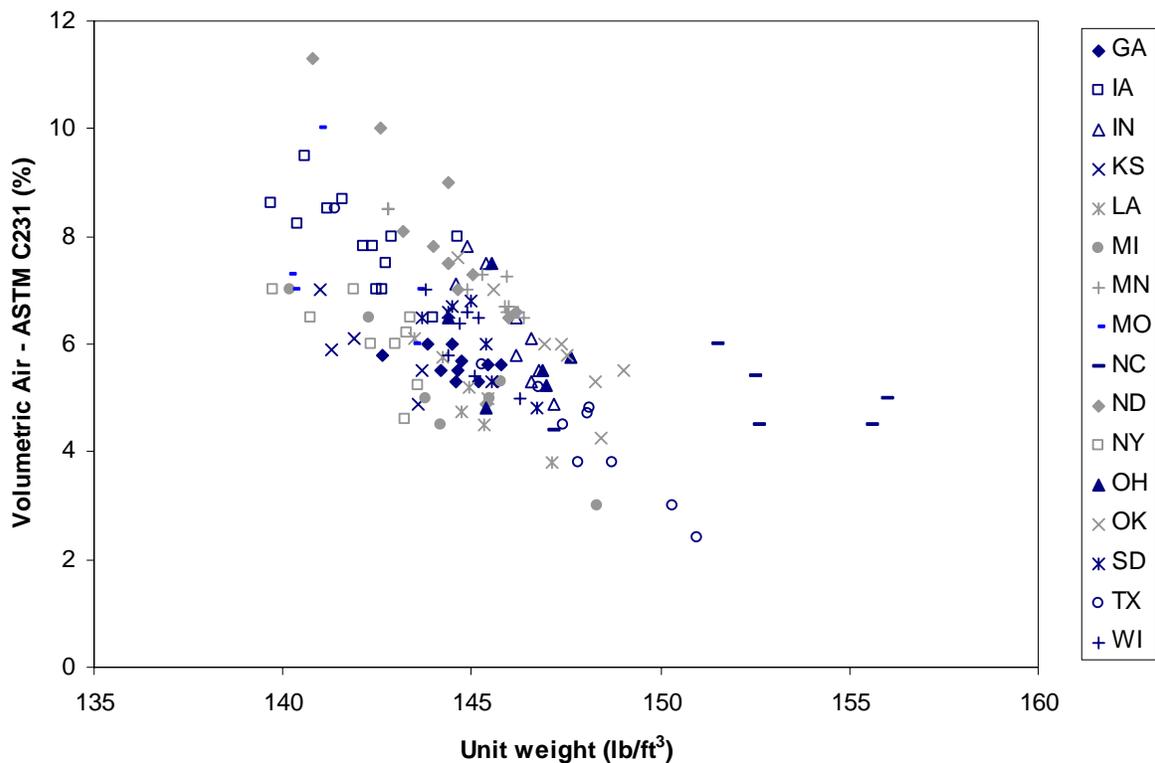
Figure 25. Air Content (Pressure Method) vs. Unit Weight of Fresh Concrete

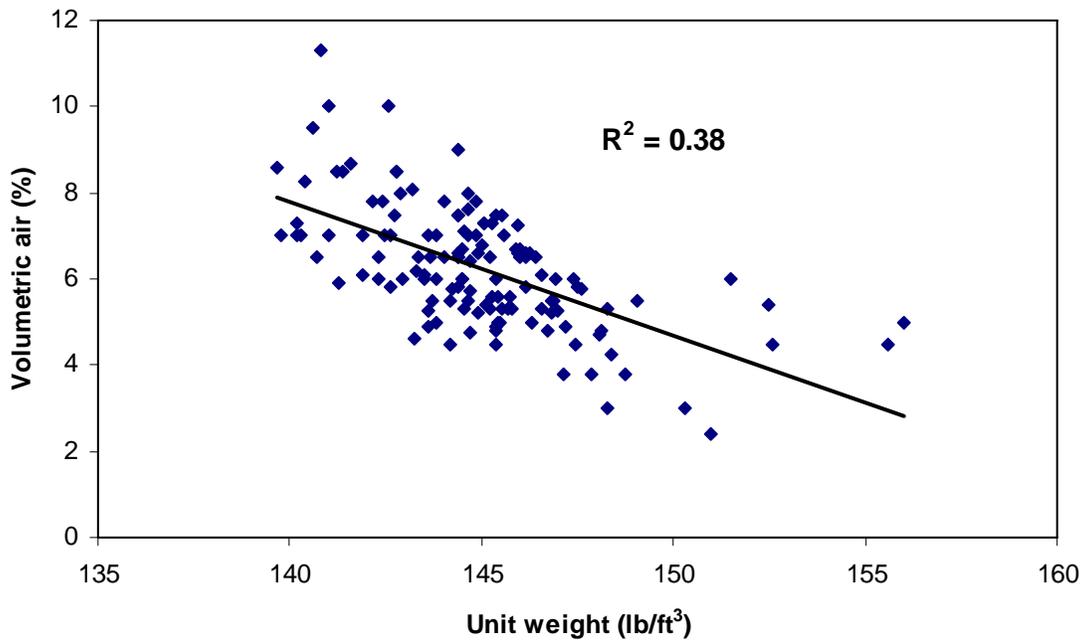
Figure 26. Volumetric Air Content–Unit Weight Correlation

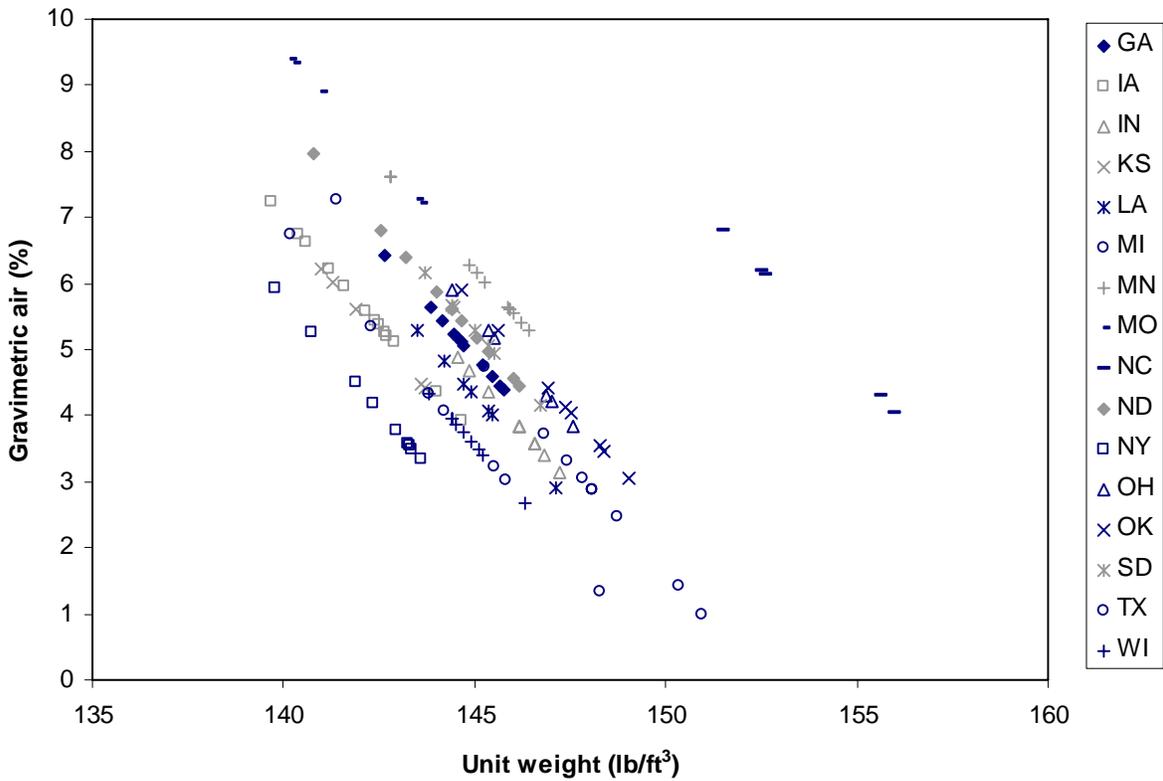
Figure 27. Gravimetric Air Content vs. Unit Weight of Fresh Concrete

The air content results obtained using the gravimetric method are shown in Figure 27. Note the improved correlation between air content and unit weight. The better correlation occurs because the air content is measured based on the unit weight values and the theoretical mix design proportions. Again, note that North Carolina appears to fall out of the general trend shown by the other states. Figure 28 shows the fair correlation, with an R^2 about 0.44, between gravimetric and volumetric air content.

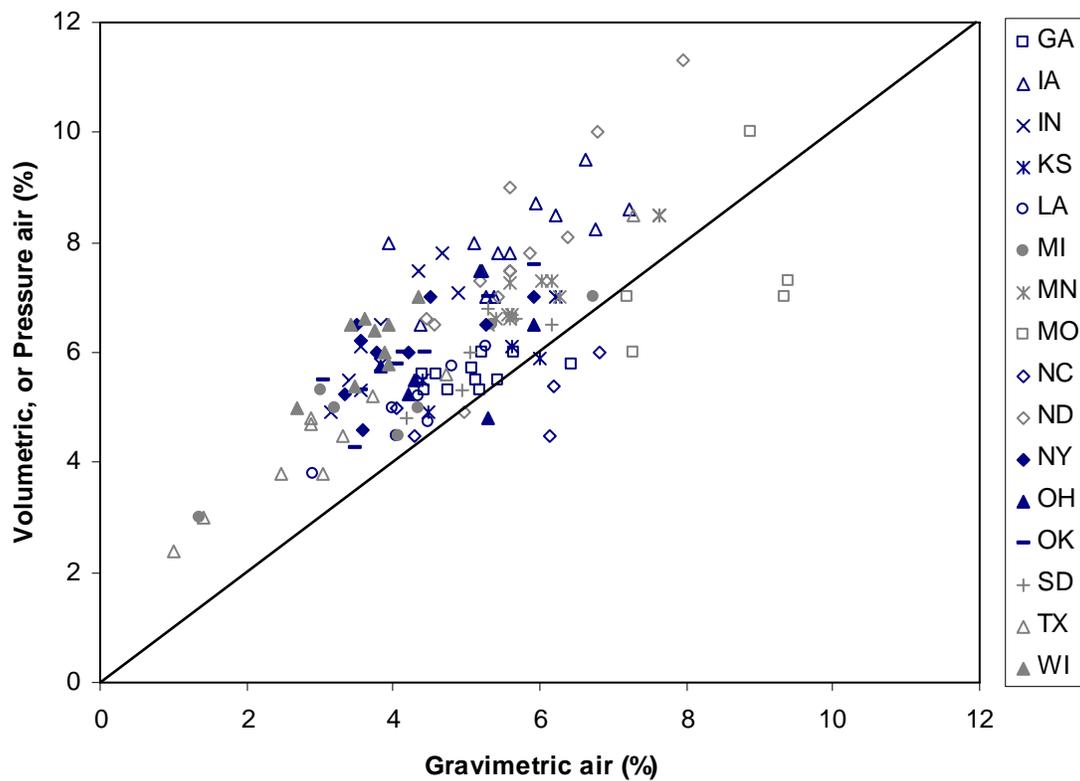
Figure 28. Correlation between Gravimetric Air Content and Volumetric Air Content

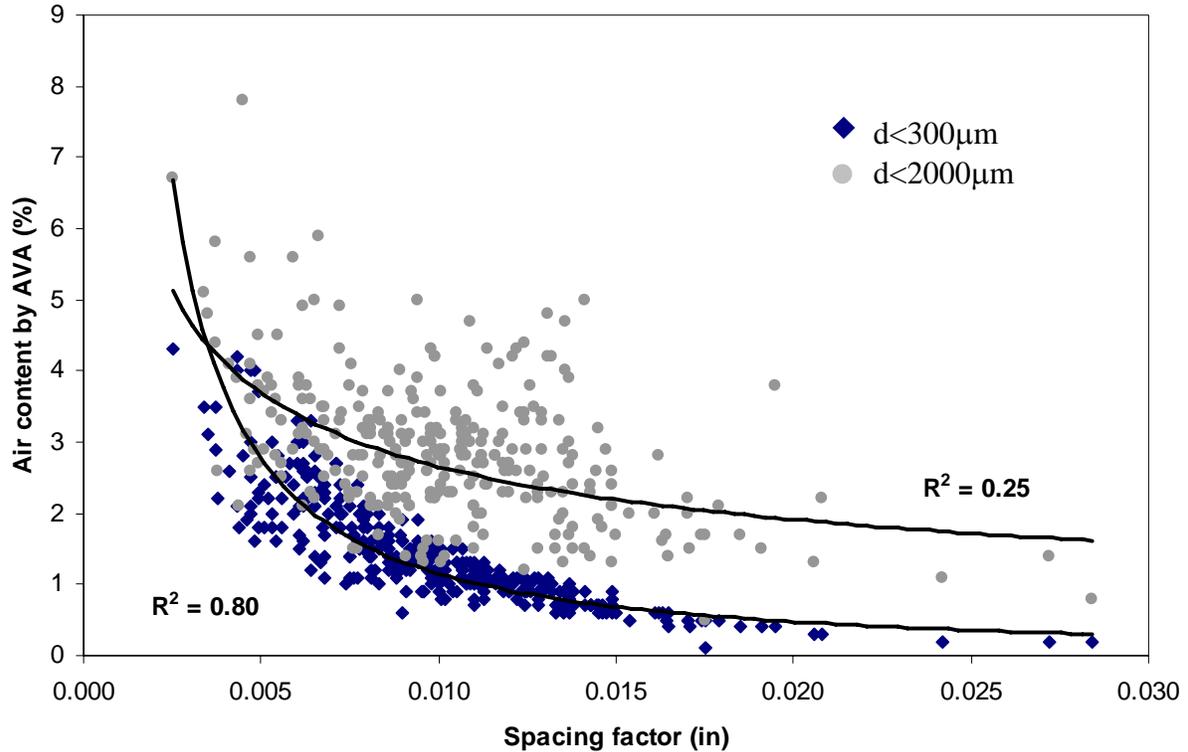
Figure 29. Relationship between AVA Air Content, Bubble Size, and Spacing Factor

Note that the air contents determined by the AVA do not equal the air contents determined by the pressure or gravimetric methods. These differences exist because the AVA does not measure the larger bubble sizes and ends the test at 25 minutes, even though there may be smaller bubbles remaining in the blue fluid-mortar mixture.

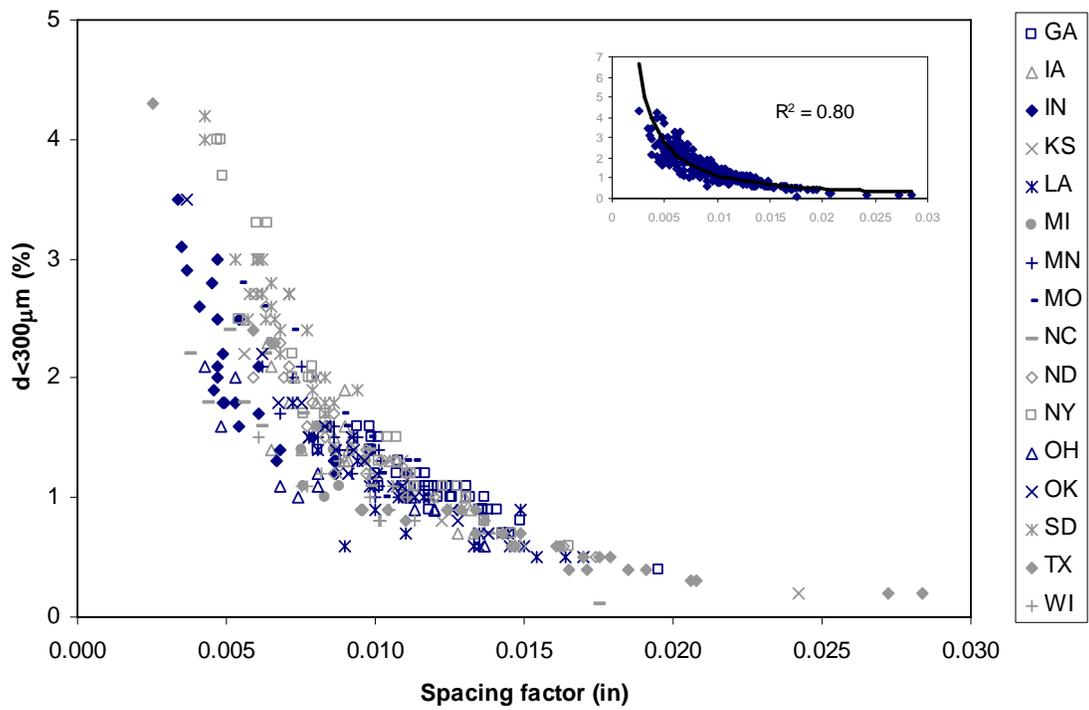
Figure 30. Correlation between 300 μm Diameter Bubble Size and Spacing Factor

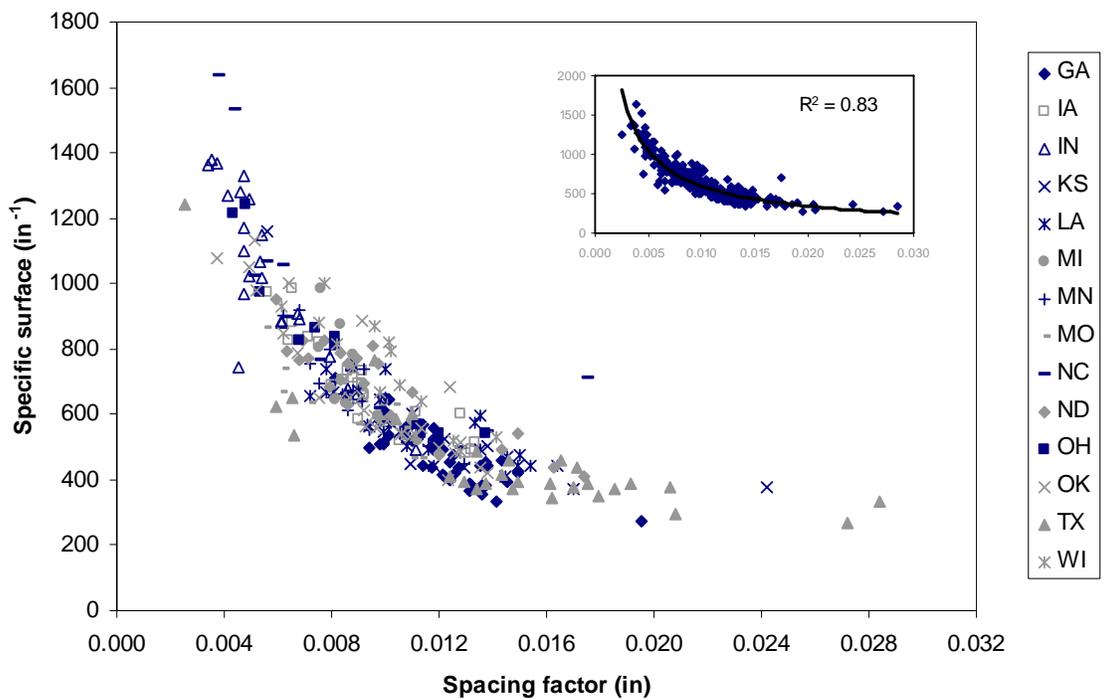
Figure 31. Relationship between Specific Surface and Spacing Factor for All AVA Data

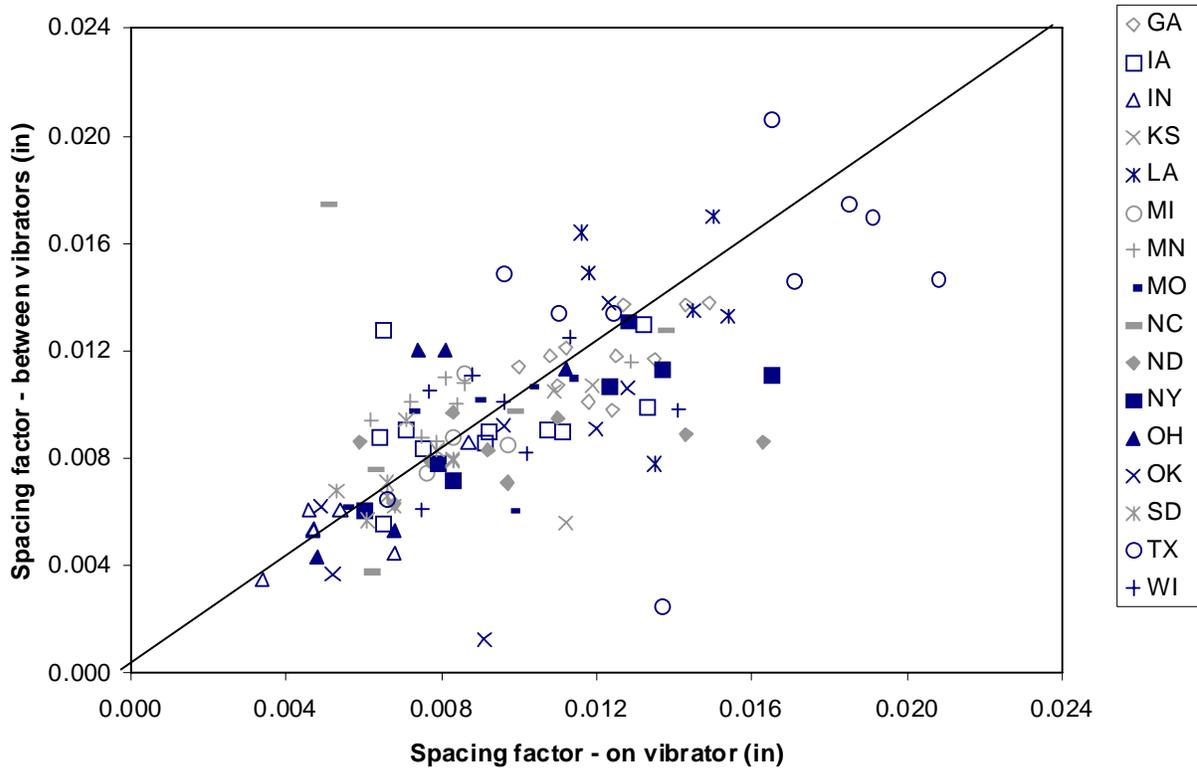
Figure 32. Spacing Factor between Vibrators vs. Spacing Factor on Vibrators

Figure 32 shows the relationship between the on-vibrator and between-vibrator spacing factors. Note that about half of the results fall above and below the line of equality, which suggests that vibration has little effect on spacing factor when compared to samples taken from between the vibrators. The same trend is valid for the entrained air voids below 300 micron. The authors note that the relationships presented here for locations ahead, behind on vibrator trail and behind between vibrator trail, are for these mixtures only.
