Material and Construction Optimization for Prevention of Premature Pavement Distress in PCC Pavements: Final Report

National Concrete Pavement
Technology Center

Final Report
March 2008

Federal Highway Administration Pooled Fund Study TPF-5(066)

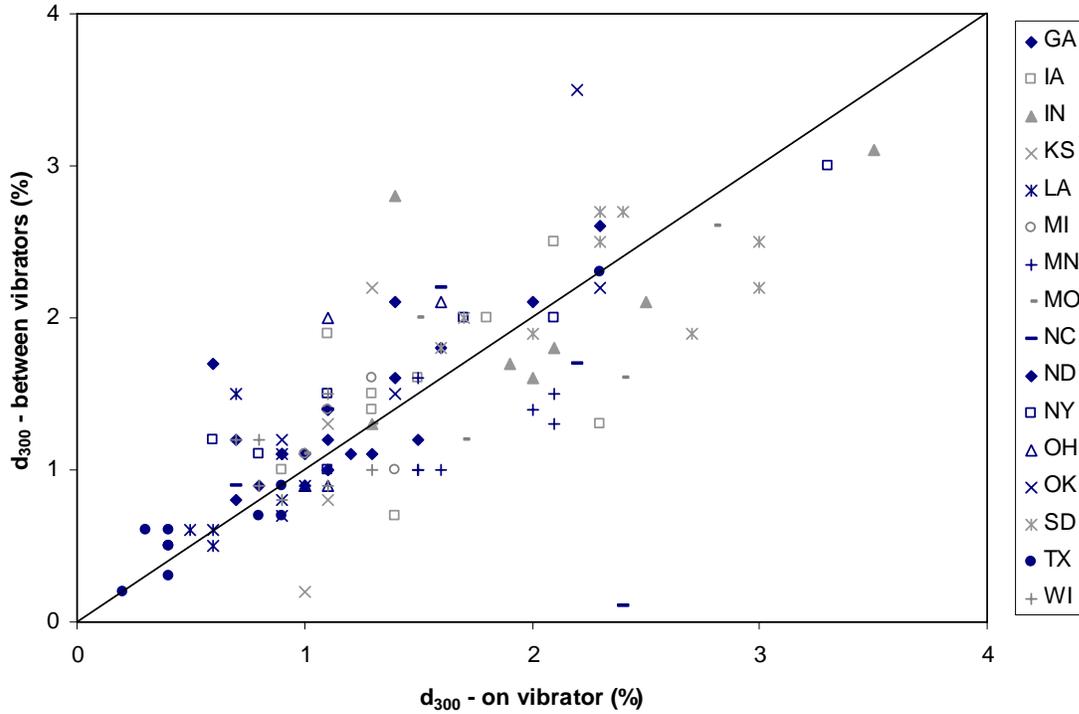
Figure 33. d₃₀₀ between Vibrators vs. d₃₀₀ on Vibrators

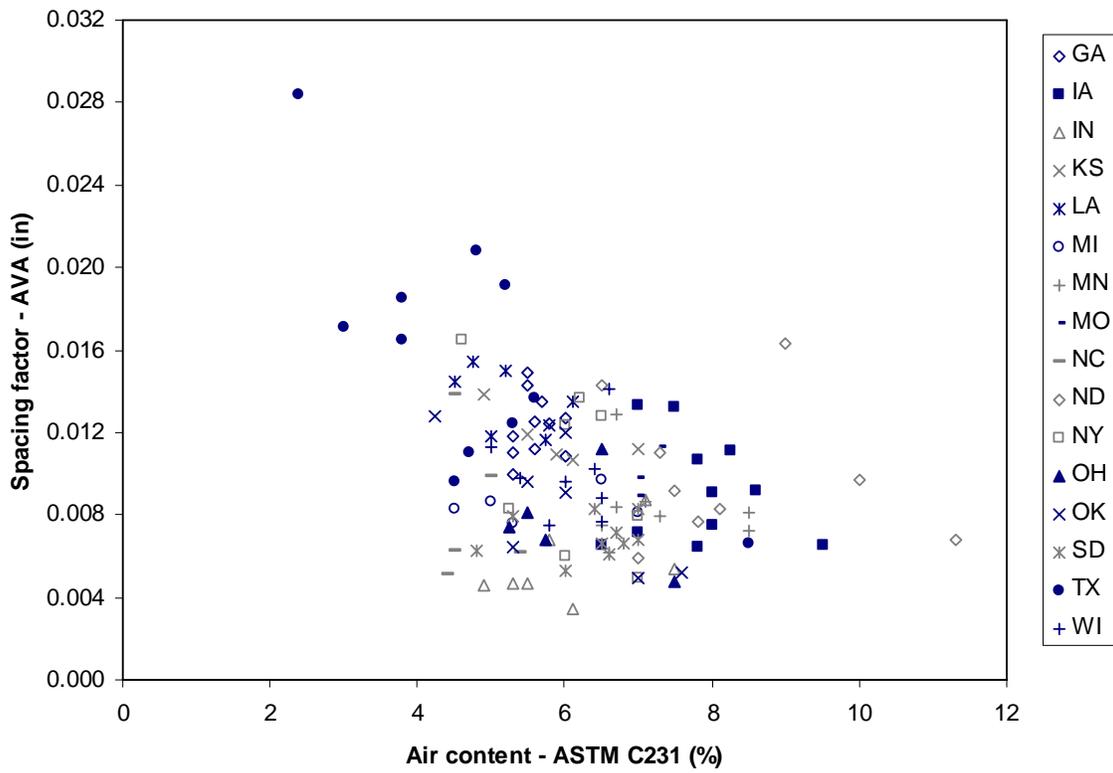
Figure 34. Spacing Factor vs. Pressure Method Air Content

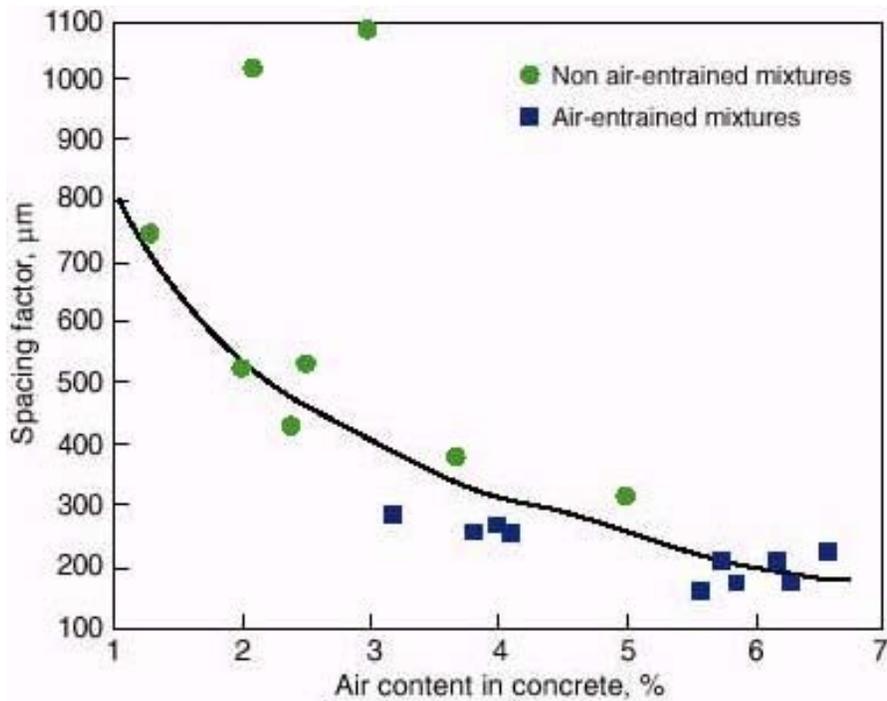
Figure 35. Spacing Factor vs. Air Content (Canadian Cement Association)

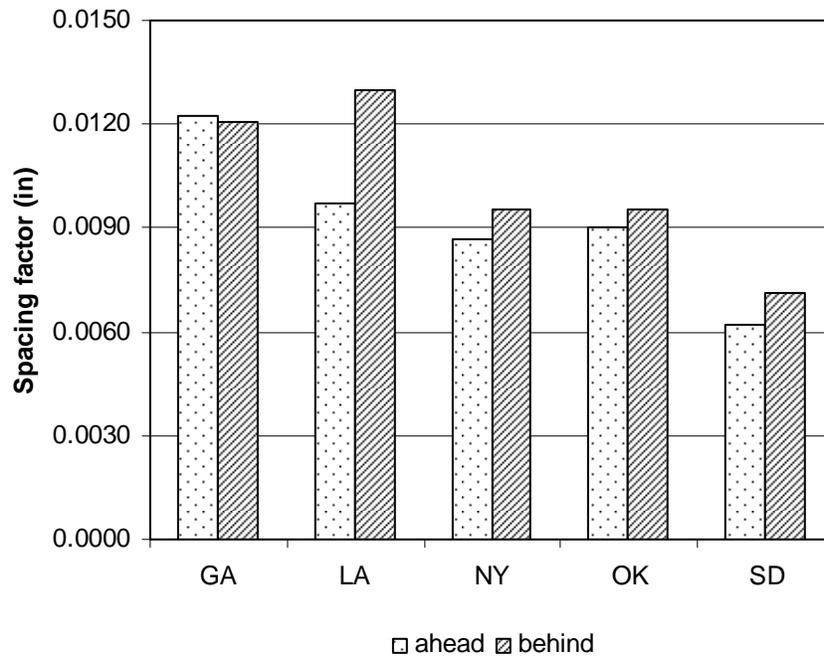
Figure 36. Spacing Factor in Front and behind the Paver for GA, LA, and OK

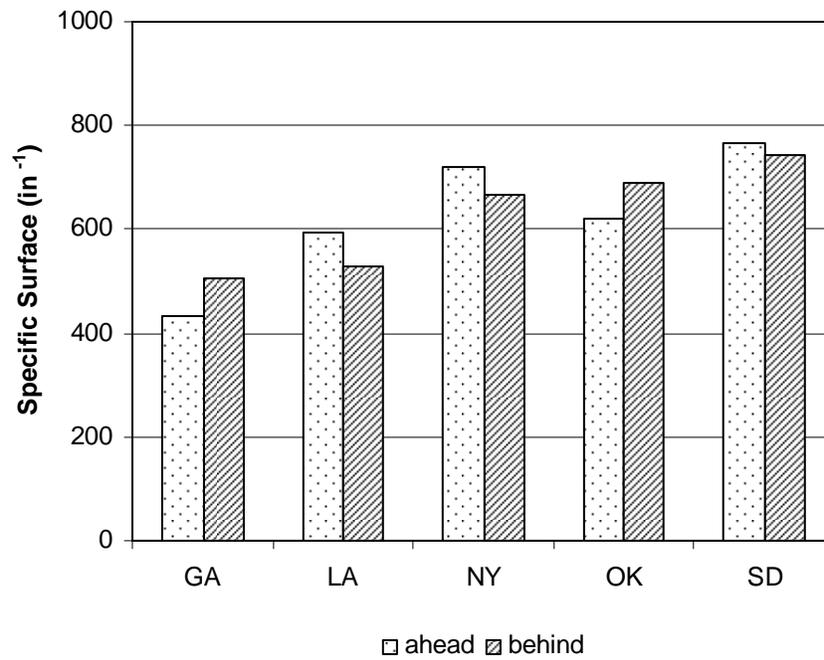
Figure 37. Specific Surface in Front and behind Paver for GA, LA, and OK

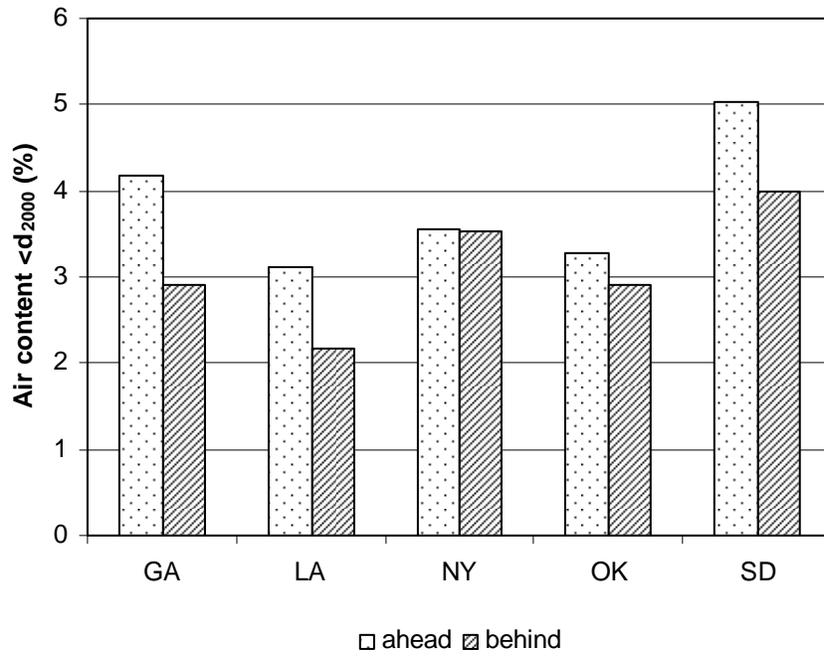
Figure 38. Percent Air Content $<d_{2000}$ in Front and behind Paver

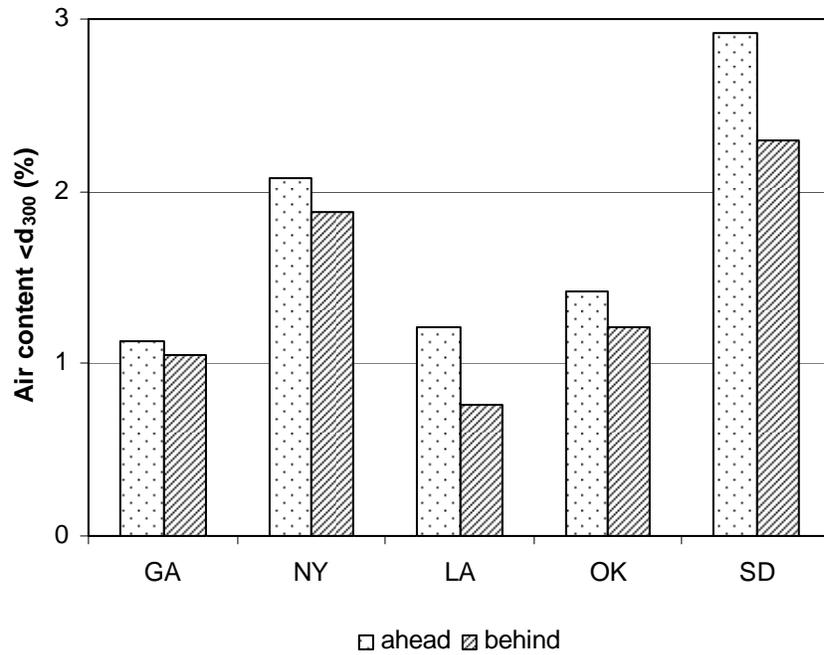
Figure 39. Percent Air Content $<d_{300}$ in Front and behind Paver

Georgia and Oklahoma, but the results are significant for Louisiana. The results show a small drop in the percentage of air content less than 300 microns, expected due to the vibration of concrete as it passes through the paver.

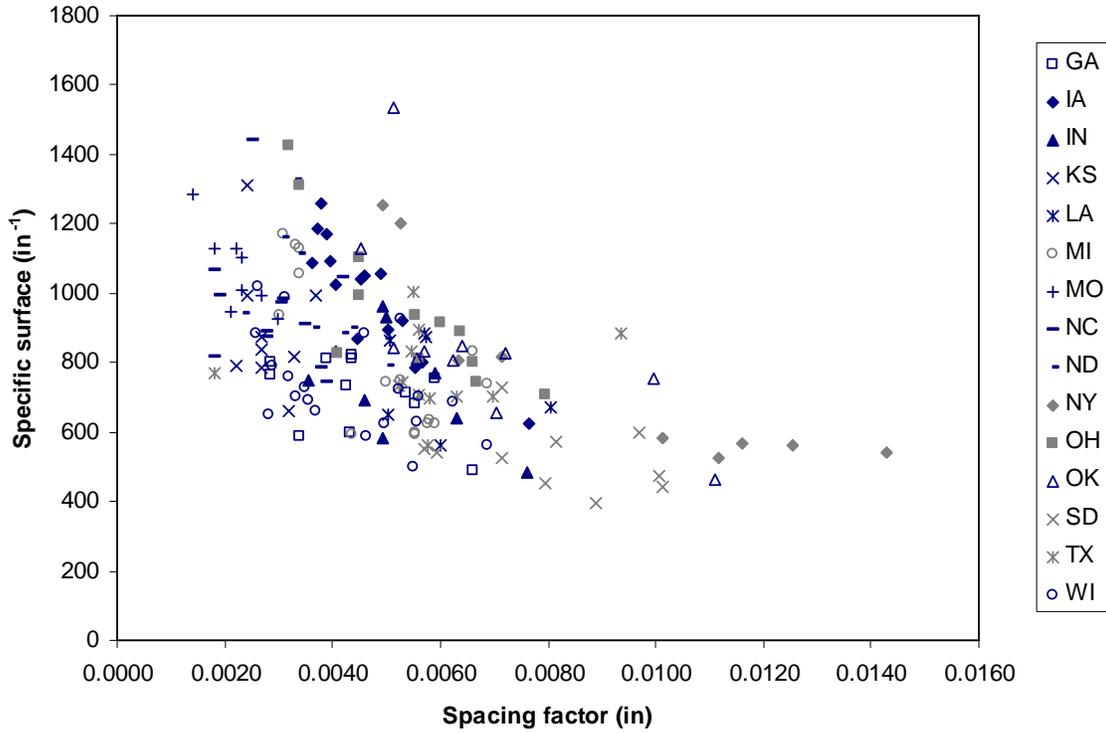
Figure 40. Specific Surface vs. Spacing Factor for the Rapid Air Results

rapid air spacing factor. Note that the AVA predicts a larger spacing factor than the rapid air test, which may explain why a sample may fail the AVA test but pass a rapid air or linear traverse test.

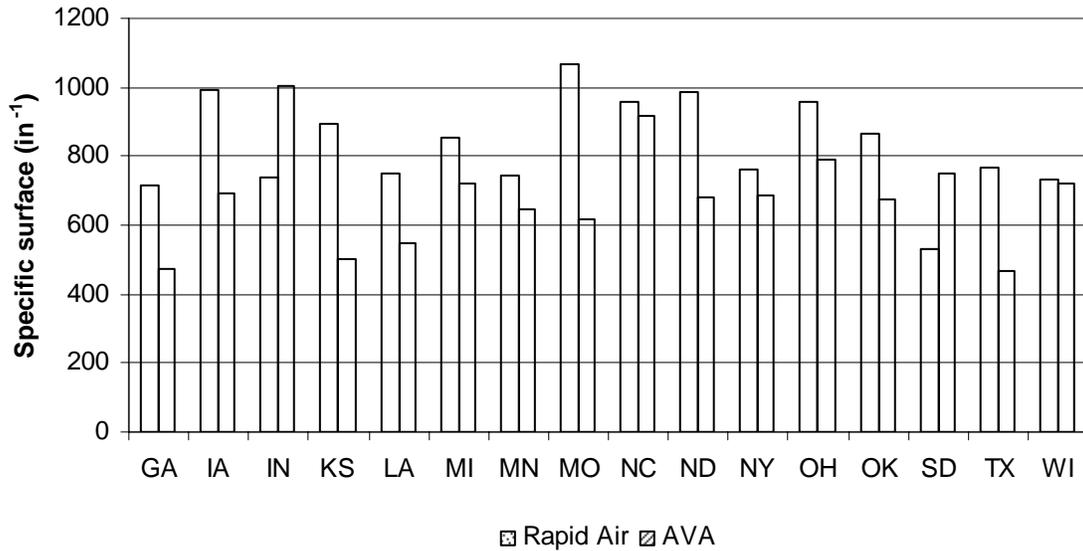
Figure 43. AVA and Rapid Air Specific Surface Comparison for Each State

For specific surface and spacing factor, Figures 43 and 44, respectively, show the relationship between the average AVA data and rapid air test data for each state. Note the tendency of the rapid air test to predict large specific surface values and the tendency of the AVA to predict increased spacing factors, thereby, the AVA results indicate a less durable concrete.

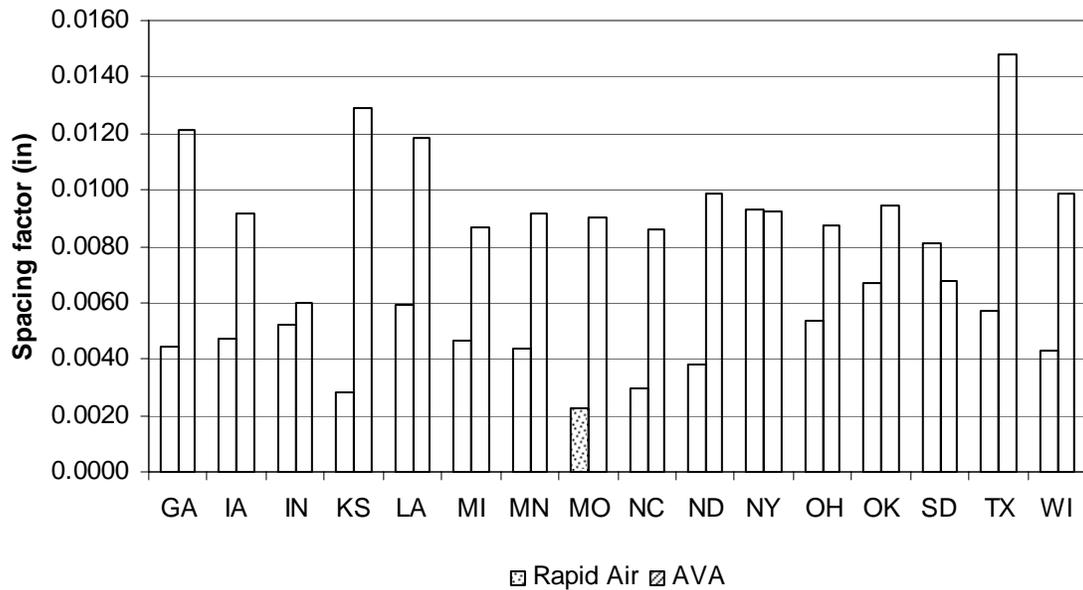
Figure 44. AVA and Rapid Air Spacing Factor Comparison for Each State

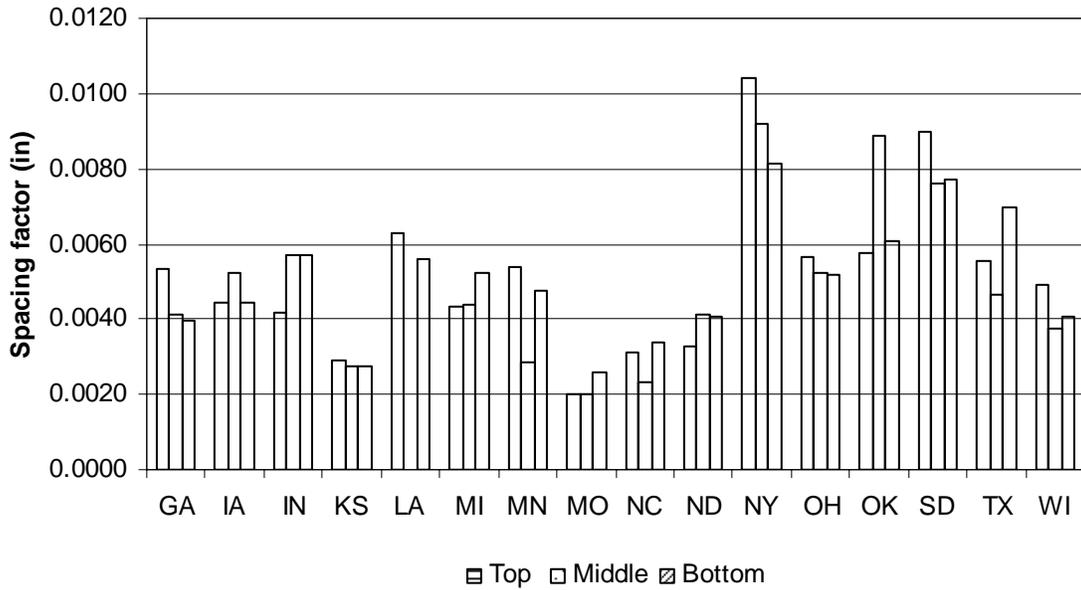
Figure 45. Rapid Air Specific Surface vs. Pavement Depth for Each State

specific surface from the top of the core to the bottom. This trend is expected because the top of the pavement is more directly subjected to the effects of vibration during paving. The authors note that although the spacing factor is increased near the surface, the concrete is still expected to be durable.

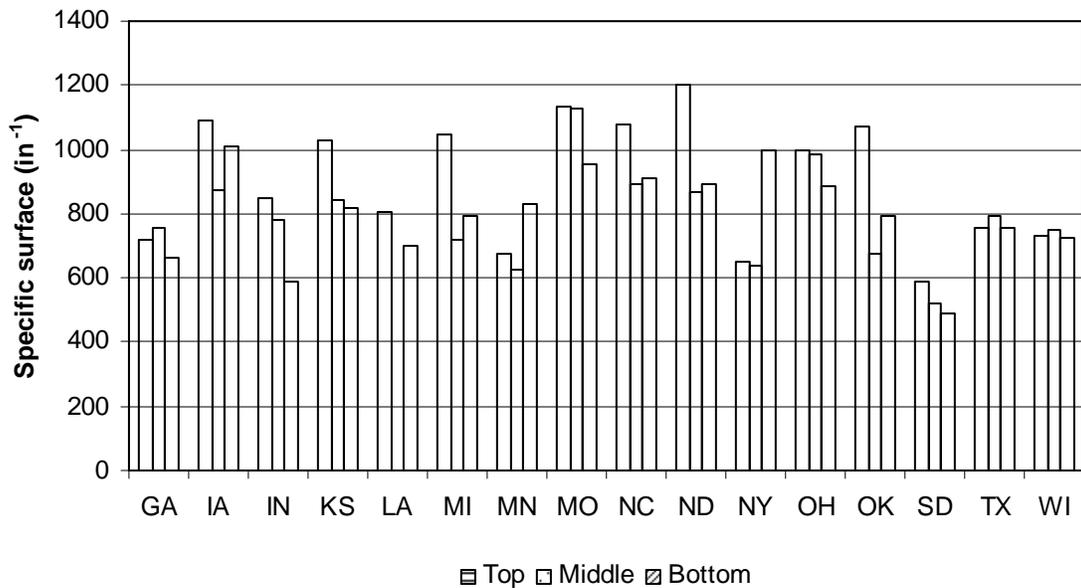
Figure 46. Rapid Air Spacing Factor vs. Pavement Depth for Each State

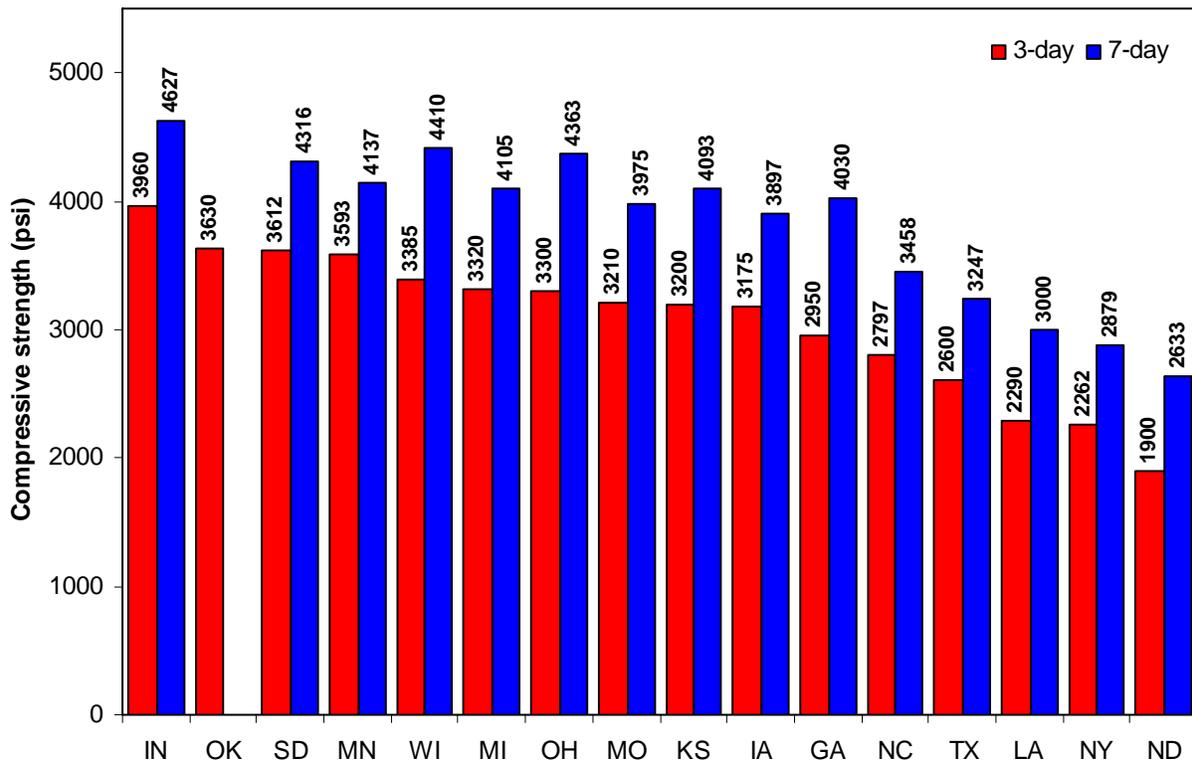
Figure 47. Average Three- and Seven-Day Compressive Strengths for Each State

Concrete compressive strength is generally used as an acceptance criterion for opening the roadway to traffic. Early-age compressive strength is important to contractors because it allows them to decide when to use the finished pavement as a haul road for construction traffic or when to allow lane shifts. Figure 29 shows the three- and seven-day compressive strengths for each state in order of three-day compressive strength. As noted in Appendix B.4, the strength requirement for opening the pavement to traffic was generally 3,000 psi. Nearly all concrete mixes for each state reached that milestone in seven days, with about 64% reaching 3,000 psi after three days.

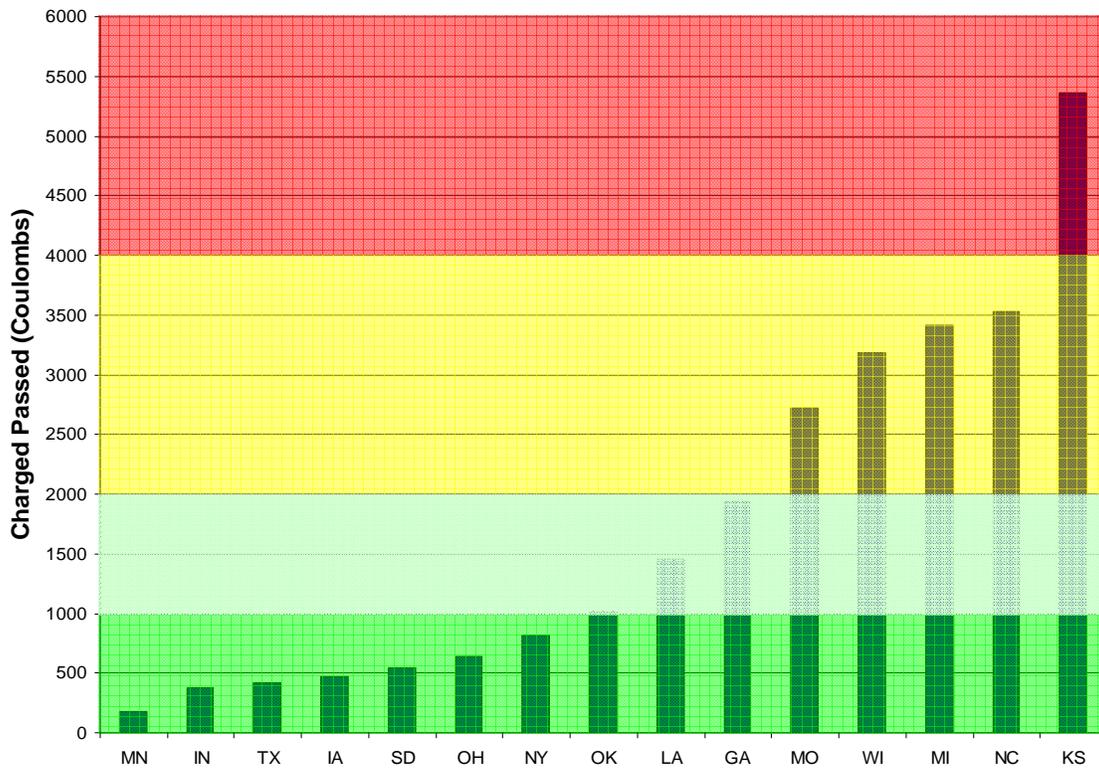
Figure 48. Rapid Chloride Permeability Results

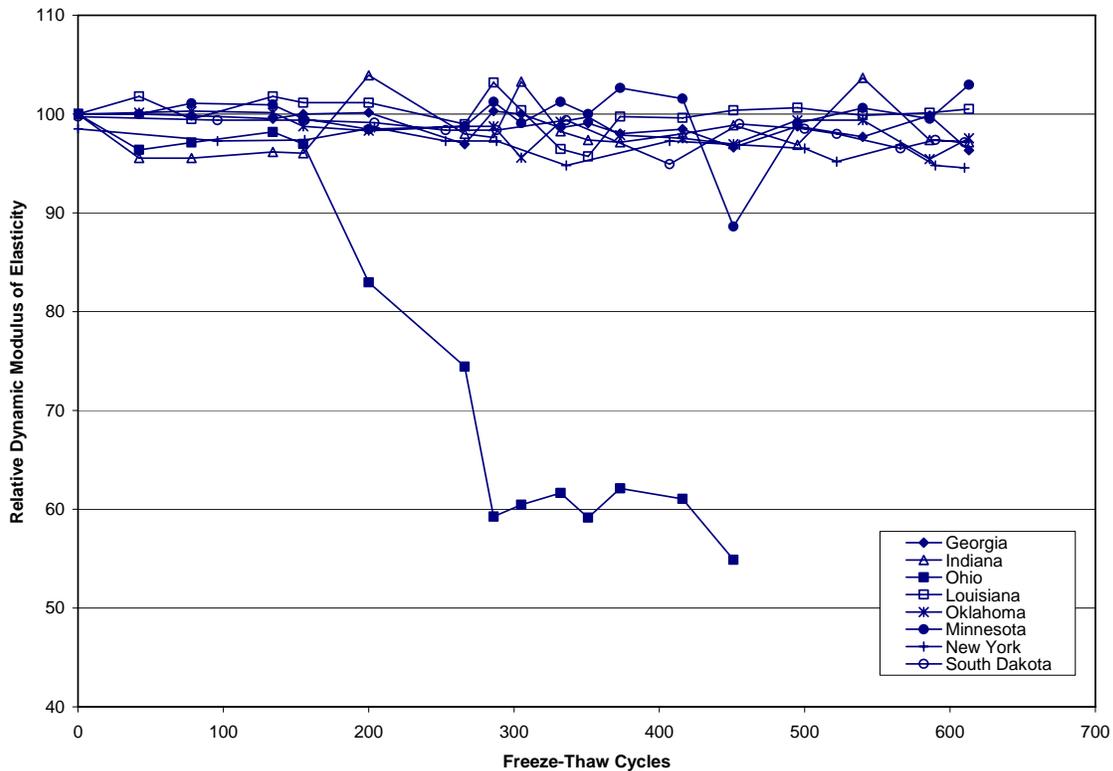
Figure 49. Freeze-Thaw Results for GA, OH, OK, IN, LA, MN, NY, and SD

The freeze-thaw test was used to correlate the spacing factor of fresh concrete to freeze-thaw durability. For the purposes of this study, the research team extracted a four-inch core from the pavement and placed it into the freeze-thaw tank. Note that the results, shown in Figure 49, represent only one sample from each of six states. The results indicate that the Ohio pavement may not perform as well as the others tested, but the freeze-thaw durability factor still exceeds failure criteria.

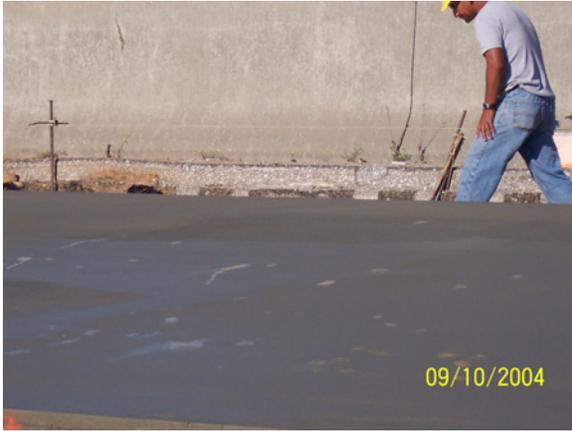
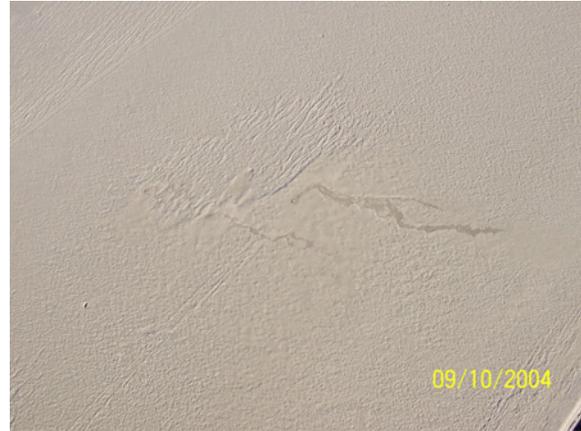
Figure C.5. Bleeding on the Slab Surface, Kansas Shadow Project

- Air content tested ahead of the paver during the demonstration ranged from 4.9% to 7.0%; the average air content of the 5 tests conducted was 5.9%. The lowest air test of 4.9% was observed on September 10, 2004, within the first 90 minutes of paving on the I-35 project. The research team observed bleeding on the slab surface while taking fresh concrete samples. Pictures of the bleeding are shown in Figure C.5.

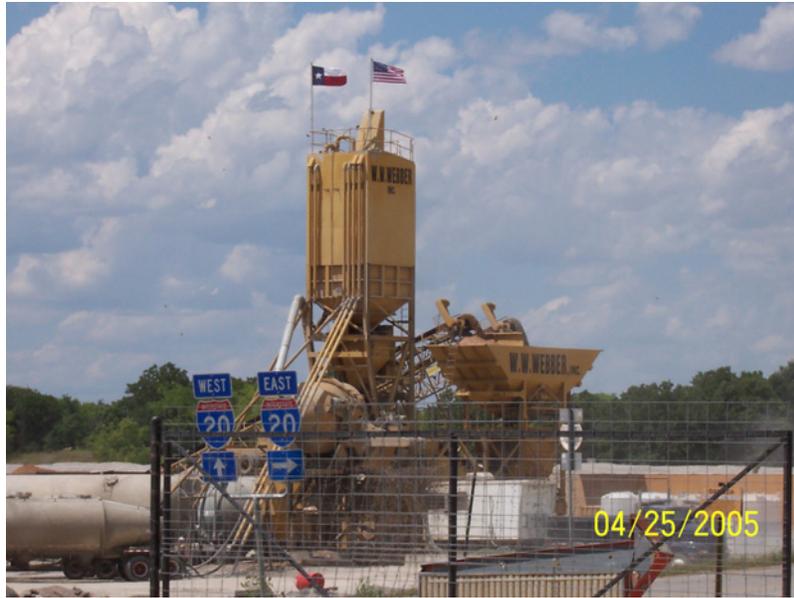
Figure C.14. Batch Plant near the Texas Shadow Project Site

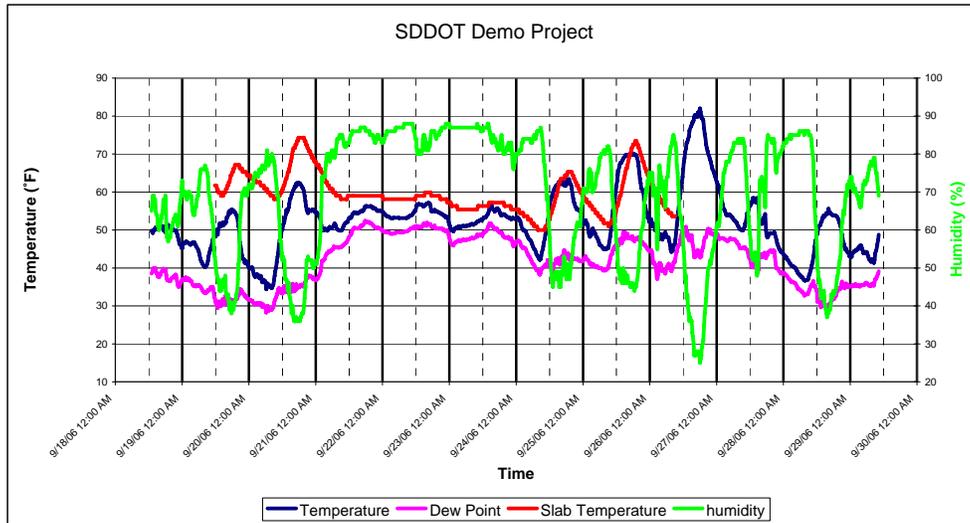
Figure C.19. Various Temperature Indicators for the South Dakota Shadow Project

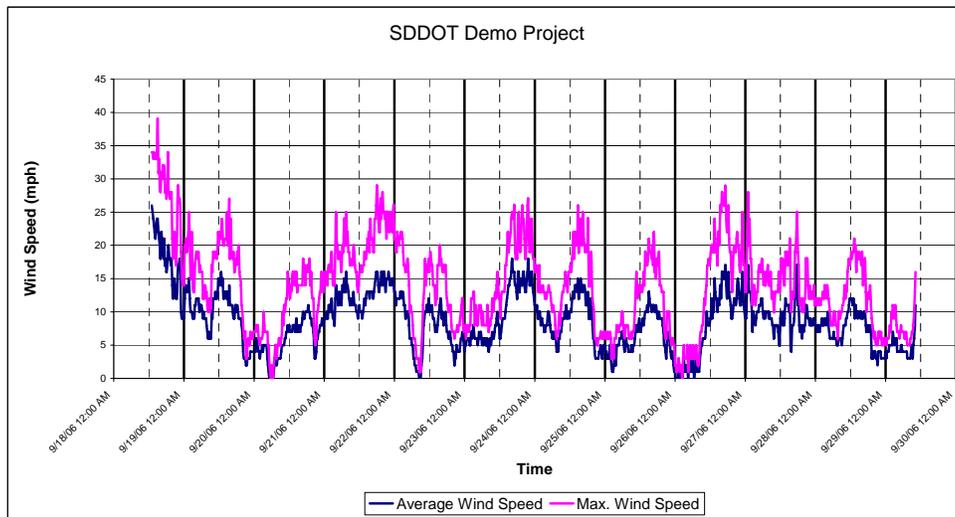
Figure C.20. Wind Speeds during the South Dakota Shadow Project

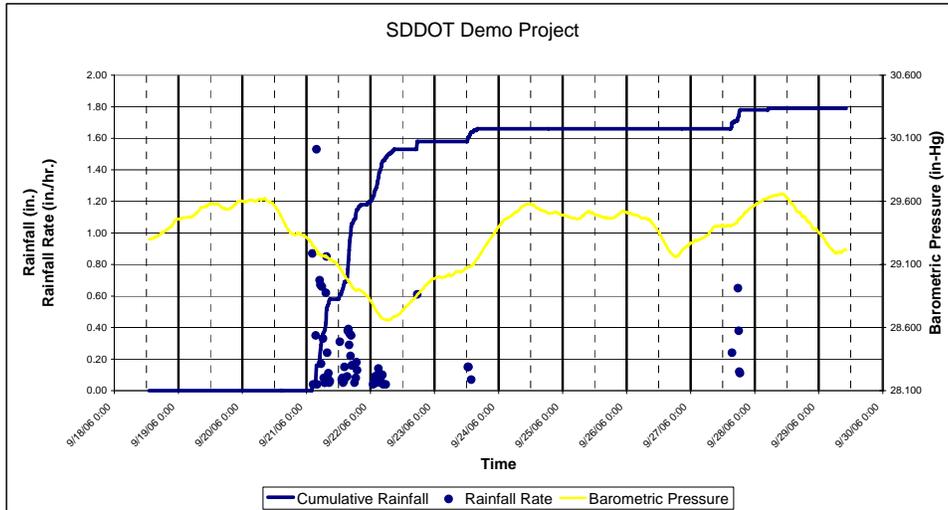
Figure C.21. Rainfall during the South Dakota Shadow Project

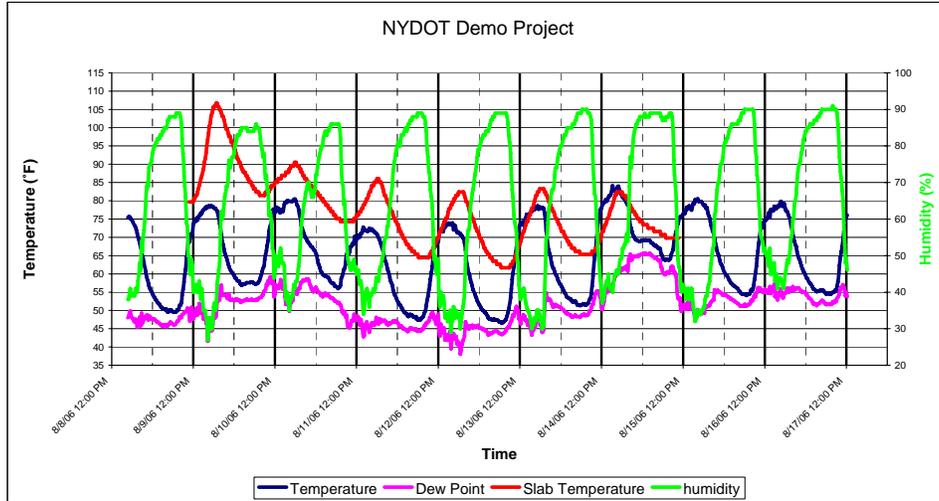
Figure C.23. Various Temperature Indicators for the New York Shadow Project

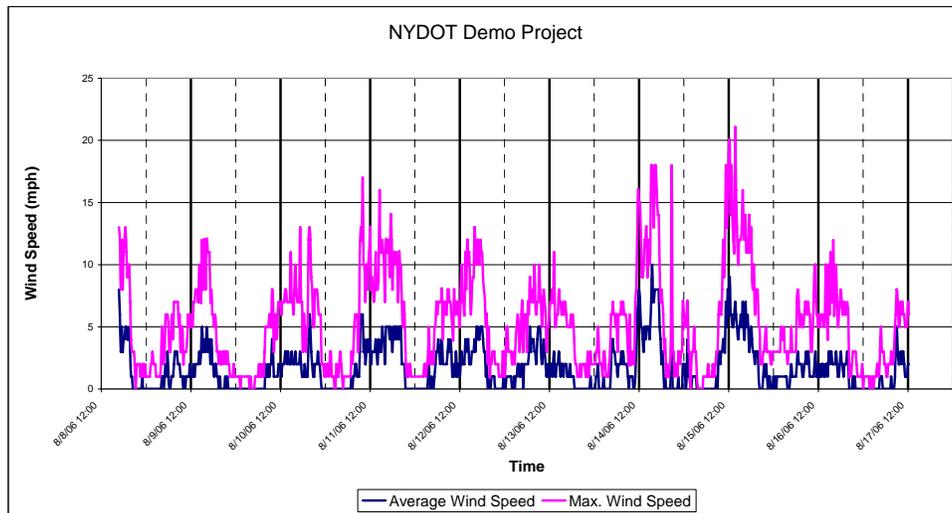
Figure C.24. Wind Speeds during the New York Shadow Project

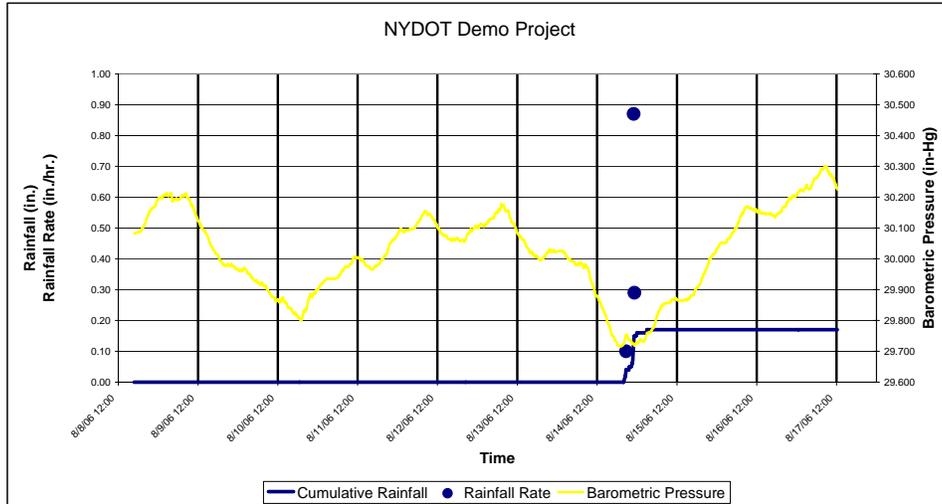
Figure C.25. Rainfall during the New York Shadow Project
