The Effectiveness of Iowa's Automated Red Light Running Enforcement Programs

Final Report
December 2007

Sponsored by
the Iowa Department of Transportation
(CTRE Project 05-226)

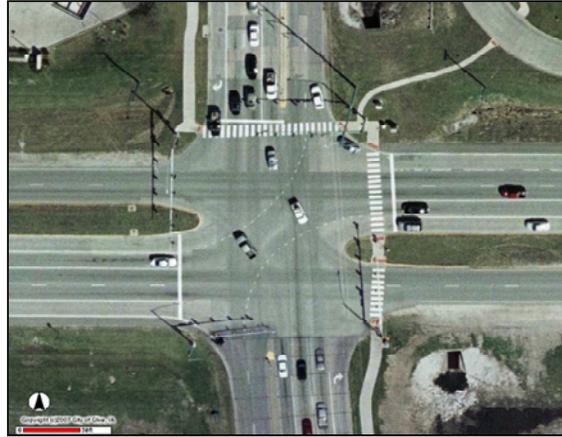
Aerial View of 100th St. & Hickman Rd.

Figure 3.12. Roadway, traffic, and signal timing characteristics for 100th St. & Hickman Rd.
