Clear Lake Watershed Storm Water Improvement Project (Phase 2)

Final Report

Watershed Name: Clear Lake Watershed

Grant Agreement Number: 7003-001

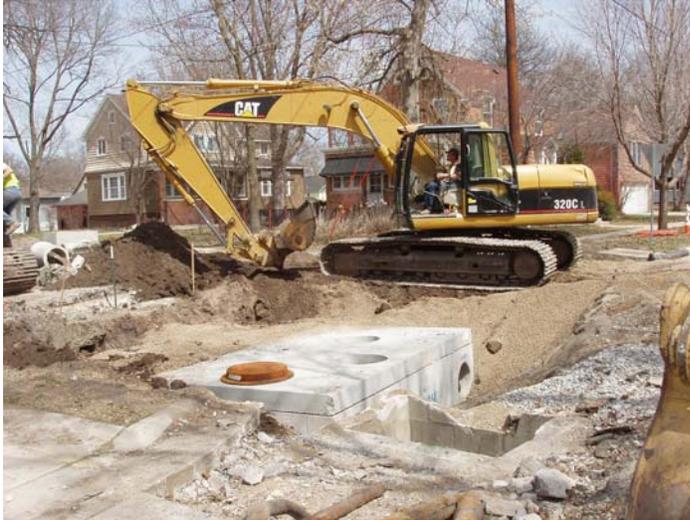
Grit Collection Chamber Installation

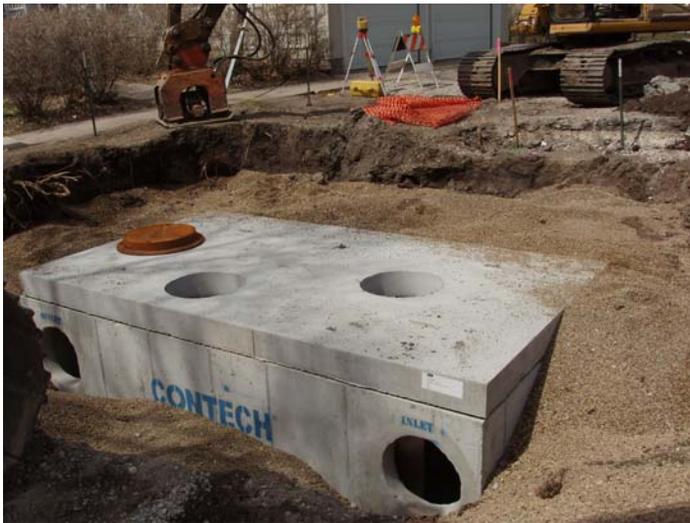
Grit Collection Chamber Installation
