FINAL REPORT
WIRB Matching Grant

Project # 6034-016

Lake Colchester/Middle Creek

**Lakewood Village Association &
Lakewood Benefited Recreational Lake District**

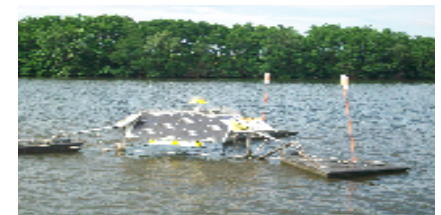
Lake Circulator Operational

- No blue-green or other algae growth have occurred since installation. Improved aesthetic appeal in improved water clarity and quality; improved recreational abilities such as swimming, fishing, boating; improved aquatic vegetation quantity and quality, and additional species and quantity of habitat are documented.

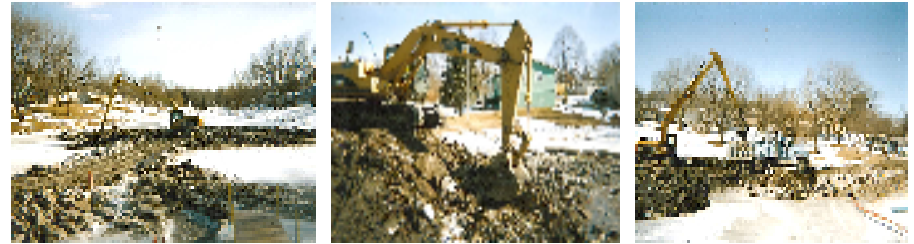
Finger Pond Excavation – February, 2009 @ ~1,300 CY

- Finger Pond - ~1,300 CY silt was removed in February, 2009 at a cost of \$36,000. Significant contributions (in addition to matching funder) were made in the amount \$10,000 by the LVA in order to accomplish additional silt removals from the Finger Pond inlet.

- Prior to excavation and removal of silt, a maximum of 3-6" depth of dark brown water existed. After excavation, this area is 4-5' depth. Since this is a major inlet to Lake Colchester, the excavation creates mitigation site for future silt deposits which can more easily be accessed and removed.

- Budget estimates fell short of actual costs of excavation construction. In the Finger Pond excavation, the difficult location (within a neighborhood setting) presented access and egress challenges and liabilities for heavy construction equipment. As well, spoil site distance was costly. Contractors recommended a winter project to freeze the silt (after draining the pond.) Attempts to drain the pond were ineffective due to upstream run-off.

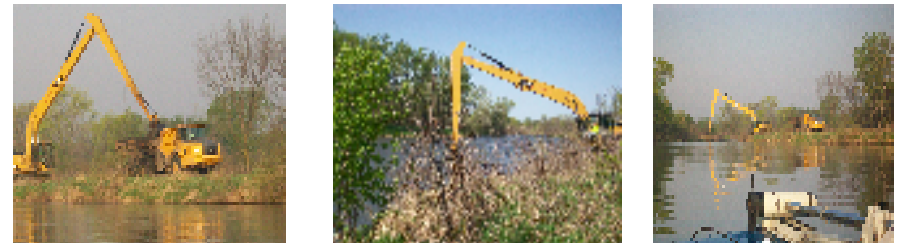
West End/North Shore Excavation – April/May, 2010 @ ~6,174 CY

- West End/North Shore Inlet ~6,174 CY silt was excavated in April/May 2010 Cost: \$168,000 – along 2,000 feet of shoreline – increased from 3-6" depth to 5 ft depth.

- Creation of a 20 yard bank slope was created after construction (excavation) for a future aquatic plantings site.
- Site restoration included natural re-seeding of 10 acres along the shoreline area; and shoreline was re-stabilized.

- The West End (North Shore) project also required a haul road to be constructed in order to access the DNR-permitted spoil site. This, along with required site restoration and engineering costs for the project, represented an unforeseen, significant portion of the cost of the project.

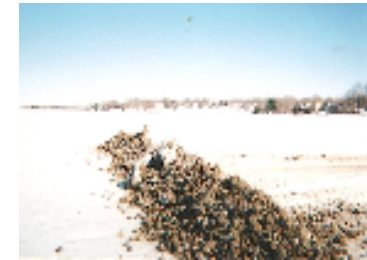
12 Trees Cut @ N Shoreline

- Over 90 custom built structures and/or natural structures were placed in Lake Colchester over the course of the three-year project to create
- Natural structures included cutting and placing 12 trees along the north shoreline and in various coves. A 17 ton river rock structure was placed off a popular shoreline and boat fishing location – Gazebo Point.

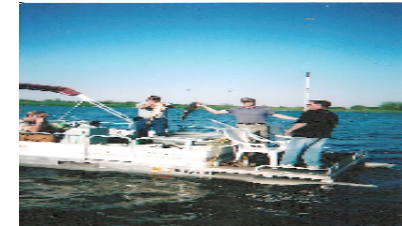
Fish Shocking/Removal

- Removed 11,112 total pounds: 5,190 lbs. Catfish; 4,437 lbs. carp, and 1,485 lbs. shad.
- Variety of Methods Used: Feeders, Nets, Traps, bow/arrow; traditional rod & reels, shocking. Bow and arrow, cast netting and shocking were most effective methods of removal.

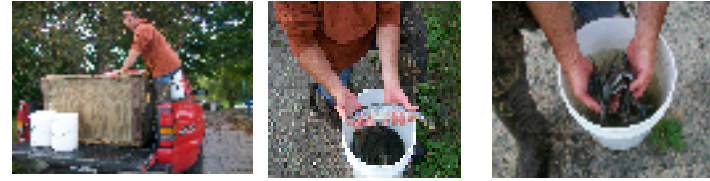
Delivery and Stocking of Predatory Fish Species

- "Catch & Release" regulations were implemented and enforced.
- Ideal time for stocking is typically later in the year. Survival is greatly improved by investing in larger fish. Fishing reports, winter severity, and other conditions were utilized to determine species, size and quantities to order..

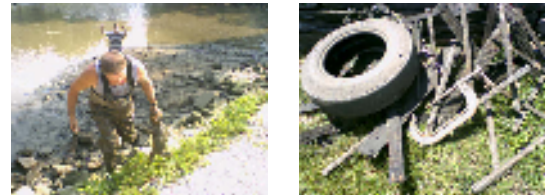
Volunteers' Clean-up 5 Acre Park Watershed Area

- In addition to paid staff efforts, volunteers worked more than 2,500 hours during the three year project to clean-up watershed areas, prepare shoreline areas for aquatic plantings, remove large debris from the lake and inlet areas (see photo.) from the damage. Volunteers also conducted silt analysis and water quality measurements, provide GPS locations, mapping, and many other project-related activities in order maximize the overall success of the project. Additionally, Watershed Committee members met bi-weekly during the project to make vital decisions and monitor all aspects of the project.

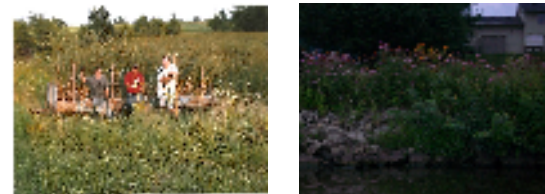
Shoreline Restorations
West End & Beardsley Inlets

- Severely eroded and sougled areas of shoreline were graded and restored with aquatic vegetation where possible. Restoration/re-seeding of construction sites (excavation of silt) was required in contracts.
