Laboratory Investigation of Bridge Strip Seal Joint Termination Details

Final Report
February 2016

IOWA STATE UNIVERSITY
Institute for Transportation

Sponsored by
Federal Highway Administration
Iowa Department of Transportation
(InTrans Project 14-302)

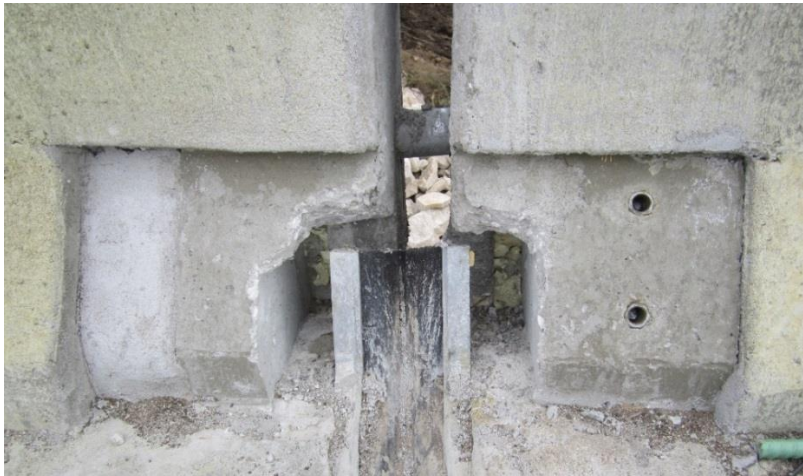
Figure 5. Field construction of termination detail

To date, most post-construction issues arise from the blackout detail and how it is often constructed. Typical construction practice for creating the strip seal termination blackout is to leave a void in the barrier rail around and behind the strip seal turn-up (Figure 5) when the barrier rail is cast; the contractor then comes back and hand forms/packs the area behind the turn-up with concrete to accommodate the complex geometries present in the area.

Field inspections have found that the poor performance of the current Iowa DOT termination detail often stems from the fact that the blackout region around the strip seal turn-up is not fabricated with the best construction methods and/or quality control practices. Often, a larger than necessary void in the barrier rail is left around and behind the strip seal turn-up during barrier rail construction, and the void is later filled by hand packing concrete into it.

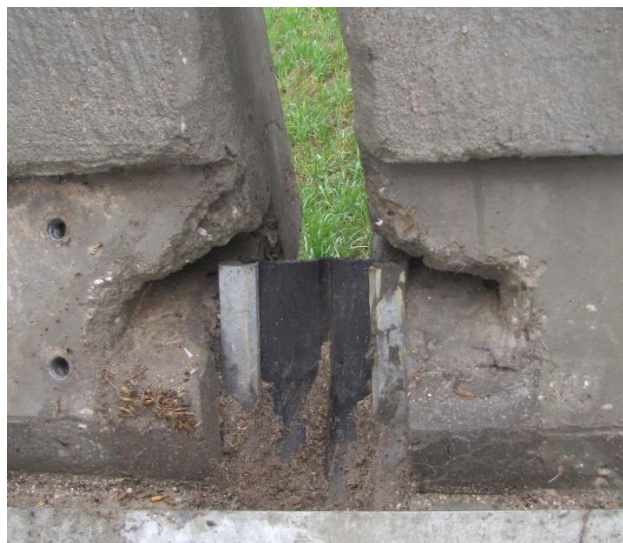
Figure 6. Finished construction of termination detail

Not only is this process cumbersome, but the resulting finish is often less than ideal (Figure 6).

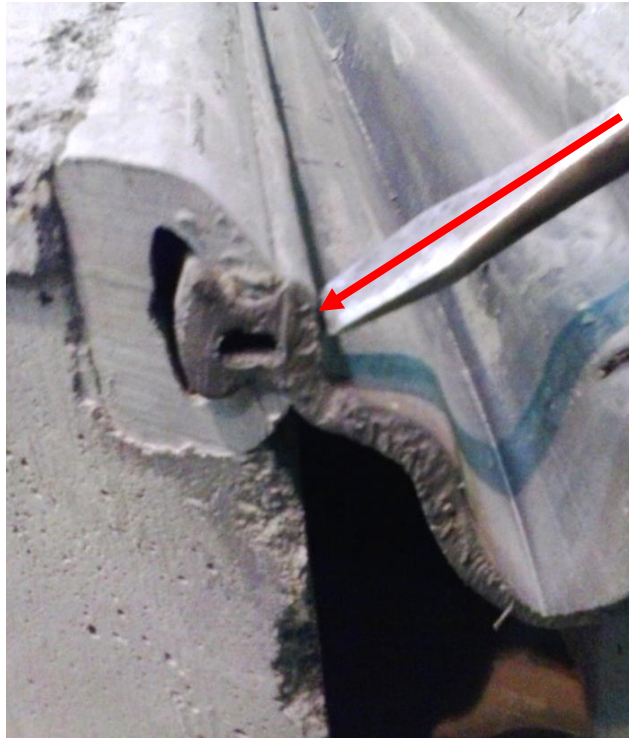
Figure 18. D.S. Brown strip seal

A cross-section of the D.S. Brown strip seal gland and extrusion is shown in Figure 18.

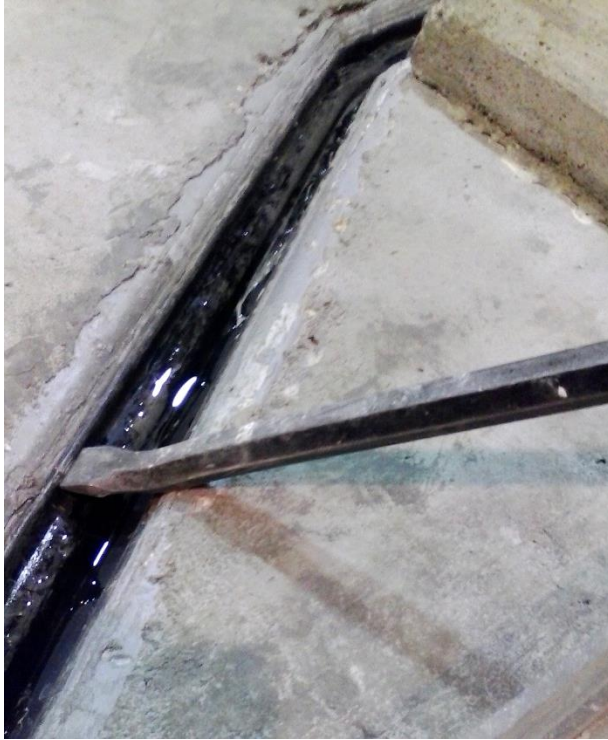
Figure 19. D.S. Brown gland installation

The technique used for installing the gland is shown in Figure 19, where the crowbar pries against the opposite face of the extrusion, pressing the gland into the extrusion, inch-by-inch along the length of the extrusion.

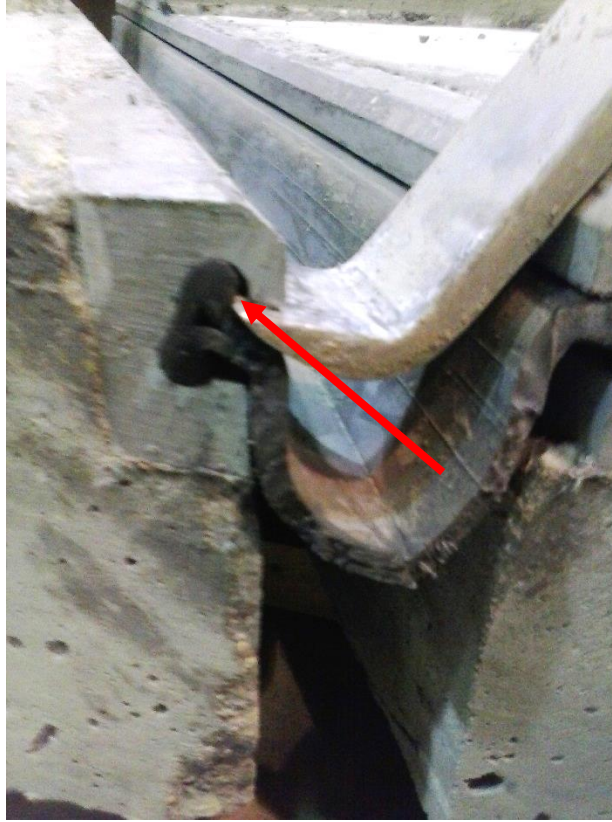
Figure 20. Watson Bowman Acme strip seal

The Watson Bowman Acme strip seal product is shown in Figure 20.

The direction of force, which is referred to as the lifting force, required to install the gland is shown with the arrow in the figure. For this strip seal, a special tool with a bent and tapered end, provided by the manufacturer, is used to install the lug of the gland into the extrusion (Figure 21).

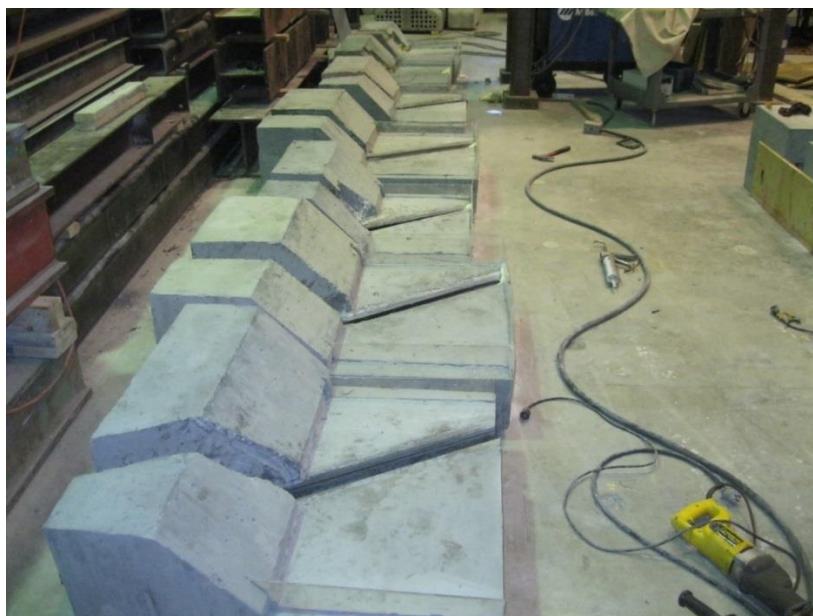
Figure 28. Laboratory specimens for testing

For each design alternative, two lab specimens were constructed, one using the D.S. Brown strip seal and the other using the Watson Bowman Acme strip seal. Figure 28 shows the cluster of laboratory specimens before testing.

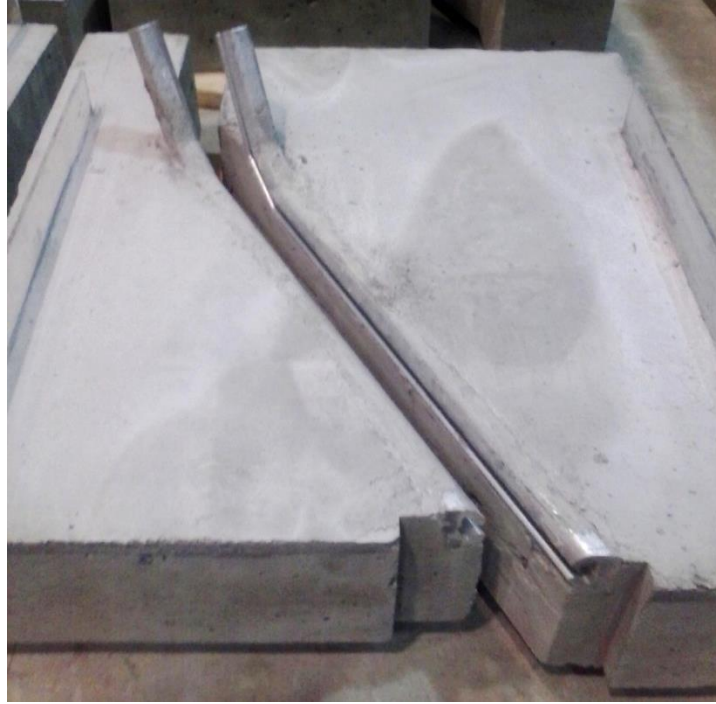
Figure 29. Strip seal construction before barrier rail placement

Construction of the turn-up detail began with erecting the deck formwork and duct taping over the cavity on the metal extrusion to ensure concrete would not fill or contaminate the cavity during the concrete pour. Next, the metal extrusions were attached to the deck formwork and the concrete was poured and finished with a trowel (Figure 29).

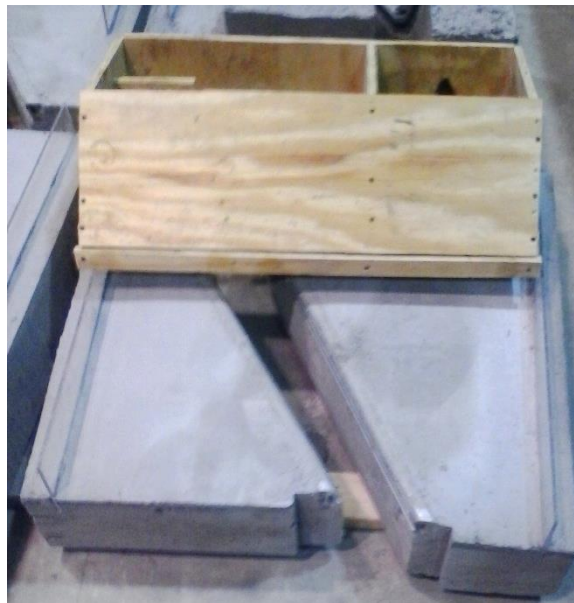
Figure 30. Barrier rail formwork

Next, the barrier rail was constructed around the turn-up portion of the extrusion, formwork was erected (Figure 30), and the blockout area, which facilitates gland installation, was created.

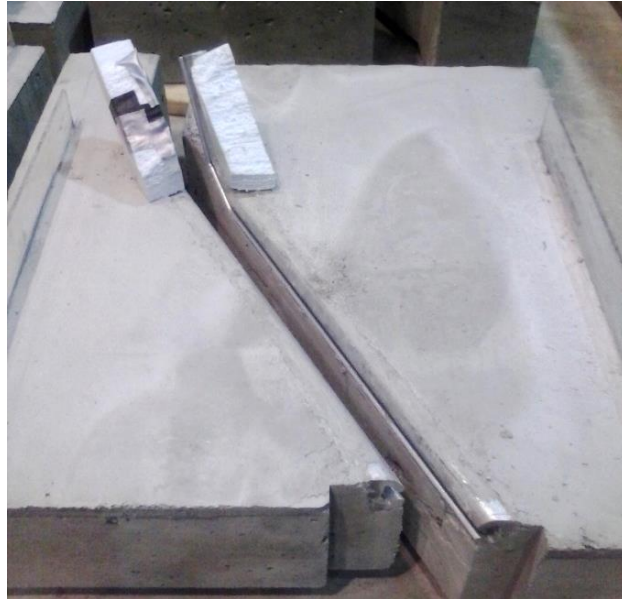
Figure 31. Blue insulation board used for blackout

To thoroughly investigate creation of the blackout, two methods of creation were tested. The first method used blue insulation board, which was cut to the rough shape and placed in front of the extrusions (Figure 31).

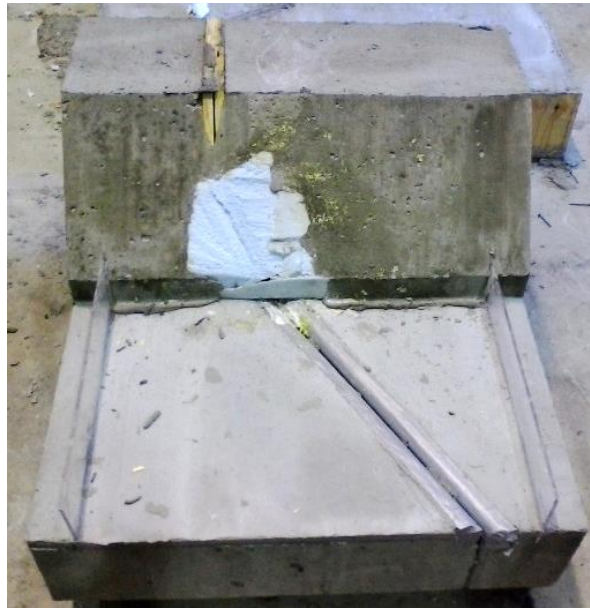
Figure 32. Completed blackout area using insulation board

Additional slivers and scrap pieces of the board were then used to detail the rest of the blackout area (Figure 32).

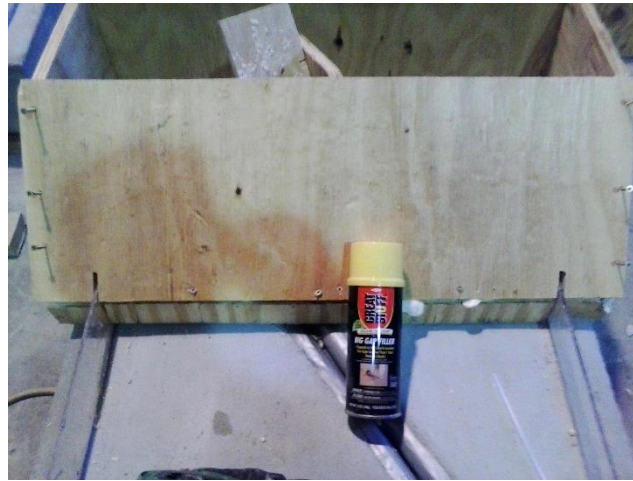
Figure 33. Expanding foam in a can

The second option investigated for creating the blockout area was spray foam from a can. The foam was sprayed into a closed void the shape of the blockout and left to cure overnight (Figure 33).

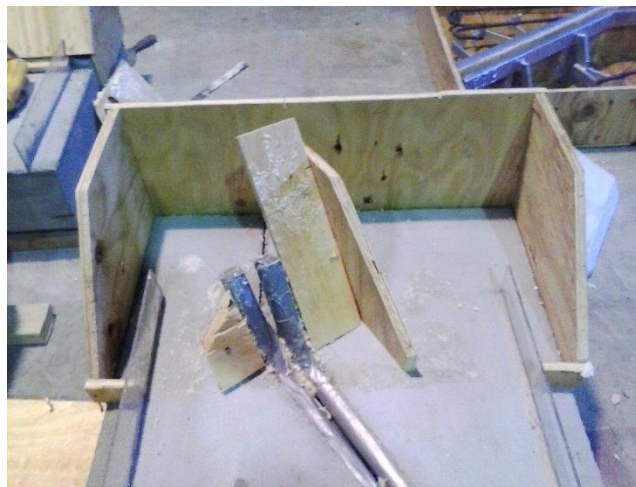
Figure 34. Plywood used to create foam enclosure

The spray foam bonded to the plywood used in creating the blockout area (Figure 34), which then tore the foam open when removed.

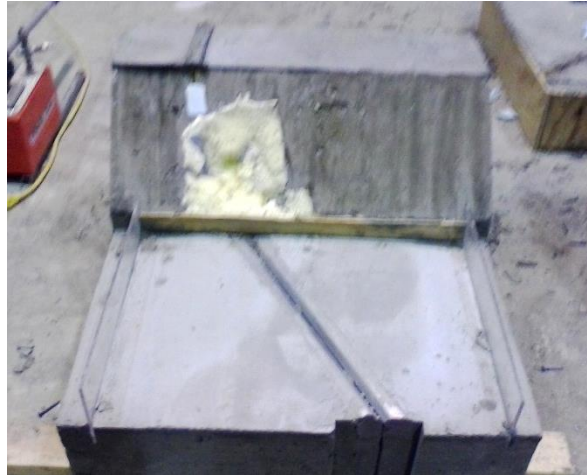
Figure 35. Barrier rail with spray foam

A second can was used to spray another lift of foam and, once cured, was trimmed to the desired shape of the blockout; then the concrete barrier rail was poured (Figure 35).

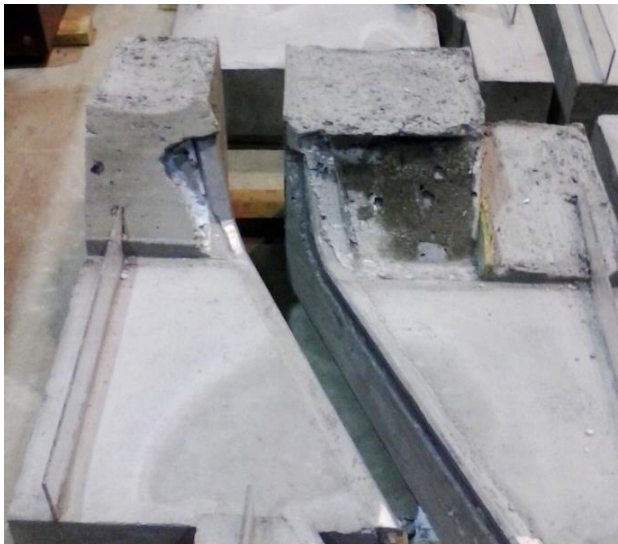
The deck pour encapsulation method is an alternate construction sequence to build the current Iowa termination detail. This method encapsulates the turn-up portion of the strip seal with concrete at the same time the deck is poured (Figures 38 and 39).

Figure 38. Turn-up portion of the strip seal with foam encapsulated in concrete at the same time the deck was poured

Figure 39. Turn-up portion of the strip seal encapsulated in concrete at the same time the deck was poured

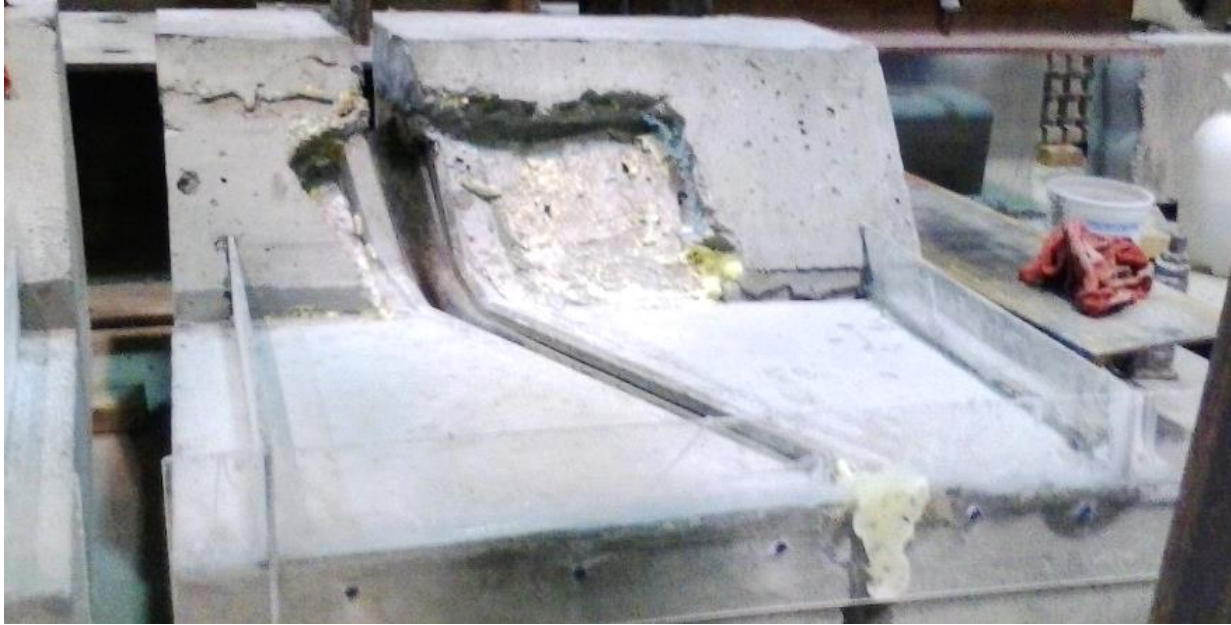
Figure 40. Completed barrier rail

This modified sequence allows the full barrier rail to be cast over the top of the strip seal and resulting encapsulation in one step (Figure 40), whether the rail is slip formed or formed by hand.

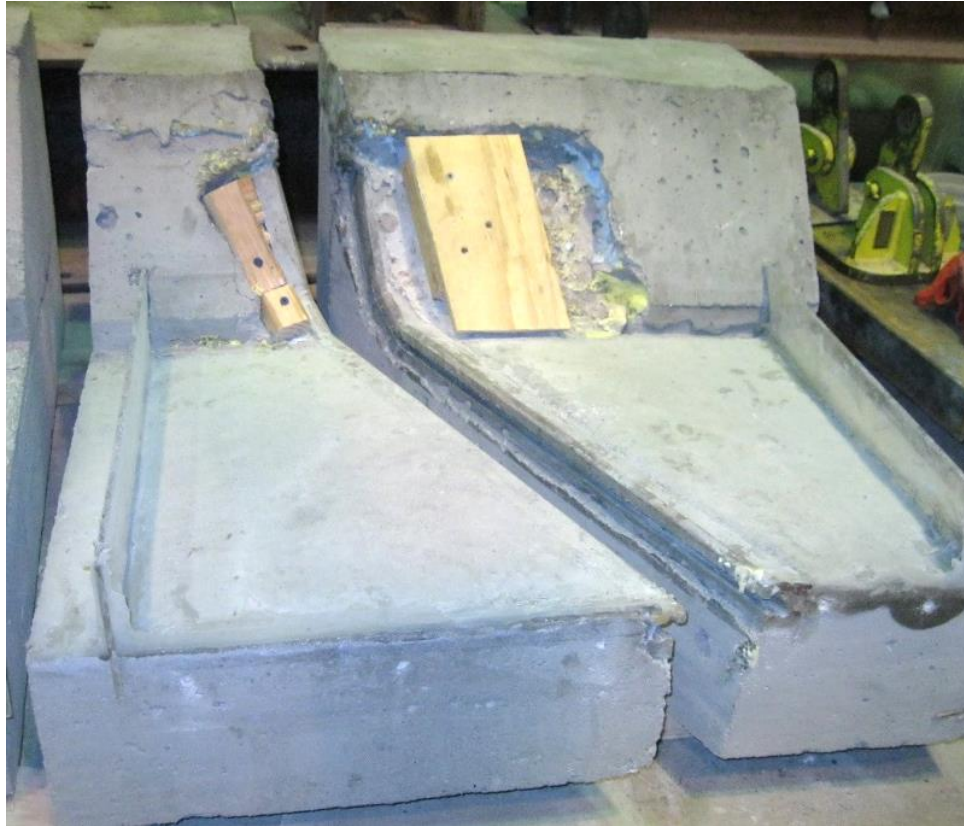
To test this idea, wood was attached in the blackout area to reduce the size of the working room, only leaving room directly in front of the extrusions (Figure 42).

Figure 42. Wood attached in the blackout area to reduce the size of the working room, only leaving room directly in front of the extrusions

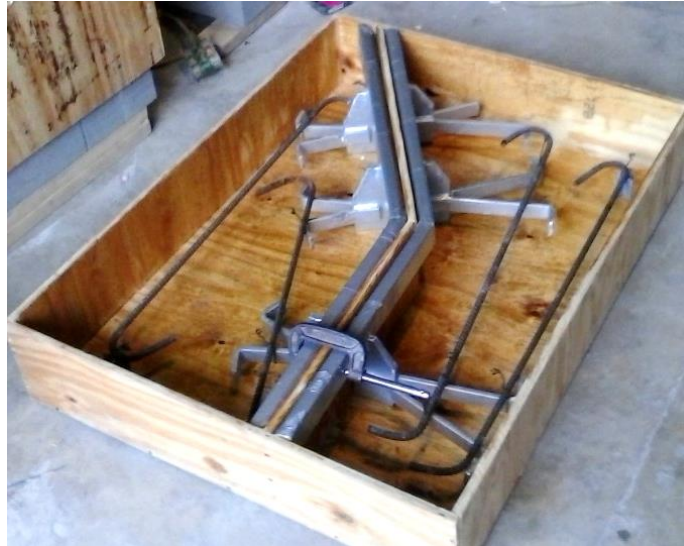
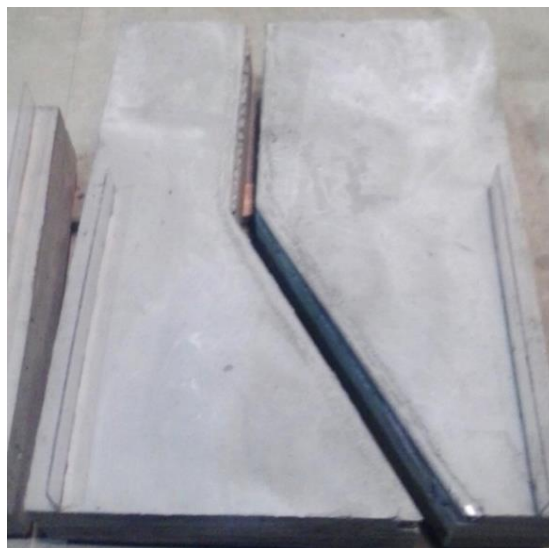
Construction of the straight-through and dogleg specimens began with forming and pouring the concrete deck (Figures 43 and 44).

Figure 43. Deck formwork for straight-through and dogleg specimens

Figure 44. Finished concrete deck for straight-through and dogleg specimens

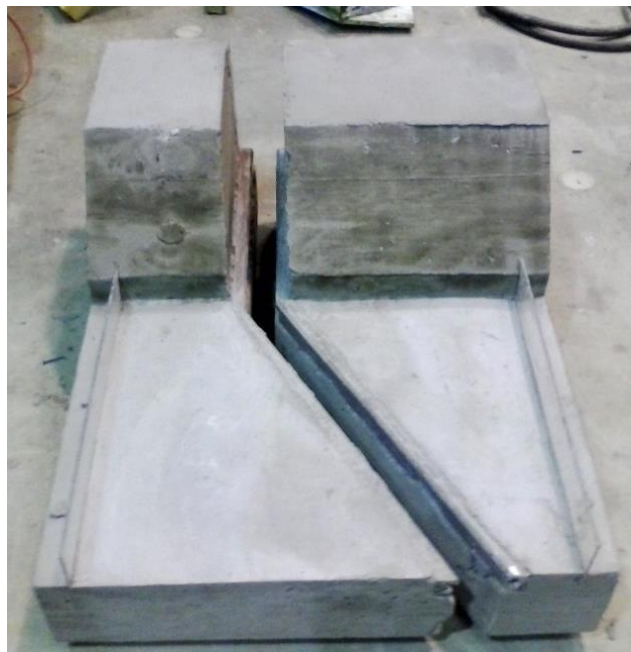
Figure 46. Finished barrier rail for straight-through and dogleg detail

Using a hammer and putty knife, the insulation board was removed from the rail with ease (Figure 46).

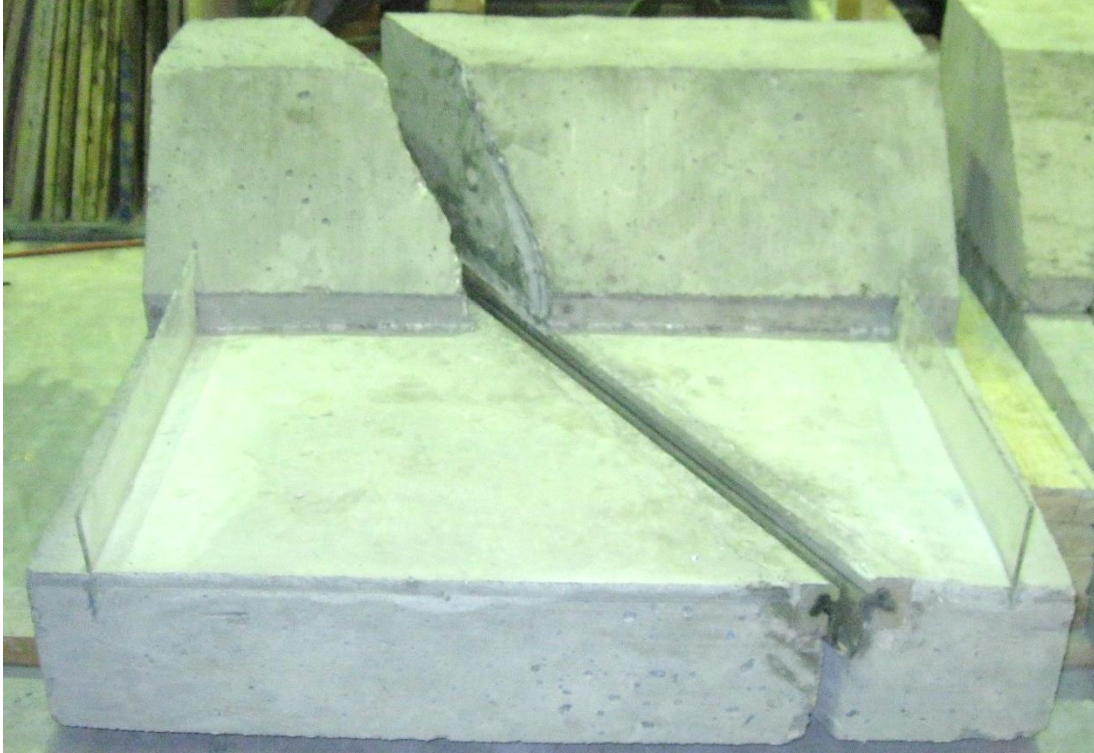
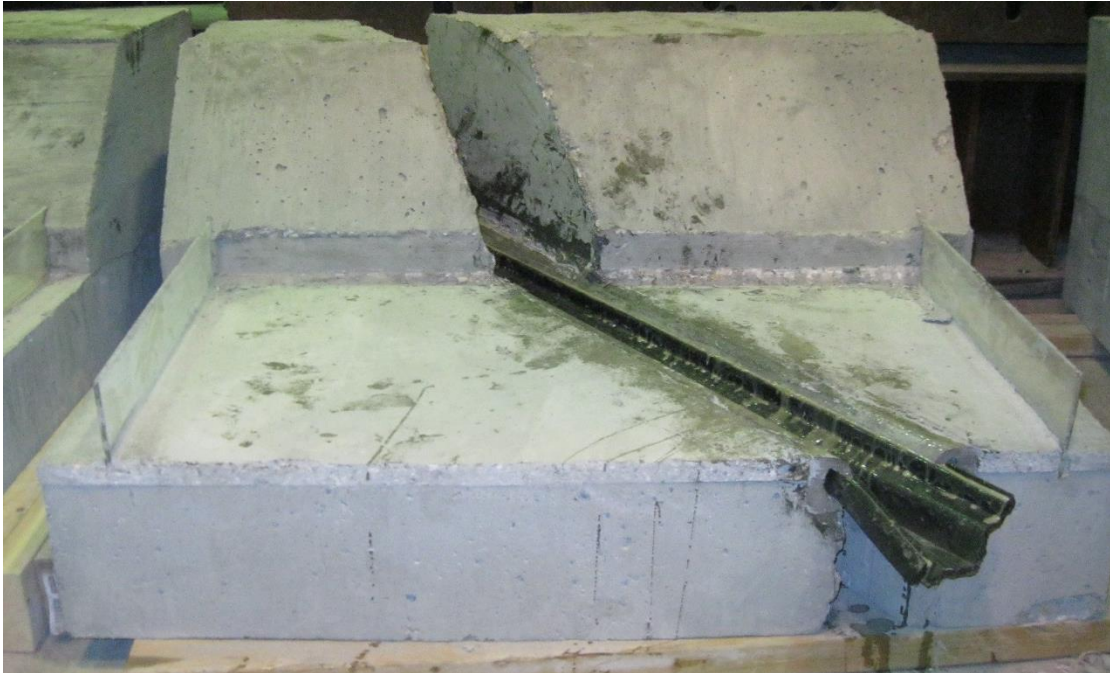
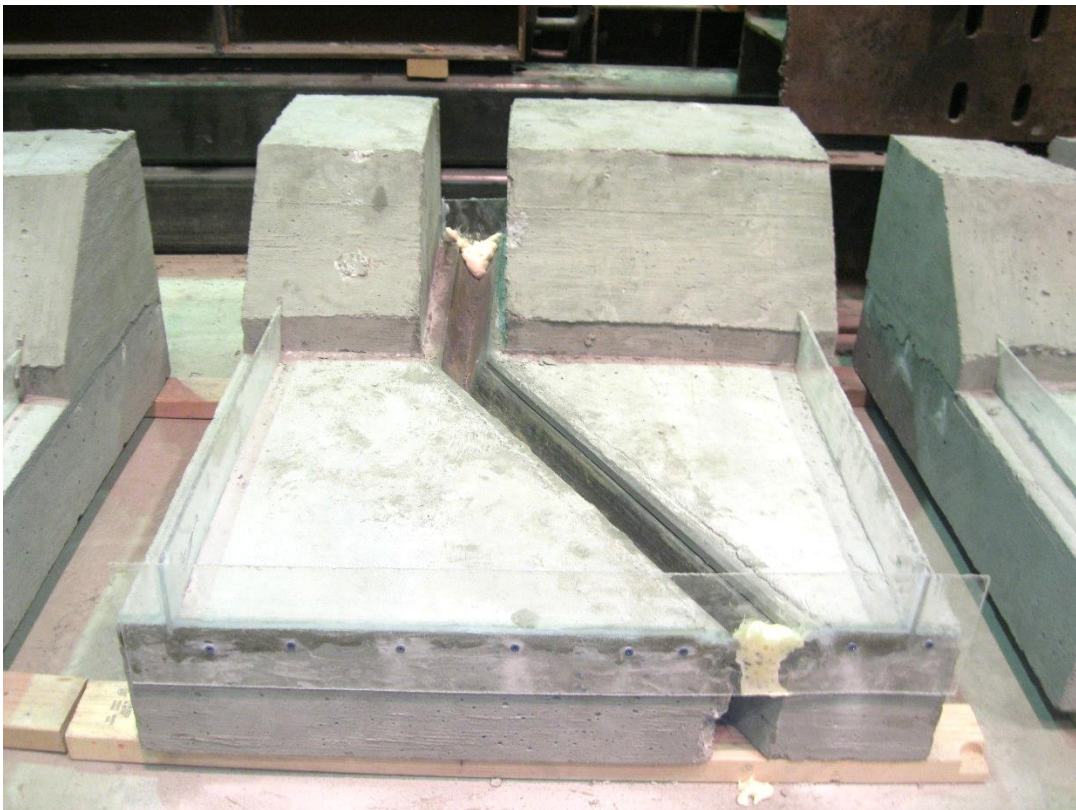
The researchers constructed four straight-through and dogleg specimens in the laboratory (Figures 47 through 50).

Figure 47. Straight-through termination specimen using Watson Bowman Acme seal

Figure 48. Straight-through termination specimen using D.S. Brown seal

Figure 49. Straight-through dogleg termination specimen using Watson Bowman Acme seal

Figure 50. Straight-through dogleg termination specimen using D.S. Brown seal

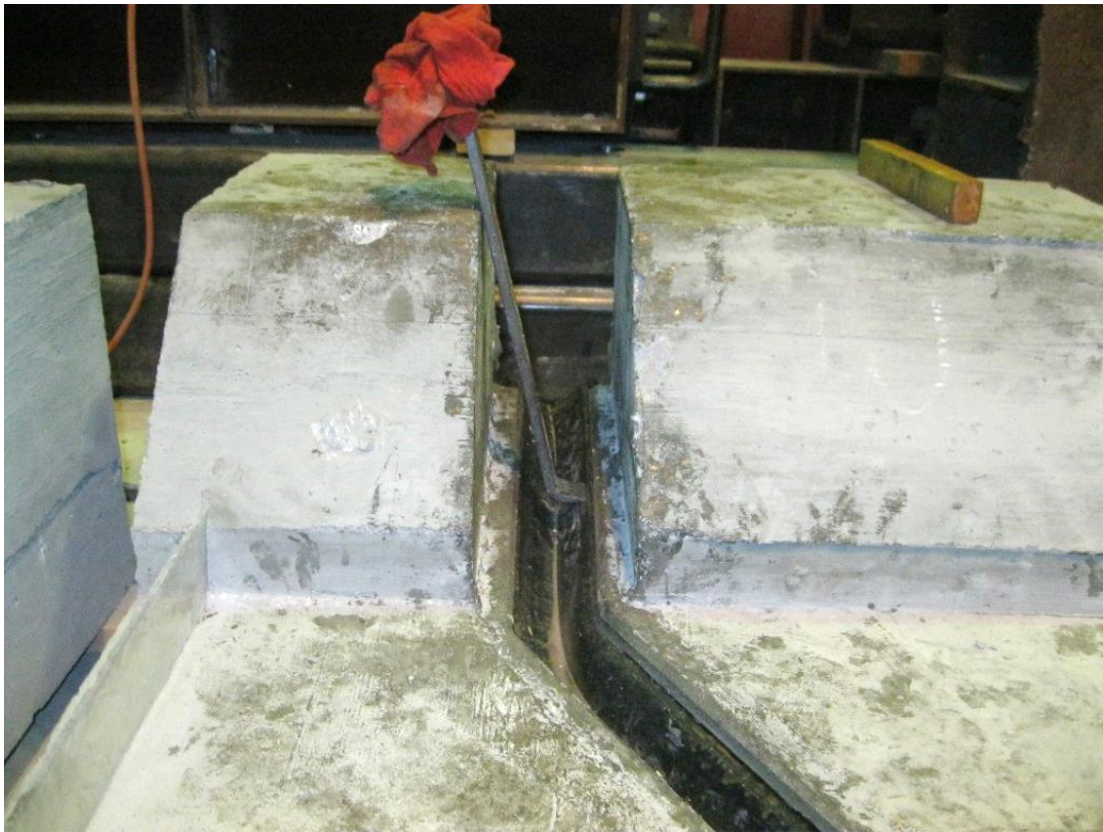
Figure 51. Watson Bowman Acme gland installation tool limited by mid-height barrier rail

During investigation and design of these details, concerns were expressed related to two key areas: the amount of working room between the barrier rails once fully cast to facilitate installation/repair of the strip seal gland and control of runoff water passing between the barrier rails and off the end of the gland.

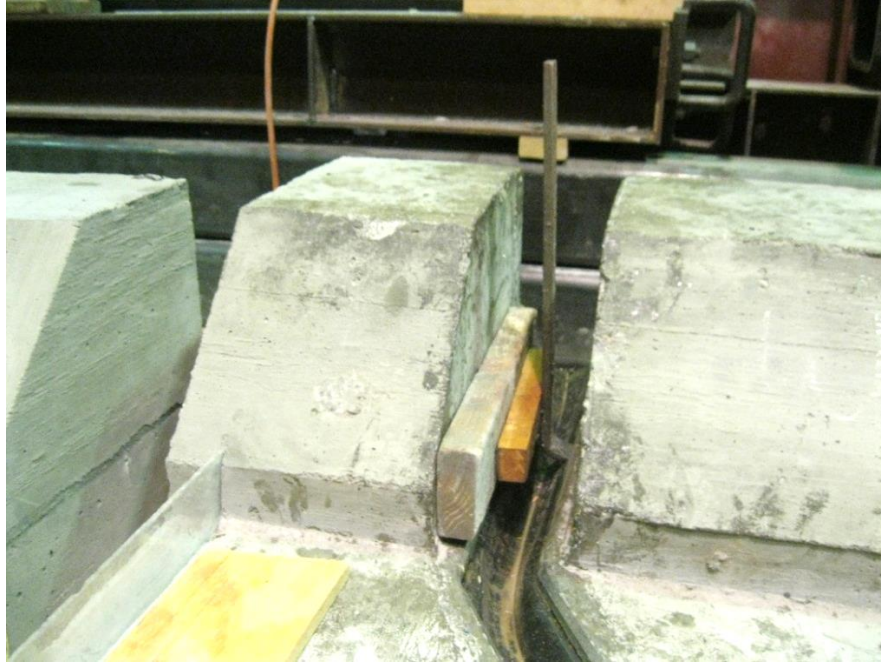
Figure 52. Wood blocking used between mid-height barrier rails with Watson Bowman Acme gland installation tool

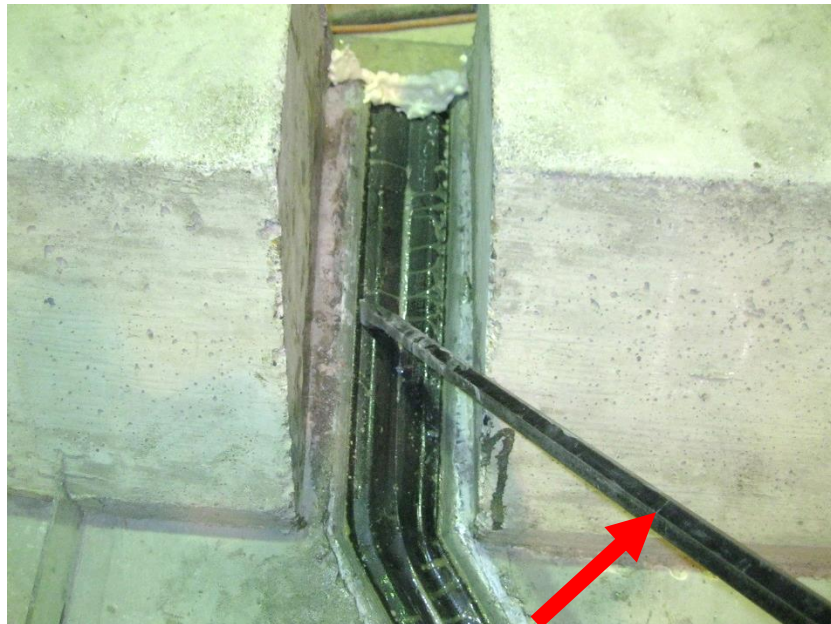
Figure 53. Use of a crowbar to install D.S. Brown gland

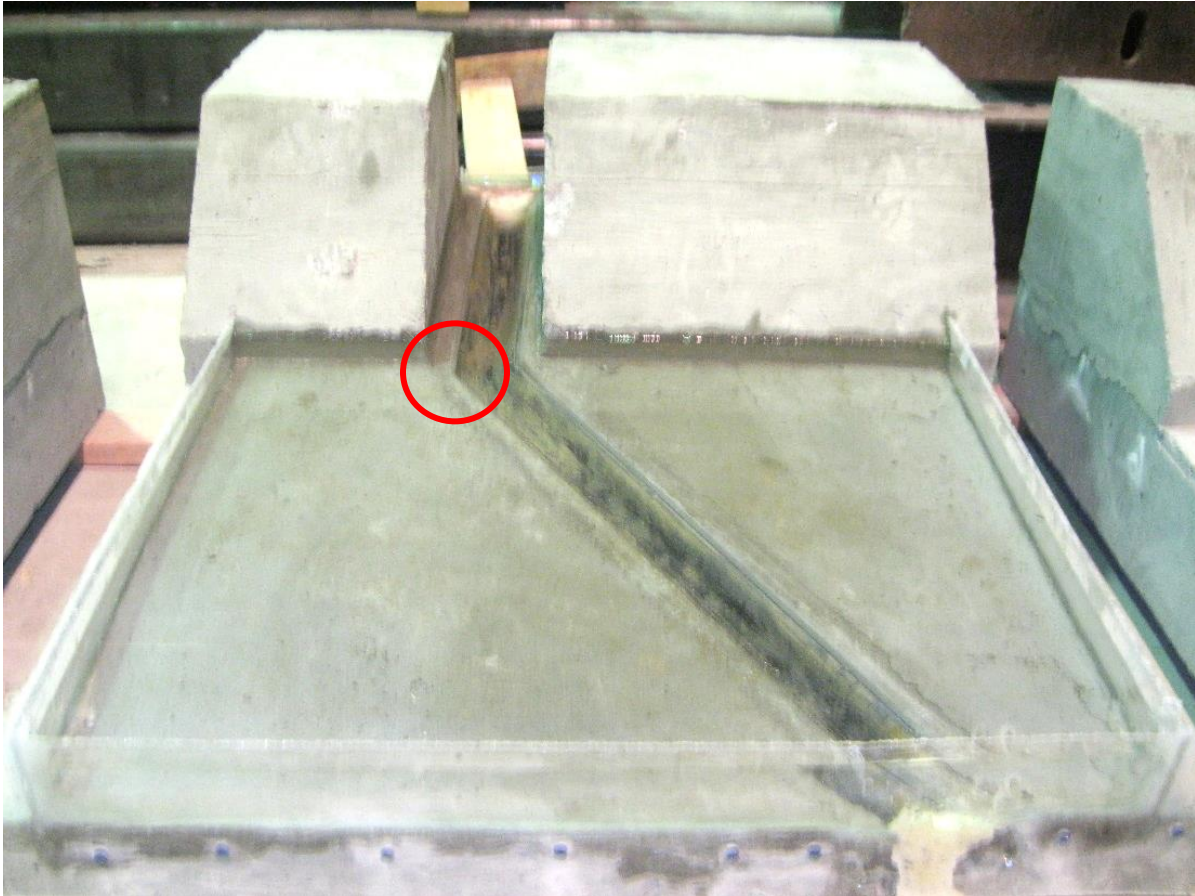
Figure 54. Watson Bowman Acme dogleg specimen with leaking gland

In the laboratory, the Watson Bowman strip seal straight-through detail passed the ponding test, while the Watson Bowman dogleg detail did not. The dogleg detail did not pass any of the ponding tests performed after multiple attempts to install the gland properly. The dogleg bend in the metal extrusion was too sharp for the gland to be properly installed into the extrusion, which caused water to leak through the gland/extrusion/joint.

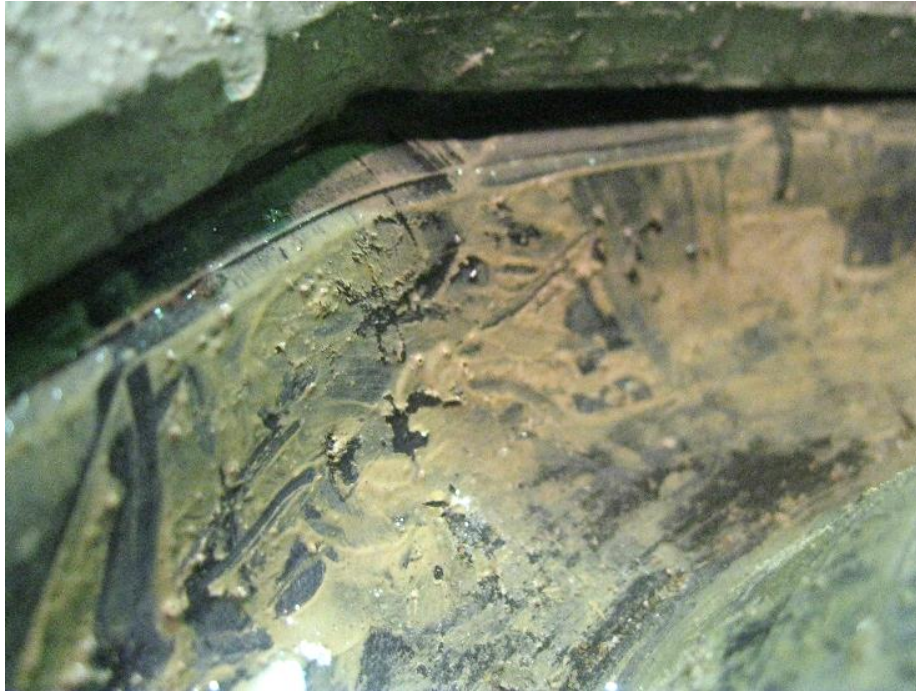
Figure 55. Improper gland installation causing leak in Watson Bowman Acme dogleg specimen

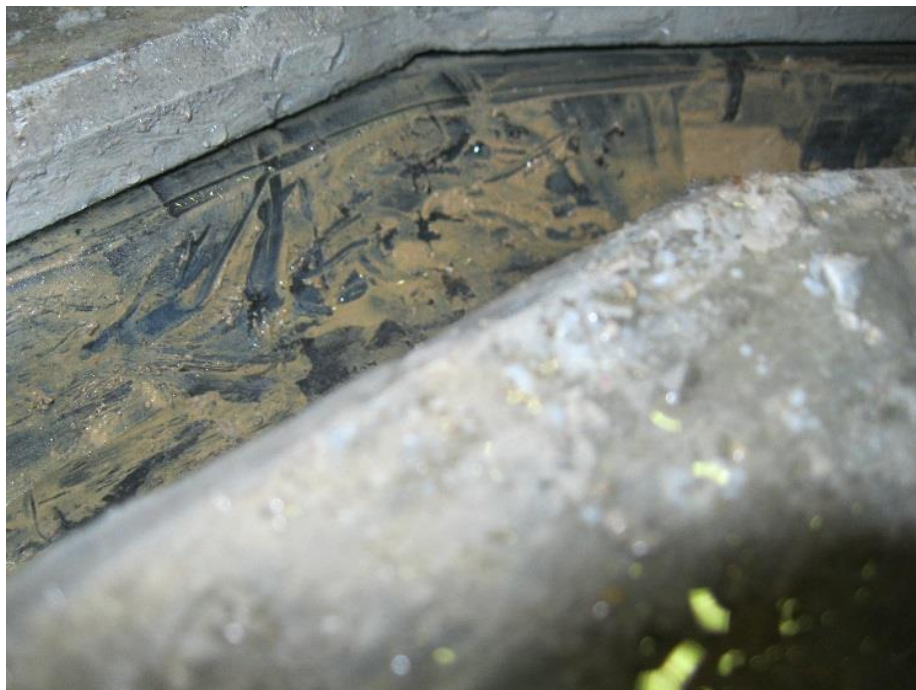
Figure 56. Second attempt to properly install gland in Watson Bowman Acme dogleg specimen

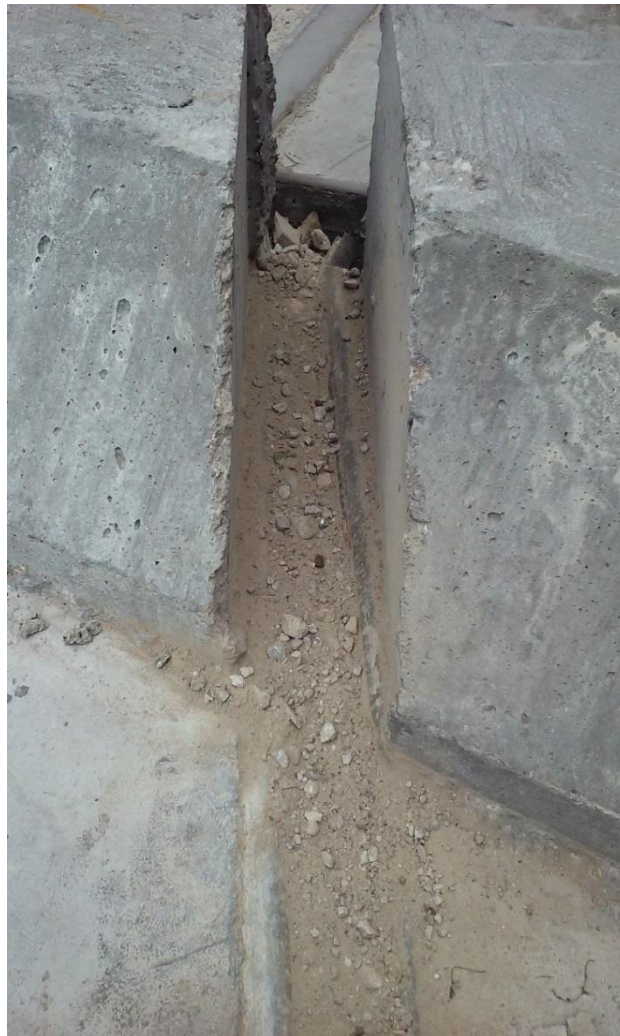
Figure 57. Mixture of dry debris placed on top of strip seal specimen

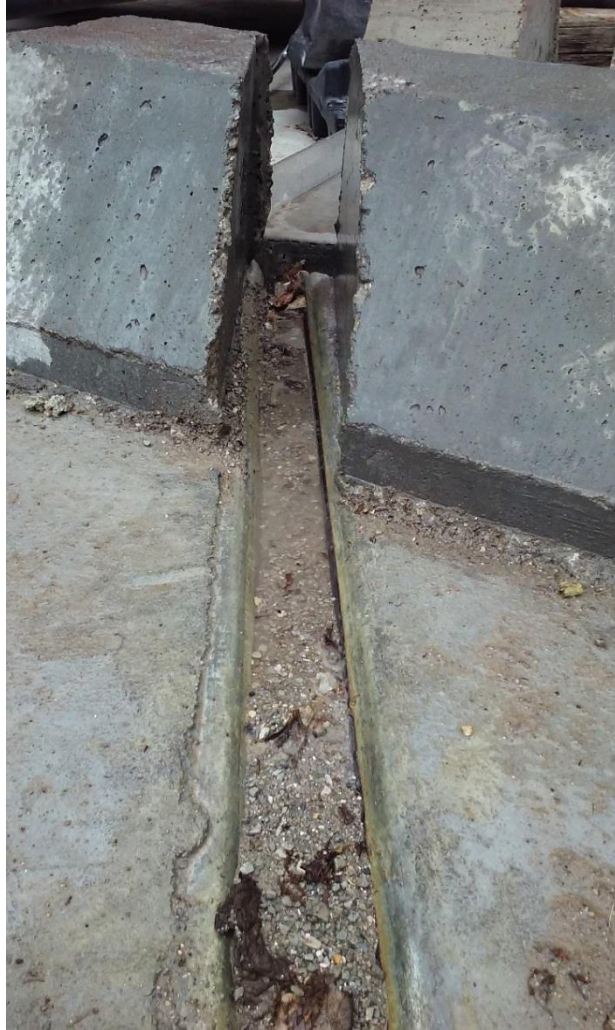
Figure 58. Mixture of debris on top of strip seal specimen after simulating water flowing heavily off the bridge

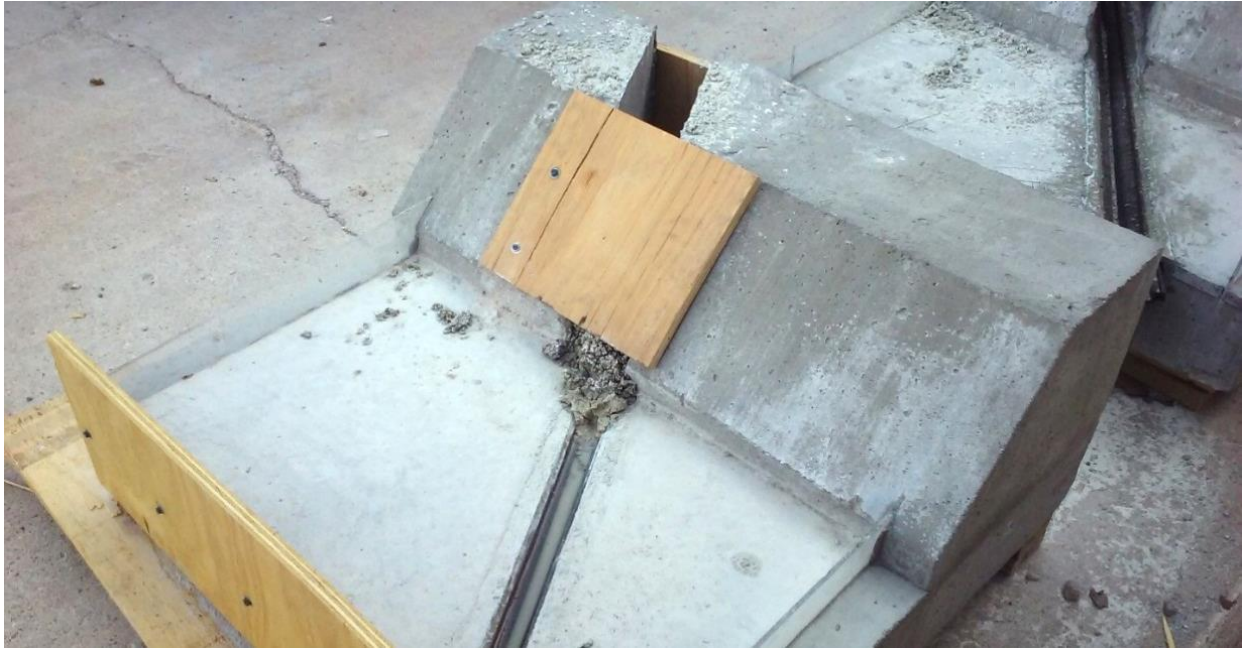
Figure 59. Bentonite option termination specimen

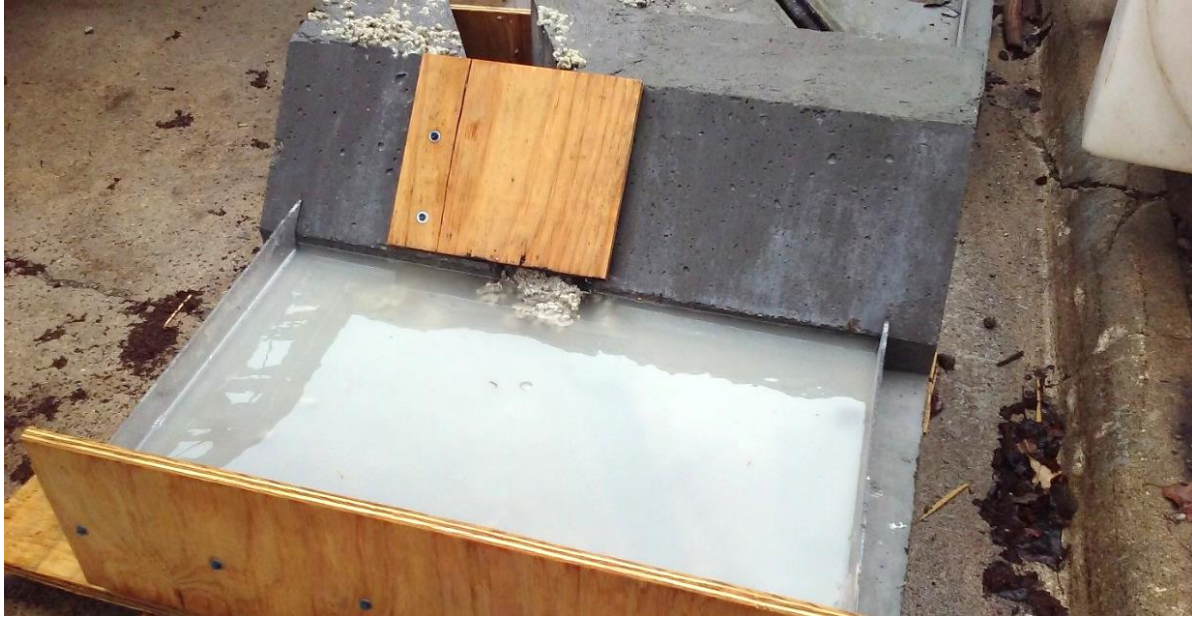
Figure 61. Bentonite option specimen during ponding test

The bentonite clay proved to work well at creating a watertight seal to the termination area and passed multiple ponding tests. However, repeated ponding tests caused some of the bentonite clay to fall out of containment within the barrier rail void and onto the deck.

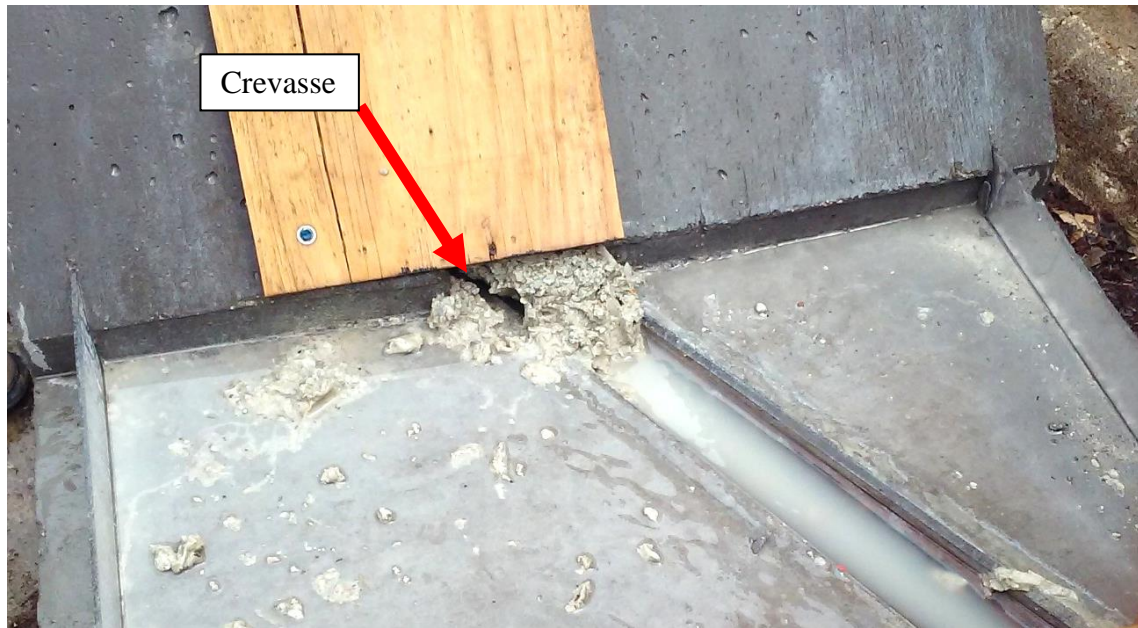
Figure 62. Crevasse that had formed in saturated bentonite causing ponding test failure
