**A DIFFERENT PERSPECTIVE
FOR INVESTIGATION OF
PCC PAVEMENT DETERIORATION**

Interim Report
for
Iowa DOT
Research Project HR-2074

A Different Perspective
for Investigation of
PCC Pavement Deterioration

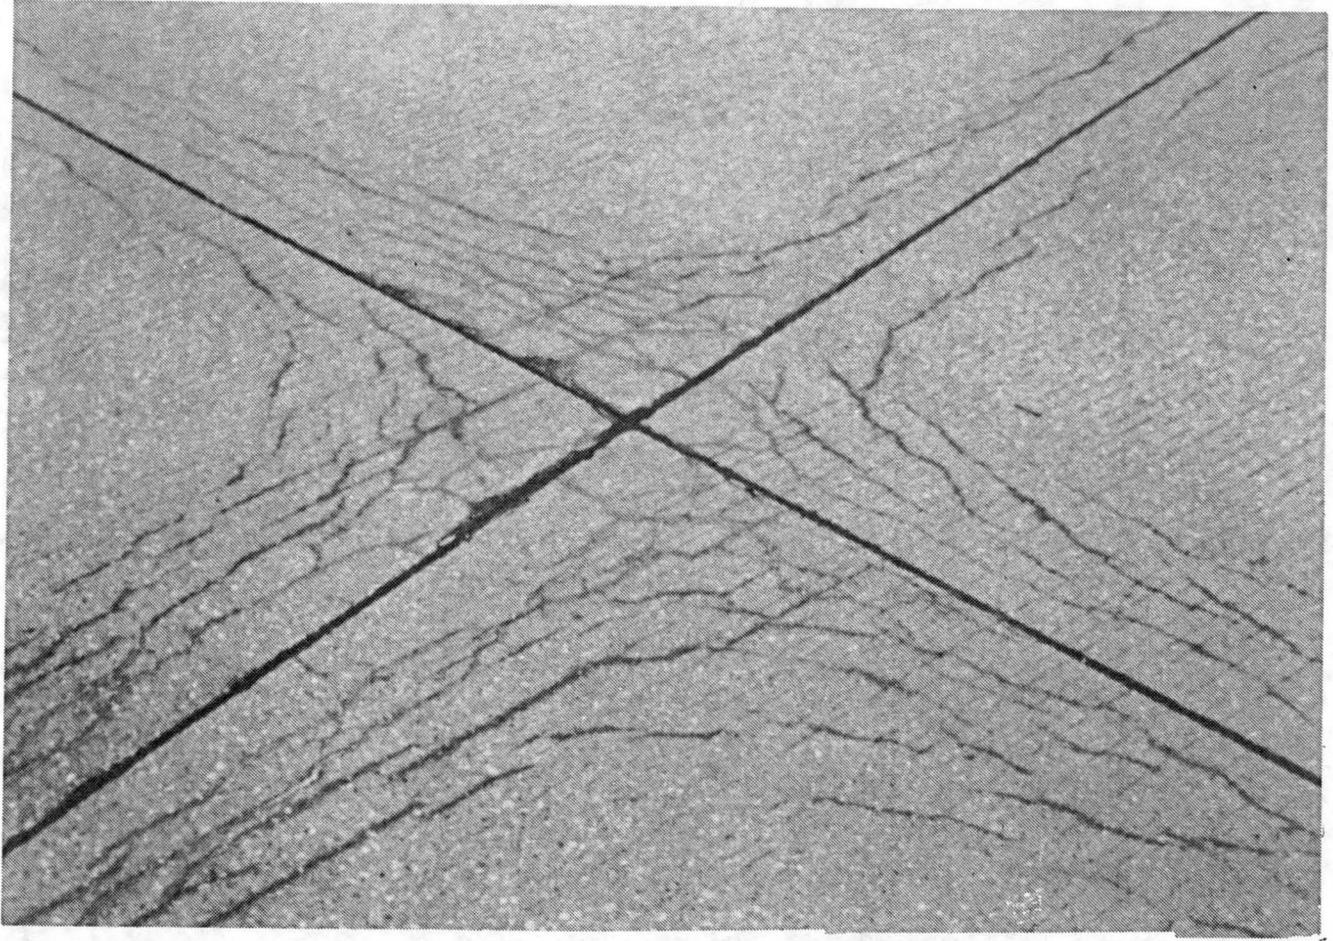
FIGURE 1 TYPICAL D CRACKING OF PCC PAVEMENT

In the late 1950's, Iowa was faced with severe PCC pavement deterioration. Some pavements that were only 15 years old were exhibiting a substantial crack pattern. This deterioration was referred to as D cracking (Figure 1). After substantial research, the cause of this deterioration was related to a certain type of carbonate coarse aggregate. The initiating cause was identified as crushed limestone aggregate containing a predominance and substantial volume of pores in the 0.04 to 0.2 μm diameter pore size. Since the 1930's, Iowa has maintained an excellent record of the ledges and quarry locations of crushed stone used in Iowa PCC pavement and their performance by time to visible deterioration. The D cracking problem was solved by identifying the ledge or ledges in each quarry that would cause D cracking and prohibiting their use in Iowa Primary pavement. The Iowa limestone producers use selective quarrying and bench their operation to remove the undesirable ledges.

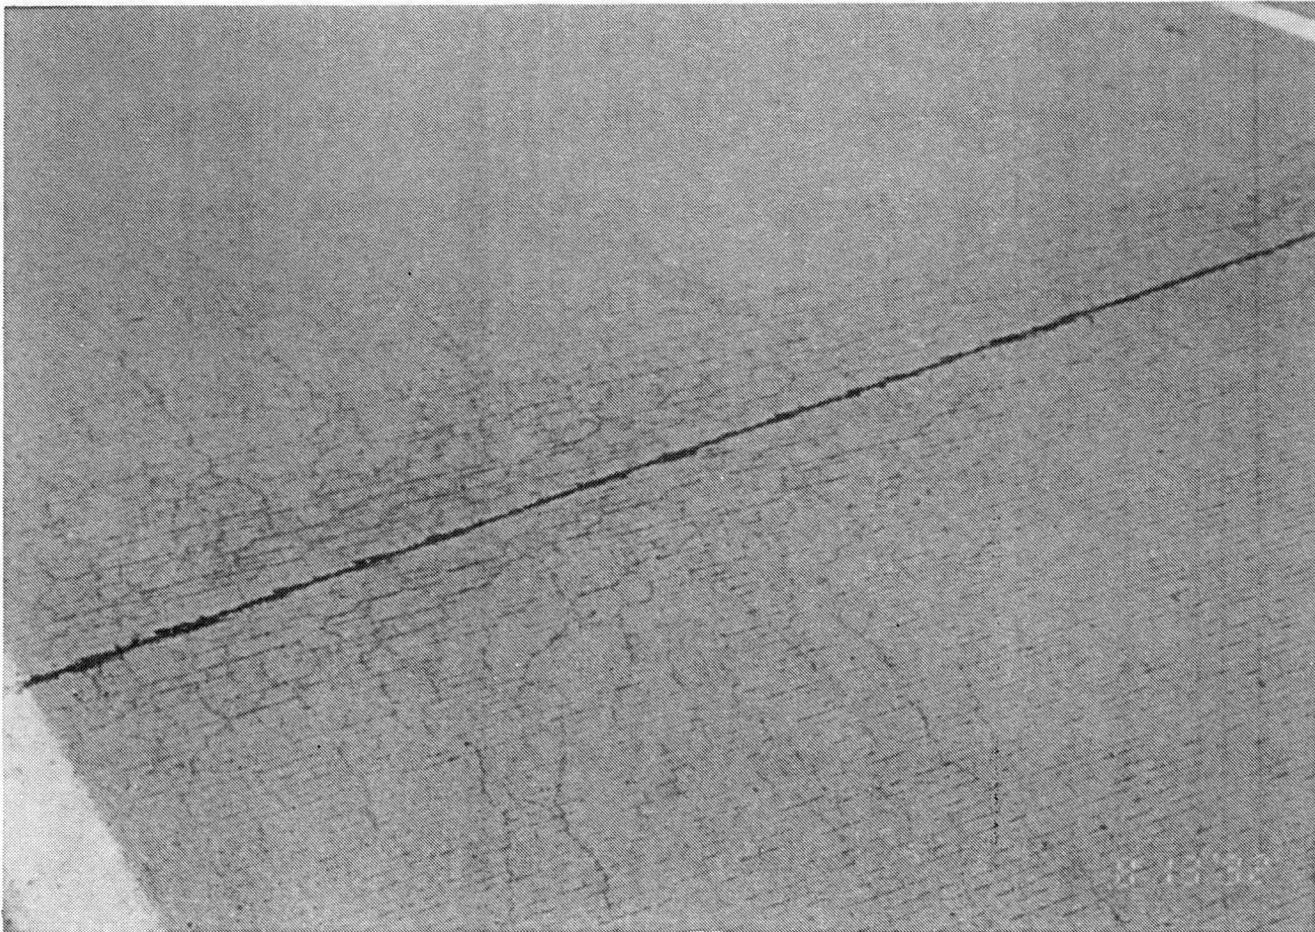
FIGURE 2 THE CRACKING PATTERN OF US 20 IN CENTRAL IOWA

In 1990, the Iowa DOT encountered a very challenging problem. A ten mile section of new four-lane divided highway in central Iowa (US 20 from Fort Dodge to Webster City) was exhibiting distress cracking (Figure 2) at an age of only three years. In other

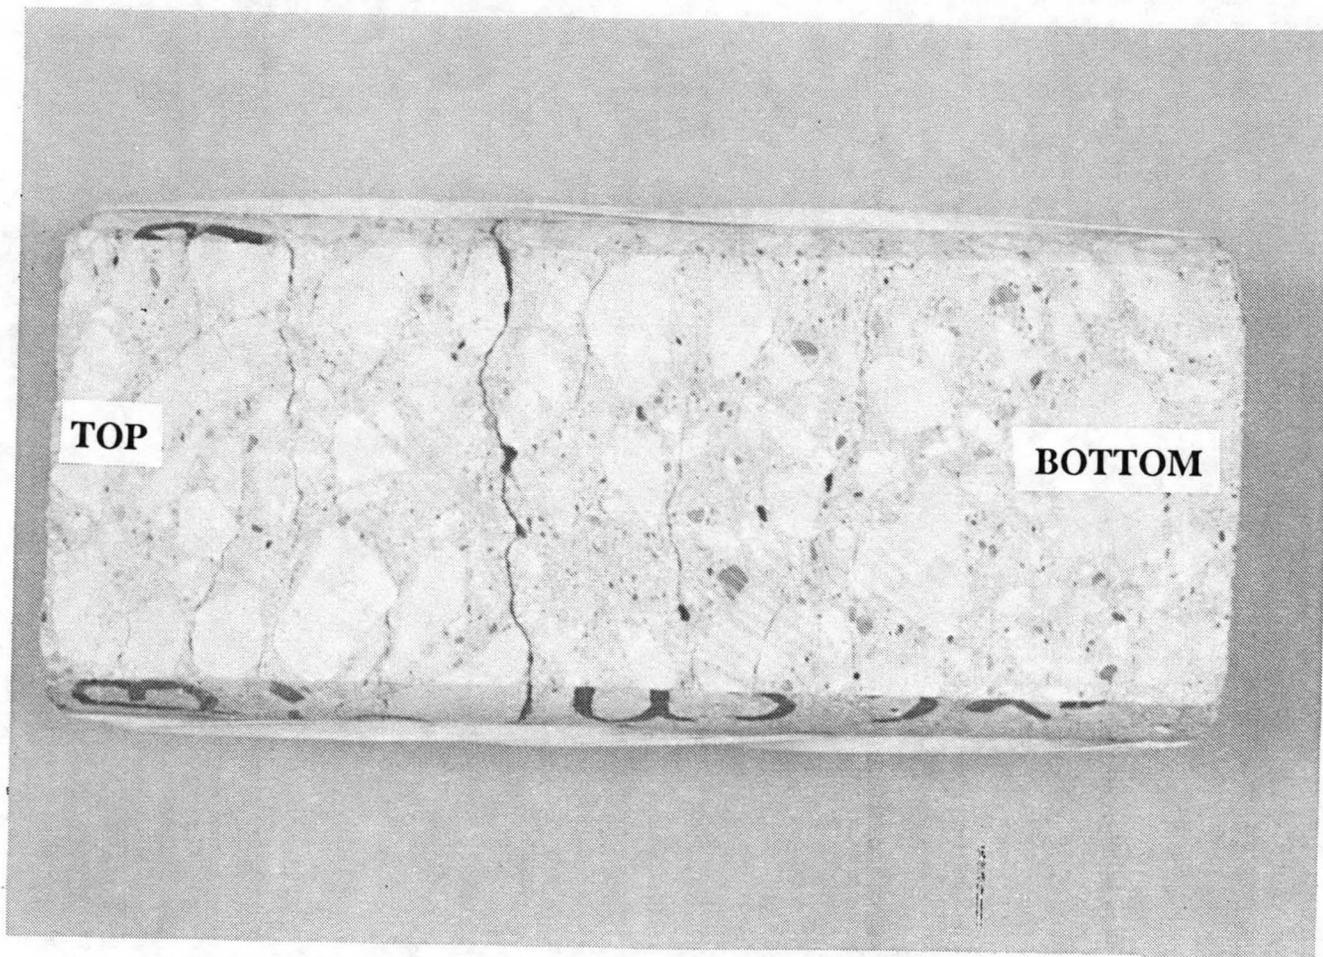
**FIGURE 3 A US 20 CORE SHOWING FEW CRACKS
IN THE COARSE AGGREGATE**

premature PCC pavement failures, the primary factor relating to the deterioration was the coarse aggregate. In this case, the coarse aggregate was a crushed limestone (Gilmore City Ledge) from the Fort Dodge Mine that had an excellent performance record when used in PCC pavement. An examination of cores from the pavement and particularly one adjacent to the joint (Figure 3) revealed very few cracks passing through the coarse aggregate particles. The cracks were predominately confined to the matrix.

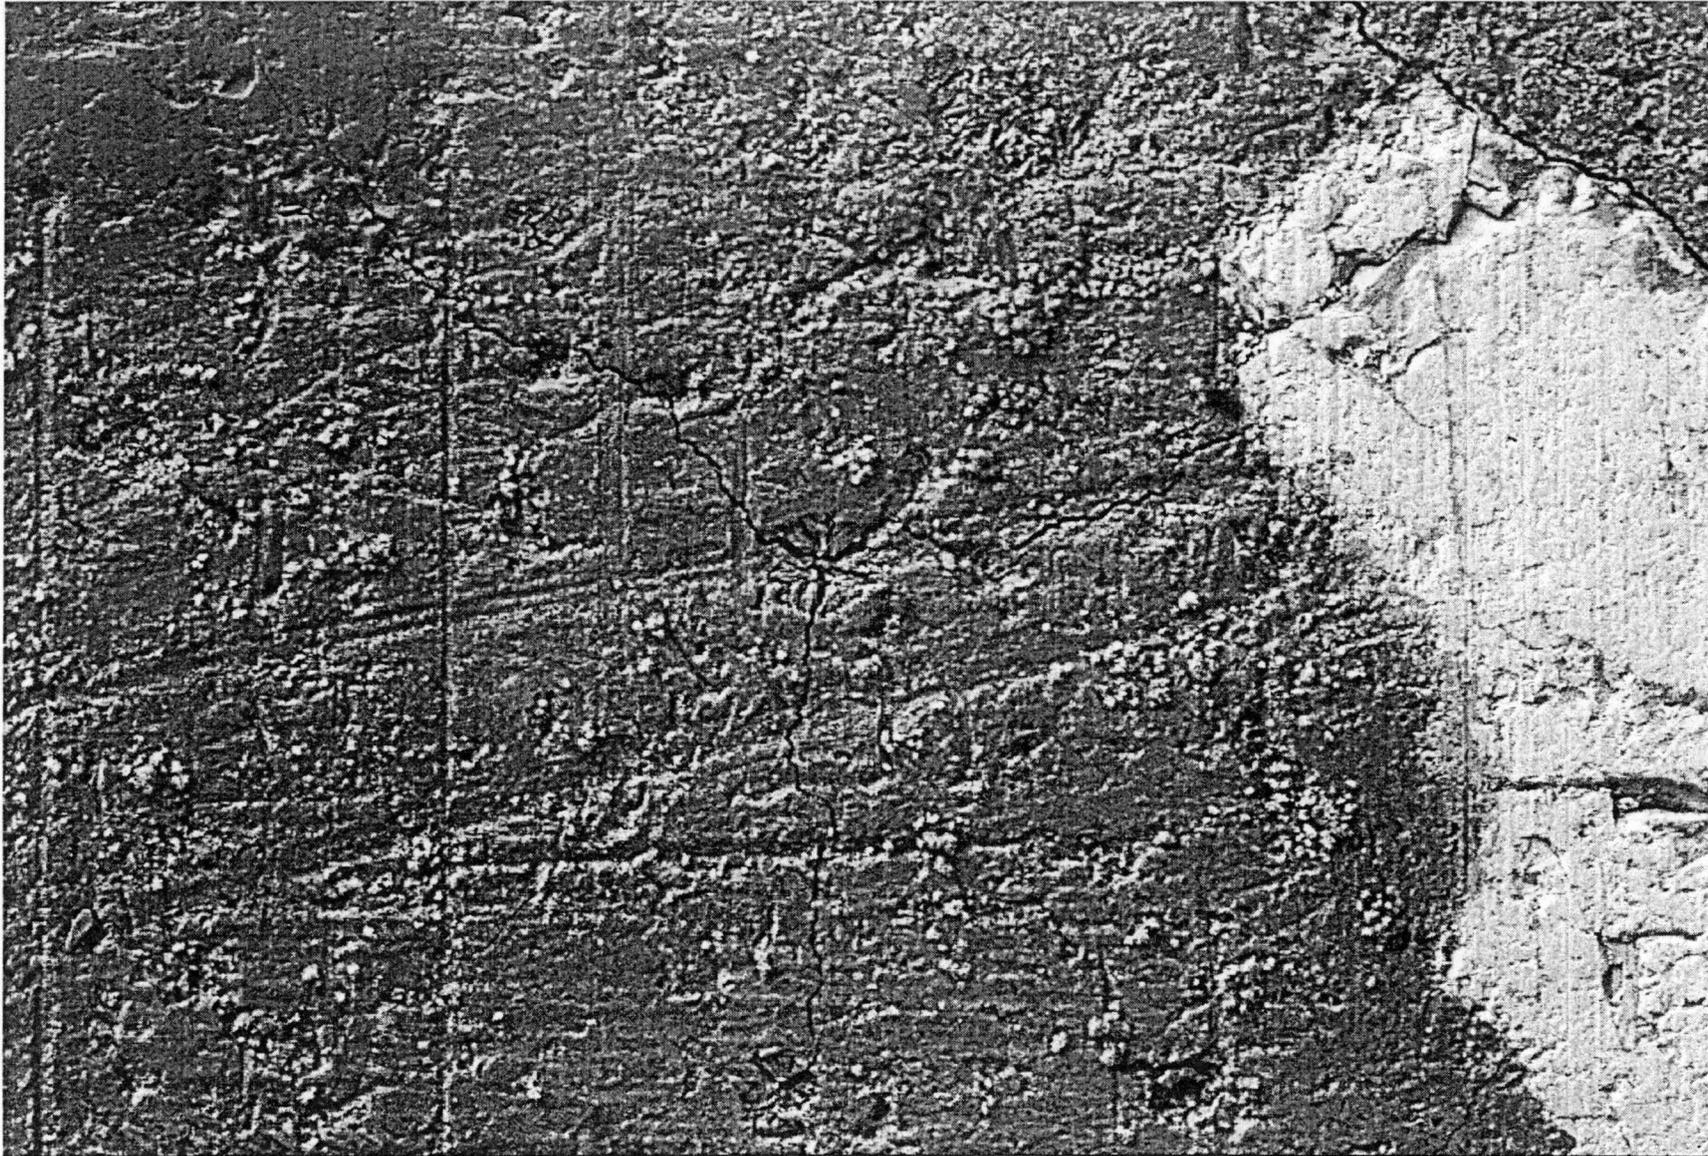
This same sawed and polished piece of PCC was then observed using the Hitachi low vacuum SEM. A backscattered electron (BSE) photomicrograph of round air voids was obtained (Figure 4). The SEM identified smaller voids nearly filled and larger voids partially filled with the whitish material. Distress cracks passed through a series of these air voids.

**FIGURE 4 A 200X BSE PHOTOMICROGRAPH
OF THE PCC AIR VOIDS ON IOWA US 20**

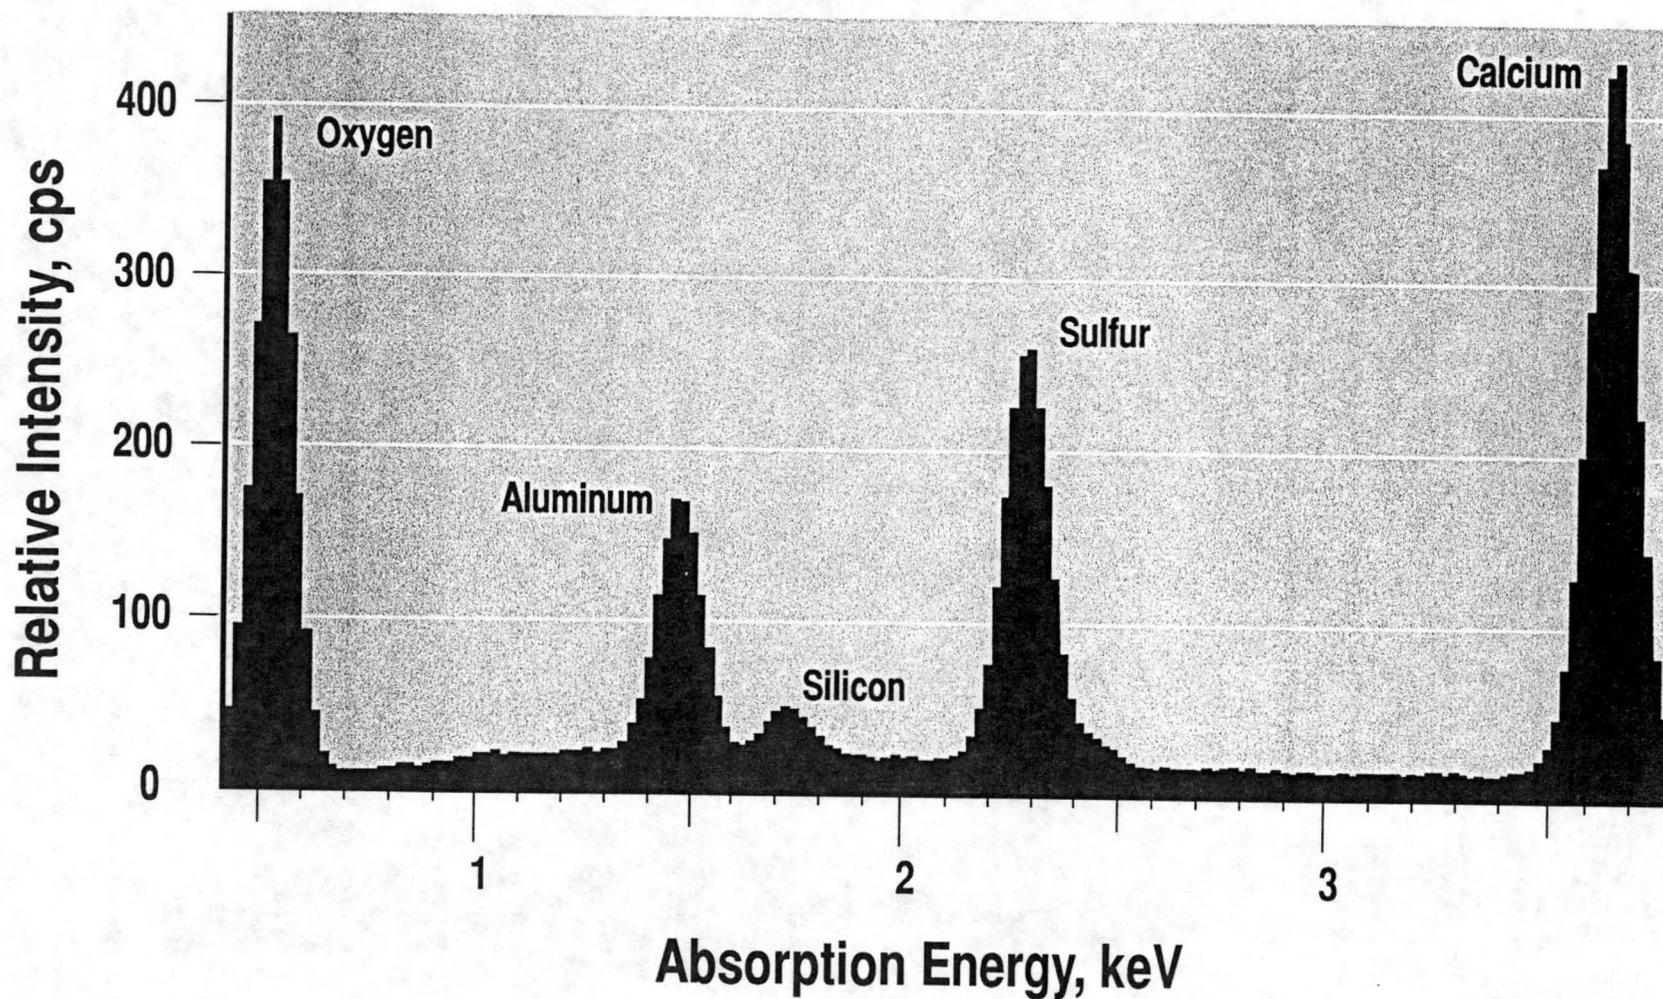
voids was obtained (Figure 5). This spectrum showed major peaks for oxygen, aluminum, sulfur and calcium, supporting the conclusion that the whitish material in the voids is ettringite. There is a minor silicon peak, but no sodium or potassium peak; thereby, supporting the finding that the material in the void is not silica gel.

Figure 5
An Energy Dispersion Spectrum
of the Whitish Material in the Air Voids

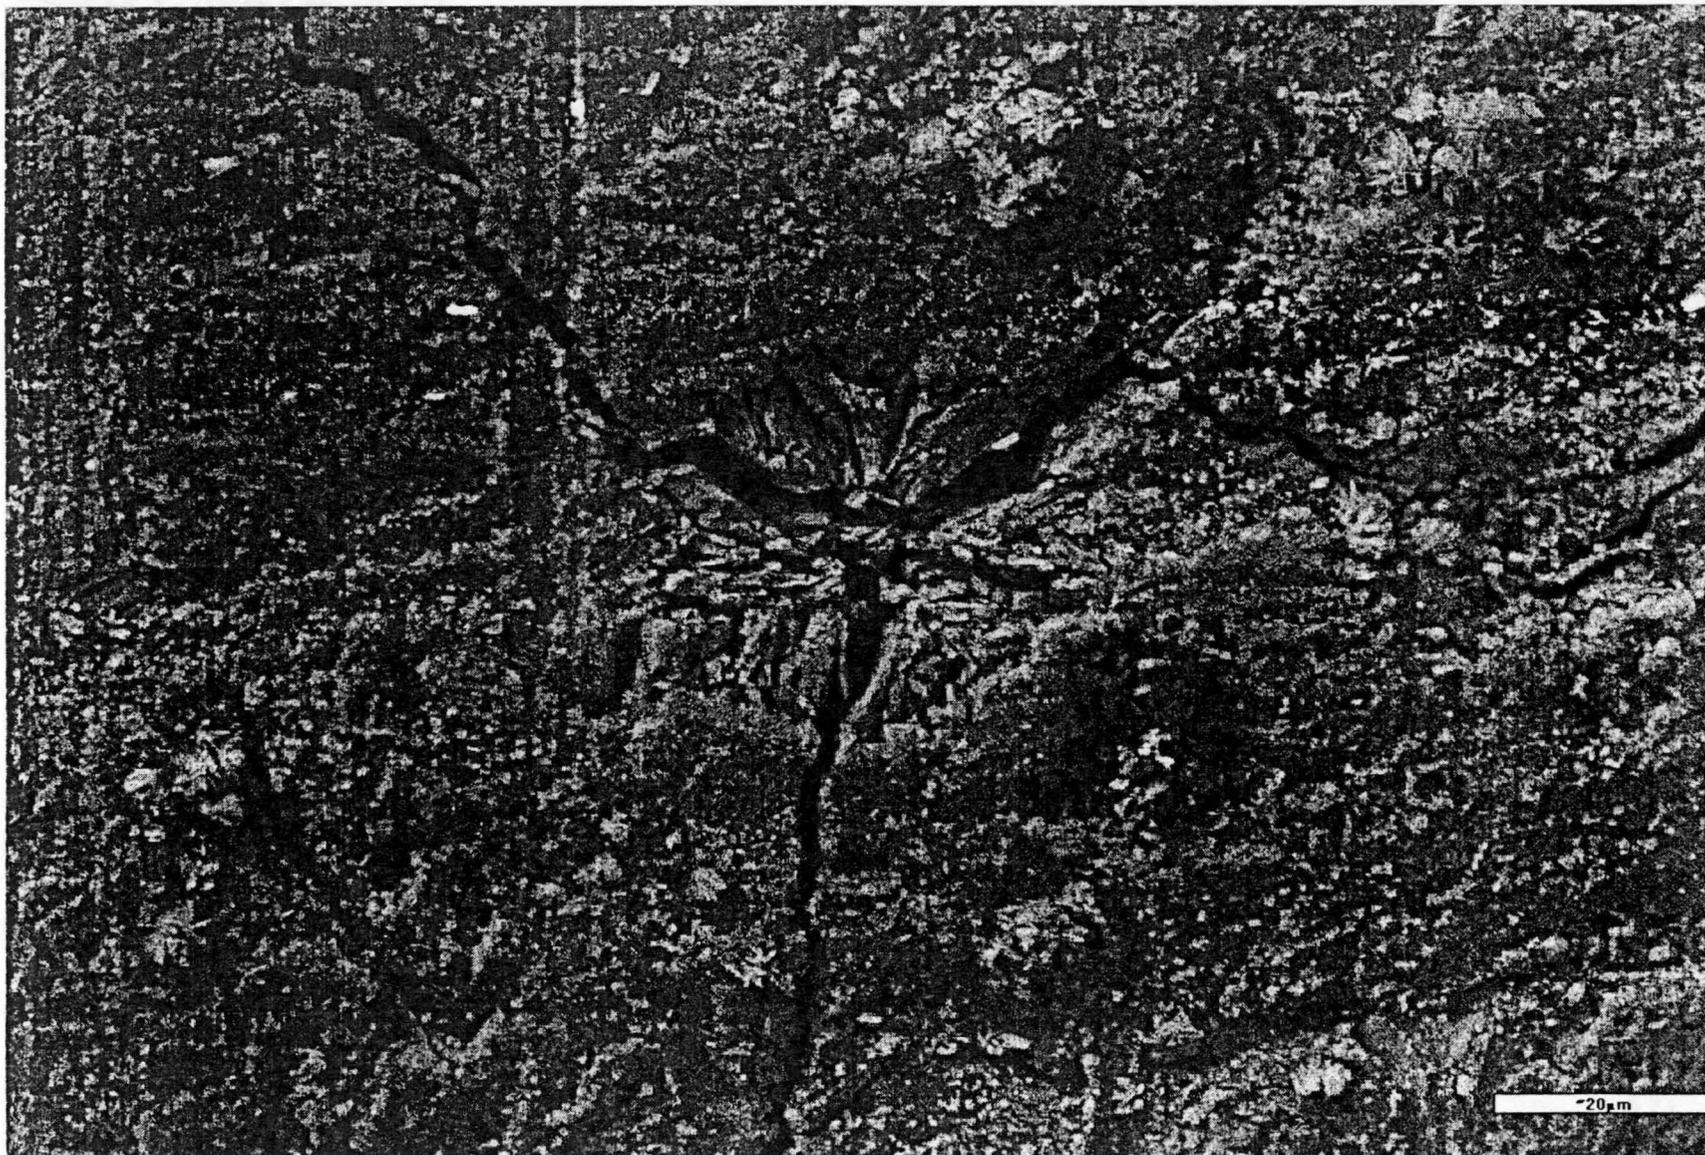
The SEM also identified cracks radiating from some of these air voids (Figure 6). This would indicate that this air void was a center-of-pressure in the development of these cracks. There was another interesting feature of the ettringite in these voids with the radiating cracks. The ettringite was filling these voids, but the ettringite did not fill the crack inside or outside of the round voids. This led to the conclusion that the void was filled with ettringite before the cracks developed.

FIGURE 6 A 100X BSE PHOTOMICROGRAPH OF IOWA 20 SHOWING CRACKS RADIATING FROM THE ETTRINGITE FILLED AIR VOIDS

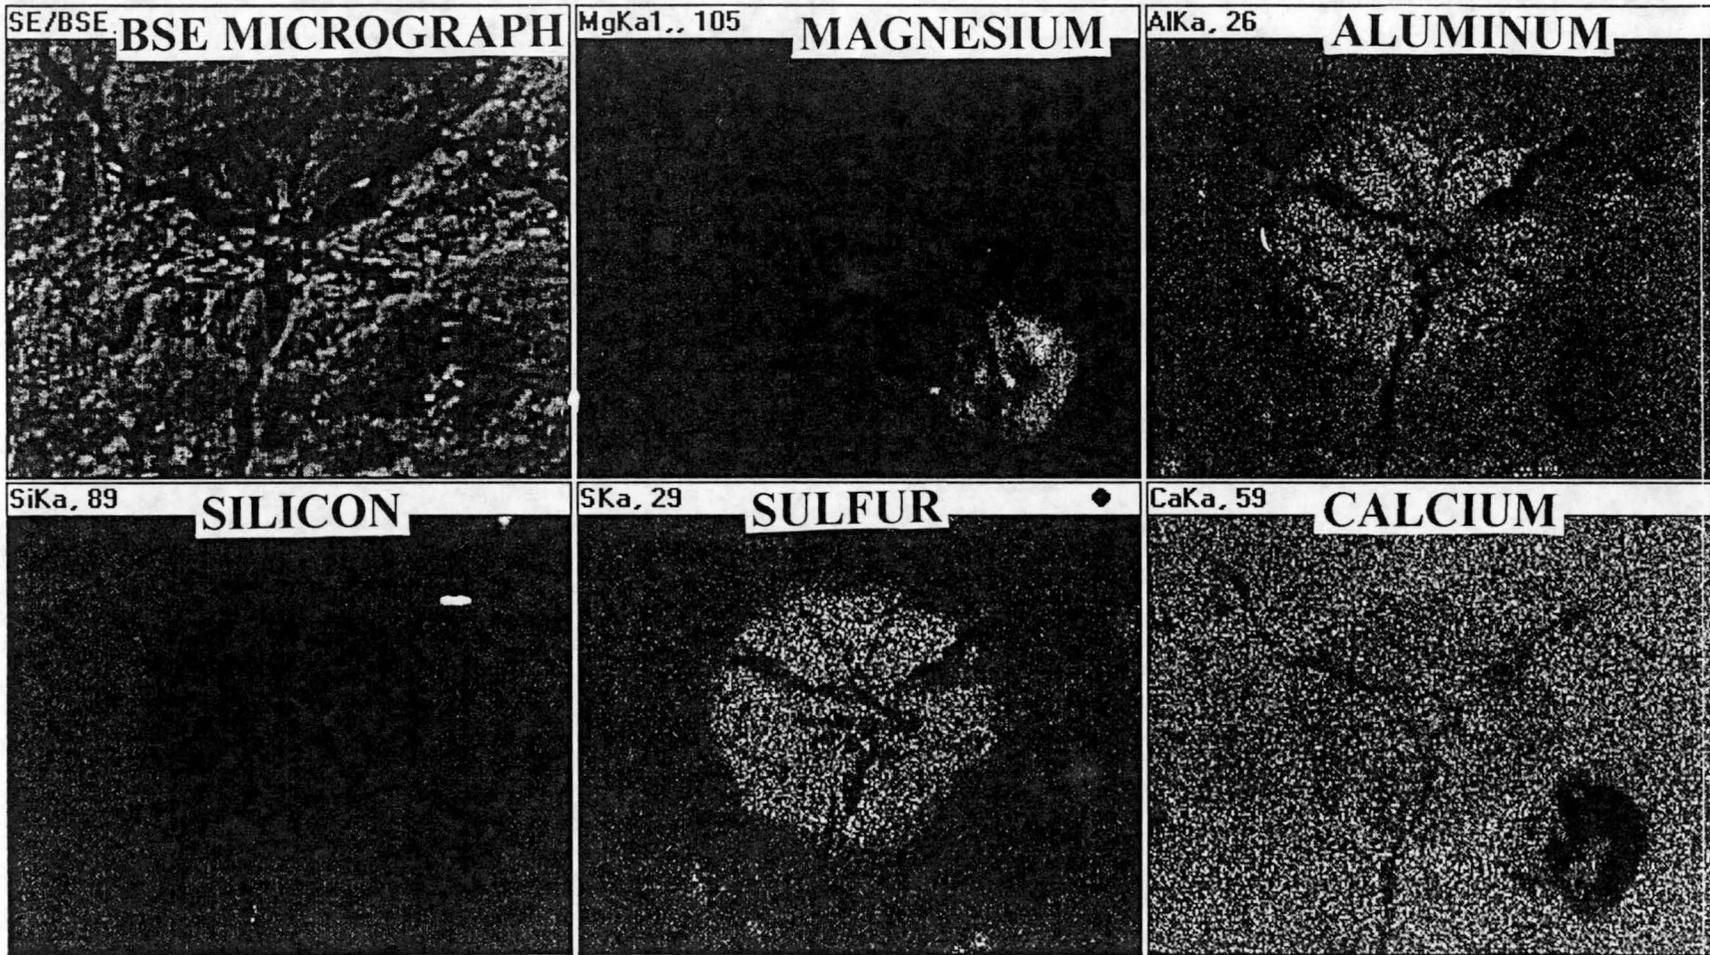
The elemental maps (Figure 7) showed little or no silicon in the filled air voids. The round air voids could easily be identified because they were black on the silicon elemental map, showing that there was almost no silicon in the whitish material in the air voids and substantially more silicon in the PCC surrounding the air voids. This led to the conclusion that the whitish material in the air voids is not silica gel.

Elemental maps were obtained for 11 different elements (only a selected 5 are shown in Figure 7). The elemental map that outlined the round air voids the best was sulfur-S. In the map for sulfur, the air voids were very white showing a high concentration of sulfur in the whitish material in the air voids. The aluminum map also showed whiter than the surrounding PCC. The round air voids could also be identified in the calcium map. There was substantial calcium present in both the filled air voids and the surrounding matrix, but the whitish material in the filled air voids had less calcium than the surrounding matrix. These maps led to the conclusion that the whitish material in the filled air voids was very likely ettringite.

**FIGURE 7 THE ELEMENTAL MAP FOR THE
FIGURE 6 PHOTOMICROGRAPH**

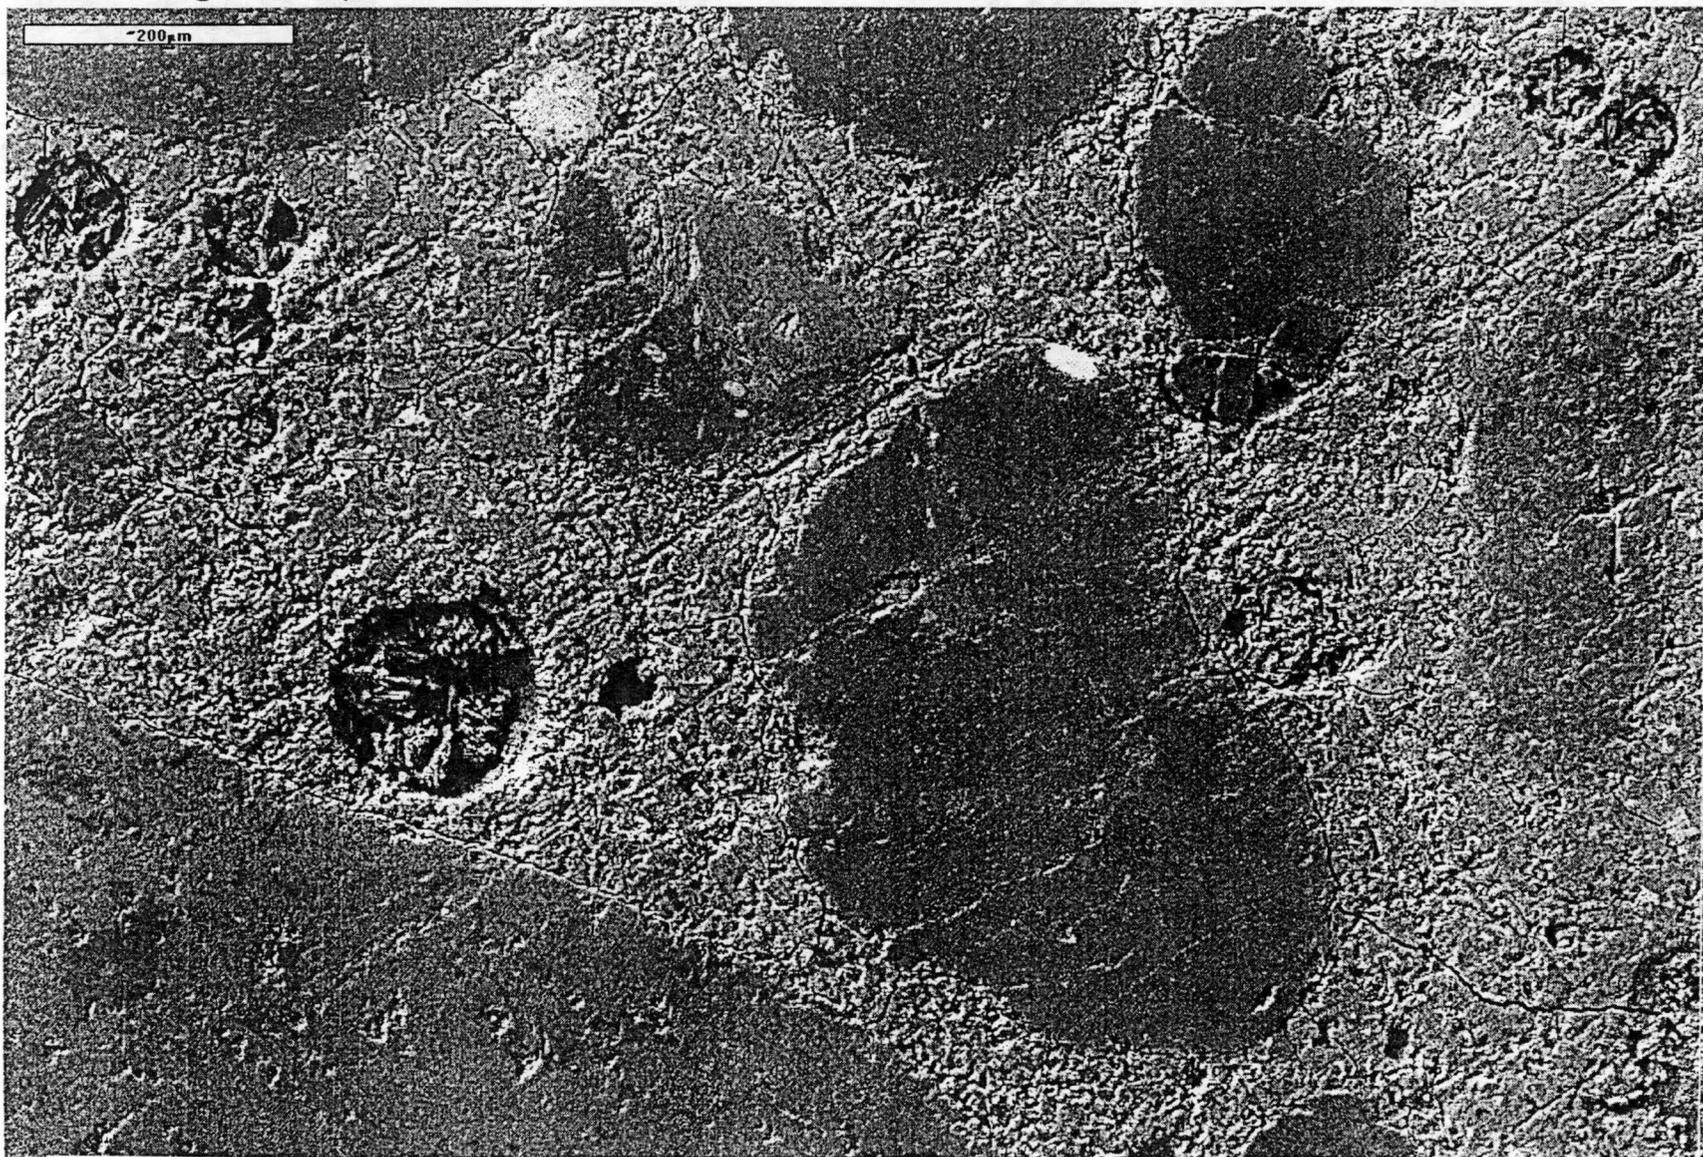
An investigation of the I-80 Aurora PCC (Figures 8 & 9) shows a high concentration of sulfur and very little silicon, again leading to the conclusion that the material is ettringite and not silica gel. An interesting note to make on the I-80 Aurora SEM data is that some of the air voids are in close proximity to these so called ASR reactive aggregates. If these reactive aggregate particles are producing silica gel, it would be a reasonable assumption that some of this expansive gel would be forced into the voids in close proximity. No concentration of silicon has been identified in these filled air voids.

**FIGURE 8 A 100X BSE PHOTOMICROGRAPH OF
A NEBRASKA I-80 AURORA PCC SAMPLE**

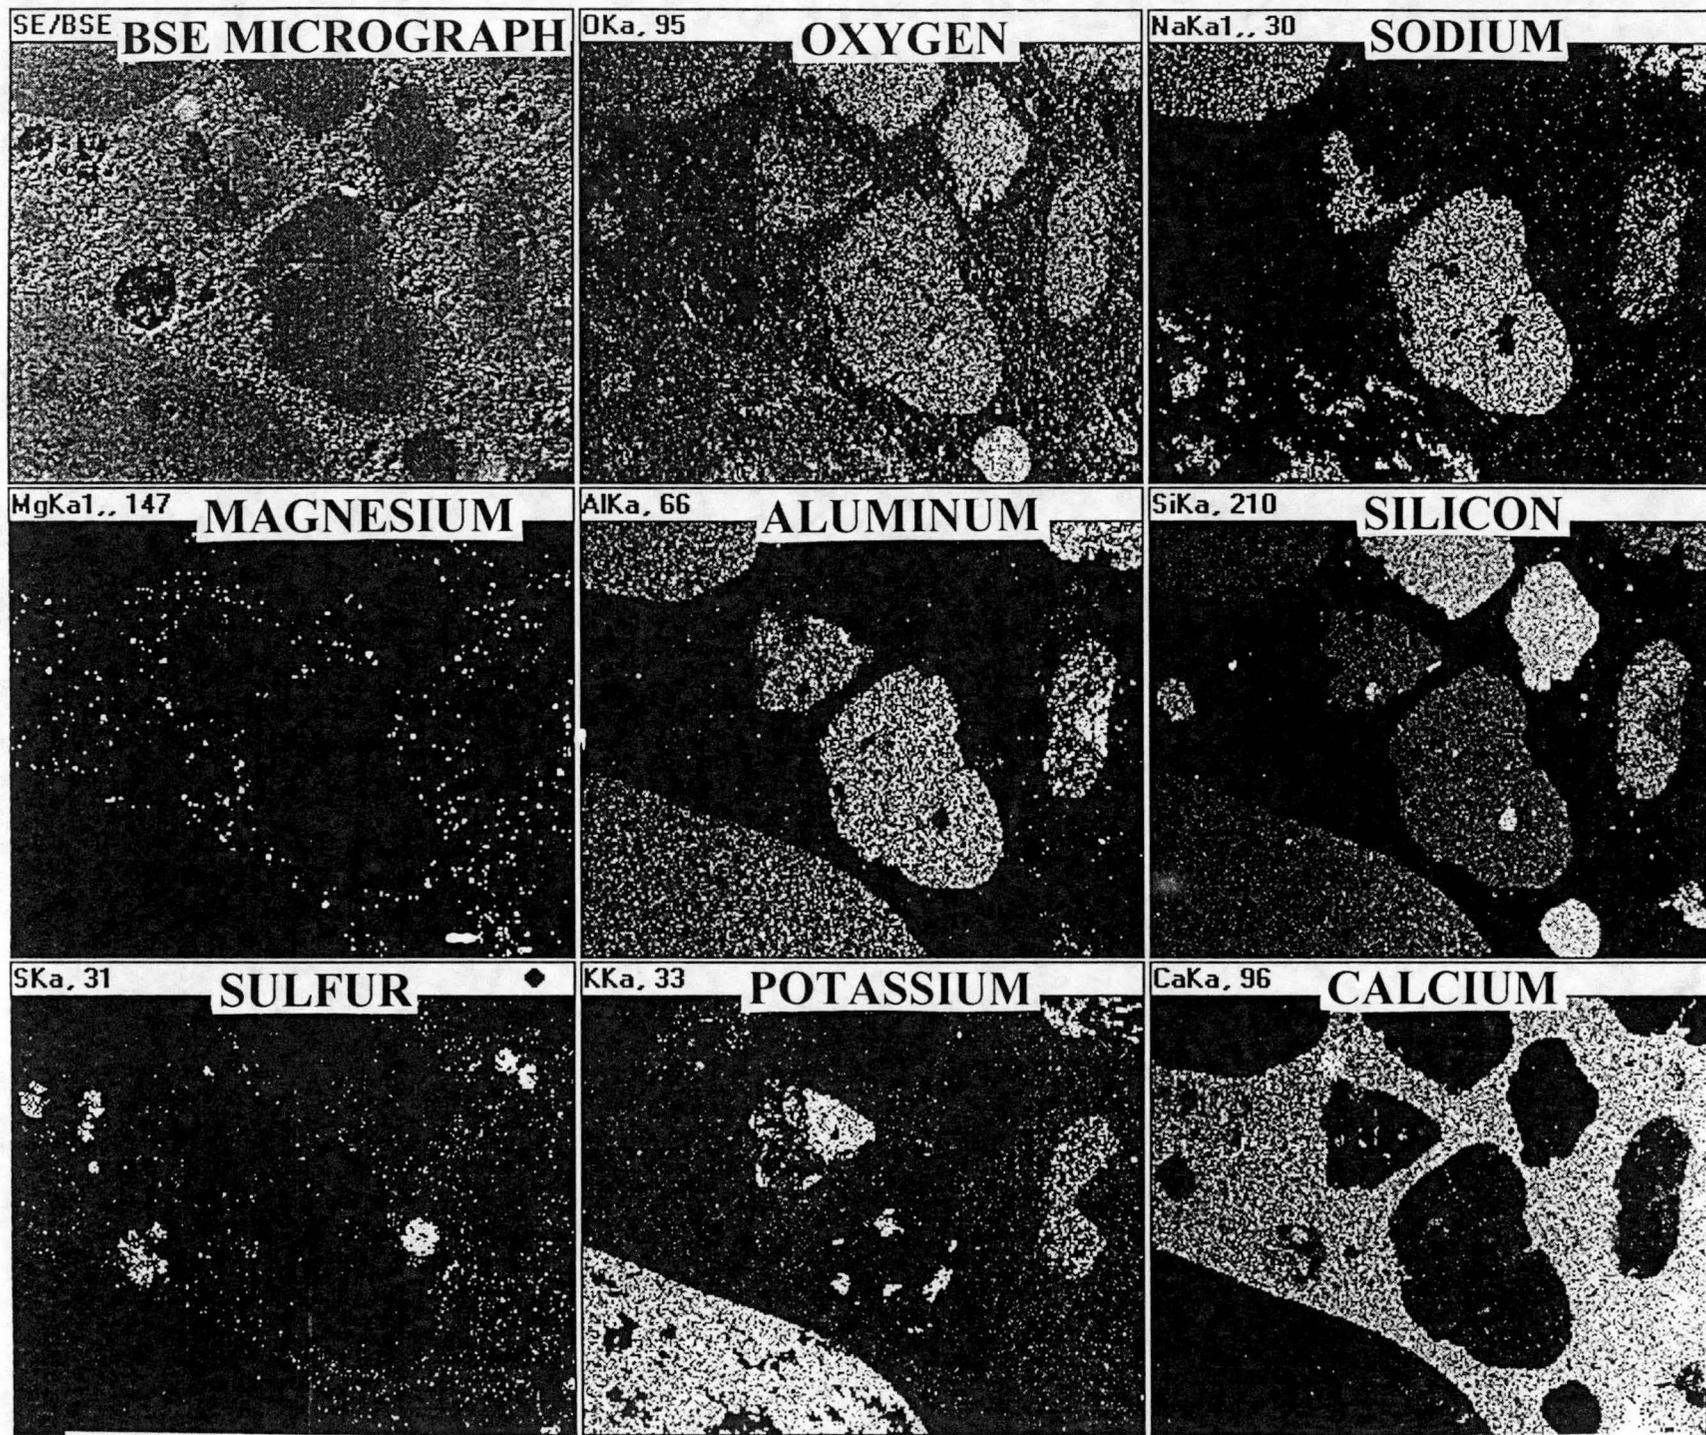
FIGURE 9 THE ELEMENTAL MAPS FOR THE FIGURE 8 PHOTOMICROGRAPH

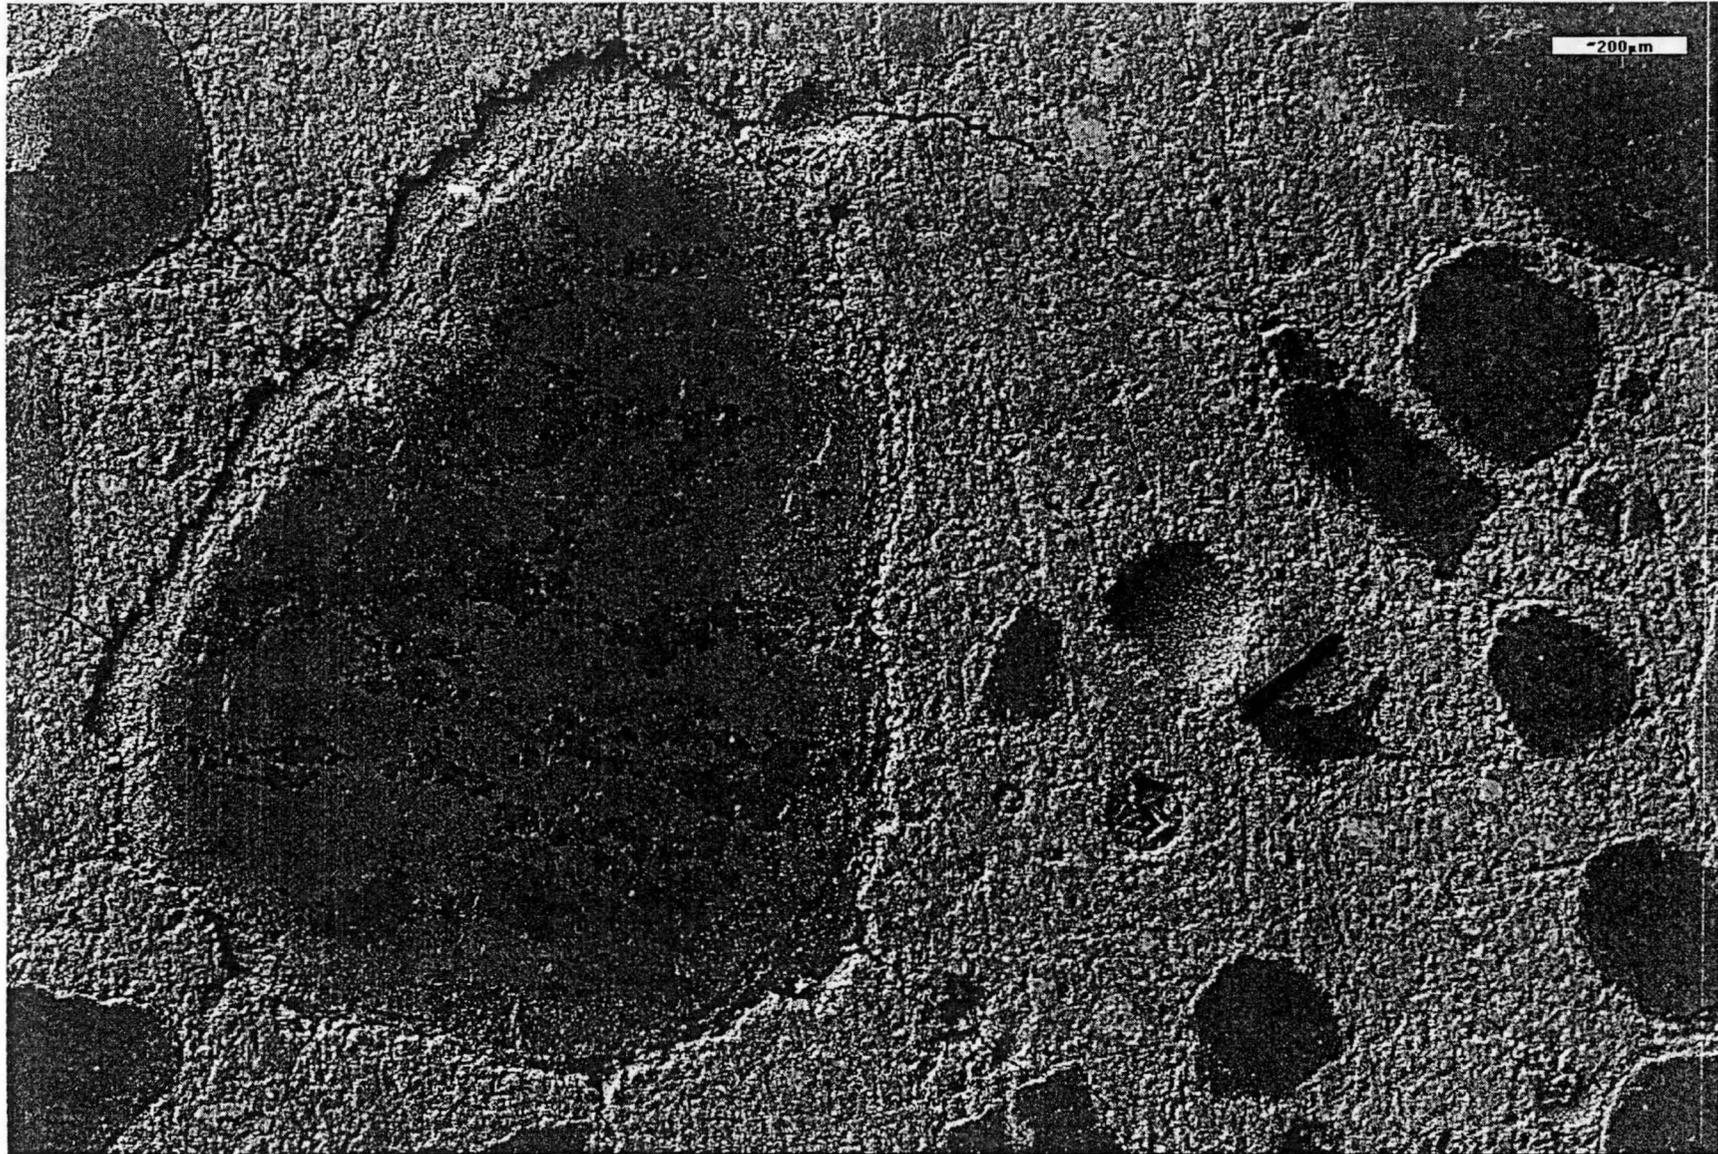
There was also a rim deposit around an aggregate particle (Figure 10). Some petrographic researchers may identify this rim as silica gel. The elemental maps of Figure 11 show that this rim does not contain silicon, so it is not silica gel. The rim material contains substantial sulfur and is, therefore, probably ettringite.

**FIGURE 10 A 100X BSE PHOTOMICROGRAPH OF A
NEBRASKA OMAHA AIRPORT PCC SAMPLE**

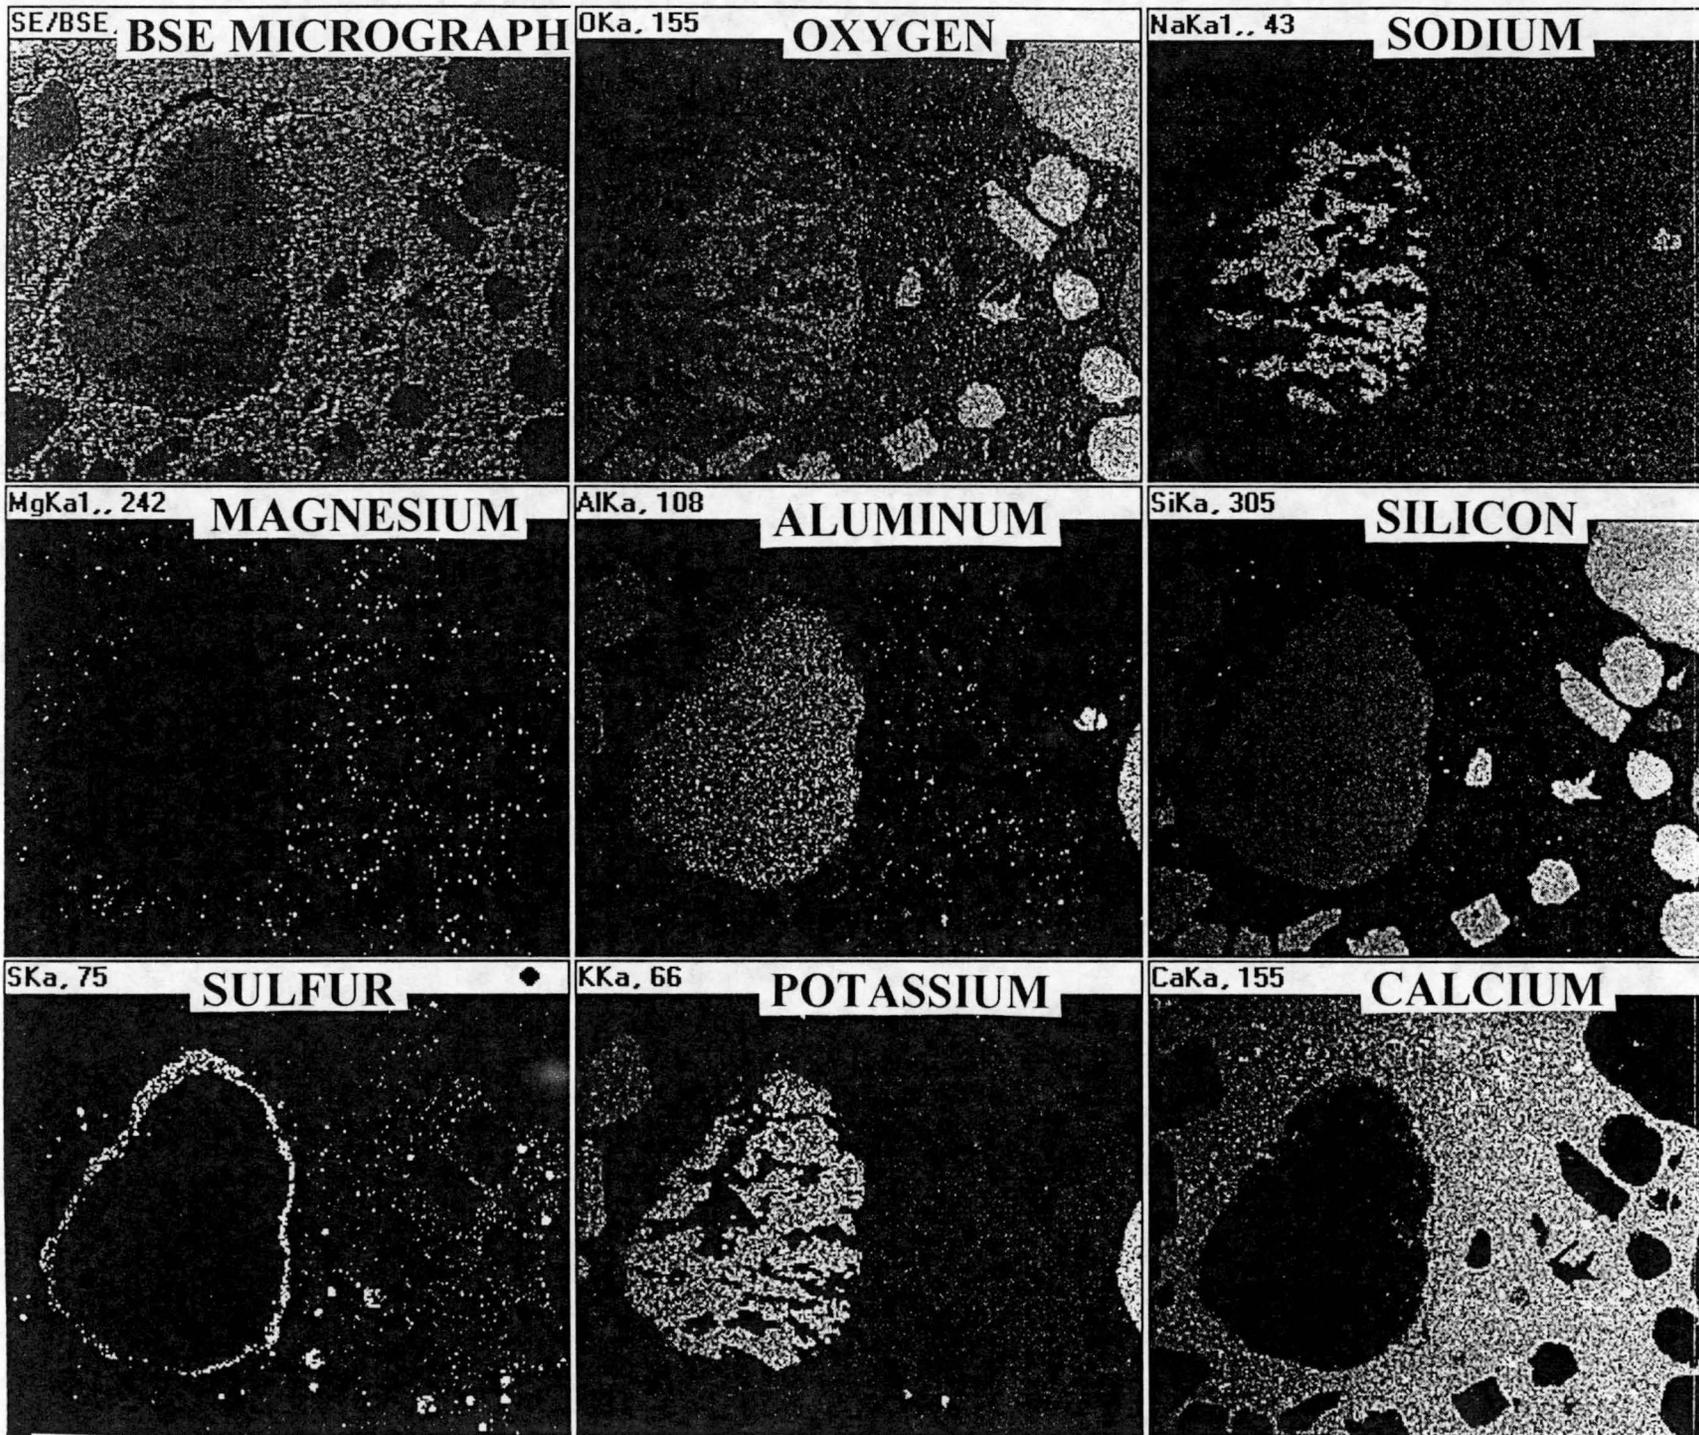
FIGURE 11 THE ELEMENTAL MAPS FOR THE FIGURE 10 PHOTOMICROGRAPHS

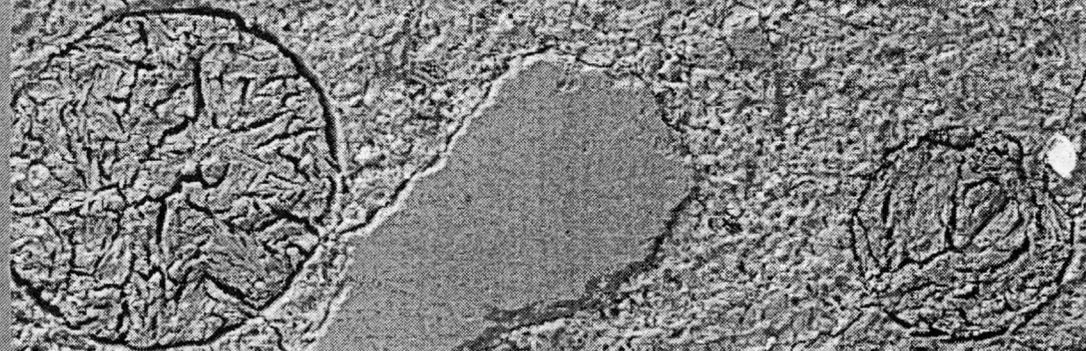
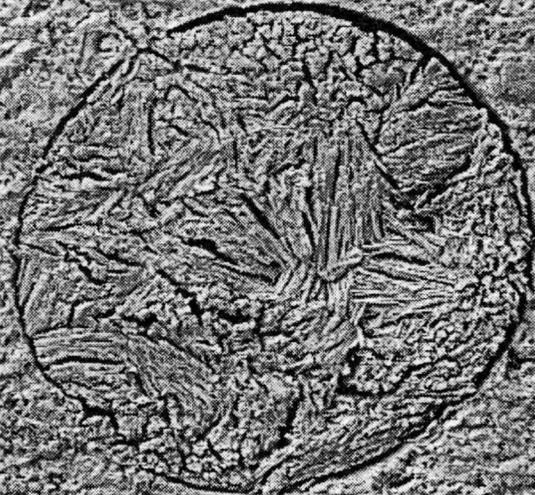
recorded prior to treatment with NaCl brine (Figure 12). The elemental maps (Figure 13) exhibited no silicon, but substantial sulfur and aluminum indicating that the material in the air voids was very likely ettringite. The NaCl treated, polished sample was put into the low vacuum SEM. After 45 minutes the ettringite in the large voids had either been dissolved or dislodged (Figure 14). Another very interesting finding was that the ettringite in the small voids had swelled and expanded. At 48 hours, the ettringite had dissolved from all of the air voids, but the expansion of the ettringite had been sufficient to lift the boundaries of the air voids (Figure 15). Another significant feature that became visible was the substantial cracking in the large air voids and the cracking through a series of air voids.

FIGURE 12 A 100X BSE PHOTOMICROGRAPH OF AIR VOIDS TIGHTLY FILLED WITH ETTRINGITE
