**A DIFFERENT PERSPECTIVE
FOR INVESTIGATION OF
PCC PAVEMENT DETERIORATION**

Interim Report
for
Iowa DOT
Research Project HR-2074

A Different Perspective
for Investigation of
PCC Pavement Deterioration

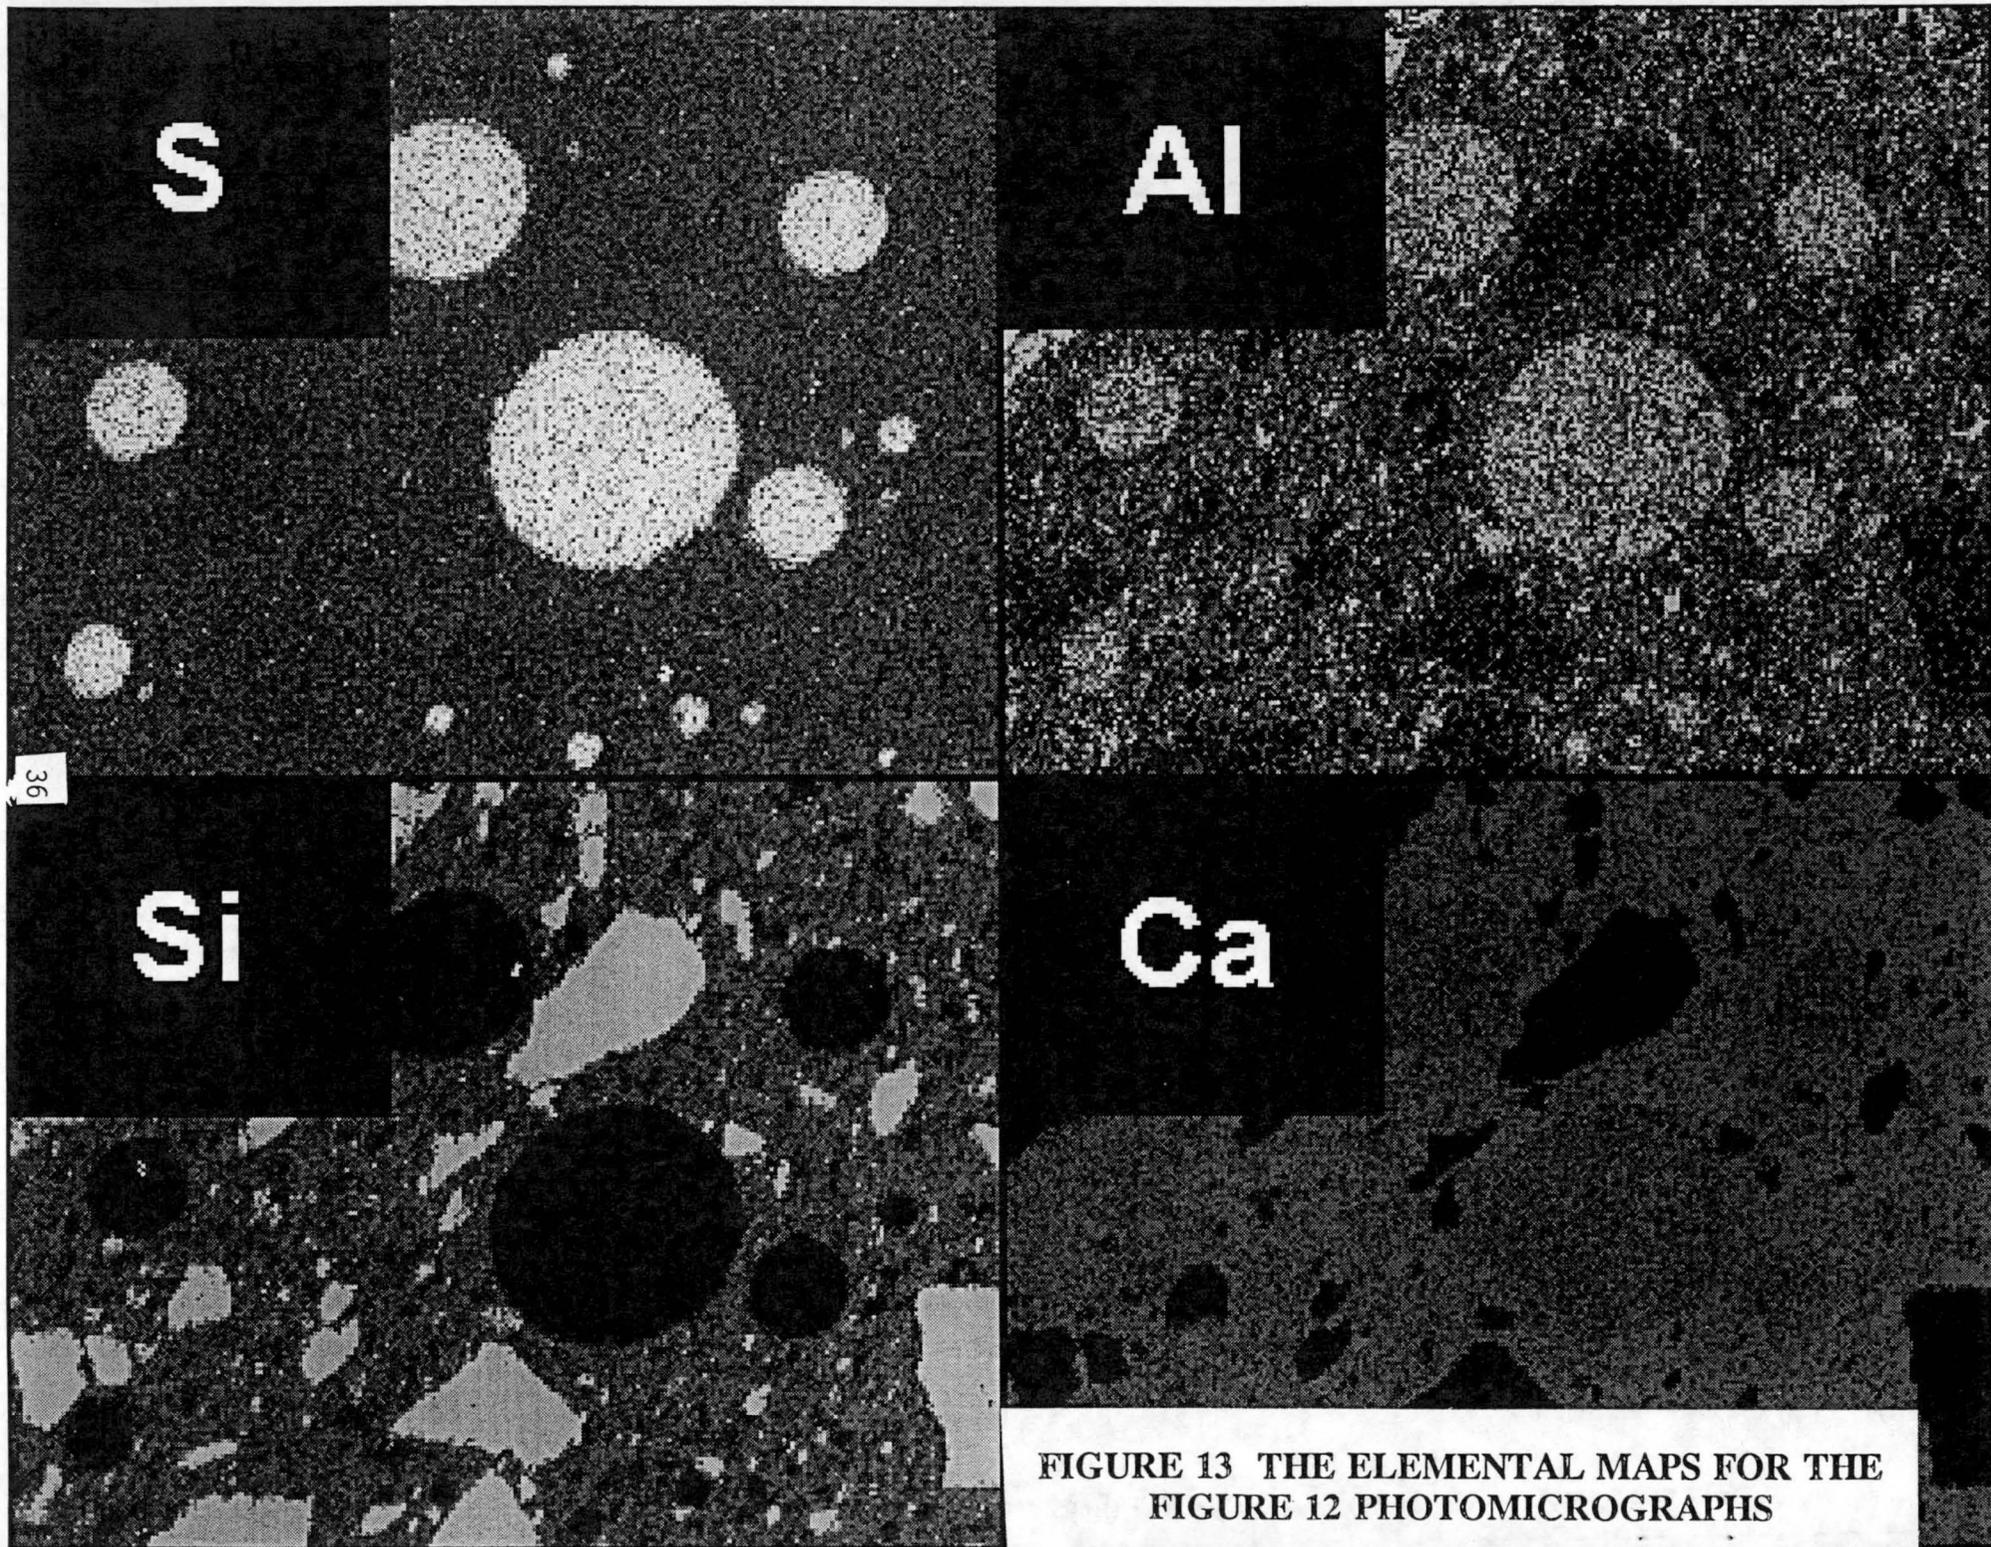
recorded prior to treatment with NaCl brine (Figure 12). The elemental maps (Figure 13) exhibited no silicon, but substantial sulfur and aluminum indicating that the material in the air voids was very likely ettringite. The NaCl treated, polished sample was put into the low vacuum SEM. After 45 minutes the ettringite in the large voids had either been dissolved or dislodged (Figure 14). Another very interesting finding was that the ettringite in the small voids had swelled and expanded. At 48 hours, the ettringite had dissolved from all of the air voids, but the expansion of the ettringite had been sufficient to lift the boundaries of the air voids (Figure 15). Another significant feature that became visible was the substantial cracking in the large air voids and the cracking through a series of air voids.

FIGURE 13 THE ELEMENTAL MAPS FOR THE FIGURE 12 PHOTOMICROGRAPHS

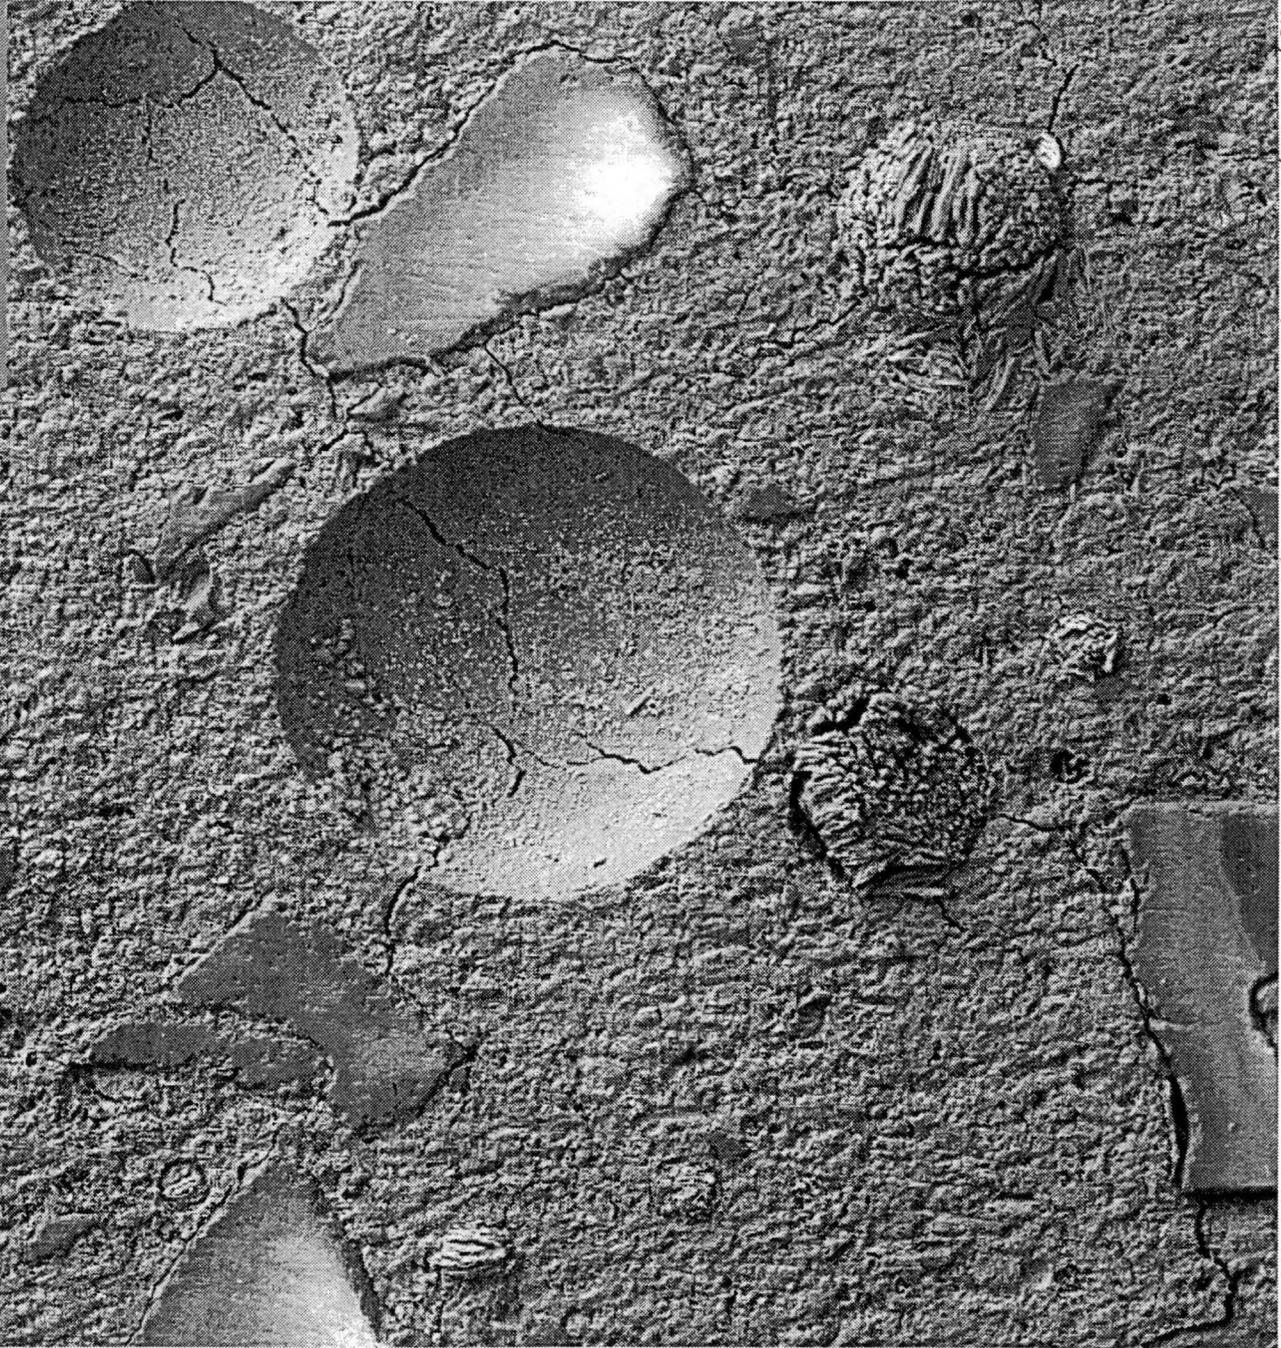
FIGURE 14 A 100X BSE PHOTOMICROGRAPH OF THE FIGURE 12 AIR VOIDS
45 MINUTES AFTER TREATMENT WITH NaCl BRINE

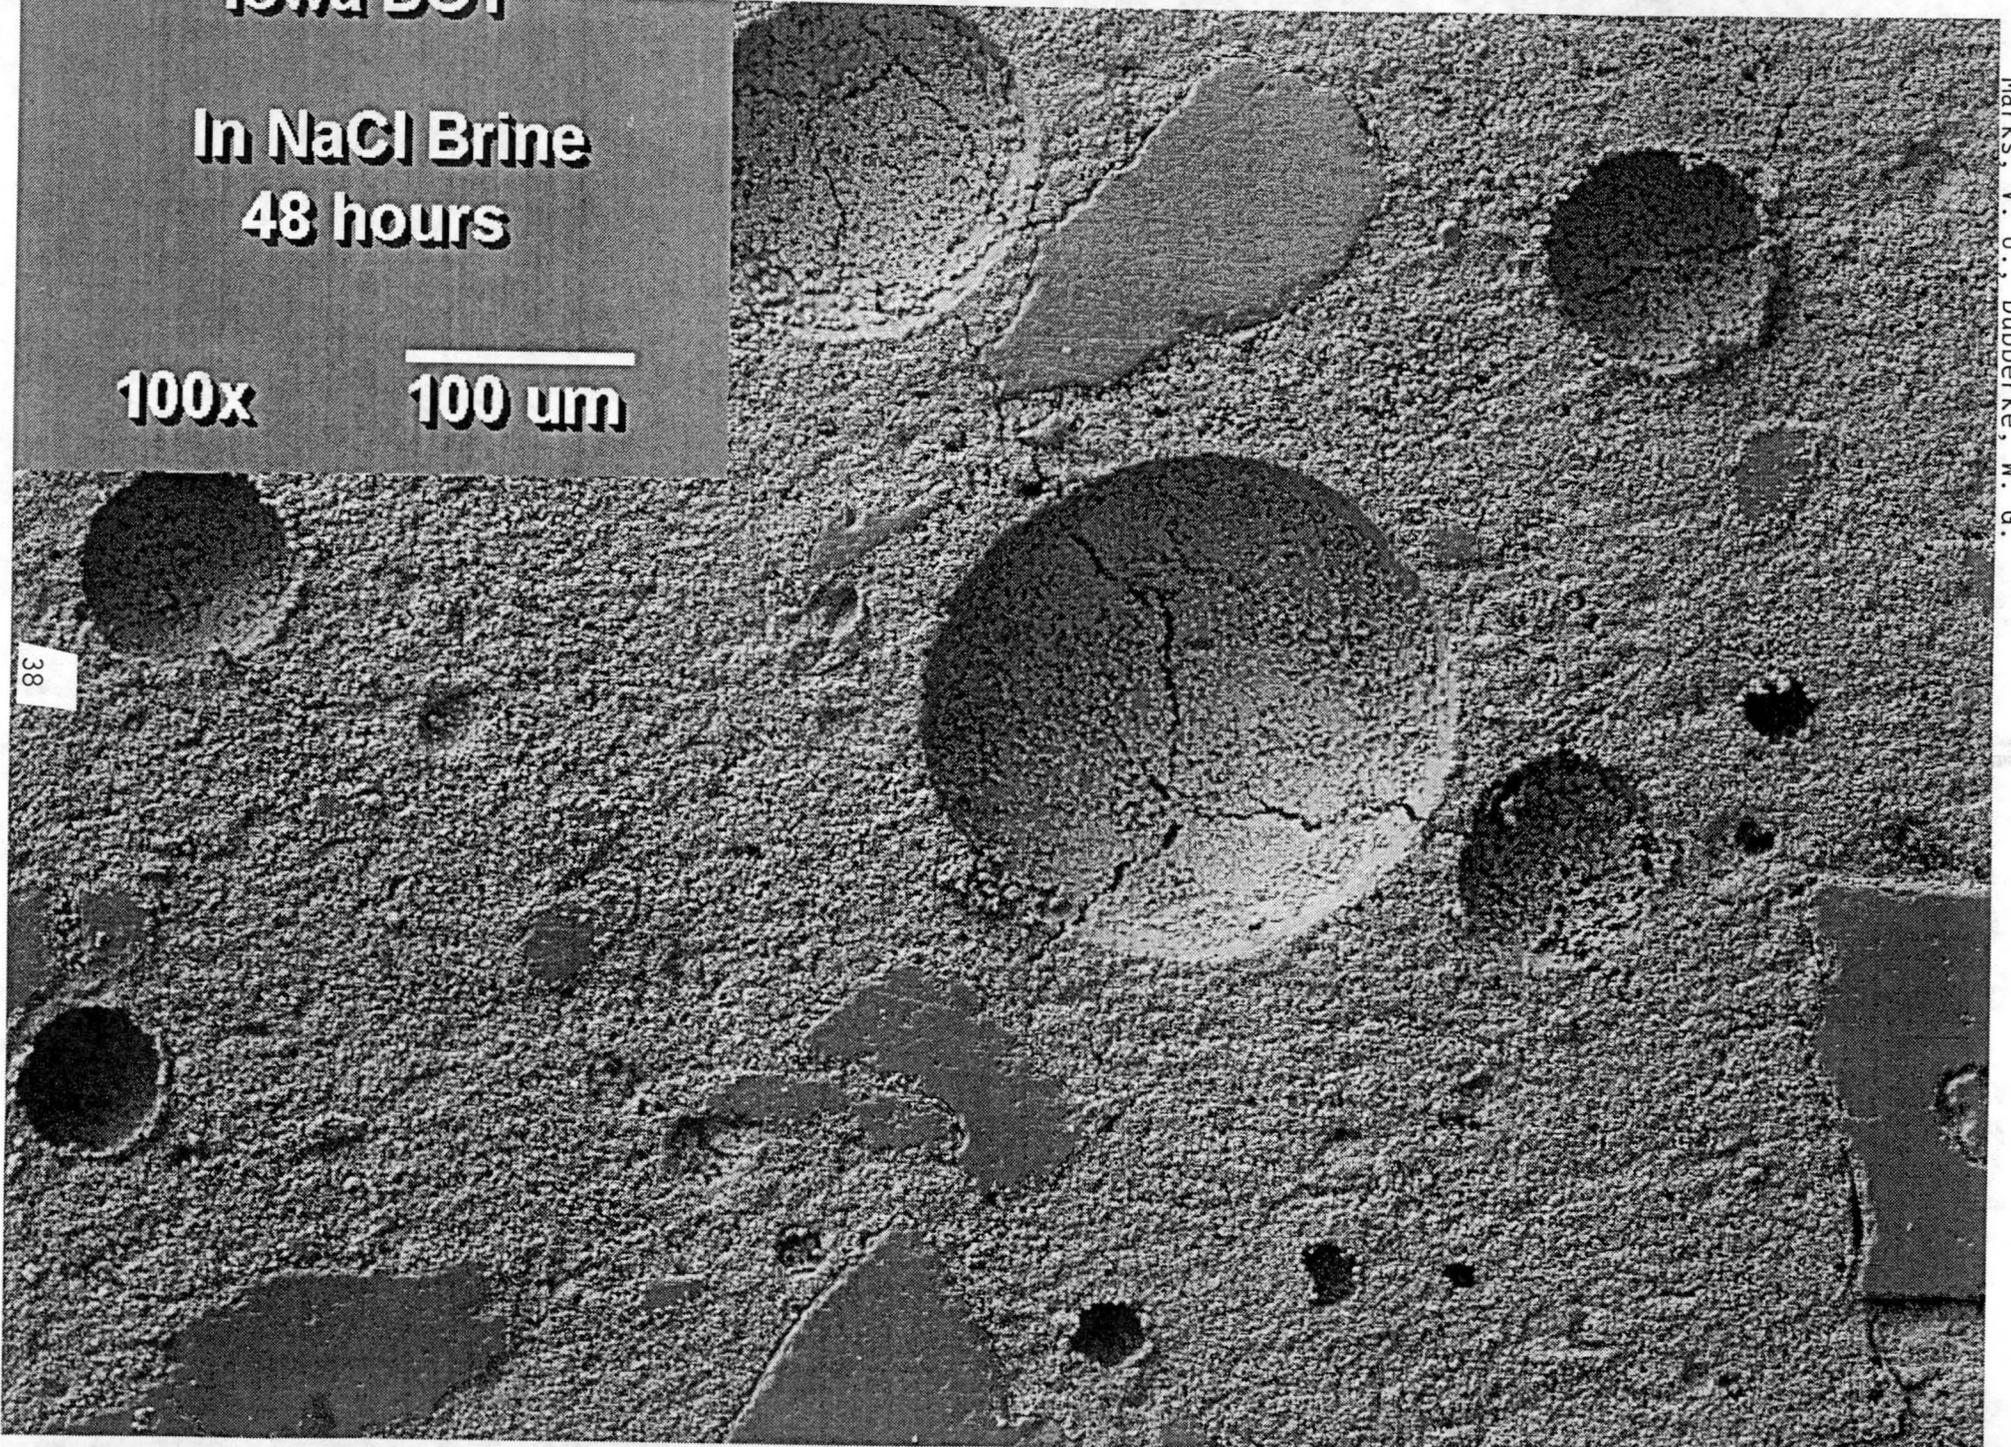
FIGURE 15 A 100X BSE PHOTOMICROGRAPH OF THE FIGURE 12 AIR VOIDS 48 HOURS AFTER TREATMENT WITH NaCl BRINE

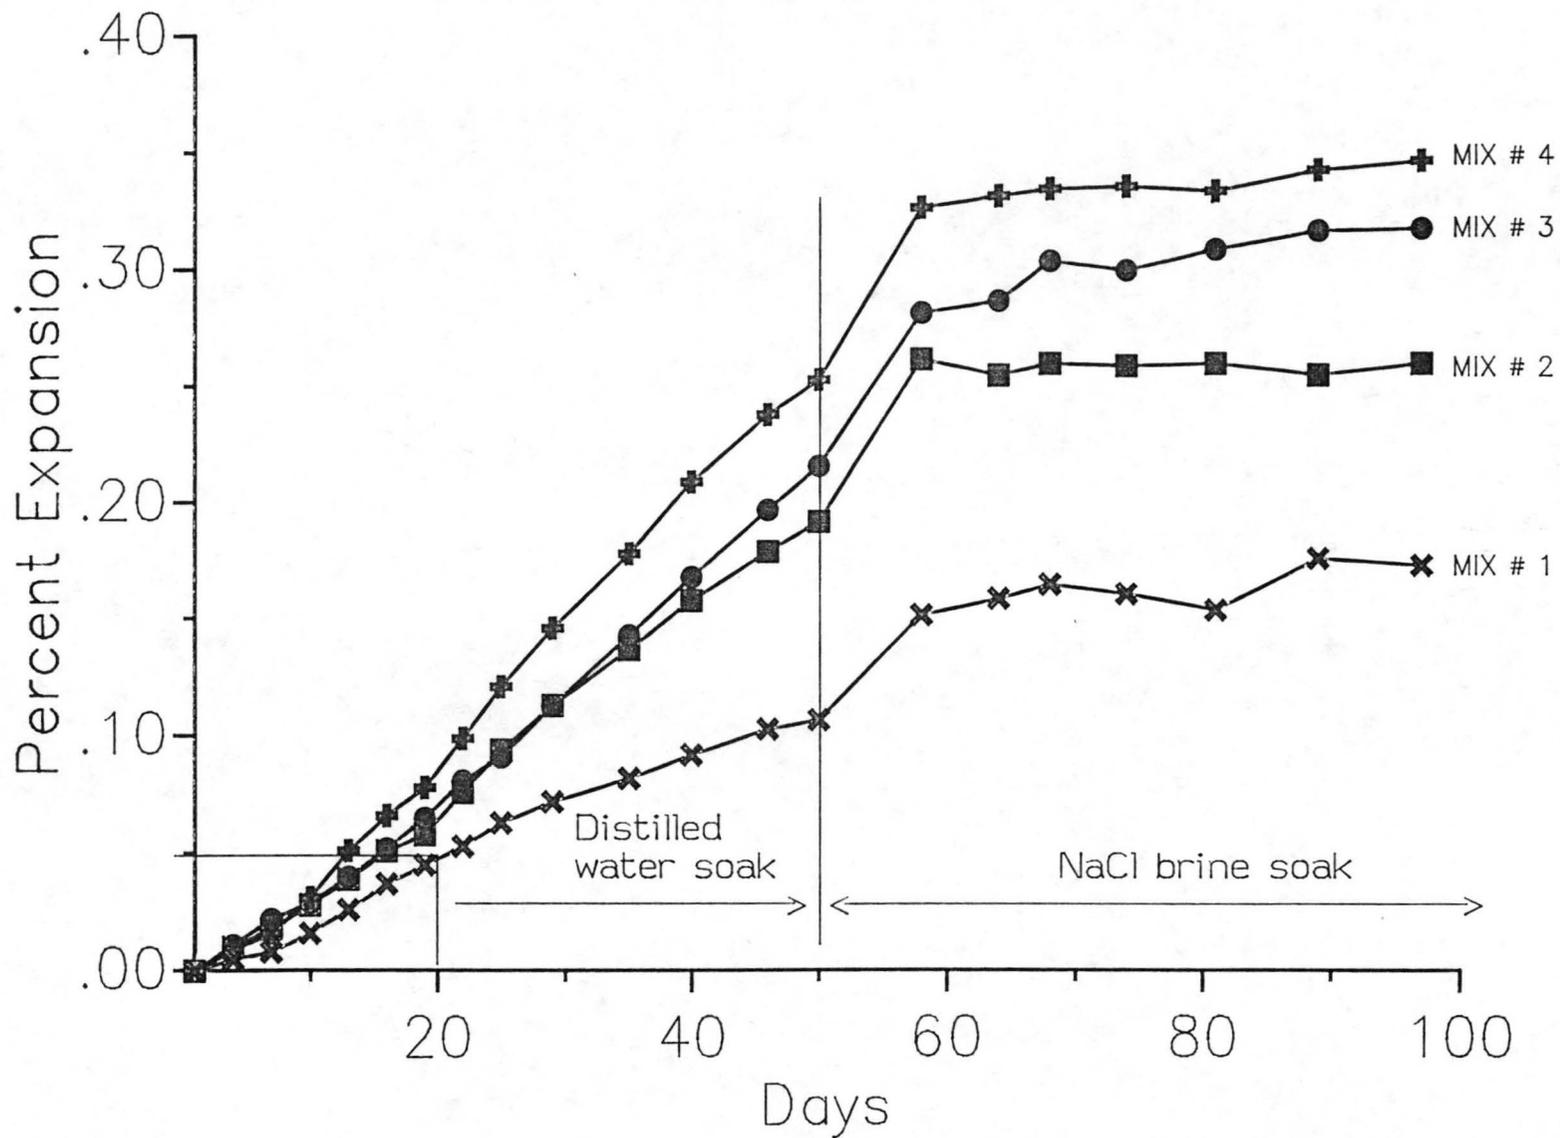
The SEM data shows that when PCC is soaked in a NaCl brine, ettringite will initially expand and then dissolve or be dislodged. Duggan cores (5) 25 mm (1 in.) in diameter and 51 mm (2 in.) long were drilled from the laboratory prepared PCC that had been stored in the moist room. This PCC had exhibited ettringite either growing in or being extruded into the air voids as described earlier in this paper. These four cores had exhibited a relatively constant rate of expansion through 50 days during a distilled water soak (Figure 16). At 50 days after

pretreatment, the four cores were changed to a NaCl brine soak. From 50 to 60 days all four cores exhibited an increased rate of expansion. After 60 days there was very little expansion indicating that the expansive mechanism had been destroyed (or dissolved). There is speculation that the expansive pressure was due to ettringite through 50 days. When subjected to NaCl at 50 days, there was increased expansion of the ettringite. The ettringite then dissolved and there was very little additional expansion. Other researchers have identified ettringite filled or partially filled voids in deteriorated PCC pavement (6) and one of those has concluded it is the cause of concrete deterioration (7, 8, 9, 10, 11).

Figure 16 DUGGAN TEST RESULTS
WITH SODIUM CHLORIDE BRINE MODIFICATION
