# Investigation of Techniques for Accelerating the Construction of Bridge Deck Overlays

**Final Report**  
**April 2016**

**IOWA STATE UNIVERSITY**  
**Institute for Transportation**

**Sponsored by**  
Federal Highway Administration  
Iowa Department of Transportation  
(InTrans Project 14-500)

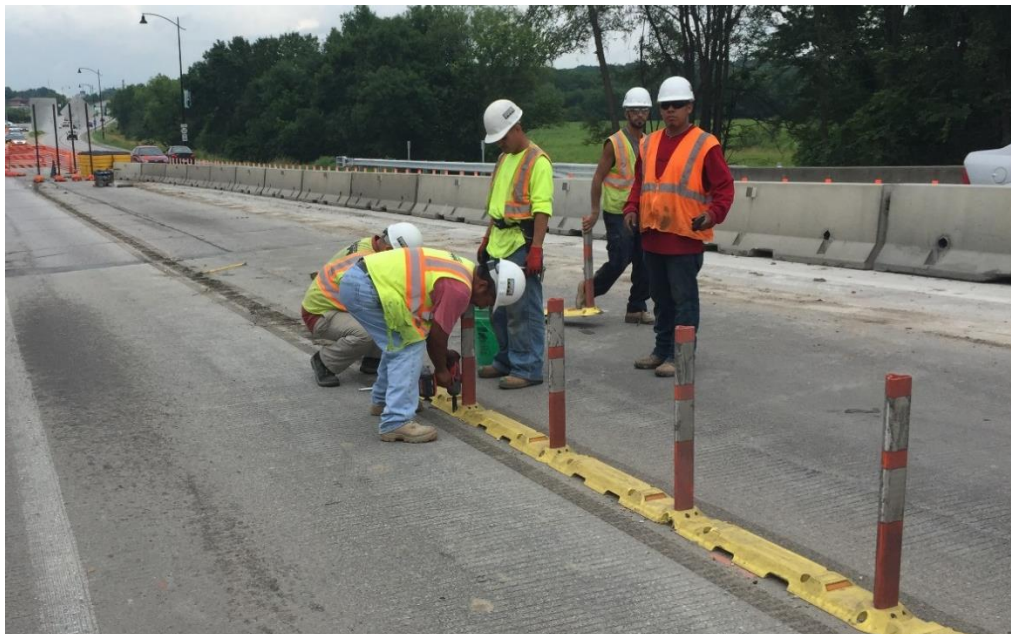
Temporary bollards were installed on the bridge deck during construction of the westbound overlay. These bollards were installed between the eastbound and westbound lanes to direct traffic safely. The bollards that were used were bolted to the deck and had to be detached using a hand drill as shown in the Figure 1.

**Figure 1. Temporary bollards being detached by workers**

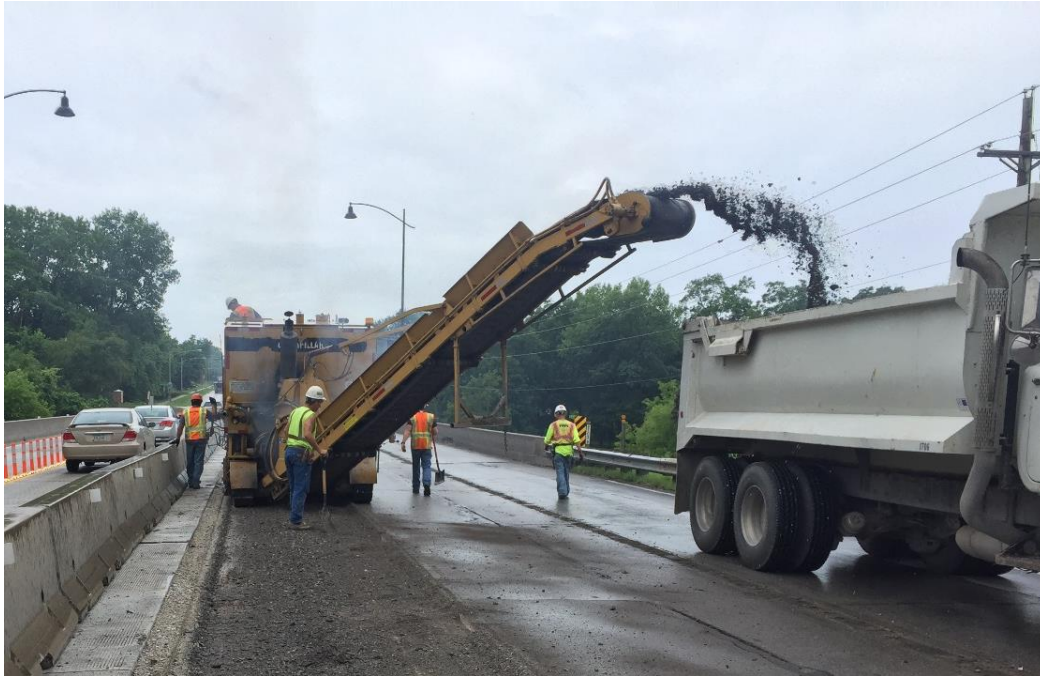
One person operated the machine and four workers watched over the machine and guided the operator. The milled concrete was transferred to a dump truck by a conveyor connected to the milling machine as shown in Figure 2.

**Figure 2. Milling machine removal of top layer of the deck**

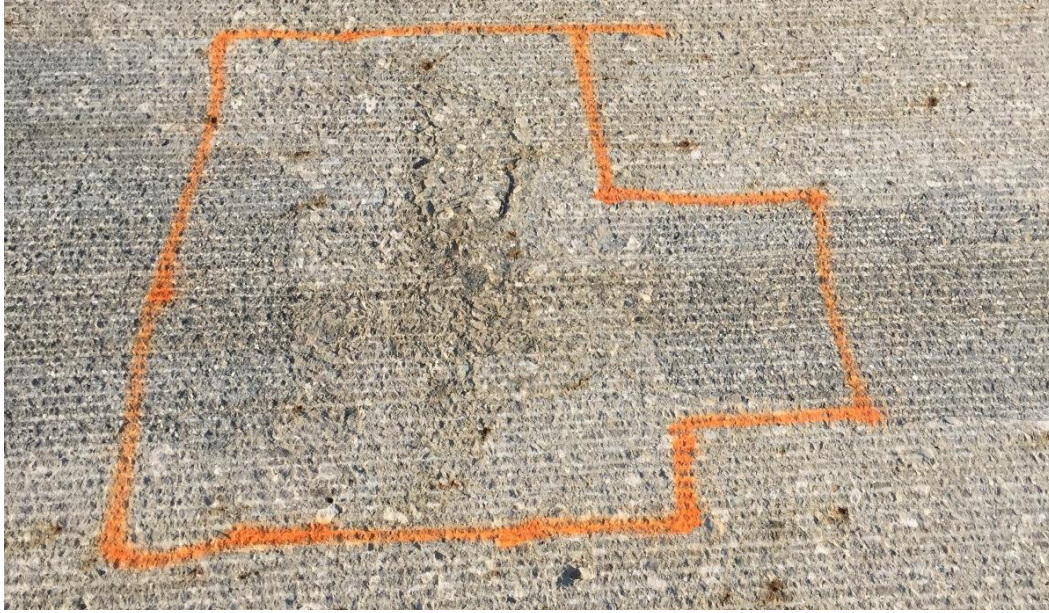
After doing five passes, all of the top layer of concrete on the deck was removed and the residual concrete was cleaned off. Alongside cleaning, the cleaned deck portion was inspected for unsound and damaged areas, which were marked for more in-depth removal as shown in Figure 3.

**Figure 3. Area marked for more in-depth removal**

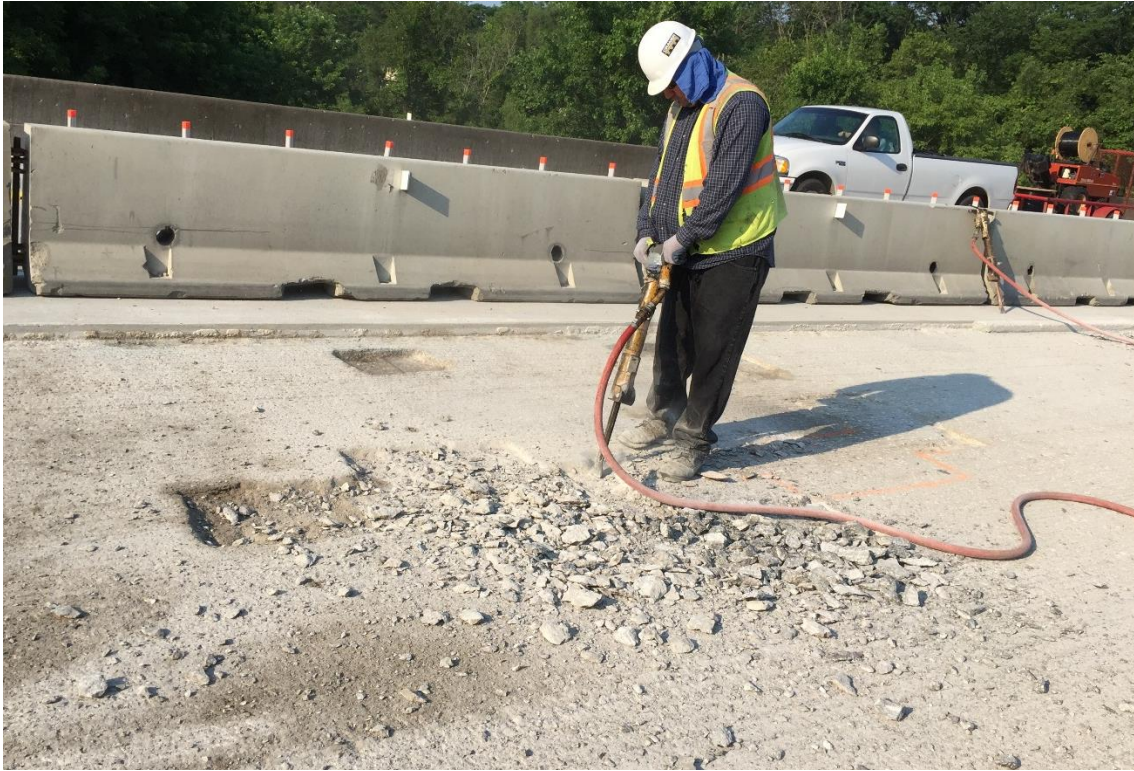
The removal of substrate concrete using the jackhammers was completed by nine workers over the course of three days. On the first day, it took an hour to prepare for the task and then removal took about six hours. By the end of second day, all marked, unsound concrete was removed. On the third day, all areas were carefully inspected and marked for additional concrete removal. After the inspection, removal of the marked concrete took place for seven additional hours. Figure 4 shows a worker removing the marked patch of concrete using a jackhammer.

**Figure 4. Removal of unsound concrete using jackhammer**

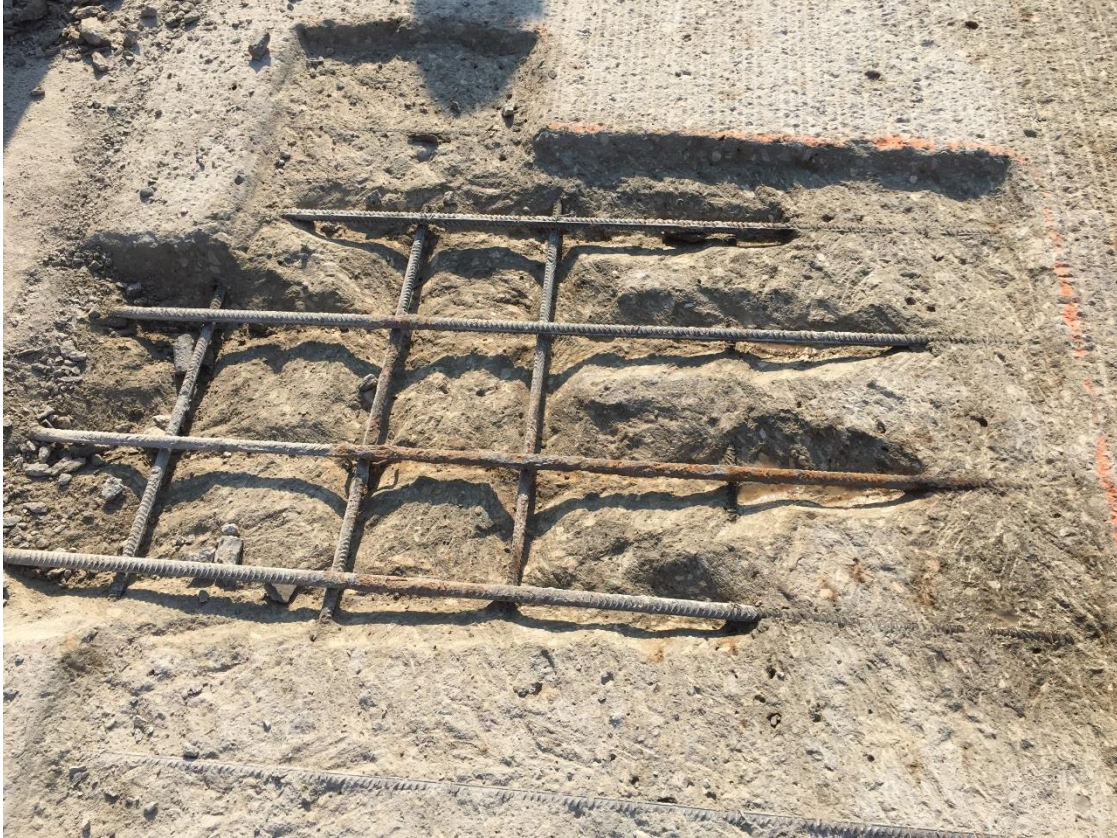
On the third day, the deck was inspected for areas where the entire reinforcing steel bar needed to be exposed. According to the contractor, about 30% of the time, the damaged concrete level is between half the diameter to the full diameter of the bar and the workers need to expose the entire reinforcing steel bar. This extra removal may take many hours to complete depending on how deep the deteriorated concrete is and over how much area it extends. In a best case scenario, it may have been possible for the entire third day of concrete removal to have been almost entirely avoided if the deteriorated concrete was just barely below the half diameter point. It seems fair to say that this additional removal may have taken 4 to 8 hours. Figure 5 shows a deteriorated area of deck concrete after removal of the substrate concrete.

**Figure 5. Deteriorated area of the deck after removal of the substrate concrete**

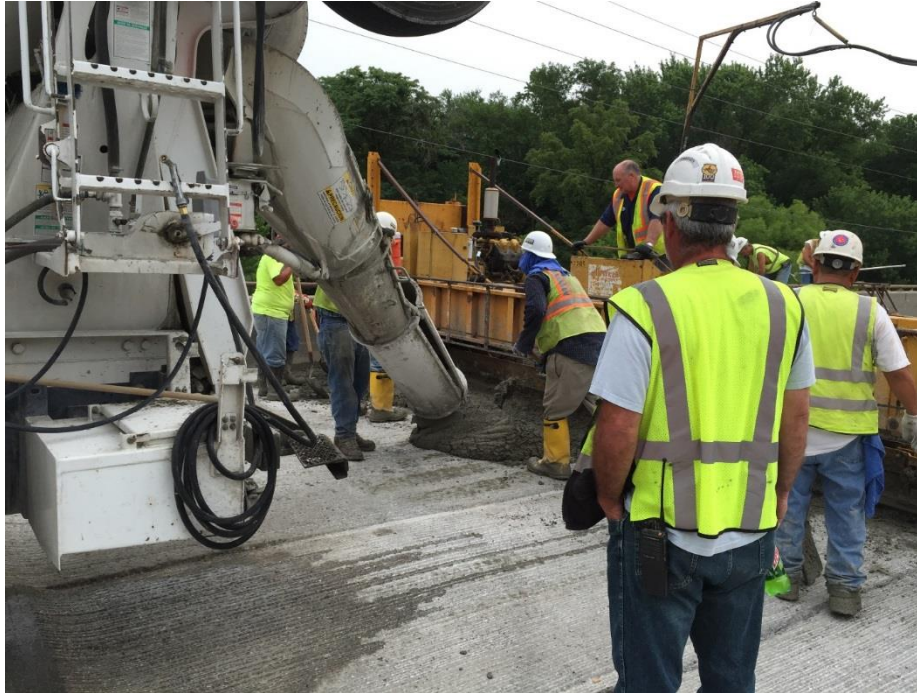
Preparatory work for overlay placement took about five hours with 10 workers. Followed by the preparation work, the ready-mixed concrete was placed on the deck as shown in Figure 6.

**Figure 6. Ready-mixed concrete being placed on the deck**

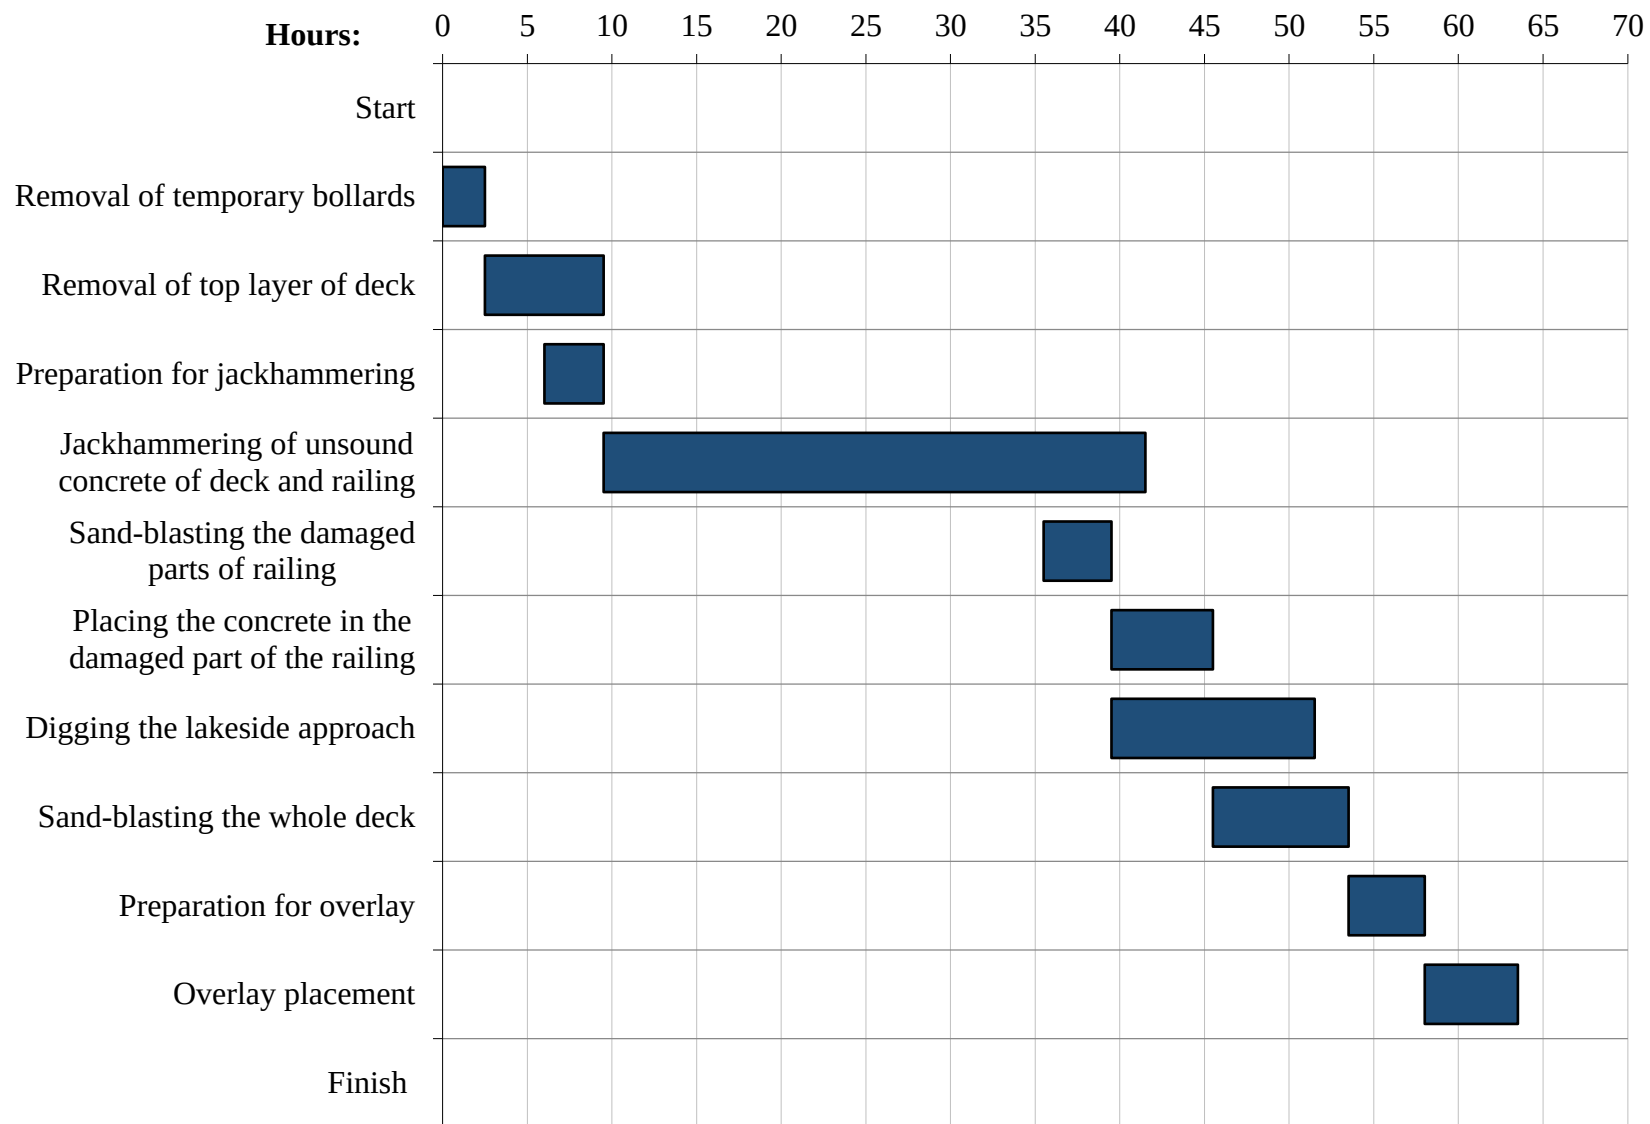
The contract proposal for the entire bridge deck overlay construction (eastbound and westbound lanes) shows a contract period of 40 working days. During this project, however, the research team only observed the overlay portion of the project, as the goal was to identify areas when traffic mobility was impacted. Collectively, the two most time-consuming operations were old concrete removal and overlay placement. If the rapid set alternatives briefly described in Chapter 2 were shown to provide the durability, permeability, abrasion resistance, freeze-thaw resistance, etc. that is needed, and if the additional concrete removal below the one-half bar diameter requirement was eliminated, it seems possible that up to 77 hours of the estimated 136 could have been saved.

**Figure 8. Eastbound overlay construction schedule as observed**

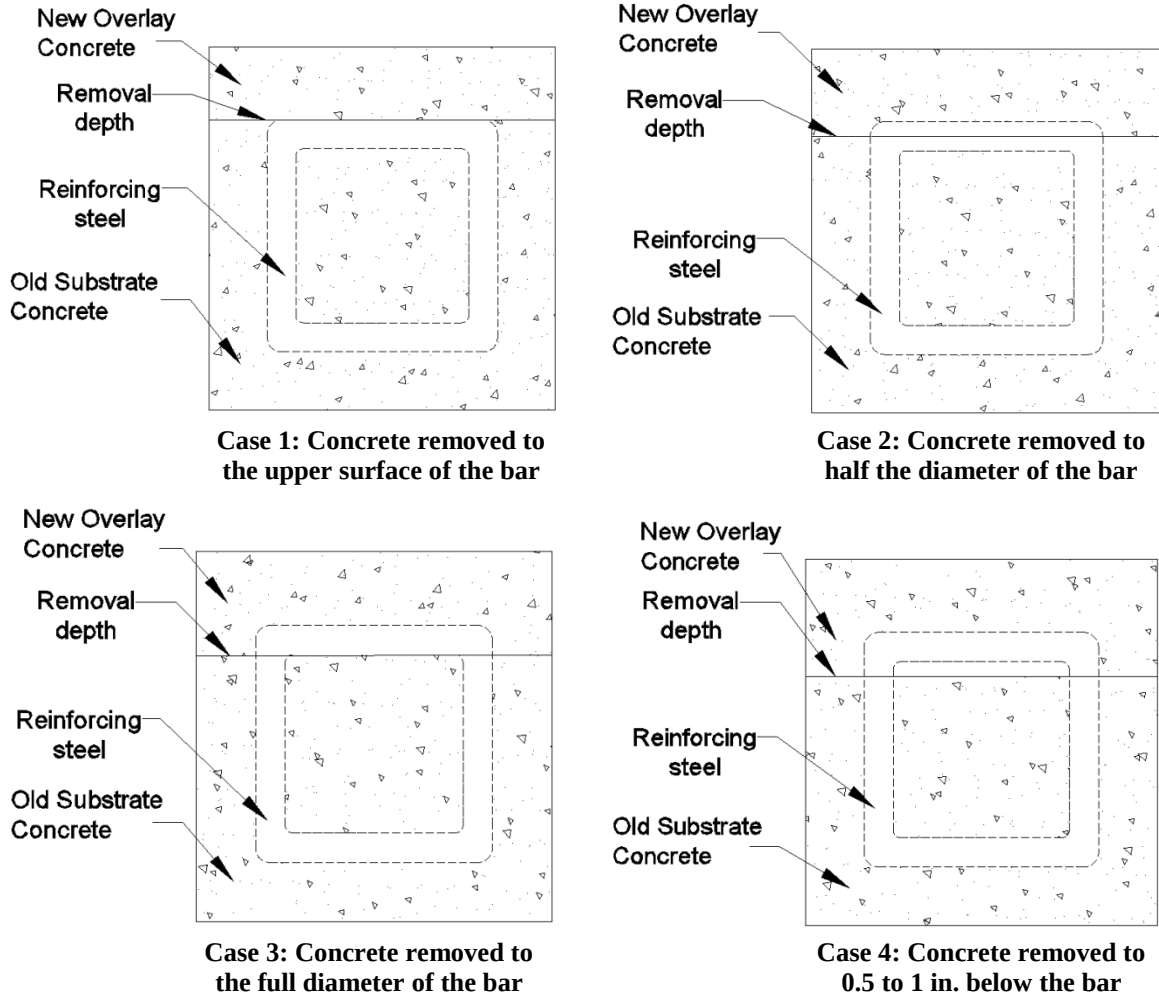
To get deeper, an additional 0.5 to 1 in. concrete was removed in addition to the full bar exposure condition.

**Figure 9. Different depths of concrete removal considered**

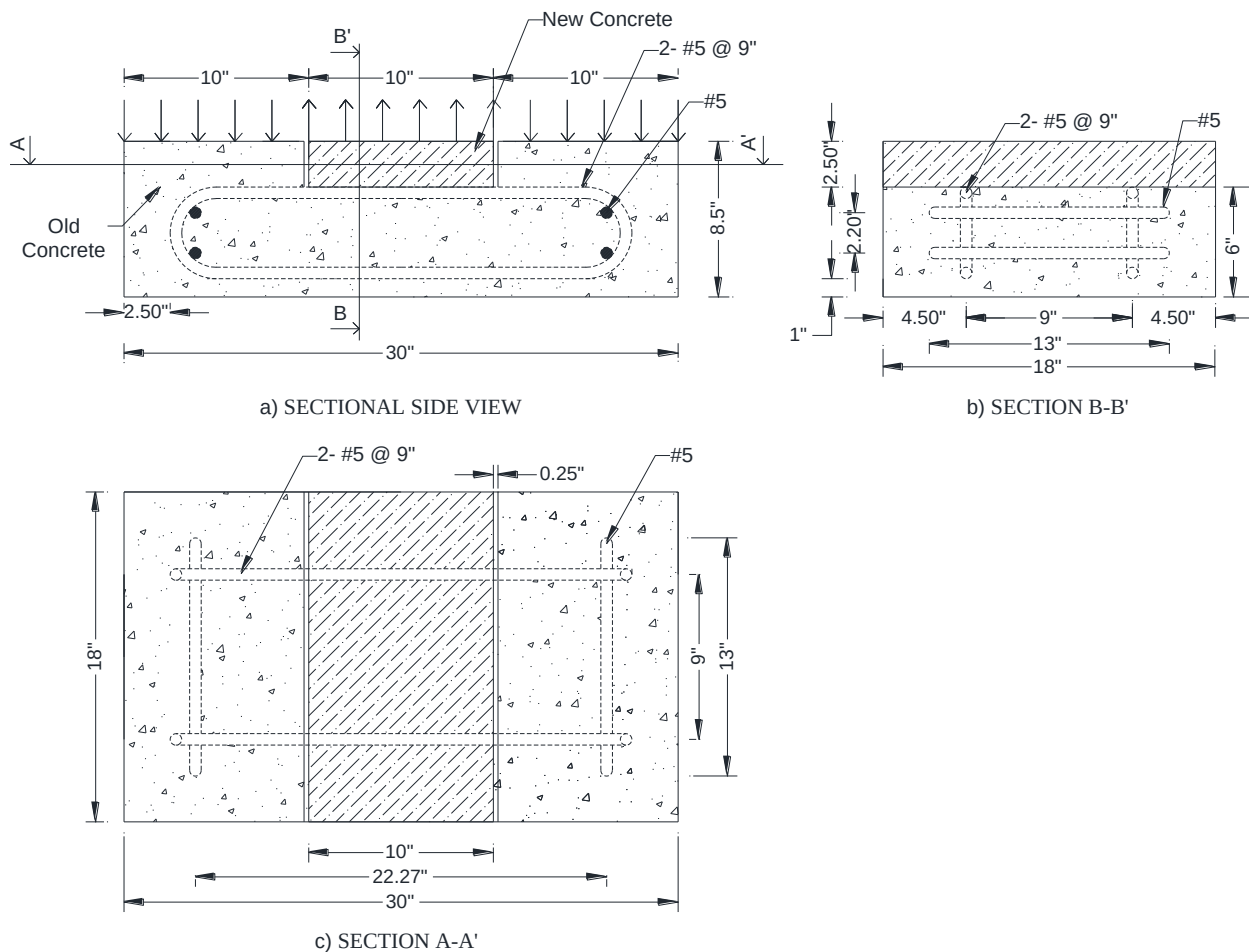
The specimens were fabricated to resemble a bridge deck slab. The dimensions of each specimen, the reinforcing steel spacing, and the detailing are all similar to an actual deck slab and are shown in Figure 10 for Case 1 (concrete removed down to the upper surface of the reinforcing bar).

**Figure 10. Pull-off test specimen schematic (Case 1)**

As shown earlier in the Figure 10 schematic (upper left), a gap is needed between the substrate concrete and the new overlay concrete for pull-off test placement of the overlay concrete. Without the gap, at the time of pull-off test loading, the vertical bond between the substrate concrete and the new overlay concrete along the edges of the overlay concrete would provide shear bond strength to resist the load in addition to the tensile bond strength provided by the horizontal bond at the bottom of the overlay concrete. To get only the tensile strength resistance, foam with a 0.25 in. thickness was glued to the C4 concrete on each side to create the voids as shown in Figure 12.

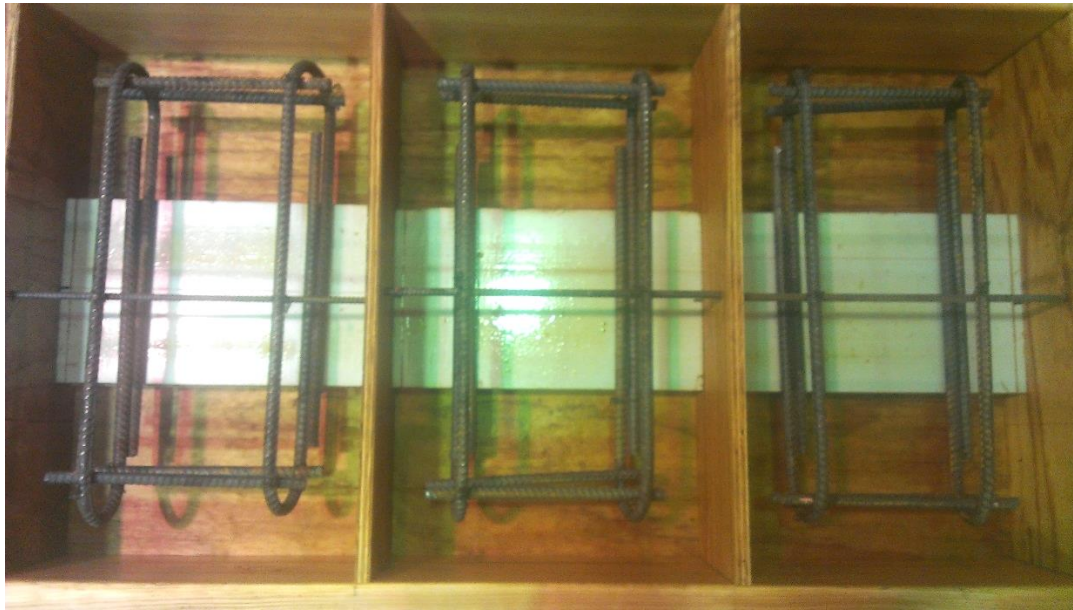
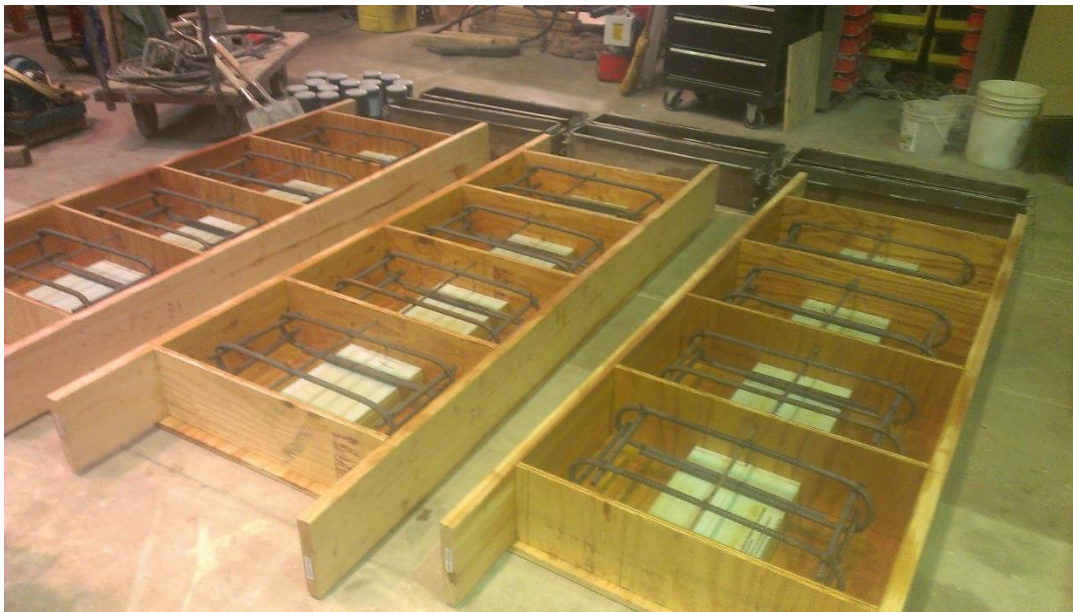
reinforcing steel was placed on the foam. An extra reinforcing steel bar was used to keep the main reinforcing steel stable horizontally. The reinforcement arrangement can be seen in Figure 11.

a) Top view

b) Angle view

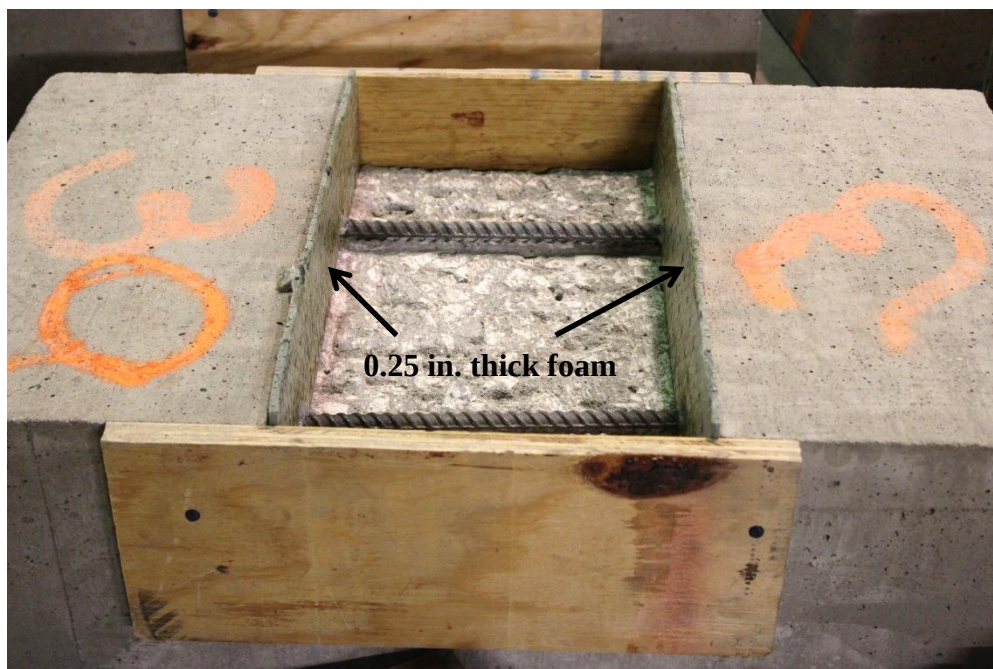
**Figure 12. Pull-off test formwork for overlay concrete placement (Case 4)**

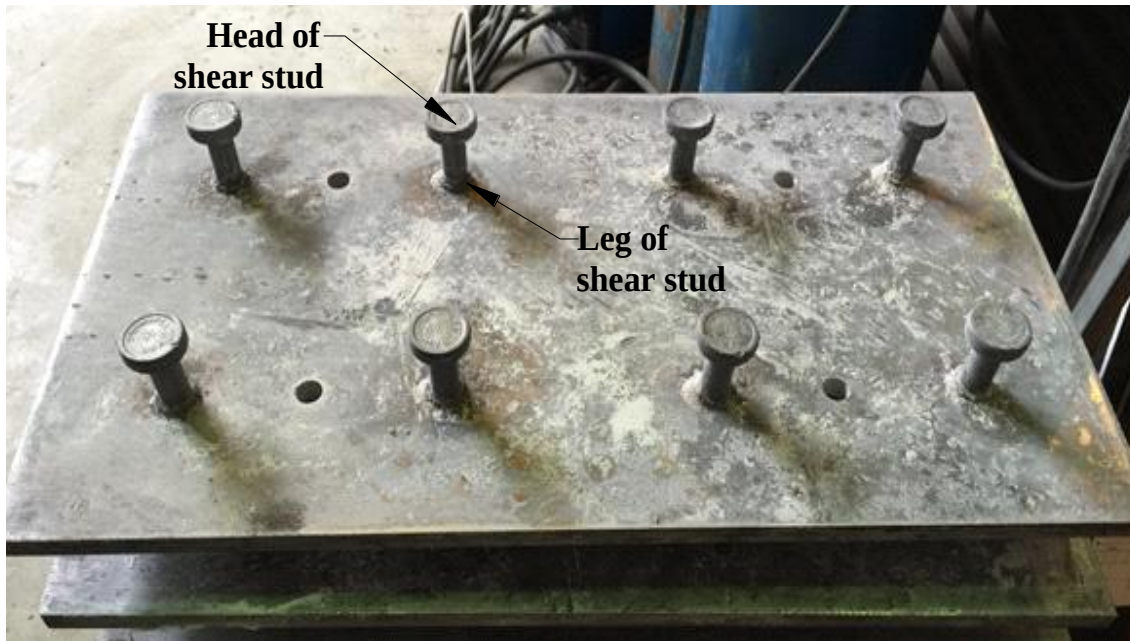
The most challenging aspect of this test was to figure out a method to apply the pull-off force to the new overlay concrete. After much discussion, shear studs welded to a steel plate, as shown in Figure 13, were used.

**Figure 13. Pull-off test steel plate with welded shear studs**

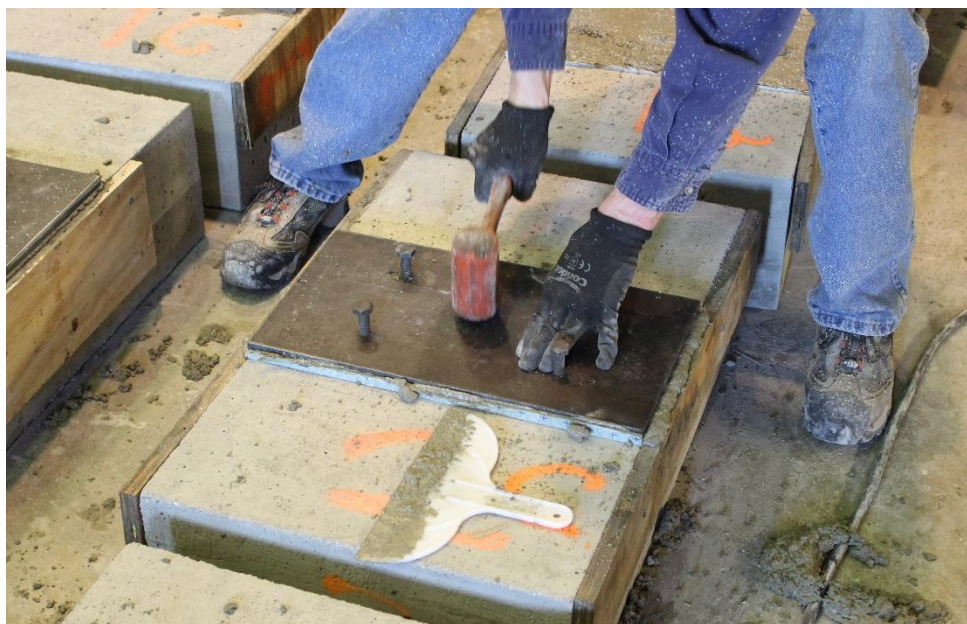
To bond the new overlay concrete to the previously placed concrete, a grout consisting of a mixture of about 5 to 6 gallons of water to each 94 lb bag of cement (12.5 to 13.8 in<sup>3</sup> of water per lb of cement) was used. The grout material was applied to the chipped portion using a stiff hand brush, just prior to placing of the overlay concrete. As soon as the grout was applied, the overlay concrete was placed so that the applied grout would still be wet when the concrete was placed. After the concrete was placed, the steel plate studs were embedded in it by firmly tapping the plate using a rubber hammer as shown in Figure 14.

**Figure 14. Tapping the steel plate to embed the shear studs on a pull-off test specimen**

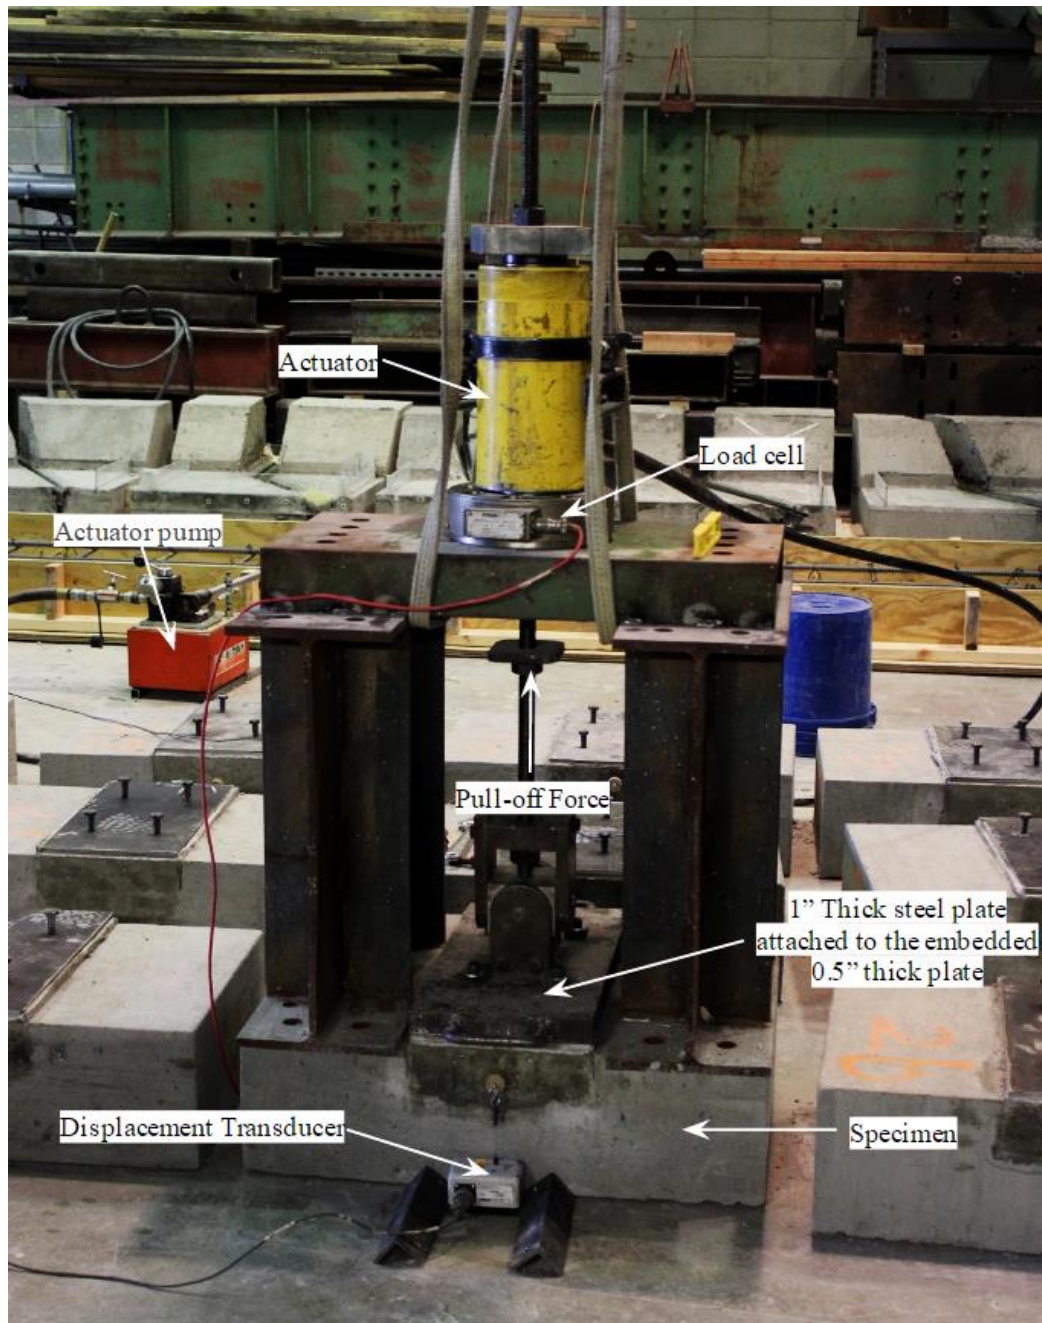
Figure 15 shows the testing arrangement for the pull-off test. Closer views of the specimens are shown in the next section.

**Figure 15. Testing arrangement for pull-off test**

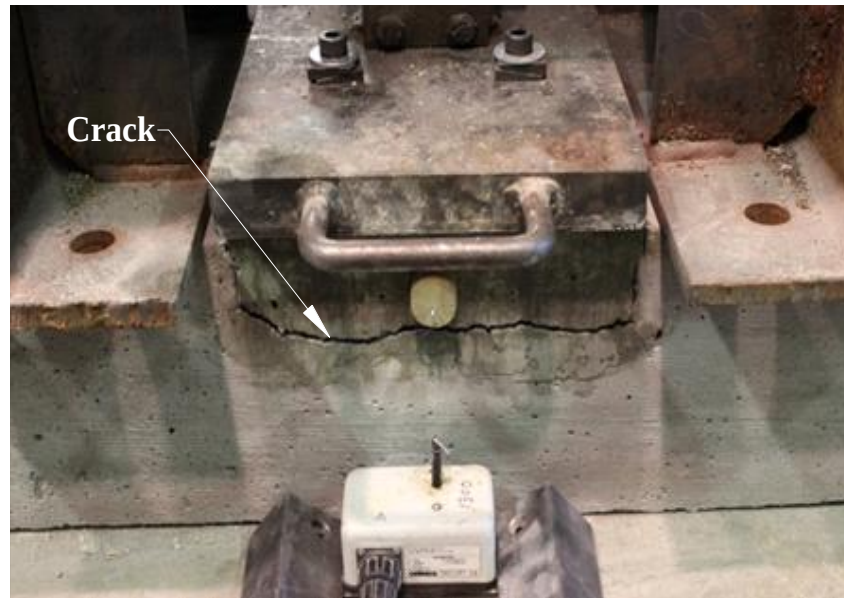
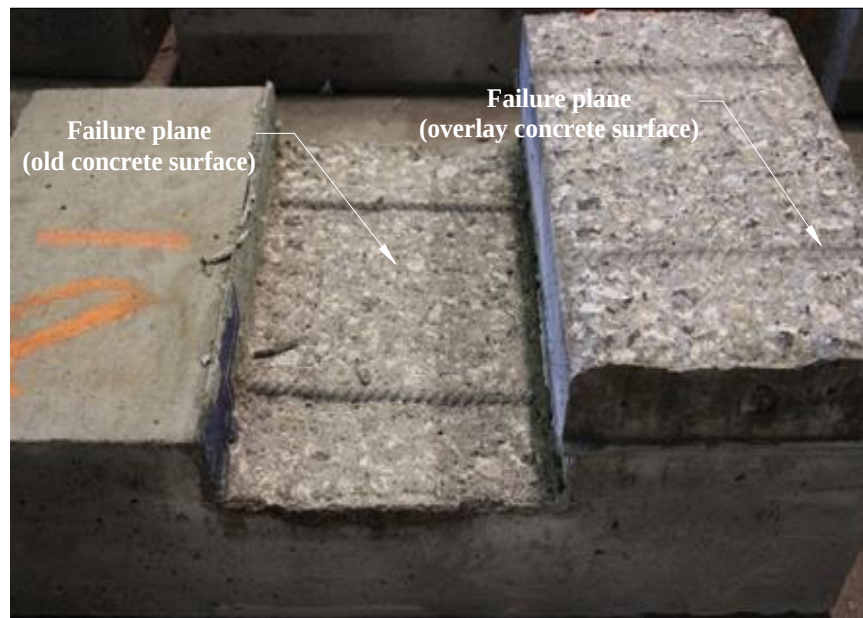
For Case 1, two of the specimens failed at the bond interface and one specimen failed in the overlay. Figure 16 shows a side view of the failure (total separation of the bond) at the interface of the substrate and new overlay concrete and a top view of the interface surface after the failure.

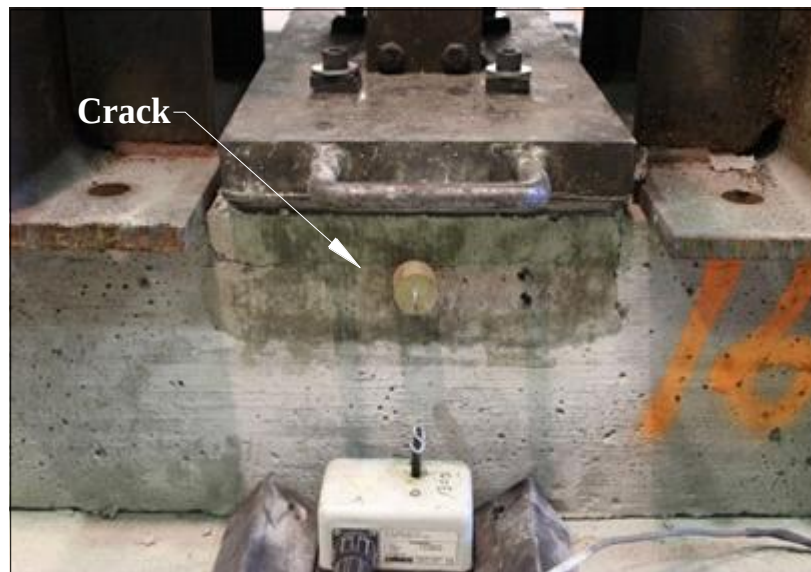
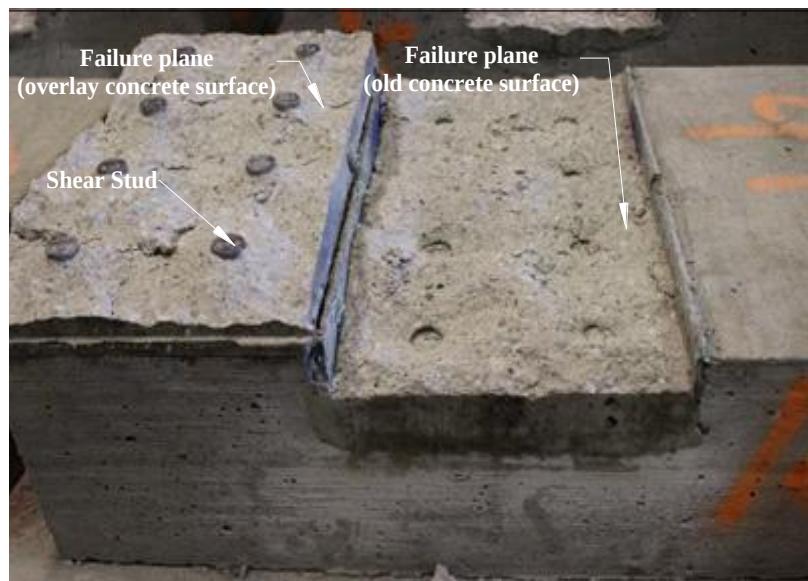
Figure 17 shows a side view of the failure of the specimen in the overlay concrete at the heads of the shear studs and a top view of the failure plane at the break in the bond.

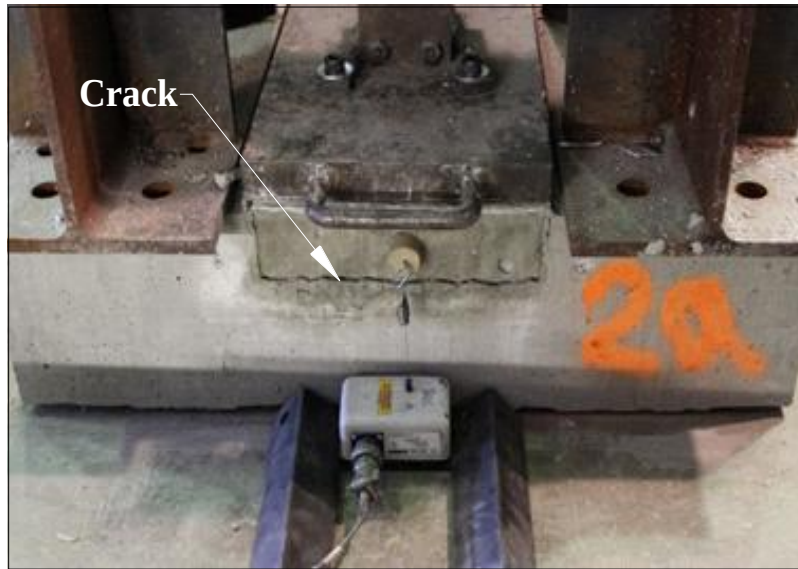
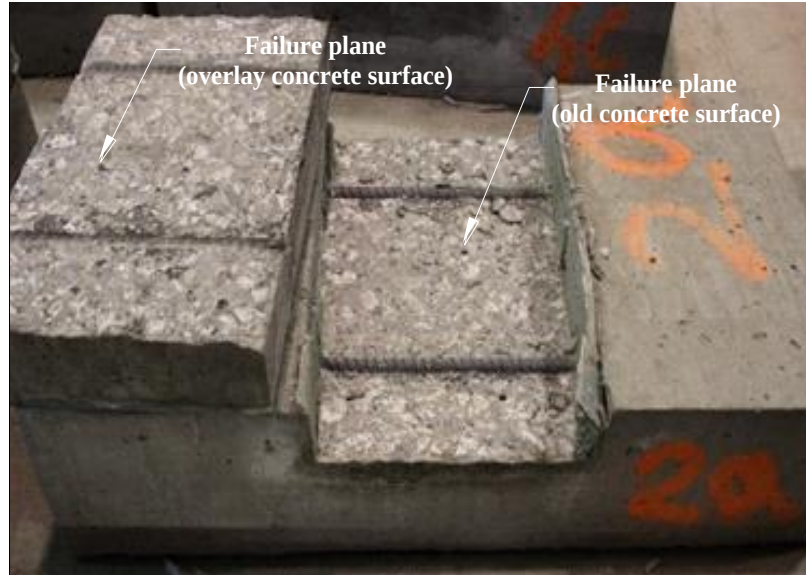
In this case, two specimen failures were observed at the bond interface and one specimen failed in the overlay concrete at the heads of the shear studs. Figure 18 shows the failure of the specimen at the interface of the substrate and new overlay concrete.

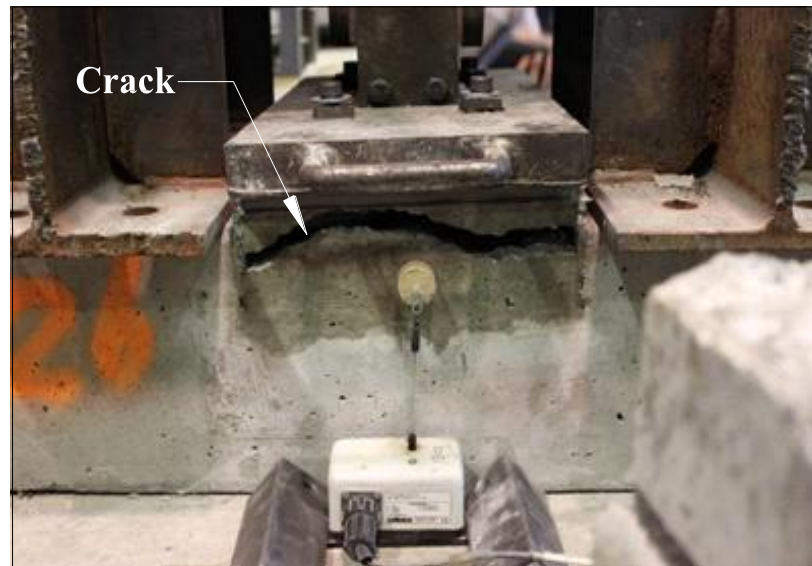
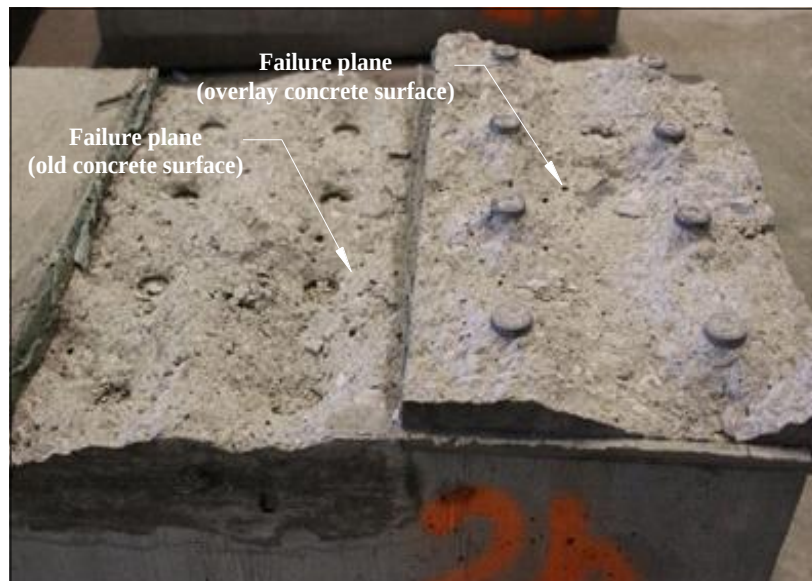
Figure 19 shows the failure of the specimen in the overlay concrete at the heads of the shear studs and the surface at which the break in the bond was observed.

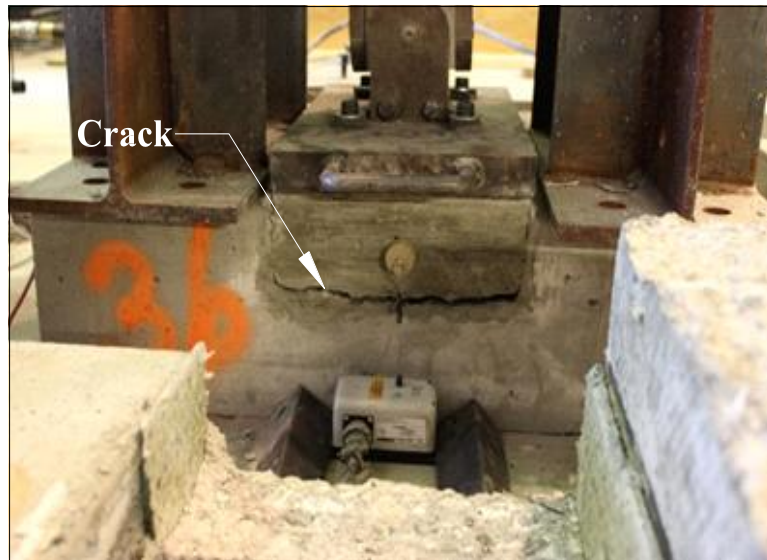
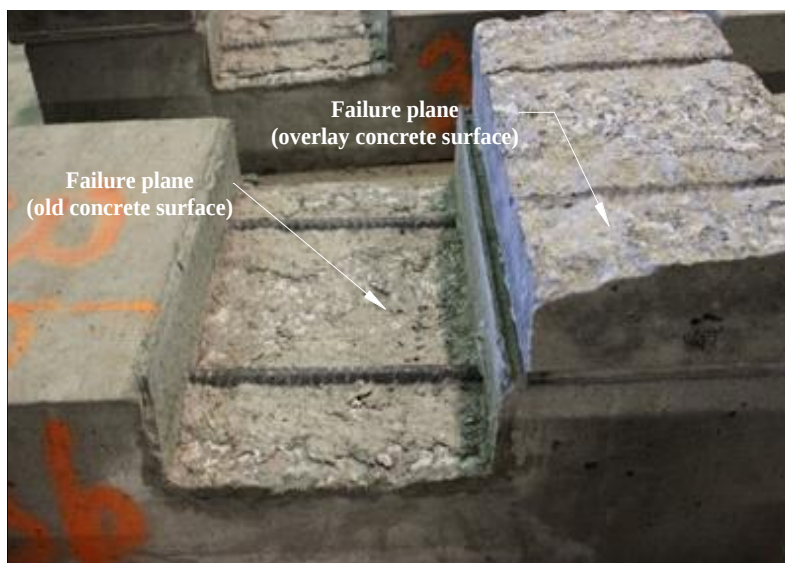
All of the specimens in this case failed at the interface level as shown in the Figure 20. The figure shows the pattern of the crack and the interface surface.

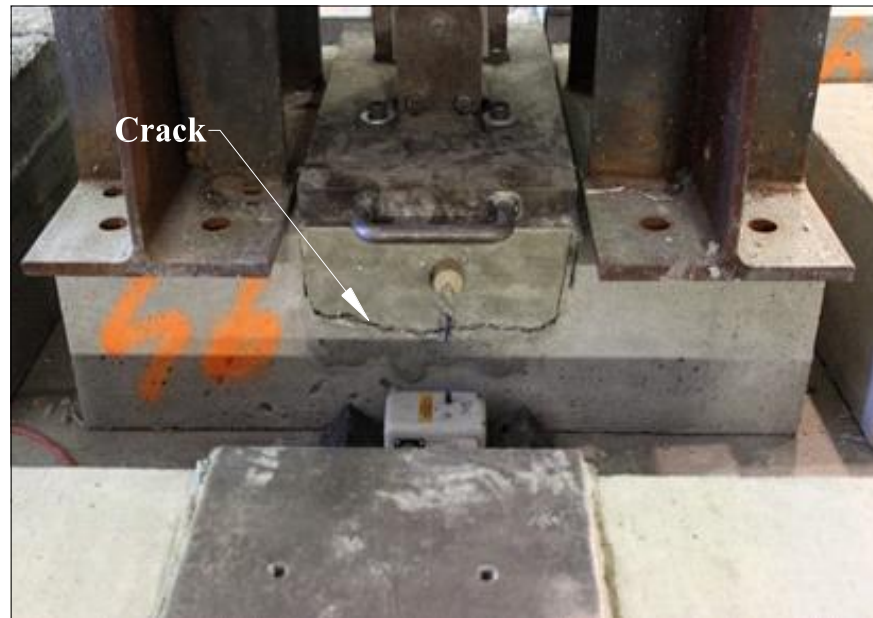
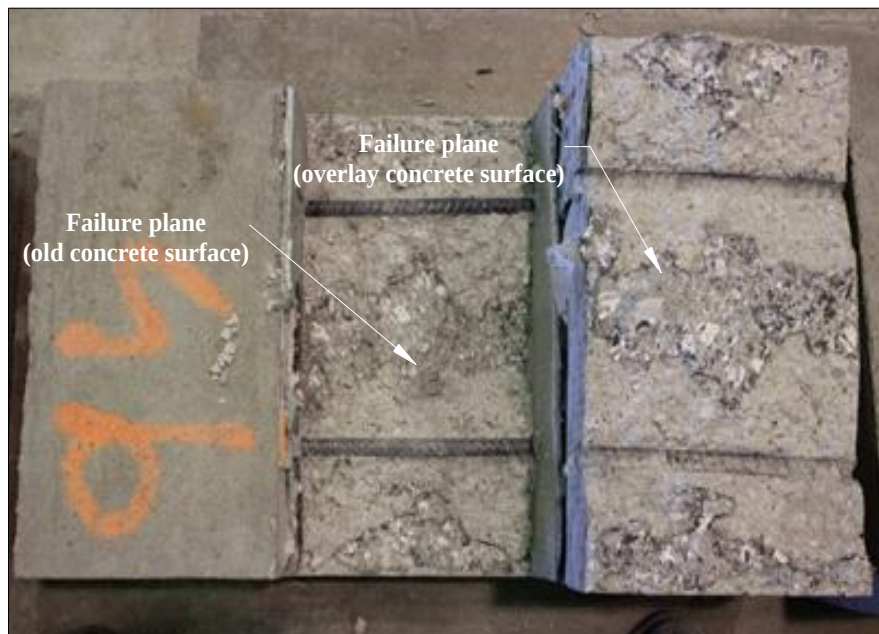
In this case, two of the specimens failed in the overlay and one specimen failed at the interface. Figure 21 shows the failure of the specimen at the interface of the substrate concrete and new overlay concrete.

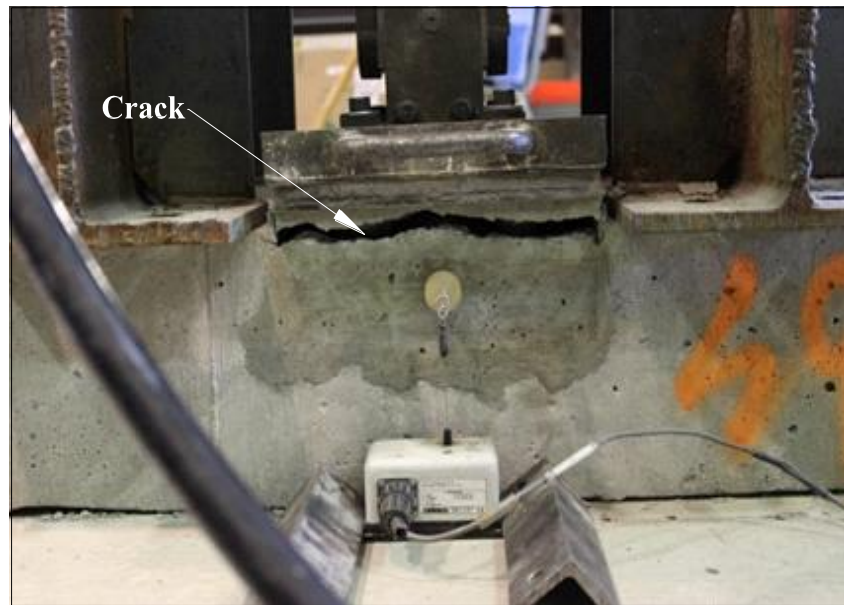
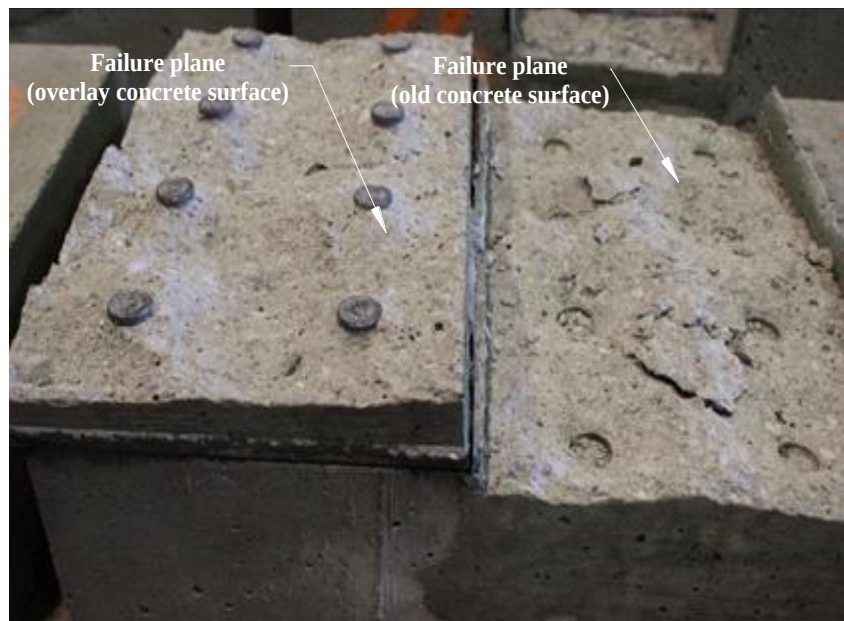
Figure 22 shows a side view of the failure of the specimen in the overlay concrete at the heads of the shear studs and a top view of the interface surface after the failure.

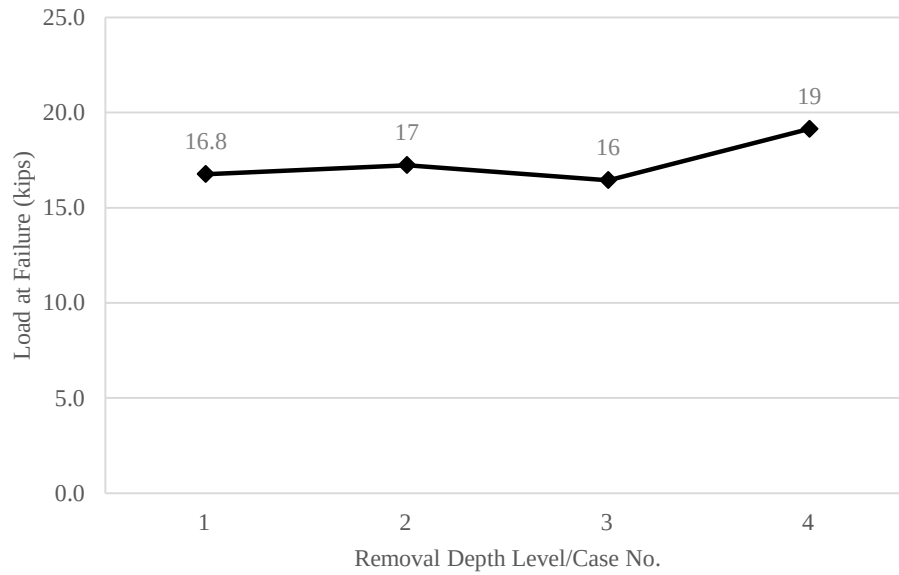
Figure 23 shows the variation of the average load at failure versus the concrete removal depth level (Case 1 through 4).

**Figure 23. Average load at failure versus concrete removal depth (pull-off test)**
