# Investigation of Techniques for Accelerating the Construction of Bridge Deck Overlays

**Final Report**  
**April 2016**

**IOWA STATE UNIVERSITY**  
**Institute for Transportation**

**Sponsored by**  
Federal Highway Administration  
Iowa Department of Transportation  
(InTrans Project 14-500)

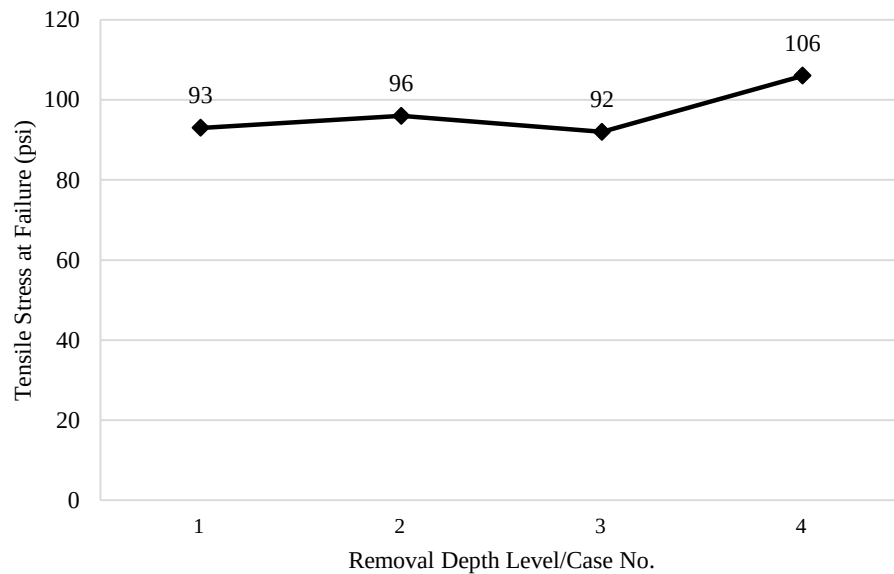
Figure 24 shows the variation of the average tensile bond stress versus the concrete removal depth level (Case 1 through 4).

**Figure 24. Average tensile stress at failure versus concrete removal depth (pull-off test)**

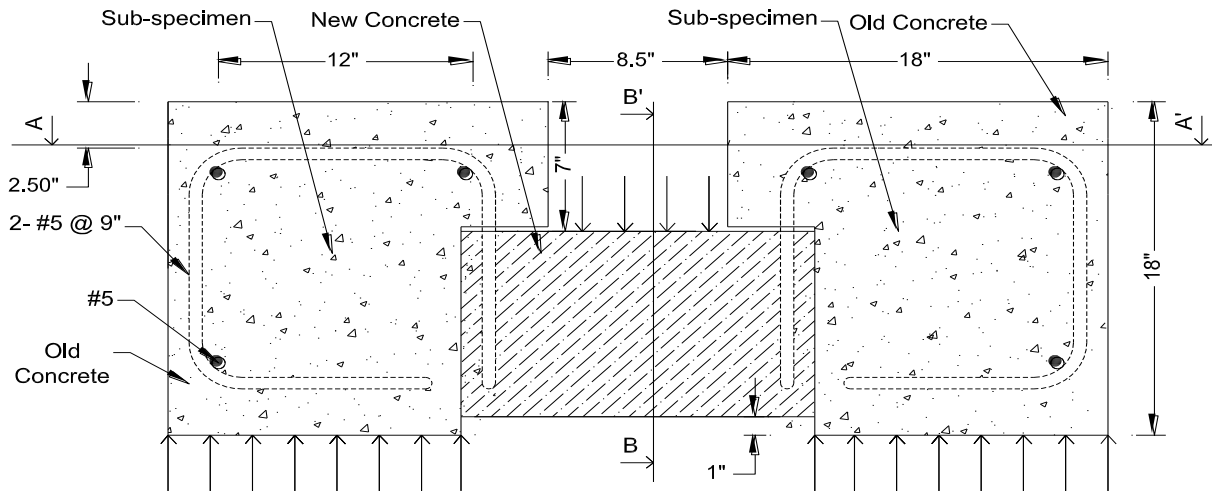
a) SECTIONAL SIDE VIEW

**Figure 26. Push-out test specimen schematic (Case 4)**

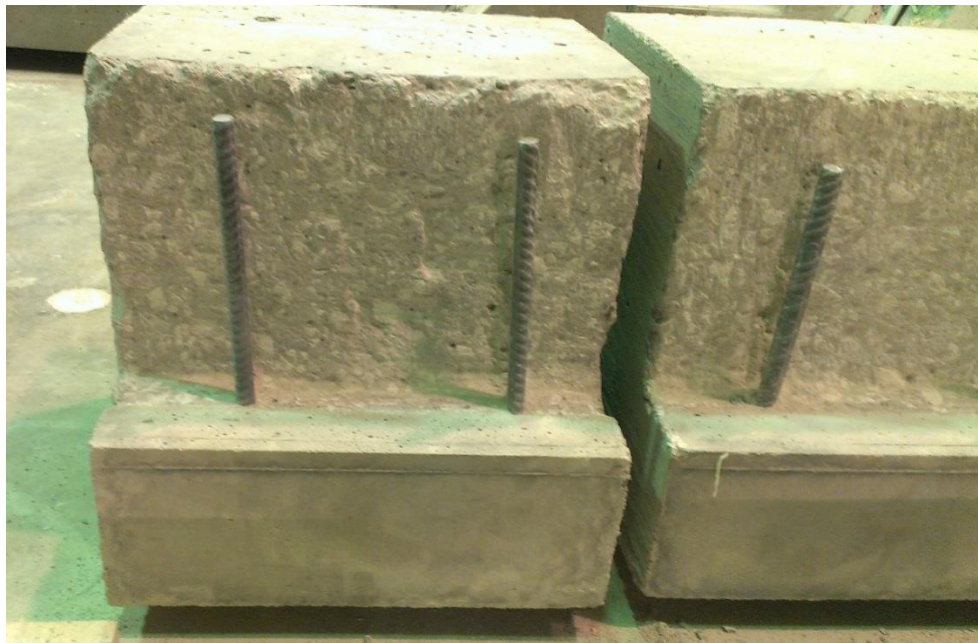
After curing the specimens for three days, the foam and the formwork were removed. The depth of the foam was only up to the face of the reinforcing steel (2.5 in.). Therefore, to achieve the different simulated concrete removal depths, additional concrete was removed and roughened using a jackhammer to the required depths, as shown in Figure 27 (Case 1 specimens only needed to have the concrete roughened).

**Figure 28. Pair of push-out test sub-specimens after concrete removal (Case 4)**

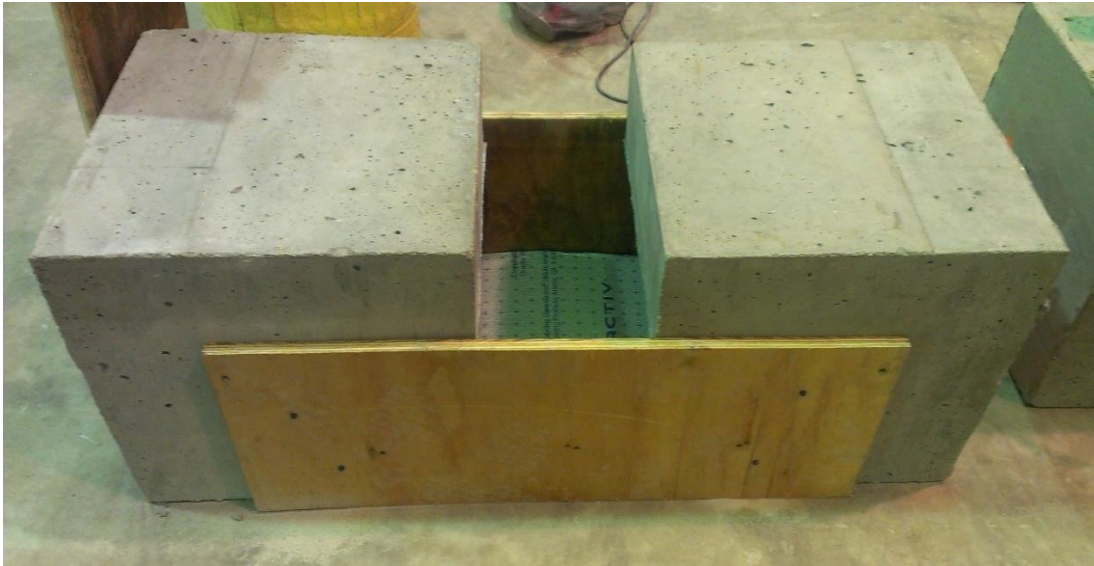
Note that a small (0.25 in.) gap was needed between the substrate concrete and the top of the overlay concrete (as shown in the schematic in Figure 25) to eliminate any tensile bond between the substrate concrete and the top of the overlay concrete. To create this gap, 0.25 in. thick foam was glued to the substrate concrete. Wooden forms were attached to the sides of each pair of specimens as shown in Figure 29 to create the space for the placement of the overlay concrete.

**Figure 29. Push-out test formwork for overlay concrete placement**

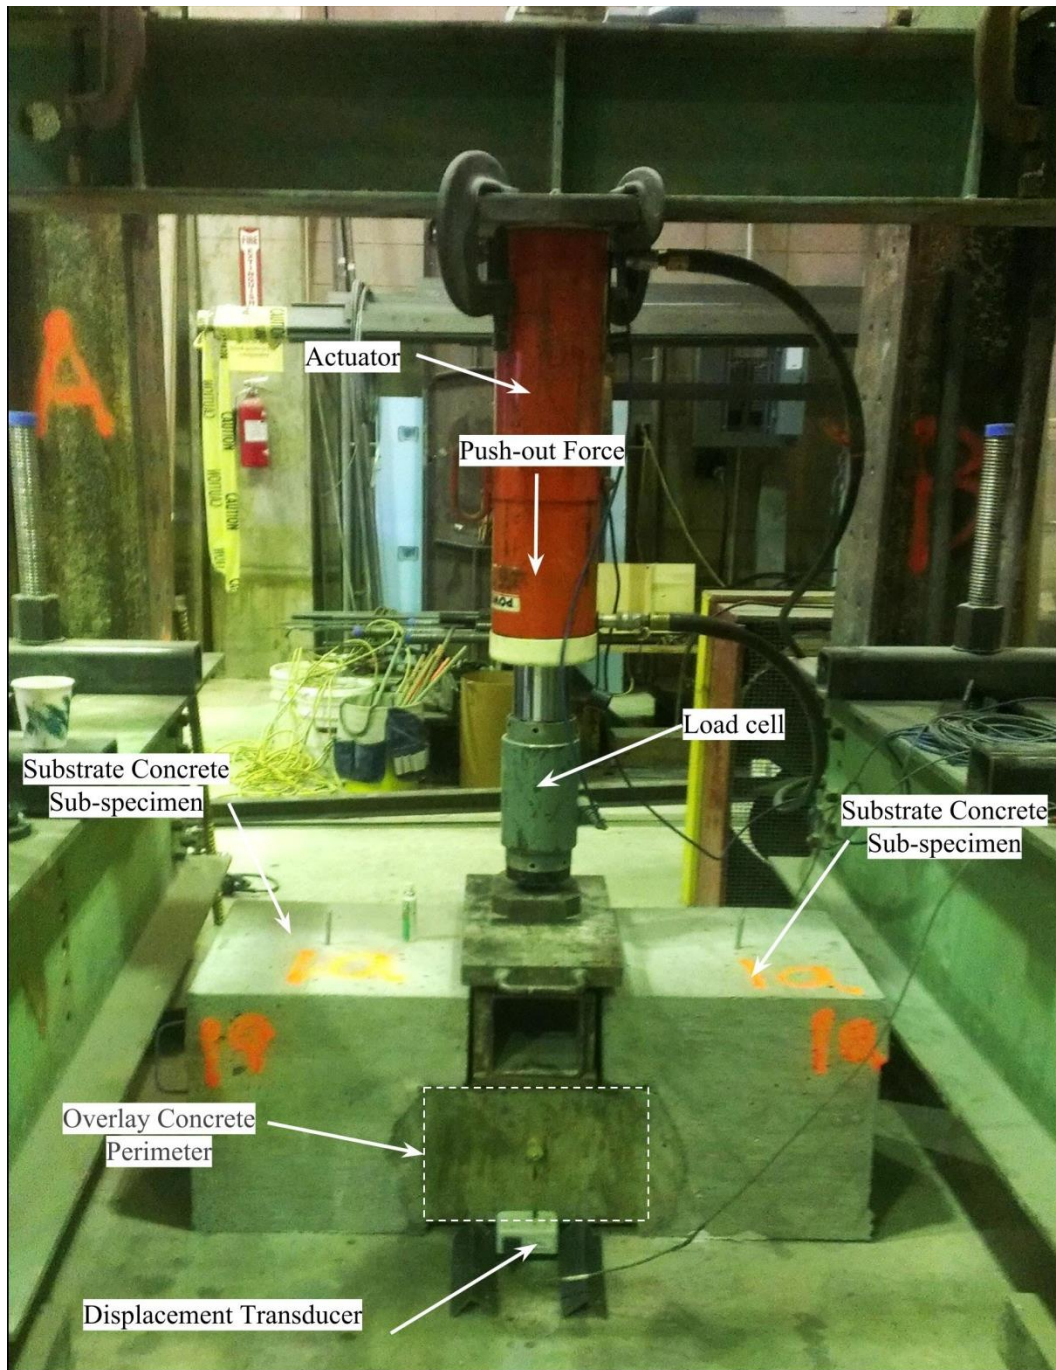
Each push-out test started 4 hours prior to 72 hours after overlay concrete placement. Figure 32 shows the testing arrangement.

**Figure 32. Testing arrangement for push-out test**

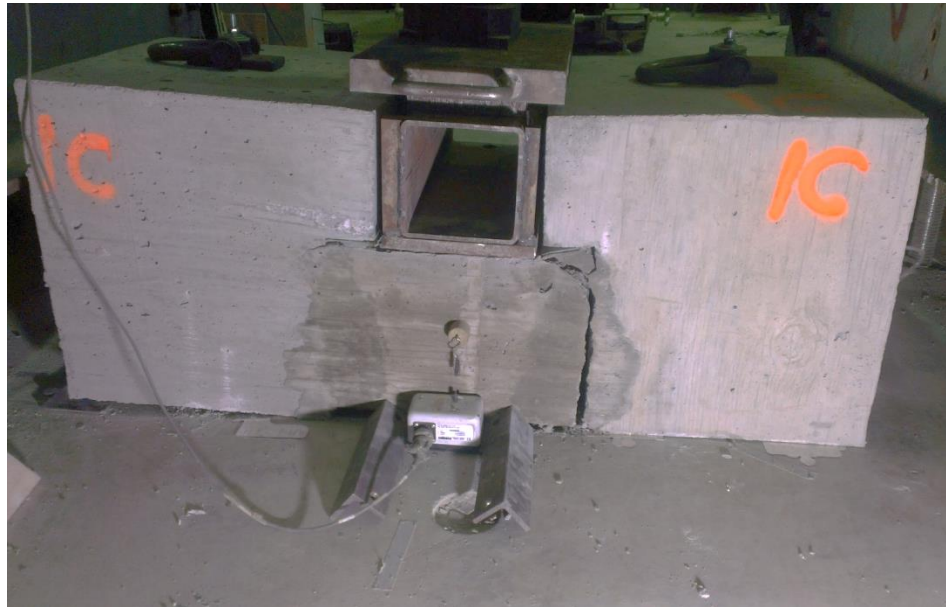
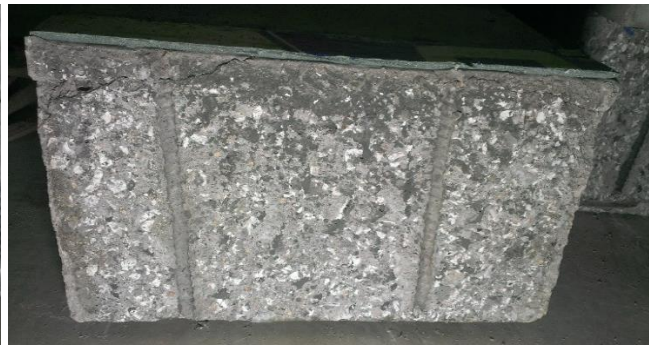
During application of the loads, sudden failures (a large drop in load and separation of one of the bonds) were observed. Figure 33(a) shows a failure surface with a crack and Figure 33(b) and (c) show an interface surface between the substrate concrete and the overlay concrete after failure.

a) Side view

b) Bond interface (substrate concrete)

c) Bond interface (overlay concrete)

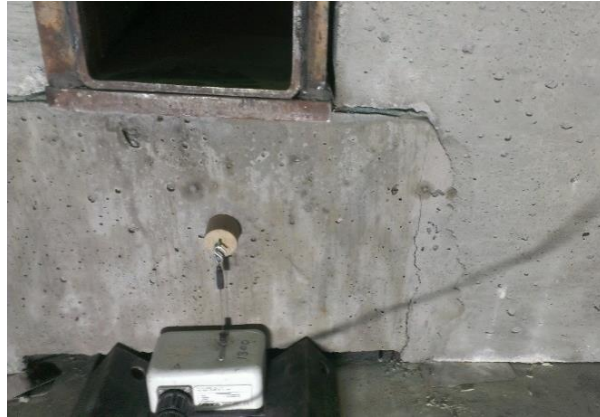
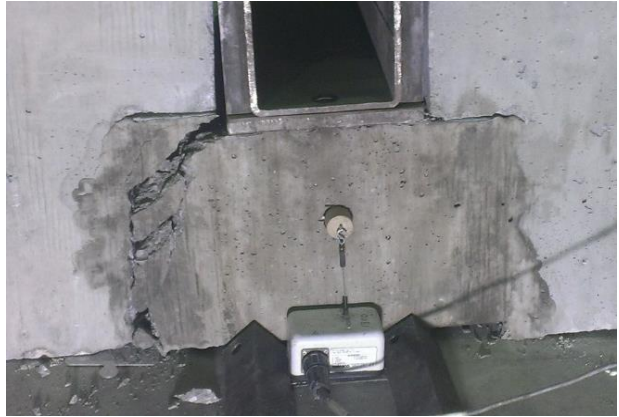
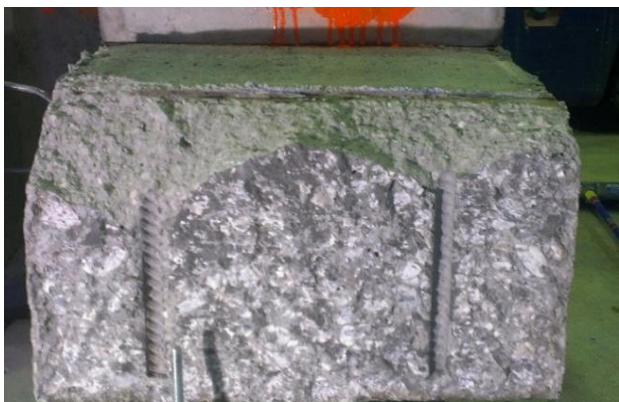
The overlay concrete for Case 2 specimens was exposed to half the diameter of the reinforcing steel. After the first cracks were observed, as shown in Figure 34(a), the specimens had not completely failed.

**a) Propagation of crack**

**b) Separation at interface**

**c) Bond interface (substrate concrete)**

**d) Bond interface (overlay concrete)**

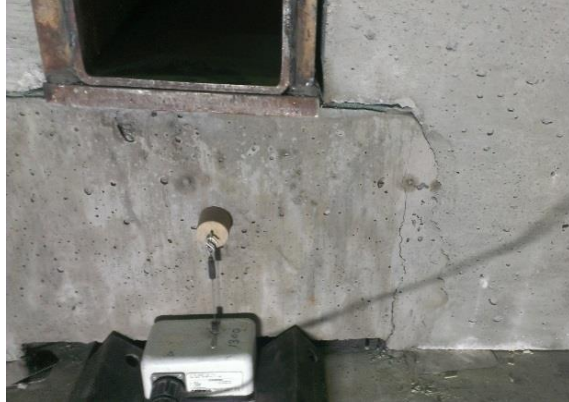
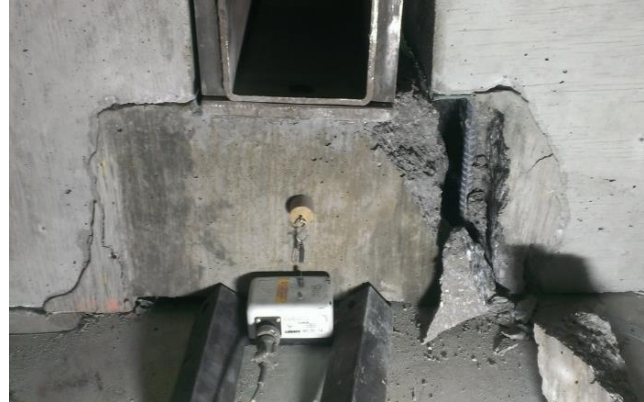
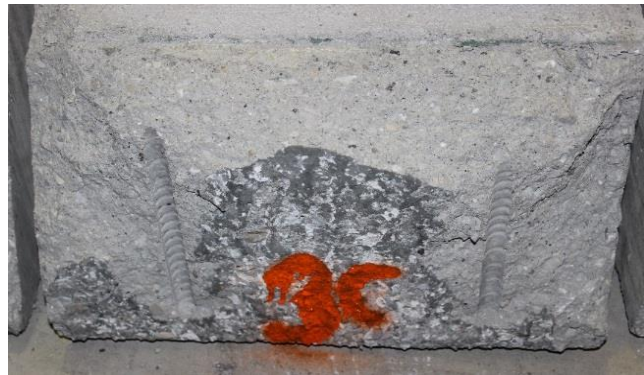
Failures similar to Case 2 were observed for Case 3 specimens; but, due to the additional exposure of the reinforcing steel to the concrete, the bonds were stronger between the concrete and the reinforcing steel, withstanding a greater load after crack initiation. Figure 35 shows the failure of a specimen.

**a) Propagation of crack**

**b) Separation at interface**

**c) Bond interface (substrate concrete)**

**d) Bond interface (overlay concrete)**

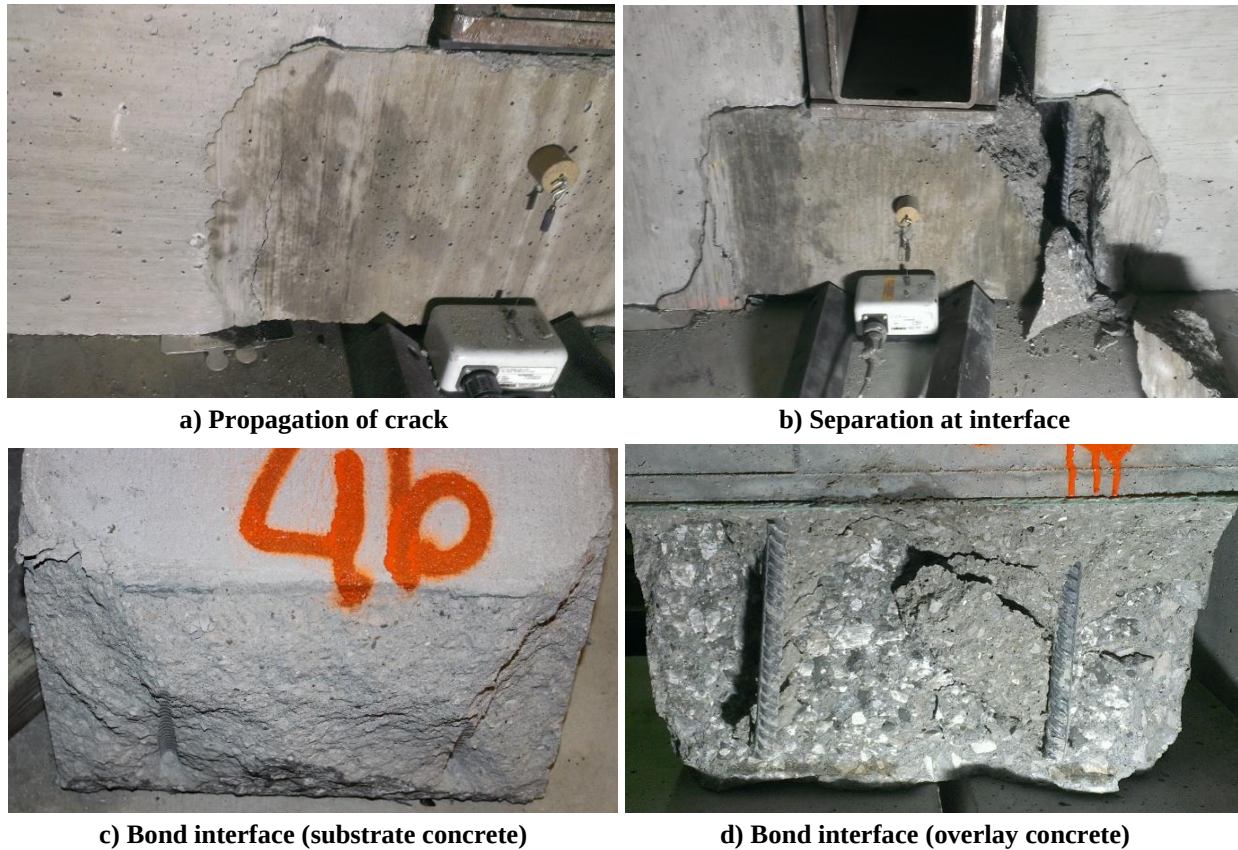
The loads for total separation of a bond were greatest for Case 4 specimens. Figure 36 shows a crack and total separation at a bond interface.

**Figure 36. Case 4 push-out test specimen failure at concrete bond interface**

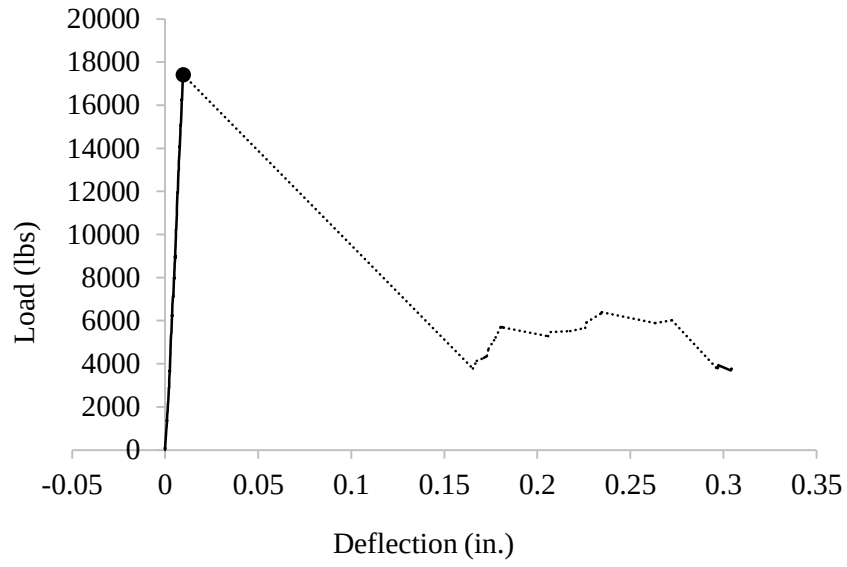
**Case 1**

Figure 37 shows the load versus deflection graph for one specimen for each of the four concrete removal depth cases. The solid circular mark on each graph represents the maximum load value for that particular specimen and the solid triangular mark represents the point where first stiffness change was observed.

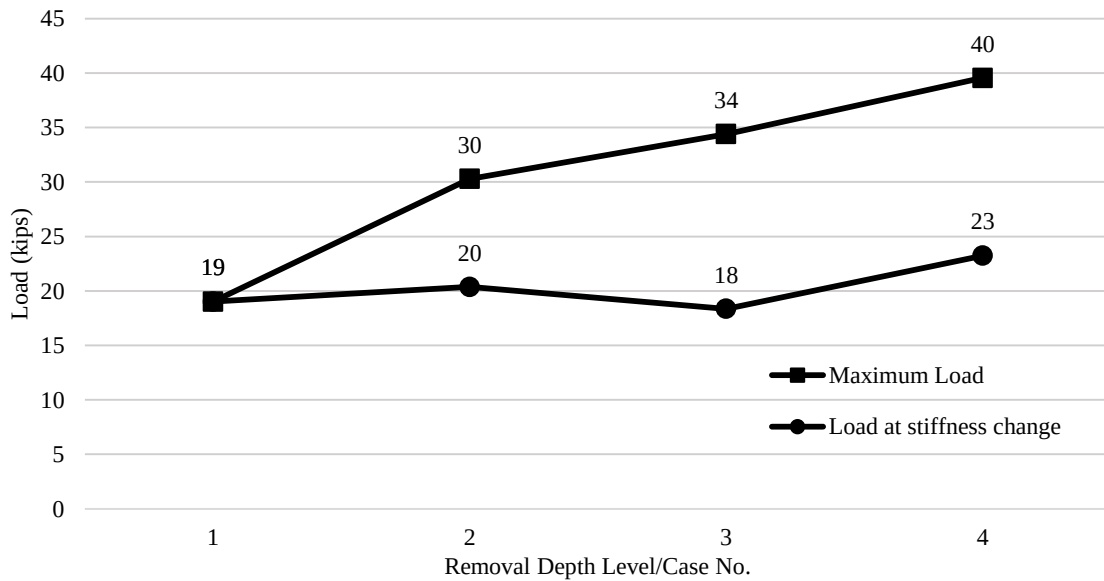
Figure 38 shows the average load at the stiffness change (triangles) and the maximum load (squares) versus the concrete removal depth case.

**Figure 38. Average load versus concrete removal depth (push-out test)**

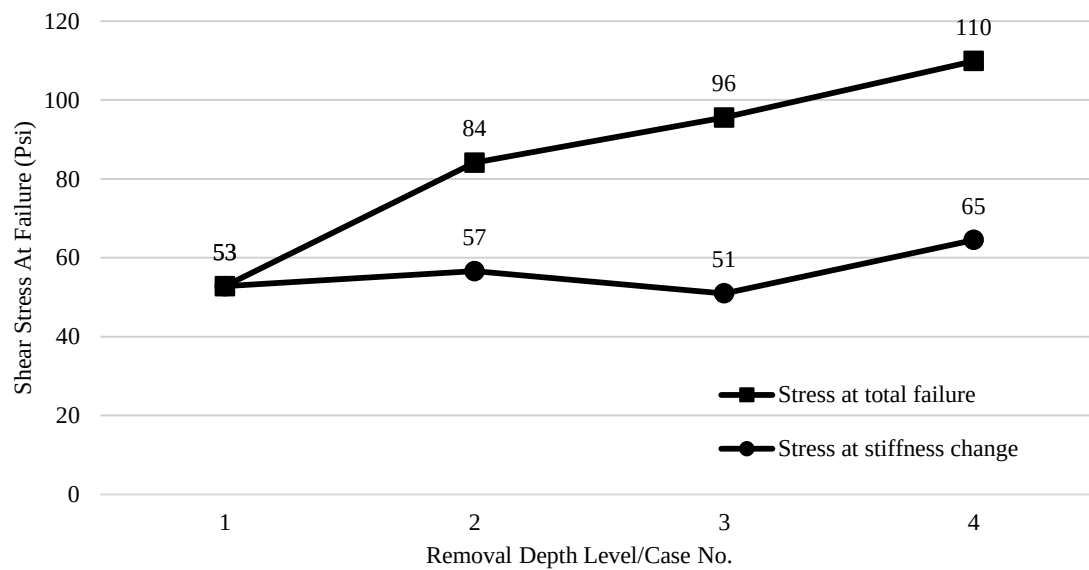
**Figure 39. Average shear stress versus concrete removal depth (push-out test)**

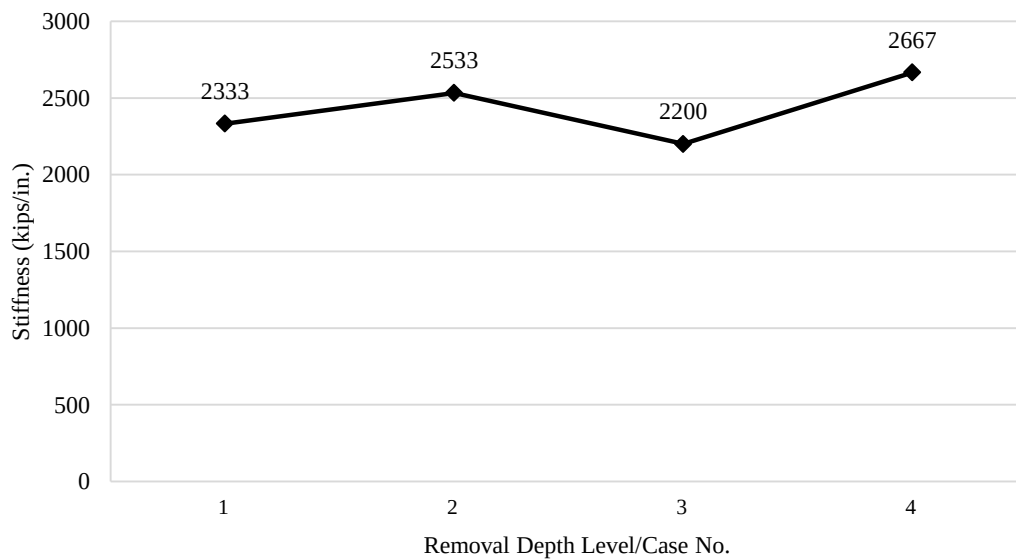
**Figure 40. Average stiffness versus concrete removal depth (push-out test)**

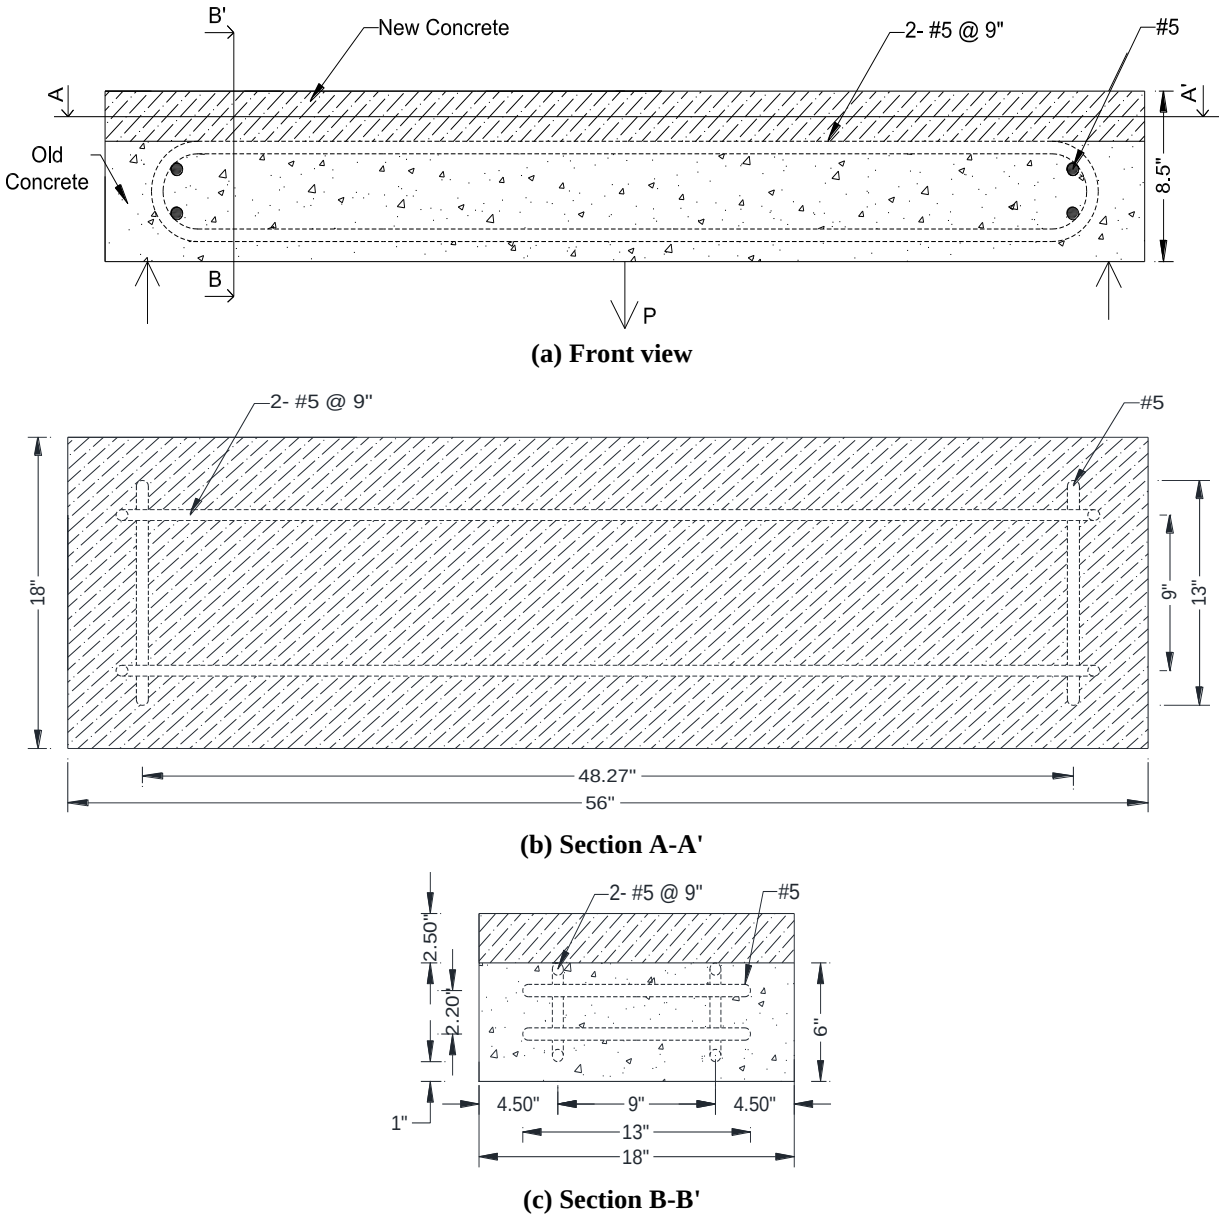
**Figure 41. Positive bending flexural test specimen schematic (Case 1)**

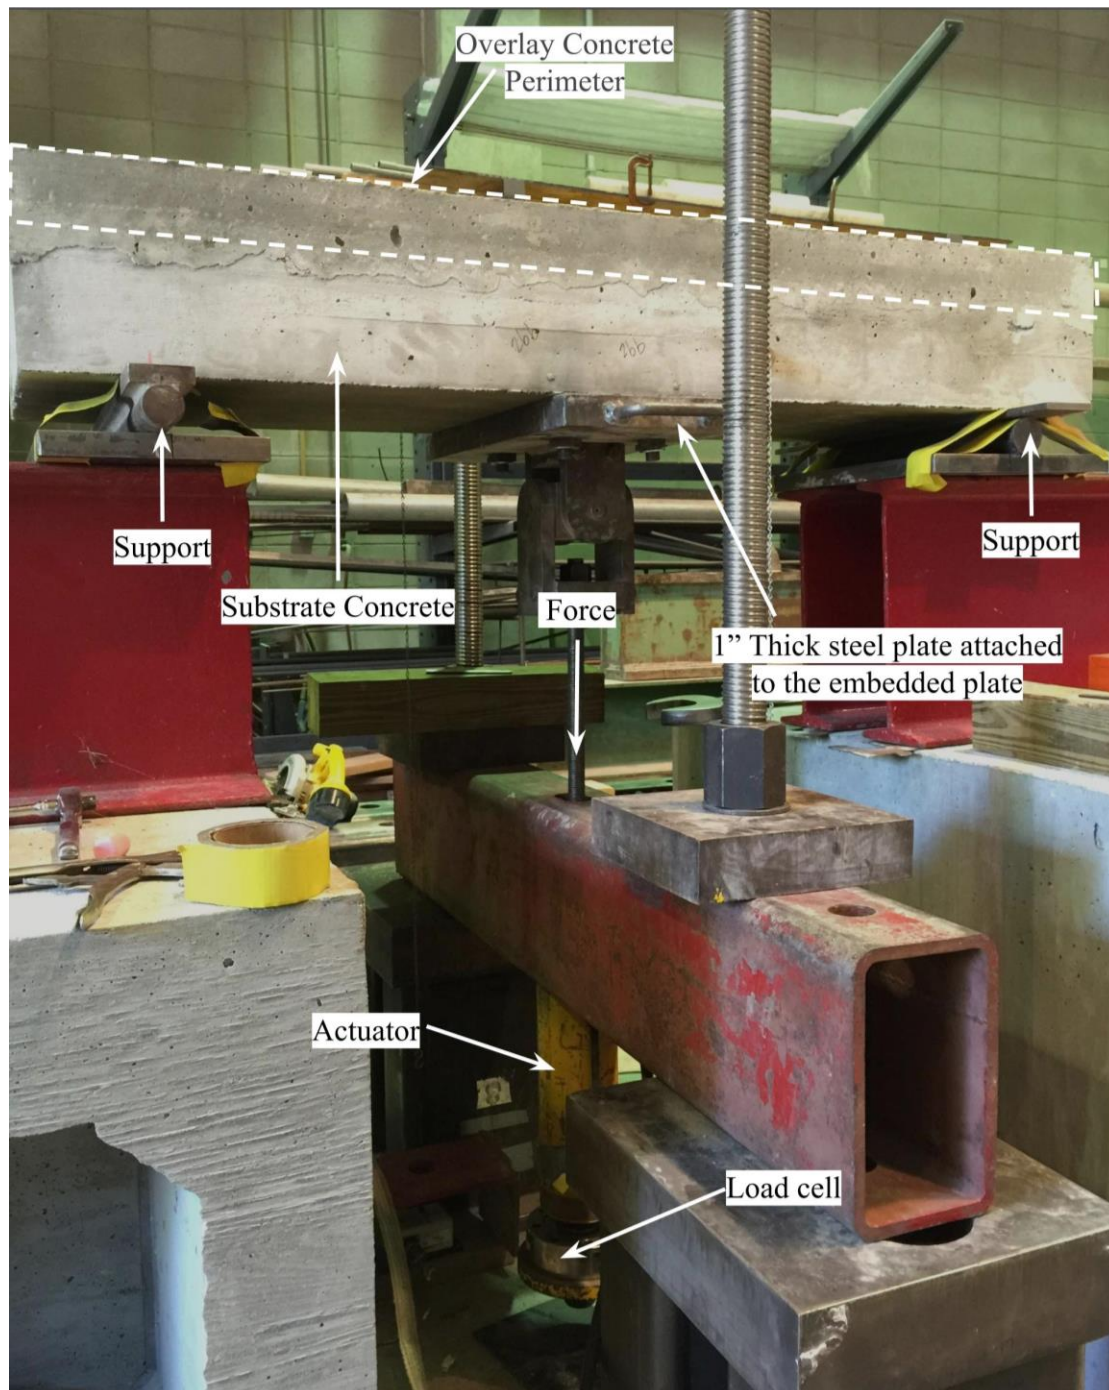
**Figure 46. Testing arrangement for positive bending flexural test**

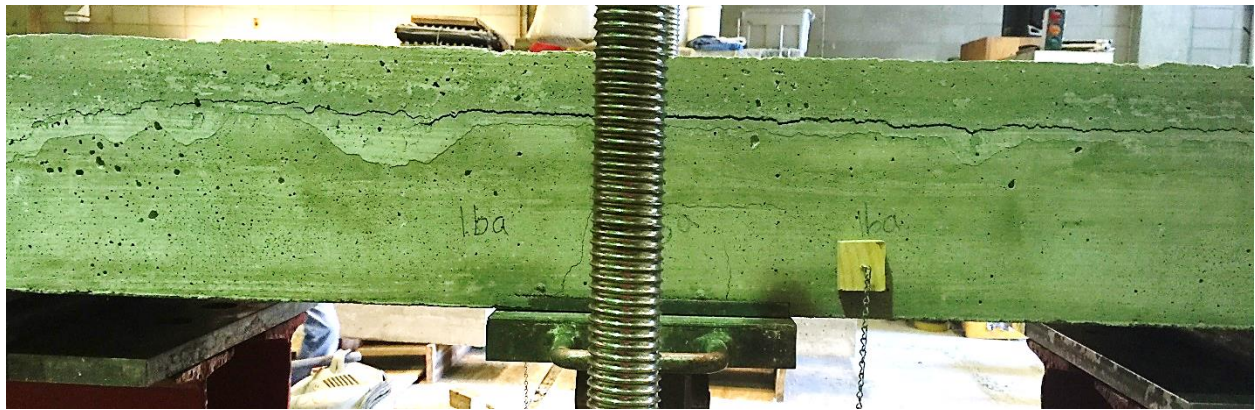
**Figure 47. Case 1 positive bending flexural test specimen failure at concrete bond interface**

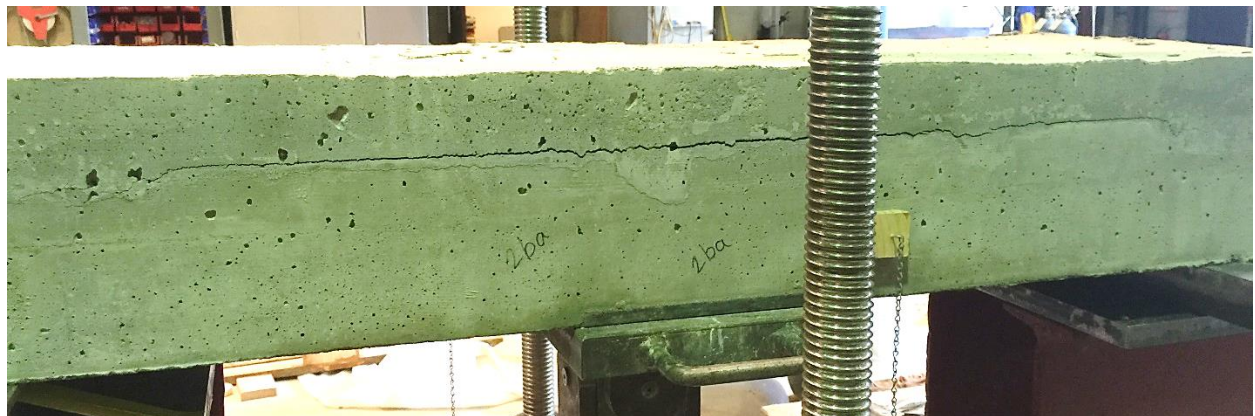
**Figure 48. Case 2 positive bending flexural test specimen failure at concrete bond interface**

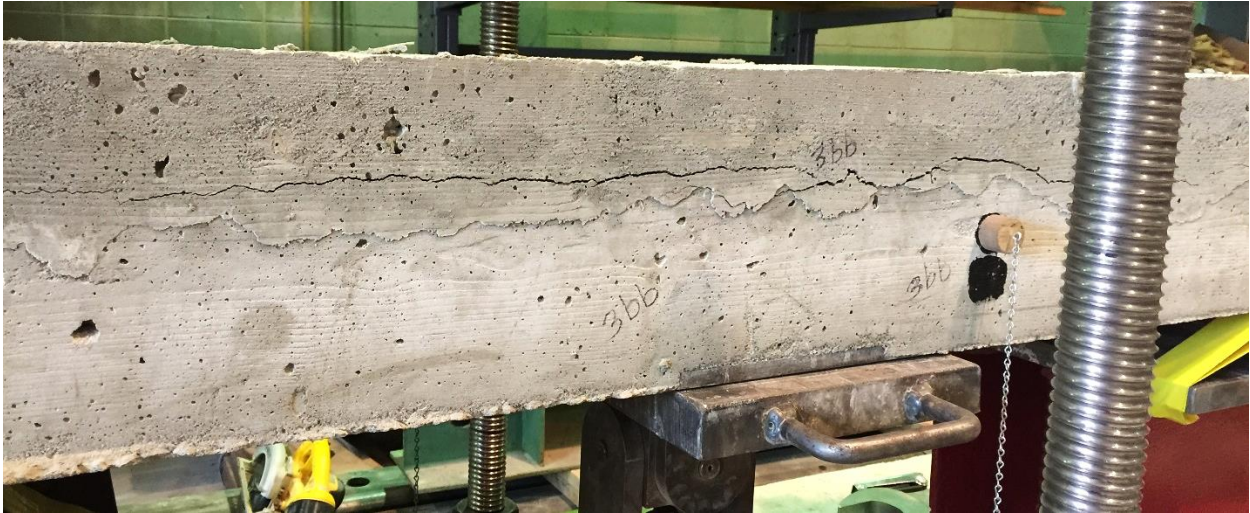
**Figure 49. Case 3 positive bending flexural test specimen failure at concrete bond interface**

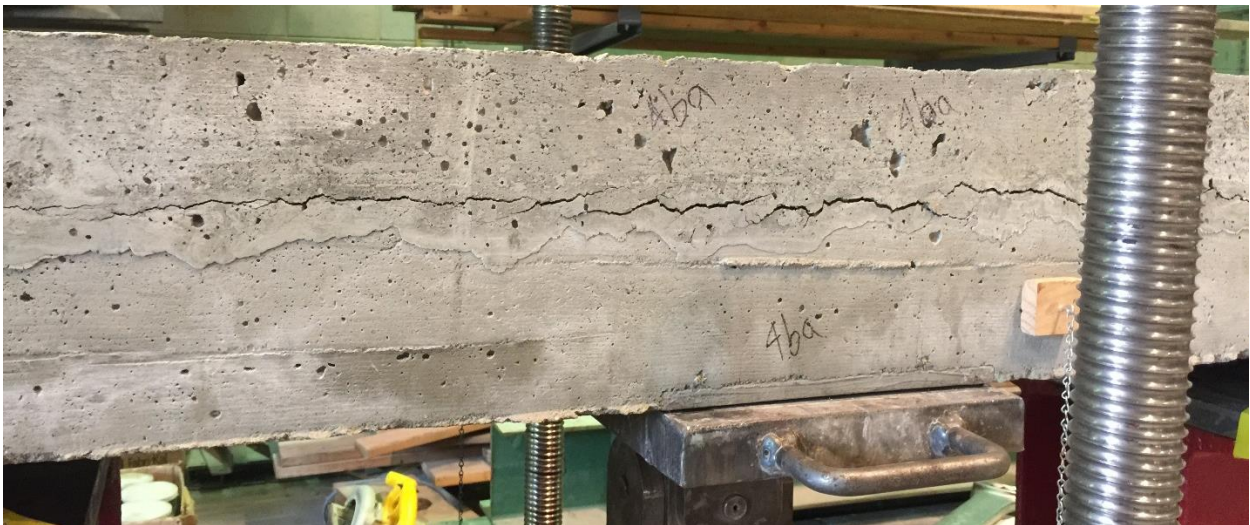
**Figure 50. Case 4 positive bending flexural test specimen failure at concrete bond interface**

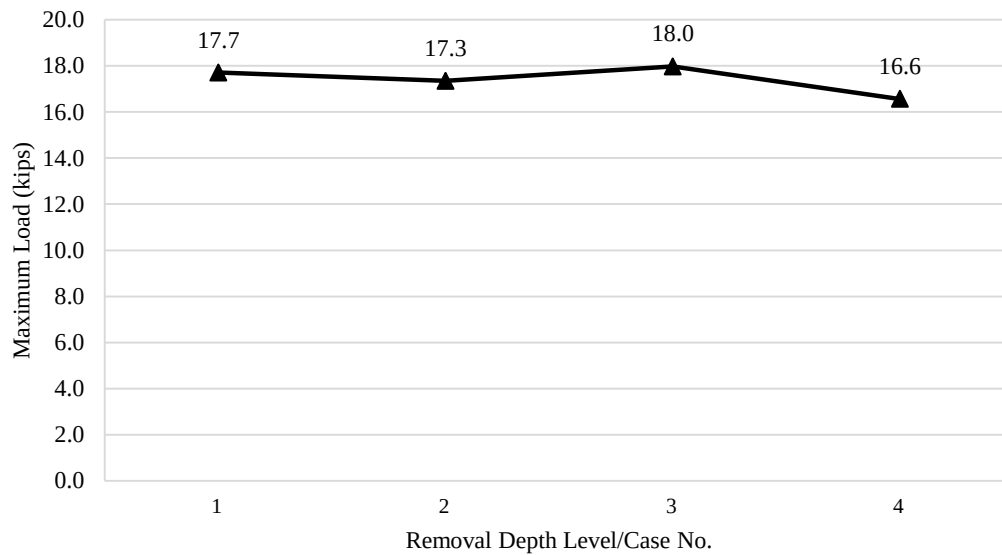
**Figure 51. Average maximum load versus concrete removal depth (positive bending flexural test)**

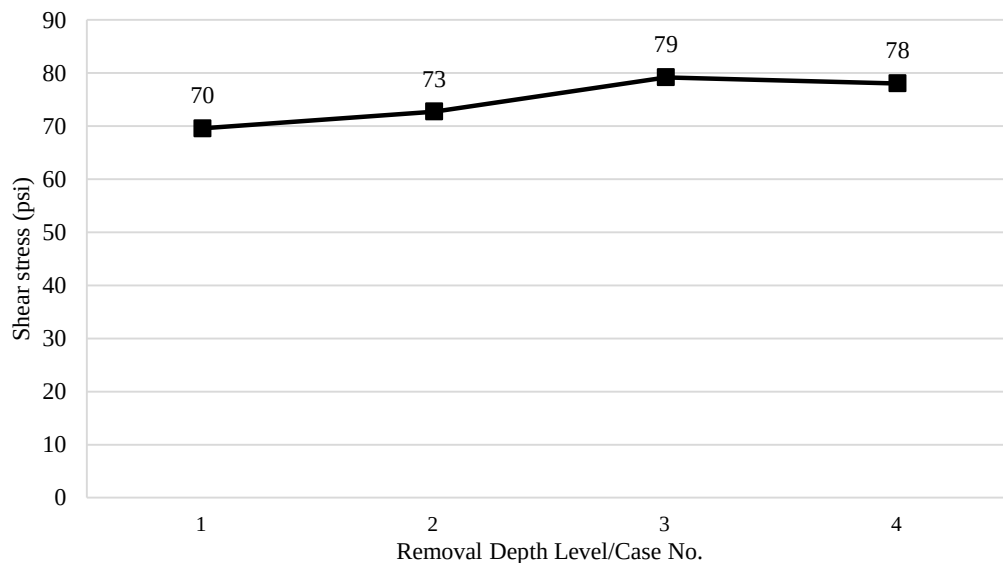
**Figure 52. Average elastic shear stress at maximum load at interface versus concrete removal depth (positive bending flexural test)**

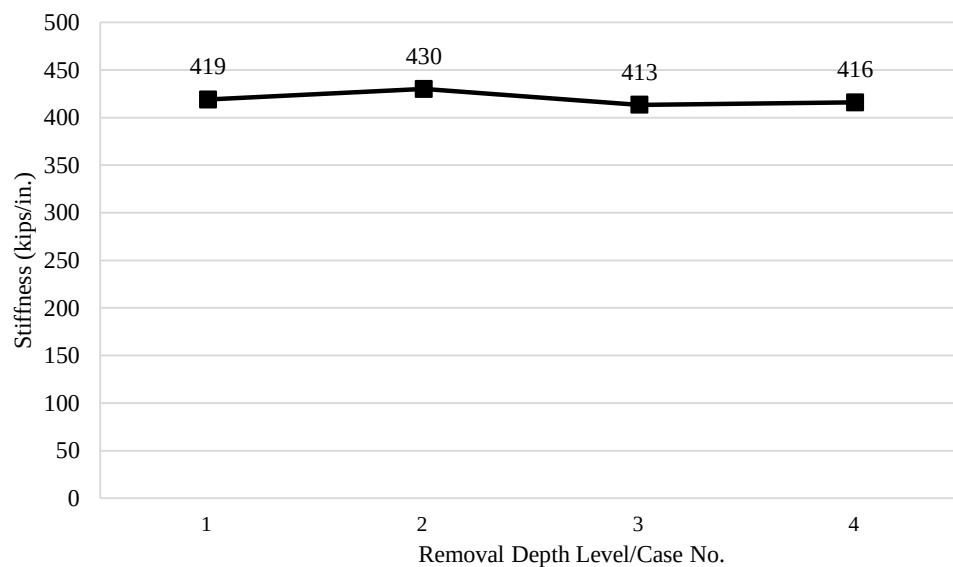
**Figure 53. Average stiffness versus concrete removal depth (positive bending flexural test)**

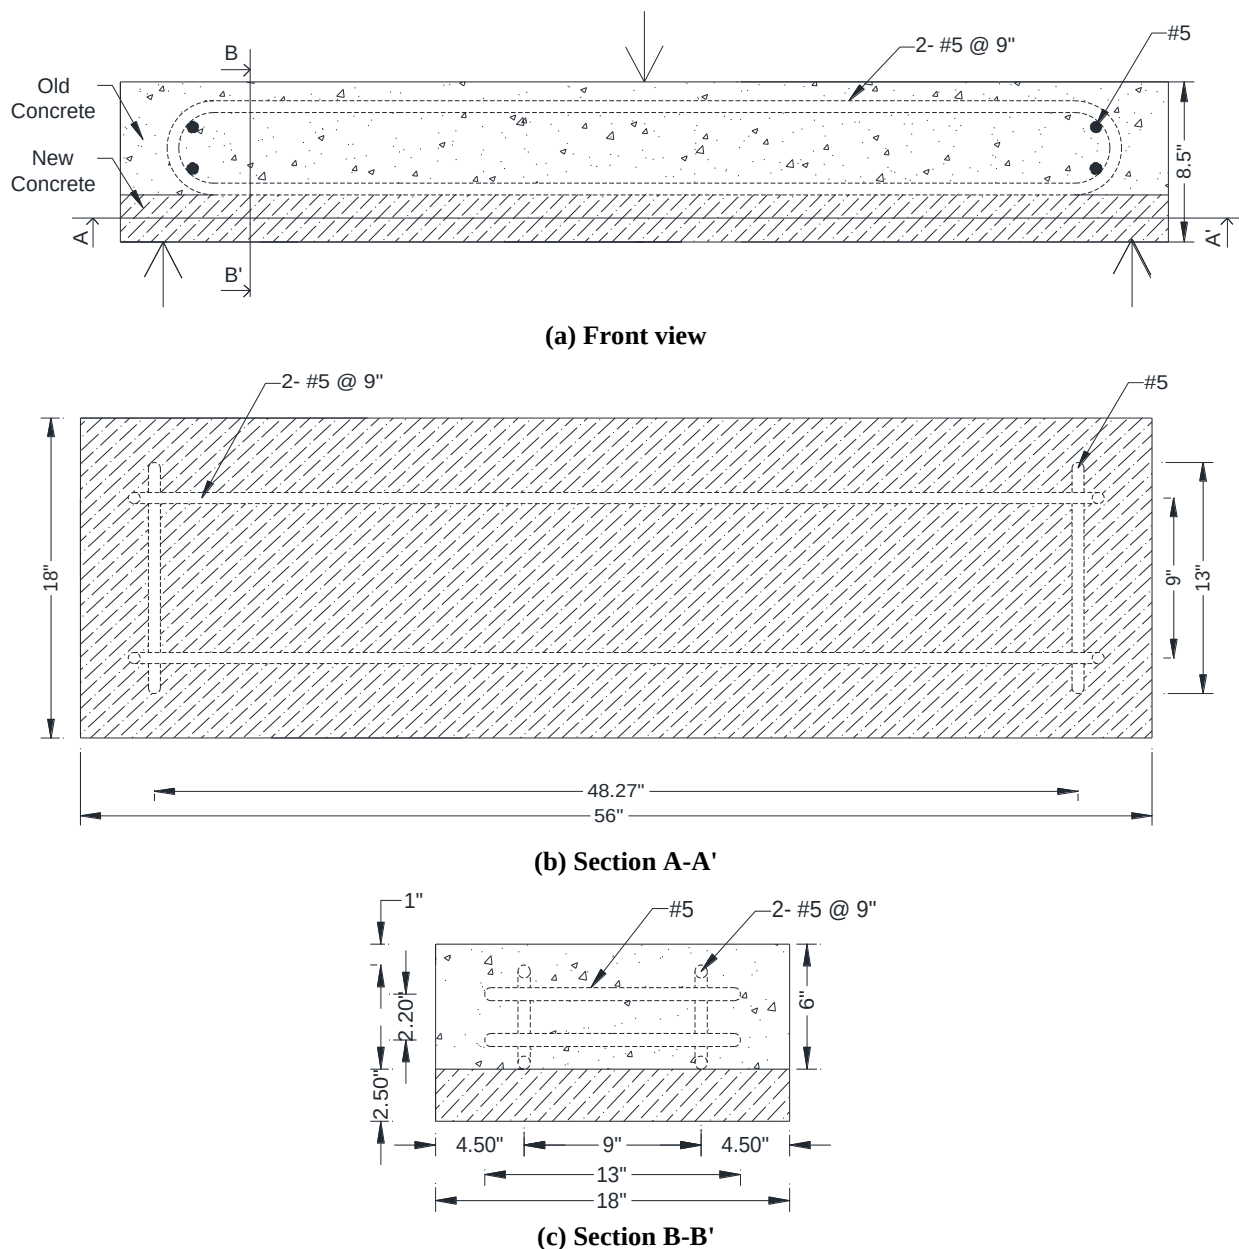
**Figure 54. Negative bending flexural test specimen schematic**

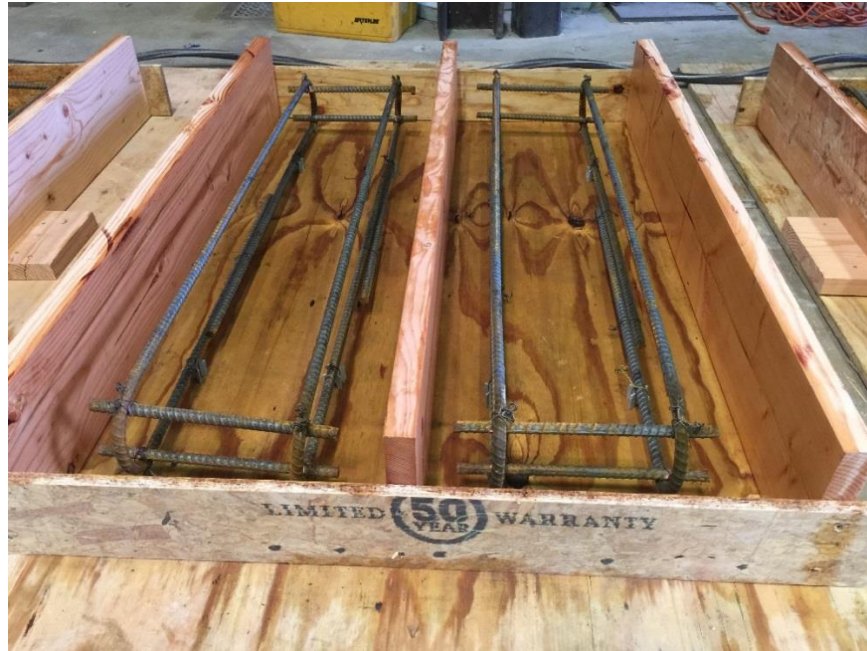
Figure 55 shows the formwork for the specimens.

**Figure 55. Negative bending flexural test formwork for substrate concrete placement**

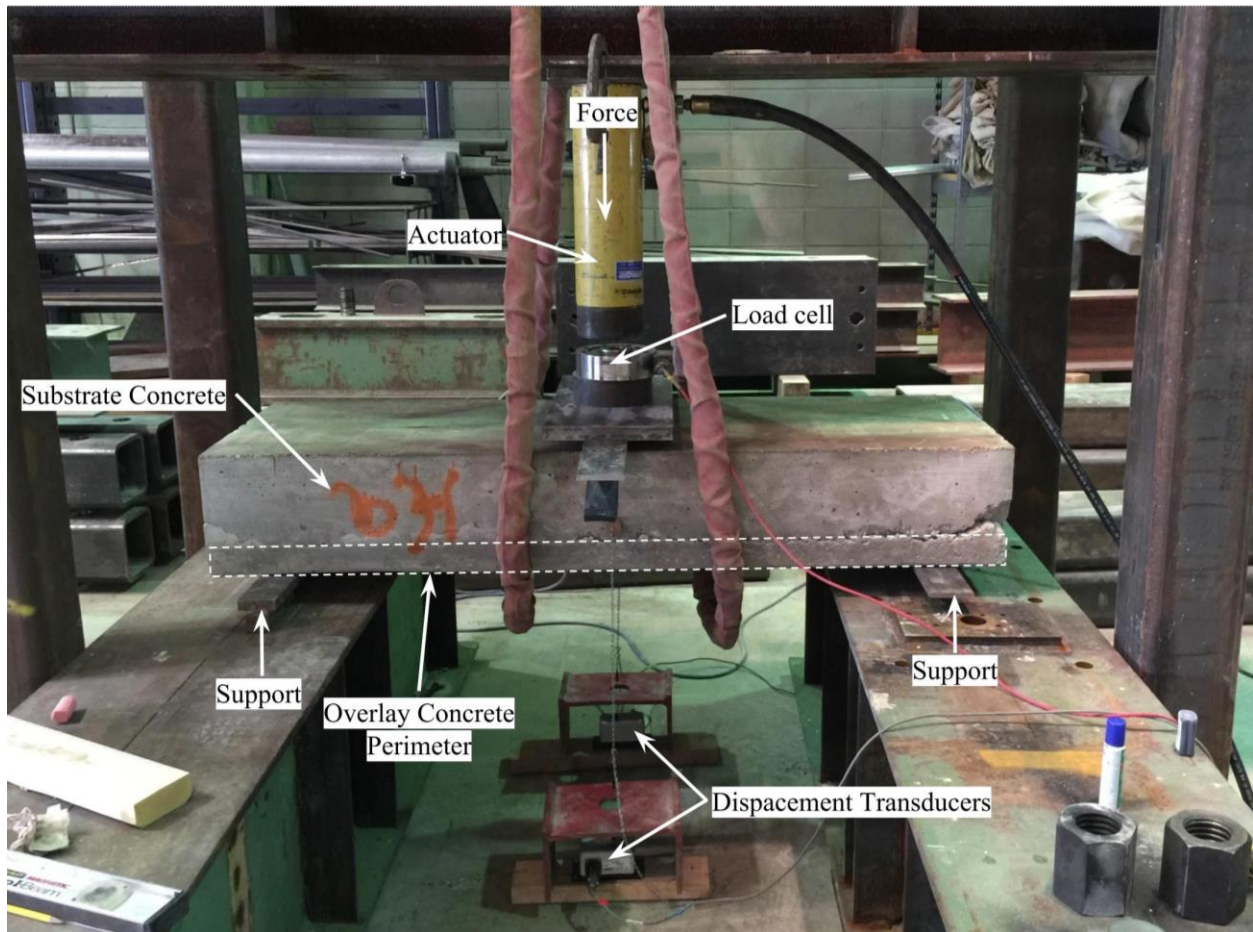
**Figure 59. Testing arrangement for negative bending flexural test**

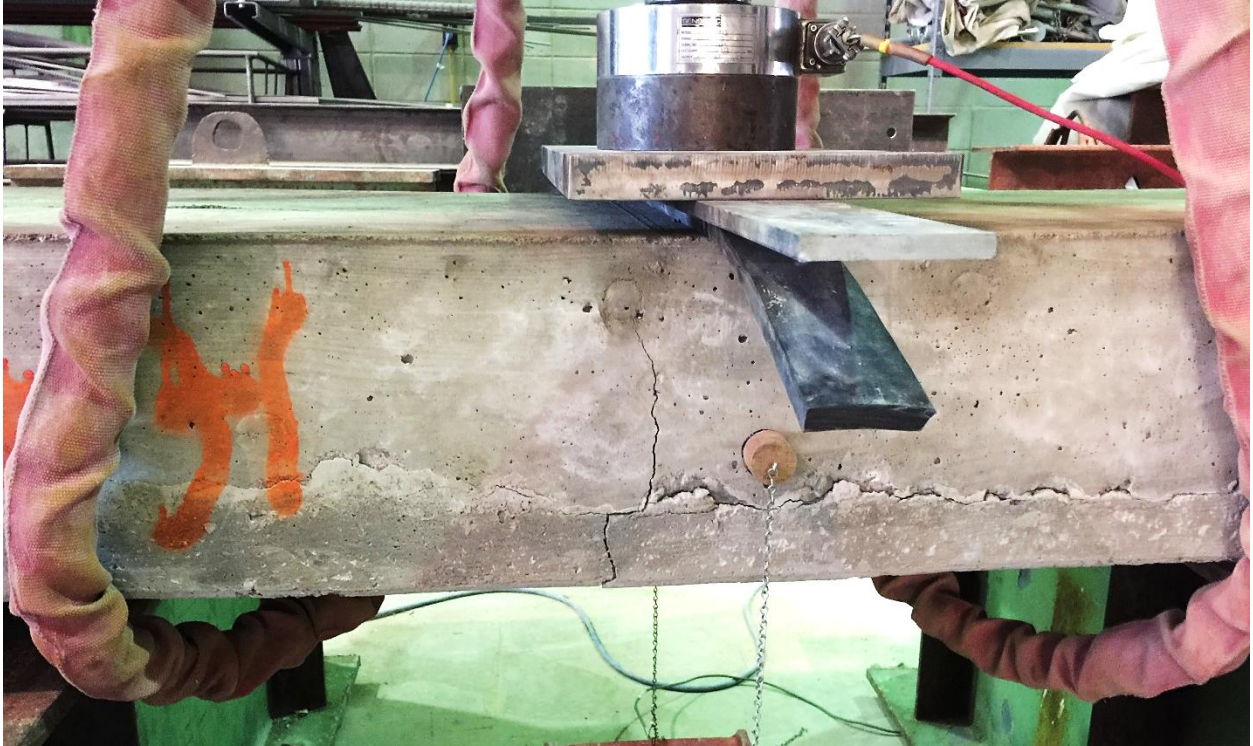
**Figure 60. Case 1 negative bending flexural test specimen failure at concrete bond interface**

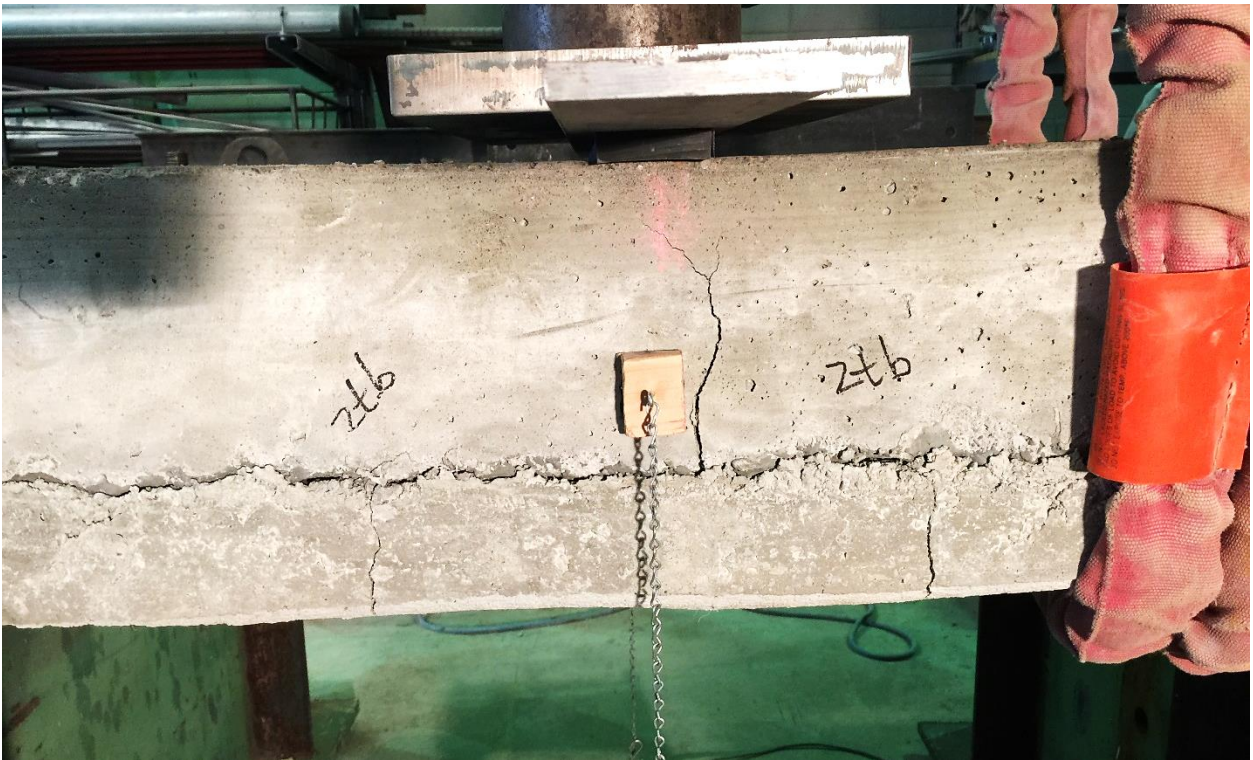
**Figure 61. Case 2 negative bending flexural test specimen failure at concrete bond interface**
