# Investigation of Techniques for Accelerating the Construction of Bridge Deck Overlays

**Final Report**  
**April 2016**

**IOWA STATE UNIVERSITY**  
**Institute for Transportation**

**Sponsored by**  
Federal Highway Administration  
Iowa Department of Transportation  
(InTrans Project 14-500)

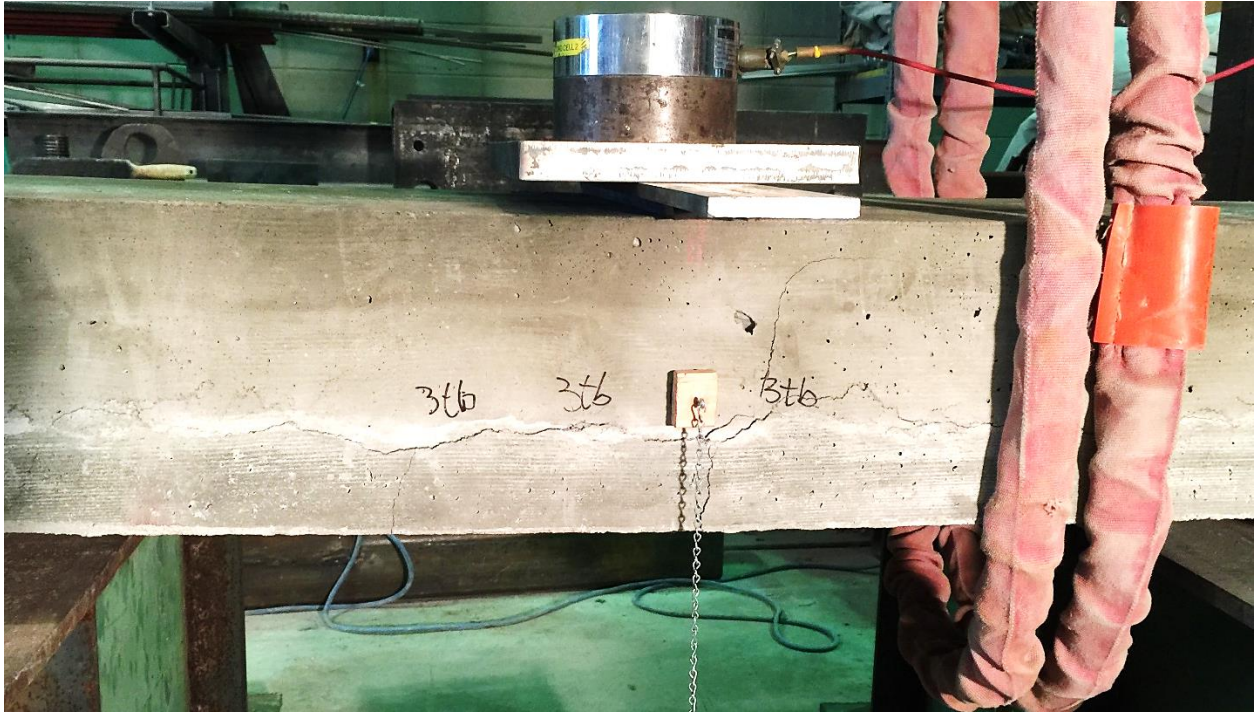
**Figure 62. Case 3 negative bending flexural test specimen failure at concrete bond interface**

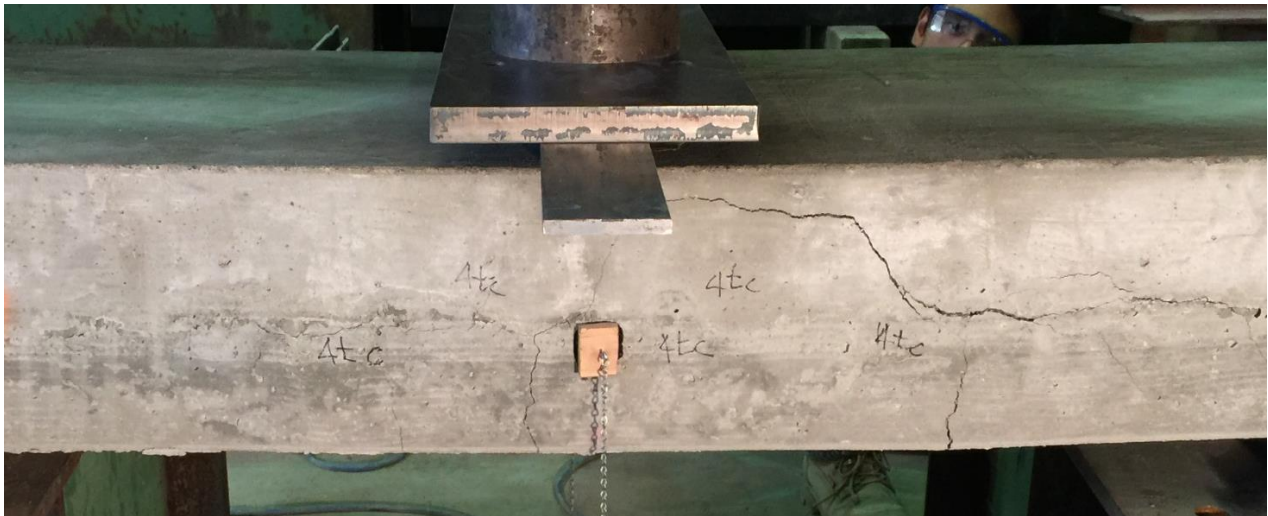
**Figure 63. Case 4 negative bending flexural test specimen failure at concrete bond interface**

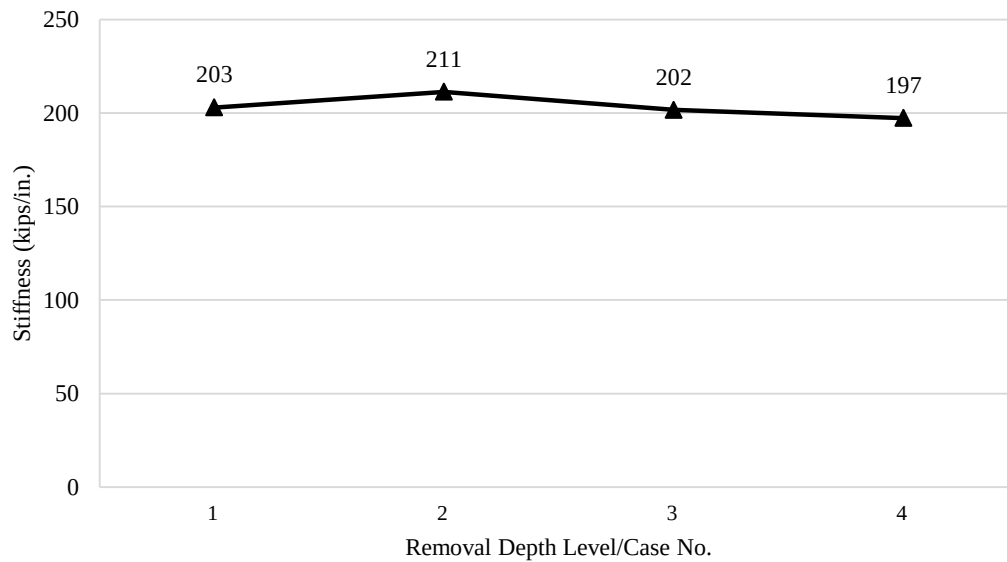
**Figure 66. Average stiffness versus concrete removal depth (negative bending flexural test)**
