INVESTIGATION OF PCC PAVEMENT DETERIORATION - A FEW FACTS ARE WORTH MORE THAN 100 OPINIONS

IOWA DEPT. OF TRANSPORTATION

Interim Report
for
Iowa DOT
Research Project HR-2074

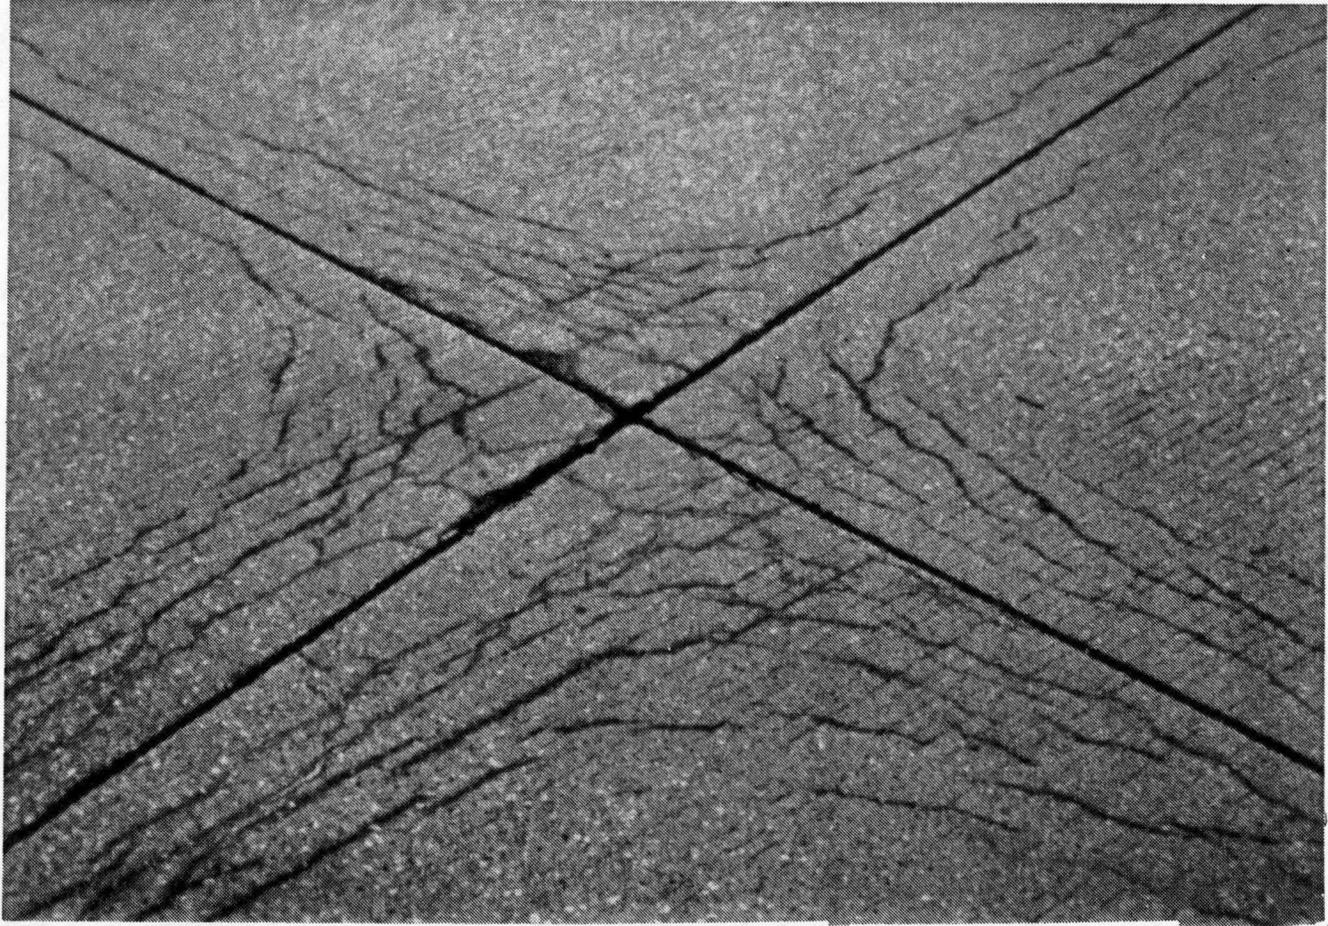
FIGURE 1 TYPICAL D CRACKING OF PCC PAVEMENT

In the late 1950's, Iowa was faced with severe PCC pavement deterioration. Some pavements that were only 15 years old were exhibiting a substantial crack pattern. This deterioration was referred to as D cracking (Figure 1). After substantial research, the cause of this deterioration was related to a certain type of carbonate coarse aggregate. The initiating cause was identified as crushed limestone aggregate containing a predominance and substantial volume of pores in the 0.04 to 0.2 μm diameter pore size. Since the 1930's, Iowa has maintained an excellent record of the ledges and quarry locations of crushed stone used in Iowa PCC pavement and their performance by time to visible deterioration. The D cracking problem was solved by

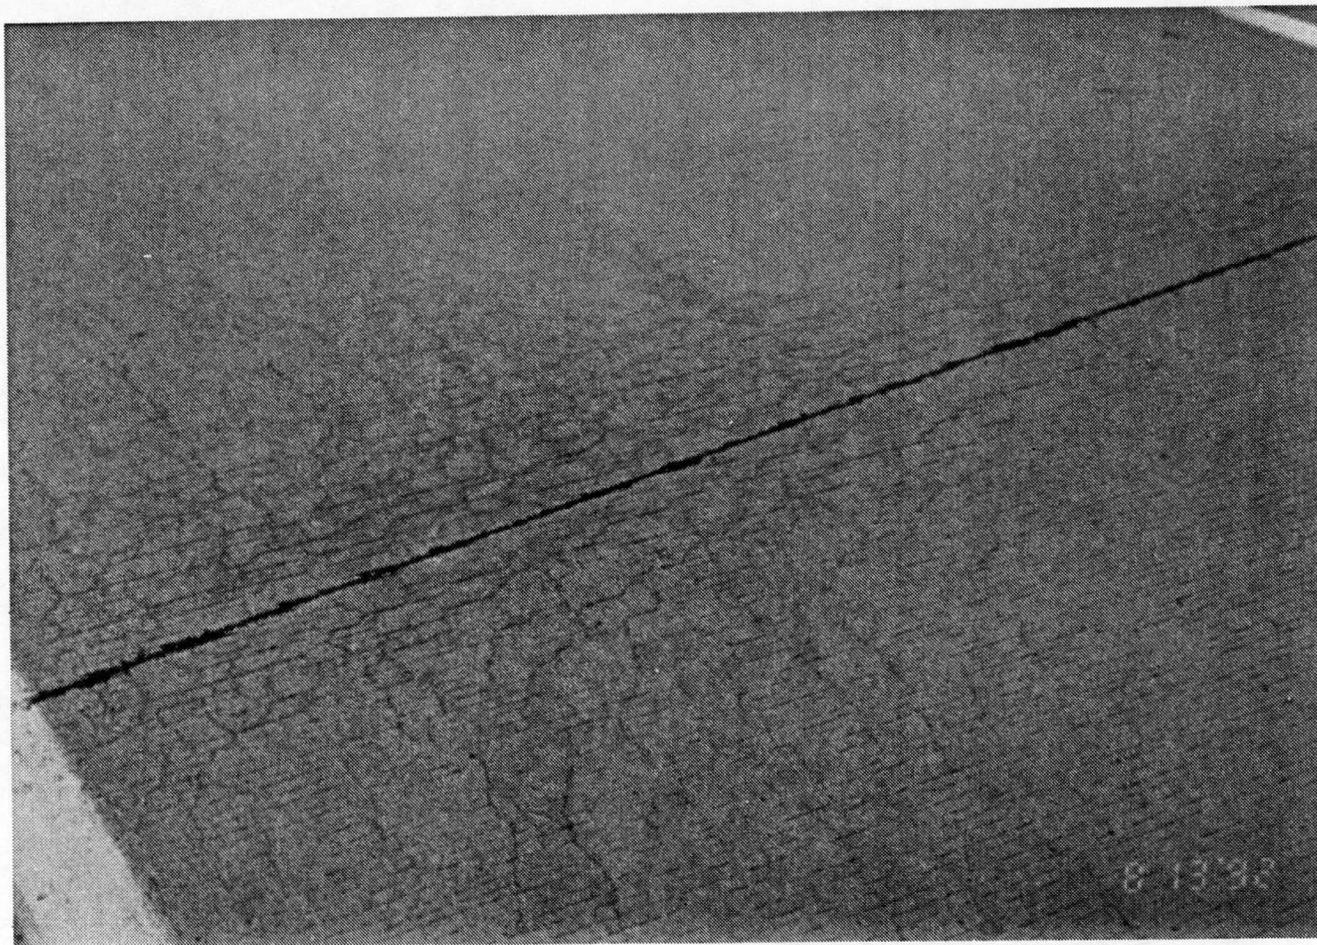
FIGURE 2 THE CRACKING PATTERN OF US 20 IN CENTRAL IOWA

In 1990, the Iowa DOT was presented with a very challenging problem. A ten mile section of new four-lane divided highway in central Iowa (US 20 from Fort Dodge to Webster City) was exhibiting distress cracking (Figure 2) at an age of only three years. In other premature PCC pavement failures, the primary factor relating to the deterioration was the coarse aggregate. In this case, the coarse aggregate was a crushed limestone (Gilmore City Ledge) from the Fort Dodge Mine that had an excellent performance record when used in PCC pavement. An examination of cores from the pavement and particularly one adjacent to the joint (Figure 3) revealed very few cracks passing through the coarse aggregate particles. The cracks were predominately confined to the matrix.

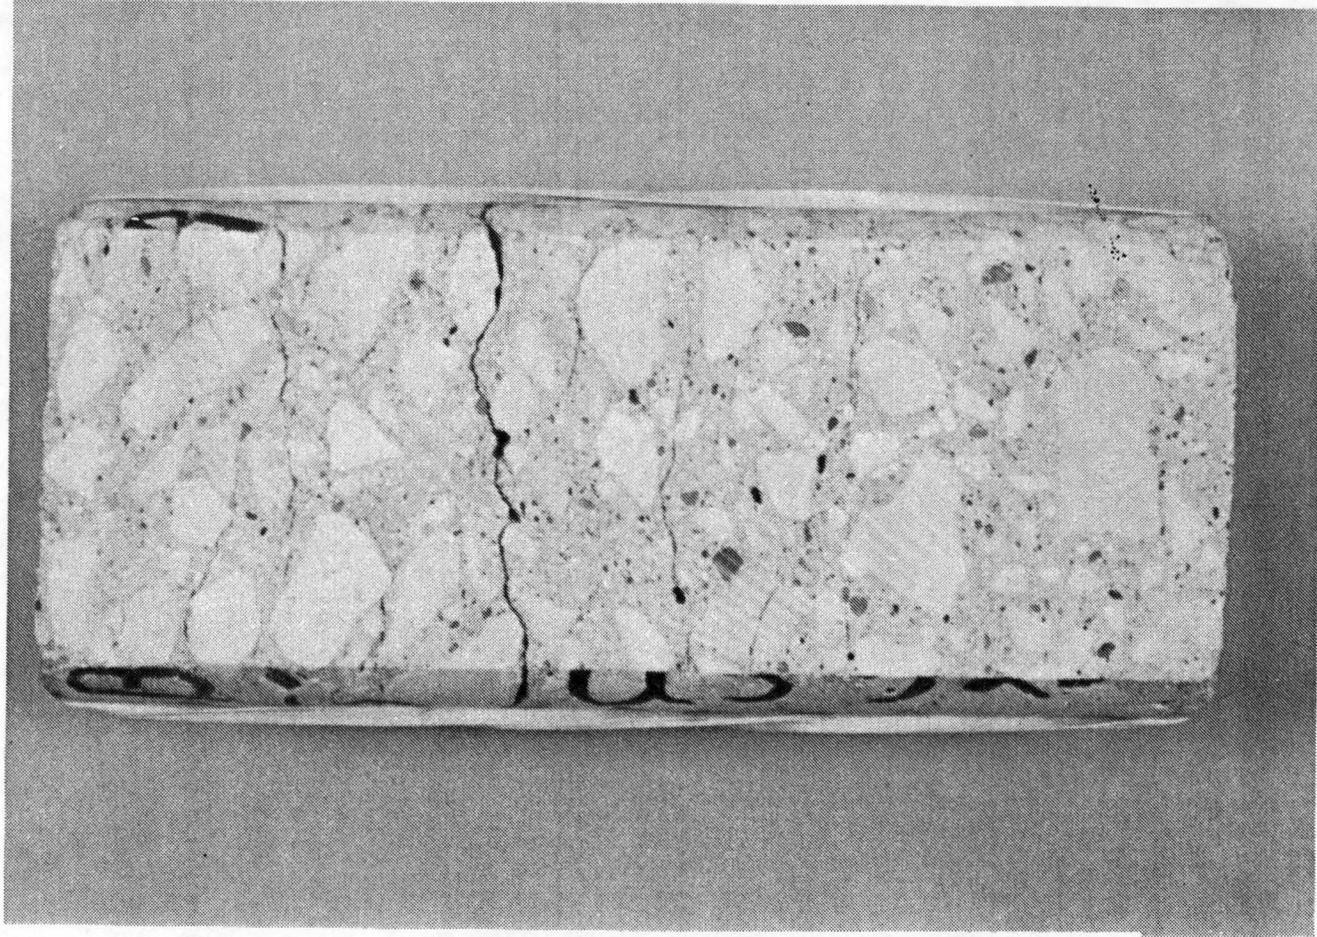
**FIGURE 3 A US 20 CORE SHOWING FEW CRACKS
IN THE COARSE AGGREGATE**

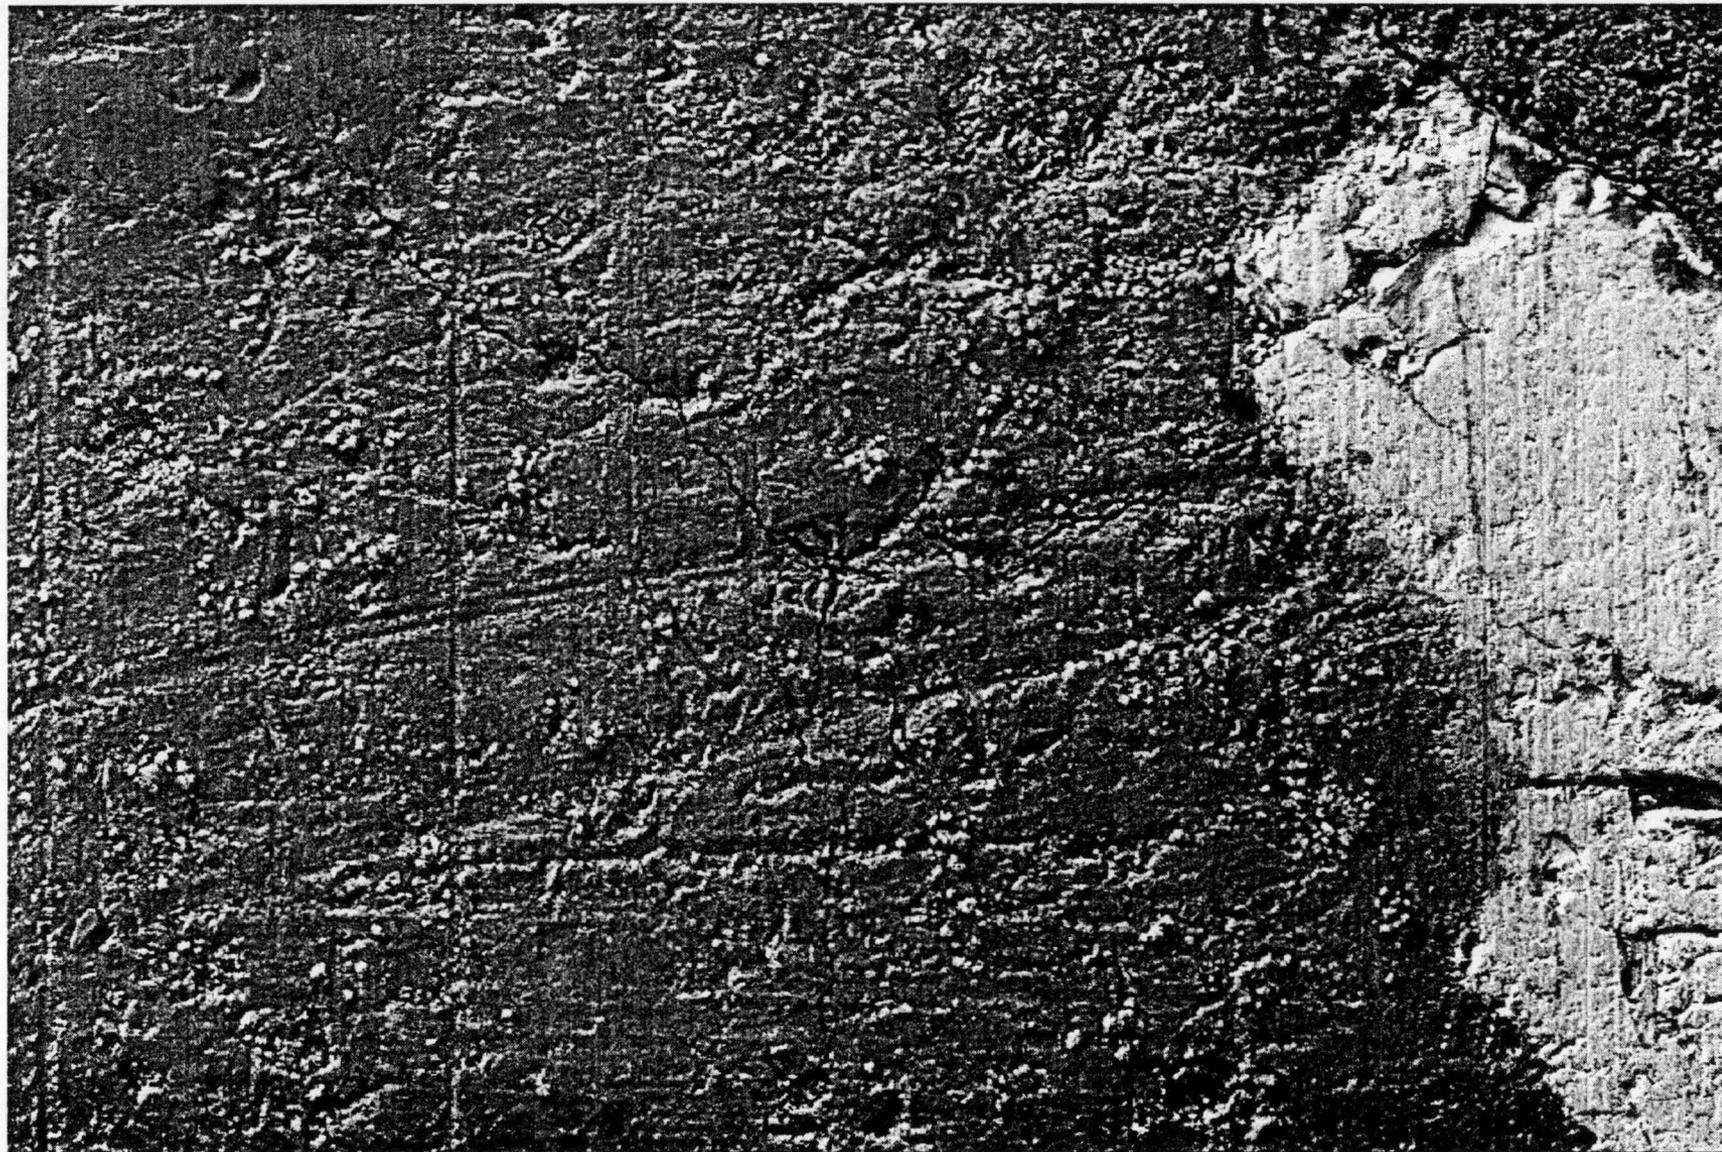
**FIGURE 4 A 200X BSE PHOTOMICROGRAPH
OF THE PCC AIR VOIDS ON IOWA US 20**

This same sawed and polished piece of PCC was then observed using the Hitachi low-vacuum SEM. A BSE photomicrograph of nice round air voids was obtained (Figure 4). This identified smaller voids nearly filled and larger voids partially filled with the whitish material.

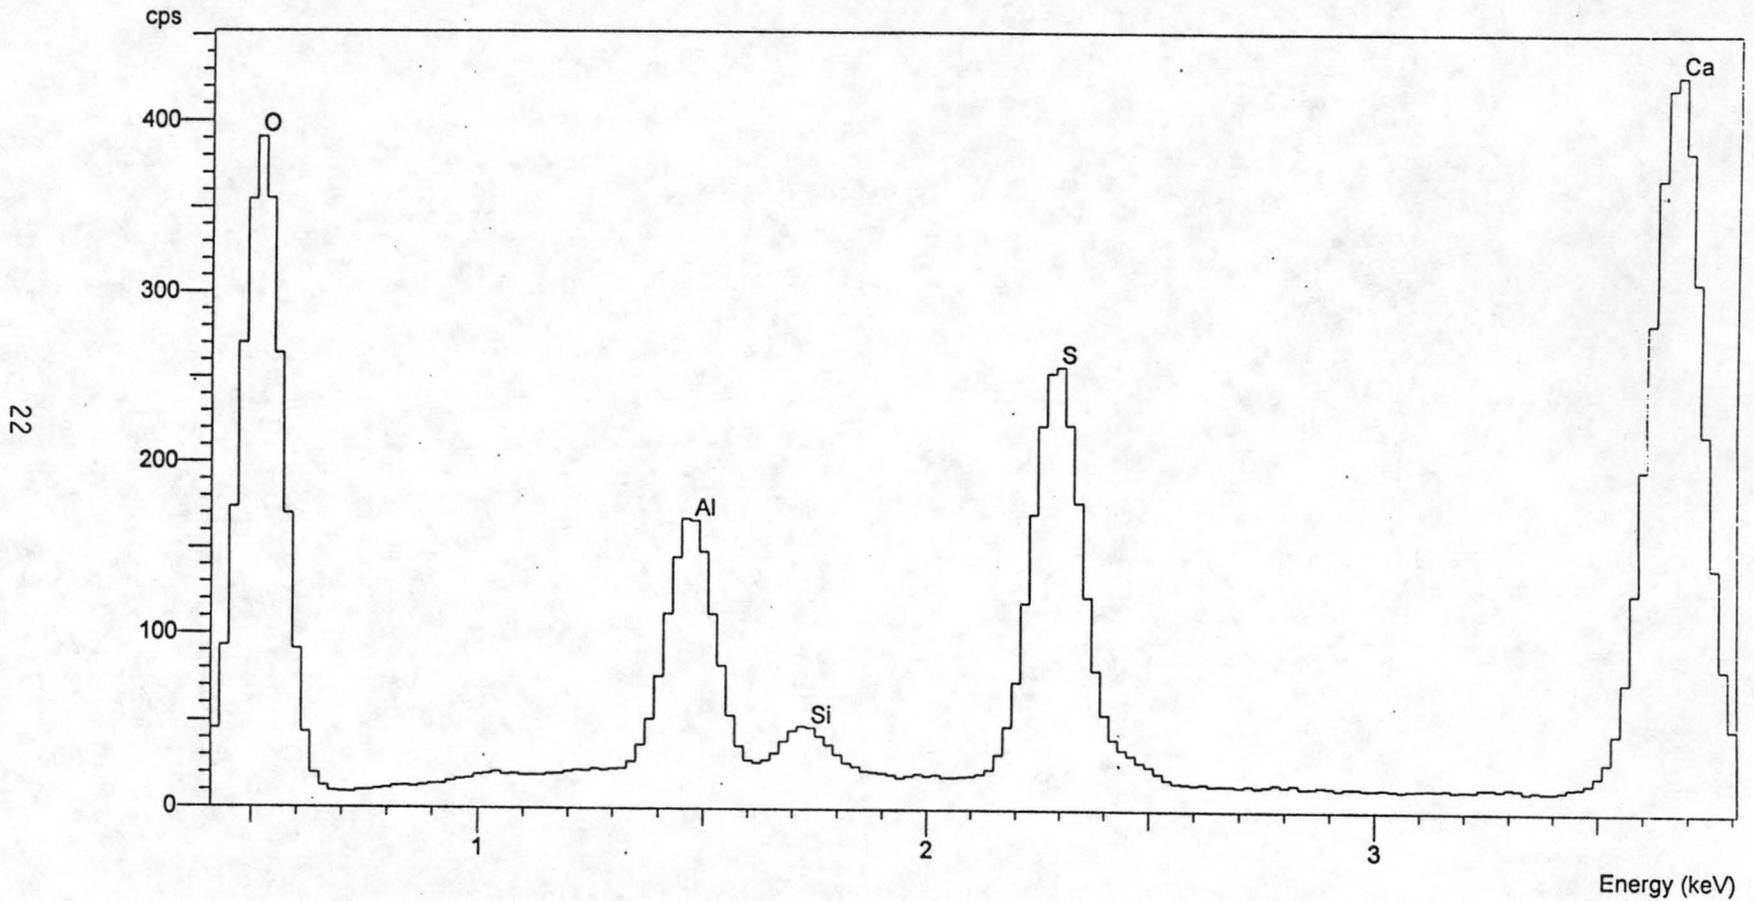
**FIGURE 5 AN ENERGY DISPERSION SPECTRUM
OF THE WHITISH MATERIAL IN THE AIR
VOIDS**

The particular interest in this case was "What elements are present in the whitish material filling the air voids?" An energy dispersion spectrum of the whitish material in the air voids was obtained (Figure 5). This spectrum showed major peaks for oxygen, aluminum, sulfur and calcium, supporting the conclusion that the whitish material in the voids is ettringite. There is a minor silicon peak, but no sodium or potassium peak, thereby, supporting the finding that the material in the void is not silica gel.

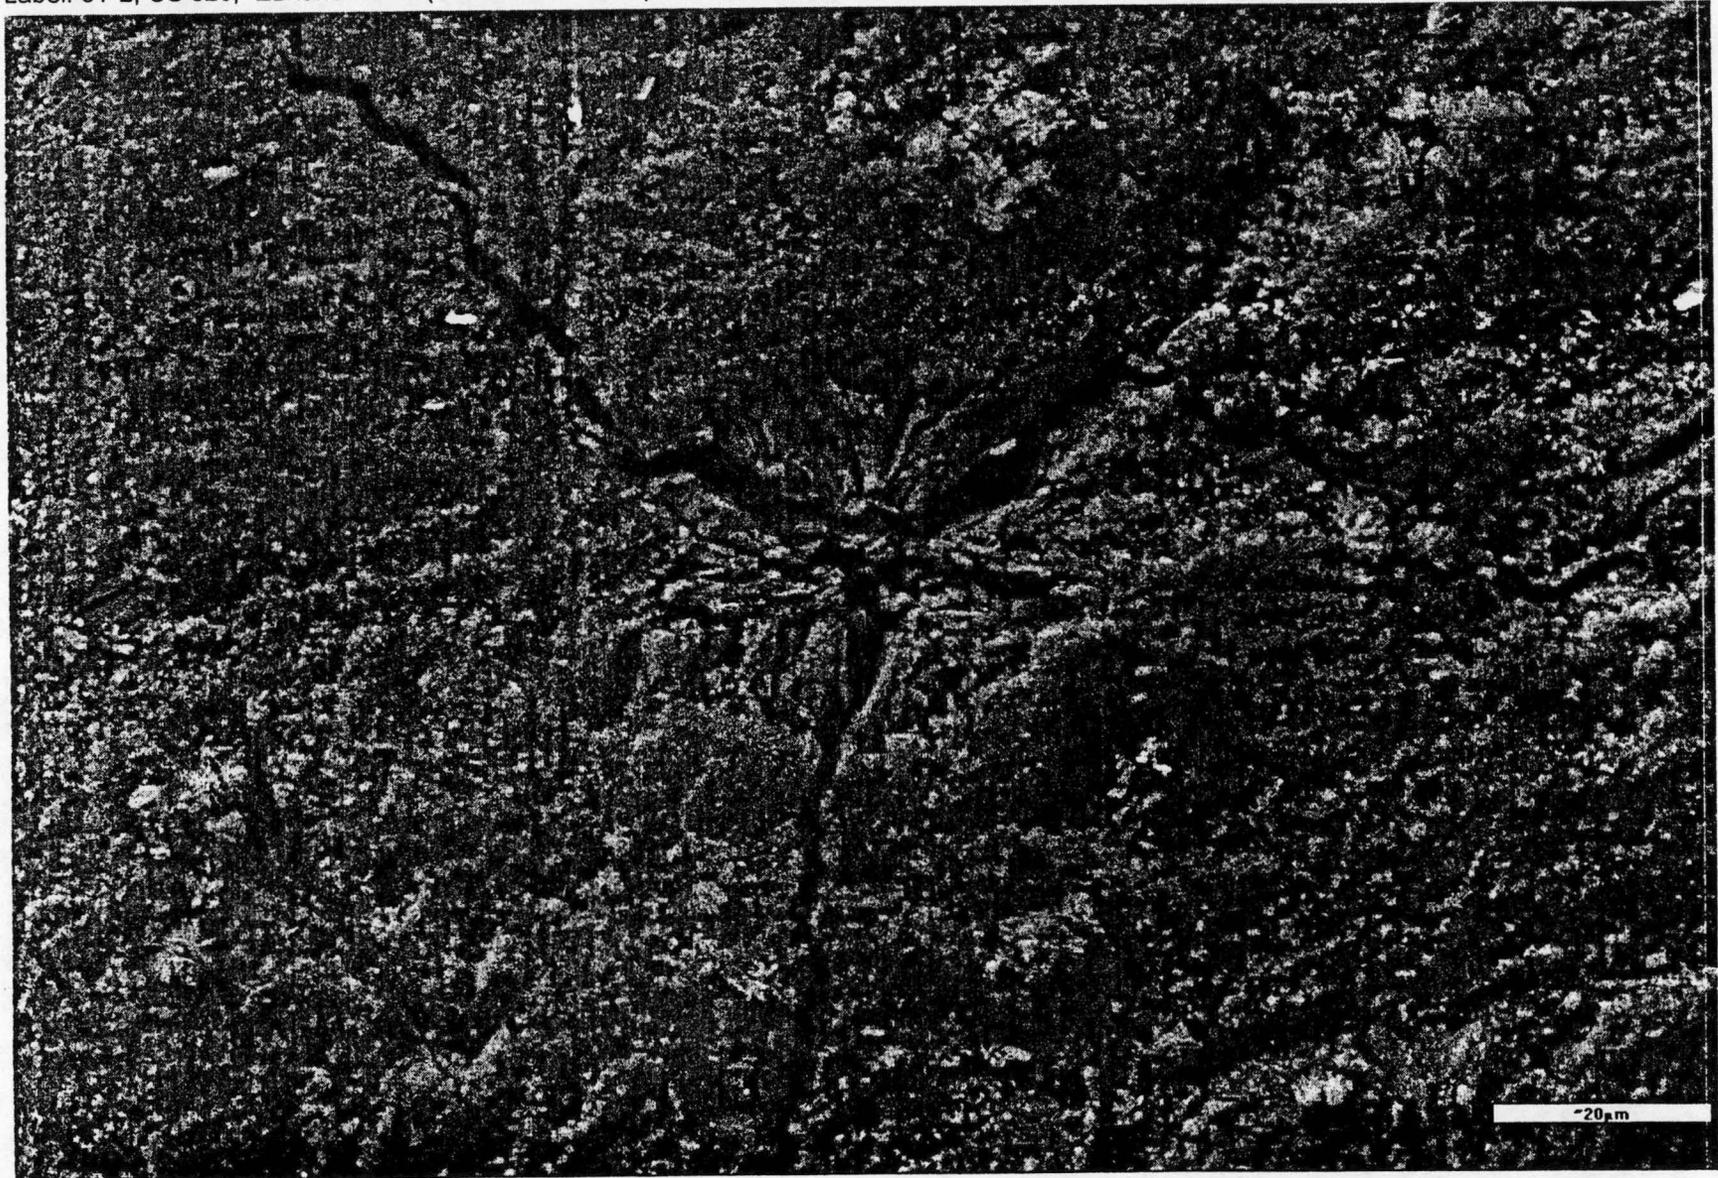
FIGURE 6 A 100X BSE PHOTOMICROGRAPH OF IOWA 20 SHOWING CRACKS RADIATING FROM THE ETTRINGITE FILLED AIR VOIDS

The SEM also identified cracks radiating from some of these air voids (Figure 6). This would support a conclusion that this air

void was a center-of-pressure in the development of these cracks. There was another interesting feature of the ettringite in these voids with the radiating cracks. The ettringite was filling these voids, but the ettringite did not extend outside of the round voids into the radiating cracks. This led to the conclusion that the void was filled with ettringite before the cracks developed.

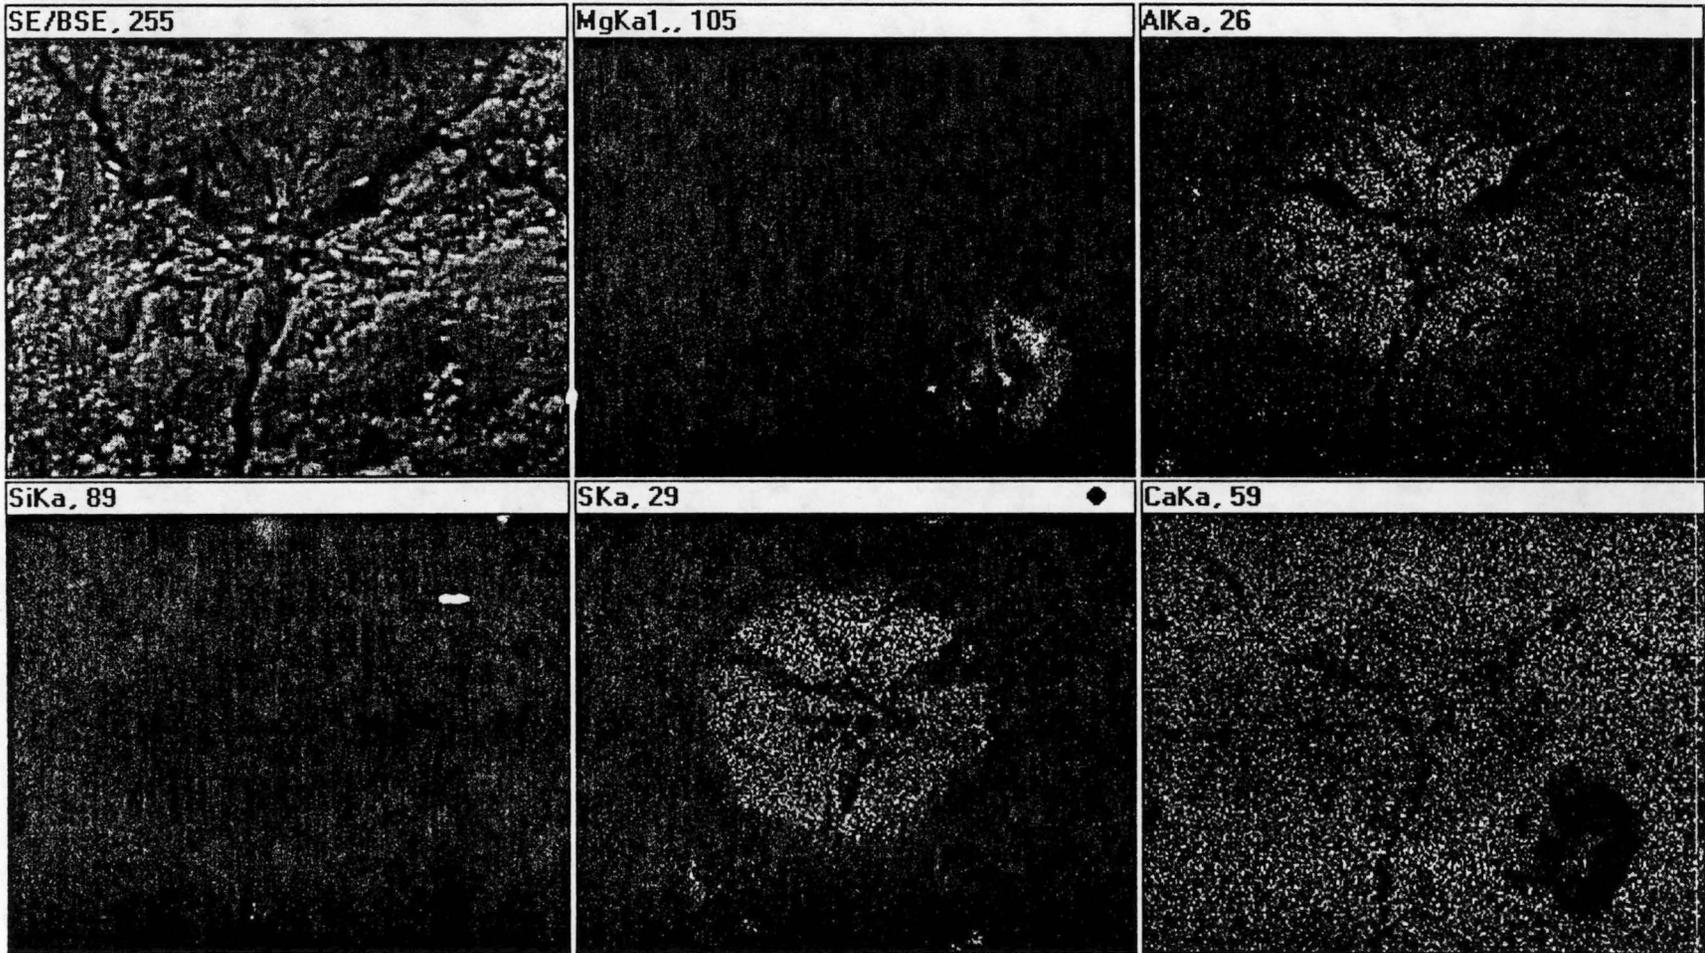
**FIGURE 7 THE ELEMENTAL MAP FOR THE
FIGURE 6 PHOTOMICROGRAPH**

The elemental maps for sodium and potassium (Figure 7) showed a general distribution of the elements and the round air voids could not be identified. The elemental map for silicon was a different story. The round air voids could easily be identified because they were black, showing that there was almost no silicon in the whitish material in the air voids and substantially more silicon in the PCC surrounding the air voids. This led to the conclusion that the whitish material in the air voids is not silica gel.

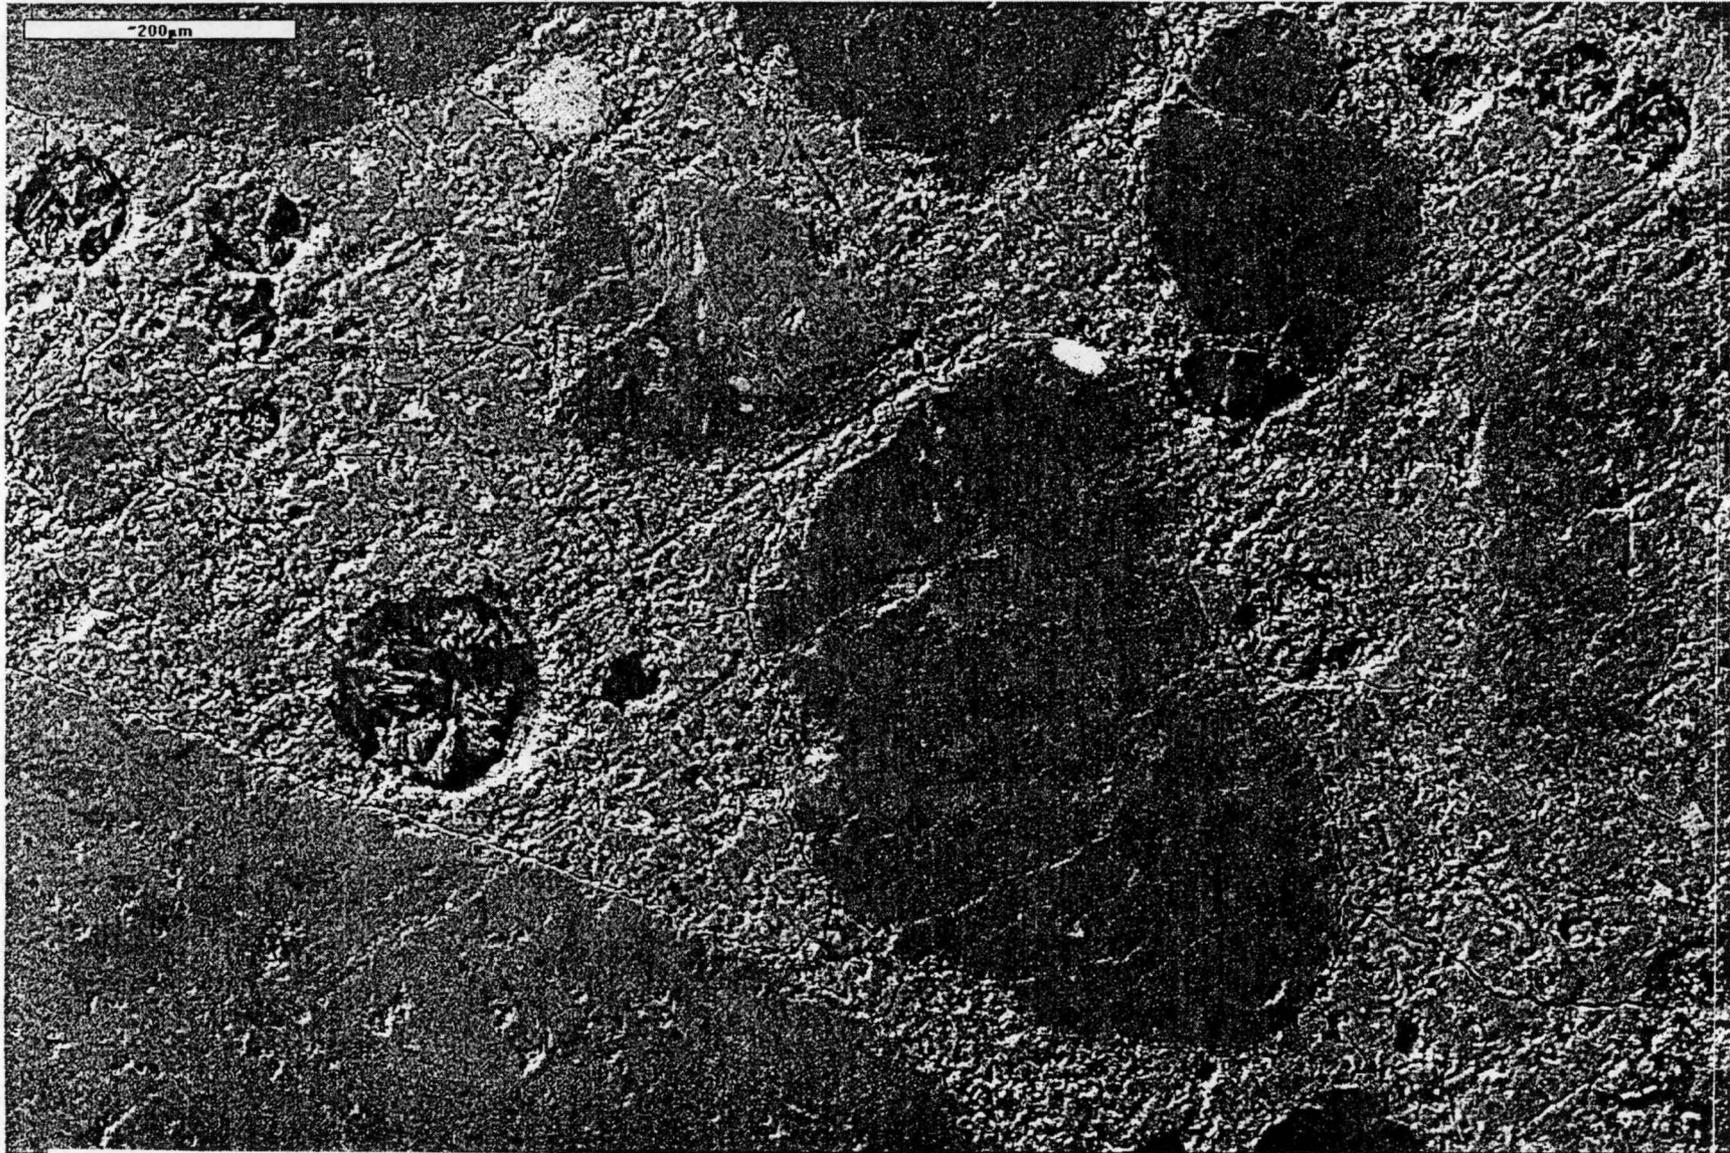
**FIGURE 8 A 100X BSE PHOTOMICROGRAPH OF
A NEBRASKA I-80 AURORA PCC SAMPLE**

An investigation of the I-80 Aurora PCC (Figures 8 & 9) show a high concentration of sulfur and very little, if any, silicon again leading to the conclusion that the material is ettringite and not silica gel. An interesting note to make on the I-80 Aurora SEM data is that some of the air voids are in close proximity to these so called ASR reactive aggregates. If these reactive aggregate particles are producing silica gel, it would be a reasonable assumption that some of this expansive gel would be forced into the voids in close proximity. No concentration of silicon has been identified in these air voids.

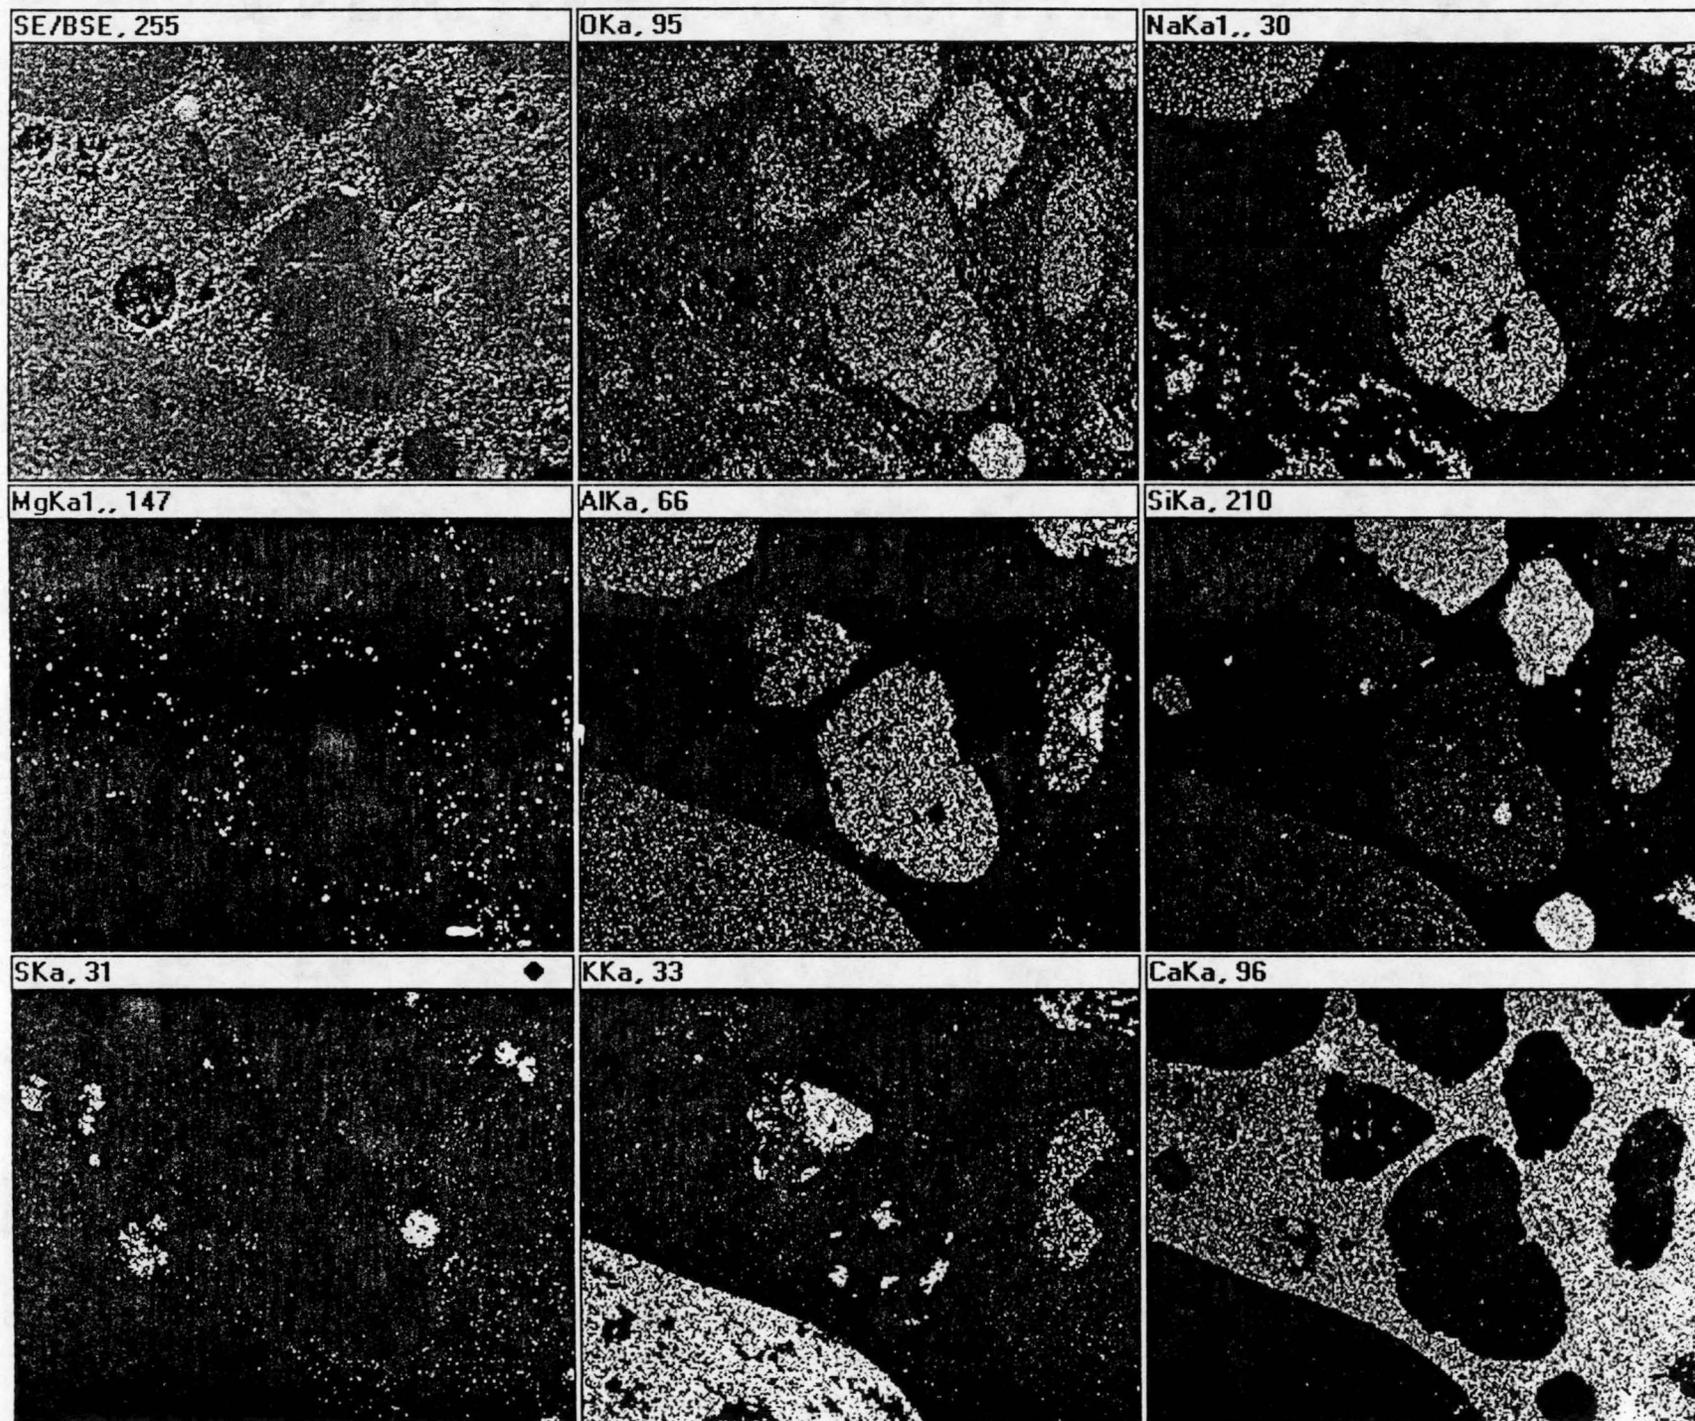
FIGURE 9 THE ELEMENTAL MAPS FOR THE FIGURE 8 PHOTOMICROGRAPH

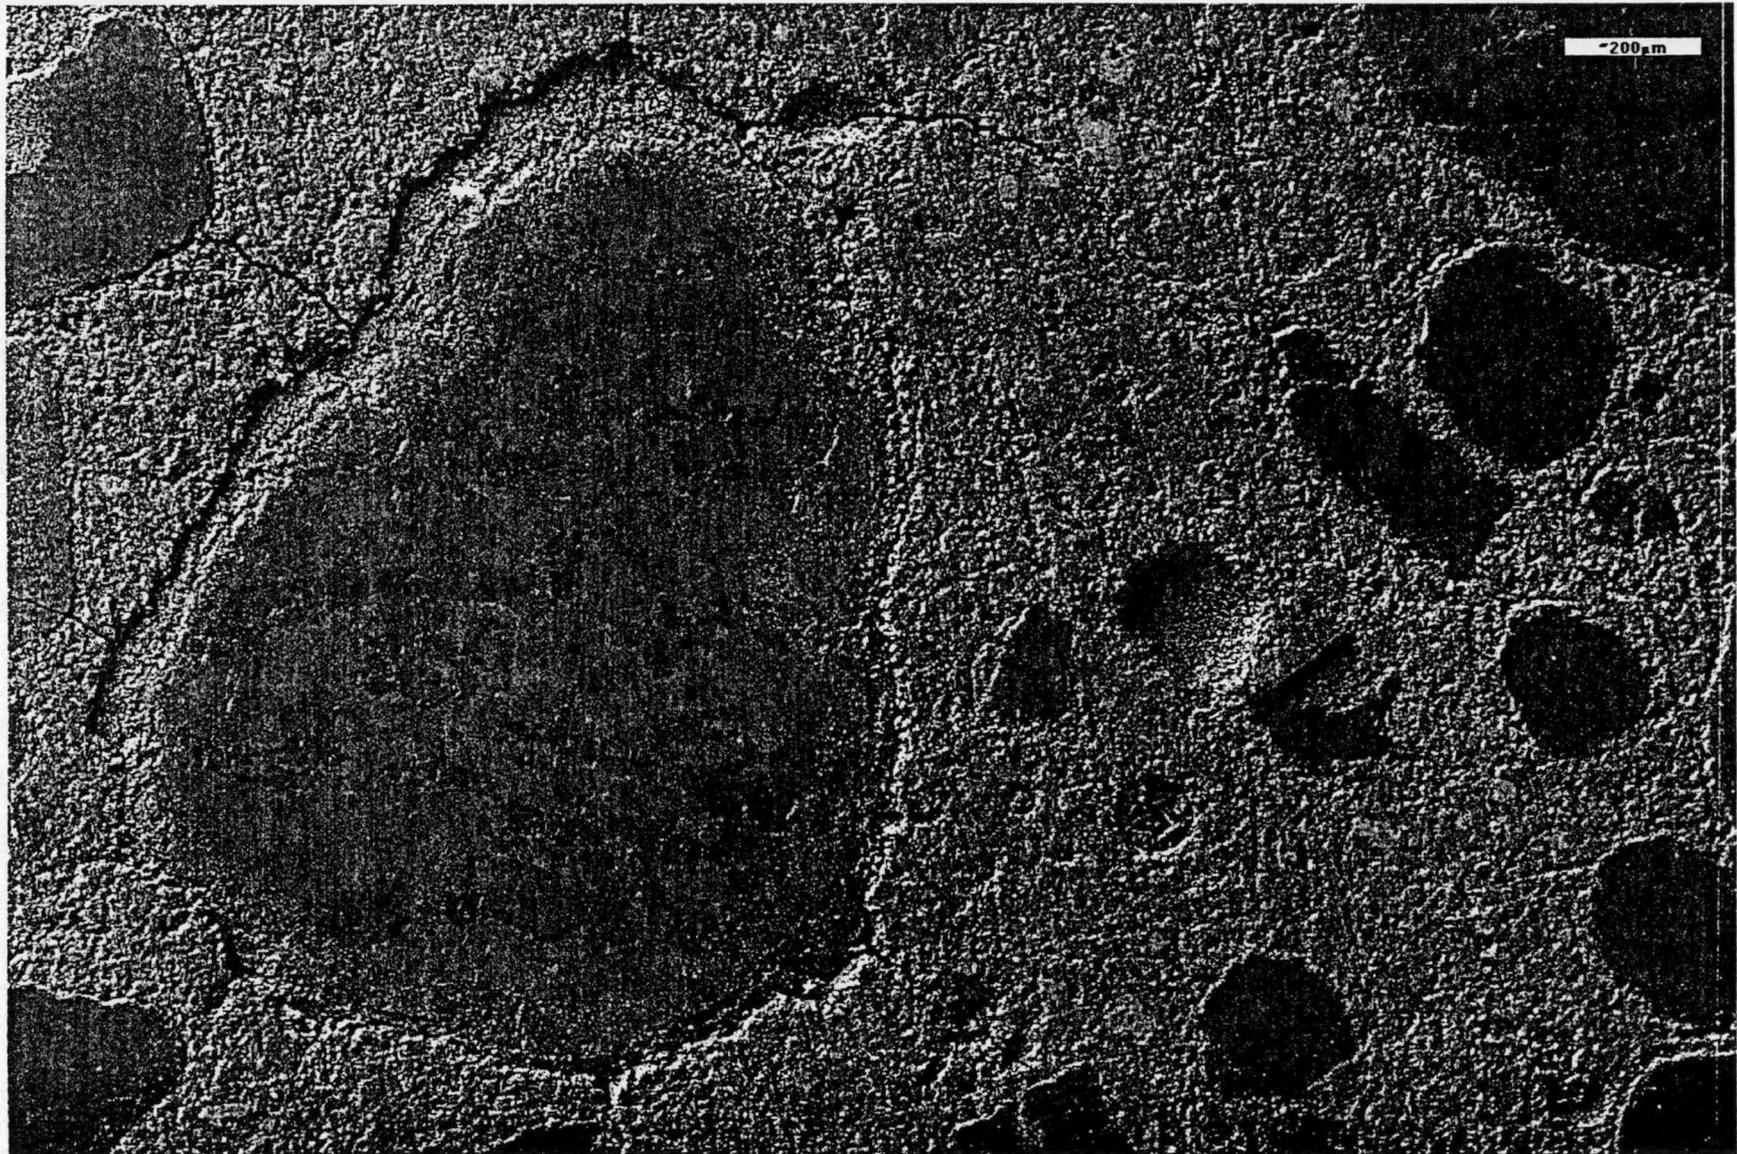
FIGURE 10 A 100X BSE PHOTOMICROGRAPH OF A NEBRASKA OHMAHA AIRPORT PCC SAMPLE

There was also a rim deposit around an aggregate particle (Figure 10). Many petrographic researchers would probably identify this rim as silica gel. The elemental maps of Figure 11 show that this rim does not contain silicon, so it is not silica gel. The rim material contains substantial sulfur and is, therefore, probably ettringite.

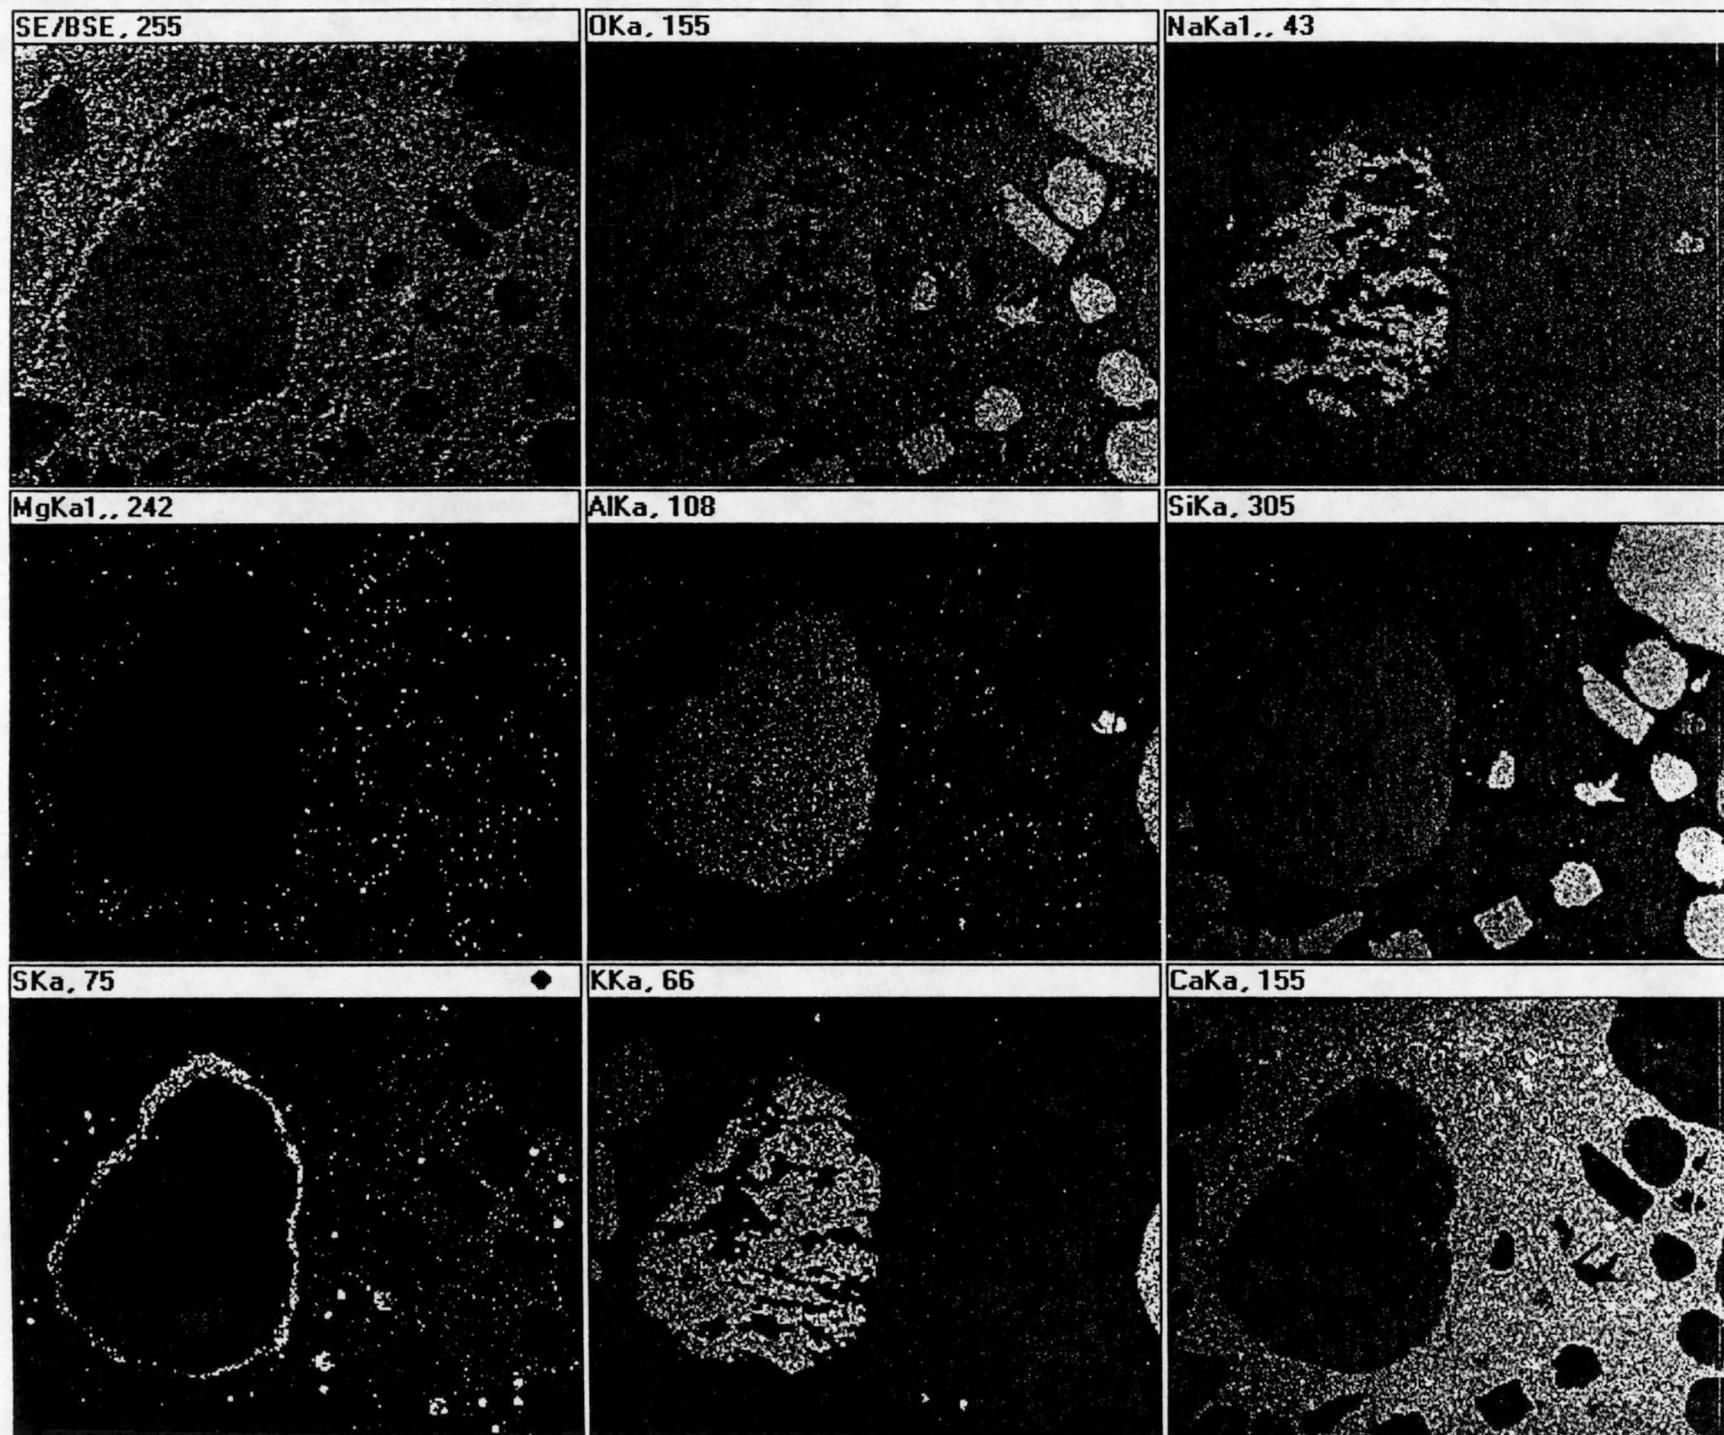
FIGURE 11 THE ELEMENTAL MAPS FOR THE FIGURE 10 PHOTOMICROGRAPHS
