INVESTIGATION OF PCC PAVEMENT DETERIORATION - A FEW FACTS ARE WORTH MORE THAN 100 OPINIONS

IOWA DEPT. OF TRANSPORTATION

Interim Report
for
Iowa DOT
Research Project HR-2074

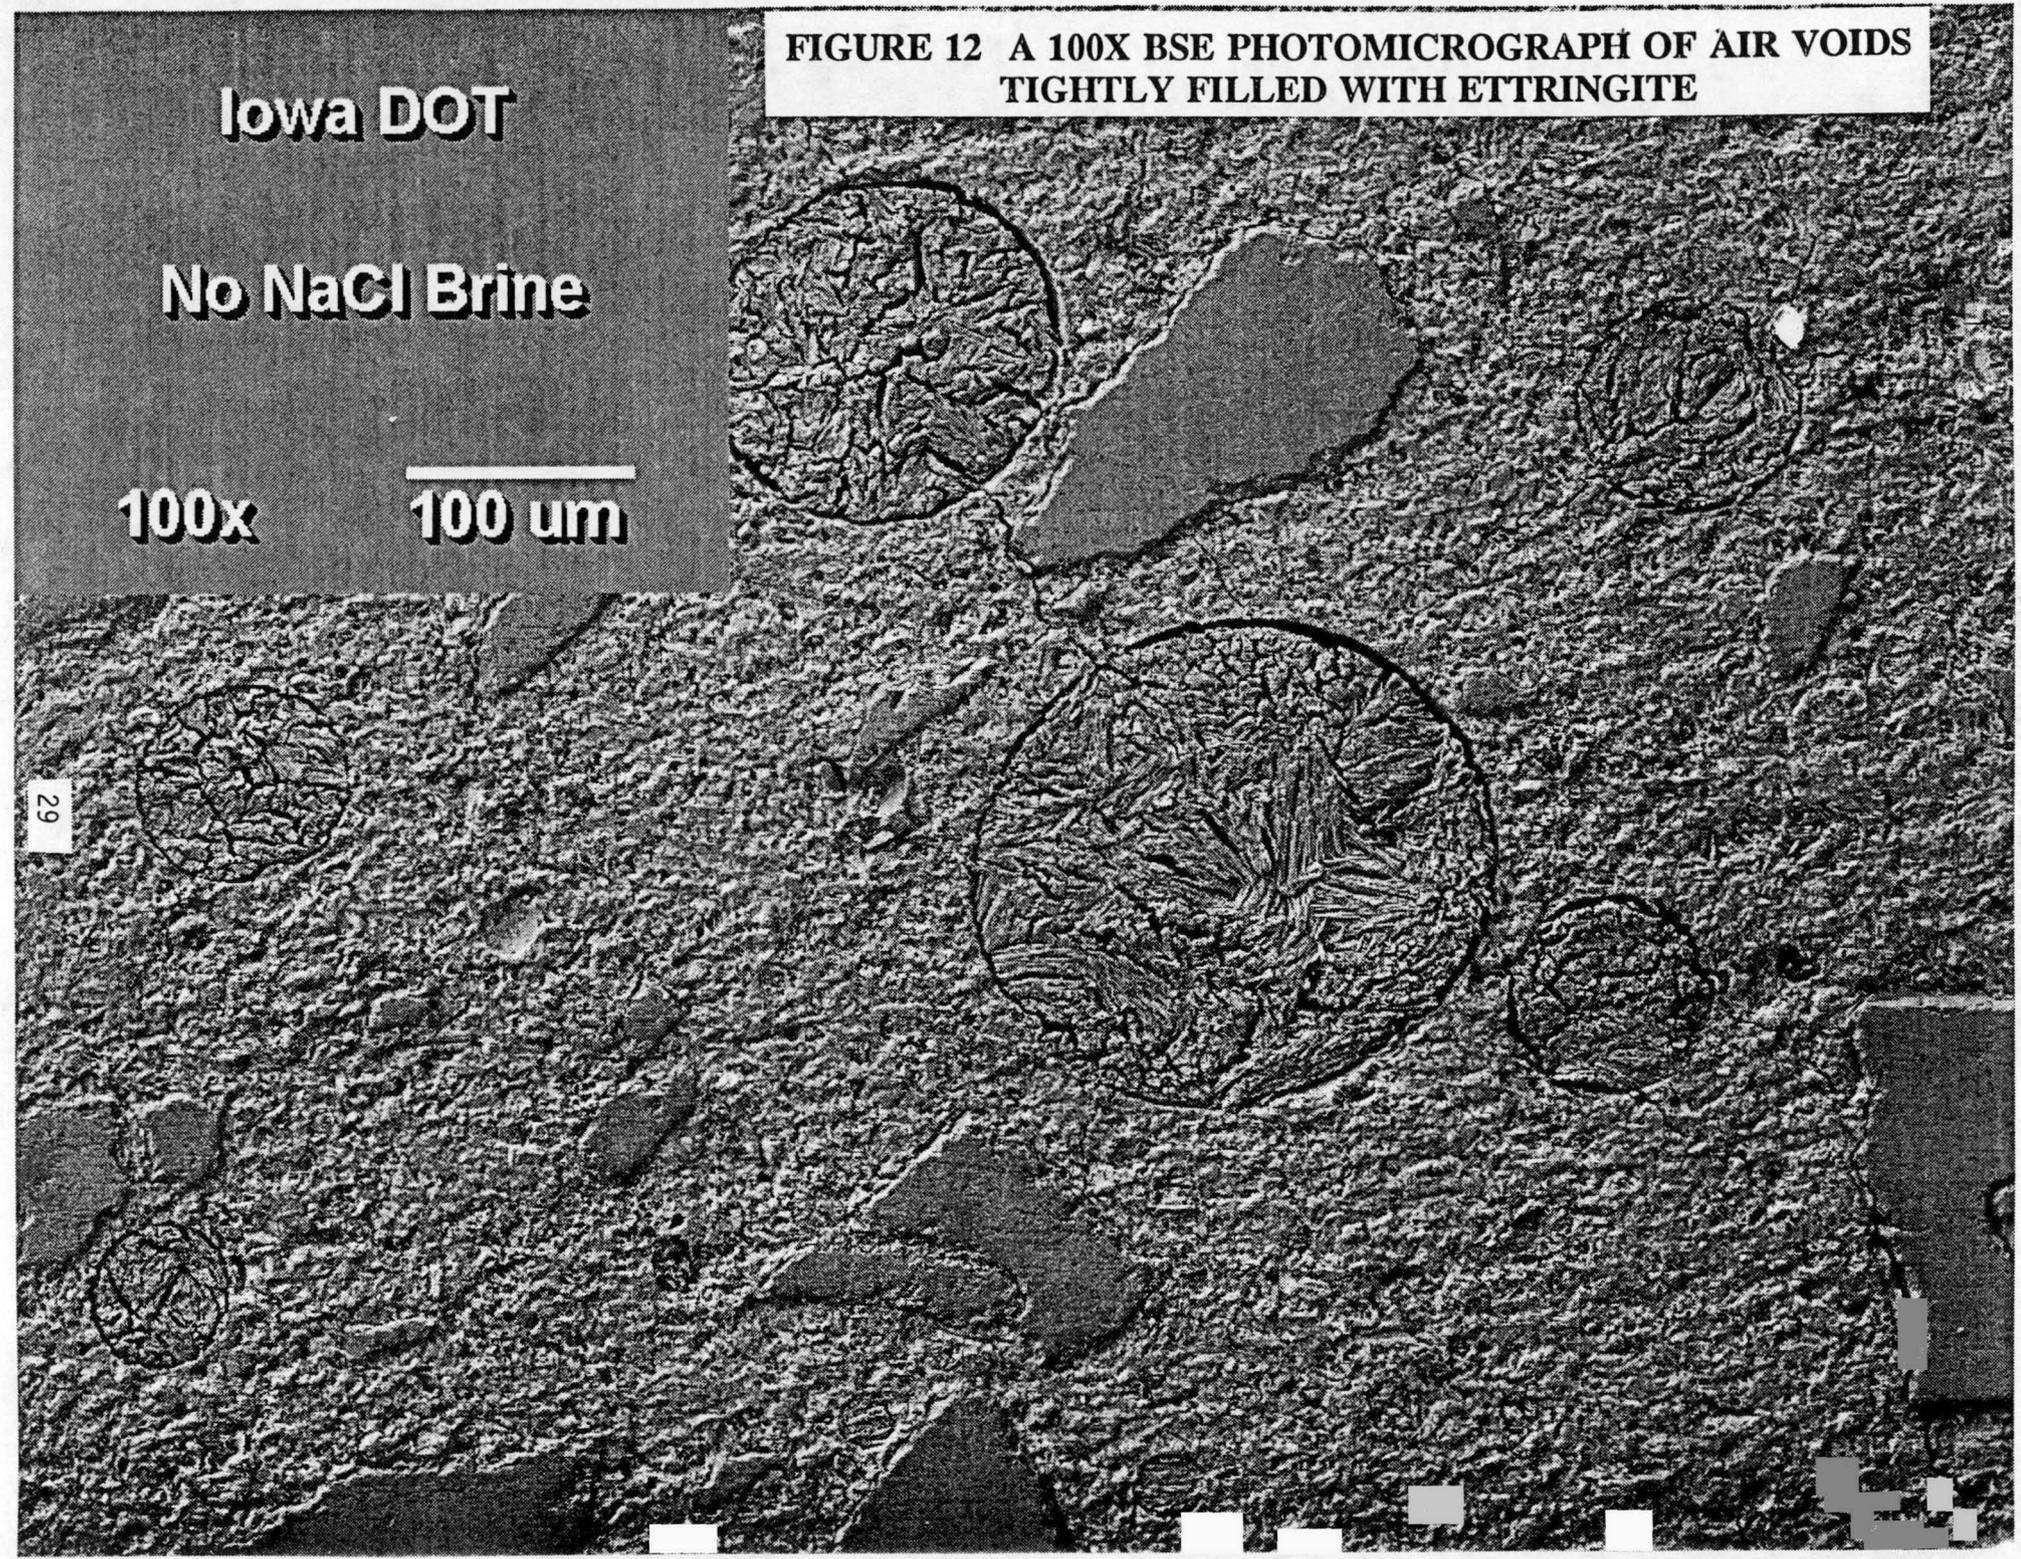
FIGURE 12 A 100X BSE PHOTOMICROGRAPH OF AIR VOIDS TIGHTLY FILLED WITH ETTRINGITE

Canadian research at the University of Manitoba had shown that ettringite would dissolve in the presence of chloride ions (4). In an effort to substantiate this in regard to the ettringite in the voids, a polished PCC surface with a few large, tightly filled voids was selected. A photomicrograph and elemental maps were recorded prior to treatment with NaCl brine (Figure 12). The elemental maps (Figure 13) exhibited no silicon, but substantial sulfur and aluminum indicating that the material in

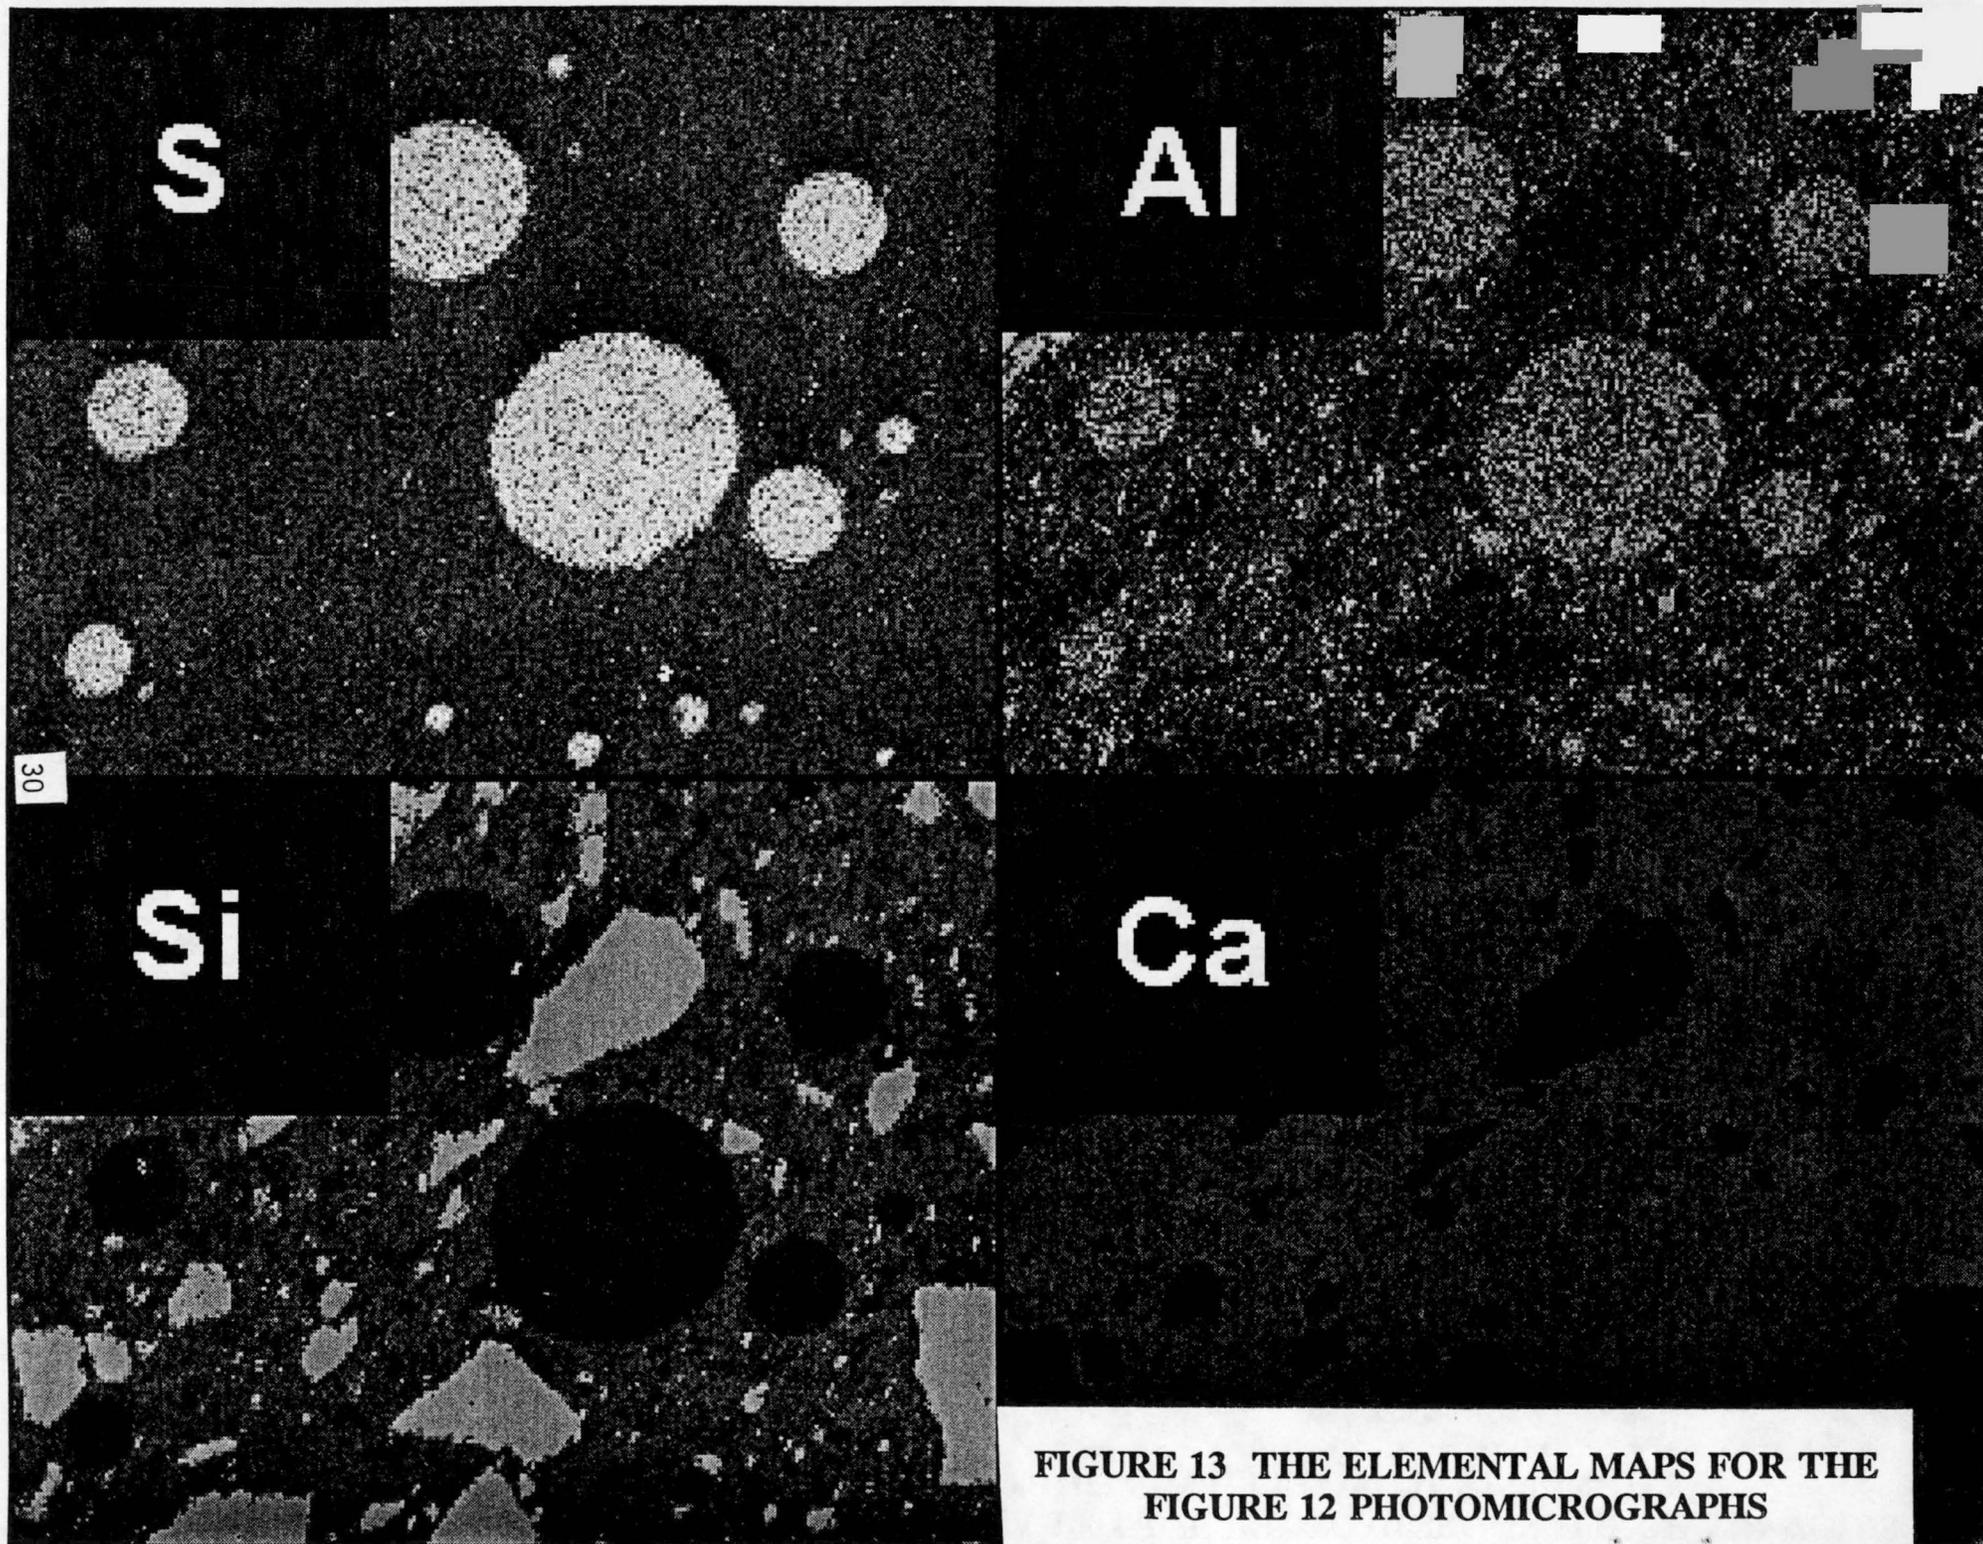
**FIGURE 13 THE ELEMENTAL MAPS FOR THE
FIGURE 12 PHOTOMICROGRAPHS**

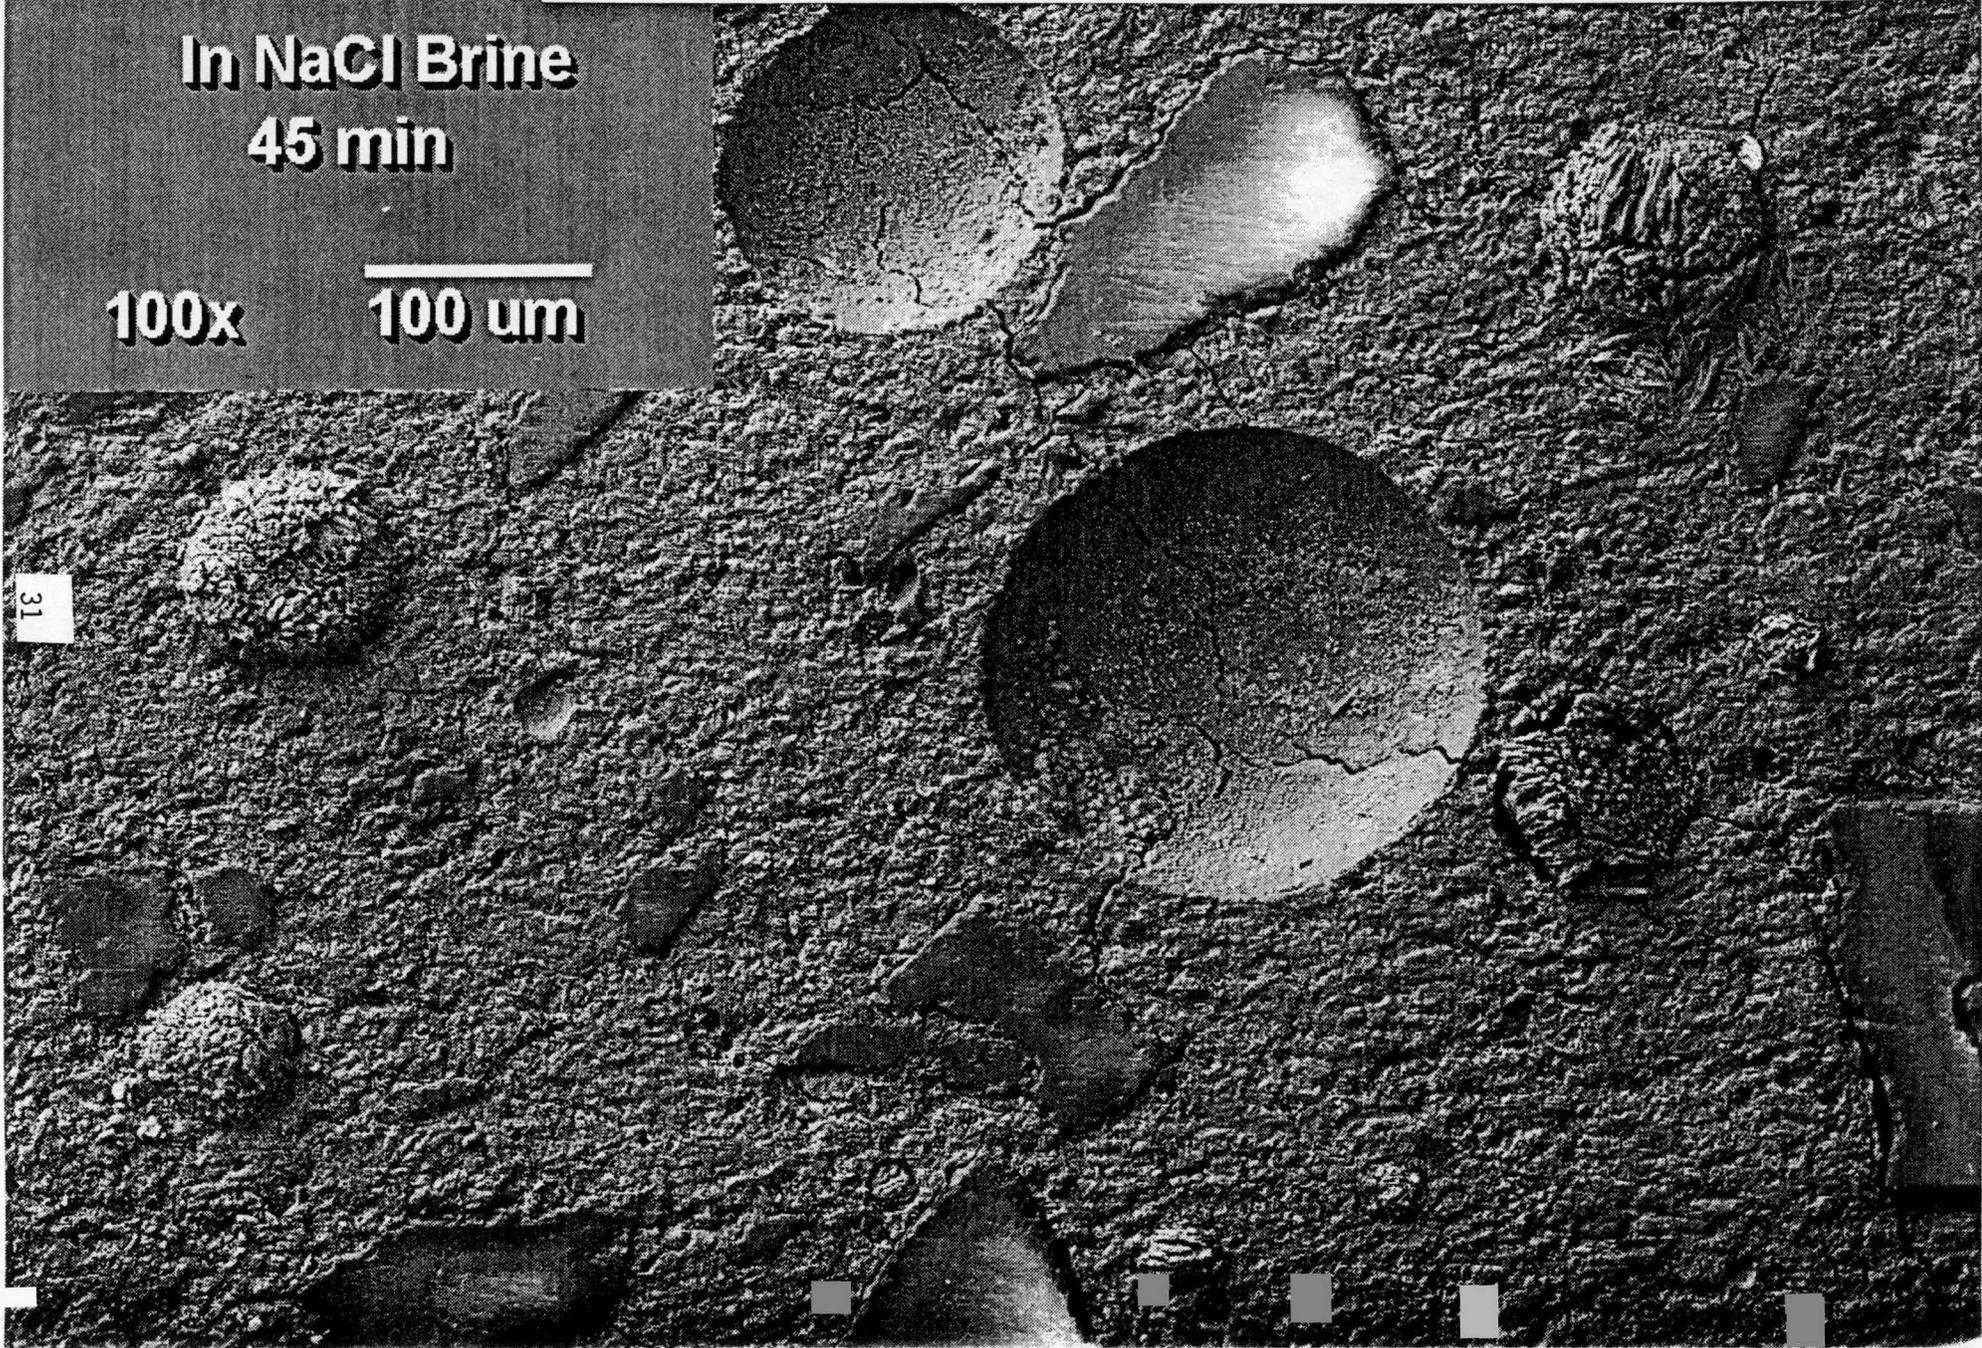
**FIGURE 14 A 100X BSE PHOTOMICROGRAPH OF THE FIGURE 12 AIR VOIDS
45 MINUTES AFTER TREATMENT WITH NaCl BRINE**

the air voids was very likely ettringite. The NaCl treated, polished sample was put into the low vacuum SEM. The ettringite in the large voids had either been dissolved or dislodged (Figure 14). Another very interesting finding was that the ettringite in the small voids had swelled and expanded. After 48 hours, the ettringite had dissolved from all of the air voids, but the expansion of the ettringite had been sufficient to lift the boundaries of the air voids (Figure 15). Another significant feature that became visible was the substantial cracking in the large air voids and the cracking through a series of air voids.

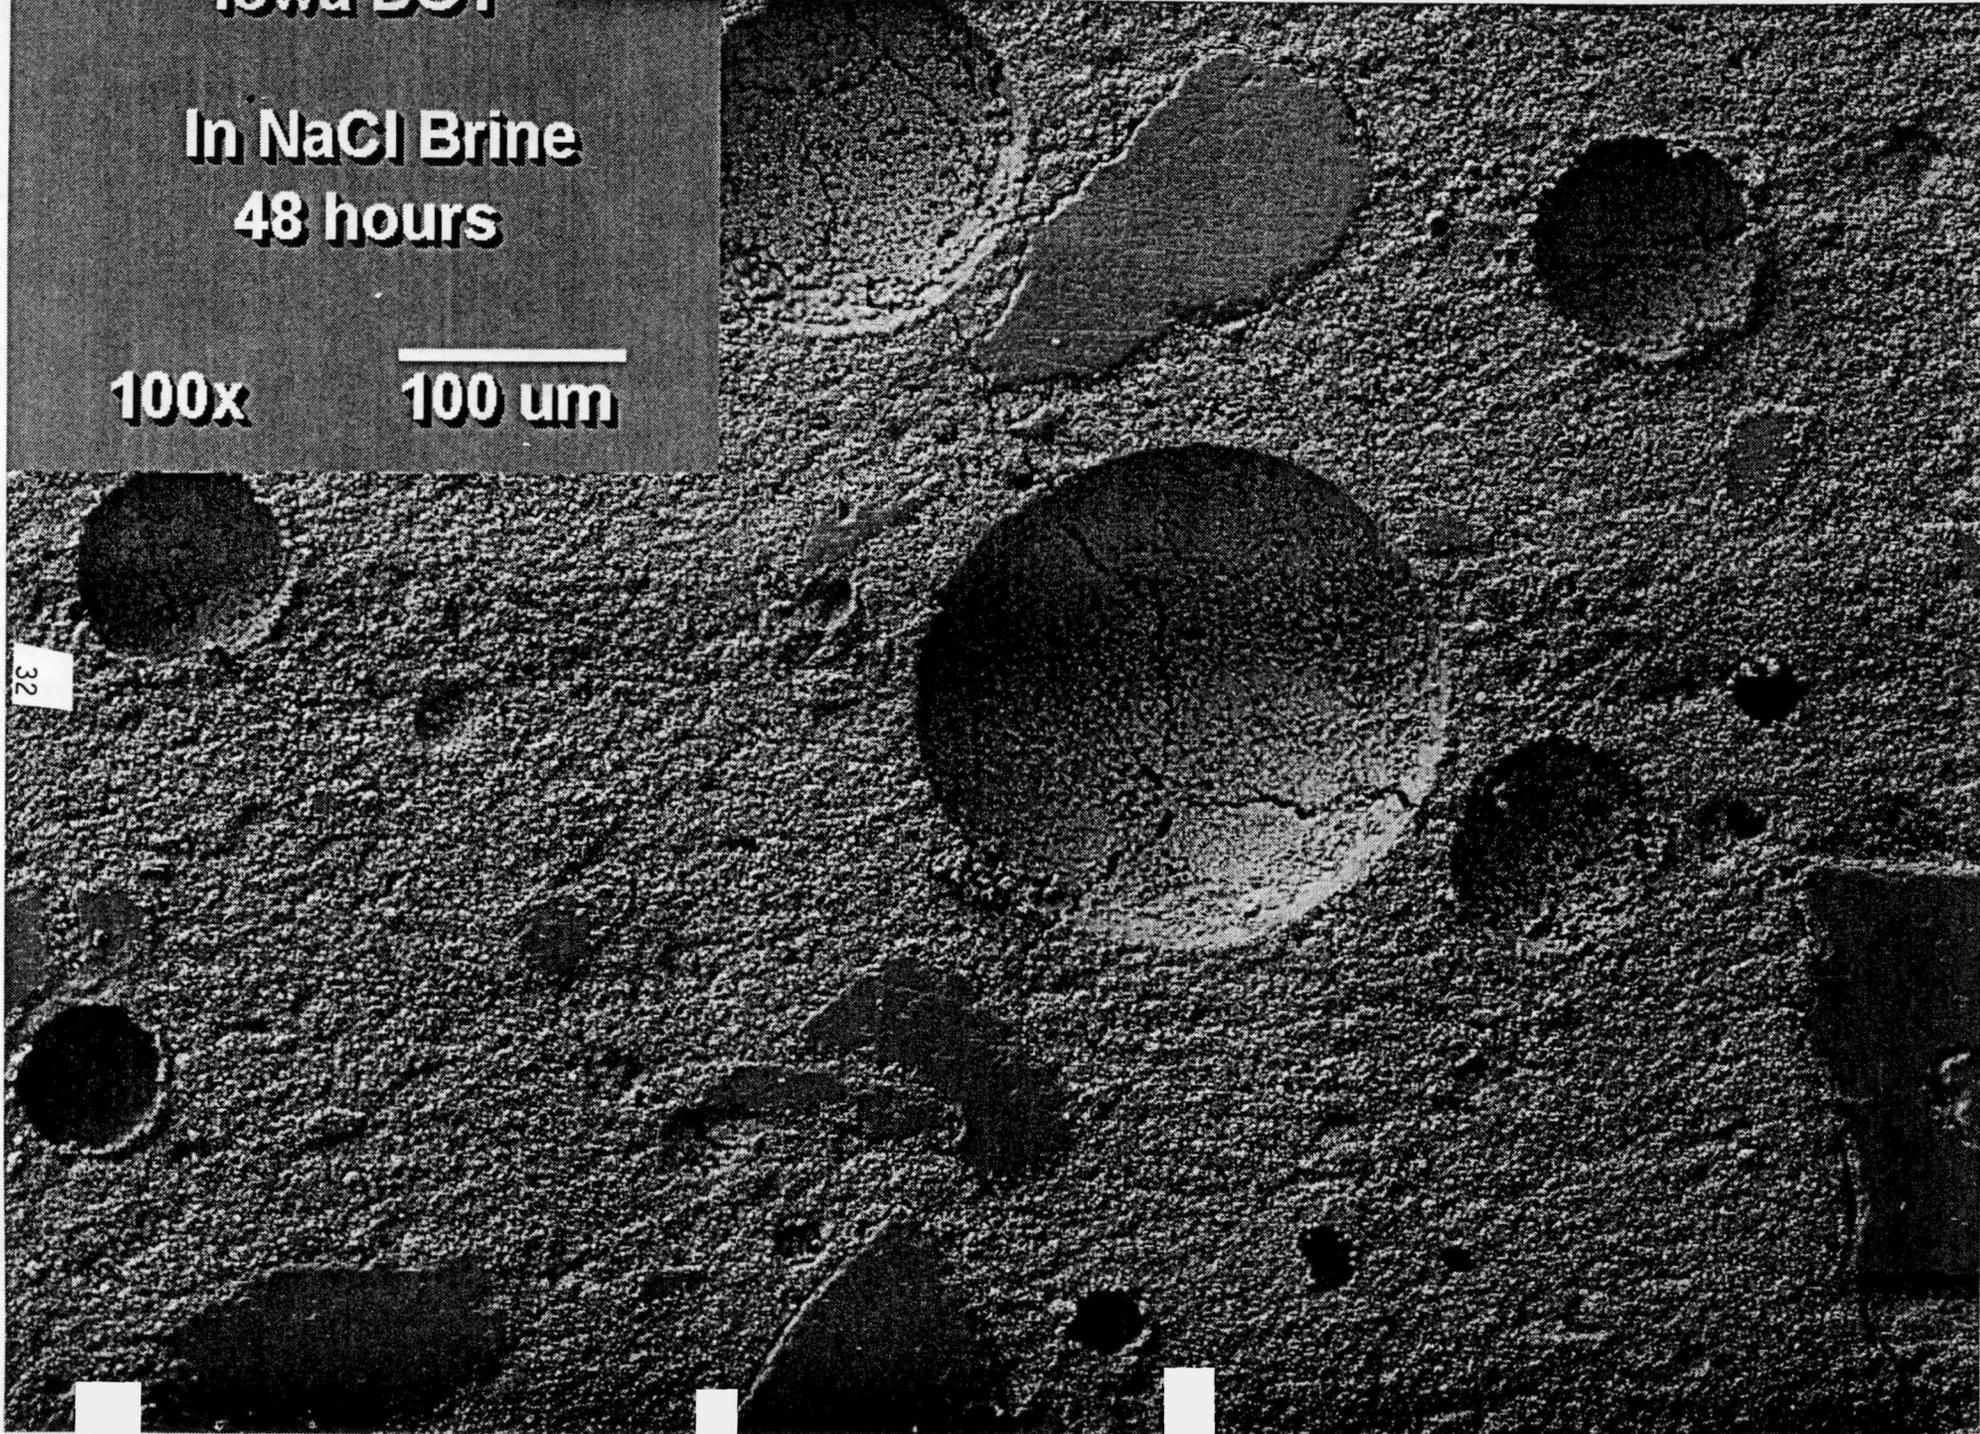
**FIGURE 15 A 100X BSE PHOTOMICROGRAPH OF THE FIGURE 12 AIR VOIDS
48 HOURS AFTER TREATMENT WITH NaCl BRINE**

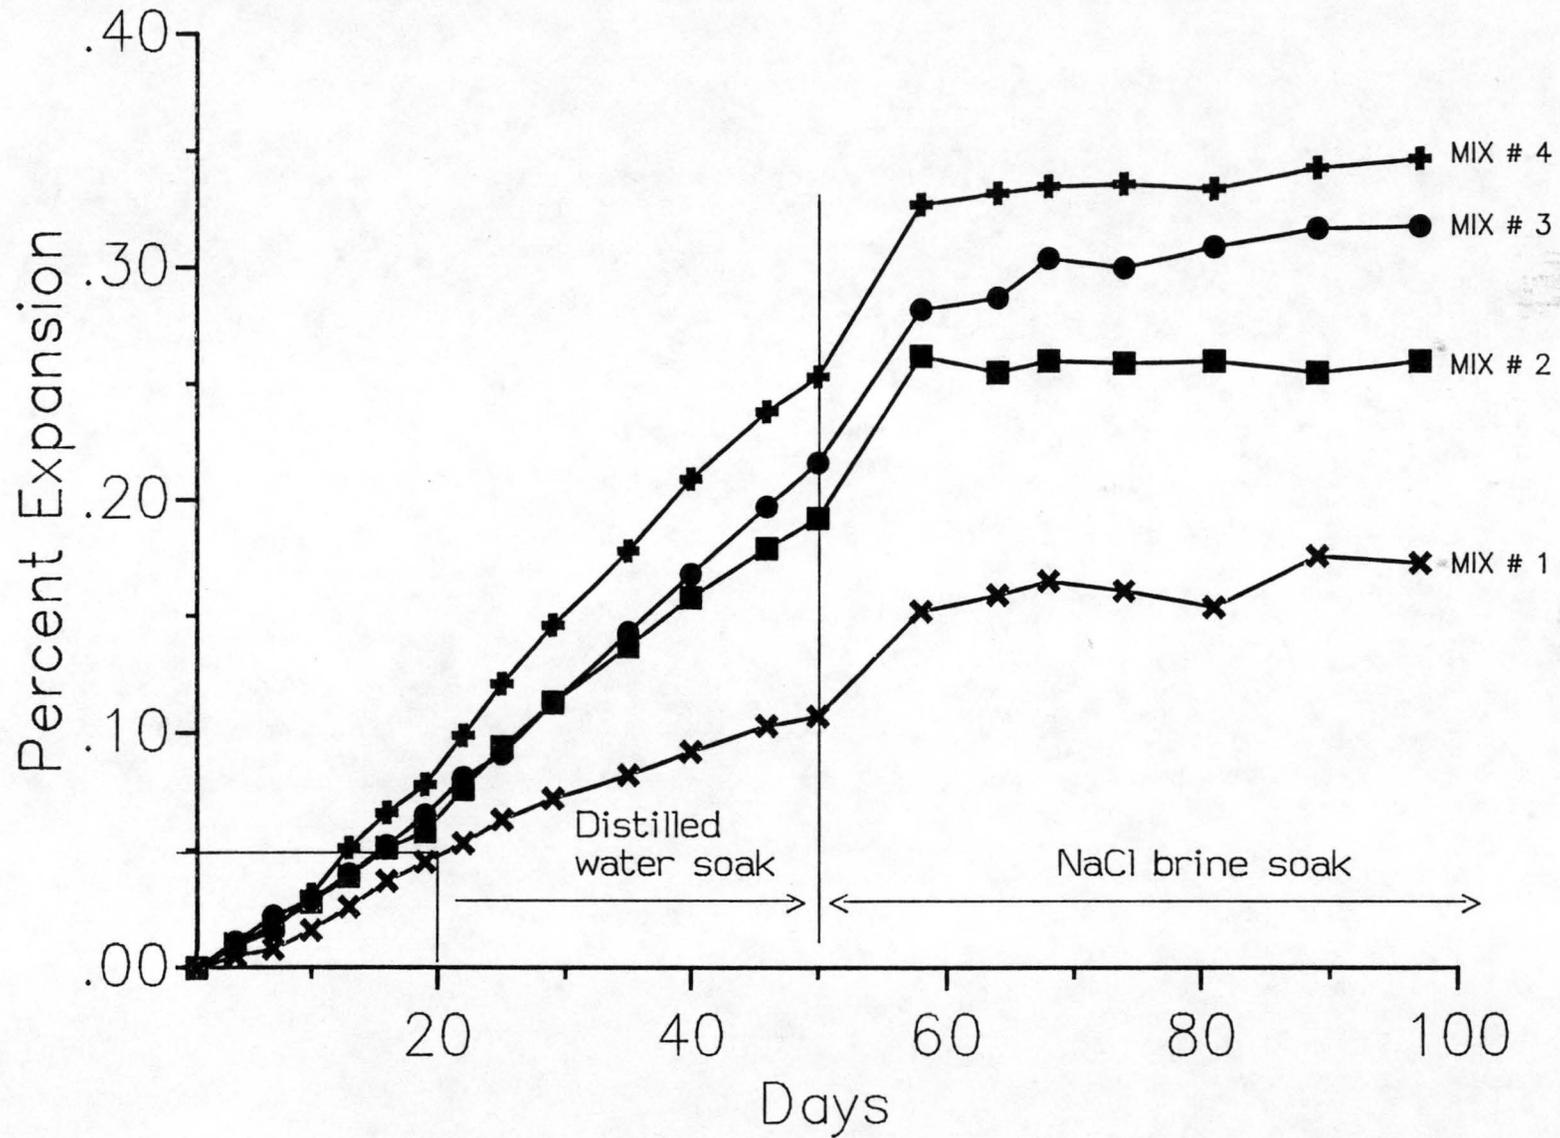
Figure 16

DUGGAN TEST RESULTS WITH SODIUM CHLORIDE BRINE MODIFICATION

The SEM data had shown relatively conclusively that when subjected to NaCl, ettringite initially expands and then dissolves. Duggan cores (5) 25 mm (1 in.) in diameter and 51 mm (2 in.) long were drilled from the laboratory prepared PCC that had been stored in the moist room. This PCC had exhibited ettringite either growing in or being extruded into the air voids as described earlier in this paper. These four cores had exhibited a relatively constant rate of expansion through 50 days during a distilled water soak (Figure 16). At 50 days after pretreatment, the four cores were changed to a NaCl brine soak. From 50 to 60 days all four cores exhibited an increased rate of expansion. After 60 days there was very little expansion indicating that the expansive mechanism had been destroyed (or dissolved). There is speculation that the expansive pressure was

due to ettringite through 50 days. When subjected to NaCl at 50 days, there was increased expansion of the ettringite. The ettringite then dissolved and there was very little additional expansion.
