Iowa Scenic Byway Program

Scenic/Heritage Byway Evaluation

By:
Decision Data Inc.
2730 S.W. 57th Street
Topeka, Kansas

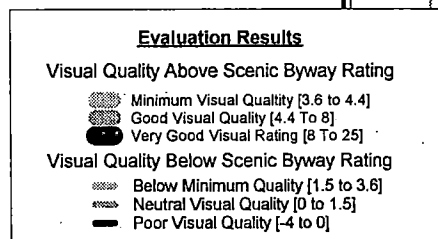
Scenic Byway Evaluation Results - Clockwise from Hopkinton Nomination #1 Delaware County

Corridor
 Begins in Hopkinton
 loops near Manchester
 and ends in Hopkinton

Note: The survey evaluation scores in both directions are included in the areas outlined on the graph.

A continuous rating of the corridor's scenic and heritage characteristics is shown in displays on Pages #1-5 through #1-8. The nominated corridor is shown on these pages as shaded lines. The type of shading and the line widths indicate the corridor's rating. Wide bands show areas rated as having good scenic quality. The graphs shown with the maps display the numerical rating. It should be noted that data in one inventory direction is reversed (through software management) so that the graphs as seen in this report reflect the ratings from the same beginning point.

- The average quality score for the scenic byway category is above 4.0. More than 50% of the corridor's length scored above 4.
- About 27% of the corridor was rated as offering good or outstanding views. Areas with high scenic quality were found in the Delhi Lake area and along Iowa 38 north of Hopkinton.
- Evaluations of roadway character and adjacent visual elements along the nominated corridors showed that over 60% of corridor offered a roadway background rated as good or outstanding.

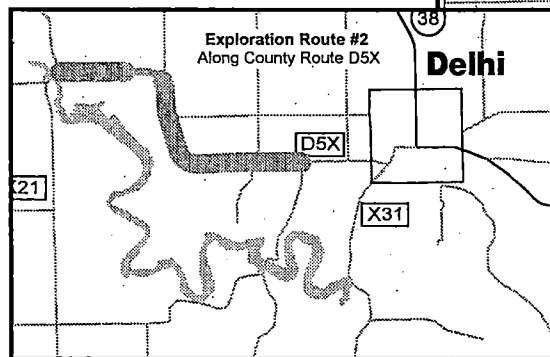
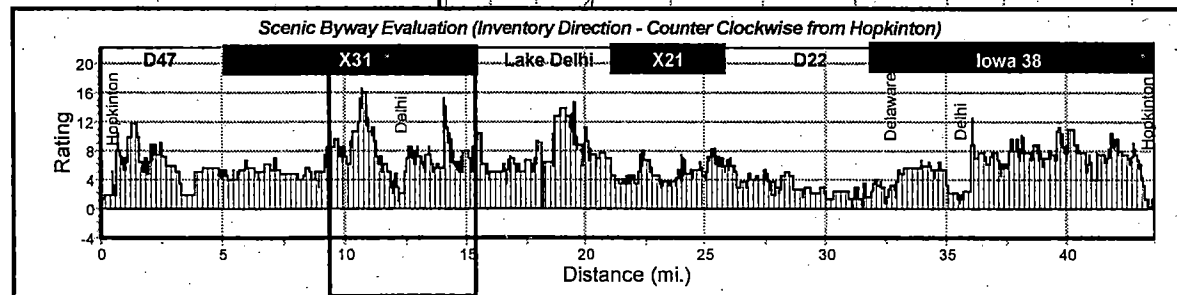
Evaluation Results - Counterclockwise from Hopkinton

Corridor
Begins in Hopkinton
loops near Manchester
and ends in Hopkinton

Note: The survey evaluation scores in both directions are included in the areas outlined on the graph.

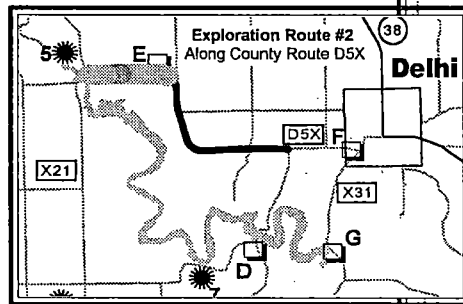
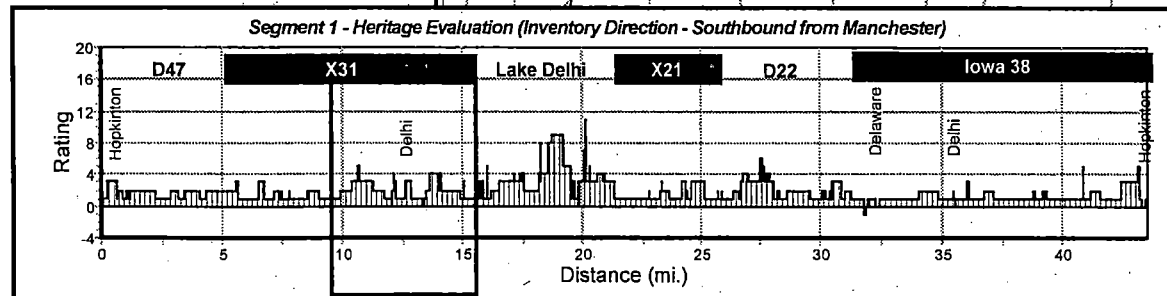
Heritage Byway Evaluation Results - Counterclockwise from Hopkinton Nomination #1 Delaware County

Corridor
Begins in Hopkinton
loops near Manchester
and ends in Hopkinton

- Evaluation Results**
- Quality Above Heritage Byway Rating
- Minimum Heritage Quality [3.6 to 4.4]
 - Good Heritage Quality [4.4 To 8]
 - Very Good Heritage Rating [8 To 25]
- Quality Below Heritage Byway Rating
- Below Minimum Quality [1.5 to 3.6]
 - Neutral Heritage Quality [0 to 1.5]
 - Poor Heritage Quality [-4 to 0]

Note: The survey evaluation scores in both directions are included in the areas outlined on the graph.

- The average quality score for the heritage byway category is below 4.0. The percentage of each segment rated above 4 is also less than 50%.
- Comparison of current land use with land use during the time frame associated with the corridor theme (from the 1860's) showed that the land use from the two periods matched along 18% of the corridor..
- Hopkinton offered some of the best land use matches found along the nominated corridor. The campus of Park College in Hopkinton is an excellent historic feature that provides its own period setting. The segment of the corridor that leads to the Turtle Creek Recreation area provides an excellent rural setting and the road alignment suggests the stagecoach route that it follows.

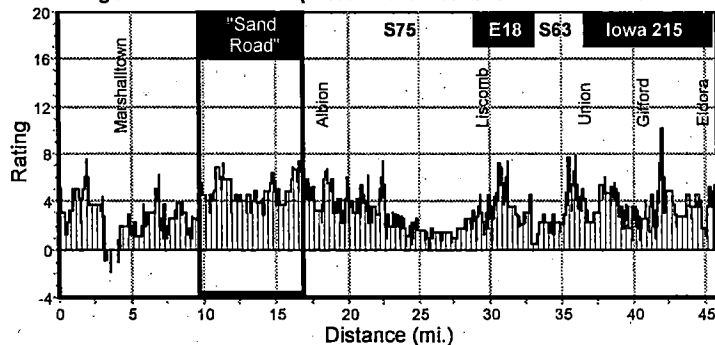
Segment 1 Scenic Score - (Northbound from Marshalltown to Eldora)

Scenic Byway Evaluation Results - Northbound Marshall, Hardin and Franklin Counties

Note: The outlined areas on the graph are loops that were traveled in both directions during the inventory. The scores shown on the graph represent both travel directions.

A continuous rating of the corridor's scenic and heritage characteristics is shown in displays on Pages #3-5 through #3-8. The nominated corridor is shown on these pages as shaded lines. The type of shading and the line widths indicate the corridor's score. Wide bands show areas rated as having good scenic or heritage quality. The graphs shown with the maps display the numerical rating. It should be noted that data in one inventory direction is reversed (through software management) so that the graphs as seen in this report reflect the ratings from the same beginning point.

- The average quality score for the scenic byway category is below 4.0 on both Segment #1 and #2. Less than 50% of the length along each corridor segment scored above 4.
- About 14% of the corridor was rated as offering good or outstanding views. Areas with high scenic quality were found in the Pine Lake State Park area along S56 north of Eldora.
- Evaluations of roadway character and adjacent visual elements along the nominated corridors showed that 18% of Segment #1 and 22% of Segment #2 offered a roadway background rated good or outstanding.

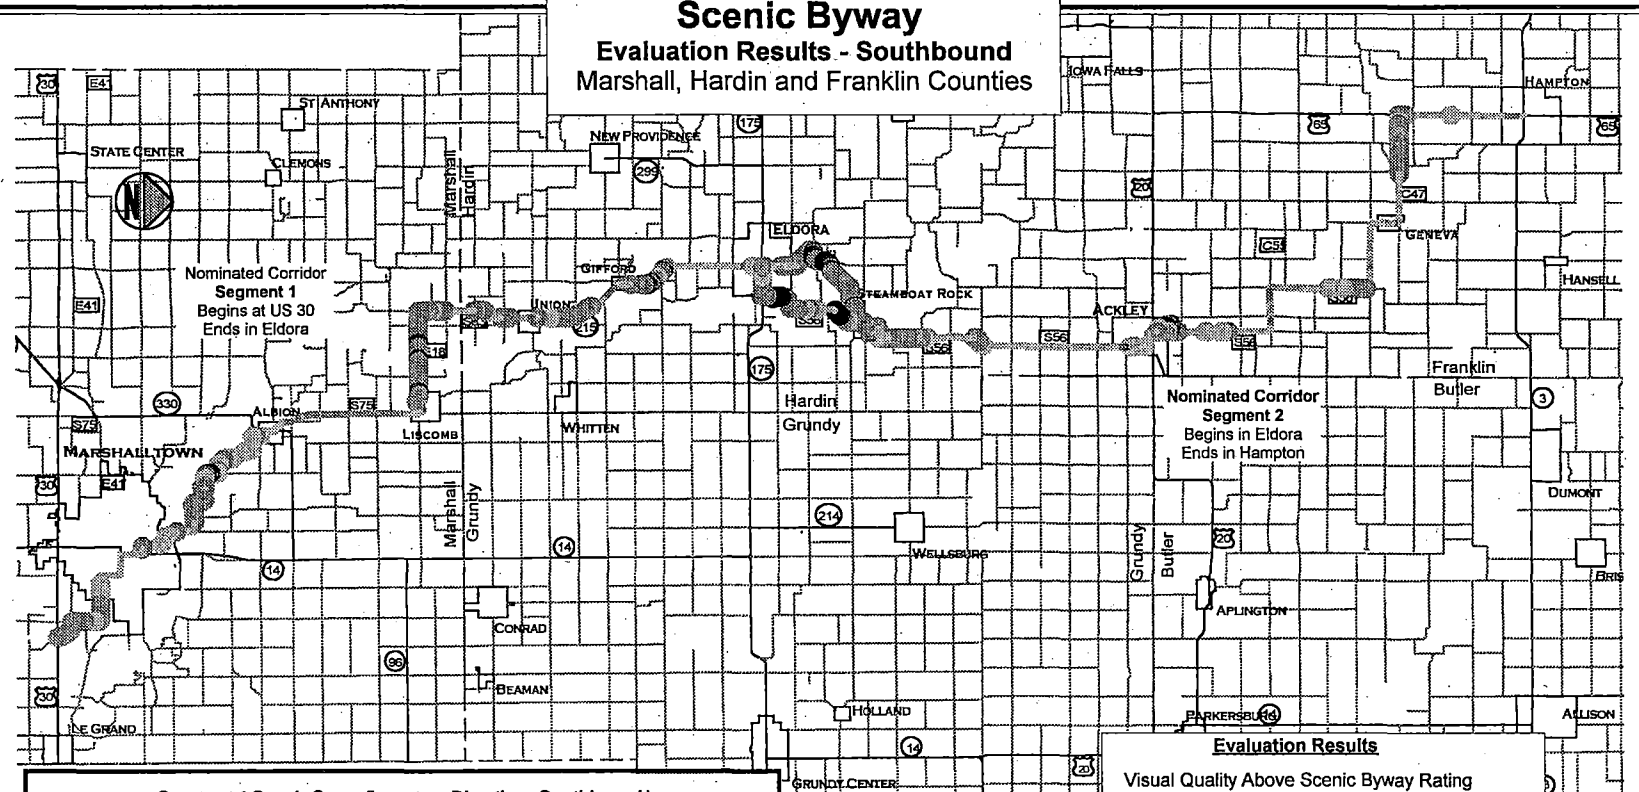
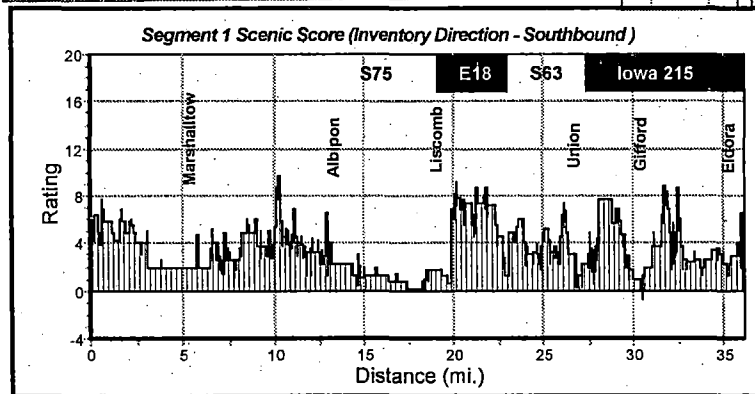
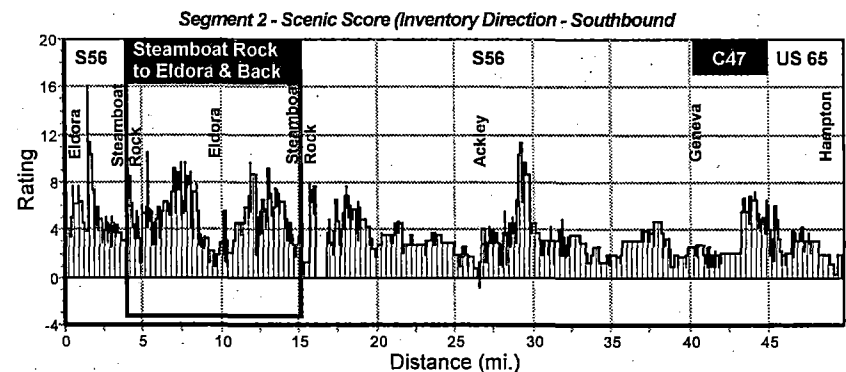
Scenic Byway Evaluation Results - Southbound Marshall, Hardin and Franklin Counties

Note: The outlined areas on the graph are loops that were traveled in both directions during the inventory. The scores shown on the graph represent both travel directions.

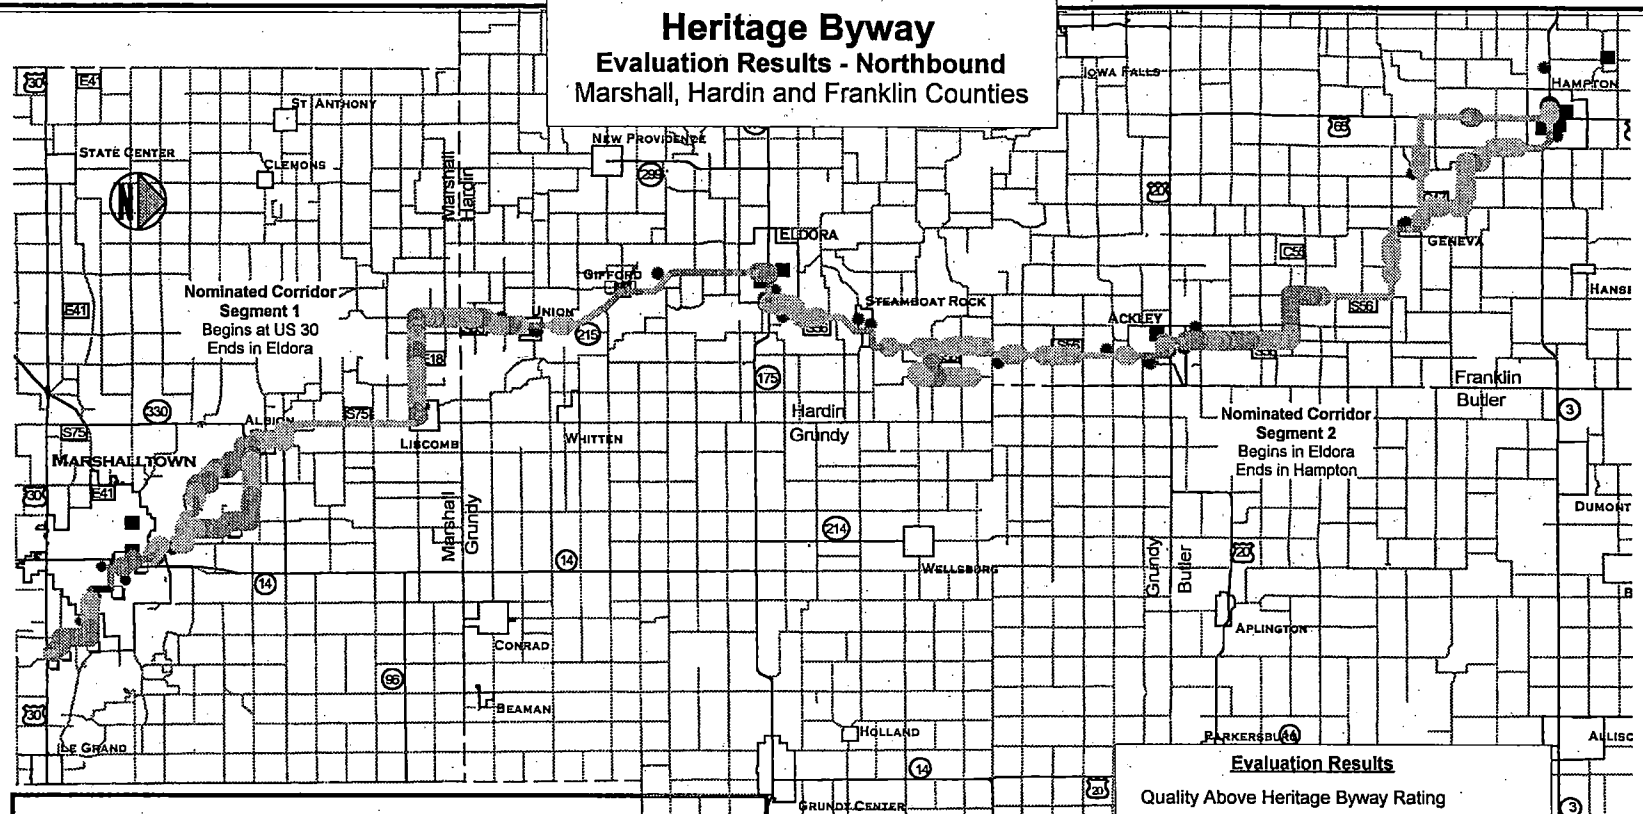
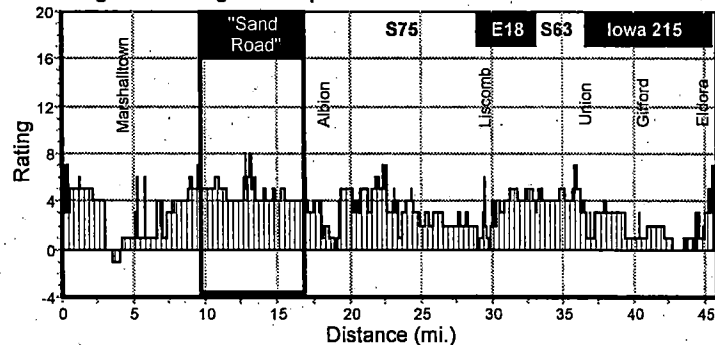
Segment 1 Heritage Score - (Northbound from Marshalltown to Eldora)

Heritage Byway Evaluation Results - Northbound Marshall, Hardin and Franklin Counties

Note: The outlined areas on the graph are loops that were traveled in both directions during the inventory. The scores shown on the graph represent both travel directions.

- The average quality score for the heritage byway category is below 4.0. The percentage of each segment that scored above 4 is also less than 50%.
- Current land use and roadway characteristics matched those anticipated during the early Glacier Trail period (from the 1920's) along a majority of the corridor. It was assumed that the current rural land uses remain generally similar to those found in the 1920's.
- Four areas offered the best roadway and land use matches found along the nominated corridor. Areas around Albion, Steamboat Rock, Eldora and Ackley all offered good heritage settings.

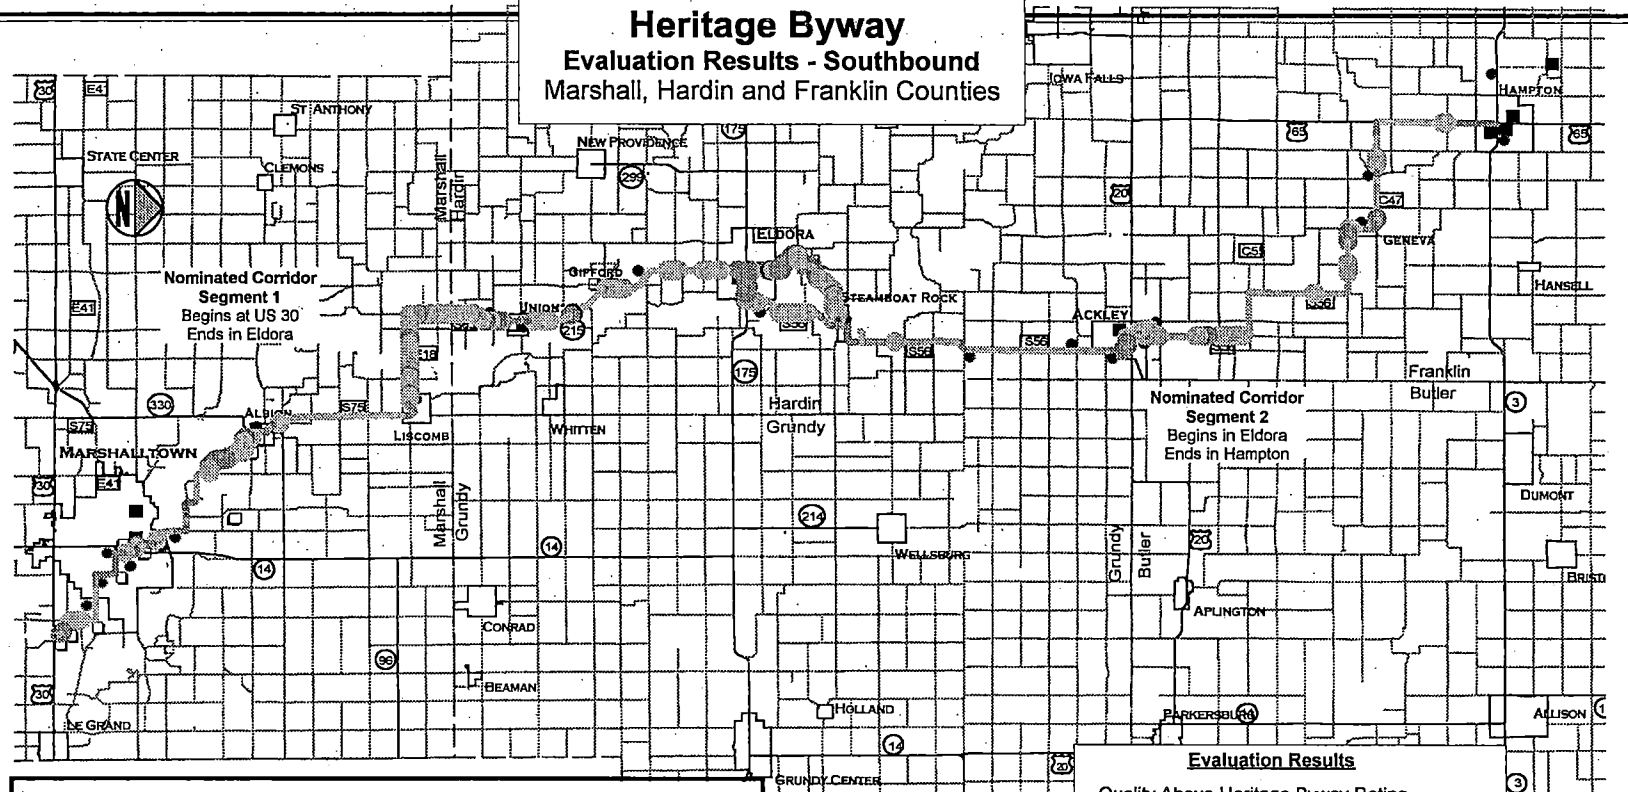
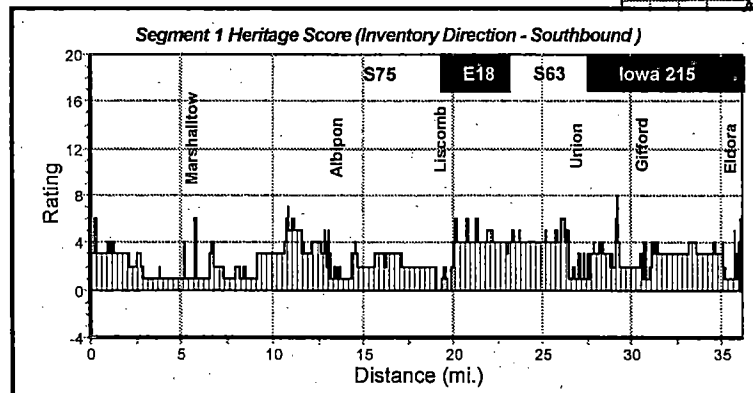
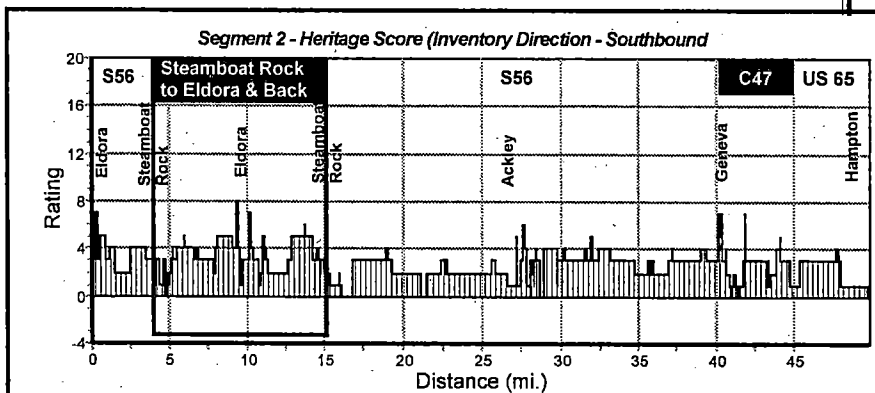
Heritage Byway Evaluation Results - Southbound Marshall, Hardin and Franklin Counties

Note: The outlined areas on the graph are loops that were traveled in both directions during the inventory. The scores shown on the graph represent both travel directions.
