Impact of Curling and Warping on Concrete Pavement

Final Report
July 2016

National Concrete Pavement
Technology Center

Sponsored by
Iowa Highway Research Board
(IHRB Project TR-668)
Iowa Department of Transportation
(InTrans Project 13-486)
Federal Highway Administration

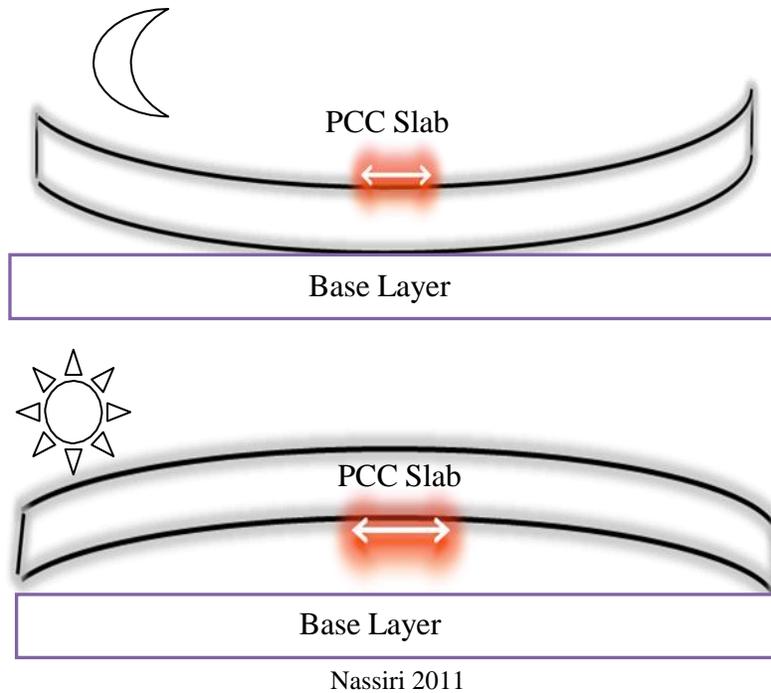
Figure 1. Stresses exerted due to PCC curling and warping: tensile stress exerted at top of PCC slab with upward curvature (top), and tensile stress exerted at bottom of PCC slab with downward curvature (bottom)

Curling and warping of the PCC slab can cause stresses as well. Once the curling and warping-induced concrete slab curvature is initiated, slab restraints will tend to exert tensile stresses in the slab that resist the differential strain response throughout the slab depth. The magnitudes of the critical tensile stresses are usually determined by sudden and drastic changes in ambient temperature (Nantung 2011). Figure 1 illustrates the tensile stresses induced in the slab due to non-uniform gradients and slab restraints.

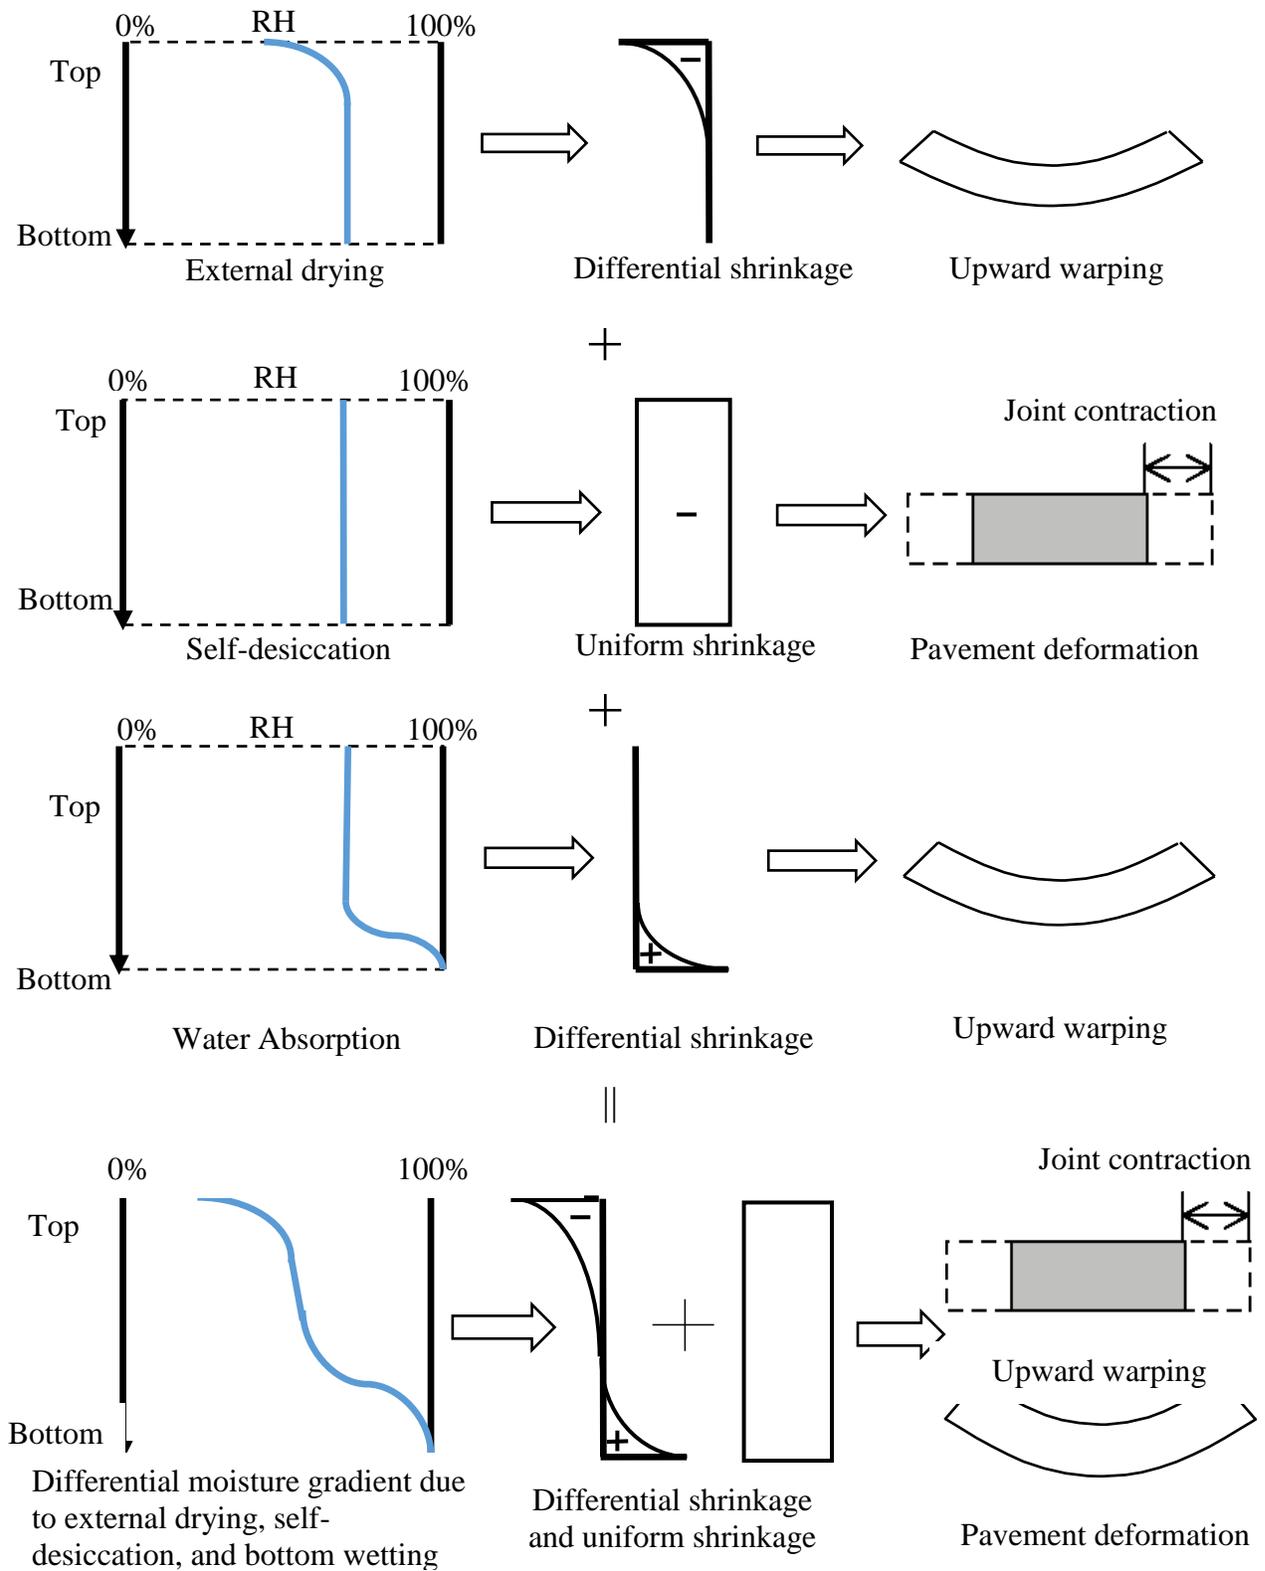
Figure 3. Typical pavement deformation under different moisture gradients

Moisture gradient can be affected by concrete shrinkage (both drying and autogenous shrinkage), w/cm ratio, concrete permeability (porosity), pavement drainage conditions (subbase layer), and atmospheric climatic conditions such as temperature, relative humidity, wind, rainfall, and snow (Asbahan 2009). Figure 3 illustrates the effect of external drying, autogenous shrinkage, and water absorption on moisture gradient.

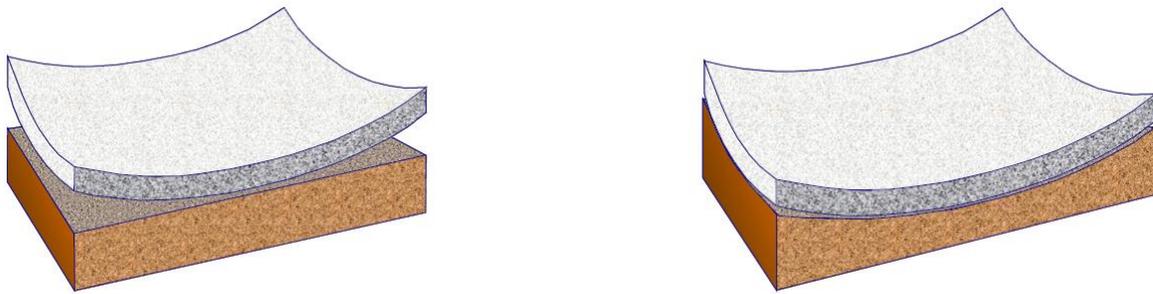
As shown in Figure 6, the PCC slab does not necessarily fully reflect the condition of the underlying supporting layer because the underlying layer is not necessarily flat (Yu et al. 2004).

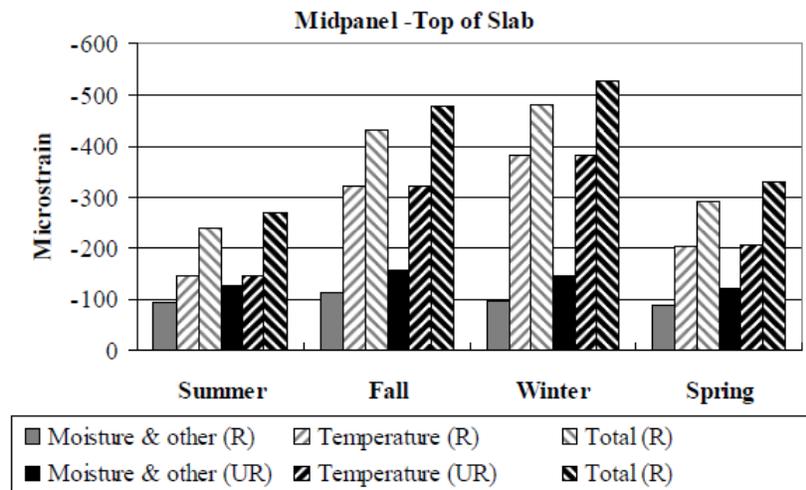
Note: the degree of curling and warping were measured using strain gages installed in the longitudinal direction at mid-panel.

- Temperature-induced strain measurements were the dominant factor contributing to the development of total strain in the concrete slabs.
- Higher temperature-induced strain measurements were observed in the winter due to the greater slab contraction resulting from ambient temperature drops.
- The strain measurements induced by moisture and other factors were higher in the fall than in other seasons in both the restrained and unrestrained slabs.

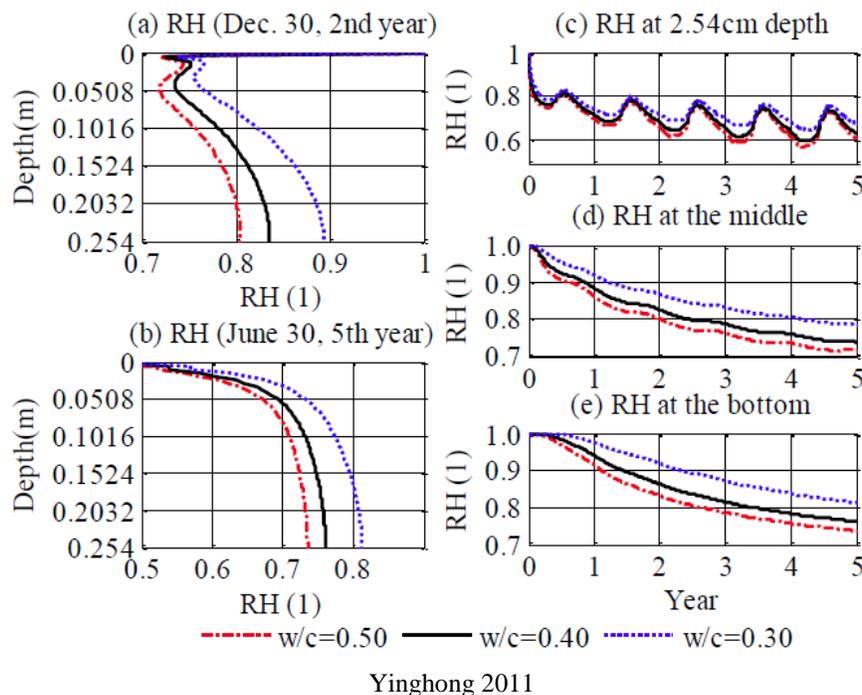
Figure 8. Effect of various w/cm ratios on RH distribution within a concrete slab

Moreover, a relatively low w/cm ratio is preferred because it can help prevent rapid moisture escape from the PCC pavement surface. A study conducted by Yinghong (2011) indicated that the changes in RH along the PCC slab are not proportional to the changes in the w/cm ratio and that a lower w/cm ratio may result in less moisture loss during the life of the pavement surface and make the pavement less susceptible to the wetting and drying cycles (see Figure 8).

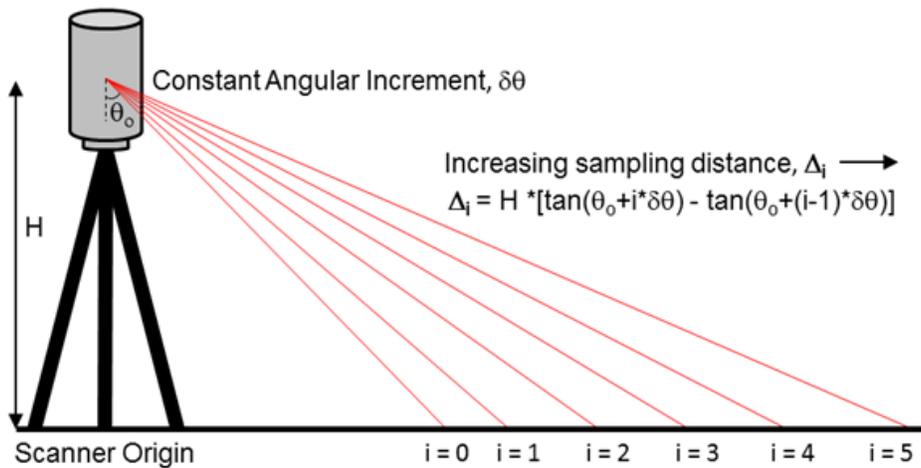
The LiDAR device used for pavement profile measurement is also called terrestrial laser scanner (TLS), which is a type of stationary LiDAR system that includes a rotary laser device mounted on a support tripod. TLS can be classified based on distance measurement methods into time-of-flight-based, phase-shift-based, and waveform processing-based systems, although their fundamental principles are similar in that they utilize the speed of laser beams and the time of travel to determine the distances from an object to the laser scanner (Caltrans 2011). A time-of-flight-based LiDAR is the most common type of scanner available on the market; a schematic diagram of such a system is given in Figure 9.

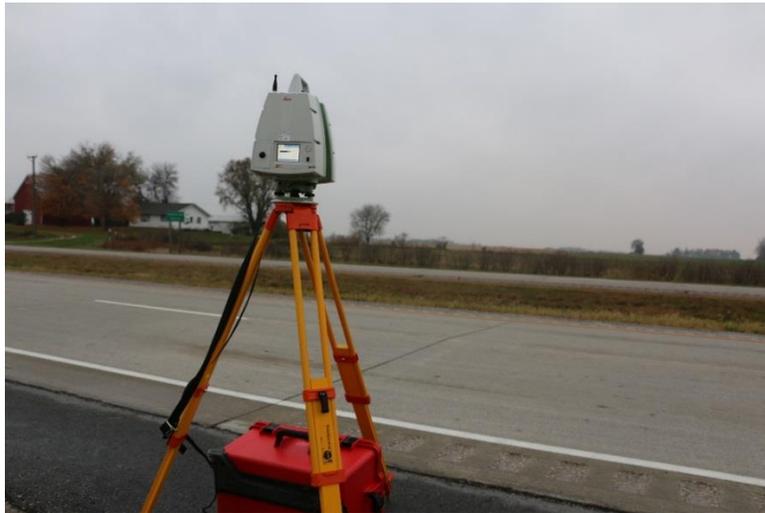
Figure 10. Leica ScanStation C10 LiDAR device

TLS is the LiDAR platform most widely used by researchers for pavement inspection applications like International Roughness Index (IRI), surface texture, cross slope, and crack detection. Compared to other platforms such as airborne laser scanners (ALS) and mobile laser scanners (MLS), TLS is a type of stationary scanning method that usually provides a smaller scanning range but a higher accuracy (0.001 in.) and denser scan; it therefore has more potential to describe the “true profile” of a pavement surface. In this project, the Leica ScanStation C10 TLS device produced by Leica Geosystems was used. It can provide high-accuracy and long-range scanning and has the advantage of fast, full-dome interior scanning. Figure 10 illustrates the Leica ScanStation C10 used in this project. Table 6 summarizes the basic properties of this device.

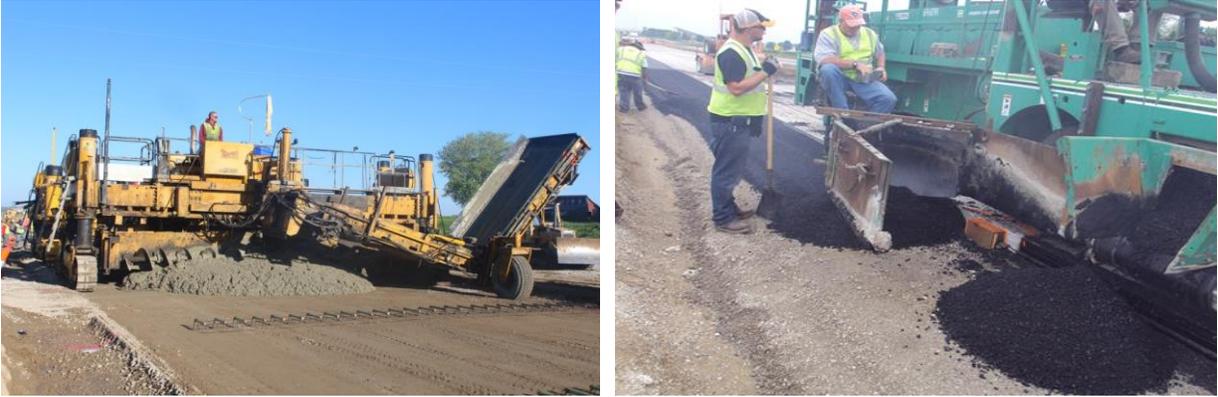
Figure 12. Site 1 pavement construction: PCC placement (left) and shoulder paving (right)

Concrete paving started in the early morning of May 24, 2013, with a maximum ambient temperature of 85°F and a minimum ambient temperature of 72°F during the day. A slipform paver moved from west to east to pour fresh concrete on the subbase. A vibrator followed the paver to consolidate the fresh concrete using vibration tubes. Surface smoothing was performed manually. A slipform paver dragging a piece of burlap was used to create texture for the pavement surface, and a chemical curing compound was sprayed on the paving surface. A heavy rain occurred just a few days after concrete paving but before shoulder paving, and a heavy rain occurred one day after construction. Shoulder backfilling was conducted 14 days after concrete paving; a 6 in. thick and approximately 4.5 ft wide hot-mix asphalt (HMA) shoulder was then placed on June 10, just three days after shoulder backfilling. One day later, a granular shoulder was added to the pavement. The constructed pavement was opened to traffic on June 14, 2013. Figure 12 presents some snapshots during the pavement construction at this site.

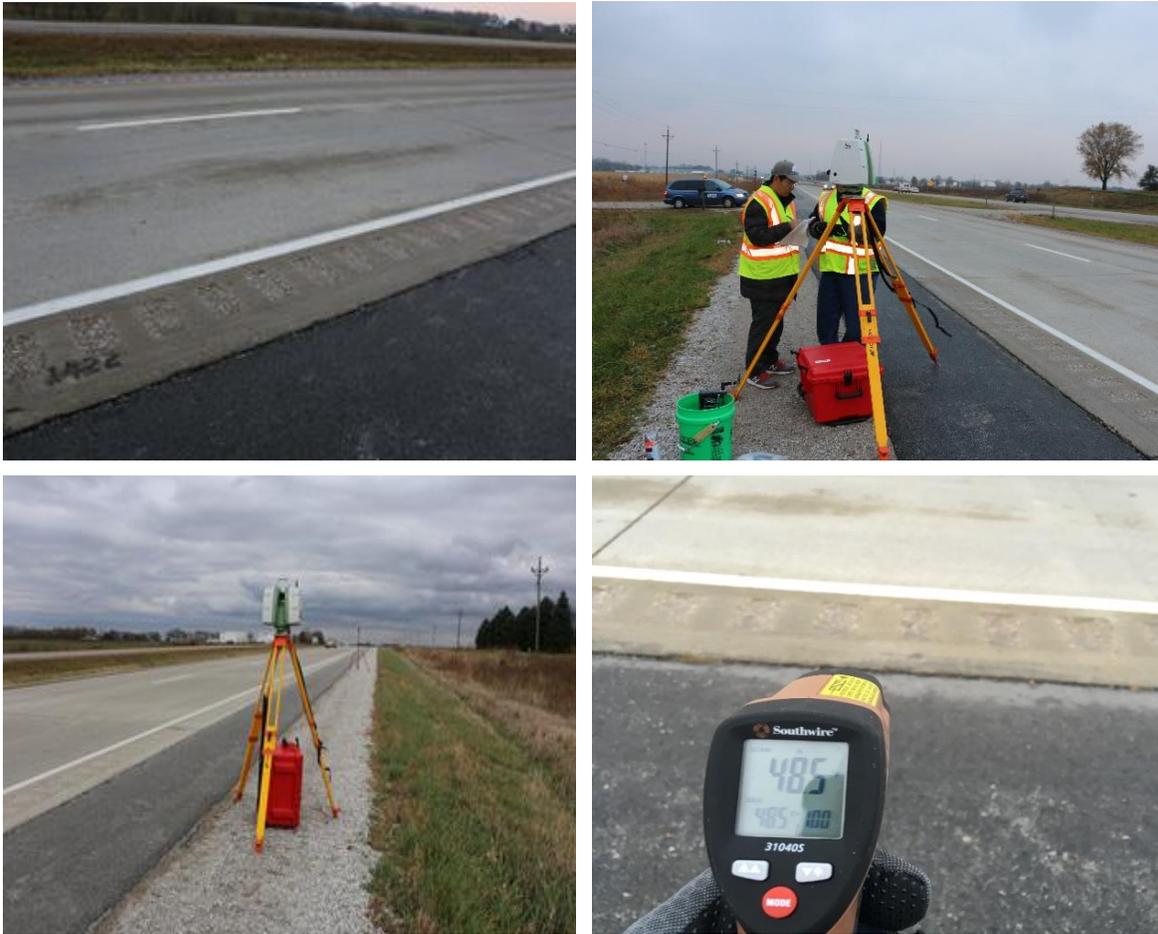
Figure 13. Field investigation on US 30 near Ames, Story County, STA 1422 (MP 152.20)

Field investigations at Site 1 on US 30 in Story County near Ames were conducted in the early morning at 8:00 a.m. and in the afternoon at 3:30 p.m. on October 28, 2015 to measure variations in slab deflection throughout the day. At this site, the Leica ScanStation C10 was used to scan the selected PCC slabs. No pavement cracks were observed at this site. Figure 13 presents some pictures of the activities performed during this field investigation.

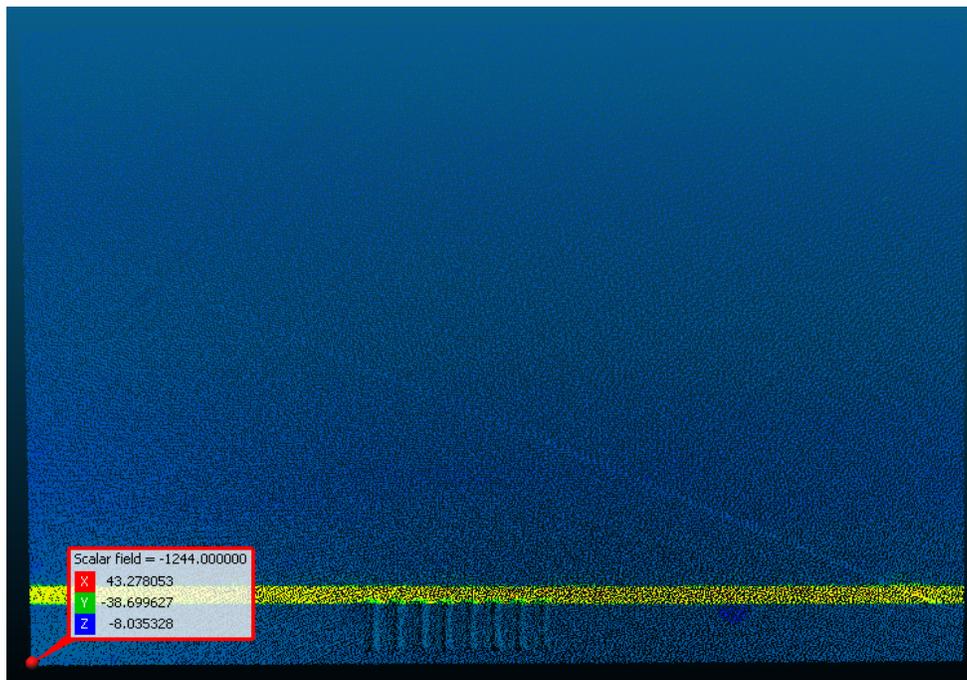
Figure 14. 3D point cloud of a single slab

1. Use CloudCompare software to “dig” the slab out from the point cloud, and then find the coordinates at every slab corner (see Figure 14).

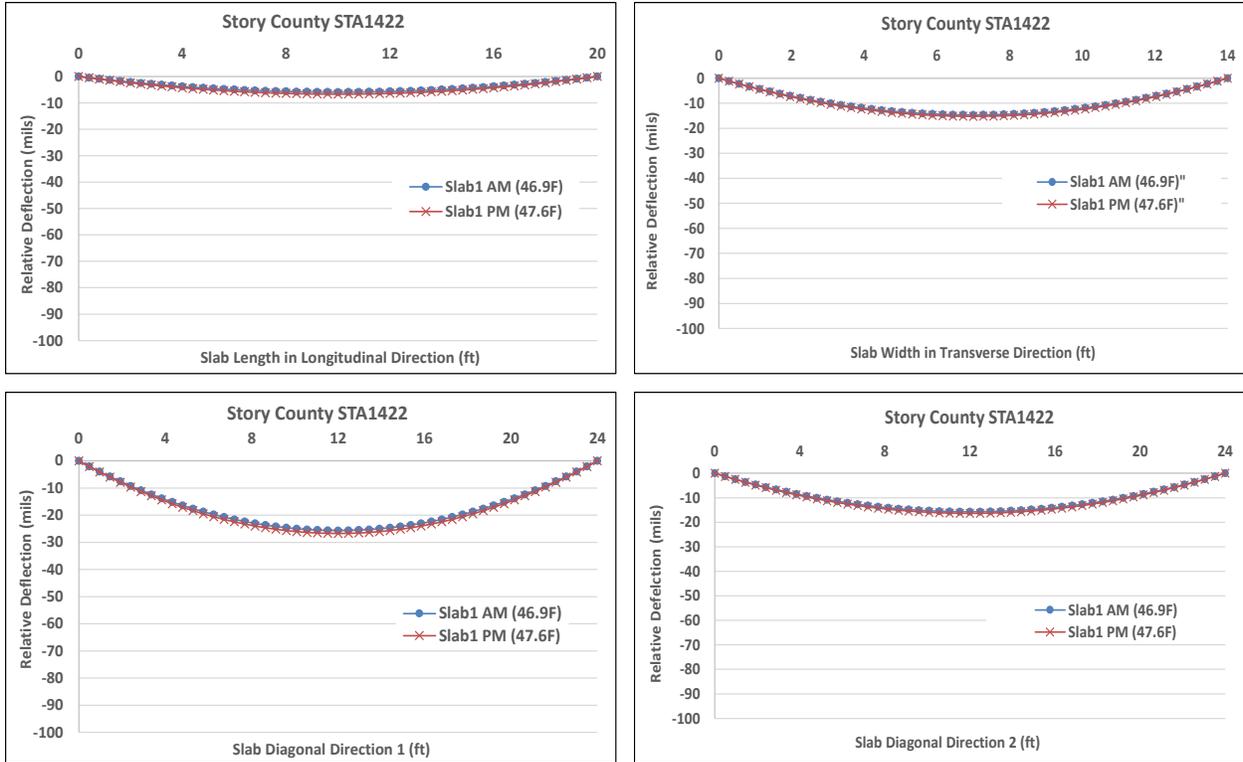
Figure 18. Morning and afternoon relative deflection of Slab 1 at Site 1: longitudinal (top left), transverse (top right), diagonal 1 (bottom left), and diagonal 2 (bottom right)

Analysis of data acquired from all six sites investigated in the field followed the exact procedure described above. A calculated positive relative deflection represents downward curling and warping while a negative relative deflection represents upward curling and warping. In this site near Ames, Story County, four slabs were selected to calculate relative deflection in the specific directions illustrated in Figure 16. Scans from both the morning and afternoon of October 28, 2015 were analyzed to compare daily variations in curling and warping. Figure 18 through Figure 21 illustrate the relative deflection calculated in the specific directions.

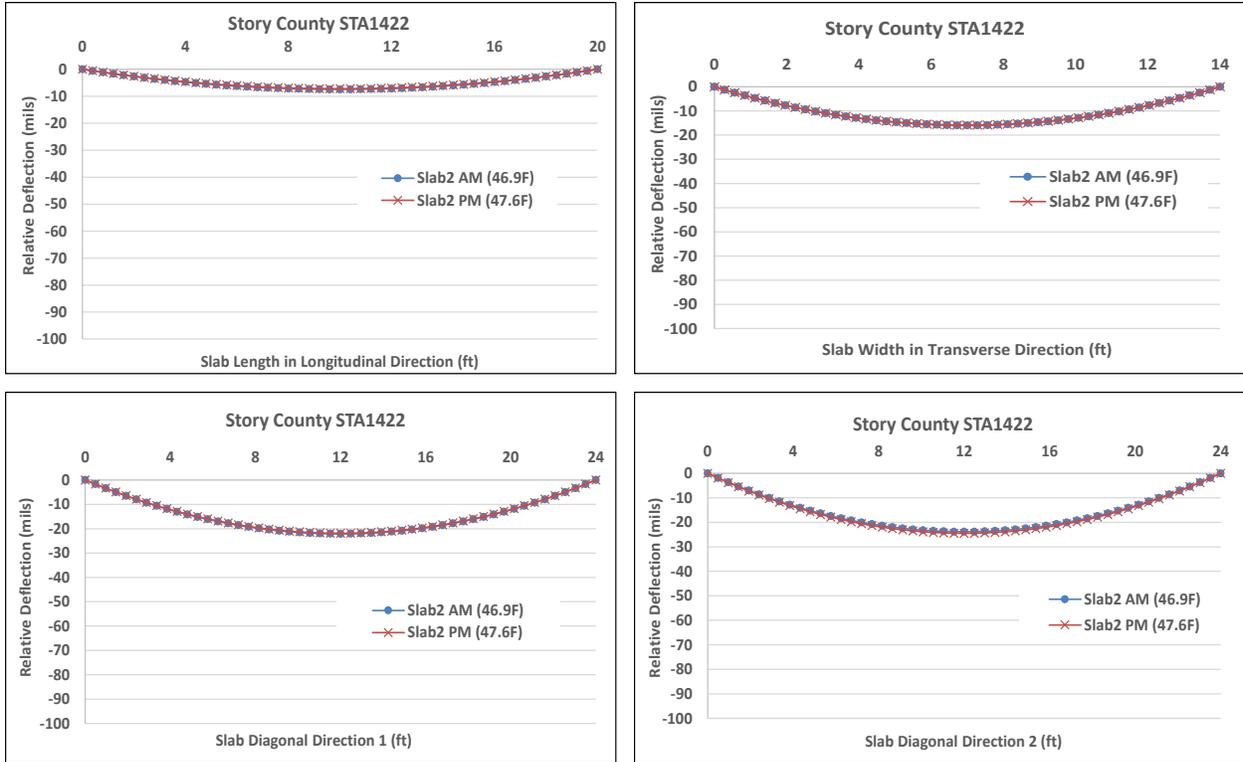
Figure 19. Morning and afternoon relative deflection of Slab 2 at Site 1: longitudinal (top left), transverse (top right), diagonal 1 (bottom left), and diagonal 2 (bottom right)

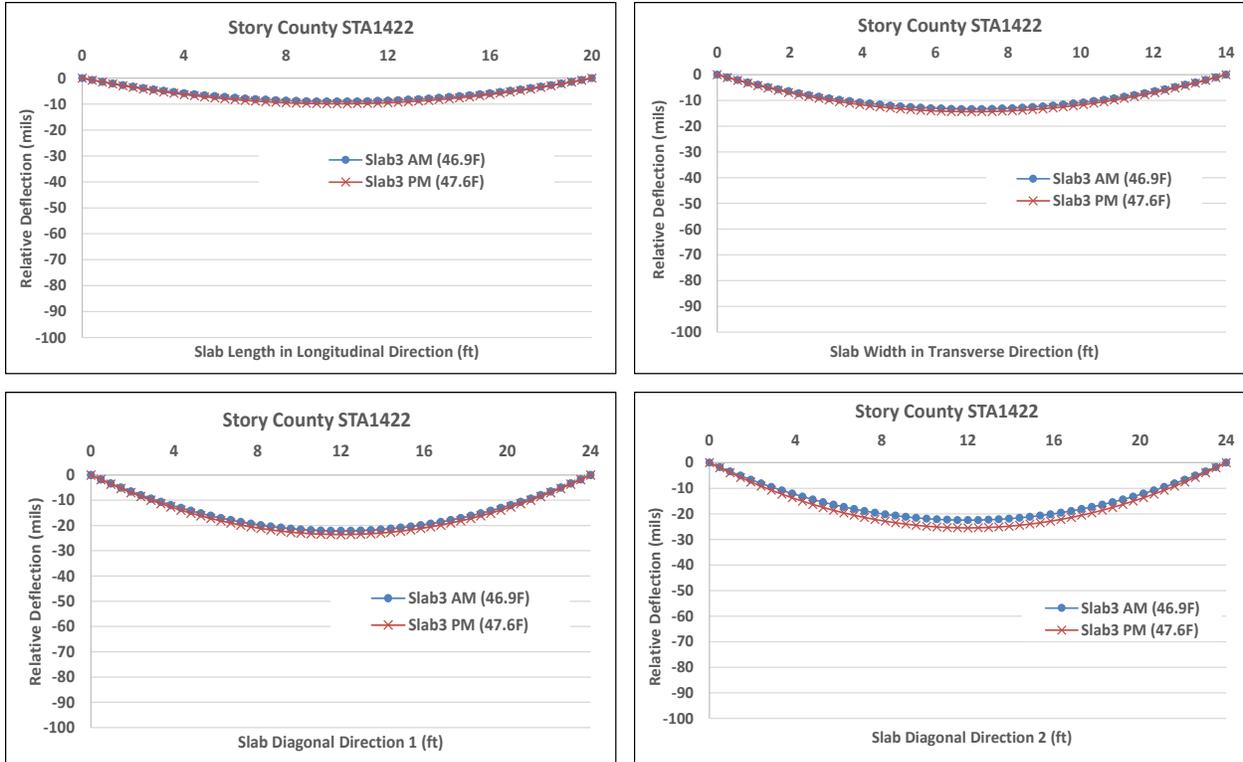
Figure 20. Morning and afternoon relative deflection of Slab 3 at Site 1: longitudinal (top left), transverse (top right), diagonal 1 (bottom left), and diagonal 2 (bottom right)

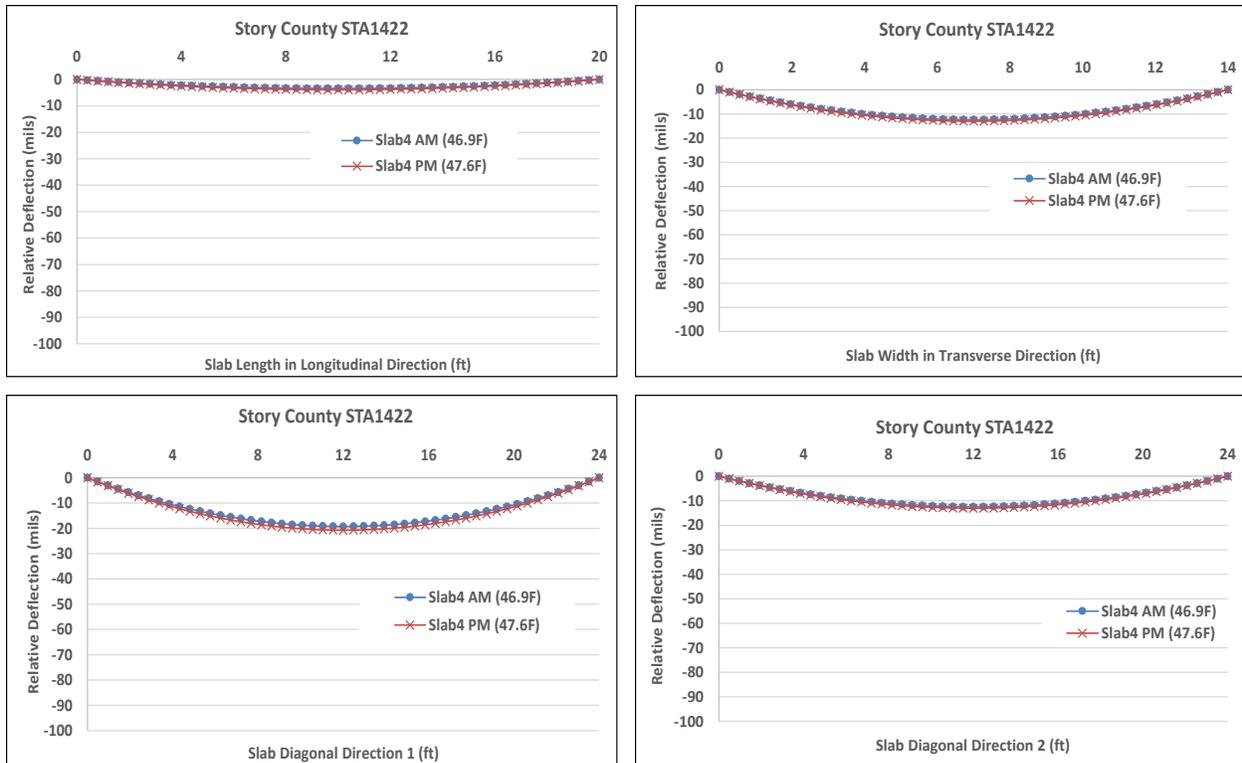
Figure 21. Morning and afternoon relative deflection of Slab 4 at Site 1: longitudinal (top left), transverse (top right), diagonal 1 (bottom left), and diagonal 2 (bottom right)

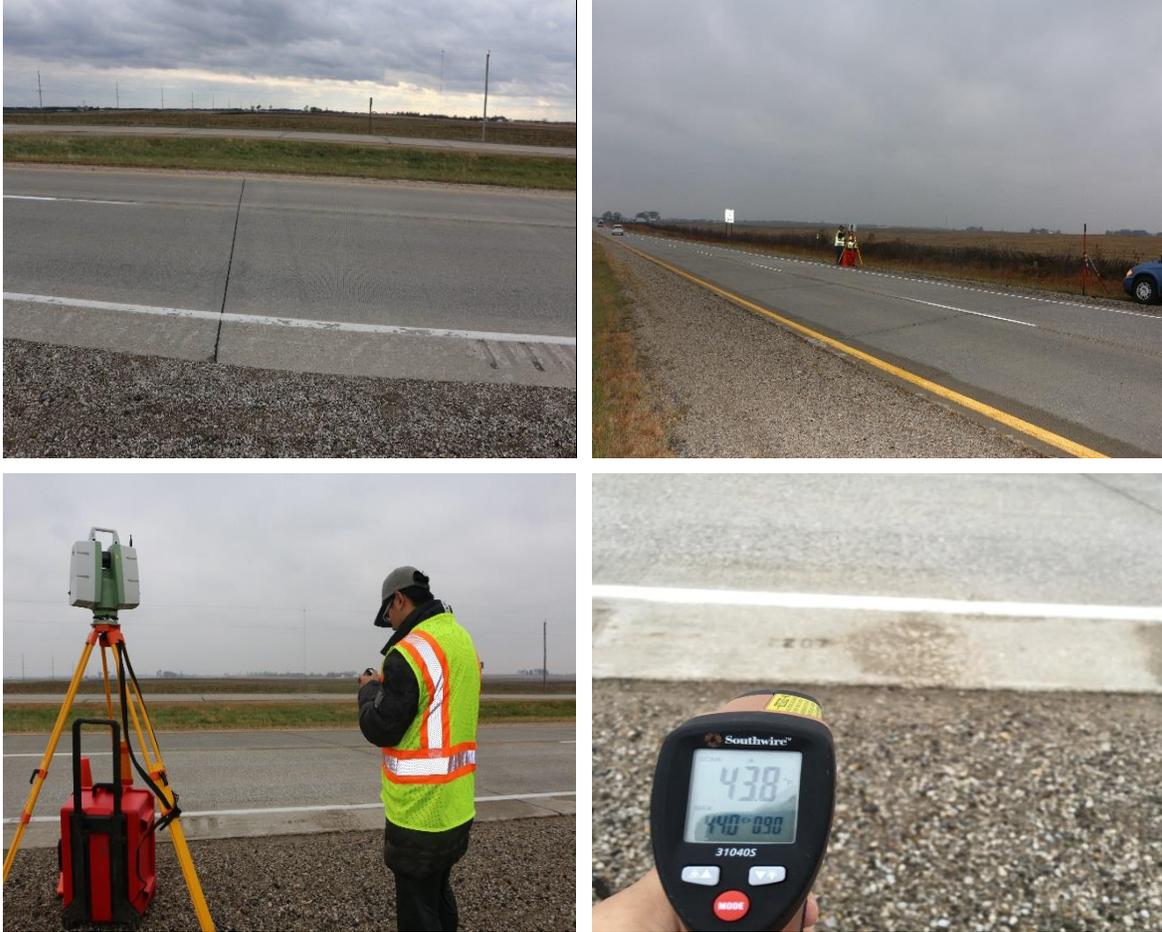
Figure 23. Field investigation on US 30 near Nevada, Story County, STA2207 (MP 159.85)

Field investigations at Site 2 on US 30 in Story County near Nevada were conducted in the morning at 9:00 a.m. and in the afternoon at 2:30 p.m. on October 28, 2015 to measure variations in slab deflection throughout the day. No pavement cracks were observed at this site. Field investigation activities conducted at this site were the same as those conducted for Site 1. Figure 23 shows some of the activities performed during the field investigation.

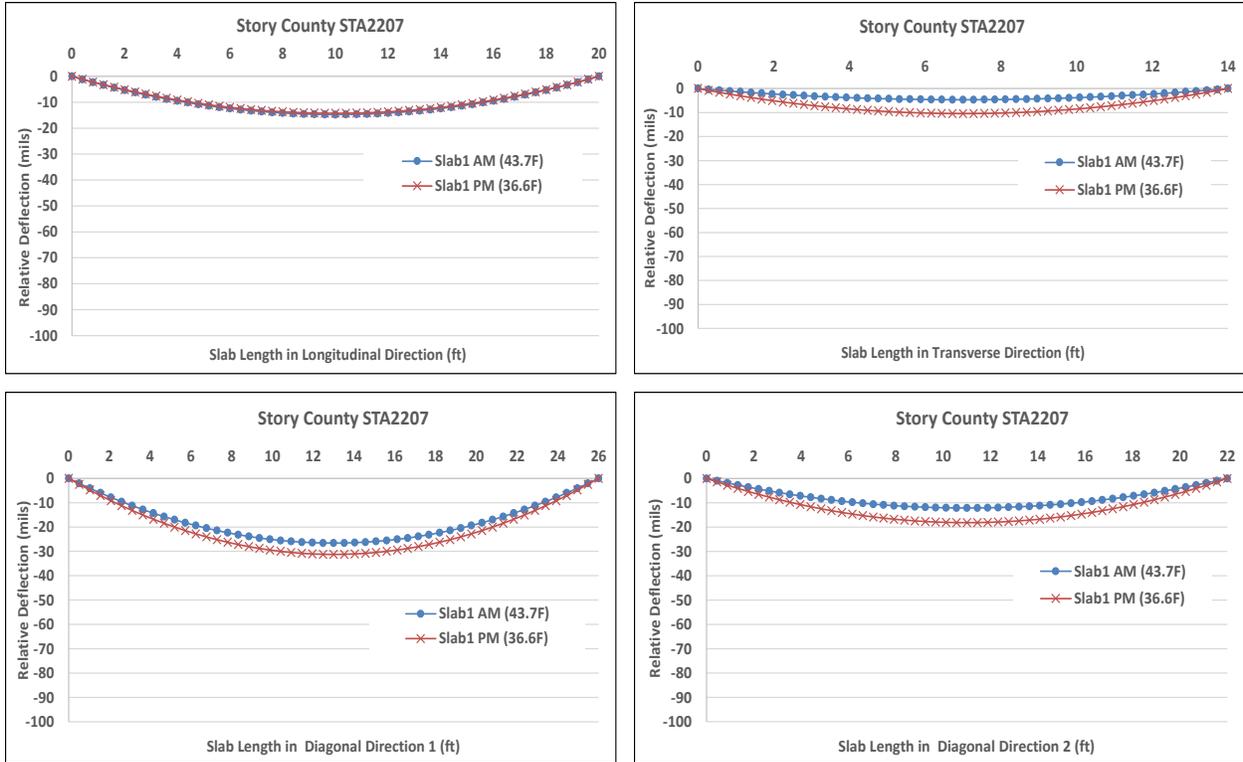
Figure 24. Morning and afternoon relative deflection of Slab 1 at Site 2: longitudinal (top left), transverse (top right), diagonal 1 (bottom left), and diagonal 2 (bottom right)

Figure 24 through Figure 27 illustrate the calculated relative deflections at STA2207, US 30 near Nevada, Story County. Four slabs were selected to compare the measurements from both the morning and afternoon.

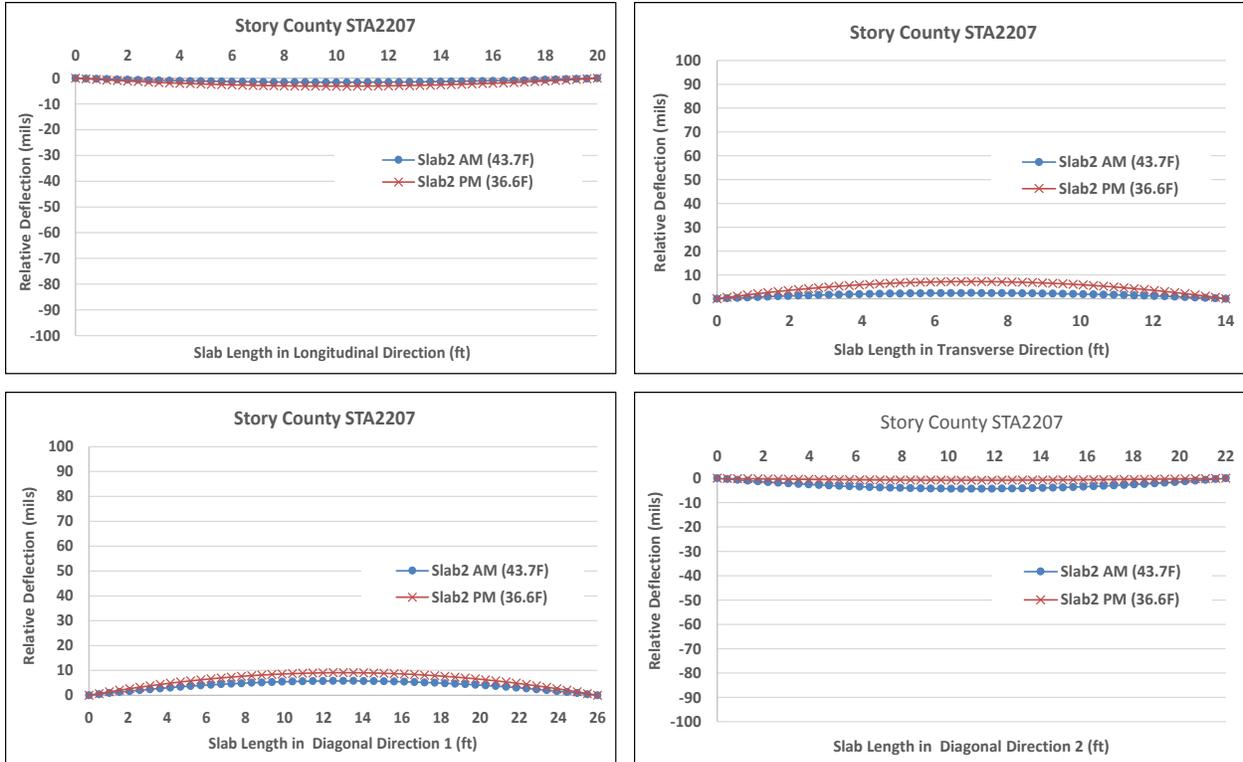
Figure 25. Morning and afternoon relative deflection of Slab 2 at Site 2: longitudinal (top left), transverse (top right), diagonal 1 (bottom left), and diagonal 2 (bottom right)

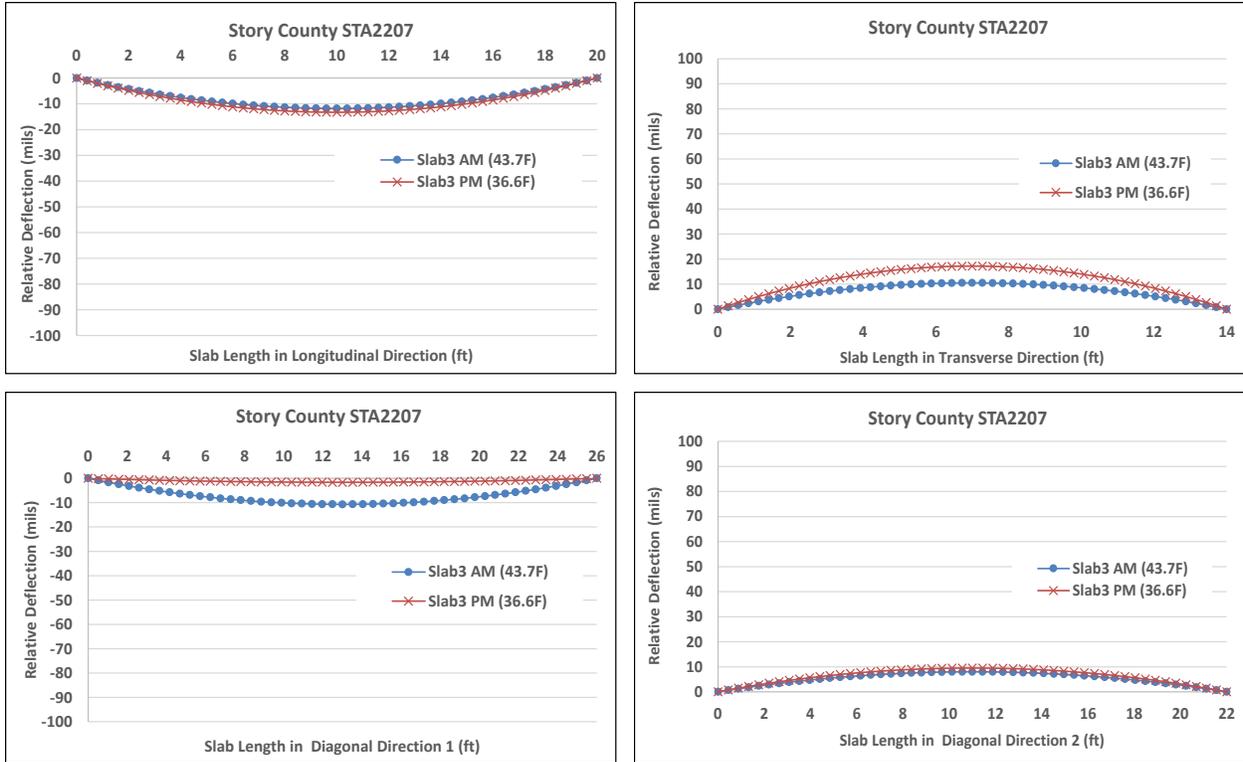
Figure 26. Morning and afternoon relative deflection of Slab 3 at Site 2: longitudinal (top left), transverse (top right), diagonal 1 (bottom left), and diagonal 2 (bottom right)

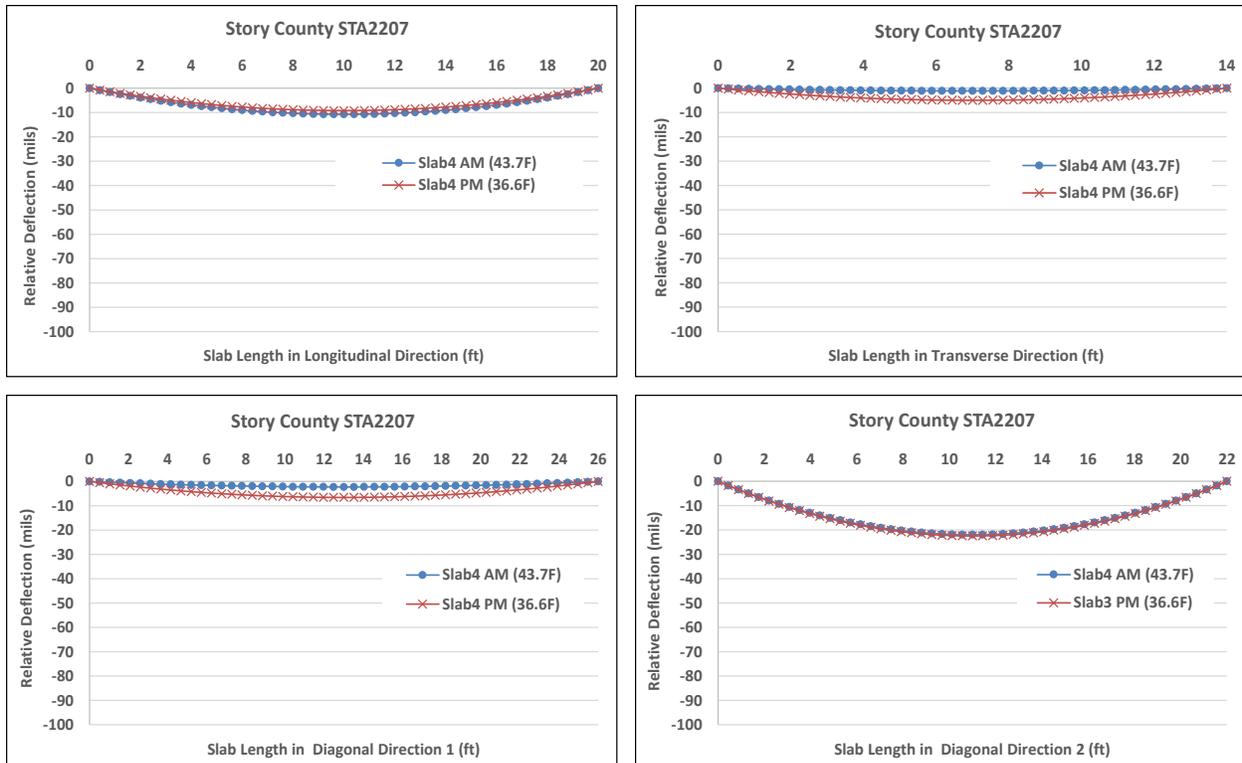
Figure 27. Morning and afternoon relative deflection of Slab 4 at Site 2: longitudinal (top left), transverse (top right), diagonal 1 (bottom left), and diagonal 2 (bottom right)

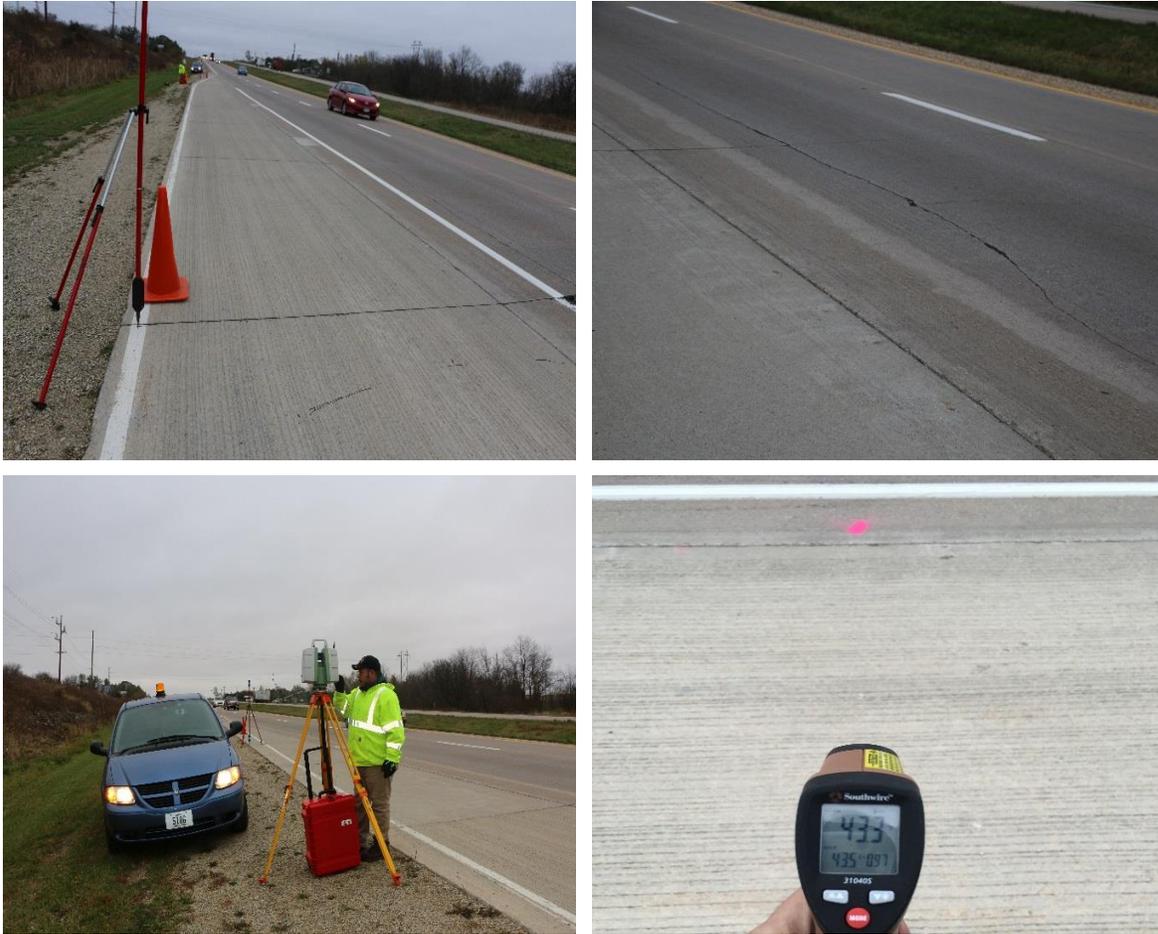
Figure 29. Field investigation on US 151 near Cedar Rapids, Linn County, STA162 (MP 32.75)

Field investigations at Site 3 on US 151 in Linn County near Cedar Rapid were conducted in the morning at 9:00 a.m. on October 29, 2015. Because diurnal temperature fluctuation is typically small in the late fall, another field investigation was performed in the afternoon at 3:30 p.m. on November 10, 2015 when the weather became a little warmer (Wells 2005). A newly added right-turn lane was found next to the surveyed slabs in the traffic lane. This right-turn lane is composed of PCC slabs with rectangular joints, which are not the same as the skewed joints adopted for the passing lane. Furthermore, longitudinal cracks that went through several slabs were found in the traffic lane. One slab also showed transverse cracking. Field investigation activities conducted at this site were the same as the activities at Site 1. Figure 29 shows some of the activities performed during this field investigation, as well as the longitudinal cracking.

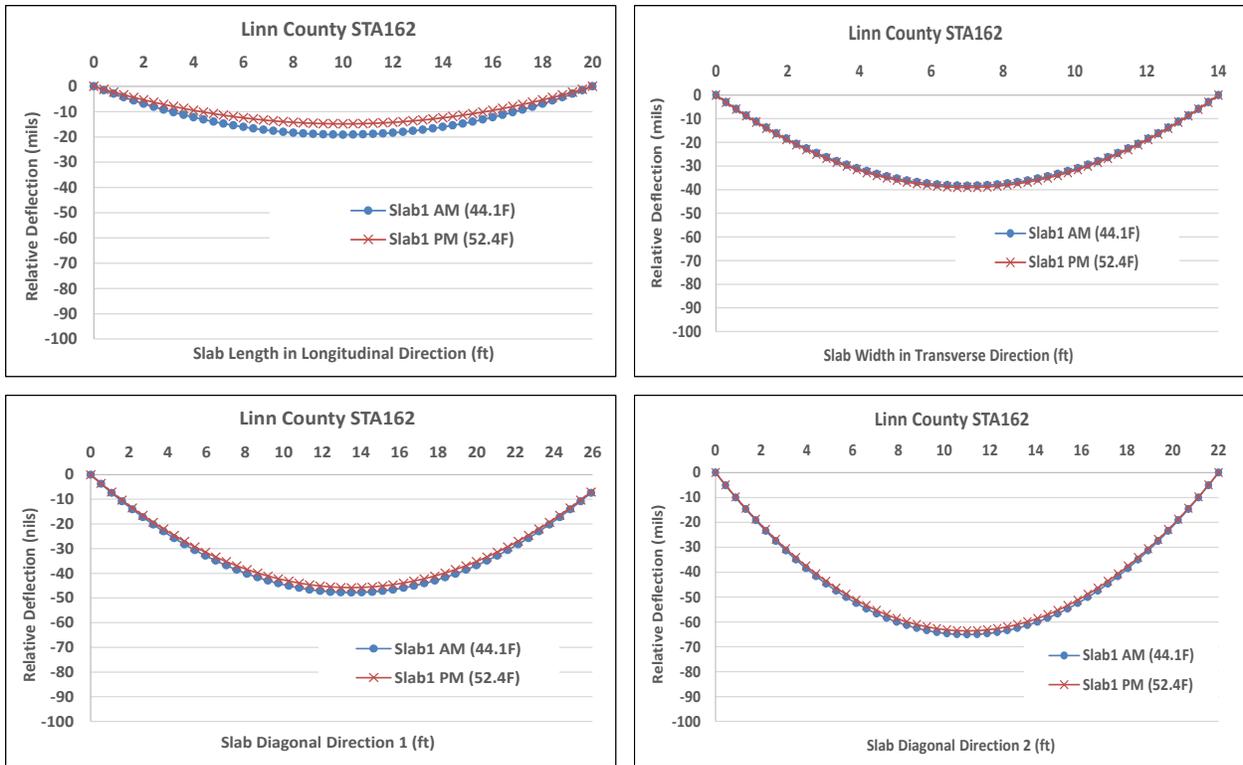
Figure 30. Morning and afternoon relative deflection of Slab 1 at Site 3: longitudinal (top left), transverse (top right), diagonal 1 (bottom left), and diagonal 2 (bottom right)

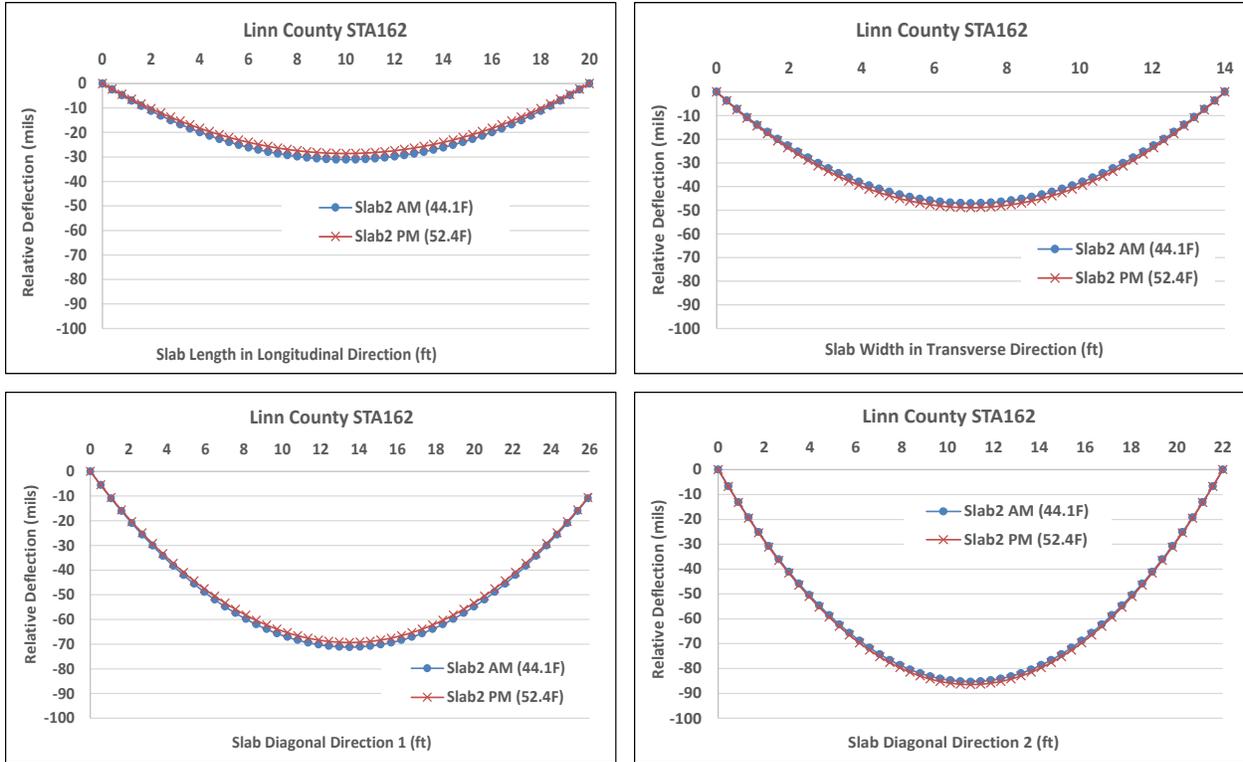
Figure 31. Morning and afternoon relative deflection of Slab 2 at Site 3: longitudinal (top left), transverse (top right), diagonal 1 (bottom left), and diagonal 2 (bottom right)

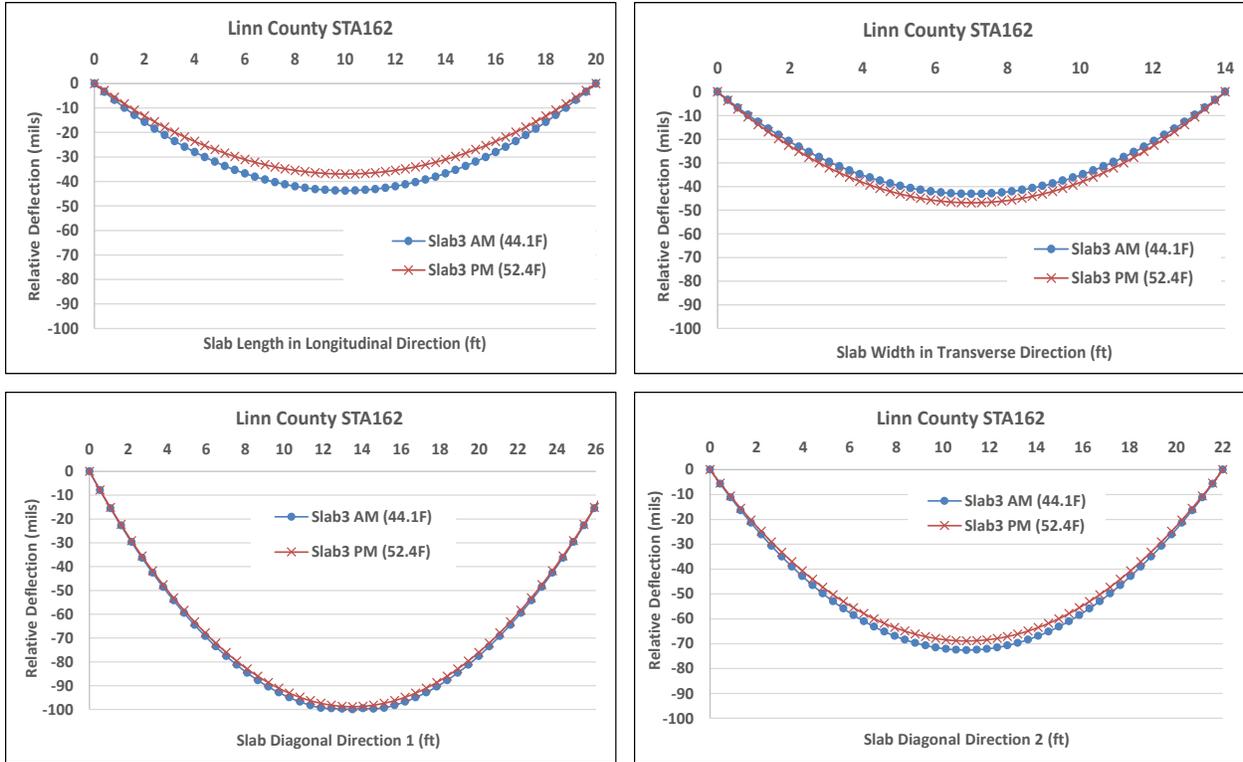
Figure 32. Morning and afternoon relative deflection of Slab 3 at Site 3: longitudinal (top left), transverse (top right), diagonal 1 (bottom left), and diagonal 2 (bottom right)
