Impact of Curling and Warping on Concrete Pavement

Final Report
July 2016

National Concrete Pavement
Technology Center

Sponsored by
Iowa Highway Research Board
(IHRB Project TR-668)
Iowa Department of Transportation
(InTrans Project 13-486)
Federal Highway Administration

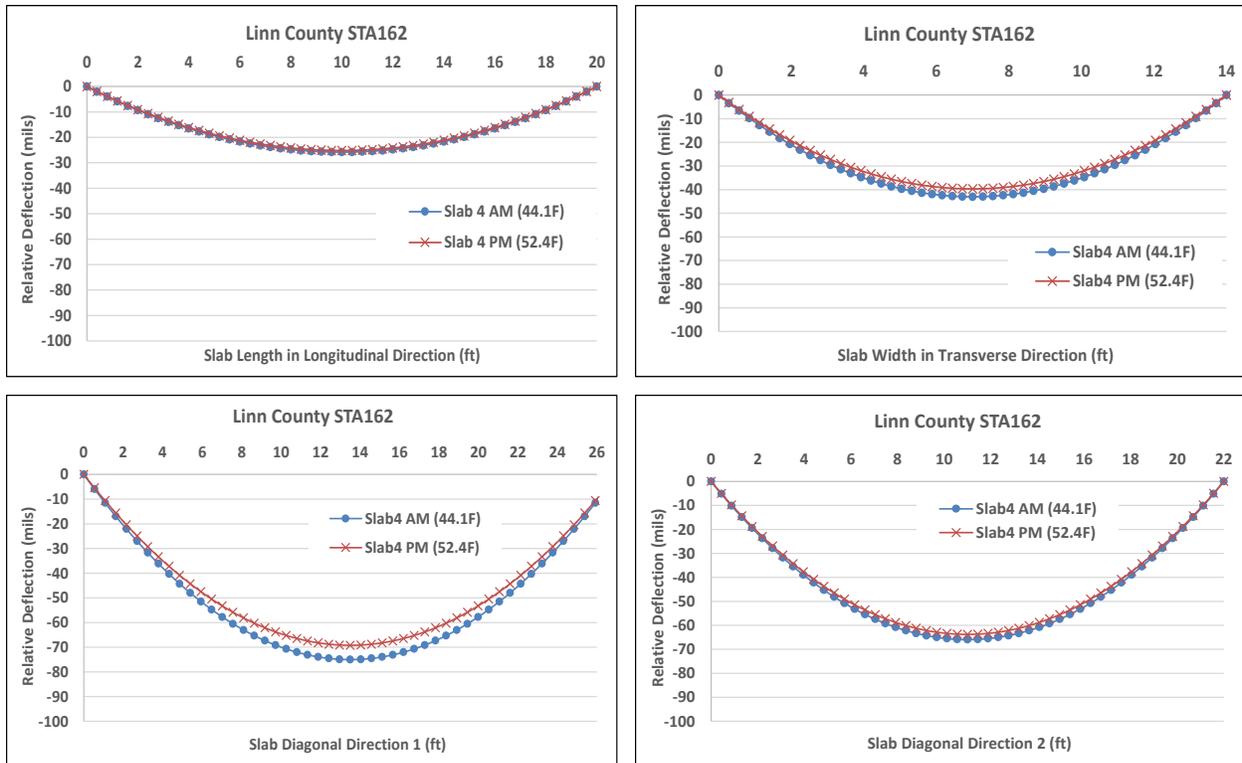
Figure 33. Morning and afternoon relative deflection of Slab 4 at Site 3: longitudinal (top left), transverse (top right), diagonal 1 (bottom left), and diagonal 2 (bottom right)

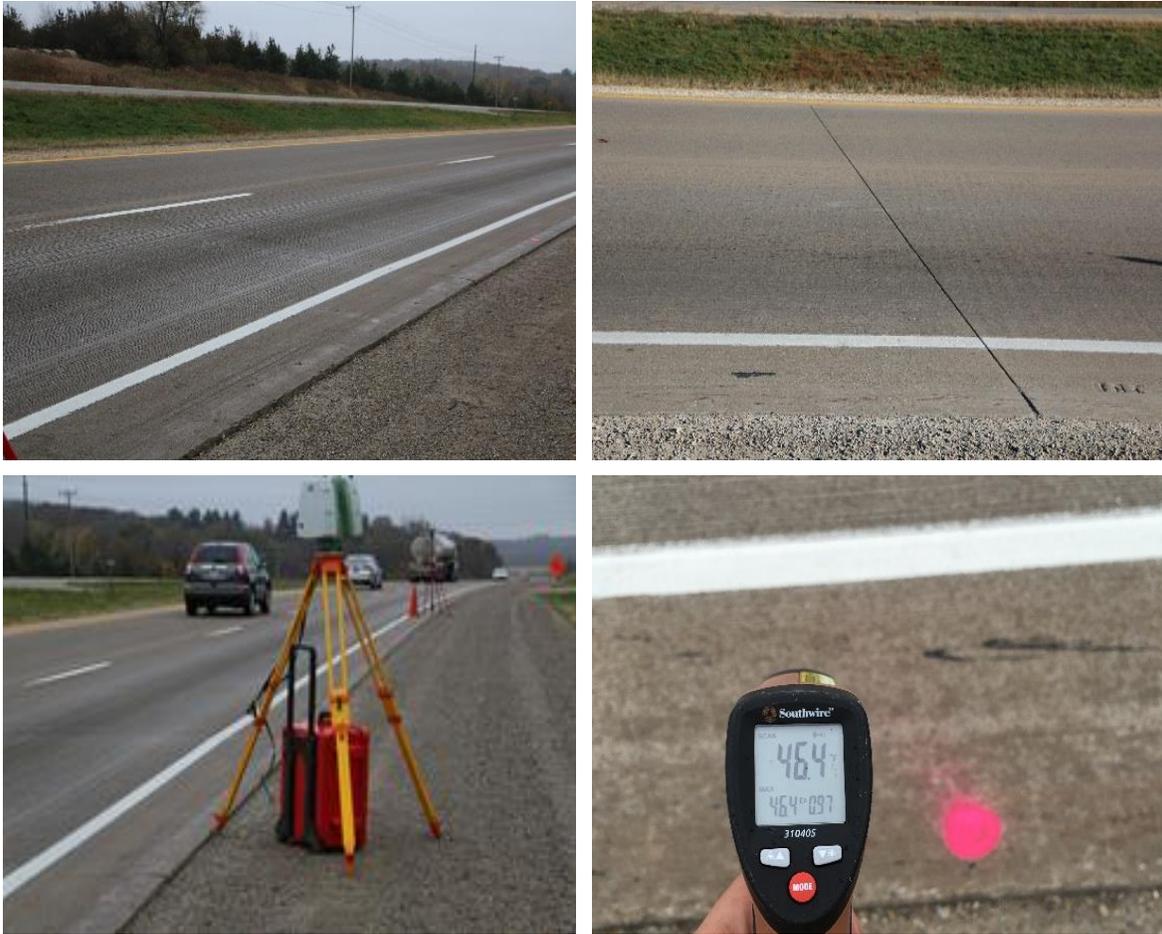
Figure 35. Field investigation on US 151 near Cedar Rapids, Linn County, STA183 (MP 33.15)

Field investigations at Site 4 on US 151 in Linn County near Cedar Rapids were conducted in the morning at 10:00 a.m. on October 29, 2015. Another field investigation was performed in the afternoon at 2:30 p.m. on November 10, 2015. At this site, the scans for the selected PCC slabs were performed at STA183 on US 151. No cracks were observed in these slabs. Field investigation activities conducted at this site were the same as the activities conducted at Site 1. Figure 35 presents some of the activities performed during this field investigation.

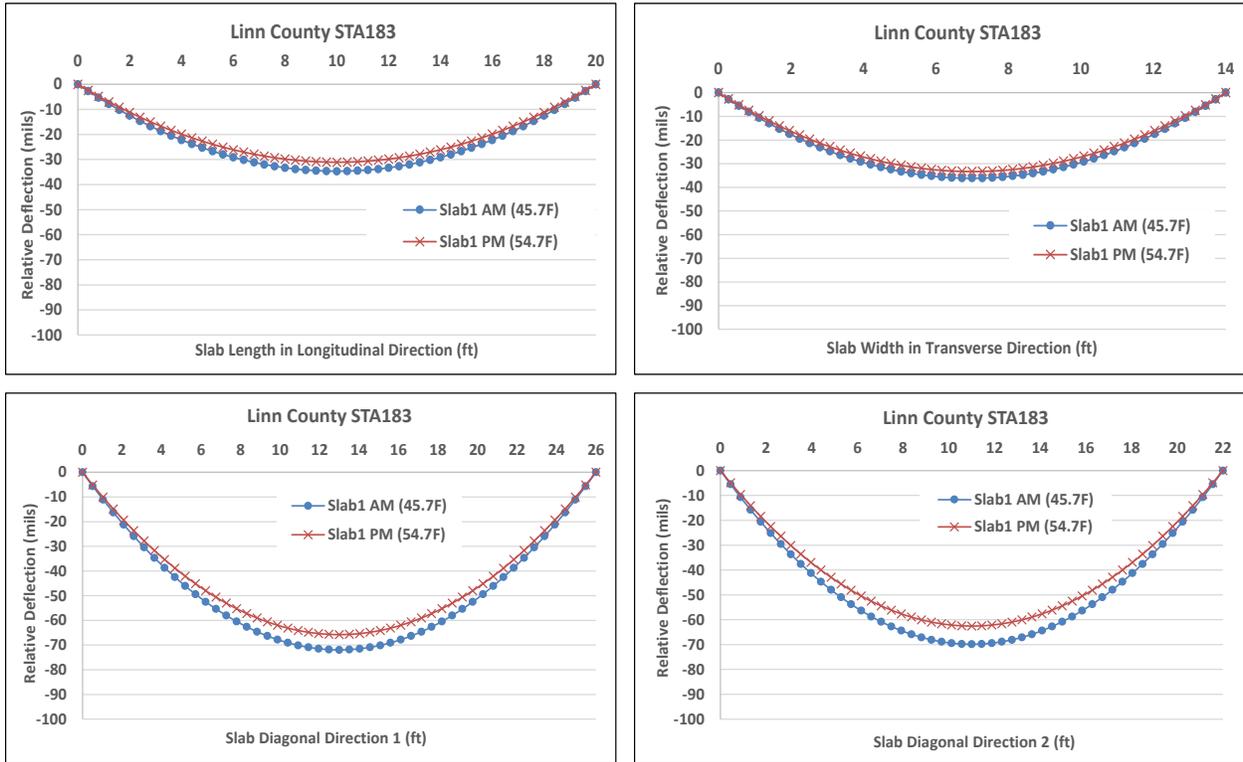
Figure 36. Morning and afternoon relative deflection of Slab 1 at Site 4: longitudinal (top left), transverse (top right), diagonal 1 (bottom left), and diagonal 2 (bottom right)

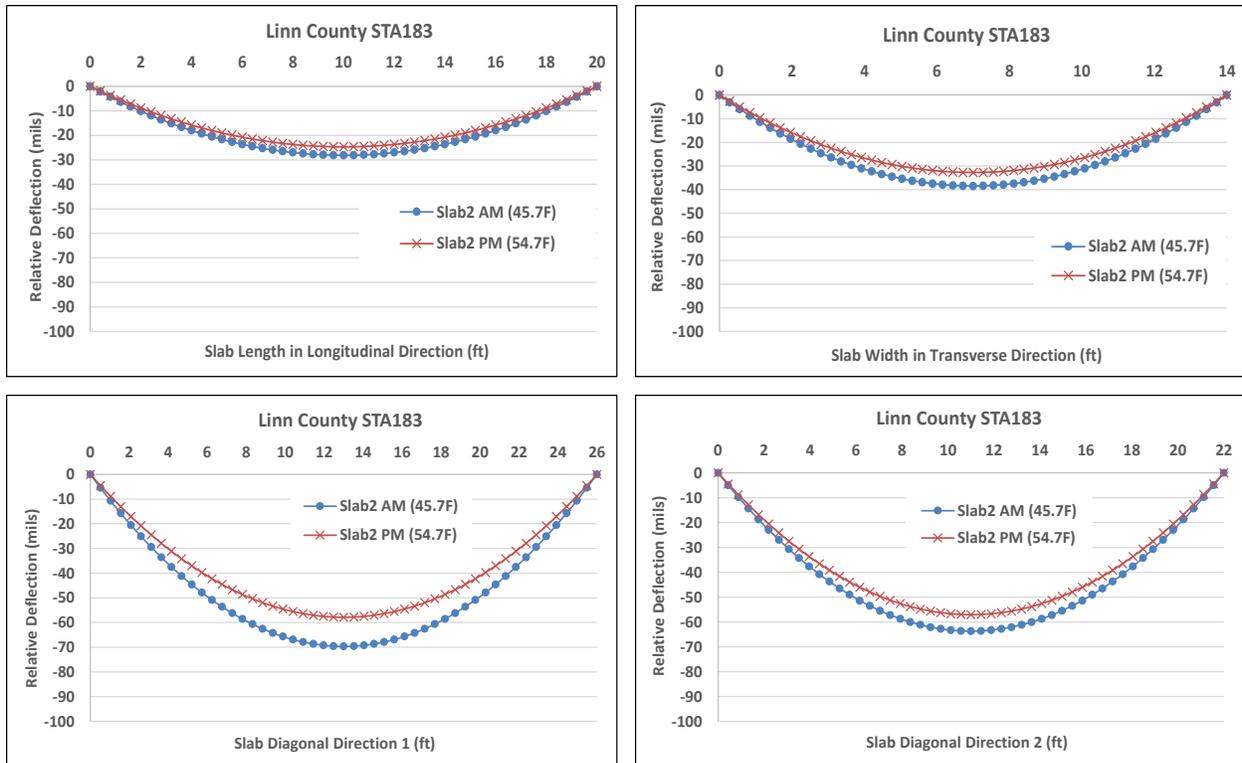
Figure 37. Morning and afternoon relative deflection of Slab 2 at Site 4: longitudinal (top left), transverse (top right), diagonal 1 (bottom left), and diagonal 2 (bottom right)

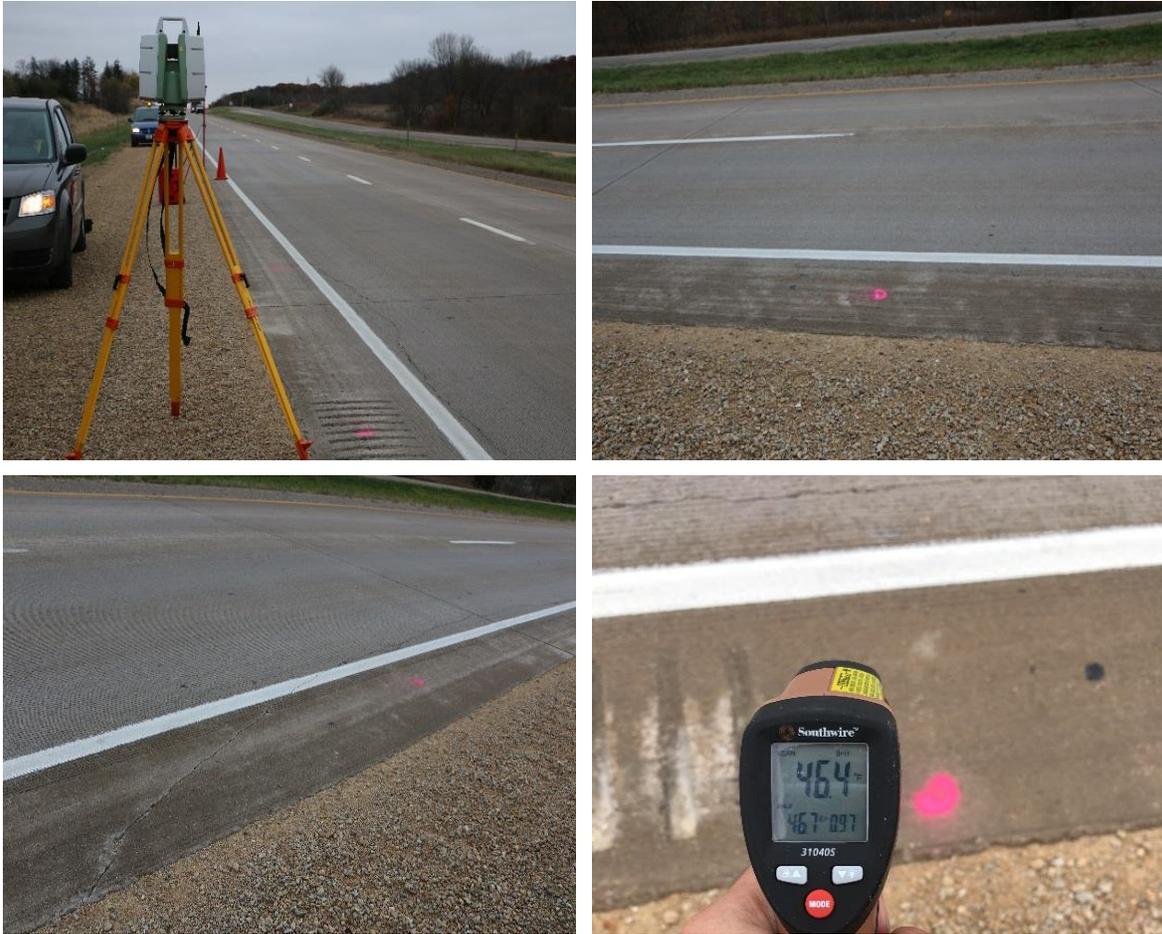
Figure 39. Field investigation on US 30 in Linn County, STA463 (MP 261.2)

Field investigations at Site 5 on US 30 in Linn County near Cedar Rapids were conducted in the morning at 11:00 a.m. on October 29, 2015. Another field investigation was performed in the afternoon at 1:00 p.m. on November 10, 2015. At this site, the scans for the selected PCC slabs were performed at STA463 on US 30. Longitudinal cracks that went through several slabs were observed in the traffic lane. Field investigation activities were the same as the activities conducted at Site 1. Figure 39 presents some of the activities performed during this field investigation.

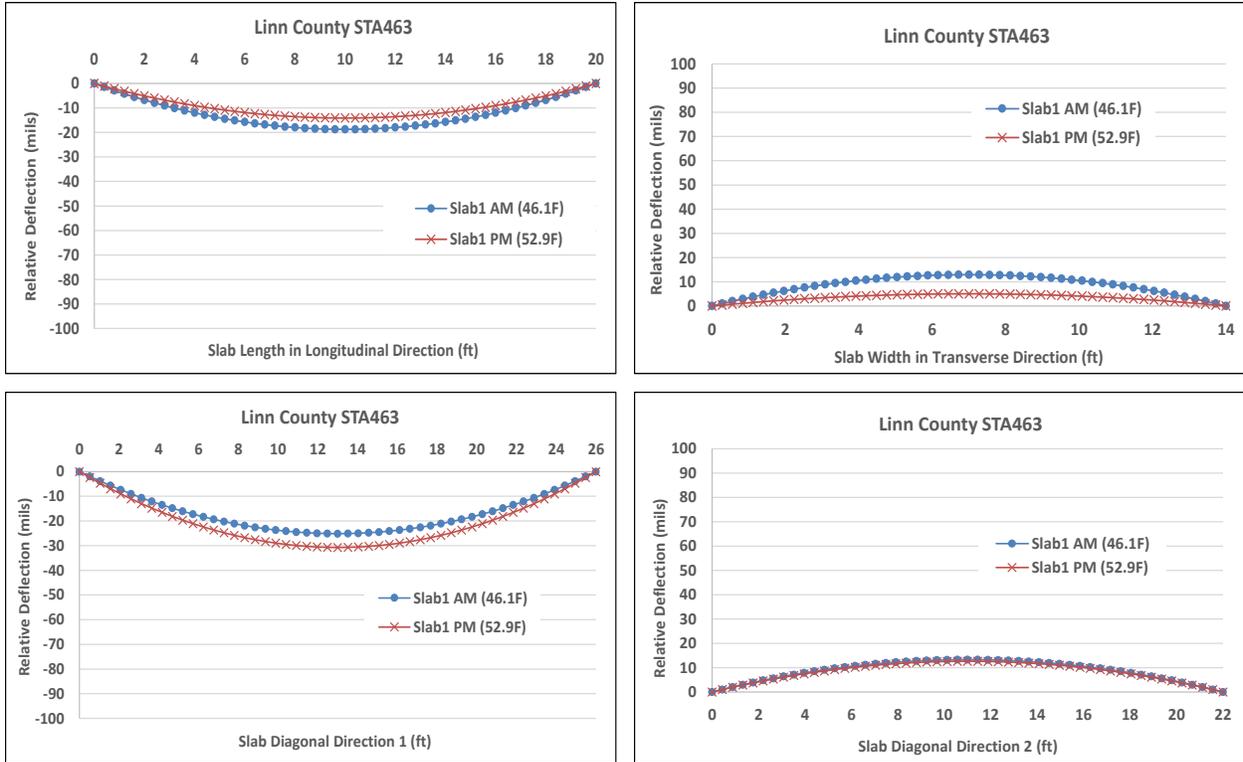
Figure 40. Morning and afternoon relative deflection of Slab 1 at Site 5: longitudinal (top left), transverse (top right), diagonal 1 (bottom left), and diagonal 2 (bottom right)

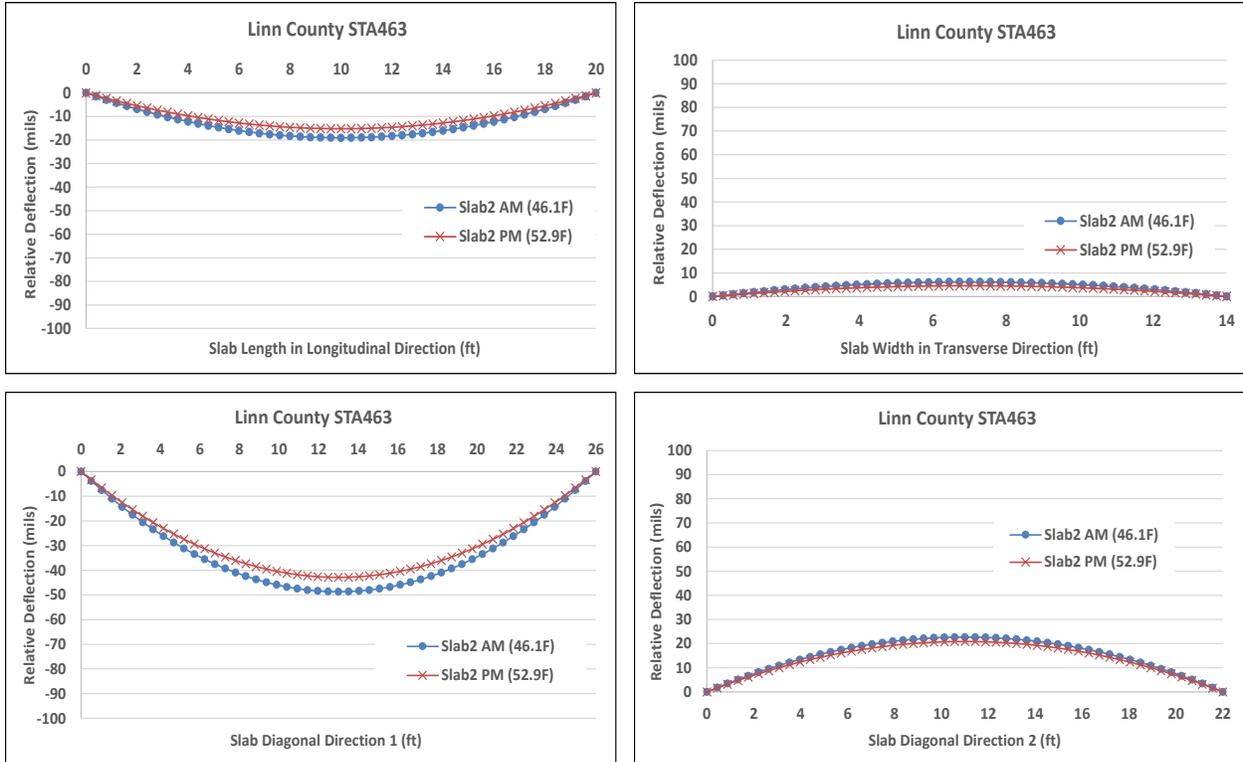
Figure 41. Morning and afternoon relative deflection of Slab 2 at Site 5: longitudinal (top left), transverse (top right), diagonal 1 (bottom left), and diagonal 2 (bottom right)

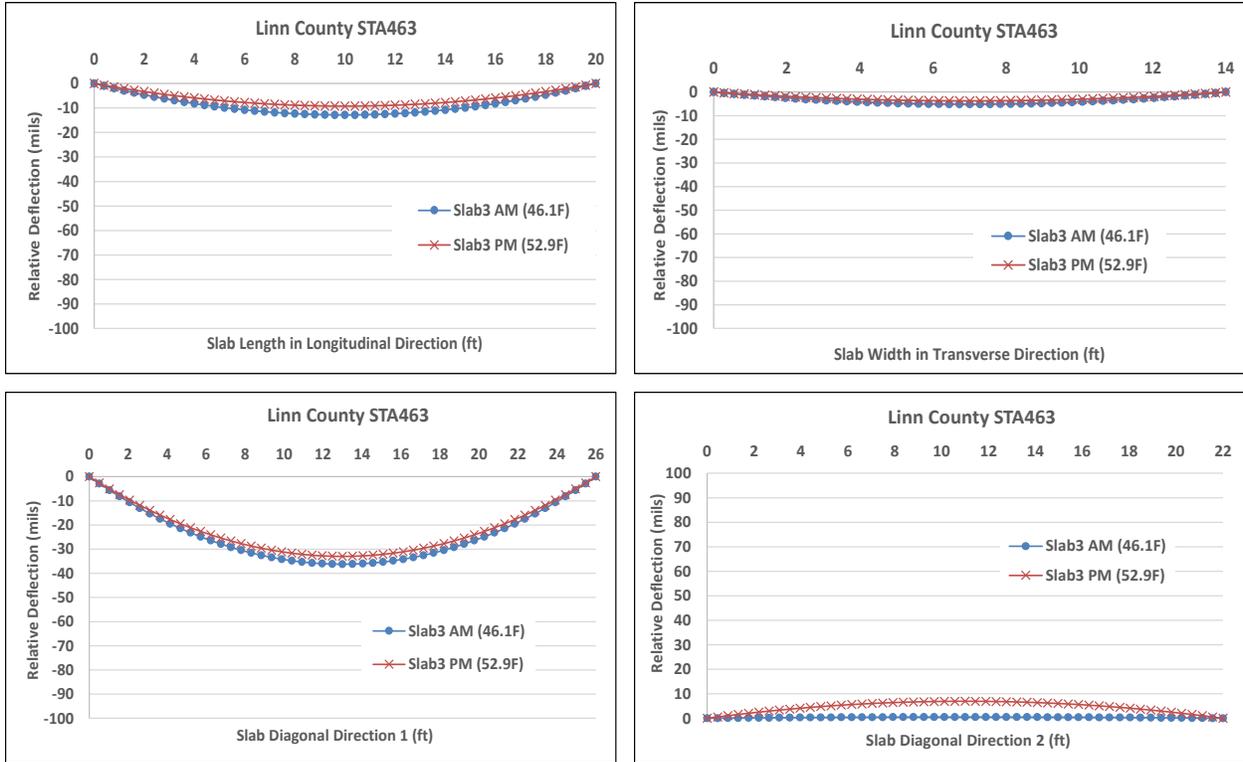
Figure 42. Morning and afternoon relative deflection of Slab 3 at Site 5: longitudinal (top left), transverse (top right), diagonal 1 (bottom left), and diagonal 2 (bottom right)

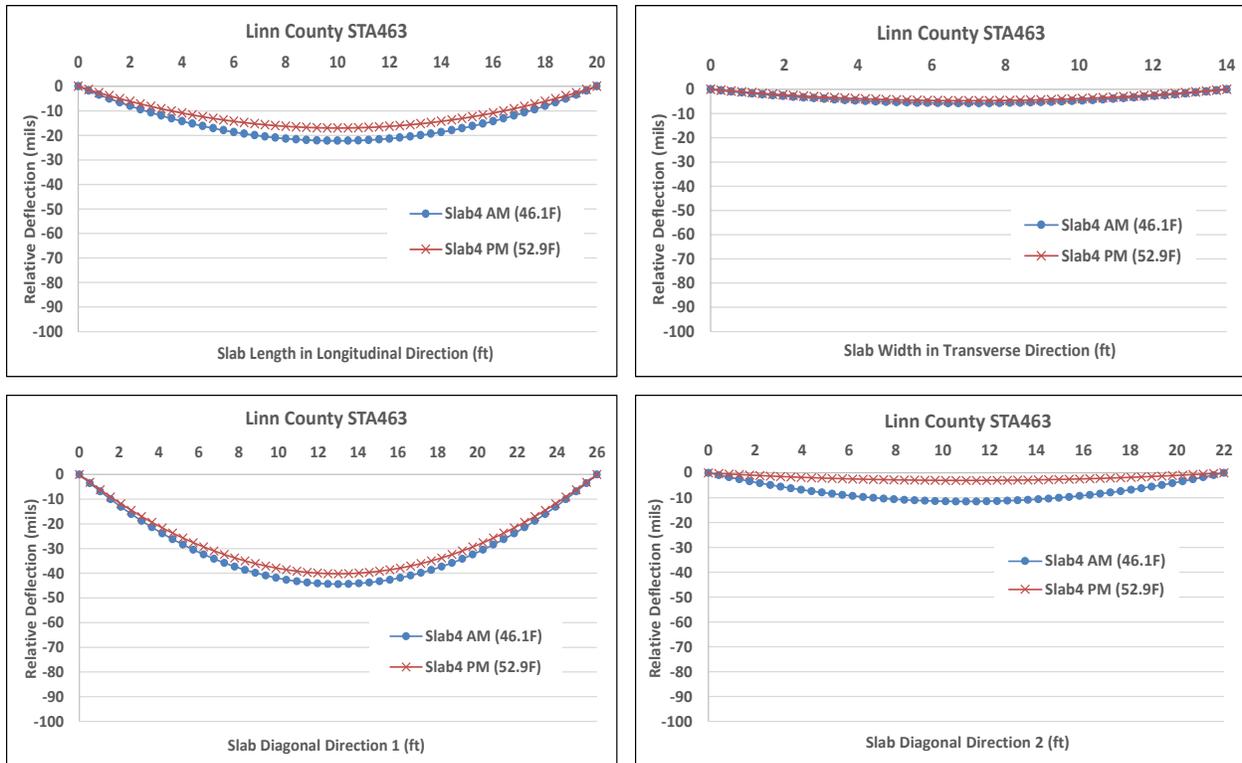
Figure 43. Morning and afternoon relative deflection of Slab 4 at Site 5: longitudinal (top left), transverse (top right), diagonal 1 (bottom left), and diagonal 2 (bottom right)

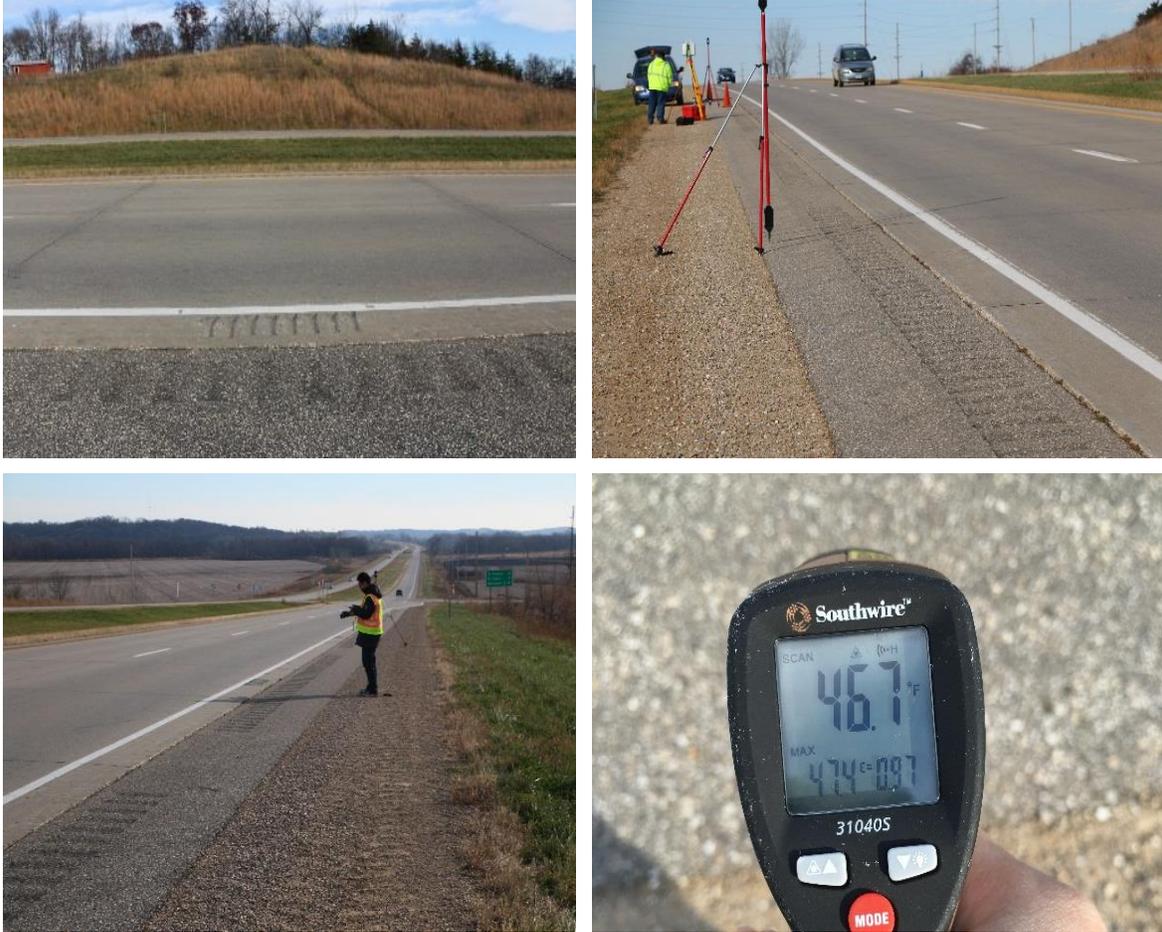
Figure 45. Field investigation on US 30 near Toledo, Tama County STA113 (MP 194.6)

Field investigations at Site 6 on US 30 in Toledo, Tama County were conducted in the morning at 11:00 a.m. on November 10, 2015. At this site, the scans for the selected PCC slabs were performed at STA113 on US 30 Highway. No cracks were found in the traffic lane. Field investigation activities were the same as the activities conducted at Site 1. Figure 45 presents some of the activities performed during this field investigation.

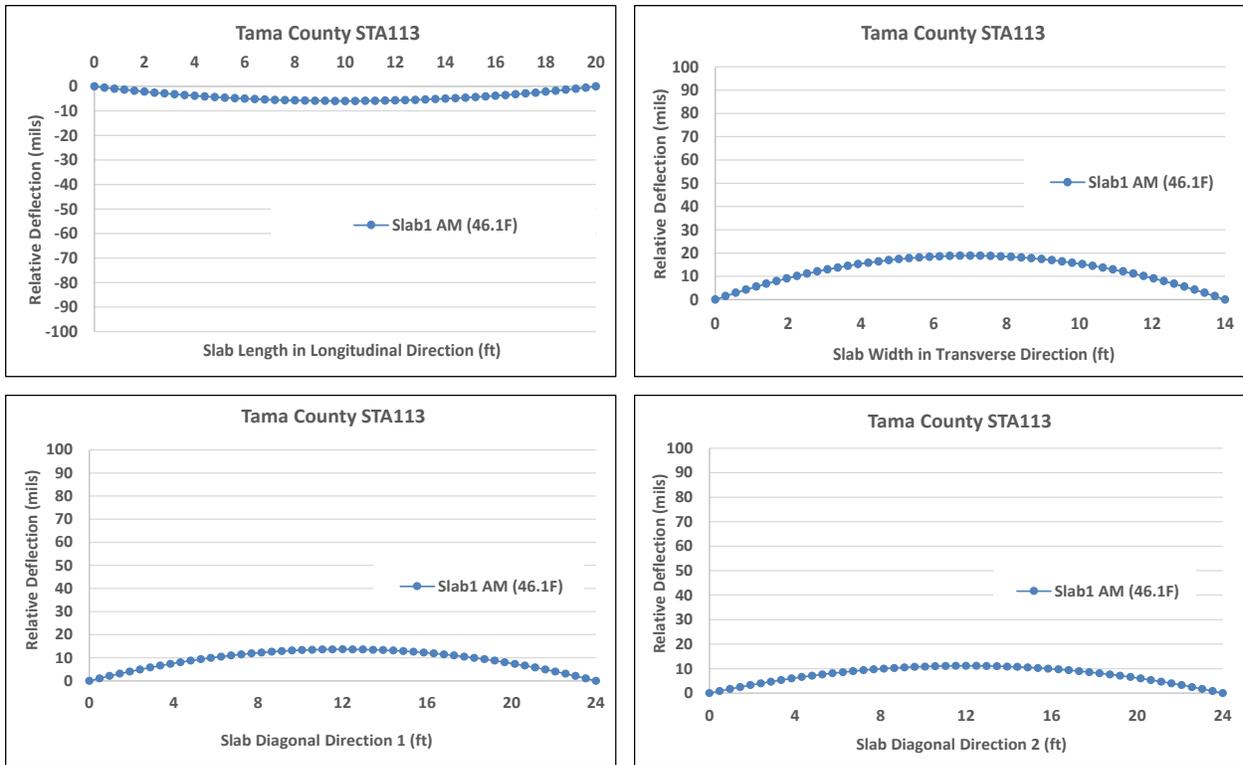
Figure 46. Morning relative deflection of Slab 1 at Site 6: longitudinal (top left), transverse (top right), diagonal 1 (bottom left), and diagonal 2 (bottom right)

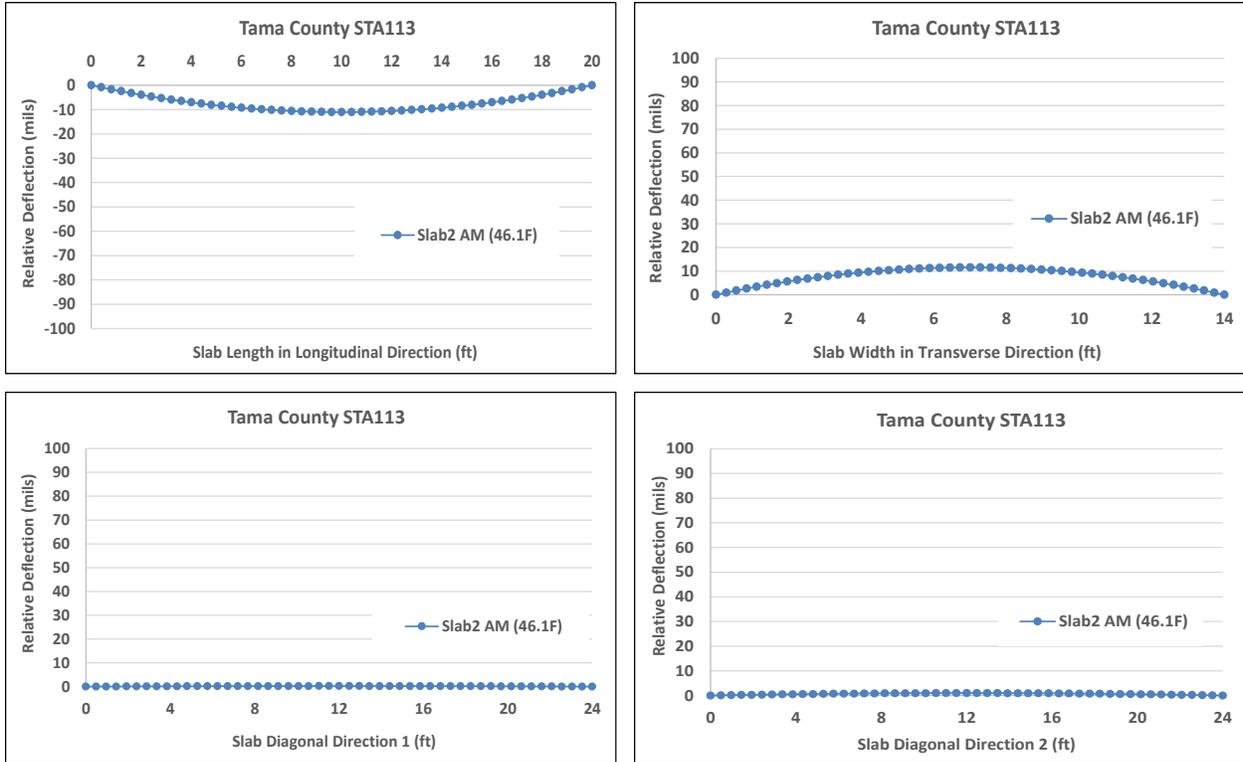
Figure 47. Morning relative deflection of Slab 2 at Site 6: longitudinal (top left), transverse (top right), diagonal 1 (bottom left), and diagonal 2 (bottom right)

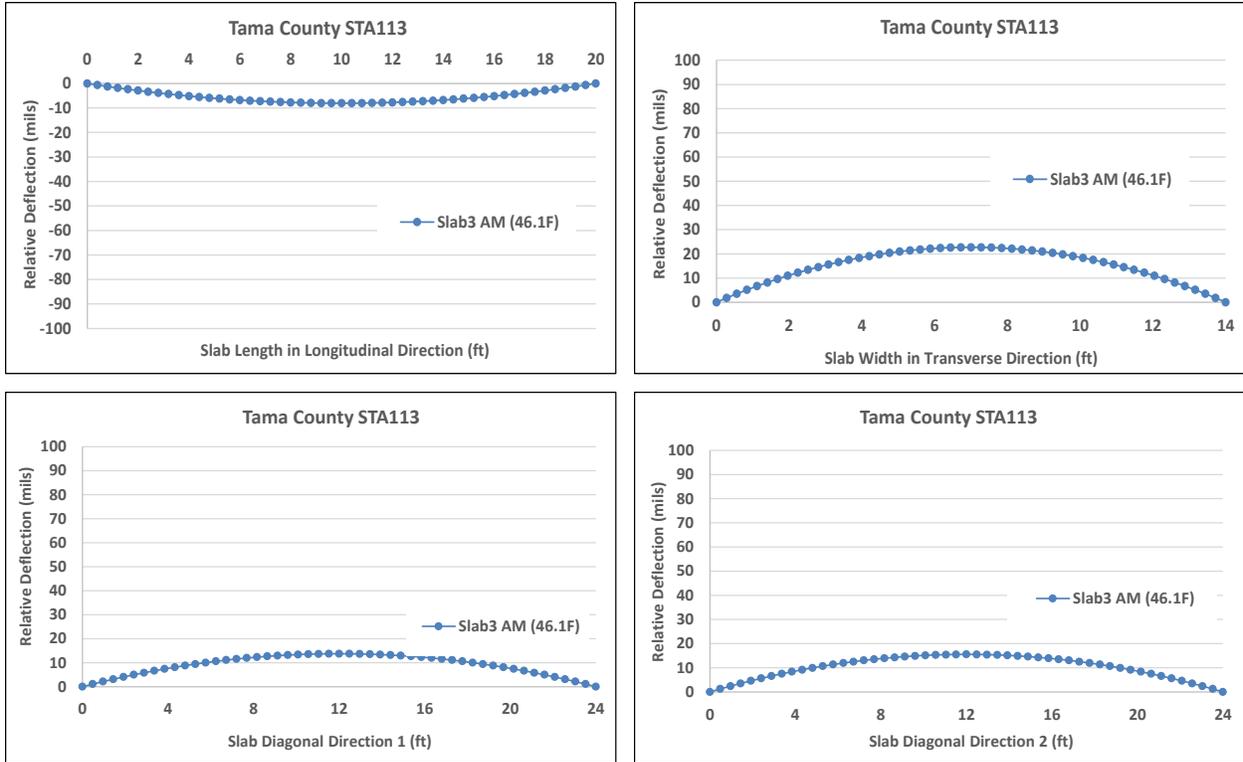
Figure 48. Morning relative deflection of Slab 3 at Site 6: longitudinal (top left), transverse (top right), diagonal 1 (bottom left), and diagonal 2 (bottom right)

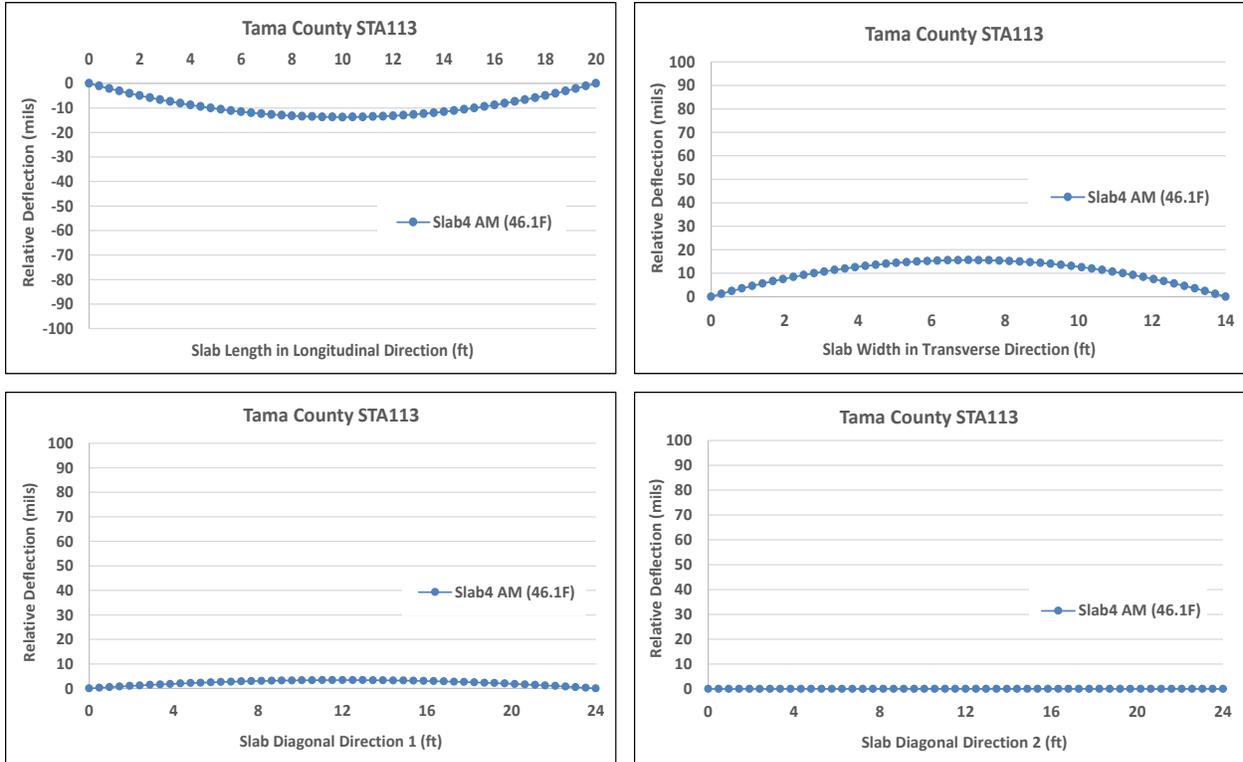
Figure 49. Morning relative deflection of Slab 4 at Site 6: longitudinal (top left), transverse (top right), diagonal 1 (bottom left), and diagonal 2 (bottom right)

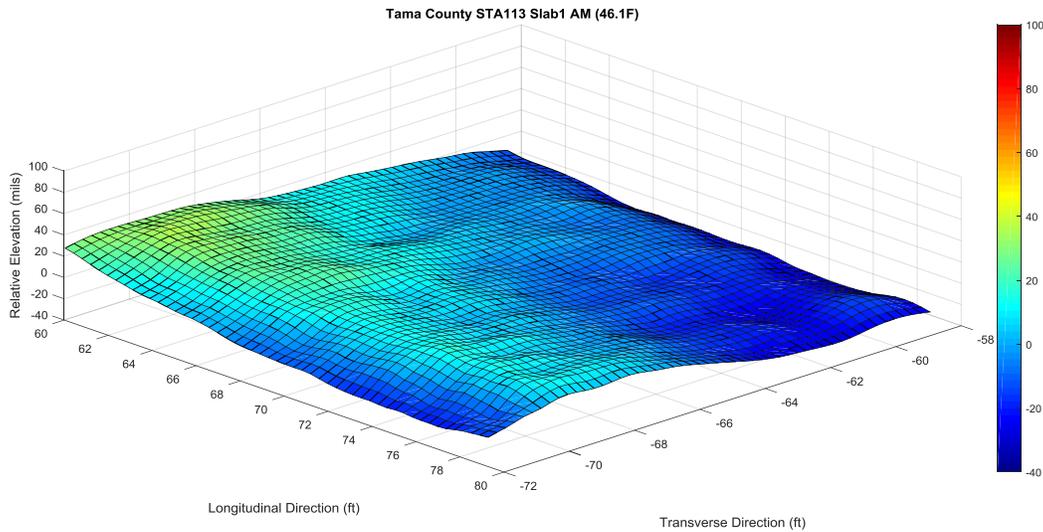
Figure 50. 3D simulation of Slab 1 at STA113 on US 30 near Toledo, Tama County

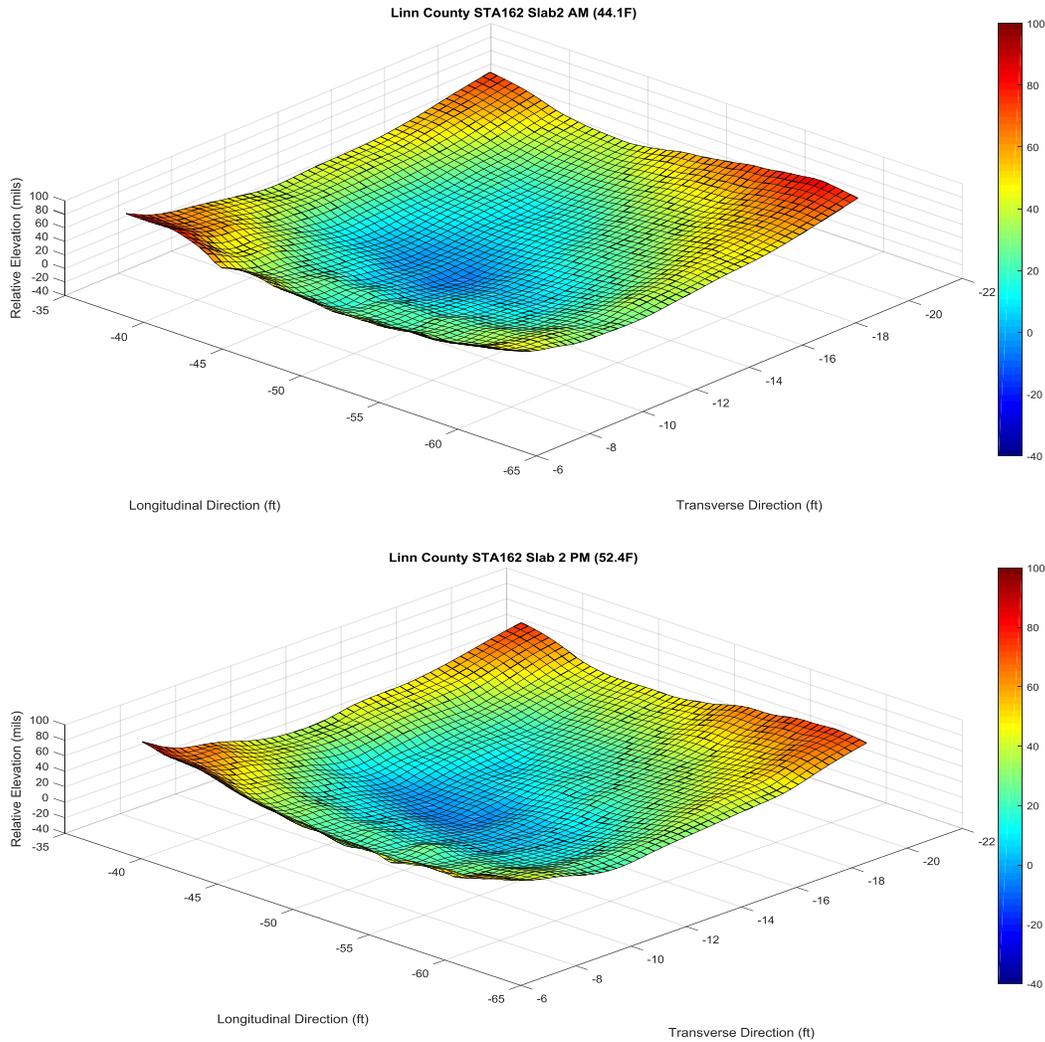
Figure 53. 3D modeling of Slab 2 at Site 3 in Linn County at STA162: slab in the morning (top) and slab in the afternoon (bottom)

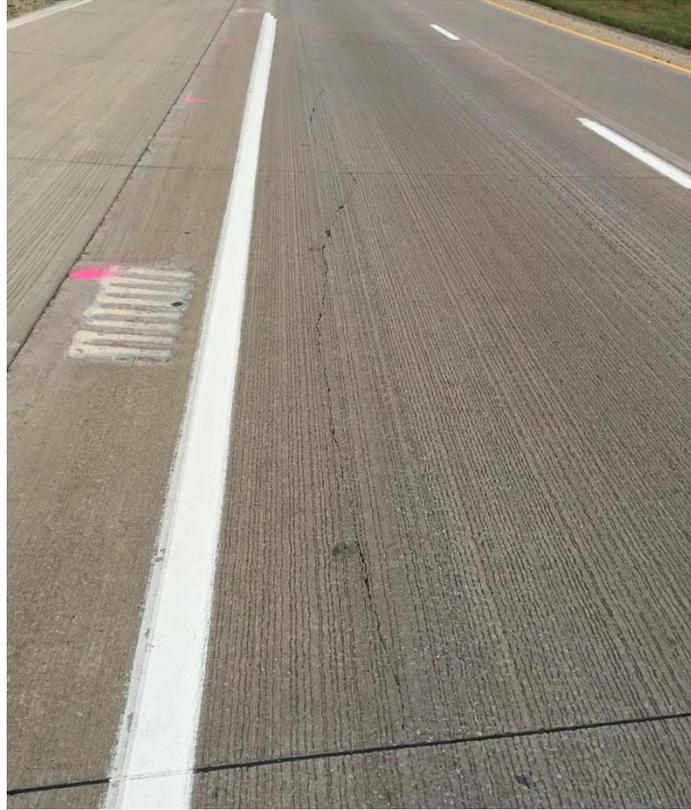
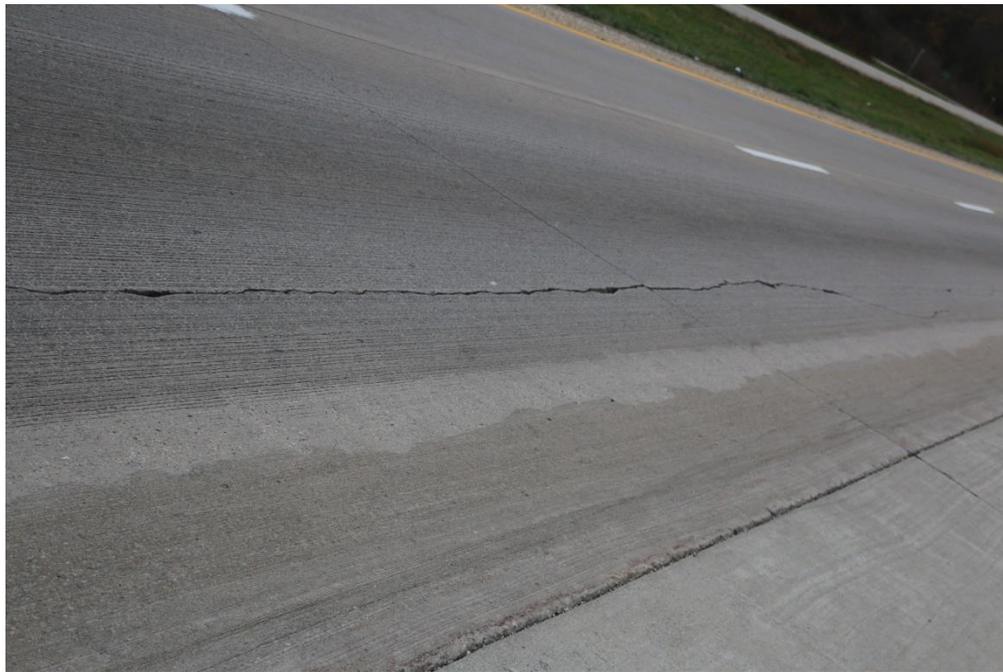
Figure 66. Slabs with cracks observed at Site 3

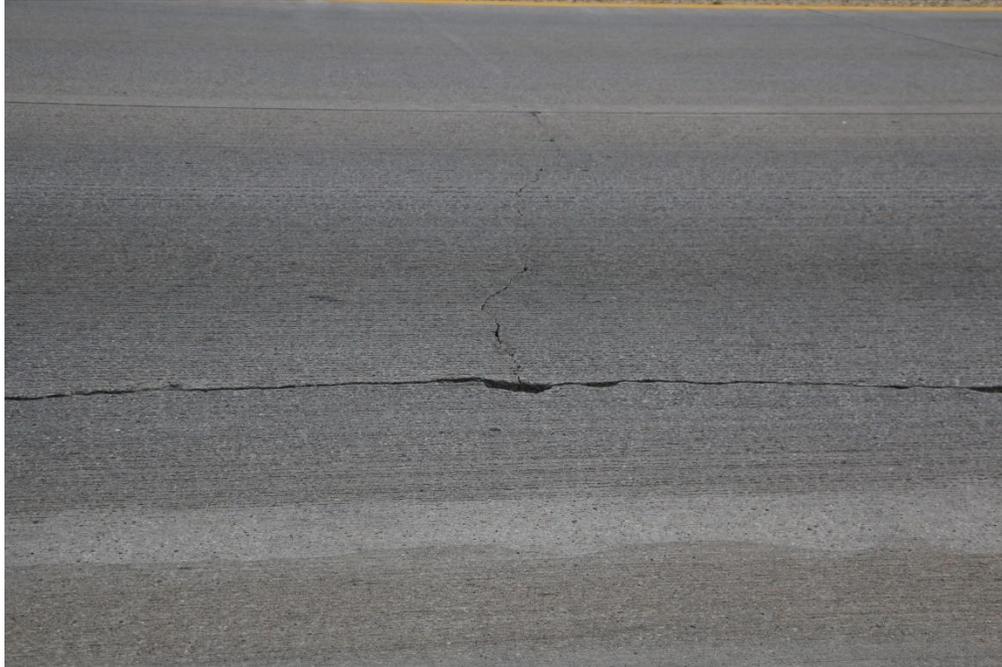
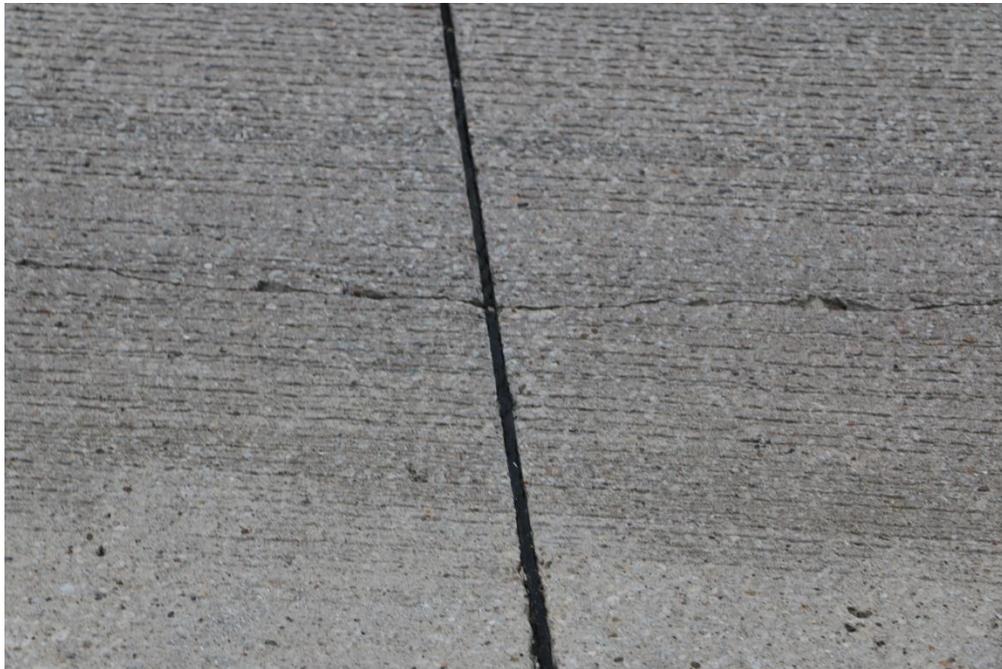
Figure 67. Transverse (top) and longitudinal (bottom) cracks at Site 3

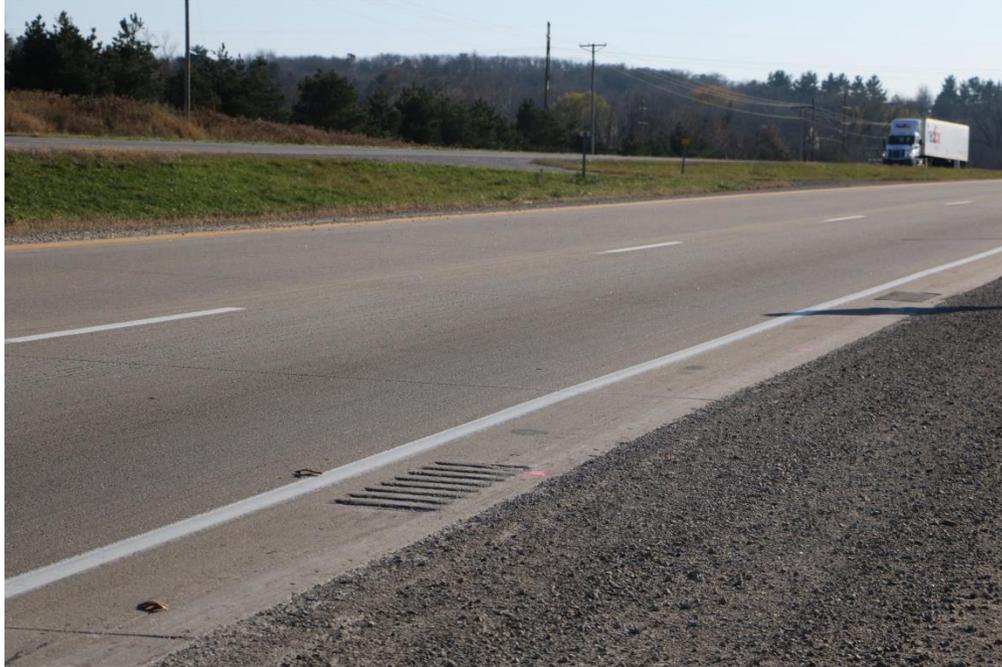
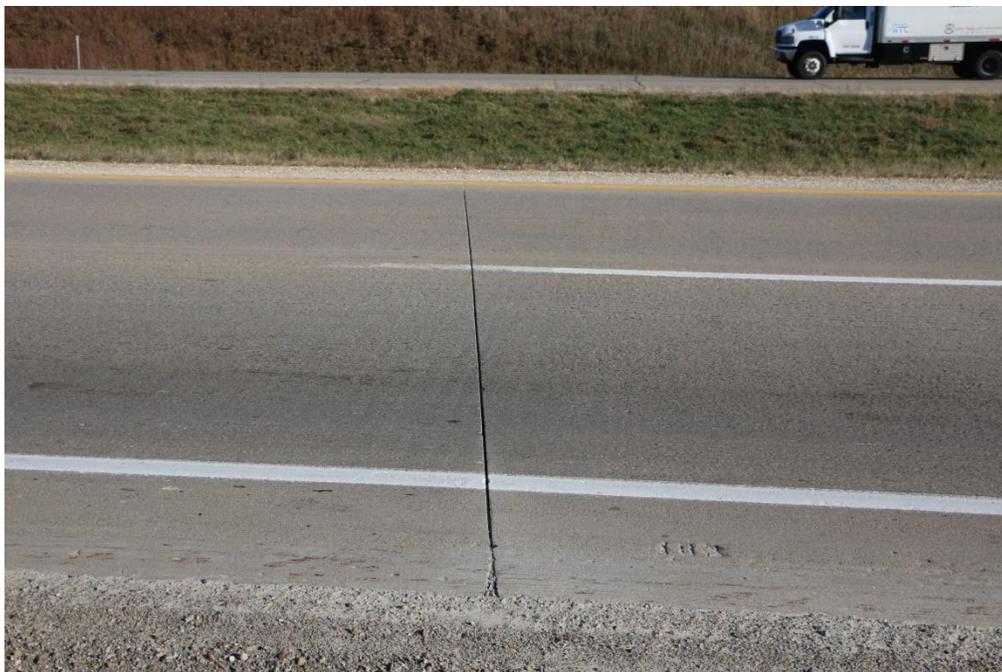
Figure 71. Pavement at Site 4 on US 151 near Cedar Rapids, Linn County, STA183 (MP 33.15) on November 10, 2015 (afternoon)

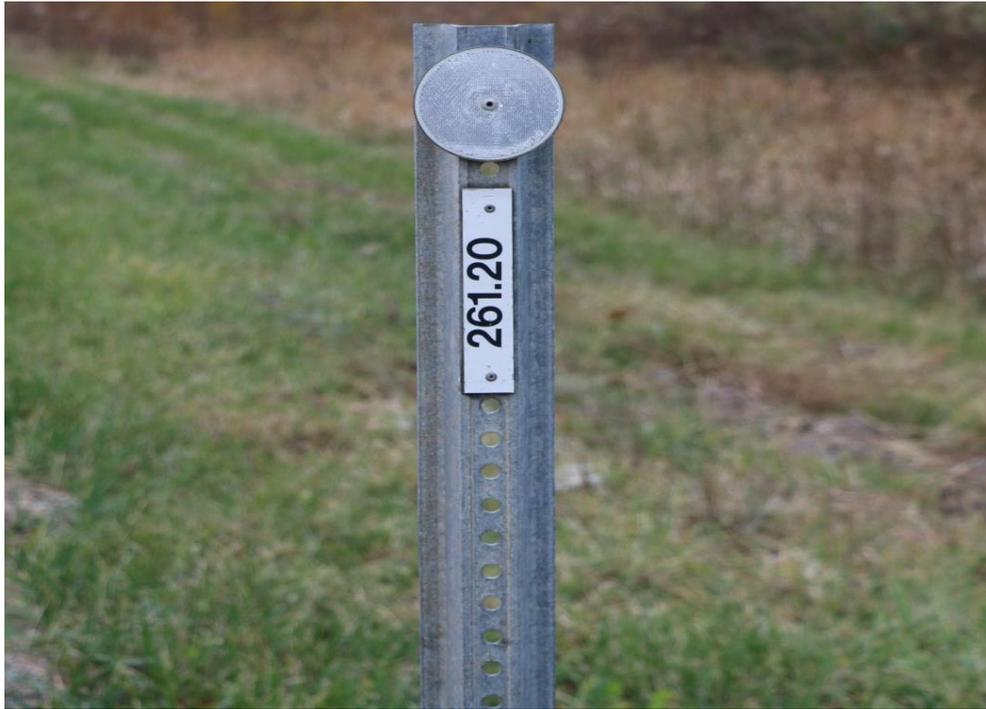
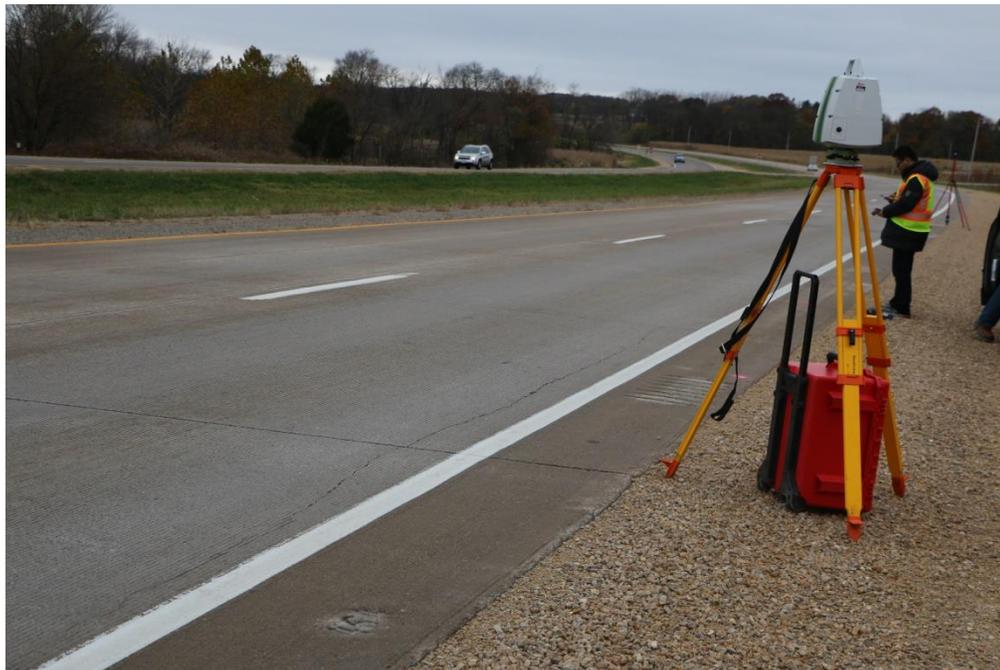
Figure 72. Field investigation at Site 5 on US 30 near Cedar Rapids, Linn County, STA463 (MP 261.2) on October 29, 2015 (morning)

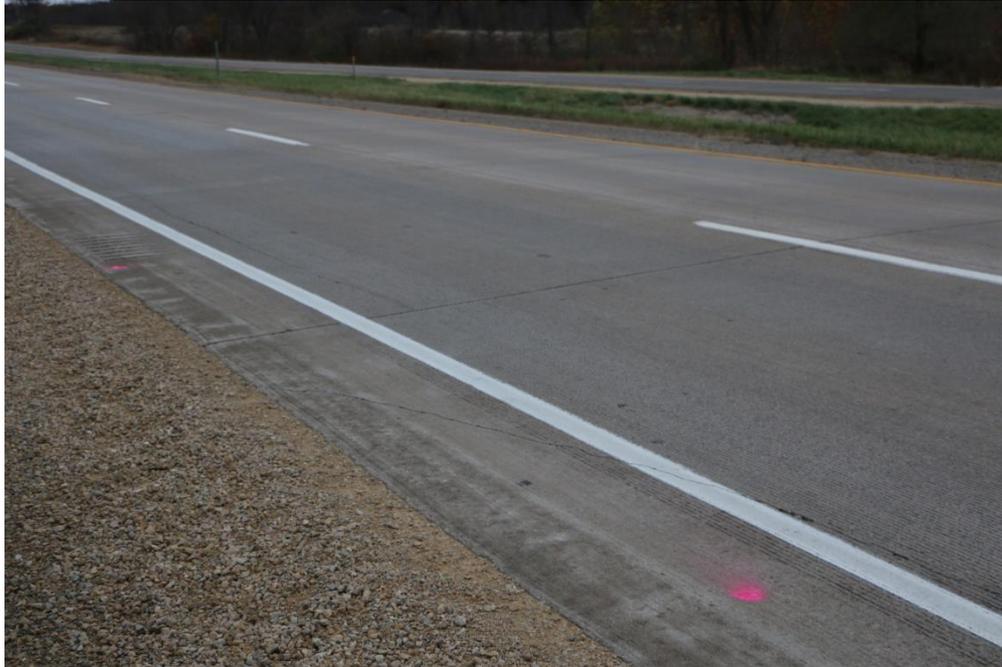
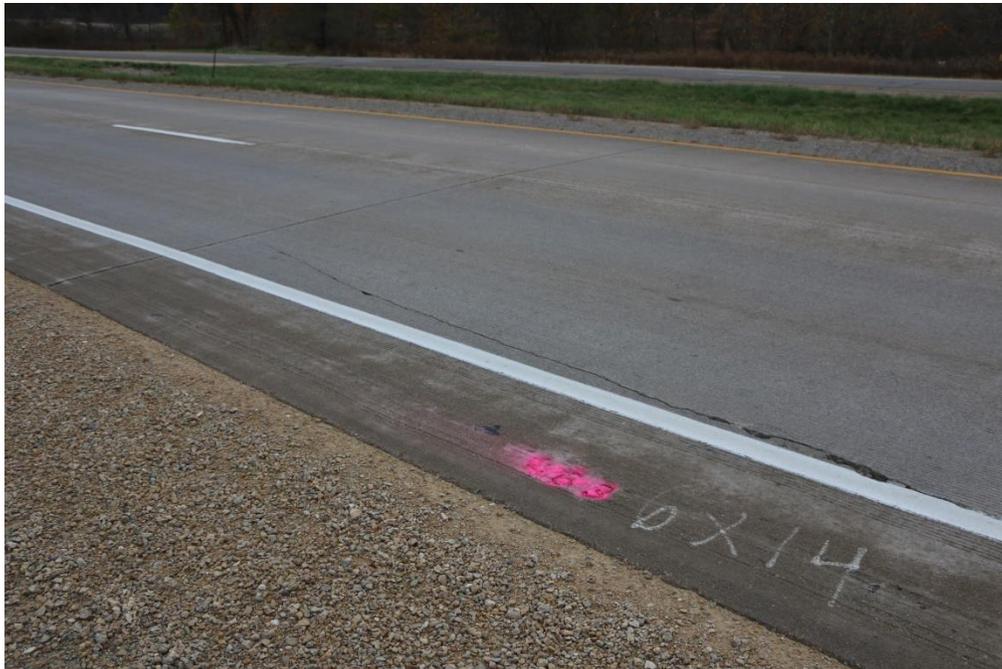
Figure 73. Pavement at Site 5 on US 30 near Cedar Rapids, Linn County, STA463 (MP 261.2) on October 29, 2015 (morning)
