Impact of Curling and Warping on Concrete Pavement

Final Report
July 2016

National Concrete Pavement
Technology Center

Sponsored by
Iowa Highway Research Board
(IHRB Project TR-668)
Iowa Department of Transportation
(InTrans Project 13-486)
Federal Highway Administration

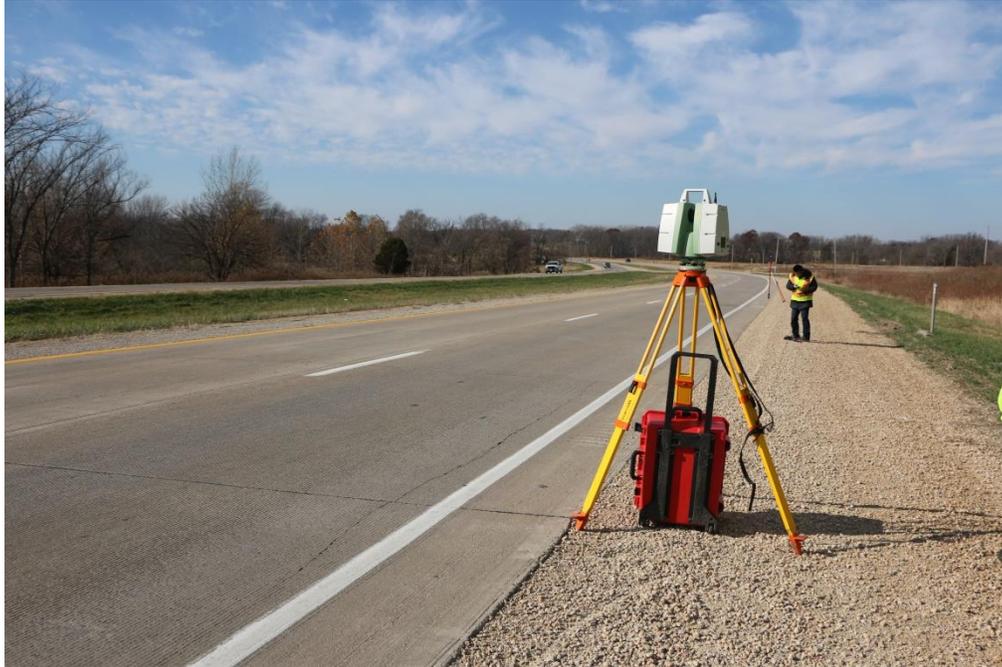
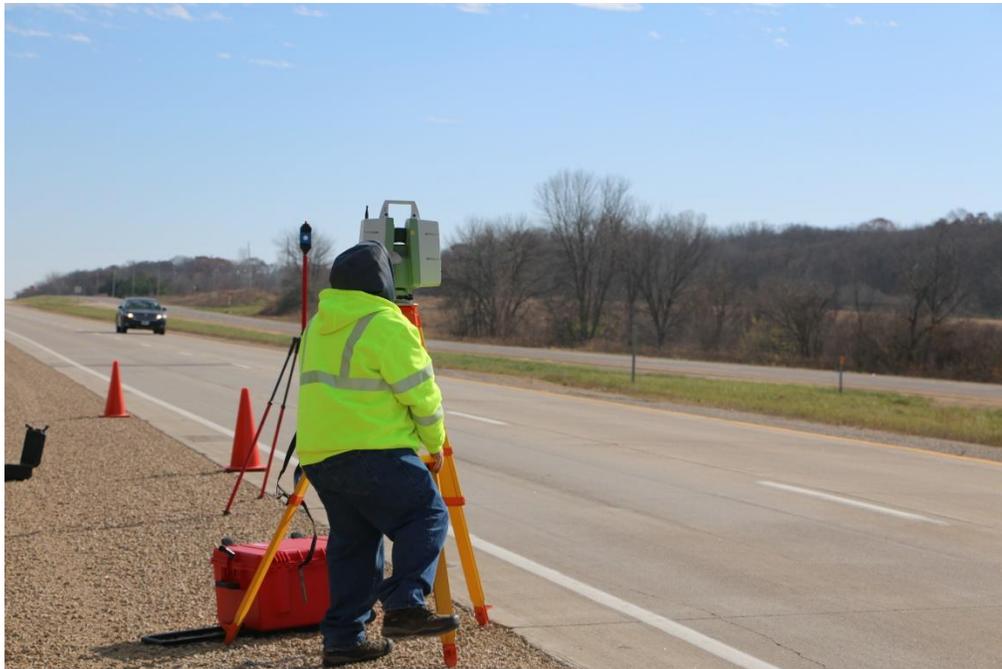
Figure 74. Field investigation at Site 5 on US 30 near Cedar Rapids, Linn County, STA463 (MP 261.2) on November 10, 2015 (afternoon)

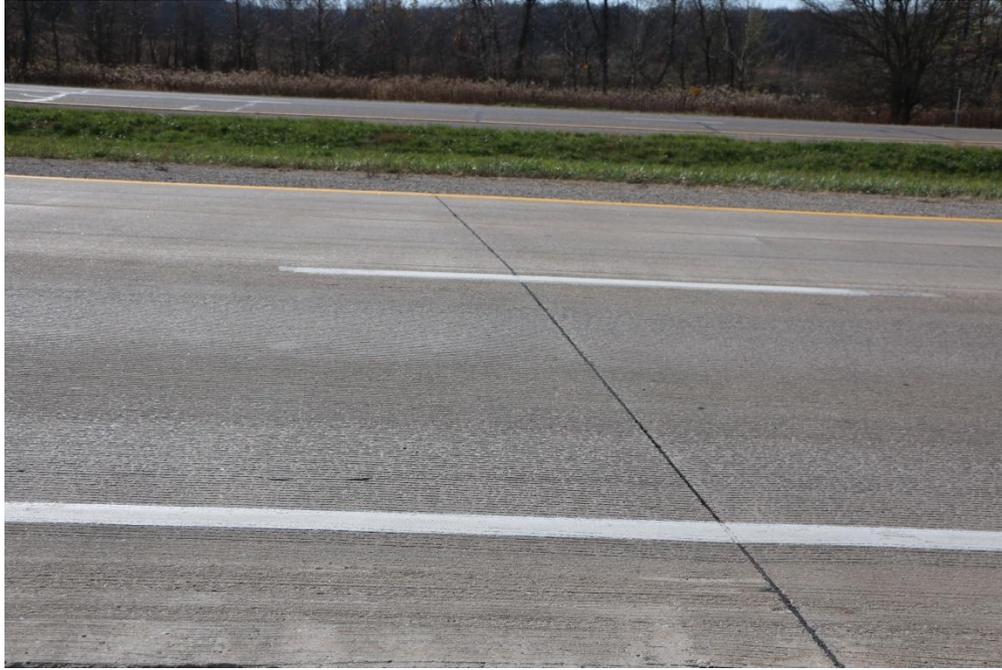
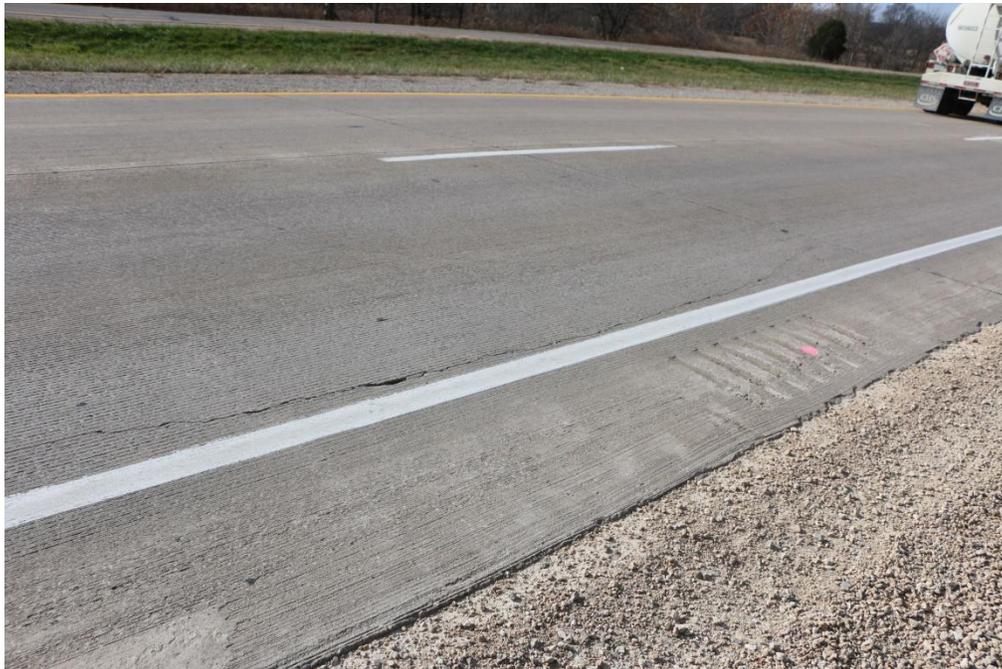
Figure 75. Pavement at Site 5 on US 30 near Cedar Rapids, Linn County, STA463 (MP 261.2) on November 10, 2015 (afternoon)

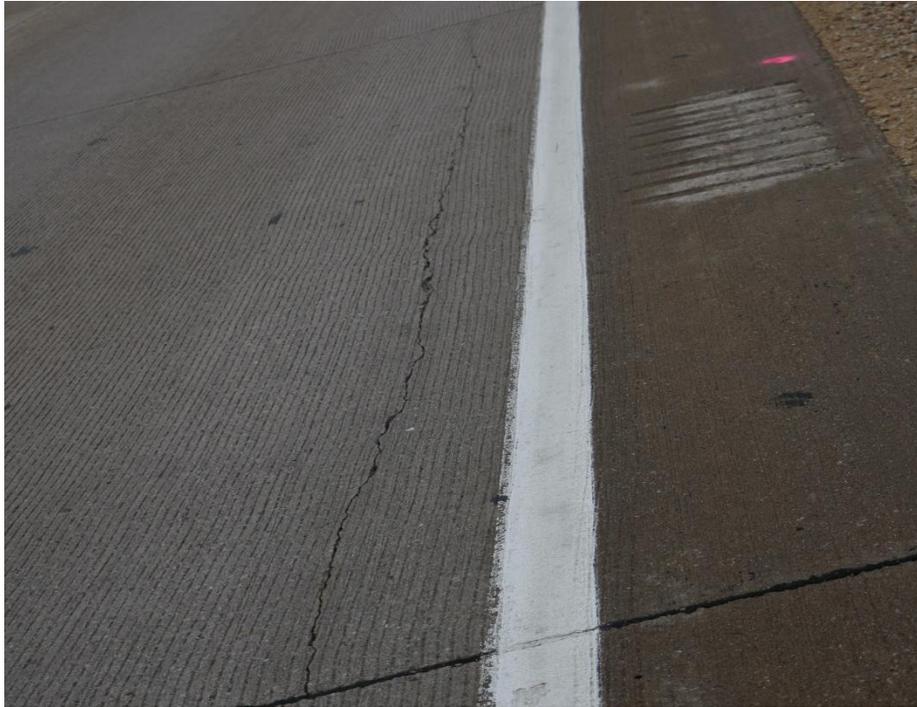
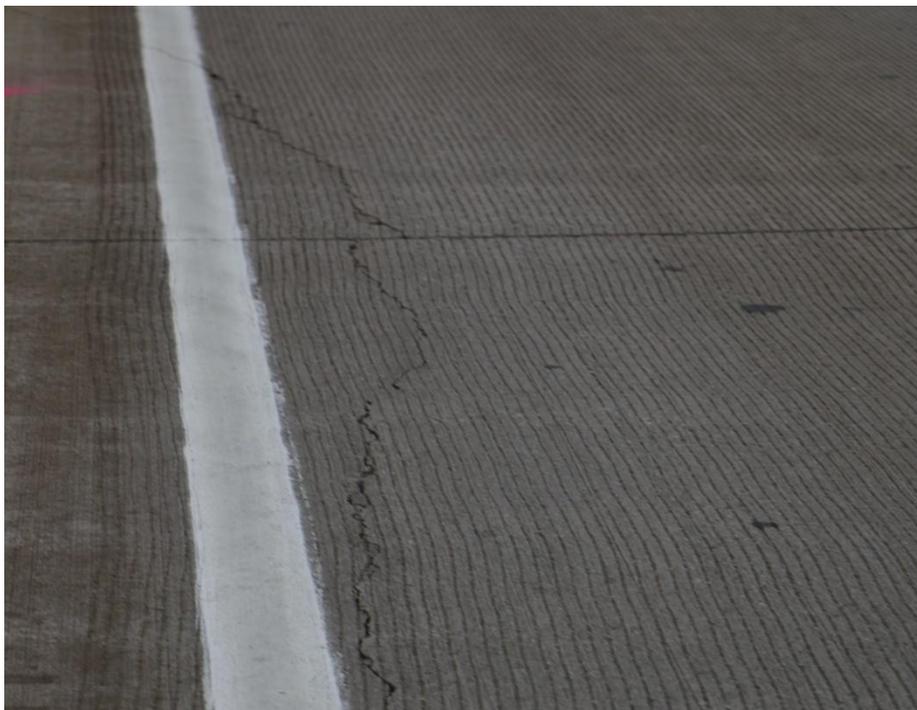
Figure 76. Slabs with cracks observed at Site 5

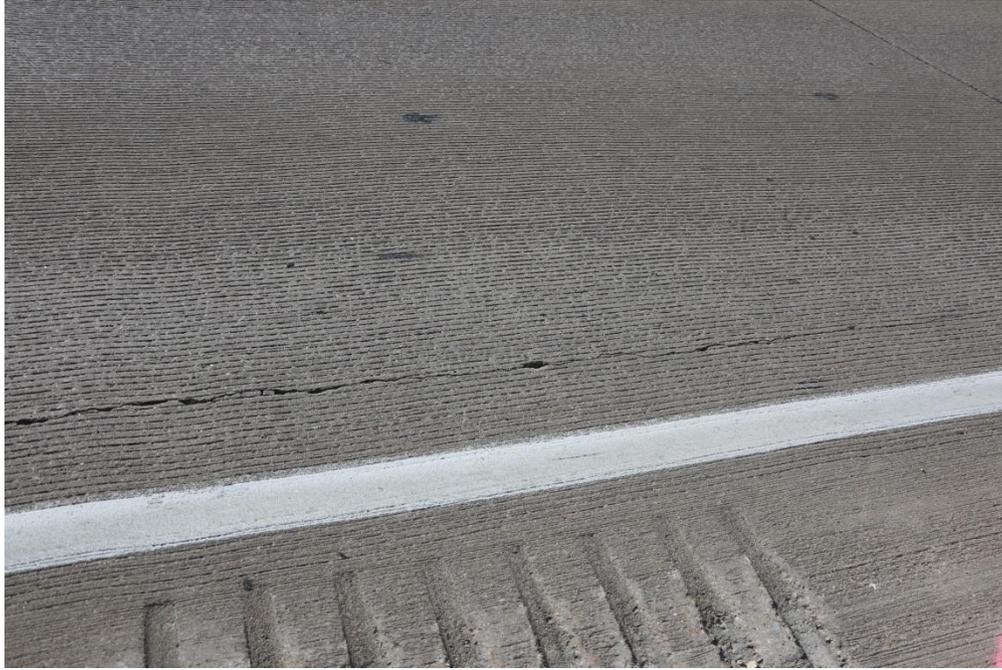
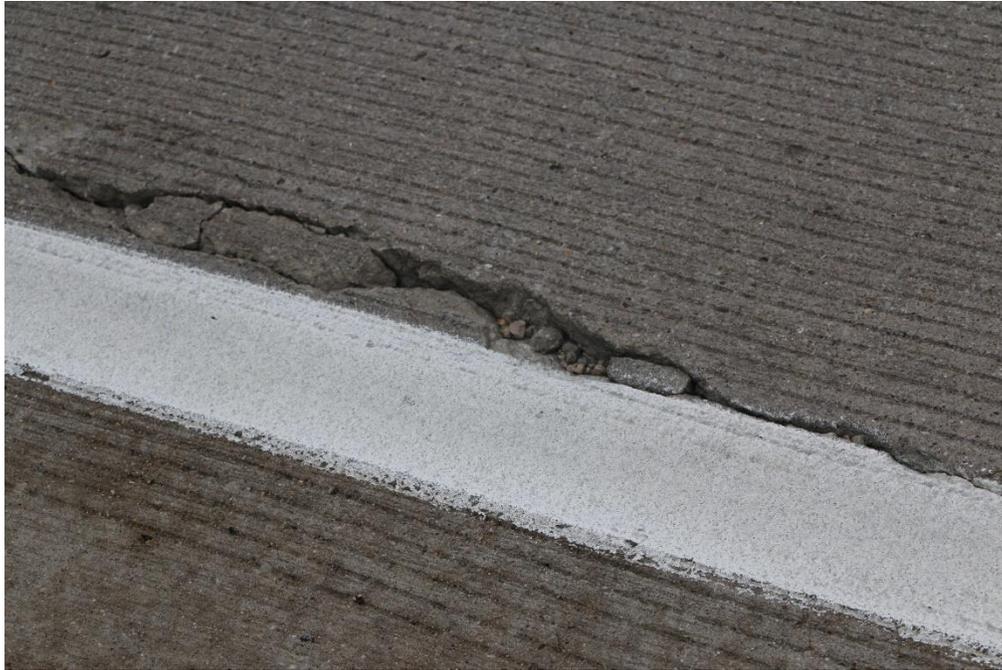
Figure 77. Longitudinal cracks at Site 5

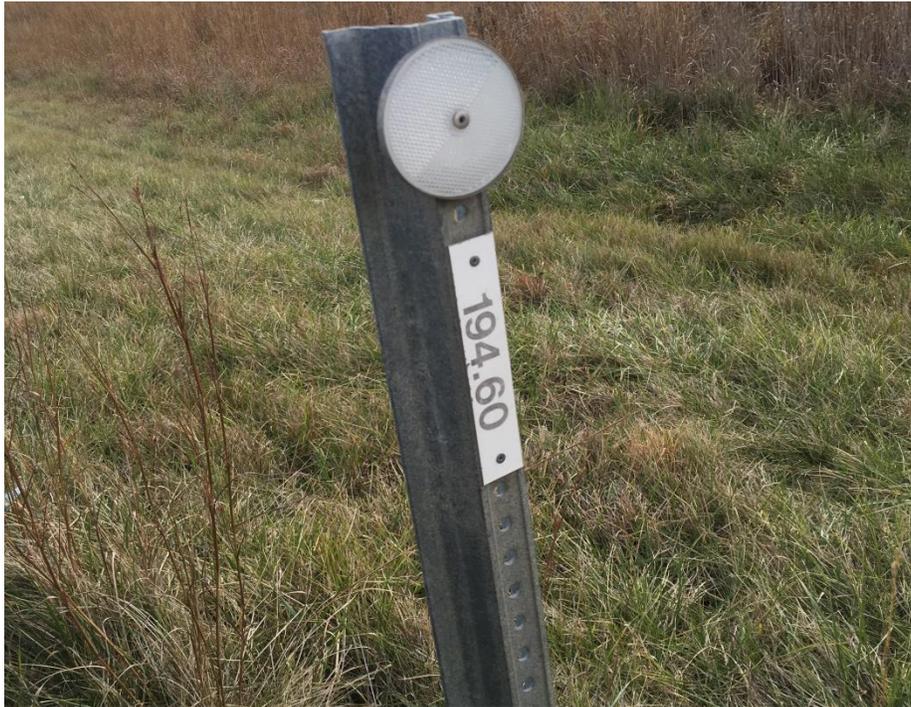
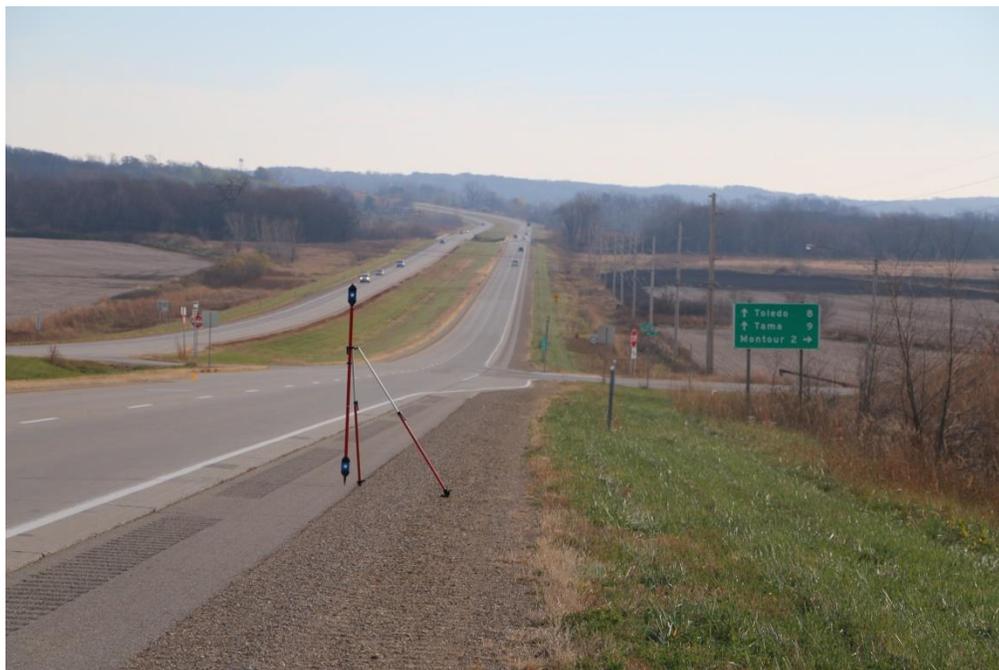
Figure 78. Field investigation at Site 6 on US 30 near Toledo, Tama County, STA113 (MP 194.6) on November 10, 2015 (morning)

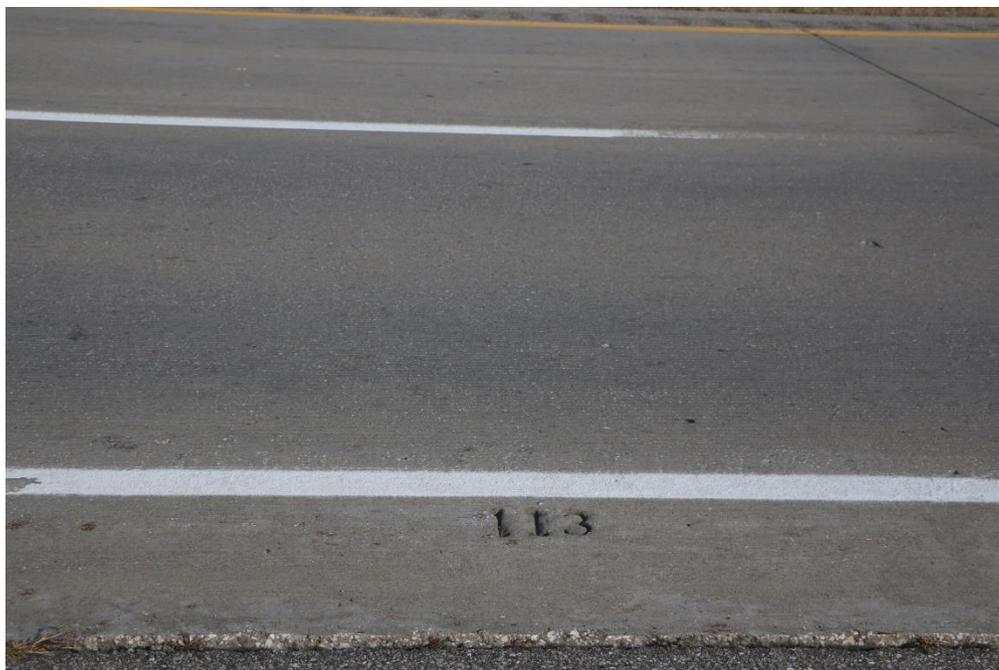
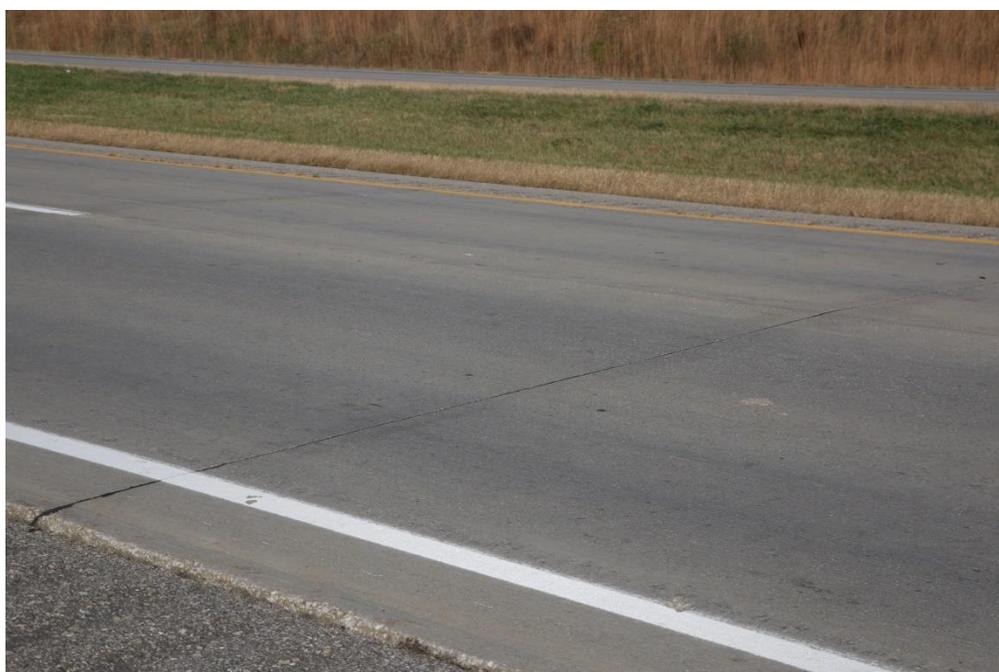
Figure 79. Site 6 on US 30 near Toledo, Tama County, STA113 (MP 194.6) on November 10, 2015 (morning)
