Effective Structural Concrete Repair Volume 2 of 3

Use of FRP to Prevent Chloride Penetration in Bridge Columns

March 2004

Iowa DOT Project TR - 428

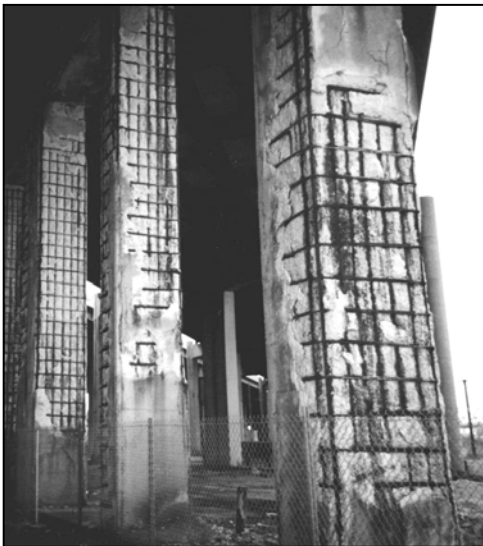
Figure 2.1 An extreme example of spalling concrete (11).

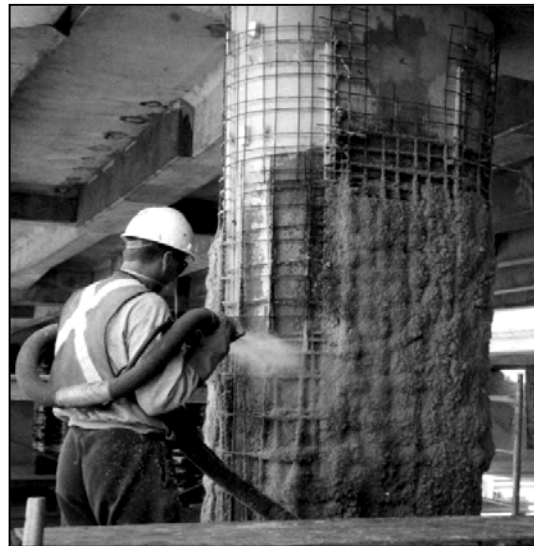
Figure 2.2 Application of an external anode with a spray-on mixture of water and cellulose fiber (11).

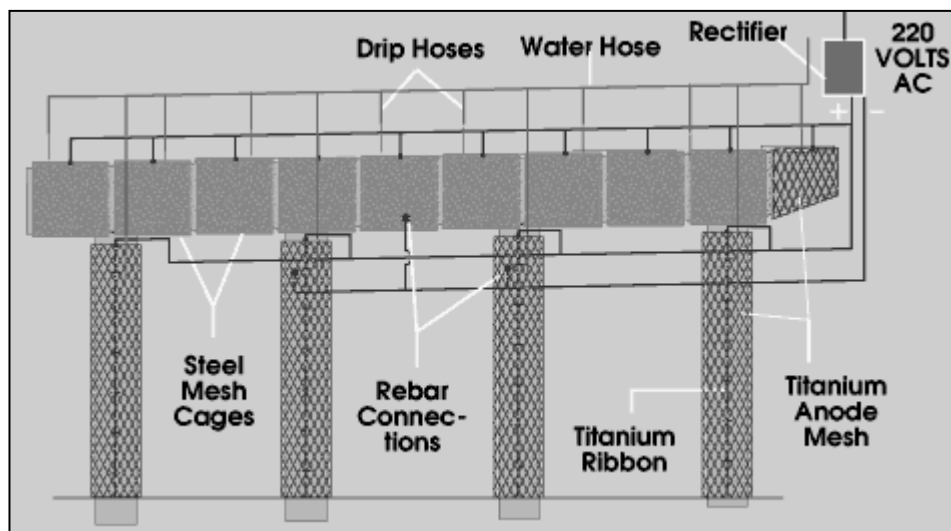
Figure 2.3 Layout of an electrochemical treatment for a reinforced concrete pier (12).

schematic view that illustrates a plan for chloride removal from a reinforced concrete bridge pier using electrochemical extraction is presented in Figure 2.3.

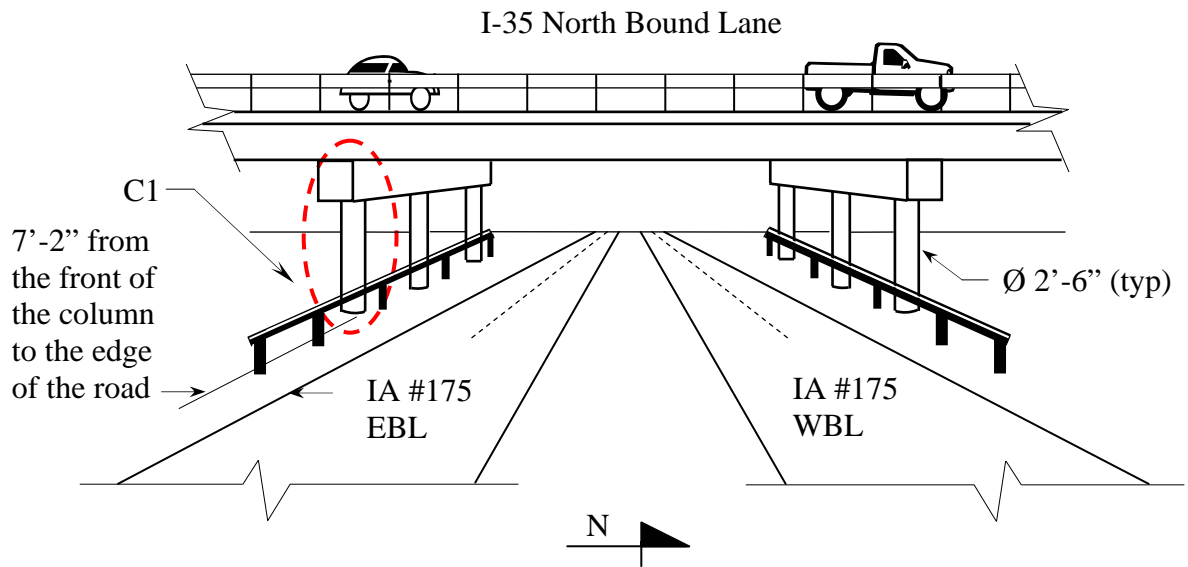
Figure 3.2 Schematic view of TS1 with key dimensions and highways.

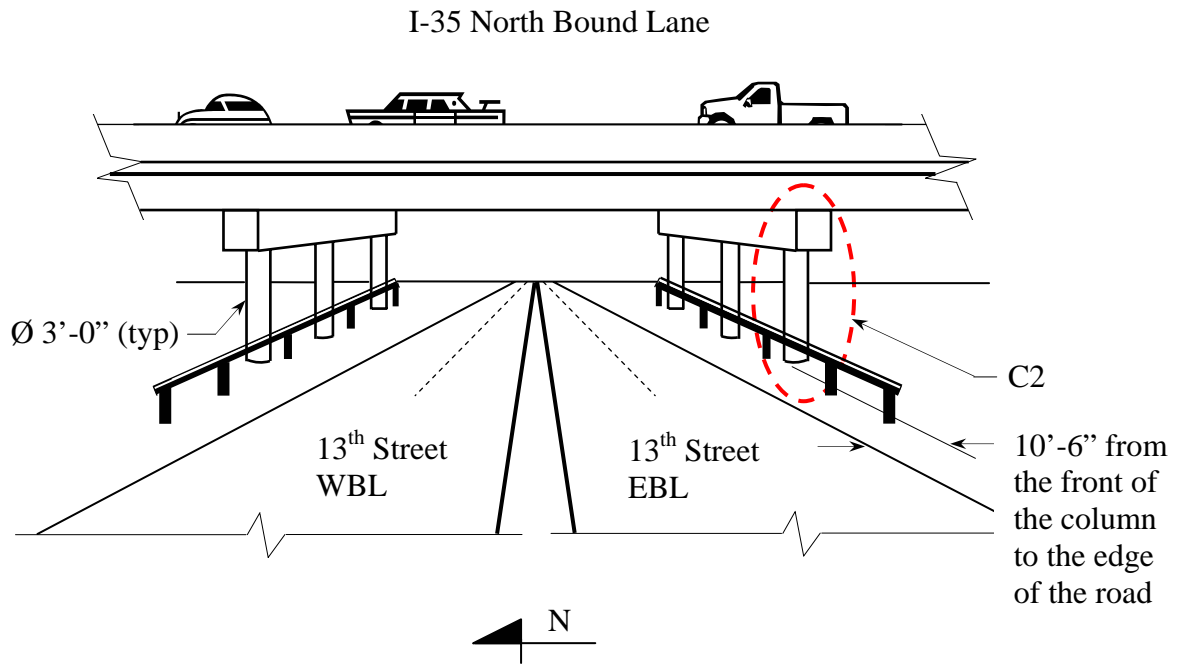
Figure 3.4 Schematic view of TS2 with key dimensions and highways.

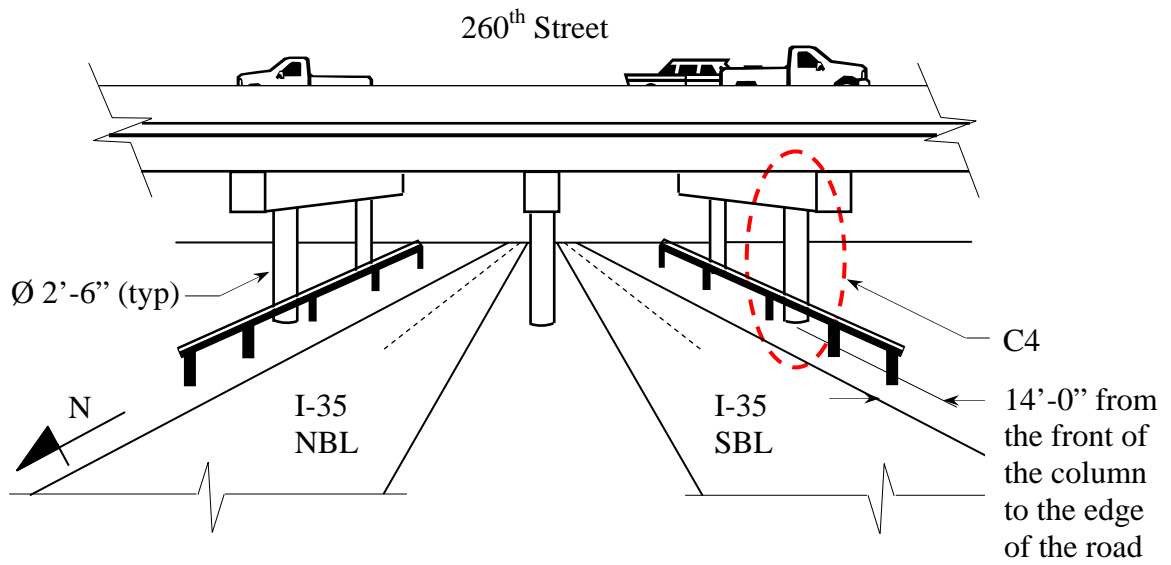
Figure 3.8 Schematic view of TS4 with key dimensions and highways.

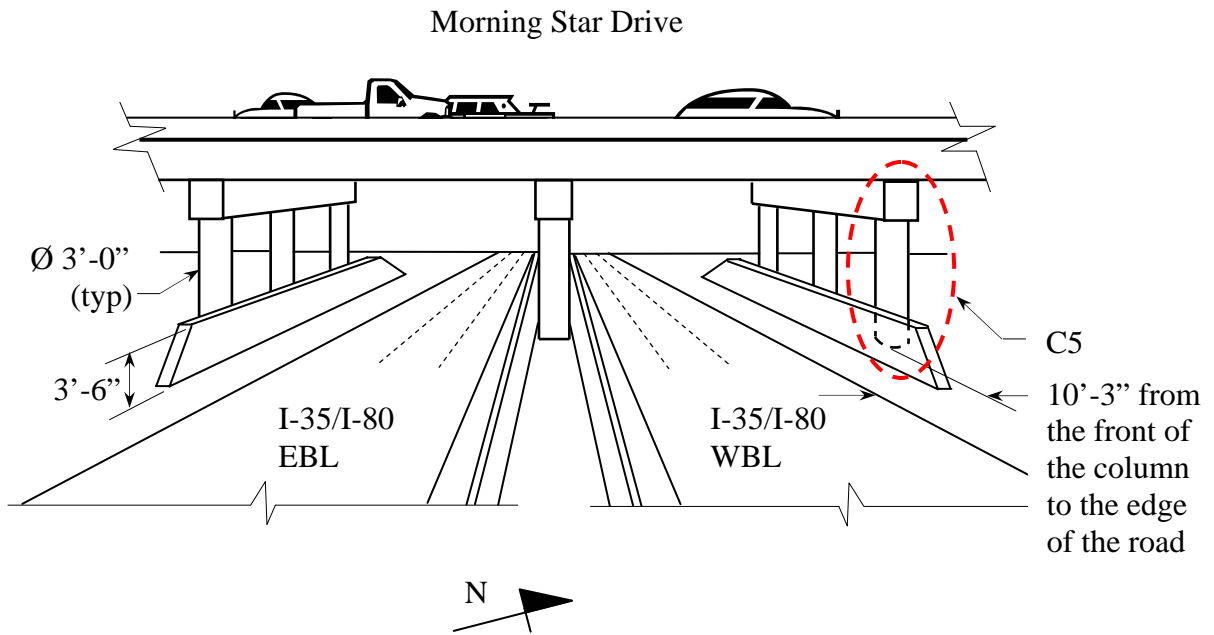
Figure 3.10 Schematic view of TS5 with key dimensions and highways.

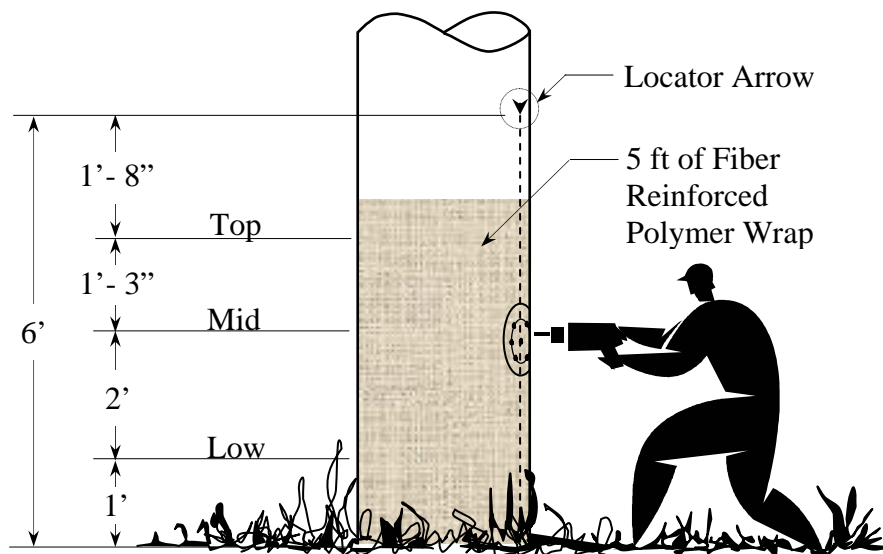
Figure 3.13 The three elevations used for powder sample collection.

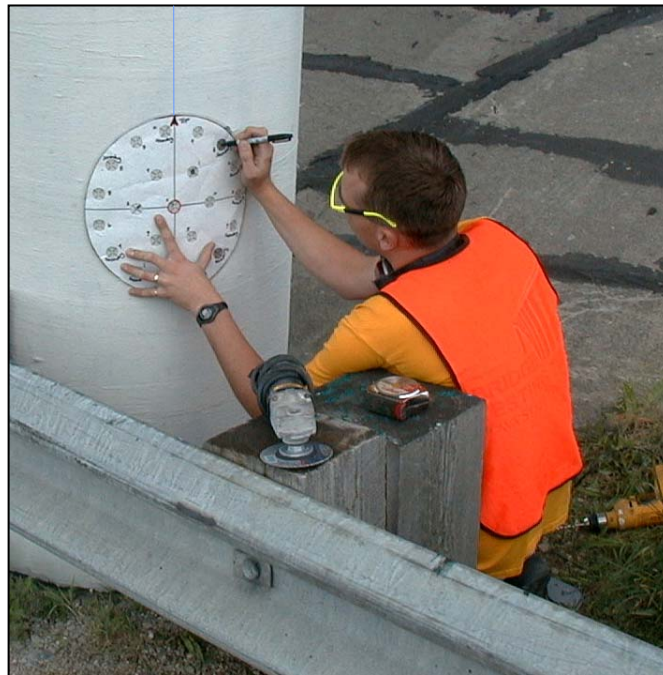
c.) Template in use at TS5

Figure 3.14 Details of the template.

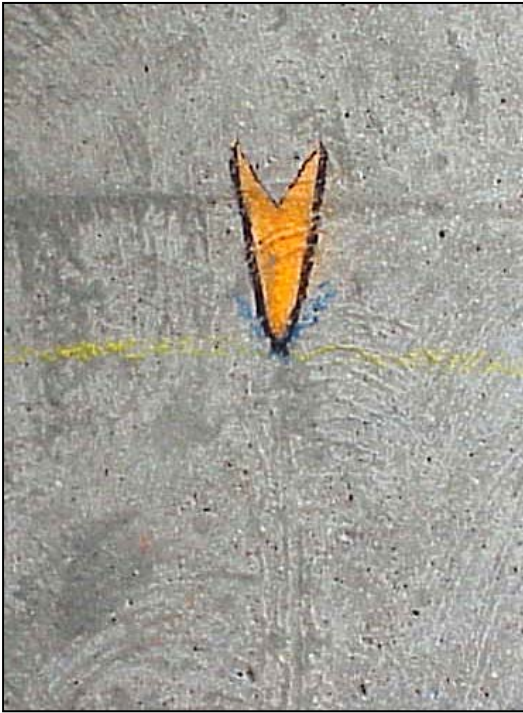
Figure 3.16 One of four locator arrows used to establish the perimeter positions.

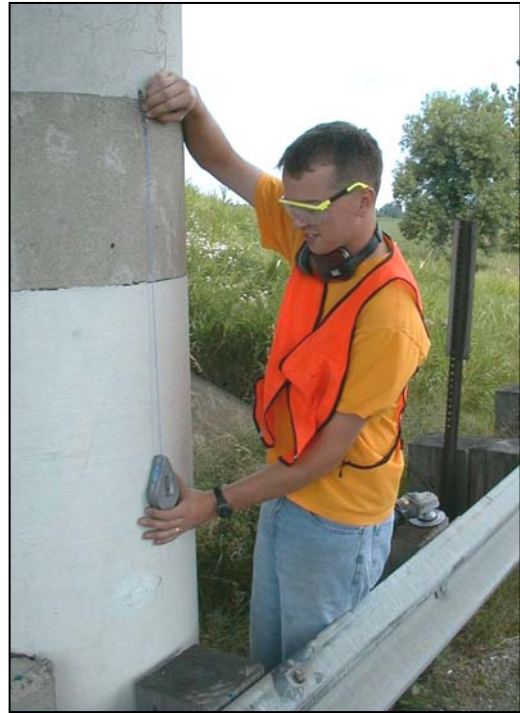
Figure 3.17 Use of a “plum-bob” to position the template.

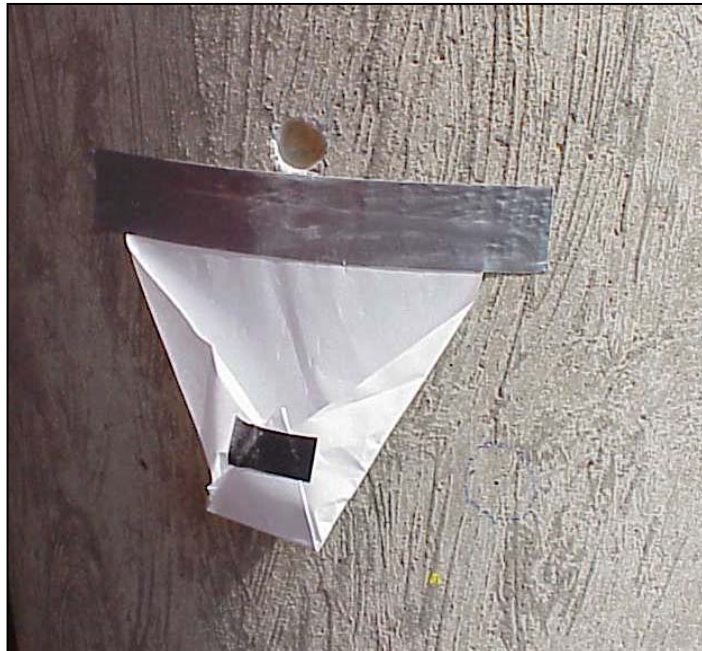
Figure 3.18 Powder collector in place at a sample station.

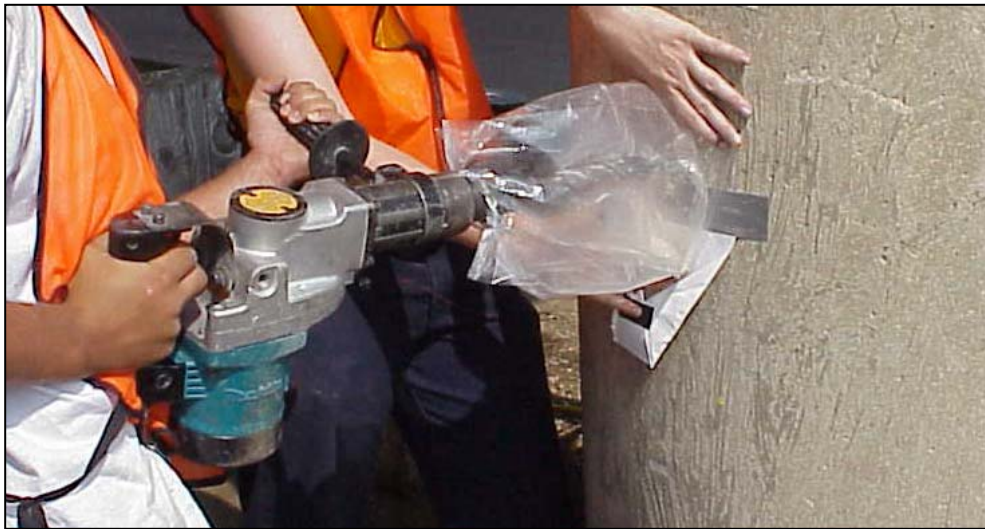
Figure 3.19 Hammer drill and plastic bag utilized in powder collection.

Once all 12 sample stations at a given test site (TS1, TS2, TS3, TS4 and TS5) were marked, drilling could commence. At each of the 12 sample stations, data were obtained at three depths, 0.5, 1.0 and 1.5 in. The three different depths made it possible to create a chloride penetration profile. To eliminate as many opportunities for contamination as possible, the top 1/16 in. of dust generated from the concrete surface was discarded. The hole was then blown out with compressed air to remove any powdered material remaining in the hole. Next, as shown in Figure 3.18, a paper collector was placed beneath the hole. The hammer drill utilized created a considerable amount of dust; thus, approximately half the powder sample was lost to the atmosphere. This was resolved by placing a plastic bag around the drill-bit and holding the open end against the concrete surface. The bag collected the dust off the drill-bit, which was poured into the paper collector when drilling was completed; this process is illustrated in Figure 3.19.

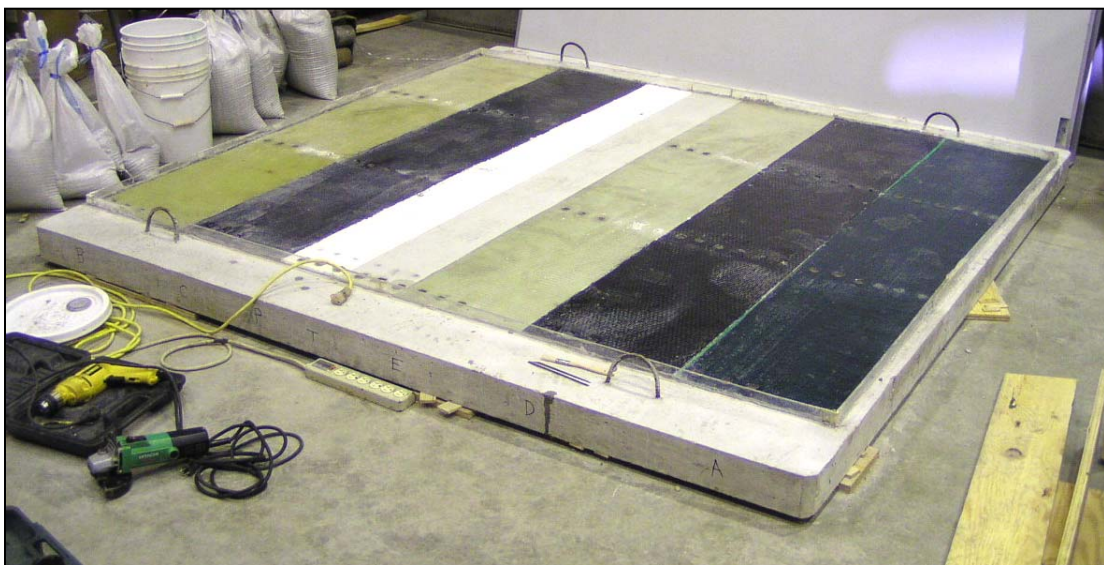
Figure 3.20 Slab 1 after all five FRP overlays and topcoats have been installed.

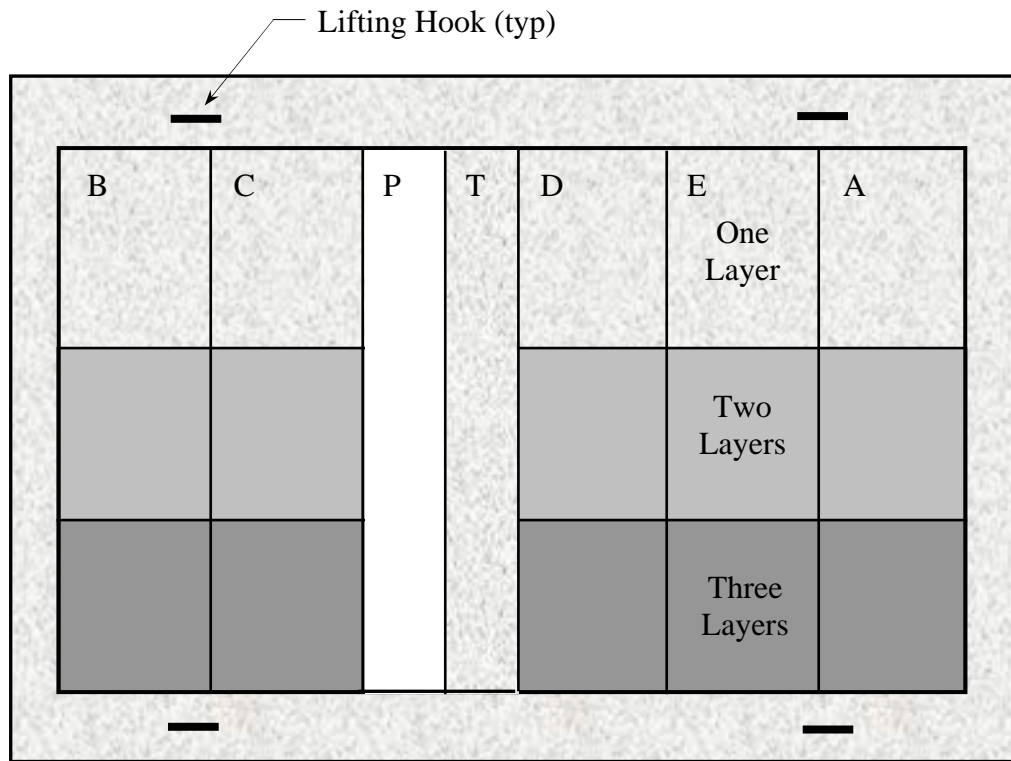
Figure 3.21 Slab 1 layout for each product and the number of layers.

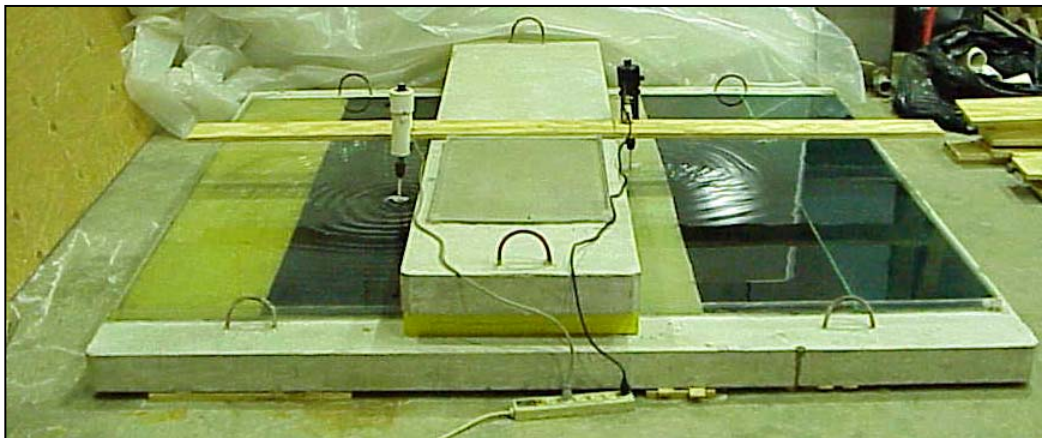
Figure 3.22 Stacked position of Slabs 1 and 2.

With everything installed, Slab 1 and Slab 2 were subjected to the three percent sodium chloride solution. Figure 3.22 illustrates the two slabs stacked and ponded. Lastly,

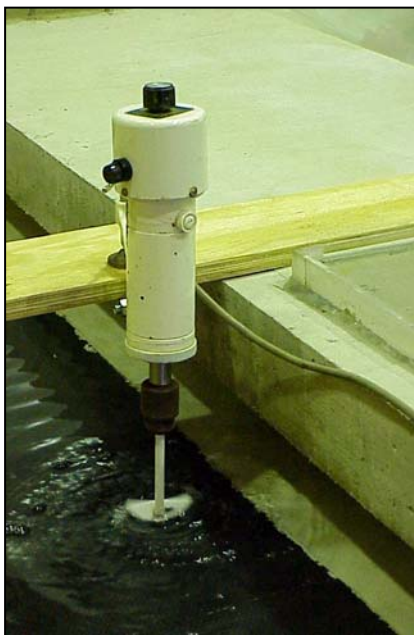
Figure 3.23 Electric mixer with a plastic paddle blade to prevent corrosion.

A system utilizing two electronic mixers placed on both sides of Slab 2 was introduced in the laboratory to keep the sodium chloride in solution. One of the electric mixers is shown in Figure 3.23 while the photograph in Figure 3.24 illustrates the position of the two mixers on Slab 2. The electronic mixers operated a paddle blade that stirs the solution. Note that the paddle blade is fabricated from plastic to eliminate corrosion. This circulation system prevented the chloride particles from settling out to maintain a constant three percent sodium chloride solution. Due to the small surface area that is ponded on Slab 2, electronic mixers were not required. Another complication with the large surface area was evaporation, thus additional sodium chloride solution needed to be added. With the mixers, a uniform mixture was quickly achieved between the existing and the added solution.

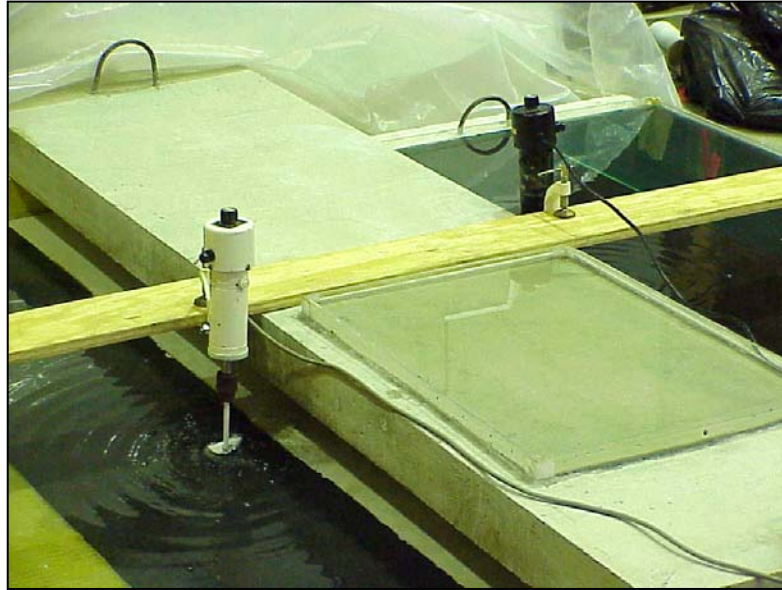
Figure 3.24 Position of the two electric mixers on the stacked slabs.

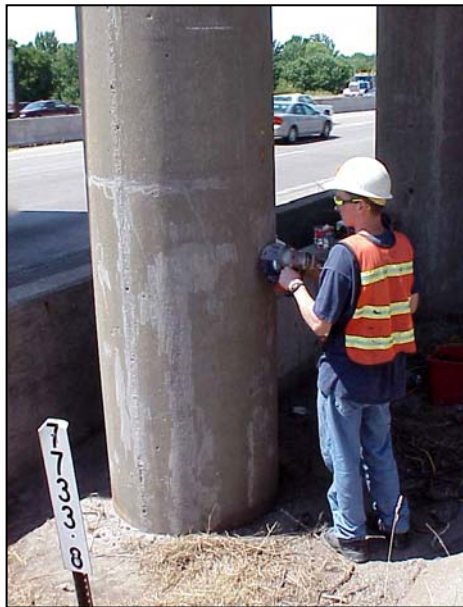
Figure 3.25 Preparation of the concrete surface.

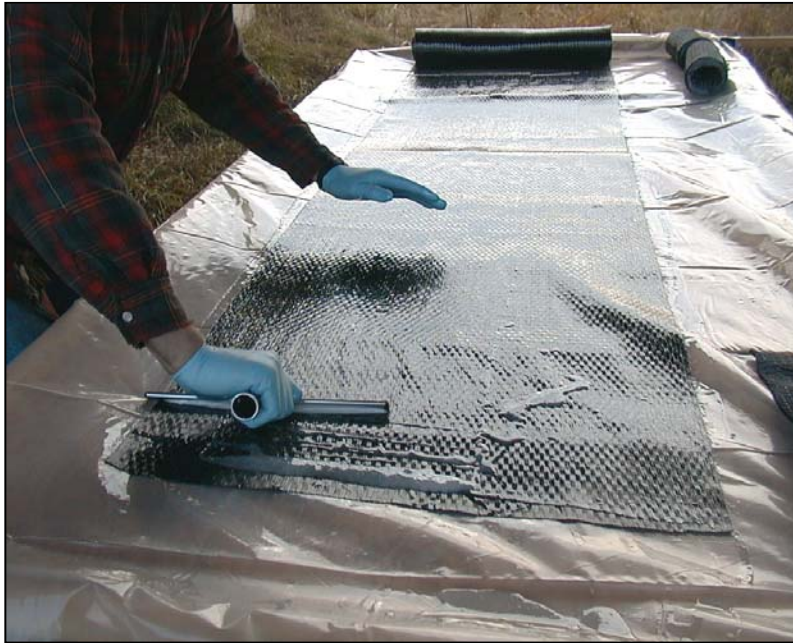
Figure 3.27 Work the epoxy into the fibers with a squeegee.

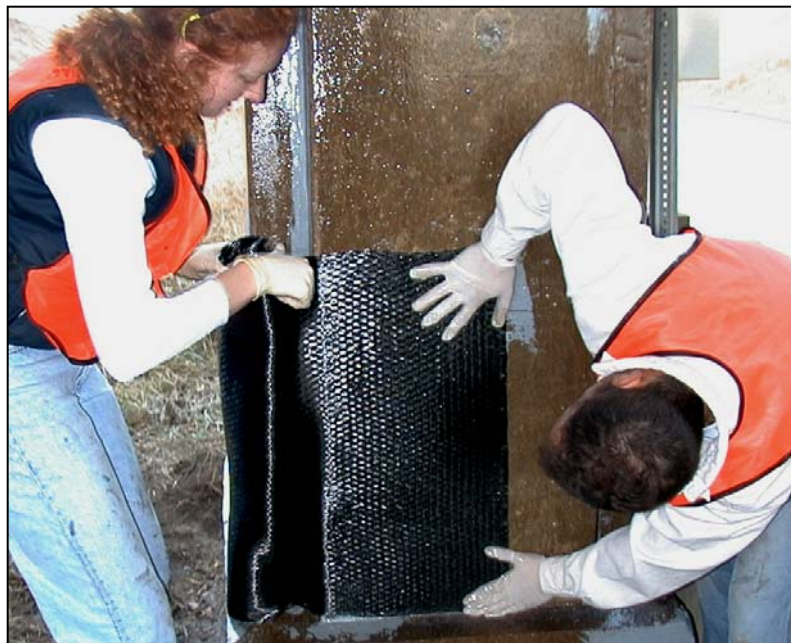
Figure 3.28 For ease in installation, unroll the FRP sheets onto the column.

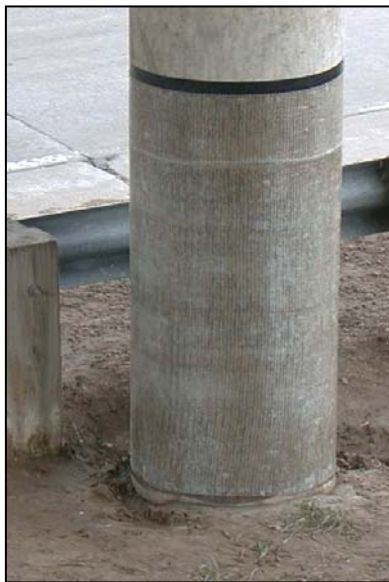
Figure 3.29 Completed glass FRP wrap at TS1.

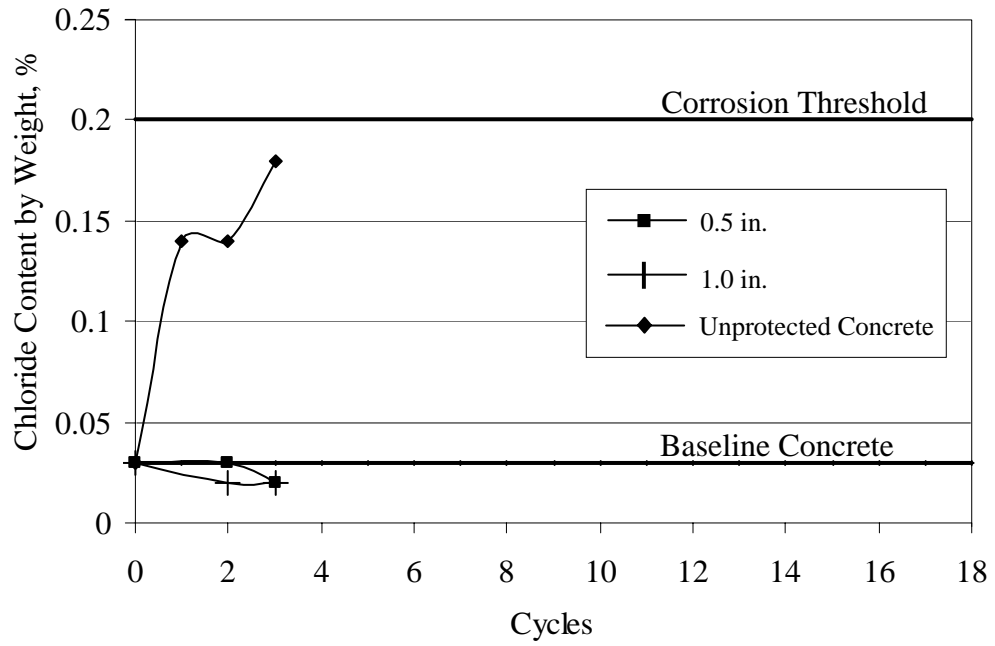
Figure 4.1 Chloride penetration profile for one layer of Product A.

All FRP overlays have kept the chloride level below the corrosion threshold. Products A, B, C and E (Figure 4.1 - 4.3 and Figure 4.5) have more specifically kept the level of chlorides the same as in the concrete in Slab 2 not subjected to the sodium chloride solution. This indicates that these four products have prevented chloride penetration to the

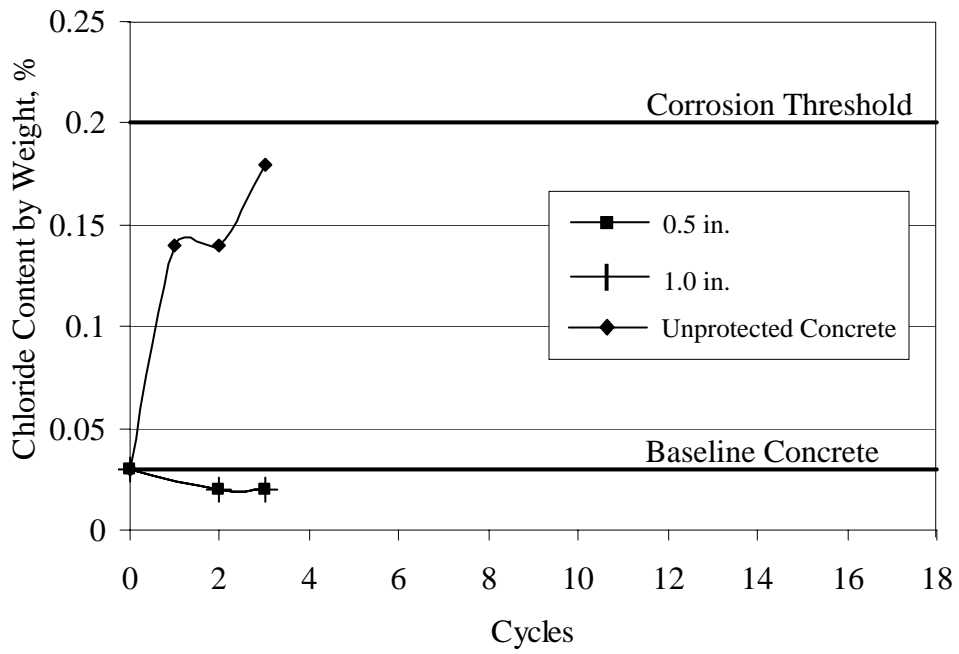
Figure 4.2 Chloride penetration profile for one layer of Product B.

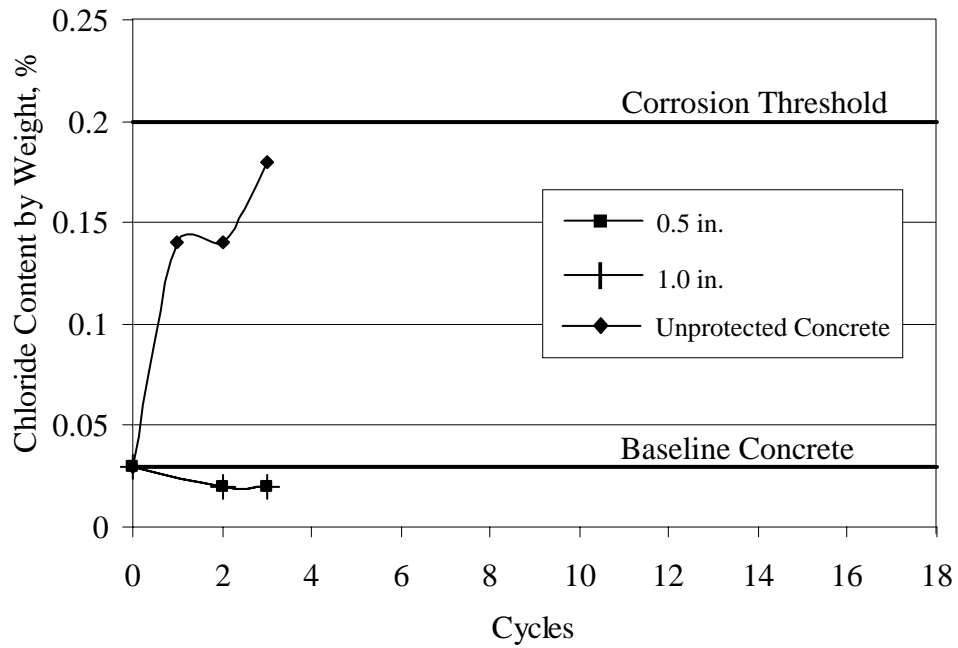
Figure 4.3 Chloride penetration profile for one layer of Product C.

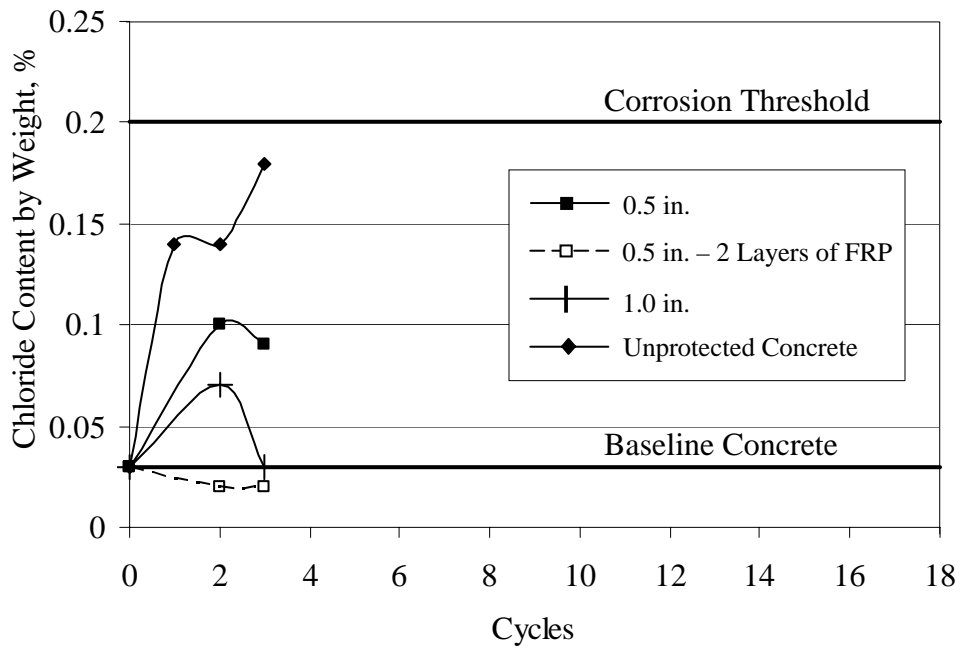
Figure 4.4 Chloride penetration profile for two layers of Product D.

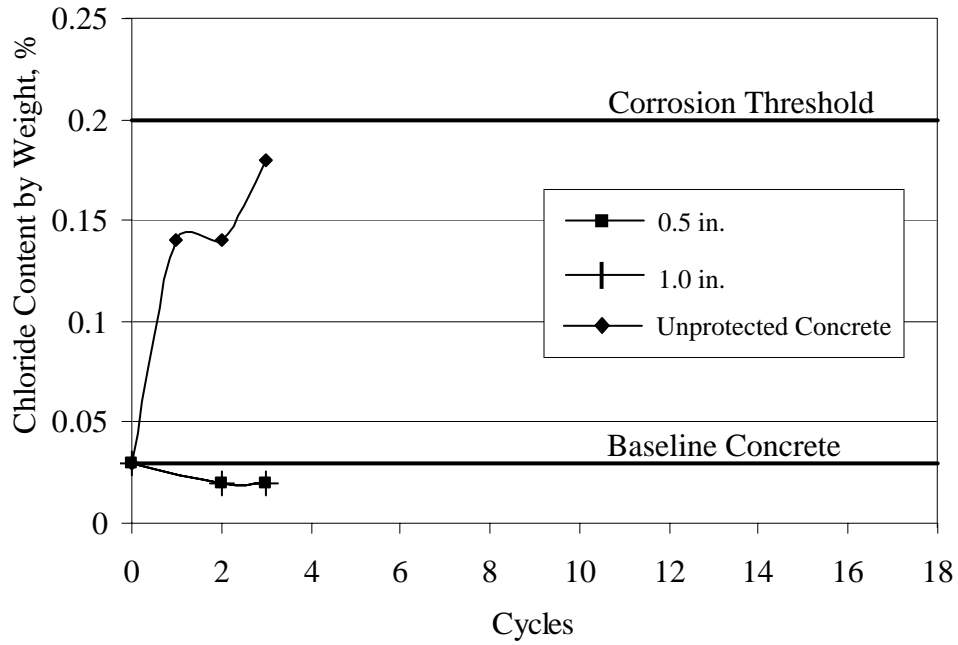
Figure 4.5 Chloride penetration profile for one layer of Product E.

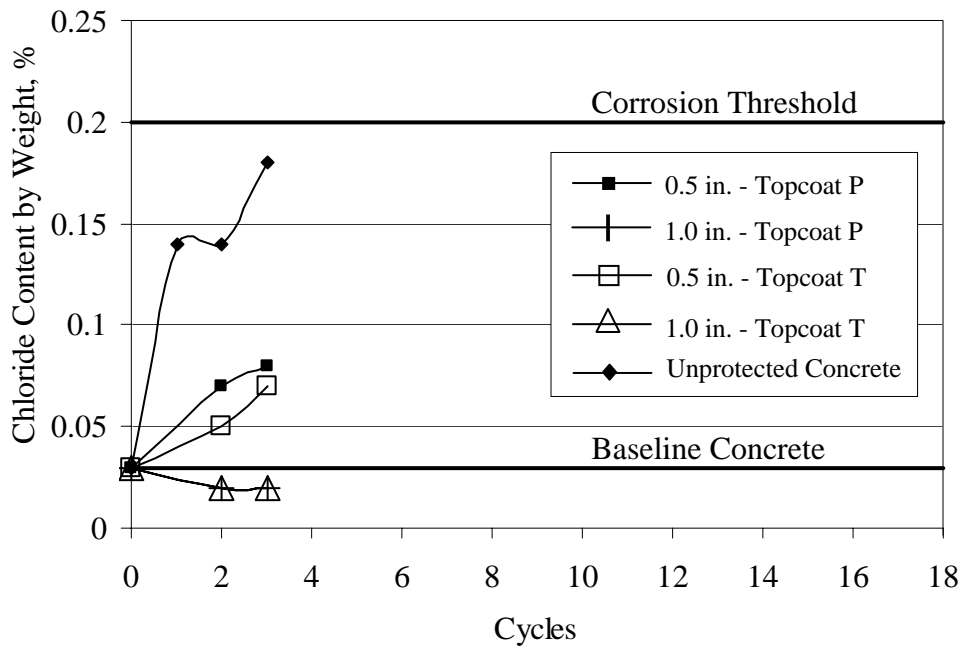
Figure 4.6 Chloride penetration profile for Products T and P.

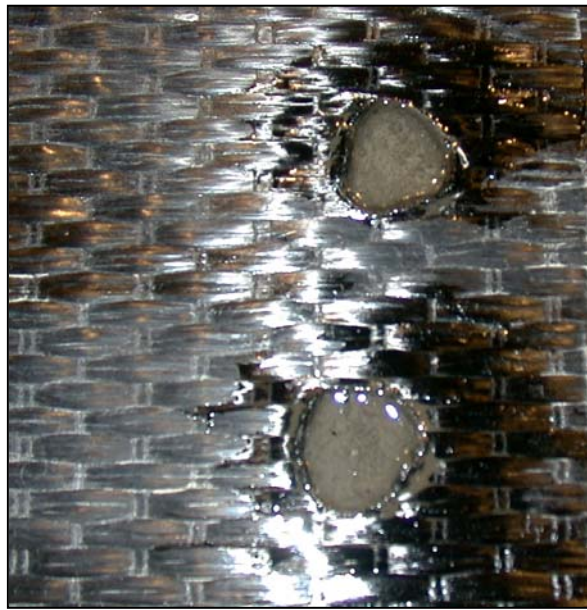
Figure 4.7 Epoxy patched sample stations from the first cycle.

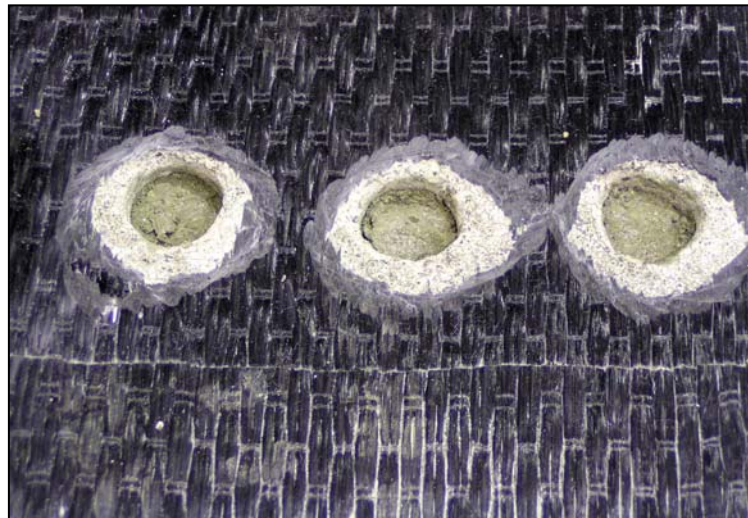
Figure 4.8 Sample stations from the second cycle where the surrounding FRP fiber system has been removed.

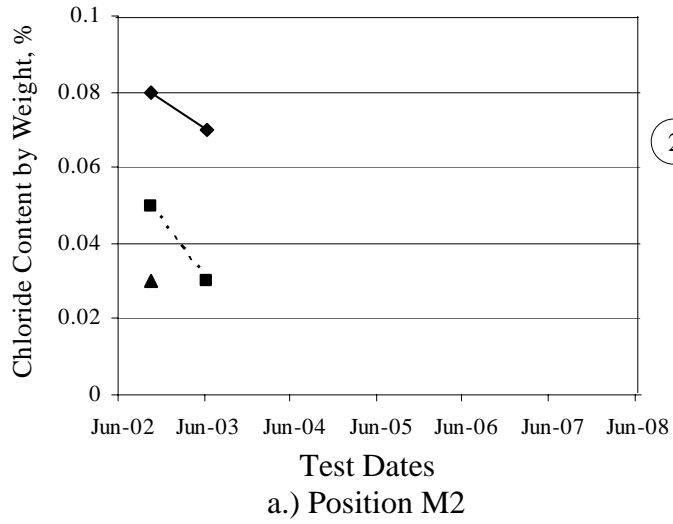
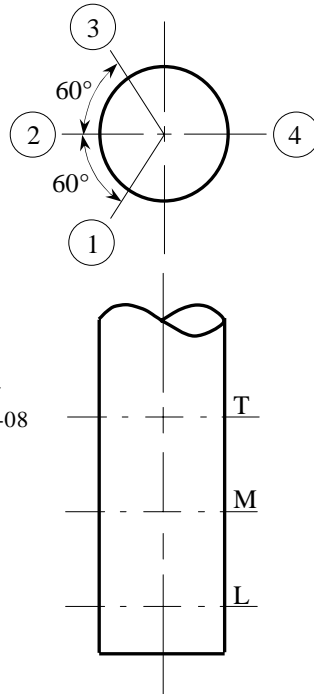
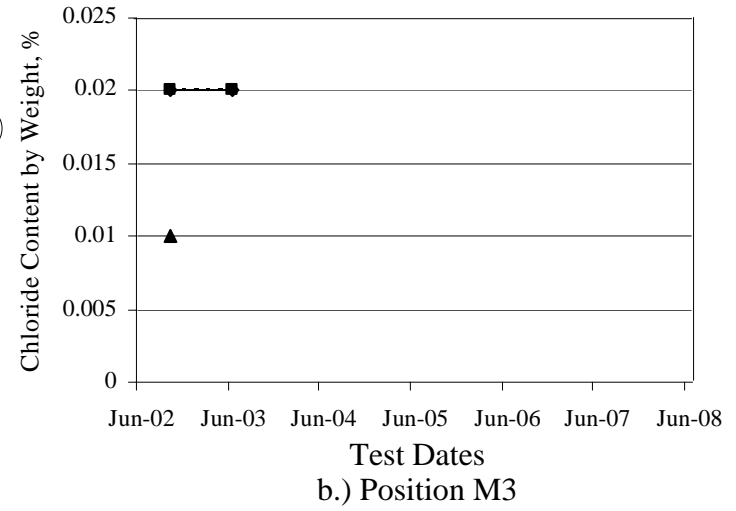
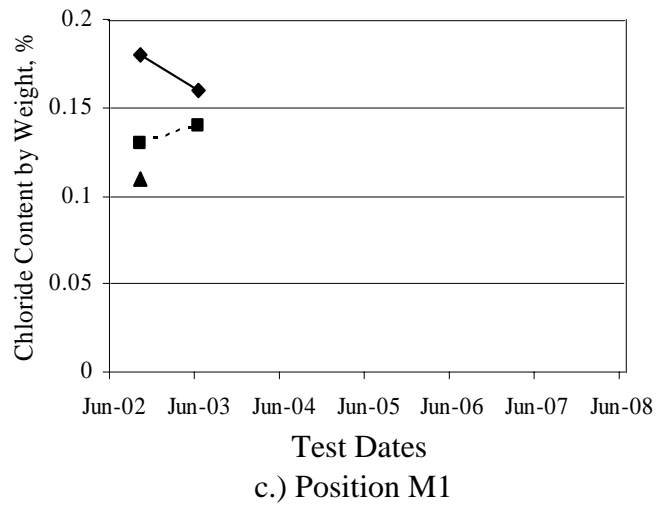
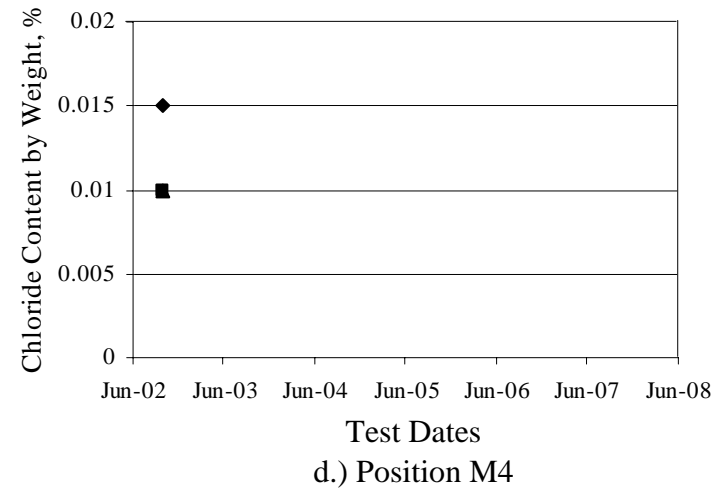
Figure 4.9 Chloride content at the Mid-height position of C1.

Baseline data were gathered during the summer of 2002 and is displayed as the June 2002 data in Figure 4.9. As mentioned previously, baseline data were collected at three depths and at twelve locations on the column's perimeter. The baseline data generated a comprehensive overview of the chloride levels beneath the column's surface. After all the powder samples were analyzed, it was noted that for all three heights; low, mid and top, Positions 1 and 2 were consistently the samples with the highest level of chlorides. Note that the sketch of the column in Figure 4.9 illustrates Positions 1 - 4 around the column, with Position 2 being the closest to moving traffic. Since each test site had higher chloride levels in relatively the same location, the decision was made to only test one height at each of the five stations for the next five years. For each test site, the "Mid" elevation is the only elevation that has a second data point representing the chloride level after the first year with

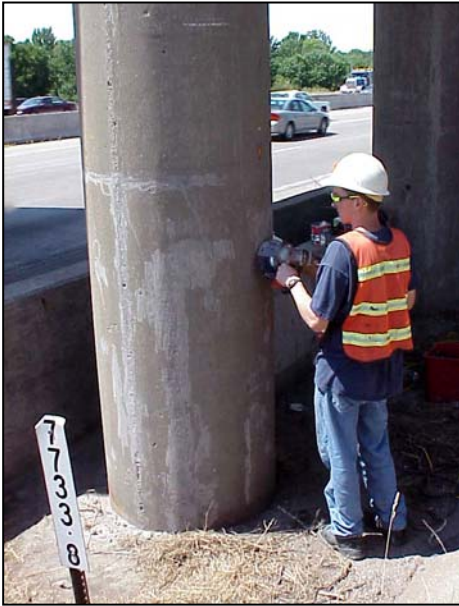
Figure A.11 Grind the concrete surface to remove any unevenness.

To establish a strong bond between the concrete and each FRP product, the surface of the column needs to be properly prepared. Should any holes or cracks be present, these also need to be repaired.

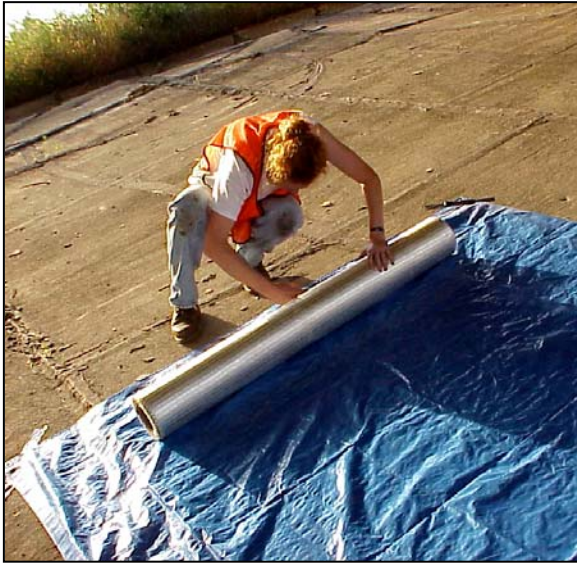
Figure A.18 Use a tarp or other protective cover to lay out the fiber.

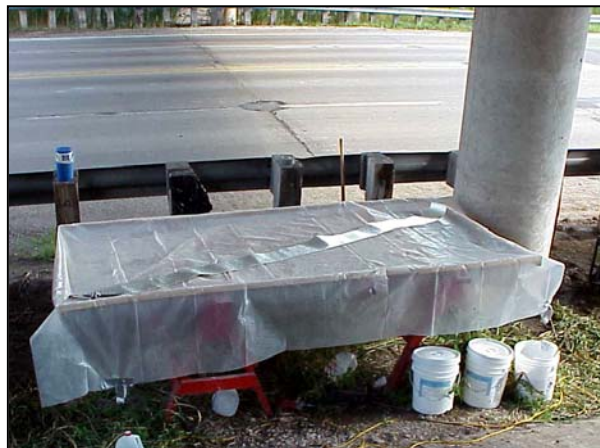
Figure A.20 Create a temporary saturation trough.

- **Step 1.** Build a temporary work table for the saturation of the fibers. The trough illustrated in Figure A.20 consists of two sawhorses with plywood spanning between them. Next, a 2 in. x 2 in. frame can be attached to the edge of the plywood raising the sides to create a dam. To complete the trough, cover the entire bench top with a sheet of plastic.

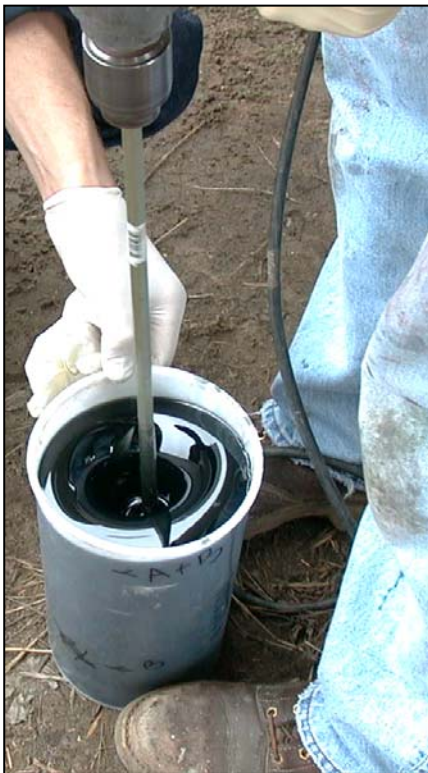
Figure A.21 Mix the epoxy's main agent and hardener in a clean container for the time specified by the manufacturer.

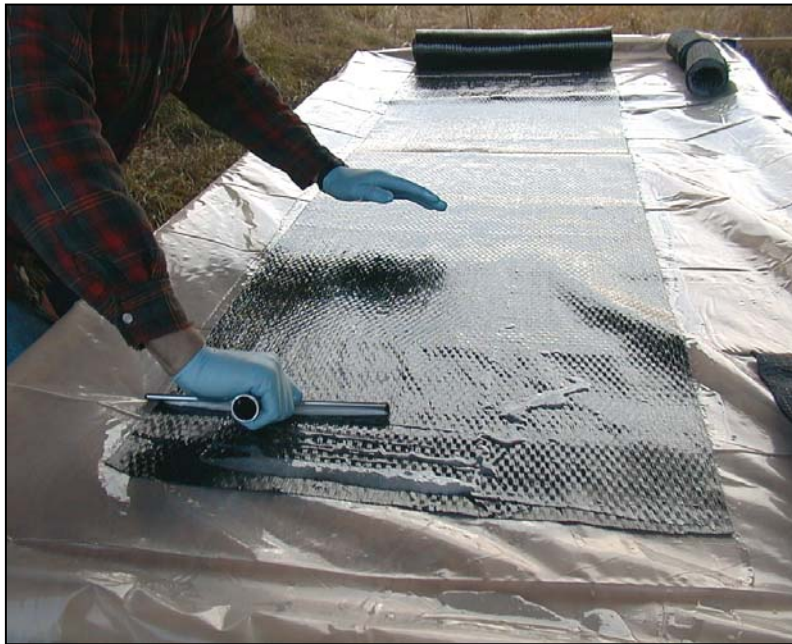
Figure A.28 Move squeegee in the direction of the fibers to work in the epoxy.

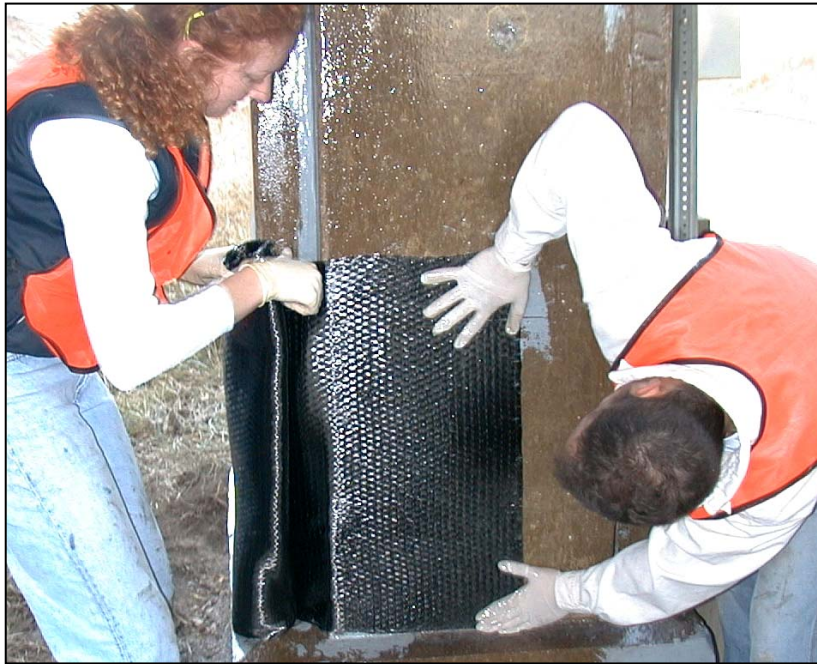
Figure A.29 Utilize two people to unroll the FRP sheet.

- Step 4. Carefully roll the FRP sheet on a tube. For ease of handling, a piece of PVC piping can be used to wrap the fiber around. The wrap is then installed on the column by “unrolling” the FRP sheet. Figure A.29 illustrates the “unrolling” process. Note that the fibers become very slick when saturated and are difficult to handle. This procedure also requires at least two people. One person holds the initial end tight while the second one smoothes the fiber around the column. Both workers wear gloves at all times throughout this process.

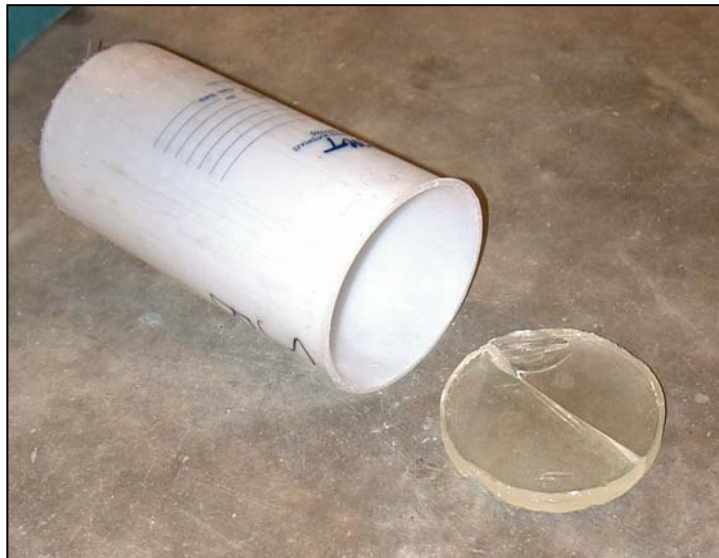
Figure A.32 Let the epoxy set-up overnight and the hardened substance can be removed, allowing the containers to be used again.

- Step 1. Clean all the tools as soon as the application process is completed. The mixer bit and roller handles can be cleaned with acetone only while the epoxy matrix is still wet. However, if the epoxy has dried it can only be cleaned by chipping it off.
- Step 2. For the mixing containers, let the unused epoxy set-up and harden. Within 24 hours, the containers can be turned over and the epoxy can be knocked out in large pieces as depicted in Figure A.32.

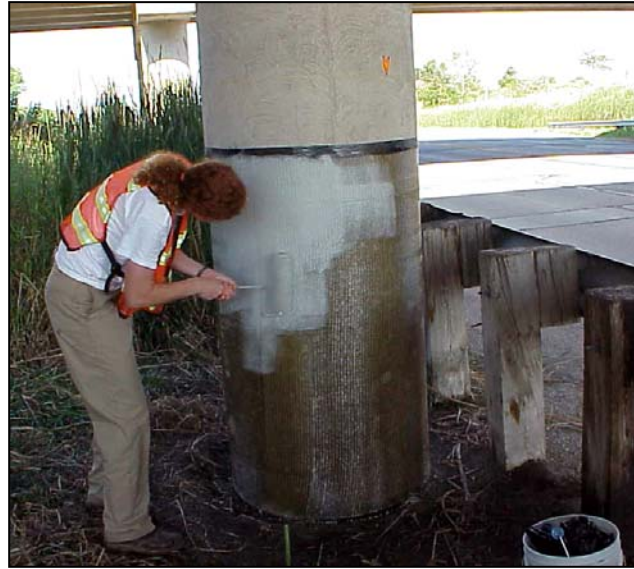
Figure A.34 Roll on the topcoat with a long nap roller.
