Effective Structural Concrete Repair Volume 2 of 3

Use of FRP to Prevent Chloride Penetration in Bridge Columns

March 2004

Iowa DOT Project TR - 428

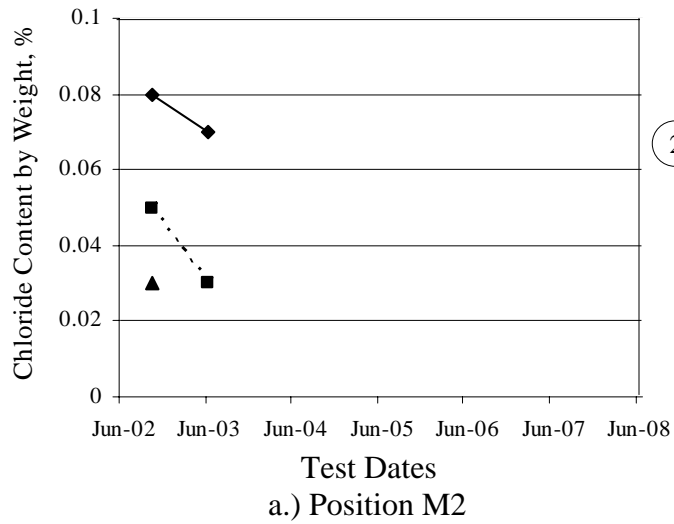
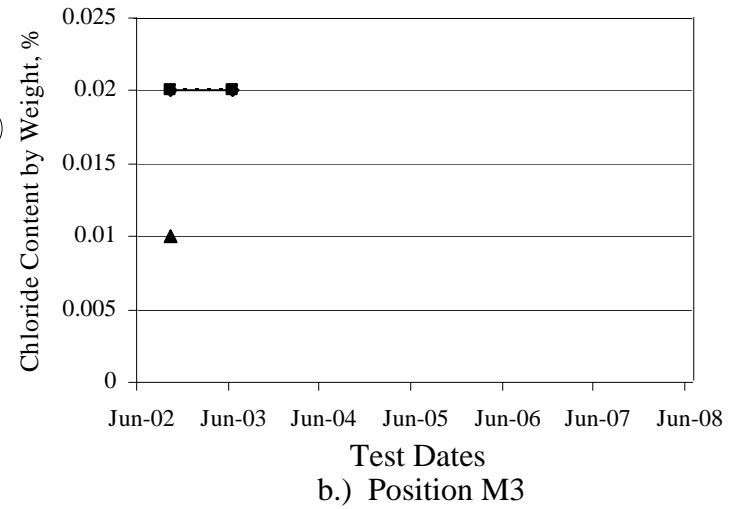
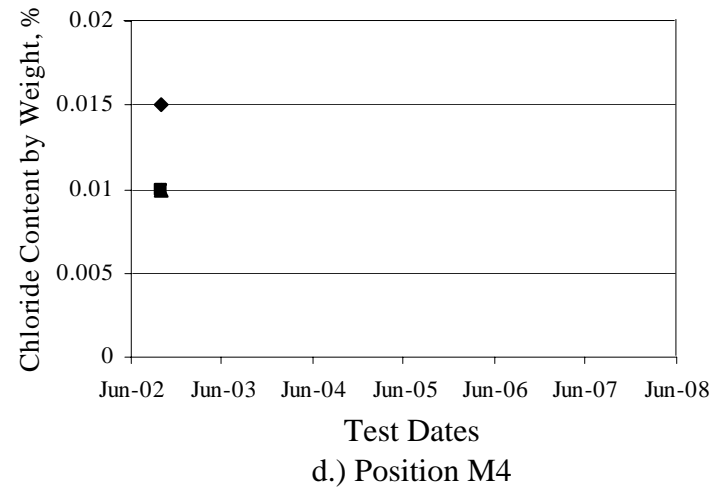
Figure B.2 Chloride content at the Mid-height position of C1.

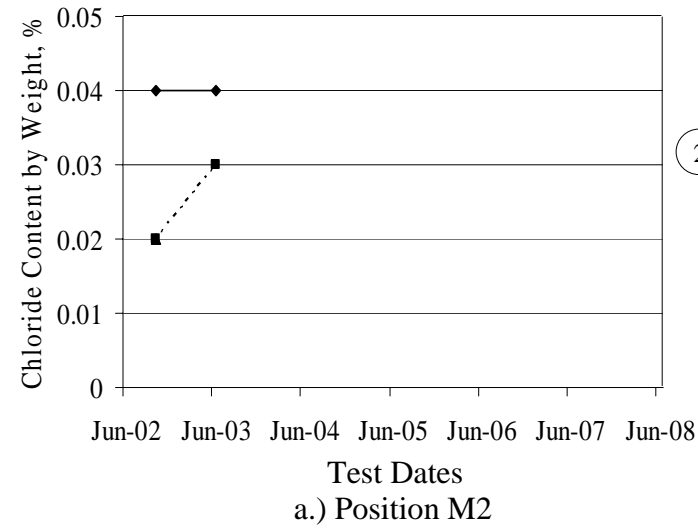
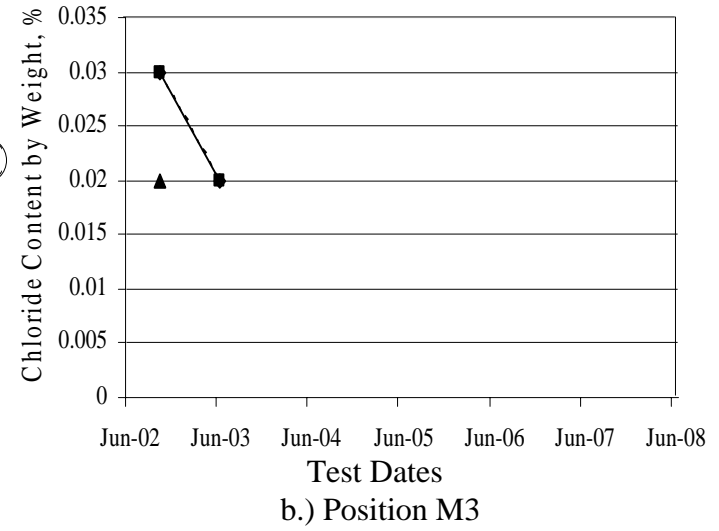
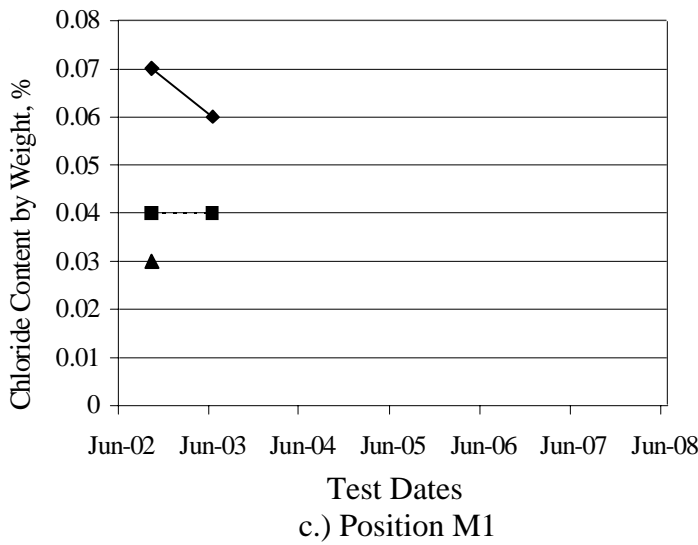
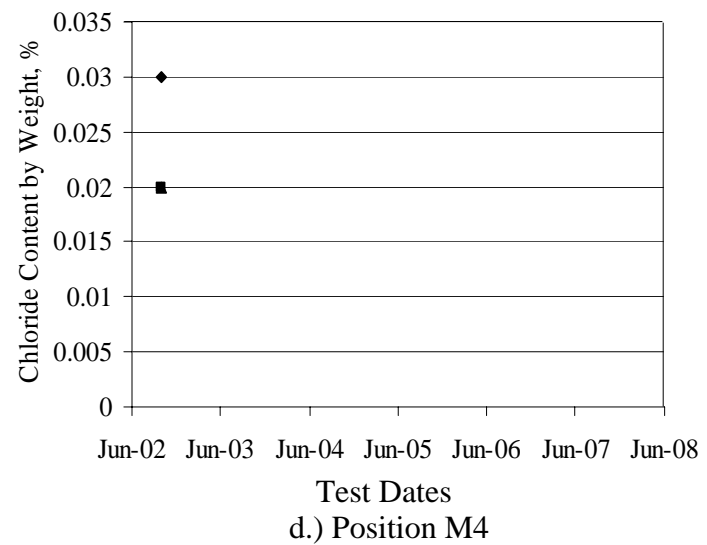
Figure B.5 Chloride content at the Mid-height position of C2.

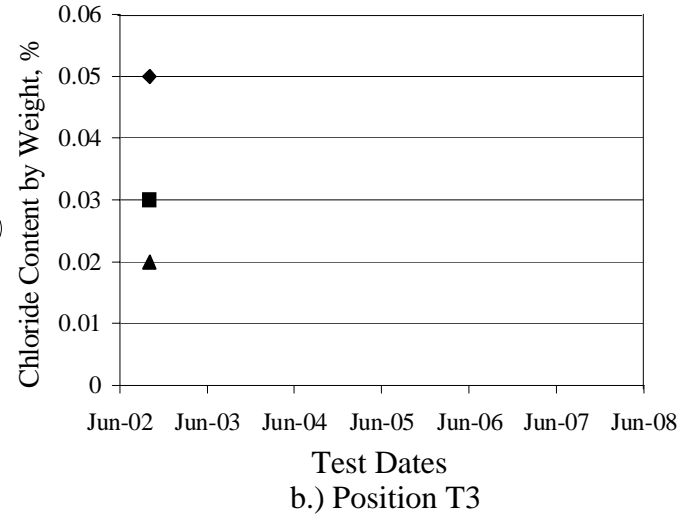
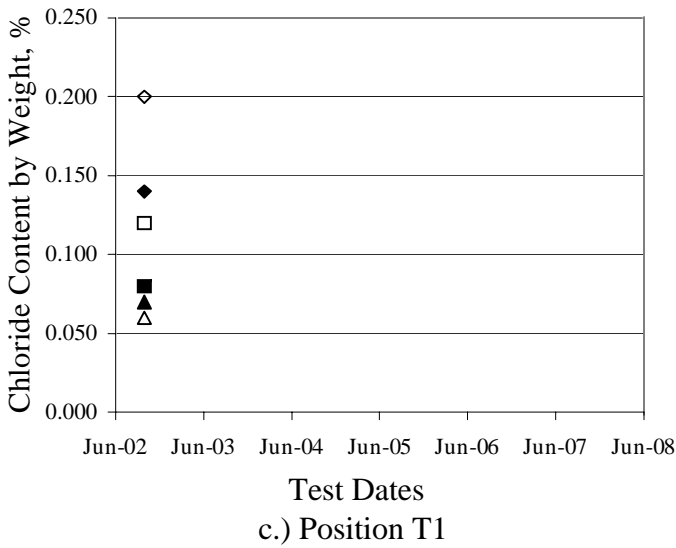
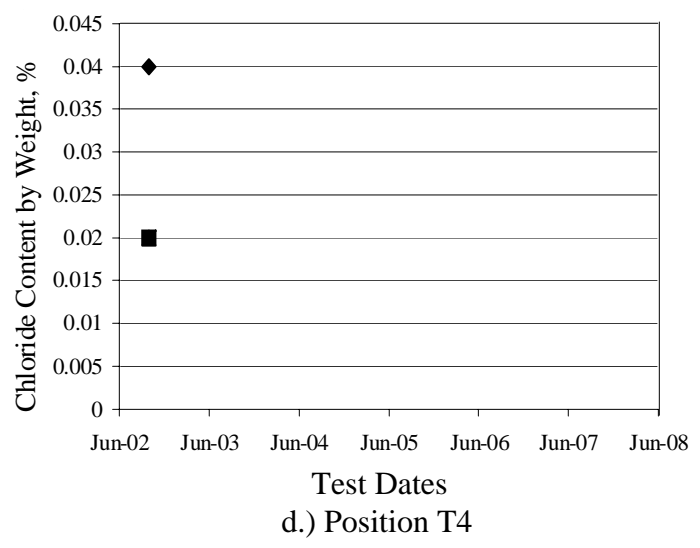
Figure B.7 Chloride content at the Top position of C3 and the TS3 control.

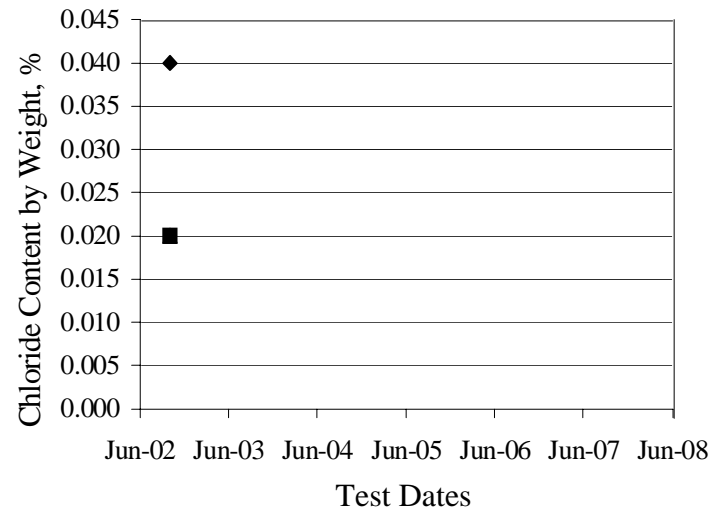
d.) Position M4

Figure B.8 Chloride content at the Mid-height position of C3.

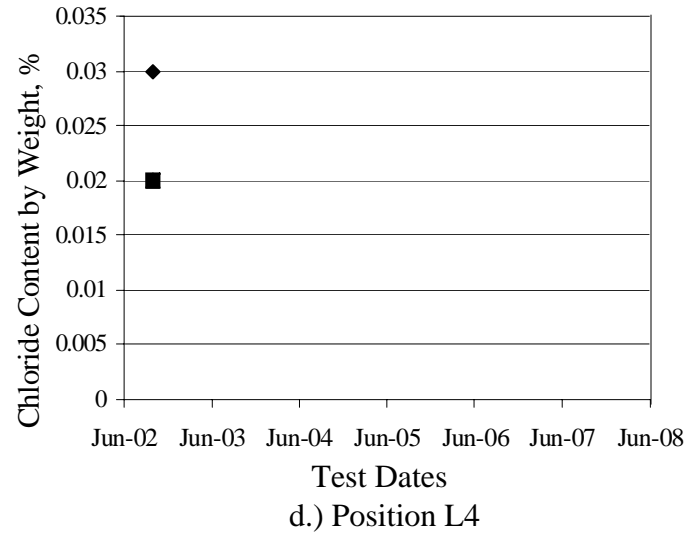
Figure B.9 Chloride content at the Low position of C3 and the TS3 control.

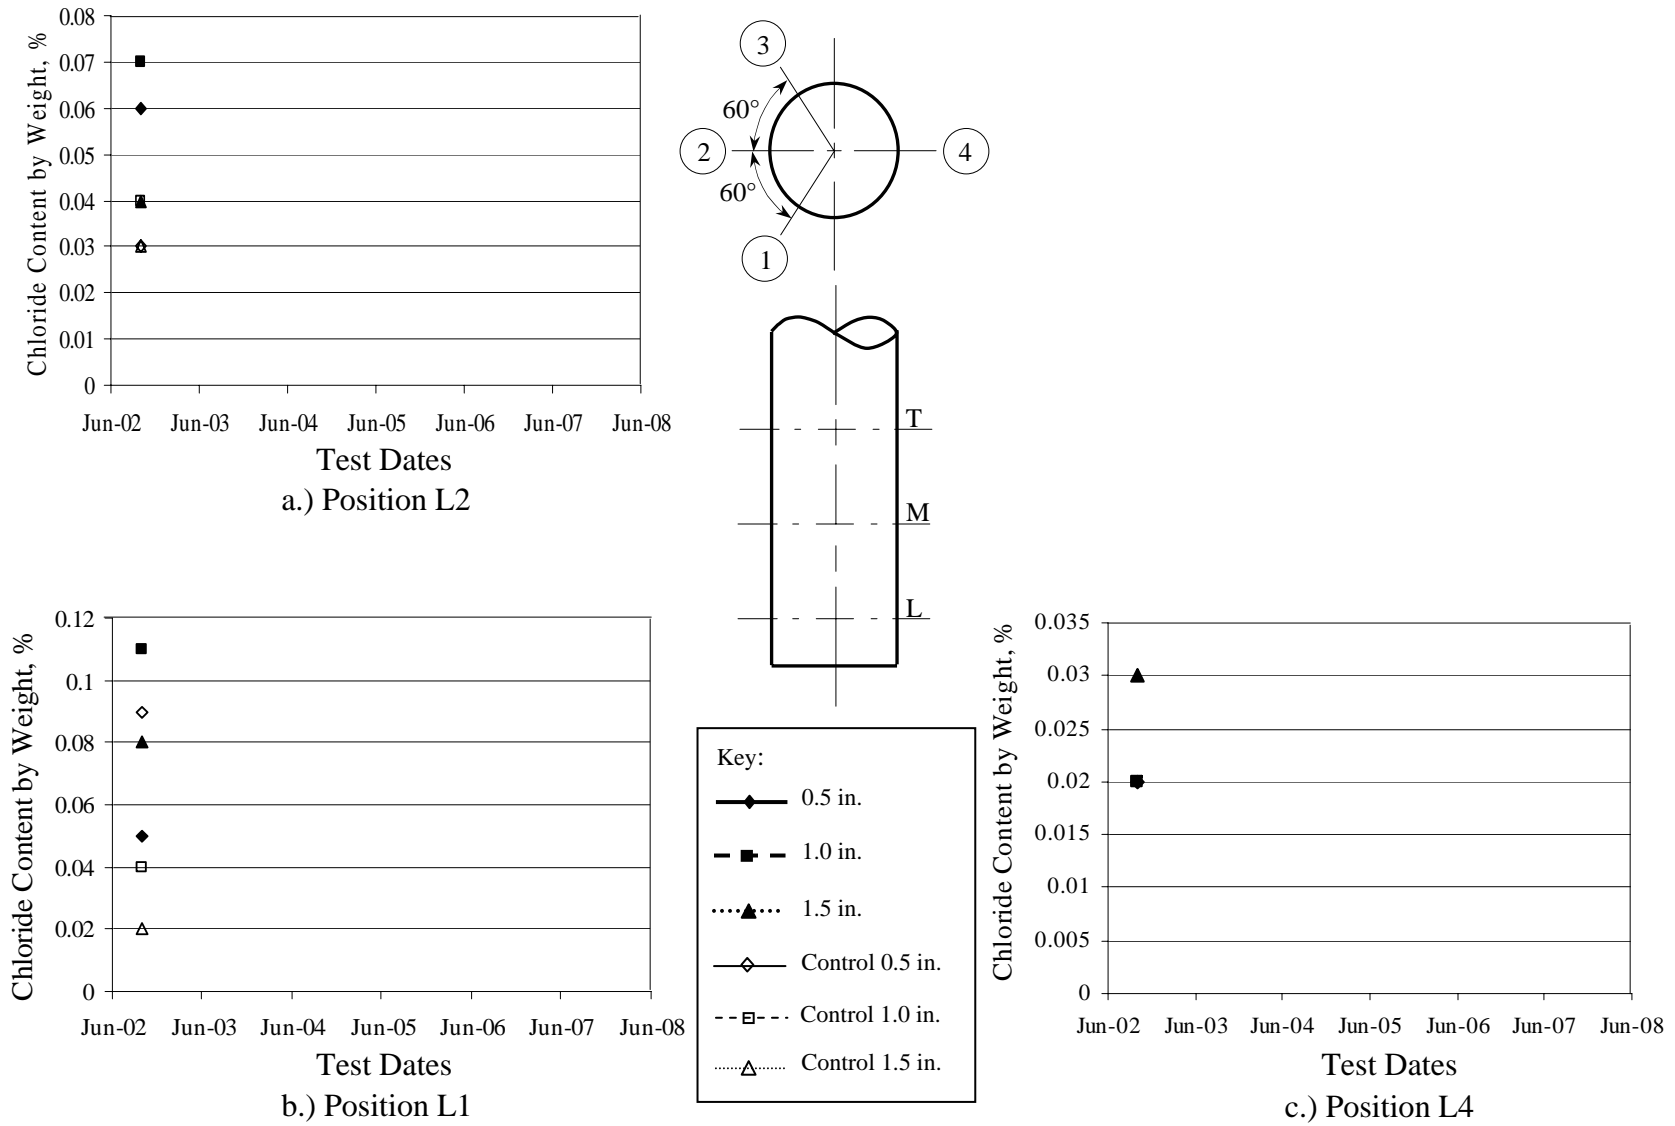
Figure B.12 Chloride content at the Low position of C4 and the TS4 control.

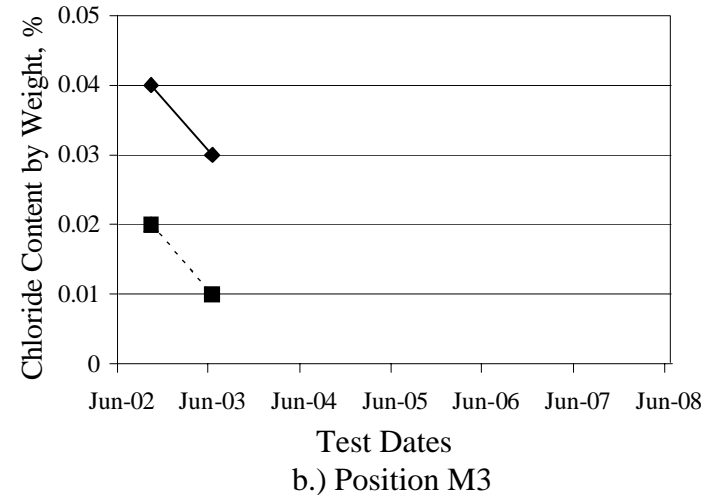
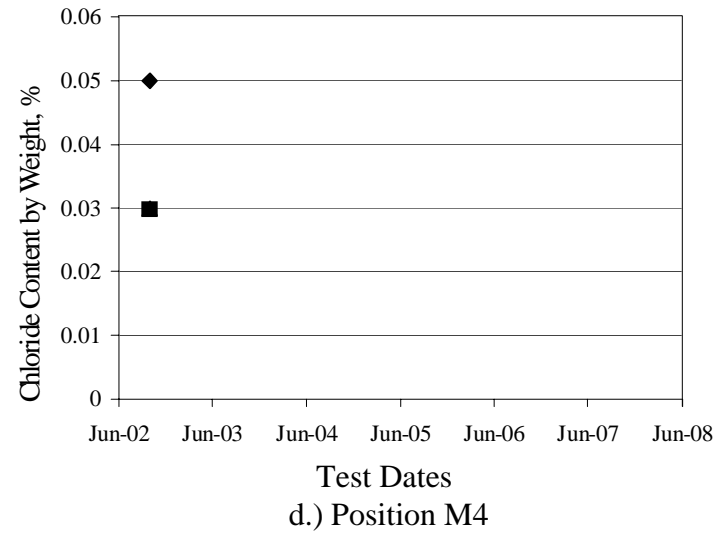
Figure B.14 Chloride content at the Mid-height position of C5.

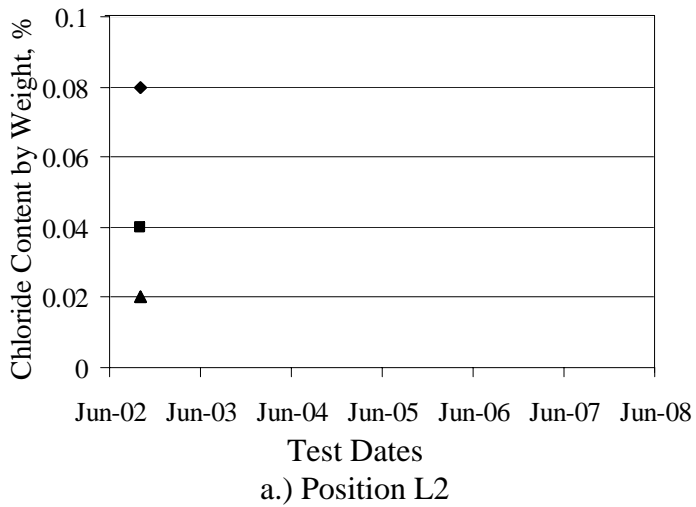
Figure B.15 Chloride content at the Low position of C5 and the TS5 control.
