# Evaluation of the Buchanan County IBRD Bridge on Victor Avenue over Prairie Creek

Final Report  
September 2017

**Sponsored by**  
Iowa Department of Transportation  
(InTrans Project 12-427)  
Federal Highway Administration  
Innovative Bridge Research and  
Deployment (IBRD) Program

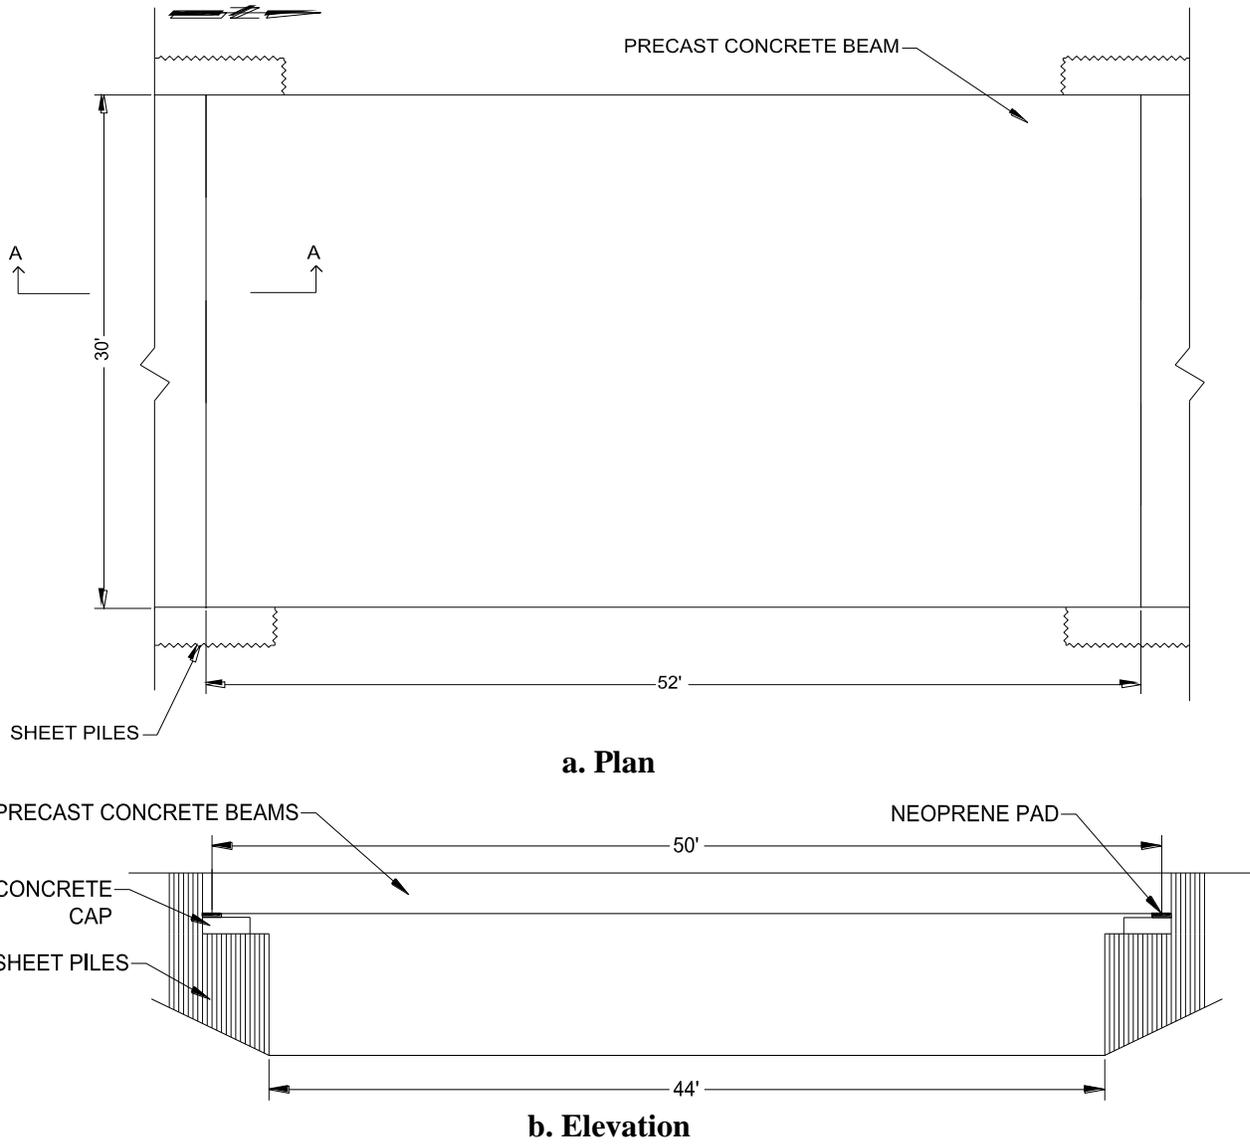
**Figure 2. Plan and elevation views of the bridge**

The replacement bridge was designed for HL-93 loading plus 20 lb/ft<sup>2</sup> for a future wearing surface. It consists of precast box beams and guardrails with a GRS abutment and a sheet pile foundation system. Each of the five precast concrete beams is 6 ft wide, creating the 30 ft bridge width. Figure 2 shows a plan and elevation view of the bridge.

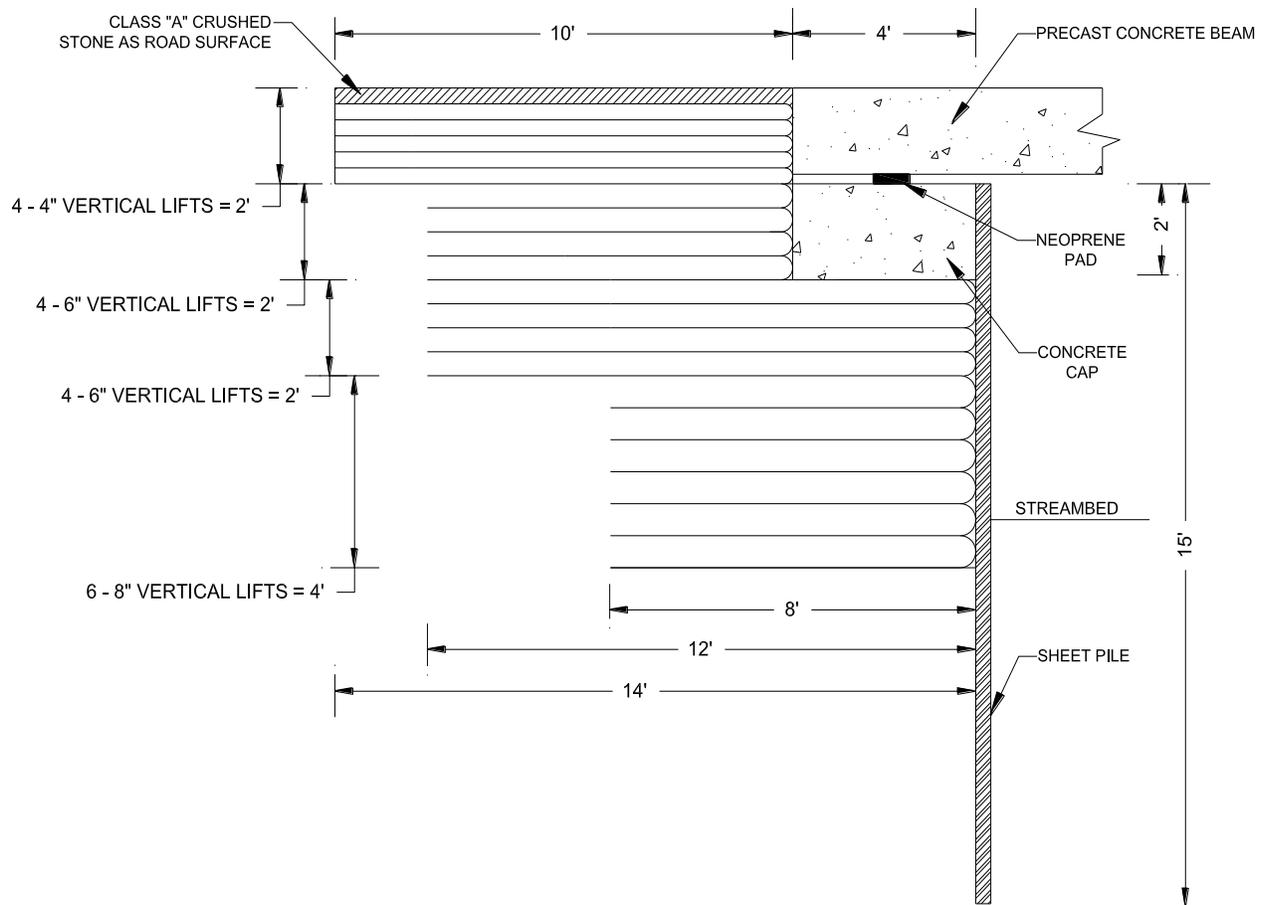
**Figure 3. Abutment details (Section A-A)**

Figure 3 shows a cross-sectional view of the substructure including details of the GRS abutments and concrete caps.

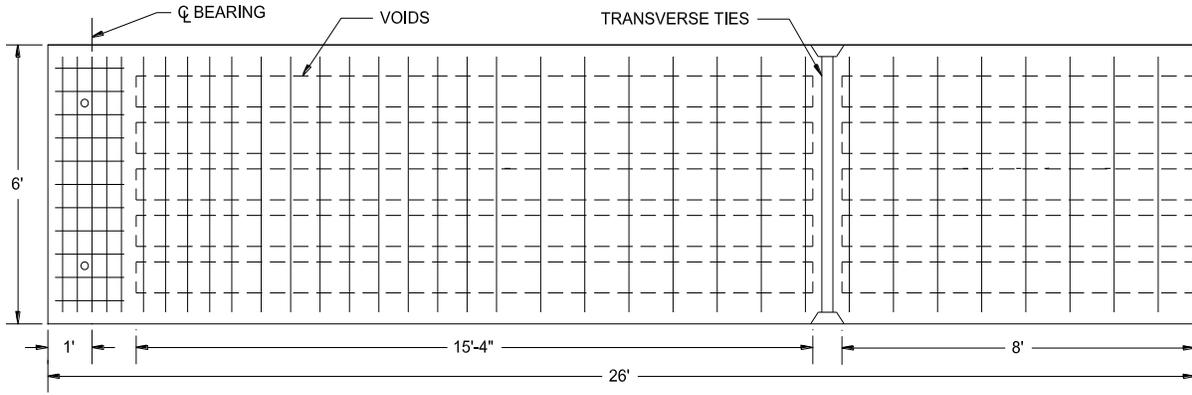
**Figure 4. Sectional plan view of beam**

by 52 ft long (Figure 4 and Figure 5 ). Figure 4 shows the as-designed plan view of one beam for one-half of each beam. In this figure, the longitudinal reinforcement is not shown to improve clarity.

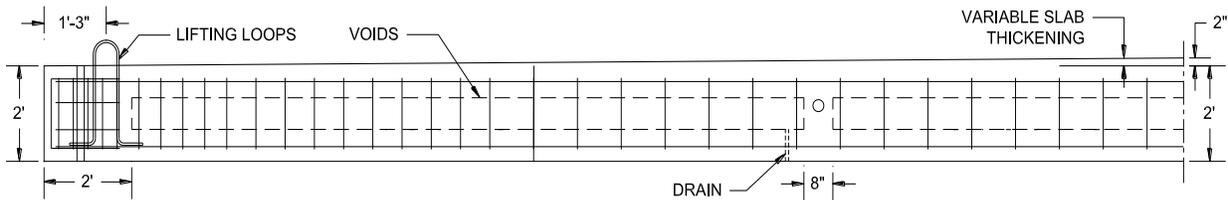
**Figure 5. Sectional elevation view of beam**

Figure 5 shows an as-designed elevation view of the beam.

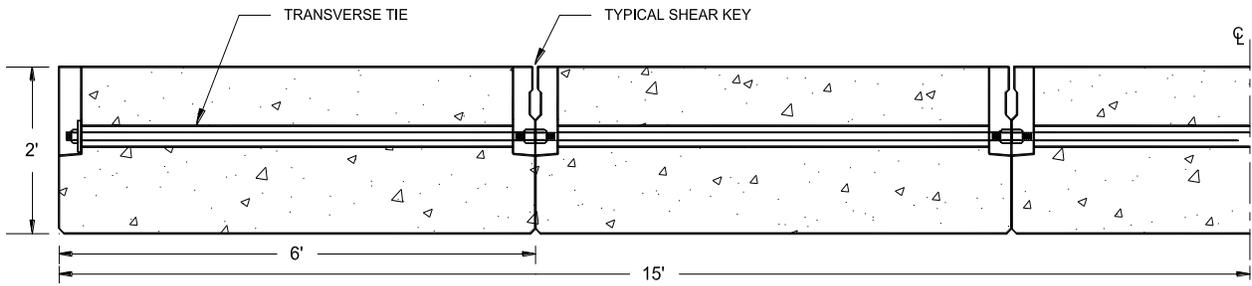
**Figure 6. Deck cross-section at the transverse ties**

To connect adjacent boxes, grouted shear keys were provided at the longitudinal joints between adjacent girders to ensure a load-sharing mechanism. Per the design plans, keyway grout with 5.0 ksi compressive strength at 24 hours was to be used to fill the shear key. Figure 6 shows the bridge cross-section at a typical transverse tie.

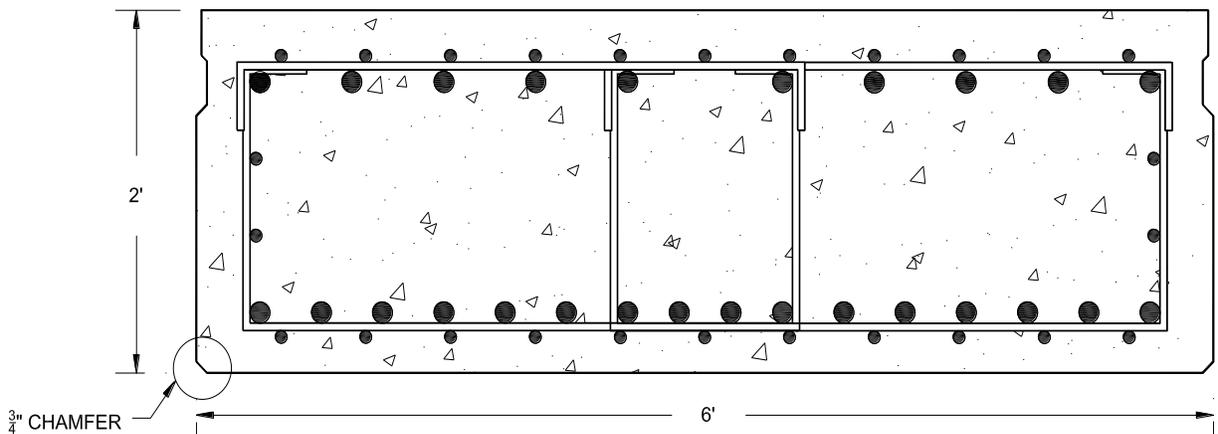
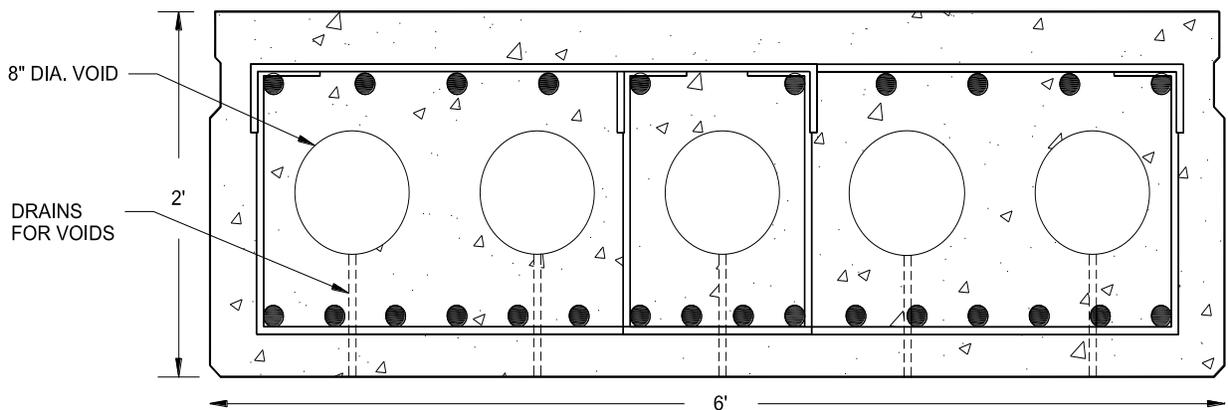
**Figure 7. Beam interior span sections**

Figure 7a shows the as-designed beam cross-section at the centerline of bearing while Figure 7b shows the beam cross-section at midspan. In this figure five 8 in. diameter voids placed 5 in. (end to end) apart are shown. Every void was to be provided with a drain for water as shown in Figure 7b. It should be noted that the contractor elected to not include the voids in the box beams.

**a. Beam cross-section at centerline of bearing**

**b. Beam cross-section at midspan**

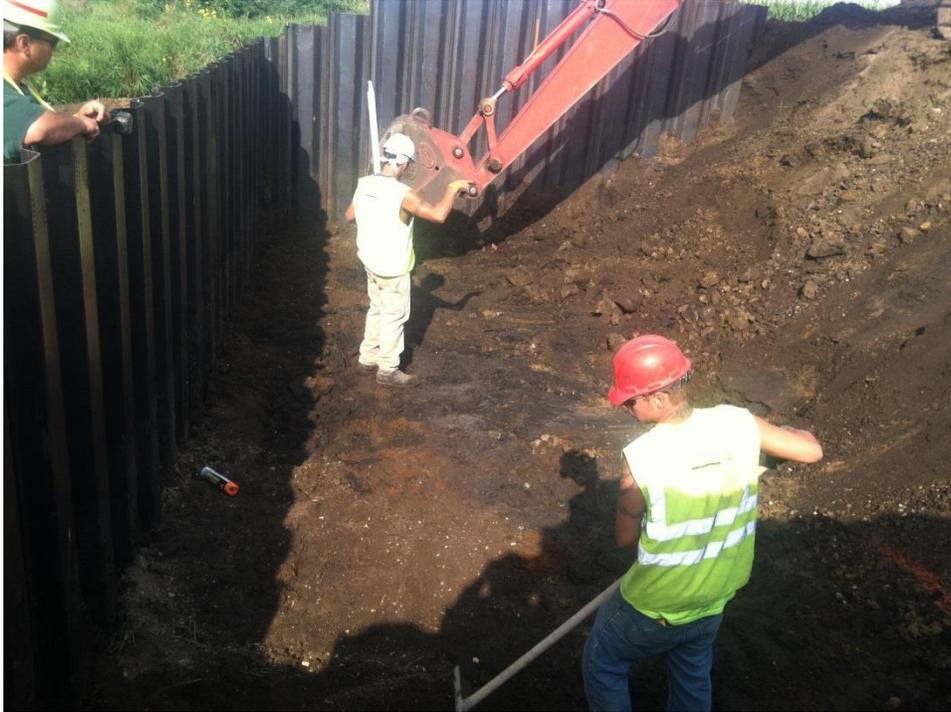
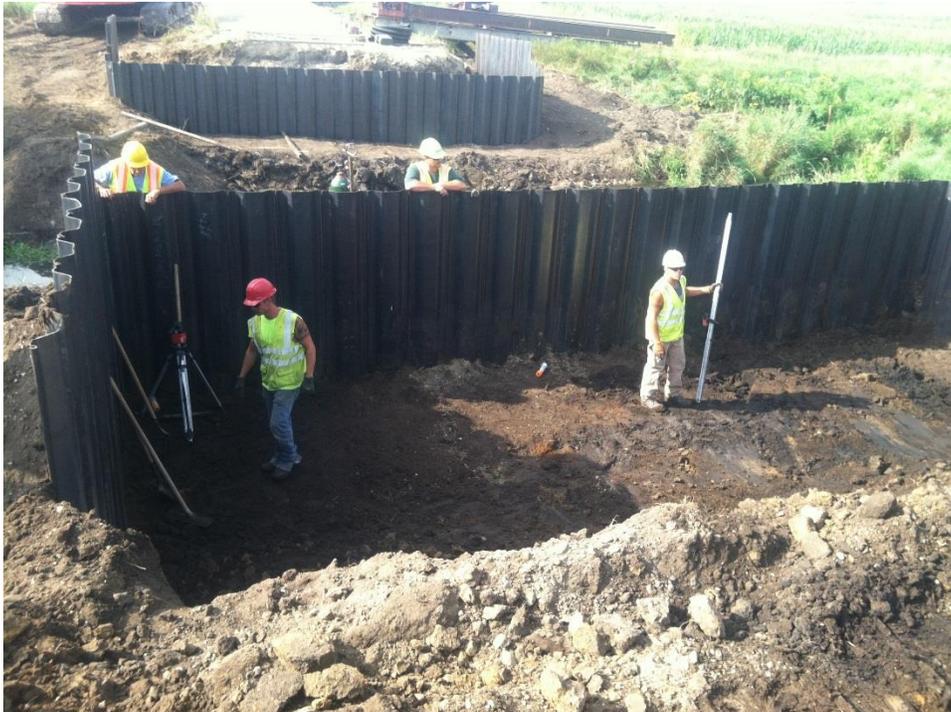
The construction of the GRS abutments involved first installing the sheet piles to the design length and excavating the material to about 10 ft below the final bridge elevation. The excavation elevations were monitored using a robotic total station during construction. Excavation of the north abutment is shown in Figure 8.

**Figure 8. Excavation of the GRS backfill area after installing sheet pile abutments**

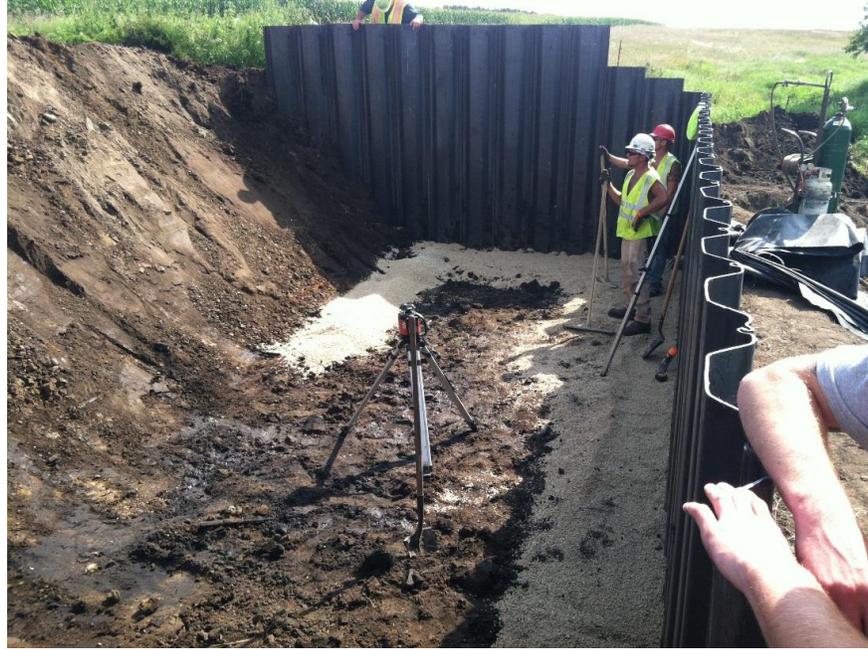
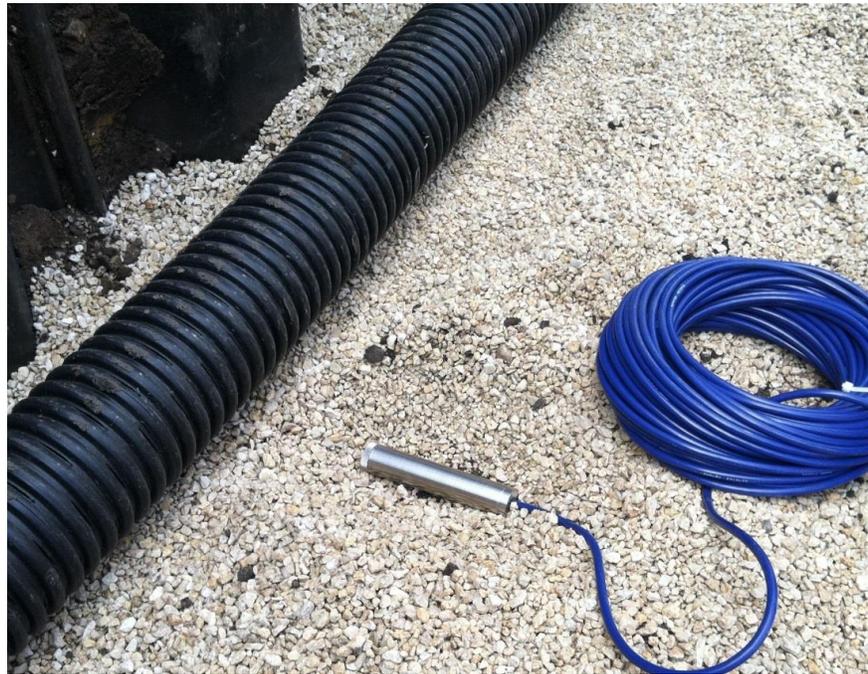
A 6 in. perforated drain tile was installed around the sheet pile, near the bottom of the excavation on a bed of porous backfill material (see Figure 9).

**Figure 9. Placement of porous backfill material around the sheet pile edge for installation of drain tile and a pore pressure sensor next to the drain tile**

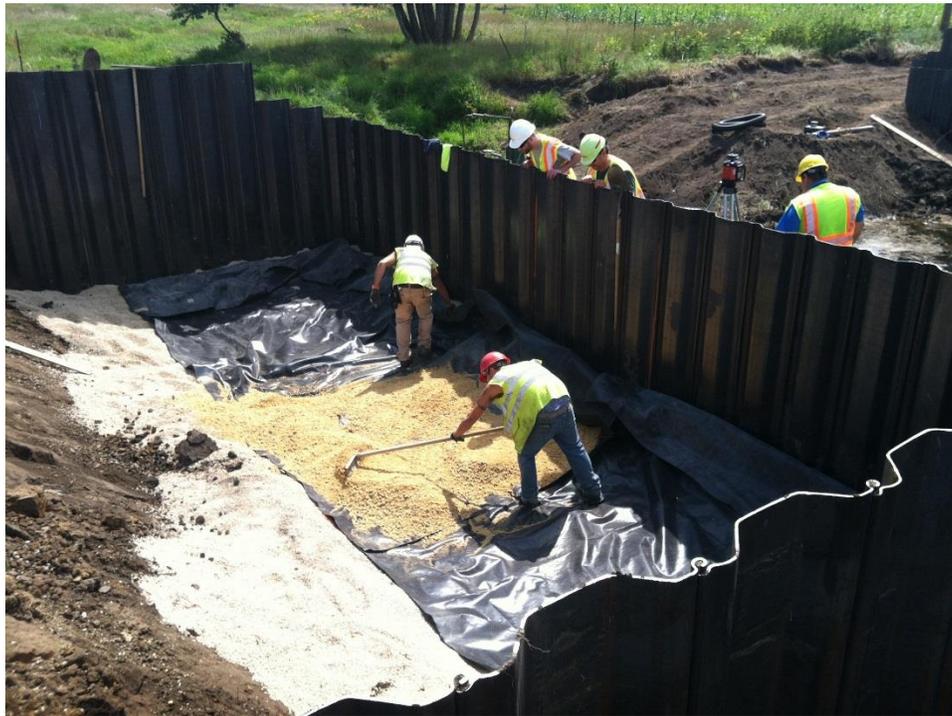
Crushed limestone backfill material was placed in 6 in. lifts (after compaction) in the bottom 4 ft, and in 4 in. lifts above that (see Figure 10).

**Figure 10. Placement of geosynthetic material and aggregate backfill material**

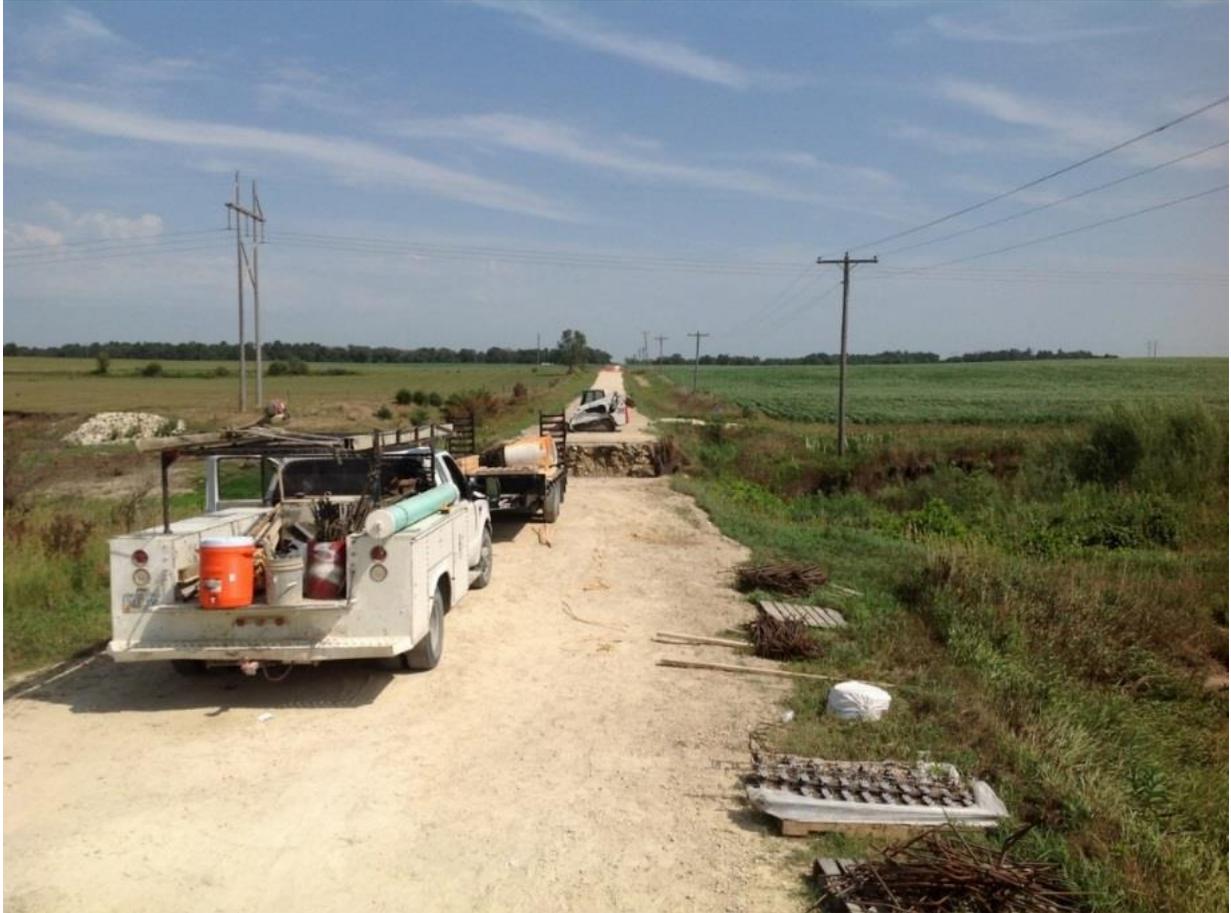
**Figure 11. Construction job site**

Figure 11 shows the bridge construction site after removal of the existing bridge.

At the time this image was captured, the new abutments and replacement box beams had not yet been constructed. The timber formwork used for beam fabrication is shown in Figure 12.

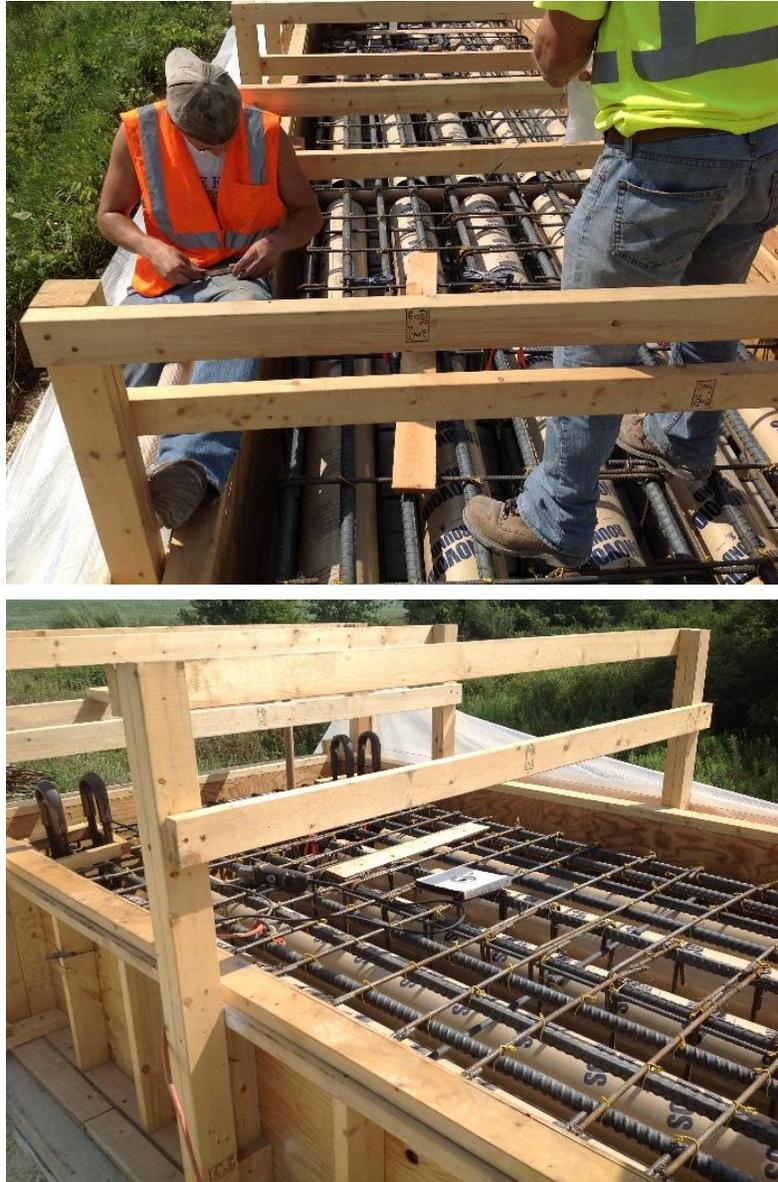
**Figure 12. Steel reinforcing cage for beam**

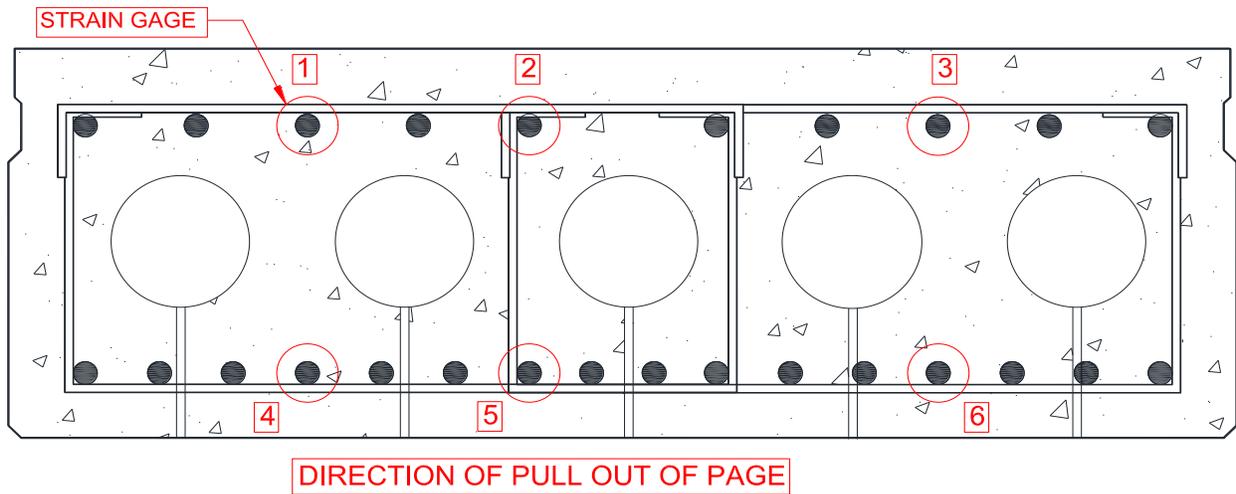
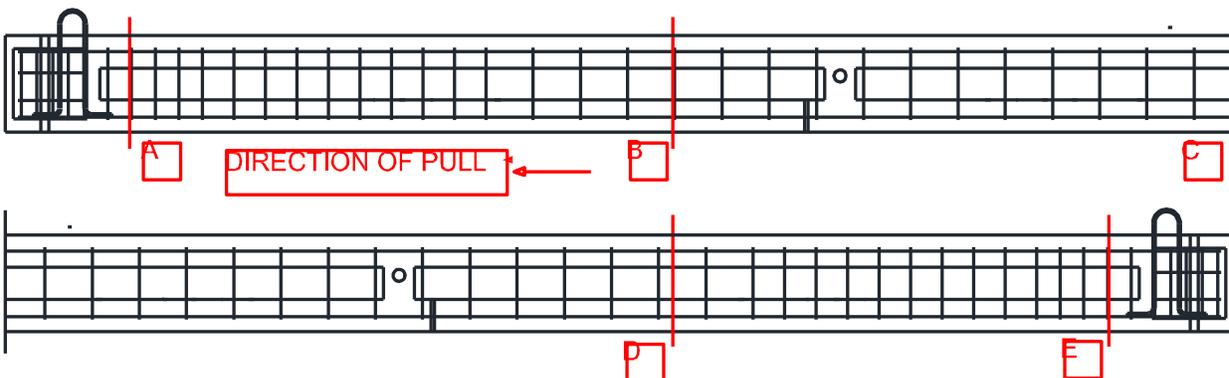
**Figure 13. Internal instrumentation layout**

For the test beam, strain gages were mounted on six different longitudinal bars, designated as 1 through 6 in Figure 13a.

a. Stain gage locations on longitudinal bars (at 1, 2, and 3, top, and 4, 5, and 6, bottom) over a beam cross-section

b. Strain gages at A, B, C, D, and E on longitudinal bars (top and bottom)

Five cross-sections were instrumented with strain gages, labeled A through E in Figure 13b. Figure 14 shows a typical installation of a strain gage on the longitudinal reinforcement.

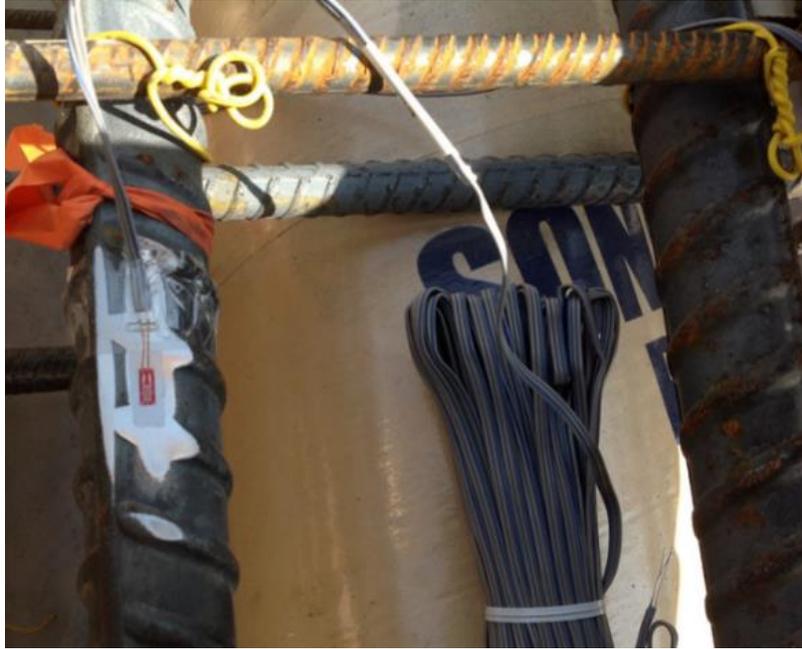
**Figure 14. Gage installation on reinforcement**

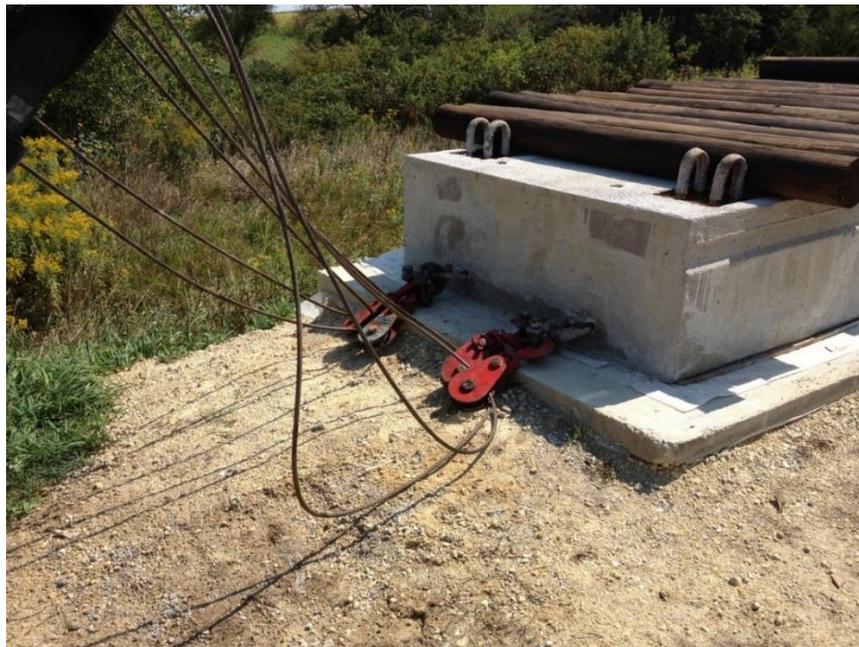
The first attempt to position a beam (the “test” beam) was with a tow truck. Figure 15 shows the horizontal pulling loops on the end of the beam, which were installed for this purpose.

**Figure 15. Lifting/pulling setup**

The beam was planned to be moved by putting treated poles (shown on top of the beam in Figure 15 and Figure 16) under the beam and sliding it over the timbers. Figure 16 shows the beam when it was lifted on one end.

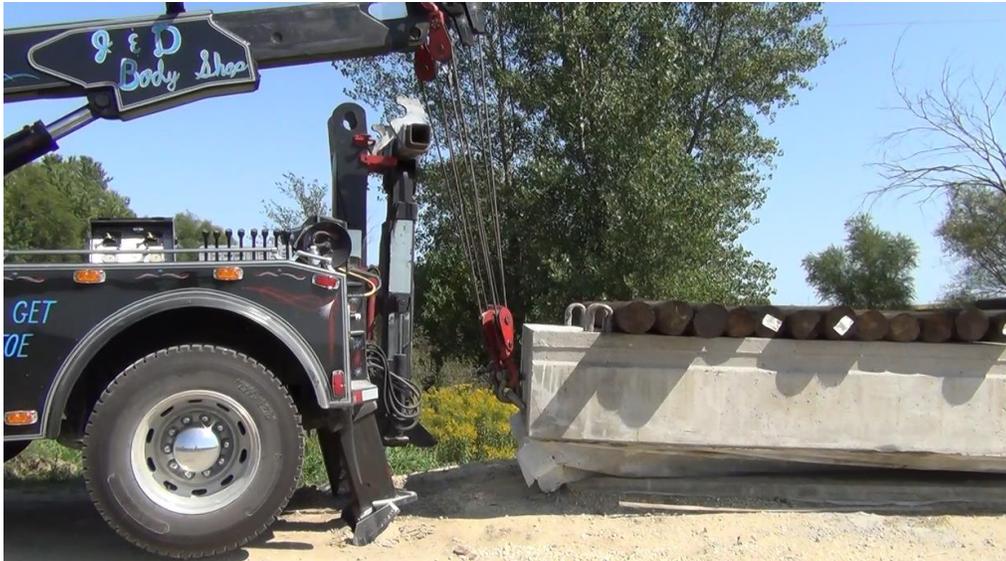
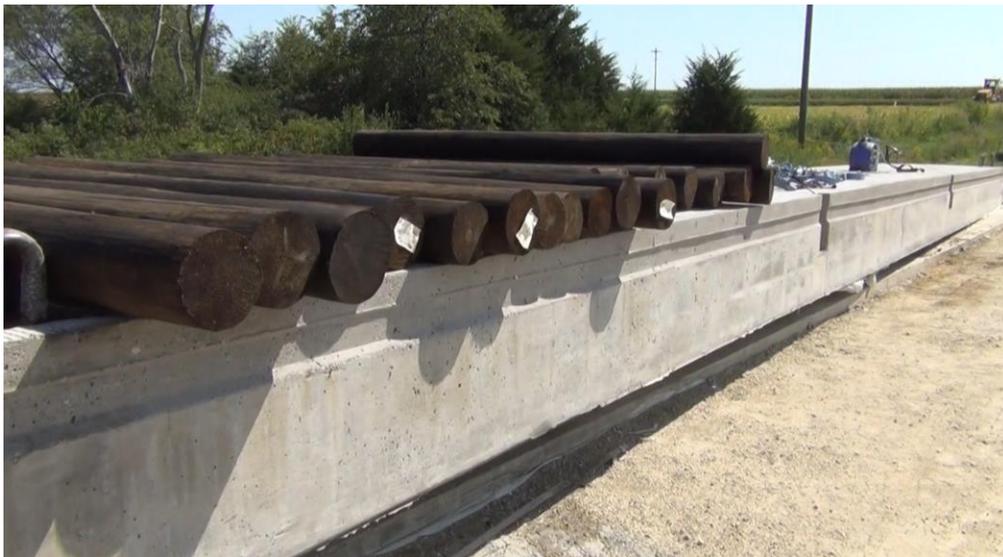
**a. Beam lifted by tow truck**

**b. The beam when one end was lifted by the tow truck**

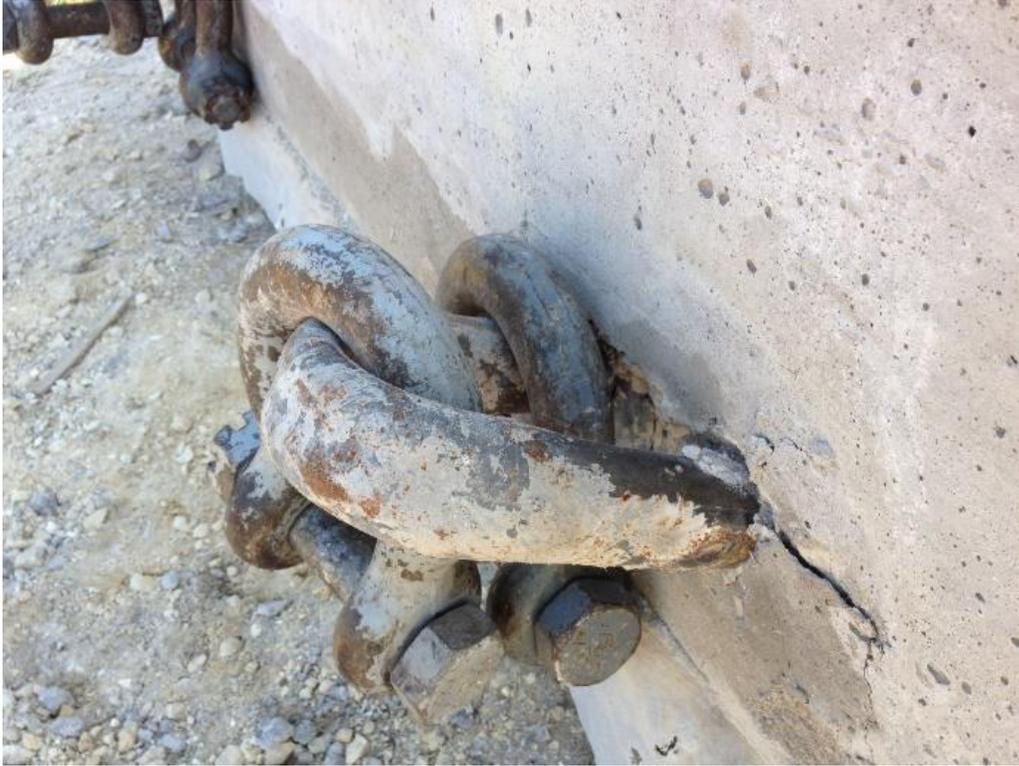
During the lift of the beam, three important observations were made. First, there was extreme bending of the pulling loops and a crack that propagated from the pulling loop, as shown in Figure 17.

**Figure 17. Horizontal pulling loops after lift**

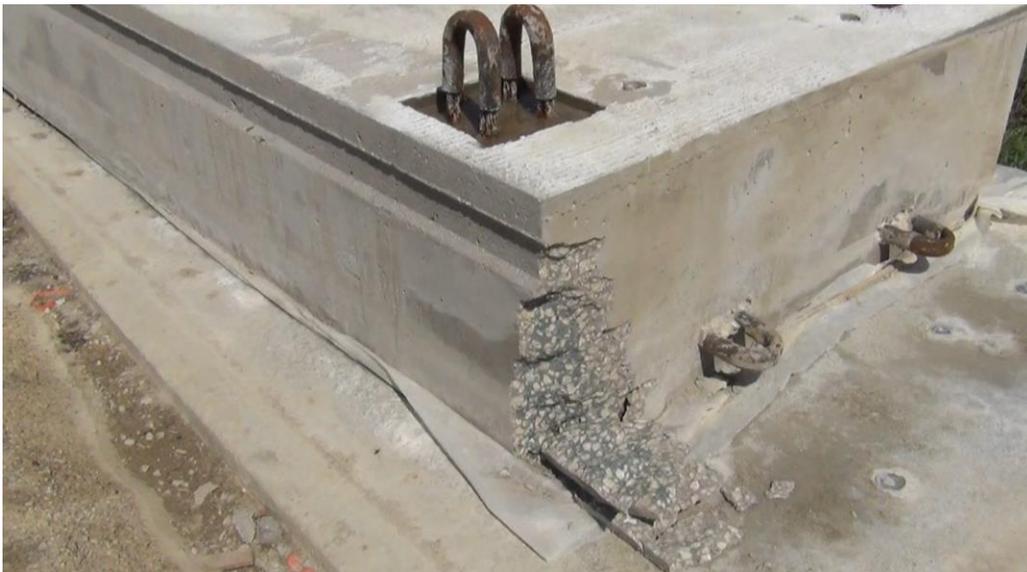
Second, there was concrete spalling on the end opposite the pulling end of the beam as shown in Figure 18.

**Figure 18. Concrete spalling on non-pulling end of the beam**

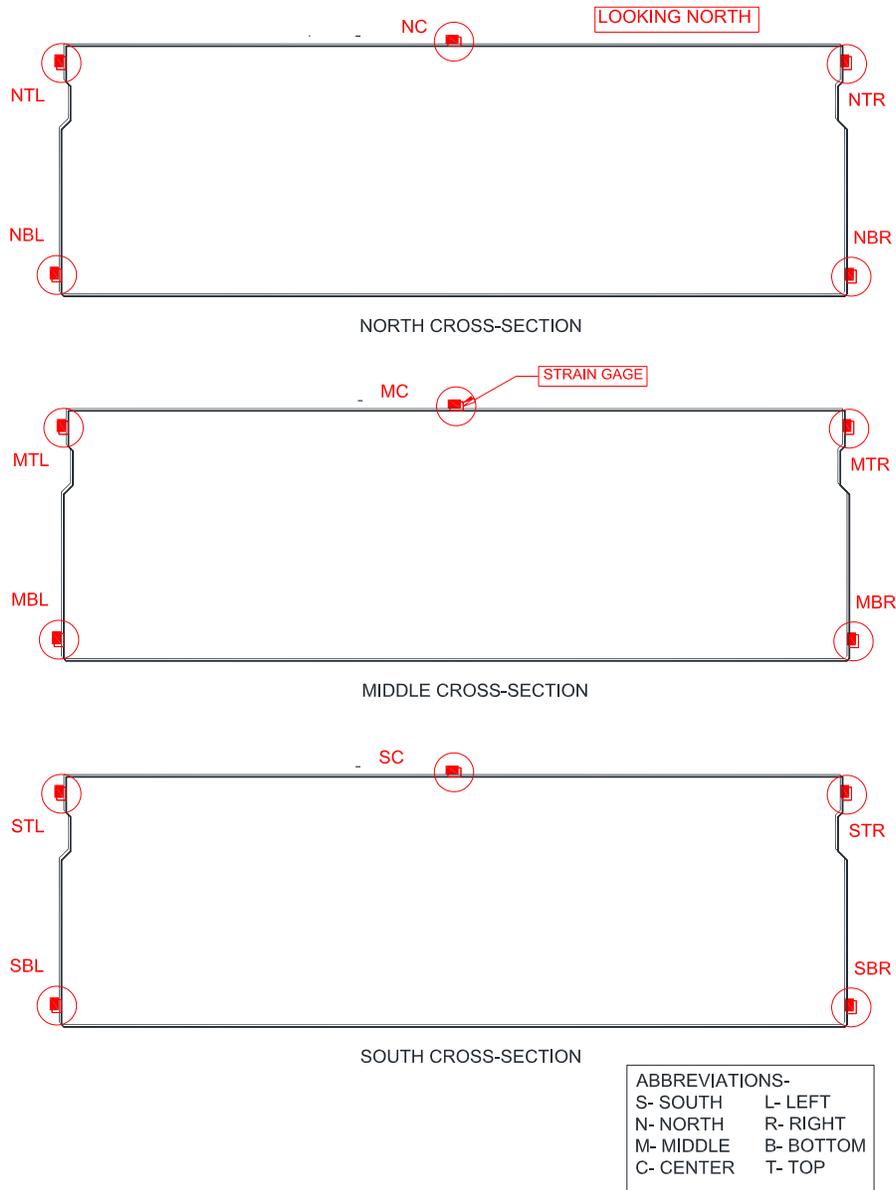
The contractor selected for the project elected to use two backhoes to move the beams from their fabrication site to their final position on the bridge abutments. To document the behavior including peak behaviors, a series of externally mounted strain gages were installed on one beam prior to moving it. The external strain gages were mounted at three different cross-sections, one at 9 ft 8 in. from both the north and south ends and one at mid-span. The gage layout and the designations for those gages are shown in Figure 19.

**Figure 19. Strain gage layout for backhoe lift/move**

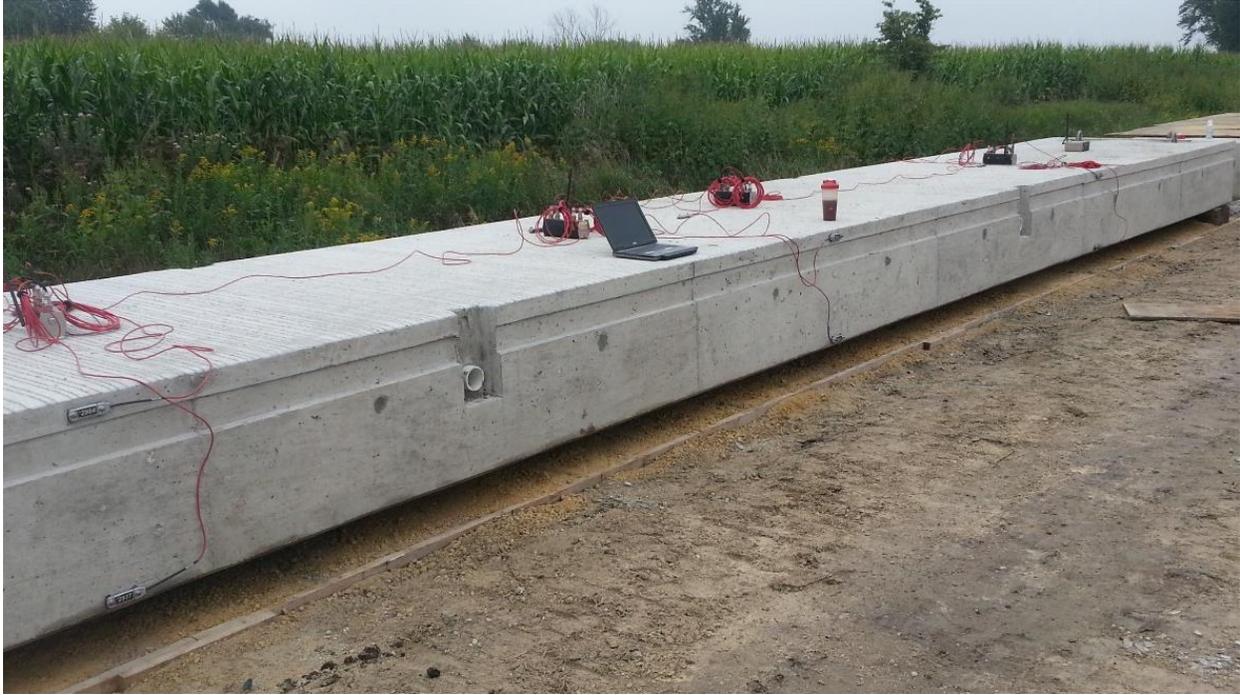
All externally mounted gages had an effective gage length of 3 in. Figure 20 shows the strain gages mounted on the beam and data collection system that was used to record the strain during the beam move.

**Figure 20. Installed strain gages and data collection system for lift/move**

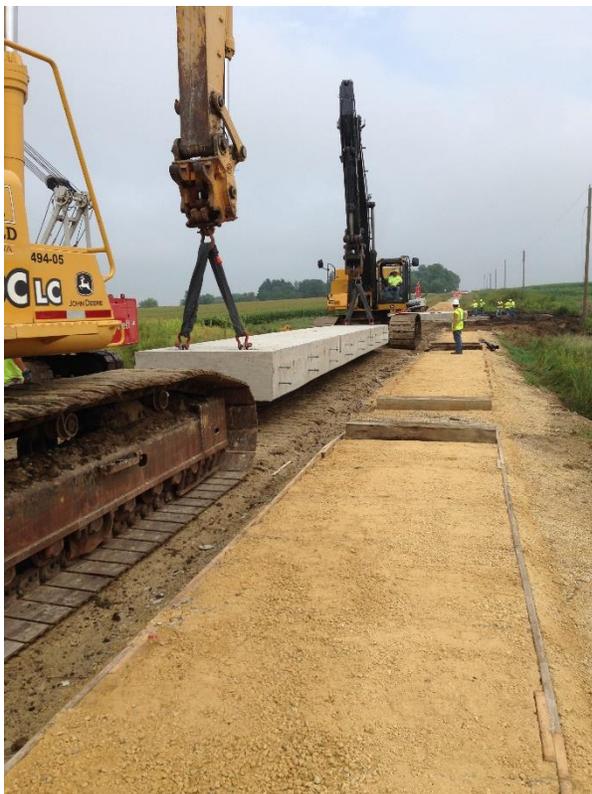
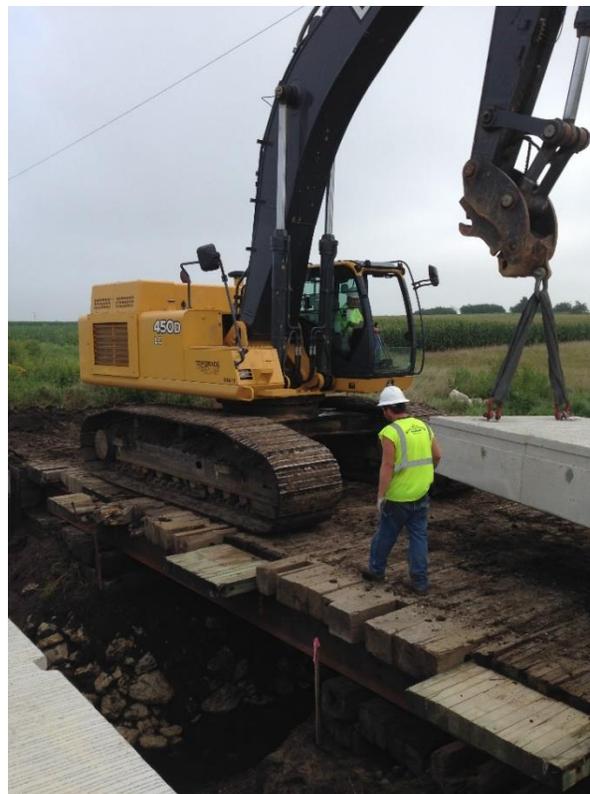
To facilitate placing the beams, a temporary bridge was constructed over the creek by placing steel girders across the creek and placing timber deck panels over the girders to make a traversable surface. As shown in Figure 21a, the two backhoes lifted the beam using preinstalled lifting loops.

**a. Beam lift**

**b. Beam move over the creek**

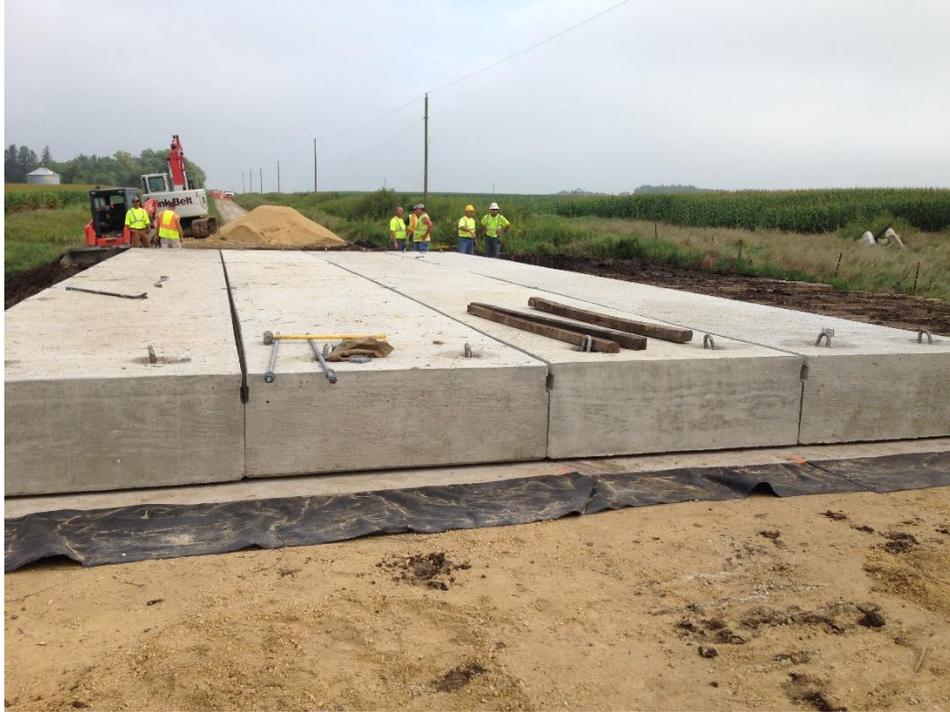
Figure 22 shows four beams that had been placed on the concrete abutments while Figure 23 shows the fifth beam being moved to its designated location.

**Figure 22. Four beams placed over the creek on the concrete abutments**

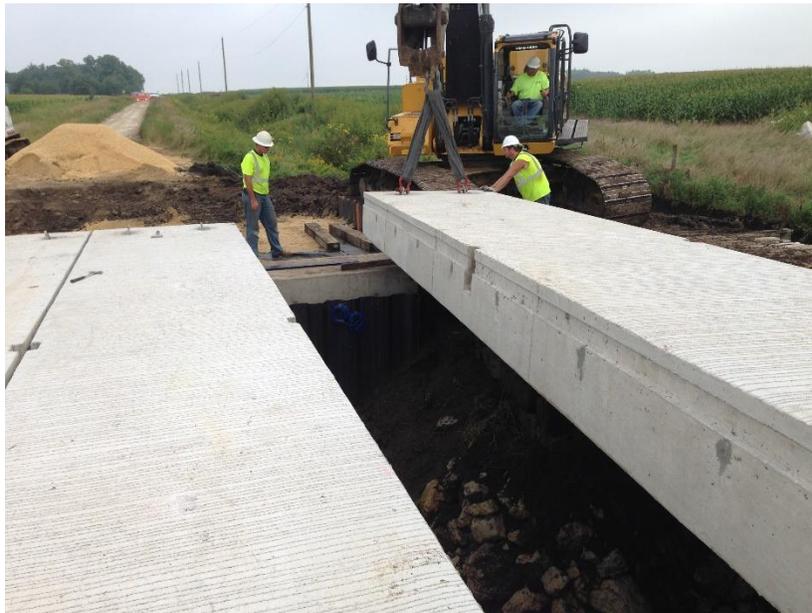
**Figure 23. Fifth beam being moved to its position using backhoe**

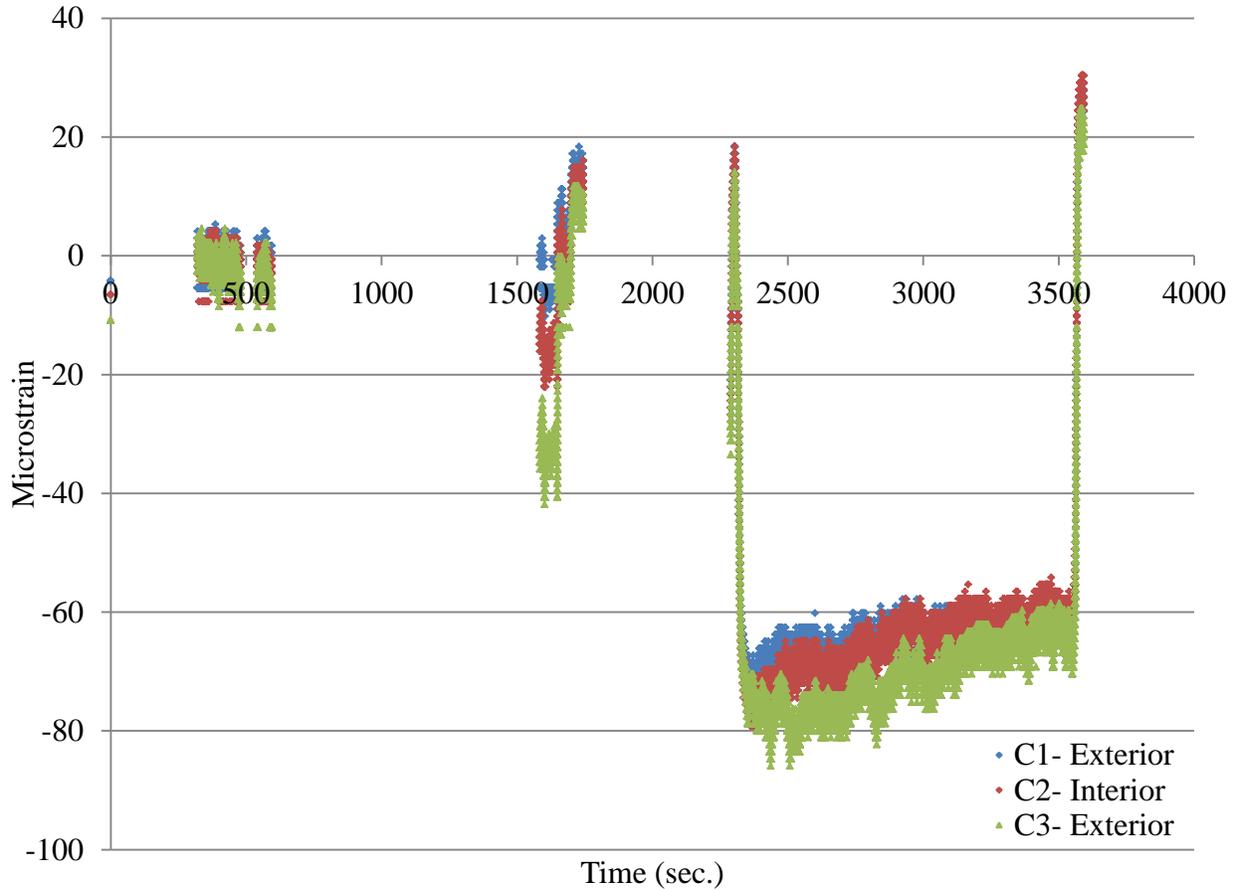
During the lifting/pulling of the “test” beam attempt, internal strain data were recorded. Figure 24 shows the strains from the three internal gages on top at mid-span (i.e., C1, C2, and C3 in Figure 13).

**Figure 24. Typical top bar strain history (cross-section C top gages)**

The microstrain values in Figure 24 are shown against time in seconds. Initially, an attempt was made to slide the beam without lifting it. However, while applying the pulling force, the front wheels of the tow truck lifted off the ground several inches. As a result, the pulling was stopped there. The strain values for this pull are shown around 500 sec. Another attempt was then made to pull the beam after the truck was positioned on more solid ground. This attempt also caused lifting of the front of the truck. This attempt was after 1,500 sec. (before 2,000 sec.) from the start of the test, as shown in the figure.

their peak values during this activity, which occurred between 2,000 and 4,000 seconds, as shown in Figure 24. Lifting of the beam resulted in positive bending (compression on top and tension on the bottom). Figure 25 shows the strain history of the bottom internal mid-span gage (C5 in Figure 13) with time.

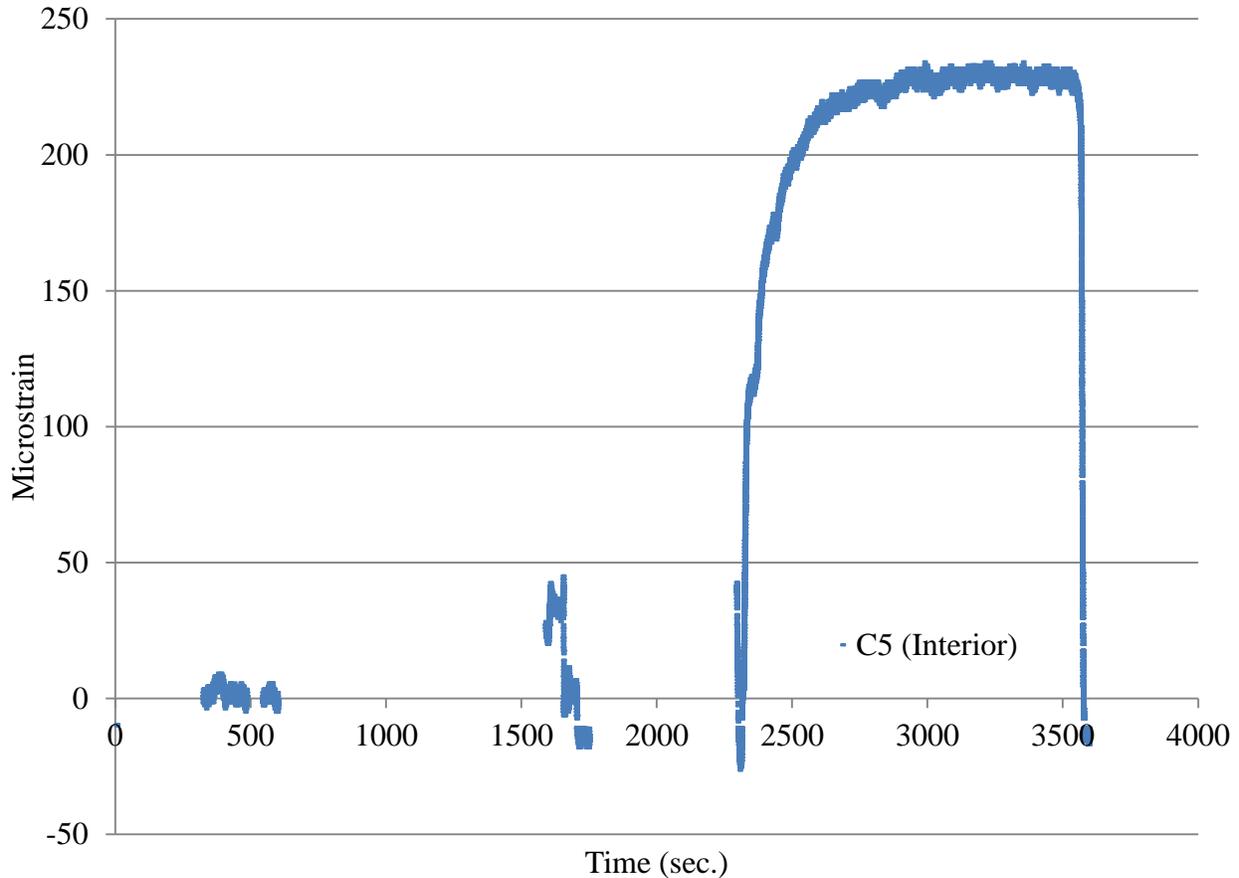
**Figure 25. Typical bottom bar strain history (cross-section C bottom gage)**
