# Evaluation of the Buchanan County IBRD Bridge on Victor Avenue over Prairie Creek

Final Report  
September 2017

**Sponsored by**  
Iowa Department of Transportation  
(InTrans Project 12-427)  
Federal Highway Administration  
Innovative Bridge Research and  
Deployment (IBRD) Program

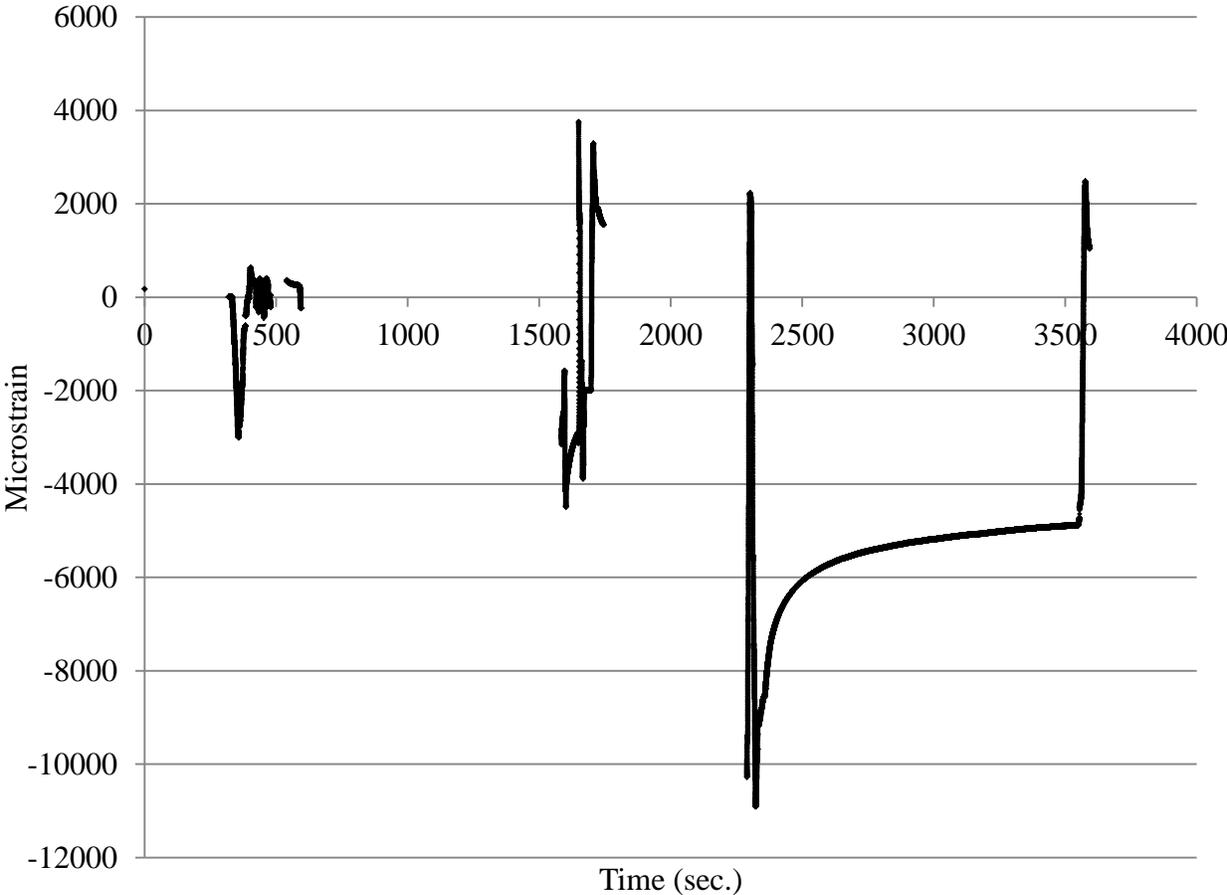
In addition to the instrumentation on the longitudinal bars, one strain gage was installed on top of each horizontal pulling loop. The peak value in this case was more than 10,000 microstrains due to the compression caused by the loop bending. Figure 26 shows the microstrain values over time for this gage.

**Figure 26. Horizontal pulling loop strain**

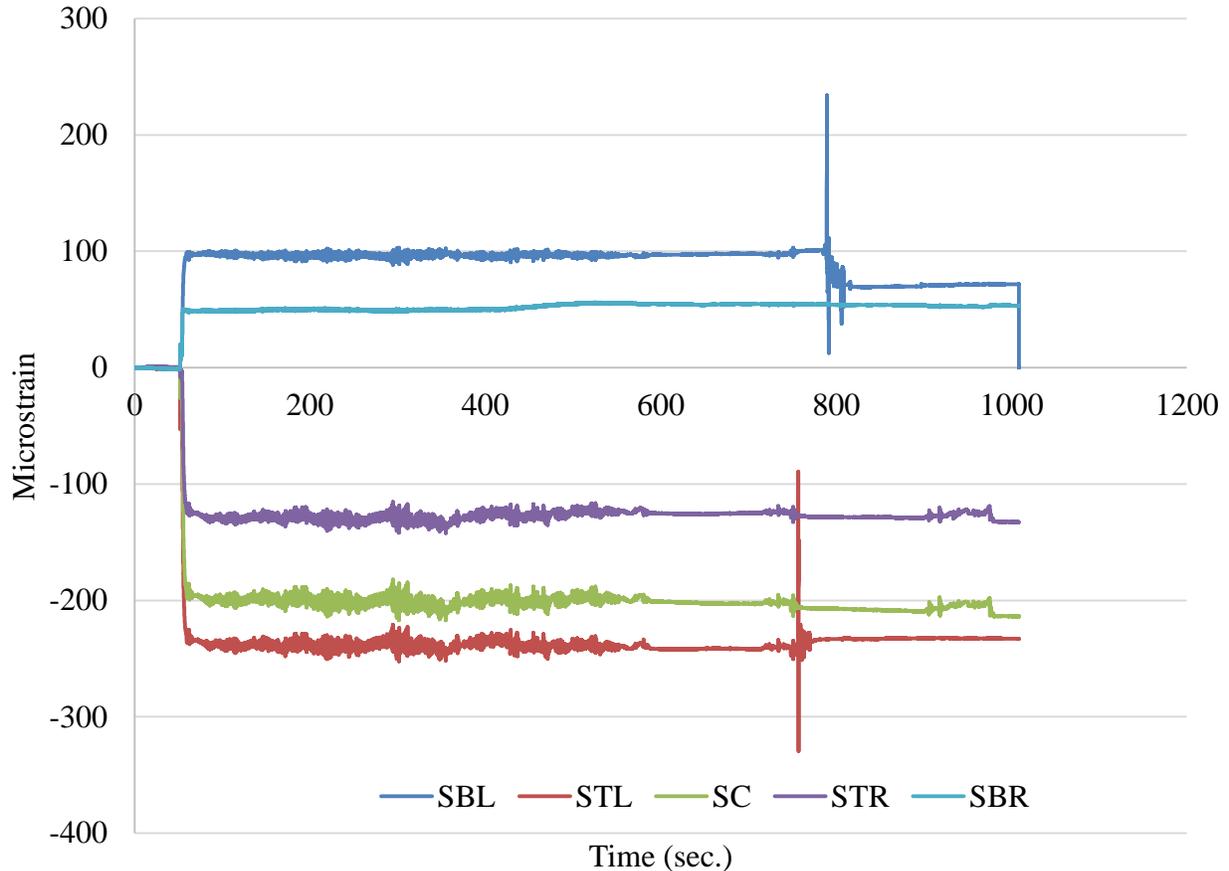
As previously mentioned, the contractor elected to use a pair of backhoes to lift, move, and place the bridge beams. Figure 27 shows the strain history for the external south cross-section gages (shown in Figure 19) during this process.

**Figure 27. Strain history for south cross-section**

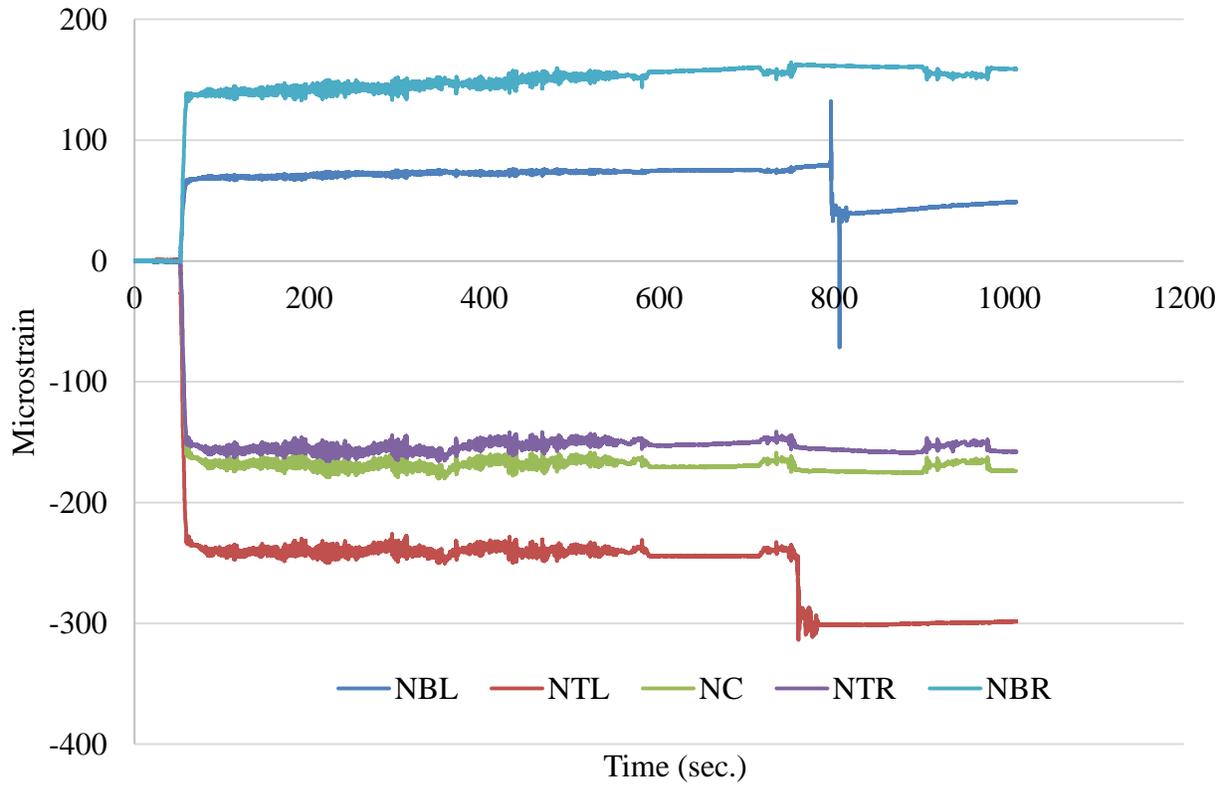
Figure 28 and Figure 29 show the strain history for the north and middle cross-sections, respectively.

**Figure 28. Strain history for north cross-section**

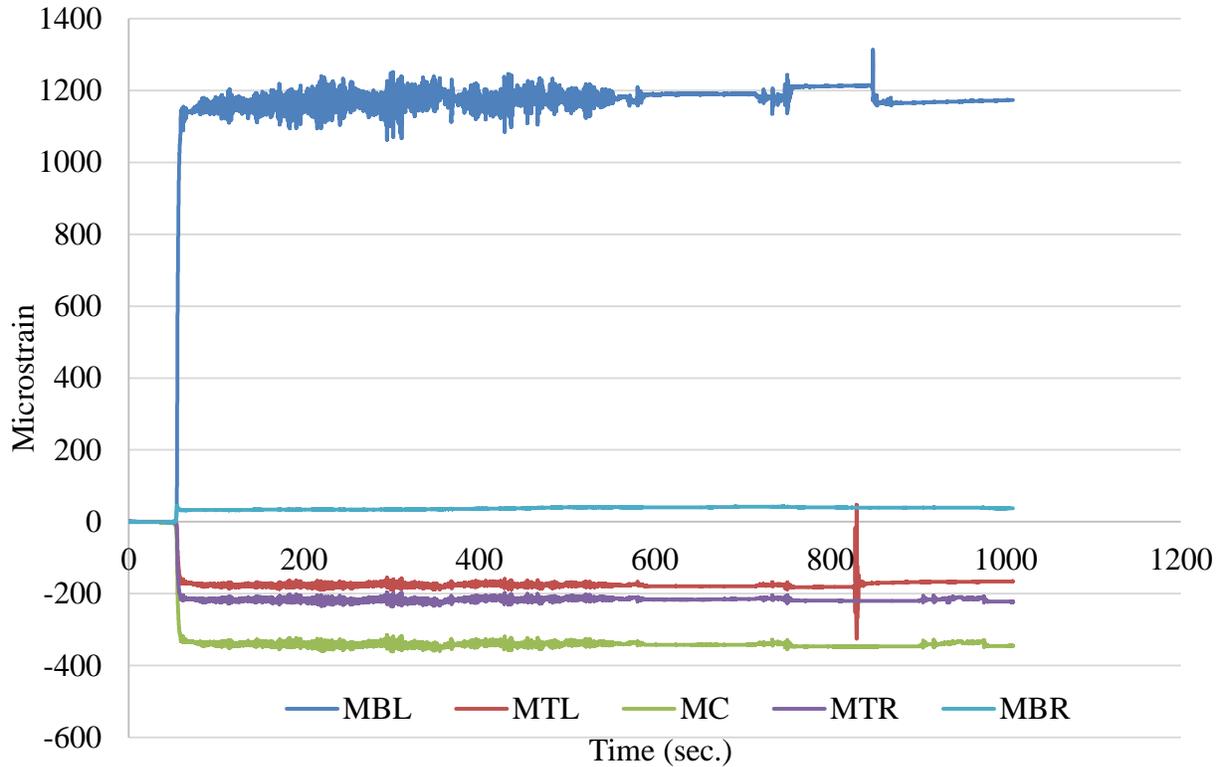
**Figure 29. Strain history for middle cross-section**

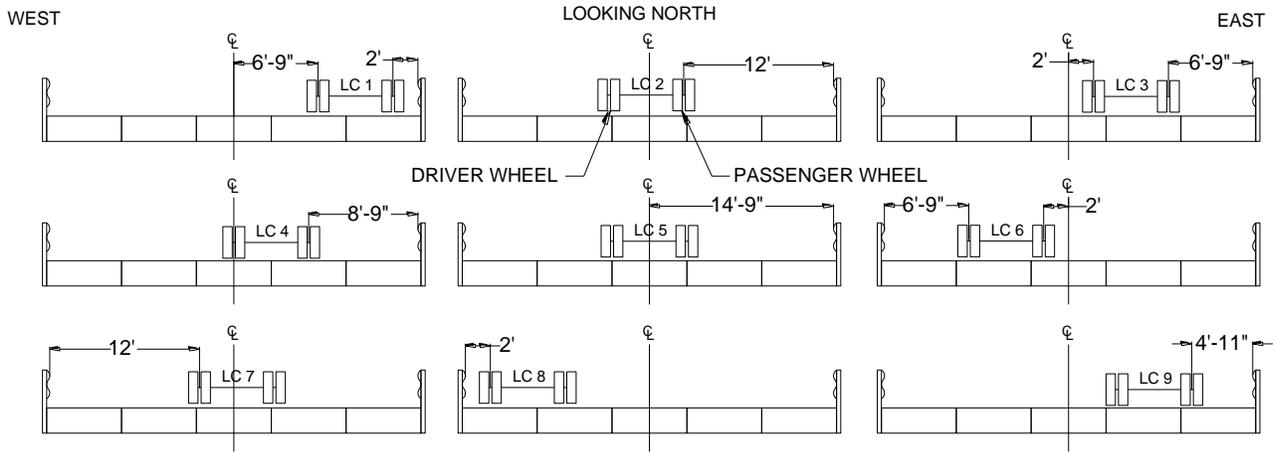
After construction of the bridge, live load testing of was carried out, annually, for three consecutive years (2014, 2015 and 2016). For the load tests, the bridge beams were instrumented with externally mounted strain gages. Following instrument installation, a loaded truck was driven over the bridge while recording the data from the gages. Figure 30 shows the different load cases that were used for the tests.

**Figure 30. Load cases**

In this figure, the transverse location of the truck is shown. Gages were installed on the beams to record the longitudinal strain in the beams and deflection transducers were installed to measure the relative displacement between adjacent beams. Figure 31 shows the instrumentation layout and nomenclature.

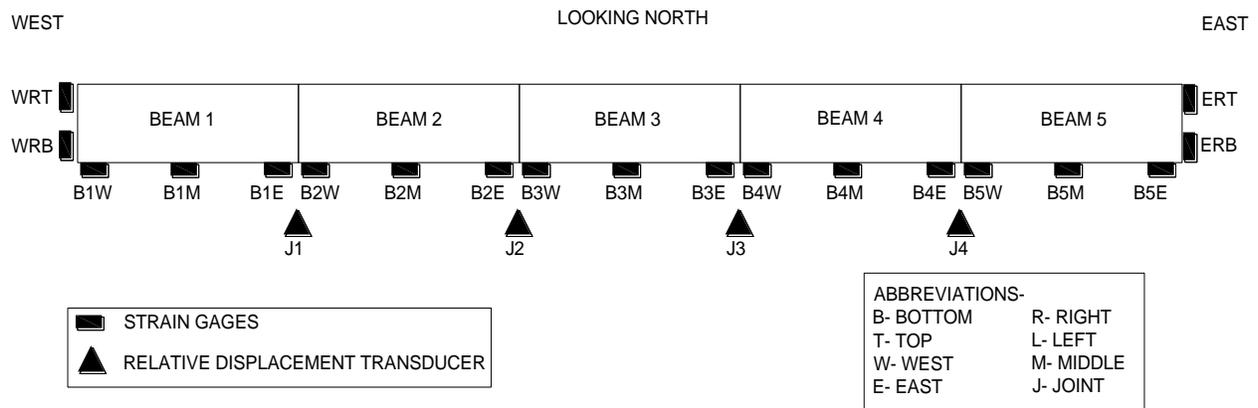
**Figure 31. Instrumentation layout and nomenclature**

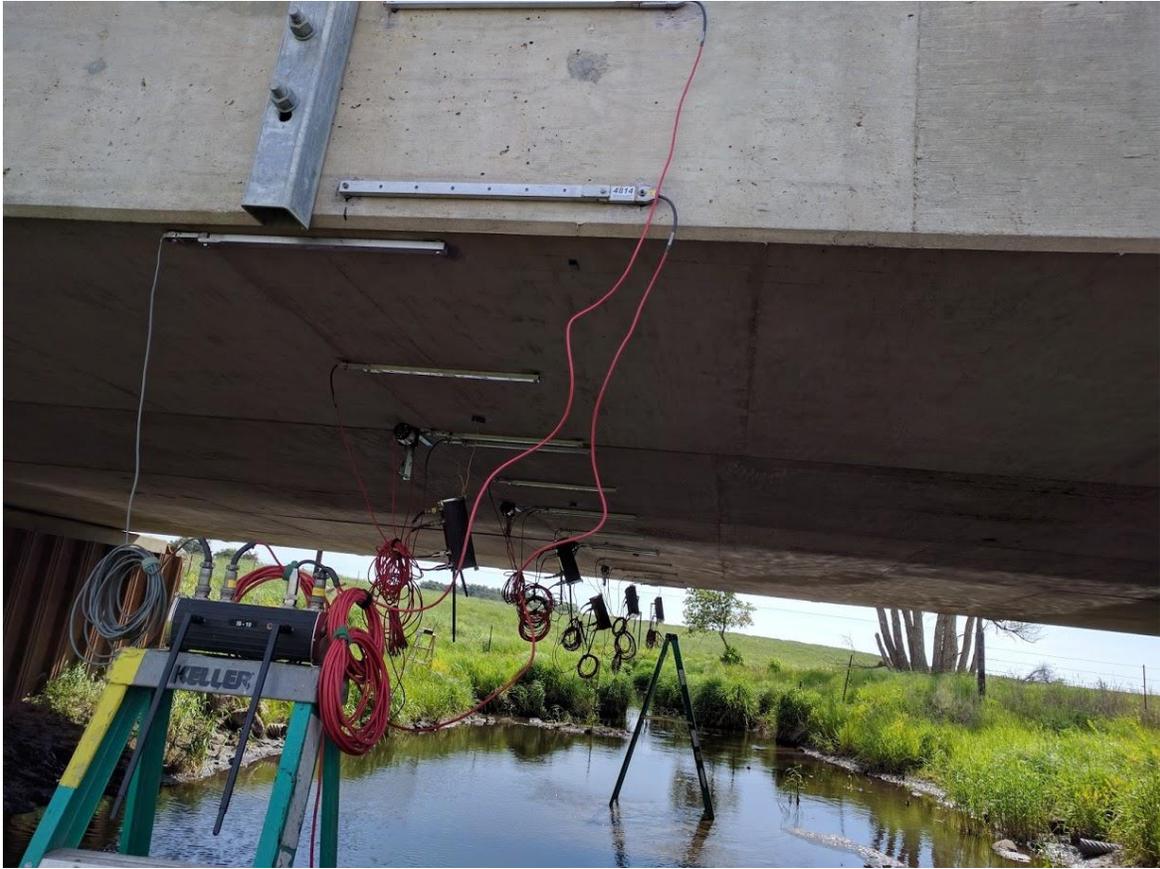
Figure 32 shows the bridge after all external instrumentation was installed. Figure 33 shows a close-up view of the relative displacement gage setup that was used to monitor for relative moment between adjacent beams.

**Figure 32. Instrumentation mounted on the bridge**

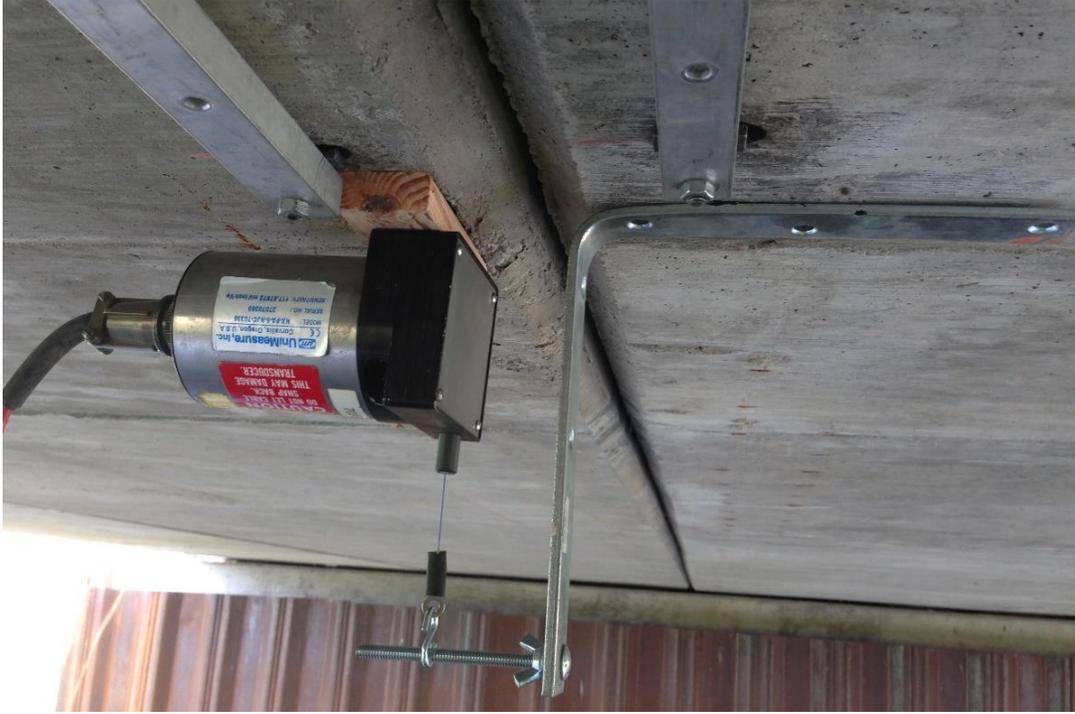
**Figure 33. Relative displacement gage setup**

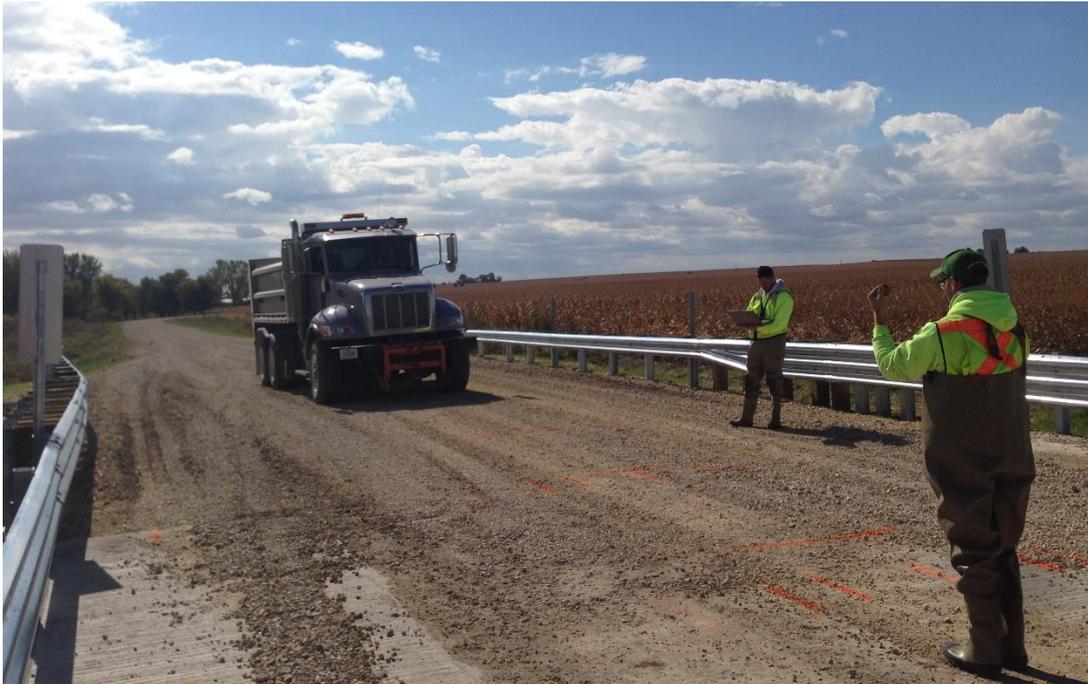
Figure 34 shows the loaded tandem-axle dump truck being guided across the bridge in a pre-designated position. For each load case, the truck was slowly driven (approximately 3 mph) from one end to other while keeping the truck in a consistent transverse position.

**Figure 34. Live load testing on the bridge**

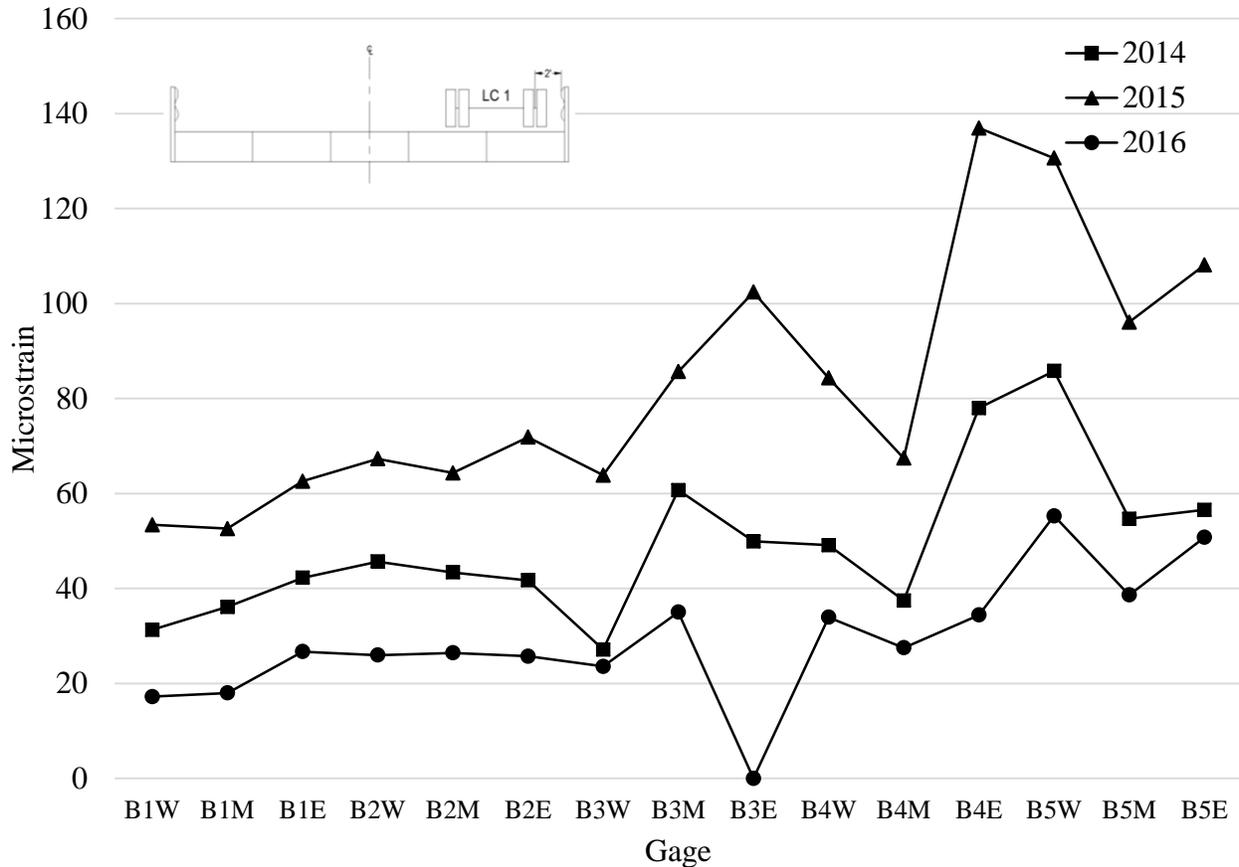
Figure 35 shows the strain distribution for Load Case 1 (LC-1) for all three years.

**Figure 35. Longitudinal strain distribution over the transverse mid-span (LC-1)**

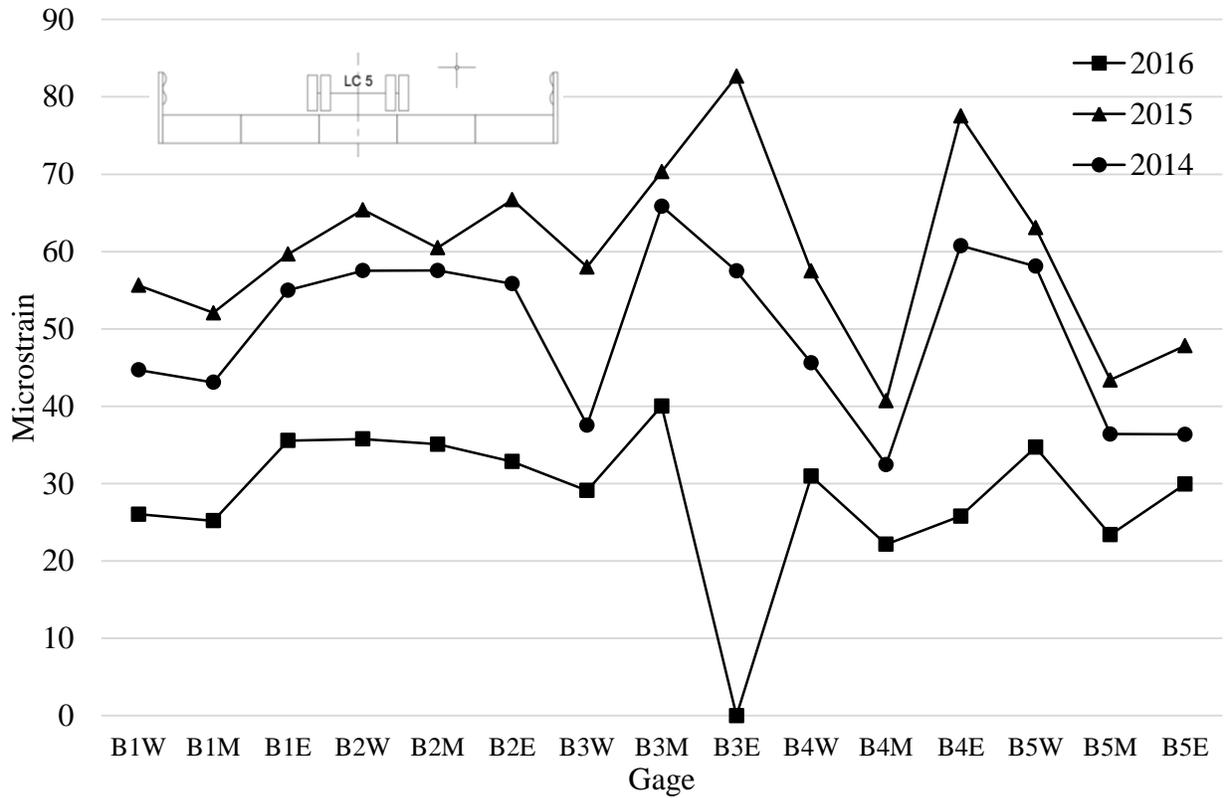
Figure 36 shows the strain distribution at mid-span for LC-5, when the truck is centered laterally on the bridge.

**Figure 36. Longitudinal strain distribution over the transverse mid-span (LC-5)**

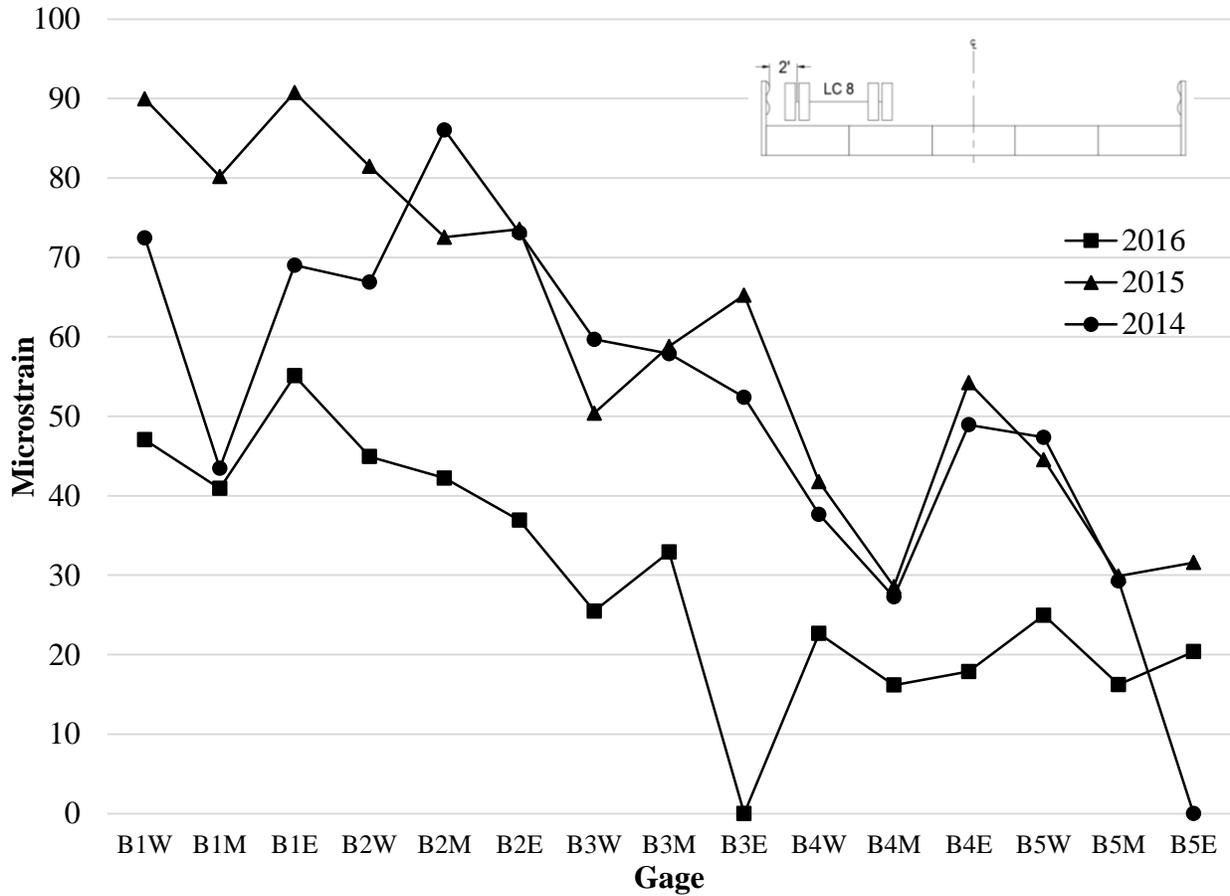
Figure 37 shows the strain distribution at mid-span for LC-8 when the truck was driven very close to the west curb. The peak strain value in this case was 90 microstrains.

**Figure 37. Longitudinal strain distribution over the transverse mid-span (LC-8)**

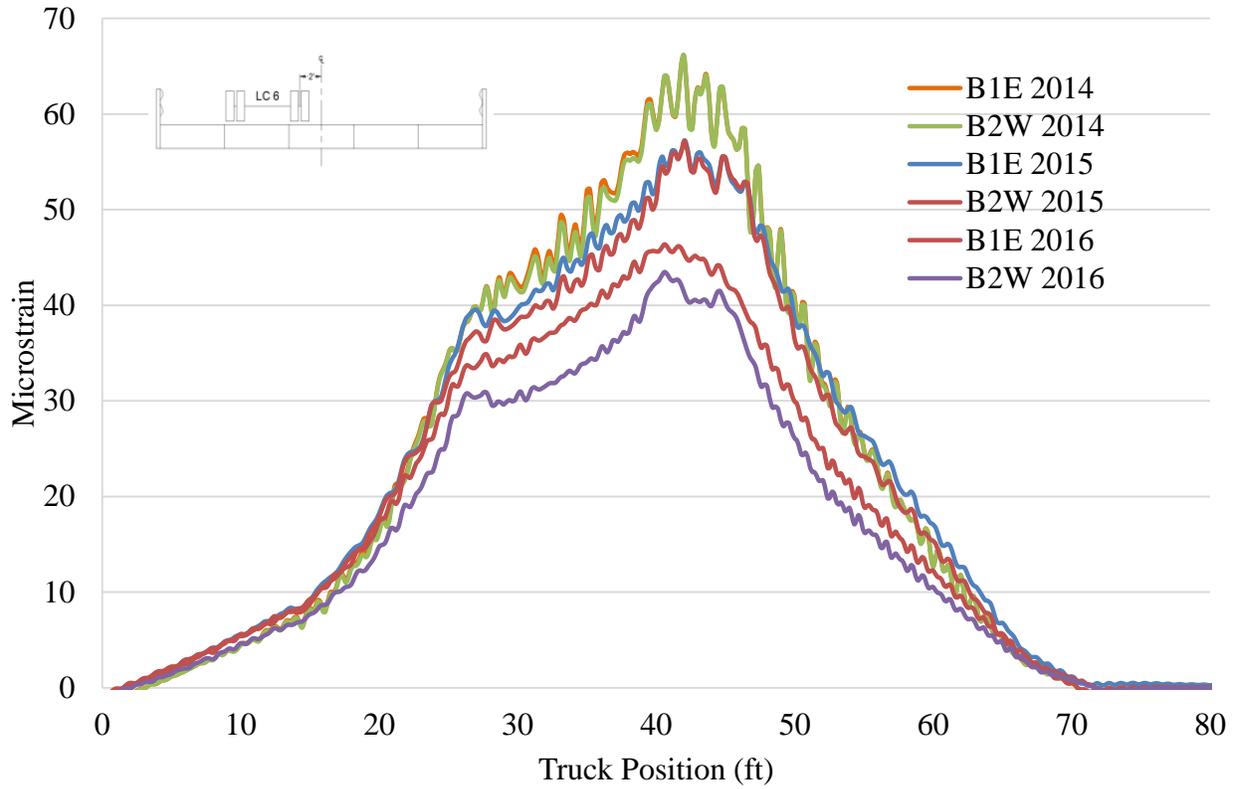
Figure 38 shows the history of strain gages B1E and B2W mounted near Joint J1 for LC-6. The peak strain value is reached when the truck is above the strain gages, i.e., mid-span.

**Figure 38. History of the strain gages near Joint J1 (LC-6)**

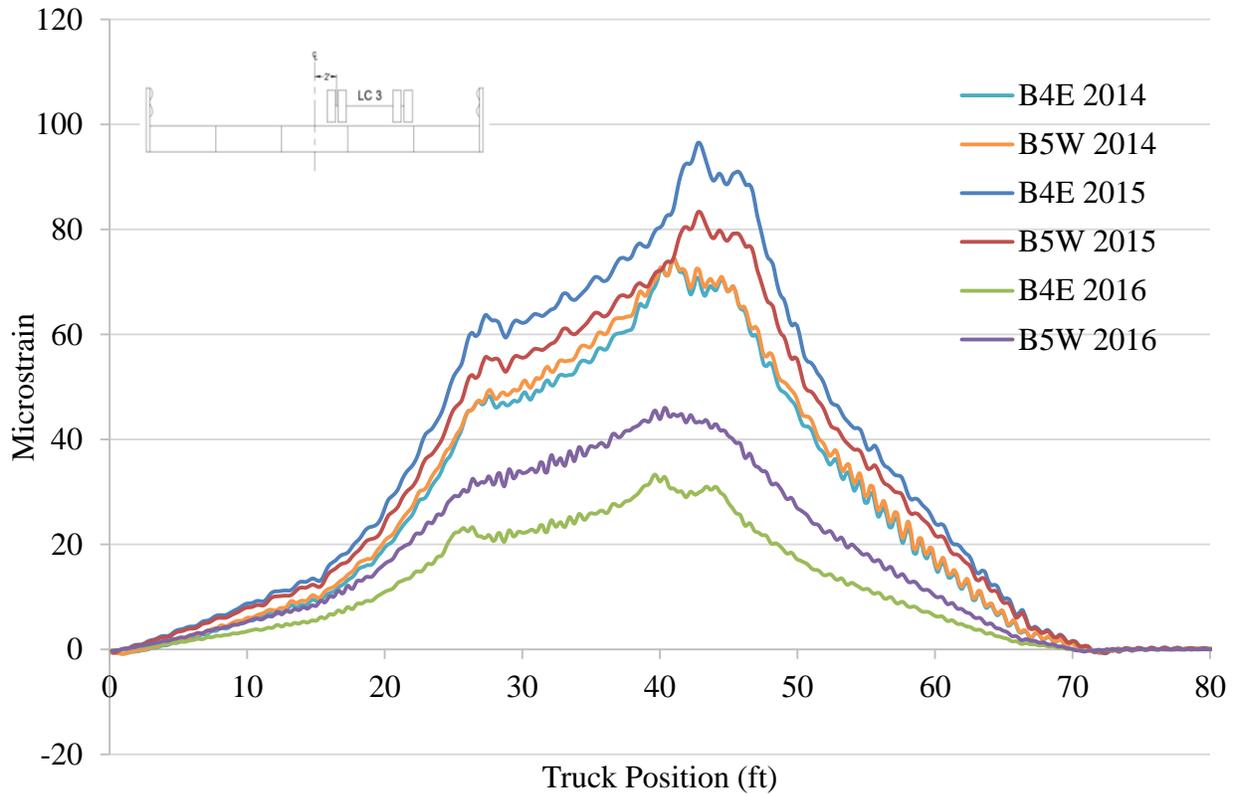
Figure 39 shows the history of strain gages B4E and B5W mounted near Joint J4 for LC-3.

**Figure 39. History of the strain gages near Joint J4 (LC-3)**

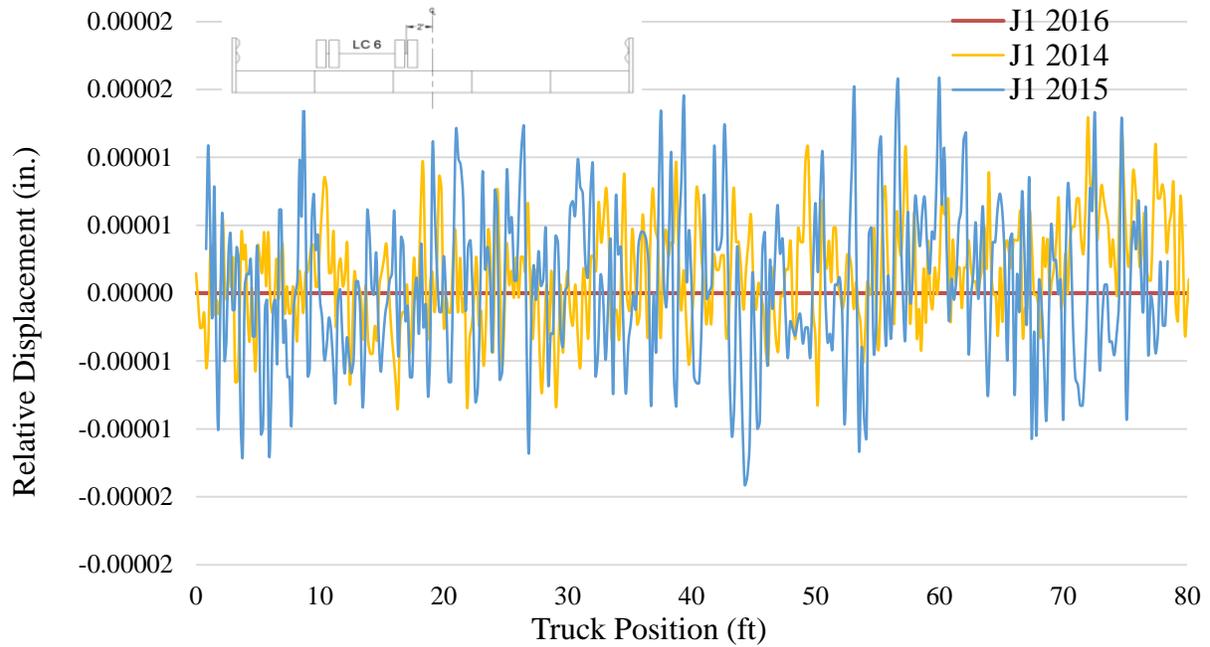
Figure 40 shows the history of relative displacement between Beam 1 and Beam 2 at Joint J1 for LC-6 for all three years.

**Figure 40. History of relative displacement at Joint J1 (LC-6)**

From this history, it can be seen that, the relative displacement transducer for the year 2016 failed. The peak relative displacement value was about 0.00002 in., which is small.

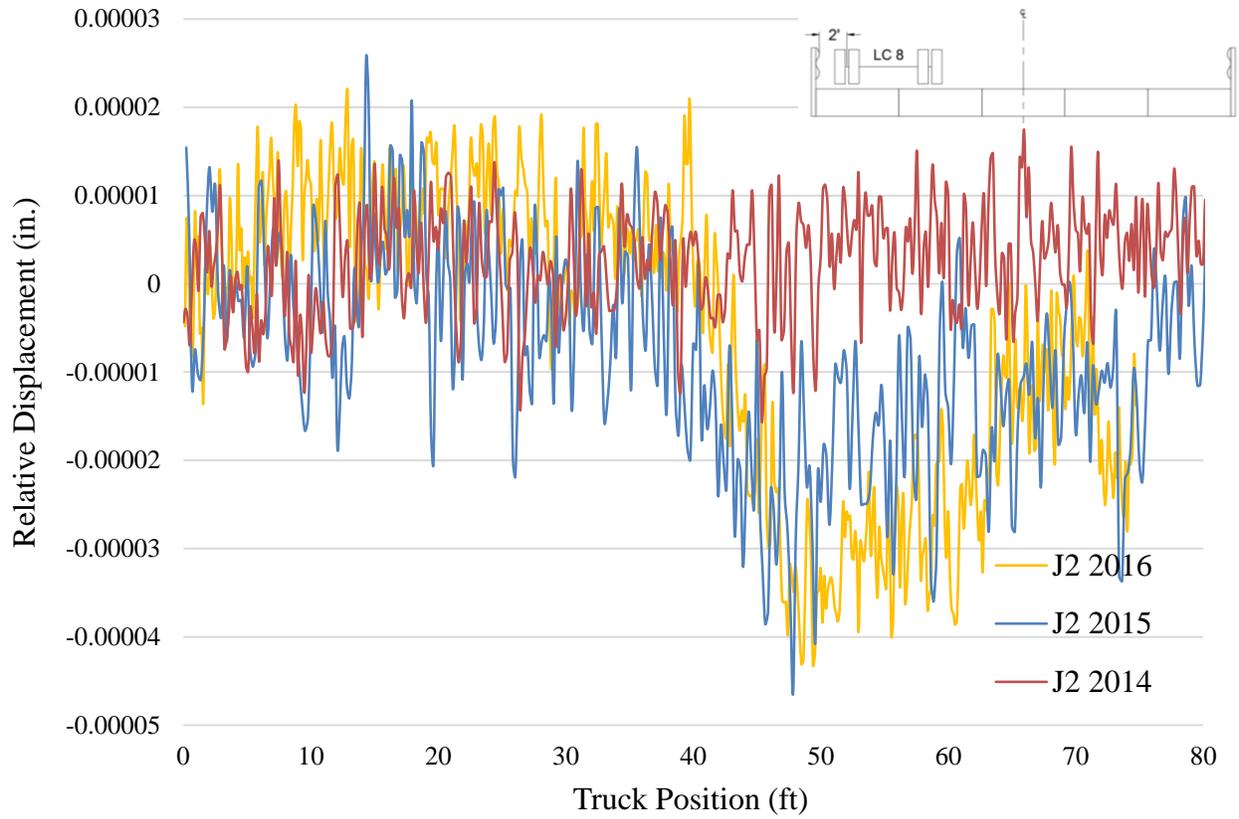
Similarly, Figure 41, Figure 42, and Figure 43 show the relative displacement at the joints J2 (LC-6), J3 (LC-9), and J4 (LC-3) respectively.

**Figure 41. History of relative displacement at Joint J2 (LC-8)**

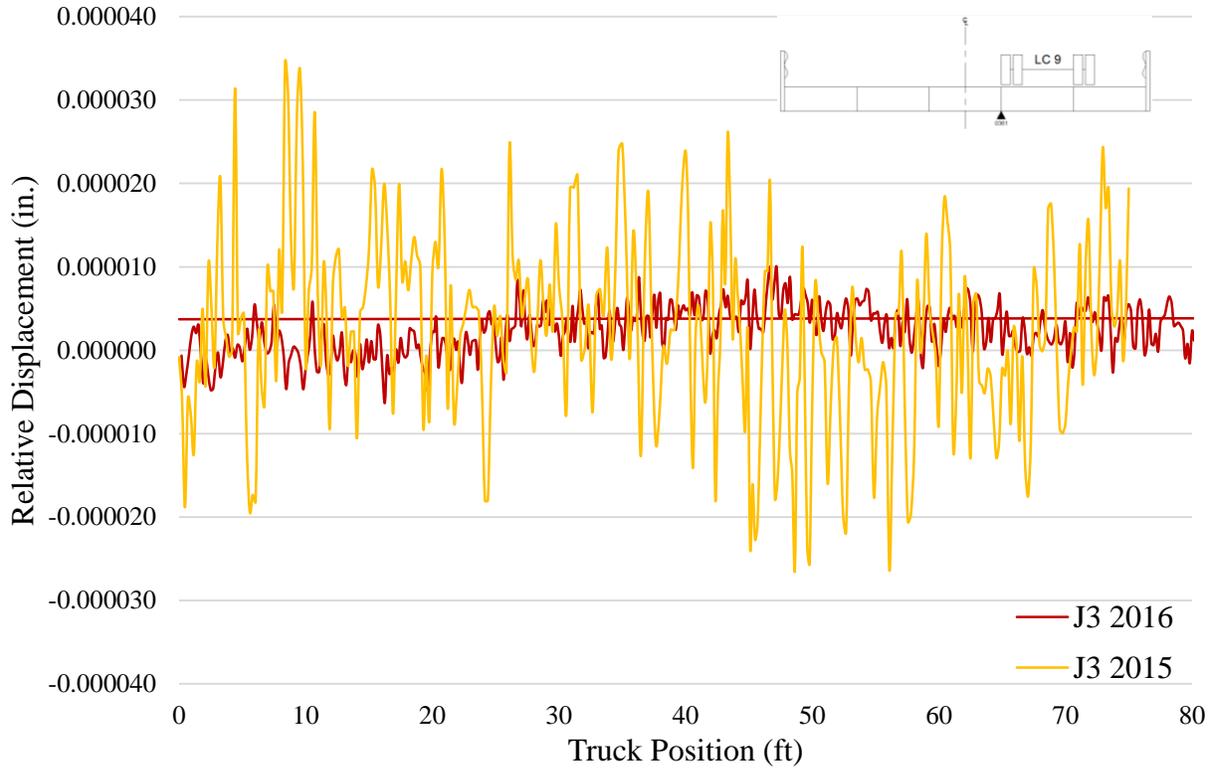
**Figure 42. History of relative displacement at Joint J3 (LC-9)**

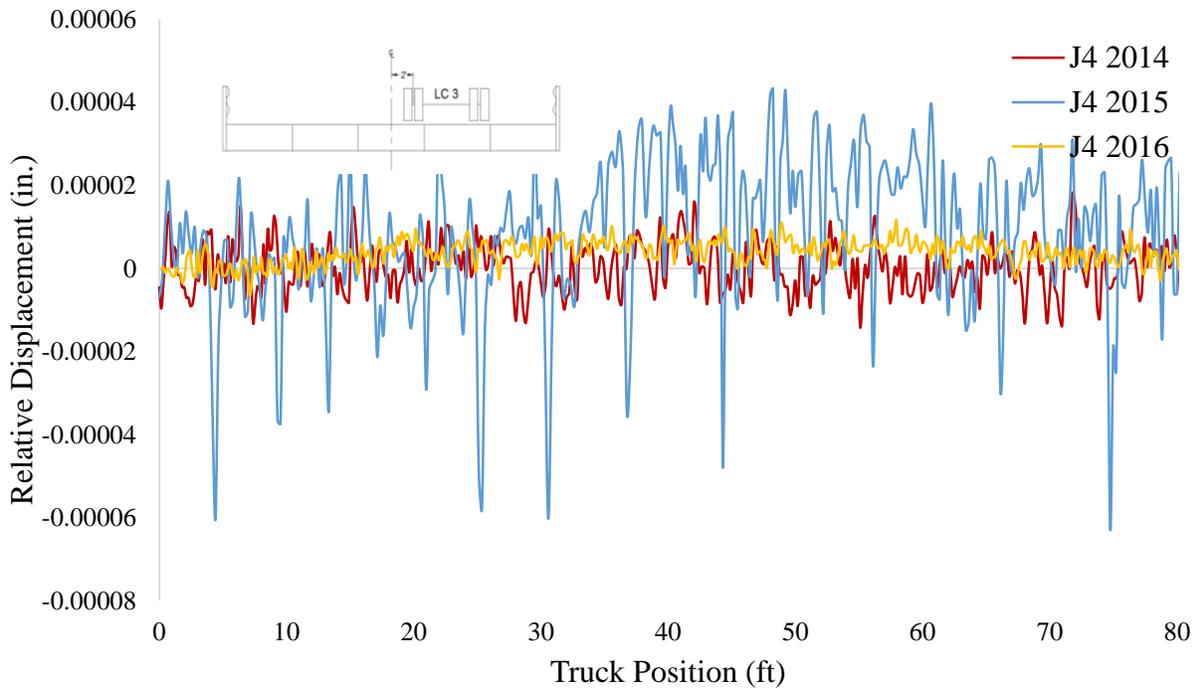
**Figure 43. History of relative displacement at Joint J4 (LC-3)**

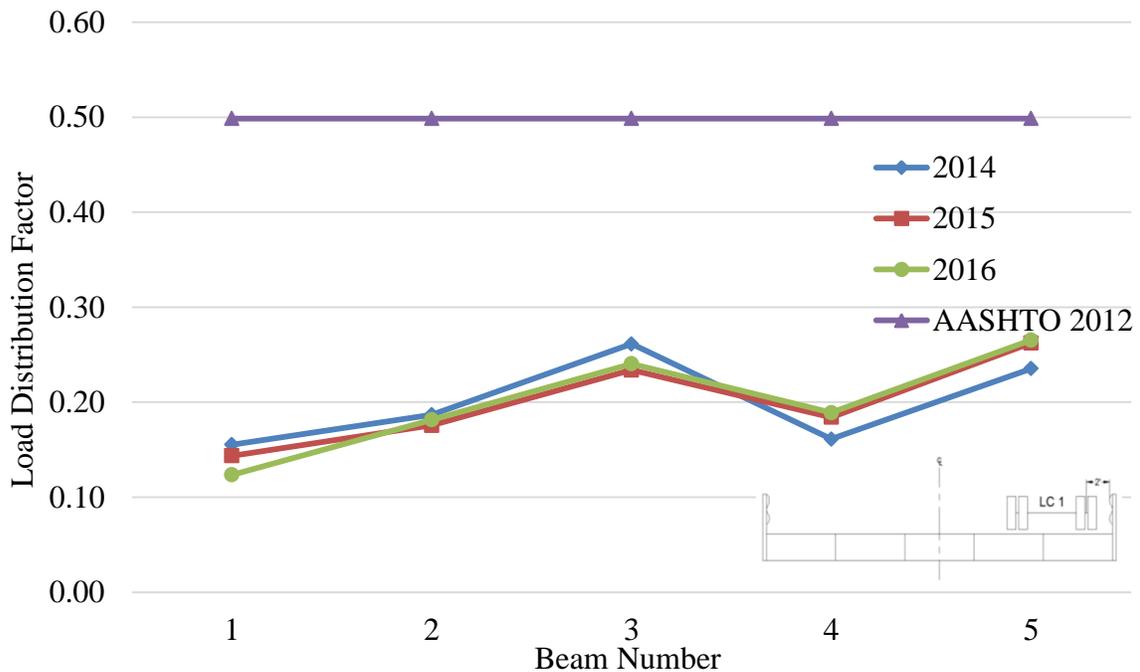
Figure 44 through Figure 48 show the three-year experimental versus AASHTO-specified load distribution factors for LC-1, LC-3, LC-5, LC-6, and LC-8, respectively.

**Figure 44. Experimental and AASHTO-specified load distribution factors for LC-1**

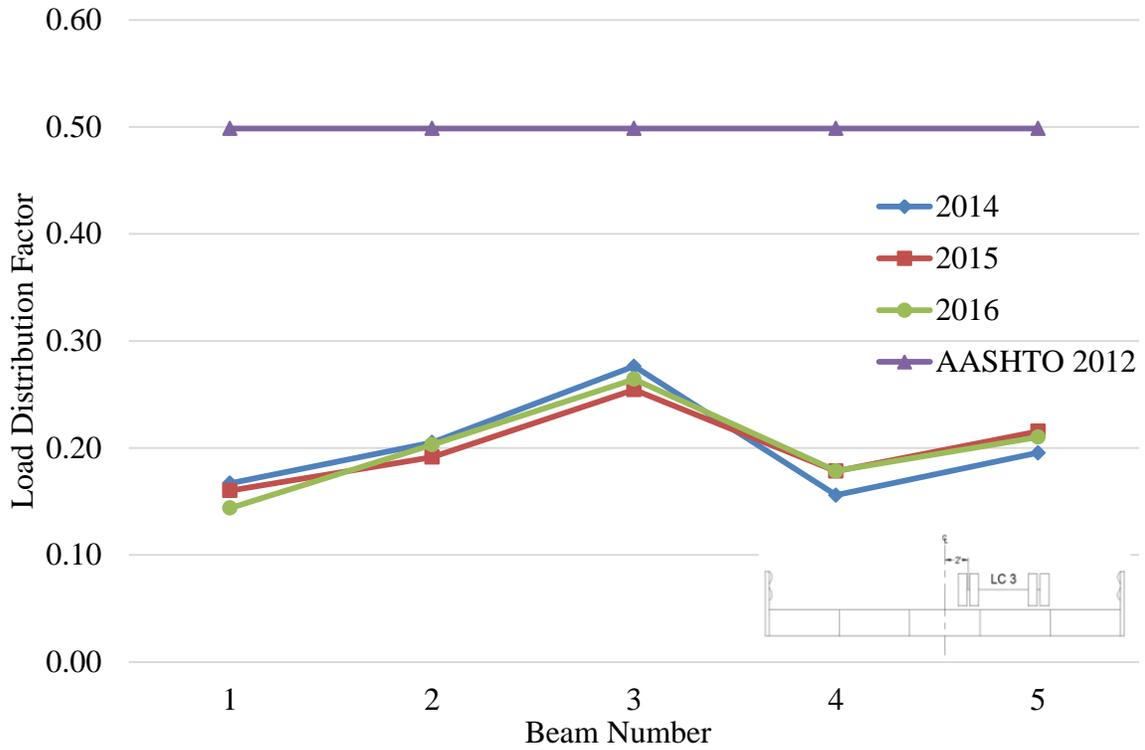
**Figure 45. Experimental and AASHTO-specified load distribution factors for LC-3**

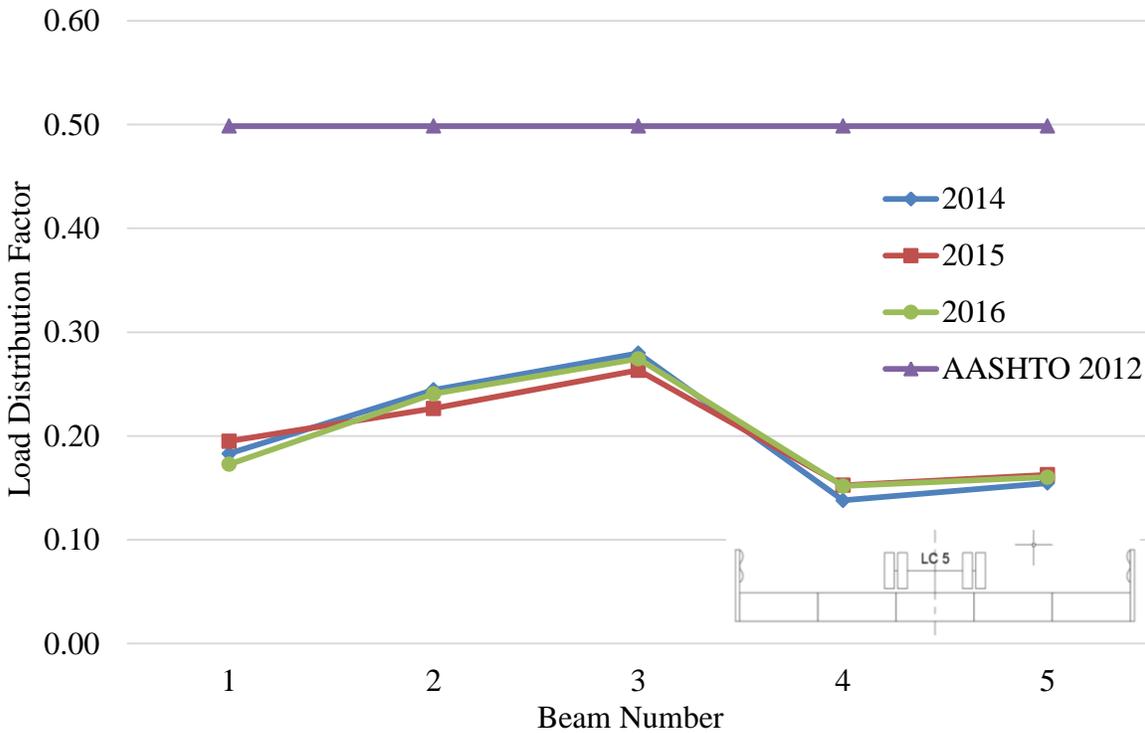
**Figure 46. Experimental and AASHTO-specified load distribution factors for LC-5**

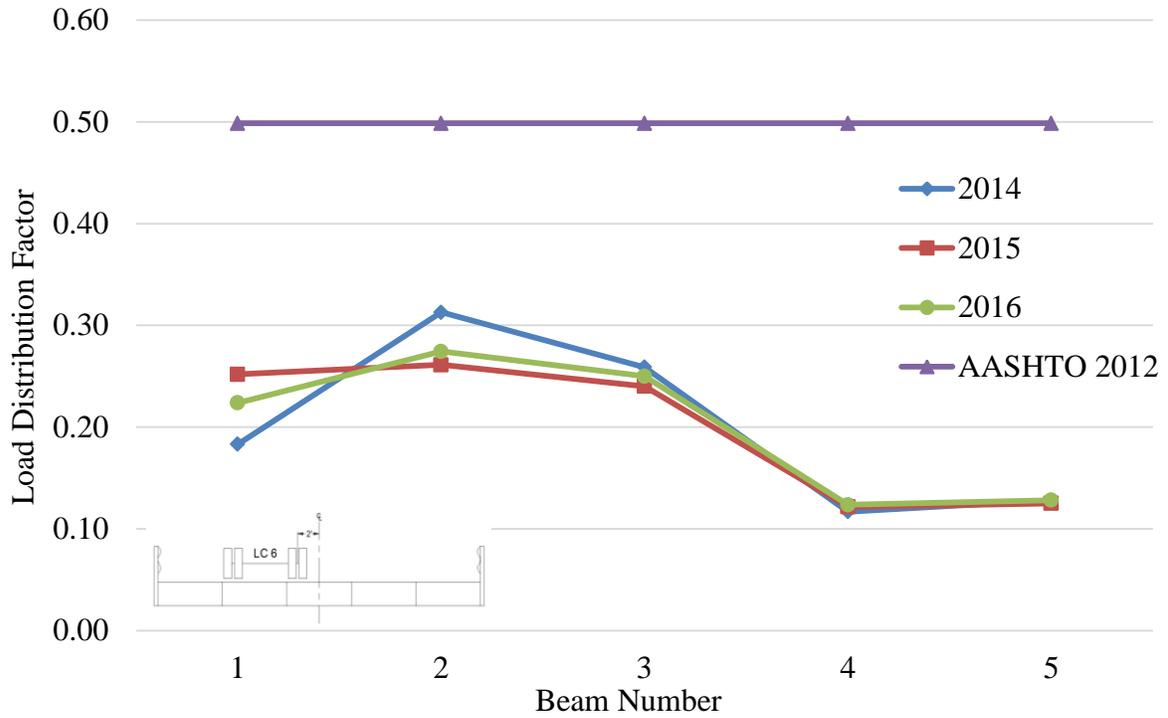
**Figure 47. Experimental and AASHTO-specified load distribution factors for LC-6**

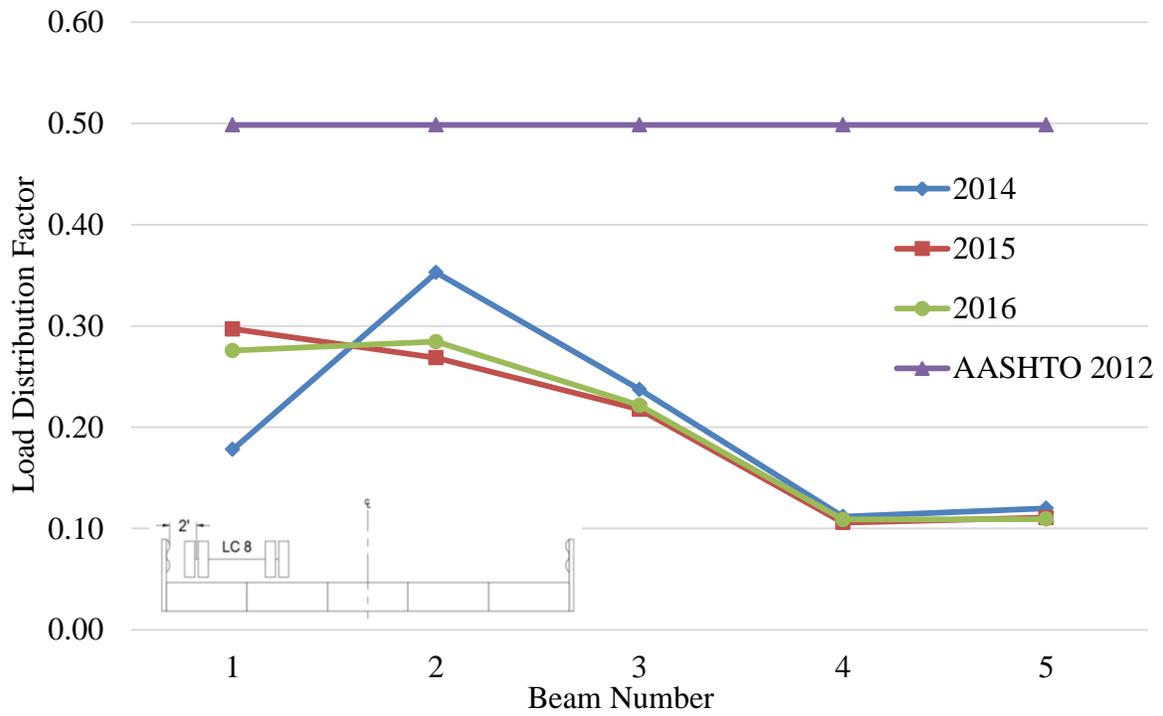
**Figure 48. Experimental and AASHTO-specified load distribution factors for LC-8**

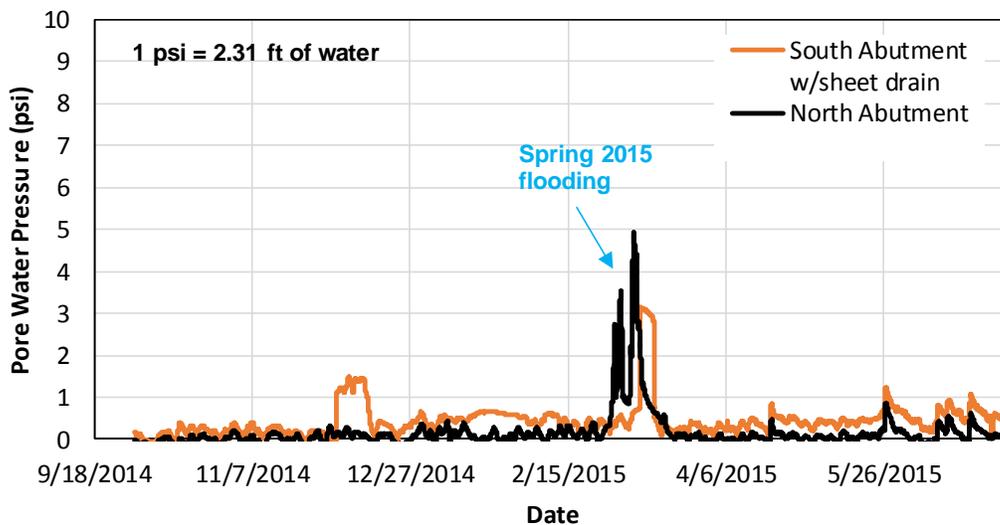
Pore water pressure in both abutments were monitored from October 2014 (shortly after construction) until June 2015. The pore pressure represents the water pressure near the drain tile elevation near the bottom the GRS fill in both abutments. Results are presented in Figure 49.

**Figure 49. Pore water pressure in north and south abutments**
