# Evaluation of the Buchanan County IBRD Bridge on Victor Avenue over Prairie Creek

Final Report  
September 2017

**Sponsored by**  
Iowa Department of Transportation  
(InTrans Project 12-427)  
Federal Highway Administration  
Innovative Bridge Research and  
Deployment (IBRD) Program

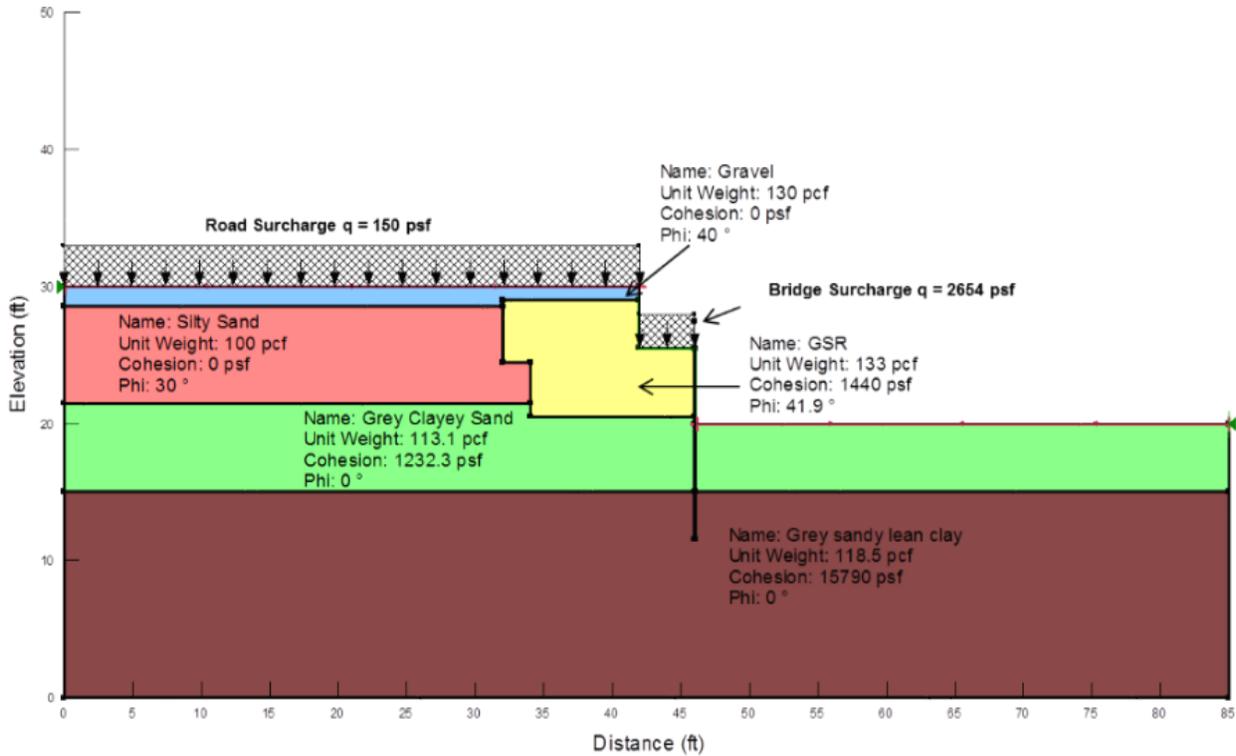
Figure 52. Soil cross-section profile setup for slope stability analysis
