# Connection Details and Field Implementation of UHPC Piles – Phase II

**Final Report**  
**September 2019**

**Sponsored by**  
Iowa Highway Research Board  
(IHRB Project TR-615)  
Iowa Department of Transportation  
(InTrans Project 09-363)

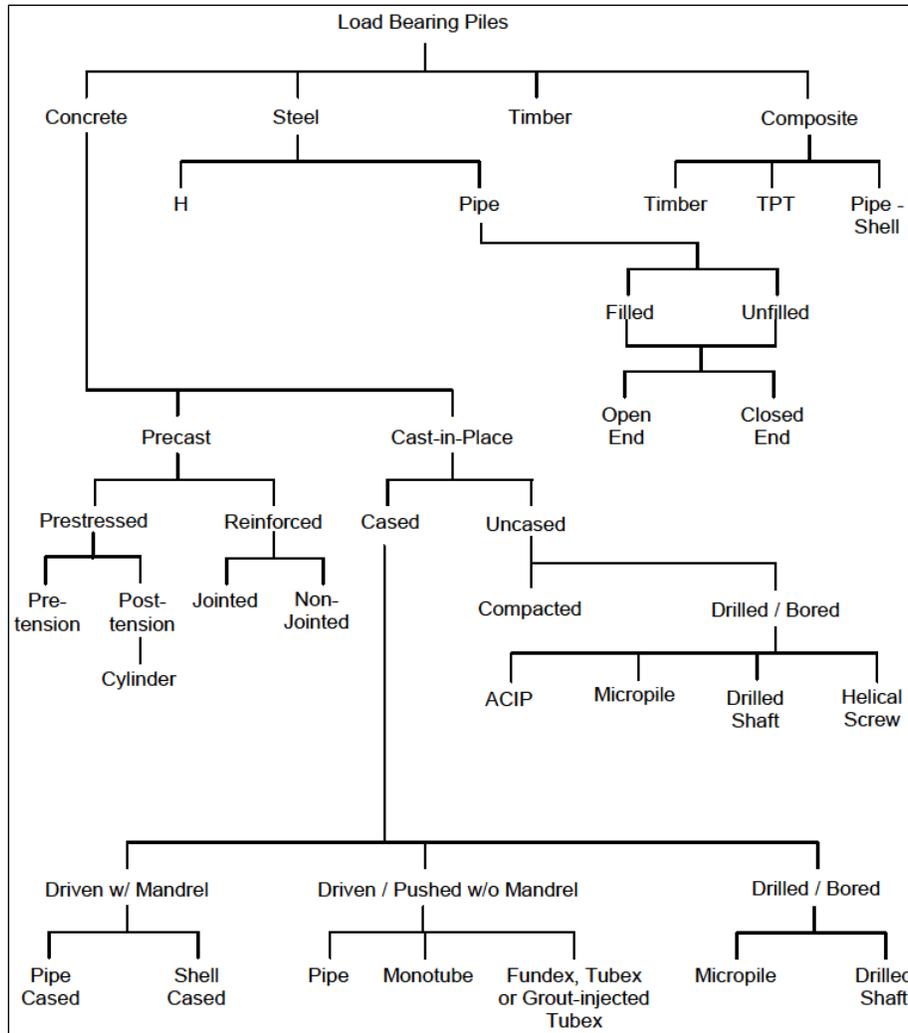
**Figure 1-1. Deep foundation type options**

There are many different types of piles used to support structural loads in the US. The four main categories are concrete, steel, timber, and composite piles, which are then broken up into many subgroups as shown in Figure 1-1.

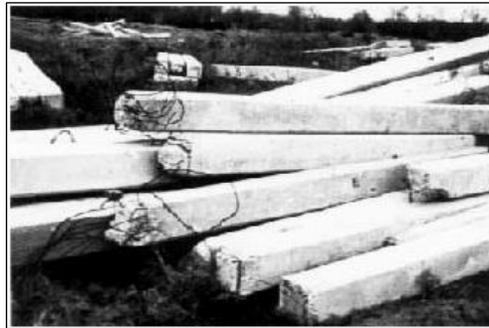
DiMillio 1999

Concrete piles can fail as a result of large compressive stresses developed during driving. This can be attributed to an excessively large driving hammer used during installation or when driving through hard soil conditions. Figure 1-2 illustrates the crushing of concrete due to hard driving conditions for normal concrete piles.

**Figure 1-2. Concrete piles damaged by difficult driving conditions**

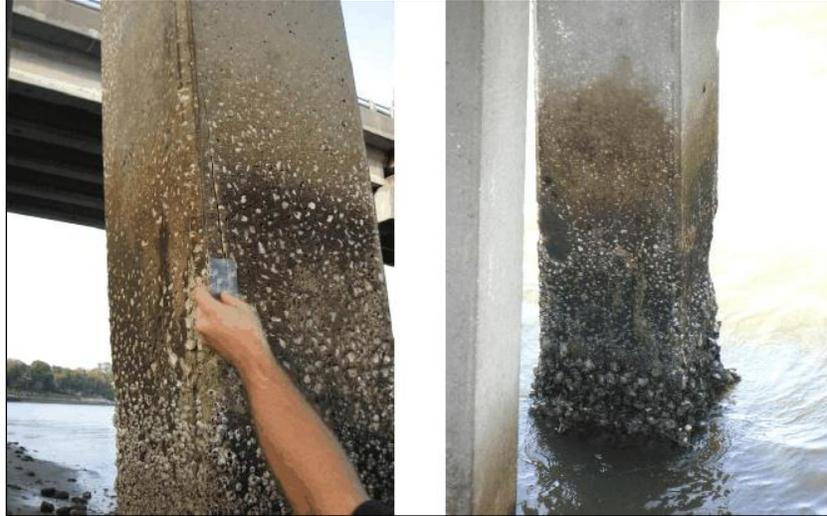
Moser et al. 2011

Precast concrete piles that are subjected to sulfate ions undergo an expansive chemical reaction, which leads to cracking and spalling of the concrete and ultimately a reduction in available structural capacity (Moser et al. 2011). When concrete piles are subjected to chlorides, it is the steel reinforcement that will corrode instead of the concrete itself. As the reinforcement steel expands from corrosion, the concrete bursts. This type of corrosion leads to loss of bond between steel and concrete as well as a reduction in pile capacity (Moser et al. 2011). Figure 1-3 depicts the bursting of the concrete due to corrosion of the reinforcement steel as well as the abrasion of the water.

**Figure 1-3. Damage to prestressed concrete pile due to corrosion**

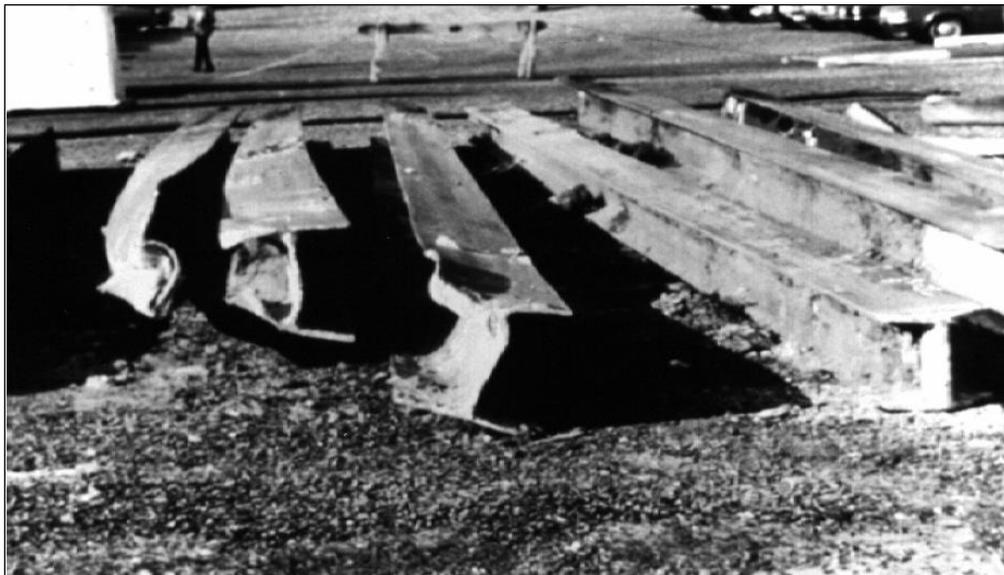
Hannigan et al. 2006b

Steel H-piles are commonly used in Iowa for integral abutment bridges. During driving, the disadvantages of steel H-piles include buckling under harsh driving conditions, as well as the tendency to deviate from the designed location when obstructions are encountered, such as boulders. When driving steel H-piles through very dense gravels or soils containing boulders, the toe of the pile may severely deform and separation of the flanges and web may occur as shown in Figure 1-4.

**Figure 1-4. Damaged H-pile toe**

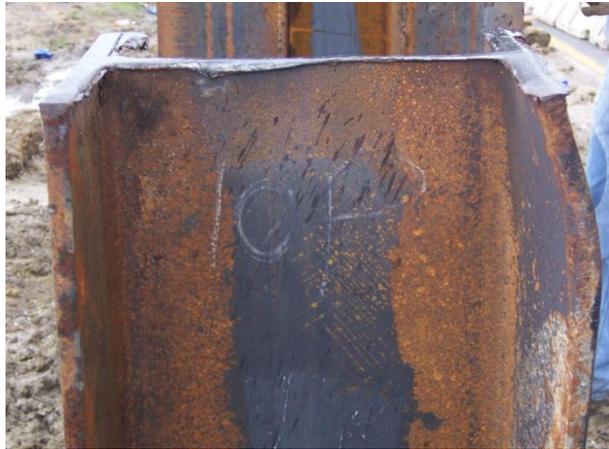
Ng et al. 2011

Additionally, the Iowa DOT requires the top 12 in. of all steel piles to be trimmed due to the expected deformation of the pile head during driving (Iowa DOT 2011), which is depicted in Figure 1-5.

**Figure 1-5. Typical damage to top steel H-piles due to driving**

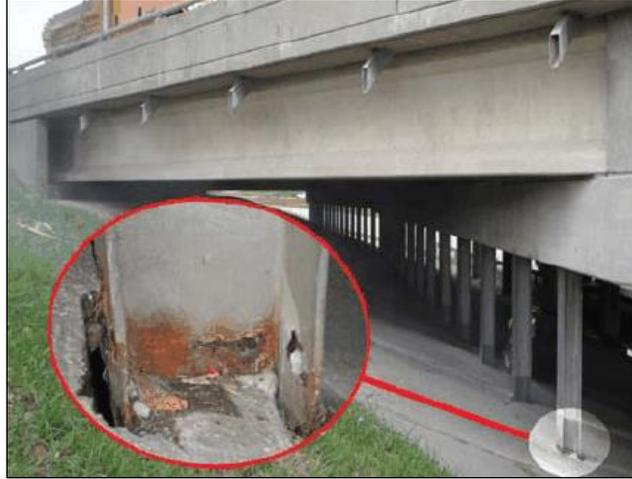
Ehsani et al. 2012, QuakeWrap, Inc. © 2012 National Council of Structural Engineers Associations, used with permission

Corrosion of steel piles does not only happen beneath the soil; Figure 1-6 indicates severe corrosion to the steel H-piles used in a bridge in St. Louis, Missouri located above the soil.

**Figure 1-6. Corroded steel H-pile**

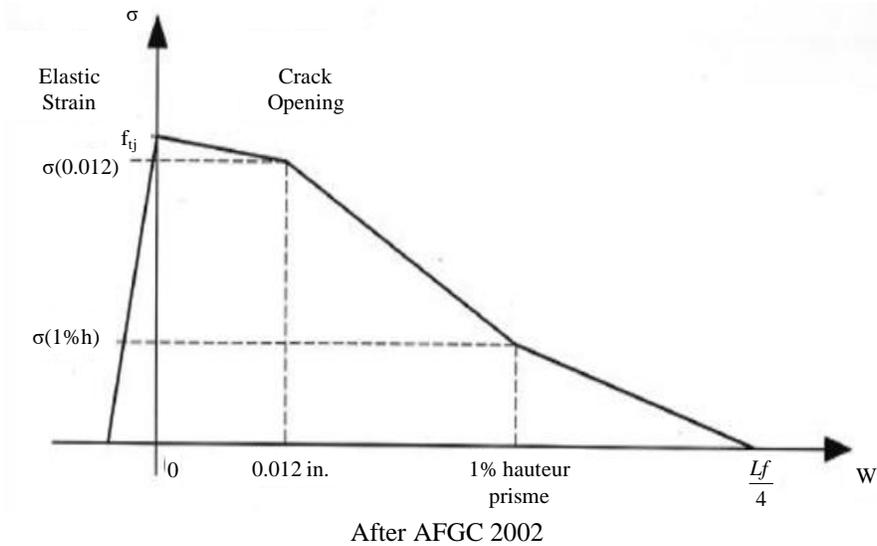
**Figure 2-2. Simplified tensile-strength law**

AFGC (2002) proposed the relationship given in Figure 2-2 for crack width versus stress.

The allowable tensile stress versus crack width for UHPC was given in Figure 2-2. Based on components of UHPC, Vande Voort et al. (2008) reported tensile strain limits for the behavior of UHPC corresponding to the stresses in Figure 2-2. Accordingly, 160 microstrains represents the barrier when micro-cracking begins at the extreme tension fiber, and 1,350 microstrains is when visible cracking begins. The strain limit of the extreme tension fiber to facilitate the fiber to pull out of the UHPC is 2,400 microstrains. The model in Figure 2-2 was updated to include the values as shown in Figure 3-12.

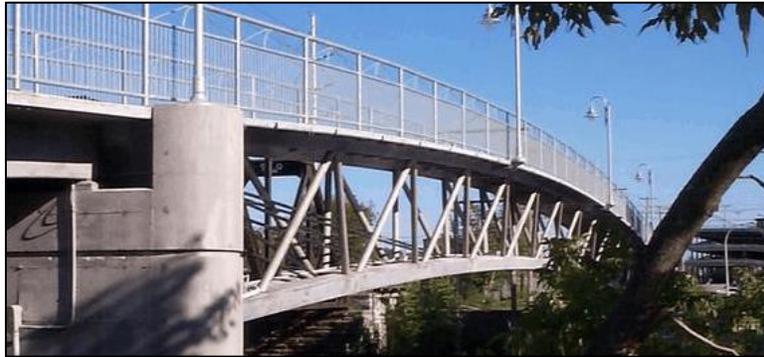
© Ductal 2012, <https://www.ductal.com/en>

Several traffic and foot bridges have been constructed around the world using UHPC for design and construction of the structural components. The first of these bridges was the Sherbrooke pedestrian bridge shown in Figure 2-3, which was constructed in Quebec, Canada in July of 1997.

**Figure 2-3. Sherbrooke pedestrian bridge, Quebec, Canada**

It is the world's first pedestrian bridge to have RPC components. The deck and the top and bottom chord of the open-web space trusses were made with RPC, which had a 29 ksi compressive strength. The web of the truss contained RPC but was confined by stainless steel tubes (Blais and Couture 1999). To date, two other pedestrian bridges with UHPC structural members have been constructed in Canada (Perry and Seibert 2011).

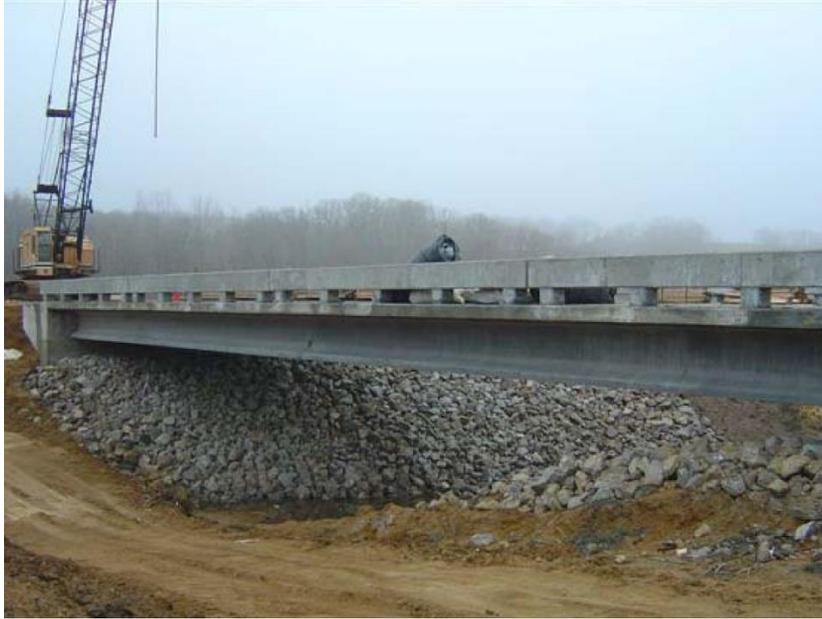
Wipf et al. 2009

The first UHPC bridge in the US was a 110 ft single-span bridge built in Wapello County, Iowa in 2006 using UHPC bridge beams as shown in Figure 2-4.

**Figure 2-4. The UHPC girder bridge in Wapello County, Iowa**

The bridge project allowed researchers to develop a shear design procedure, evaluate the performance of the UHPC girder, and evaluate the structural performance of the bridge (Wipf et al. 2009).

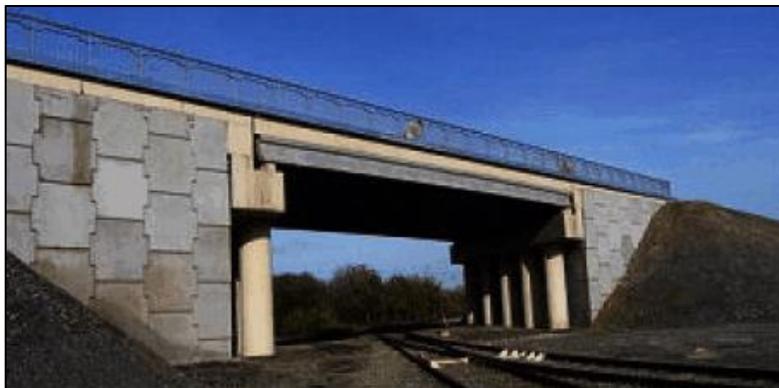
Behloul et al. 2006

In Mayenne, France, the Saint Pierre La Cour Bridge was built in 2005 with two lanes for traffic and one lane for pedestrians and is pictured in Figure 2-5.

**Figure 2-5. Saint Pierre La Cour Bridge in France after completion**

Ductal was used for the pretensioned beams and thin precast deck. The bridge was designed by VSL International and Bouygues Travaux Publics S.A.S. using the new recommendations for the use of ultra-high strength concretes reinforced with fibers (Behloul et al. 2006).

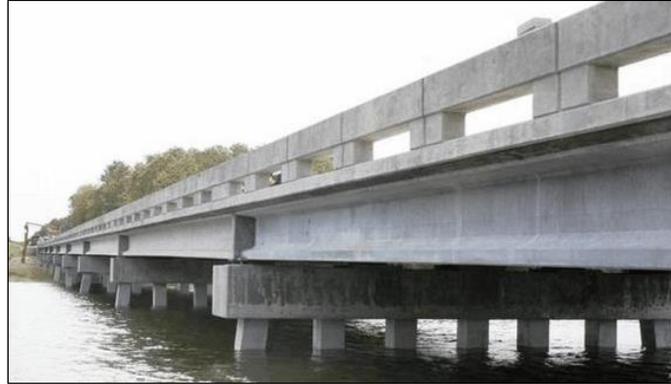
© Ductal 2019, <https://www.ductal.com/en>

The Cat Point Creek Bridge was constructed in 2008 and was the first bridge involving UHPC structural components to be constructed in Richmond County, Virginia. One of the 10 spans of the bridge contains UHPC girders, as shown in Figure 2-6, which were monitored over a period for performance compared to the HPC girders for the other 9 spans (Ozyildirim 2011).

**Figure 2-6. Cat Point Creek Bridge with UHPC girders on one span in Virginia**

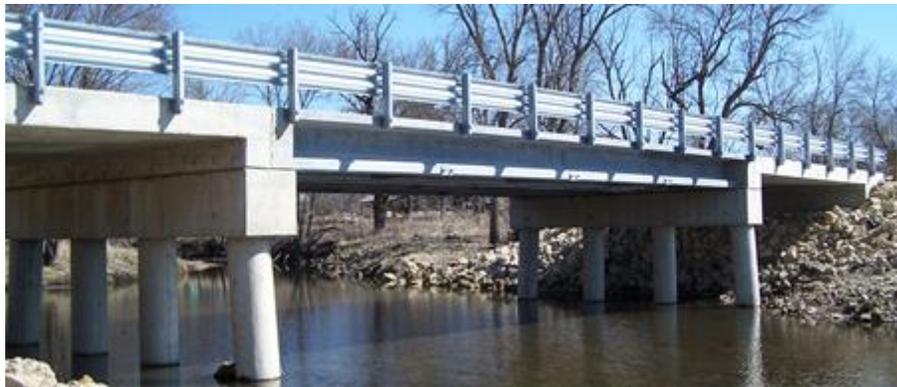
FHWA 2010

Jakway Park Bridge was built using UHPC Pi-girders in Buchanan County, Iowa. This was the first highway bridge using UHPC batched in a ready-mixed truck. The bridge was open to traffic in November 2008 (PCA 2012). A picture of the Jakway Park Bridge is shown in Figure 2-7.

**Figure 2-7. Jakway Park Bridge in Iowa using Pi-girders**

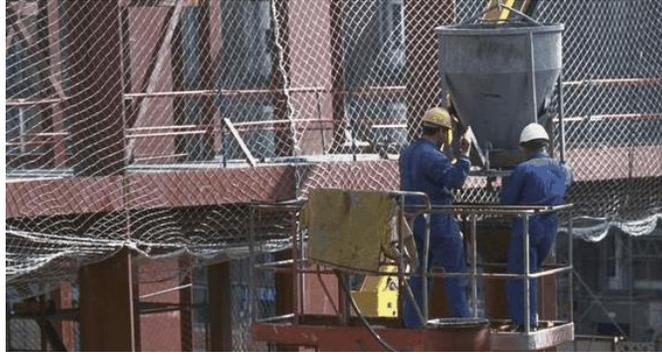
© Ductal 2012, <https://www.ductal.com/en>

The Queen Sofia Museum in Madrid, Spain underwent an expansion by adding three new buildings on a support structure consisting of 24 slender steel columns in 2005. To support the new structures, Ductal was poured directly inside of the steel columns (Ductal 2012). Figure 2-8 shows how the UHPC was handled for the onsite mix and pour of the tall, thin columns.

**Figure 2-8. Onsite pour for UHPC columns during Queen Sofia Museum expansion**

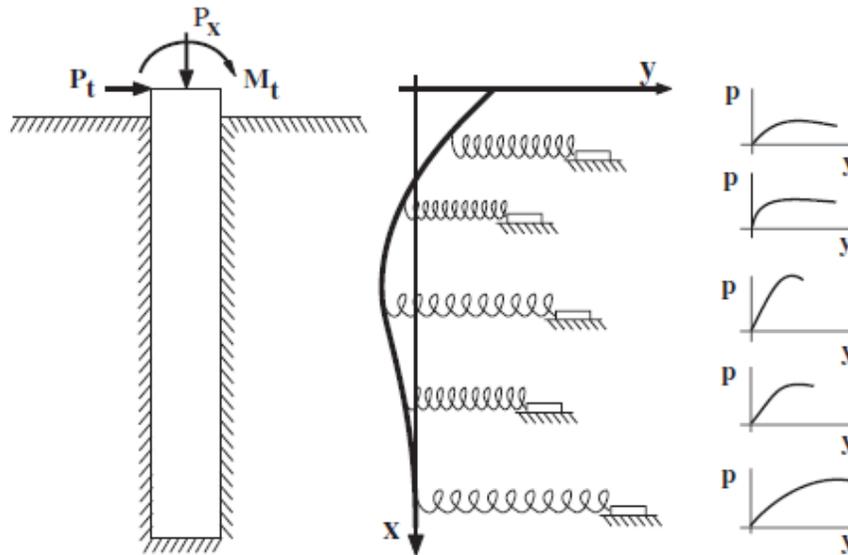
The way LPILE analyzes a pile under a lateral load is by using the concept of Winkler analysis. Figure 2-9 illustrates the model used within LPILE.

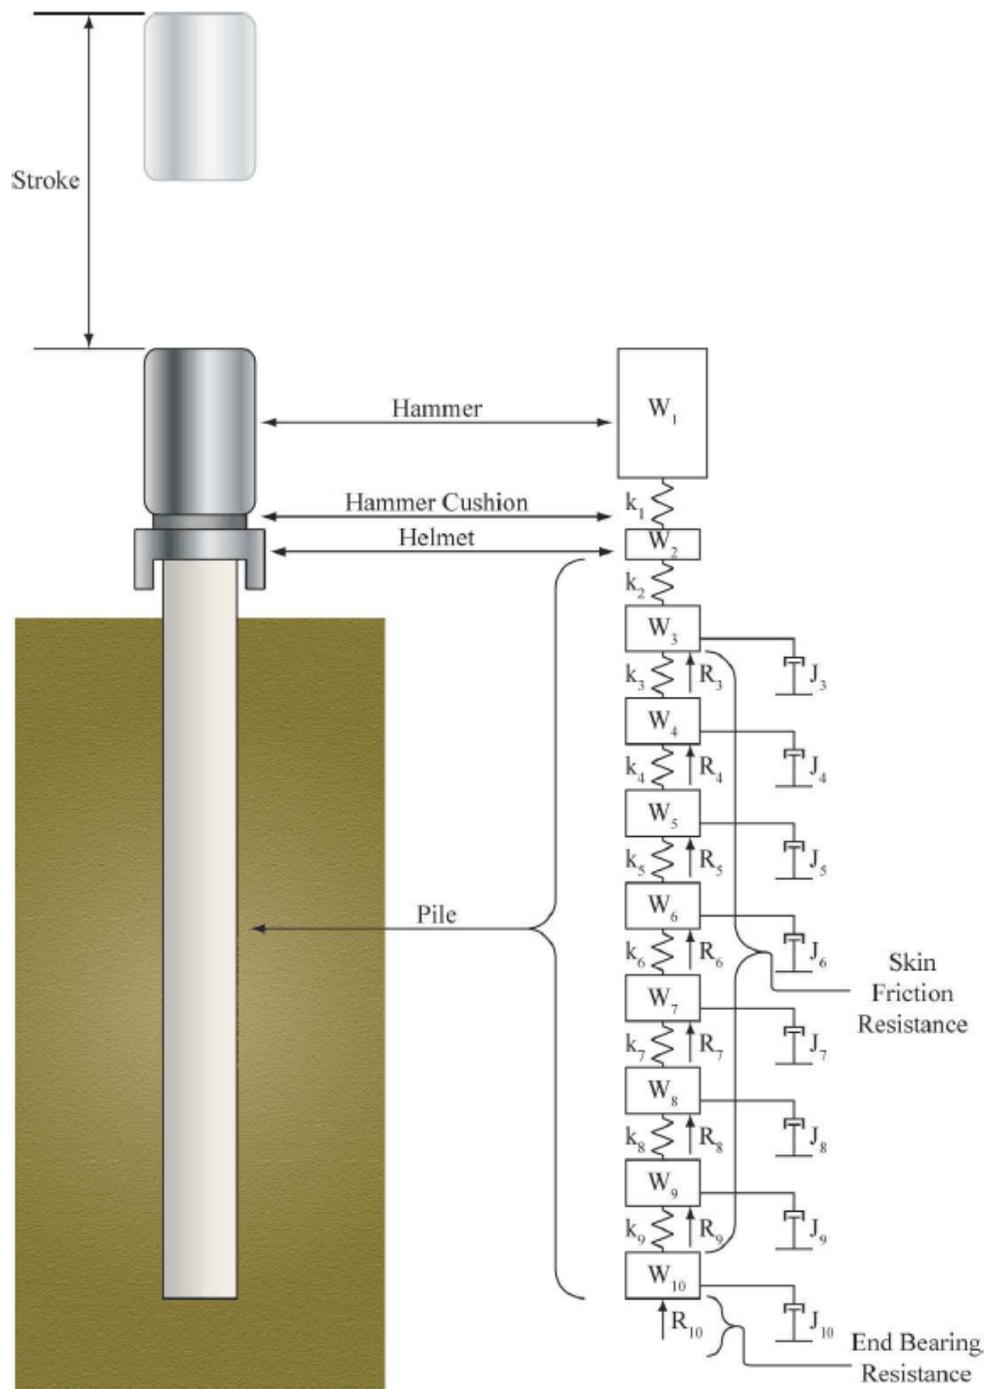
Figure 2-11 illustrates the model of the hammer, pile, and soil system during driving within GRLWEAP.

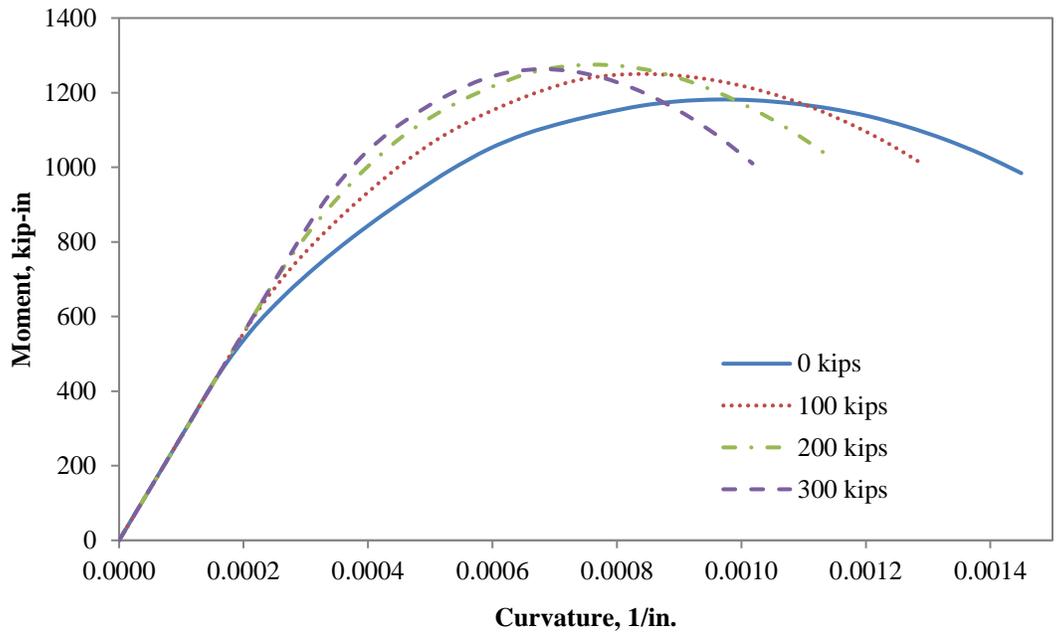
**Figure 3-4. Moment-curvature of the UHPC pile section subjected to weak-axis bending with varying axial loads**

Figure 3-4 shows the moment-curvature response of the UHPC pile section in weak-axis bending subjected to various axial loads.

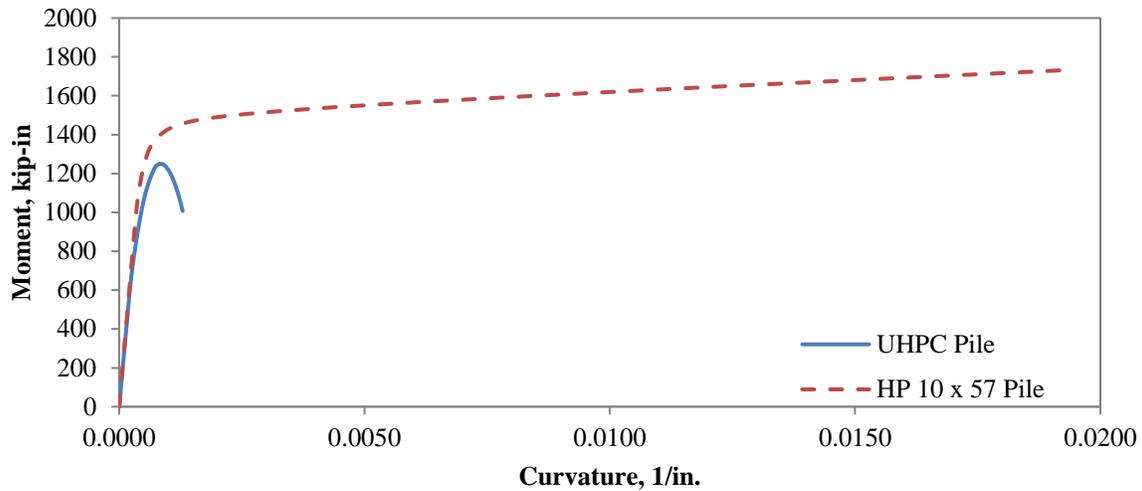
**Figure 3-10. Moment-curvature response at 100 kip axial load comparing a UHPC pile and an HP 10 × 57 pile in weak-axis bending**

A comparison between UHPC piles and steel HP 10 × 57 piles is shown for weak-axis bending in Figure 3-10 at an axial load of 100 kips.

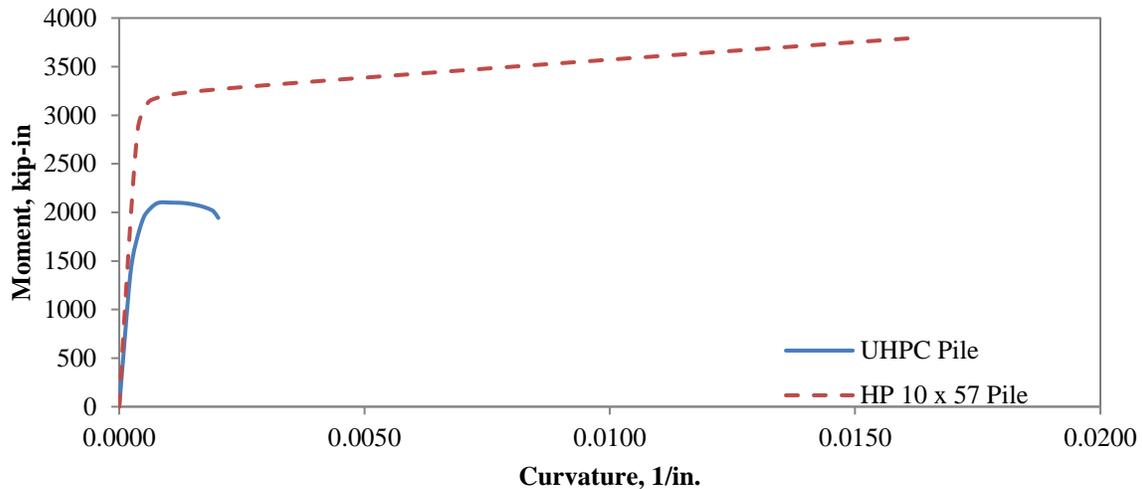
**Figure 3-11. Moment-curvature response at 100 kip axial load comparing a UHPC pile and an HP 10 × 57 pile in strong-axis bending**

Like the weak-axis bending piles, the maximum moment, ultimate curvature, ultimate moment, and stiffness are higher for a strong-axis bending steel HP 10 × 57 pile than a strong-axis bending UHPC pile, as illustrated in Figure 3-11.

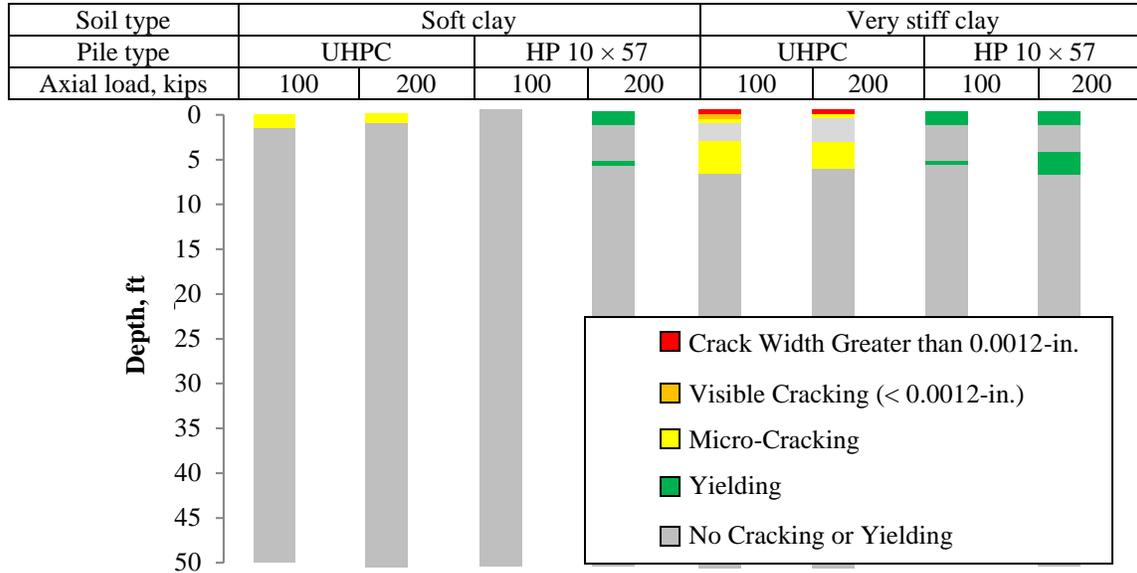
**Figure 3-13. Cracking or yielding along the length of piles subjected to 1.00 in. of lateral displacement without a prebored hole**

Figure 3-13 through Figure 3-16 illustrate the location and extent of flexural cracking along the length of a UHPC pile as well as the location of yielding for steel HP 10 × 57 piles under various conditions.

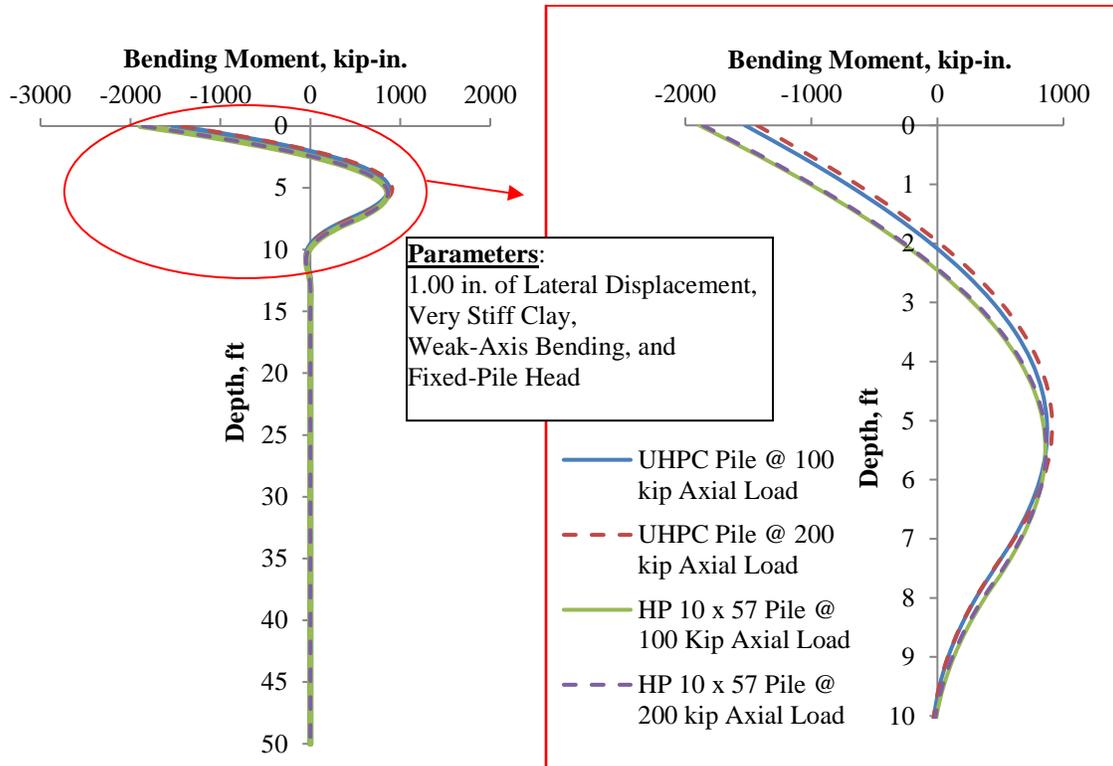
**Figure 3-17. Performance difference between a UHPC pile and an HP 10 × 57 pile**

When comparing the differences in performance between the UHPC pile and the HP 10 × 57 pile while keeping all of the parameters the same, the maximum moments and maximum shear forces induced in both piles are almost identical as shown in Figure 3-17.

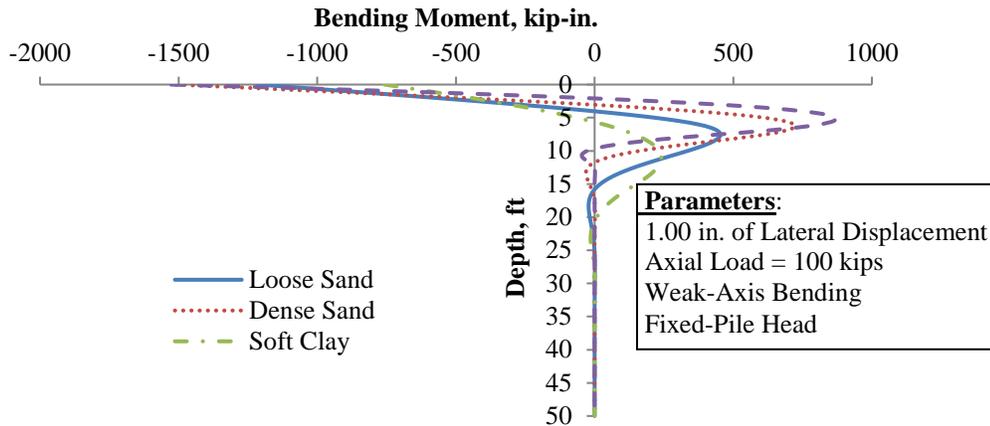
**Figure 3-18. Effect of soil type on UHPC pile behavior**

As the soil becomes softer, the location of the second maximum moment for fixed-pile head conditions is deeper than for stiffer or denser soils. Figure 3-18 illustrates the effect the soil has on the pile’s bending moments.

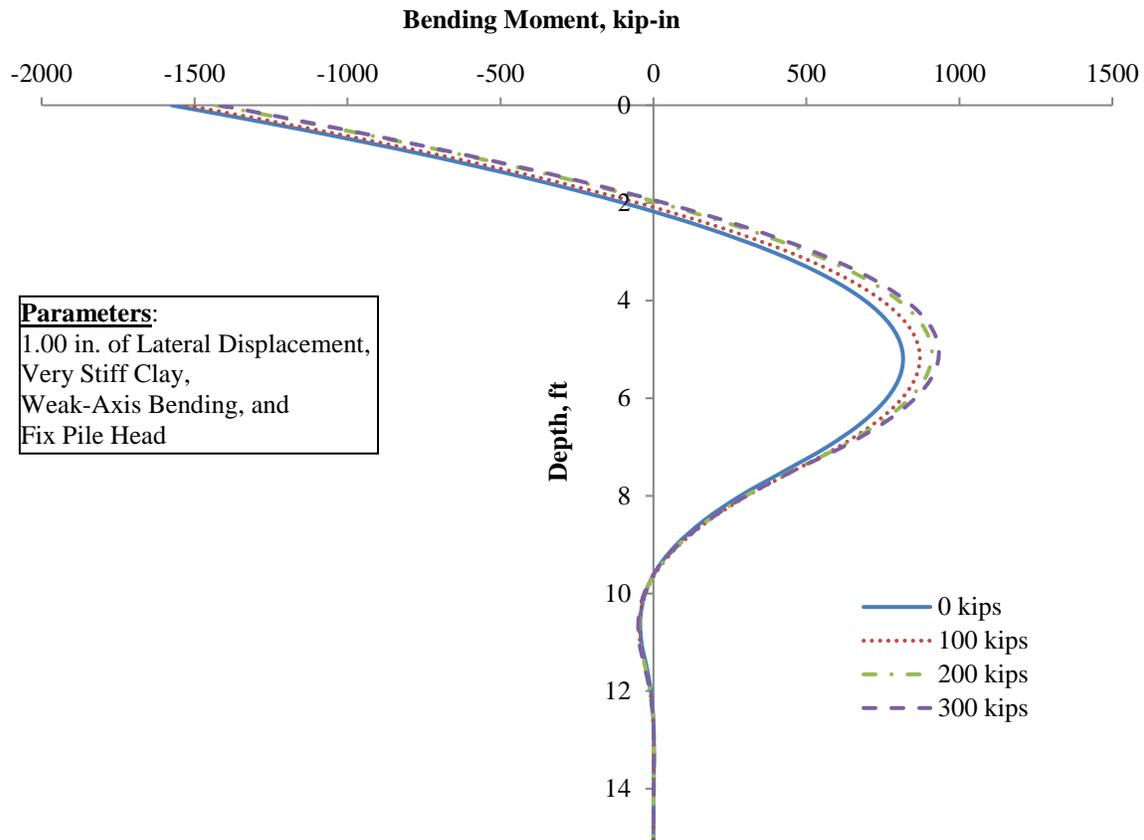
**Figure 3-20. Comparison of bending moment when varying the axial load for UHPC piles**

to weak-axis bending but increased for the UHPC pile subjected to strong-axis bending. For strong-axis, HP 10 × 57 piles, the maximum moment increased from 0 kips to 100 kips but decreased for 200 and 300 kips. Also, the locations of the second maximum moment remains relatively constant, but the magnitude increases as the axial load increases for the weak-axis bending case as shown in Figure 3-20.

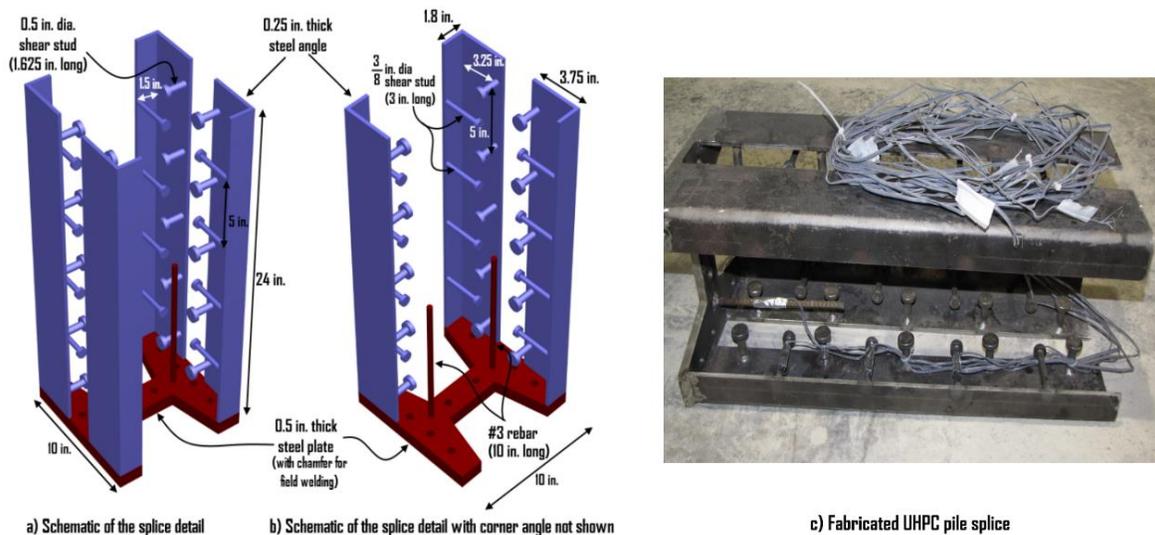
**Figure 4-2. Schematic and fabricated UHPC splice embedment details**

can be estimated using the WEAP analysis. However, in this project, the pile splice was designed to have a minimum of 50% of the UHPC pile capacity in tension. This value was chosen based on the experience of the research team with the level of tensile stresses observed in piles during driving in Iowa soils in previous research projects. For the bridges designed to Iowa DOT standards, the piles are not expected to see any tension in service. So, the chosen value for the splice capacity in tension is conservative. The cross-section of corner steel angles, weld lengths, and thickness were calculated to meet this strength requirement for the splice and details are shown in Figure 4-2.

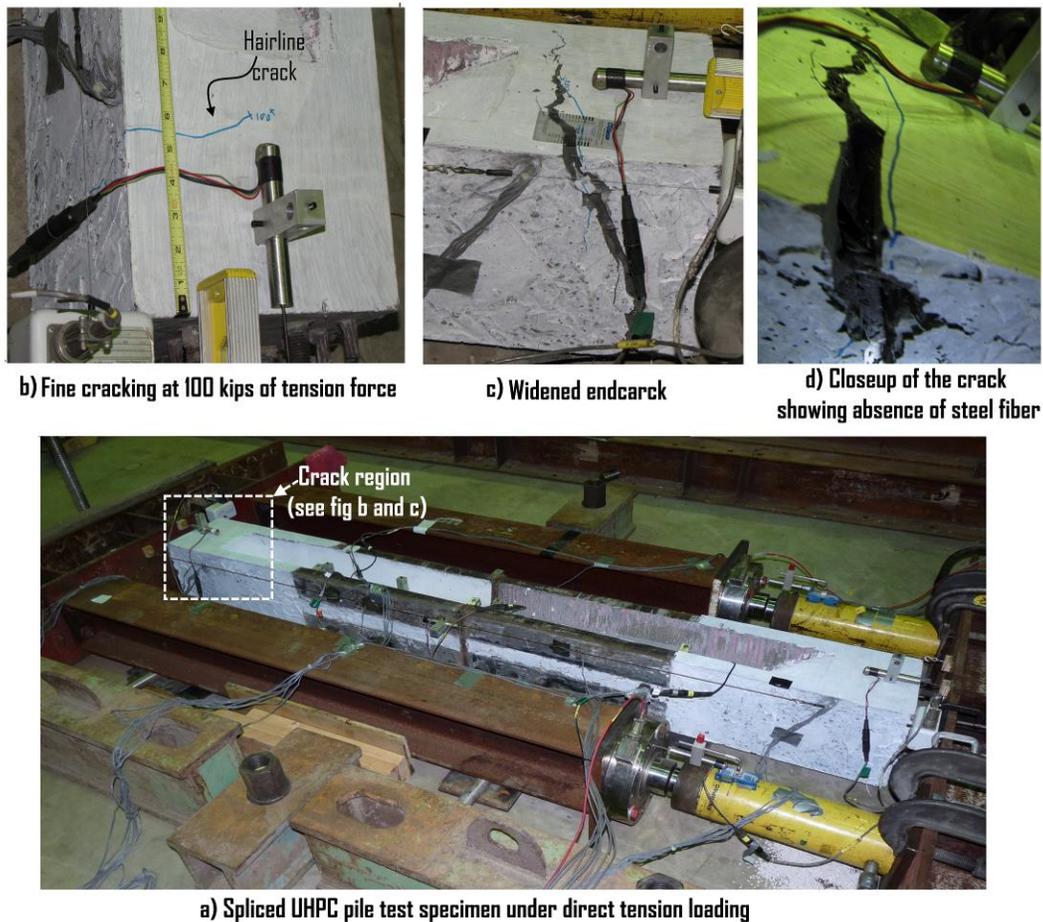
**Figure 4-6. Crack formation in the spliced specimen end region at 100 kips of load**

The UHPC spliced pile was subjected to direct tension load at 10 kips increments using the hydraulic jacks. Both hydraulic jacks were controlled using a single pump to have equal displacements in the hydraulic jacks and thus apply pure tension force on the specimen. During the test, the data from all gages and displacement devices were recorded using a computer-based data acquisition system at a 1 Hz frequency. At a total load of 45 kips, oil leakage from one of the hoses connected to loading jacks was observed. The hydraulic jacks were then unloaded to zero force, and the leaking hose was replaced. All the instrumentation was reinitialized before the loading was reapplied. During loading, at a total load of 103 kips, noises were heard and fine hairline cracks appeared at nearly 6 in. from the right end of the specimen (Figure 4-6b), where the cross-section transitioned to a 10 in. square section.

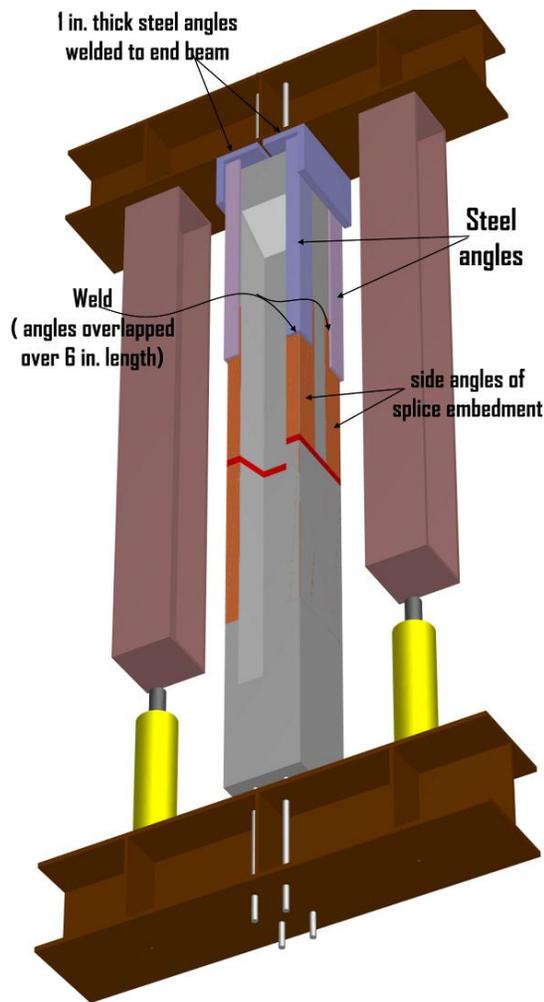
The maximum applied tension load of 103 kips corresponded to 27.4% of the unspliced pile tension capacity. In order to subject the pile splice to tension loads up to 50% of the pile capacity, a retrofit to load application using stiff steel angles was designed and implemented. The retrofit included welding four steel angles to 1 in. thick angles, which were welded to the end beams of the test setup (Figure 4-7a).

a) Schematic of retrofit to test setup to apply tension loads (retrofit shown on oneside only for clarity)

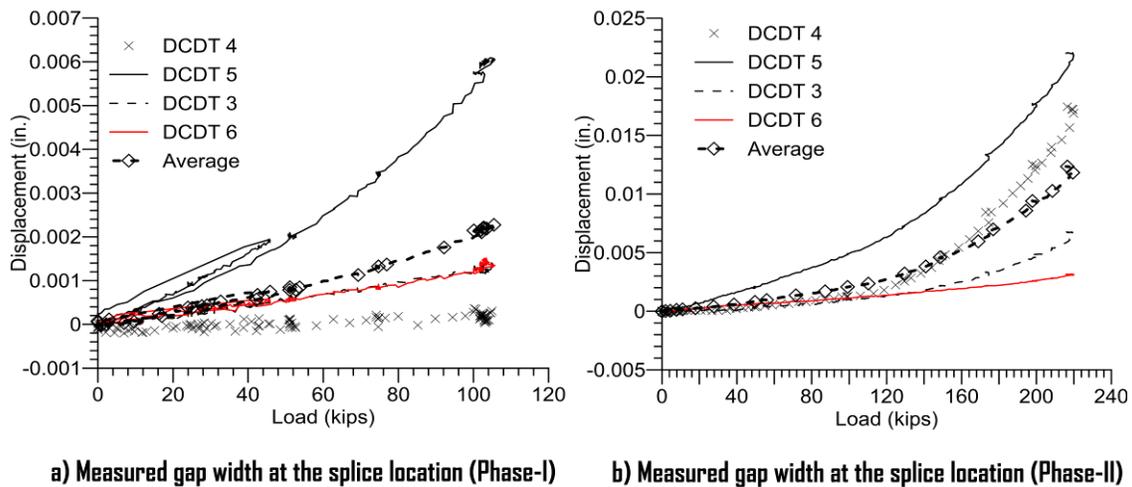
**Figure 4-8. Measured gap width between splice end plate and UHPC at the splice location**

The measured gap/crack opening between the splice end plate and UHPC as a function of load is shown in Figure 4-8.

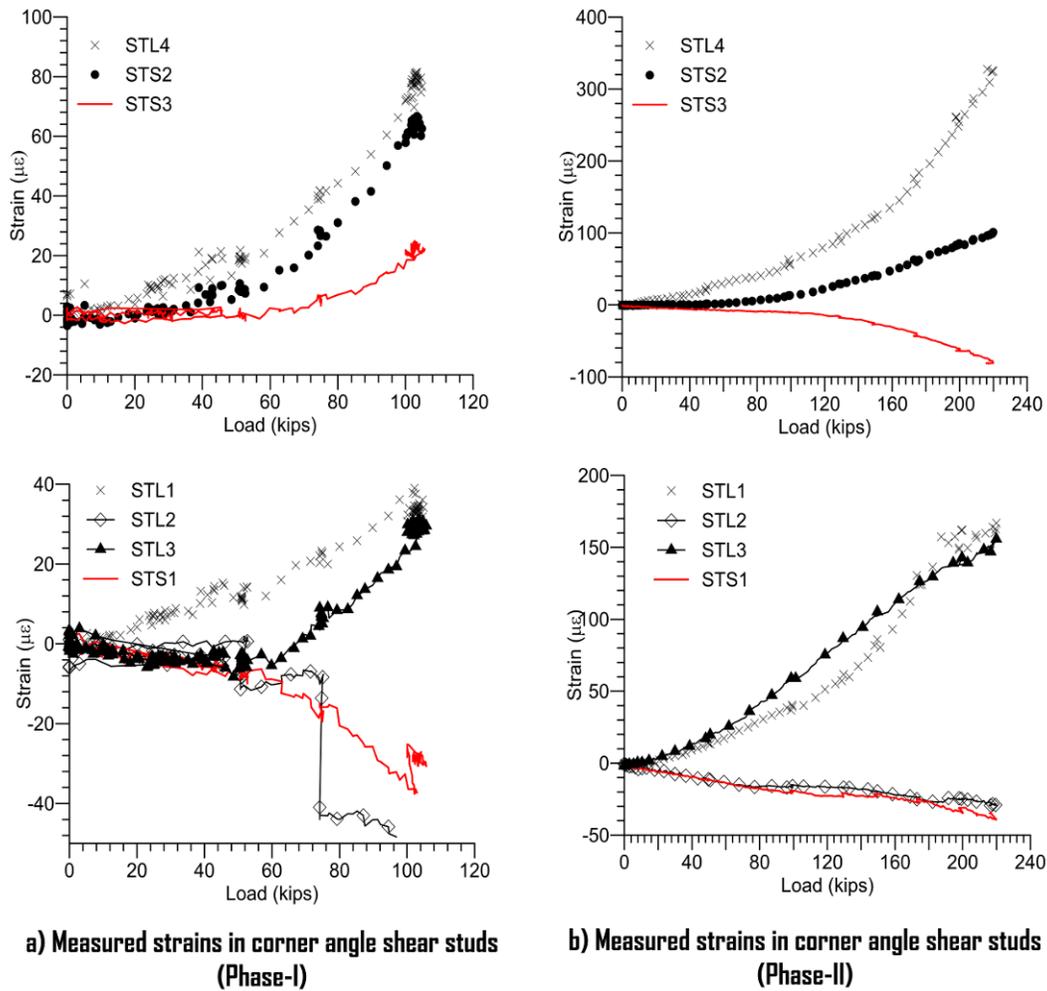
**Figure 4-10. Measured strains in shear studs along the corner angles in splice detail**

The measured strains in the long and short shear studs along the corner angles with respect to applied loading is shown in Figure 4-10.

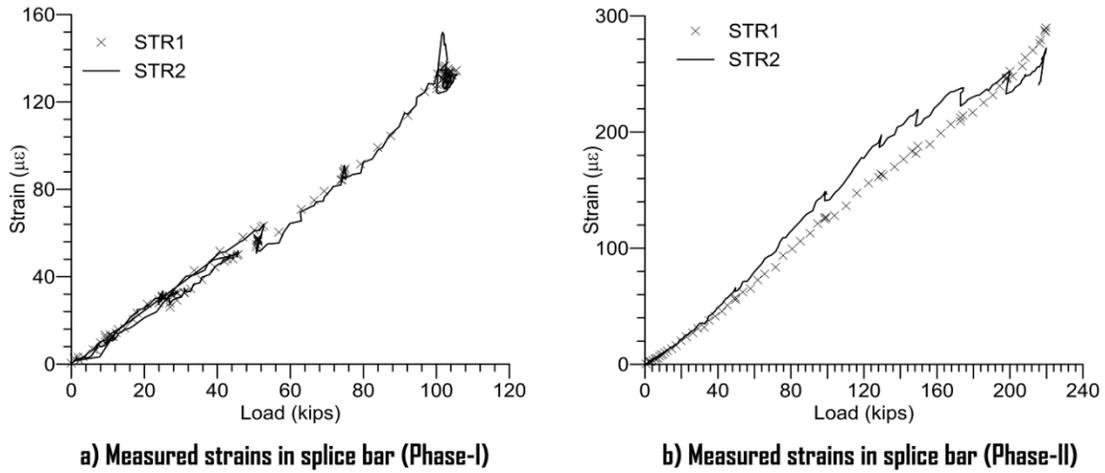
**Figure 4-11. Measured strains in the #3 rebar in the splice detail**

The measured strain in the #3 rebar welded to the splice end plate is shown in Figure 4-11.

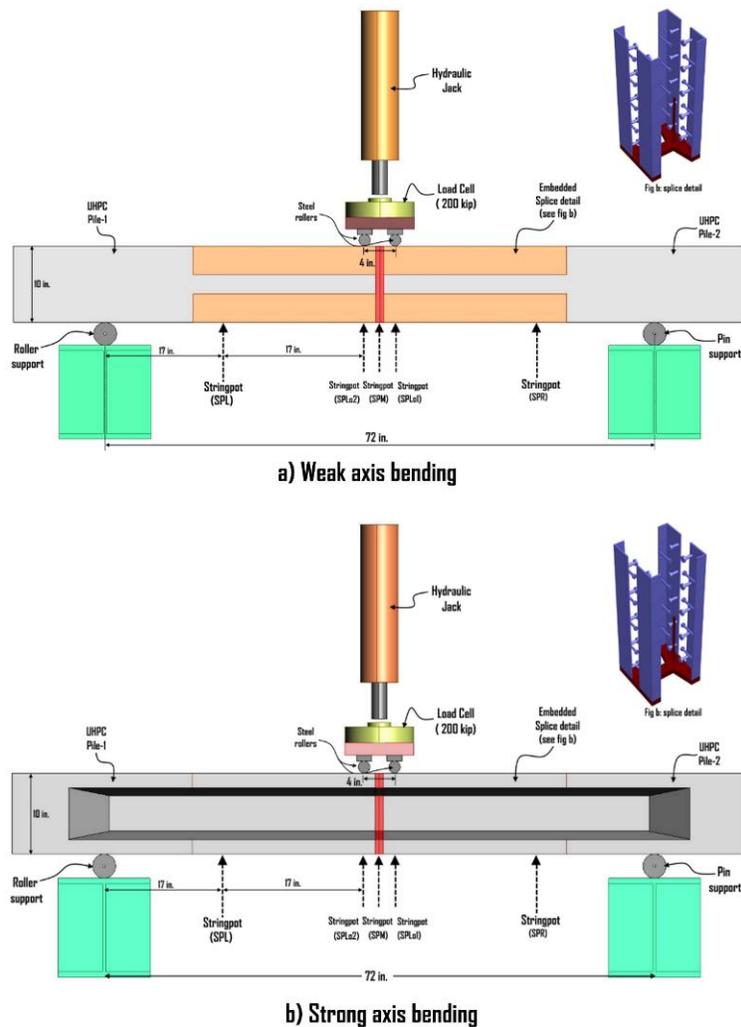
**Figure 4-14. Schematic of the test setup for bending test of splice UHPC pile**

The flexural capacity of the splice connection in both weak- and strong-axis directions were evaluated using a simply supported configuration as shown in Figure 4-14.

Several different types of instruments were used for this study, including LVDTs and string potentiometers to capture deflections and curvature at the splice locations. A total of five string potentiometers were used to measure vertical displacements along the span of the spliced specimens. The string potentiometers were located at the quarter points (i.e., 17 in. from the supports), at the load points (i.e., at 2 in. from center), and at the center (i.e., splice location). The locations and identifications used for these string potentiometers are shown in Figure 4-14 and Figure 4-15.

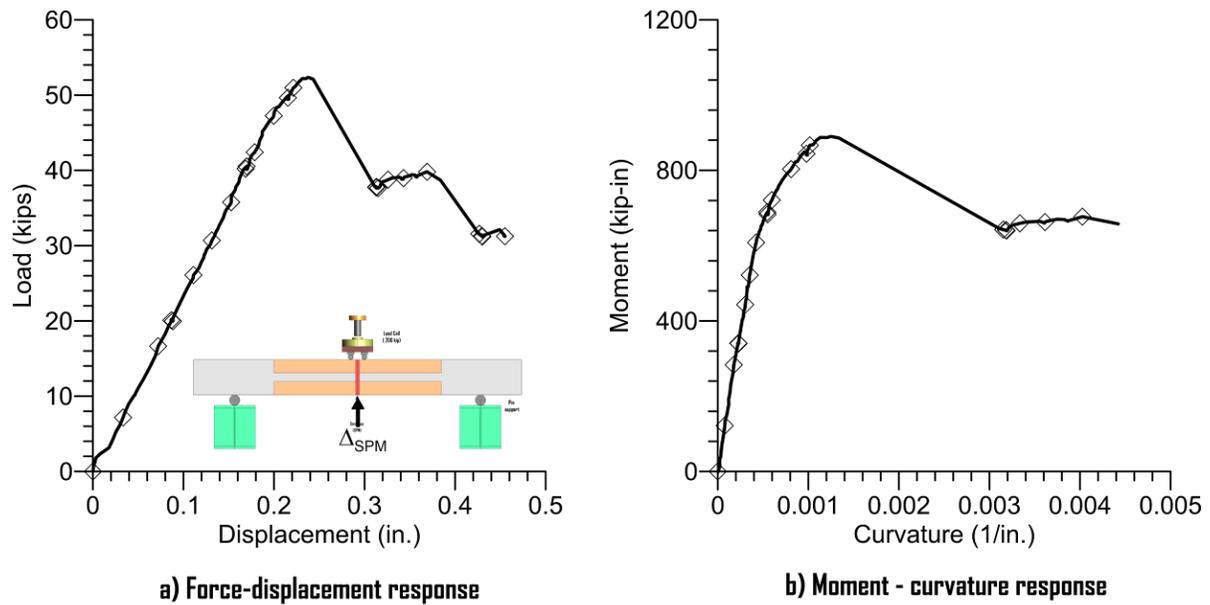
**Figure 4-16. Observed force-displacement and moment-curvature response of splice region in weak-axis direction**

The measured force-displacement and moment-curvature responses of the splice region in the weak direction are shown in Figure 4-16a, and Figure 4-16b, respectively.

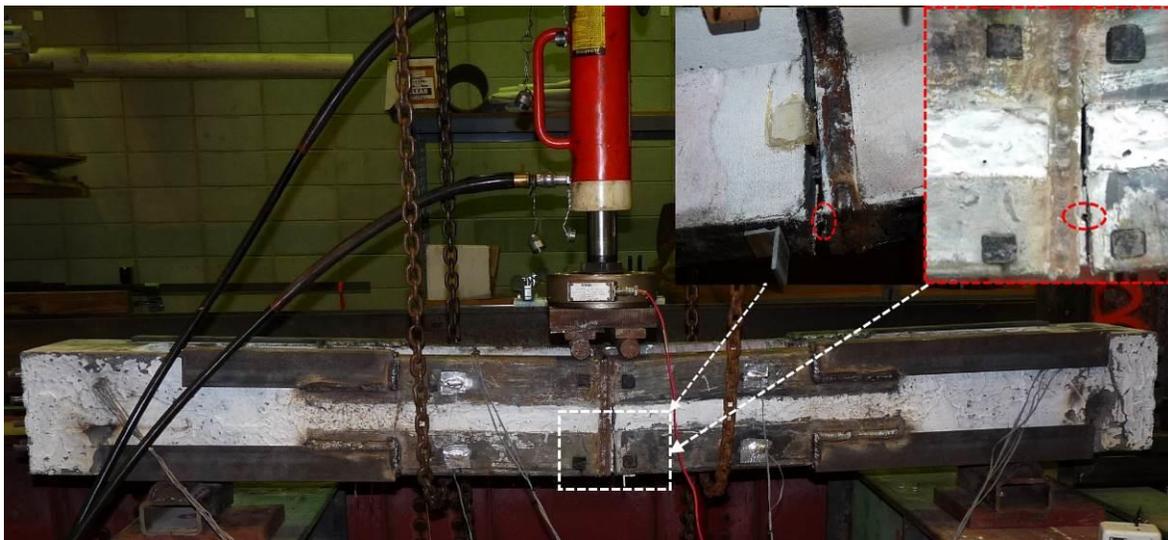
**Figure 4-17. Failure of test specimen in weak-axis bending and close-up of the failed welds**

The curvature at the splice location was calculated using the LVDTs along the height of the splice region. The splice region experienced failure at a maximum load of 52 kips with the fracture of the weld between the corner angles and the 1/2 in. end plate (Figure 4-17).

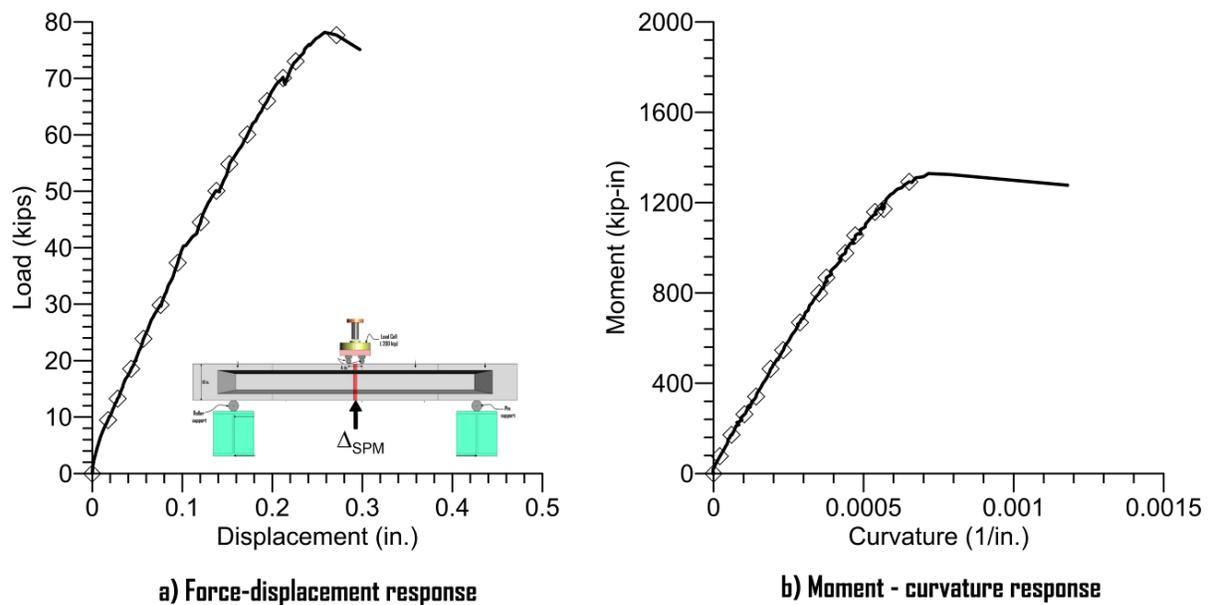
**Figure 4-18. Observed force-displacement and moment-curvature response of splice region in strong-axis direction**

The measured force-displacement and moment-curvature responses of the splice region in the weak direction are shown in Figure 4-18a and Figure 4-18b, respectively.
