# Connection Details and Field Implementation of UHPC Piles – Phase II

**Final Report**  
**September 2019**

**Sponsored by**  
Iowa Highway Research Board  
(IHRB Project TR-615)  
Iowa Department of Transportation  
(InTrans Project 09-363)

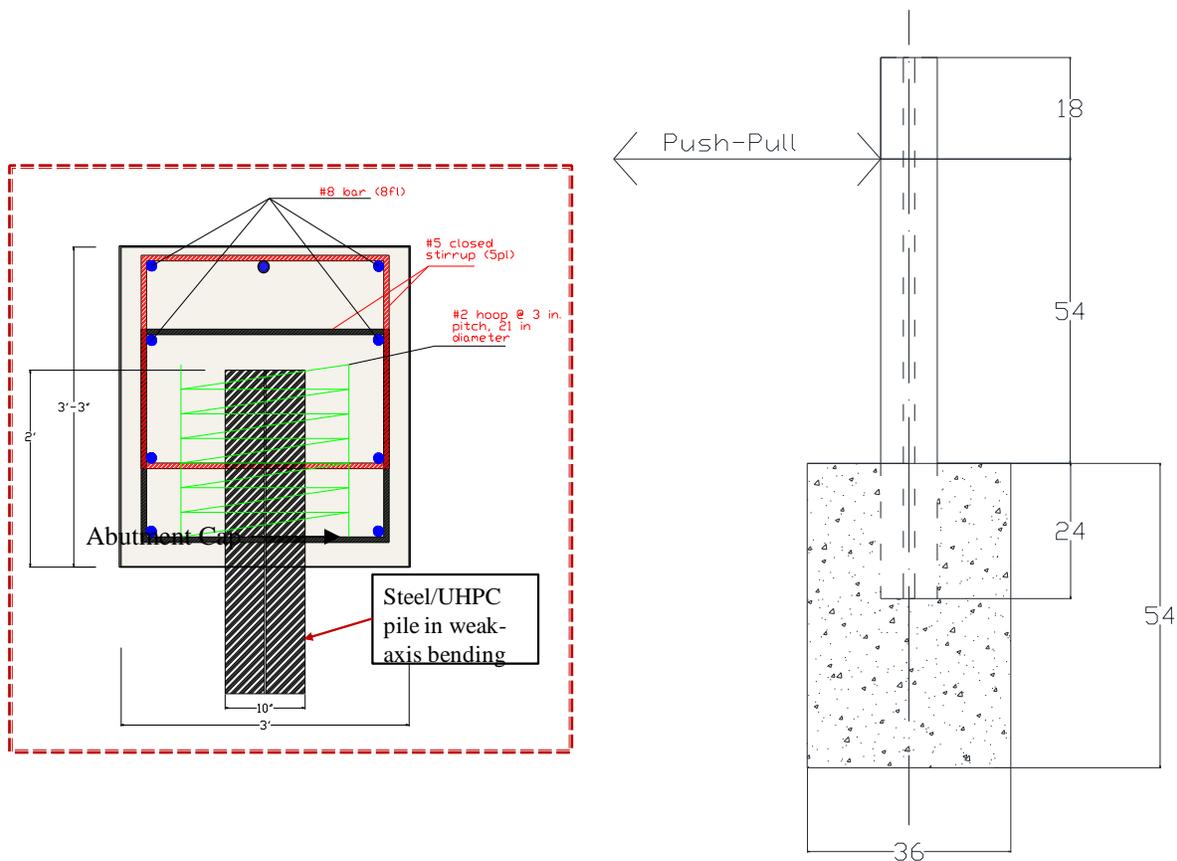
**Figure 5-3. Outer dimensions of the abutment block for SPAC-1 and UPAC-2**

The portion of the section modeled in the laboratory is the blue dotted line box found in Figure 5-2, and it was rotated 180° for ease of construction and testing, which is shown in Figure 5-3.

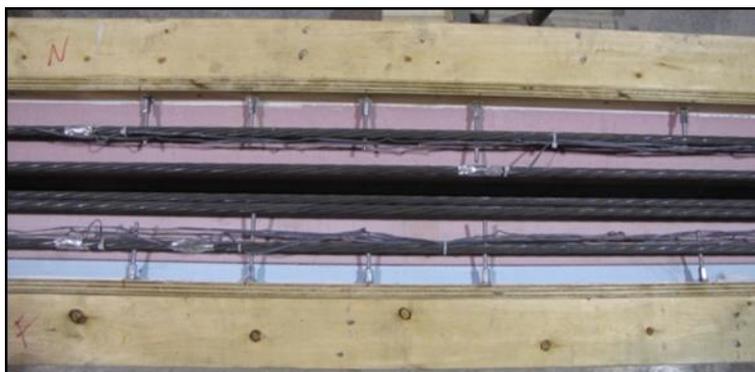
The UHPC laboratory test pile units were instrumented with strain gages on February 8, 2011 at Coreslab Structures, Inc. in Bellevue, Nebraska. The instrumentation scheme for the steel and UHPC test units under weak-axis bending were kept identical and determined from the LPILE analysis results described in Sections 3.2 and 5.3, and the test setup, which is described in Section 5.5. The UHPC pile tests with precast abutment have slightly different instrumentation compared to the weak-axis bending tests. All the UHPC piles were cast with  $\frac{1}{4}$  in. embedded threaded couplers to attach various instruments during testing, as shown in Figure 5-5.

**Figure 5-5. Threaded  $\frac{1}{4}$  in. coupler inserts in the UHPC pile formwork to attach instrumentation**

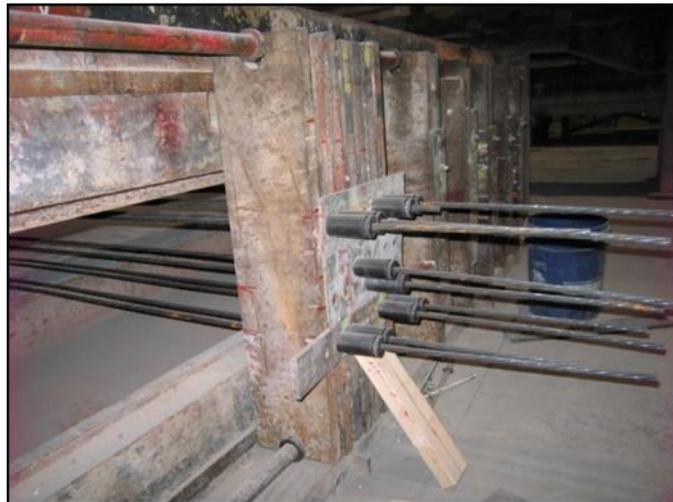
After the Styrofoam was in place, the final six prestressing strands were arranged and stressed to their initial prestress of 202.5 ksi, as shown in Figure 5-8.

**Figure 5-8. Prestressing strands layout at the anchorage end**

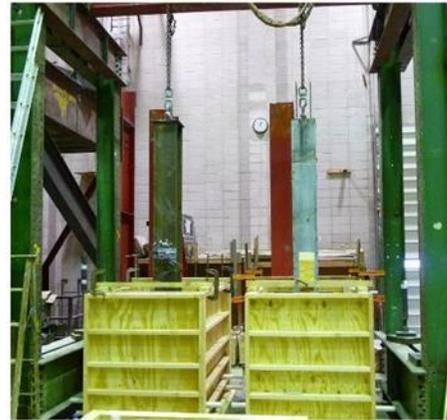
c) Casting setup for Steel and UHPC pile

**Figure 5-10. Reinforcement and construction of abutment specimens for steel and UHPC piles in weak-axis bending**

The formwork for the abutments were made out of plywood and had the specified steel reinforcement inside as shown in Figure 5-10b. The pile specimens were attached to a steel beam and hung in the desired location with 2 ft of the pile head embedded in the pile cap as shown in Figure 5-10c. The abutment caps were constructed using standard Iowa DOT concrete mix with 4 ksi compressive strength. The concrete was batched at Iowa State Ready Mix Concrete plant and transported to the structural engineering laboratory by a concrete truck. The base blocks were constructed on the same day using a 5 ksi concrete, early strength mix. Since the base blocks don't have any influence on the performance of the pile-to-abutment connections, a standard mix design available at the local ready-mixed plant was used. The concrete from the ready-mixed truck was first poured into a concrete bucket, which was lifted with the overhead

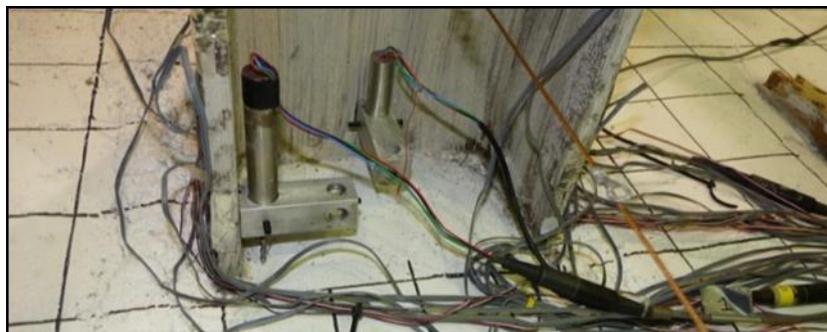
LVDTs, as shown in Figure 5-15, were used to measure the rotation and displacements at different location along the pile.

**Figure 5-15. LVDTs used near the base of the test pile during laboratory testing**

They were attached to the test unit using an epoxy. Rotation meters were also used to measure the rotation of the test unit at three locations on the pile and were also attached using epoxy. A rotation meter is shown in Figure 5-16.

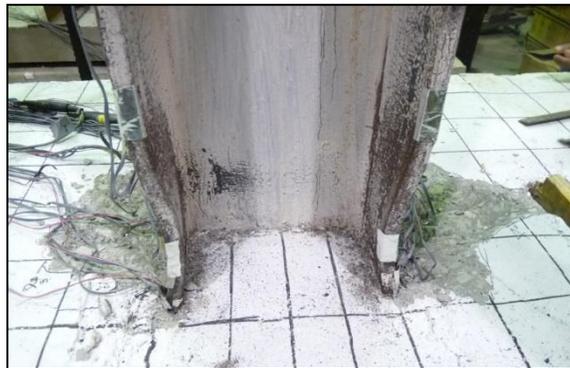
When the lateral displacement became large, buckling of the flanges near the pile-to-abutment interface was visible. Additionally, concrete adjacent to the pile on the top surface started to spall off the abutment cap when the pile was subjected to 4.0 in. of lateral displacement. Figure 5-20 shows the buckling and spalling of abutment cap concrete after the first cycle of 4 in. of lateral displacement.

**Figure 5-20. Buckling of HP 10 × 57 steel pile and spalling at top surface of abutment cap**

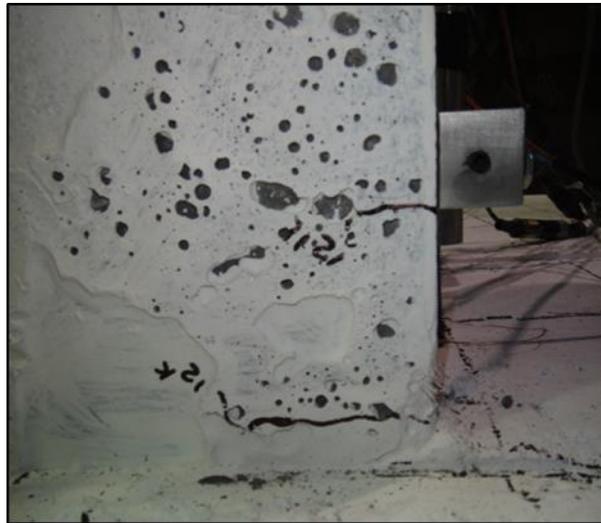
Two hairline cracks as shown in Figure 5-24 developed on the UPAC-1 test pile near the pile-to-abutment interface at a lateral load of 12 kips during Phase I testing with an axial load of 100 kips.

**Figure 5-24. Hairline tensile cracks on UHPC pile in UPAC-1 at 12 kip lateral load step with 100 kip axial load**

Once Phase I testing was complete and the lateral load was returned to zero, all of the observed cracks were completely closed. No new cracks were developed during Phase II testing with the increased axial load. Also, the cracks from Phase I were not visible up to the lateral load of  $\pm 12$  kips in the Phase II testing. During the Phase III testing, minor crushing of UHPC near the base of the pile became visible at 1.0 in. of lateral displacement. Figure 5-25 shows the minor crushing of UHPC after cycling through the three 1.0 in. cycles.

During testing, two hairline tension cracks developed at 12 kips as shown in Figure 5-24, but were completely closed at 0 kip lateral load and 0 in. lateral displacement, and thus they can be considered in the range between micro-cracking and visible cracking. The Iowa DOT deems that hairline cracks are acceptable for UHPC members as long as the widths are negligibly small and are not expected to widen due to repeated loading under the most critical service load conditions (Aaleti et al. 2014). With a higher axial load in the pile, formation of hairline cracks will be delayed. Figure 5-26 compares the force-displacement response between UHPC and steel HP 10 × 57 piles up to ±0.5 in. of laboratory lateral displacement.

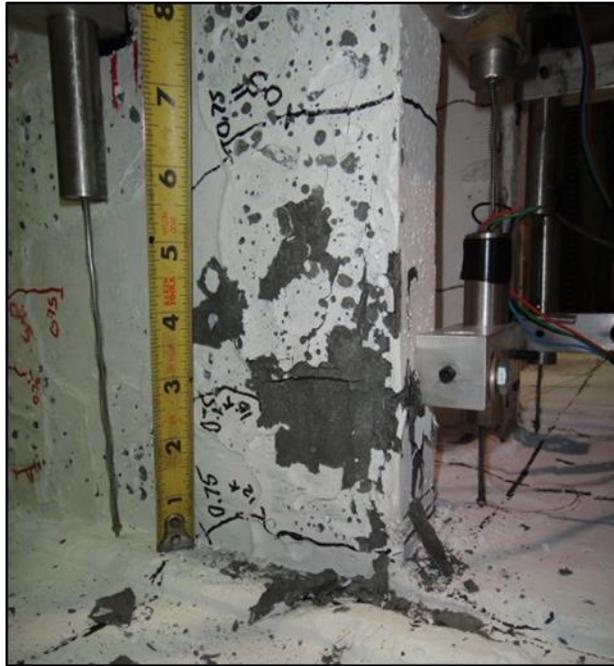
**Figure 5-25. Spalled region of the UHPC pile due to crushing during the UPAC-1 test after completing of the 1.0 in. load displacement cycles**

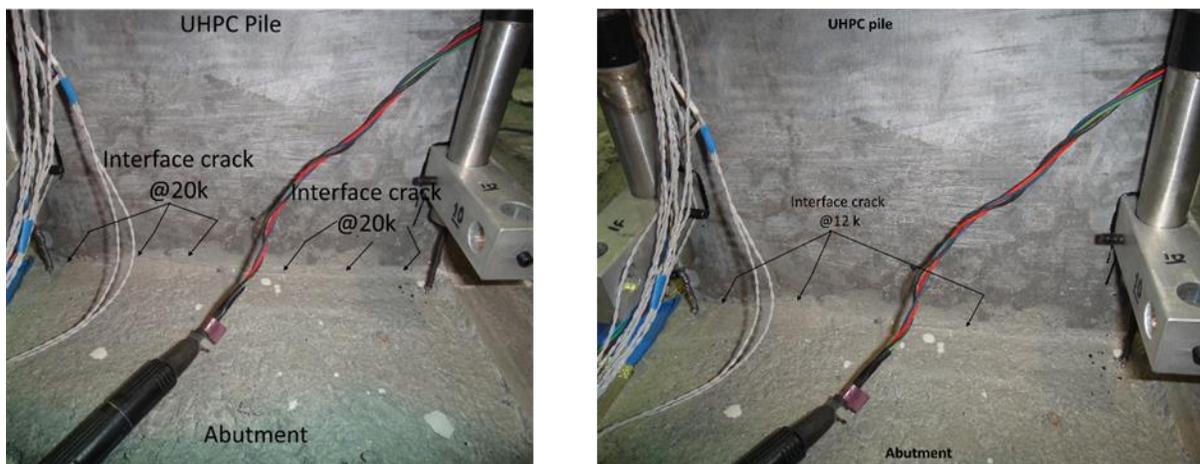
(a) Cracking at interface at 20 k load, Phase I    (b) Cracking at interface at 12 k load, Phase II

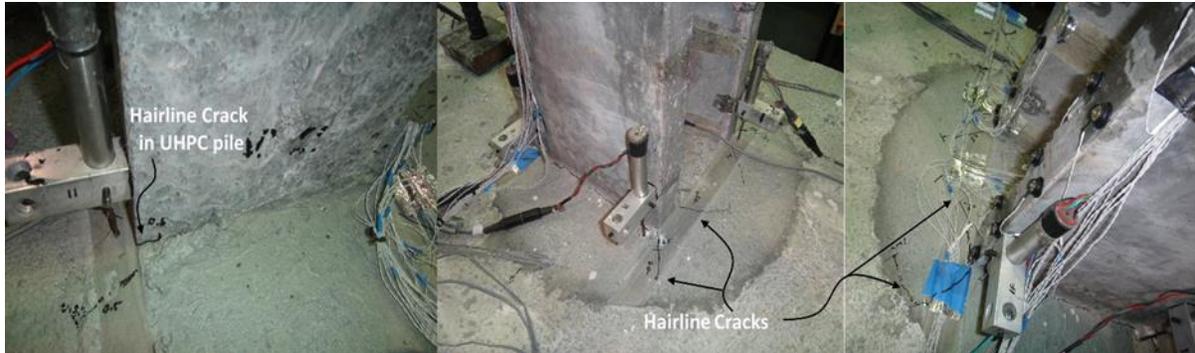
(a) Cracking at 0.5 in. lateral displacement during Phase III testing

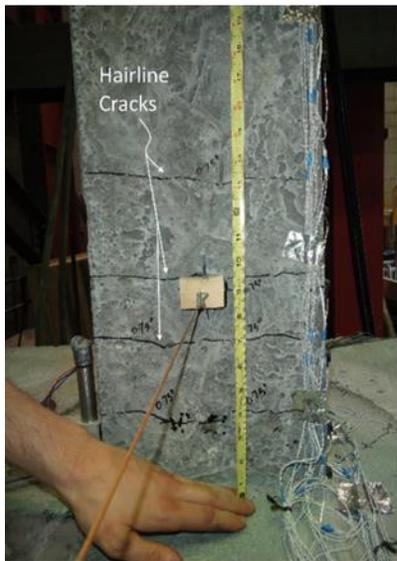
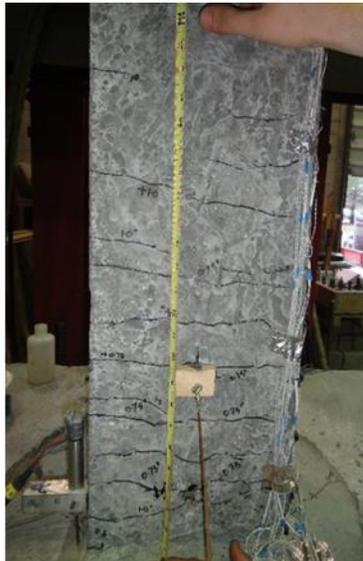
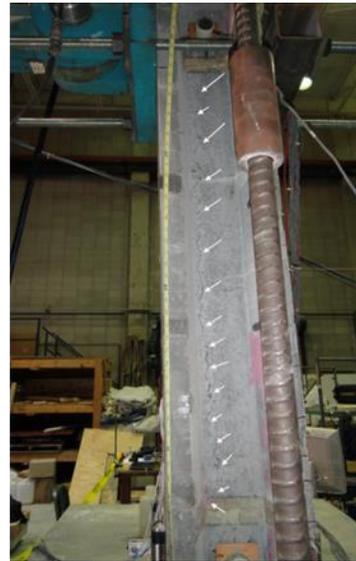
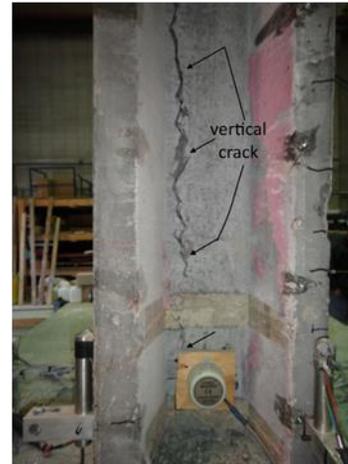
(b) Cracking at +0.5 in.

(c) Cracking at +1.0 in.

(d) Vertical crack at +1.0 in.

(e) Crushing of UHPC in flanges at 1.5 in. (f) Widened vertical crack in web at 1.5 in.

**Figure 5-32. Observed damage in the UHPC pile and abutment during Phase III testing**

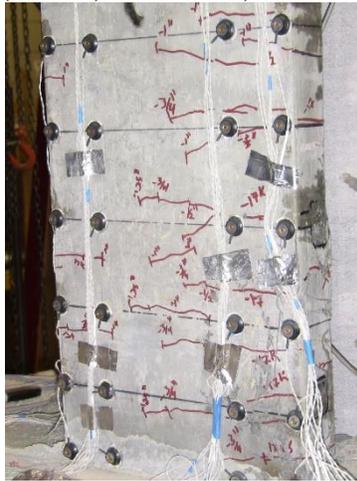
d) Cracking in pile flange at 1.25 in. top displacement (Phase III)

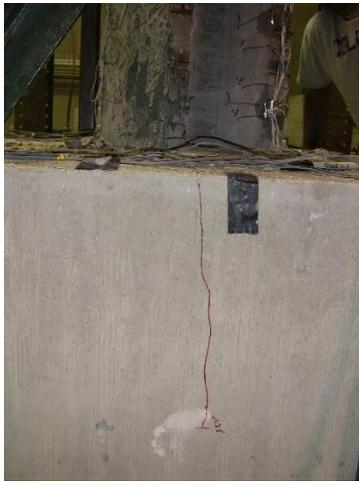
f) Cracking in abutment at 1.25 in. top displacement (Phase III)

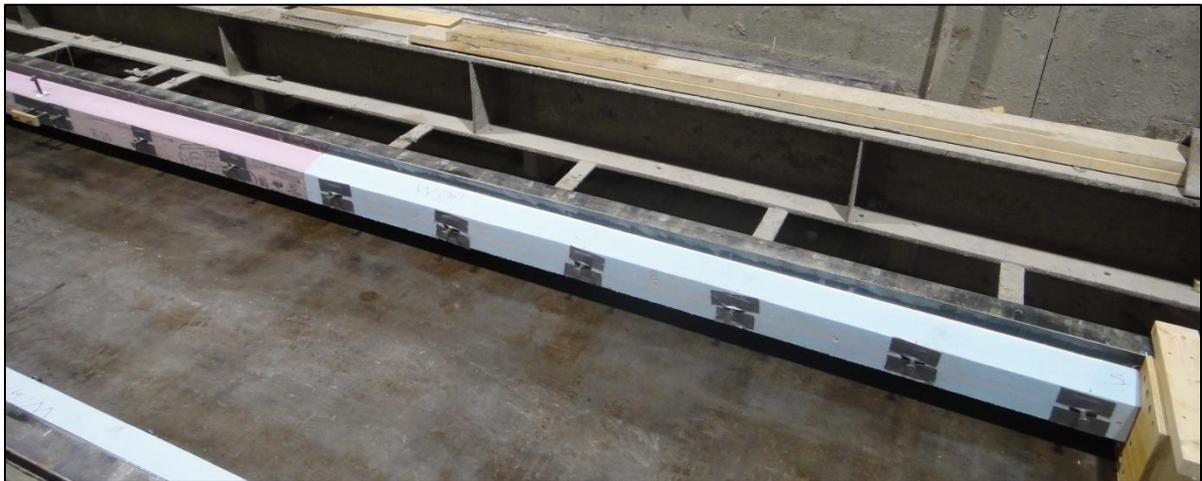
Additionally, steel plates were embedded into the web of the UHPC pile to provide a surface to weld a steel pipe that the ShapeAccelArray (SAA) could be inserted into after driving (Measurand Inc. 2011). A total of twelve 2 in. by 4 in. steel plates that are ¼ in. thick with shear studs welded in the center were embedded into the web of P4 on one side for a total length of 20 ft with a spacing of 18 in. except over the splice where 36 in. spacing was used. The Styrofoam inserts were cut at the location of the steel plates so that the plate would fit inside of the Styrofoam so not to reduce the area of the web too much as shown in Figure 6-3.

**Figure 6-3. Locations of steel plates embedded into P4**

The shear stud was the only part of the plate and shear stud combination that would be embedded in the UHPC.

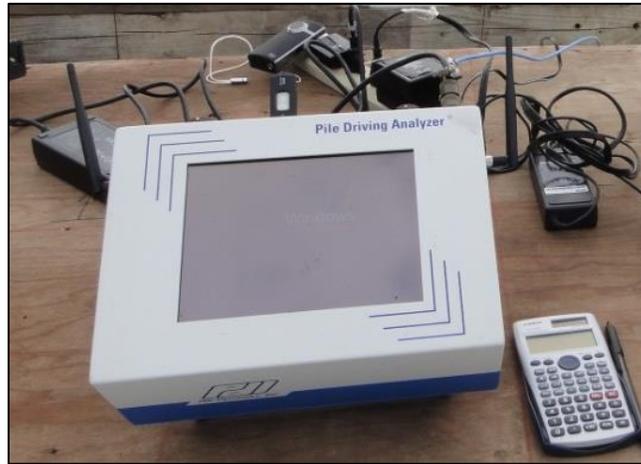
driving of the UHPC pile. The readings were wirelessly transmitted to the PDA unit provided by the Iowa DOT as shown in Figure 6-5.

**Figure 6-5. PDA unit provided by the Iowa DOT**

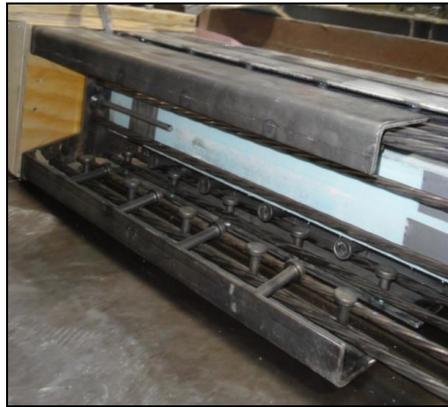
The two fabricated splices were installed as shown in Figure 6-11.

**Figure 6-11. Splice at a UHPC pile end prior to placing the formwork**

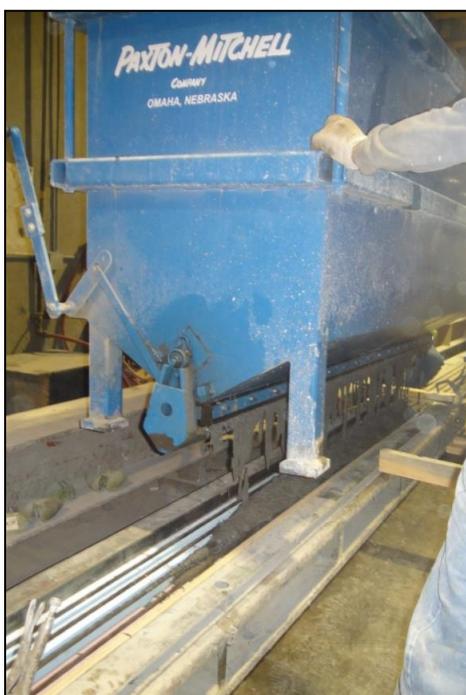
**Figure 6-14. Pouring the UHPC from the bin into the forms**

The UHPC was poured into the forms for all of the field test units and production pile as depicted in Figure 6-14.

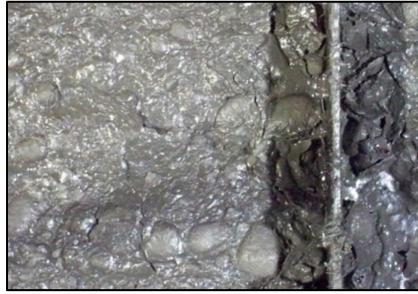
**Figure 6-15. Clumps in UHPC after batching for the 11/21/2011 pour**

Test pile P3 was poured on November 21, 2011 at Coreslab Structures, Inc in Bellevue, Nebraska. The UHPC used for P3 had clumps of cement as shown Figure 6-15.

The clumps are thought to have been caused by the age of the Ductal material, and the clumps came from the bags at the bottom of the pallet used to store the UHPC mix.

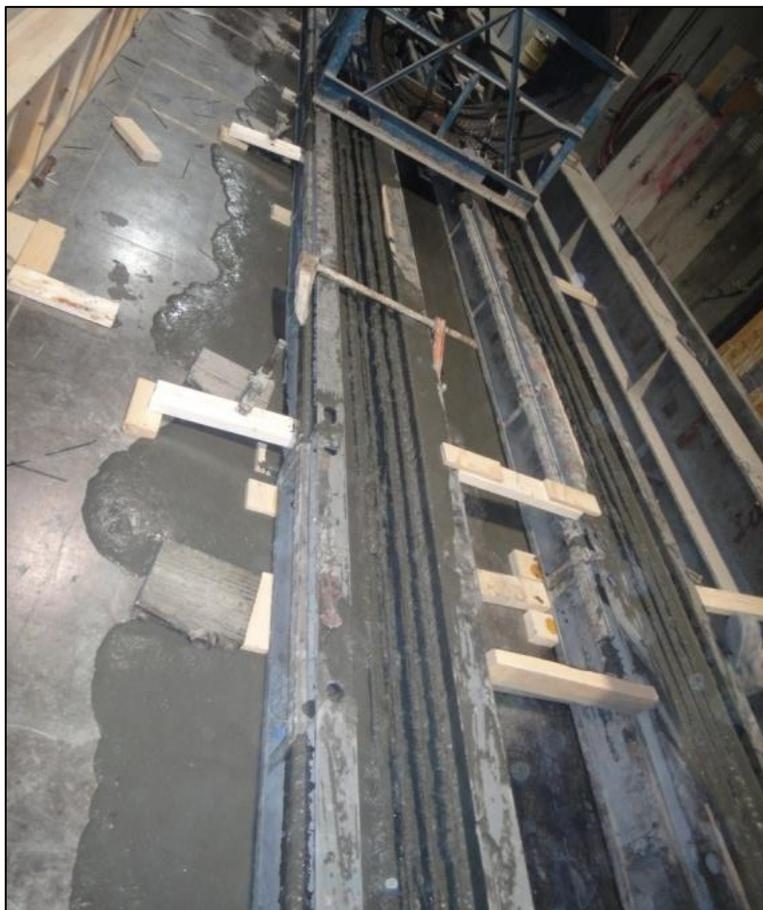
**Figure 6-16. Steel forms beginning to tilt causing UHPC to leak**

Once the concrete was batched and transported to the casting bed, the UHPC was poured into the forms. As the forms began to be filled with UHPC, the formwork shifted, and UHPC leaked out from underneath the formwork and caused the forms to start floating as shown in Figure 6-16.

The concreting was paused to reposition the forms and weigh them down, so they would stop floating. To weigh the forms down back into position, rolls of prestressing strands and large concrete blocks were lifted by the crane and placed on top of the formwork. There was a waiting time of about 55 minutes before pouring continued. The UHPC left inside of the forms was raked to join the two layers together.

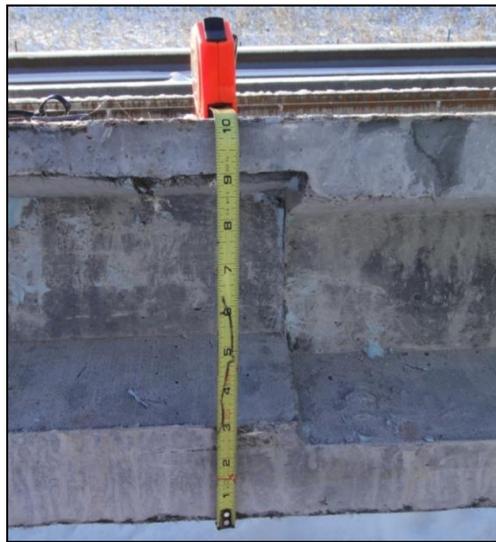
**Figure 6-17. Change in the flange thickness of P3**

After the forms were stripped, some noticeable defects were found. Figure 6-17 indicates that the Styrofoam portion of the form became detached and began to float for one of the form sections.

No cracking from the prestressing was found on the top side where the flange was only 1 in. thick instead of the specified 1.8 in. It was decided to use P3 for field testing even with the identified defects.

As mentioned in Section 6.4.4, there were some defects in the pile from the prefabrication process. One of the defects is an inconsistent flange thickness near the pile head, which could cause a change in stiffness and an unsymmetrical cross-section.

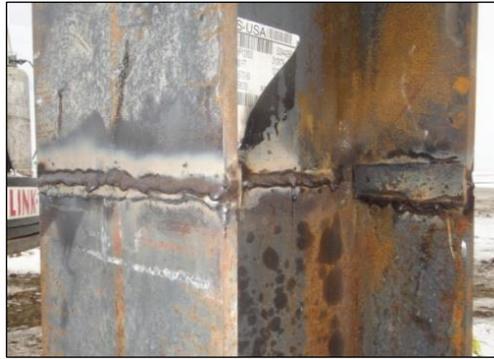
**Figure 6-24. Steel HP 12 × 53 butt-weld splice**

Since the anchor piles were specified to be 80 ft in length, two 40 ft sections were spliced together for the anchor pile. After the first 40 ft section was installed, the second 40 ft section was picked up by the crane, and the two piles were spliced together by a butt-weld shown in Figure 6-24.

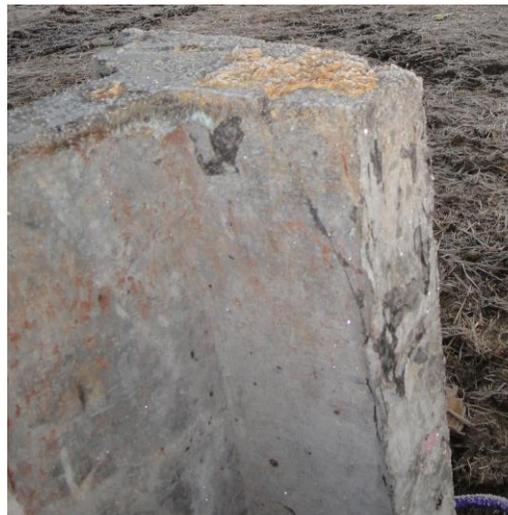
**Figure 6-26. Slight damage observed to P3 pile head after driving the pile in place**

A 4 in. plywood pile cushion was used for the UHPC test piles, but both P3 and P4 punched through the pile cushion shortly after driving had begun. Instead of replacing the cushion with a new cushion, the pile was driven with essentially no cushion based on the experience in Phase I (Vande Voort et al. 2008). There was slight damage to P3 and no visible damage to P4 as shown in Figure 6-26 and Figure 6-27, respectively.

The reason for the damage to P3 was the pile head was not perfectly centered under the helmet. It is also important to note that P3 tilted slightly during driving.

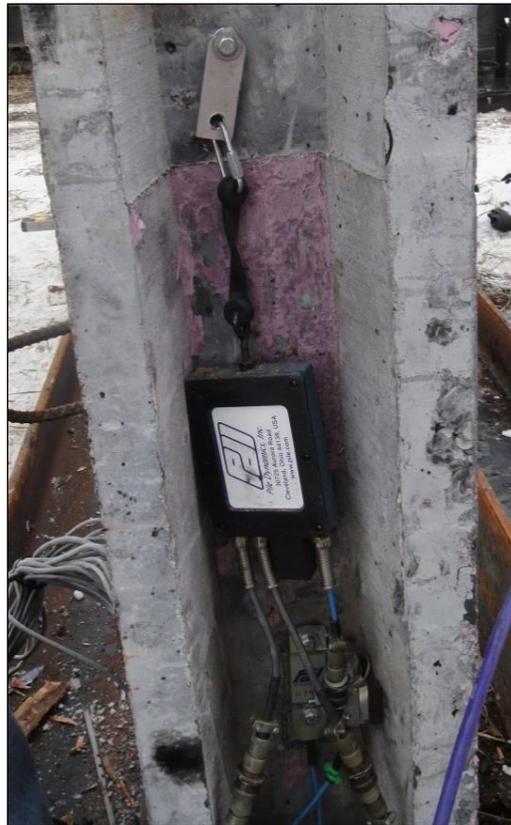
**Figure 6-28. Attached PDA equipment during the installation of P3**

P3 had a maximum measured compressive stress during driving of 5.4 ksi, and the maximum measured tensile stress was 0.2 ksi, which was measured by the PDA equipment attached near the pile head as shown in Figure 6-28.

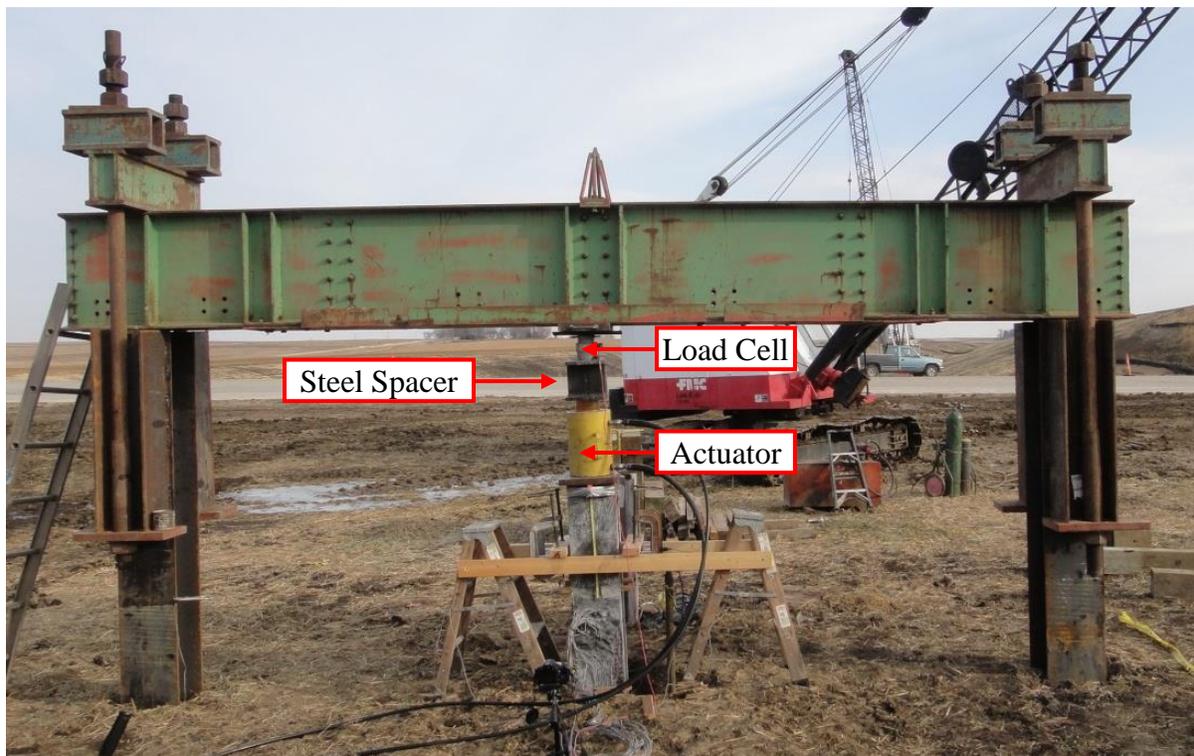
**Figure 6-31. Completed axial load test setup**

After the seven-day restrrike, the top 12 in. was cut off of the anchor piles and two shorter HP 10 × 57 pieces were welded to each of the anchor piles. The main reaction beam was lifted and placed on the protruding flanges of the pile's shorter side pieces. The 3 in. diameter rods were lowered through the holes in the height adjusters and clamping beams and through the spaces between each side pile piece web and each corresponding anchor pile web. Finally, sleeved rod nuts were tightened against the bottom plate directly underneath each side pile piece. The completed load frame is shown in Figure 6-31.

A hydraulic jack was used to apply a vertical load on P3 and imposed an equal and opposite load upward on the main reaction beam. The main reaction beam reacted upward against the clamping beams and transferred to the 3 in. diameter rods on either side of the main reaction beam. The rods reacted against the plates on the bottoms of each side pile piece, and the welds transferred the vertical load from the side pile pieces to the anchor piles and then to the soil. The anchor piles were subjected to axial tension throughout the test.

The load capacity of the test frame was controlled by the friction capacity of the anchor piles. Using a safety factor of two on the capacity of the anchor piles, the maximum load that could be applied to P3 was 340 kips. If the friction capacity of the anchor piles was not exceeded first, the load test frame could be used to apply a load of 680 kips to P3, which would be controlled by the tension capacity of the 3 in. diameter rods.

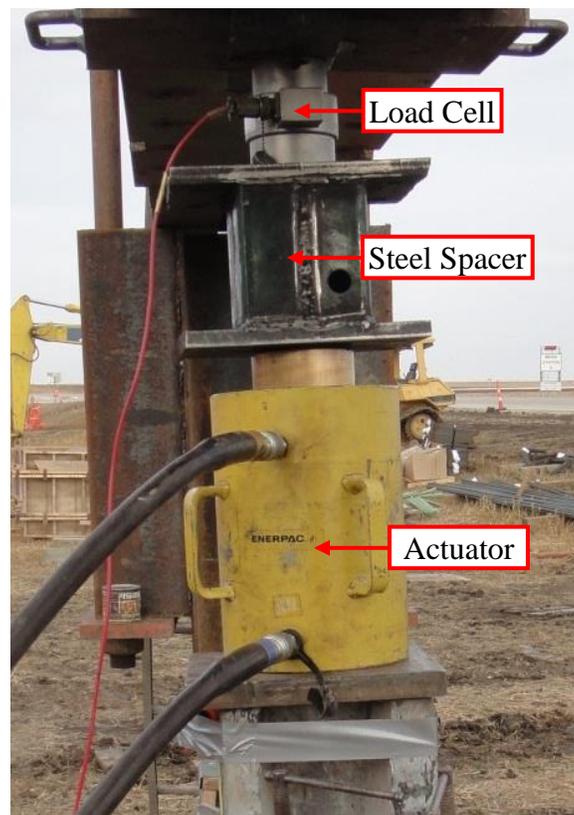
**Figure 6-32. Vertical load testing equipment**

A 200 ton hydraulic jack was used to apply the vertical load on P3, and a 400 kip load cell was used to measure the applied load as shown in Figure 6-32.

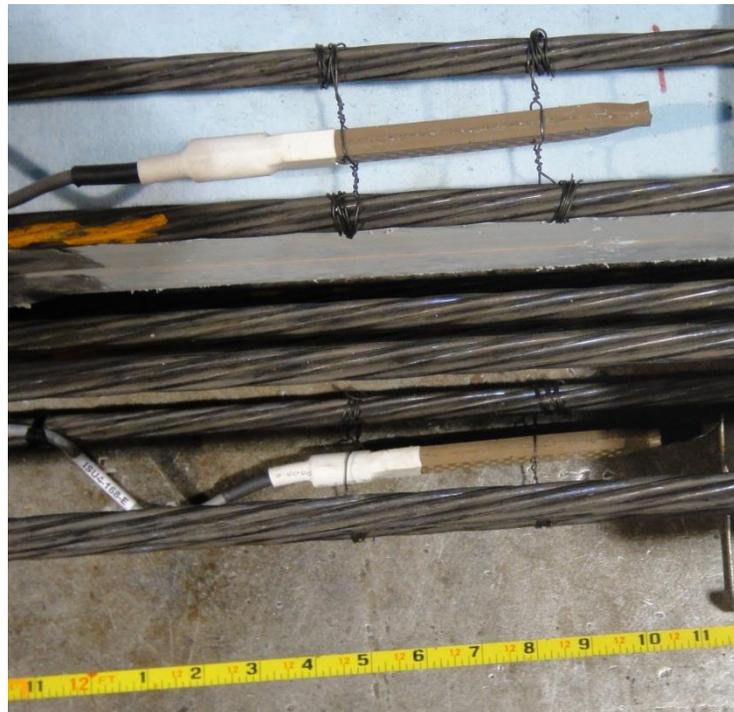
**Figure 6-38. Suspended embedded strain gages**

There are some possible reasons that the load transfer obtained at the ground surface does not match the measured applied load. One such reason could be due to the prefabrication process. The embedded strain gages were hung between two prestressing strands as shown in Figure 6-38.

When UHPC was poured, the gages could have tilted in the y-direction or shifted in the x-direction, causing the gage to be subjected to bending. Also, when the gage shifts the distance from the gage to the neutral axis changes from the specified distance and could be different for every gage.

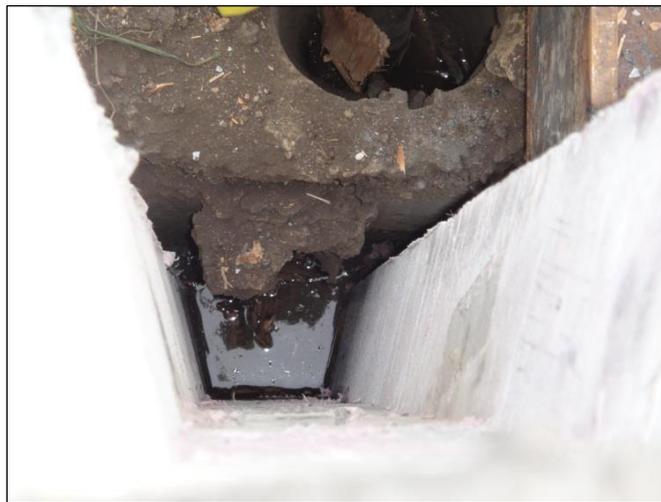
**Figure 6-40. Void that formed from installation of P3**

To install the push-in pressure cells, 4 in. diameter holes were drilled, and the cells were pushed to the specified depth. The depth of one of the push-in pressure cells was 15 ft and the other was 20 ft from the ground surface. The proximity of these cells may have led to a reduction of the skin resistance along the pile, resulting in some eccentricity as a result of the non-uniform forces resisting the vertical load. In addition to the push-in pressure cells, it is worth noting that a void filled with water around P3 was formed due to driving as shown in Figure 6-40.

The depth of the void was measured to be 5 ft deep from the ground surface.

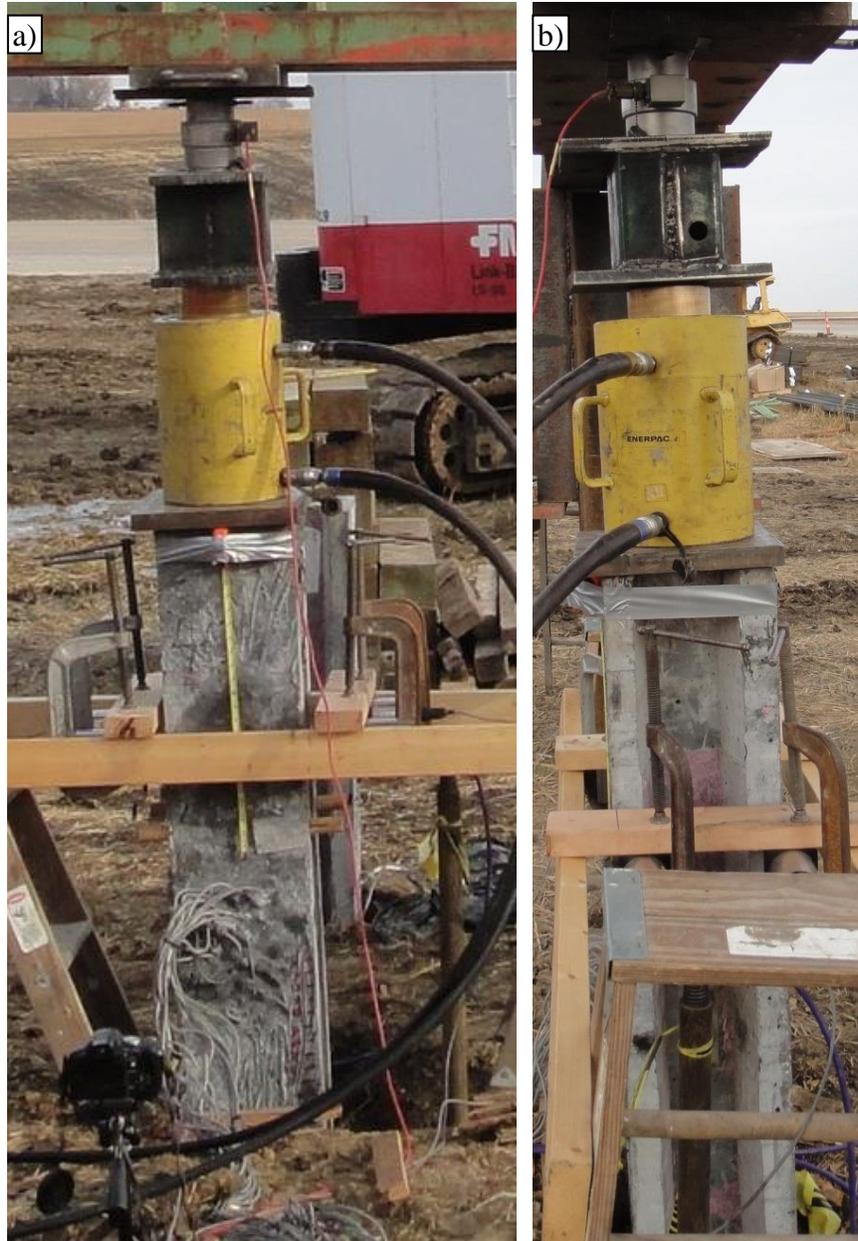
**Figure 6-41. Tilt of P3 after driving in the (a) weak-axis and (b) strong-axis direction**

After the installation was complete, it was noticed that the pile was not installed vertically, but at an angle in both the x-axis and y-axis direction. Figure 6-41a and b show the tilt of P3 in the strong-axis and weak-axis direction, respectively.

There was another issue during testing, which is due to the actuator being not positioned exactly on the center of the pile. This caused the vertical force to be applied with an eccentricity. There was an eccentricity in the x-axis and y-axis directions, which are also shown in Figure 6-41a and b, respectively.

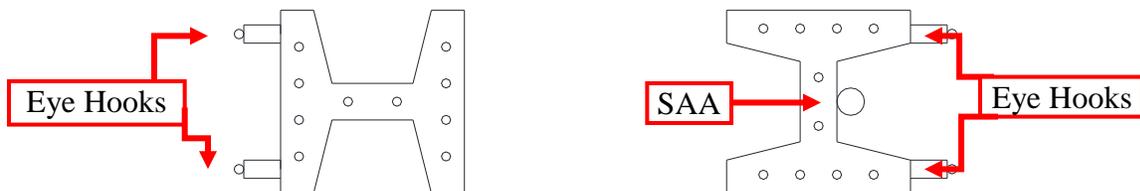
**Figure 6-47. Illustration of eye hook and SAA Instrumentation location**

Test data on the UHPC piles were measured independently from each other as illustrated in Figure 6-47.

A new piece of equipment was purchased to measure the displacement along the length of P4, which is called the SAA. The SAA was inserted into a steel tube that was welded to the embedded plates. The SAA ran along the east side of P4 as illustrated in Figure 6-47 for 20 ft. Three dimensional displacements and rotations were read starting 34.25 in. from the pile head. The x-axis of the SAA was lined up with the lateral force direction.

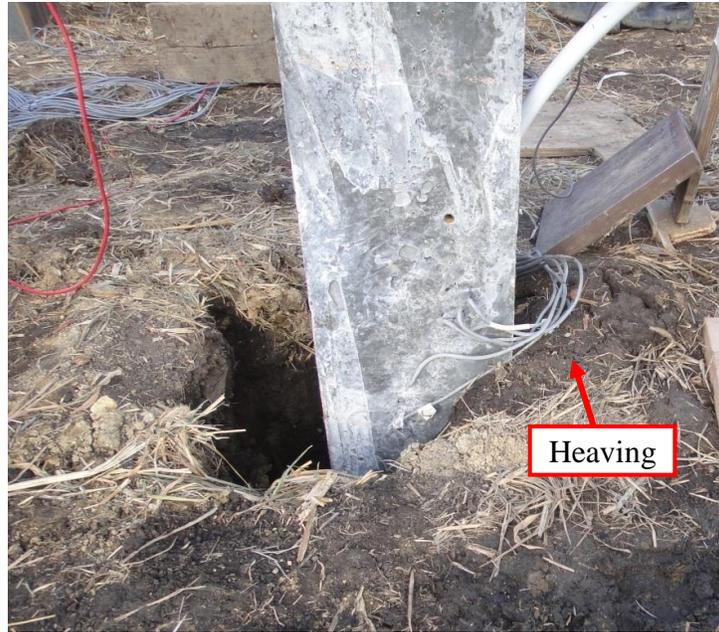
**Figure 6-51. Heaving of soil during lateral load test of P4**

The pile was subjected to a maximum load of 20.6 kips with a corresponding lateral displacement of 8.3 in. during the first cycle. The maximum displacement achieved in the pile was 10 in. of lateral displacement. There was noticeable heaving of the soil on one side of the pile during the test, as shown in Figure 6-51.

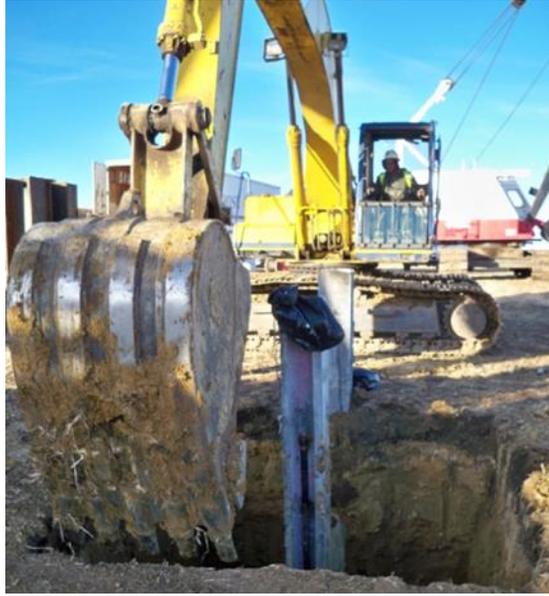
**Figure 6-53. Excavation of soil surrounding P4**

The visual evaluation of the splice performance in P4 during the lateral load test was done by excavating the soil down to the location of the splice as shown in Figure 6-53.

The contractor tried to pull the pile out of the ground using a crane but had to terminate this plan because the crane was starting to tip. As a result, the excavation was completed on January 5, 2012 and only went 12 ft below the ground surface to the location of the splice.

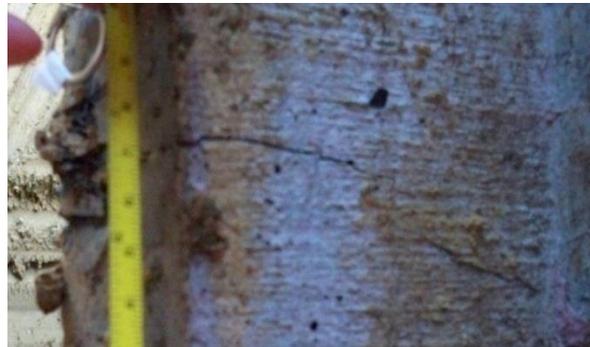
**Figure 6-54. Flexural crack found 9 ft from the ground surface on P4 due to the lateral load test**

A fairly large crack was discovered 9 ft from the pile head on the tension side of P4, which corresponded to the maximum moment location predicted in LPILE as described in Section 6.6.5. Figure 6-54 depicts the crack on the northwest corner of P4. No damage was observed in the splice.

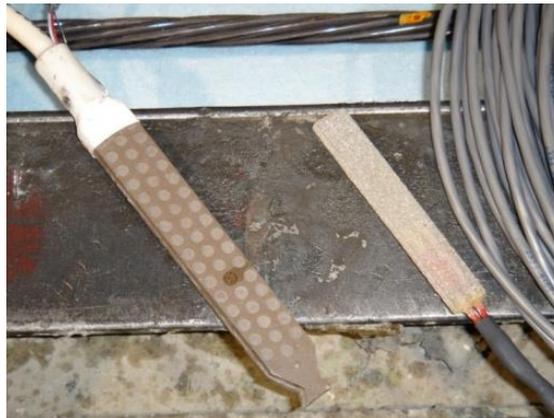
**Figure 7-3. Embedded concrete strain gages for UW1-2**

The instrumentation used for the first UHPC production pile (UW1-1) was the same embedded concrete gages as described in Section 6.2 and shown in Figure 6-1. A second production pile (UW1-2) was needed because UW1-1 was dropped from the crane due to the use of inadequate hook and poor handling in the field and was deemed unusable as a production pile (Section 7.5). Due to the limited amount of time to gather instrumentation for the second production pile (UW1-2), two different types of concrete embedment gages were used along this pile. The two types of gages are shown in Figure 7-3.

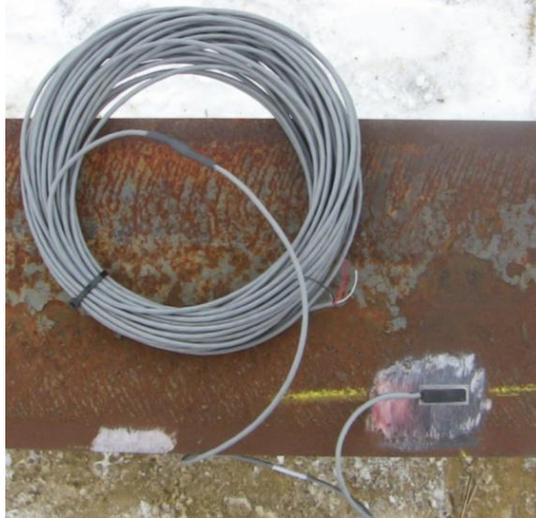
**Figure 7-4. Weldable steel strain gages used to monitor steel HP 10 × 57 production piles**

For the steel piles, weldable strain gages were used as shown in Figure 7-4.

All of the production piles had two gages at each level that were on the diagonal to measure the curvature of the pile during the expansion and contraction of the integral bridge due to thermal movements.

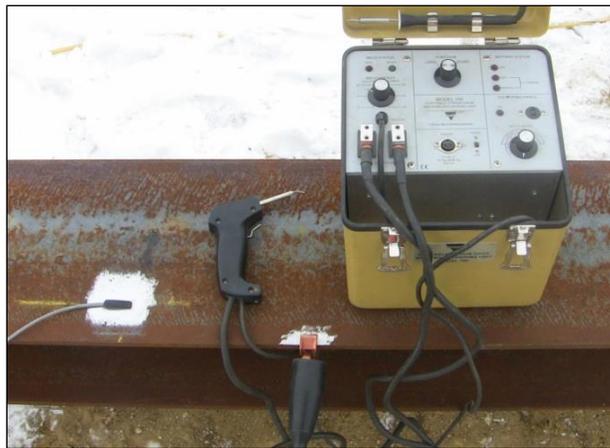
**Figure 7-7. Tack welding machine**

To instrument the steel H-piles, weldable gages were used to measure the strain in the steel along the length of the pile. In order to secure the gages, a tack welder, shown in Figure 7-7, was used for gage installation.

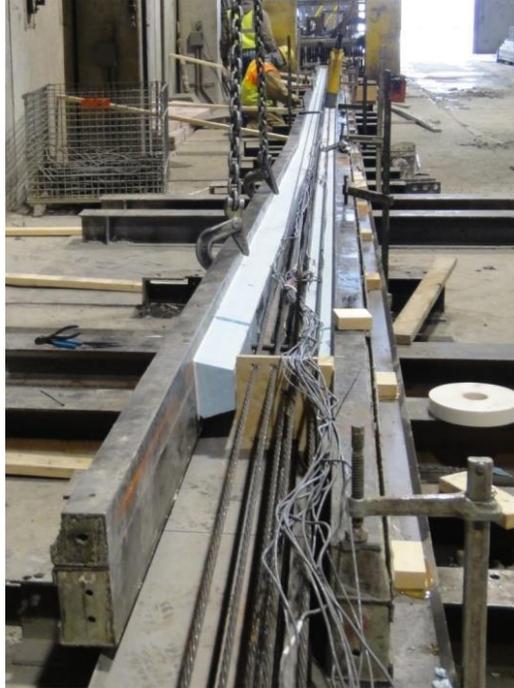
**Figure 7-11. Closing the side forms before casting UW1-2**

The casting process and steam treatment were the same as outlined in Section 6.3 for UW1-2. One side of the steel forms was left off while all 10 prestressing strands were arranged and stressed to their initial prestress of 202.5 ksi. Because the side of the forms was left off, 12 strain gages could be installed along the pile's length. No inserts were added for the PDA equipment since it was just as easy to drill through the UHPC with a 3/8 in. diameter concrete drill. After the instrumentation was complete, the forms were closed as shown in Figure 7-11 by lifting the steel side with the overhead crane and then locked into place.

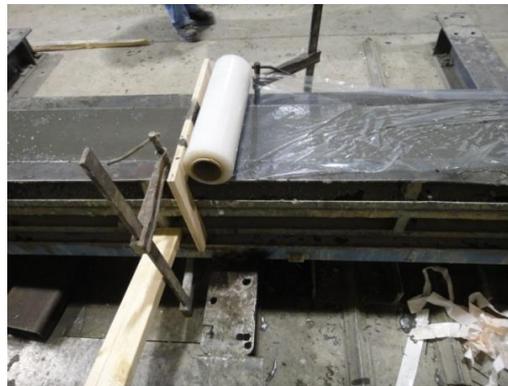
**Figure 7-12. Plastic wrap cover for UW1-2 at the end of casting**

The UHPC was mixed using the precaster's 4.0 yd<sup>3</sup> mixer at the batch plant. A total of 1 yd<sup>3</sup> of Ductal was used for the pour. After completing the batching of the UHPC mix, it was poured into a large bin and transported by a fork lift to the building where the UHPC forms were located. The UHPC was then poured into the forms. Once the pour was complete, the top surface of UW1-2 was covered with plastic wrap to prevent moisture loss as shown in Figure 7-12.

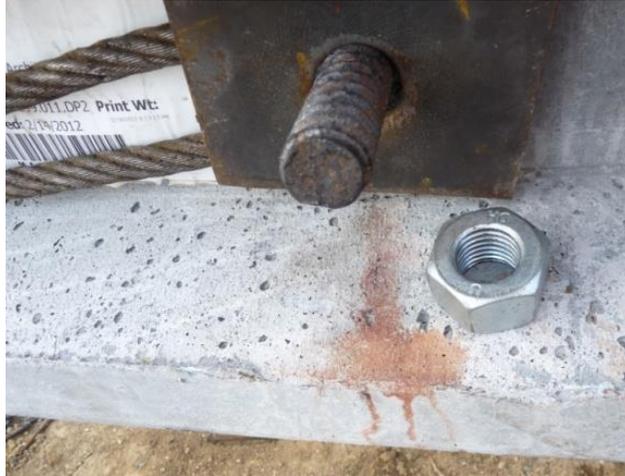
**Figure 7-14. Proposed pickup point**

In order to lift the pile at the construction site, it was initially decided to slip a cable loop over the threaded rod and secure it in place using a washer and a nut as shown in Figure 7-14.

However, this detail could not be constructed at the site because the thread size of the nut was much smaller than that of the threaded rod. Instead, an additional washer was welded to the threaded rod (Figure 7-15) to ensure that the cable loop would not slip off the threaded rod when picking up the pile.

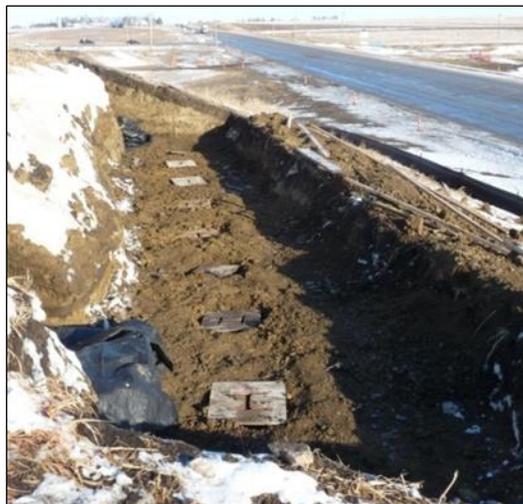
**Figure 7-16. Layout of abutment piles**

The same driving system described in Section 6.4.3 was used to drive the steel HP 10 × 57 piles and UW1-2. Figure 7-16 illustrates the layout of the abutment piles within the abutment.

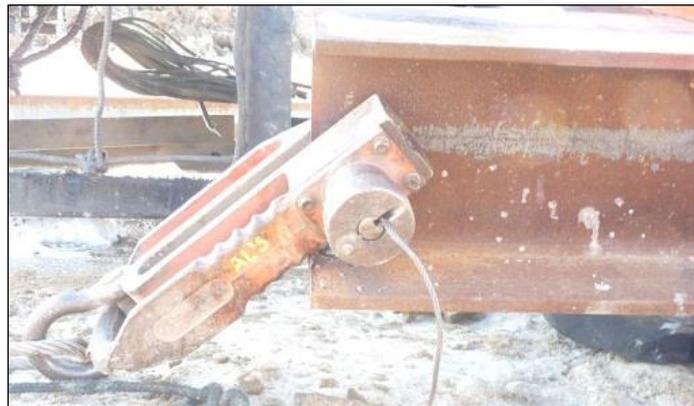
**Figure 7-17. Steel HP 10 × 57 production pile pickup point**

The PDA equipment was bolted to the HP 10 × 57 piles while lying on the ground as described in Section 6.4.5. Once completed, the steel piles were lifted into position using the pickup point shown in Figure 7-17.

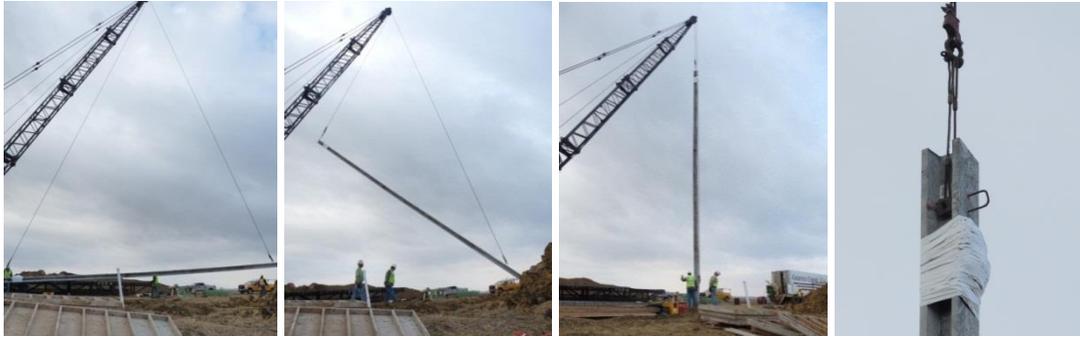
**Figure 7-18. Stages in lifting UW1-2**

The new pickup point designed for UW1-2 worked very well. To reduce the amount of stresses on the UHPC pile, the pile was picked up by the new pickup point at the pile head and the inserted prestressing strand hook at the pile toe. Once the pile was lifted off the ground, the crane operator rotated the pile to the vertical position in the air as shown in Figure 7-18.

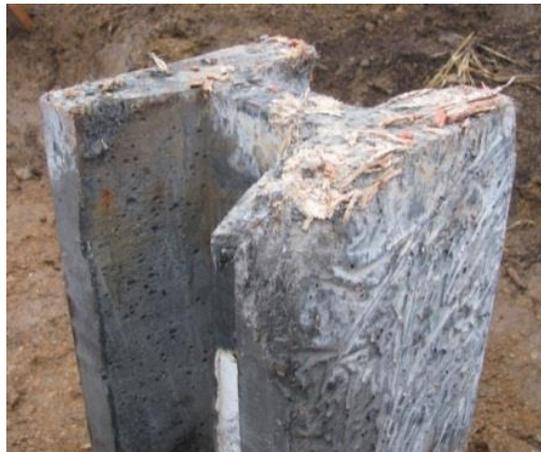
**Figure 7-19. Damage to the pile head of UW1-2**

A 4 in. plywood pile cushion was used to protect the UHPC pile head, but UW1-2 punched through the pile cushion shortly after driving had begun. Instead of replacing the cushion with a new one, the pile was driven with essentially no cushion. There was slight damage to the pile head corners of UW1-2 as shown in Figure 7-19.

The reason for the damage was that the pile head was not perfectly centered under the helmet. It is also important to note that the UW1-2 was slightly tilted after driving and on the back side of the prebored hole as shown in Figure 7-20, which might have reduced the effectiveness of the prebored hole.

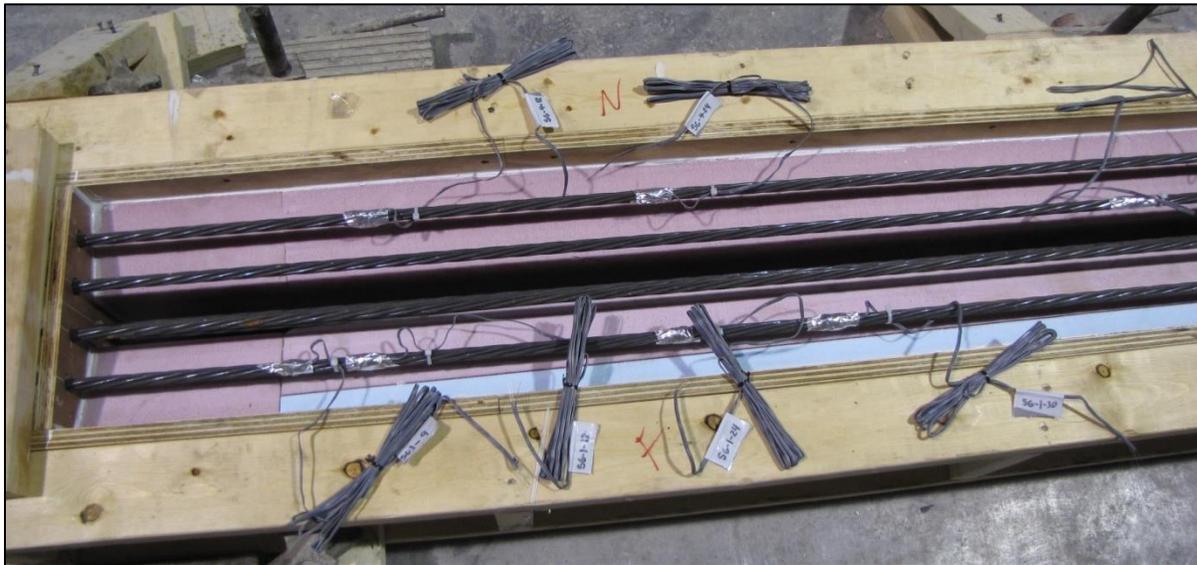
**Figure D-1. TML strain gage after aluminum foil was applied**

4. After curing is complete, remove the polyethylene sheet, and raise the gage leads with a pair of tweezers
5. Protect the gage by covering it with a water proofing agent, followed by Butyl rubber, and finally aluminum tape (See Figure D-1)

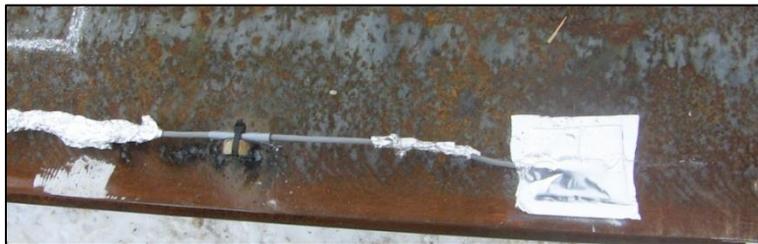
**Figure D-2. Installed weldable strain gage**

15. Wrap the cable with aluminum foil to protect the cables during welding of the protective angle (See Figure D-2)
16. Secure the cables to the nuts welded onto the pile with zip ties

17. Weld the steel angle over the cables 4 in. every 24 in., but adjusting the location of the weld when near the location of a gage
